TEST REPORT

Study of Frost /Dew Cover on Precision Approach Path Indicators (PAPI)

Contract No. 5115

AARME/E-98-13

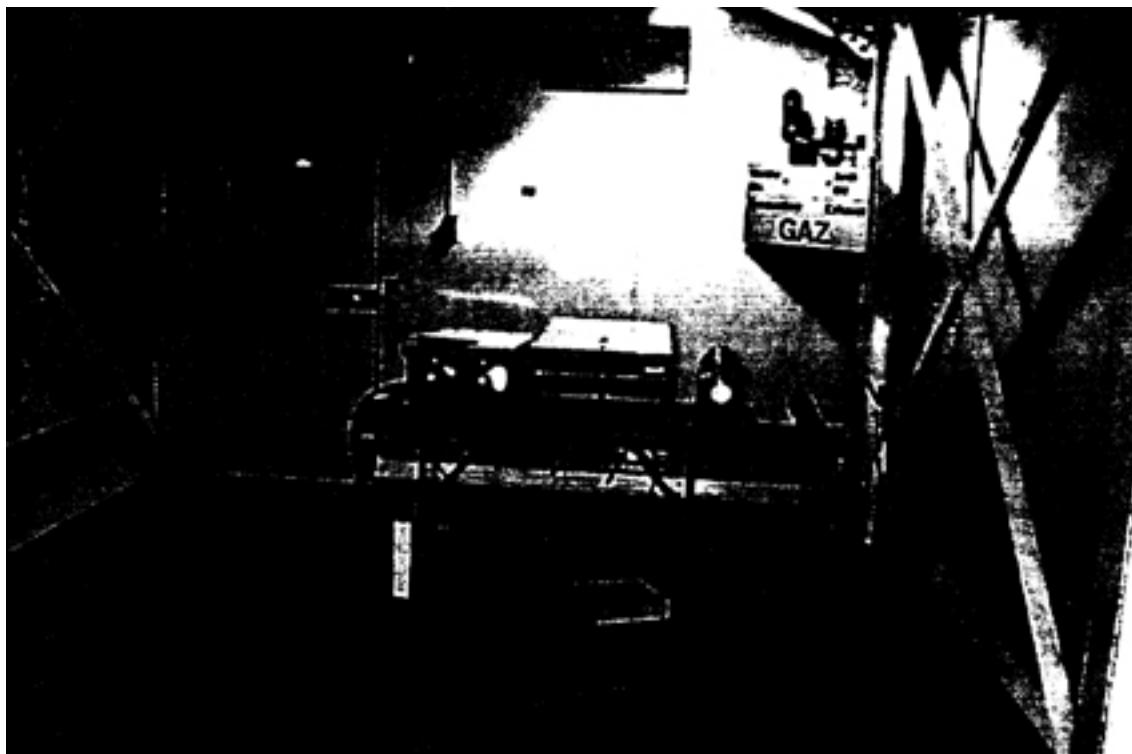
8. Papi installation.

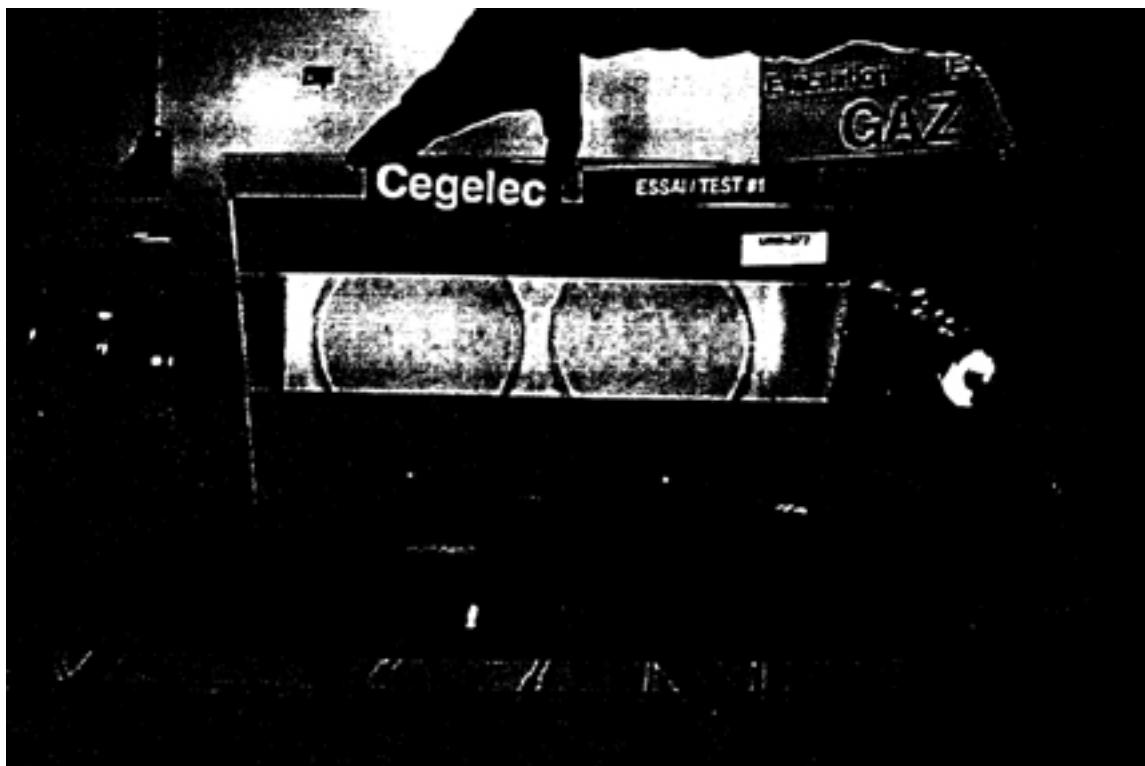
9. Test #1, pre-test.

10. Test #1, post-test.

Test #	PAPI Manufacturer	Cover glass (Yes/No)	Ice Thickness (inch)	RMS Current (Amp)	Defrosting time (min.)
1	Cegelec	No	.060	6.6	24 minutes
2	ADB/Siemens	No	.060	6.6	22 minutes
3	Crouse-Hinds	No	.055	6.6	6 minutes
4	ADB/Siemens	Yes/Wired	.053	6.6	32 minutes
5	ADB/Siemens	Yes/Antifog	.060	6.6	32 minutes
6	ADB/Siemens	Yes/Regular	.060	6.6	32 minutes

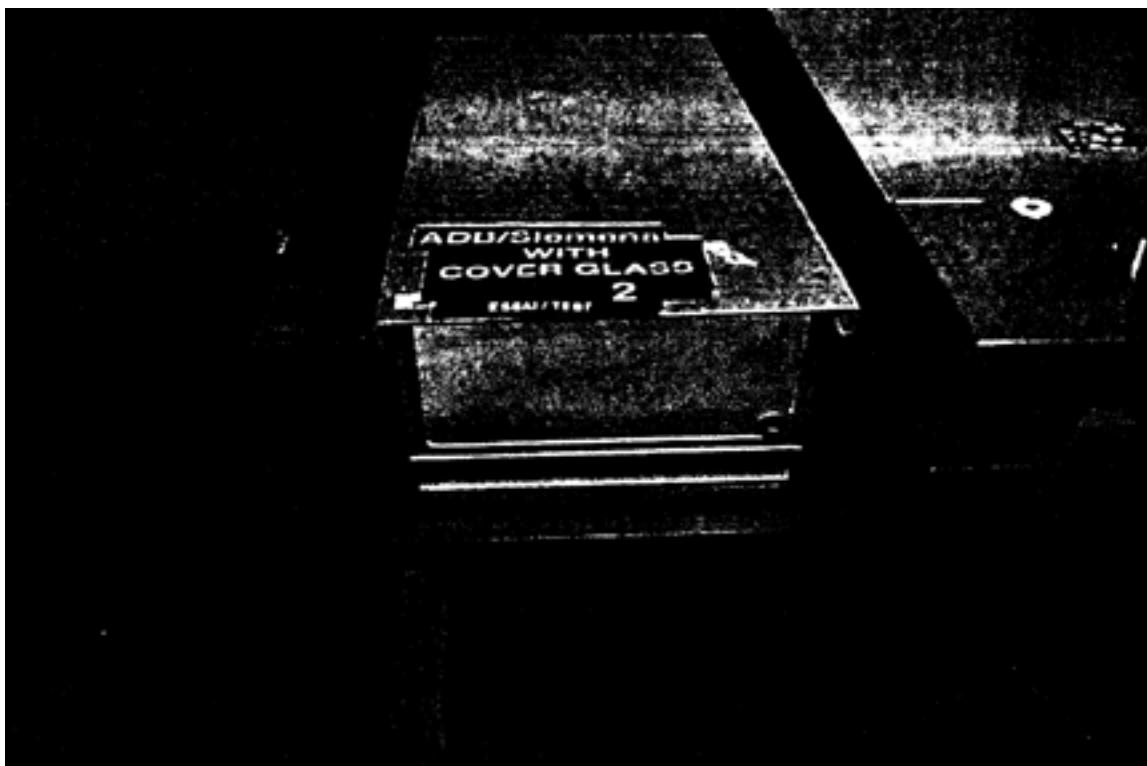
11. Test #2, pre-test.

12. Test #2, post-test.

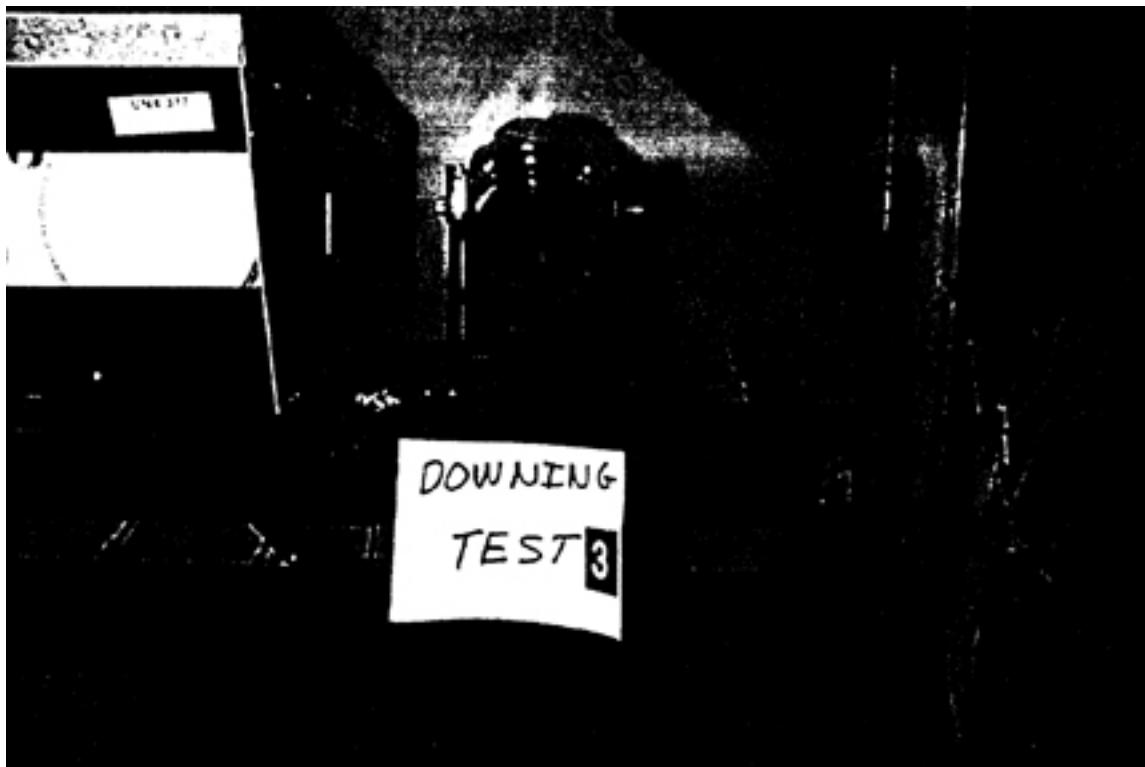
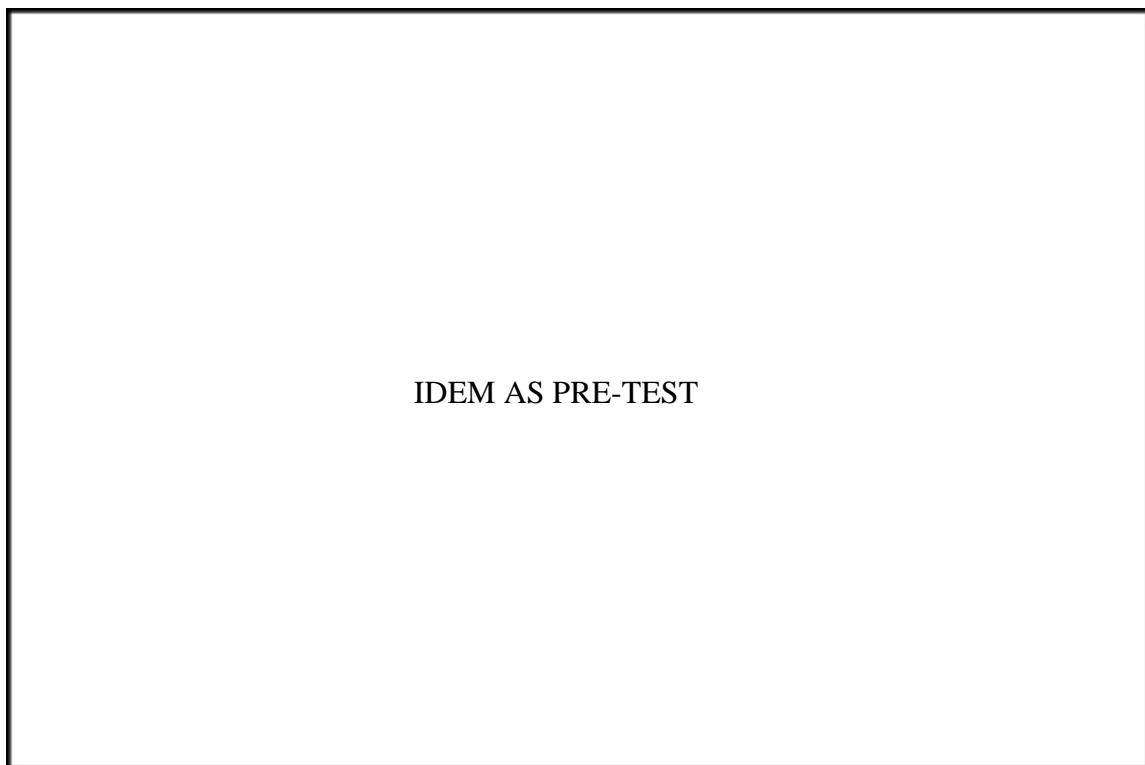
13. Test #3, pre-test.

14. Test #3, post-test.

Temperature PAPI	-5°C	-10°C	-20°C	-30°C
CROUSE-HINDS	Test #3 6 min. Complete defrosting	Test # 30 9.30 min. Complete signal, a little frost on edge.	Test #99 6.5 min. Small donut hole, waterdrops, complete signal. (5113) Test #13 – 8 min.	Test #58 15 min. Light frost on top section.
CEGELEC	Test #1 24 min. Good signal ± 10 min.	Test #28 30 min. Good signal ± 20 min. Donut hole large.	Test #98 19 min. Donut hole, waterdrops, complete signal (5113) Test #1 – 56 min.	Test #57 53.5 min. Light signal ± 10min/ Good signal ± 20min/ Complete ±30 min. Donut hole, poor defrosting of lens
SIEMENS NO GLASS	Test #2 22 min. Total signal with 1 cm of ice around lens on 5cm long (Good signal ± 10 min)	Test #29 26 min. Donut hole – Complete signal.	Test #97 14 min. Donut hole, waterdrops, complete signal. (5113) Test #14 – 30 min.	Test #56 30 min. Donut hole – Signal OK at ± 15 min.
SIEMENS REGULAR	Test #6 32 min. Donut hole – Complete signal around ± 20 min.	Test #33 17 min. Complete signal – Donut hole	Test #94 8 min. Donut hole, water drops, correction, with cover glass, complete signal	Test #59 10.10 min. Donut hole, complete signal.

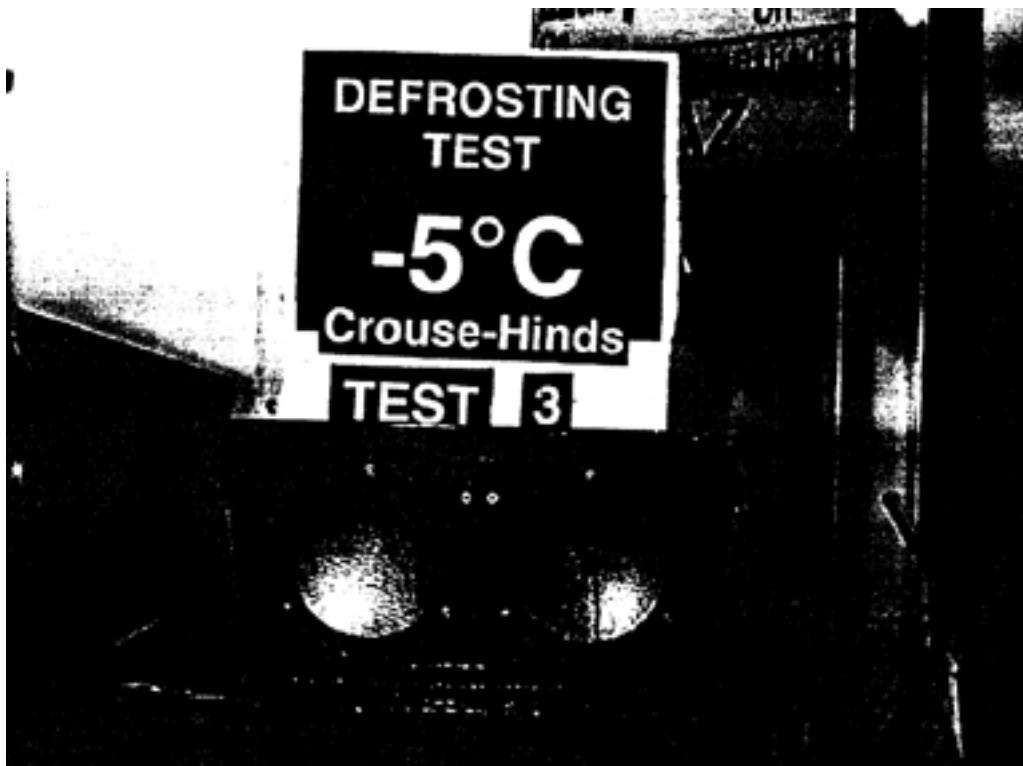
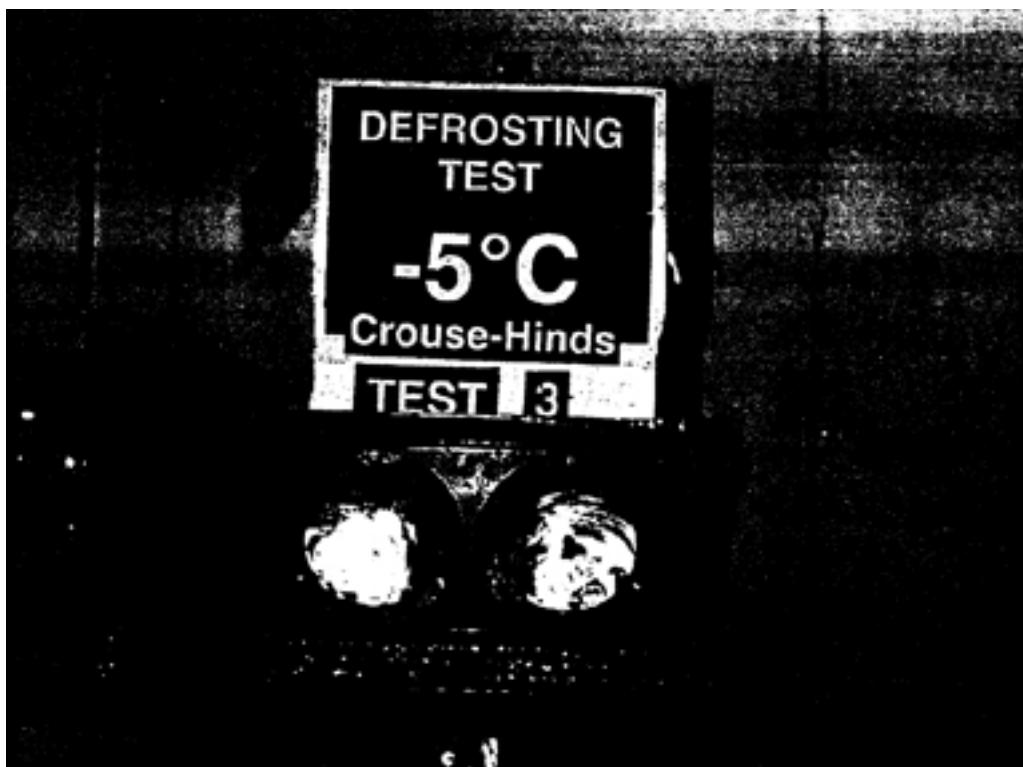
5. Test #3, pre-test.

6. Test #3, post-test.

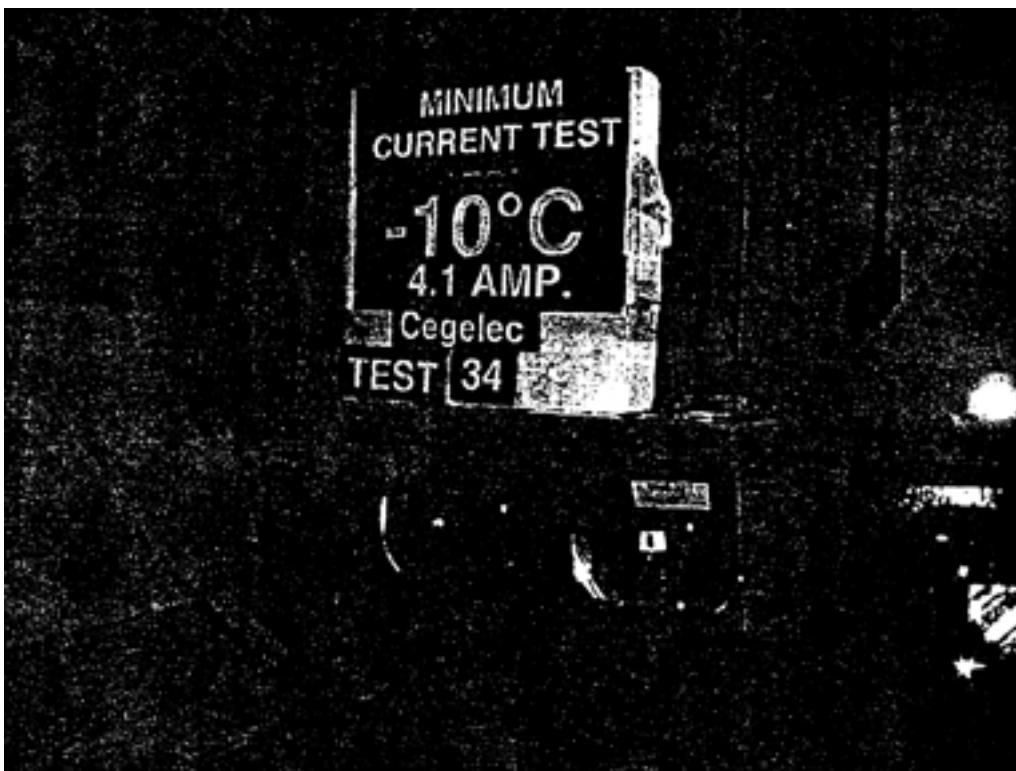
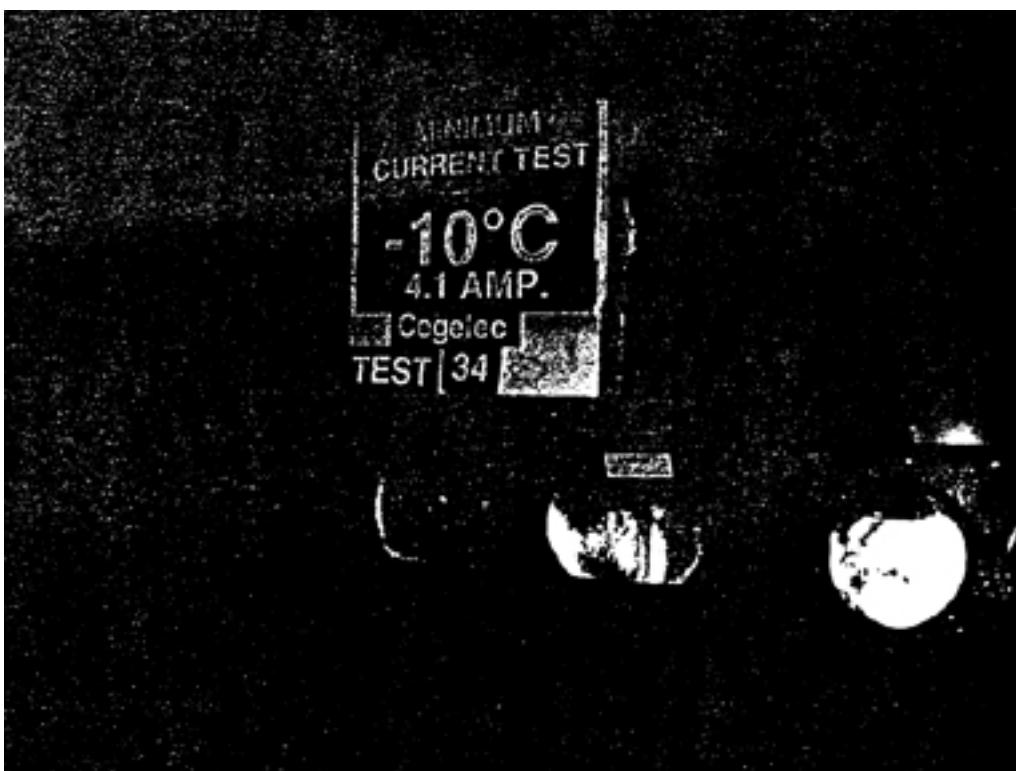
13. Test #34, pre-test.

14. Test #34, post-test.

Test #	PAPI Manufacturer	Cover glass (Yes/No)	RMS Current (Amp)	Lens/glass Temperature (°C)	Accumulation of frost (Yes/No)
34	Cegelec	No	4.1	19.6	Yes
35	ADB/Siemens	Yes/Regular	4.1	21.3	Yes
36	ADB/Siemens	Yes/Regular	5.2	47.8	Yes
37	ADB/Siemens	Yes/Regular	6.6	94.5	No
38	ADB/Siemens	Yes/Antifog	4.1	28.5	Yes
39	ADB/Siemens	Yes/Antifog	5.2	61.3	Yes
40	ADB/Siemens	Yes/Antifog	6.6	116.9	No
41	ADB/Siemens	Yes/Wired	4.1	23.6	Yes
42	ADB/Siemens	Yes/Wired	4.8	44.4	Yes (donut)
43	ADB/Siemens	Yes/Wired	5.2	56.4	Yes small donut
44	ADB/Siemens	Yes/Wired	5.5	66.3	Yes light frost
45	ADB/Siemens	Yes/Wired	6.6	102.3	No
46	ADB/Siemens	No Glass	4.1	12.3	Yes total frost
47	ADB/Siemens	No Glass	4.8	26.3	Yes total frost
48	ADB/Siemens	No Glass	5.2	36.6	Yes donut signal partial
49	ADB/Siemens	No Glass	5.5	43.7	Yes + glass donut
50	ADB/Siemens	No Glass	6.6	78.5	No
51	Cegelec	No	4.8	38.2	Yes donut
52	Cegelec	No	5.2	51.5	No small 5 mm around

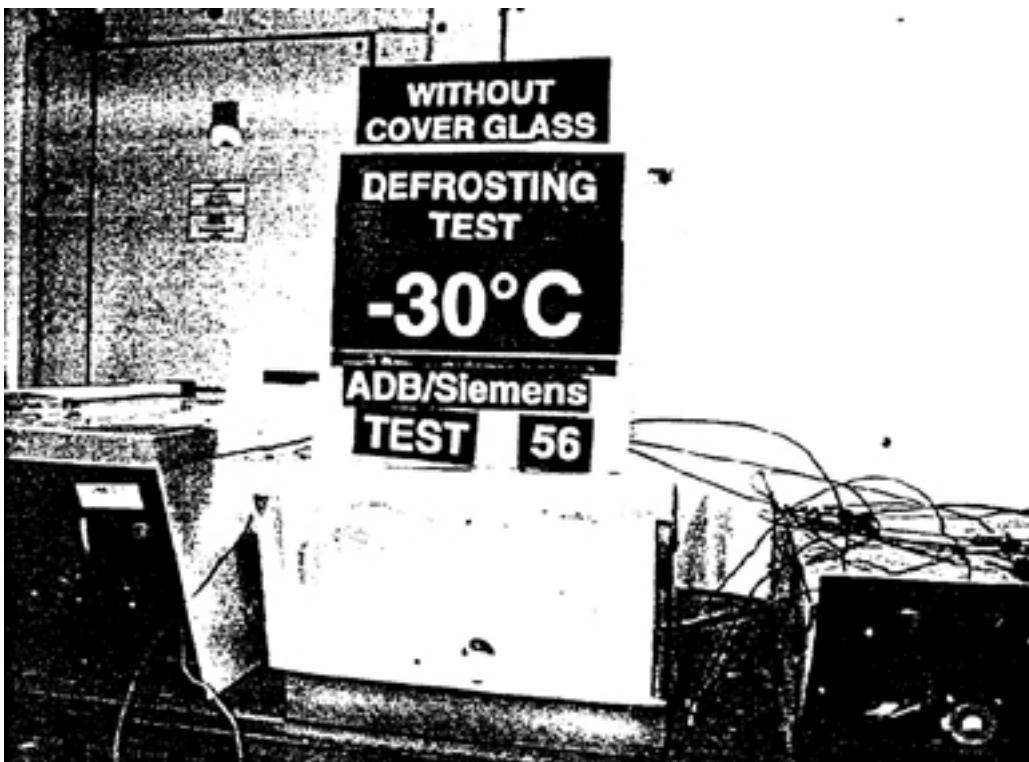
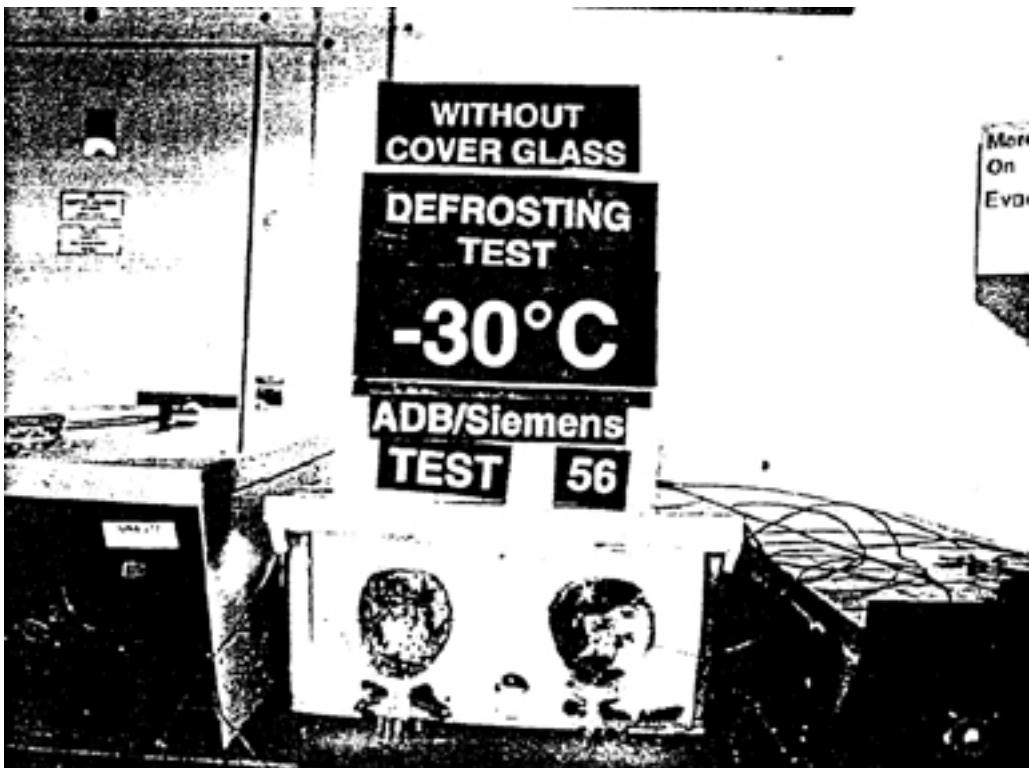
1. Test #56, pre-test.

2. Test #56, post-test.

Test #	PAPI Manufacturer	Cover glass (Yes/No)	Ice Thickness (inch)	RMS Current (Amp)	Defrosting time (min.)
56	ADB/Siemens	No	.070	6.6	30 minutes/ uneven icing
57	Cegelec	No	.070	6.6	53.5 minutes
58	Crouse-Hinds	No	.065	6.6	15 min./ light icing at the top
59	ADB/Siemens	Yes/Regular	.066	6.6	10 min/10 sec. (donut)
60	ADB/Siemens	Yes/Wired	.068	6.6	8 min/40 sec. (donut)
61	ADB/Siemens	Yes/Antifog	.070	6.6	9 min/35 sec.

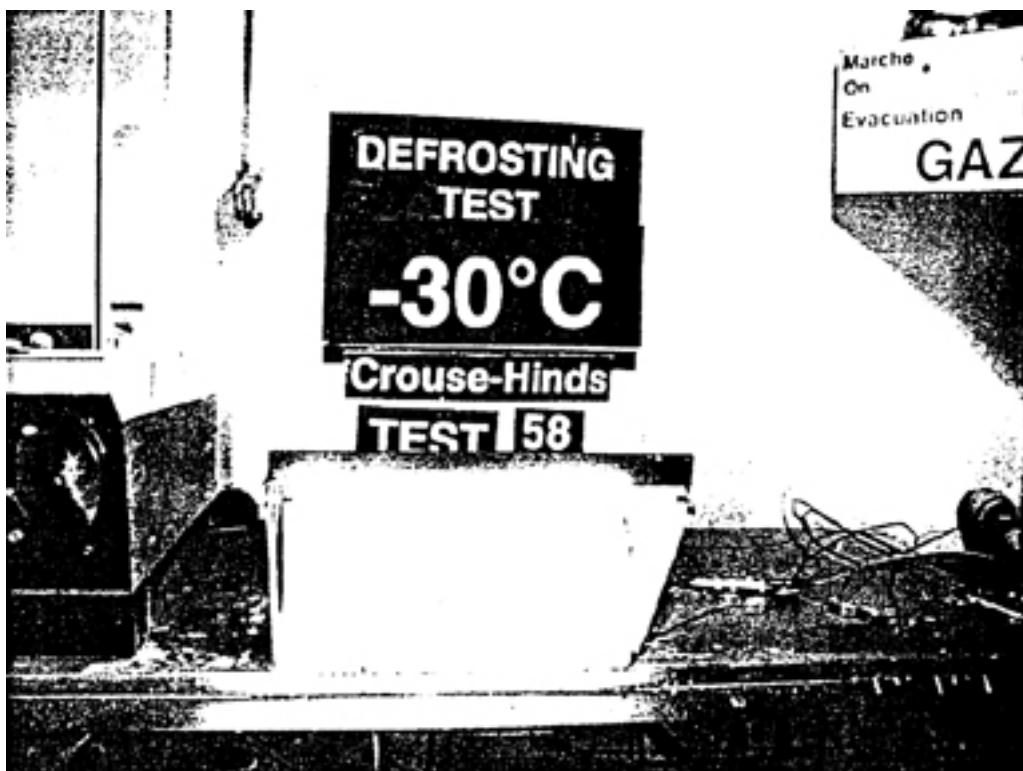
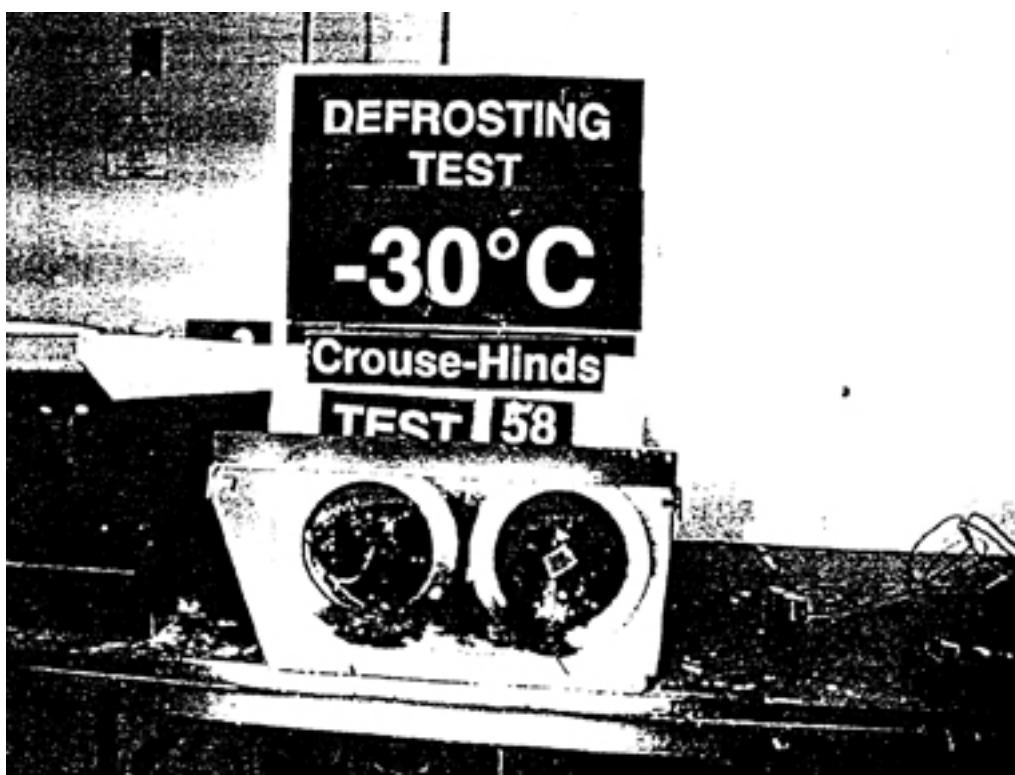
5. Test #58, pre-test.

6. Test #58, post-test.

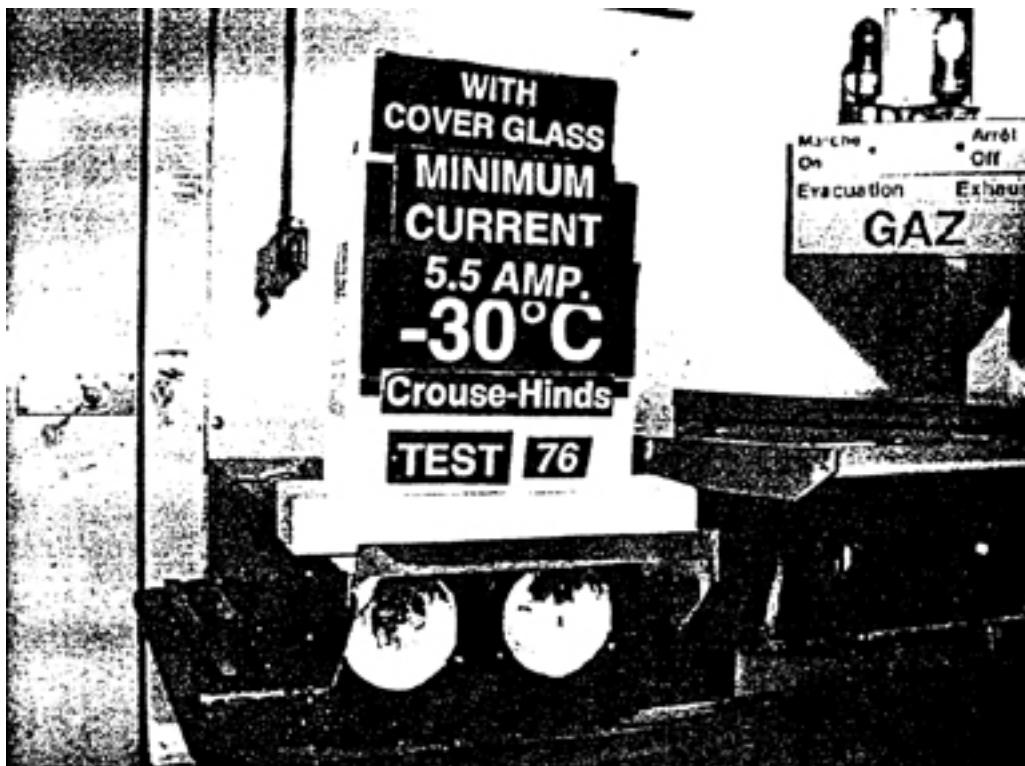
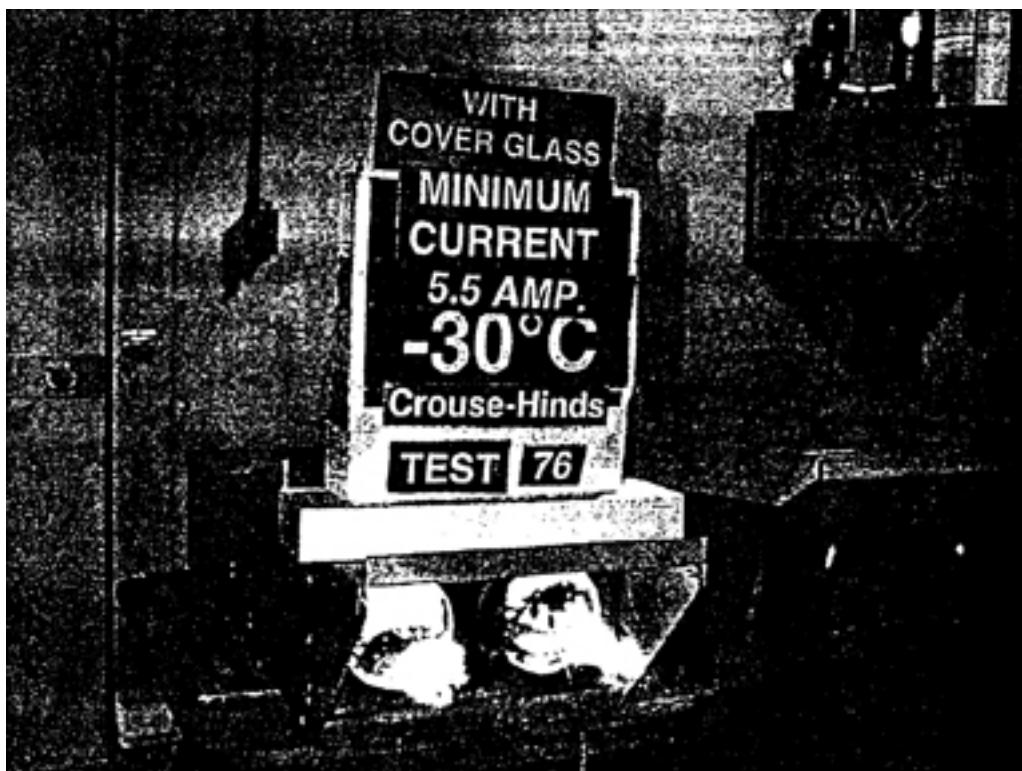
13. Test #76, pre-test.

14. Test #76, post-test.

Test #	PAPI Manufacturer	Cover glass (Yes/No)	RMS Current (Amp)	Lens/glass Temperature (°C)	Accumulation of frost (Yes/No)
62	ADB/Siemens	No	5.5	35.1	Yes
63	ADB/Siemens	No	6.6	59.6	Yes
64	ADB/Siemens	Yes/Antifog	5.5	63.5	Yes
65	ADB/Siemens	Yes/Antifog	6.6	101.3	Yes (donut)
66	ADB/Siemens	Yes/Regular	5.5	50.8	Yes
67	ADB/Siemens	Yes/Regular	6.6	94.0	Yes (donut)
68	ADB/Siemens	Yes/Wired	5.5	53.9	Yes (donut)
69	ADB/Siemens	Yes/Wired	6.6	106.1	Yes (donut)
70	Cegelec	No	5.2	31.5	Yes
71	Cegelec	No	5.5	29.2	Yes
72	Cegelec	No	6.6	61.2	Yes
73	Crouse-Hinds	No	4.1	-3.9	Low temperature
74	Crouse-Hinds	No	4.8	10.5	Yes
75	Crouse-Hinds	No	5.2	22.4	Yes
76	Crouse-Hinds	No	5.5	32.1	Yes
77	Crouse-Hinds	No	6.6	63.9	No

Temperature	PAPI	-5°C	-10°C	-20°C	-30°C
CROUSE-HINDS		Test #23 2.8 Amps Complete frosting 2.8 no melting 1.4°C	Test #53 3.4 Amps Complete frosting no melting 2.2°C	Test #15 (5113) 4.1 Amps No. ref. 8.1°C	Test #76 5.5 Amps Complete frosting and defrosting 32.1°C
CEGELEC		Test #25 3.4 Amps Light frost melting 11.4°C	Test #57 4.8 Amps Low signal ± 10min/ good signal ± 20min/ complete ± 30 min Donut hole, poor defrosting of lens. 38.2°C	Test #90 5.2 Amps Small donut, low signal 29.9°C	Test #72 6.6 Amps Donut hole, low signal 61.2°C
SIEMENS NO GLASS		Test #20 3.4 Amps Yes slowly 6.4°C	Test #48 5.2 Amps Yes, donut hole, partial signal 36.6°C	Test #19 5.2 Amps Yes slowly 17.0°C	Test #63 6.6 Amps Yes complete frosting No melting 59.6°C
SIEMENS REGULAR		Test #8 3.4 Amps Donut hole, defrosting 16.3°C	Test #35 4.1 Amps Donut hole 21.3°C	Test #84 5.5 Amps Yes, donut hole with water drops, low signal 58.4°C	Test #67 6.6 Amps Donut hole, water drops 94.0°C

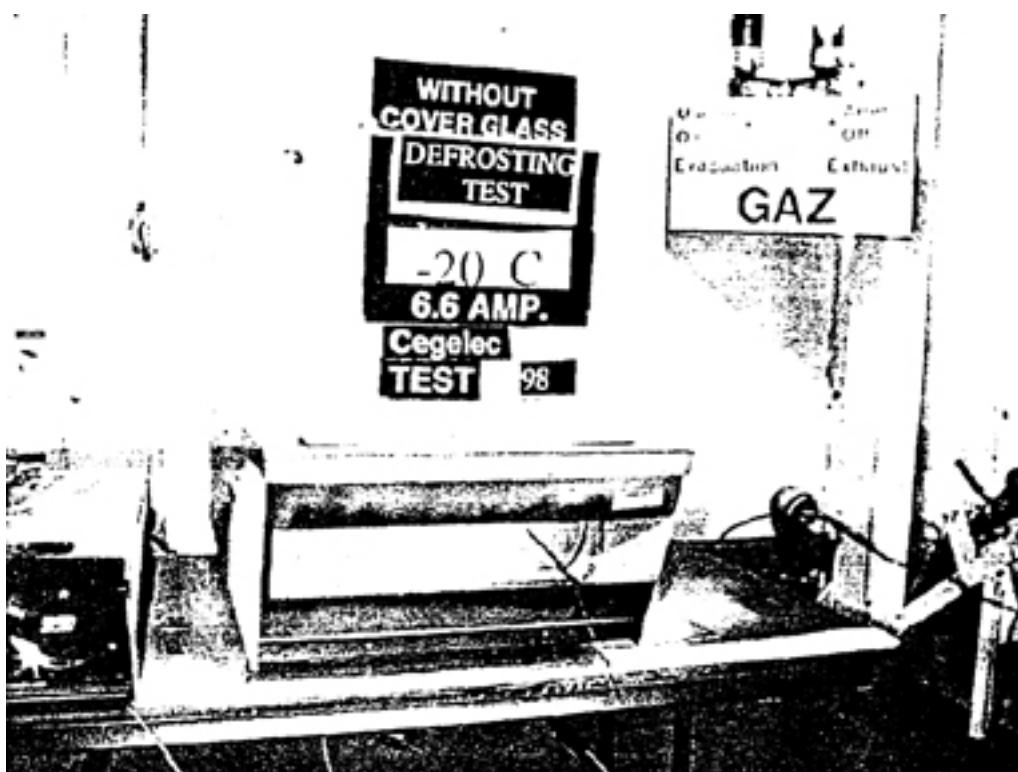
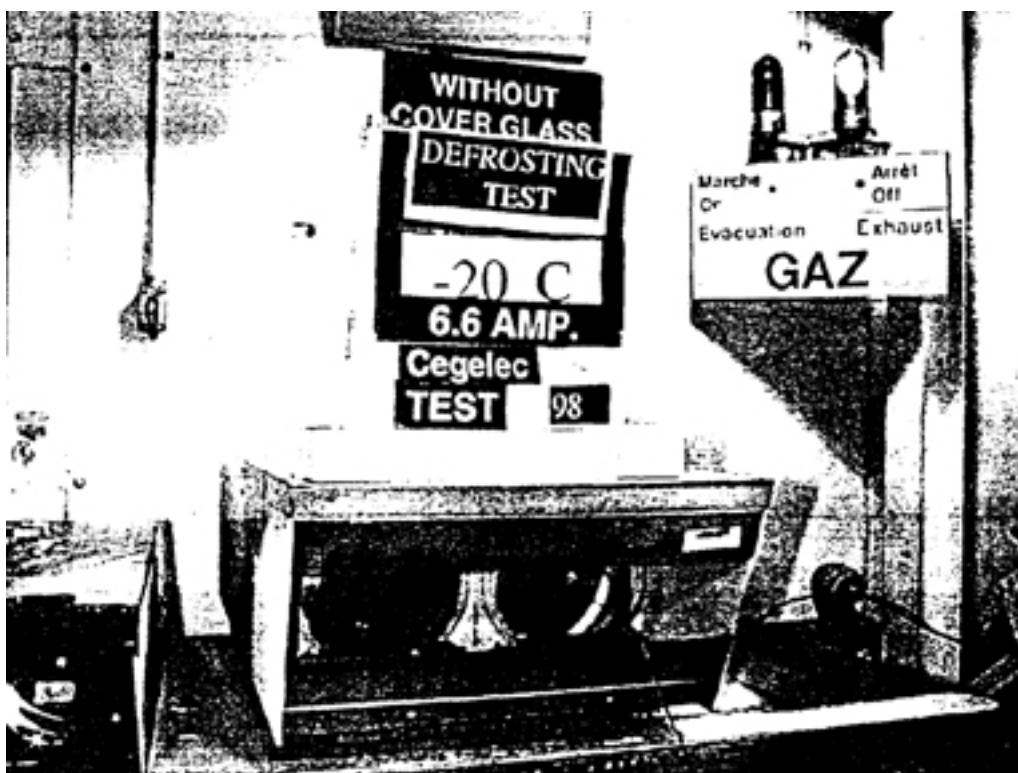
29. Test #98, pre-test.

30. Test #98, post-test.

Test #	PAPI Manufacturer	Cover glass (Yes/No)	Ice Thickness (inch)	RMS Current (Amp)	Defrosting time (min.)
94	ADB/Siemens	Yes/Regular	.070	6.6	8 minutes
95	ADB/Siemens	Yes/Wired	.080	6.6	5 minutes
96	ADB/Siemens	Yes/Antifog	.075	6.6	7 minutes
97	ADB/Siemens	No/Glass	.065	6.6	14 minutes
98	Cegelec	No	.060	6.6	19 minutes
99	Crouse-Hind	No	.065	6.6	6.5 minutes

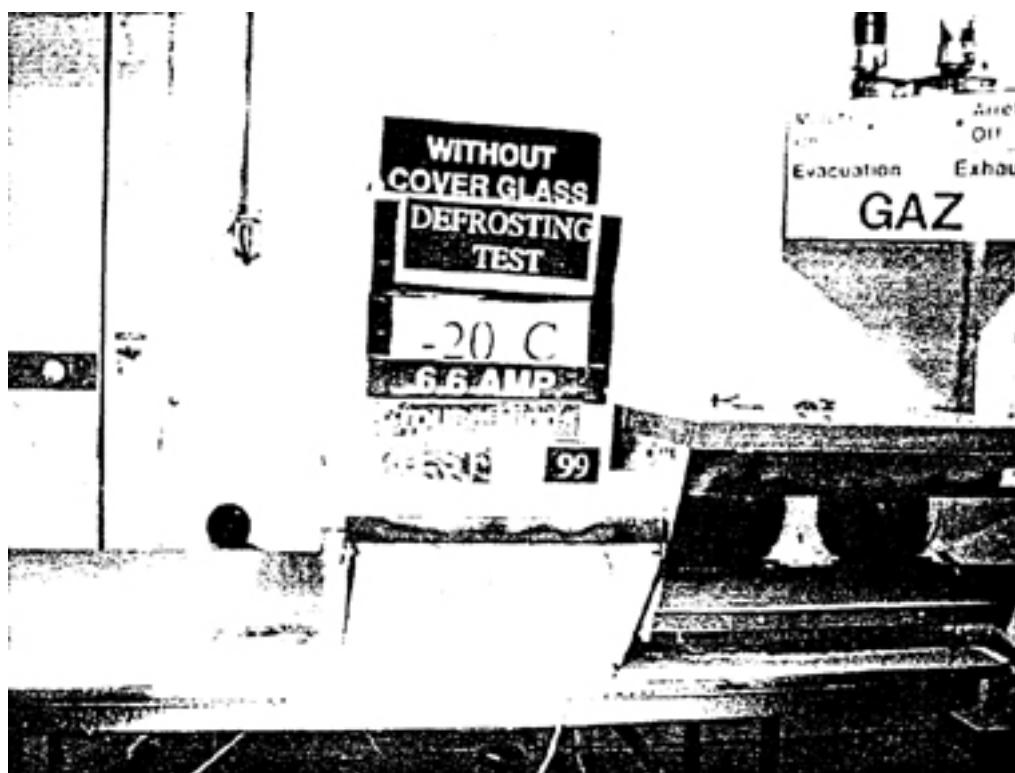
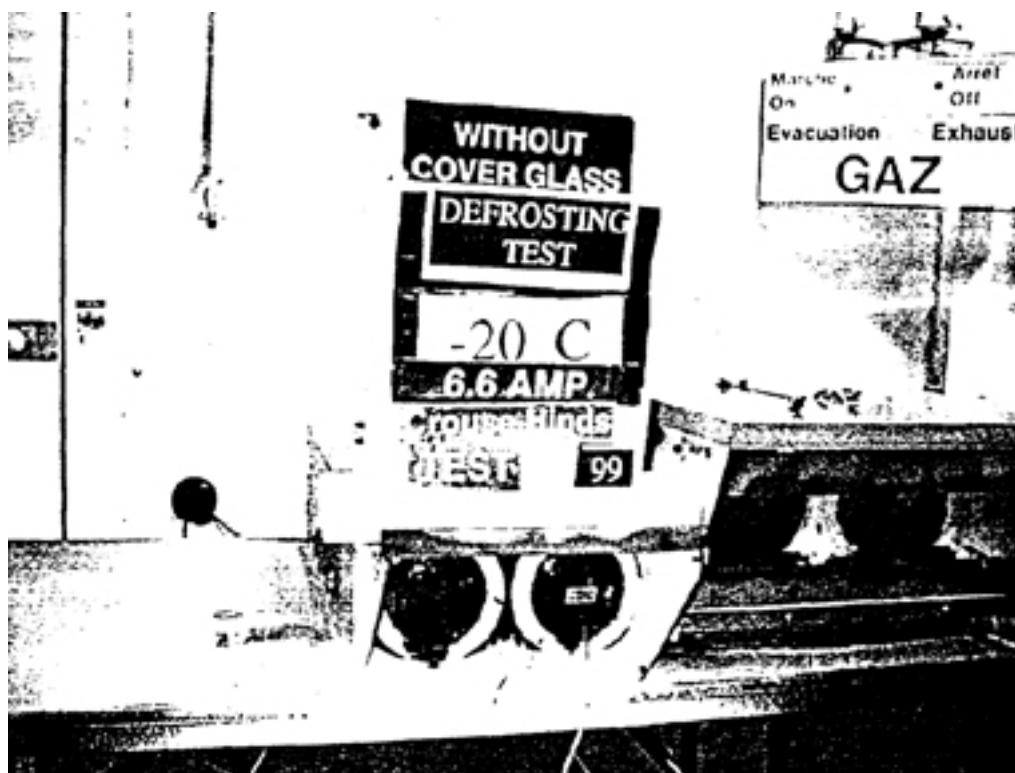
31. Test #99, pre-test.

32. Test #99, post-test.
