Compendium of Monitoring Activities at Disposal at Sea Sites in 2003-2004.

Disposal at Sea Program
Marine Environment Branch
National Programs Directorate
Environmental Protection Service
Environment Canada

June 2005

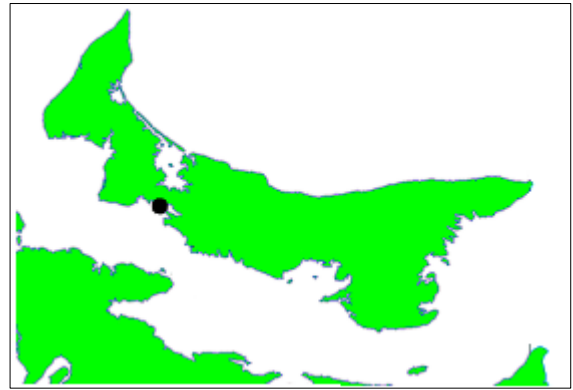
Figure 1. Location of Summerside

Summerside harbour is located on the south-western shore of Prince Edward Island, adjacent to the Northumberland Strait (See Figure 1).

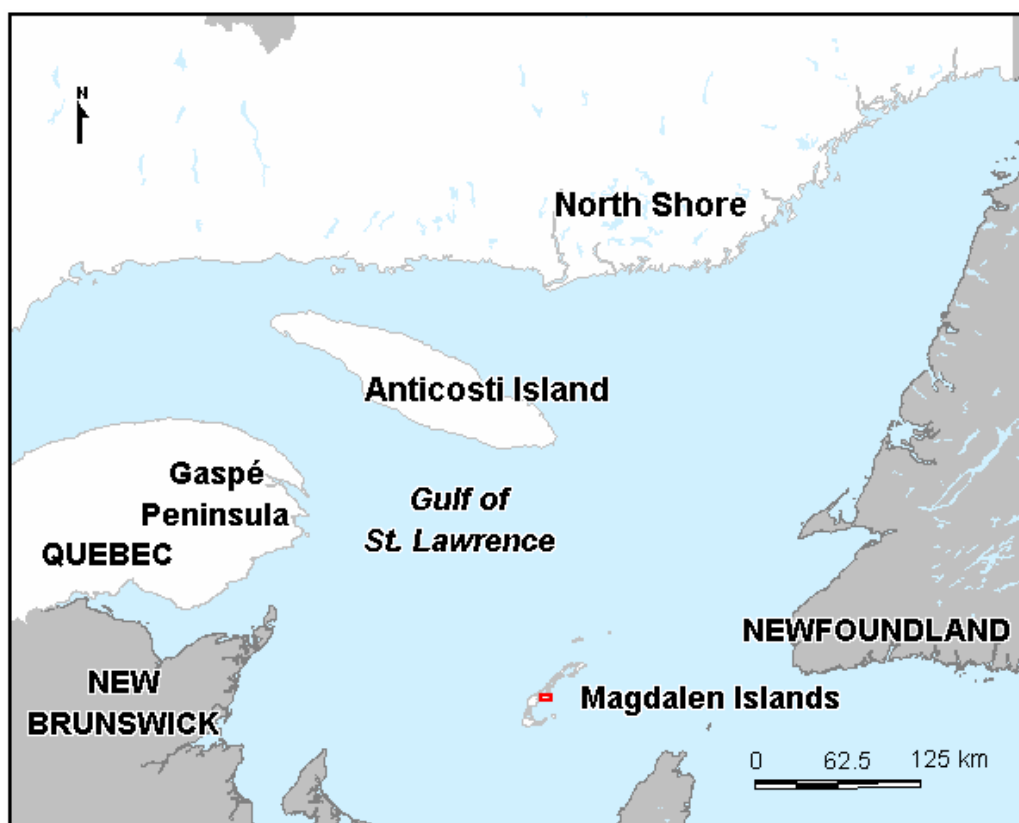
Figure 13. Location of the study area

In August 2001, bathymetric surveys were conducted at site PB-8 at Pointe-Basse. The surveys were conducted using a CHS vessel equipped with a SIMRAD EM-3000 multibeam system and various other equipment, including a DGPS. In addition to bathymetric data, this system was used to obtain acoustic reflectivity data and images of the ocean floor relief. With these two types of data, it was possible in most cases to accurately locate and delineate the sediment mounds at site PB-8 (Figure 14 and Figure 9 in the previous section).

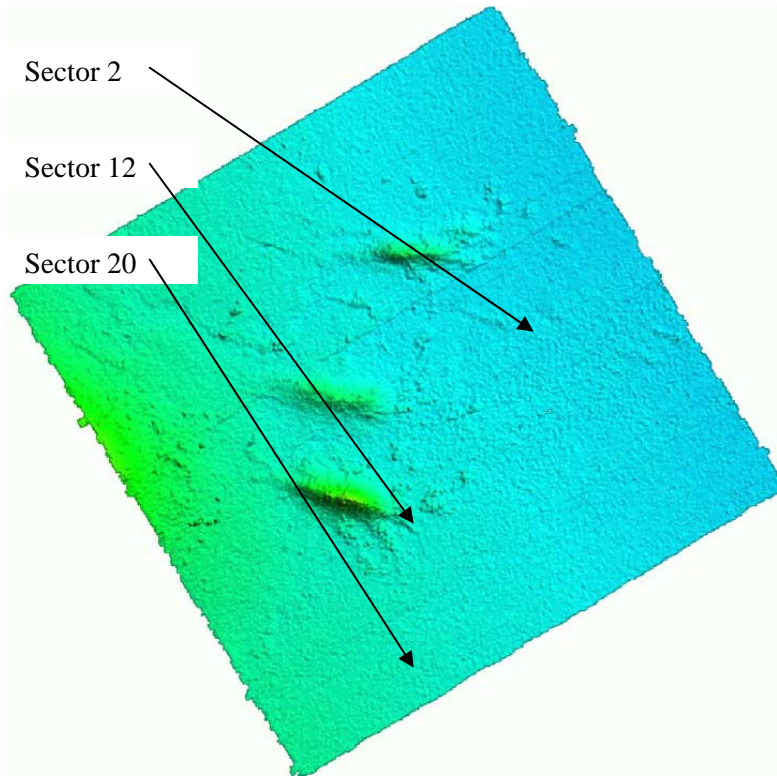
Multi beam sonar surveys were carried out in 2001 and 2002 and are reported in this report as data was not available for previous monitoring compendia. Comparison of these sonar surveys (Figures 16 and 17) revealed a shift of about 0.5 m on average between the two surveys with the majority of the losses occurring in sector 20 which was the steepest of the 3 piles. This shift is likely due to settling and slumping of the spoil piles and minor transport of material. The comparison showed widespread deposition of minor amounts of material within the disposal site. The maximum change noted by the sonar was -2.6 m to + 0.8 m, however, analysis revealed that these large changes in elevation were limited to the area around the ice scour noted in Figure 17. There was no evidence of large scale offsite transport of material.

Figure 16. 2002 multi beam sonar image of the disposal site. 3 distinct piles of spoil can be seen in locations corresponding to disposal site sectors #2, 12 and 20

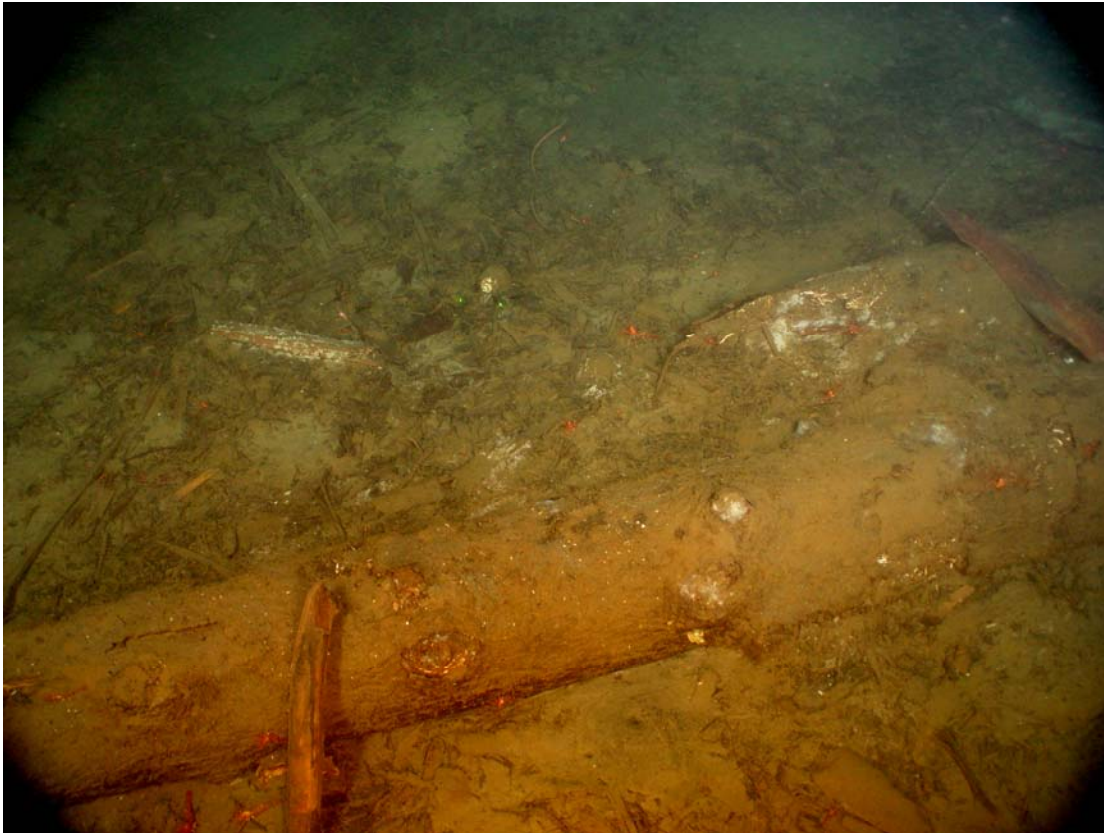
Figure 18. Image of the seafloor at Five Finger Island Disposal Site, October 2003.

record conditions (i.e. biological and geophysical changes and any currents related effects) of the disposal site and the surrounding area and are being processed. Still digital camera images and Interactive-Realtime-Logging images were are collected and are being processed.
