Dissolved Gas Supersaturation Monitoring At Three Hydroelectric Generating Facilities in the Yukon, Canada, in August of 1997 and 1998

B. L. Antcliffe and A. von Finster

**Canadian Technical Report of
Fisheries and Aquatic Sciences 2275**

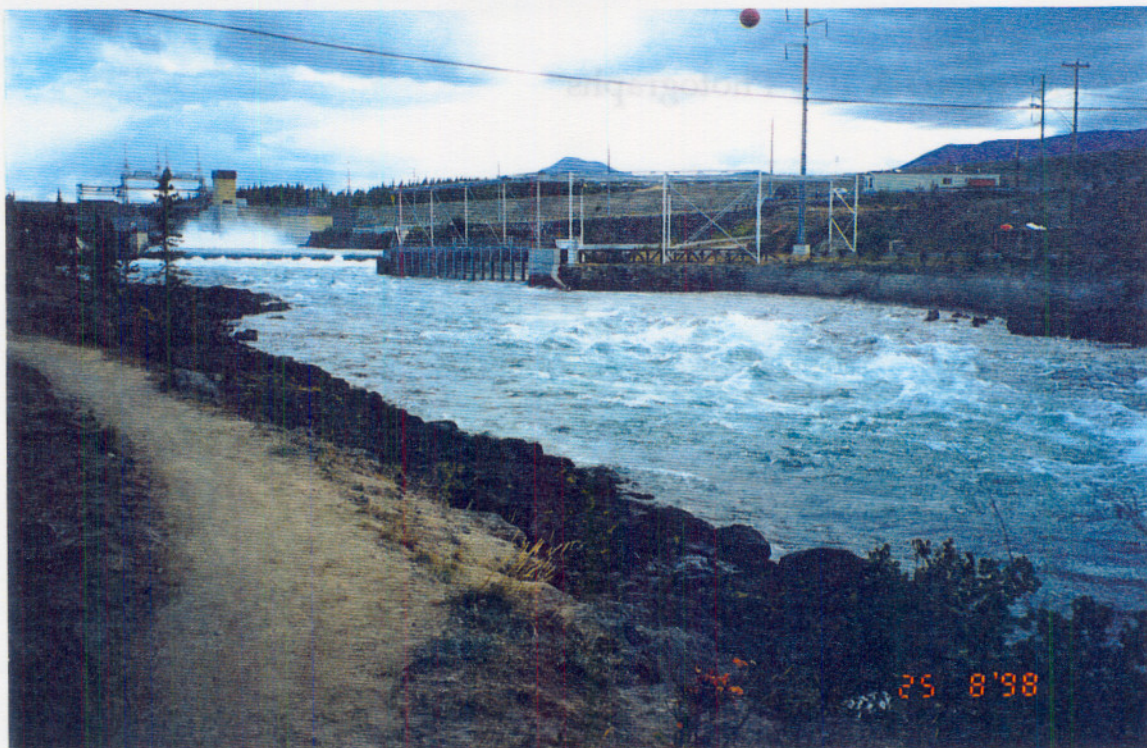
Photo. #1 Whitehorse Rapids Dam showing discharge from two spill way gates.

The Whitehorse Rapids Generating Facility (40 MGW) is located on the Yukon River in Whitehorse. It consists of the Whitehorse Rapids Dam with two spill gates (Photo. # 1 and 2); a power canal to channel water to turbine units #1, 2, and 3; turbine unit #4 and its tailrace channel (which enters the river below the dam but above the release from turbine units #1, 2, and 3); a fish barrier weir, located downstream of the spill gates but upstream of the end of the tailrace from unit #4; and a fish ladder, which enters immediately downstream of the barrier weir. Figure 1 shows the configuration of the project and some sampling sites.

The relatively low levels of DGS measured downstream of the spill gates are not surprising, given that the spill gates act as low-level ports, and the discharge appears to have a horizontal velocity component. This would tend to prevent much or most of the water from plunging to depth, where hydrostatic pressure would force gas from inside air bubbles into solution. Although some turbines may produce DGS as a result of air entrainment, at Whitehorse Rapids, turbines #1 to 3 and #4 do not produce any significant DGS.

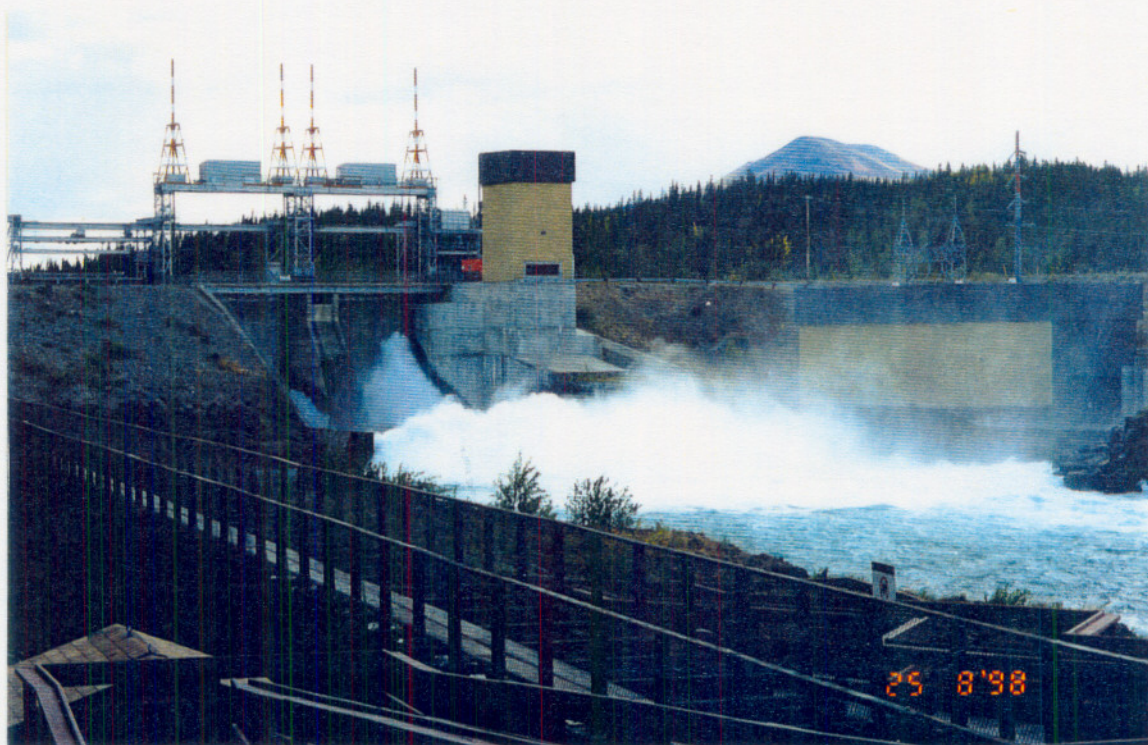
Photo. #2 Whitehorse Rapids Dam showing discharge from two spill way gates, and fish screens blocking fish access into the turbine unit #4 tailrace. Sampling site WRD2 located 75m downstream of fish screens on east river bank.

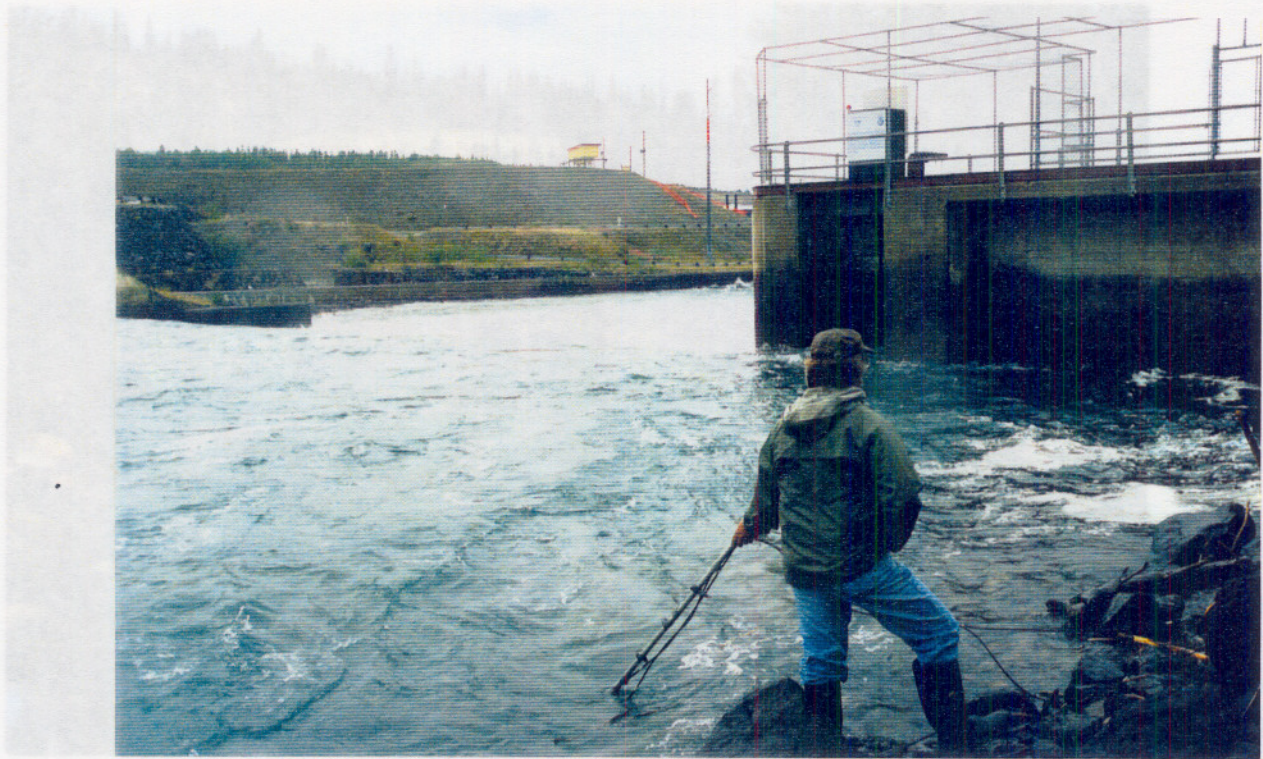
Photo. #3 Sampling at site WRD1, the Yukon River downstream of the spill gates at Whitehorse Rapids Dam, and immediately upstream of the fish collection chamber and weir, east bank.

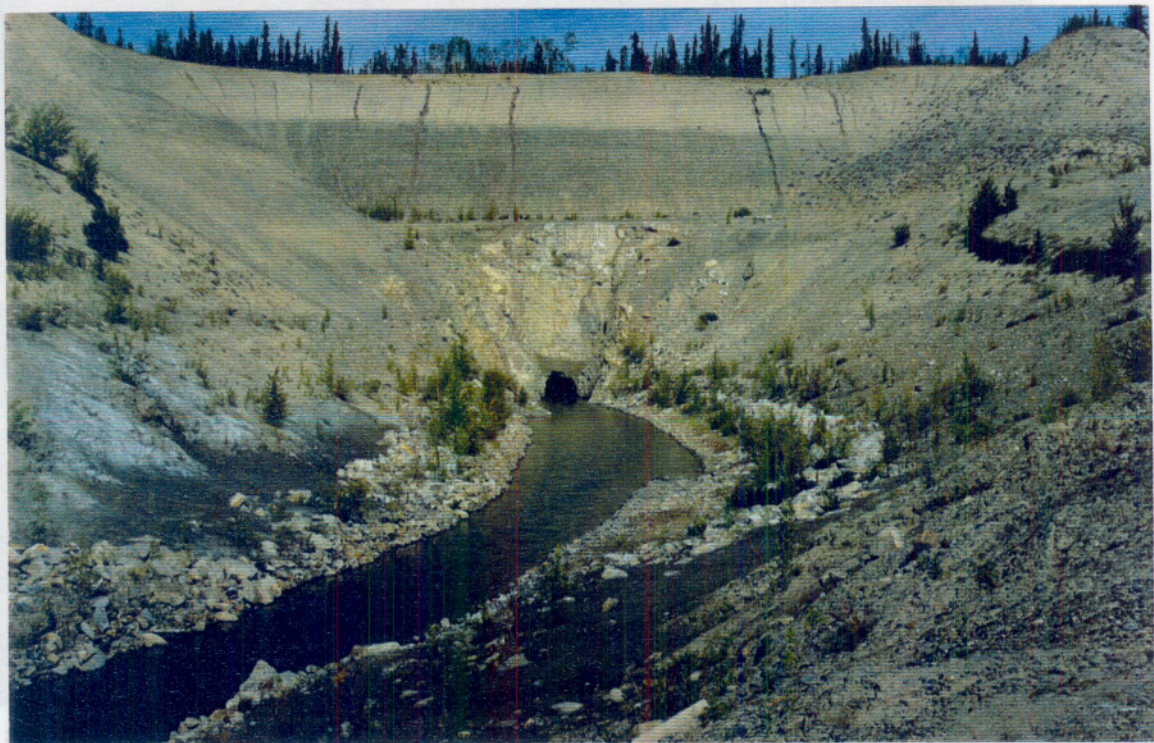
Photo. #4 Tailrace channel at Aishihik Generating Station.

In 1997, upstream sampling sites were located on Aishihik and Canyon Lakes. Downstream sampling sites were located in the tailrace channel, as shown in Photo. # 4 and 5, and the Aishihik River, downstream of the confluence of the tailrace channel with the East and West Aishihik Rivers. In 1998, the tailrace channel was resampled, at approximately the same location as in 1997. A more detailed description of sampling sites is provided in Appendix 4 (1997 sampling) and 5 (1998 sampling).

The water depth in this channel is typically very shallow. Although maximum water depths of up to 1 to 1.5 m may be found, the average water depth is much lower. During 1997, the water depth was approximately 0.2 metres on average, and 0.3 to 0.35 m in the thalweg. The utilisation of the channel or the Aishihik River to which it discharges by fish has been little studied. However, some species are thought to use this channel.

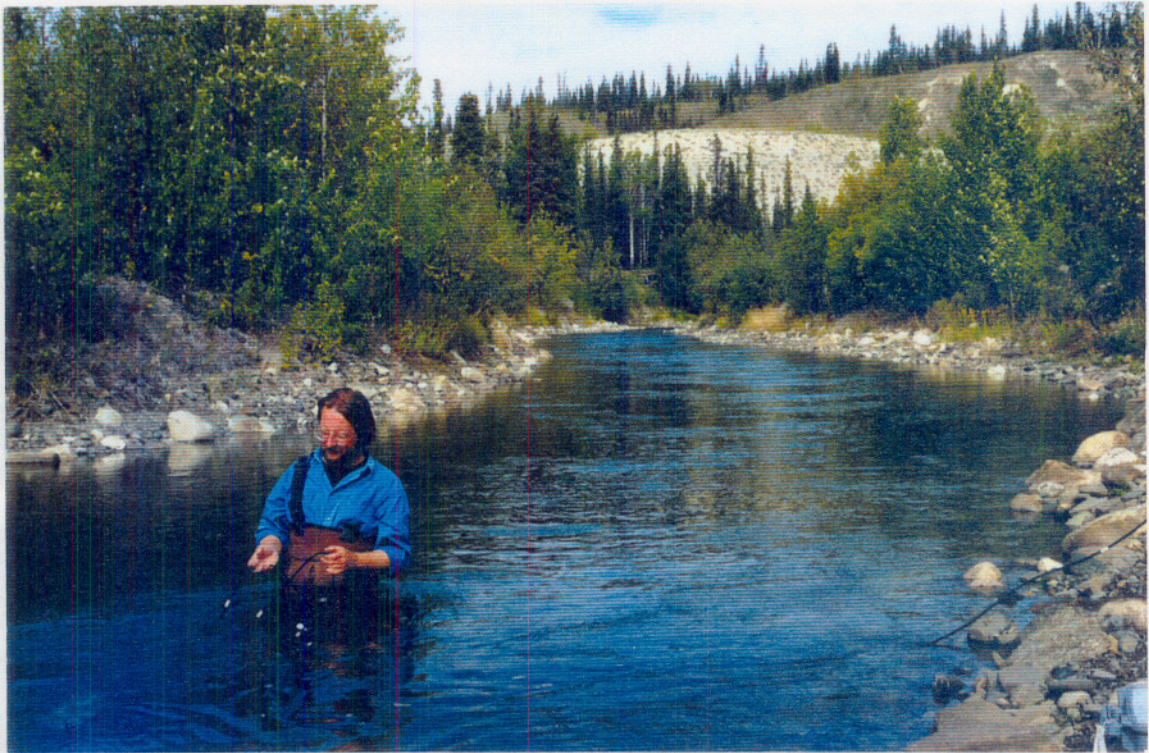
Photo. #5 Sampling in the Aishihik tailrace channel (site: AD1)

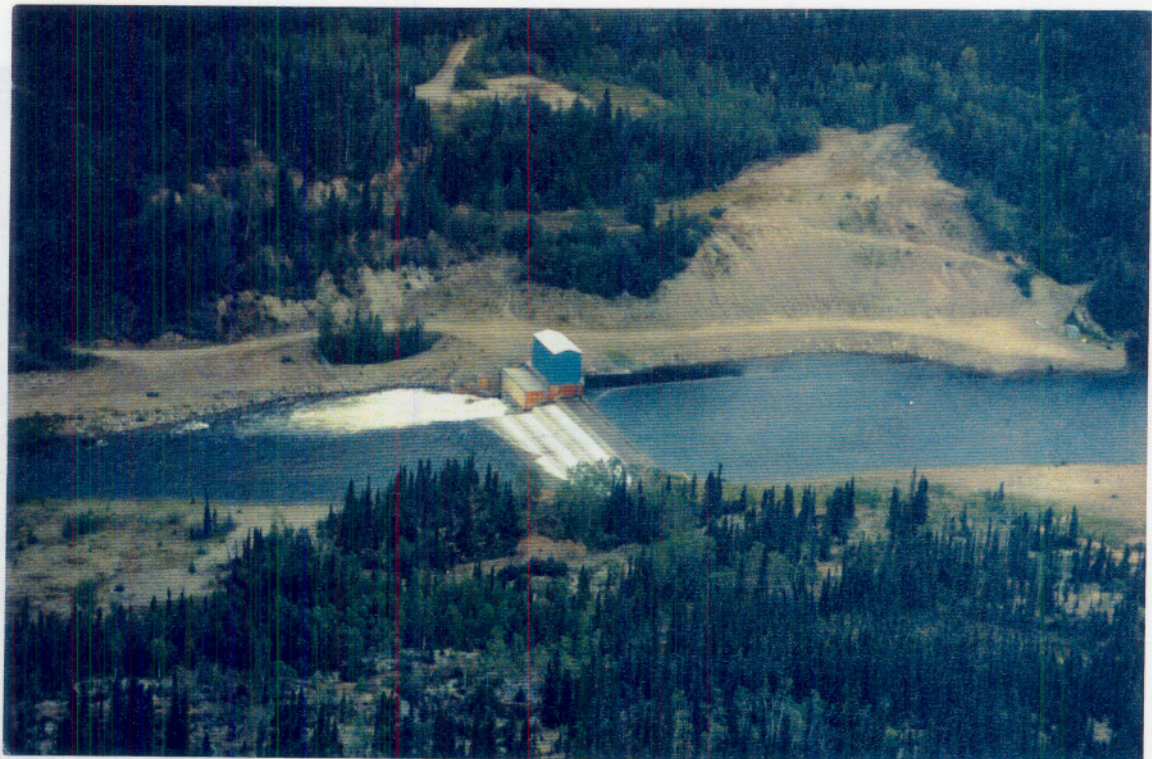
Photo. #6 Mayo Storage Dam. The downstream sampling site (MSD1) was located near the large rock in the left-hand corner of the photo.

The Mayo facility consists of the Mayo Storage Dam at the outlet of Mayo Lake (Photo. #6). A second dam (Wareham Dam) is located about 40 km downstream on the Mayo River and impounds water to form Wareham Lake (Photo. #7). The inlet to the generating facility is located immediately upstream of the dam on the east side of the river. The generating plant comprises two 2.5 MGW turbines. Exhaust water from the turbines joins the river about 500 meters downstream of the dam (Photo. #8). A spillway releases water from the dam to the river channel below (Photo. #9).

The Mayo facility was sampled in 1997 only. Sampling sites were located upstream of the Mayo Storage Dam, immediately downstream of the release (near the large rock shown on the left-hand side of Photo. #6), and further downstream on the Mayo River at the bridge located upstream of the confluence with Davidson Creek. At Wareham Dam, sampling sites were located immediately upstream of the dam at the inlet to the generating facility, downstream of the spillway (immediately upstream from the generating station), at the turbine outflow, and further downstream on the Mayo River at the Silver Trail/Mayo Road bridge. Detailed descriptions of sampling sites can be found in Appendix 7.

At the Mayo Storage Dam, TGP at the upstream site (104.2%, $\Delta P = 30$ mmHg) was similar to that measured downstream of the dam (103.4 % to 104.3%, or $\Delta P = 24$ to 30 mmHg).

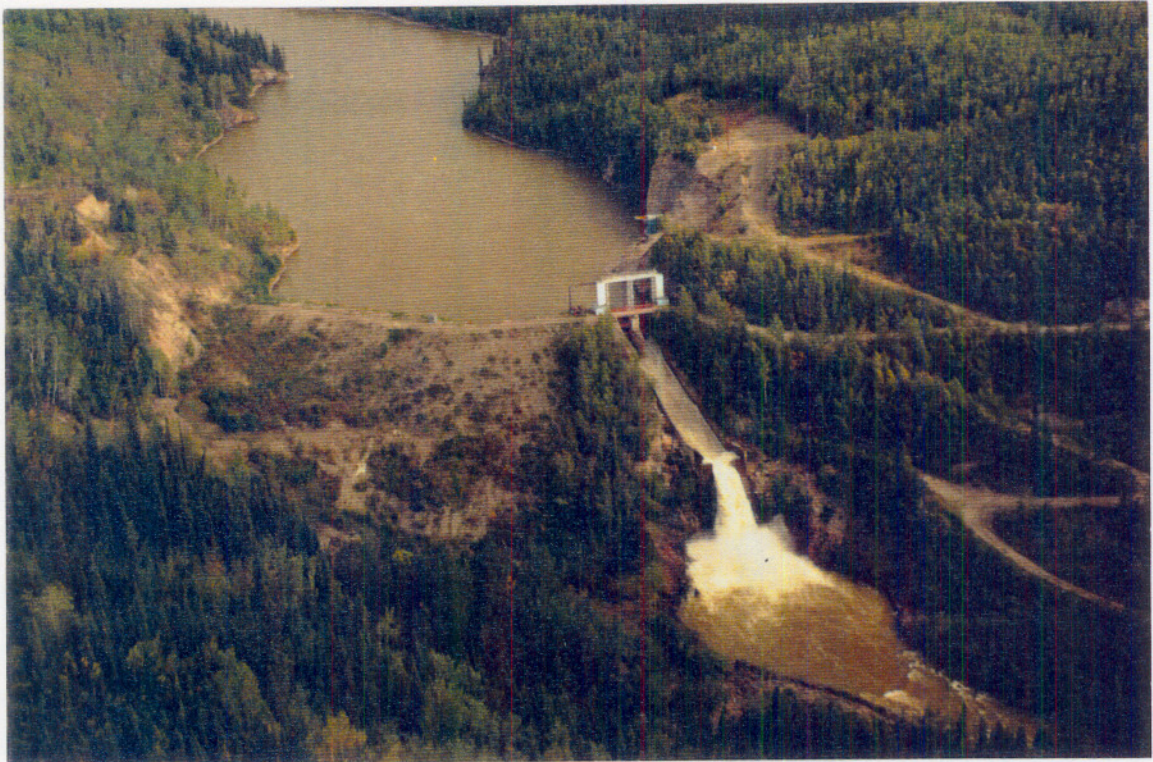
Photo. #7 Wareham Lake Dam and spillway. The inlet to the generating facility is located immediately upstream of the dam on the east side of the river.

TGP upstream of the Wareham dam was 102.2% ($\Delta P = 16$ mmHg), and it was elevated to 105.6% ($\Delta P = 39$ mmHg) below the spillway, at a sampling depth of 0.6m. TGP was 103.9% ($\Delta P = 27$ mmHg) downstream of the turbine outflow, at a sampling depth of 2m, and 105.4% ($\Delta P = 38$ mmHg) downstream of the flow from the turbines and spillway, at a depth of 0.6m. At Silver Trail bridge on the Mayo River, TGP was reduced to 103% ($\Delta P = 21$ mmHg), at a depth of 1.6m.

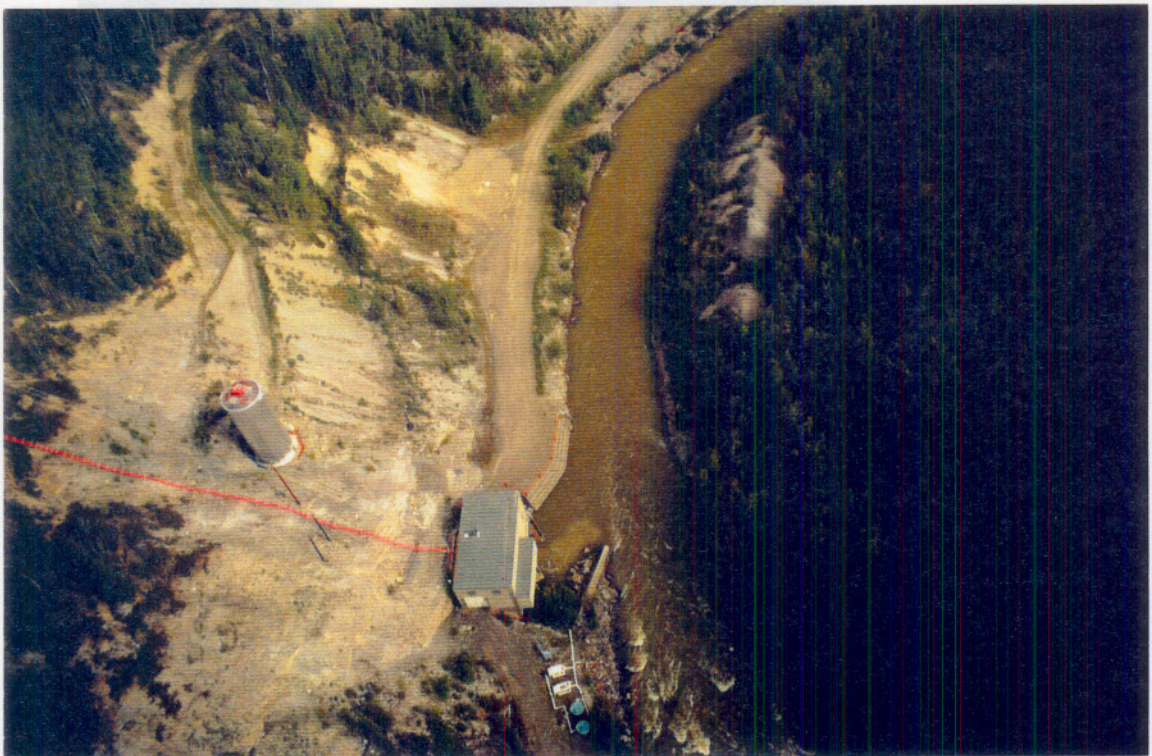
Photo. #8 Wareham Lake Dam generating station on the Mayo River, approximately 500 m below the Wareham Lake Dam and spillway structure.

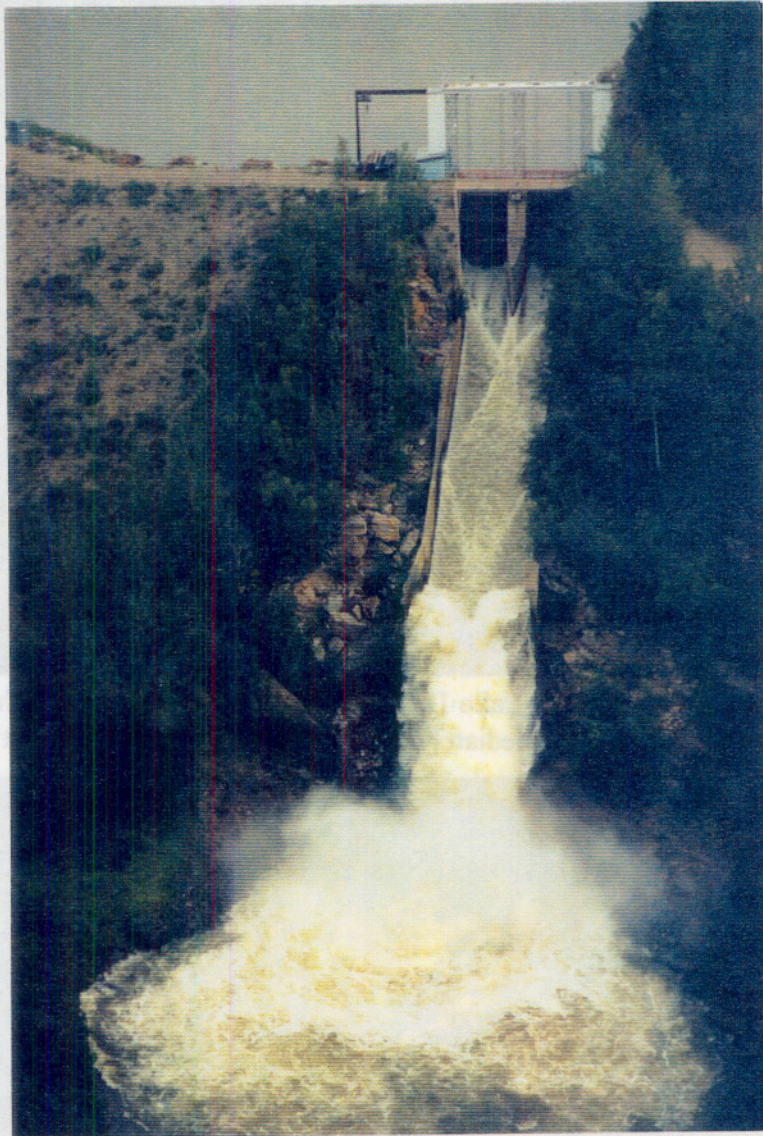
Photo. #9 Wareham Lake Dam spillway.

The characteristics of the spillway suggest that TGP should be elevated. Air entrained in the spilled water appears to plunge to depth in the plunge pool, providing conditions appropriate for the elevation of TGP. However, TGP may dissipate quickly in the river downstream of the spillway. Further sampling should be conducted during spill conditions to confirm the 1998 measurements.

As noted above, TGP measurements in the Mayo River downstream of the Wareham dam spillway were considered to be lower than expected, based on the volume of spill and the spillway configuration. A further limited program of measurement is recommended under a high flow and a moderate flow regime to confirm that spill does not elevate TGP to levels of concern. Decisions on further sampling should be made at the conclusion of the analysis of the data from these tests.
