Identification of Barriers Affecting the Movement of Morrison Creek Lamprey (*Lampetra richardsoni marifuga*) Within its Natural Range

**Canadian Manuscript Report of
Fisheries and Aquatic Sciences 3043**

IDENTIFICATION OF BARRIERS AFFECTING THE MOVEMENT OF MORRISON
CREEK LAMPREY (*Lampetra richardsoni marifuga*) WITHIN ITS NATURAL RANGE

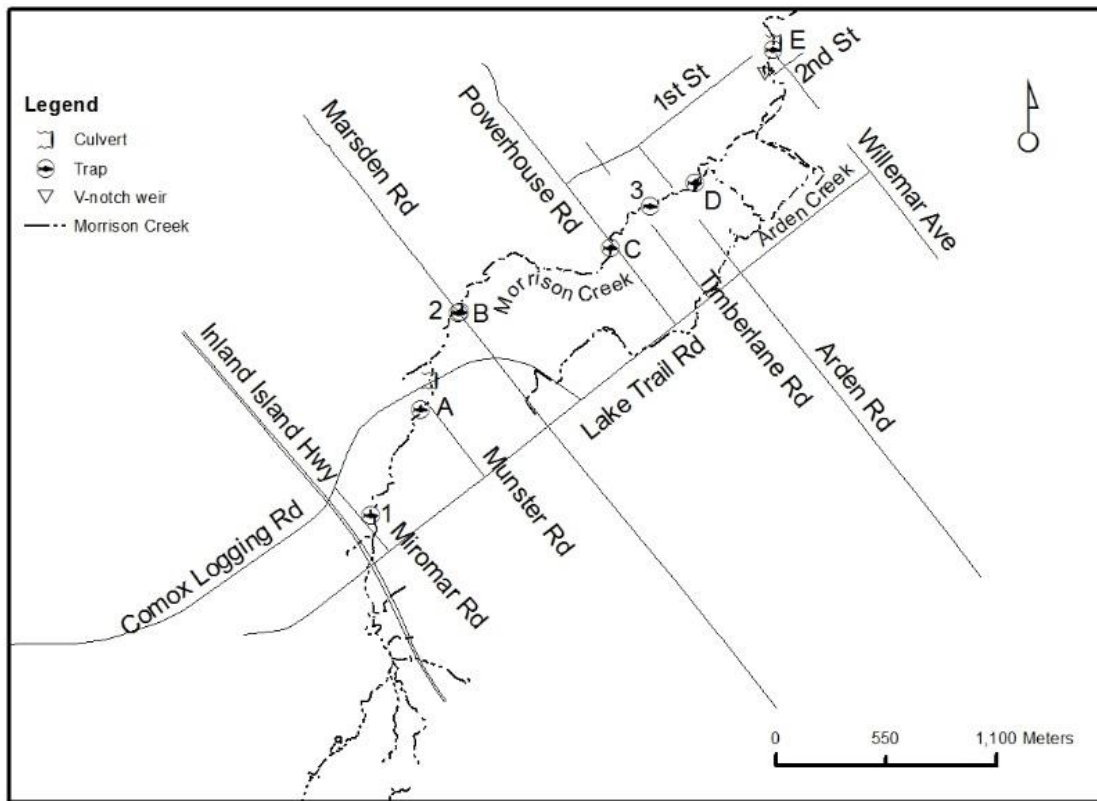
Figure 1. Map of Morrison Creek identifying the locations of Barriers 1-3 in relation to trapping sites in 1983, 1984, 1987 (Sites 1-3) and trapping sites in 2011 and 2012 (Sites A-E) (not all sites were used in all years). Barrier 1 (culvert) is located between trapping sites A and B; barrier 2 (v-notched weir) is located between trapping sites D and E; barrier 3 (culvert) is located immediately downstream of trapping site E.

Traps were installed in up to three locations (Sites 1-3) in 1983, 1984 and 1987 in Morrison Creek (Figure 1). In 2011, two sites were trapped for the duration of the field season, one in Roy Morrison Park (Site D), the other at Willemar and 1st Street (Site E). The Munster Road trap (Site A) was removed approximately half way through the season and re-installed at Powerhouse Road (Site C). In 2012, three traps were monitored, the Roy Morrison Park trap (Site D), Marsden Road trap (Site B) and Willemar and 1st Street trap (Site E). Physical barriers have been identified in relation to trapping locations (Figure 1).

Mapping trapping sites in relation to barrier locations (Figure 1) was performed in order to discuss the possibility of impacts on catch rates due to habitat fragmentation caused by barriers.

Barrier 1, the hung culvert under Comox Logging Rd., is located immediately downstream of trapping location 1 (used in the 1980s) and immediately downstream of trapping location A (used in 2011, 2012) (Figure 1). Between barrier 1 and barrier 2, the v-notched weir, are trapping sites 2 and 3 (used in the 1980s) and trapping sites B, C, D (used in 2011 and/or 2012). The third barrier, a hung culvert under 1st St. is located immediately downstream of trapping site E used in 2011 and 2012.

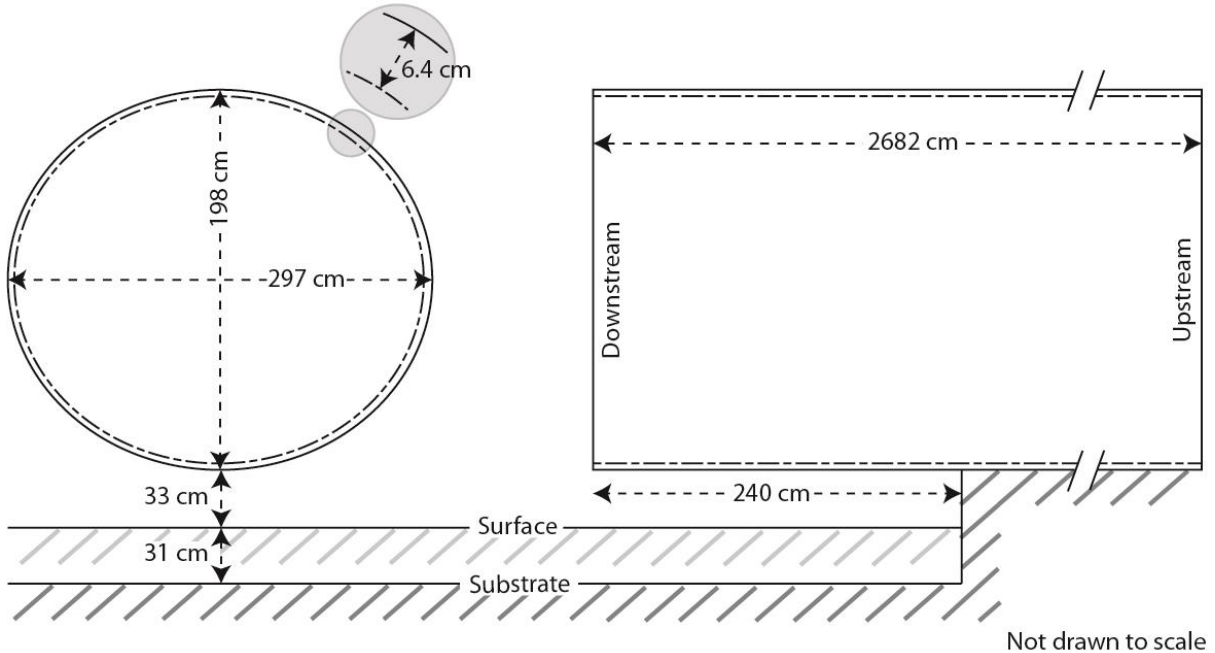
Barrier 1 is a culvert located under Comox Logging Road, in Courtenay, upstream from the intersection of this road and Marsden Road. The culvert is a standard corrugated metal culvert. The approximate dimensions of the culvert are: 297 cm in diameter, 198 cm in height and 2682 cm long with a corrugation depth of 6.4 cm (Figure 2).

Figure 2. Schematic of Barrier 1, a hung culvert located at 49°40'16.35"N; 125° 2'23.51"W. Measurements taken in May, 2013.

The upstream end of this culvert poses no impediment to the movement of lamprey. There is evidence of beaver activity immediately upstream and it is highly probable that water flow is changed somewhat with these activities, however lamprey have the ability to move under and around obstacles such as sticks, twigs and mud used in the building of beaver dams and lodges. The upstream end of the culvert is level with the substrate and water flow can continue to move into the culvert at all times.

When applying the vertical drop/jump criteria, the vertical head rates a passability score of 0 making this barrier automatically impassable to lamprey without any further analysis. However, analysis was continued to provide information for recommendations. Moderate water turbulence associated with the culvert rated a passability score of 0.3. The presence of resting locations downstream of the culvert as well as the gap width of the culvert scored 1.

The slope/swim criteria (Table 4) applied to the culvert showed that the slope of the structure given the length posed no impediment to passability of lamprey although the length of the structure by itself was found to be a partial obstacle with a passability score of 0.3. Although the length of the culvert cannot be changed, modifications, such as baffles, may be able to aid in lamprey passage. The gap width of the culvert poses no impediment to movement.

Two impassable objects have been identified as barriers to lamprey movement and access to critical habitat within Morrison Creek. At the very least, fixing the obstacles to allow lamprey full access year round will maximize the access to critical habitat. In order to achieve this the downstream side of the culvert located under Comox Logging Road should be remediated in order to eliminate or significantly reduce the hydraulic head. A substrate structure attached to the culvert ending under the water could suffice to address this issue and allow lamprey a surface to “swim up” under low to moderately turbulent water. Ramps have been shown to successfully aid the movement of Pacific lamprey (*Entosphenus tridentatus*) over/through hydroelectric dams on the Columbia River (Reinhardt et al. 2008; Moser et al. 2006), similar structures could be used in Morrison Creek to aid in the passage through culverts. The angle of the structure with respect to water flow should be taken into consideration in the design as well as the development of methods of assessing the success of the structure as has been done for other lamprey species.

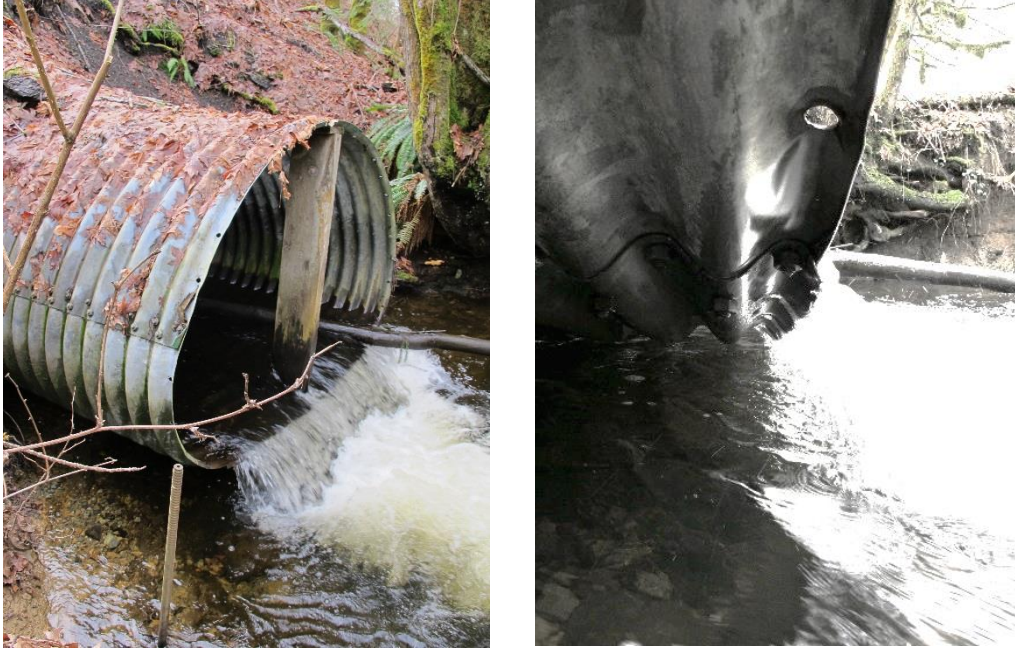
The downstream side is a considerable obstacle to the upstream movement of lamprey. This obstacle is a hung culvert, overhanging the bank by approximately 240 cm. The distance from the bottom mid-point of the culvert to the substrate is 64 cm (as measured on May 2013) the distance of water fall from the mid-point of the culvert to the surface of the water was 33 cm. Water was exiting the culvert with high turbulence making it difficult to measure depth of water (Figures 3a, b).

Figure 3. Photographs of Barrier 1, a hung culvert, taken in May, 2013. A) Downstream view of culvert demonstrating the distance from the lip of the culvert to the surface of the water as well as water turbulence B) Close up of culvert overhang and distance from lip of the culvert to the surface of the water.

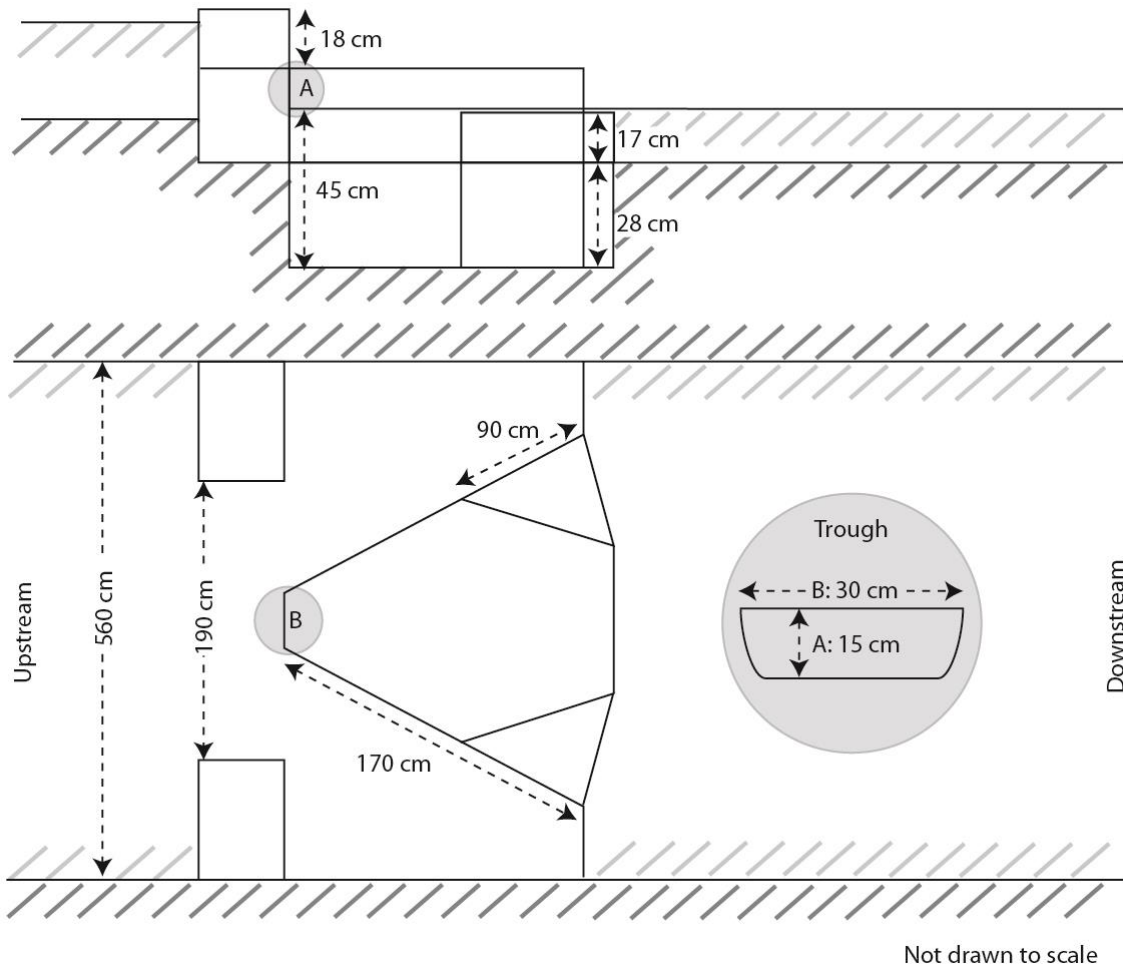
This V-notch weir is installed at the end of 2nd Street, upstream from the intersection of First Street and Willemar Road in Courtenay. The weir was installed in the 1980s to aid in the passage of anadromous salmon in Morrison Creek. Adjacent to this weir, a diversion channel was rehabilitated in 2009 to allow fish to circumvent the weir. Unfortunately, during low water, the diversion channel may become dry and the only available passage upstream and downstream is through the weir.

Figure 4. Schematic of Barrier 2, a v-notched weir located at 49°41'7.62"N; 125° 0'59.29"W. Approximate measurements taken May, 2013. Side view above, aerial view below.

The vertical drop as measured in May 2013 (Figure 4) from the bottom of the v-notch to the surface of the plunge pool was between 40-55 cm, the distance from the bottom of the v-notch to the sediment surface was 85cm. As there was high water flow, all of the water was not diverted into the notch but fell over plywood sheeting creating a “waterfall” into the pool below (Figure 5). At the base of the waterfall is a plunge pool which is barricaded off from the rest of the stream by a wall that on the inside is approximately 45 cm deep and on the outside is approximately 17 cm deep. This wall may be of significance to lamprey during times when water flows are decreased. There are no impediments to the downstream migrating juvenile lamprey unless the water levels are low and they become entrained in the plunge pool.

When applying the vertical drop/jump criteria, the vertical head rates a passability score of 0 making this weir automatically impassable to lamprey without any further analysis (Table 3). However, the analysis was continued in order to provide information for recommendations. Moderate water turbulence was observed as a result of this weir rating a passability score of 0.3. The presence of resting locations downstream as well as a gap width of 30 cm both rated passability scores of 1 making these features no impediment to lamprey movement.

In order to address the issues with the v-notched weir, the recommendation is to remove the weir entirely and remediate the stream in accordance with lamprey habitat requirements being cognizant of the requirements of other fish species utilizing Morrison Creek.

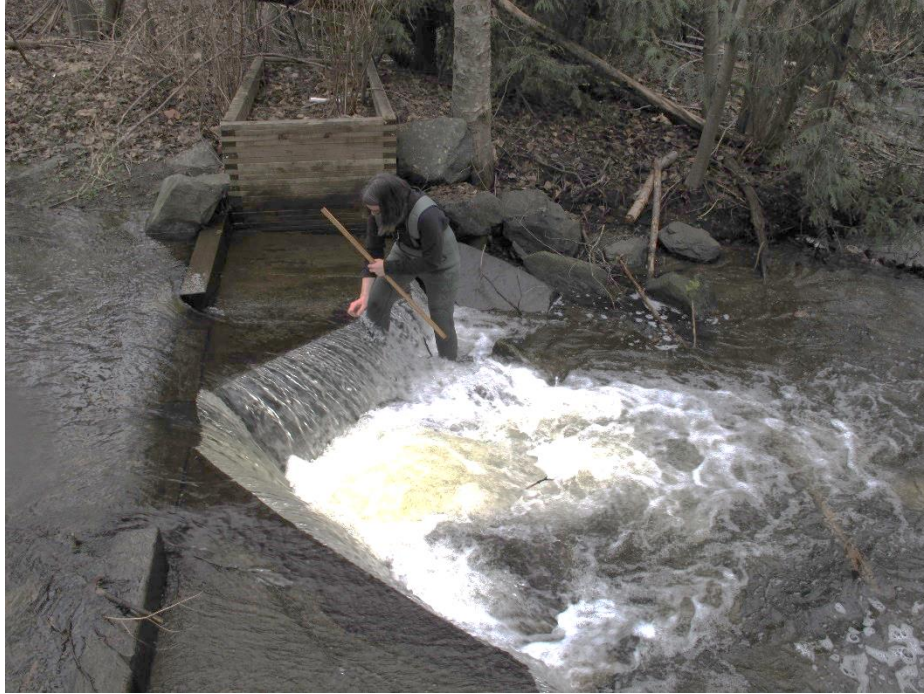
Figure 5. Photograph of Barrier 2, v-notched weir, taken in May, 2013.

There is a retaining wall over which the water falls and a “step” on each side, currently submerged under the water. The depth from the wall to these steps is approximately 43 cm.

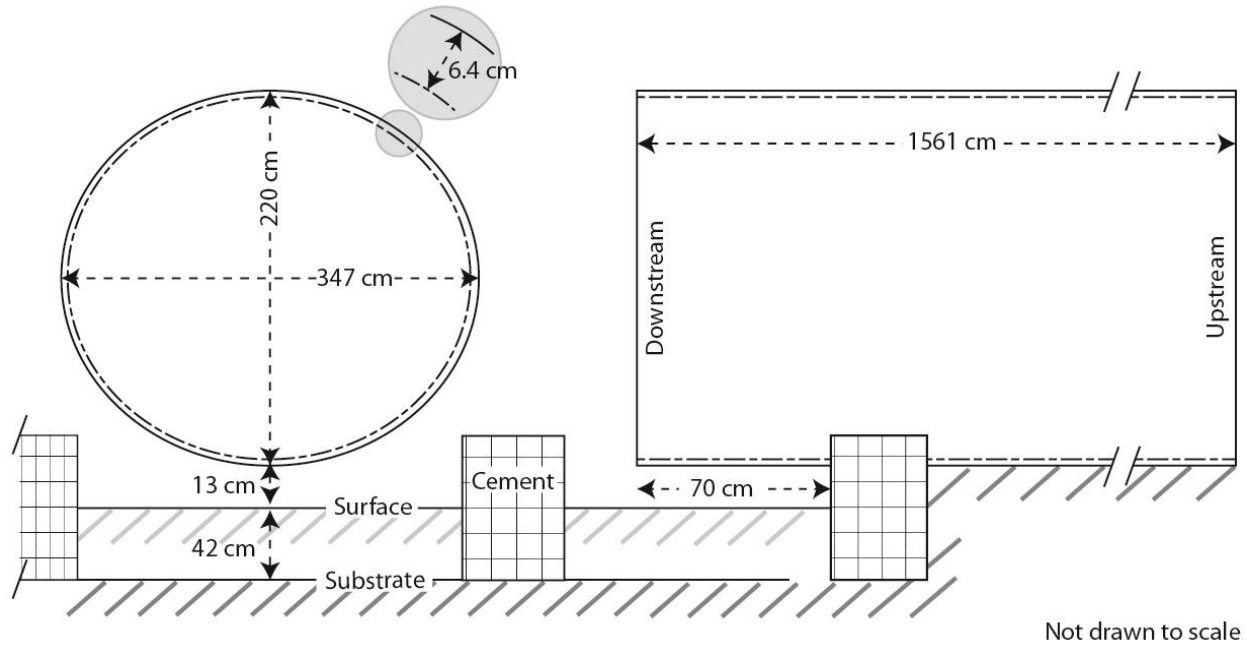
This culvert is located under First Street in Courtenay at the intersection of Willemar Road near Puntledge Park. The obstacle is a hung culvert, overhanging the bank by approximately 70 cm. It is a standard corrugated metal culvert approximately 347 cm in width, 220 cm in height and 1561 cm long with a corrugation depth of 6.4 cm (Figure 6).

Figure 6. Schematic of Barrier 3, a hung culvert located at 49°41'12.43"N; 125° 0'58.46"W. Measurements taken in May, 2013.

The upstream end of this culvert poses no impediment to the movement of lamprey. The downstream end in May 2013 did not pose an impediment to lamprey movement but at very low water levels, it may be an issue (Figure 7). The distance from the bottom mid-point of the culvert to the substrate is 55 cm, the distance of water fall from the mid-point of the culvert to the surface of the water was 13 cm.

When applying the vertical drop/jump criteria, the vertical head rates a passability score of 1, no obstacle to movement (Table 3). Moderate water turbulence associated with the culvert rated a passability score of 0.3, a partial high impact obstacle. The presence of resting locations downstream of the culvert as well as the gap width of the culvert scored 1, no obstacle, as was found for the other two barriers.

The slope/swim criteria (Table 4) applied to the culvert showed that the slope of the structure given the length posed no impediment to passability of lamprey, although the length of the structure by

itself was found to be a partial obstacle with a passability score of 0.3, the same result as found for the other culvert. It is possible that modifications to the culvert may be able to aid in lamprey passage. The gap width of the culvert poses no impediment to movement.

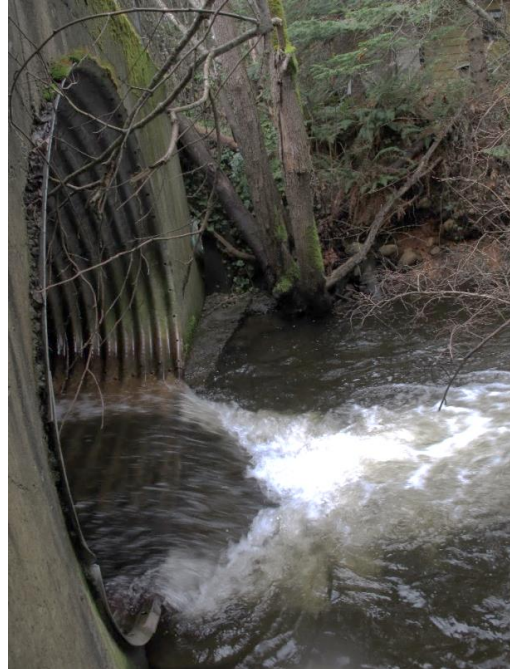
Figure 7. Photograph of Barrier 3, a hung culvert, taken in May, 2013.
