# Blistering in SBS Polymer Modified Bituminous Roofs

**This Update, based on an IRC study, describes causes of blistering in styrene-butadiene-styrene (SBS) modified bituminous roofs, suggests ways to prevent it and recommends methods to deal with it.**

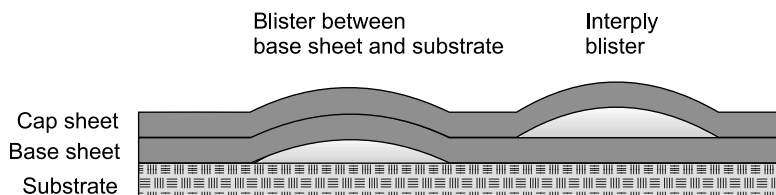
In asphalt-based roofs, blisters occur frequently. Blisters are pockets of entrapped air and/or moisture in roof membranes. They can occur between the cap and the base sheets and/or between the base sheet and the substrate (Figure 1). Blisters range from barely detectable spongy spots to bloated humps several square metres in

**Figure 1.** Blistering locations in modified bituminous membranes

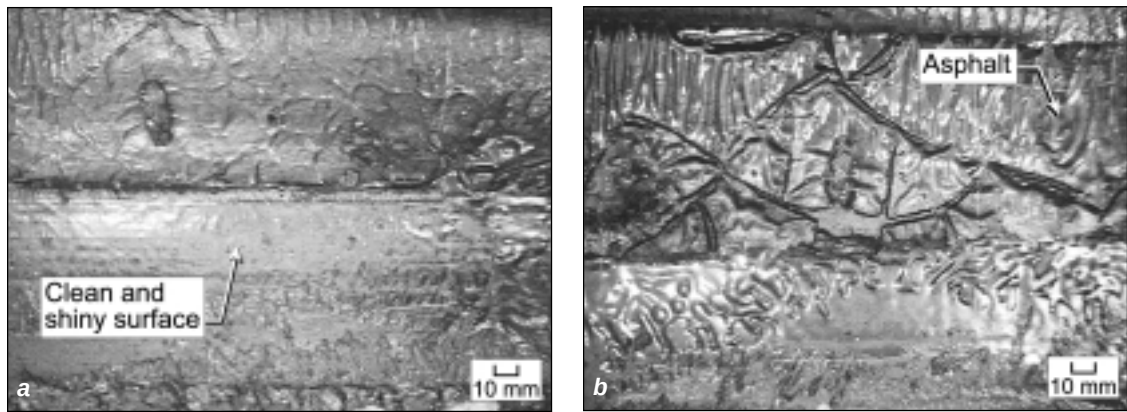
Good interply bonding is important to resist blister growth. During hot application, the asphalt should flow readily to “wet” the surface of the sheet and remain hot enough until the cap sheet is put on. Otherwise, the bonding between the sheets will be poor, and blister growth will be encouraged. Figure 2a shows the underside of the cap sheet of a blister. It is shiny and clean, with almost no asphalt adhered to it. Since the interfacial bonding between the asphalt

**Figure 2.** Poor interply bonding due to low application temperature  
(a) Cap sheet, (b) Base sheet

and the base sheet appeared to be good (Figure 2b), the temperature of the mopping asphalt was initially high enough. It is suspected that the asphalt cooled rapidly during the mopping process, so that the temperature fell below the equiviscous temperature (EVT) range of the asphalt before the cap sheet was put on. To minimize temperature drop, the cap sheet should be applied as soon as the asphalt is mopped.

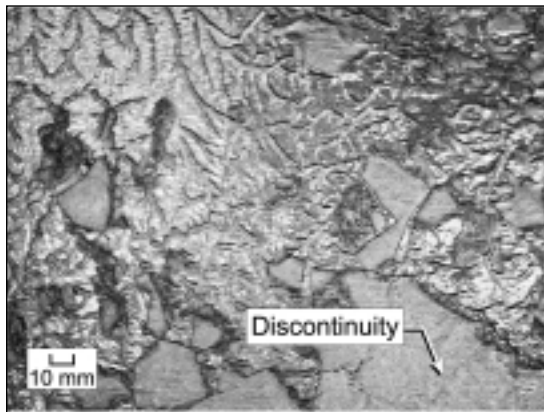
The mopping asphalt should be applied uniformly. In Figure 3, the discontinuities seen in the asphalt were likely the result of mopping skips caused by the lack of uniformity in the mopping process. The mopping asphalt in this sample was found to contain foreign bodies (sand, fillers, aggregates or other contaminants). These foreign bodies may make the asphalt more difficult to handle and harder to mop uniformly. As a result, skips occur in the mopping, and become voids. It is important to remember that mopping asphalt is primarily an adhesive between the modified bituminous sheets, and adhesives work best applied in thin layers.

**Figure 3.** Discontinuity in mopping asphalt due to non-uniform mopping process

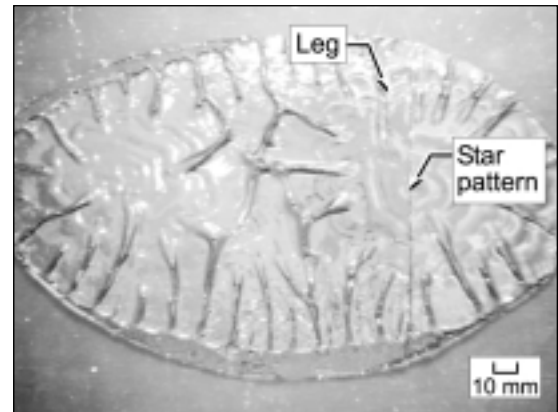
Uncoated spots are also potential origins of blisters. The “star-like” uncoated patterns in Figure 4 were likely the origins of the two adjoining blisters. The centre of the pattern was bare, with almost no asphalt adhering to it. The “legs” (or stalactites and stalagmites) bridged the cap and the base sheets inside the periphery of the blister. These “legs” were likely formed by the yielding and stretching of the mopping asphalt at the periphery of the void, during the expansion of the blister at high temperature. One possible cause was the presence of liquid parting agent at the interface of the cap and base sheets. Liquid parting agent was sometimes applied in the past to the ply and base sheets to prevent sticking in the roll, but is rarely used now. Another possible cause was that the membrane was not flat when it was rolled out during mopping. The cap sheet bonded well to the base sheet at the flat areas but voids were left between the sheets at the raised, uneven areas. These voids may not be noticeable during installation but they grow with time.

**Figure 4.** Uncoated spots are potential origins of blisters.
