Juvenile Salmonid Utilization of Selected Habitat Restoration Projects in Southern Interior British Columbia

D. Pehl (edited by M.B. Flynn)

2009

**Canadian Manuscript Report of
Fisheries and Aquatic Sciences 2868**

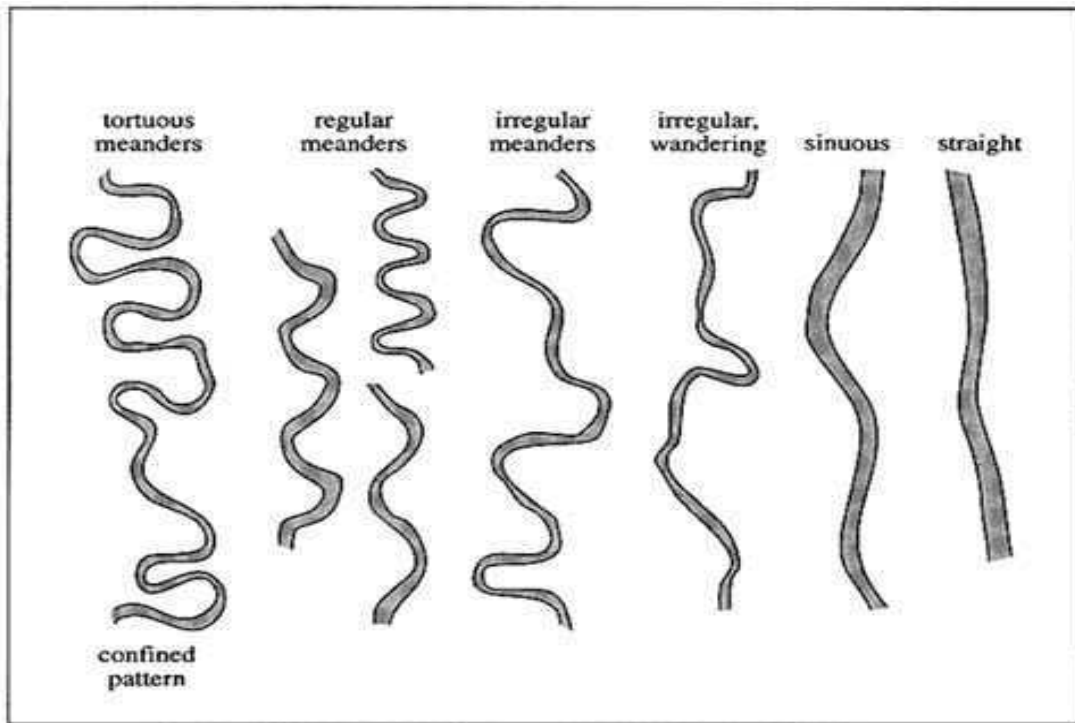
Channel patterns were classified visually for each site using the following index in accordance with the Forest Practices Code Channel Assessment Procedure Guidebook 1996:

Figure 14: Channel pattern classifications

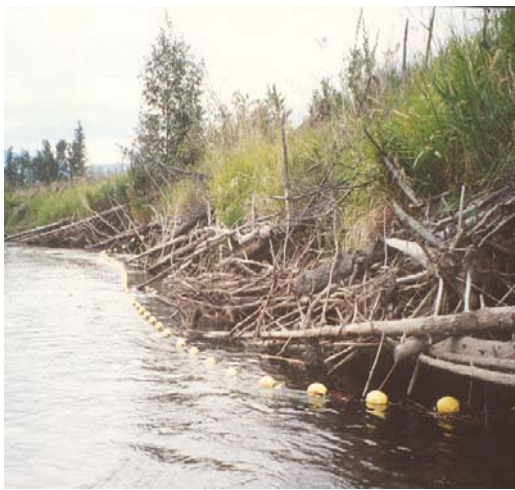
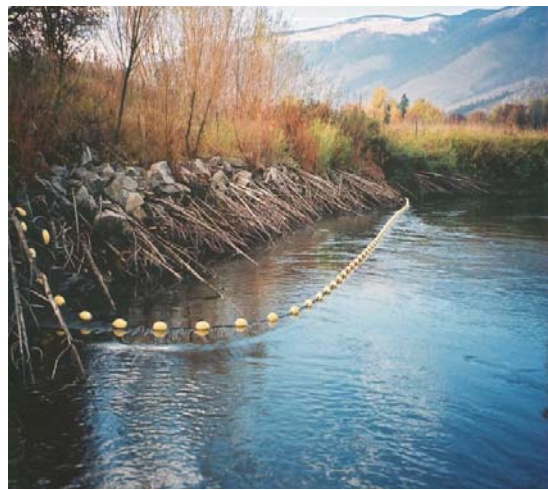
Two types of tree revetment structures were observed; traditional tree revetments and spielings. Traditional tree revetments consist of whole coniferous trees anchored to the stream bank. Trees are typically oriented with the butt anchored to the stream bank and the tips facing downstream in the wetted channel. Spielings are constructed by installing vertical stakes along an eroding bank site and weaving live willow cuttings or branches between the stakes to form a ‘living wall’. Visible structural failure and bank erosion was noticeable at most of these sites. Older tree revetment structures were generally rated lower for structural integrity when compared to other types of bank restorations. However, many of these sites were built to provide short-term stability (approx. 10 years) and are nearing or have surpassed their designed life span.

Figure 16: Traditional-style tree revetments (a) Deadman River and (b) Salmon River.

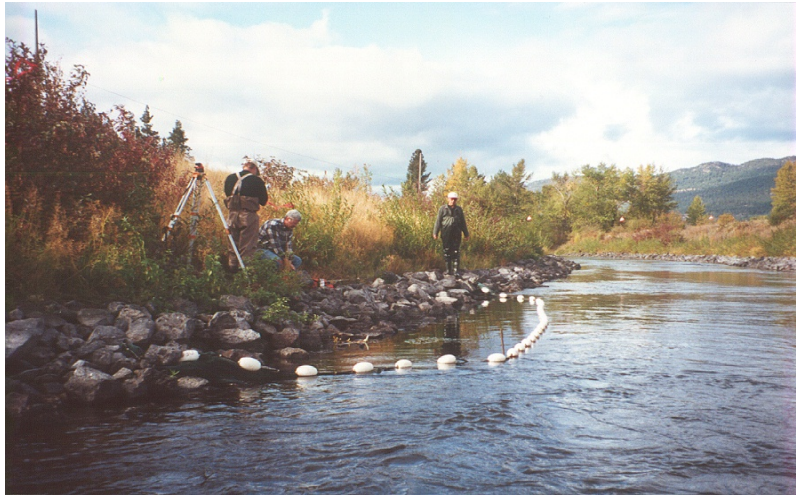
Banks stabilized by rip-rap placement were highly variable in the size and amount of rock used. Most rip-rap sites showed minimal or no structural failure. Any failure was usually a result of unsuitable rock size, slope characteristics or poor protection at the base of the slope. Certain rip-rap applications have exhibited relatively low fish habitat productivity due to poor physical complexity, diversity and hydraulic function. Preliminary data from this study suggest only a weak correlation of juvenile coho utilization with rip-rap sites. Any juvenile coho utilization of rip-rap sites was associated with woody debris trapped within the rocks.

Figure 17: Typical rip-rap bank protection on the lower Nicola River.

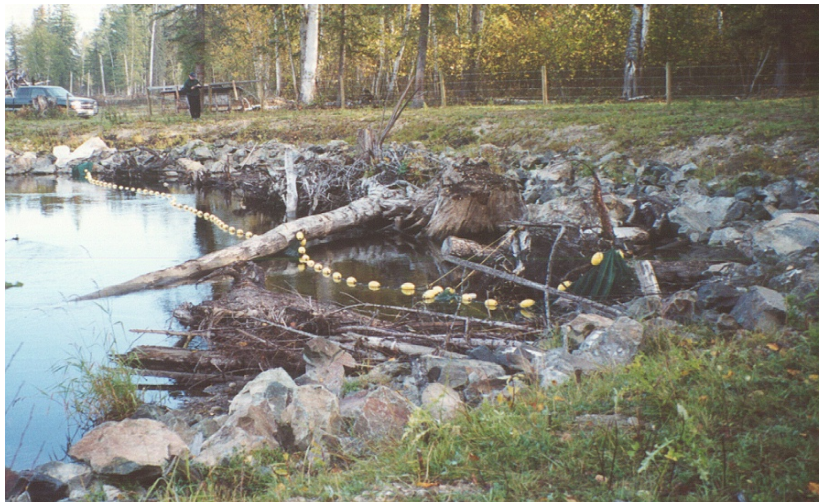
Although the traditional application of only wood (tree revetment) or rock (rip-rap) is still used, integrated techniques combining large woody debris and rip-rap that address a greater degree of bank stabilization, as well as providing fish habitat, are now being used. Rock-based bank restoration with large woody debris (usually rootwads) anchored throughout the site was the common technique assessed. They rated high in structural integrity and provided adequate fish habitat value. The woody debris provided most of the fish habitat value by increasing cover and complexity and providing hydraulic diversity. Fish habitat ratings varied from very poor to excellent depending on woody debris placement and abundance.

Figure 18: Good habitat value provided by rip-rap and large woody debris on Mann Creek.

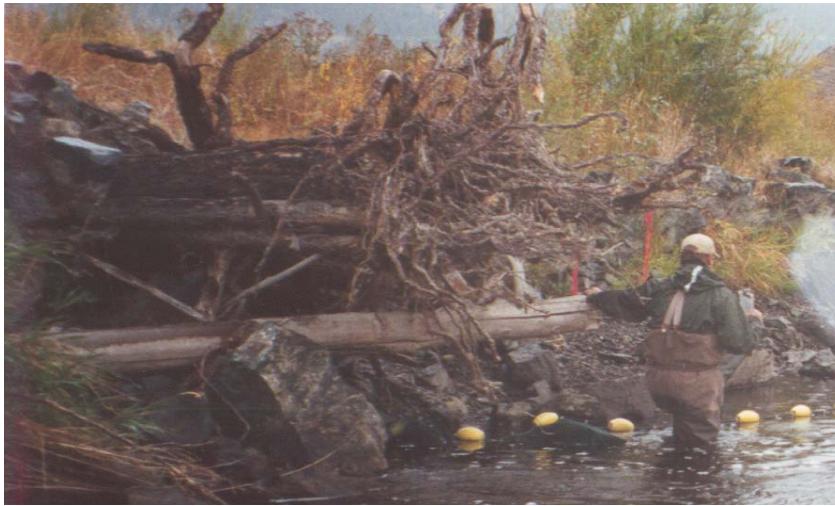
One problem limiting fish and habitat values at a number of sites is the placement of woody debris structures too high on the stream bank and out of lower stream flows. Although providing some benefit, such placement fails to provide productive instream habitat in the form of cover, shade, physical and hydraulic complexity, and aquatic insect production at low flows.

Figure 19: Elevated rootwad placement provided limited fish habitat value.

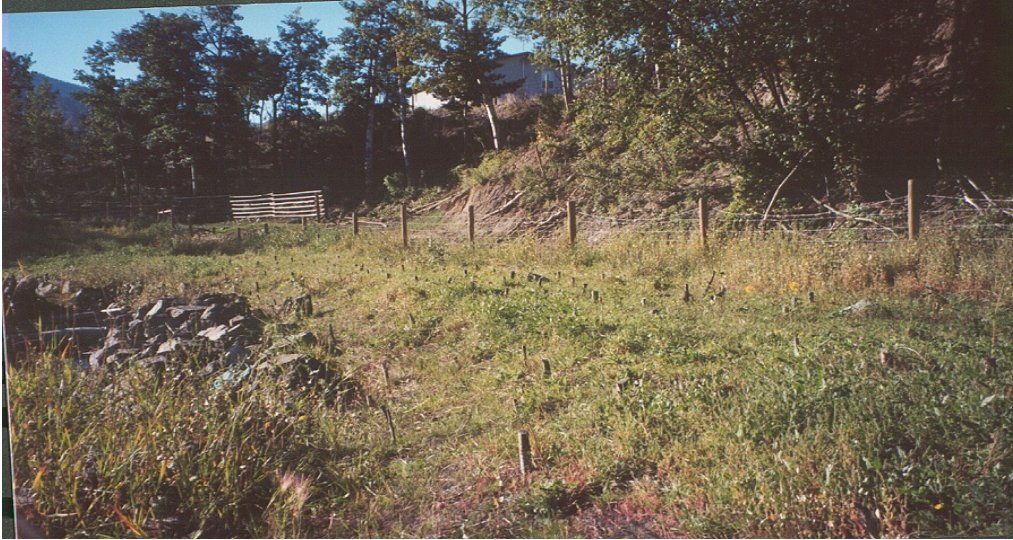
Extensive effort has been directed at re-establishing protected stream bank corridors. However, survival of planted cuttings (usually willow) and rooted stock (various species) was low at most restoration sites evaluated. Deadman, Bonaparte and Nicola River sites exhibited the lowest survival of riparian re-vegetation, collectively estimated at less than five percent. A commitment by landowners to properly maintain livestock exclusion areas and riparian vegetation after construction is vital to the success and survival of stream bank vegetation. However, livestock access into some protected stream bank areas was observed. Although watering during summer months can increase survival of planted stocks, at some sites it appeared that irrigation and regular maintenance was ineffective. This may be due to poor irrigation timing or planting technique (e.g. cut stock planted upside down or cut stock not planted deep enough or into groundwater). Cuttings should be planted near the wetted perimeter and into groundwater.

Figure 20: An example of poor re-vegetation success on the Bonaparte River.

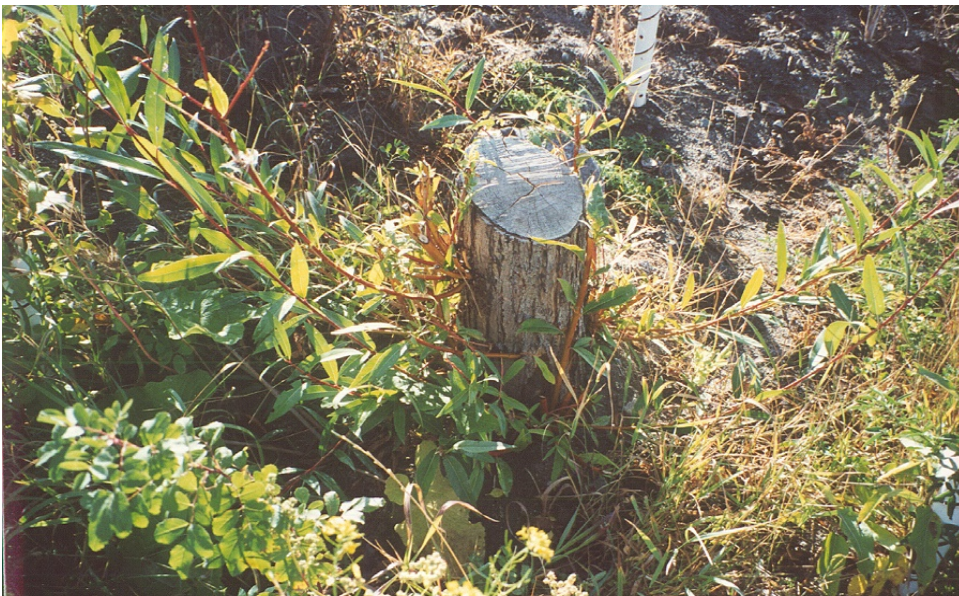
A variety of planting techniques have been used to restore riparian areas. This assessment study has identified some trends with respect to successful riparian planting techniques in the British Columbia Interior. Large diameter cut stock generally had considerably better survival than small diameter whips. The greatest survival of whips occurred on the lower slope of restoration banks, usually within 1-2 m of the wetted channel. It would appear that more monitoring and detailed guidelines on planting techniques would improve the success of riparian re-vegetation.

Figure 21: Large diameter cut stock producing good initial re-growth.

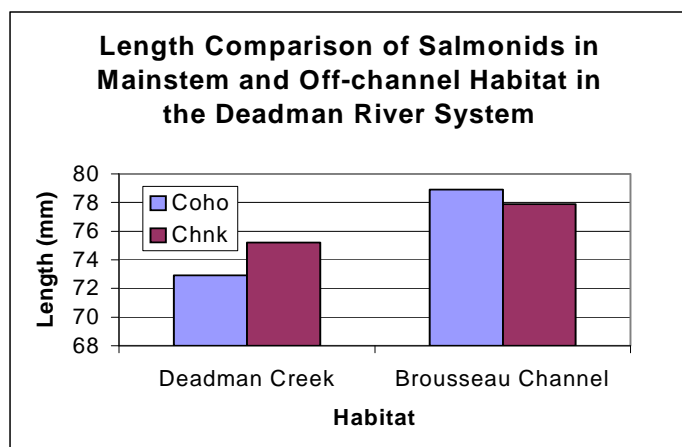
Length and weight measurements of juvenile coho indicated this restored off-channel may be more productive than the mainstem. The average coho length in the off-channel was 78.9 mm compared to average coho length in the mainstem of 72.9 mm. The largest juvenile coho and chinook were trapped in pools created by beaver activity at the downstream end of the channel.

Figure 23: Comparison of coho and chinook lengths in mainstem restoration sites and the restored off-channel October, 2001.

The restored off-channel also had considerable differences in relative species abundance compared to the mainstem. Relative abundance of rainbow trout, chinook and coho in the channel were 39.3 %, 23.7 % and 37.0 % respectively (mainstem relative abundance was 60.4 %, 12.8 % and 26.8 %).

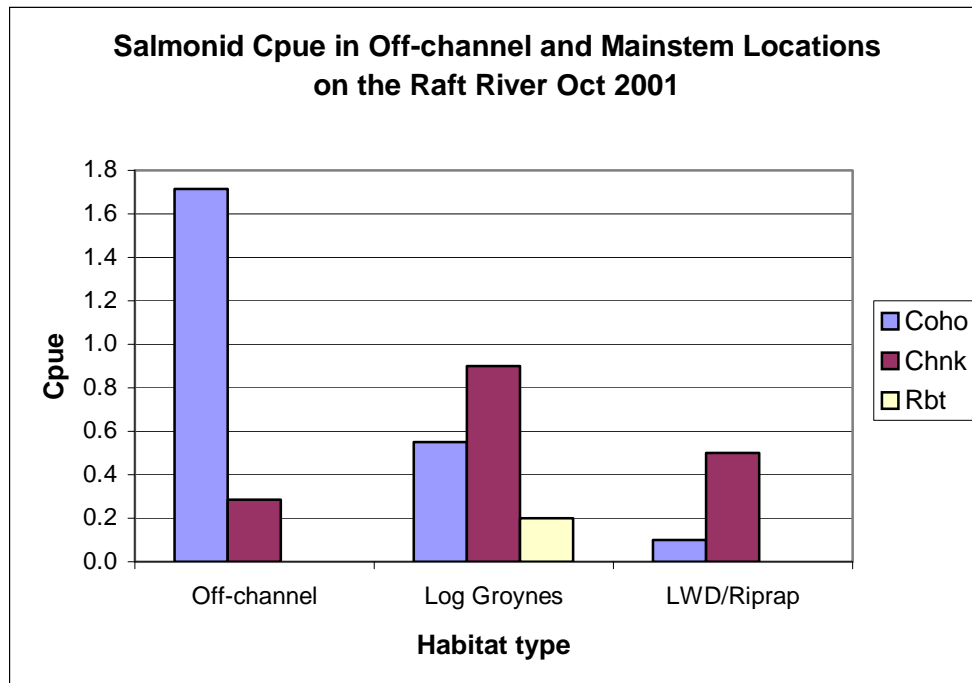
Sites in Raft River showed a more even distribution of coho and chinook, however there were distinct differences between mainstem and off-channel sites (Figure 24). In the two mainstem sites, chinook juveniles were most abundant followed by coho and rainbow trout. In the Raft off-channel, coho were most abundant followed by chinook. No rainbow were captured in the Raft off-channel.

Figure 24: Comparison of Cpue for salmonid species in the Raft River mainstem and off-channel restoration sites.
