TP 185E
Issue 3/2010

AVIATION SAFETY LETTER

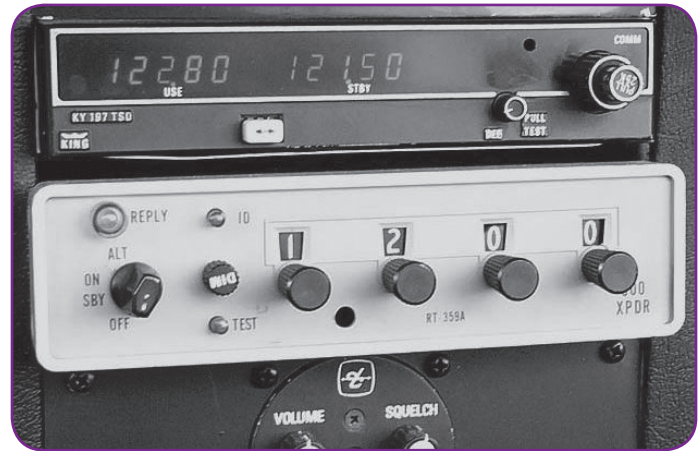
Transponders are pretty valuable pieces of equipment and assist ATC in providing a safe, orderly, and expeditious flow of air traffic. Pictured above is a basic transponder set at the VFR code of 1200, and mounted directly under a typical VHF communication radio. (Photo: Adam Hunt)

Well, let’s look at *Canadian Aviation Regulation* (CAR) 605.35, which covers transponders and automatic pressure-altitude reporting equipment. We’ll leave the pressure-altitude part of it alone, even though the same regulations apply. Remember also that transponder airspace is specified in the *Designated Airspace Handbook* (DAH) and includes all Class A, B, and C airspace. It also includes any Class D or E airspace specified as transponder airspace.

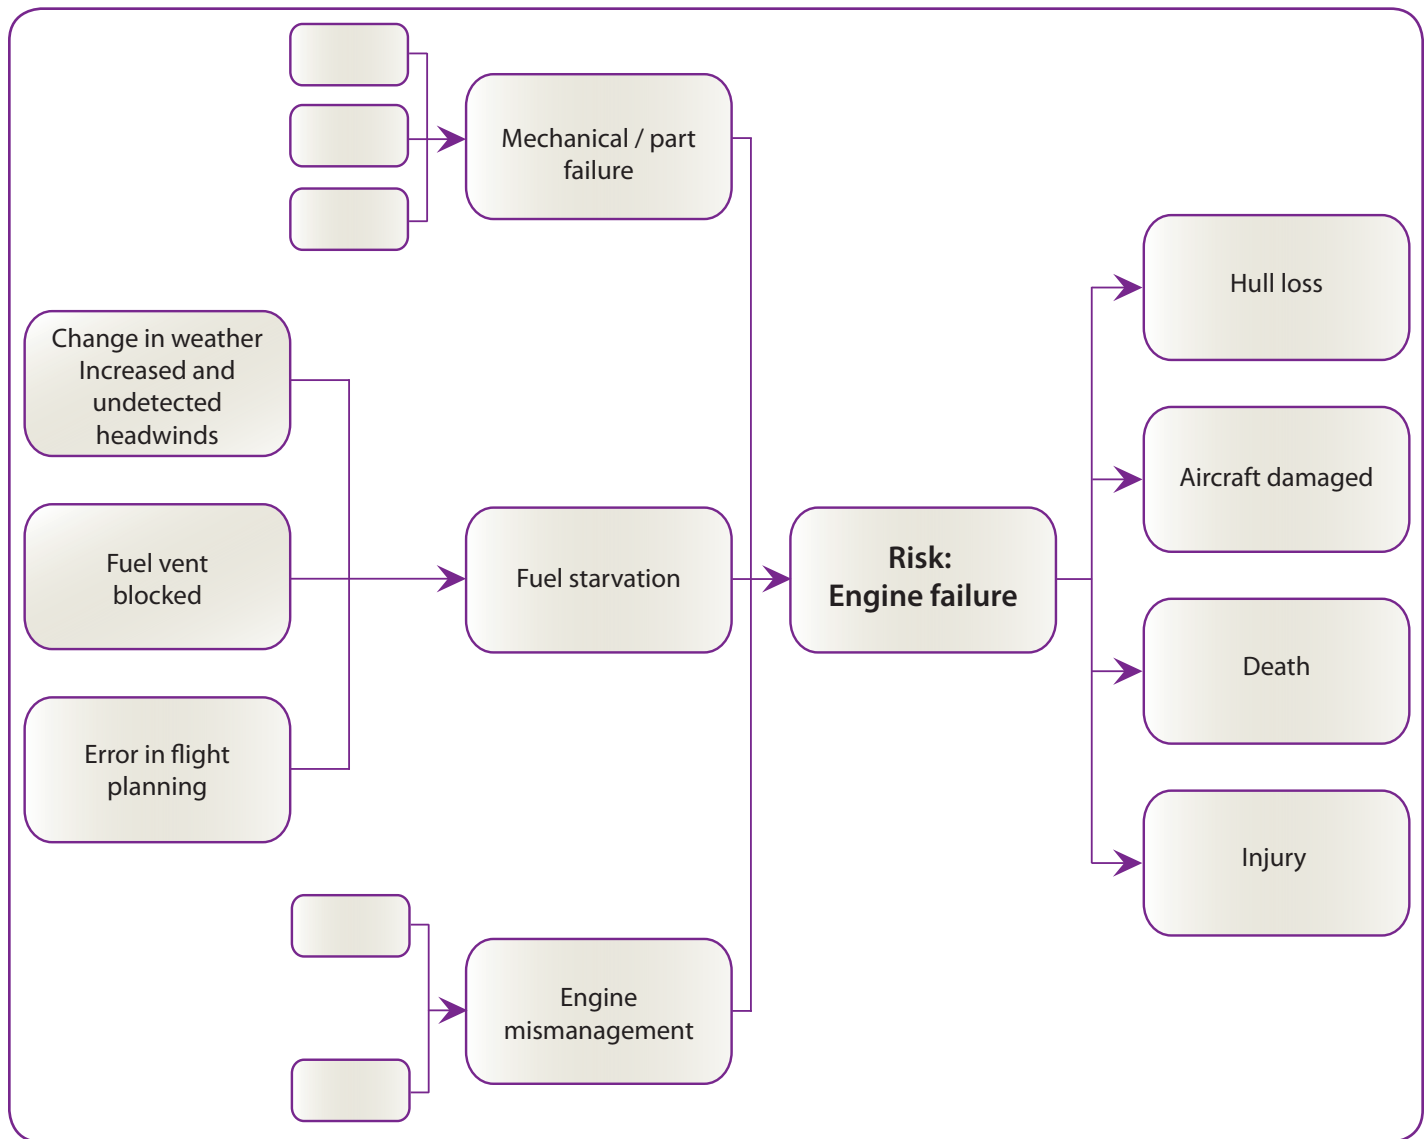
Figure 2

At this level of sophistication we may classify the types of cause. Commonly used categories are natural, economic, technical and human^{viii}. In the example in Figure 2, there are natural, technical, and human causes and each type would be mitigated differently. In addition, identifying a type of cause helps ensure that a range of possibilities has been covered. If you have natural, economic and technical causes, but have failed to consider human causes, you might wish to expand your scenario-building efforts.

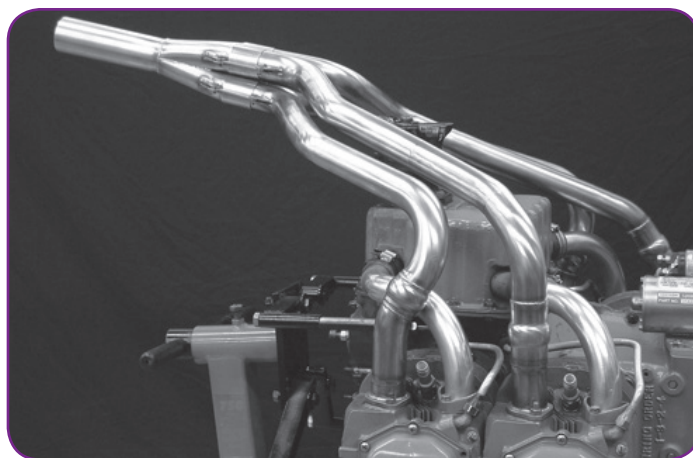
Proper exhaust system inspection is critical to safe operation.

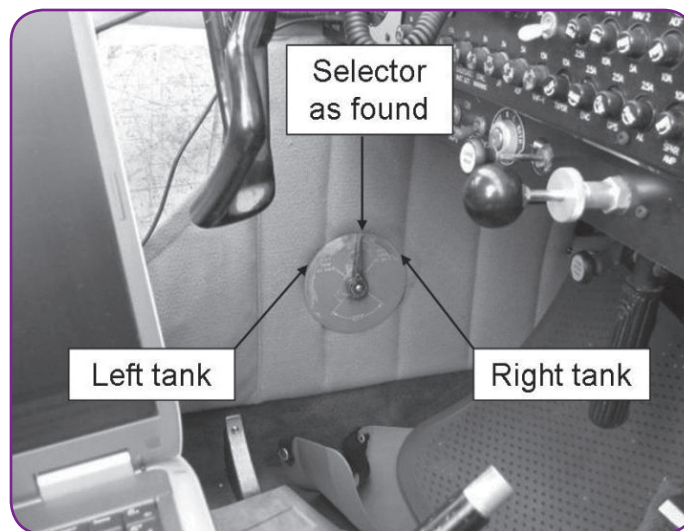
When the aircraft was recovered, the fuel selector was found positioned midway between the right and left fuel-tank selection positions. Testing of the fuel system with the engine in the accident aircraft running revealed that, by positioning the fuel selector in the midway position, the fuel flow to the engine was reduced to a fuel starvation state, followed by engine stoppage. Examination of the fuel system revealed no anomalies, with the exception of the fuel selector. The fuel selector was very difficult to move, and the detent positions were barely perceptible. The condition of the fuel selector valve assembly was consistent with a component that was not maintained in accordance with the manufacturer’s maintenance recommendations.

The fuel selector valve installed in the accident aircraft is a three-position type valve. An integral part of the valve is a tapered plug cock. This tapered plug cock, unless properly lubricated, is subject to binding or “freezing” caused by fuel coming in contact with the plug cock and gradually dissolving the film of lubricant, by the presence of foreign material, or by hardened or congealed lubricants, usually of the wrong type.

Fuel selector, as found

On June 5, 1972, Piper Aircraft Corporation issued Service Bulletin (SB) No. 355, titled *Fuel Selector Valve Lubrication*. SB No. 355 is applicable to Piper aircraft model PA-28-180 (serial numbers 28-1 to 28-7105179 inclusive), as well as to other small Piper aircraft. The primary objective of this SB is to ensure that the fuel selector valve is periodically and properly inspected and lubricated. The compliance time was within 10 hr of operation of the effective date indicated on the SB. The inspection/maintenance provisions of this SB were to be repeated at: each 100-hr interval, until the aircraft reached 400 hr of operation; then every additional 400 hr of operation or annually, whichever occurred first; or whenever the fuel selector valve was difficult to operate. This SB had not been completed on the occurrence aircraft, nor was the owner aware of its existence.

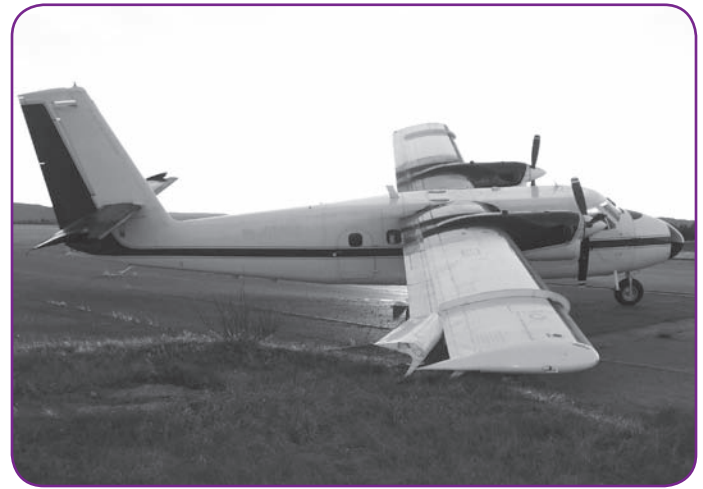
TSB Final Report A06A0114—Collision with Obstacle During Takeoff

On November 6, 2006, a de Havilland DHC-6-300 Twin Otter had been converted from float to wheel landing gear and was being repositioned from the Marine Atlantic dock to the Goose Bay, N.L., airport. During the takeoff from the dock, the main wheels of the aircraft struck a wooden safety curb that surrounded the dock perimeter. After visually inspecting the landing gear in flight, the pilots continued the planned flight and landed at the Goose Bay airport. On landing, the right main gear collapsed and separated from the aircraft. The aircraft veered to the right and came to rest on a taxiway on the right side of the runway. There was damage to the right landing gear, the right wing tip, and the outboard

aileron hinge. There were no injuries to the two pilots on board. The accident occurred at 16:31 Atlantic Standard Time (AST), during daylight hours.

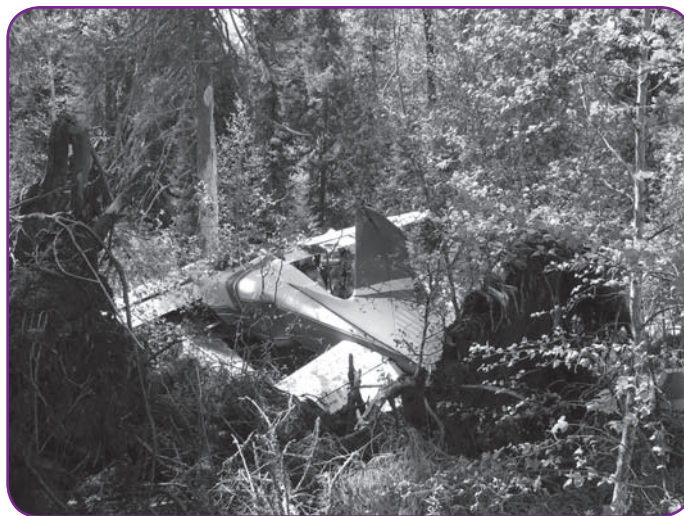
Damage to the aircraft was consistent with an impact with the ground after a low-level wing stall. The aircraft's exact flight path could not be determined. However, conditions were conducive for low-level wind shear at the time of the accident, and the aircraft was configured for takeoff or manoeuvring flight. A possible accident scenario is that the aircraft encountered wind shear while

manoeuvring in the vicinity of the operator's boat cache north of Miller Lake, resulting in a stall at an altitude from which the pilot could not recover.

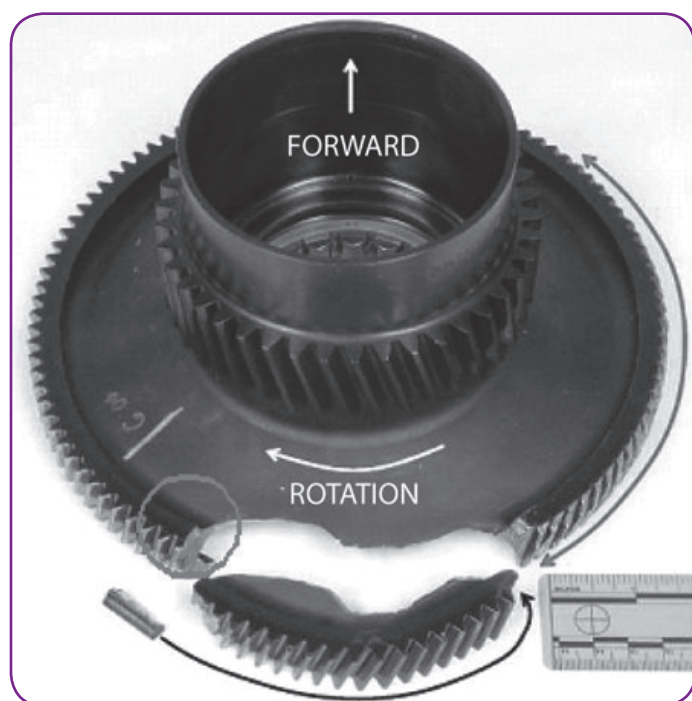
Broken torquemeter gear

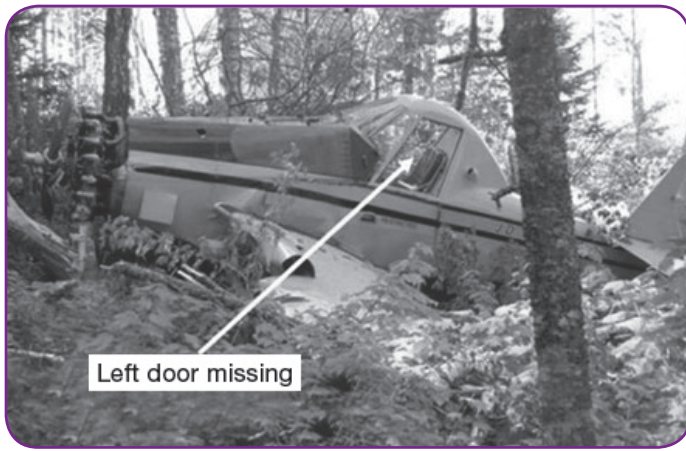
Aircraft's final position

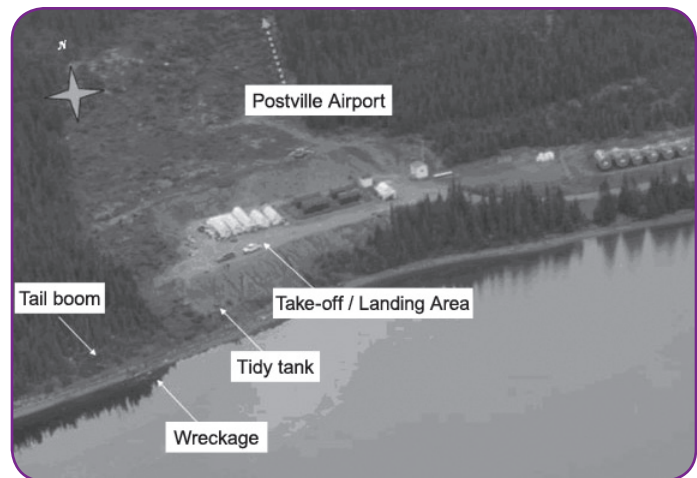
Photograph of accident area

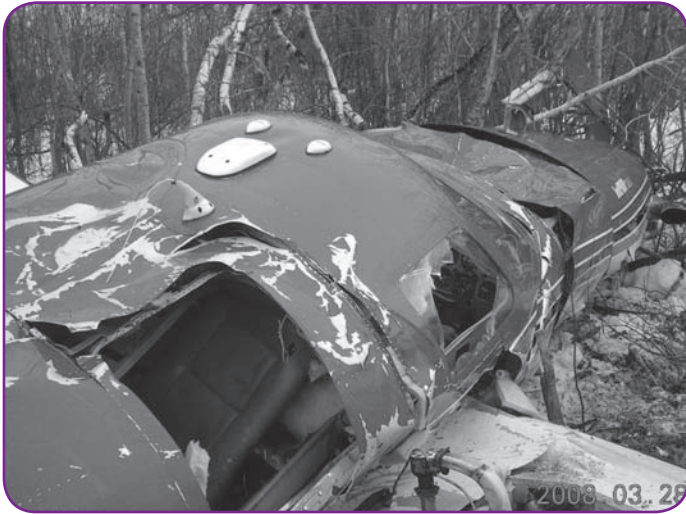
The aircraft was observed on radar to make several heading and altitude changes before commencing a right turn and a steep descent, after which the radar target was lost. An emergency locator transmitter (ELT) signal was received by the Lloydminster, Alta., flight service station (FSS) for about 1½ min before it stopped. The wreckage was found by the Royal Canadian Mounted Police (RCMP) about 16 NM northeast of Wainwright, Alta., at about 12:05 MDT. None of the five people on board survived.

1. The gyro-horizon failed due to excessive wear on bearings and other components, resulting from a lack of maintenance and due to a vacuum system that was possibly not at minimum operating requirements for the instrument.
