## **Fire Performance of Houses**

### **Study of Unprotected Floor Assemblies in Basement Fire Scenarios**

### **Part 1 – Results of Tests UF-01 and UF-02 (Solid Wood Joists)**

Research Report: IRC-RR-246

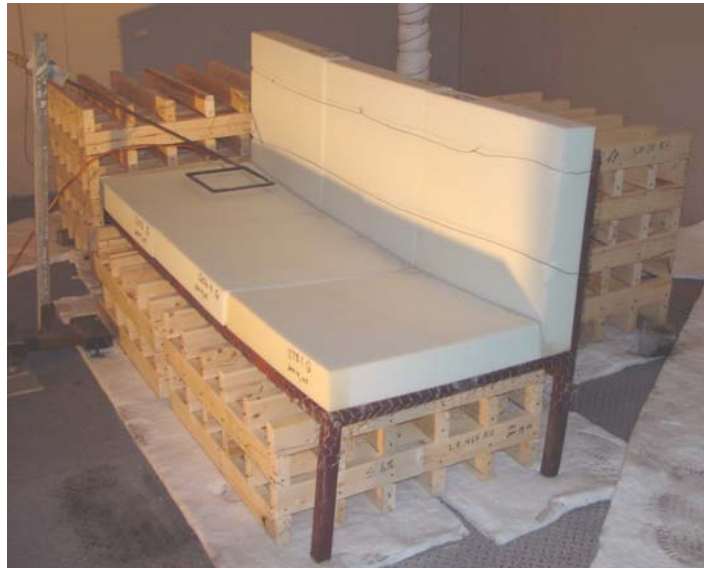
**Figure 6.** Fuel package

The selection of the fuel load and its arrangement in the fire compartment was a critical element in this experimental work. A study was conducted to select the fire scenario and fuel package, which was used in this phase of the project [6]. This fuel package consisted of a mock-up sofa constructed with 9 kg of exposed polyurethane foam (PUF), the dominant combustible constituent of upholstered furniture, and 190 kg of wood cribs beside and underneath the mock-up sofa. A photograph of the fuel package is shown in Figure 6. The mock-up sofa was constructed with 6 blocks of flexible polyurethane foam (with a density of  $32.8 \text{ kg/m}^3$ ) placed on a metal frame. Each block was 610 mm long by 610 mm wide and 100 mm or 150 mm thick. The 150-mm thick foam blocks were used for the backrest and the 100 mm thick foam blocks for the seat cushion. The PUF foam was used without any upholstery fabric that is used in typical upholstered furniture. The wood cribs were made with spruce lumber pieces, each piece measuring 38 mm x 89 mm x 800 mm. For the small cribs located under the mock-up sofa, four layers with six pieces per layer were used. The other two cribs used eight layers.

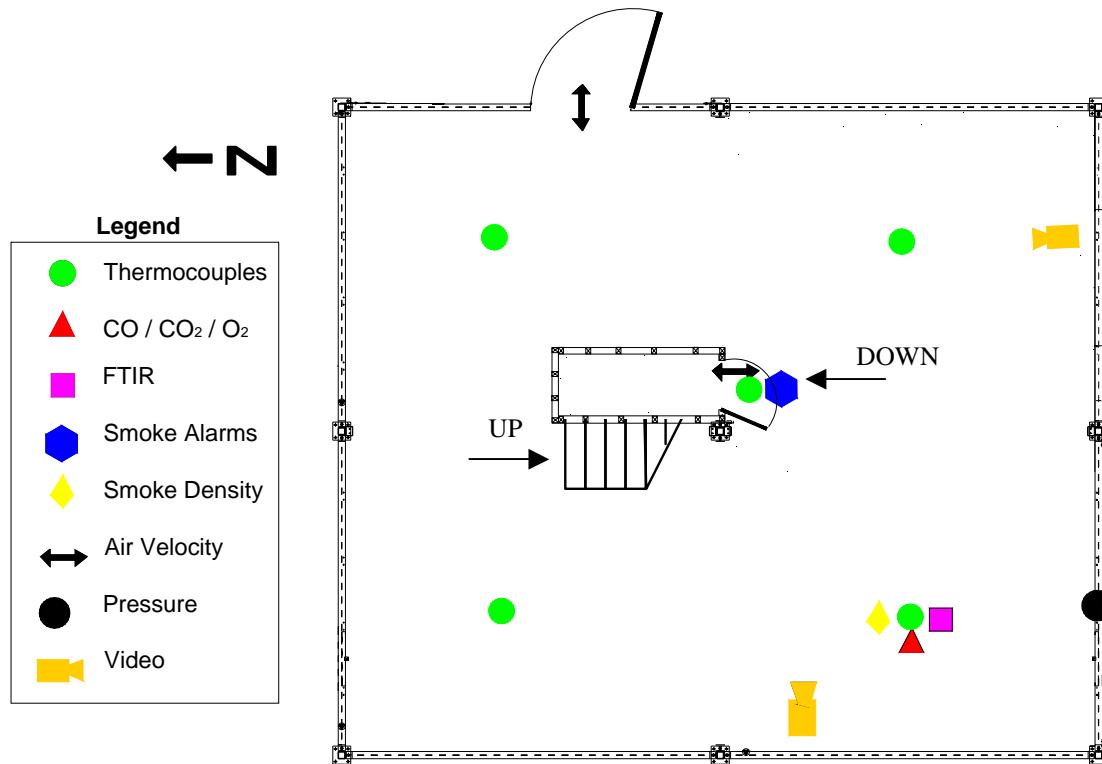
The positioning of the instrumentation on the first storey is shown in Figure 9.

**Figure 9. First storey instrumentation**

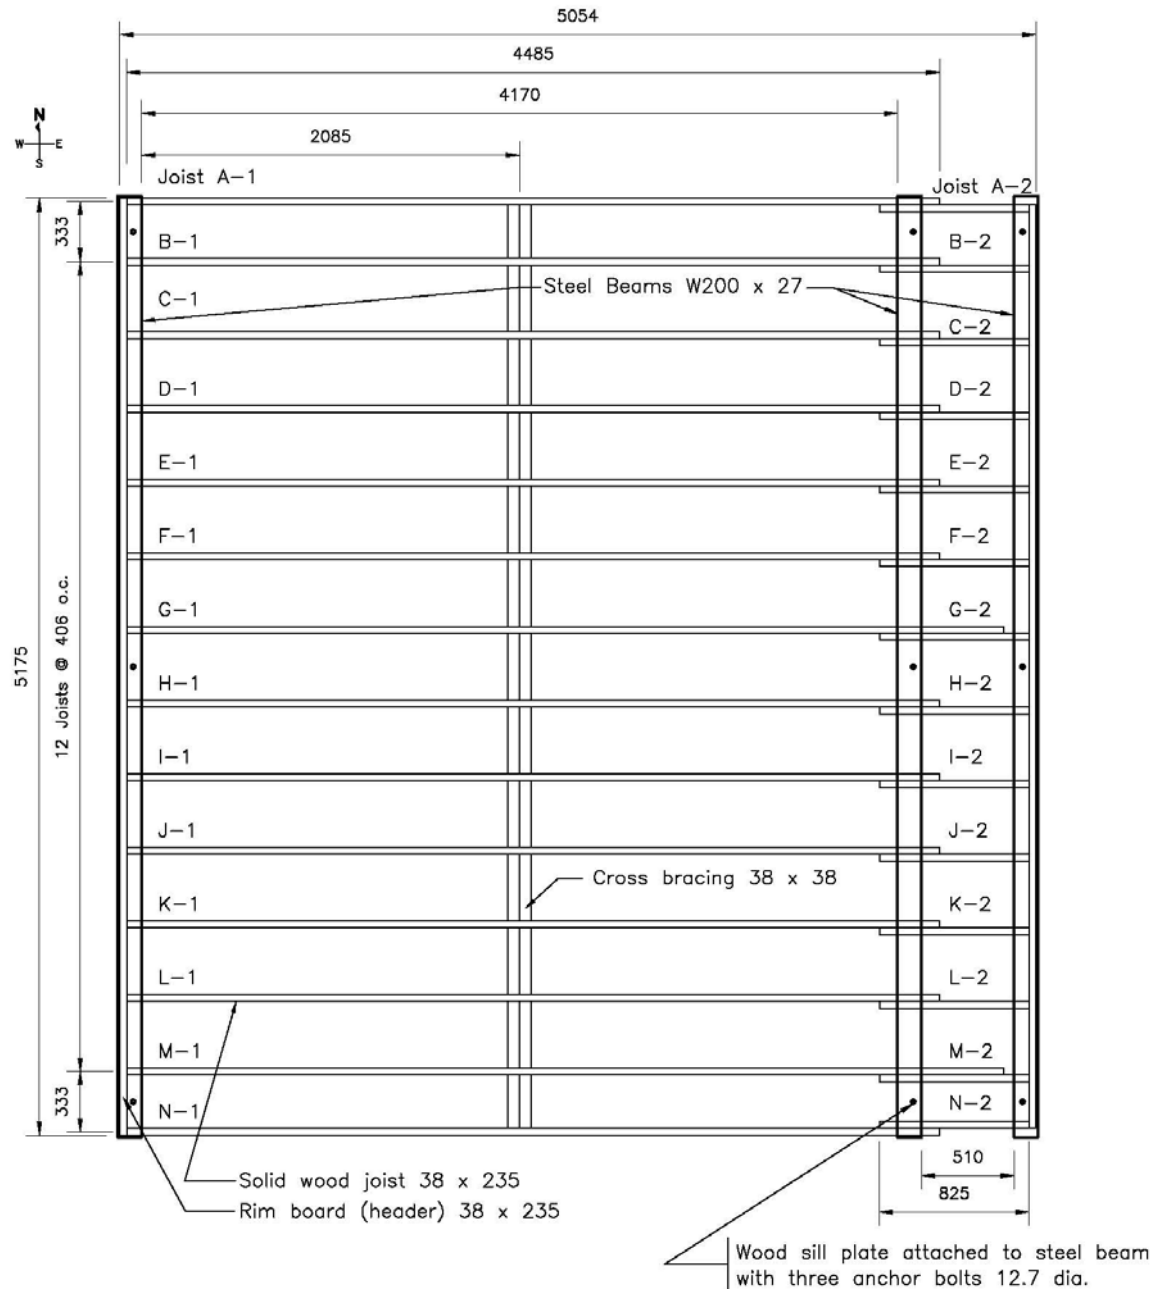
**Figure 11. Solid wood joist layout details** (all dimensions in mm).

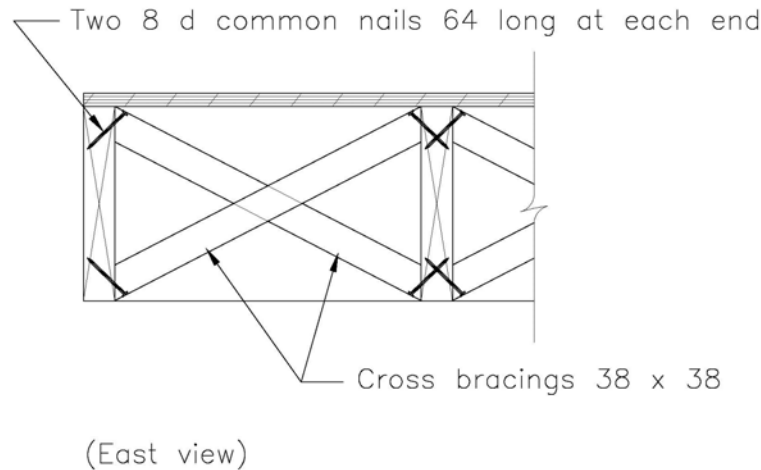
**Figure 14. Cross bracing details** (all dimensions in mm).

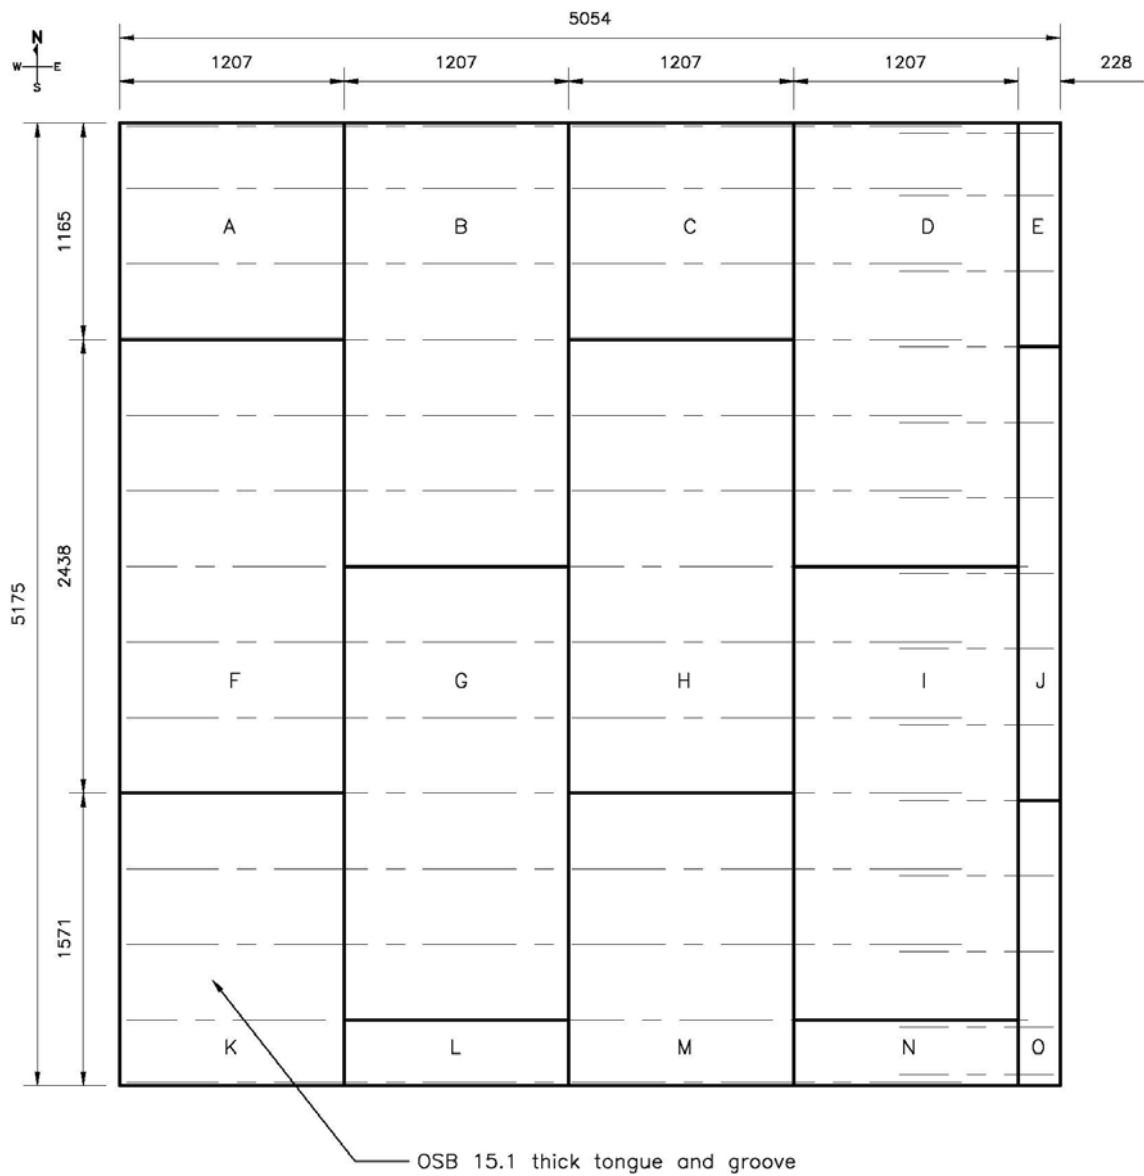
**Figure 15. Subfloor layout** (all dimensions in mm).

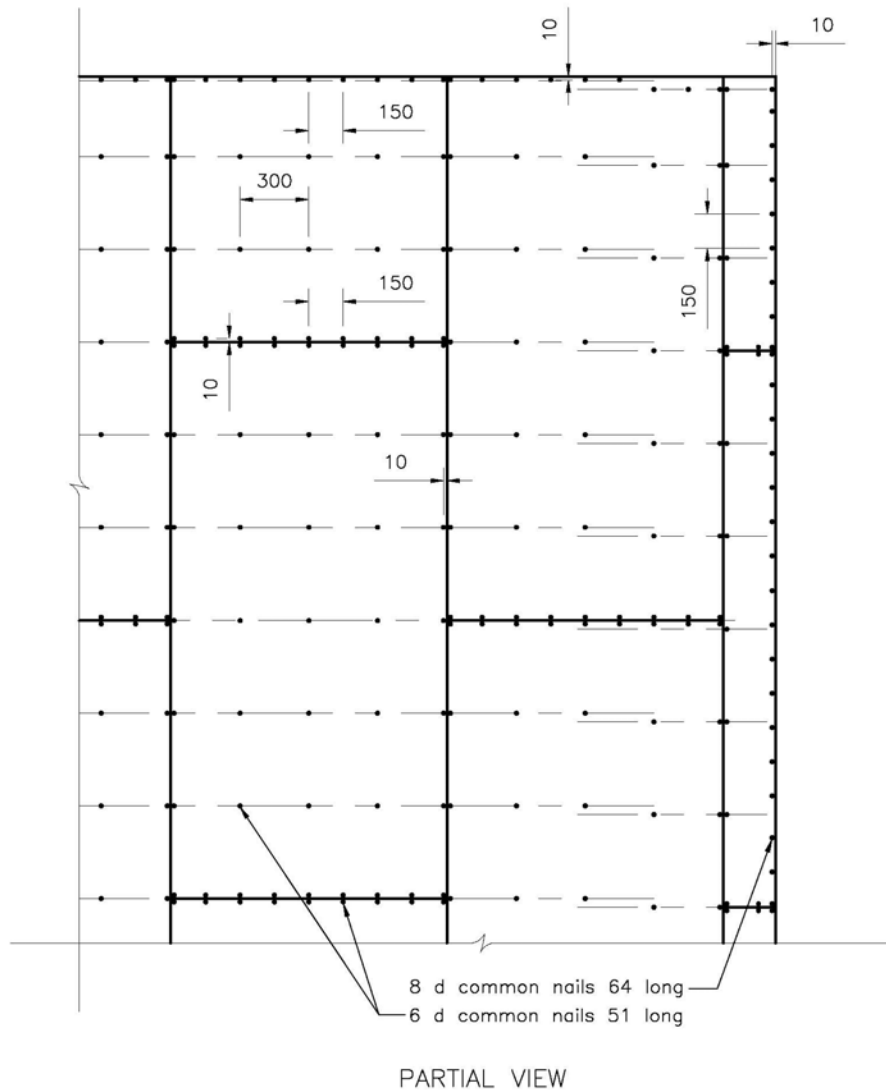
OSB was used as the subfloor material in the floor assemblies. The specific OSB material used was selected based on a separate study documented in reference [5]. The subfloor panels were 15.1 mm thick in both assemblies, with a full panel size being 1.2 x 2.4 m. The longer panel edges had a tongue and groove profile while the short panel edges were square-butt ends. Figure 15 shows the layout of the subfloor. The nailing pattern and description of nails used to attach the OSB panels to the wood joists and rim board (header) are shown in Figure 16.

**Figure 16. Subfloor nail pattern and nail description** (all dimensions in mm).

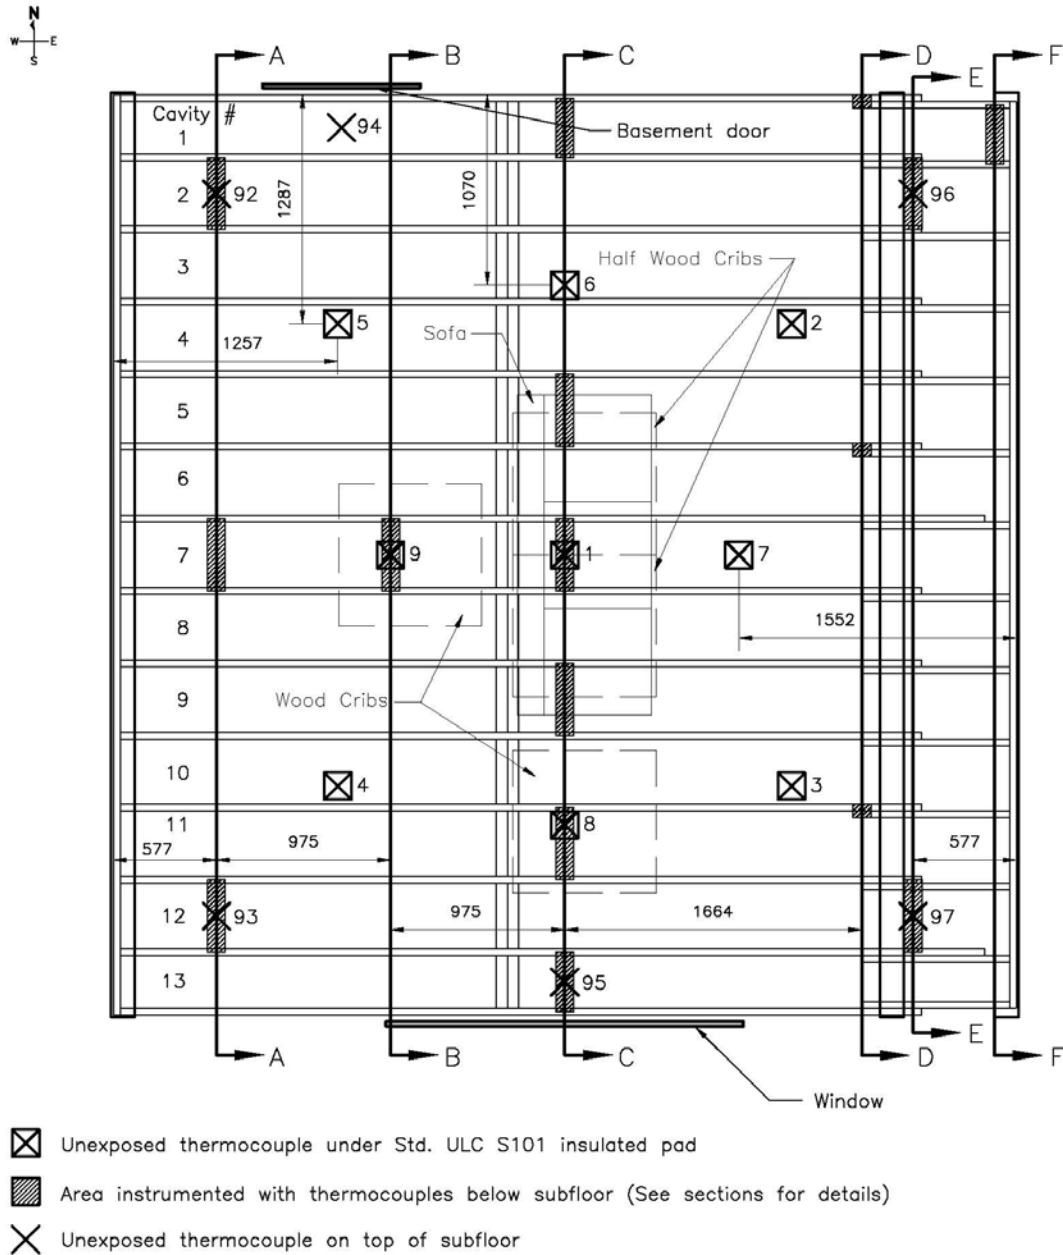
Ninety-seven Type K (20 gauge) chromel-alumel thermocouples, with a thickness of 0.91 mm, were used for measuring temperatures at a number of locations throughout each assembly. The thermocouple locations on the unexposed and exposed sides of the assemblies are shown in Figure 17 and Figure 18. These locations were chosen to monitor the conditions of the assembly at critical locations during the fire tests.

**Figure 17. Thermocouples locations** (all dimensions in mm).

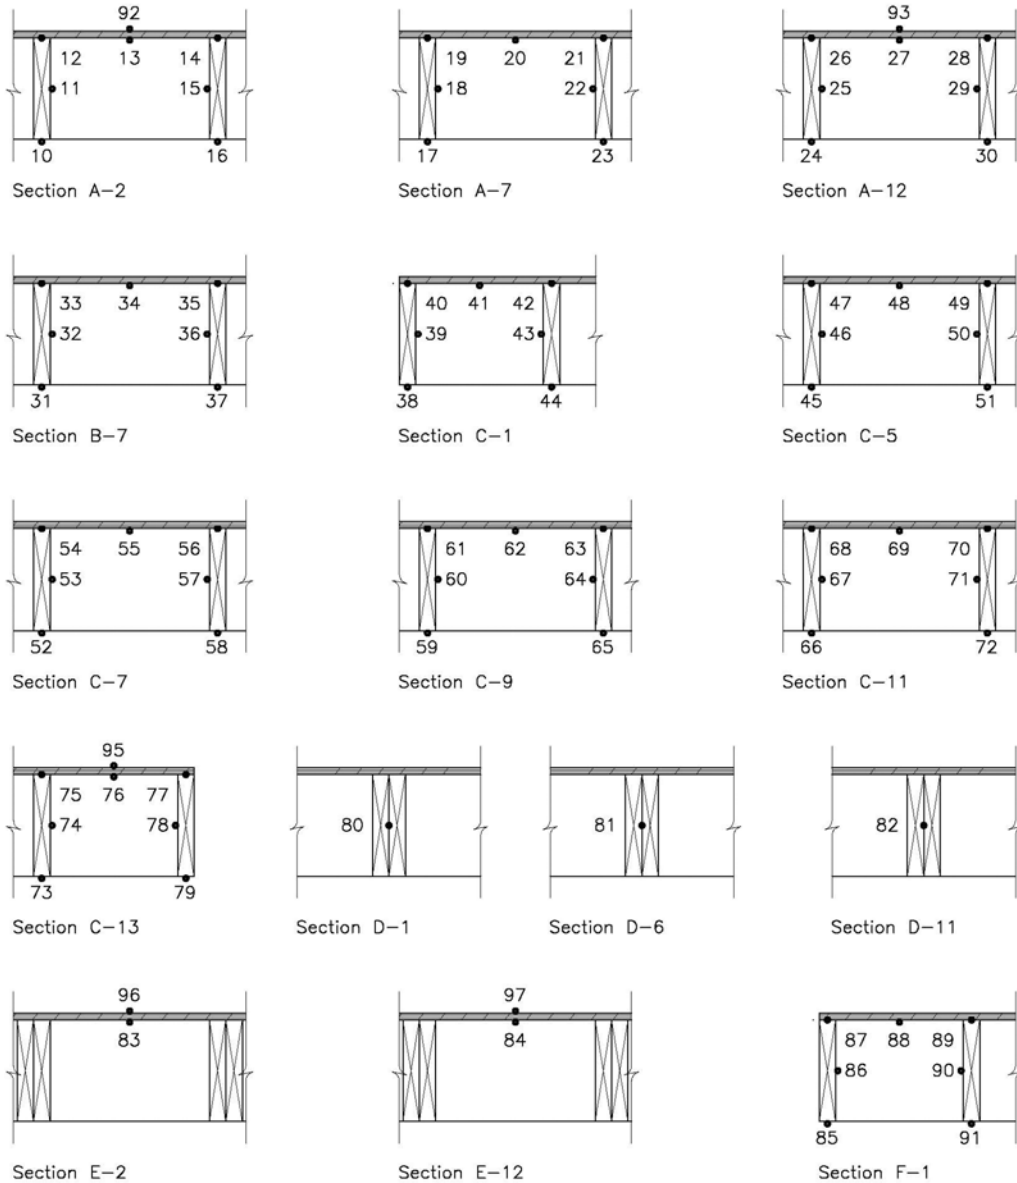
**Figure 18. Thermocouples locations reflecting the different sections shown in Figure 17**

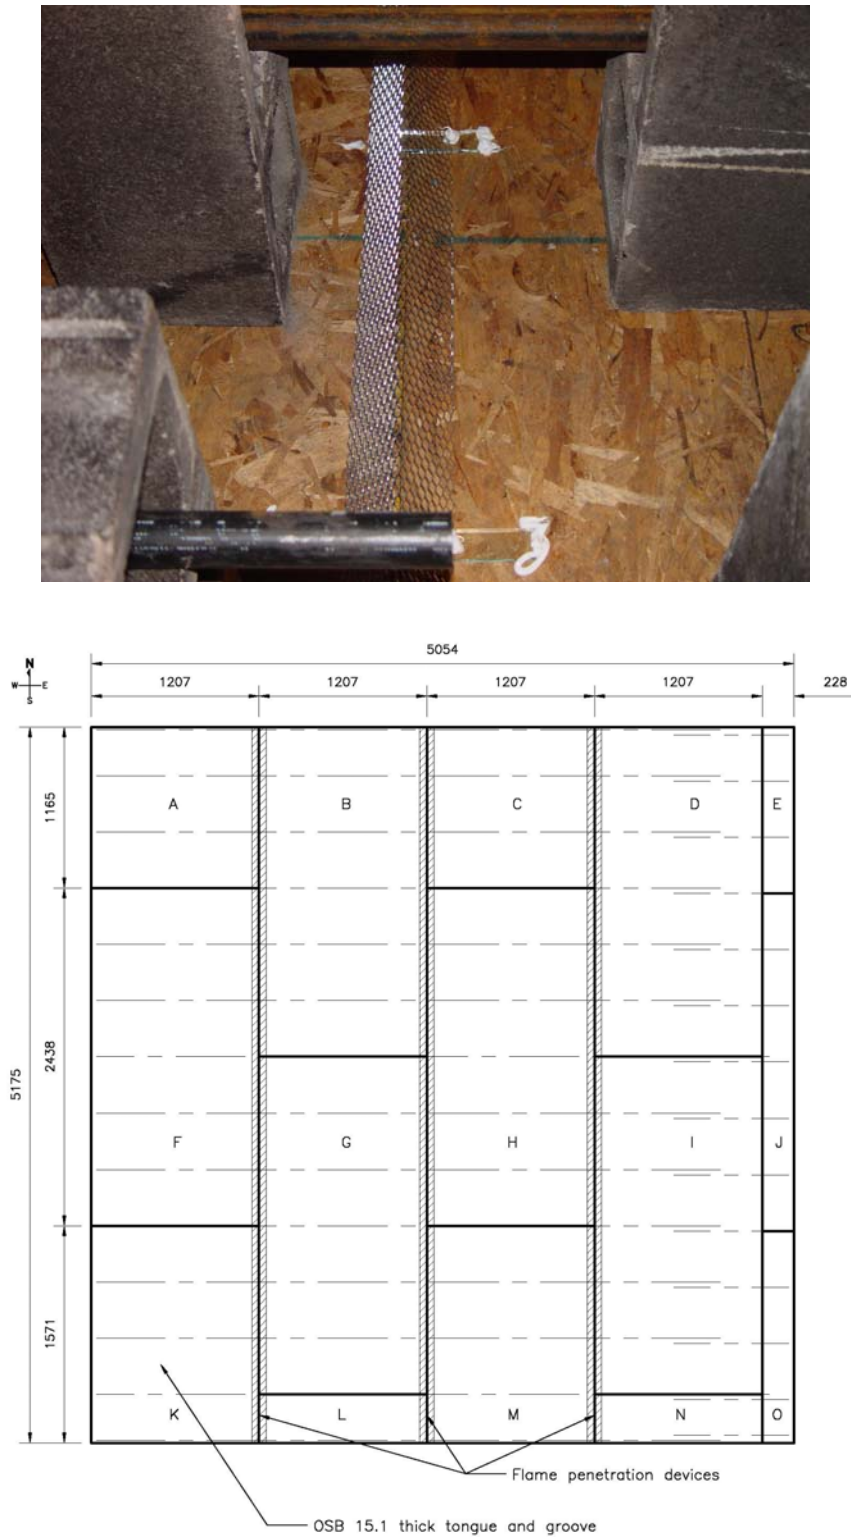
Flame penetration through the floor assembly is considered to be an initial indicator of the impending failure of the assembly. For test UF-01, cameras on the first storey were used to observe the flames penetrating through the floor. However, the visibility during the test was too poor for the cameras to see the flame penetration; consequently, a device was developed and used for the remaining tests to better determine the time for flames to penetrate the floor. The special device consisted of a wire mesh placed at 3 locations on the unexposed surface of the floor assembly, specifically at three of the

tongue and groove joints, as shown in Figure 19. A detailed description of the device is provided in reference [8]

**Figure 19. Wire mesh device to detect flame penetration** (all dimensions in mm).

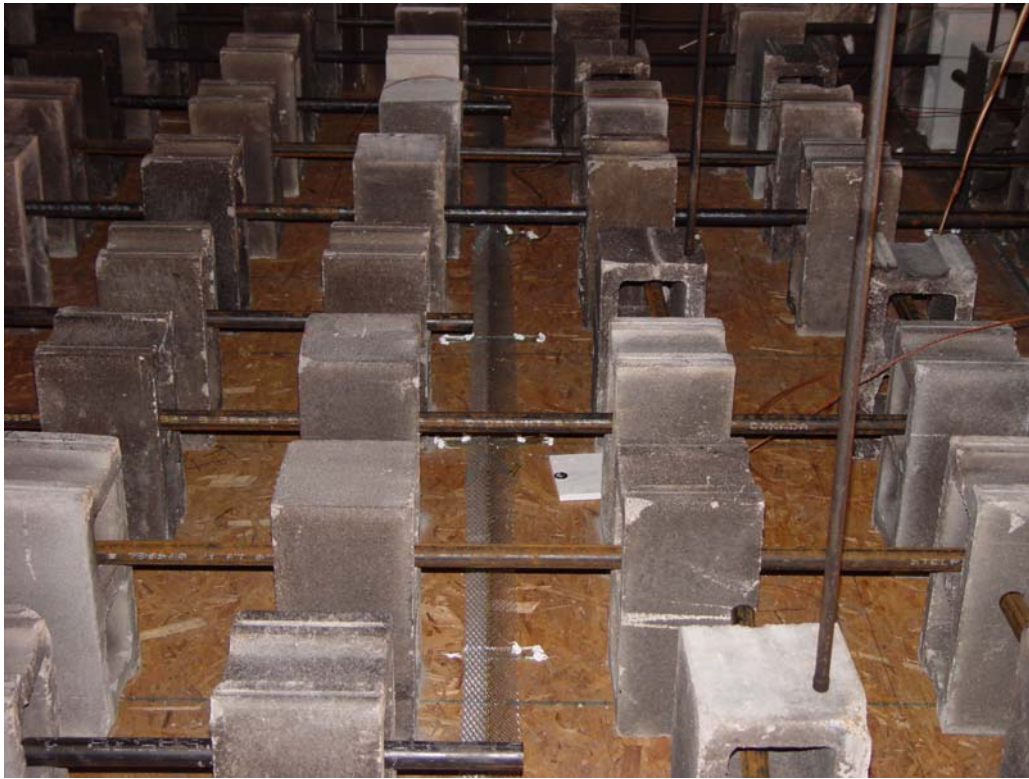
The loading method consisted of 144 hollow concrete blocks (totalling 2490 kg) distributed uniformly on the floor as shown in Figure 20. The blocks were 190 x 190 x 390 mm (nominal 8" x 8" x 16") and weighed 17.3 kg each. To prevent the blocks from falling into the basement and causing any damage, a restraining system was designed using a series of pipes attached to beams on both ends, which were secured to the steel frame of the 3-storey house, as shown in Figure 21. The pipes were inserted through the hollow cores of the concrete blocks prior to the fire tests. The weight of the pipes was included in the total imposed load.

**Figure 21. Loading blocks restraining system**

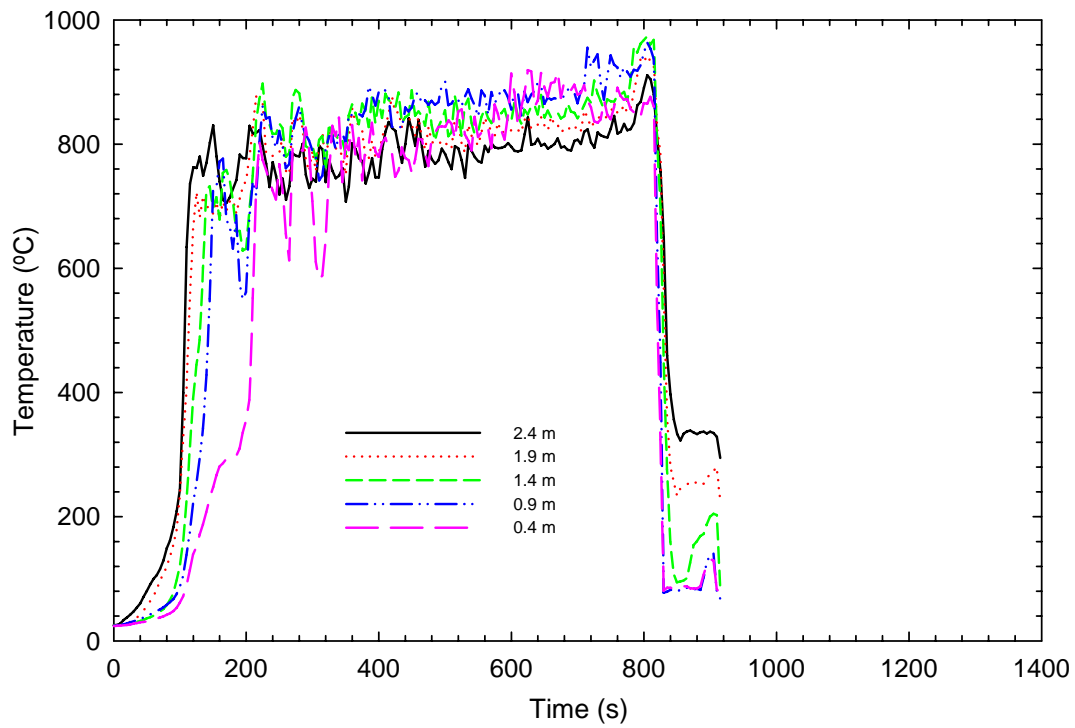
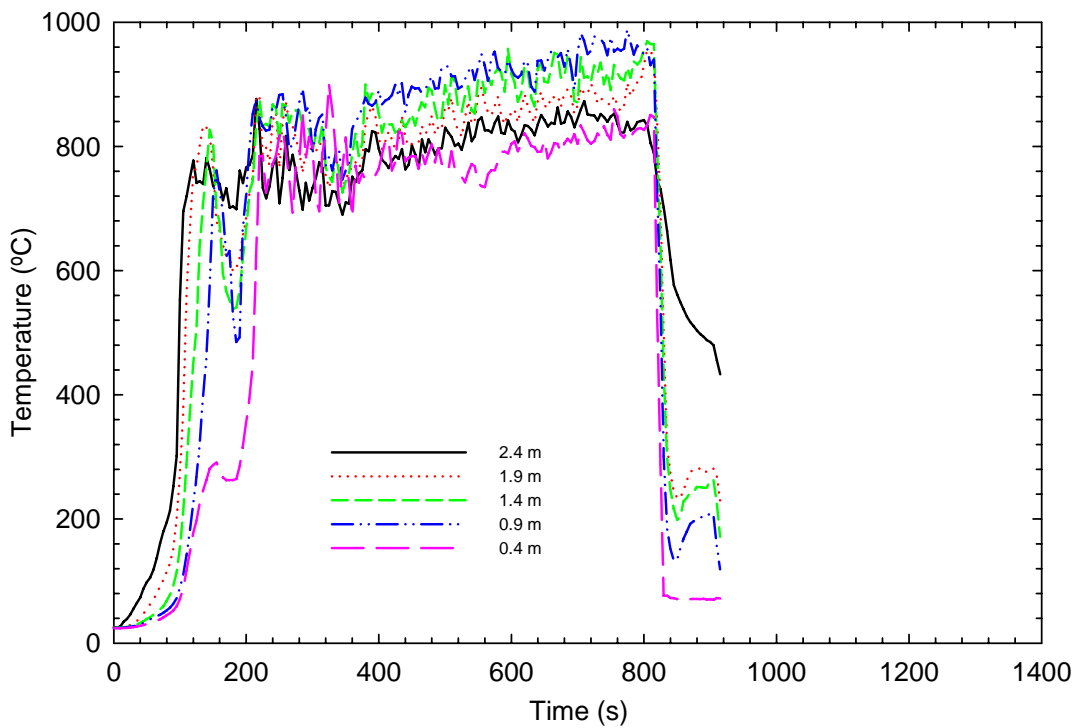
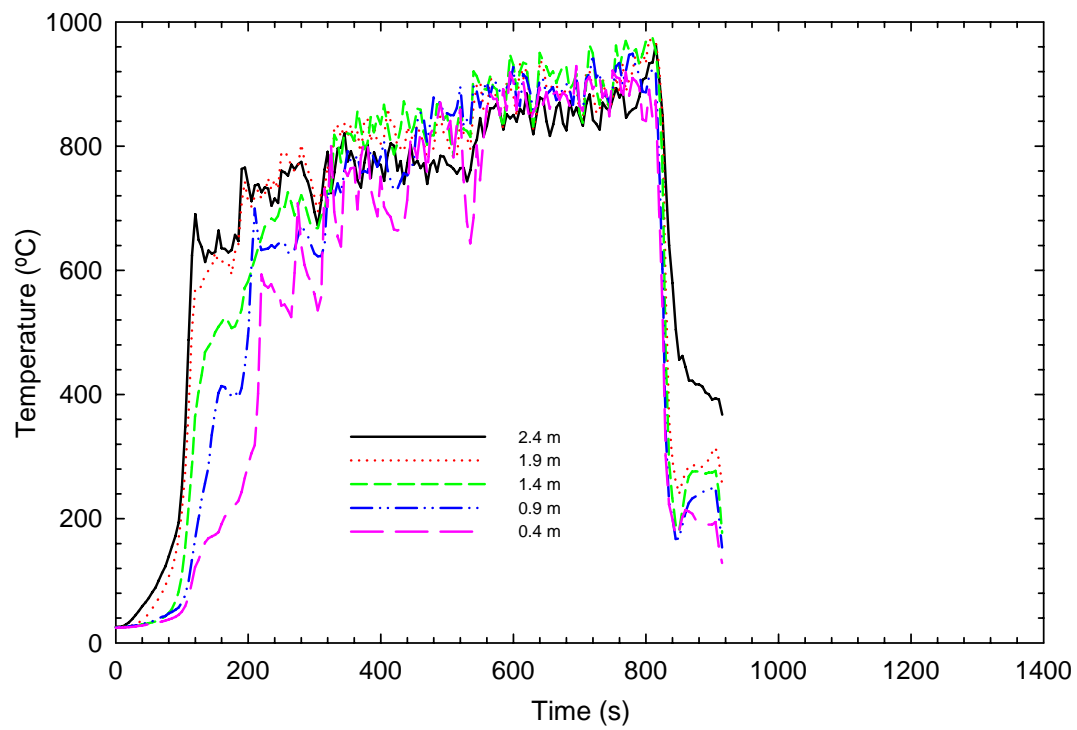
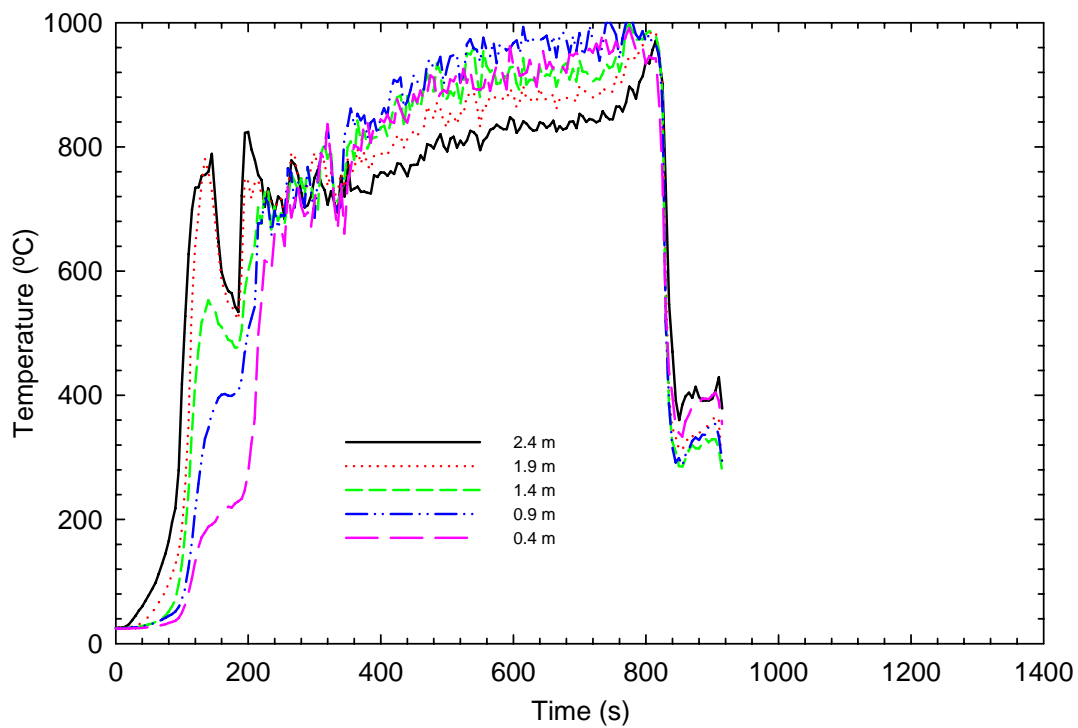
In the case of UF-01 (open basement doorway), Figure 22, the temperatures rose to a maximum of 700 to 800°C in the first 120 s. The initial peak temperature was likely due to the high rate of heat release from the mock-up sofa near its peak burning rate. As shown in the figures, the initial temperature rise was faster at the 2.4 m height than the other heights because the hot smoke layer formed first at the ceiling and flames also impinged on the ceiling.

Just after the maximum temperature was reached, there was a slight decrease in temperatures likely due to the combined effect of opening the basement window at 105 s and the fact that a significant portion of the polyurethane foam component of the fuel package had been consumed. The temperatures decreased further after the exterior door was opened, which created a movement of air and smoke between the basement and first storey. The fresh air coming from the basement window also increased the combustion of the wood cribs and the exposed floor assembly, which caused the temperatures to begin increasing steadily again, reaching a maximum temperature of just under 1000°C.

It should be noted that the first peak in the temperature (due to the mock-up sofa burning) was lowest in the case of the NE tree. This may be partially attributed to the fact that the NE corner was the least impacted by the fire, as it was farthest away from the fire source and that most of the hot gases were moving to the upper storeys through the SE to NW path.

**Figure 22 (a and b). TC Trees in the basement for UF-01**

**Figure 22 (c and d). TC Trees in the basement for UF-01**

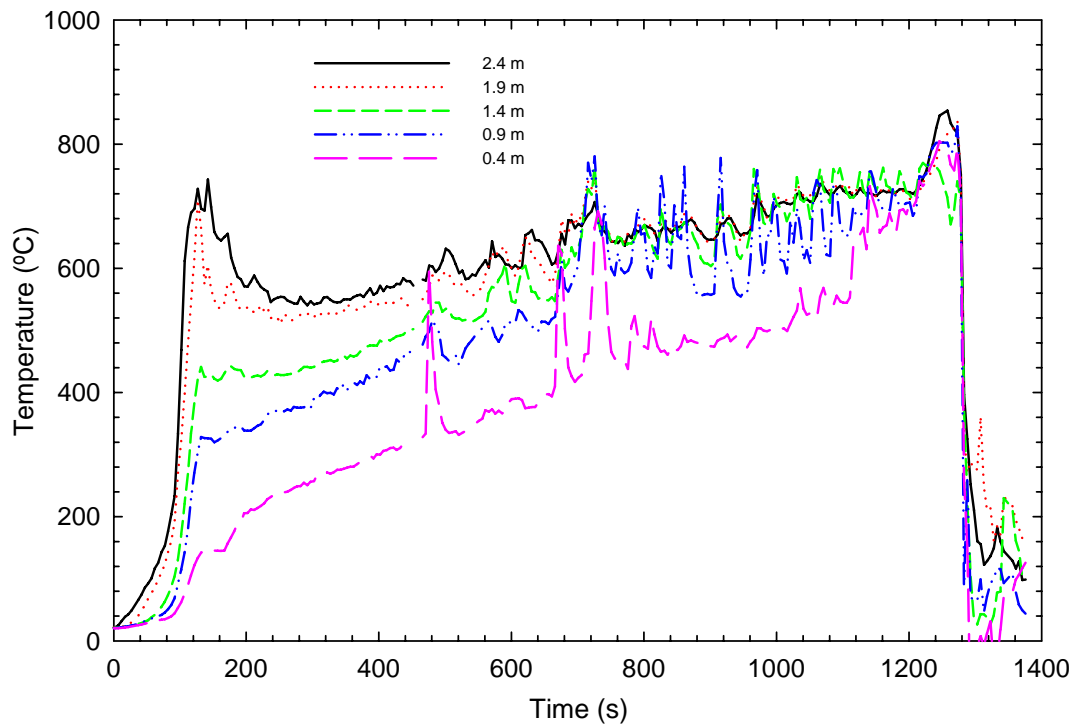
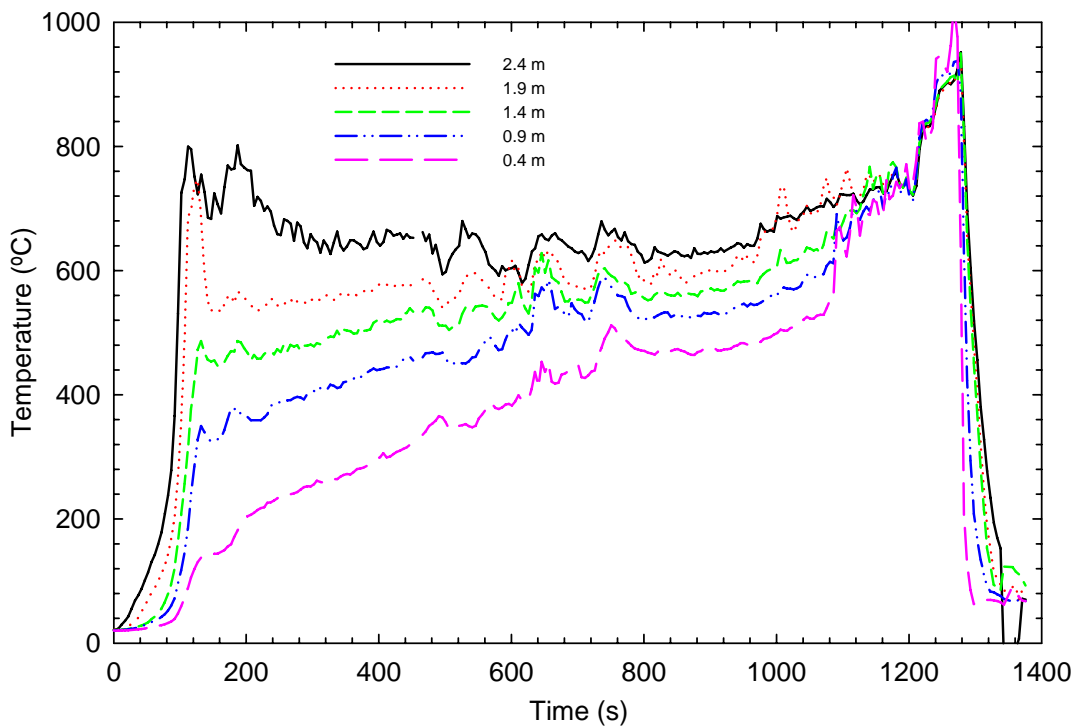
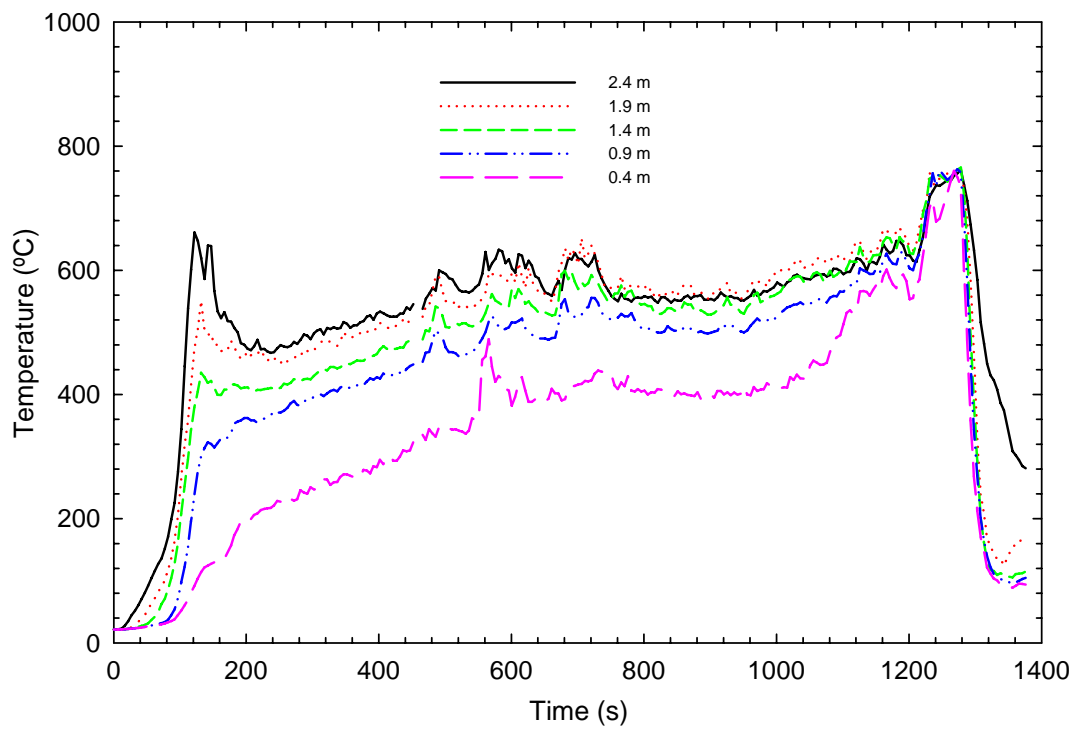
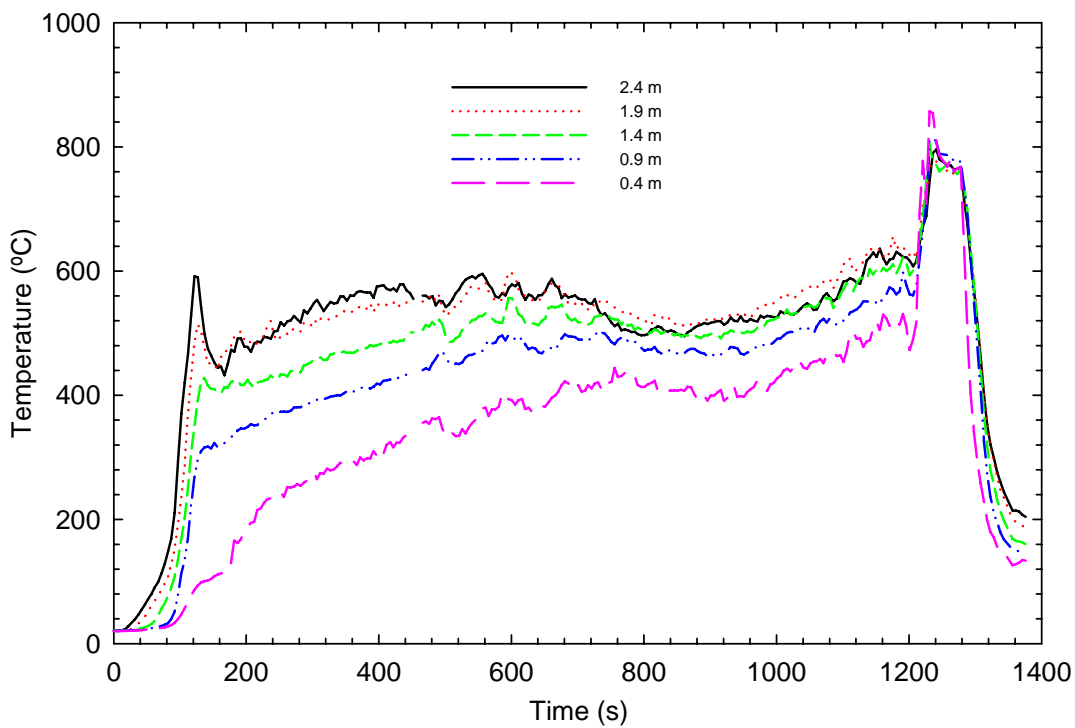
For both UF-01 and UF-02, the combustion was dominated by the mock-up sofa during the first 120 to 180 s, while the wood cribs and floor assembly, including the subfloor, provided the fuel for combustion after this period. The duration of the fire was shorter for UF-01 compared to UF-02 because the availability of more air in Test UF-01 resulted in faster and more efficient combustion. For UF-02, combustion air was limited until late in the test.

**Figure 23 (a and b). TC Trees in the basement for UF-02**

**Figure 23 (c and d). TC Trees in the basement for UF-02**

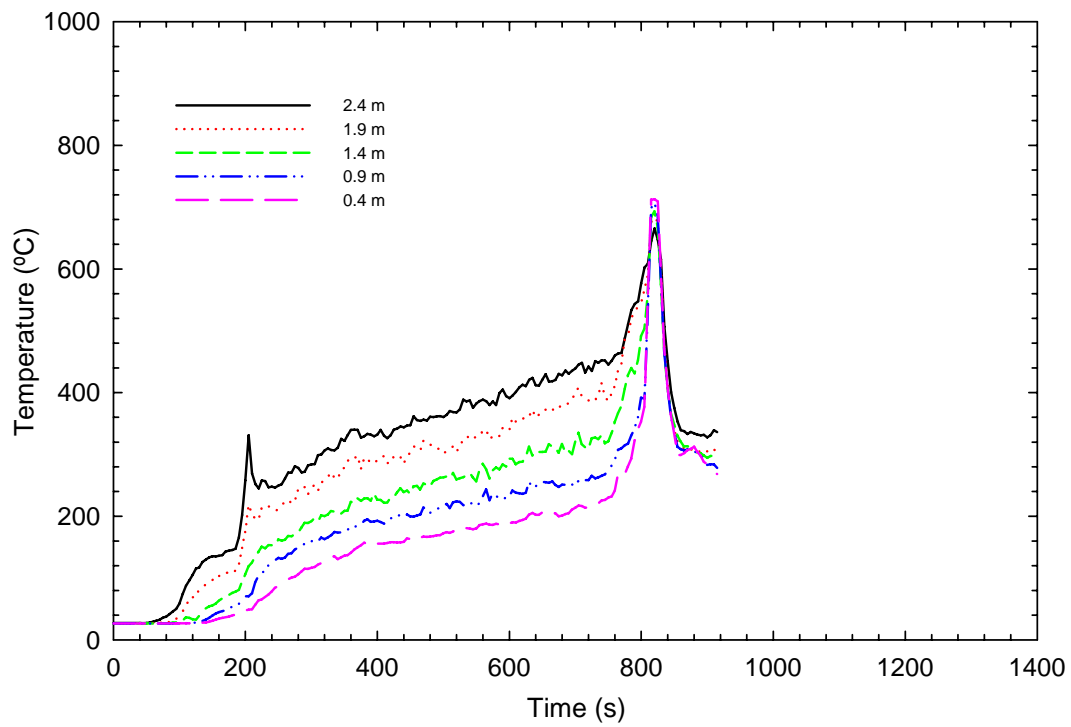
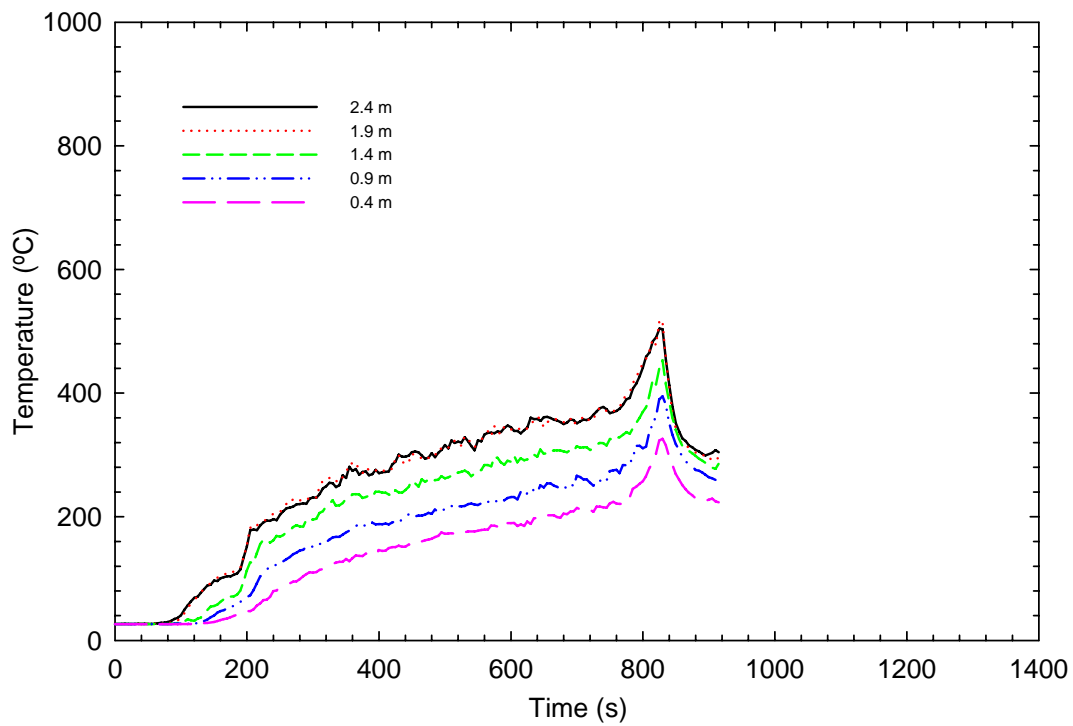
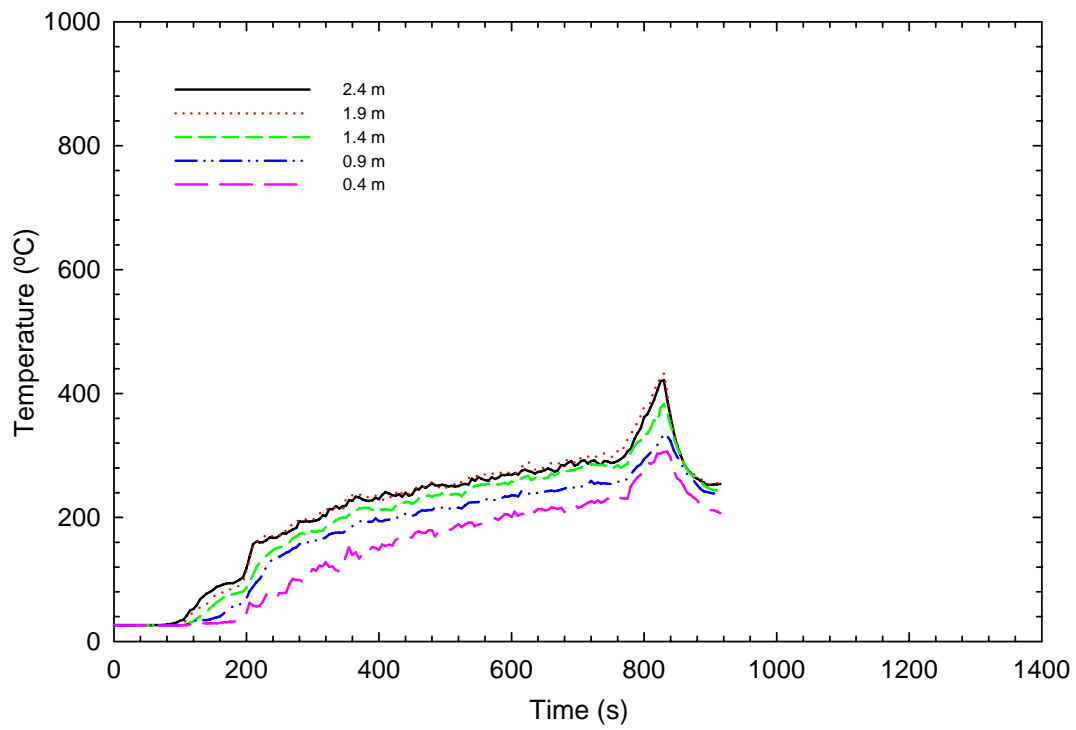
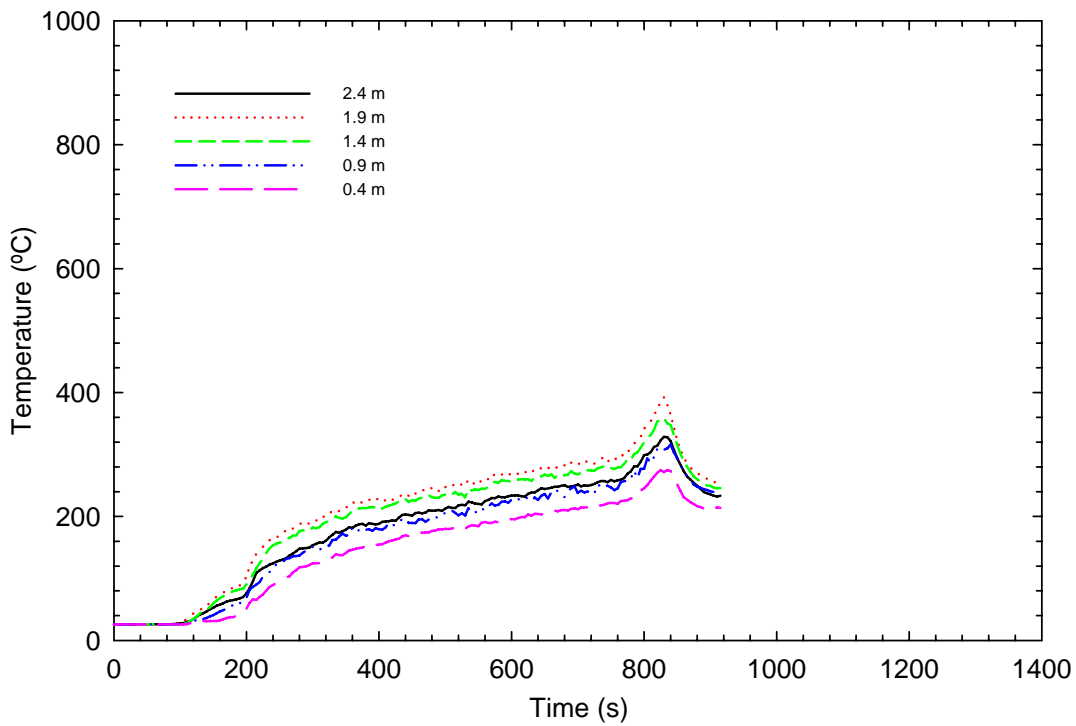
**Figure 24 (a and b). TC trees in the first storey for UF-01**

**Figure 24 (c and d). TC trees in the first storey for UF-01**

The temperatures recorded in the first storey for test UF-02 were much lower before flame penetration occurred than those recorded in UF-01. After flame penetration, temperatures in UF-02 showed a very sharp increase compared to UF-01. The peak values were also higher for UF-02 than UF-01.
