## **Fire Performance of Houses**

### **Study of Unprotected Floor Assemblies in Basement Fire Scenarios**

### **Part 1 – Results of Tests UF-01 and UF-02 (Solid Wood Joists)**

Research Report: IRC-RR-246

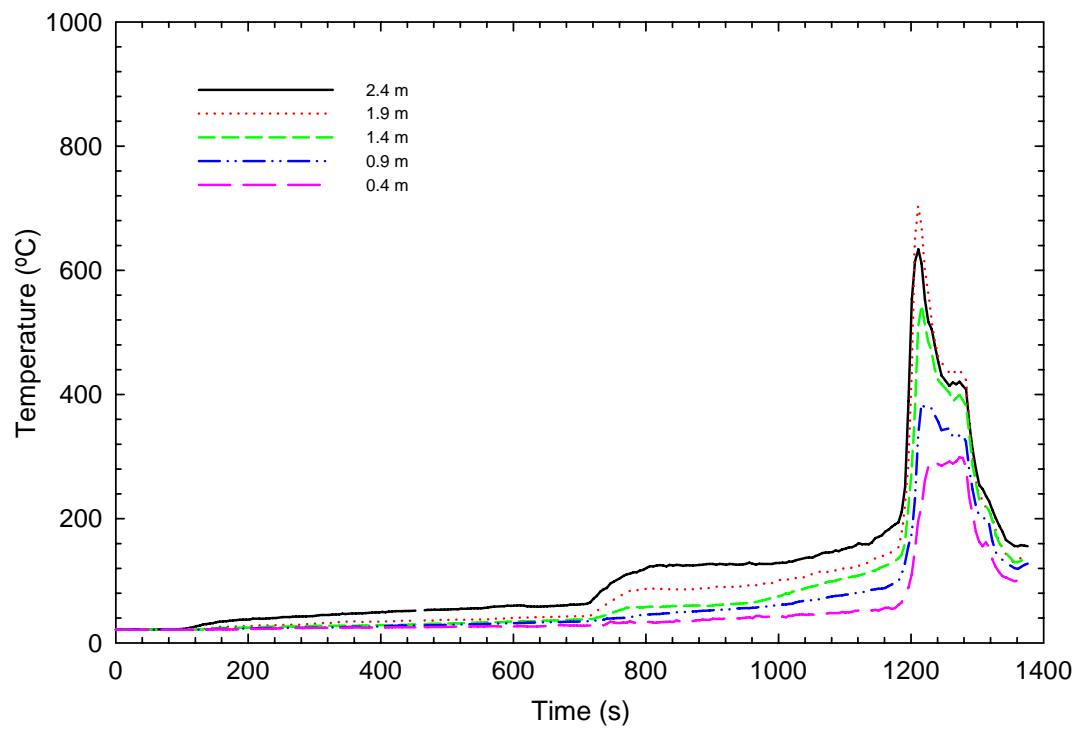
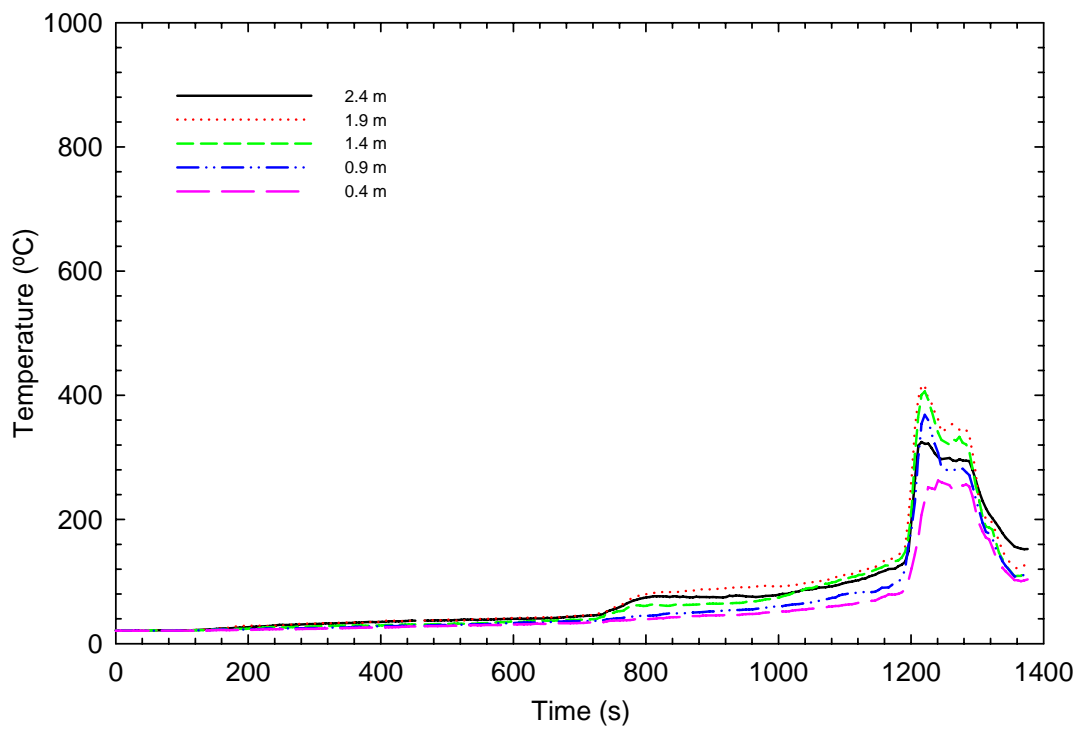
In the case of UF-02 (closed basement doorway), Figure 25, the temperatures increased very slowly mainly because the doorway was closed and the only source of heat being through the floor assembly from below. The migration of the hot gases and smoke to the first storey did not start until late in the test when openings started forming in the floor or from the burning of the basement door. The highest temperatures were recorded at the SE tree because the fire in the basement was positioned just under the location of this thermocouple tree. The temperatures measured at the other three thermocouple tree locations were comparable. At around 1160 s, all the trees showed a sharp increase in temperatures, which may be an indication that flames had penetrated through the floor. The peak temperatures were 850, 620, 640 and 400°C for SE, SW, NE and NW, respectively. After about 1240 s, the test was terminated; consequently the temperatures started decaying because of the extinguishment of the fire.

**Figure 25 (c and d). TC trees in the first storey for UF-02**

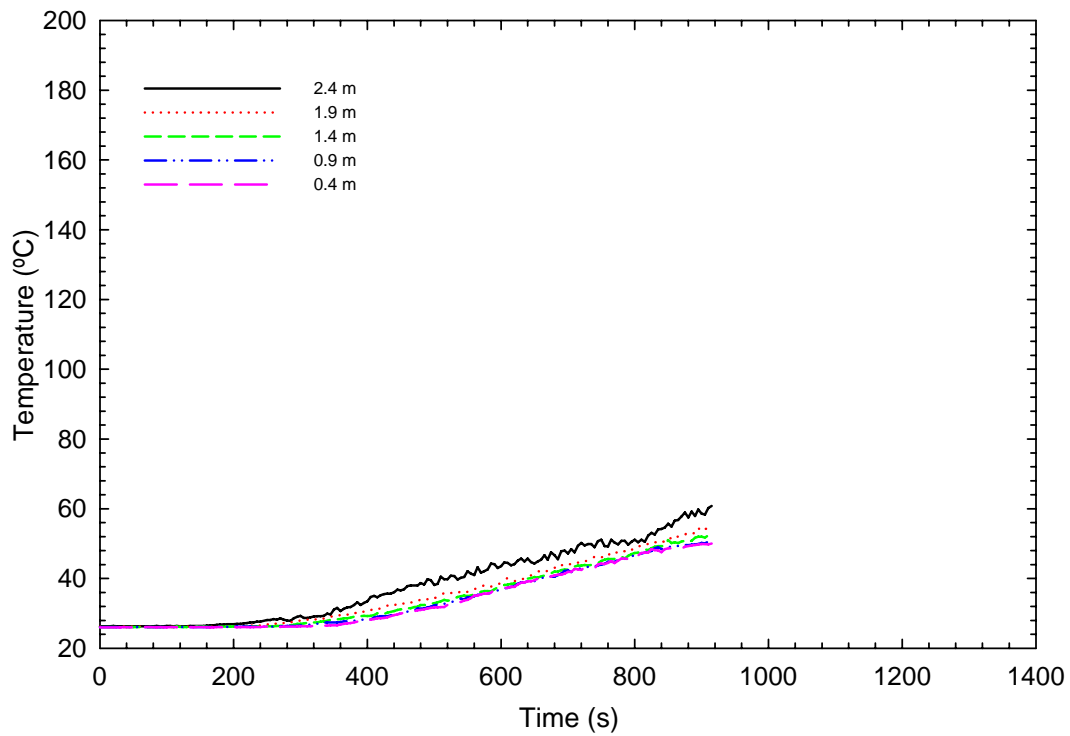
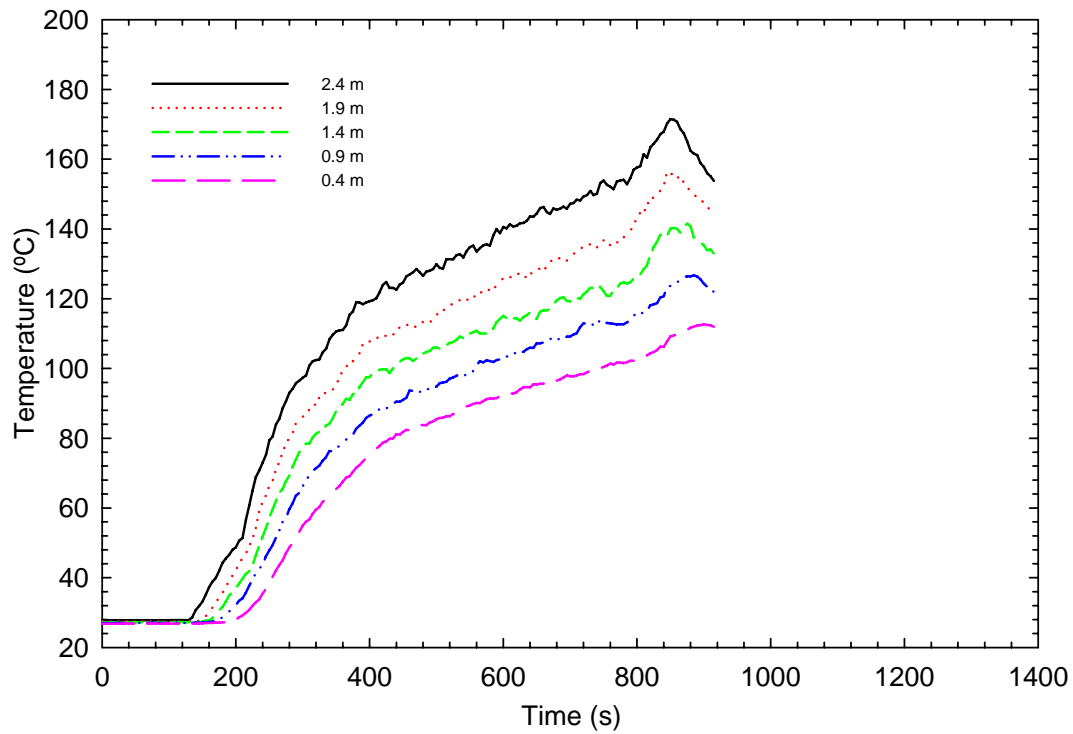
**Figure 26. TC trees in the second storey bedrooms for UF-01  
(SE bedroom: door closed; SW bedroom: door open)**

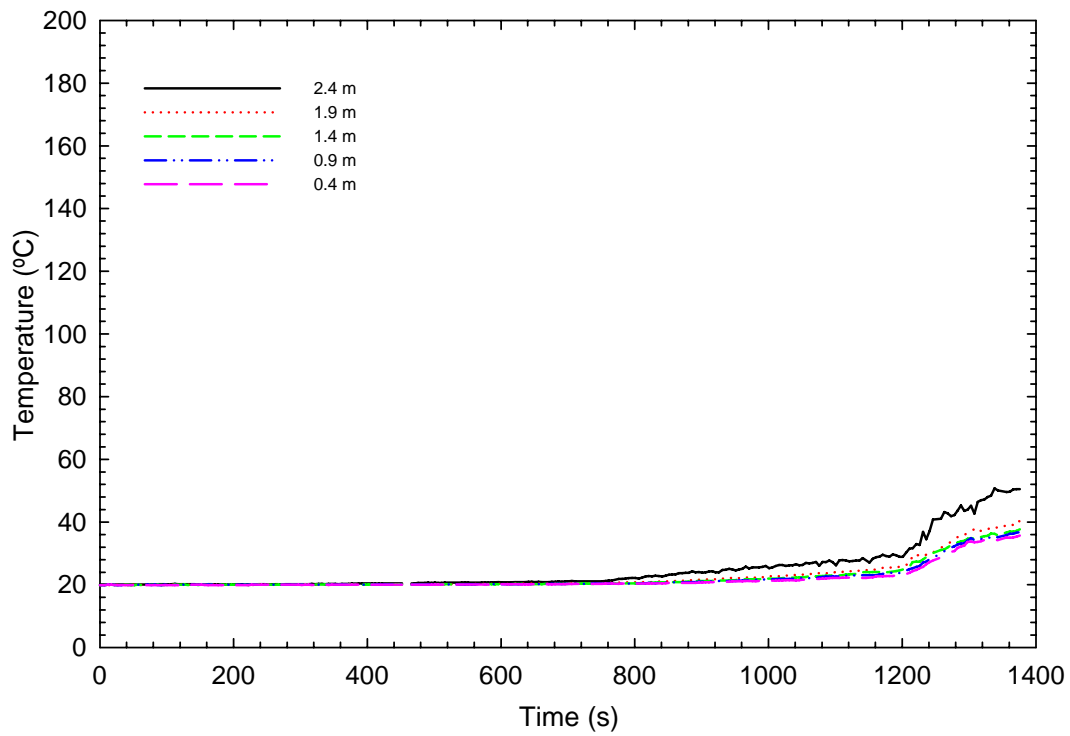
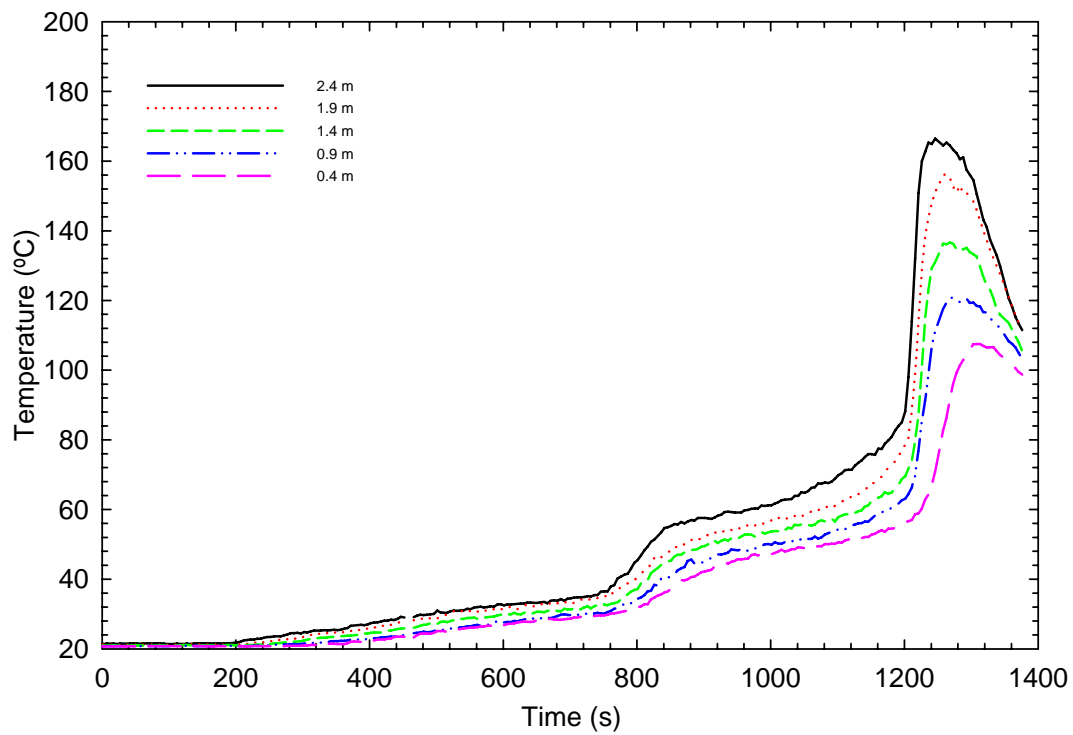
Figure 27 (a) and Figure 27 (b) show the temperatures in the SE and SW bedrooms, respectively for Test UF-02. The door to the SE bedroom was closed while the door to the SW bedroom was open. Ambient temperature was measured for about the first 800 s for the SE bedroom and 200 s for SW bedroom. After these times, the temperatures, at different heights within the rooms, started increasing. This increase was faster for the SW bedroom than the SE bedroom because more migrating hot gases and smoke entered the SW bedroom since the door was open. The smoke entered the SE bedroom mainly through gaps around the door. Maximum temperatures of about 50 and 165°C were reached at 2.4 m height above the floor level for the SE and SW bedrooms, respectively. For the SW bedroom, the temperatures showed a sudden increase around 1200 s, which may be due to flame penetrating into the first storey through the burning floor and the door to the basement, and then they started decaying after the extinguishment of the fire was initiated.

**Figure 27. TC trees in the second storey bedrooms for UF-02  
(SE bedroom: door closed; SW bedroom: door open)**

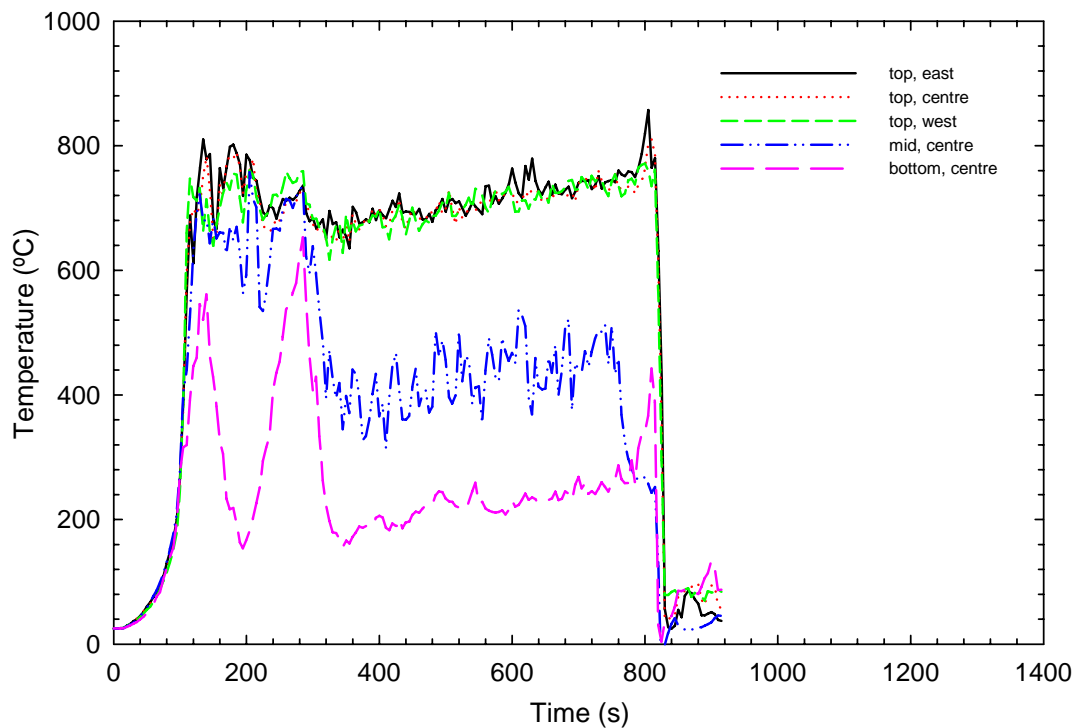
Figure 28 and Figure 29 show the temperatures recorded at the basement window for Test UF-01 and Test UF-02, respectively. For both UF-01 and UF-02, the temperatures increased to 600°C in the first 110 s. The window was opened after 105 s and 97 s, for UF-01 and UF-02, respectively, when the temperature reached 300°C at the thermocouples. After 120 s, due to air entering and smoke exiting the basement through the window, the temperatures varied depending on whether or not the flames were touching the thermocouples (the bottom TC was probably below the neutral plane).

**Figure 28. Temperatures at the window in the basement for UF-01**

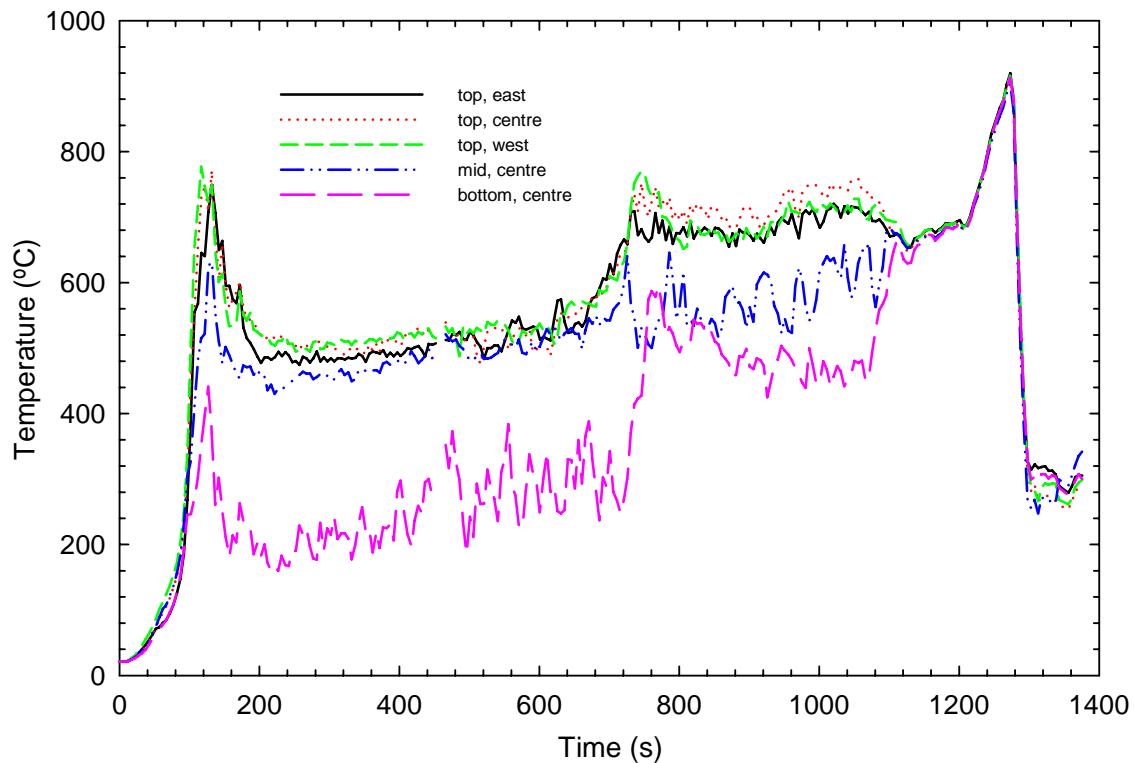
**Figure 29. Temperatures at the window in the basement for UF-02**

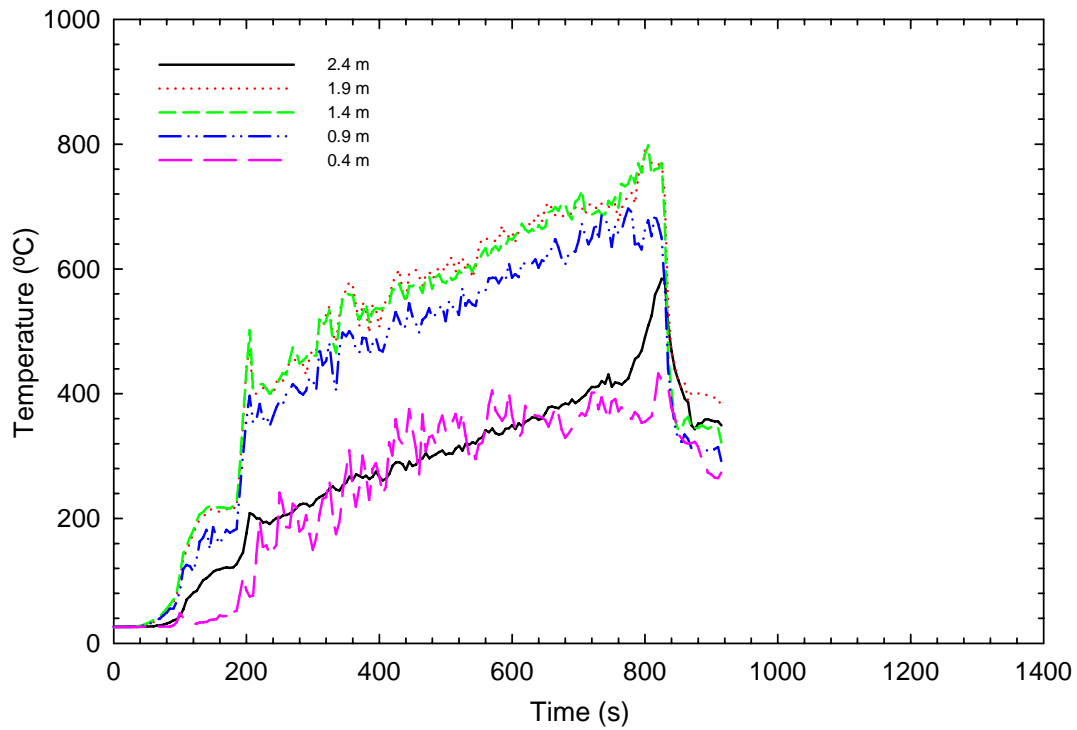
Figure 31 shows the temperatures at the top of the stairs on the first storey at different heights for Test UF-01. The conditions remained at ambient temperature for about the first 80 s. After this, temperatures, at different heights, started increasing due to the migration of hot gases and smoke from the basement to the upper storeys. A maximum temperature of about 800°C was reached at both 1.9 and 1.4 m heights but not at the 2.4 m level, probably indicating that cooler air was entering into the basement at both the upper level and lower level of the doorway. The temperatures started decaying around 800 s after the extinguishment of the fire was initiated.

**Figure 31. Temperatures on the first storey at the top of the stairs from the basement for Test UF-01**

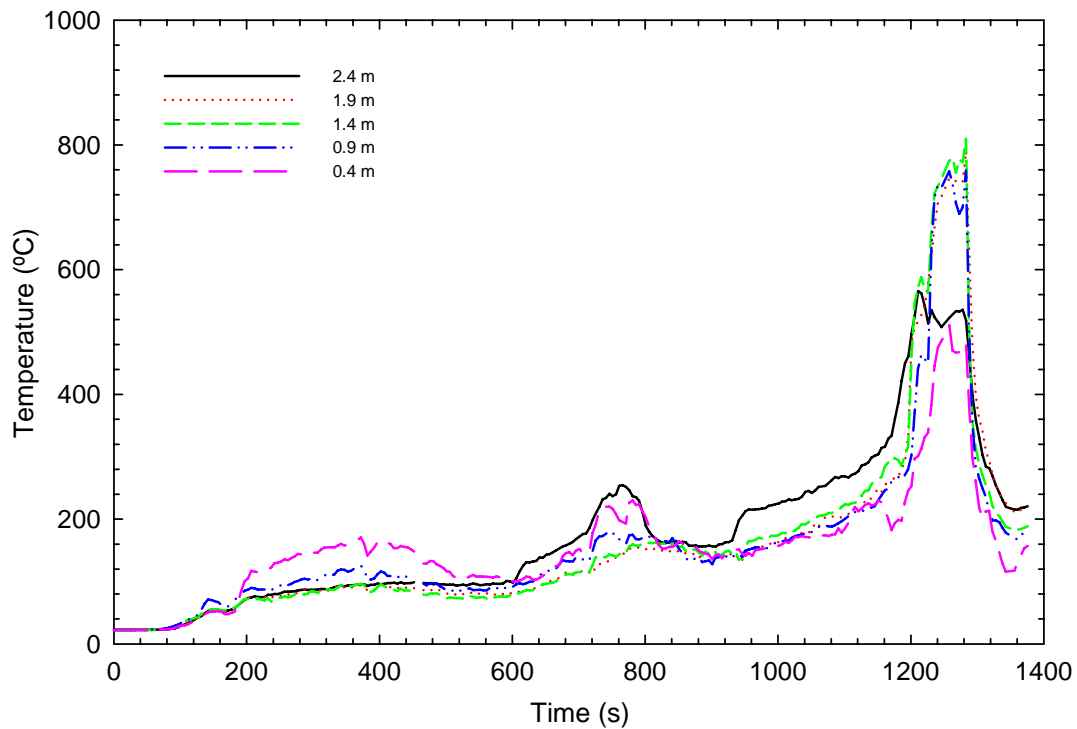
Figure 32 shows the temperatures at the top of the stairs on the first storey at different heights for Test UF-02. The conditions remained at ambient temperature for about the first 120 s. After this time, the temperatures, at different heights, started increasing very gradually due to the migration of hot gases and smoke through gaps around the floor assembly. The temperatures showed a sudden increase at about 1200 s, which may be related to flame penetrating into the first storey through the burning floor, and then they started decaying around 1240 s after the extinguishment of the fire was initiated. A maximum temperature of about 800°C was reached.

**Figure 32. Temperatures on the first storey at the top of the stairs from the basement [unexposed side of basement door] for Test UF-02**

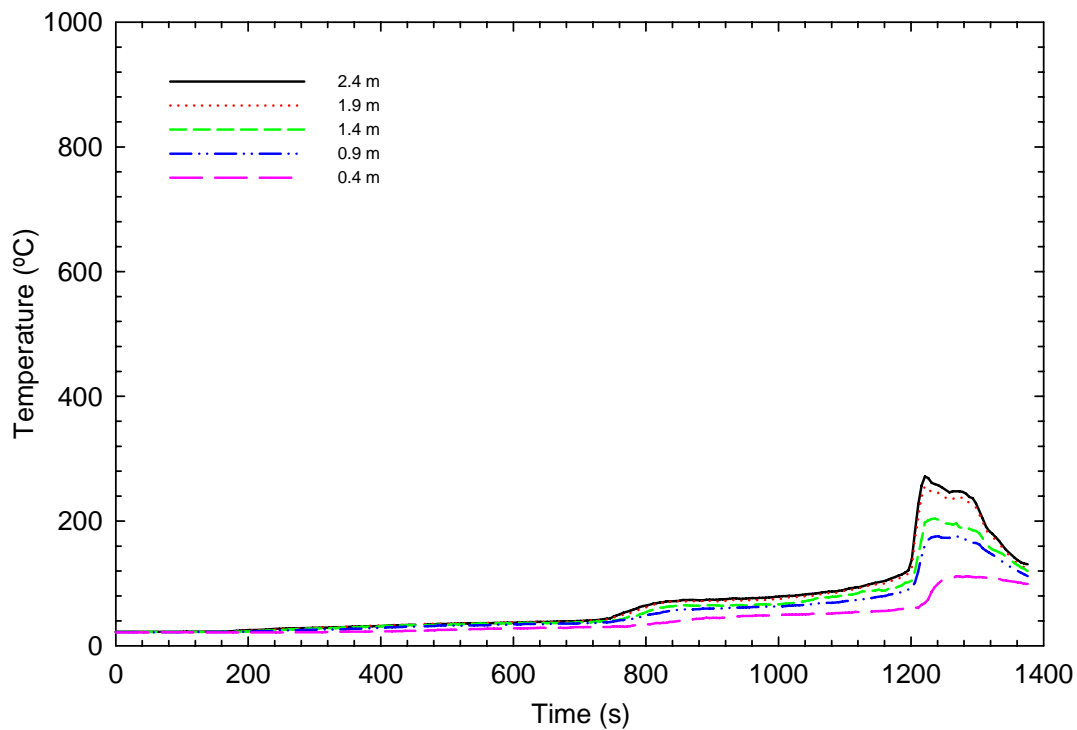
Figure 34 shows the temperatures at the top of the stairs on the second storey at different heights for Test UF-02. The trend was similar to the results for UF-01, but the temperatures measured during Test UF-02 were lower in the first 800 s. The conditions remained at ambient temperature for about the first 200 s. After this time, the temperatures, at different heights, started increasing very gradually due to some migration of hot gases and smoke mainly through gaps around the floor assembly. A maximum temperature of about 280°C was reached at the 2.4 m height. The temperatures showed a sudden increase at about 1200 s, which may be related to flame penetrating into the first storey through the burning floor, and then they started decaying around 1240 s after the extinguishment of the fire was initiated.

**Figure 34. Temperatures on the second storey at the stairs for UF-02**

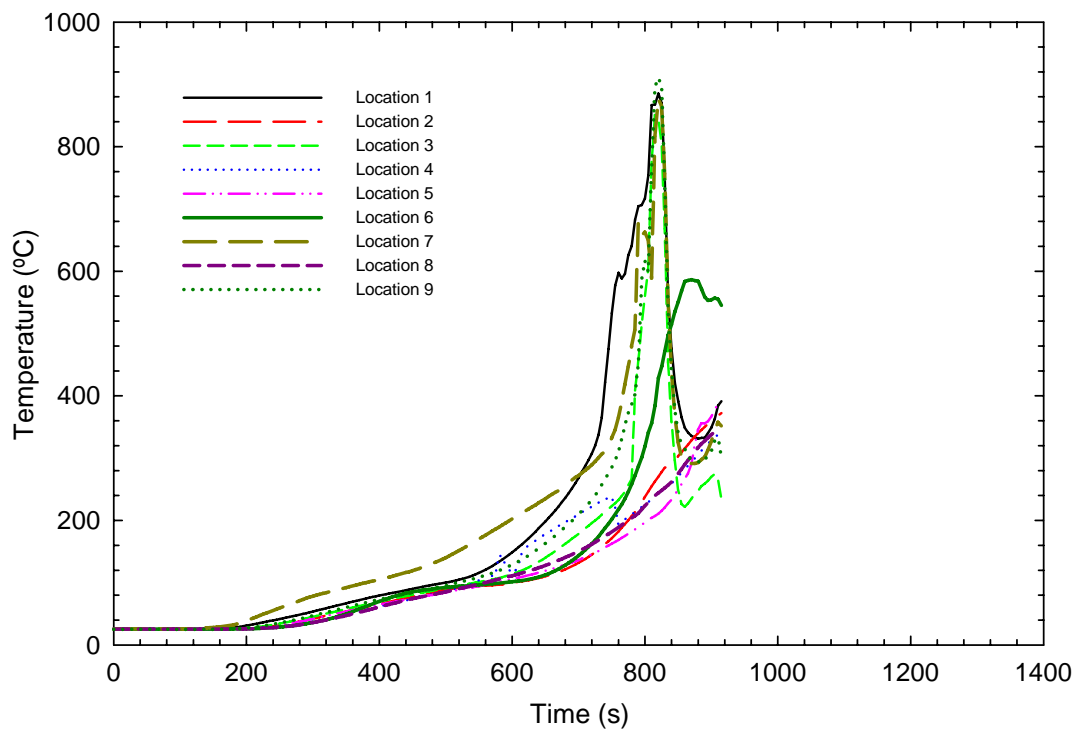
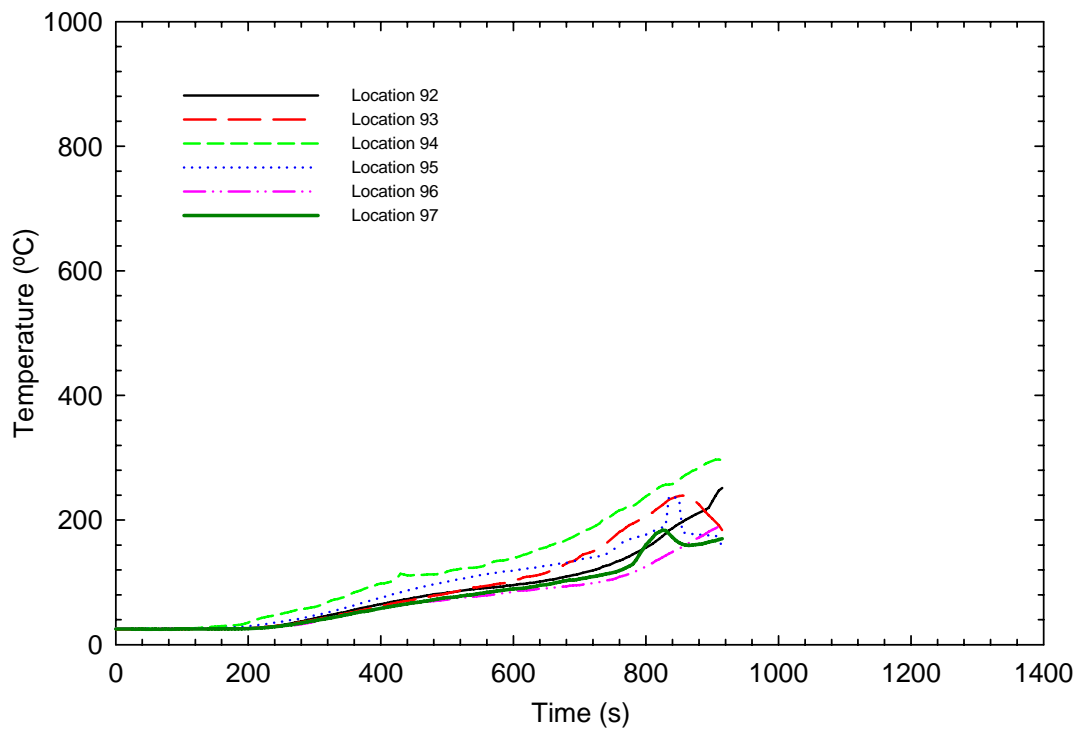
a) Unexposed TCs under insulated pad on top of subfloor

b) Bare TCs on unexposed (top) side of the subfloor

**Figure 37. Temperatures at the unexposed side of subfloor for UF-01**

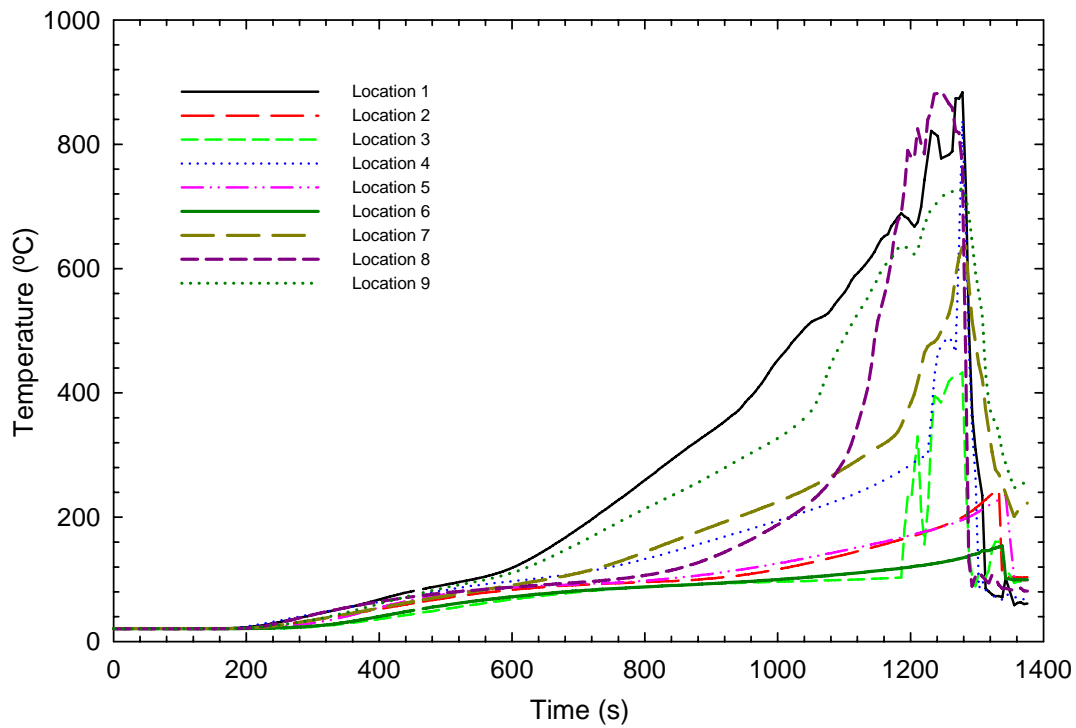
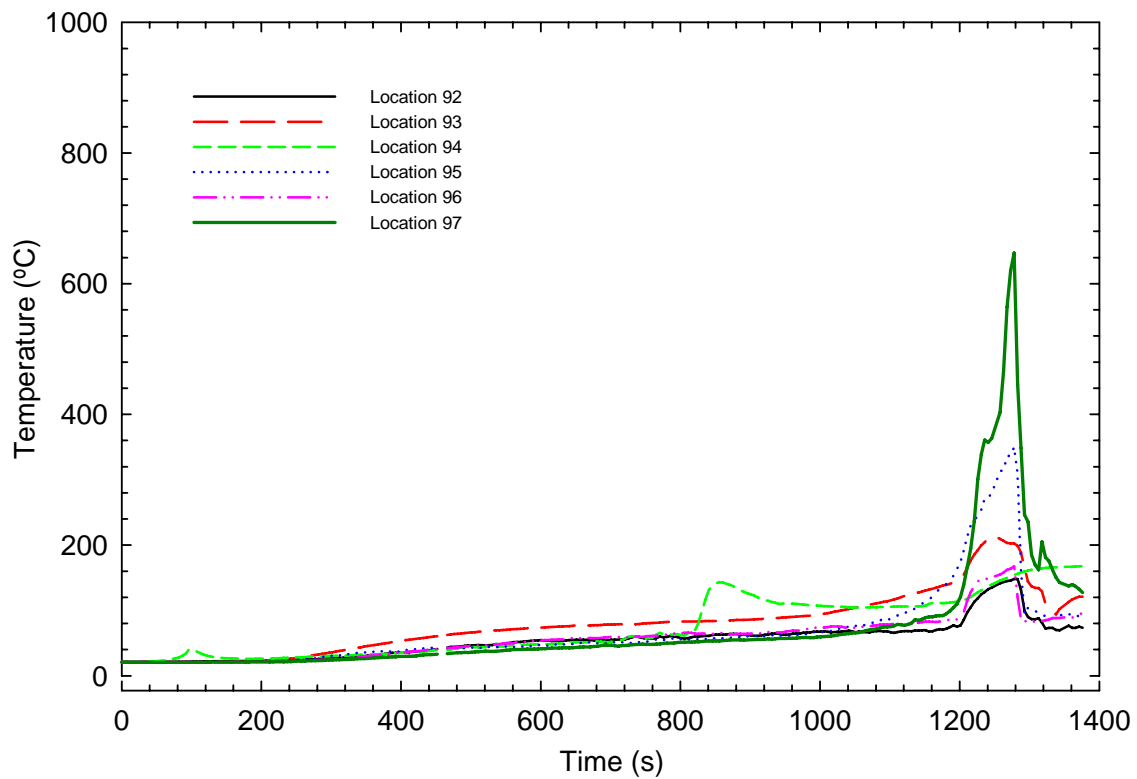
The times, corresponding to flames penetrating the floor, were comparable to those recorded using the flame-sensing devices and the time at which there was a sharp increase in temperatures at the thermocouple tree in the SE region on the first storey (see Figure 25 (a)). Subsequently, the temperatures decreased during the extinguishment of the fire.

**Figure 38. Temperatures at the unexposed side of subfloor for UF-02**
