## **Fire Performance of Houses**

### **Study of Unprotected Floor Assemblies in Basement Fire Scenarios**

### **Part 1 – Results of Tests UF-01 and UF-02 (Solid Wood Joists)**

Research Report: IRC-RR-246

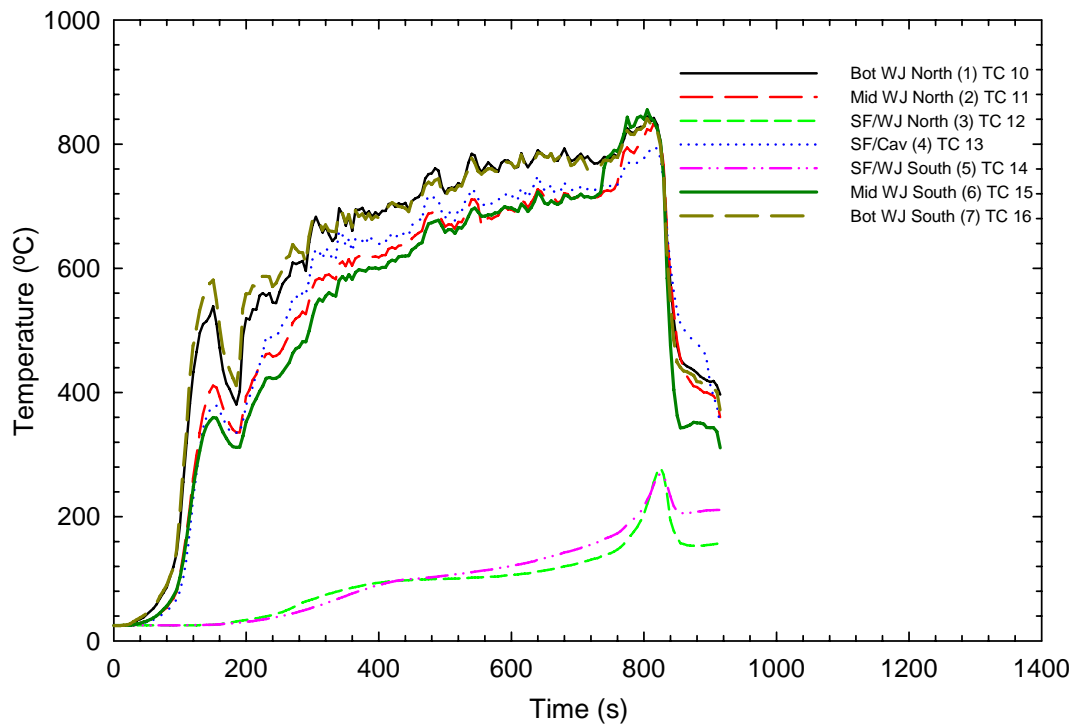
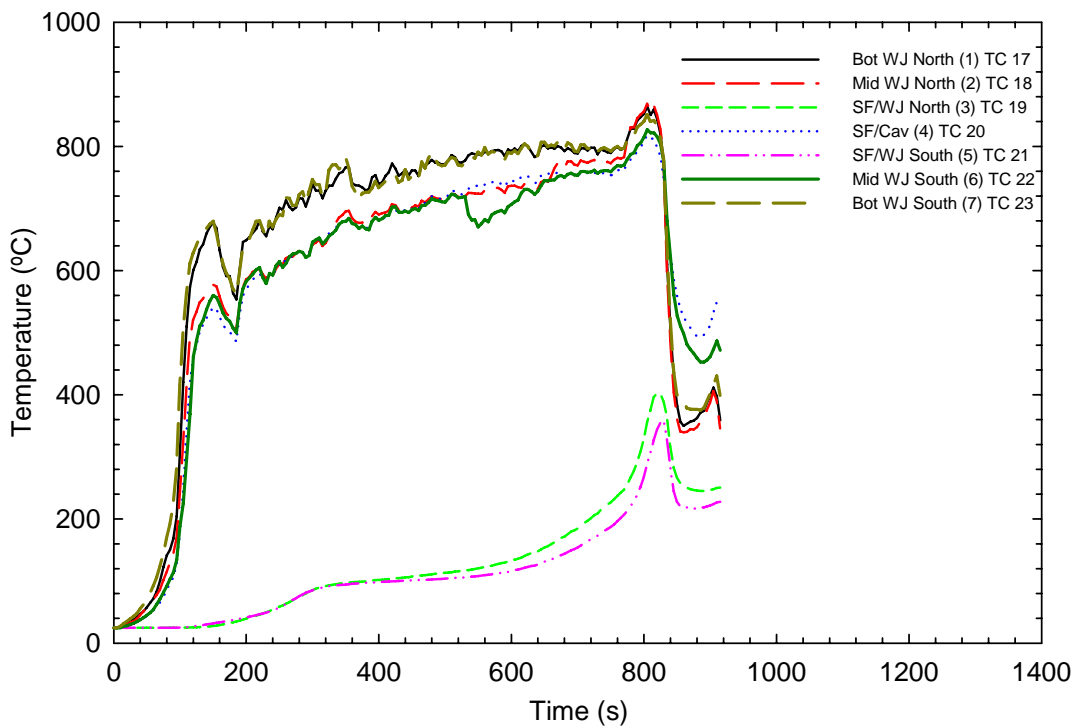
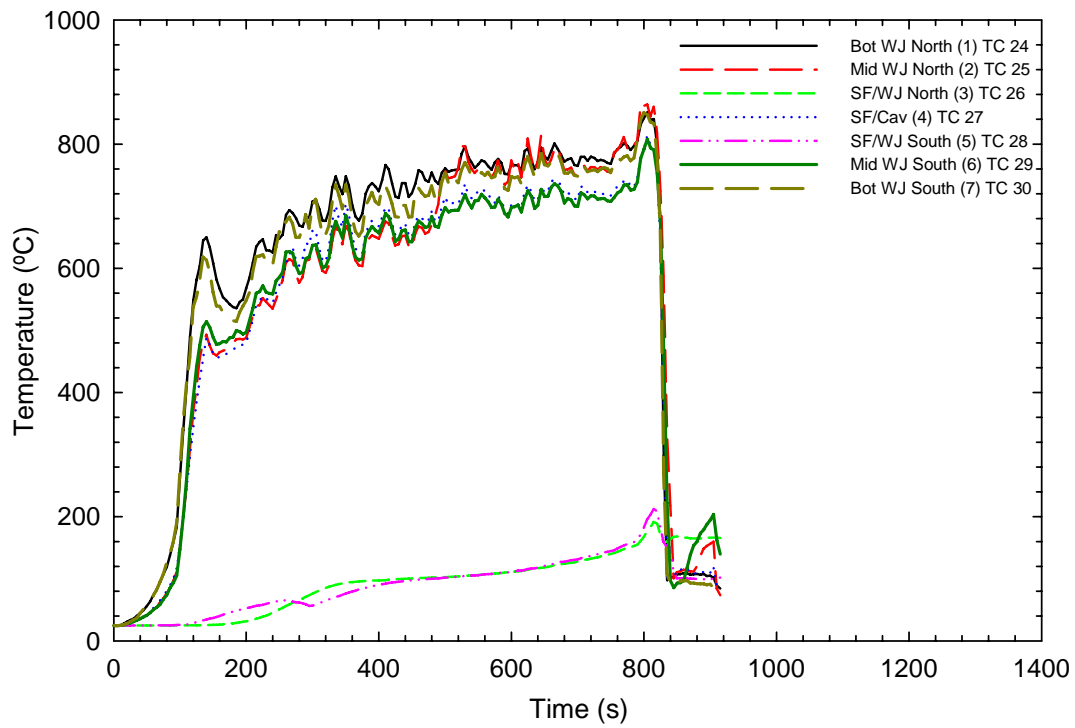
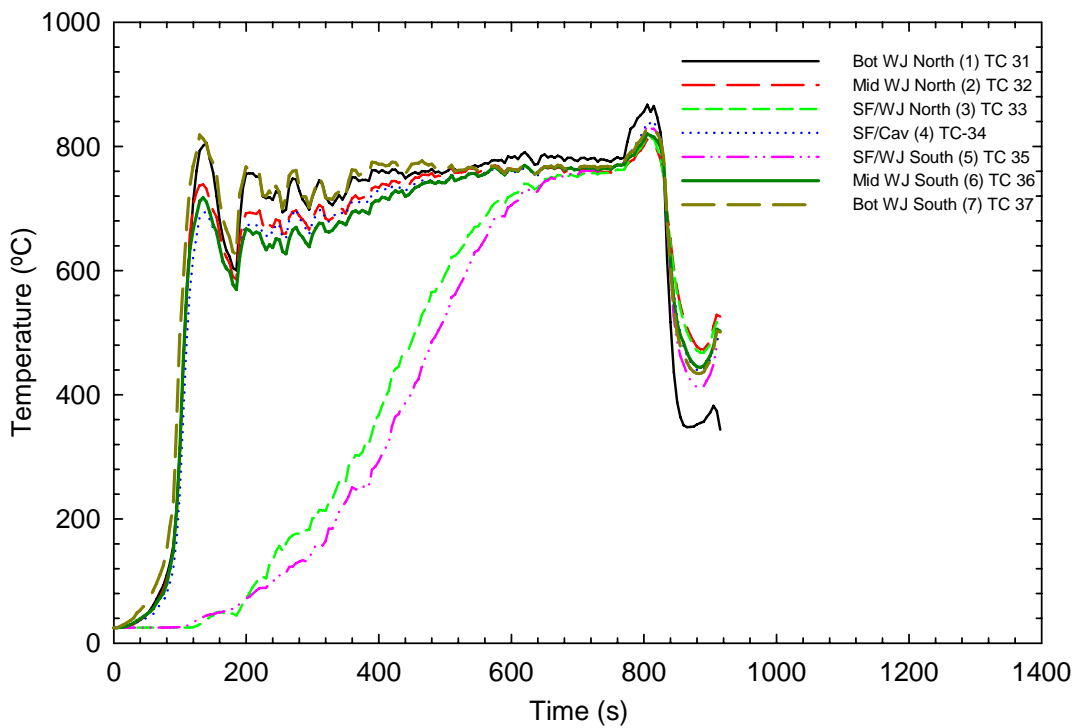
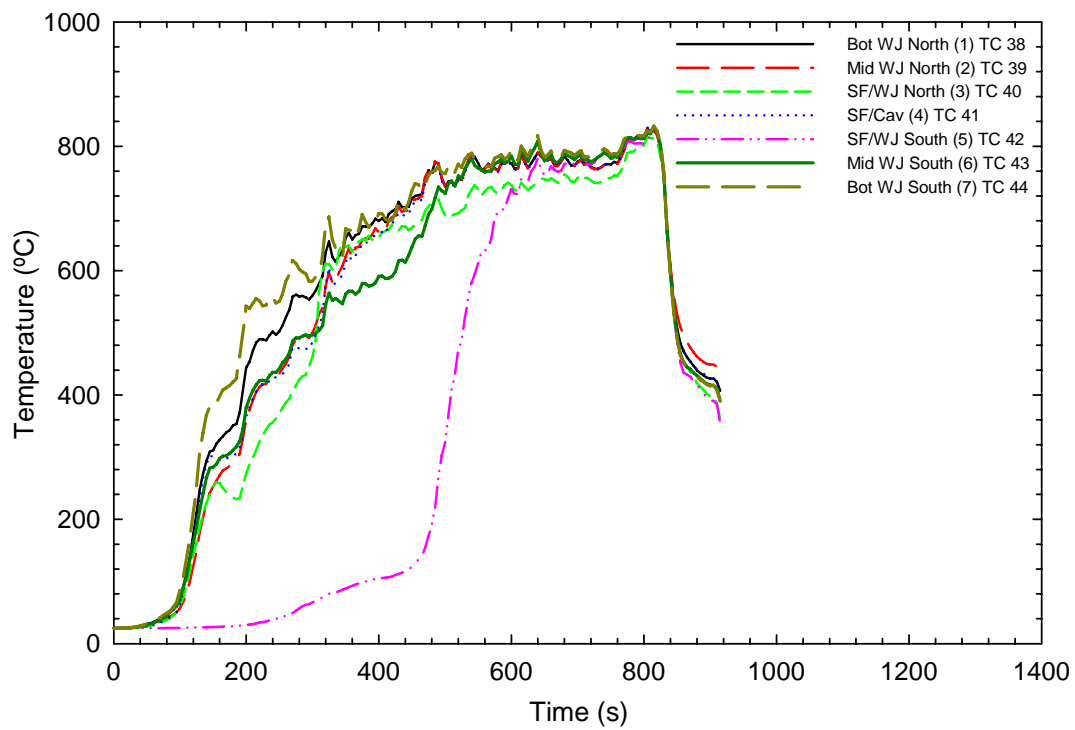
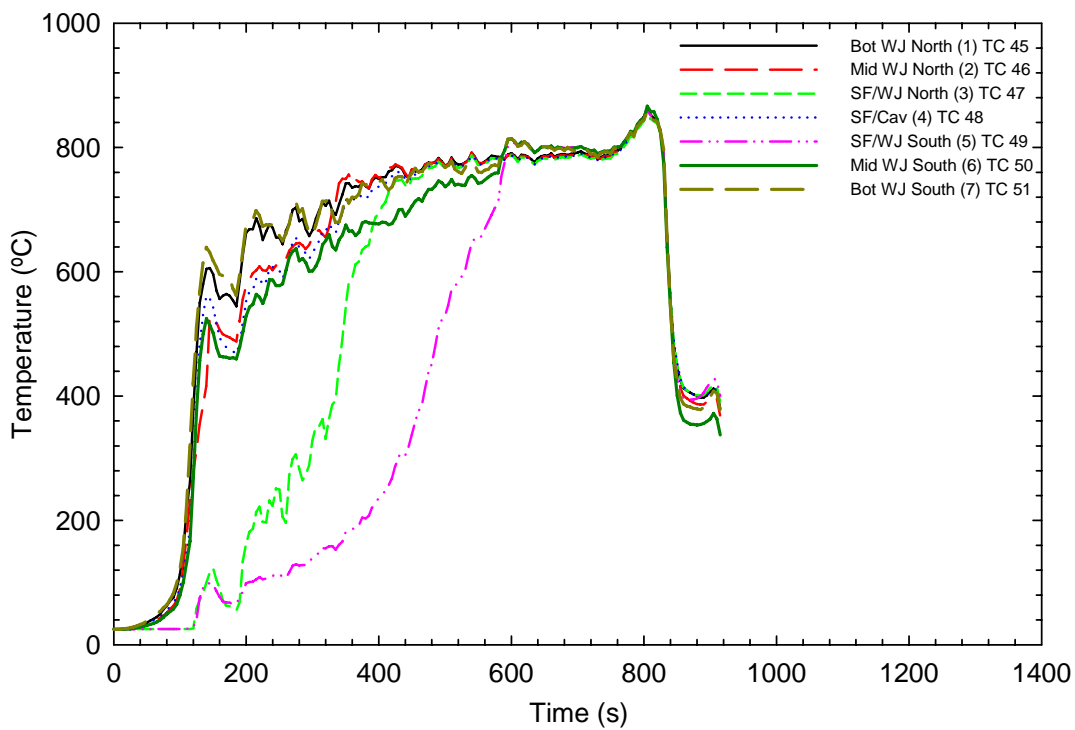
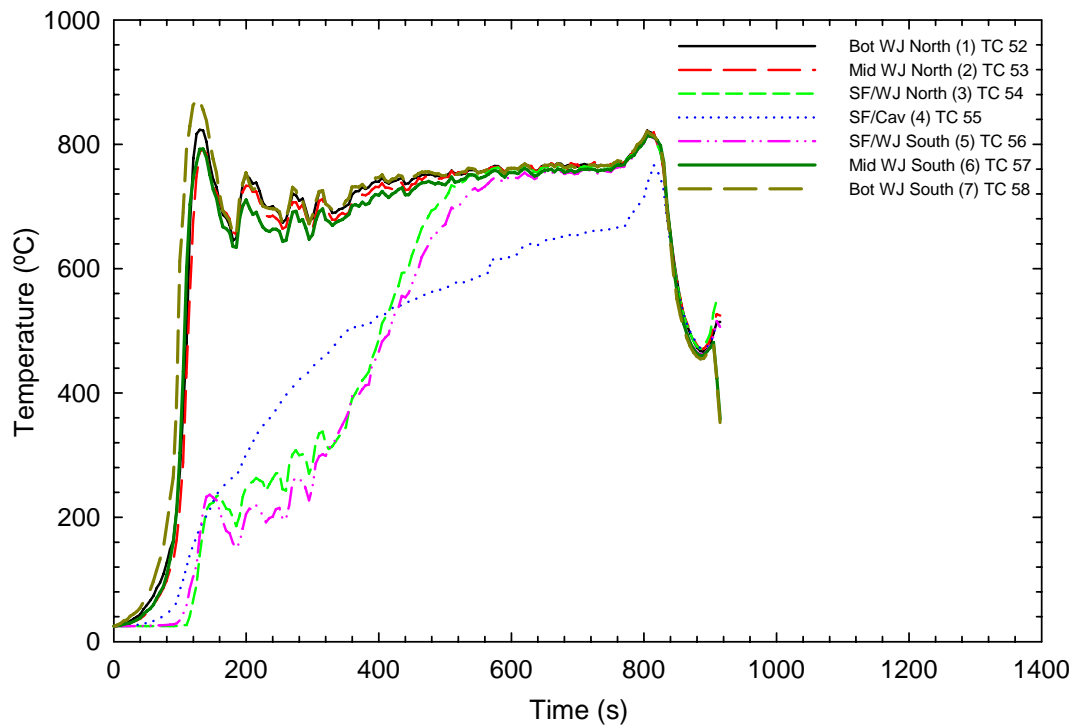
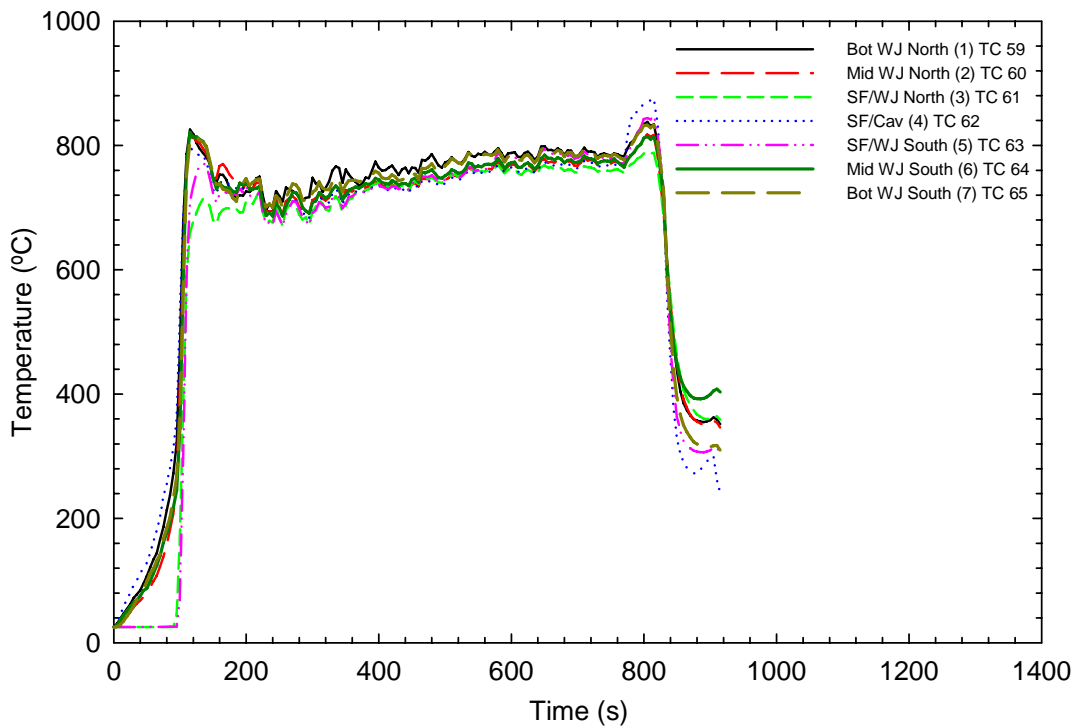
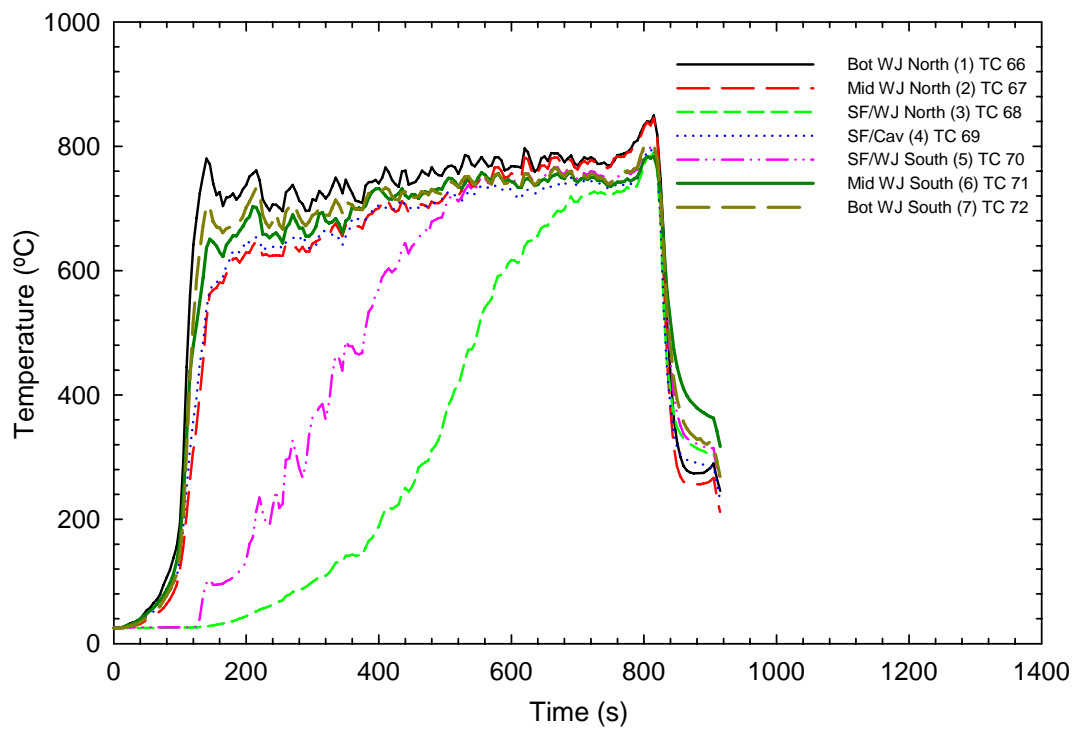
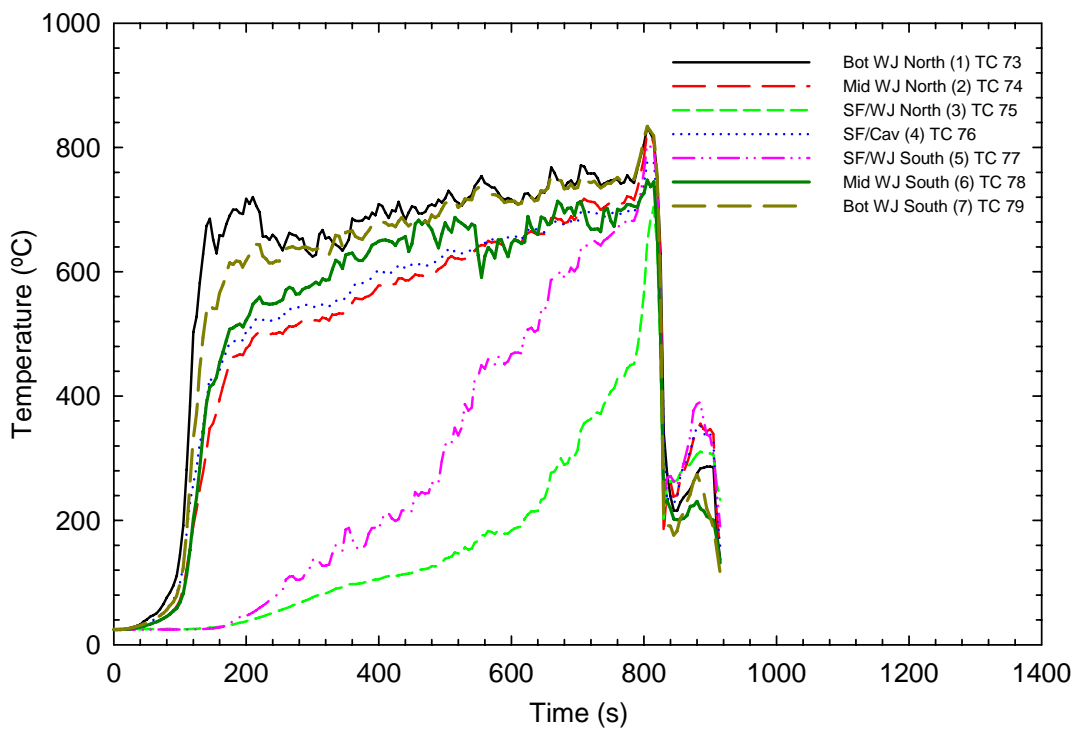
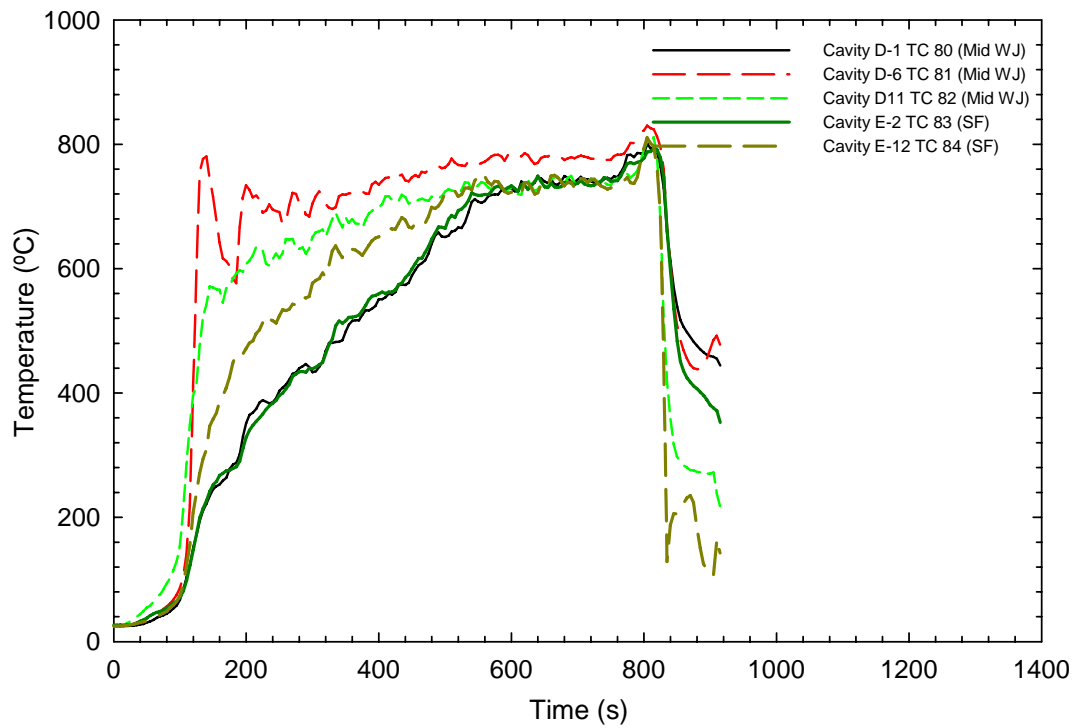
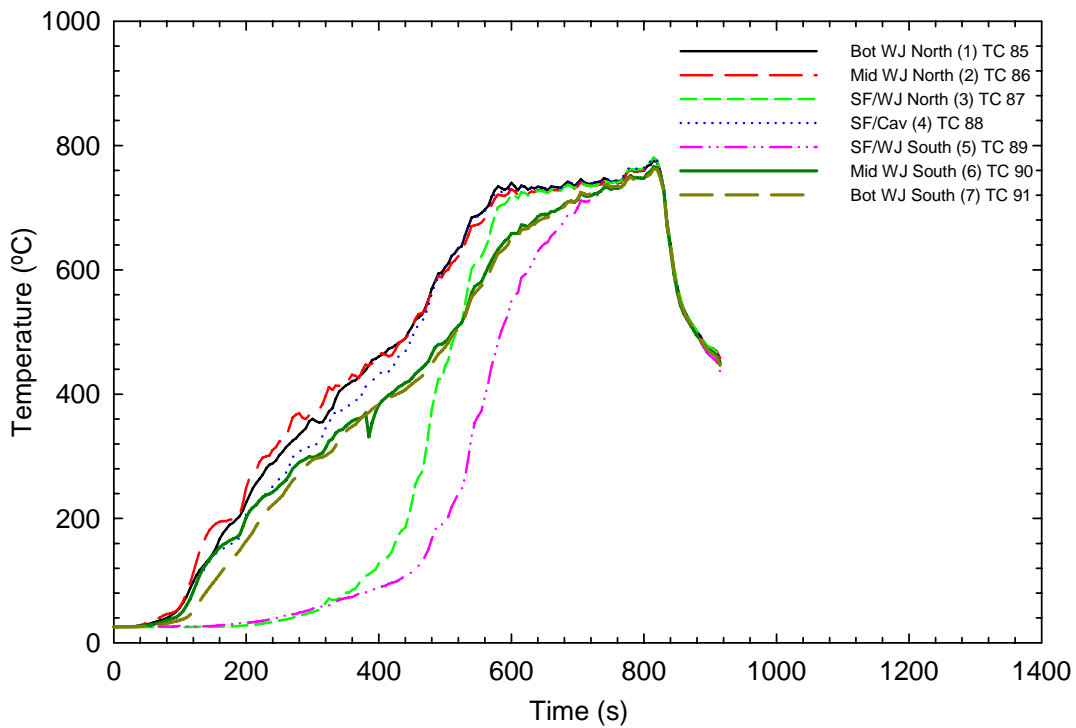
For the exposed thermocouples, the highest peak temperature (880°C) was recorded at Section C-7 (located at about the centre of the basement and directly over the burning mock-up sofa). In most cases, there was a drop in temperature measured by the exposed thermocouples just after about 160 s, which may be attributed to the fresh air coming from the open basement window and also the opening of the outside door at 180 s. The decrease in temperature lasted only about 60 s and then the temperatures either stayed almost constant or started increasing again.

The almost constant temperatures were recorded for sections B7, C-7, C-9, C-11 and C-13, which were close to the fire and the intensely burning items (mock-up sofa and cribs). This may be attributed to the fact the temperatures at these locations peaked in the initial 160 s, reaching values of approximately 800°C and could not go beyond these values due to limited air supply. The highest temperatures after 180 s were recorded at locations C-7 and C-9.

The exposed thermocouples at some locations showed a temperature increase after the decrease at 160 s (A-2, A-7, A-12, C-5). This was probably due to the fact that the temperatures at these locations had not reached their peak values as they were farther away from the burning fuel.

At approximately 760 s, the temperatures at the different locations show a slight increase probably because the flames penetrated the floor and allowed more fresh air to enter and slightly more burning to occur in the basement. The temperatures started to decrease around 820 s after the extinguishment of the fire was initiated.

**Figure 39 (a and b). Temperatures at the exposed side for UF-01**

**Figure 39 (c and d). Temperatures at the exposed side for UF-01**

**Figure 39 (e and f). Temperatures at the exposed side for UF-01**

**Figure 39 (g and h). Temperatures at the exposed side for UF-01**

**Figure 39 (i and j). Temperatures at the exposed side for UF-01**

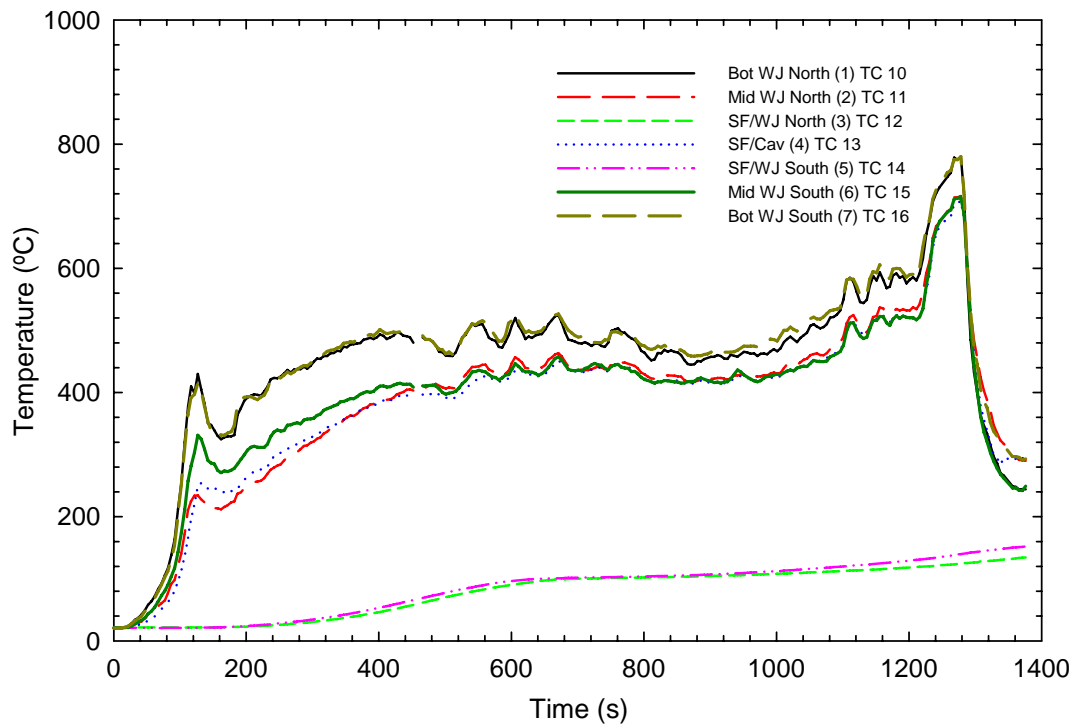
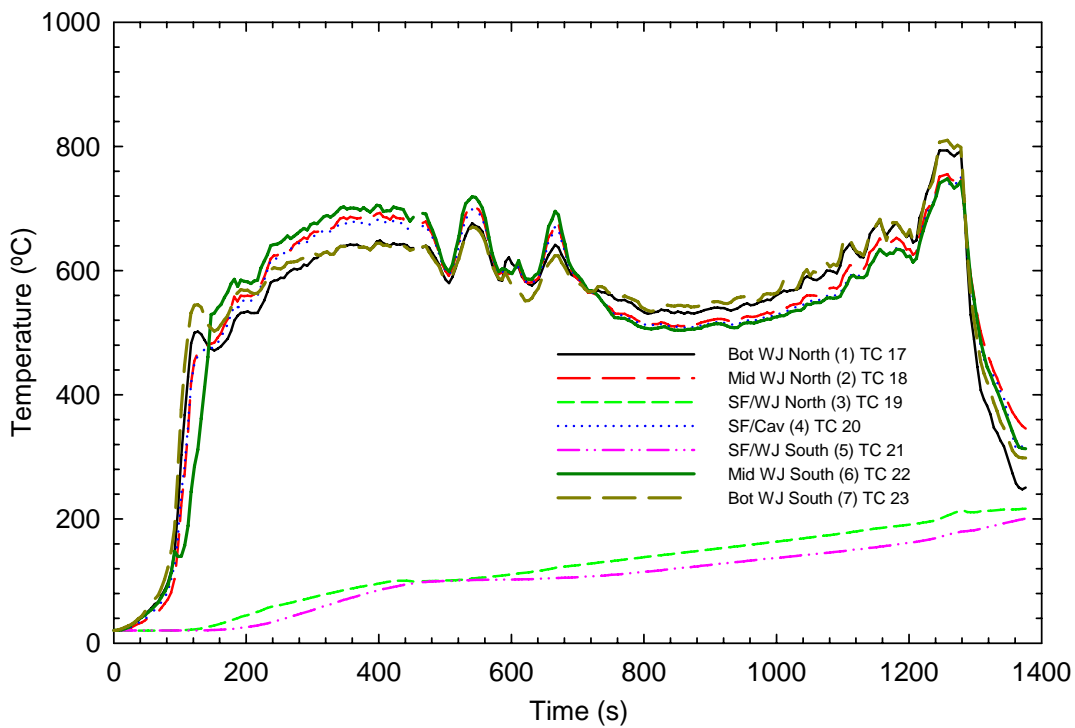
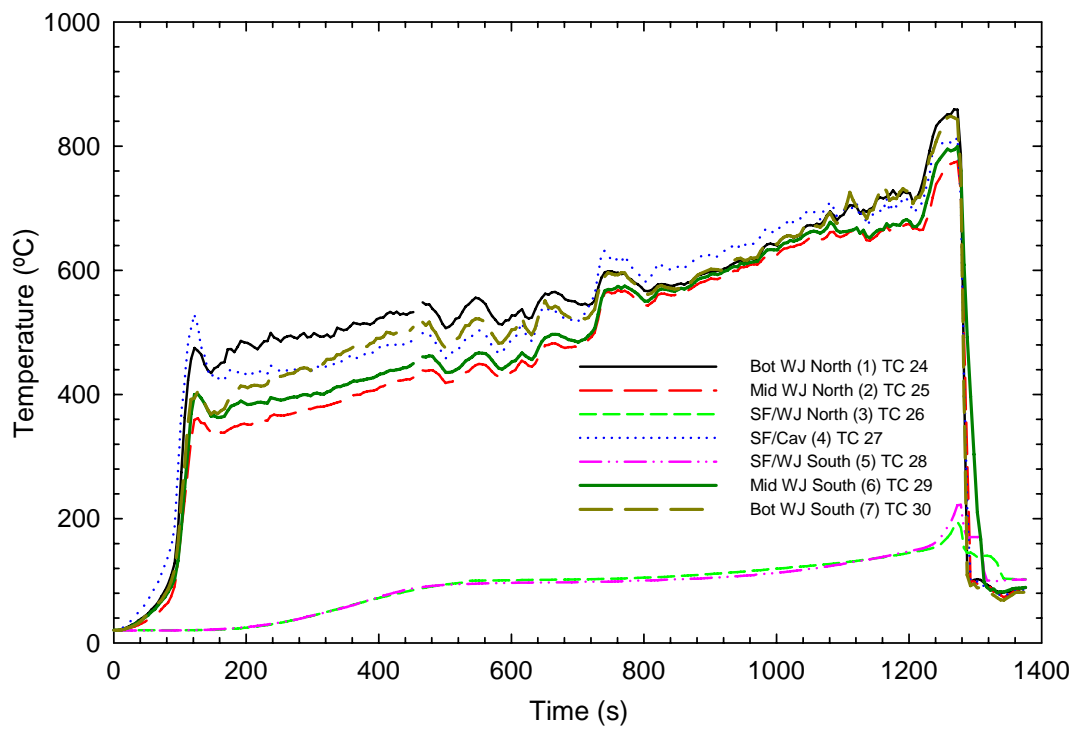
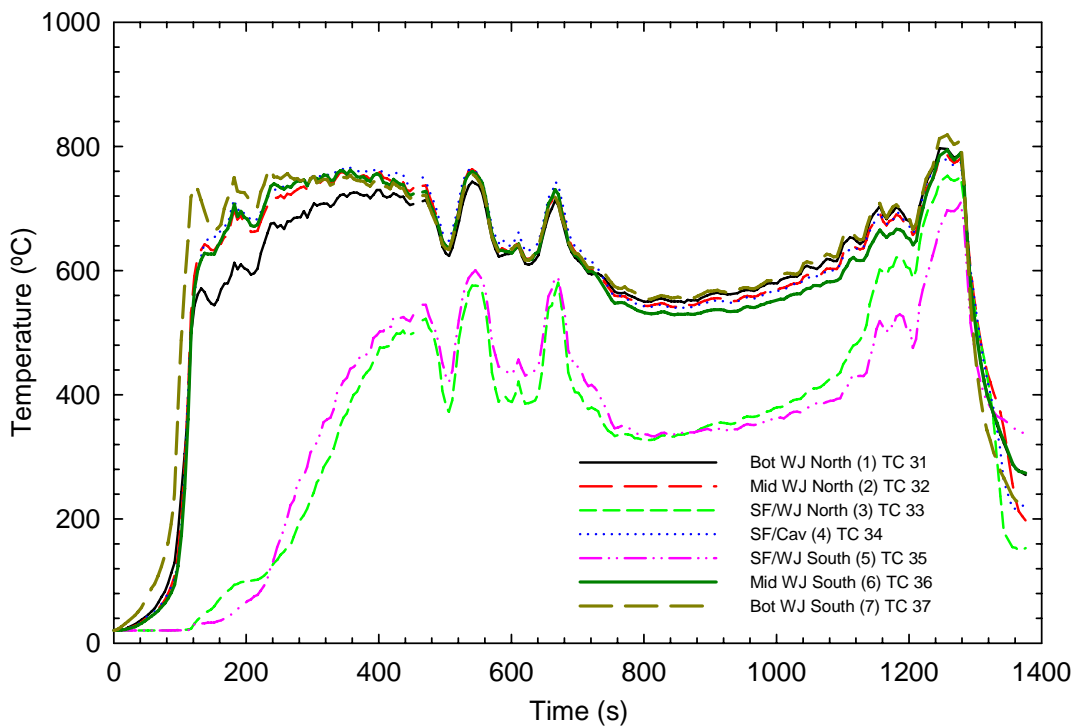
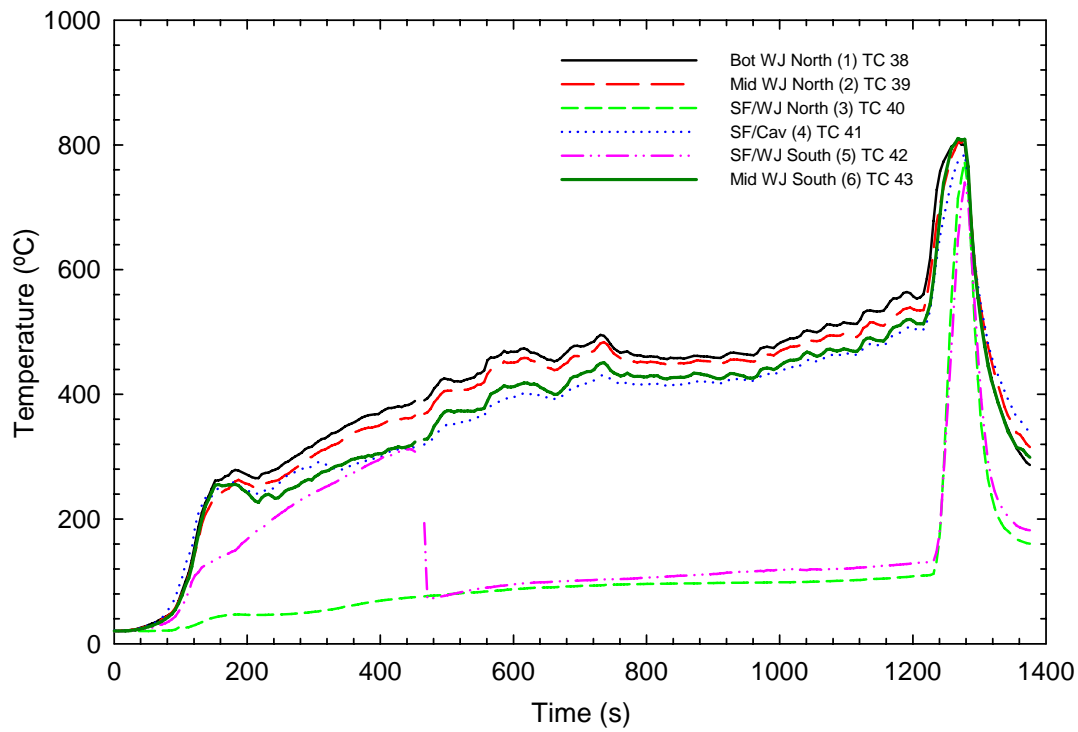
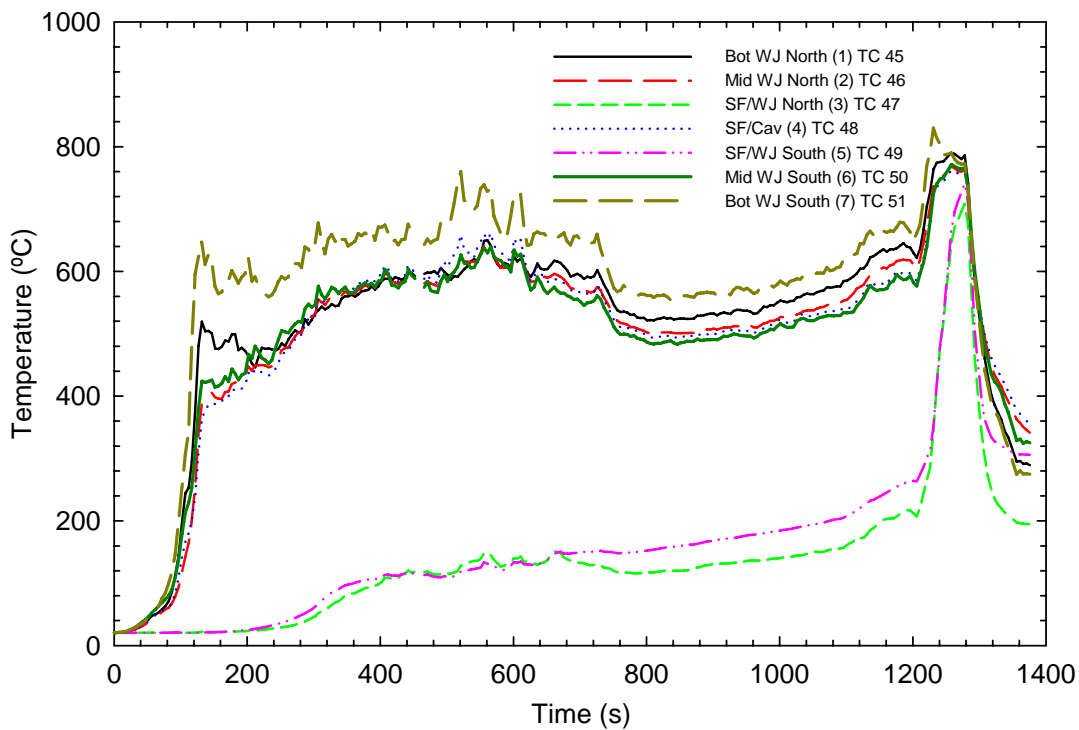
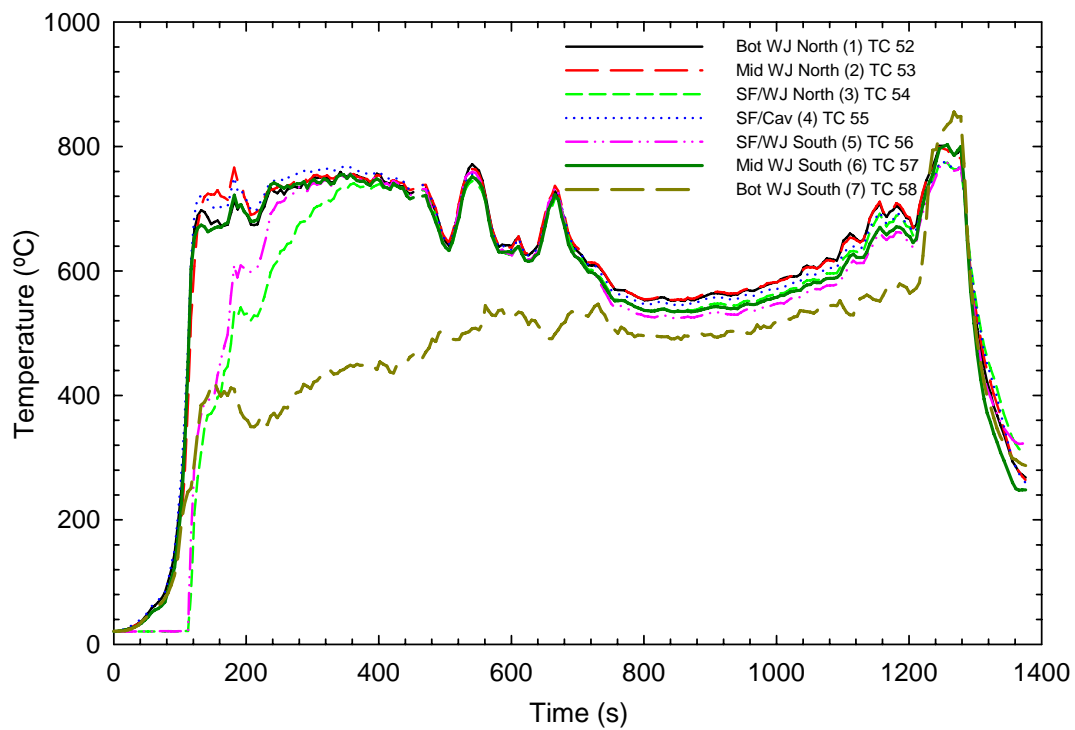
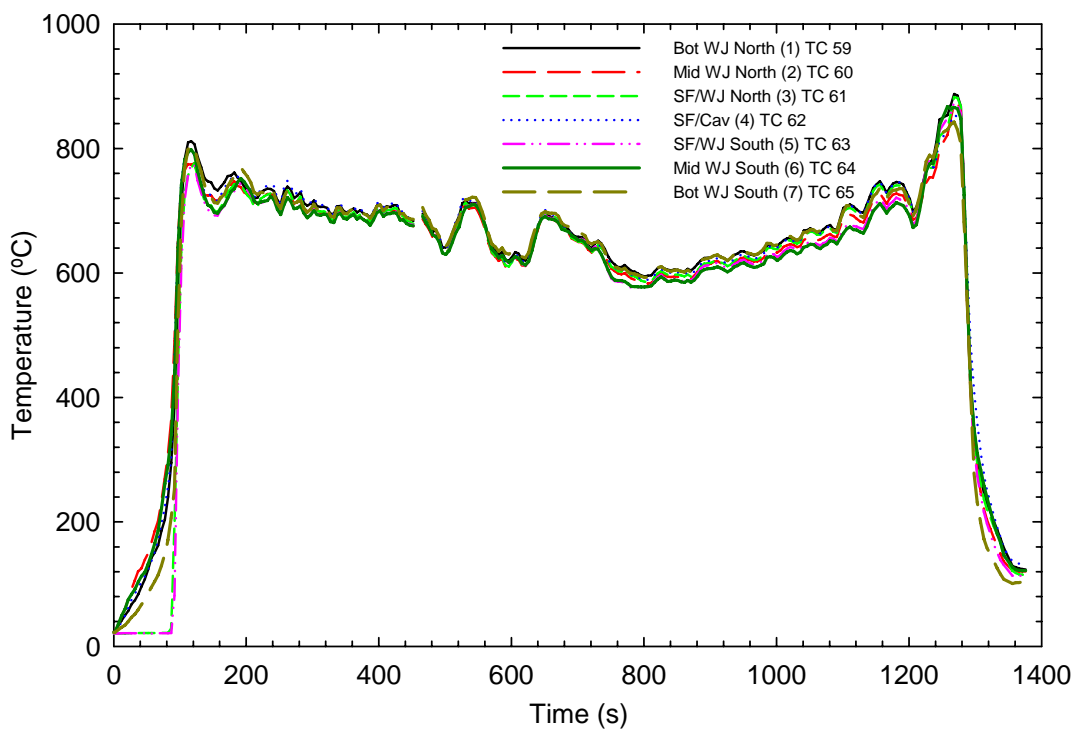
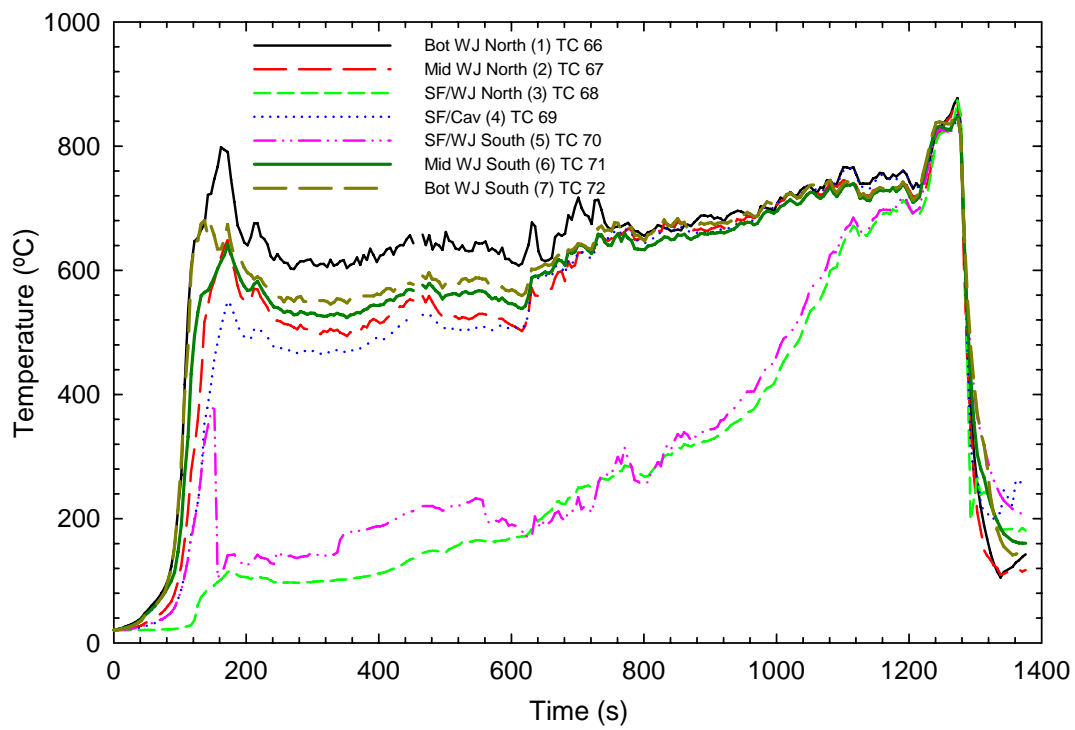
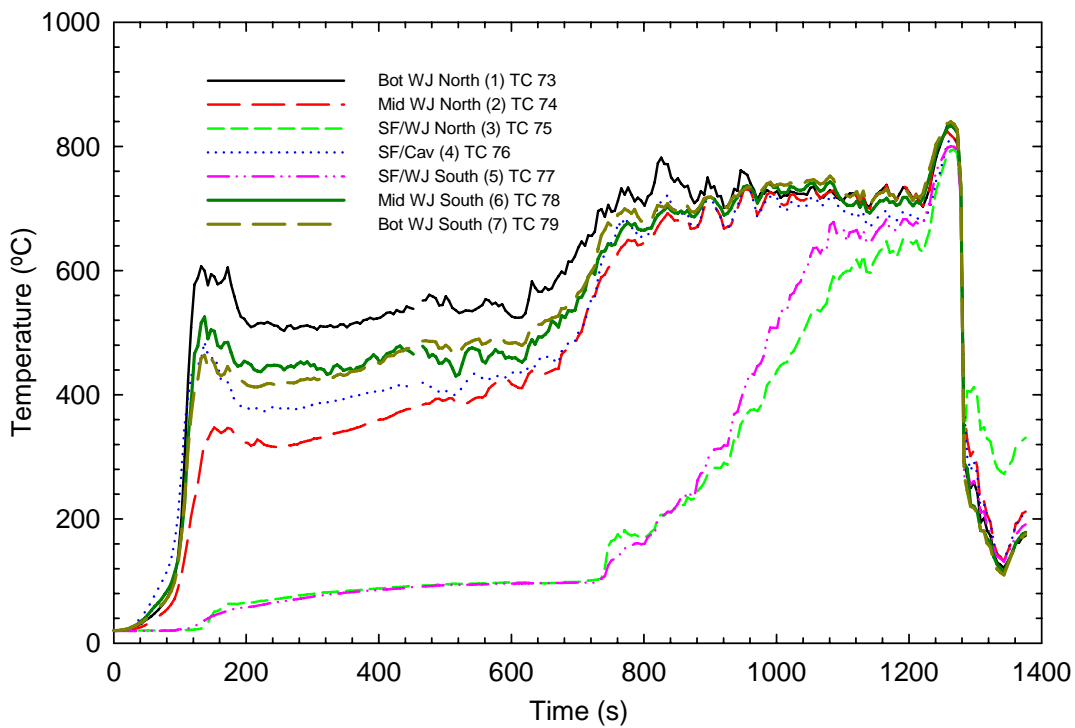
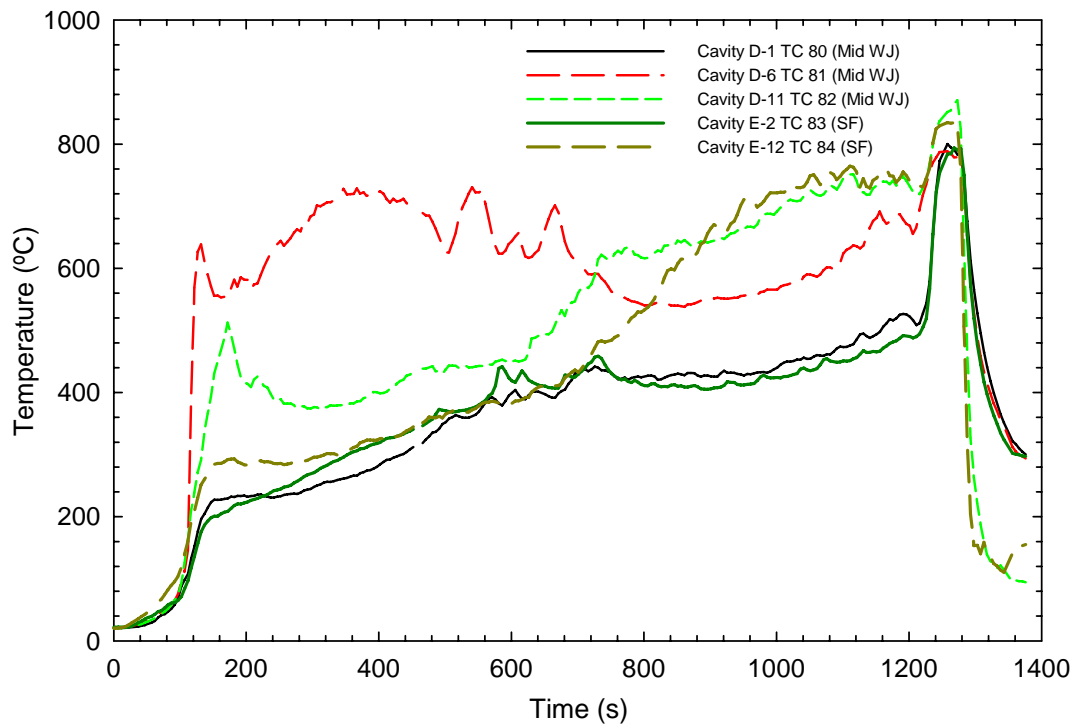
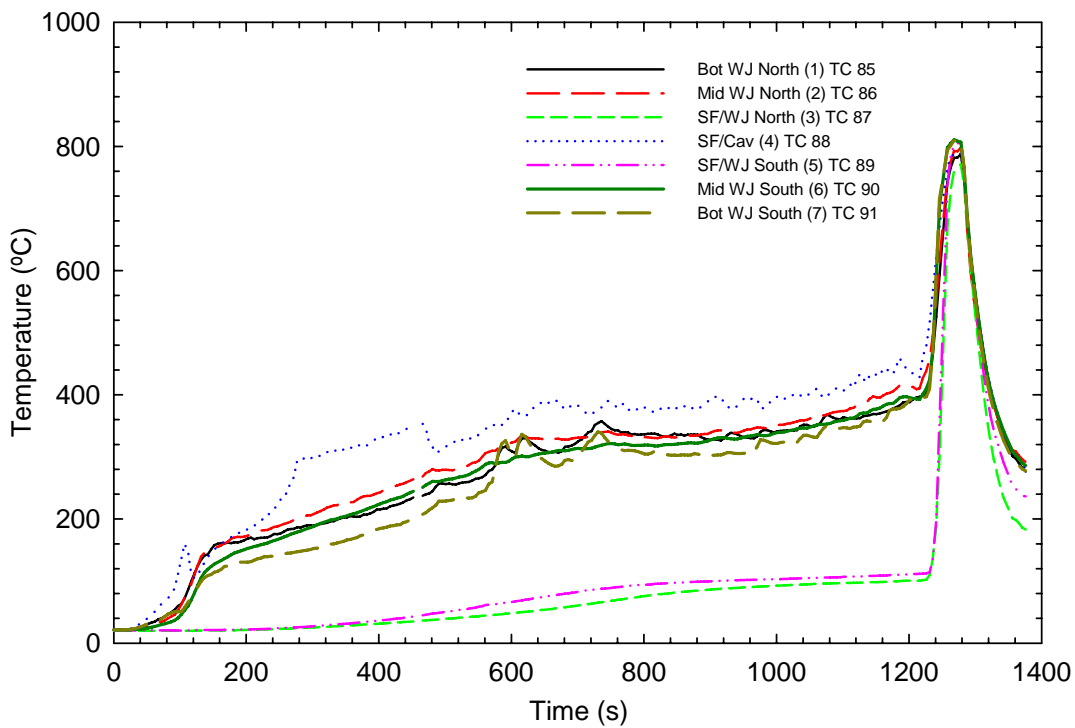
For the exposed thermocouples, the highest initial peak temperature (800°C) was recorded at Section C-9 (located directly over the burning mock-up sofa and the wood cribs).

In most cases, there was a drop in temperature just after 160 s, which may be attributed to the addition of fresh air coming from the opened basement window. The decrease in temperature lasted only about 60 s and then the temperatures either stayed constant or started increasing again. After about 500 s, there was a noticeable temperature drop and then a subsequent rise for a period of 200 s, which may be attributed to the floor being breached at some of these locations and allowing fresh air to enter from the first storey to the basement and enhancing the fuel burning in the basement. The section on “flame penetration” indicates that flames started penetrating the first storey around 600 s. This was the case for sections A-2, A-7, B-7, C-5, C-7, C-9, C-11 and C-13.

At approximately 1200 s, the temperatures at the different locations show a sharp increase probably because the flames penetrated the floor and allowed more fresh air to enter into the basement. The section on “flame penetration” indicates that flames started to penetrate into the first storey around 1160 s. In the case of A-2, A-7 and A-12, the temperatures at the SF/WJ North (3) and SF/WJ South (5) show no substantive increase in temperatures, indicating that the joists at these locations remained tightly fitted (no gaps) to the subfloor for the duration of the test. The temperatures started to decrease around 1280 s after the extinguishment of the fire was initiated.

**Figure 40 (a and b). Temperatures at the exposed side for UF-02**

**Figure 40 (c and d). Temperatures at the exposed side for UF-02**

**Figure 40 (e and f). Temperatures at the exposed side for UF-02**

**Figure 40 (g and h). Temperatures at the exposed side for UF-02**

**Figure 40 (i and j). Temperatures at the exposed side for UF-02**

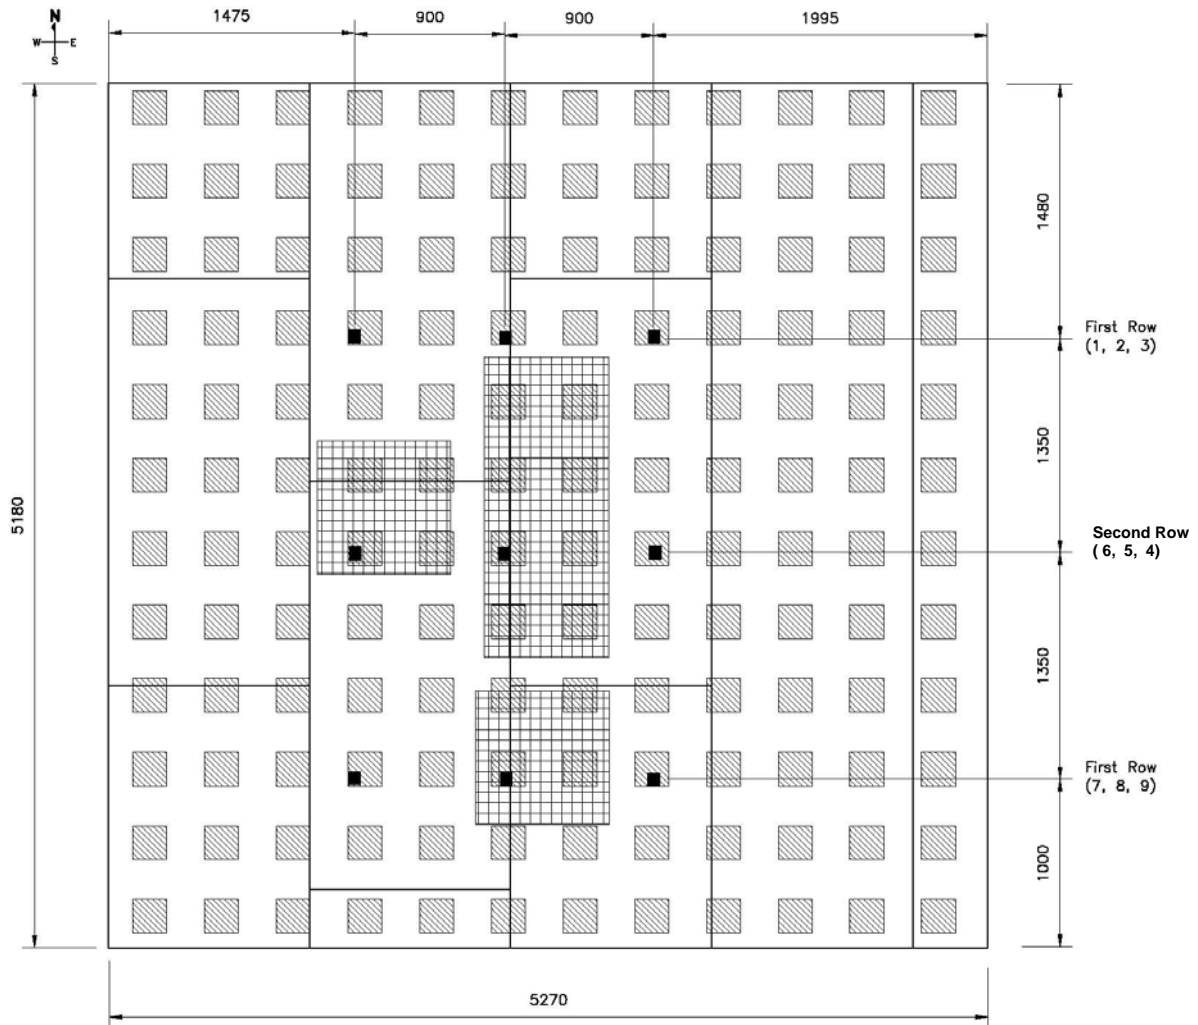
**Figure 41. Deflection points measured (all dimensions in mm)**

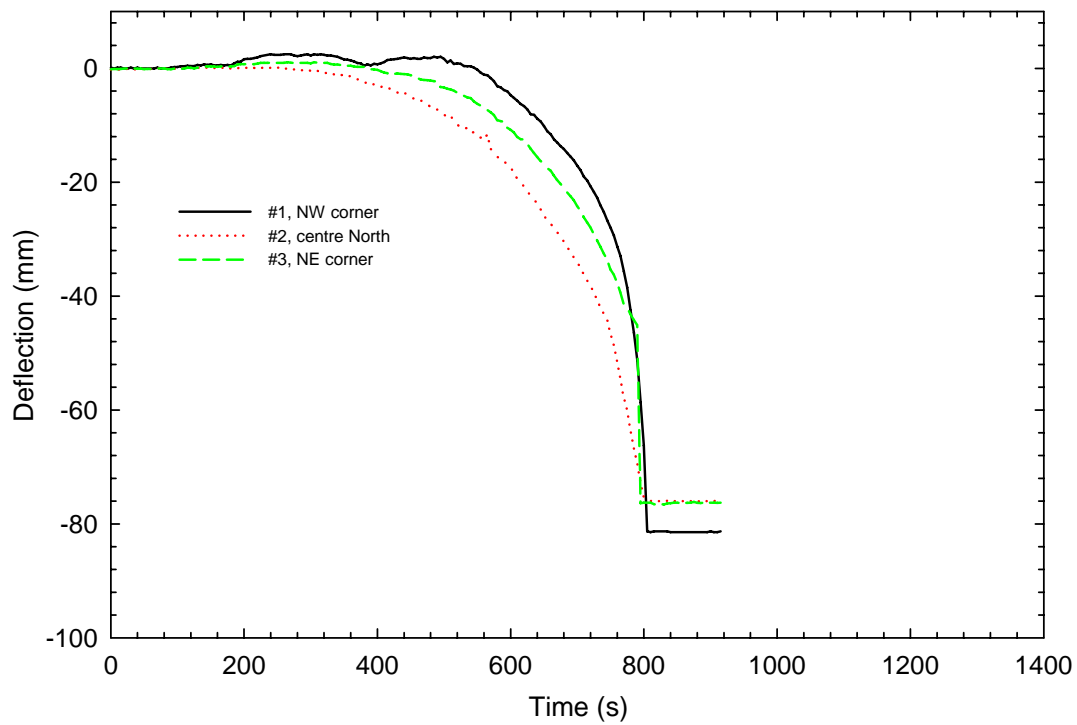
touching the concrete blocks (the after test observations confirmed that the rods were hanging in the air). The sharp increase in deflection close to 755 s is an indication that the floor assembly was deflecting at a high rate, which resulted in the blocks being dislodged and falling over. Visual observations through the rough window opening in the fire room also indicated that the blocks started falling through the subfloor around this time. The times corresponding to the sharp increase in deflection and probable fall through of the blocks are 785 s, 775 s and 785 s for points 7, 8 and 9, respectively. The time of terminating the test was 820 s.

a) Floor Deflection, for Row 1, Joist E-1
