## **Fire Performance of Houses**

### **Study of Unprotected Floor Assemblies in Basement Fire Scenarios**

### **Part 1 – Results of Tests UF-01 and UF-02 (Solid Wood Joists)**

Research Report: IRC-RR-246

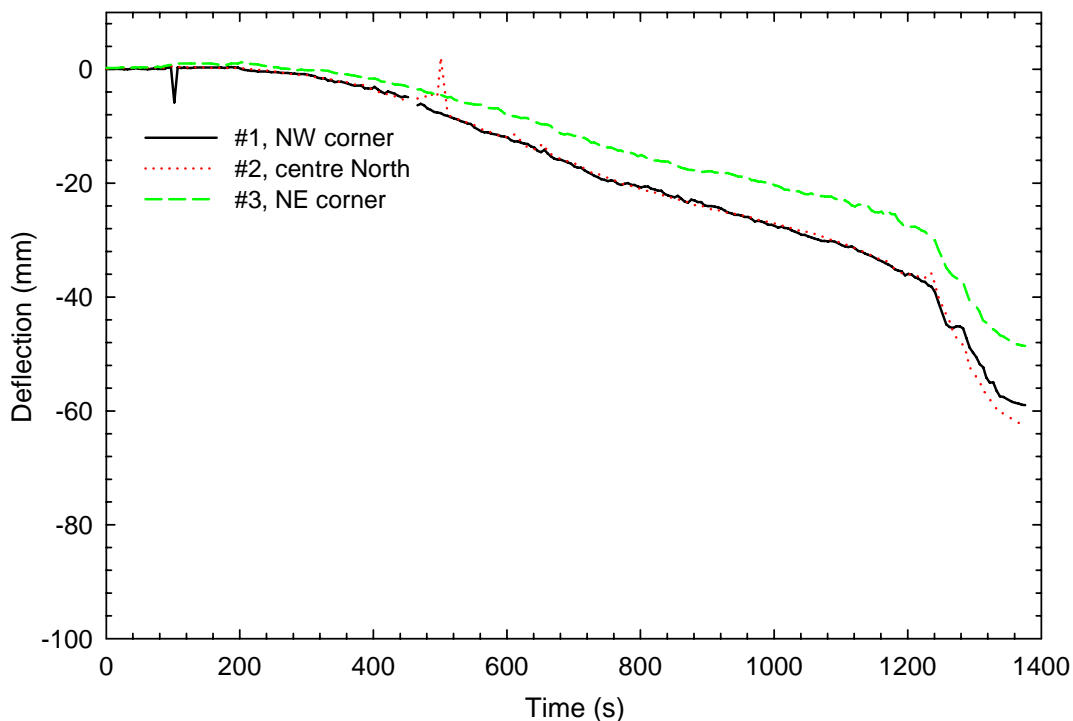
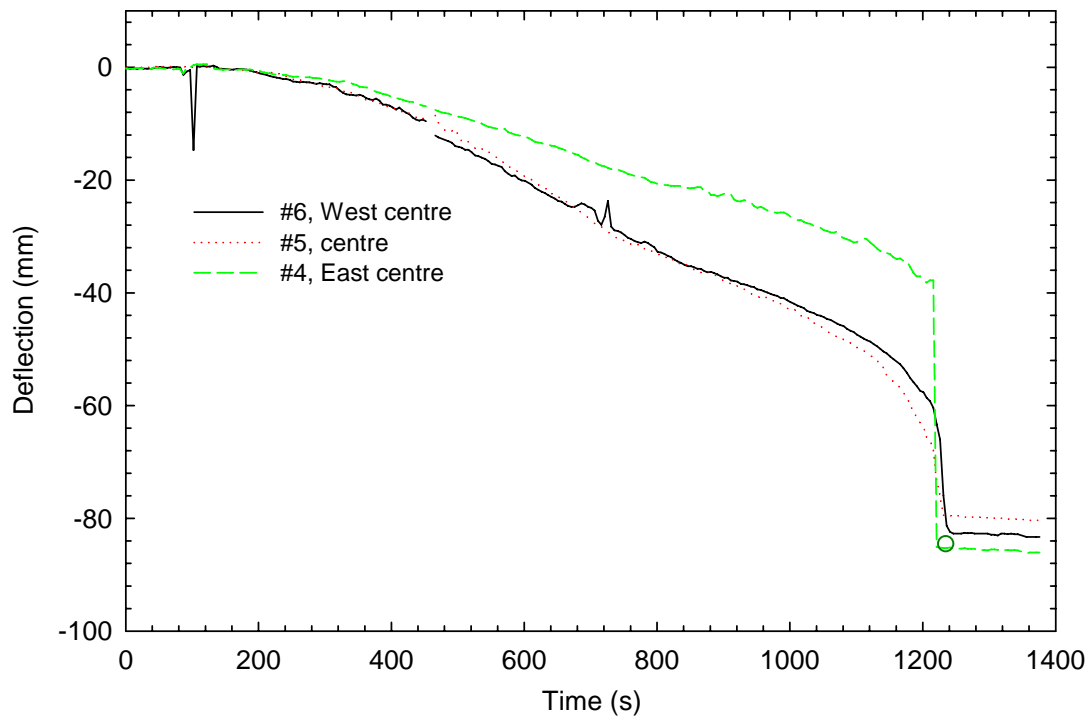
A comparison of the two tests (UF-01 and UF-02) show that the scenario with the door closed results in a less severe fire impact, consequently the loadbearing capacity of the joists and subfloor was extended, which, in turn, delayed the deflection of the floor and therefore the structural failure of the burning floor. The shortest time to reach the maximum deflection in each test (740 s for UF-01 and 1200 s for UF-02) was taken as the time after which the floor structure would be no longer usable for egress.

**Figure 43 (a). Deflection measurements for rows 1, 2 and 3 for UF-02**

**Figure 43 (b and c). Deflection measurements for rows 1, 2 and 3 for UF-02**

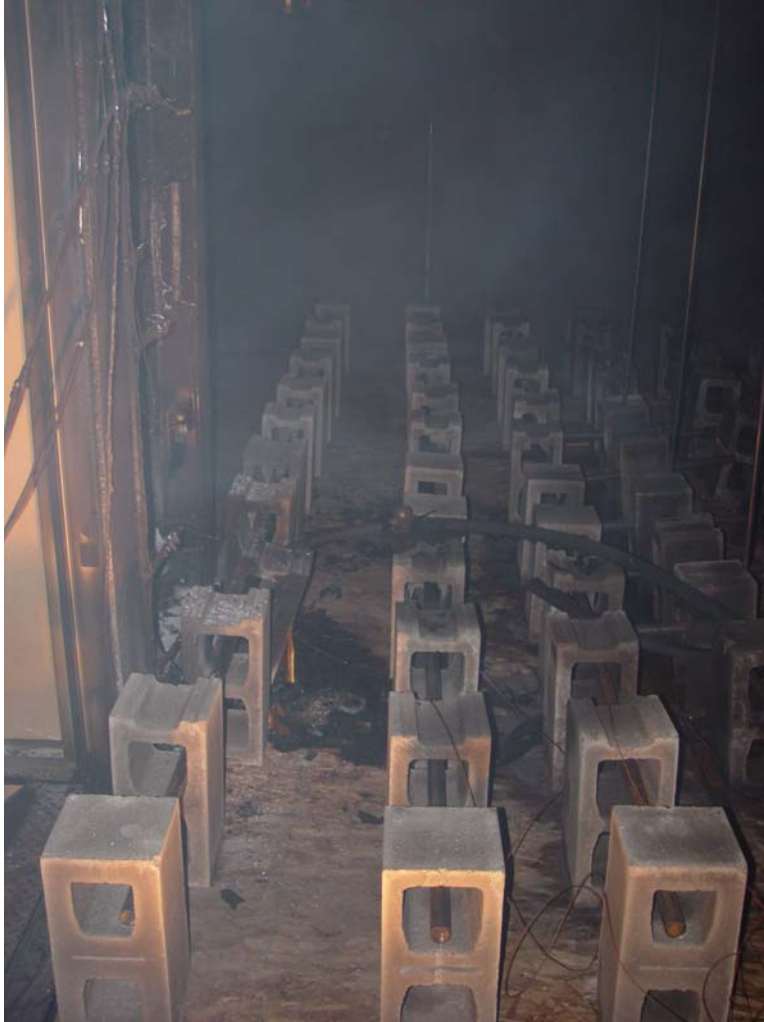
**Figure 44. Picture showing the north side holding the concrete blocks for UF-02**

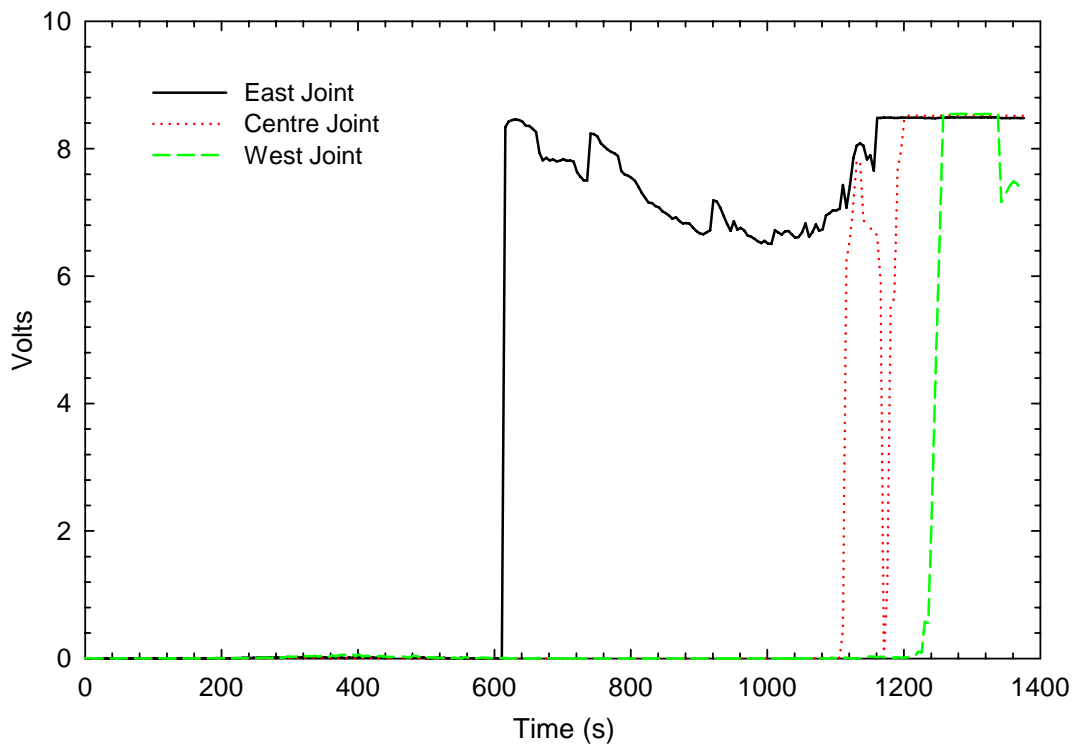
For Test UF-02, the flame penetration started first in the east side of the floor assembly. This can be attributed to the fact that the opening of the basement window and the door to the outside (1<sup>st</sup> door storey) may have created path for air to travel between the two openings (window and door) with the east side of the fire compartment as the easier path for this air movement. This also resulted in earlier flame penetration through at least one joint on the east side of the assembly. The times for flame penetration through the other joints were much later (almost double). This was not the case for UF-01, because having the basement doorway open, at the start of the test, facilitated the movement of air without the need to find any other paths through the floor assembly.

**Figure 45. Results of flame sensors at different joints**

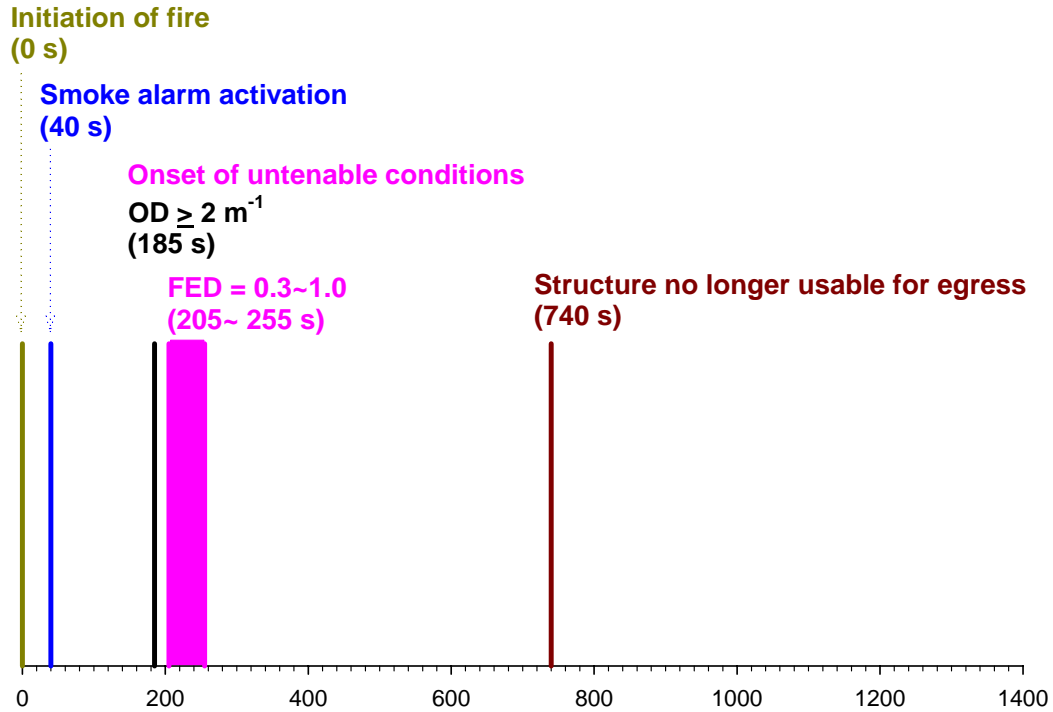
It should be mentioned that there appears to be a slightly earlier flame penetration in UF-02 compared to UF-01. This may be attributed to the lack of air in UF-02 and the fire creating a path for air and smoke to move between the basement and the first storey. The tests were terminated after some concrete blocks had started falling through the subfloor.

**Figure 56. Sequence of fire events in Test UF-01 (s)**
