Fire Performance of Houses. Phase I. Study of Unprotected Floor Assemblies in Basement Fire Scenarios Part 2

Part 2 – Results of Tests UF-03 and UF-09 (Wood I-Joists A)

Research Report: IRC-RR-247

Date: March 31, 2009

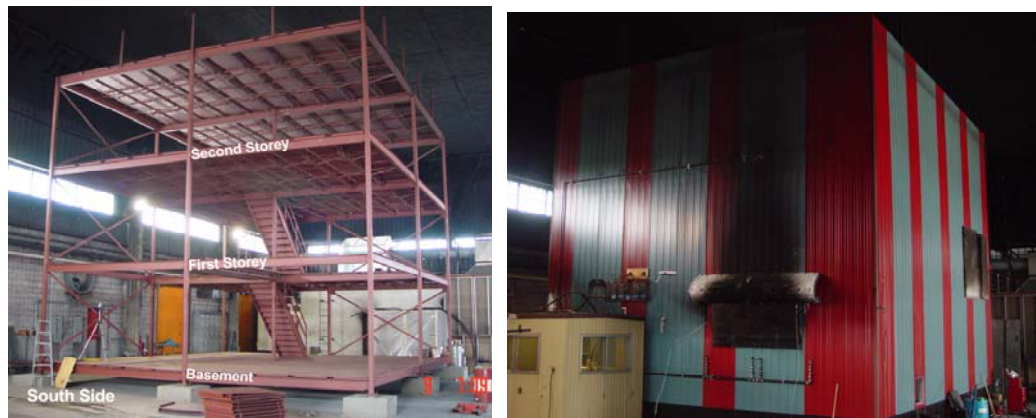
Figure 2. Three-storey facility

To undertake this research, NRC-IRC constructed a three-level experimental facility, representing a typical two-storey detached single-family house with a basement. The facility allows the study of structural fire performance, as well as smoke movement and tenability under fire conditions for single-family houses. The facility has a total floor area of approximately 95 m² per storey and is shown in Figure 2.

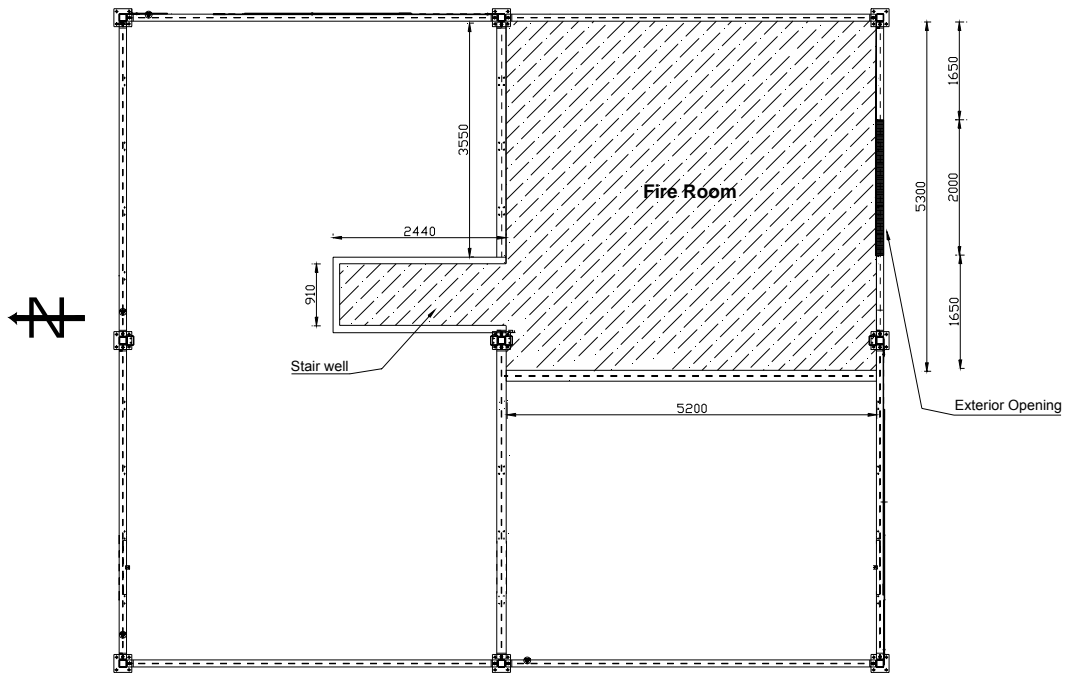
Figure 3. Basement level layout (dimensions in mm)

The layout of the basement is shown in Figure 3. The basement was partitioned to create a fire room representing a 27.6 m² basement living area, or about 1/4 of the total basement area. This compartment size was chosen based on a survey carried out by NRC [4]. The area of the basement that was not used for the fire compartment was blocked off during the fire tests. The height of the basement was 2.44 m. The ceiling clear height depended on the depth of the floor assembly being tested. A rectangular exterior opening measuring 2.0 m wide by 0.5 m high and located 1.8 m above the floor was provided in the south wall of the fire room. The size of the opening was chosen based on the results of the survey carried out by NRC [4]. A 0.91 m wide by 2.05 m high doorway opening located on the north wall of the fire room led into an empty stairwell enclosure (without a staircase). At the top of this stairwell, a 0.81 m wide by 2.05 m high doorway led into the first storey, as shown in Figure 4. This doorway either had no door (open basement doorway) or had a door in the closed position (closed basement doorway), depending on the scenario being studied. There is no requirement for a basement door in the NBCC. Section on “Openings and their States” provides more details.

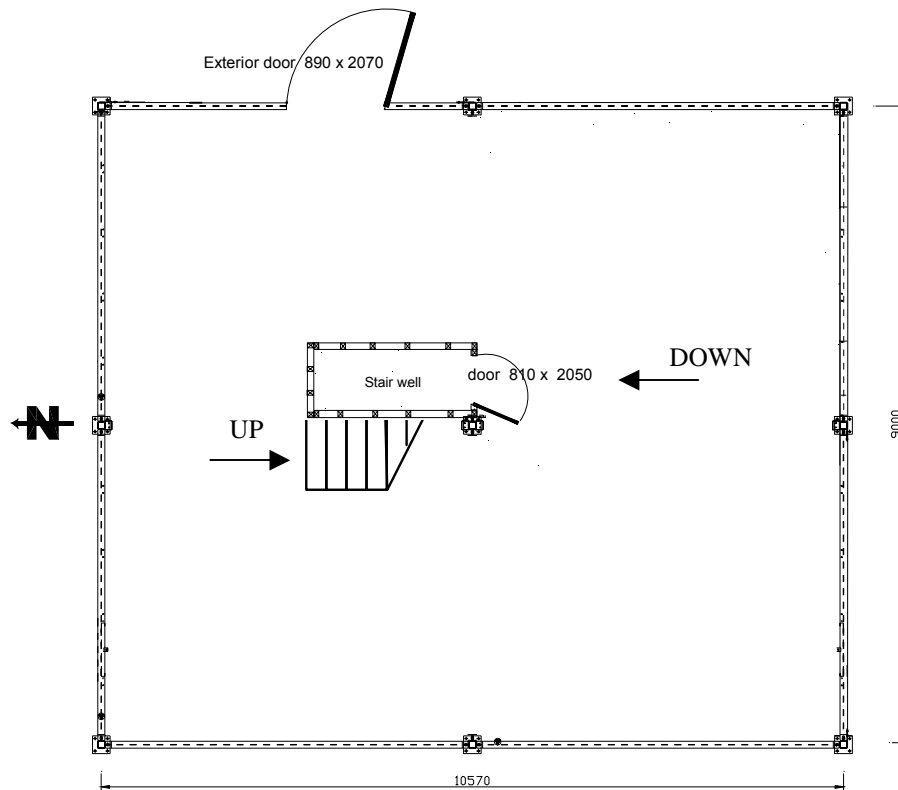
Figure 4. First storey layout (dimensions in mm)

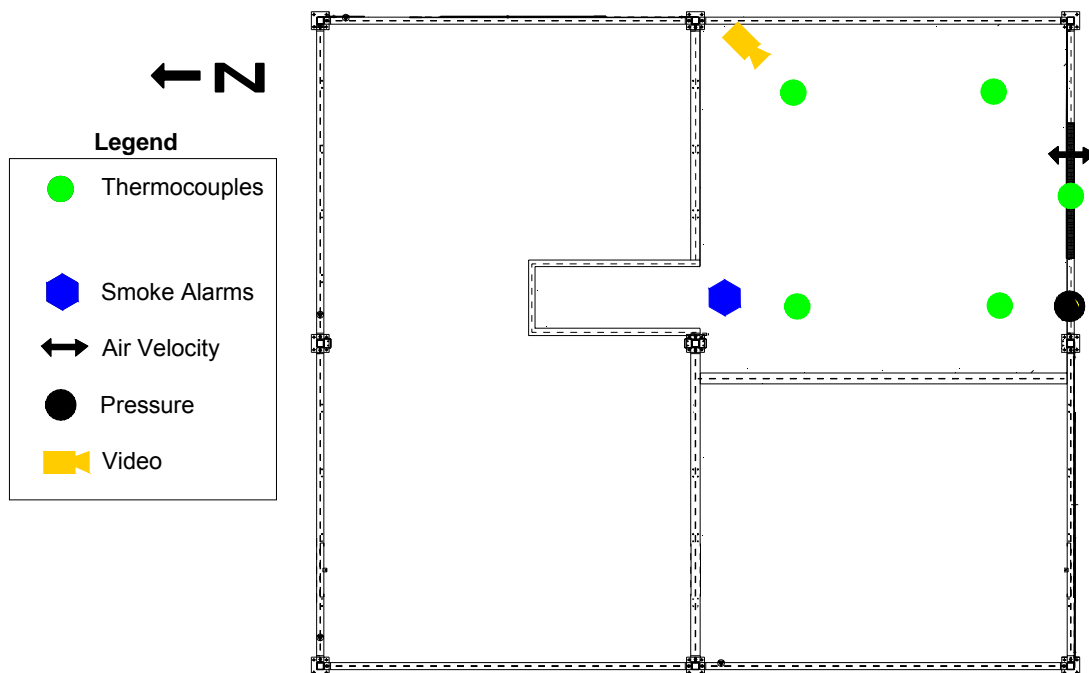
Figure 8. Fire Compartment instrumentation

The positioning of the instrumentation in the fire compartment in the basement is shown in Figure 8.

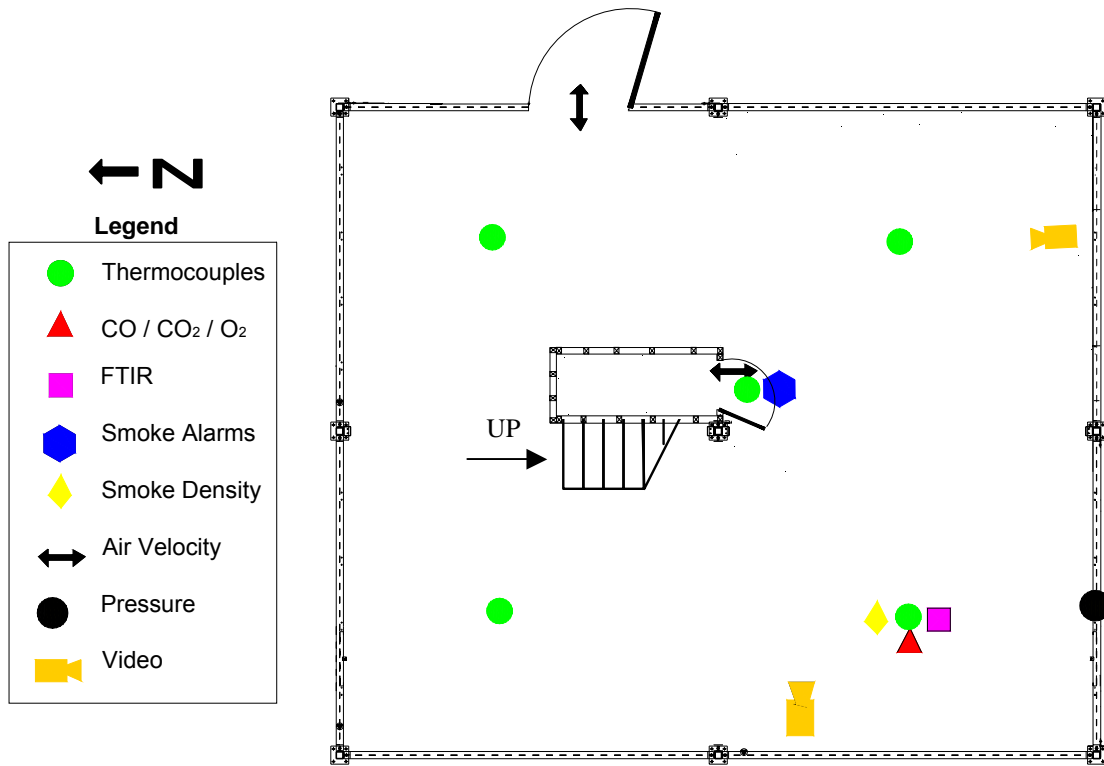
Figure 9. First storey instrumentation

The positioning of the instrumentation on the first storey is shown in Figure 9.

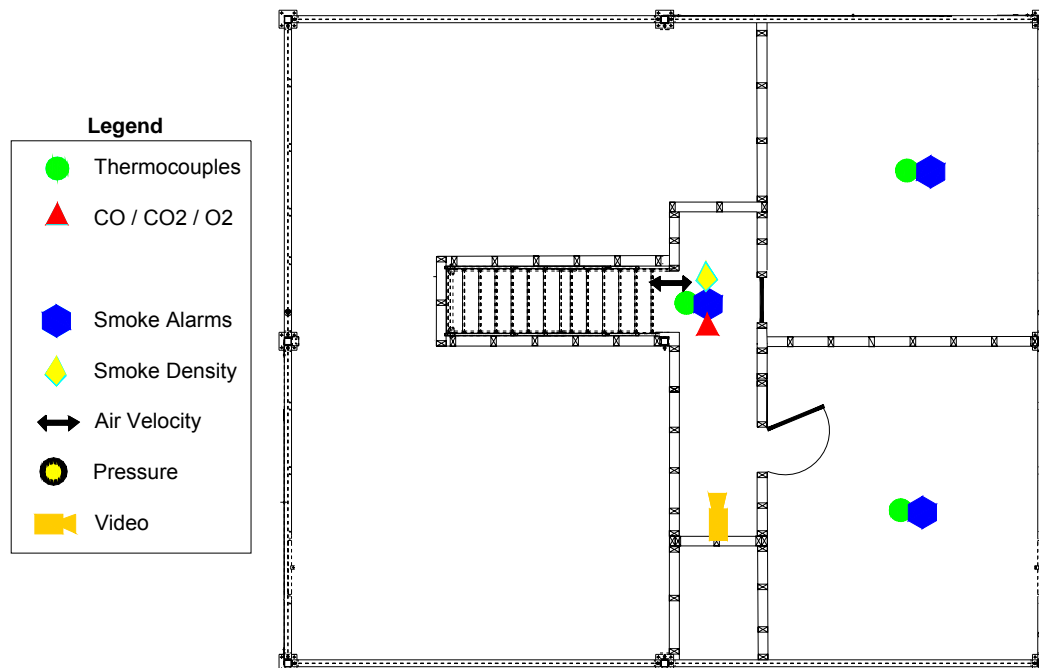
Figure 10. Second storey instrumentation

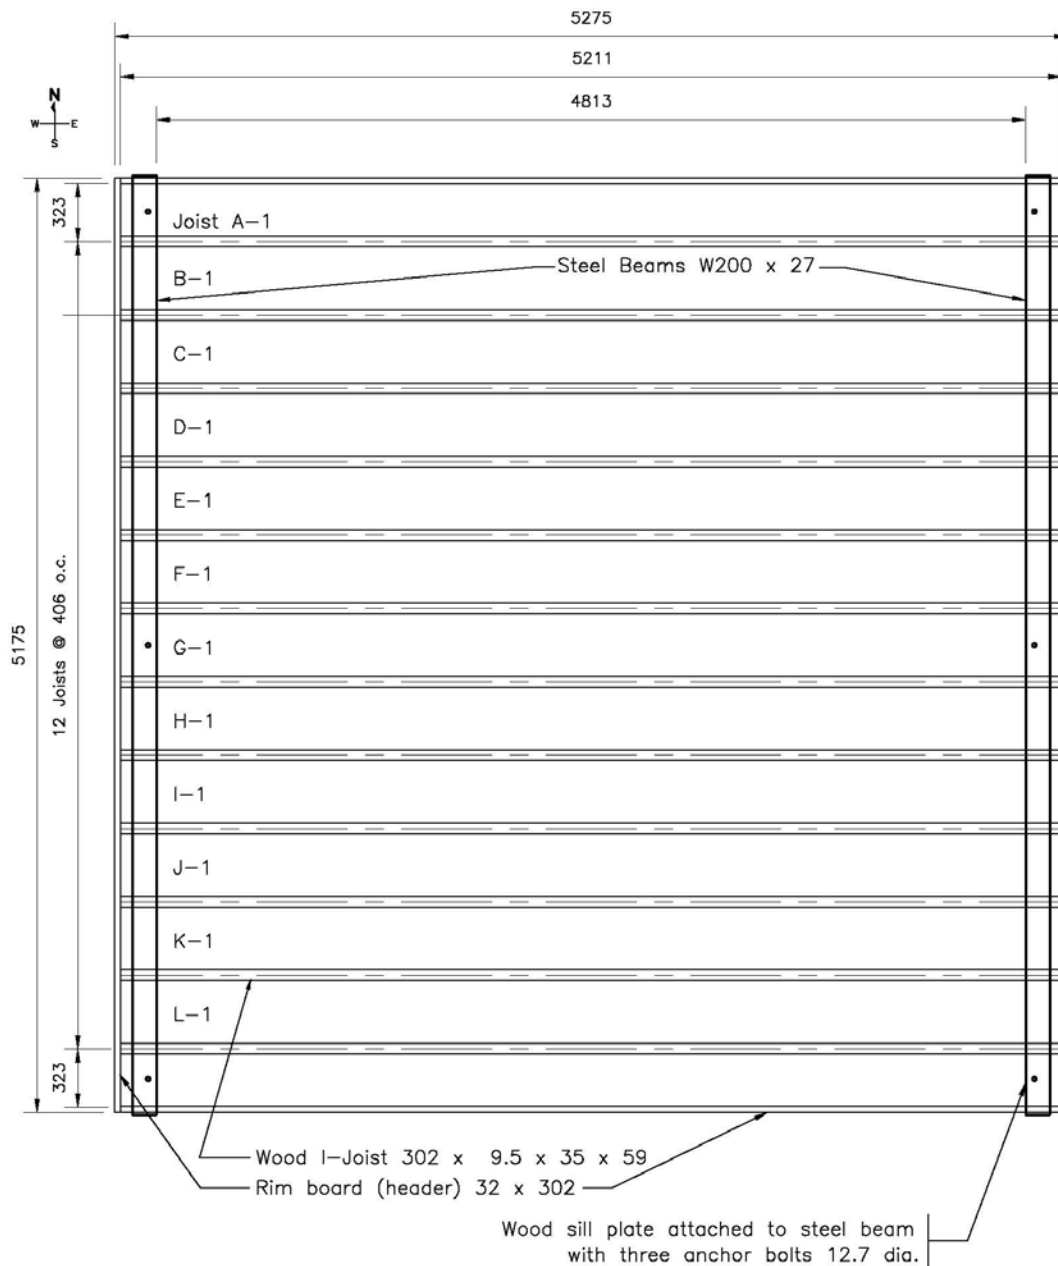
Figure 11. Wood I-joist layout details (all dimensions in mm)

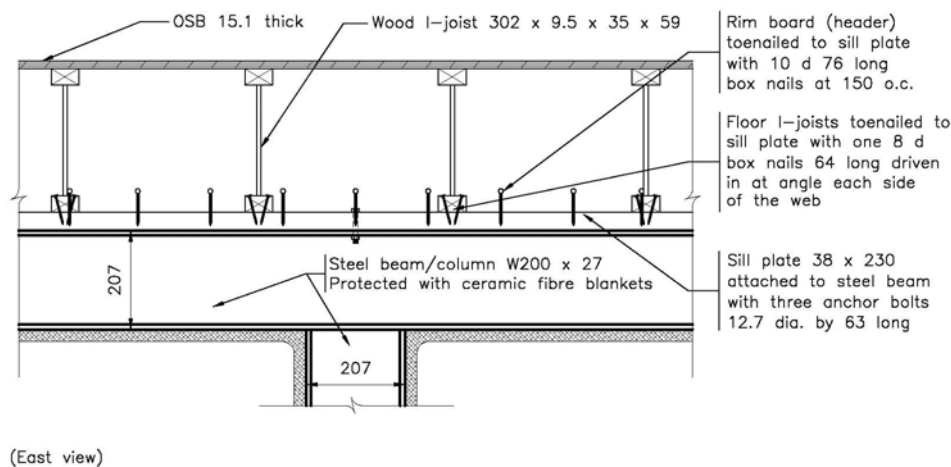
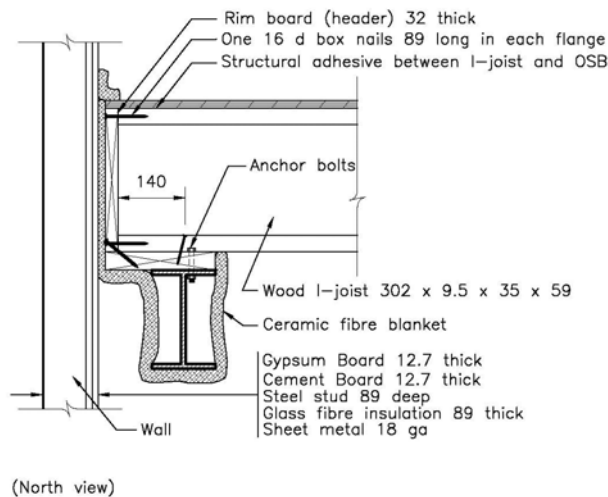
Figure 12 shows the supporting beams. Each wood I-joist floor assembly was supported by two horizontal beams, each of which was supported by two columns (a total of four columns for each assembly) as illustrated in Figure 12. The beams were bolted to the columns, which were stiffened by bars and rested stably on the floor under the weight of the assembly and beams.

Figure 12. End connection details and supports (all dimensions in mm).

Figure 12 also shows the details of the end connection. Ceramic fibre blankets were used to fill any gaps between the assembly and the end walls. Ceramic fibre blankets were also used to protect the steel beams and columns so that they were not subjected to fire and would not fail during the tests.

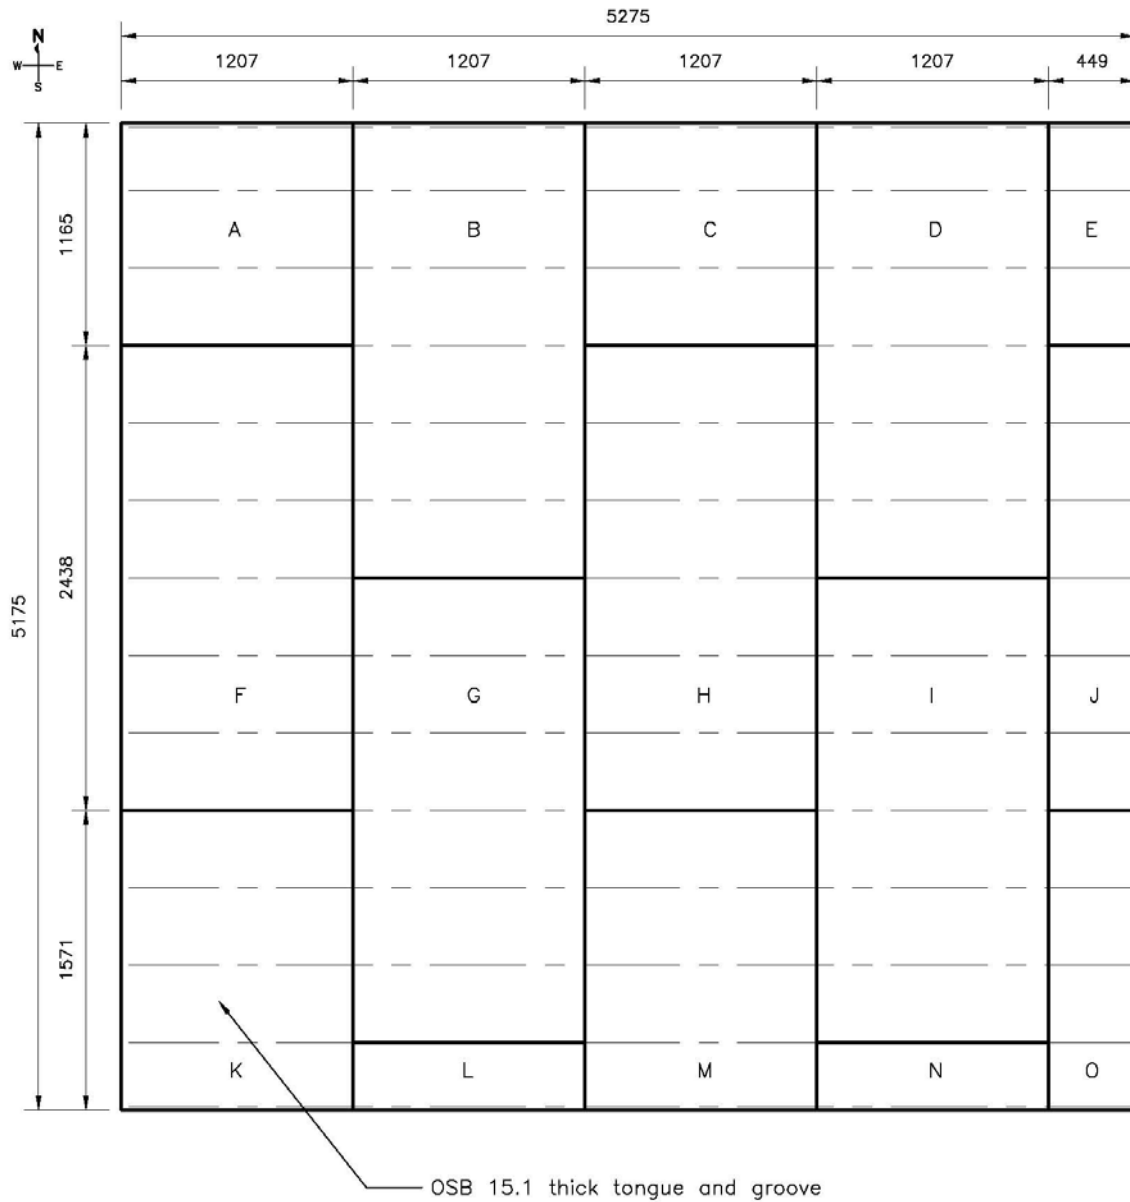
Figure 13. Subfloor layout (all dimensions in mm)

OSB was used as the subfloor material in the floor assemblies. The specific OSB material used was selected based on a separate study documented in reference [5]. The subfloor panels were 15.1 mm thick in both assemblies, with a full panel size being 1.2 x 2.4 m. The longer panel edges had a tongue and groove profile while the short panel edges were square-butt ends. Figure 13 shows the layout of the subfloor. The nailing pattern and description of nails used to attach the OSB panels to the wood I-joists A and rim board (header) are shown in Figure 14.

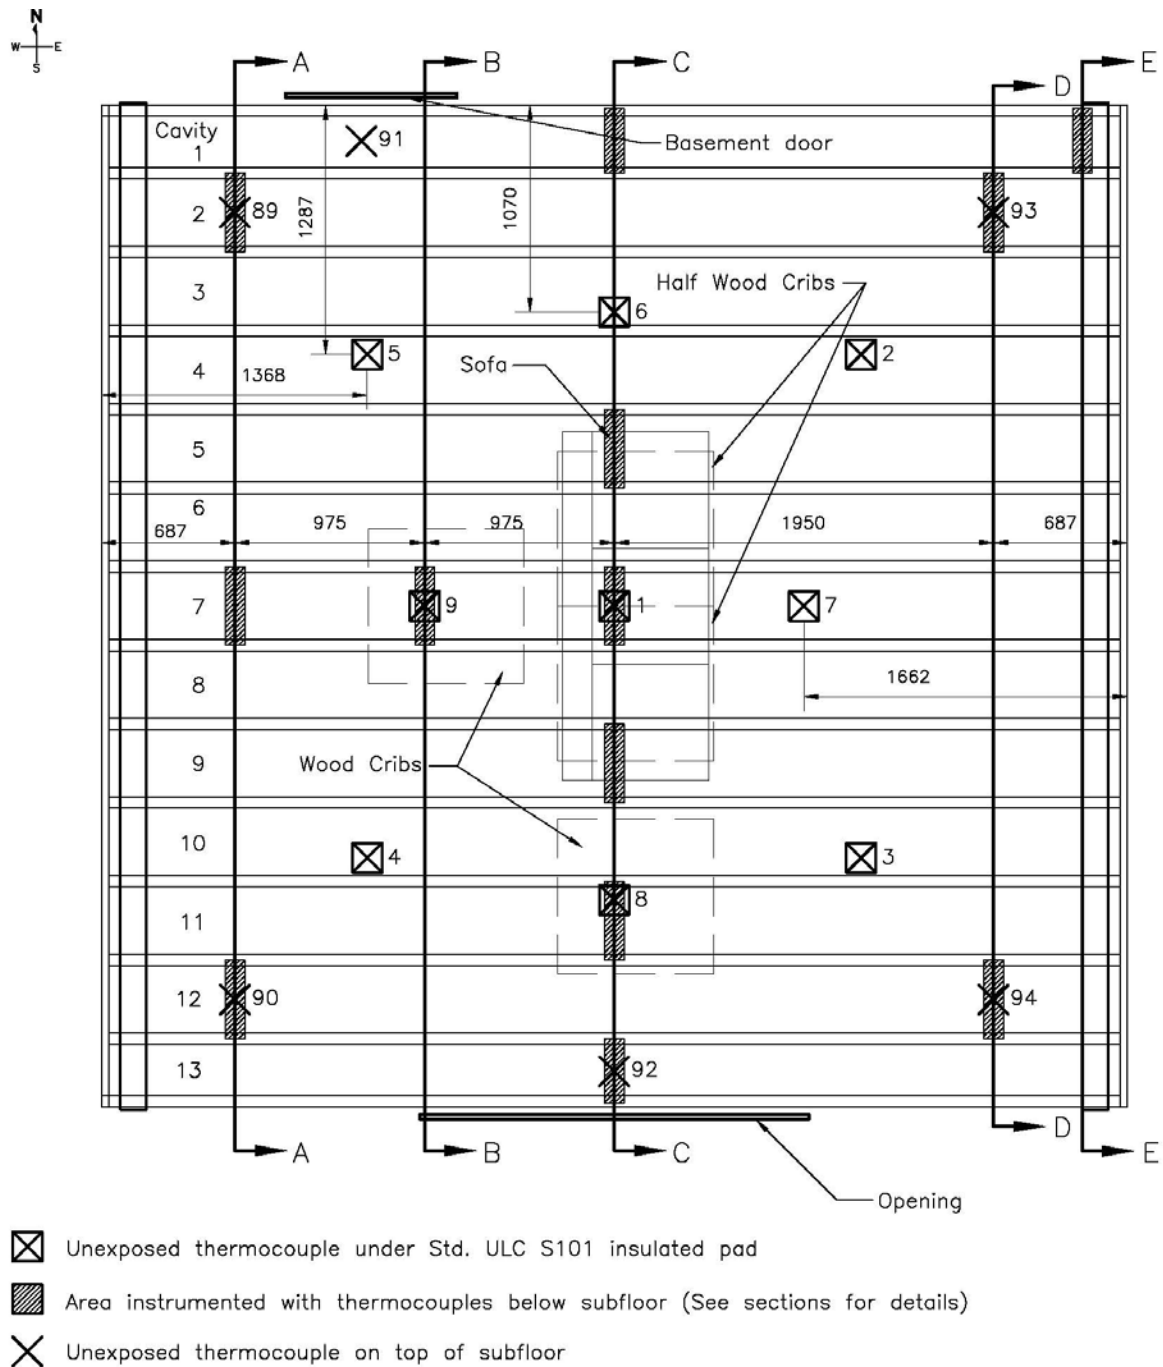
Figure 15. Thermocouples locations (all dimensions in mm)

Ninety-four Type K (20 gauge) chromel-alumel thermocouples, with a thickness of 0.91 mm, were used for measuring temperatures at a number of locations throughout each assembly. The thermocouple locations on the unexposed and exposed sides of the assemblies are shown in Figure 15 and Figure 16. These locations were chosen to monitor the conditions of the assembly at critical locations during the fire tests.

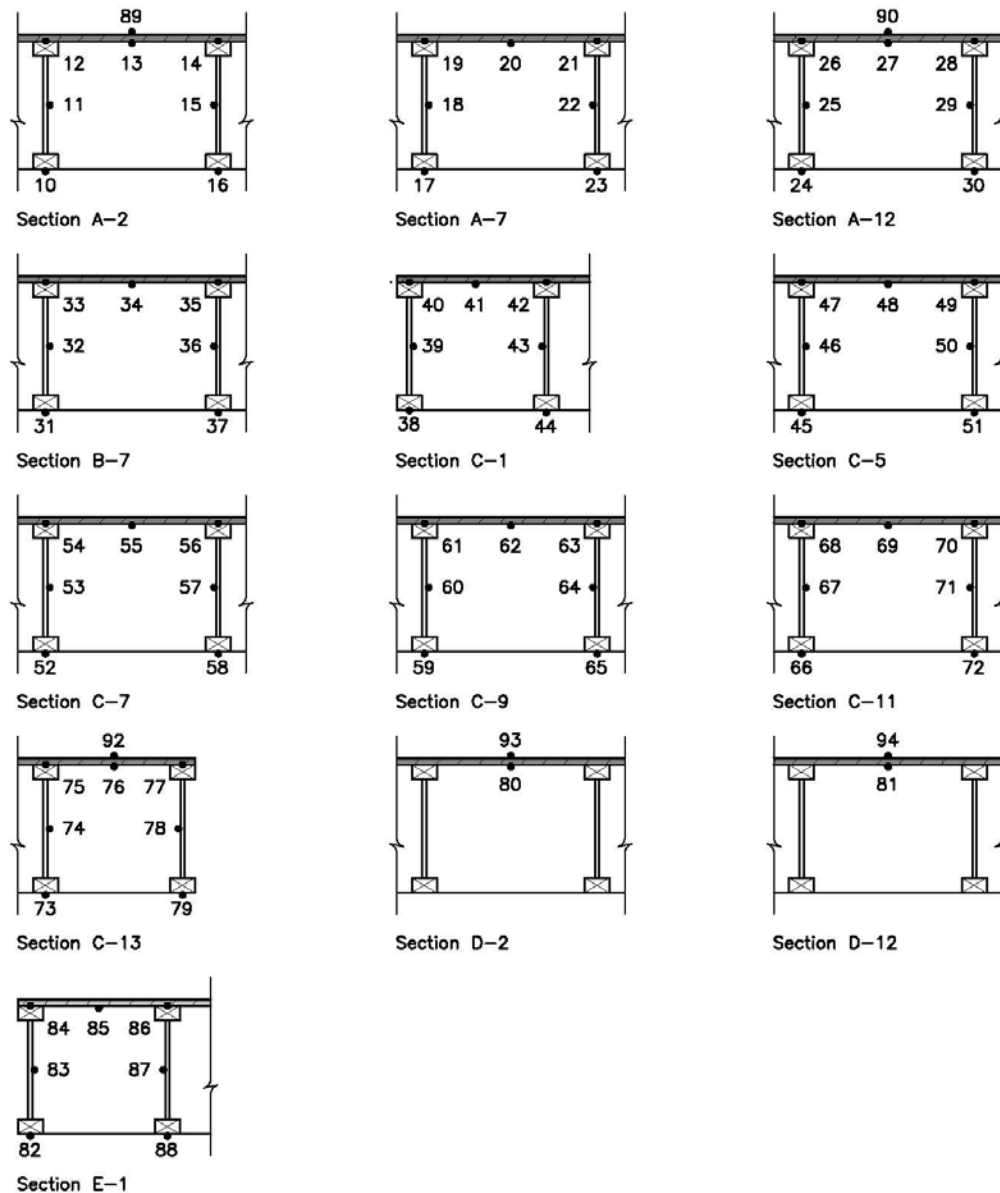
Figure 16. Thermocouples locations reflecting the different sections shown in Figure 15

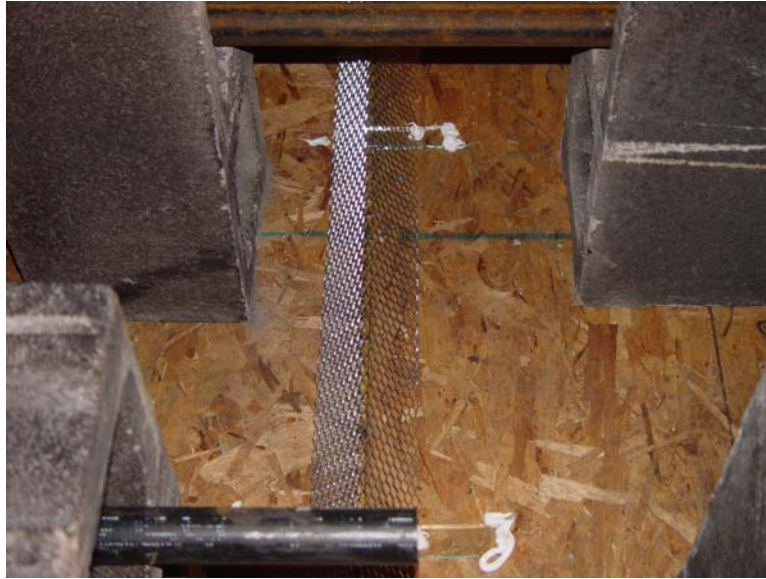
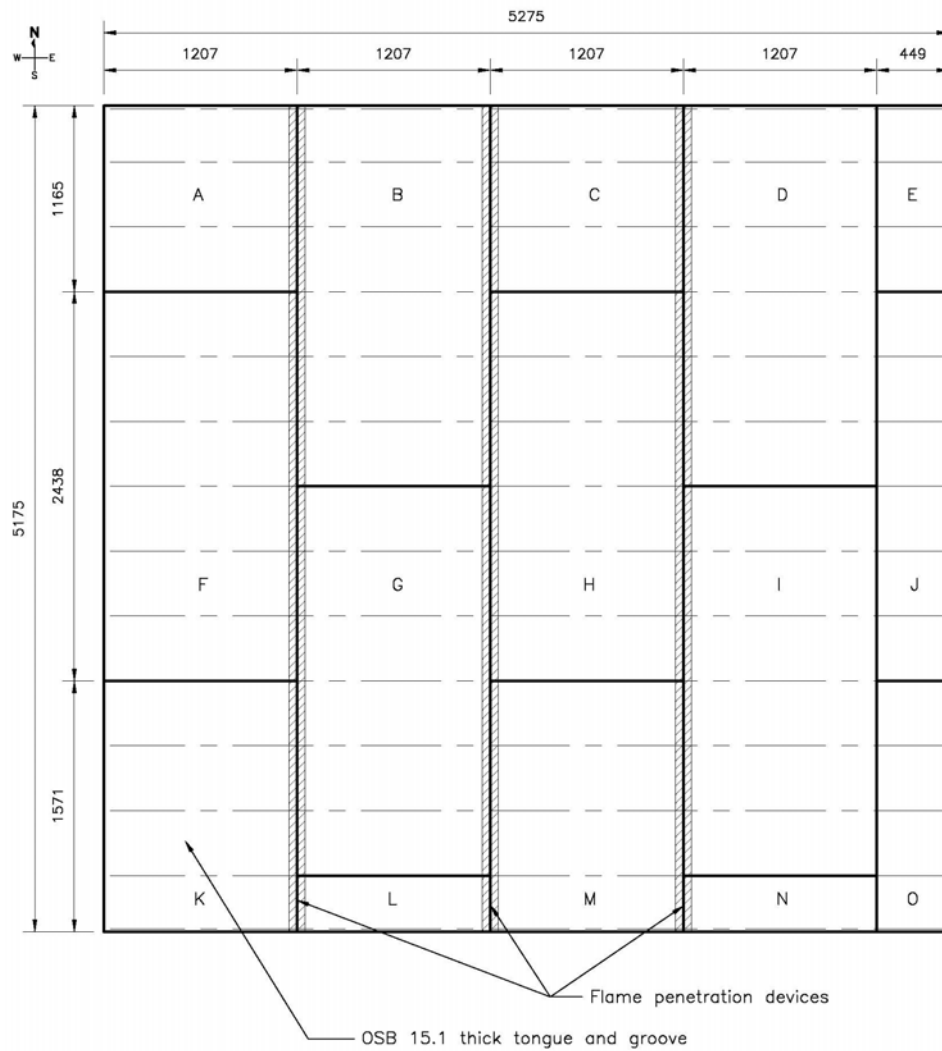
Flame penetration through the floor assembly is considered to be an initial indicator of the impending failure of the assembly. A device was developed and used for the tests to better determine the time for flames to penetrate the floor. The special device consisted of a wire mesh placed at 3 locations on the unexposed surface of the floor assembly, specifically at three of the tongue and groove joints, as shown in Figure 17. A detailed description of the device is provided in reference [8].

Figure 17. Wire mesh device to detect flame penetration (all dimensions in mm)

Figure 42 shows the results of the flame-sensing devices. Three wire meshes were installed on the top of three joints (East, Centre and West) on the unexposed side of the floor as shown in Figure 17 (instrumentation figure). There was a sudden increase in the voltage output of the flame-sensing device when flames penetrated through the floor and struck the wire meshes. As indicated by Figure 42, heavy flame penetration occurred at the joints at 480 s, which is very close to the failure of the assembly.

Figure 43 shows the results from the three flame-sensing devices, which were installed on the top of three joints (East, Centre and West) on the unexposed side of the floor as shown in Figure 17 (instrumentation figure). There was an increase in the voltage output of the device when flames penetrating through the floor struck the device. As indicated by Figure 43, the flame were penetrating at all joints at 770 s, which is very close to the assembly failure.

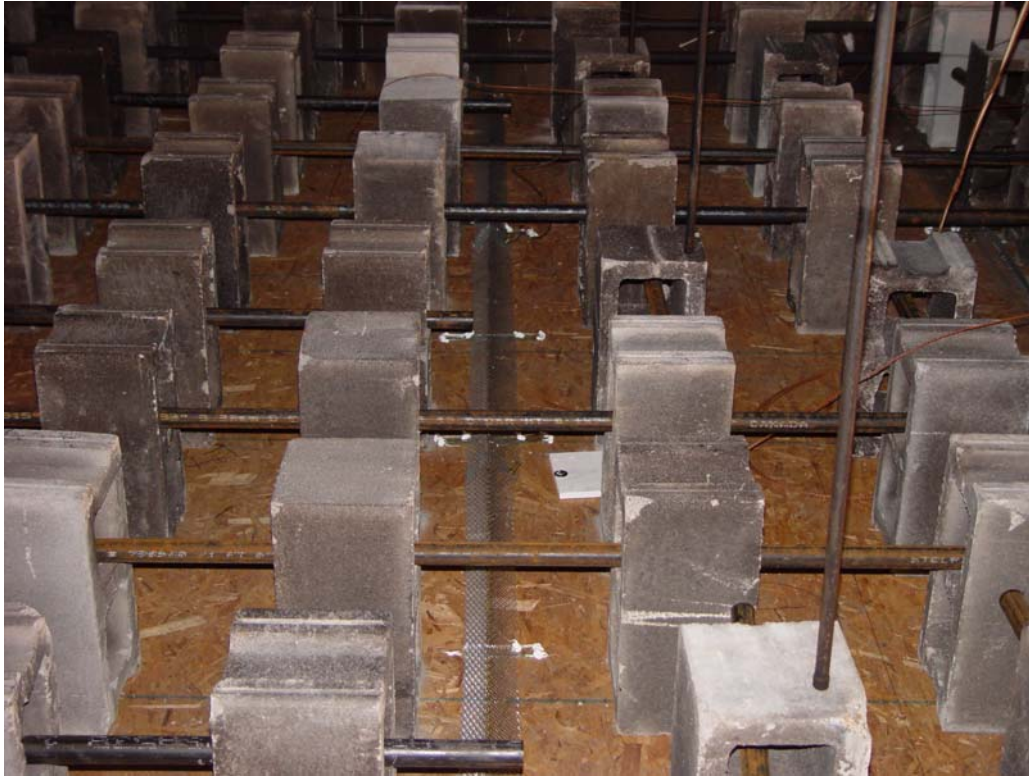
the basement and causing any damage, a restraining system was designed using a series of pipes attached to beams on both ends, which were secured to the steel frame of the 3-storey house, as shown in Figure 19. The pipes were inserted through the hollow cores of the concrete blocks prior to the fire tests. The weight of the pipes was included in the total imposed load.

Figure 19. Device to hold the loading blocks

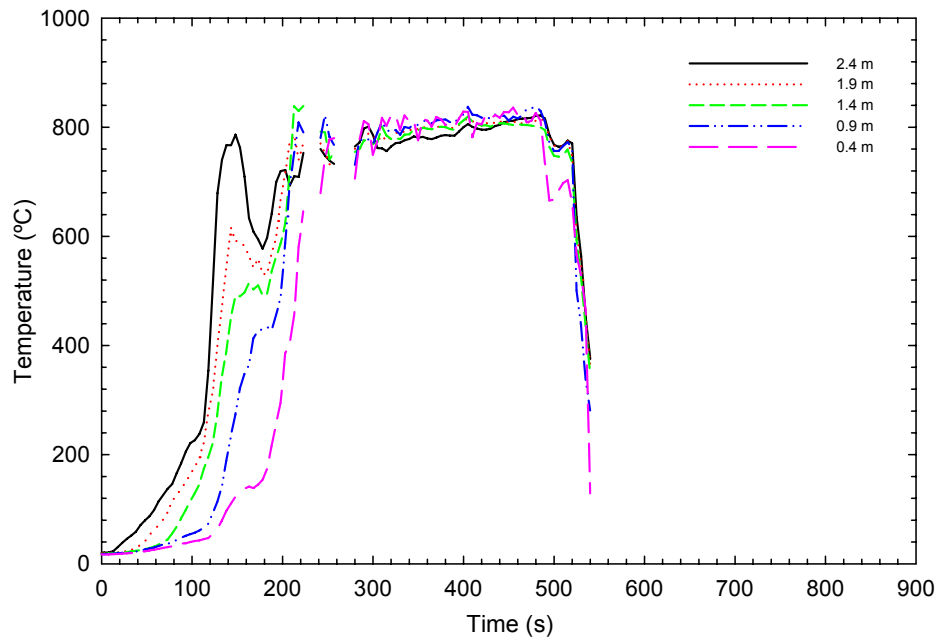
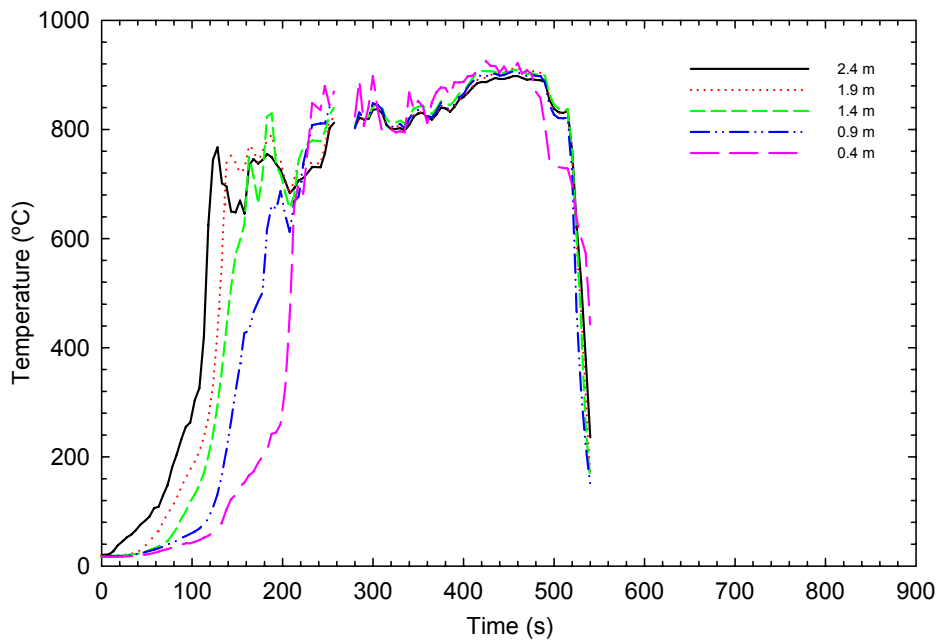
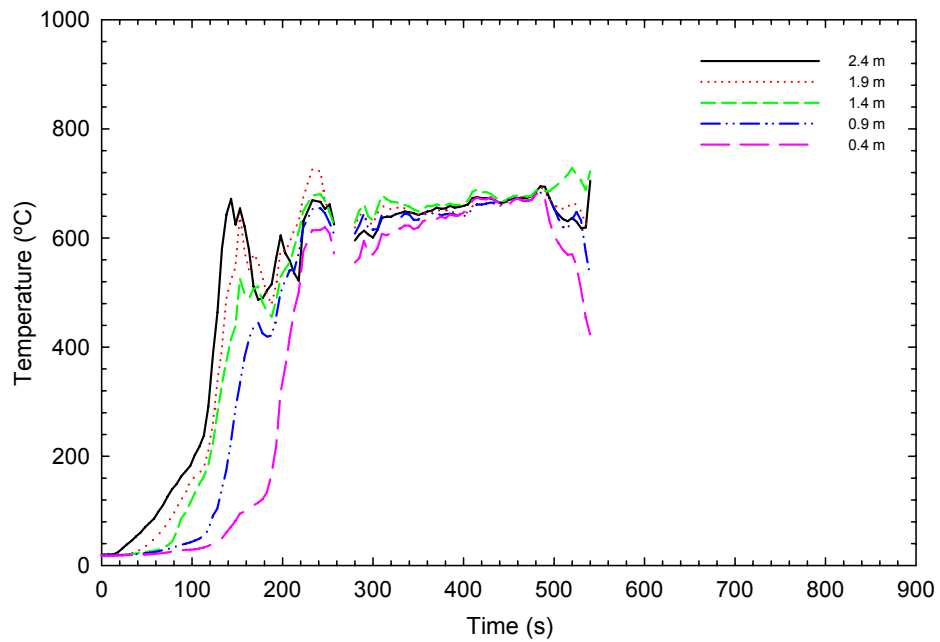
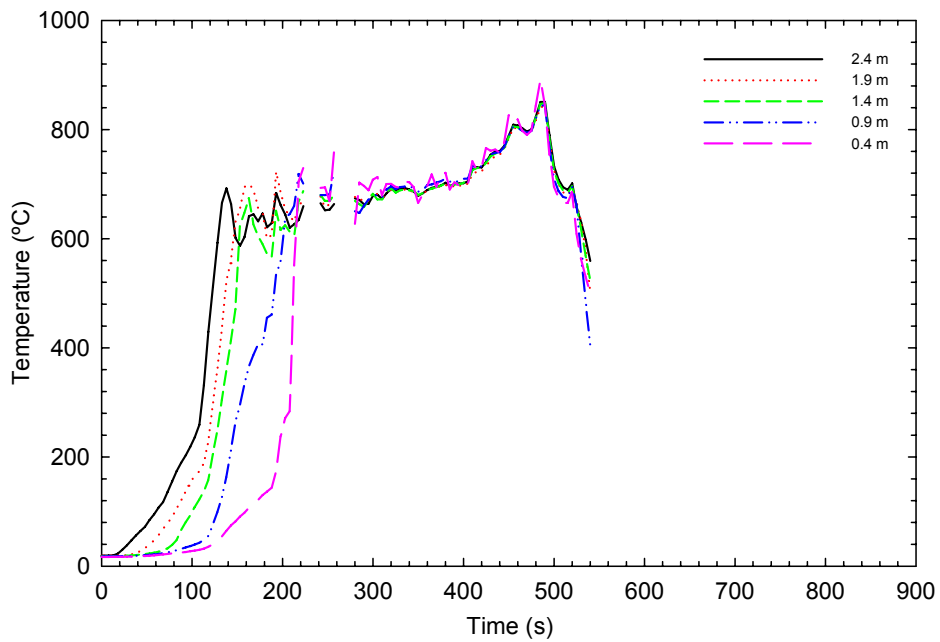
Figure 20 (a and b). TC Trees in the basement for UF-03

Figure 20 (c and d). TC Trees in the basement for UF-03

In the case of UF-03 (open basement doorway), Figure 20, the temperatures rose to a maximum of 700 to 800°C in the first 130 to 140 s. The initial peak temperature was likely due to the high rate of heat release from the mock-up sofa near its peak burning rate. As shown in the figures, the initial temperature rise was faster at the 2.4 m height than the other heights because the hot smoke layer formed first at the ceiling and flames also impinged on the ceiling. Just after the maximum temperature was reached, there was a slight decrease in temperatures likely due to the combined effect of opening the basement window at 123 s and the fact that a significant portion of the polyurethane foam component of the fuel package had been consumed. The temperatures decreased further after the exterior door was opened, which created a movement of air and smoke between the basement and first storey. The fresh air coming from the basement window also increased the combustion of the wood cribs and the exposed floor assembly, which caused the temperatures to begin increasing steadily again, reaching a maximum temperature of about 900°C. During the fully-developed phase of the fire, temperatures were slightly lower at the higher level likely due to flow stagnation at the surface and conductive heat losses through the floor assembly. Finally, the temperatures started decreasing again just after 490 s when the floor collapsed and the fire was extinguished using sprinklers. It should be noted that the temperatures (due to the mock-up sofa burning) were lower in the case of the NE tree. This may be partially attributed to the fact that the NE corner was less impacted by the fire, as it was farthest away from the fire source and that most of the hot gases were moving to the upper storeys through the SE to NW path.

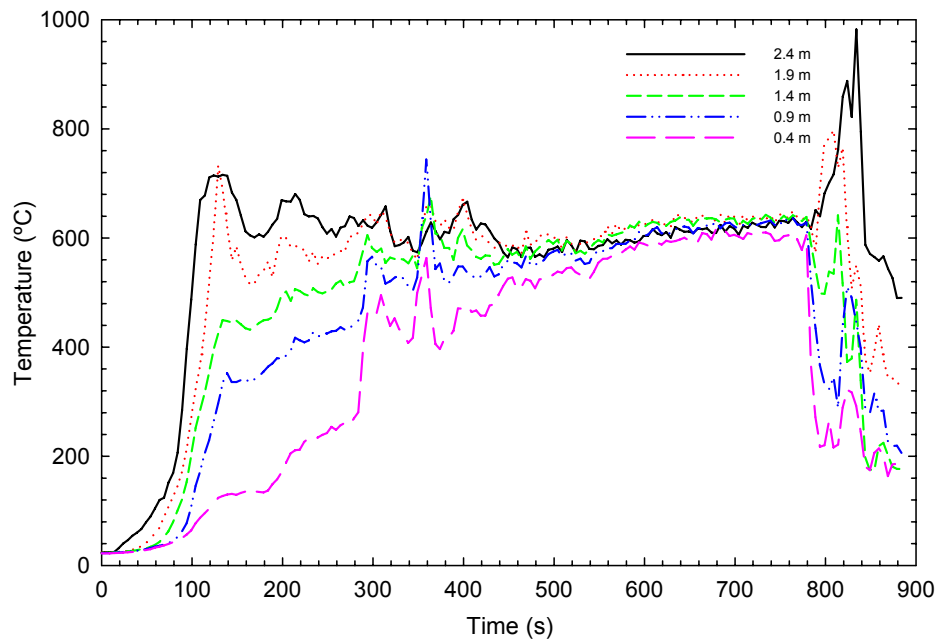
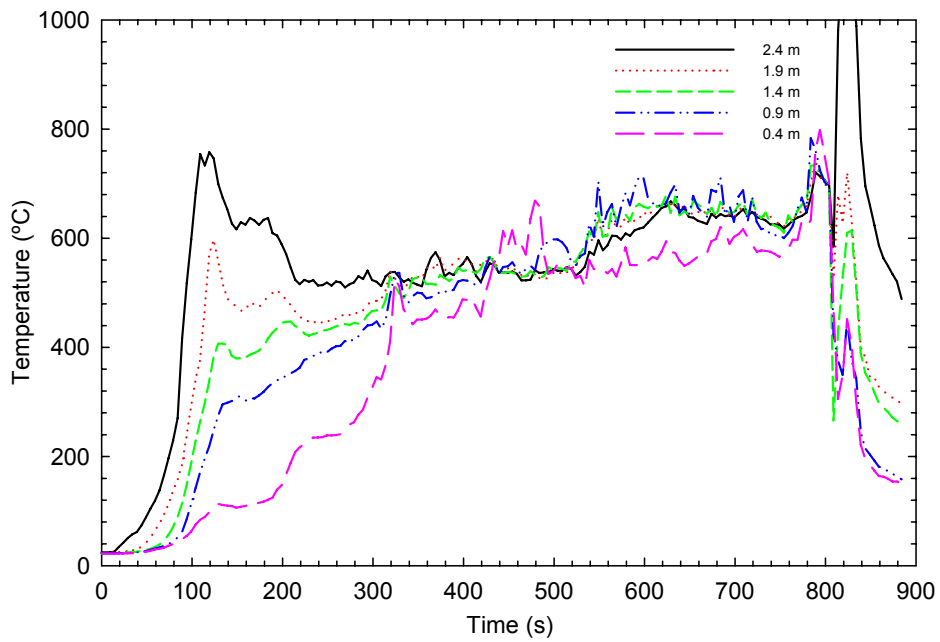
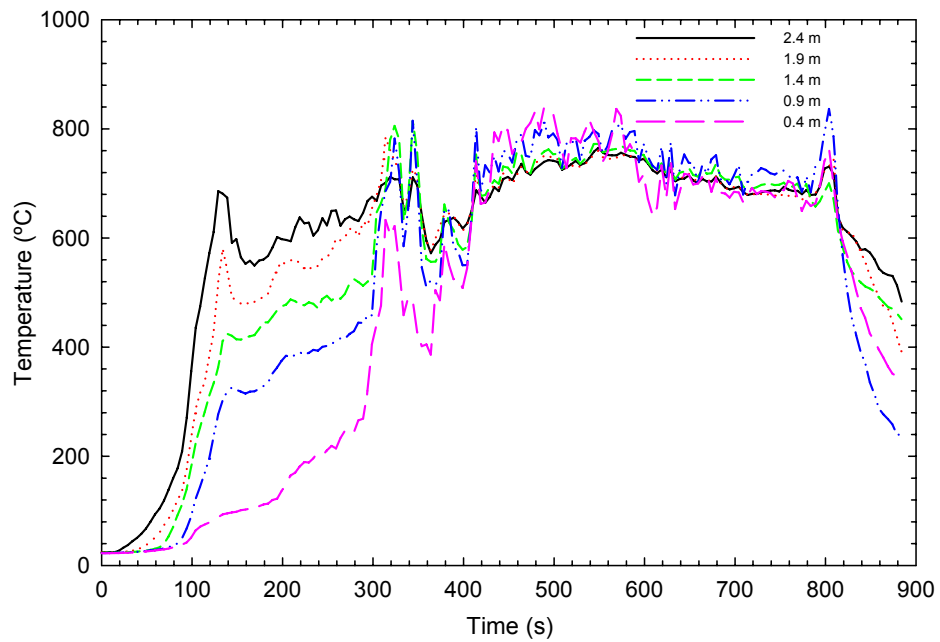
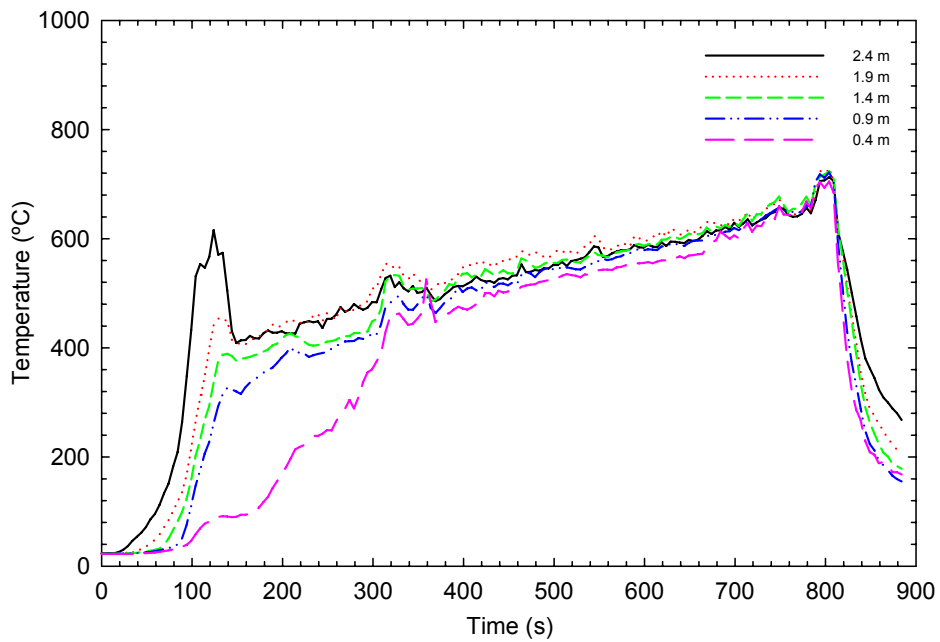
Figure 21 (a and b). TC Trees in the basement for UF-09

Figure 21 (c and d). TC Trees in the basement for UF-09

For both UF-03 and UF-09, the combustion was dominated by the mock-up sofa during the first 120 to 180 s, while the wood cribs and floor assembly, including the subfloor, provided the fuel for combustion after this period. The duration of the fire was shorter for UF-03 compared to UF-09 because the availability of more air in Test UF-03 resulted in faster and more efficient combustion. For UF-09, combustion air was limited until later in the test.

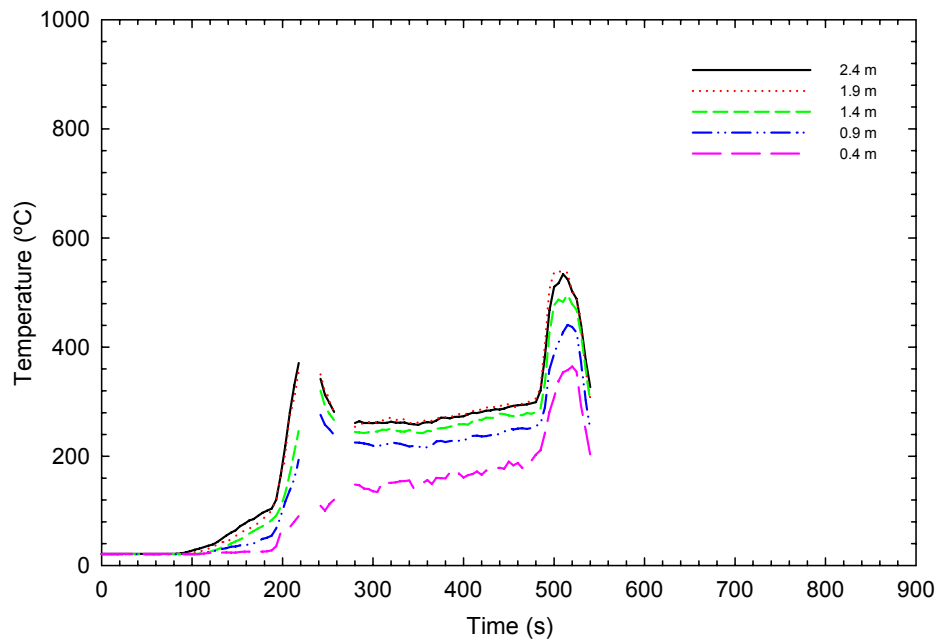
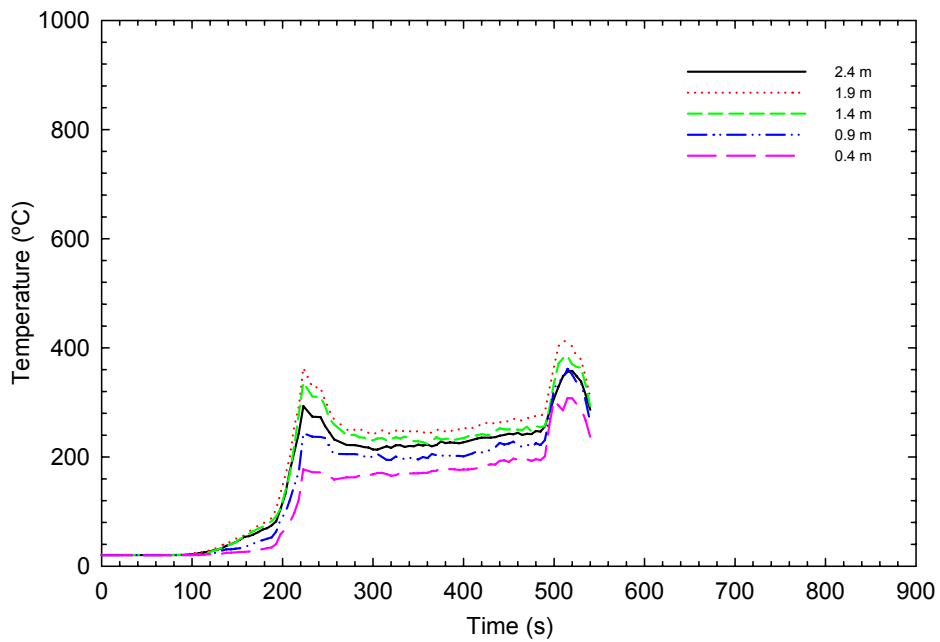
Figure 22 (c and d). TC trees in the first storey for UF-03

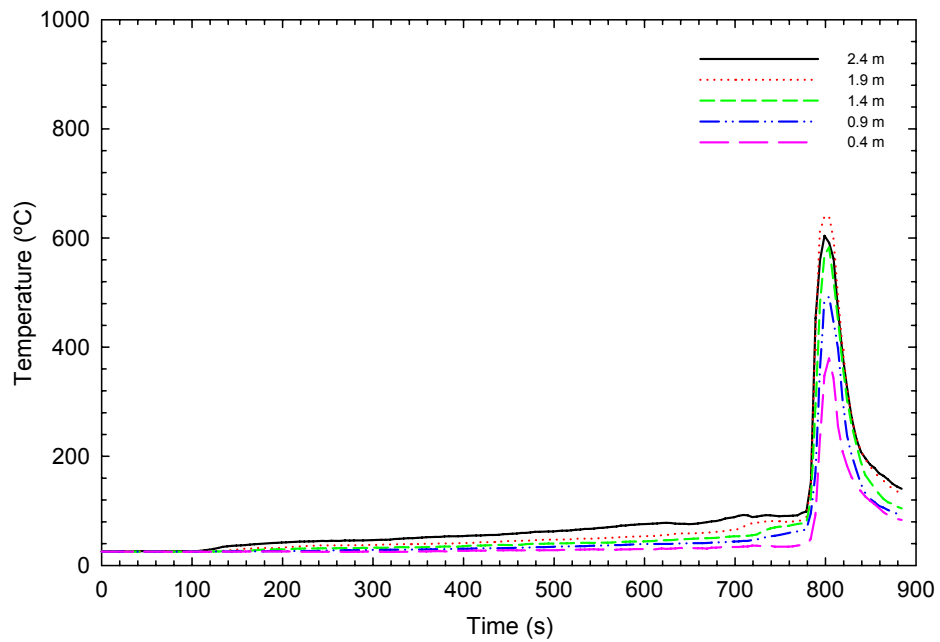
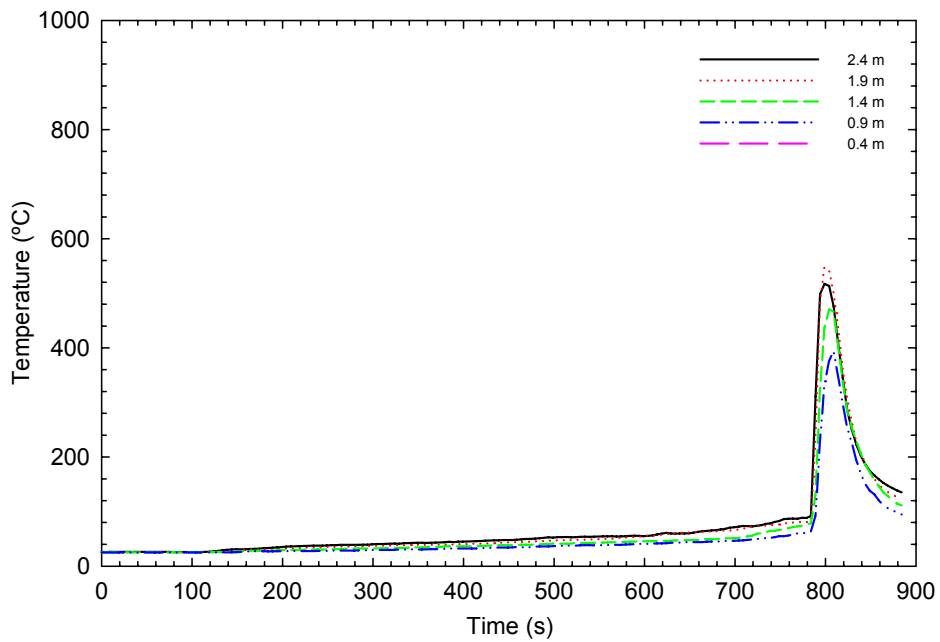
Figure 23 (c and d). TC trees in the first storey for UF-09

In the case of UF-09 (closed basement doorway), Figure 23, the temperatures increased very slowly mainly because the basement doorway was closed. The migration of the hot gases and smoke to the first storey did not start until late in the test when openings started forming in the floor or from the burning of the basement door. Before 760 s, the temperatures measured at the thermocouple tree locations were low and comparable. At around 780 s, all the thermocouple trees showed a sharp increase in temperatures, an indication that flames had penetrated through the floor. The peak temperatures were 760, 680, 640 and 530°C for SE, SW, NE and NW, respectively. After about 800 s, the test was terminated; consequently the temperatures started decaying because of the extinguishment of the fire.

The temperatures recorded in the first storey for test UF-09 were much lower before flame penetration occurred than those recorded in UF-03. After flame penetration, temperatures in UF-09 showed a very sharp increase compared to UF-03. The peak values were also higher for UF-09 than UF-03.
