Fire Performance of Houses. Phase I. Study of Unprotected Floor Assemblies in Basement Fire Scenarios Part 2

Part 2 – Results of Tests UF-03 and UF-09 (Wood I-Joists A)

Research Report: IRC-RR-247

Date: March 31, 2009

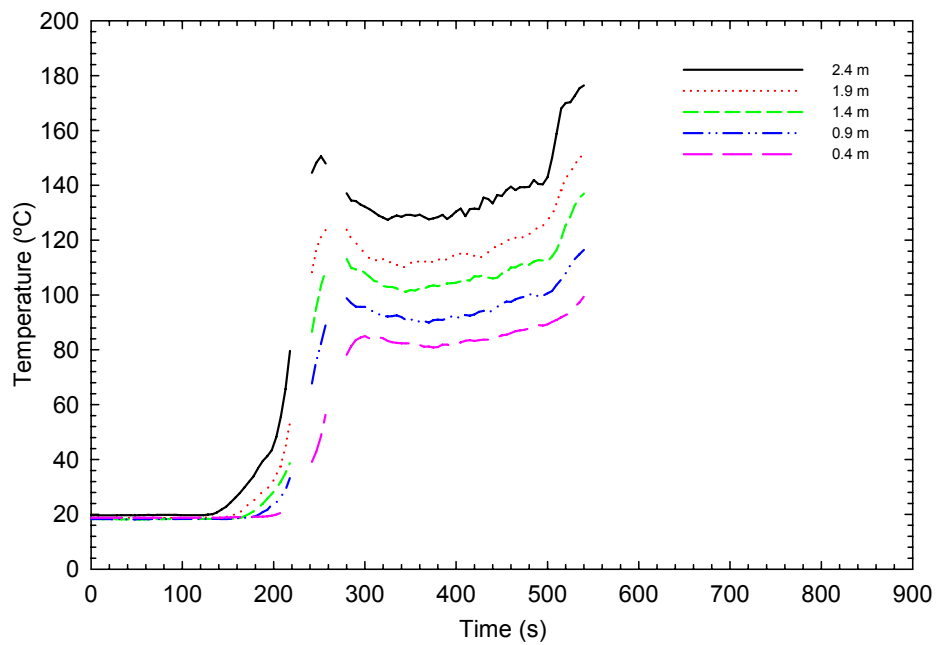
**Figure 24. TC trees in the second storey bedrooms for UF-03
(SE bedroom: door closed; SW bedroom: door open)**

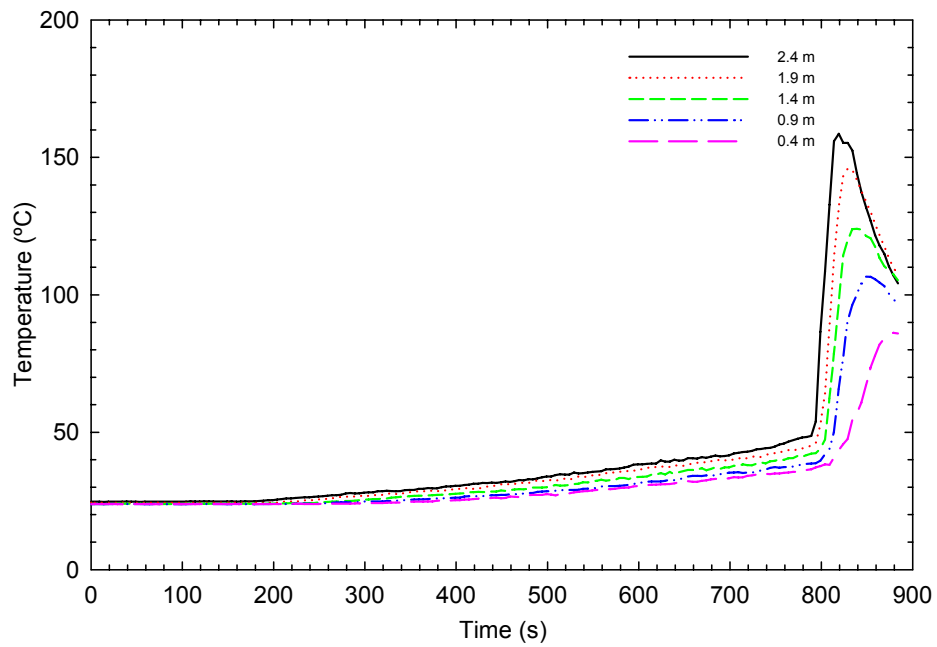
Figure 25. TC trees in the second storey bedrooms for UF-09

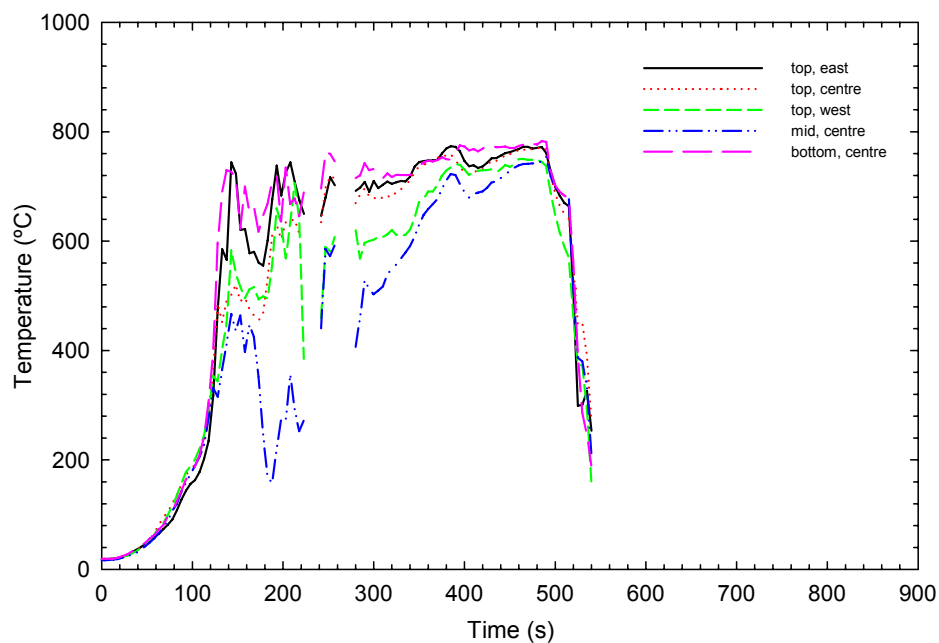
Figure 26. Temperatures at the window in the basement for UF-03

Figure 26 and Figure 27 show the temperatures recorded at the basement window for Test UF-03 and Test UF-09, respectively. For both UF-03 and UF-09, the temperatures increased to 600°C in the first 130 s. The window was opened after 123 s and 103 s, for UF-03 and UF-09, respectively, when the temperature reached 300°C at the thermocouples. After 130 s, due to air entering and smoke exiting the basement through the window, the temperatures varied depending on whether or not the flames were touching the thermocouples (the bottom TC was probably below the neutral plane).

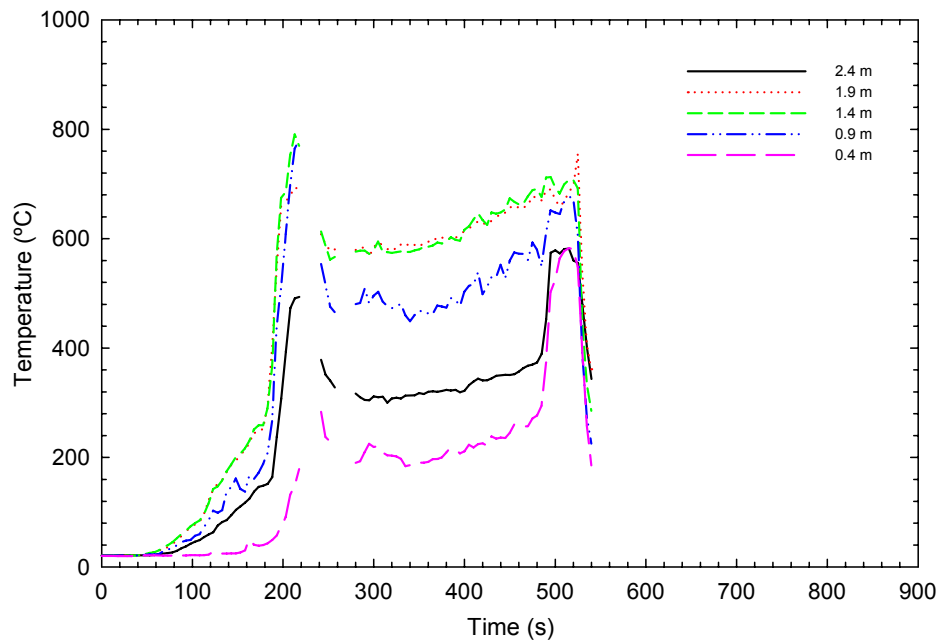
Figure 29 shows the temperatures at the top of the stairs on the first storey at different heights for Test UF-03. The conditions remained at ambient temperature for about the first 100 s. After this, temperatures, at different heights, started increasing due to the migration of hot gases and smoke from the basement to the upper storeys. A maximum temperature of about 800°C was reached and then there was a decline in temperatures after the exterior door on the first storey was open and fresh air started entering the compartment. The temperatures then remained constant, for each height, for about 200 s. After this (480 s), the temperatures started increasing again due to the extensive burning of the wood and flame penetration through the floor. The temperatures started decaying around 500 s after the extinguishment of the fire was initiated. In Figure 29, the maximum temperature was not reached at the 2.4 m level but at both the 1.9 and 1.4 m levels. This is probably an indication that cooler air was entering into the basement at both the upper level and lower level of the doorway.

Figure 29. Temperatures on the first storey at the top of the stairs from the basement for Test UF-03

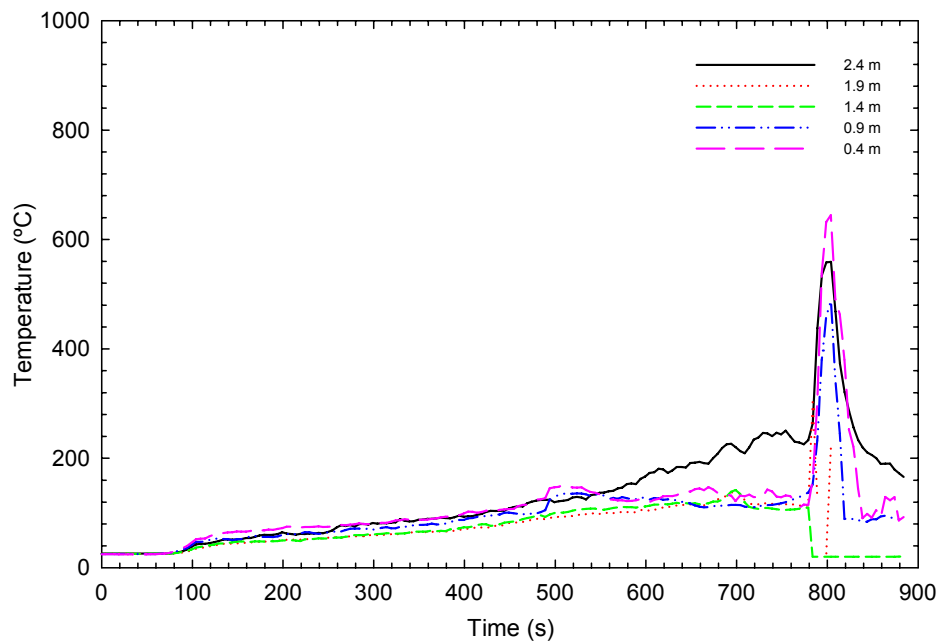
Figure 30 shows the temperatures at the top of the stairs on the first storey at different heights for Test UF-09. The conditions remained at ambient temperature for about the first 90 s. After this time, the temperatures, at different heights, started increasing very gradually due to the migration of hot gases and smoke through gaps around the floor assembly. The temperatures showed a sudden increase at about 780 s, which was related to flame penetrating into the first storey through the burning floor, and then they started decaying around 800 s after the extinguishment of the fire was initiated. A maximum temperature of about 640°C was reached.

Figure 30. Temperatures on the first storey at the top of the stairs from the basement [unexposed side of basement door] for Test UF-09

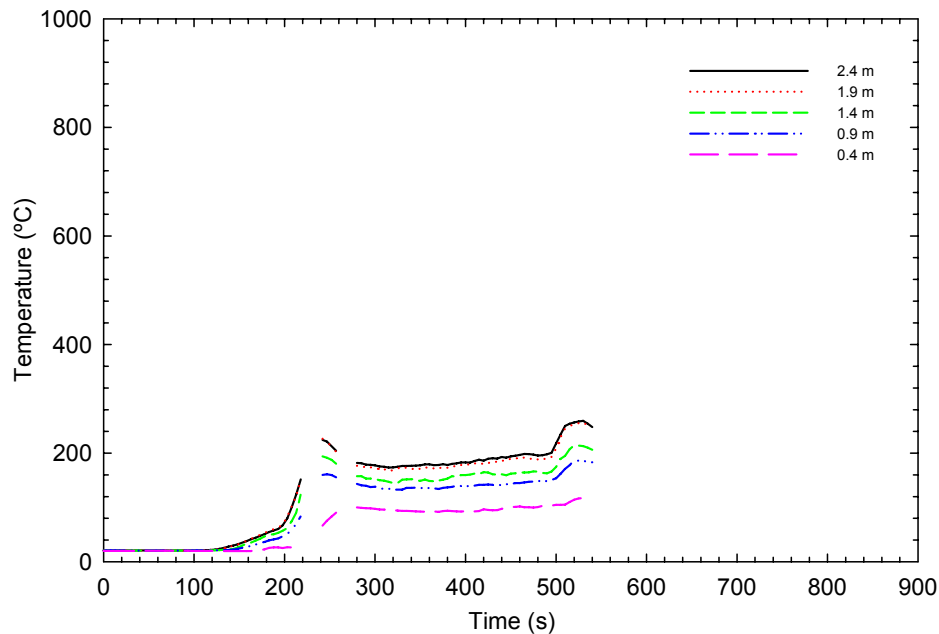
Figure 31 shows the temperatures at the top of the stairs on the second storey at different heights for Test UF-03. The conditions remained at ambient temperature for about the first 130 s. After this, temperatures, at different heights, started increasing due to the migration of hot gases and smoke from the basement to the upper storeys. A maximum temperature of about 250°C was reached at the 2.4 m height. The temperatures started decaying around 520 s after the extinguishment of the fire was initiated.

Figure 31. Temperatures on the second storey at the stairs for UF-03

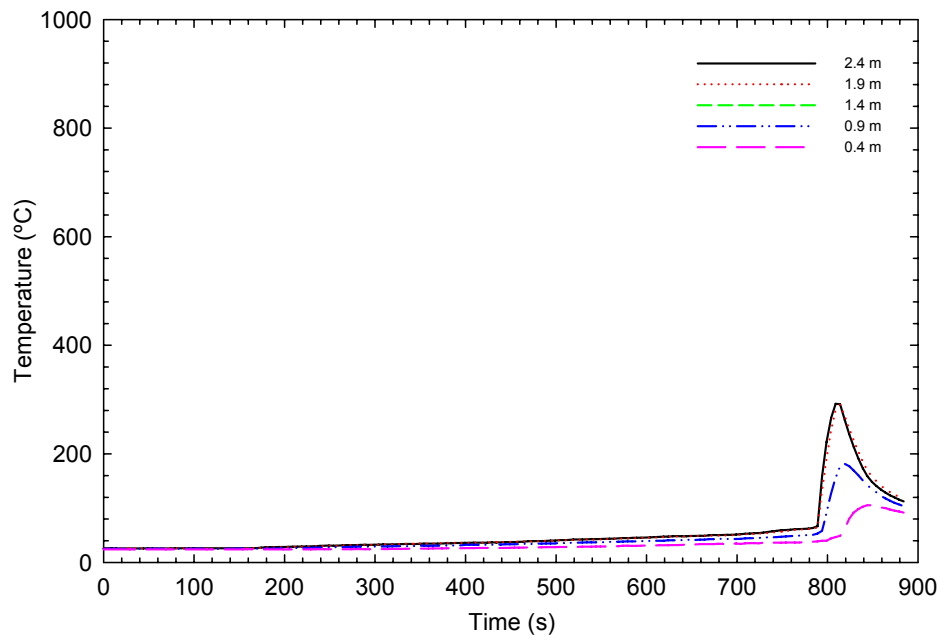
Figure 32 shows the temperatures at the top of the stairs on the second storey at different heights for Test UF-09. The trend was similar to the results for UF-03, but the temperatures measured during Test UF-09 were lower in the first 800 s. The conditions remained at ambient temperature for about the first 200 s. After this time, the temperatures, at different heights, started increasing very gradually due to some migration of hot gases and smoke mainly through gaps around the floor assembly. A maximum temperature of about 300°C was reached at the 2.4 m height near the end of the test. The temperatures showed a sudden increase at about 780 s, which was related to flame penetrating into the first storey through the burning floor, and then they started decaying around 820 s after the extinguishment of the fire was initiated.

Figure 32. Temperatures on the second storey at the stairs for UF-09

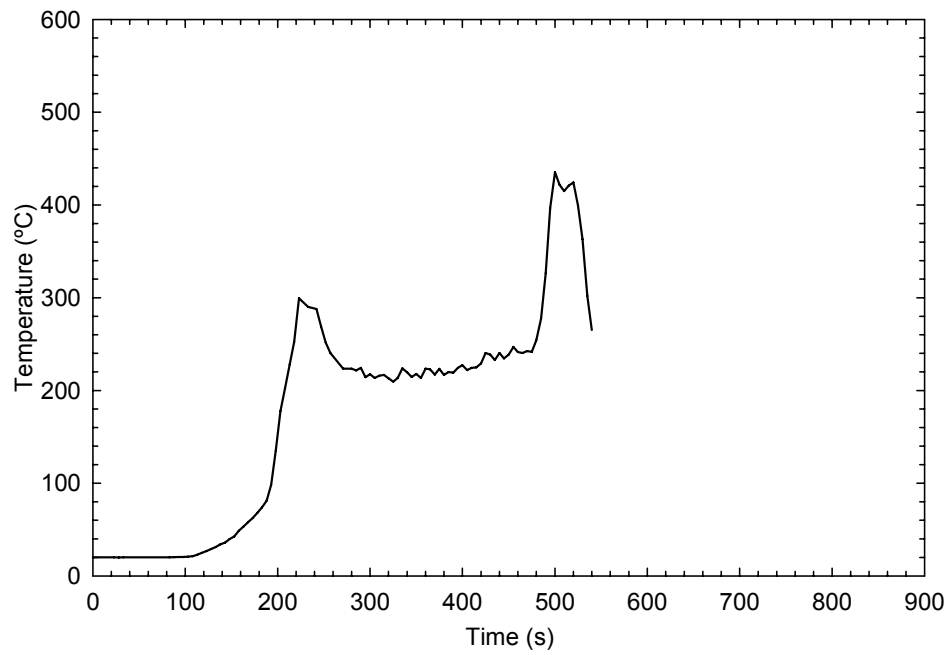
Figure 33 and Figure 34 show the temperatures at the exterior doorway on the first storey for UF-03 and UF-09, respectively. Ambient temperature was measured for about the first 100 s and 160 s for UF-03 and UF-09, respectively. After these times, the temperatures started increasing reaching 300°C at 220 s in Test UF-03 and 70°C at 780 s in Test UF-09 due to smoke and hot fire gases exiting through the open exterior door (smaller increase in temperature in Test UF-09 with the closed basement doorway). The temperature for UF-03 decreased after the first peak. Just after 475 s for UF-03 and 780 s for UF-09, there was a sharp increase in temperatures (due to flame penetration through the floor producing more radiation and hot gases in the vicinity of the exterior door). The maximum temperatures reached were about 450°C at 500 s for UF-03 and 560°C at 800 s for UF-09. The temperatures started decaying after the extinguishment of the fire was initiated.

Figure 33. Temperatures at the outside doorway on the first storey for UF-03

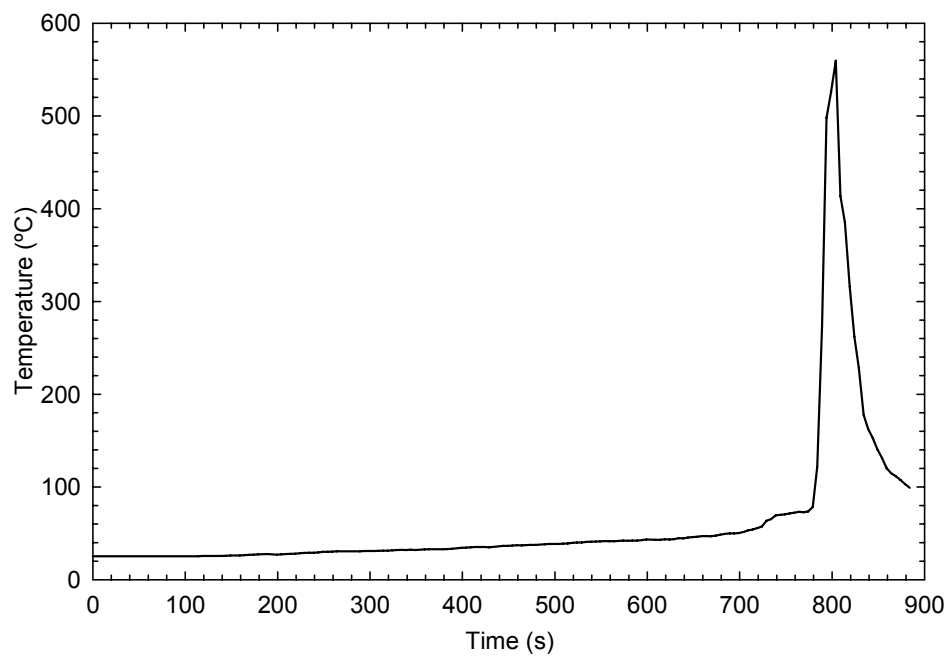
Figure 34. Temperatures at the outside doorway on the first storey for UF-09

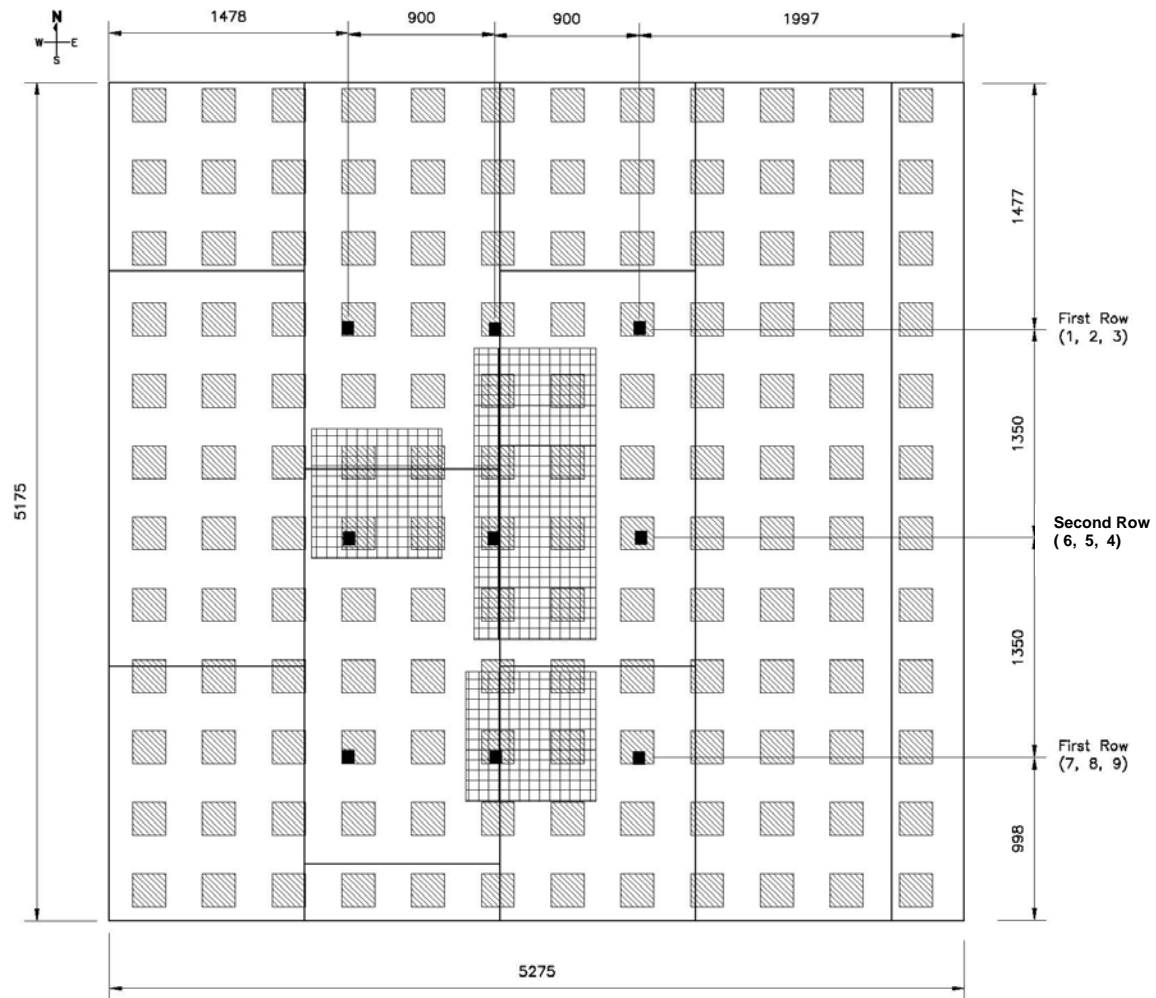
Figure 39. Deflection points measured (all dimensions in mm)

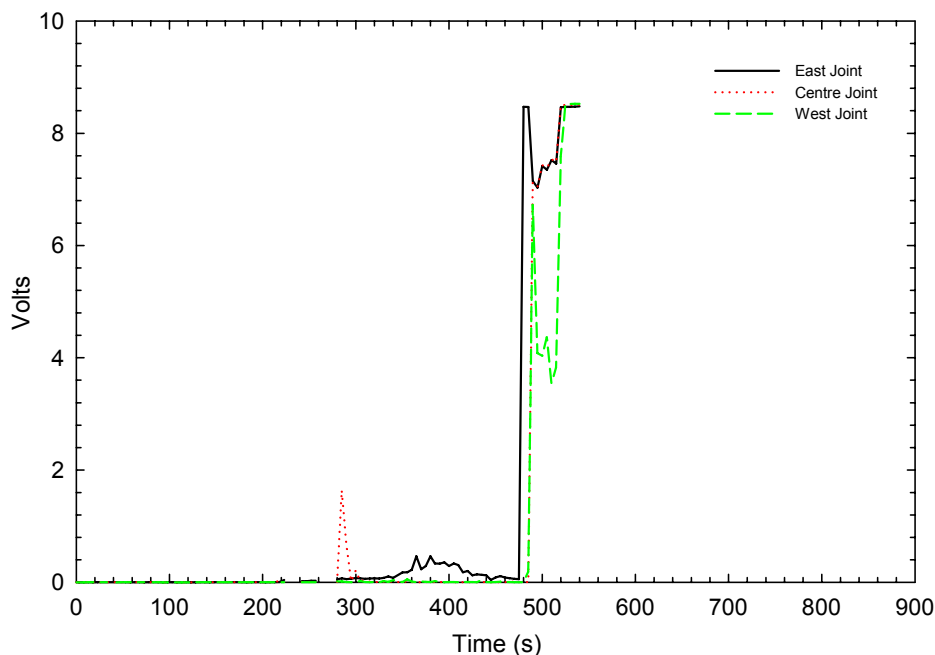
Figure 42 shows the results of the flame-sensing devices. Three wire meshes were installed on the top of three joints (East, Centre and West) on the unexposed side of the floor as shown in Figure 17 (instrumentation figure). There was a sudden increase in the voltage output of the flame-sensing device when flames penetrated through the floor and struck the wire meshes. As indicated by Figure 42, heavy flame penetration occurred at the joints at 480 s, which is very close to the failure of the assembly.

Figure 42. Results of flame sensors at different joints for UF-03

Limited amount of flames started penetrating at the centre of the floor assembly around 300 s likely due to the fact that this was the location experiencing a more aggressive attack by the fire plume from the burning fuel package located directly beneath it. In addition, the deflection of the floor was expected to be greater at the centre of the floor assembly, which would cause the joints to open earlier.

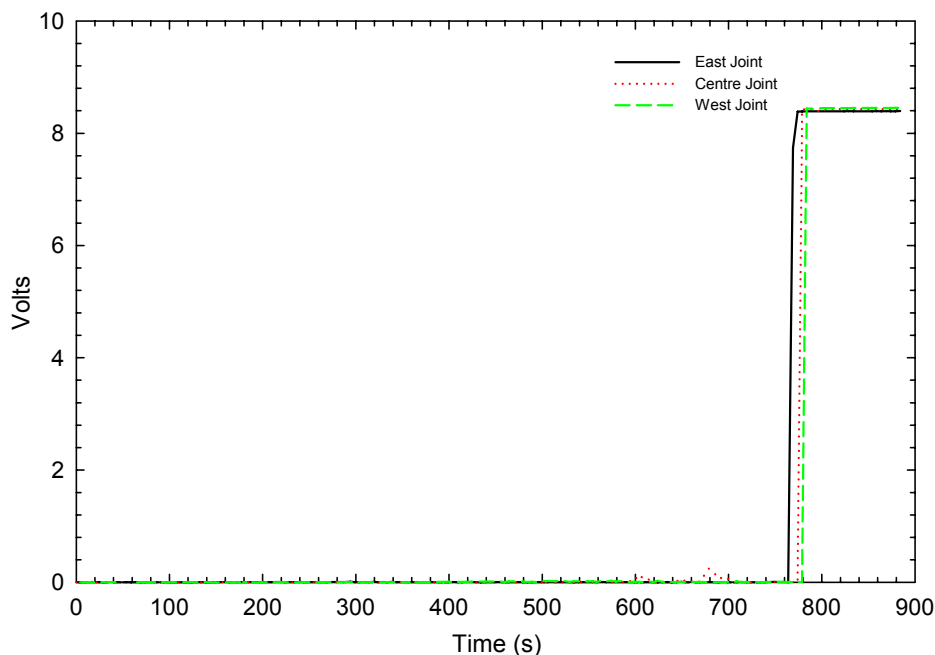
Figure 43 shows the results from the three flame-sensing devices, which were installed on the top of three joints (East, Centre and West) on the unexposed side of the floor as shown in Figure 17 (instrumentation figure). There was an increase in the voltage output of the device when flames penetrating through the floor struck the device. As indicated by Figure 43, the flame were penetrating at all joints at 770 s, which is very close to the assembly failure.

Figure 43. Results of flame sensors at different joints for UF-09

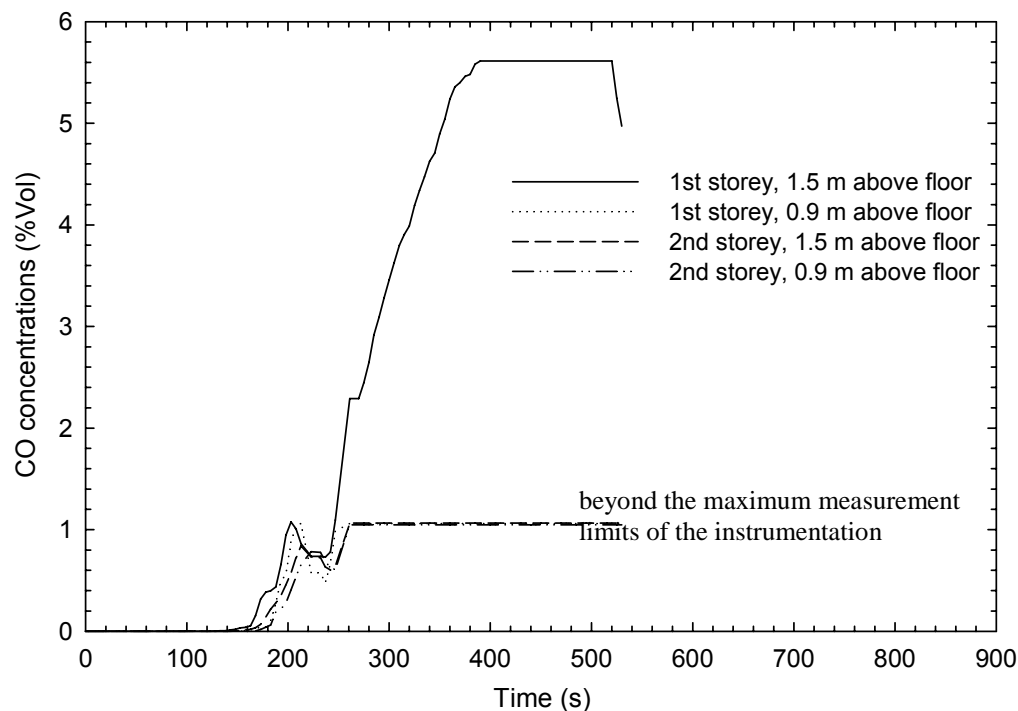
Figure 44. CO measurements for Test UF-03

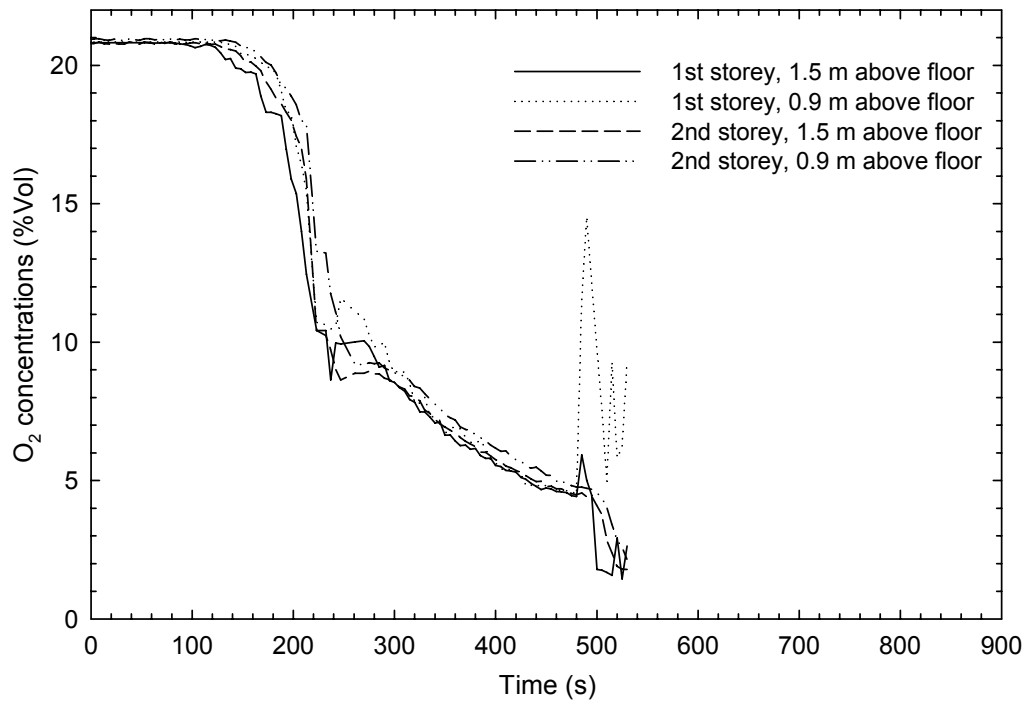
In Test UF-03 (see Figure 45), the O₂ concentration on both the first and second storeys dropped to below 10% in 240 s and to 5% at the end of the test. The O₂ vitiation alone would cause incapacitation after 385 s using $F_{in,O_2} = 1$ as a criterion, or after 320 s using

Figure 45. O₂ measurements for Test UF-03

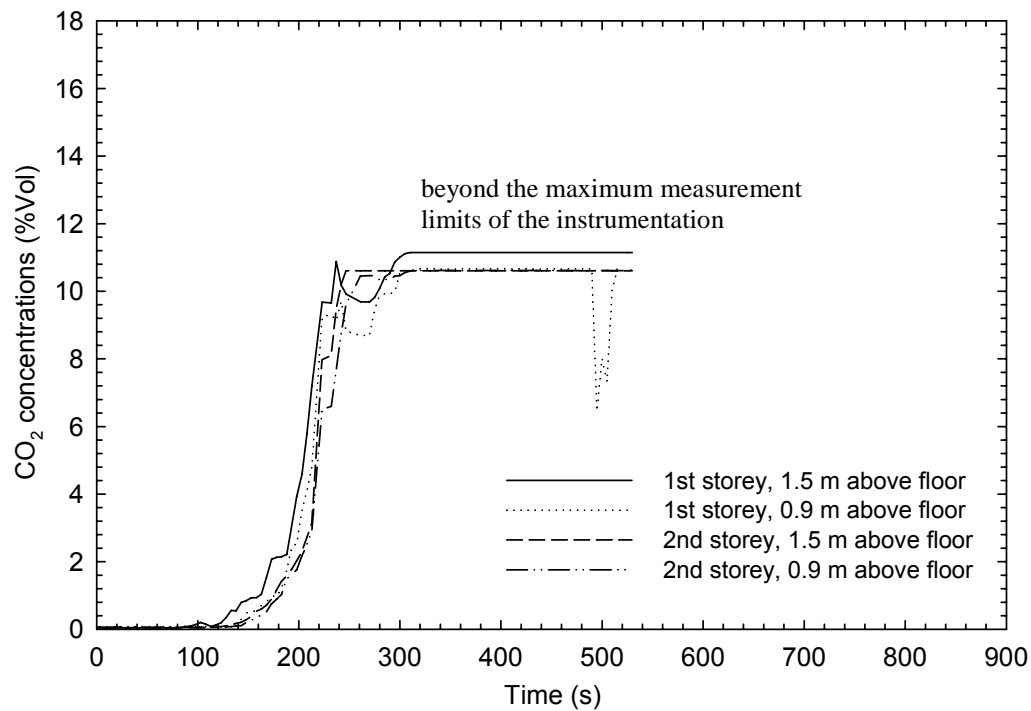
In Test UF-03 (see Figure 46), the CO₂ concentration exceeded 10% (measurement range limit of the gas analyzers) in 240 s. The increased concentration of CO₂ alone would cause incapacitation after 335-345 s (1st storey-2nd storey) using $F_{in,CO_2} = 1$ as a criterion, and after 260 s (1st storey-2nd storey) using $F_{in,CO_2} = 0.3$.

Figure 46. CO₂ measurements for Test UF-03

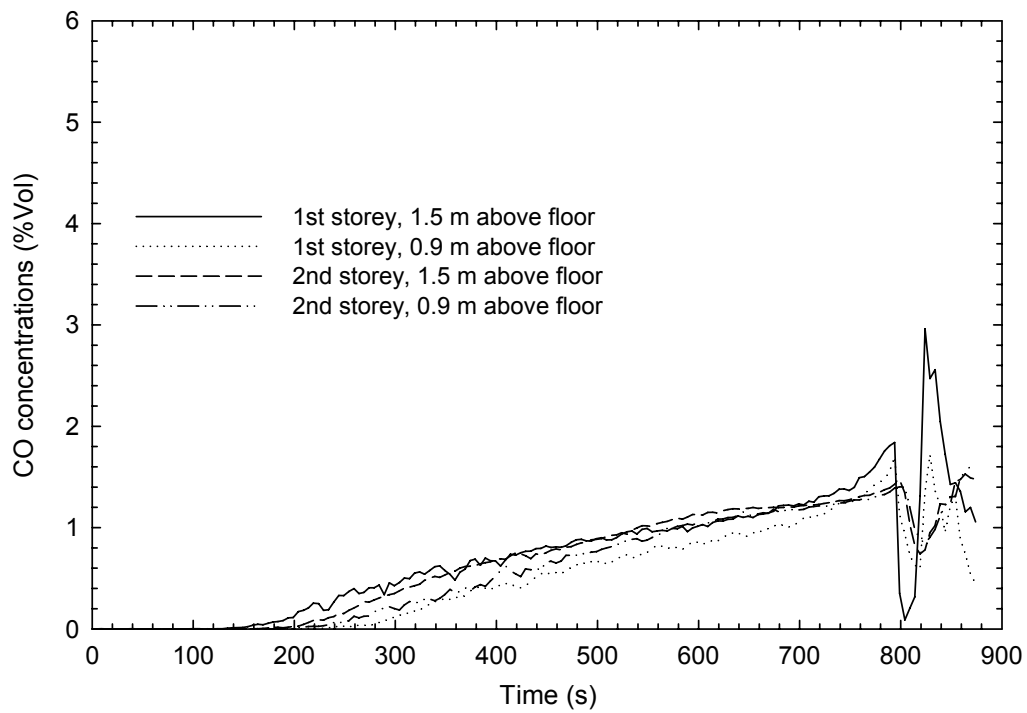
Figure 48. CO measurements for Test UF-09

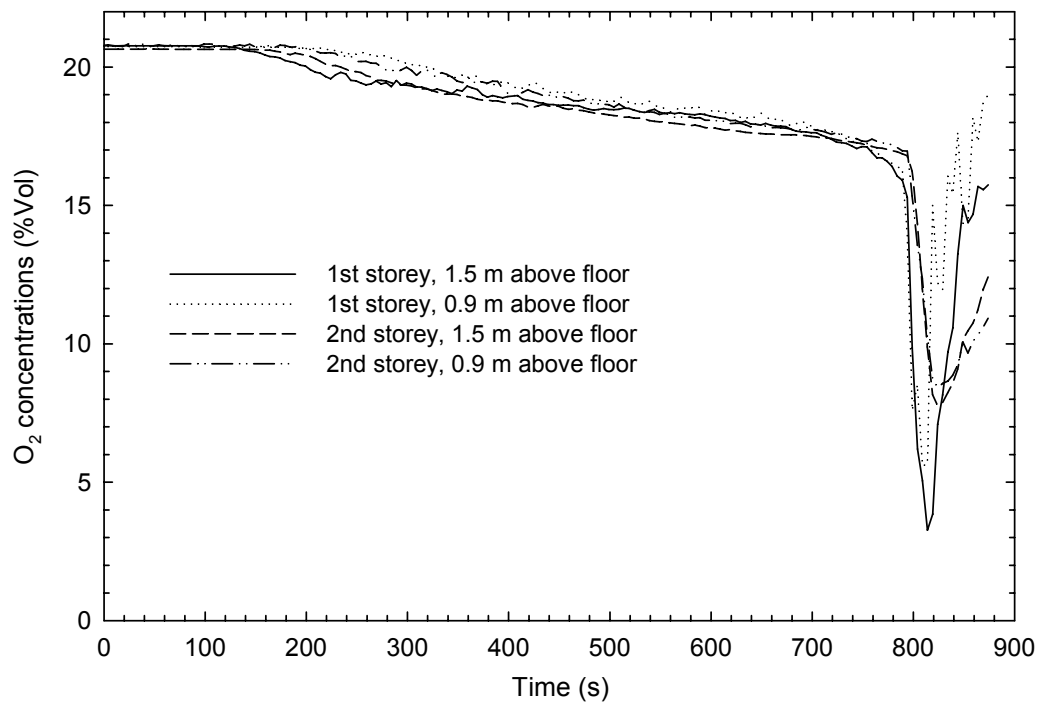
In Test UF-09 (see Figure 49), the O₂ concentrations in both storeys were above 17% till 780 s. The O₂ vitiation alone did not result in the incapacitation dose until after floor failure.

Figure 49. O₂ measurements for Test UF-09

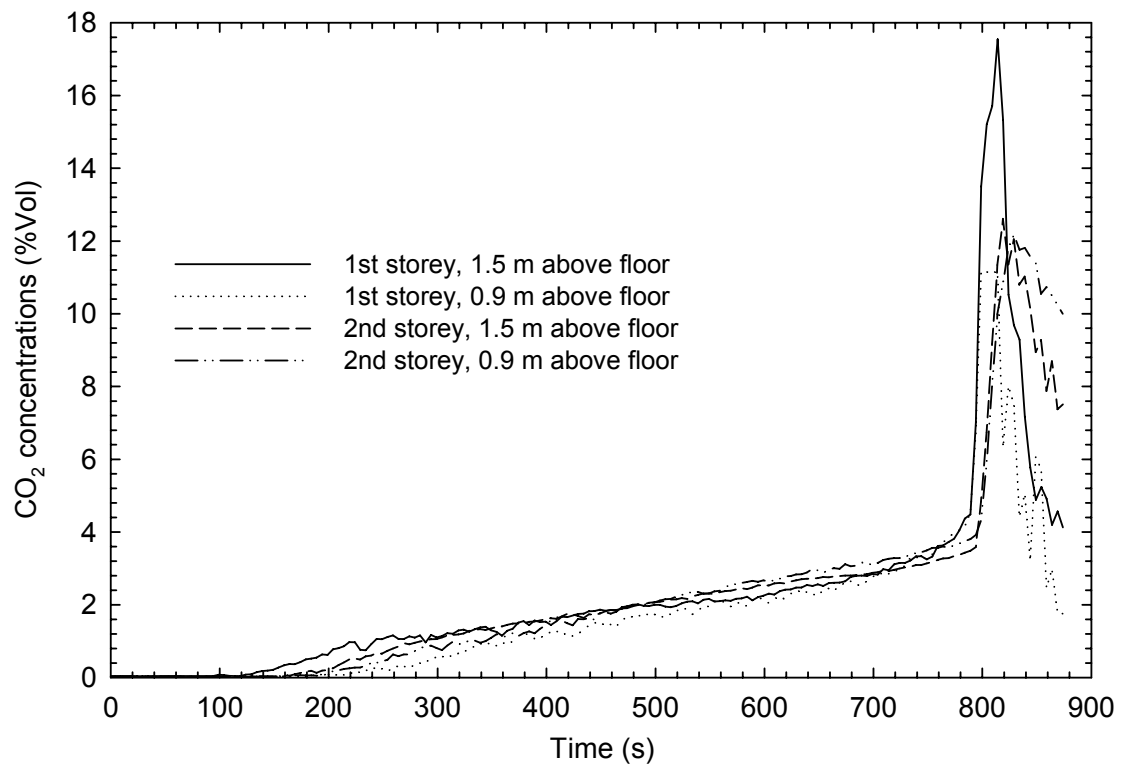
Figure 50. CO₂ measurements for Test UF-09

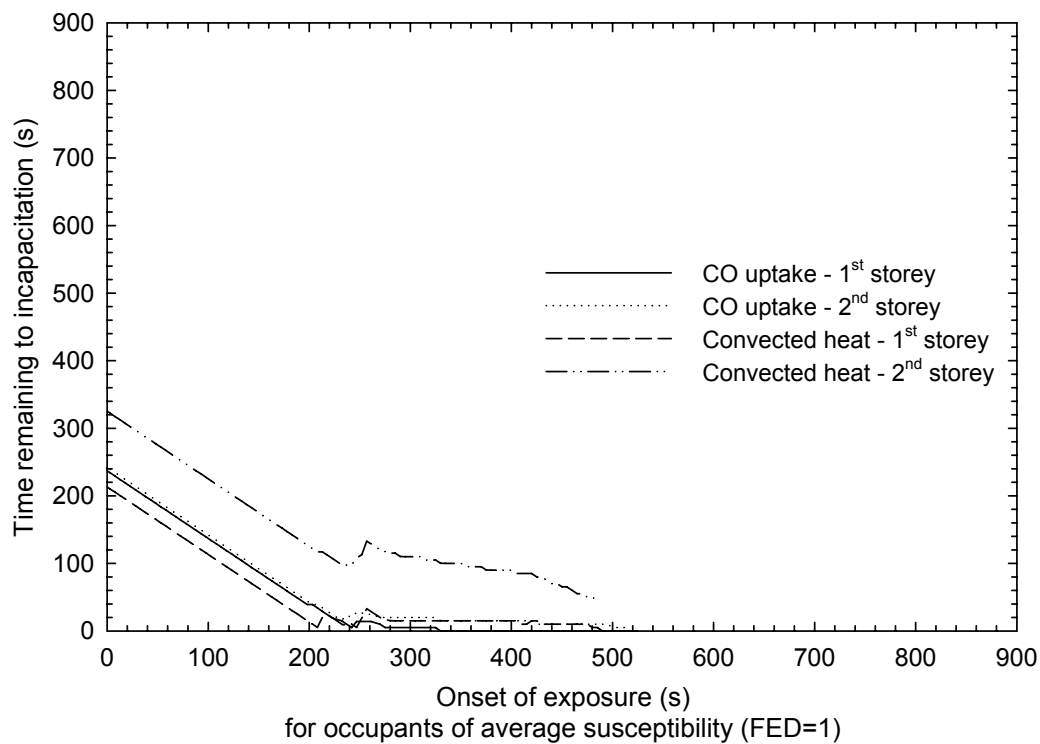
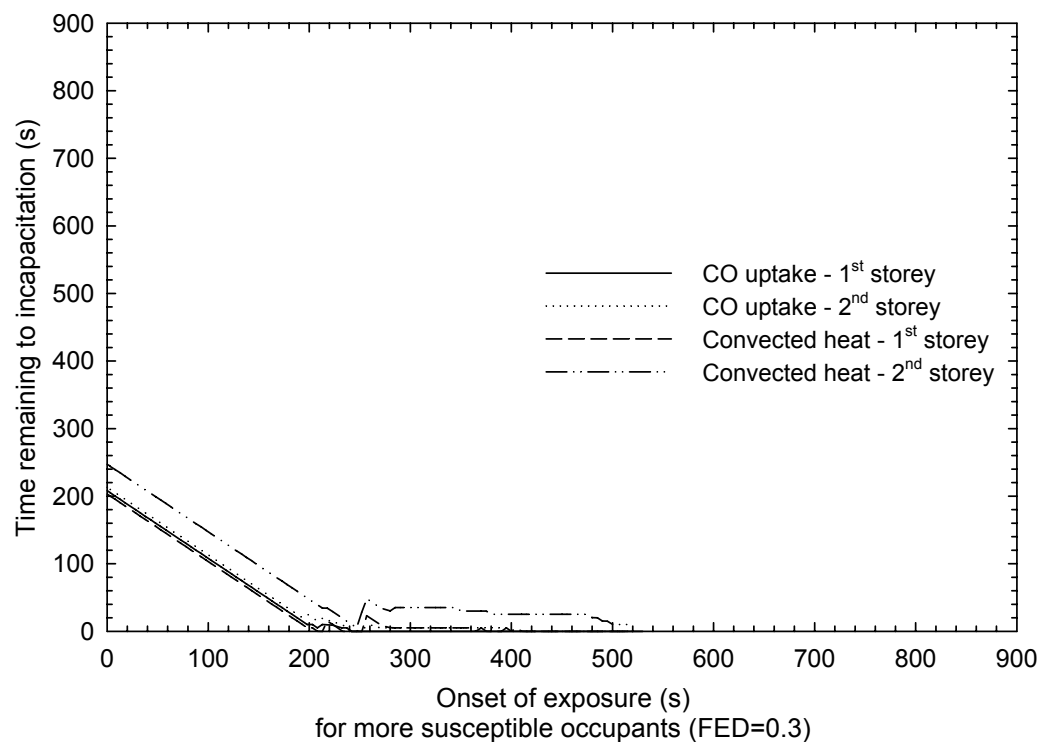
Figure 52. Time remaining to incapacitation versus onset of exposure for Test UF-03 (ignition at time zero)

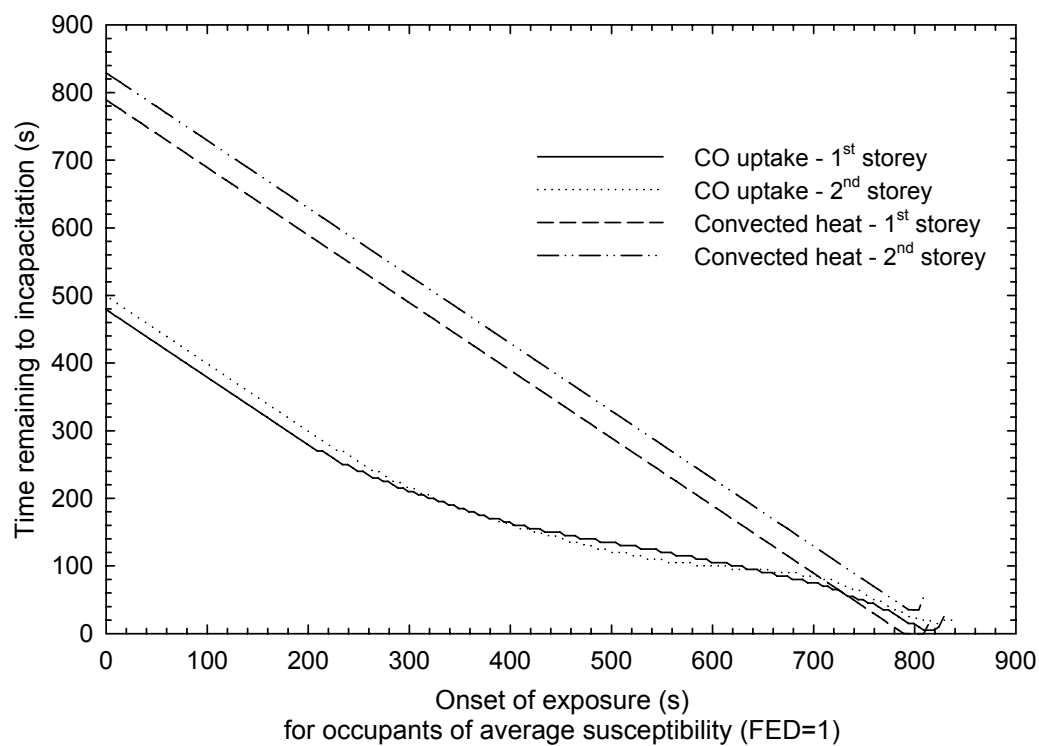
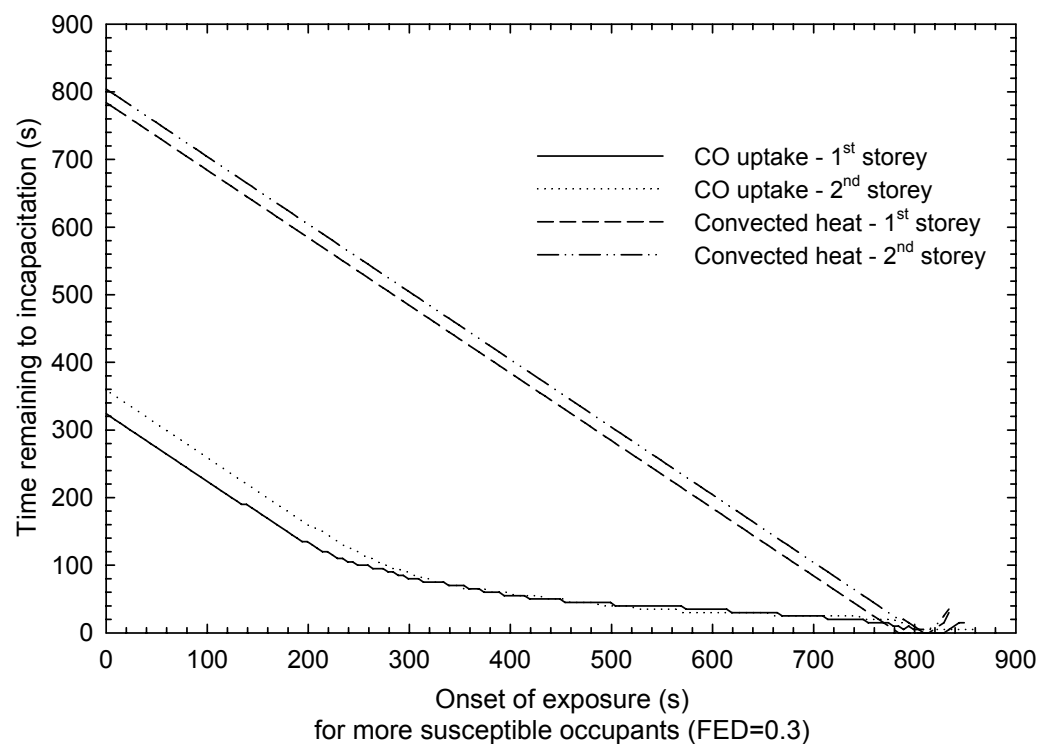
Figure 53. Time remaining to incapacitation versus onset of exposure for Test UF-09 (ignition at time zero)

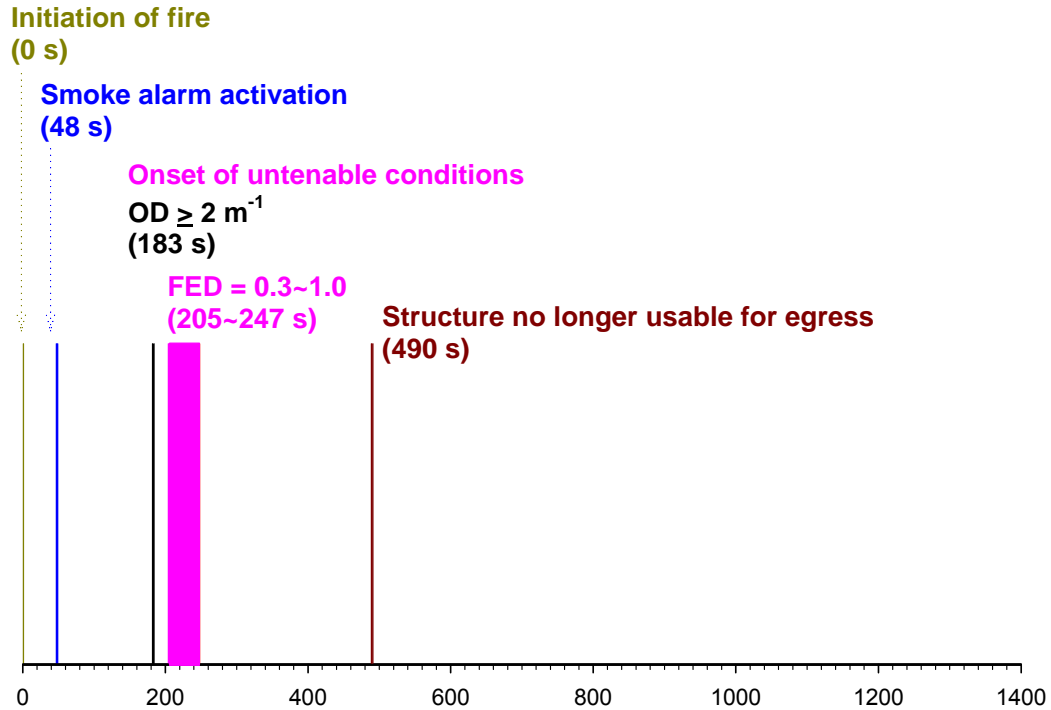
Figure 54. Sequence of fire events in Test UF-03 (s)

In both tests the untenable conditions were reached before the structural failure of the floor assembly. In Test UF-09, the presence of the closed door to the basement reduced the rate of fire growth in the basement, slowed down the transport of combustion products from the basement to the upper storeys. This prolonged the time available for escape before the onset of untenable conditions, and also delayed the time for the test assembly above the basement to reach structural failure.

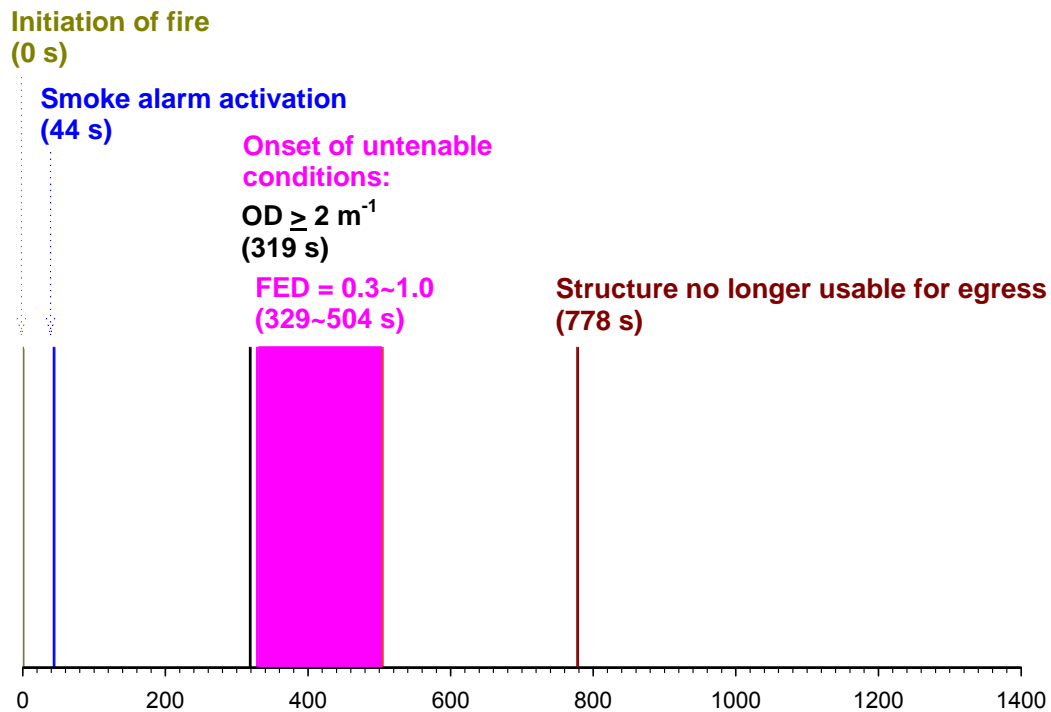
Figure 55. Sequence of fire events in Test UF-09 (s)
