Fire Performance of Houses. Phase I. Study of Unprotected Floor Assemblies in Basement Fire Scenarios Part 3

Part 3 – Results of Test UF-04 (Light-Gauge Steel C-Joists)

Research Report: IRC-RR-248

Date: March 31, 2009

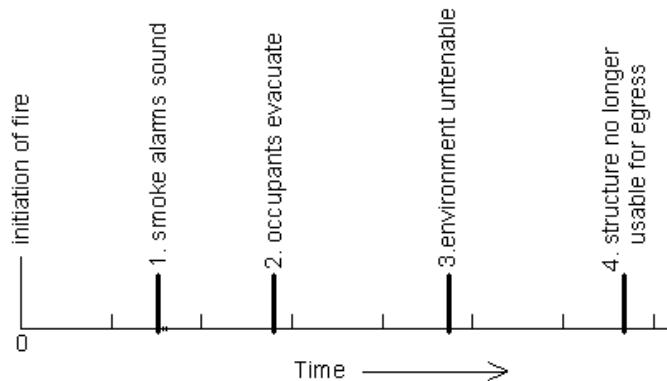
Figure 1 shows a possible chronological sequence of relevant critical events that might occur in a fire scenario. It is acknowledged that the chronology of the occurrence of events may differ, and in some cases can shift in ordering.

Figure 1. Possible chronological sequence of events affecting the life safety of occupants in a fire situation

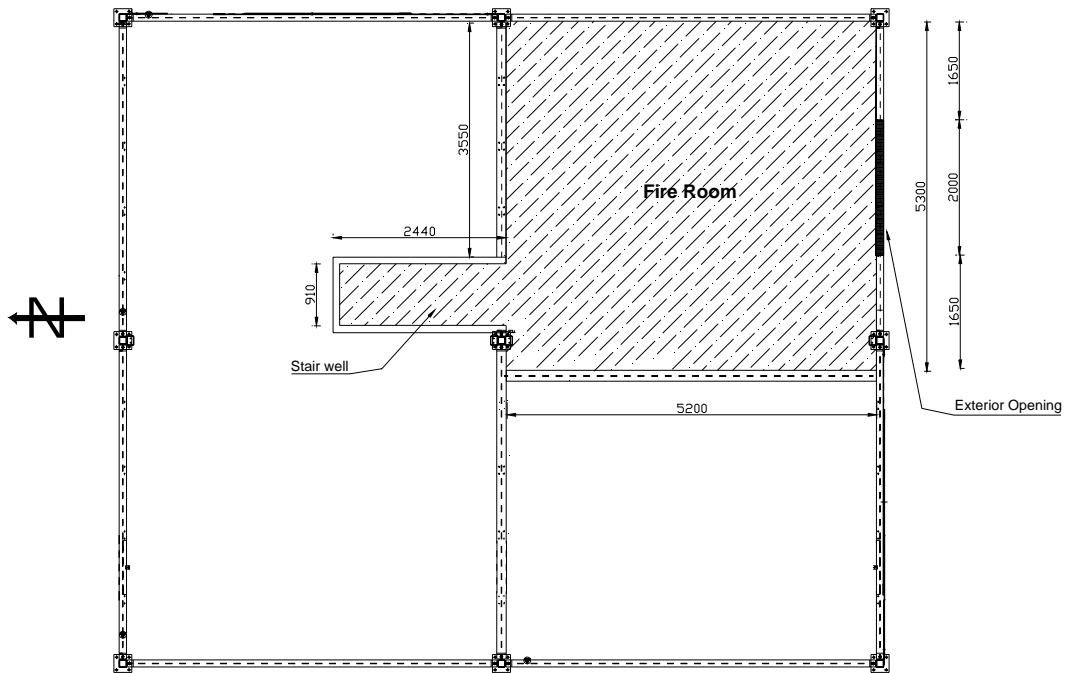
The layout of the basement is shown in Figure 3. The basement was partitioned to create a fire room representing a 27.6 m² basement living area, or about 1/4 of the total basement area. This compartment size was chosen based on a survey carried out by NRC [4]. The area of the basement that was not used for the fire compartment was blocked off during the fire tests. The height of the basement was 2.44 m. The ceiling clear height depended on the depth of the floor assembly being tested. A rectangular exterior opening measuring 2.0 m wide by 0.5 m high and located 1.8 m above the floor was provided in the south wall of the fire room. The size of the opening was chosen based on the results of the survey carried out by NRC [4]. A 0.91 m wide by 2.05 m high doorway opening located on the north wall of the fire room led into an empty stairwell enclosure (without a staircase). At the top of this stairwell, a 0.81 m wide by 2.05 m high doorway led into the first storey, as shown in Figure 4. This doorway either had no door (open basement doorway) or had a door in the closed position (closed basement doorway), depending on the scenario being studied. There is no requirement for a basement door in the NBCC. Section on “Openings and their States” provides more details.

Figure 3. Basement level layout (dimensions in mm)

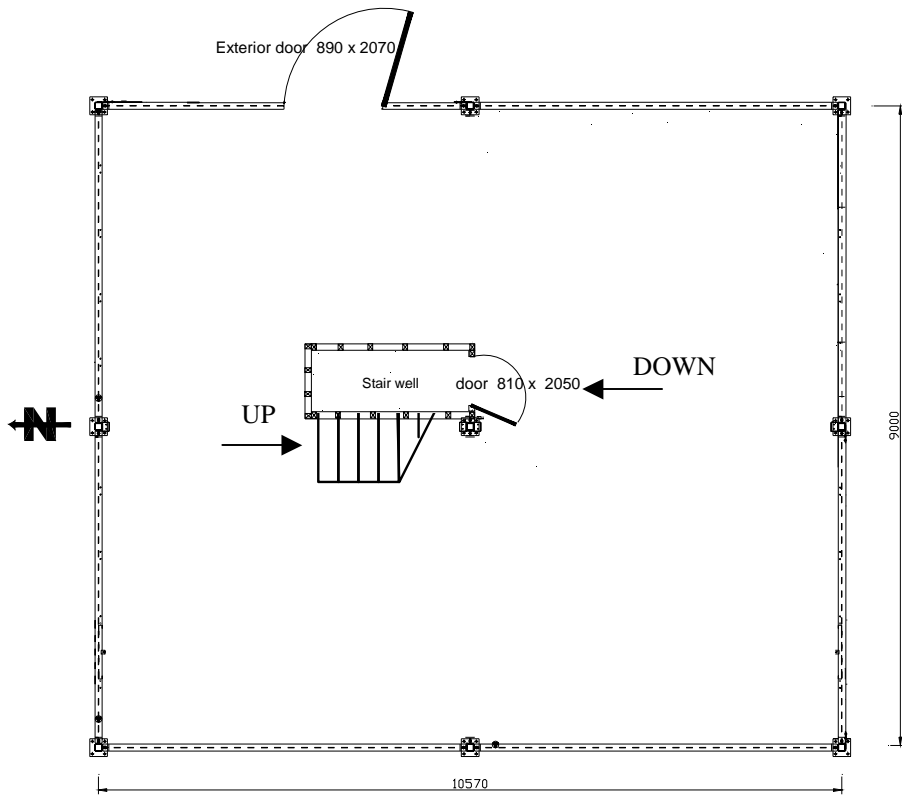
Figure 4. First storey layout (dimensions in mm)

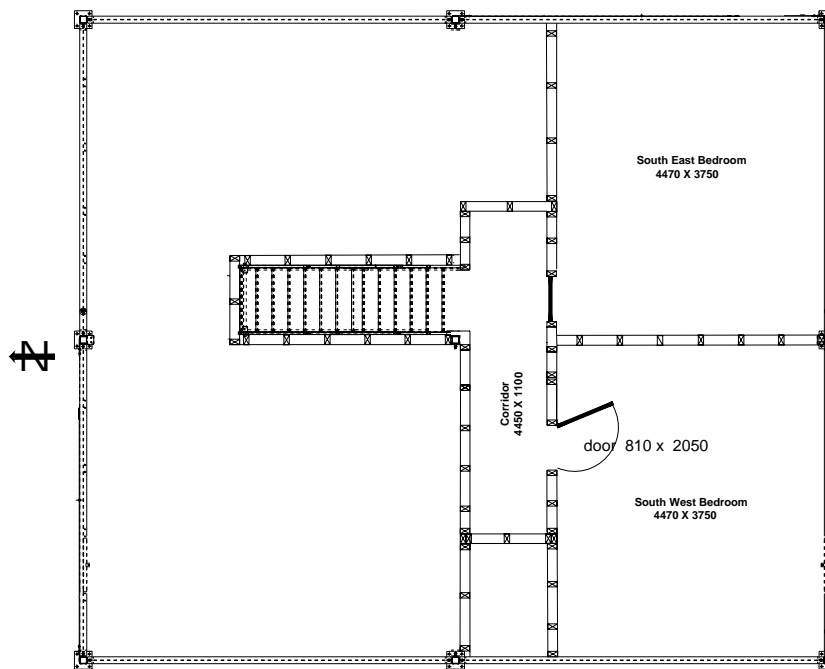
The layout of the second storey is shown in Figure 5. This storey was partitioned to contain two identical bedrooms with dimensions of 3.75 m by 4.47 m connected by a corridor with dimensions of 1.1 m x 4.45 m. The height of the storey was 2.44 m. In all tests, the door of the southeast bedroom remained closed whereas the door on the southwest bedroom was kept open. The size of the door openings was 0.81 m by 2.05 m. The remaining area of the second storey that was not used was blocked off during the fire tests.

Figure 5. Second storey layout (dimensions in mm)

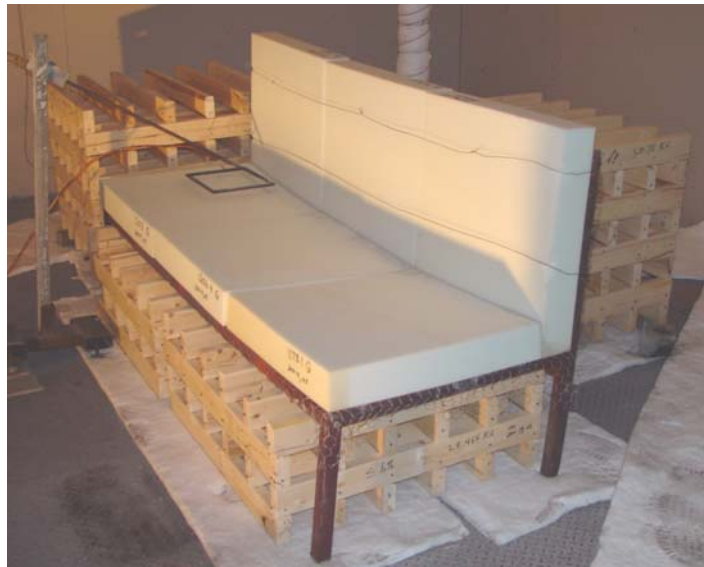
Figure 6. Fuel package

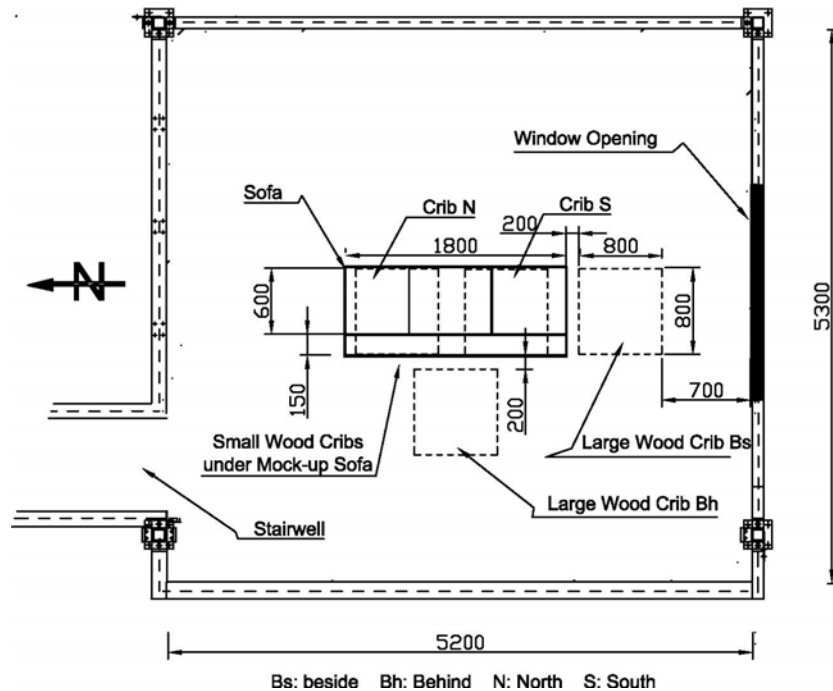
The placement of the fuel package in the basement fire compartment is illustrated in Figure 7. The mock-up sofa was located at the center of the floor area. The mock-up sofa was ignited in accordance with the ASTM 1537 test protocol [7] and the wood cribs provided the remaining fire load to sustain the fire for the desired period of time.

Figure 7. Arrangement of the fuel package in the fire compartment
(dimensions in mm)

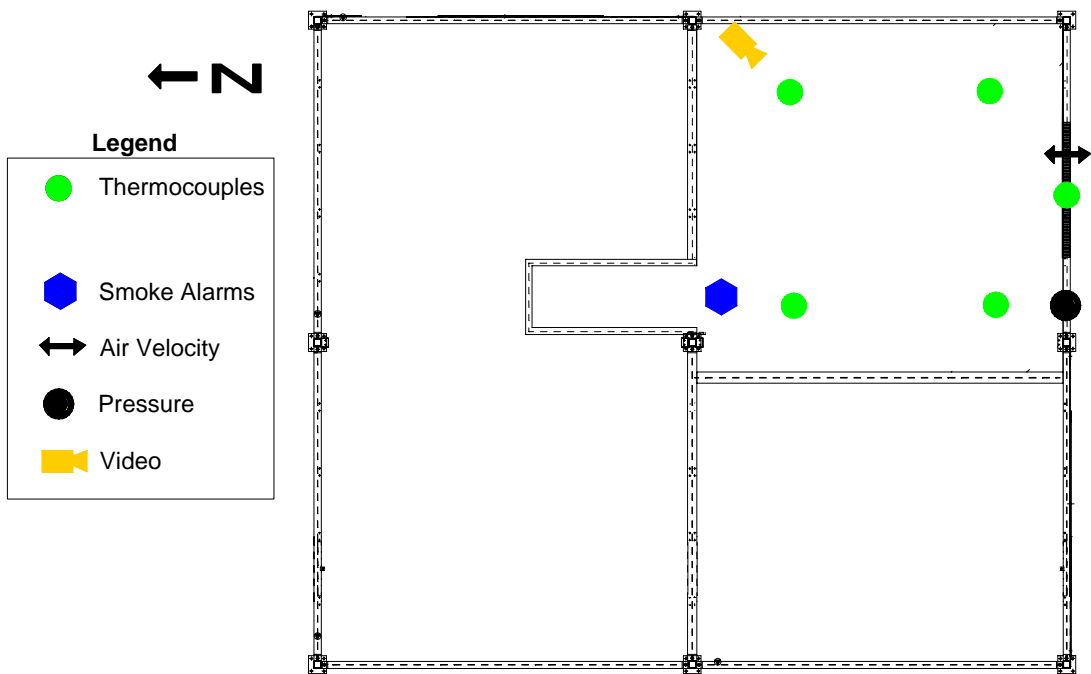
The positioning of the instrumentation in the fire compartment on the basement level is shown in Figure 8.

Figure 8. Fire Compartment instrumentation

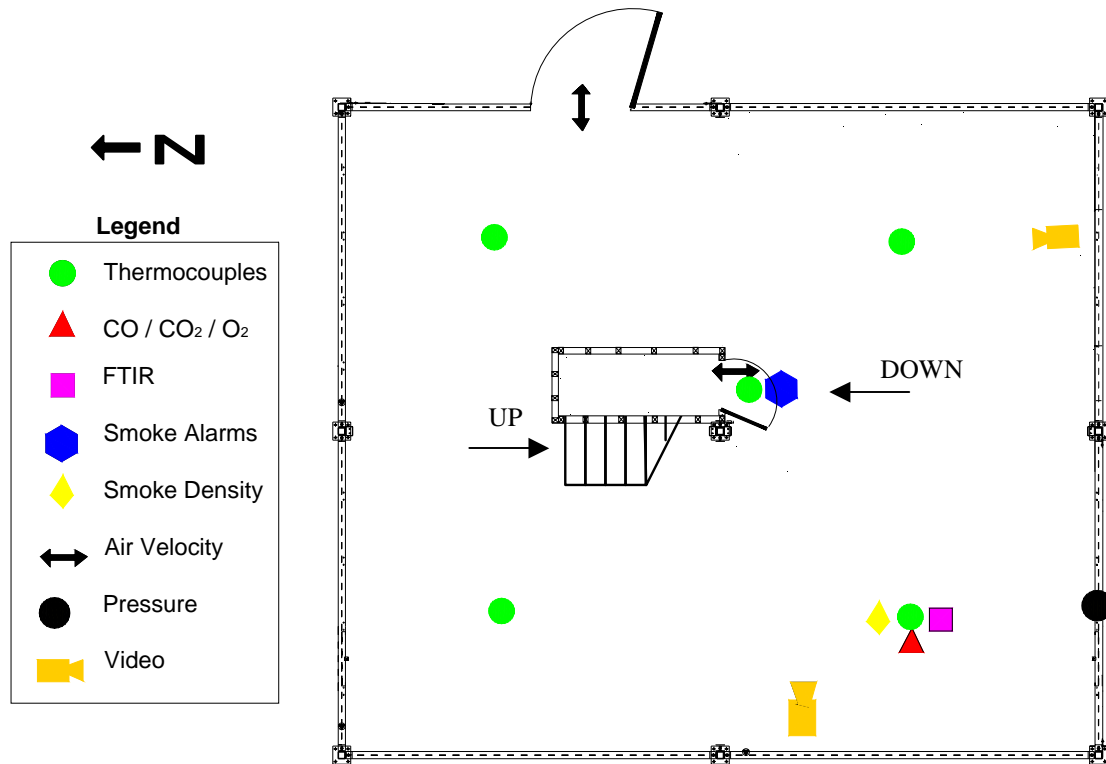
The positioning of the instrumentation on the first storey is shown in Figure 9.

Figure 9. First storey instrumentation

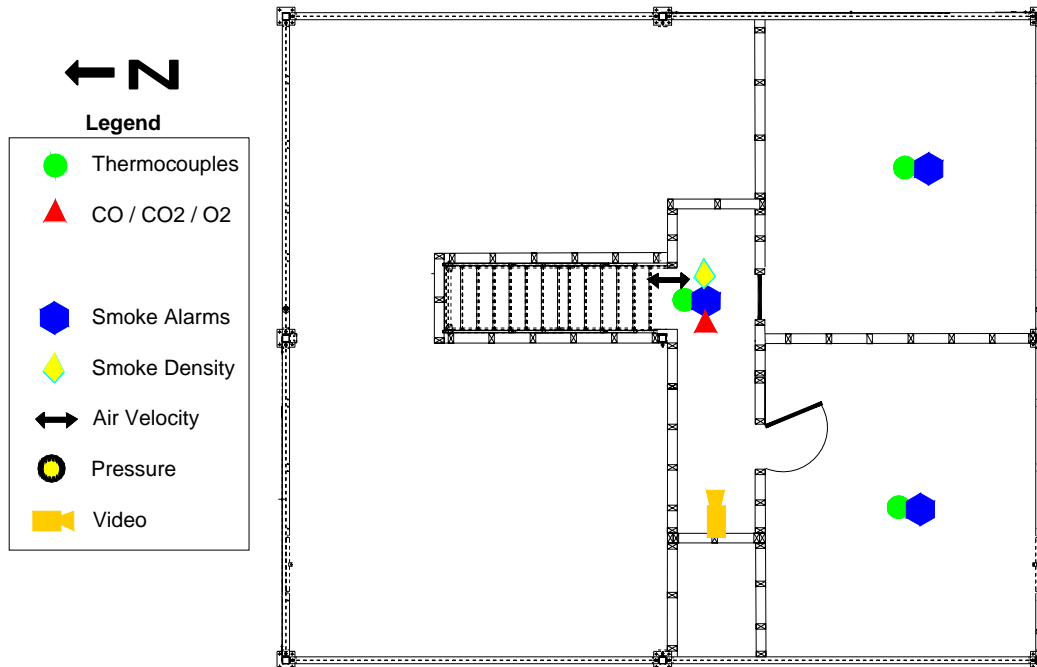
The positioning of the instrumentation on the second storey is shown in Figure 10.

Figure 10. Second storey instrumentation

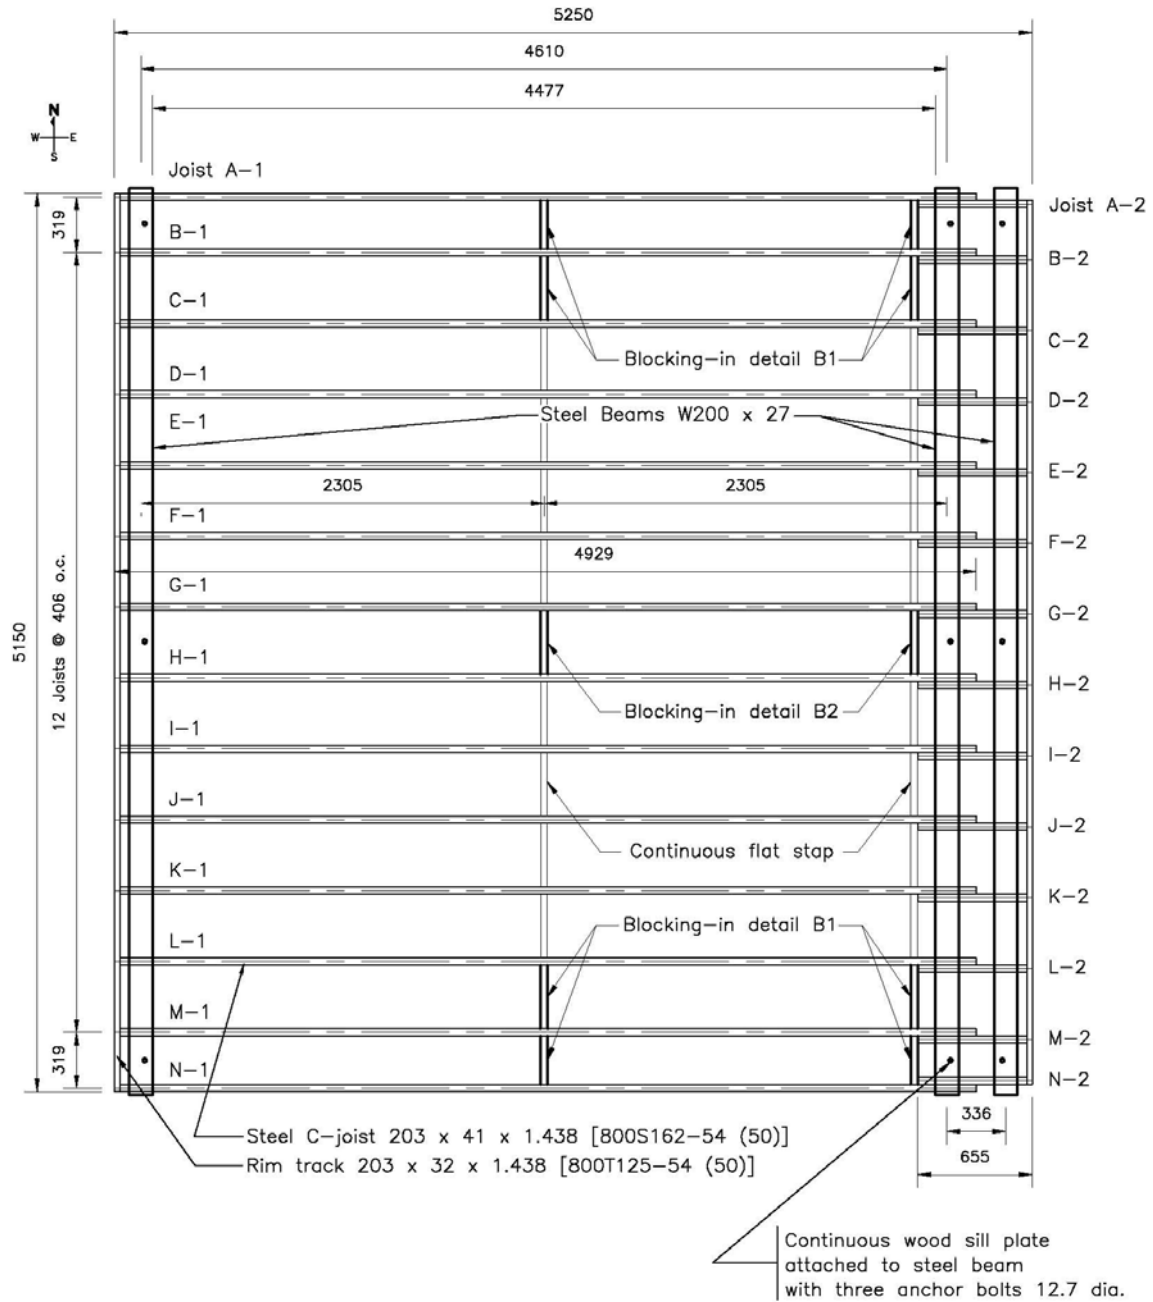
The light-gauge steel C-joists were 203 mm by 41 mm, 1.438 mm (gauge 17), and were spaced at 400 mm on centre (see Figure 11). Based on calculations of maximum strength and deflection, the C-joist span length chosen was 4.477 m (see Figure 11). Since the maximum span allowed for the steel C-joists does not extend across the entire length of the fire compartment, a beam was used as an intermediate support at the end of the 4.477-m span and a set of shorter C-joists were used to increase the span of the floor to extend to the end of the fire compartment. Figure 11, Figure 12 and Figure 13 show the details of the joist overlaps and the supporting beams. This assembly was constructed with blocking and continuous flat strap at the mid span and at the joist overlaps.

Figure 11. Steel C-joist layout details (all dimensions in mm)

In the steel C-joist test assembly, rim tracks (headers) made of steel 203 mm by 32 mm and 1.438 mm thick, were placed at the east and west sides of the floors as shown in Figure 11. In the assembly, blocking-in, stiffeners and a continuous strap were used. Details of the C-joist layout are shown in Figure 11 and Figure 14.

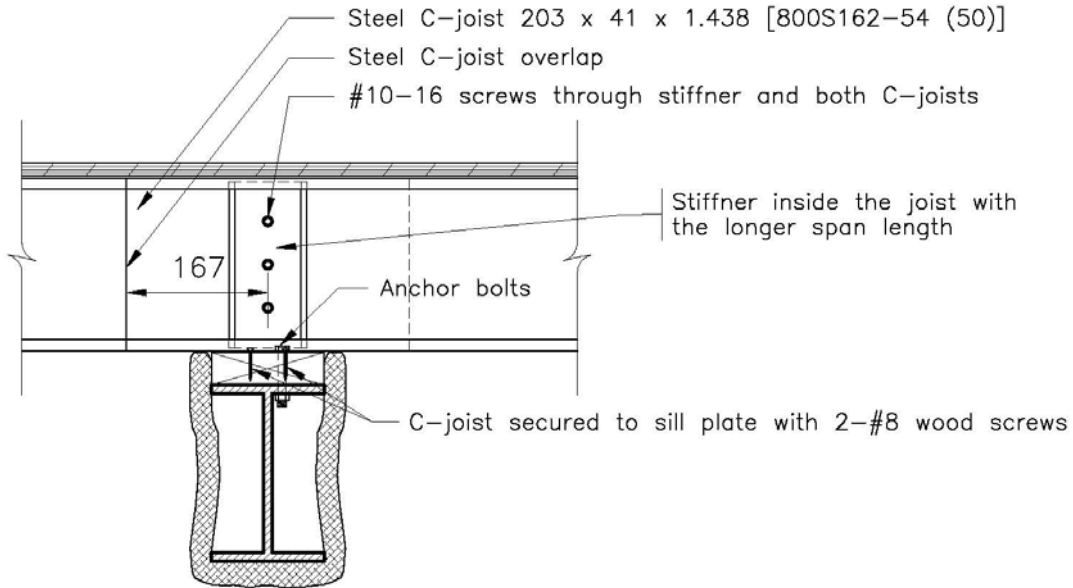
Figure 12. Steel C-joist overlap details (all dimensions in mm)

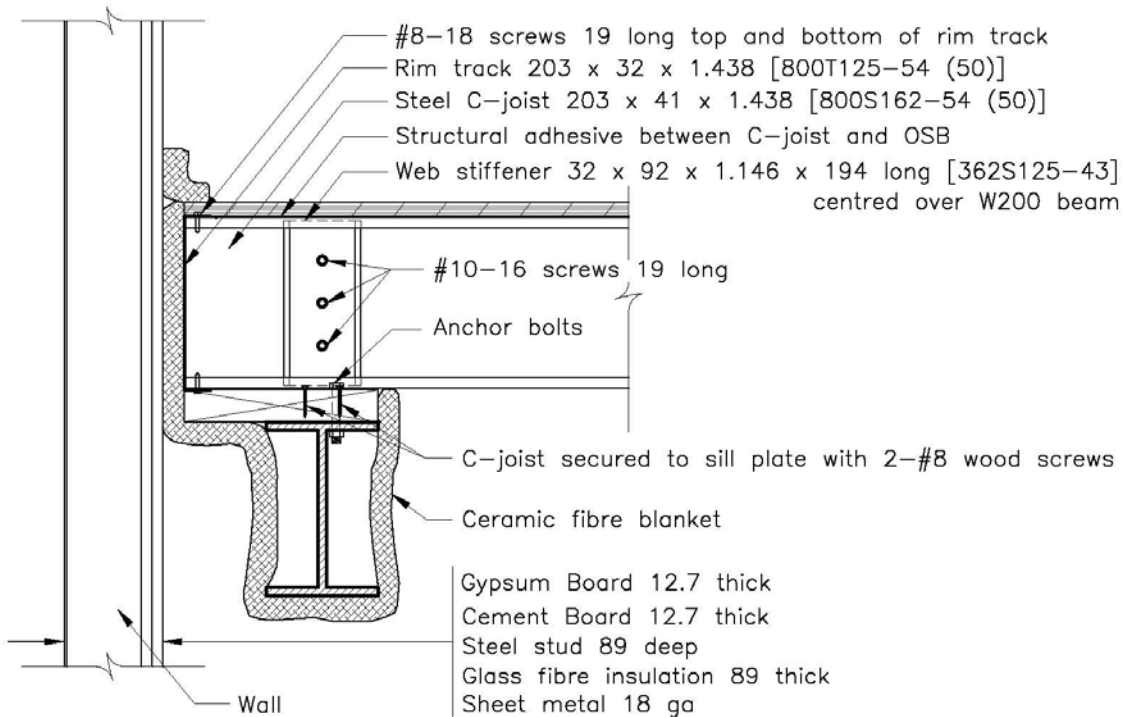
Figure 13. End connection details and supports (all dimensions in mm)

Figure 13 also shows the end connection details. Ceramic fibre blankets were used to fill any gaps between the assembly and the end walls. Ceramic fibre blankets were also used to protect the beams and columns so that they were not subjected to fire and would not fail during the test.

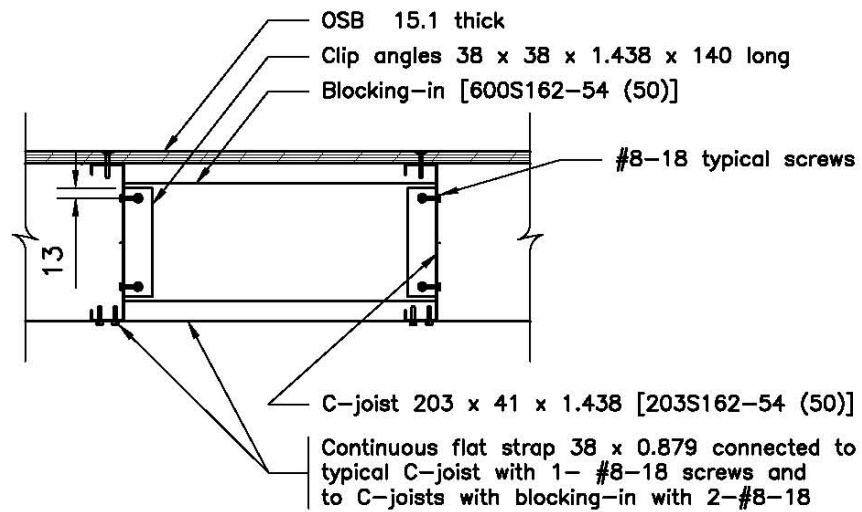
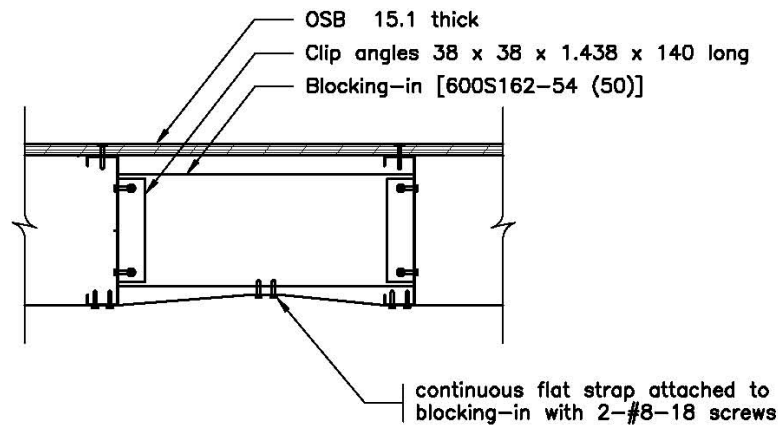
Blocking-in detail B1

Blocking-in detail B2

Figure 14. Blocking-in details (all dimensions in mm)

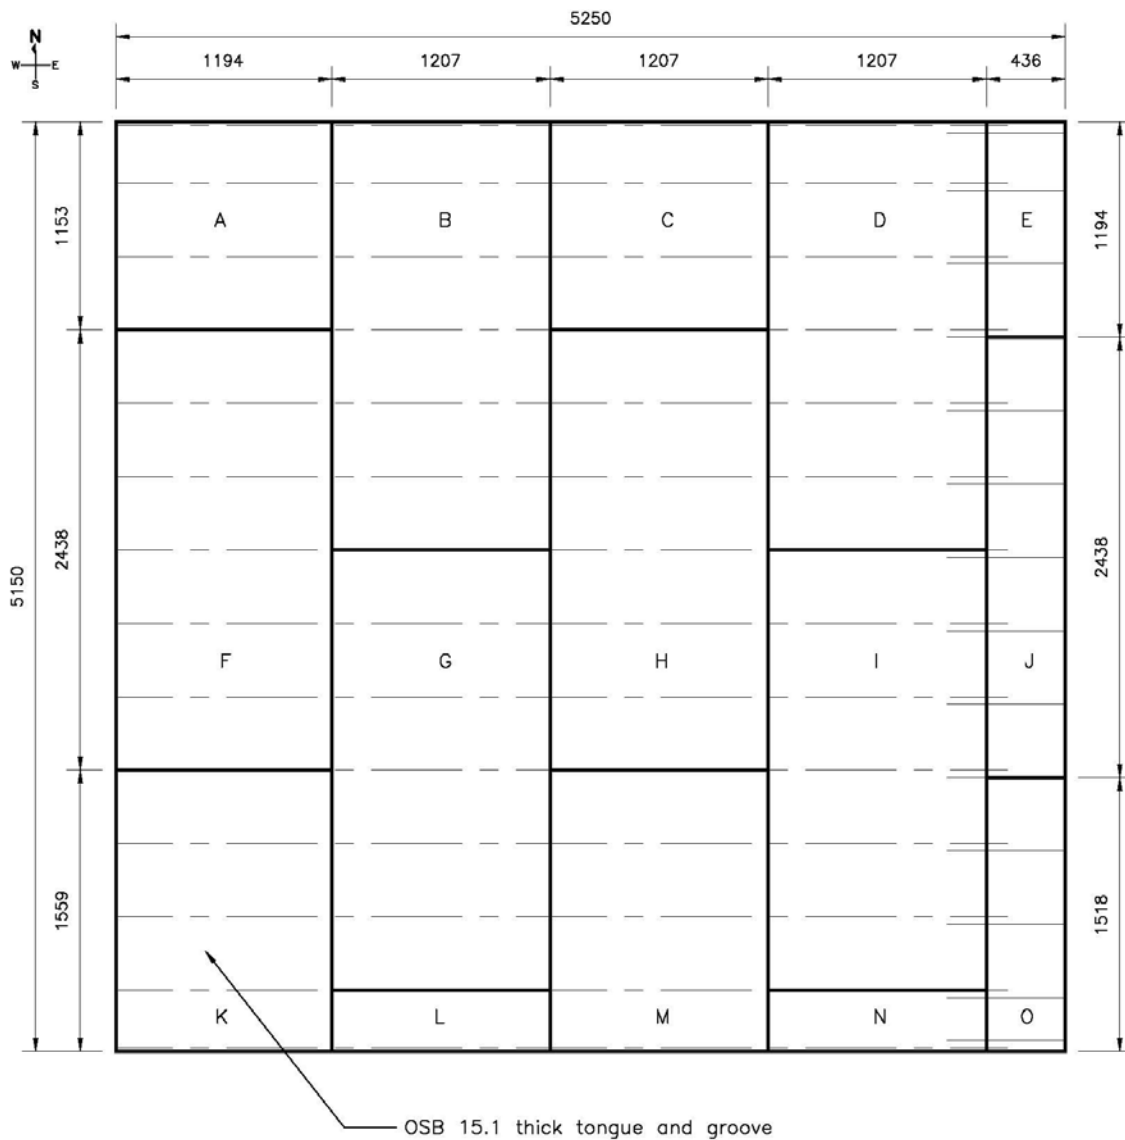
OSB was used as the subfloor material in the floor assembly. The specific OSB material used was selected based on a separate study documented in [5]. The subfloor panels were 15.1 mm thick in the assembly, with a full panel size being 1.2 x 2.4 m. The longer panel edges had a tongue and groove profile while the short panel edges were square-butt ends. Figure 15 shows the subfloor layout details. The screw pattern and description of screws used to attach the OSB panels to the steel C-joists and rim track are shown in Figure 16.

Figure 15. Subfloor layout details (all dimensions in mm)

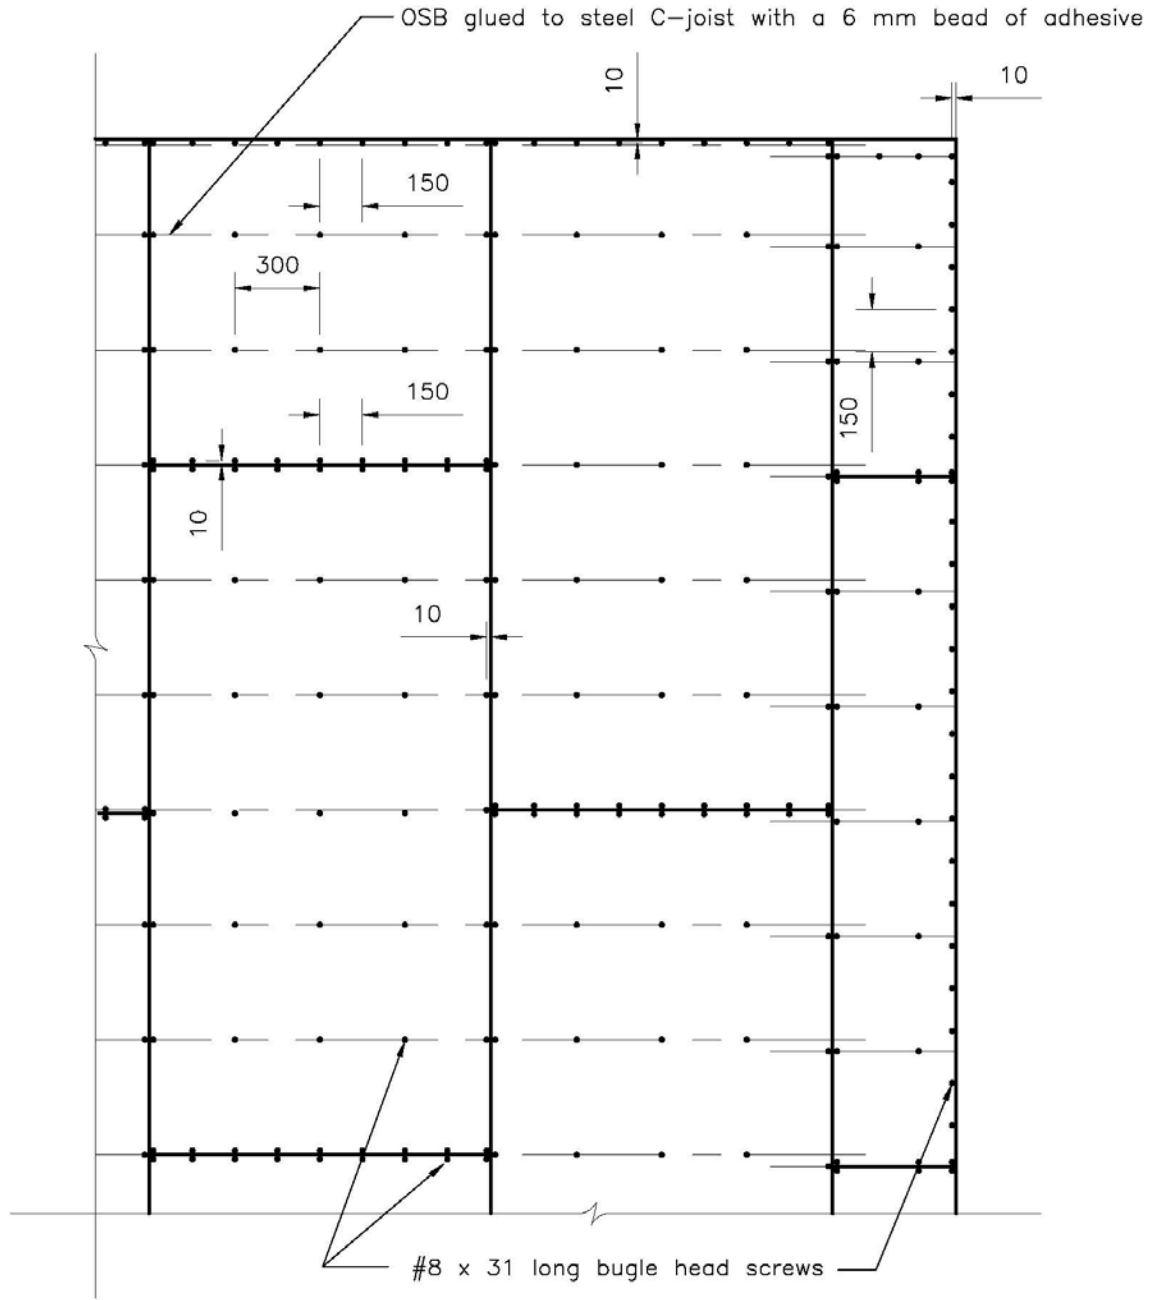
- Note: – OSB should be fully secured within 10 minutes of applying adhesive or sooner, if required by the subfloor adhesive manufacturer.
 – Two 6 mm bead of adhesive shall be used at abutting panel edges

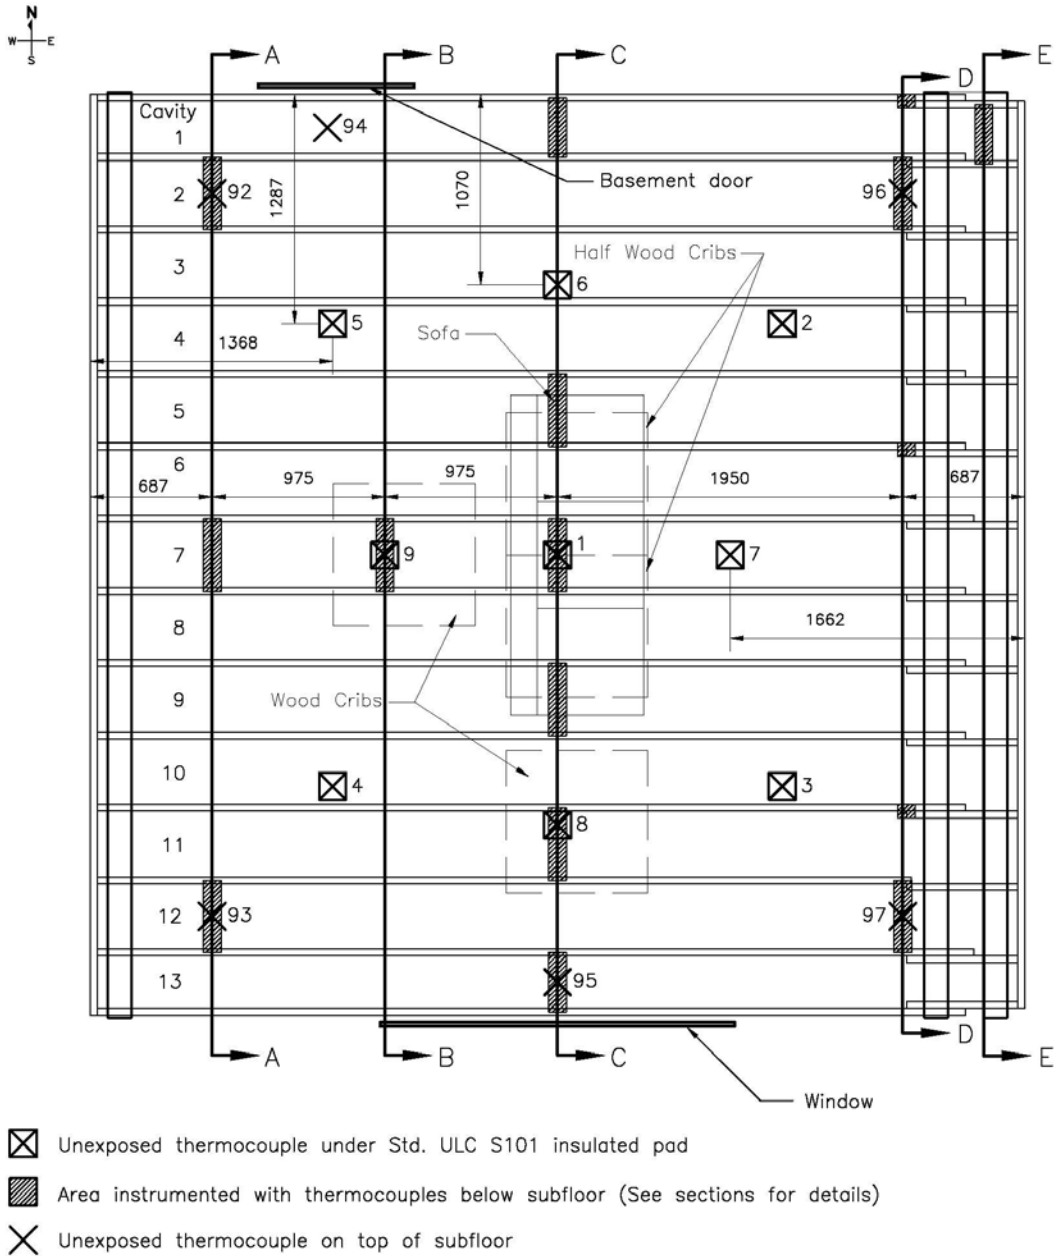
Ninety-seven Type K (20 gauge) chromel-alumel thermocouples, with a thickness of 0.91 mm, were used for measuring temperatures at a number of locations throughout the assembly. The thermocouple locations on the unexposed and exposed sides of the assembly are shown in Figure 17 and Figure 18. These locations were chosen to monitor the conditions of the assembly at critical locations during the fire test.

Figure 17. Thermocouples locations (all dimensions in mm)

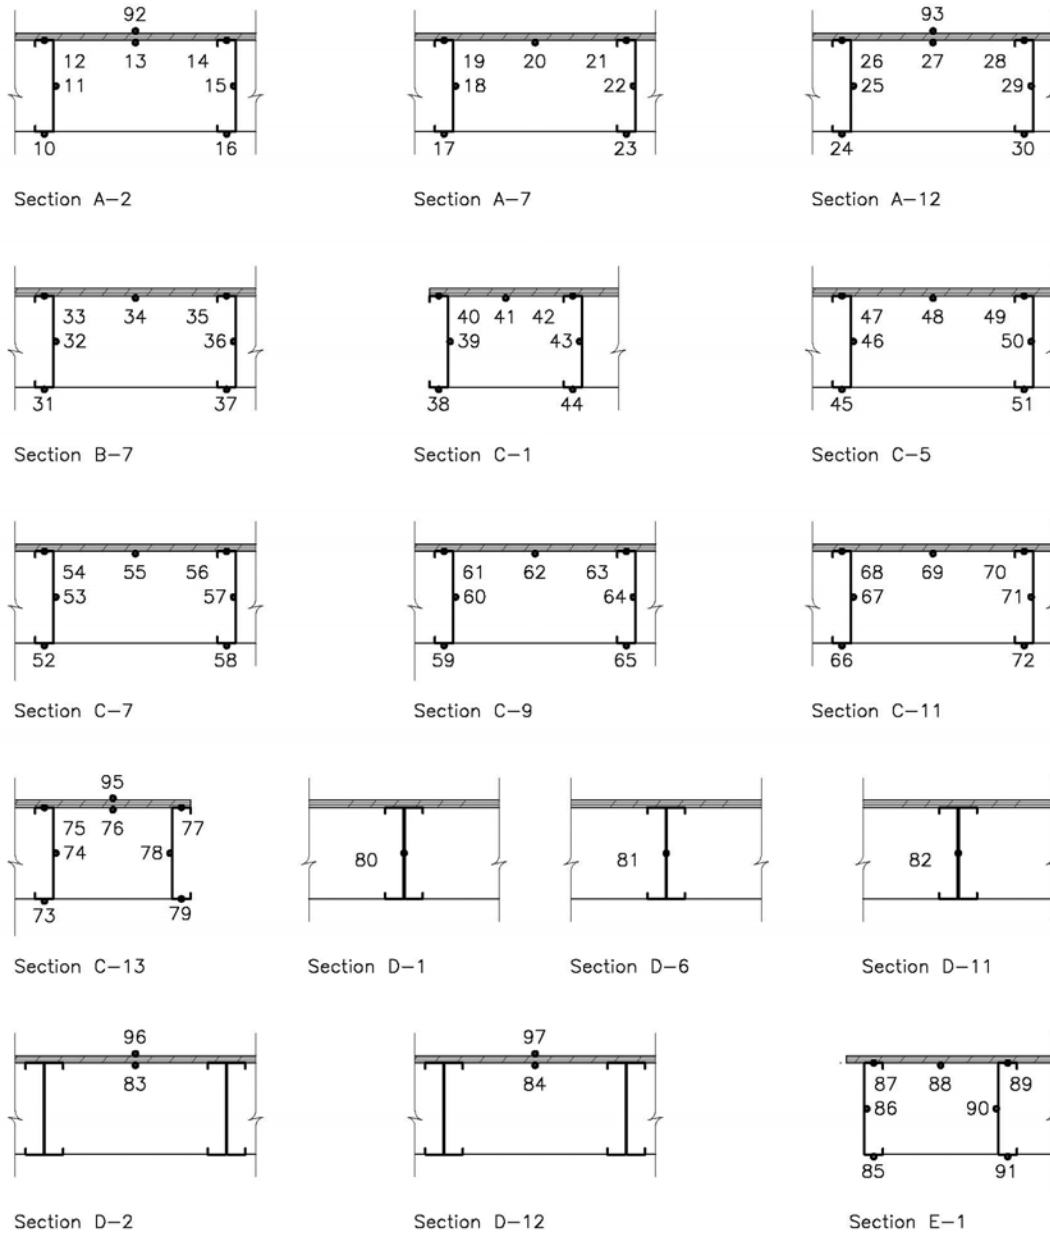
Figure 18. Thermocouples locations reflecting the different sections shown in Figure 17

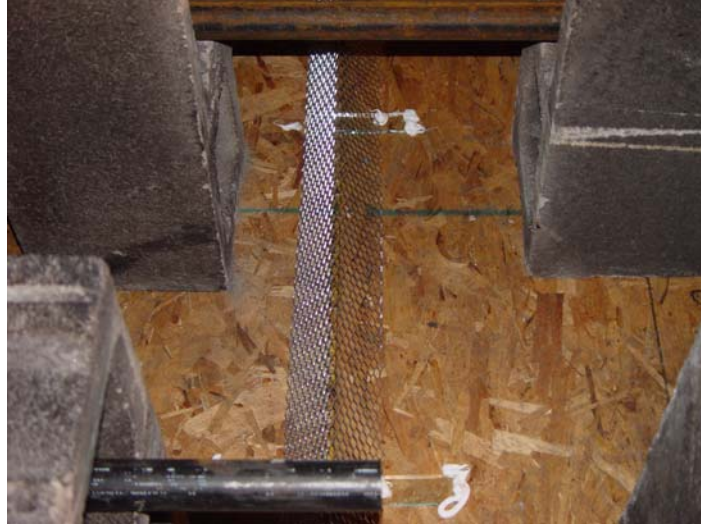
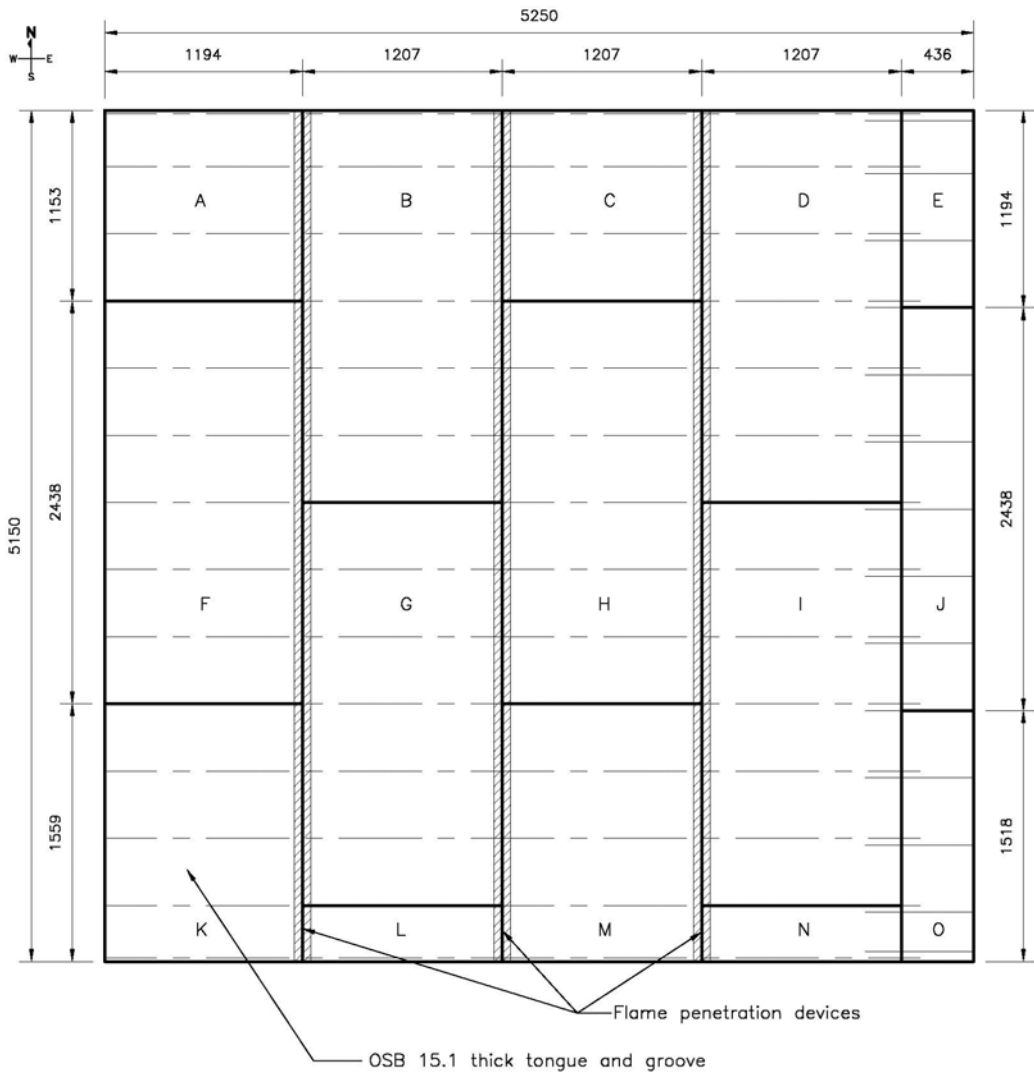
Flame penetration through the floor assembly is considered to be an initial indicator of the impending failure of the assembly. A device was developed and used for the test to better determine the time for flames to penetrate the floor. The special device consisted of a wire mesh placed at 3 locations on the unexposed surface of the floor assembly, specifically at three of the tongue and groove joints, as shown in Figure 19. A detailed description of the device is provided in [8].

Figure 19. Wire mesh device to detect flame penetration (all dimensions in mm)

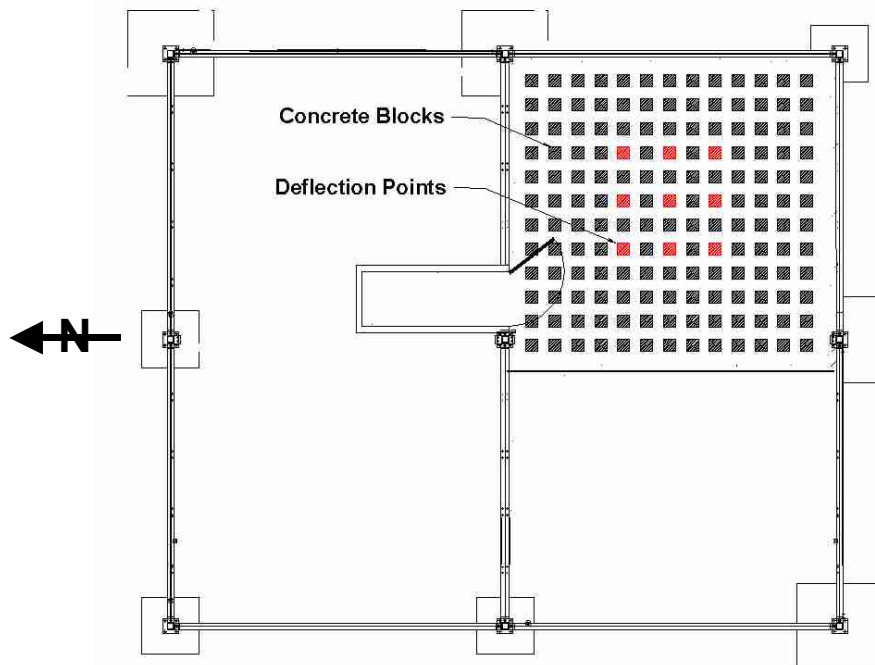
The floor deflection was measured at 9 points. The measurement technique utilized 9 rods that were touching the tops of 9 concrete blocks placed on the unexposed surface of the floor assembly at the locations shown in Figure 20. This ensured that the downward movement of the subfloor was monitored during the fire exposure. The deflections were recorded using the electro-mechanical method described in reference [9].

Figure 20. Loading blocks and locations of the deflection measurement points on the unexposed side of the floor

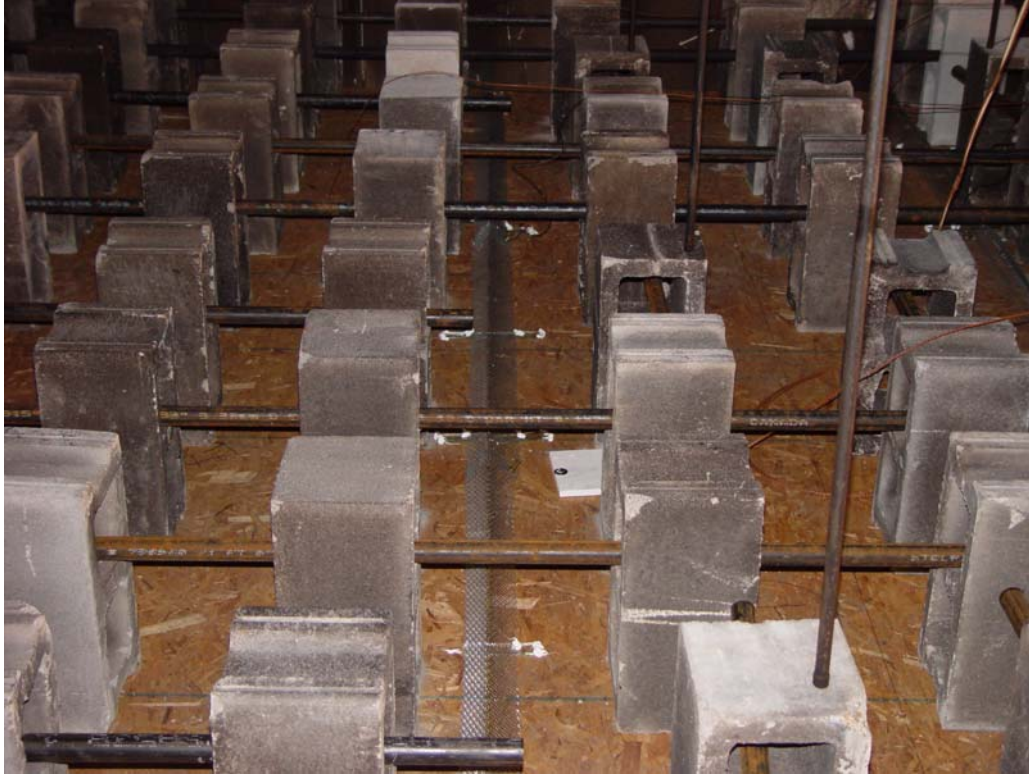
the basement and causing any damage, a restraining system was designed using a series of pipes attached to beams on both ends, which were secured to the steel frame of the 3-storey house, as shown in Figure 21. The pipes were inserted through the hollow cores of the concrete blocks prior to the fire test. The weight of the pipes was included in the total imposed load.

Figure 21. Device to hold the loading blocks

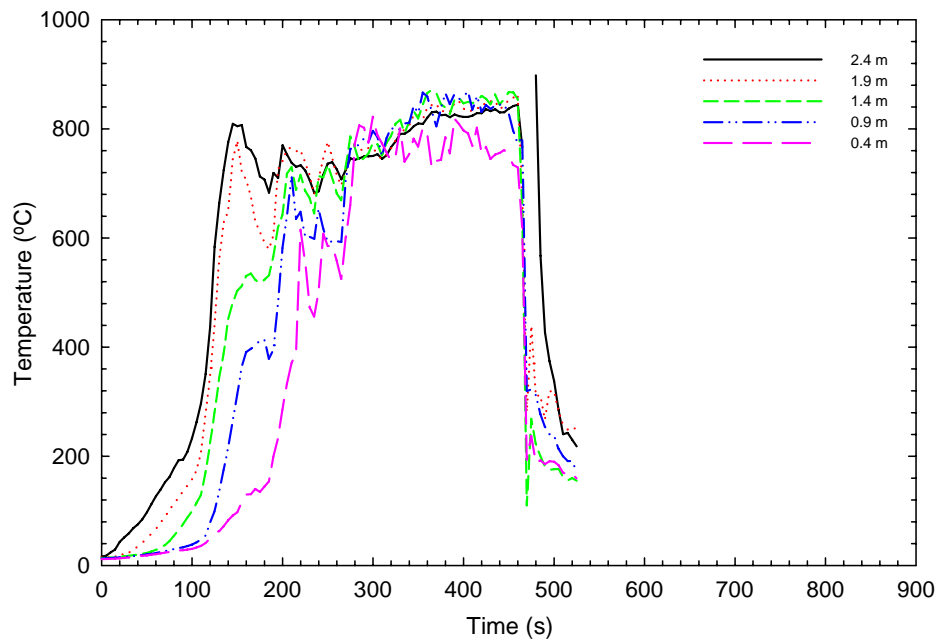
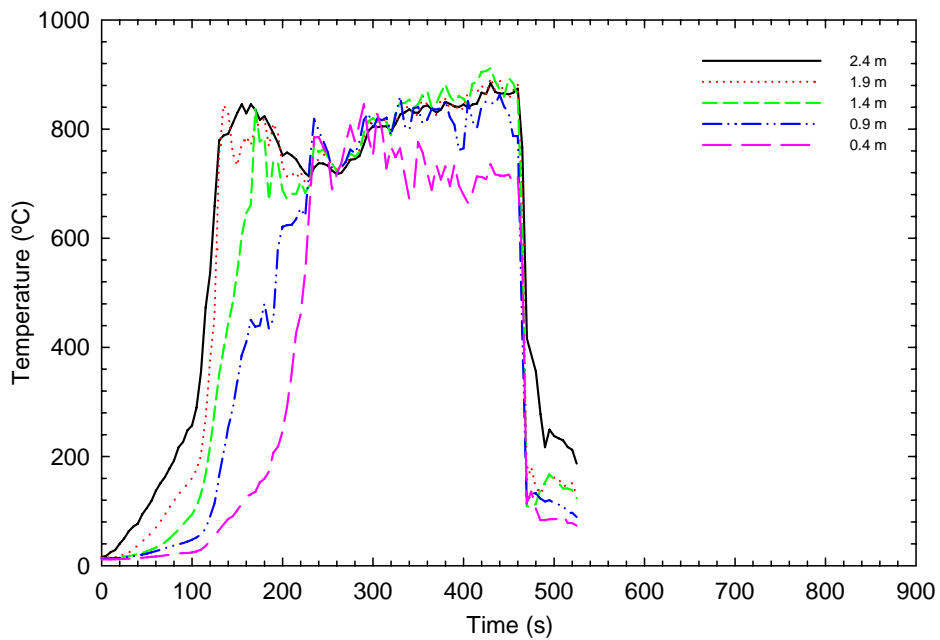
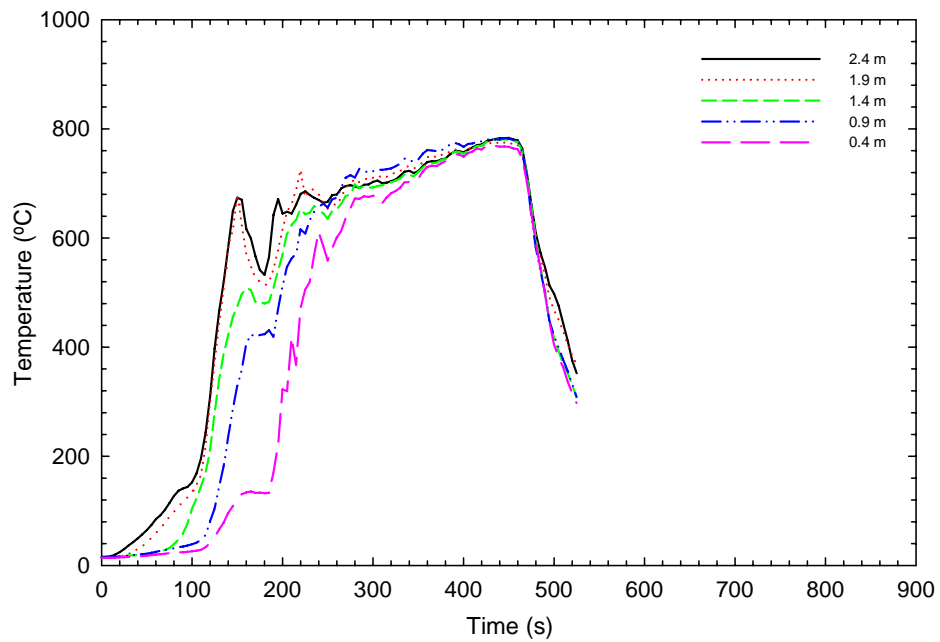
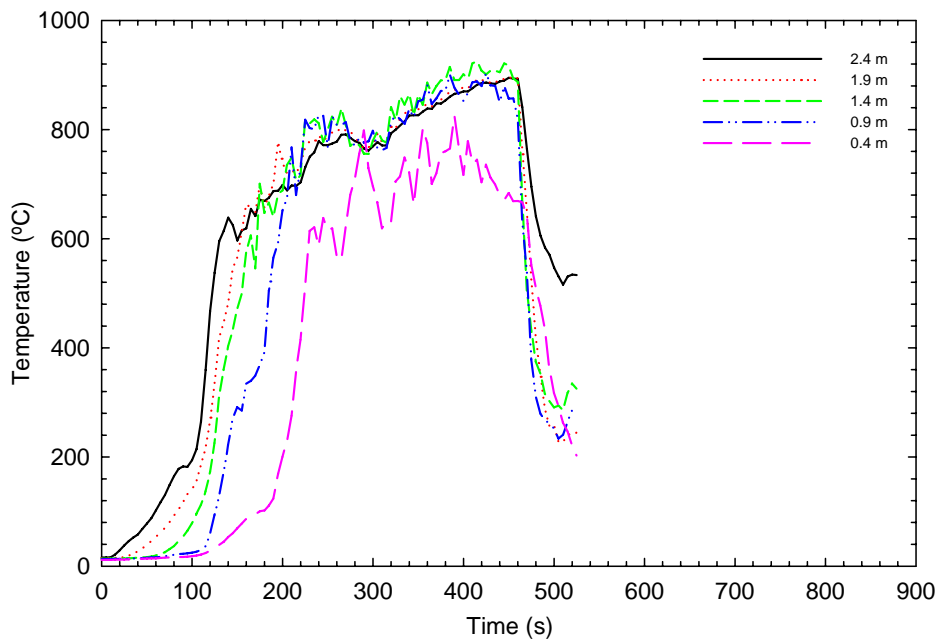
The temperatures rose to a maximum of 700 to 840°C in the first 140 to 160 s, which was due to the burning of the mock-up sofa. As shown in the figures, the initial fire growth was faster at the 2.4 m height than the other heights because the hot smoke layer formed first at the ceiling and flames were also impinging on the ceiling initially.

The fresh air coming from the basement window increased the combustion of the wood cribs, which caused the temperatures to increase steadily again, reaching a maximum of just under 900°C.

Finally, the temperatures decreased again just after 460 s when the floor started falling and the test was ended. It should be noted that the temperature was lowest in the case of the NE thermocouple tree, which may be partially attributed to the fact that the NE corner was the least impacted by the fire, as it was farthest away from the fire source and that most of the hot gases were moving to the upper storeys through the SE to NW path.

Figure 22 (a and b). TC Trees in the basement for UF-04

Figure 22 (c and d). TC Trees in the basement for UF-04
