Fire Performance of Houses. Phase I. Study of Unprotected Floor Assemblies in Basement Fire Scenarios Part 3

Part 3 – Results of Test UF-04 (Light-Gauge Steel C-Joists)

Research Report: IRC-RR-248

Date: March 31, 2009

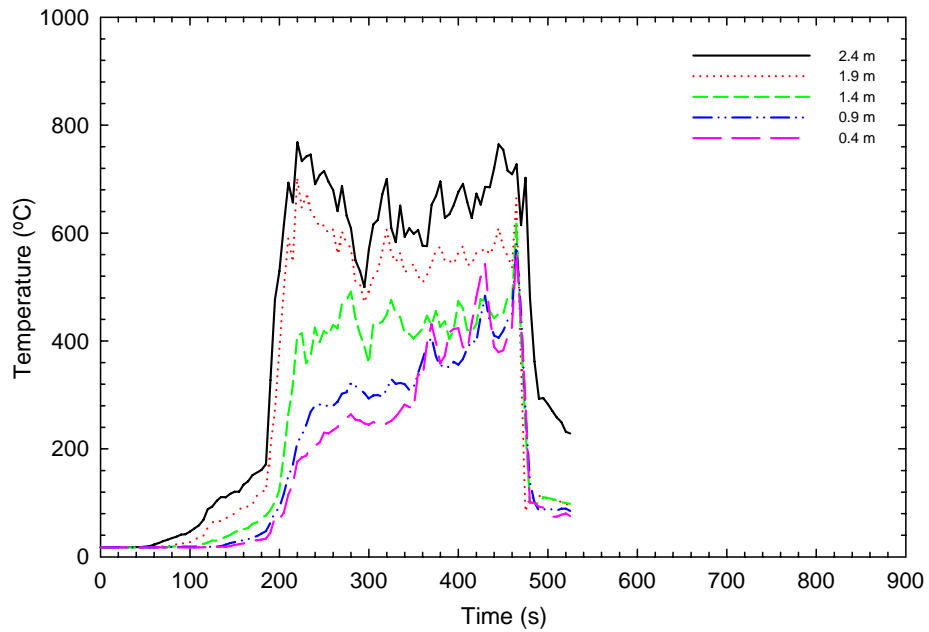
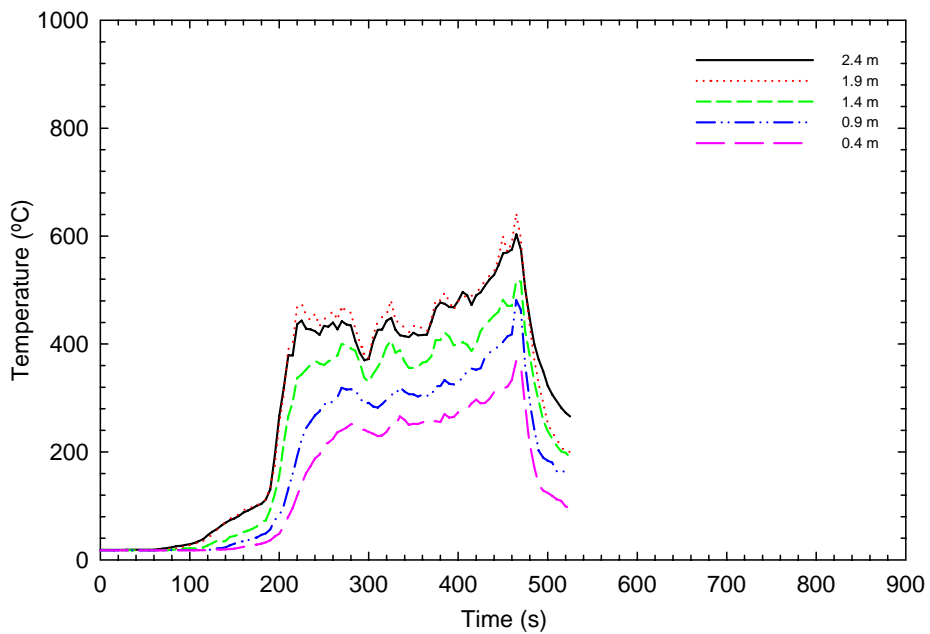
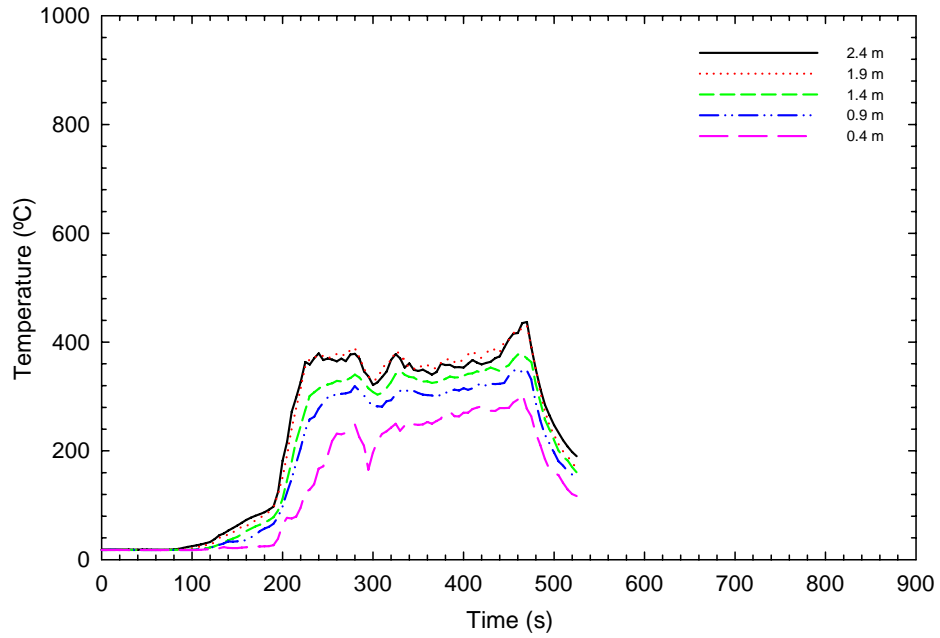
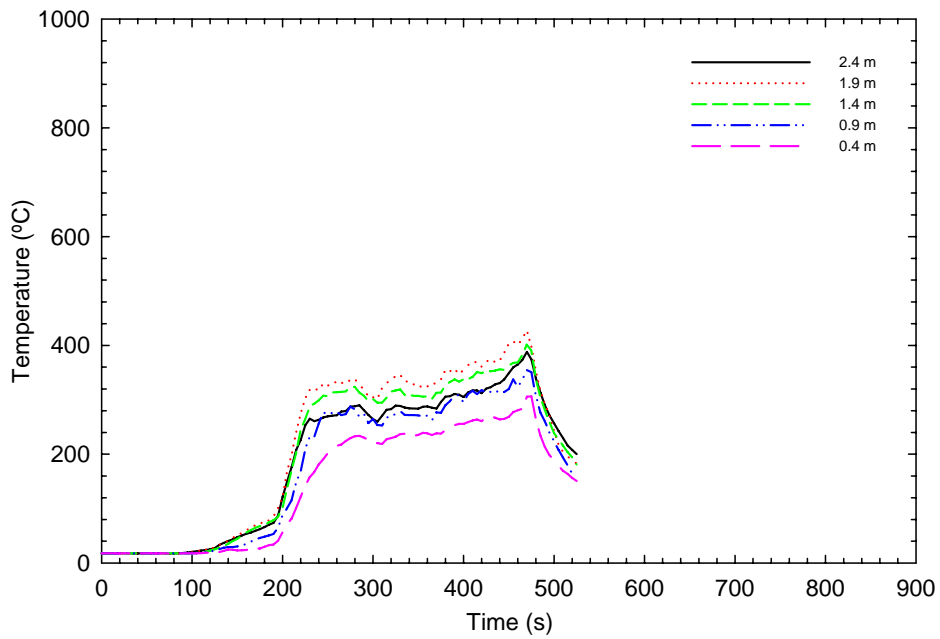
Figure 23 (a and b). TC trees in the first storey for UF-04

Figure 23 (c and d). TC trees in the first storey for UF-04

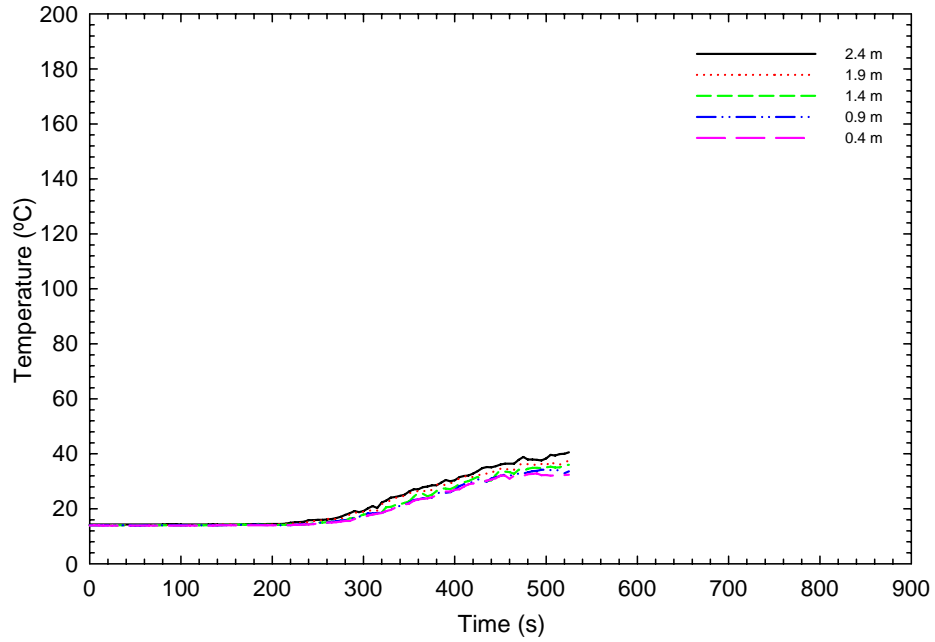
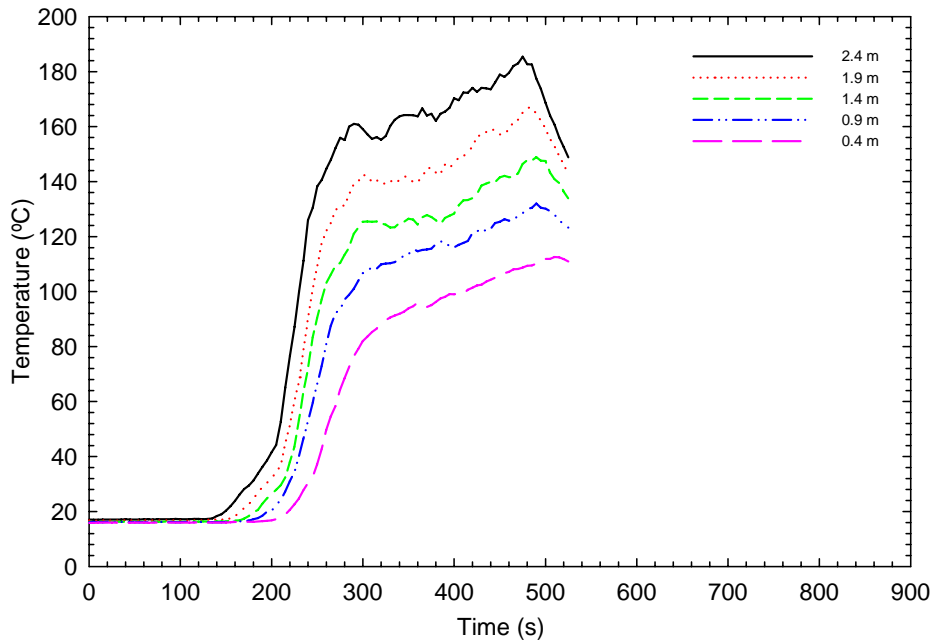
Figure 24 (a) and Figure 24 (b) show the temperatures in the SE and SW bedrooms, respectively for Test UF-04. The door to the SE bedroom was closed while the door to the SW bedroom was open. Ambient temperature was measured for about the first 220 s for the SE bedroom and 140 s for the SW bedroom. After this, the temperatures, at different heights within the rooms, start increasing. This increase was greater for the SW bedroom than the SE bedroom because the door to the SW bedroom was open. Maximum temperatures of about 40 and 180°C were reached at 2.4 m height above the floor level in the SE and SW bedrooms, respectively. For the SW bedroom, the temperatures started decaying after the extinguishment of the fire was initiated.

Figure 24. TC trees in the second storey bedrooms for UF-04

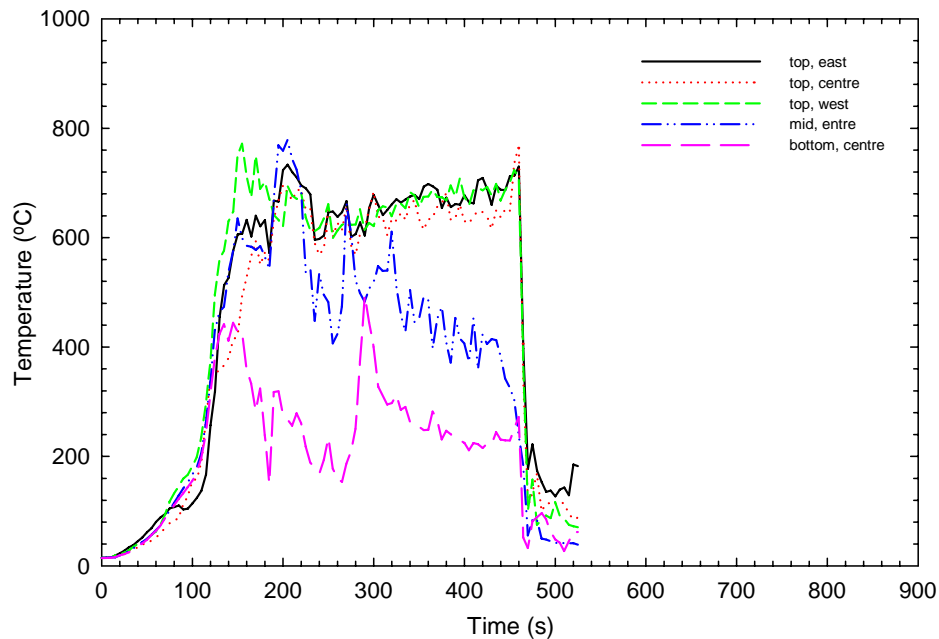
Figure 25 shows the temperatures recorded at the basement window. The temperatures increased sharply to 600°C in the first 140 s. The window was opened after 120 s when the temperatures reached 300°C. After 120 s, due to air entering and smoke exiting the basement window opening, the temperatures were scattered depending on whether or not the flames were touching the thermocouples (the bottom TC was probably below the neutral plane).

Figure 25. Temperatures at the window in the basement for UF-04

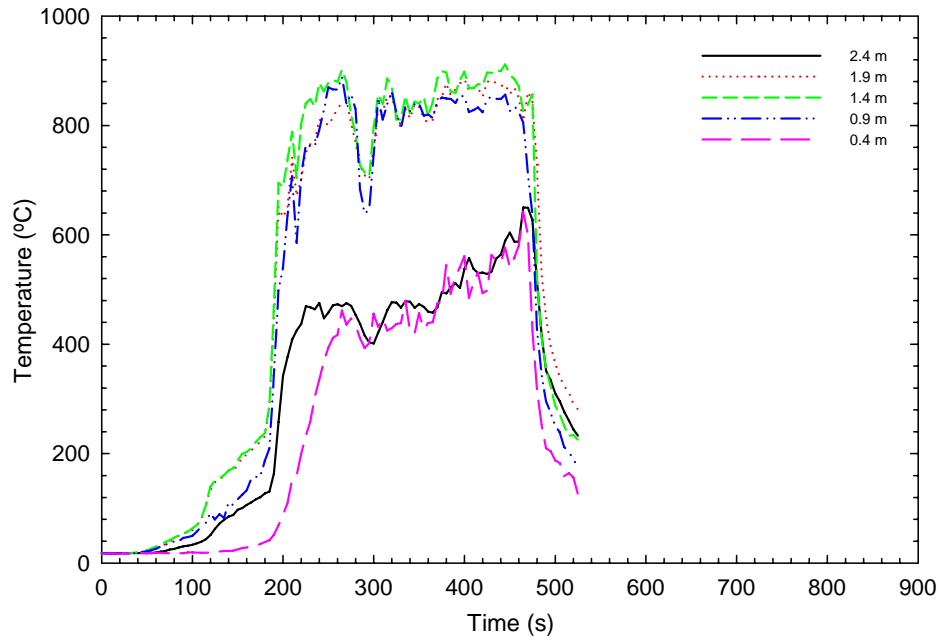
Figure 26 shows the temperatures at the top of the stairs on the first storey at different heights. The conditions remained at ambient temperature for about the first 50 s. After this, temperatures, at different heights, started increasing due to the migration of hot gases and smoke from the basement to the upper storeys. A maximum temperature of about 900°C was reached and then there was a decline in temperatures because the exterior door on the first storey was opened and fresh air entered the compartment. The temperatures then remained constant for a short time. After this, the temperatures at

2.4 and 0.4 m levels started increasing again due to the extensive burning of the wood cribs and flame penetration through the floor. The temperatures started decaying around 460 s when extinguishment of the fire was initiated. The maximum temperature was not reached at the 2.4 m level but at the 0.9, 1.4 and 1.9 m levels. This is probably an indication that cooler air was entering into the basement at both the upper level and lower level of the basement doorway.

Figure 26. Temperatures on the first storey at the top of the stairs from the basement for UF-04

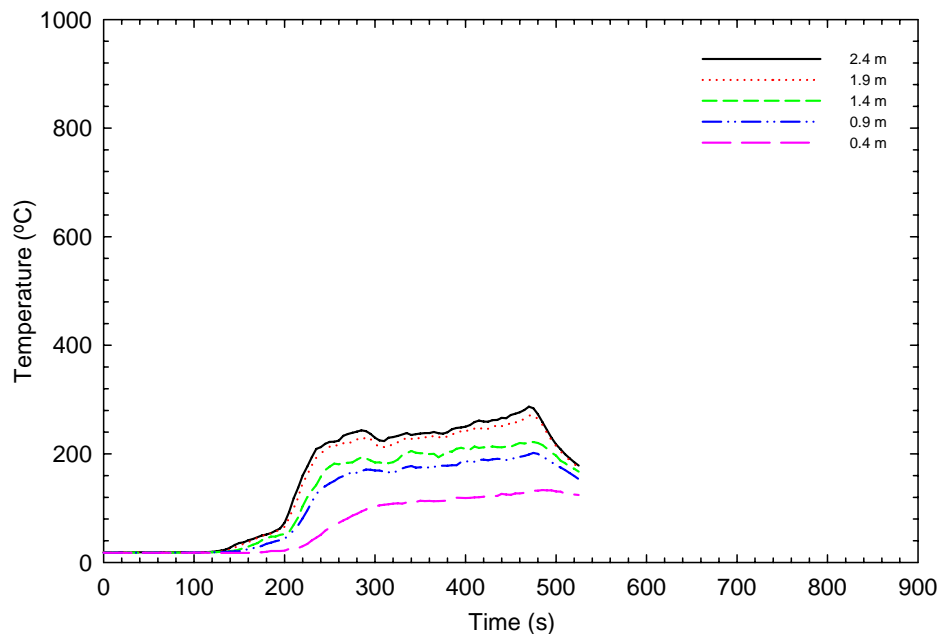
Figure 27 shows the temperatures at the top of the stairs on the second storey at different heights for Test UF-04. The conditions remained at ambient temperature for about the first 130 s. After this, temperatures, at different heights, started increasing due to the migration of hot gases and smoke from the basement to the upper storeys. A maximum temperature of about 280°C was reached at the 2.4 m height. The temperatures started decaying after the extinguishment of the fire was initiated.

Figure 27. Temperatures on the second storey at the stairs for UF-04

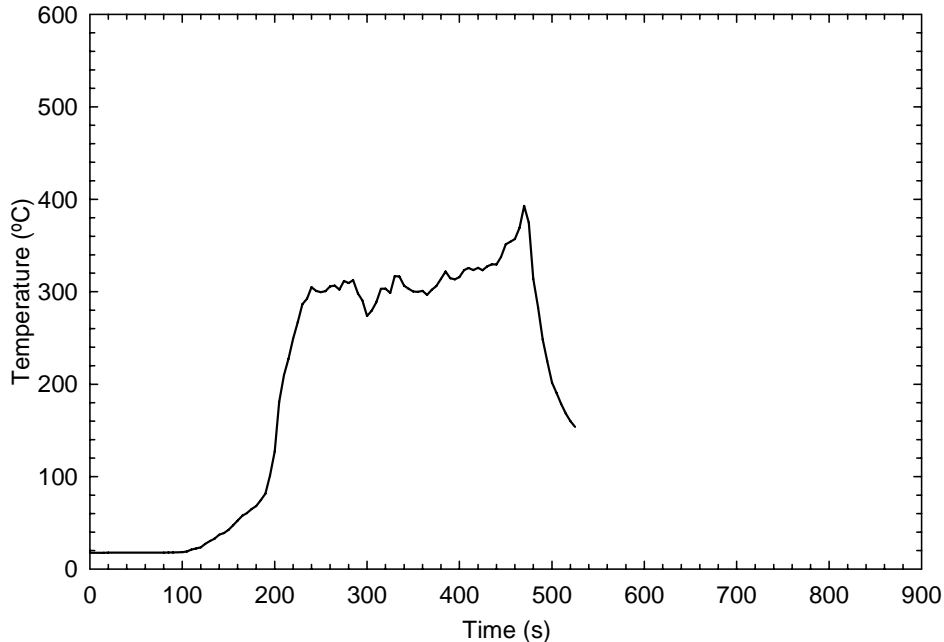
Figure 28 shows the temperatures outside the exterior door on the first storey. Ambient temperature was measured for about the first 100 s. After these times, the temperatures started increasing reaching 300°C at 220 s due to smoke and hot fire gases exiting through the open exterior door. The temperature decreased at about 260 s. Just after 440 s, there was a sharp increase in temperatures (due probably to flame penetration through the floor producing more radiation and hot gases in the vicinity of the exterior door). The temperatures started decaying after about 460 s, after the extinguishment of the fire was initiated.

Figure 28. Temperatures at the outside doorway on the first storey for UF-04

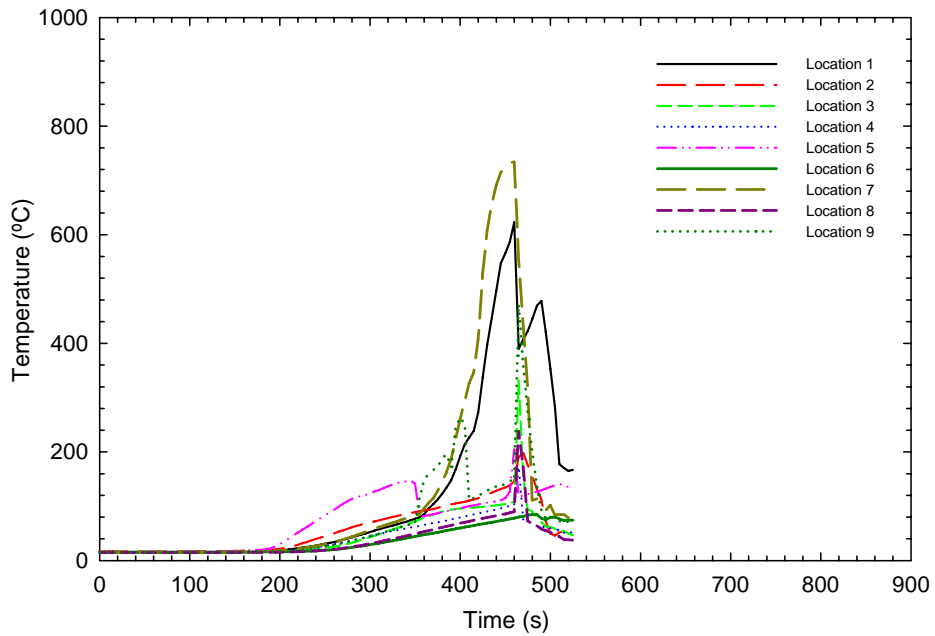
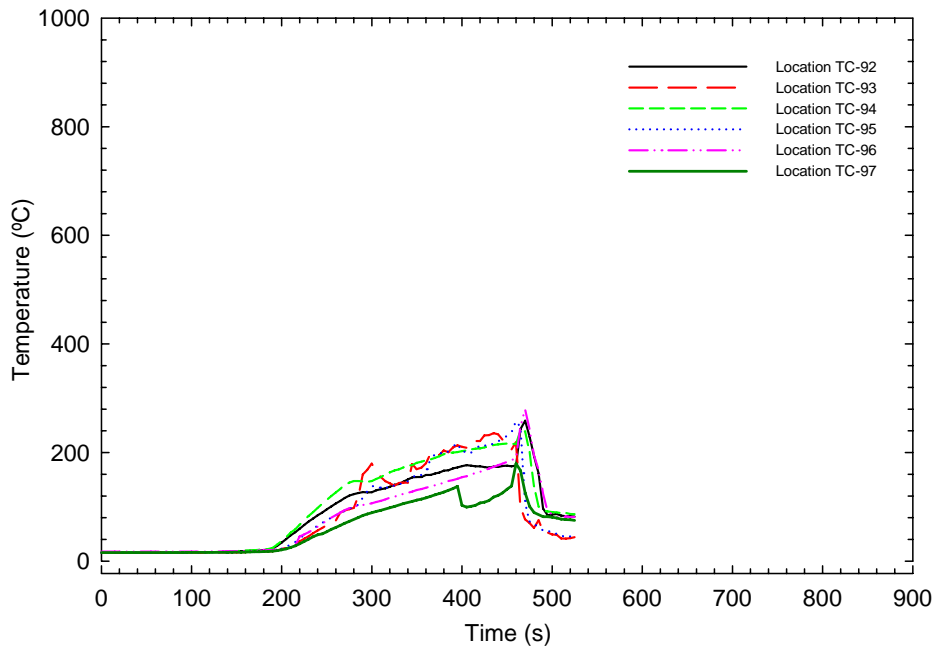
a) Unexposed TCs under insulated pad on top of subfloor.

b) Bare TCs on the unexposed (top) side of subfloor.

Figure 29. Temperatures at the unexposed side of subfloor for UF-04

It is worth mentioning that under standard fire test conditions (CAN/ULC-S101 and ASTM E 119 tests) [14], temperatures on the unexposed faces of specimens measured with uncovered TCs are always lower than those measured by TCs covered with insulated pads. In the standard tests [14], on the basis of temperature, floor failure is defined as a temperature rise of 140°C above ambient temperature for the average of the nine padded thermocouples or a temperature rise of 180°C above ambient temperature at any single point (padded thermocouple) on the unexposed side.

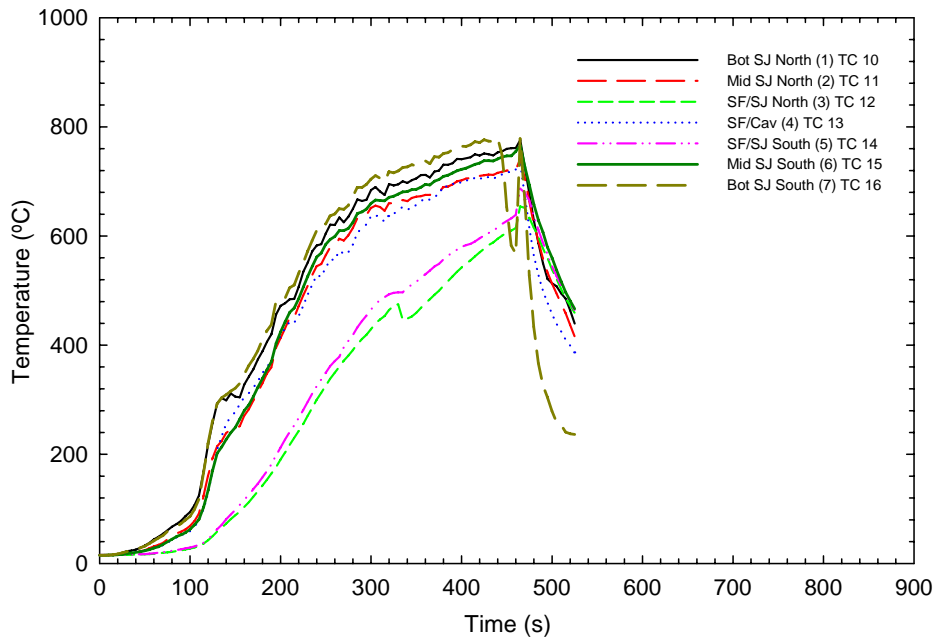
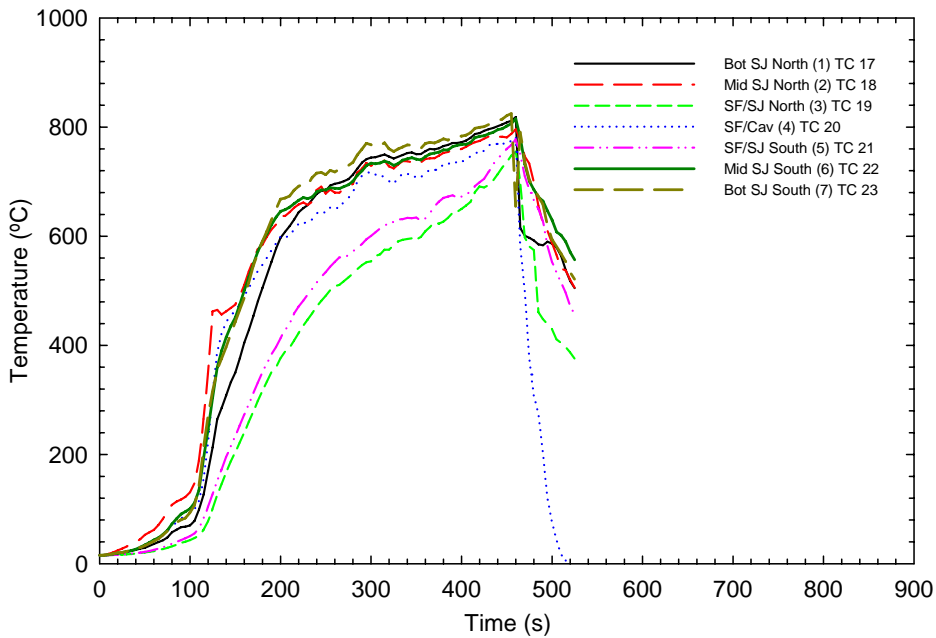
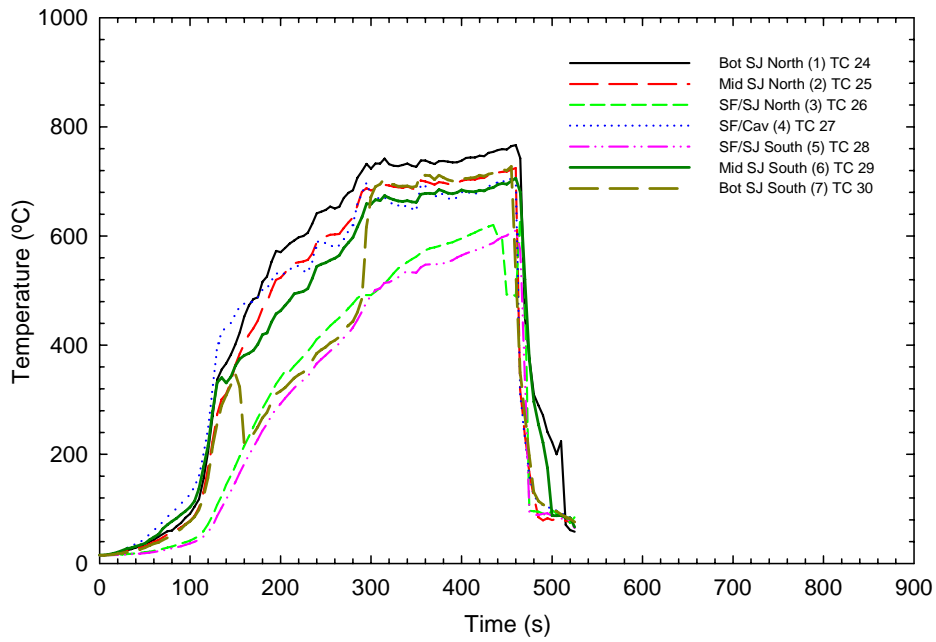
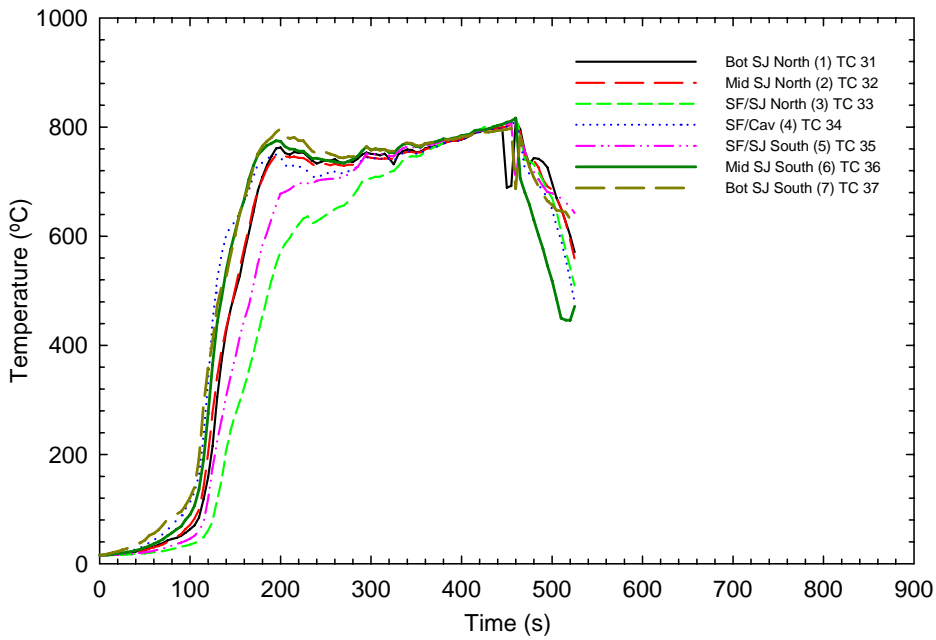
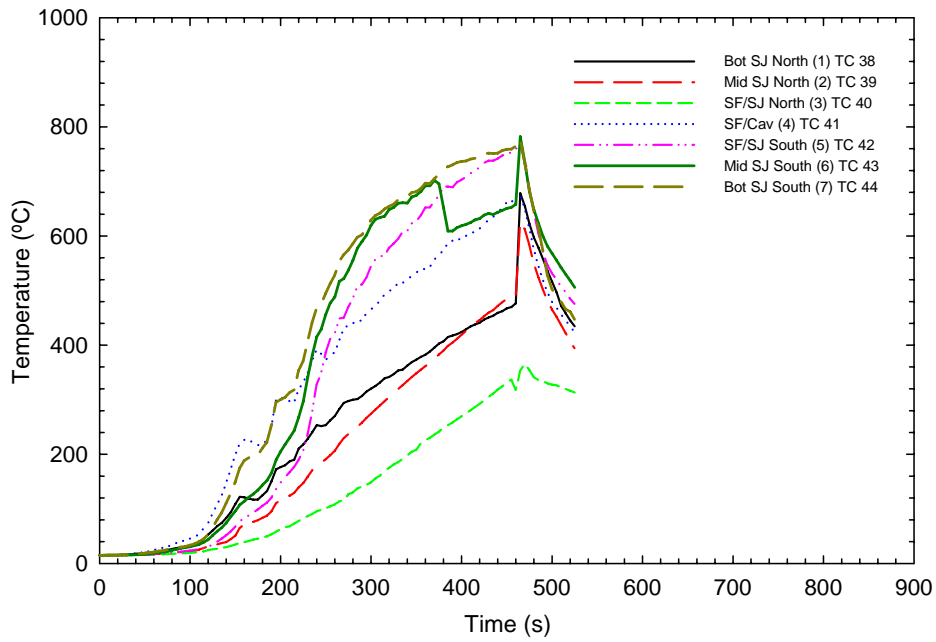
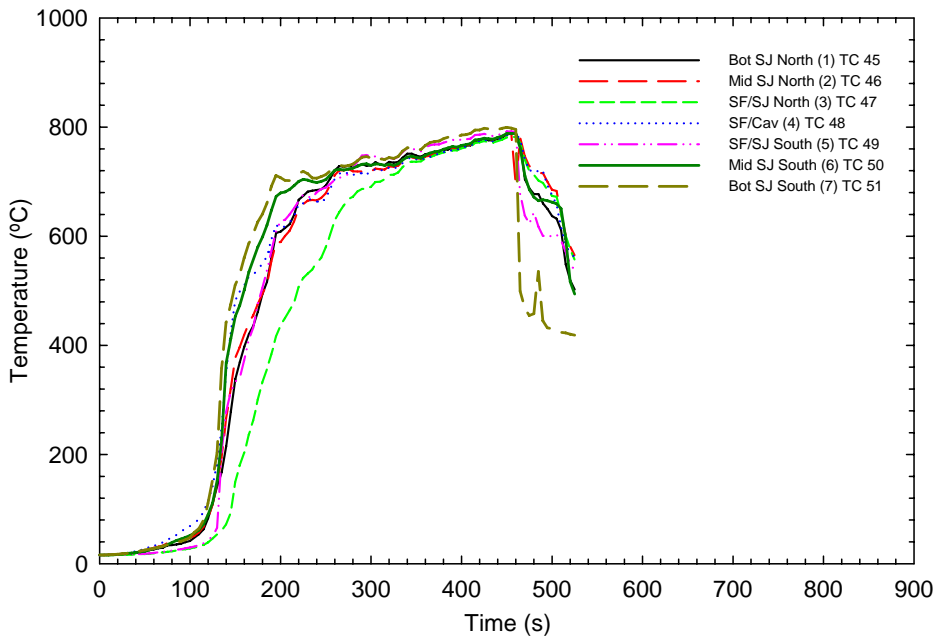
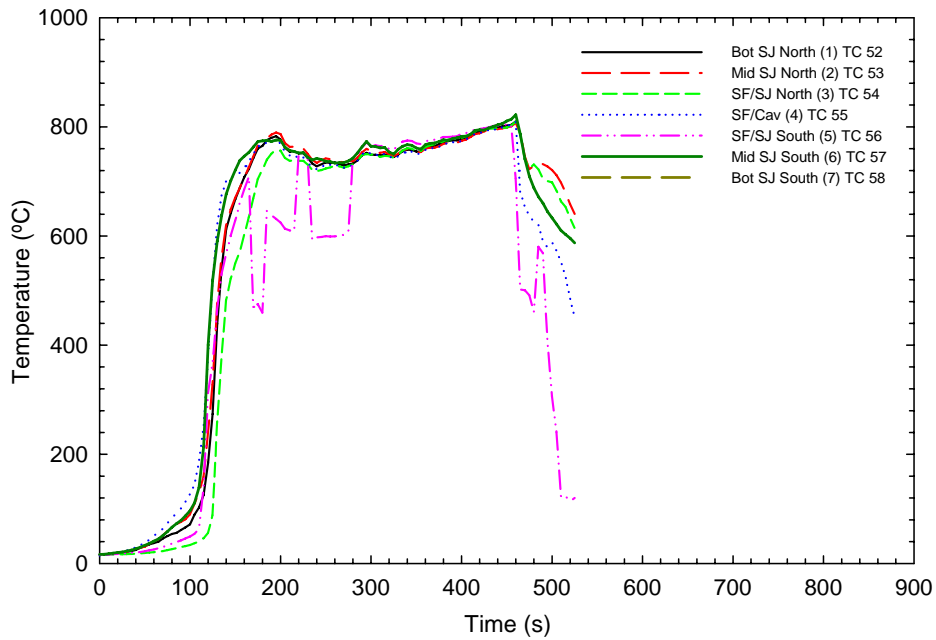
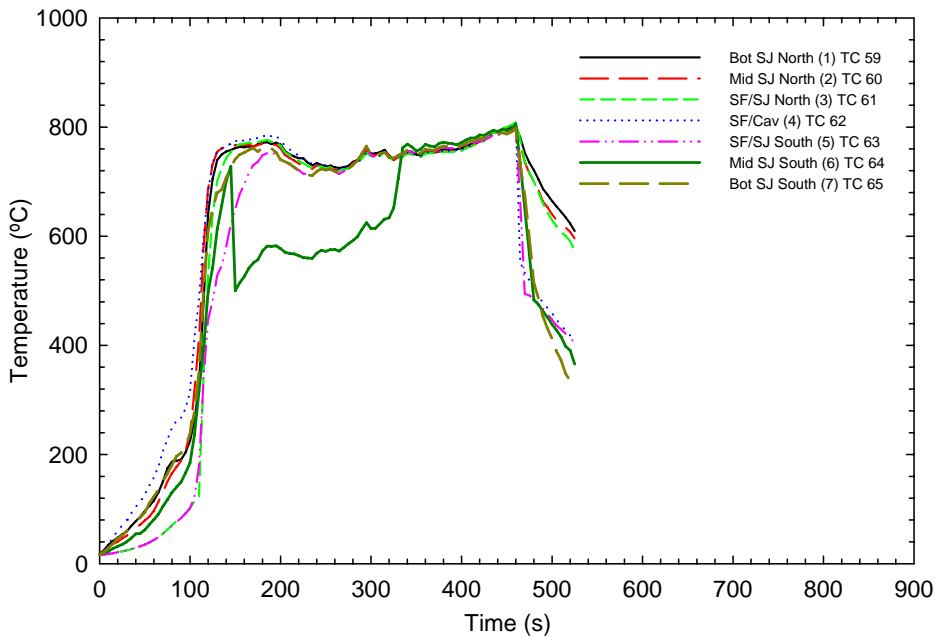
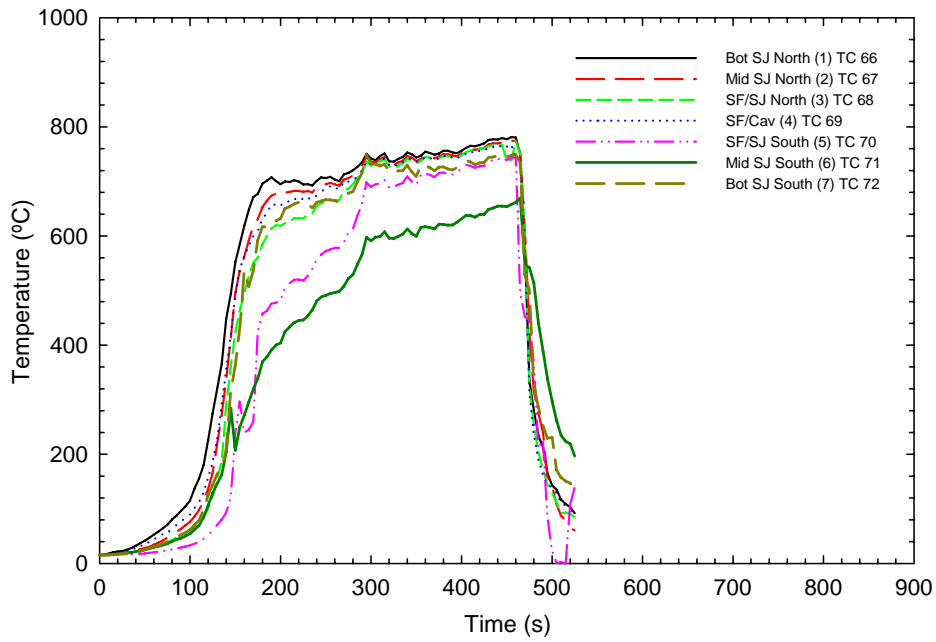
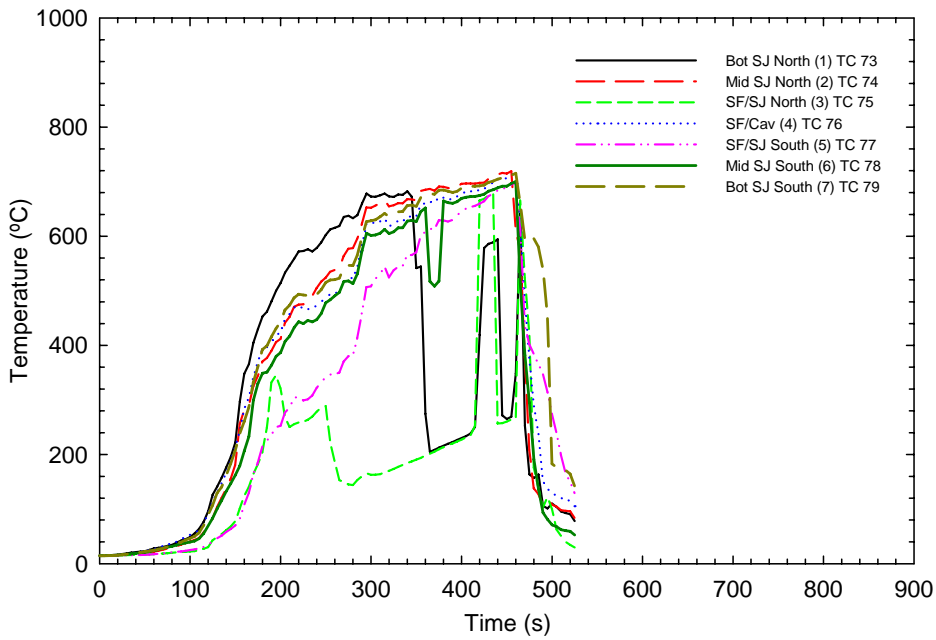
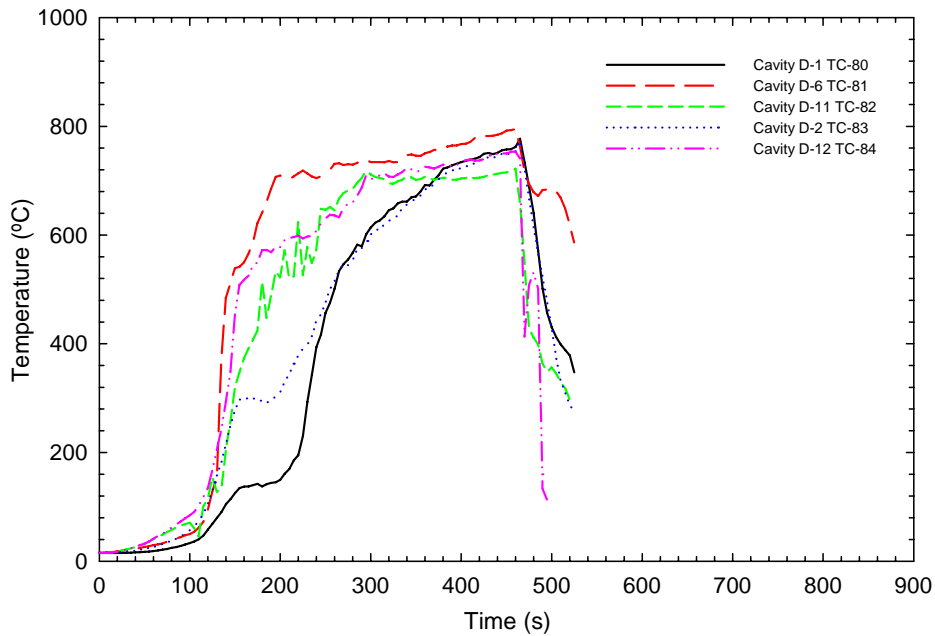
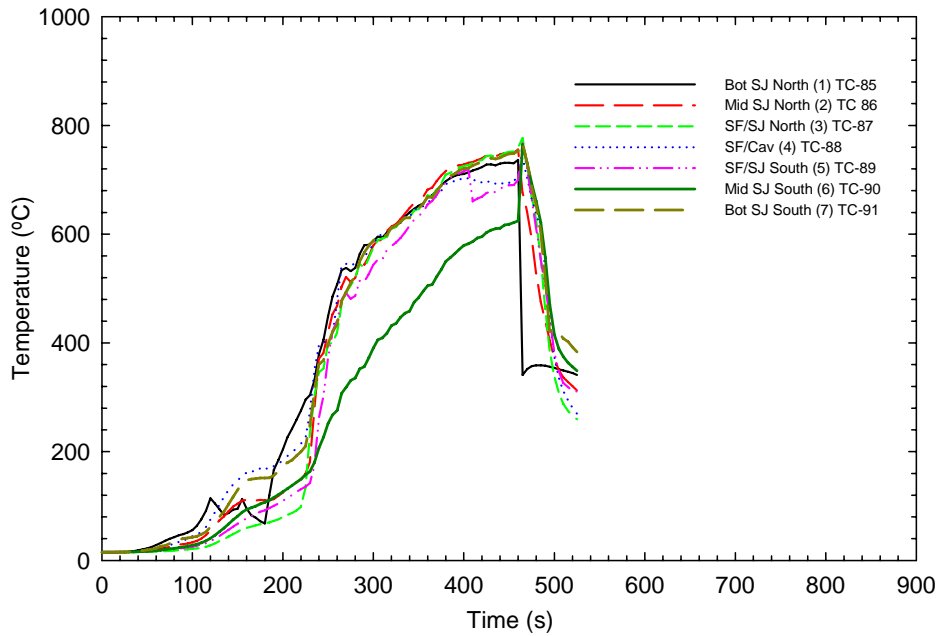
For the exposed thermocouples, the highest peak temperature (a value of about 800°C) was recorded at sections B-7, C-7, and C-9 (located very close or directly over the burning sofa mock-up and the wood cribs). In some cases, there was a drop in temperature measured by the exposed thermocouples just after 180 s, which may be attributed to the fresh air coming from the open basement window and the opening of the exterior door on the first storey at 180 s. The decrease in temperature was short and then the temperatures started increasing again.

Figure 30 (a and b). Temperatures at the exposed side for UF-04

Figure 30 (c and d). Temperatures at the exposed side for UF-04

Figure 30 (e and f). Temperatures at the exposed side for UF-04

Figure 30 (g and h). Temperatures at the exposed side for UF-04

Figure 30 (i and j). Temperatures at the exposed side for UF-04

The increase in temperature happened at different times for the different locations. The difference in time between the two SF/SJ (North and South) thermocouples is partly due to the view factor relative to the burning fuel package. In some cases, the bulk of the fuel package was 'positioned' South of the thermocouple grouping. Consequently, the thermocouple at top of the North C-joint experienced a greater heat insult from both the convective and radiative effects from the burning fuel. For the thermocouple groupings with the bulk of the fuel package located to the North, the reverse effect occurred.

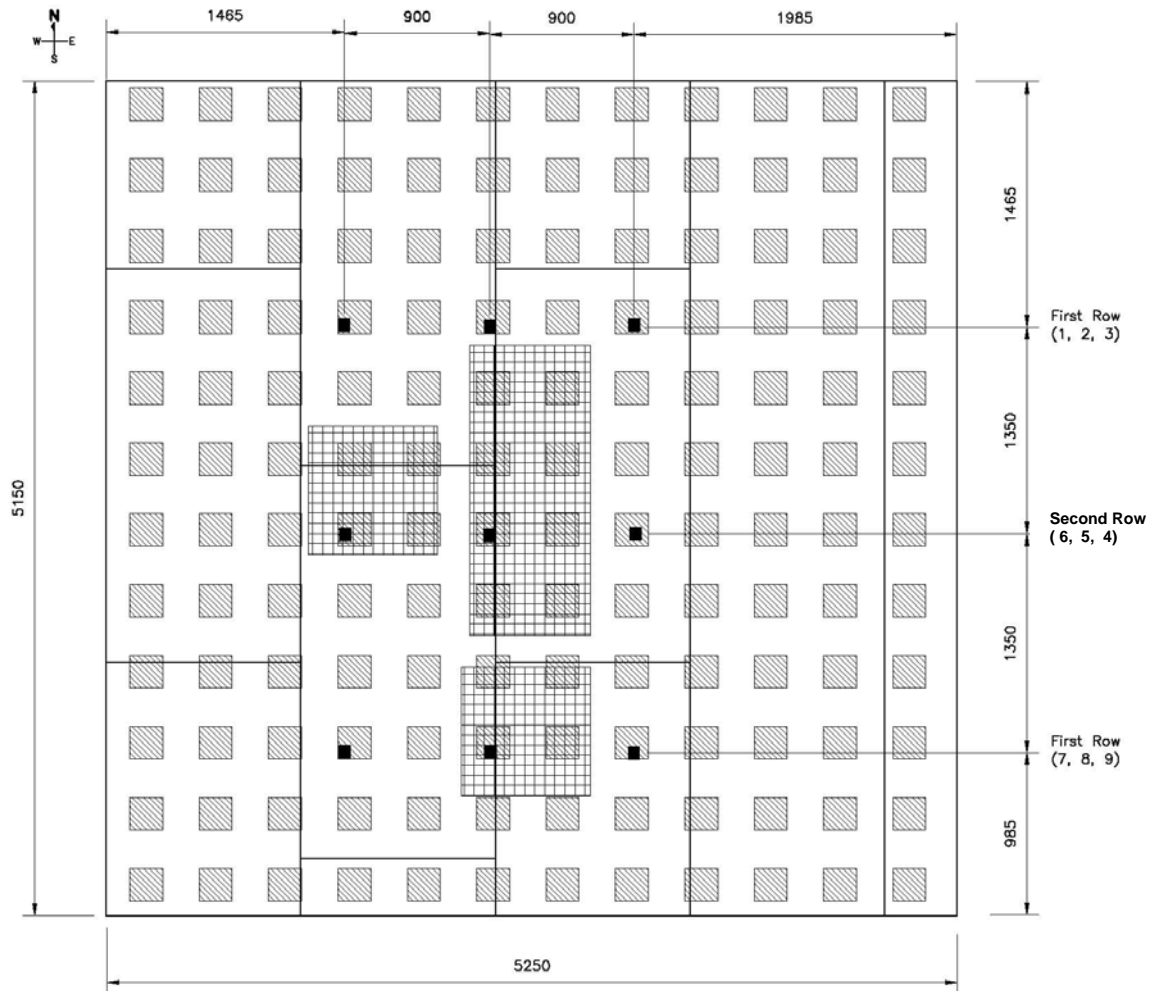
Figure 31. Deflection points measured (all dimensions in mm)

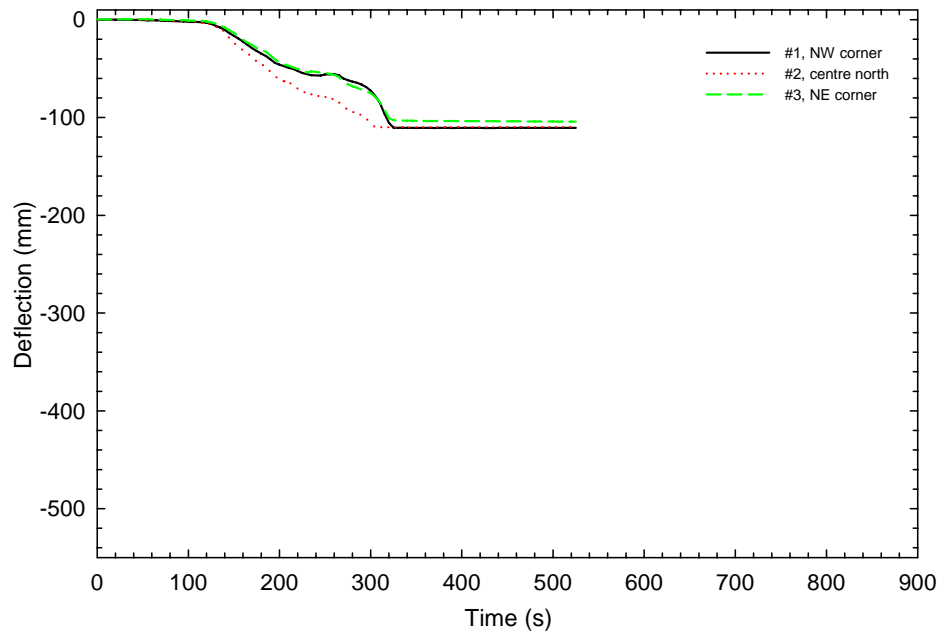
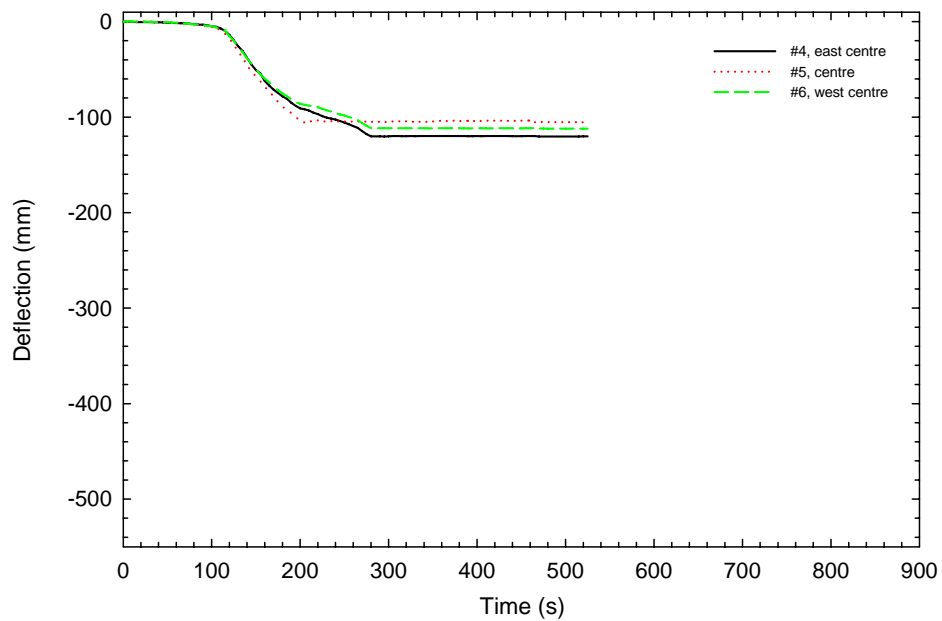
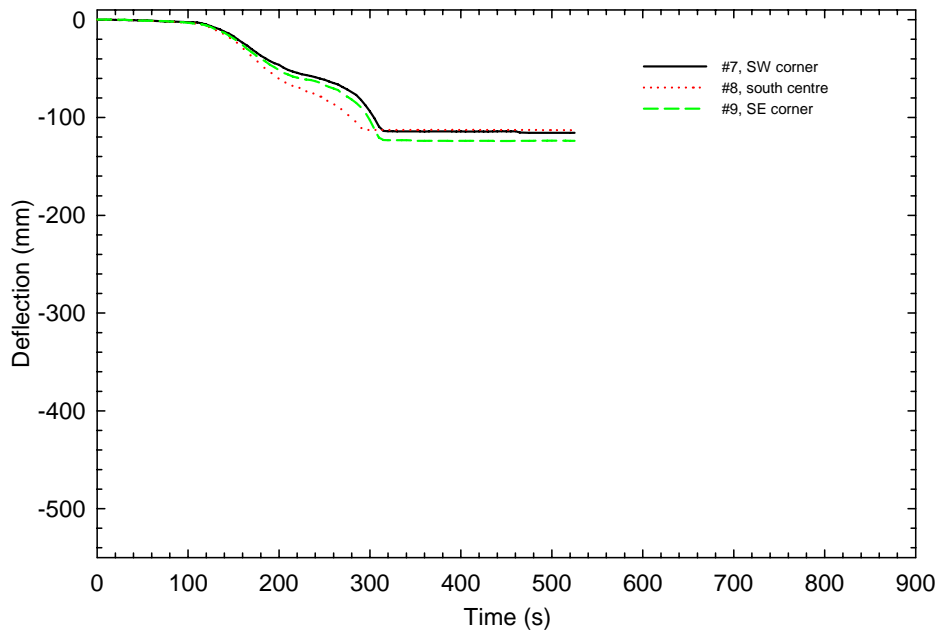
Figure 32 (a) shows the deflections measured in the first row (1, 2, and 3). Up to 120 s, the deflections were very small. After this time, the deflections increased at a relatively moderate rate, reaching a total of 110 mm at 320 s for points No. 1 and No. 2, and 110 mm after 320 s for point No. 3. After these times, all the deflections were constant, which is an indication that the rods had reached their maximum gauge length and were not touching the concrete blocks. So the measured deflections were not the maximum values before floor failure.

Figure 32 (b) shows the deflections measured in the second row (4, 5, and 6). Up to 100 s, the deflections were very small. After this time, the deflections increased at a relatively moderate rate, reaching a total of 120 mm at 280 s for point No. 4, 100 mm at 200 s for point No. 5, and 110 mm after 280 s for point No. 6. After these times, all the deflections were constant, which is an indication that the rods had reached their maximum gauge length and were not touching the concrete blocks. So the measured deflections were not the maximum values before floor failure.

Figure 32 (c) shows the deflections measured in the third row (7, 8, and 9). Up to 100 s, the deflections were very small. After this time, the deflections increased at a relatively moderate rate, reaching a total of 120 mm at 310 s for point No. 7, 120 mm at 300 s for point No. 8, and 130 mm after 310 s for point No. 9. After these times, all the deflections were constant, which is an indication that the rods had reached their maximum gauge length and were not touching the concrete blocks. So the measured deflections were not the maximum values before failure. In fact, the failure did not occur until 462 s based on visual observations through the rough window opening in the fire room.

Figure 32 (a and b). Deflection measurements for rows 1, 2 and 3 for UF-04

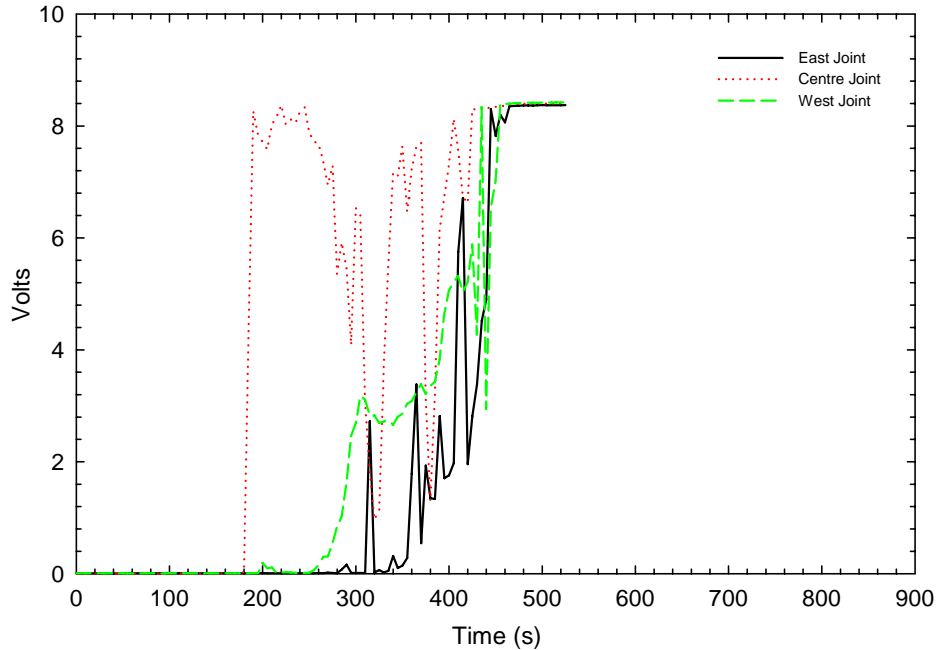
Figure 33 shows the results of the flame-sensing devices. Three wire meshes were installed on the top of three joints (East, Centre and West) on the unexposed side of the floor as shown in Figure 19 (instrumentation figure). There was a sudden increase in the voltage output of the flame-sensing device when flames penetrated through the floor and struck the wire meshes. As indicated by Figure 33, flame penetration occurred at the centre joint at 180 s, at the west joint at 300 s, and at the east joint at 340 s. This is due to the large deformations that occurred in steel and due to the joint opening created by these deformations.

Figure 33. Results of flame sensors at different joints

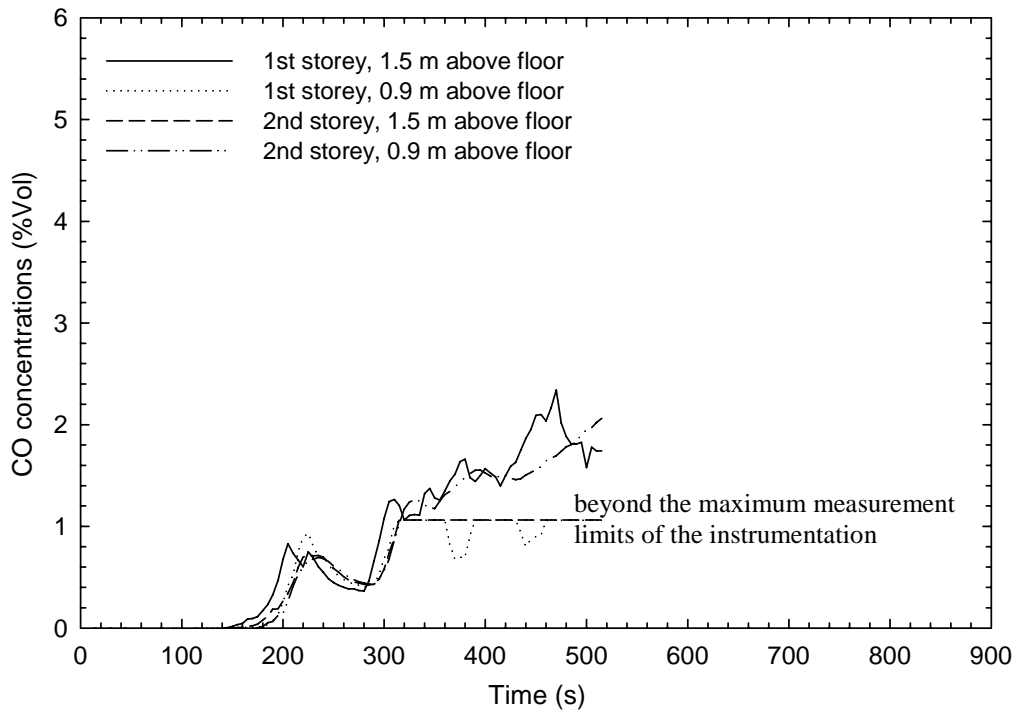
Figure 34. CO measurements for Test UF-04

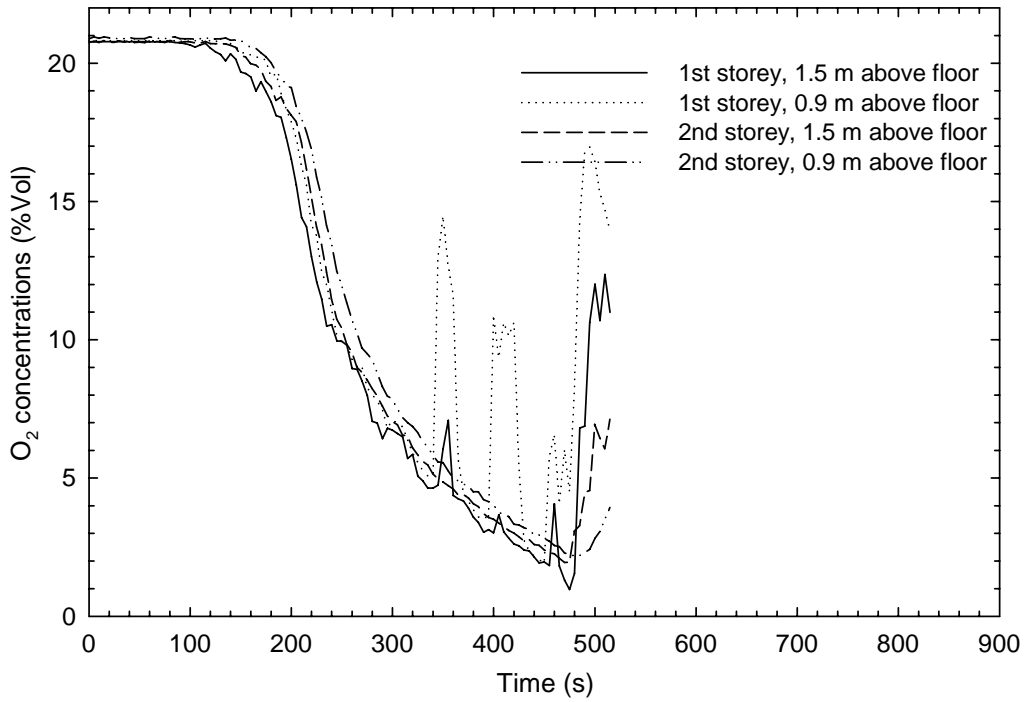
In Test UF-04 (see Figure 35), the O₂ concentration on both the first and second storeys dropped to below 10% in 250 s and to 3% at 460 s after ignition. The O₂ vitiation alone would cause incapacitation after 335-345 s (1st storey-2nd storey) using $F_{in,O_2} = 1$ as a criterion, or after 295-305 s (1st storey-2nd storey) using $F_{in,O_2} = 0.3$.

Figure 35. O₂ measurements for Test UF-04

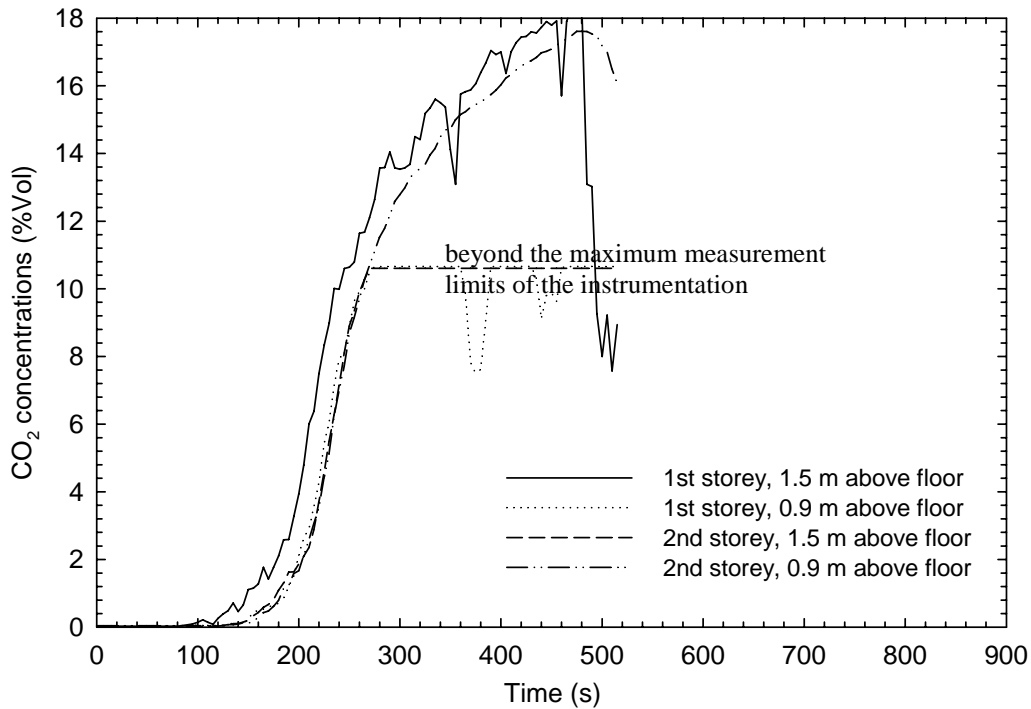
In Test UF-04 (see Figure 36), the CO₂ concentration exceeded 10% (measurement range limit of the gas analyzers) in 250 s. Note that the CO₂ concentration profile above the 10% measurement range was calculated for the first storey at the 1.5 m height using the measured O₂ and CO concentrations (CO₂%=20.9% - O₂% - ½ CO%). The increased concentration of CO₂ alone would cause incapacitation after 285-310 s (1st storey-2nd storey) using $F_{in, CO_2} = 1$ as a criterion, and after 260-280 s (1st storey-2nd storey) using $F_{in, CO_2} = 0.3$.

Figure 36. CO₂ measurements for Test UF-04
