Fire Performance of Houses. Phase I. Study of Unprotected Floor Assemblies in Basement Fire Scenarios Part 3

Part 3 – Results of Test UF-04 (Light-Gauge Steel C-Joists)

Research Report: IRC-RR-248

Date: March 31, 2009

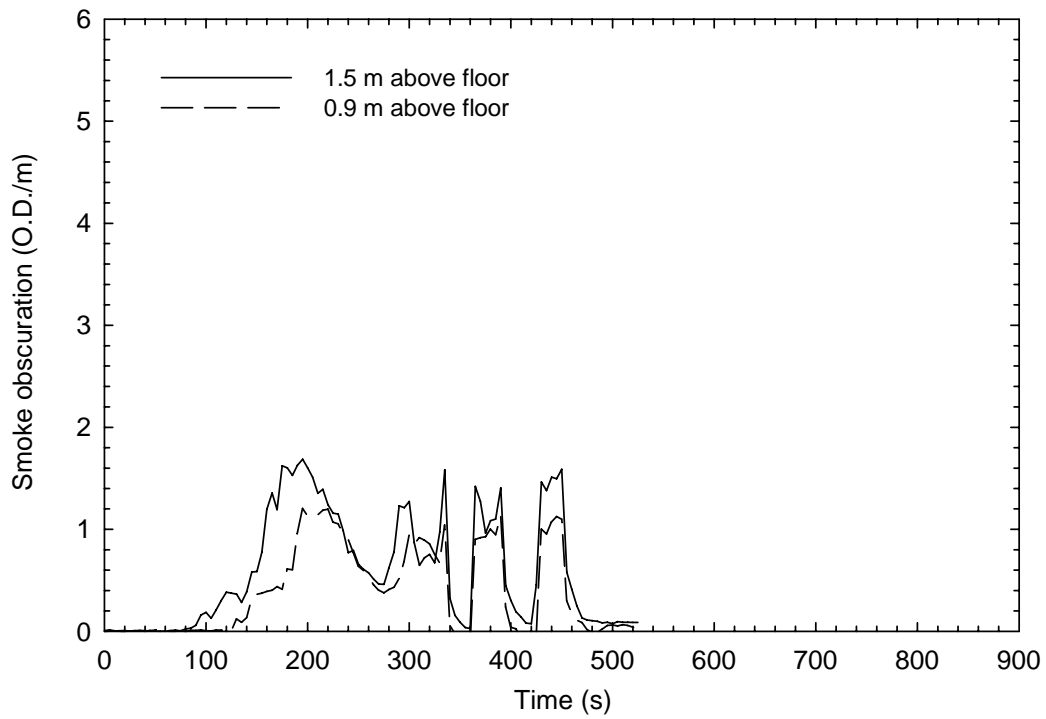
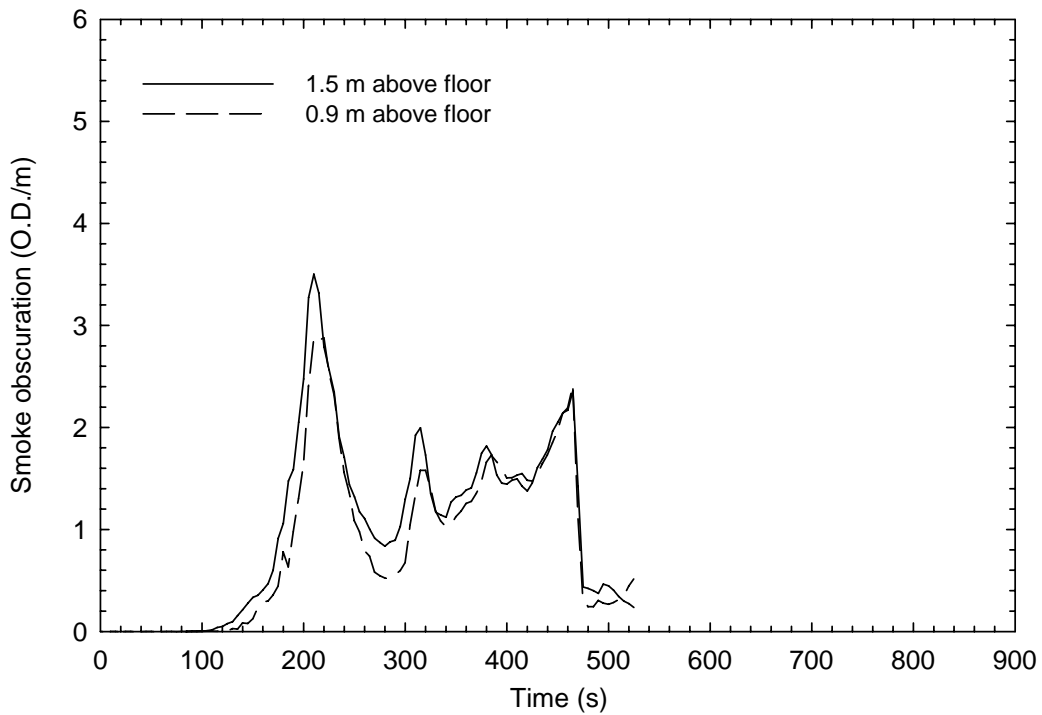
a) Smokemeters - 1st storey SW quadrant

b) Smokemeters - 2nd storey corridor

Figure 37. Optical density measurements for Test UF-04

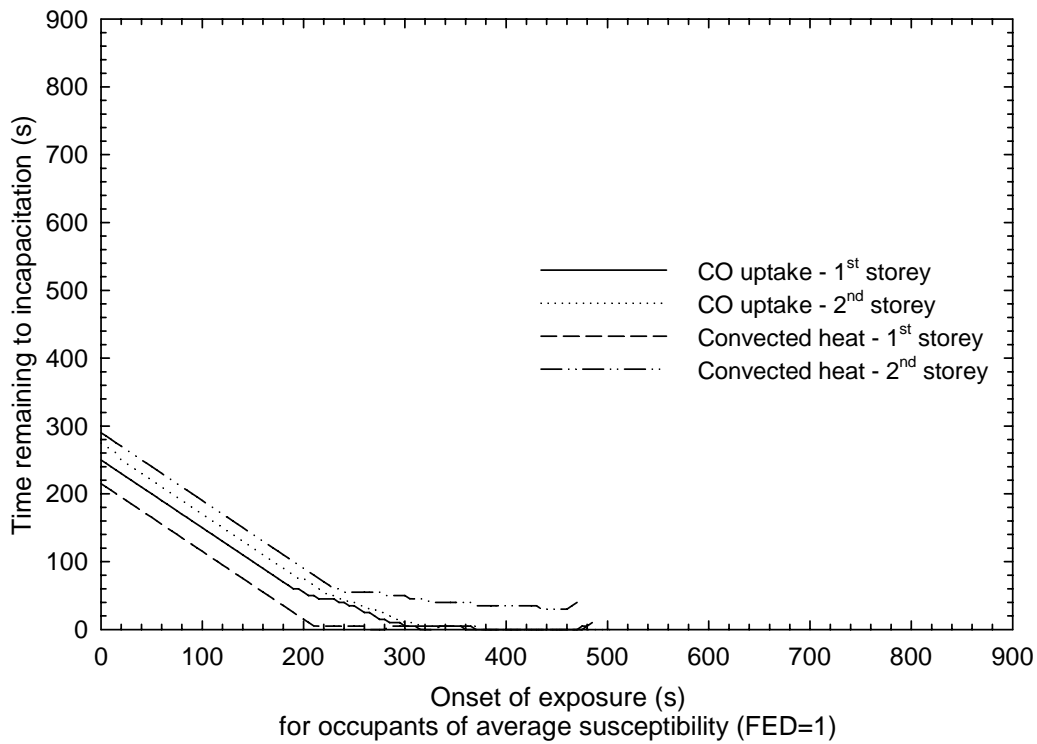
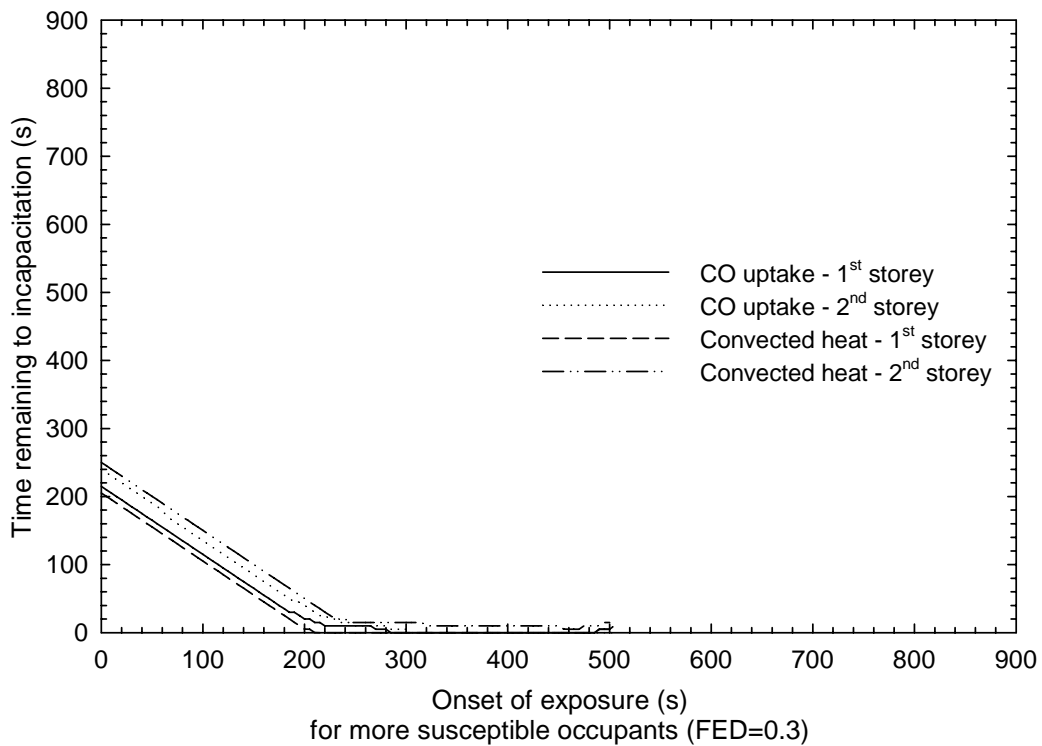
Figure 38 shows the time remaining to incapacitation calculated from the convected heat and hyperventilated CO exposure for people of average susceptibility (FED=1) and for more susceptible occupants (FED=0.3) as a function of onset of exposure. Again, this calculation was associated with particular positions where the concentrations or temperatures were measured (each calculated time applies to an occupant who would have stayed at that particular location). The actual time to incapacitation would be in between the times calculated for different locations since an occupant would have moved through different locations during egress.

Figure 38. Time remaining to incapacitation versus onset of exposure for Test UF-04 (ignition at time zero)

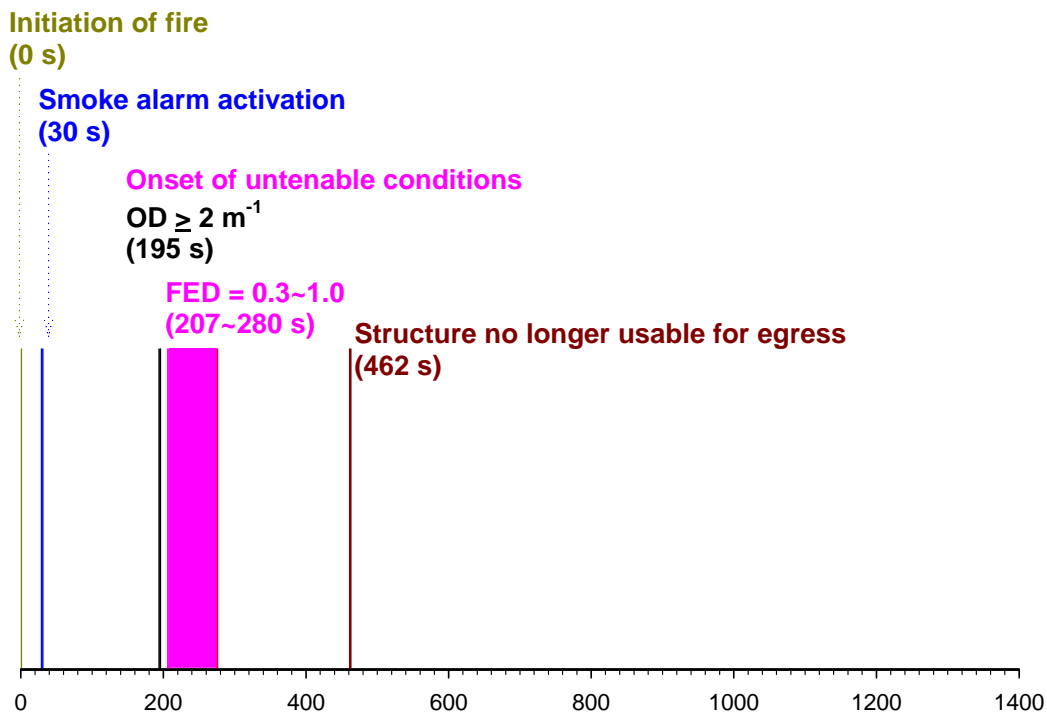
The timing for onset of potentially untenable conditions includes those for the complete smoke obscuration ($OD \geq 2 \text{ m}^{-1}$) and for exposure to heat and narcotic gases for susceptible ($FED = 0.3$) and average ($FED = 1.0$) occupants (see Section 3.7 for detailed discussions). The untenable conditions were reached before the structural failure of the floor assembly. The time after which the floor structure would be no longer usable for egress (462 s for UF-04) was based on the shortest time to reach the maximum deflection. The test was terminated after the floor failure.

Figure 39. Sequence of fire events in Test UF-04 (s)
