Fire Performance of Houses. Phase I.  
Study of Unprotected Floor Assemblies in  
Basement Fire Scenarios  
Part 6

### **Part 6 – Results of Tests UF-07 and UF-08 (Metal-Web-Connected Wood Trusses)**

Research Report: IRC-RR-251

Date: March 31, 2009

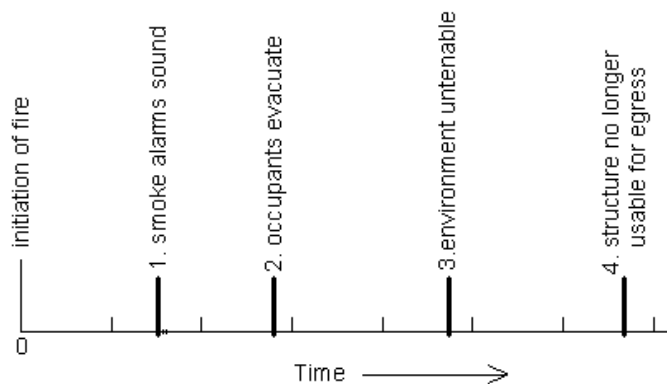
**Figure 1. Possible chronological sequence of events affecting the life safety of occupants in a fire situation**

Figure 1 shows a possible chronological sequence of relevant critical events that might occur in a fire scenario. It is acknowledged that the chronology of the occurrence of events may differ, and in some cases can shift in ordering.

Phase 1 (2004 to 2007) of the experimental study focused on basement fires and their impacts on the structural integrity of unprotected floor assemblies above a basement and the tenability conditions in a full-scale test facility. It is acknowledged that, a basement is not the most frequent site of household fires but it is the fire location that is most likely to create the greatest challenge to the structural integrity of the 1<sup>st</sup> storey structure, which typically provides the main egress routes. The study of fires originating in basements also provides a good model for the migration of combustion products throughout the house and its egress paths. The data collected during this phase of the project provided important indicators for identifying and evaluating the sequence for the occurrence of critical events shown in Figure 1.

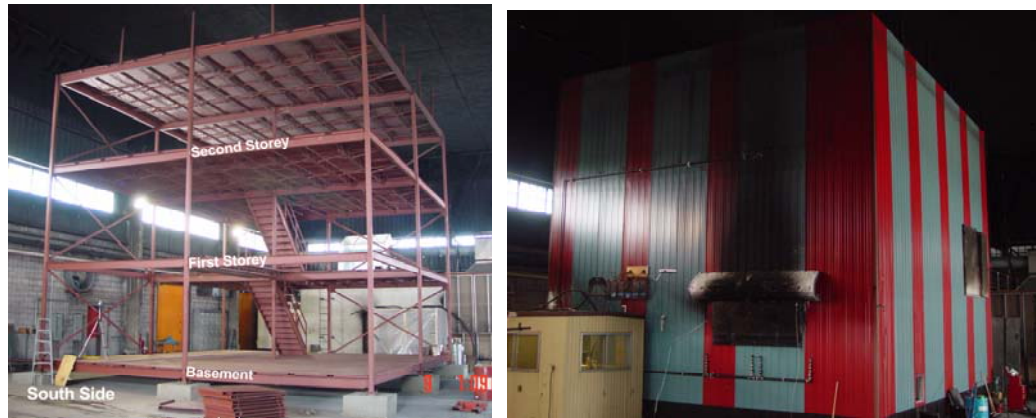
**Figure 2. Three-storey facility**

To undertake this research, NRC-IRC constructed a three-level experimental facility, representing a typical two-storey detached single-family house with a basement. The facility allows the study of structural fire performance, as well as smoke movement and tenability under fire conditions for single-family houses. The facility has a total floor area of approximately 95 m<sup>2</sup> per storey and is shown in Figure 2.

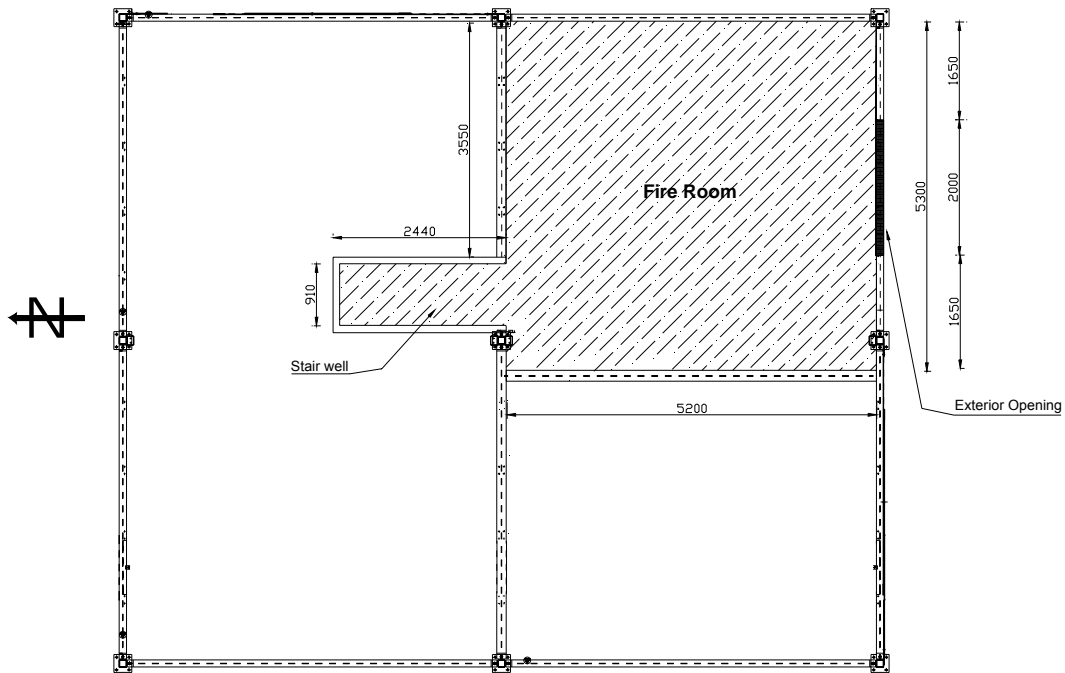
**Figure 3. Basement level layout (dimensions in mm)**

The layout of the basement is shown in Figure 3. The basement was partitioned to create a fire room representing a 27.6 m<sup>2</sup> basement living area, or about 1/4 of the total basement area. This compartment size was chosen based on a survey carried out by NRC [4]. The area of the basement that was not used for the fire compartment was blocked off during the fire tests. The height of the basement was 2.44 m. The ceiling clear height depended on the depth of the floor assembly being tested. A rectangular exterior opening measuring 2.0 m wide by 0.5 m high and located 1.8 m above the floor was provided in the south wall of the fire room. The size of the opening was chosen based on the results of the survey carried out by NRC [4]. A 0.91 m wide by 2.05 m high doorway opening located on the north wall of the fire room led into an empty stairwell enclosure (without a staircase). At the top of this stairwell, a 0.81 m wide by 2.05 m high doorway led into the first storey, as shown in Figure 4. This doorway either had no door (open basement doorway) or had a door in the closed position (closed basement doorway), depending on the scenario being studied. There is no requirement for a basement door in the NBCC. Section on “Openings and their States” provides more details.

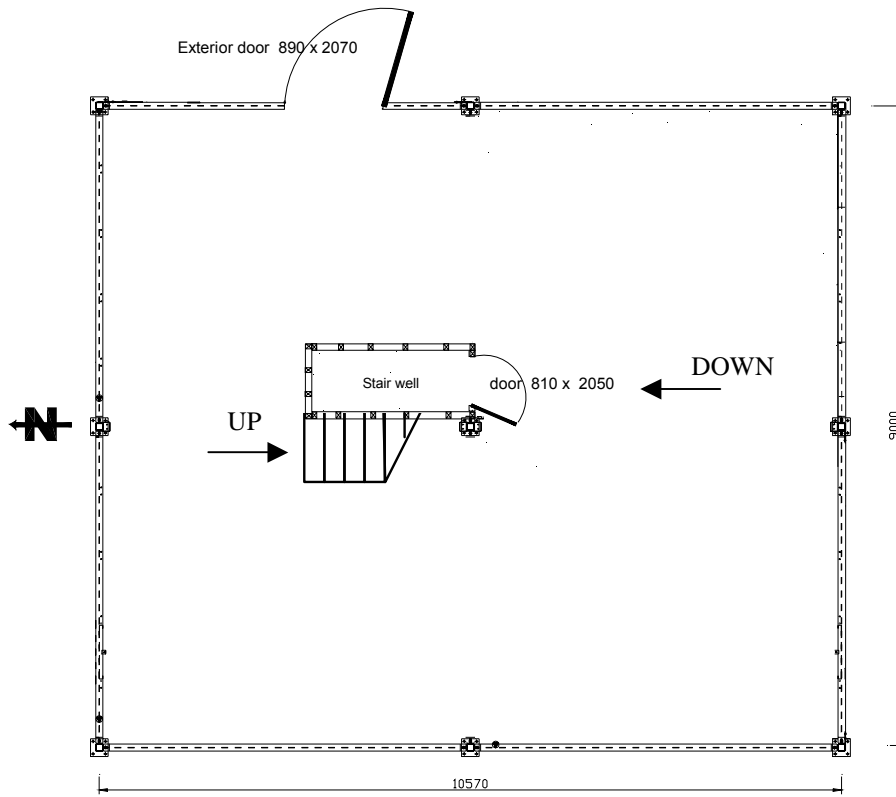
Figure 4. First storey layout (dimensions in mm)

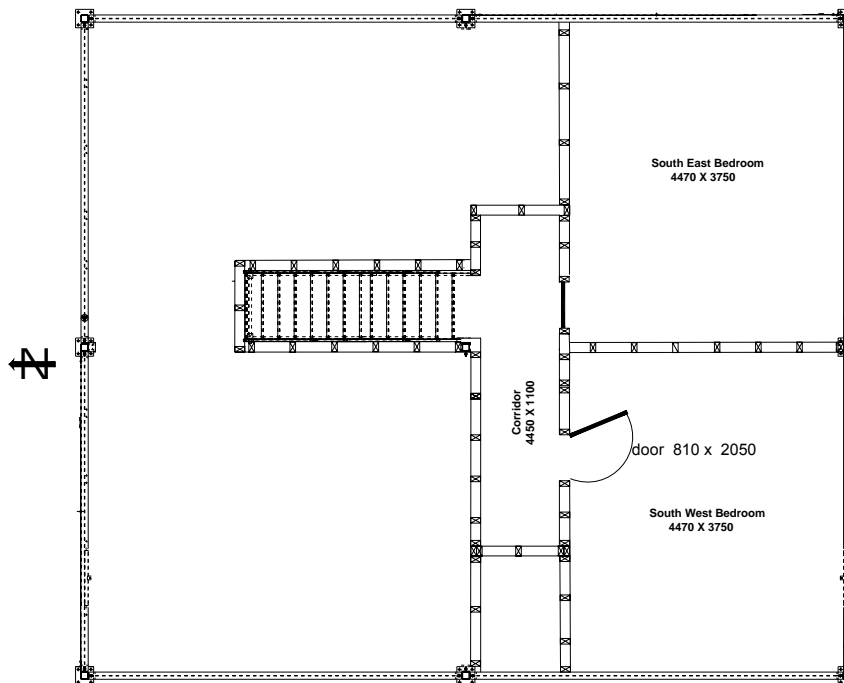
Figure 5. Second storey layout (dimensions in mm)

The layout of the second storey is shown in Figure 5. This storey was partitioned to contain two identical bedrooms with dimensions of 3.75 m by 4.47 m connected by a corridor with dimensions of 1.1 m x 4.45 m. The height of the storey was 2.44 m. In all tests, the door of the southeast bedroom remained closed whereas the door on the southwest bedroom was kept open. The size of the door openings was 0.81 m by 2.05 m. The remaining area of the second storey that was not used was blocked off during the fire tests.

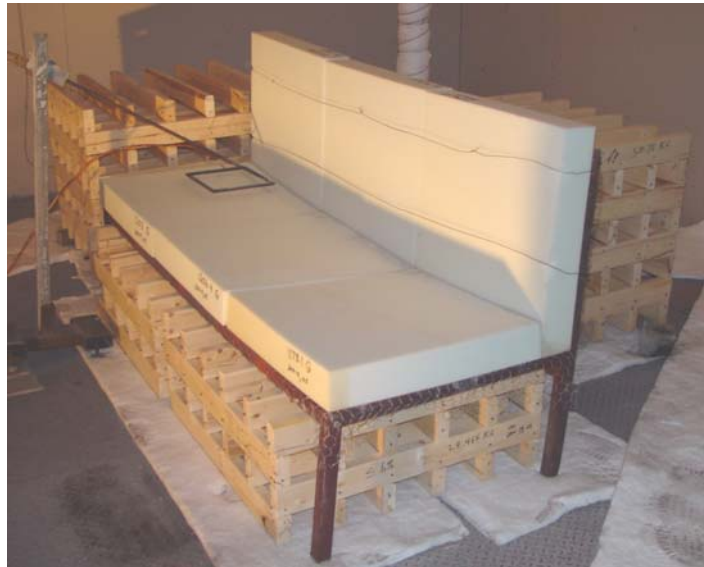
**Figure 6.** Fuel package

consisted of a mock-up sofa constructed with 9 kg of exposed polyurethane foam (PUF), the dominant combustible constituent of upholstered furniture, and 190 kg of wood cribs beside and underneath the mock-up sofa. A photograph of the fuel package is shown in Figure 6. The mock-up sofa was constructed with 6 blocks of flexible polyurethane foam (with a density of 32.8 kg/m<sup>3</sup>) placed on a metal frame. Each block was 610 mm long by 610 mm wide and 100 mm or 150 mm thick. The 150-mm thick foam blocks were used for the backrest and the 100 mm thick foam blocks for the seat cushion. The PUF foam was used without any upholstery fabric that is used in typical upholstered furniture. The wood cribs were made with spruce lumber pieces, each piece measuring 38 mm x 89 mm x 800 mm. For the small cribs located under the mock-up sofa, four layers with six pieces per layer were used. The other two cribs used eight layers.

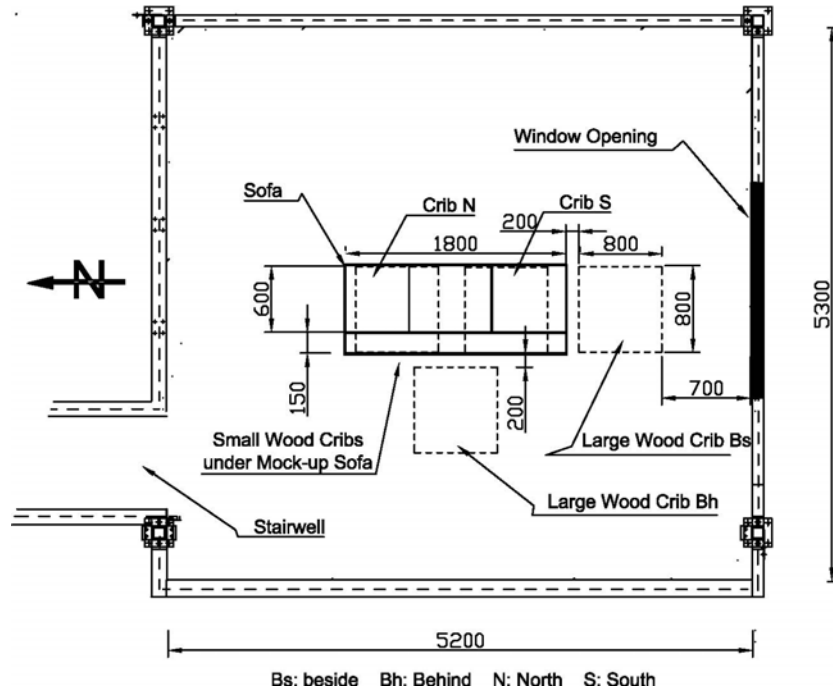
**Figure 7. Arrangement of the fuel package in the fire compartment**  
(dimensions in mm)

The placement of the fuel package in the basement fire compartment is illustrated in Figure 7. The mock-up sofa was located at the center of the floor area. The mock-up sofa was ignited in accordance with the ASTM 1537 test protocol [7] and the wood cribs provided the remaining fire load to sustain the fire for the desired period of time.

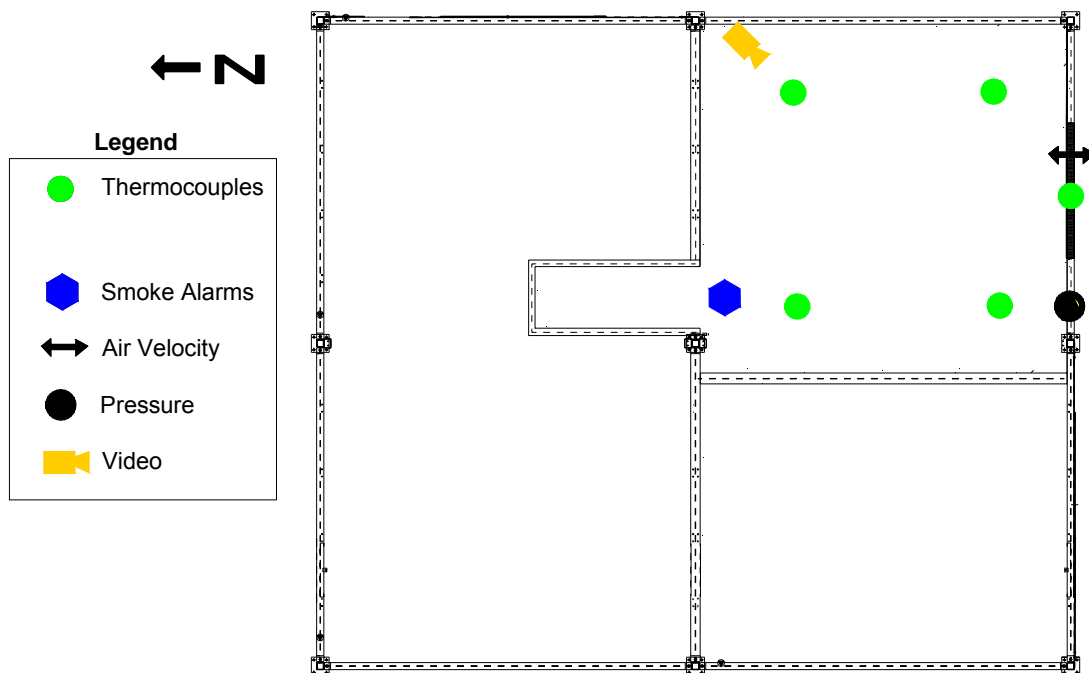
**Figure 8. Fire Compartment instrumentation**

The positioning of the instrumentation in the fire compartment on the basement level is shown in Figure 8.

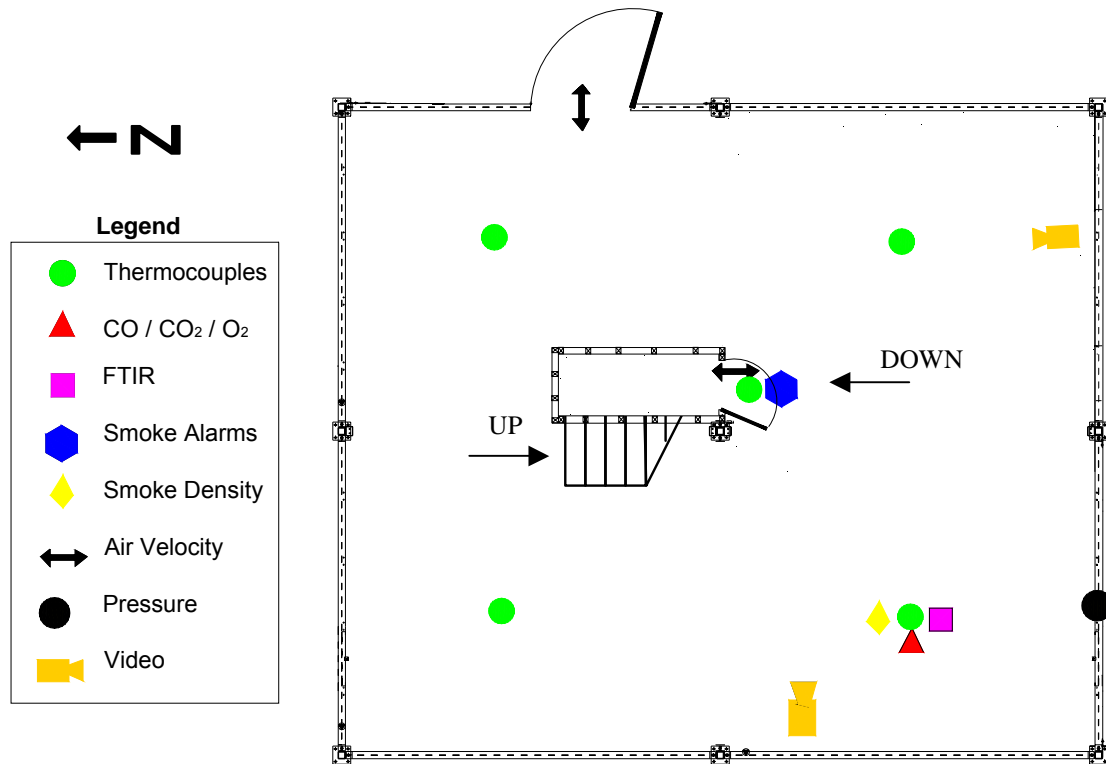
**Figure 9. First storey instrumentation**

The positioning of the instrumentation on the first storey is shown in Figure 9.

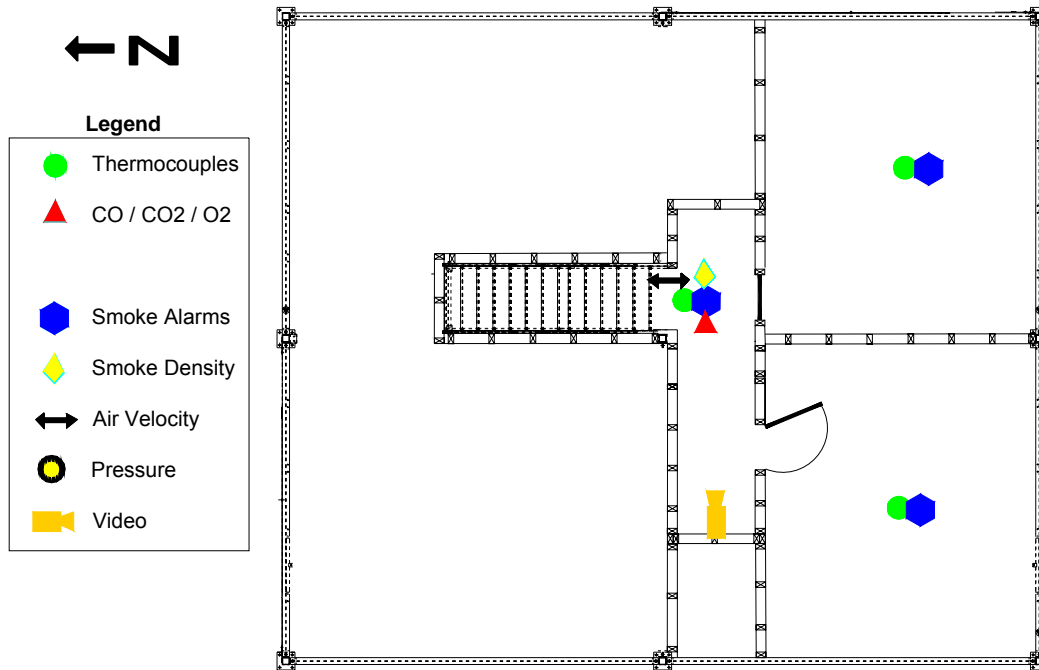
**Figure 10. Second storey instrumentation**

The positioning of the instrumentation on the second storey is shown in Figure 10.

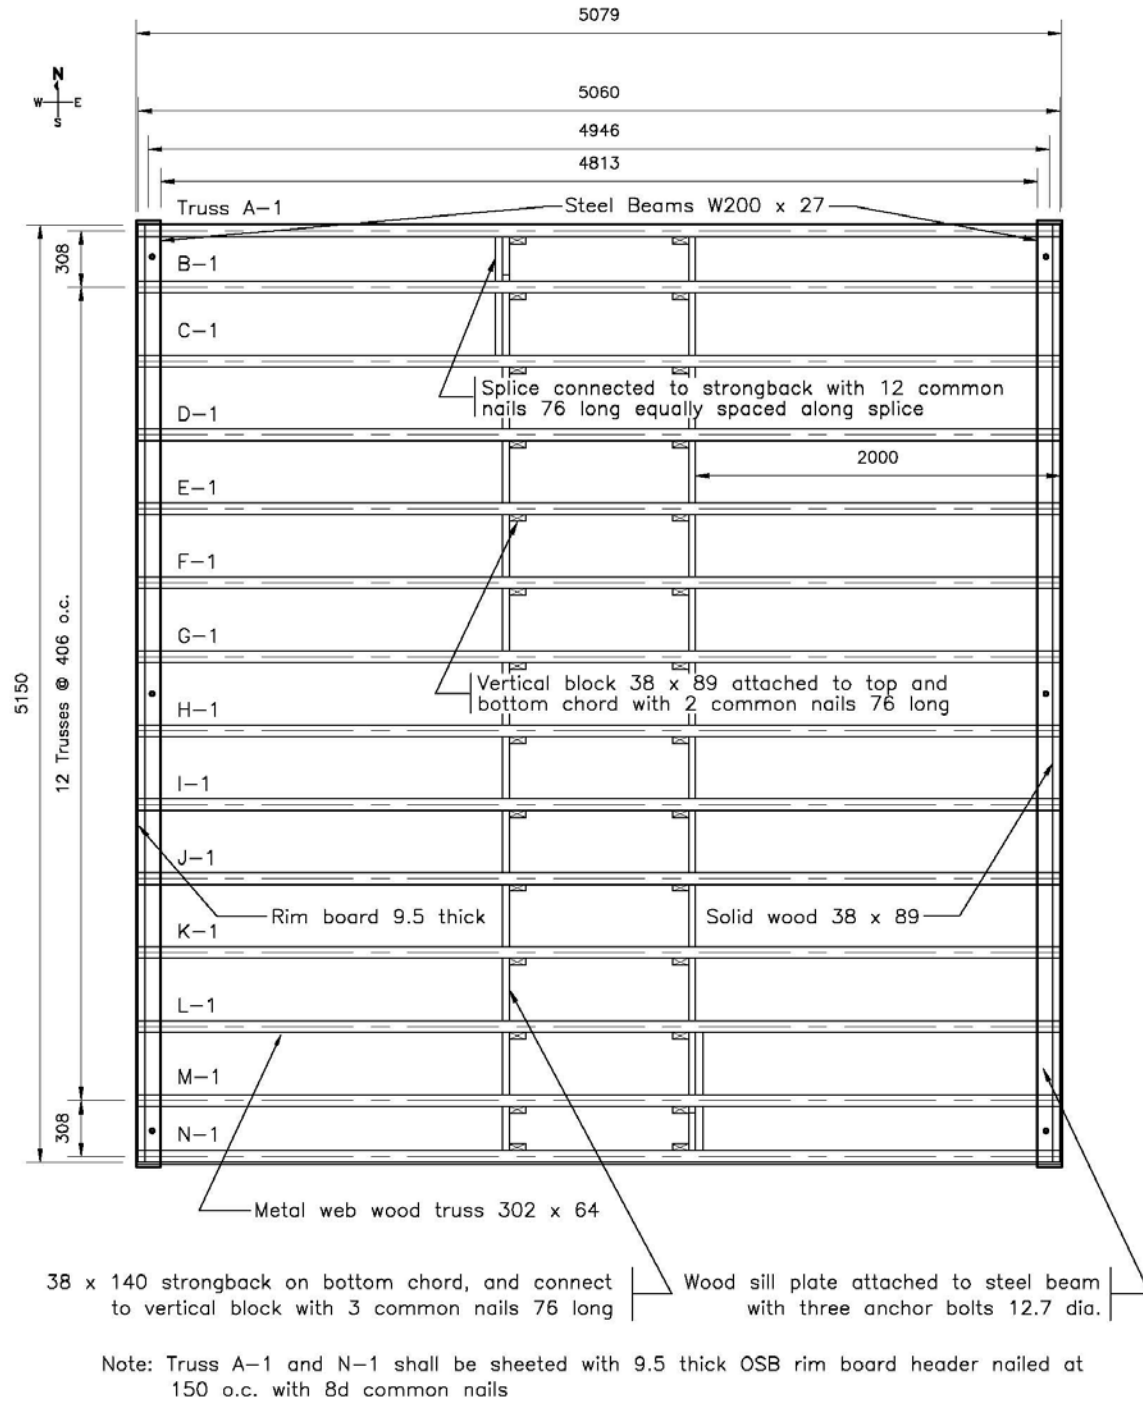
**Figure 11. Metal-Web-Connected Wood Truss layout details** (all dimensions in mm)

The metal-web-connected wood trusses were 302 mm deep, with cords of dimensions 38 mm x 64 mm. The metal webs (20 gauge) had teeth 9.5 mm long and 0.0171 teeth per square millimeter. The trusses were spaced at 400 mm on centre (see Figure 11). The bottom cords of the trusses were reinforced with 2 strongbacks 38 mm x 140 mm located toward the centre of the span (see Figure 11). Based on calculations of maximum strength and deflection, the truss span length chosen was 4.813 m (see Figure 11). This span allowed the metal-web wood trusses to extend across the entire length of the fire compartment (with no need for an intermediate support). Figure 12 shows the supporting beams.

Figure 39 shows the 9 deflection measurement points (see also Figure 11 for the truss closest to the deflection points). The points of measurement were chosen as they were located in the middle of the fire compartment just above the fire load where the impact of the fire on the structural integrity of the floor assembly was anticipated to be the greatest. Some measurement points were aligned with one of the trusses, while the other row was positioned between trusses. Figure 40 and Figure 41 show the deflections at the 9 measurement points for Tests UF-07 and UF-08.

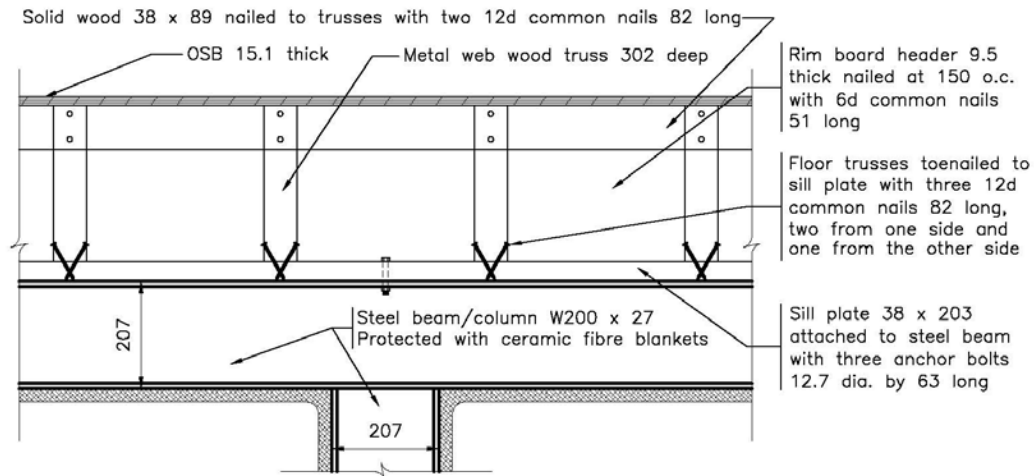
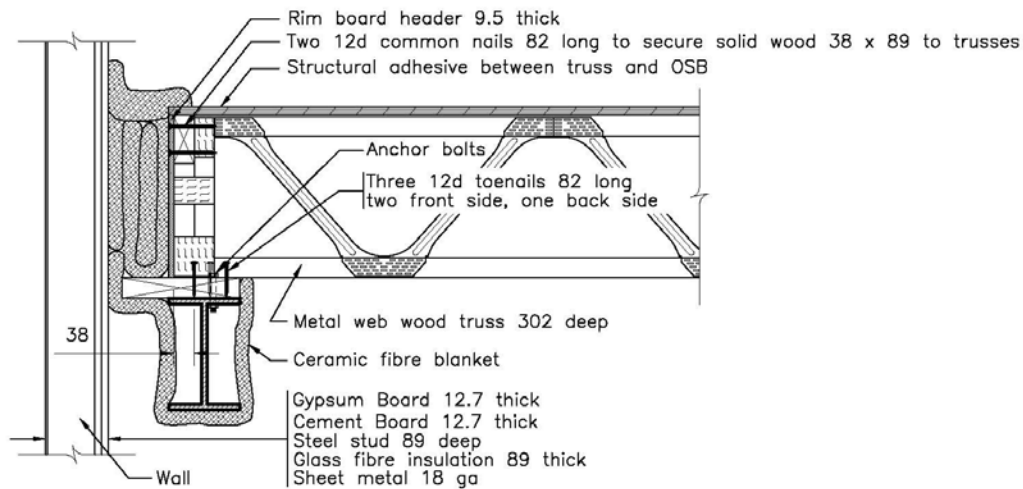
(East view)

(North view)

**Figure 12. End connection details and supports (all dimensions in mm)**

Each metal-web wood truss floor assembly was supported by two horizontal beams, each of which was supported by two columns (a total of four columns for each assembly) as illustrated in Figure 12. The beams were bolted to the columns, which were stiffened by bars and rested stably on the floor under the weight of the assembly and beams.

Figure 12 also shows the details of the end connection. Ceramic fibre blankets were used to fill any gaps between the assembly and the end walls. Ceramic fibre blankets were also used to protect the steel beams and columns so that they were not subjected to fire and would not fail during the tests.

solid wood 38 mm x 89 mm was added at the top ends of the trusses to provide lateral support, see Figure 11 and Figure 12.

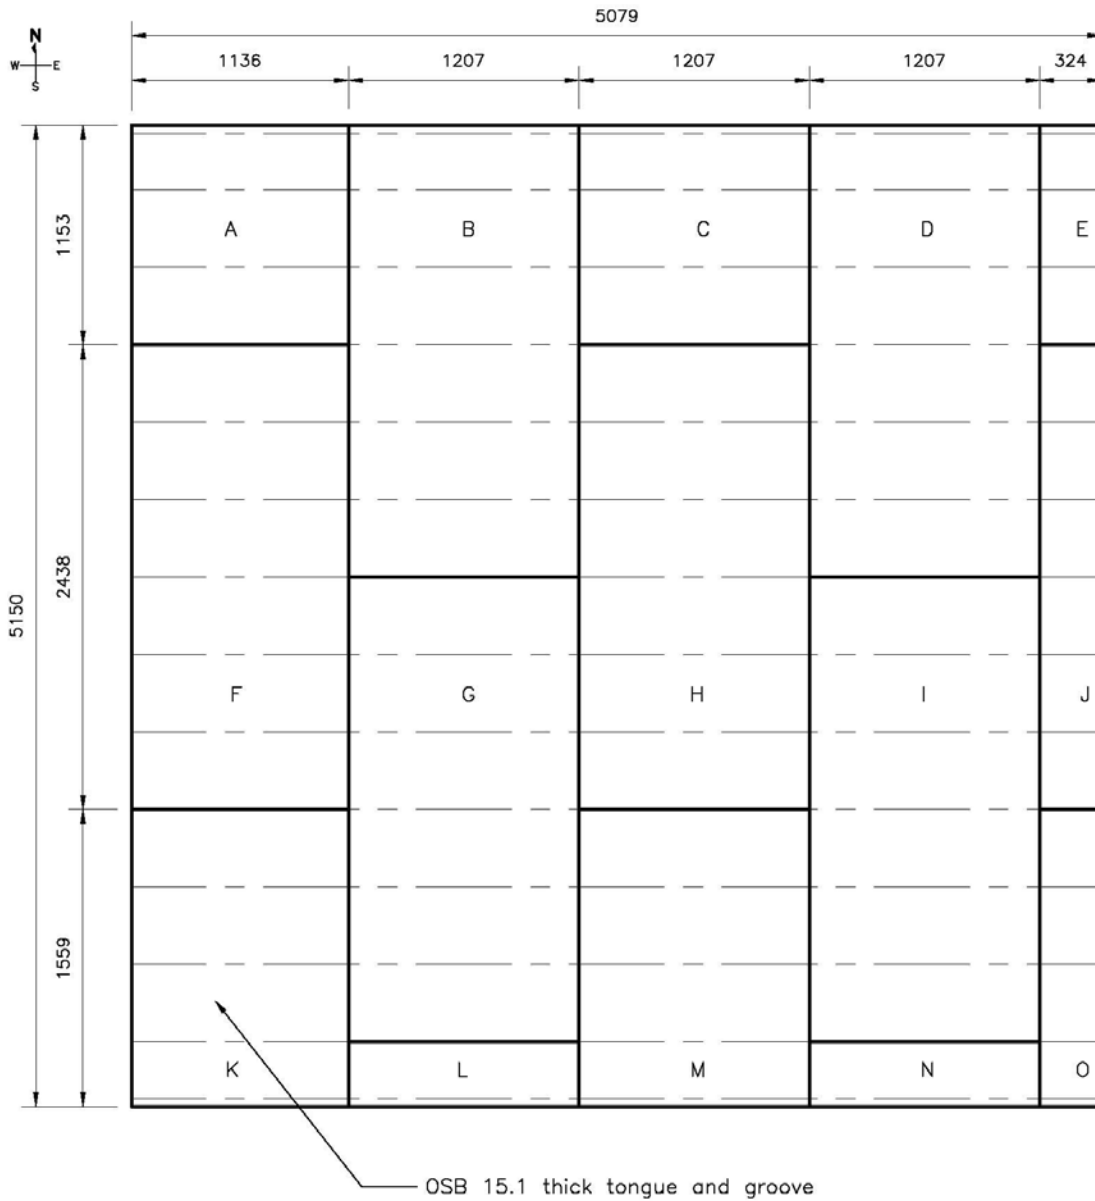
**Figure 13. Subfloor layout details** (all dimensions in mm)

OSB was used as the subfloor material in the floor assemblies. The specific OSB material used was selected based on a separate study documented in reference [5]. The subfloor panels were 15.1 mm thick in both assemblies, with a full panel size being 1.2 x 2.4 m. The longer panel edges had a tongue and groove profile while the short panel edges were square-butt ends. Figure 13 shows the layout of the subfloor. The screw pattern and description of screws used to attach the OSB panels to the metal-web wood trusses are shown in Figure 14.

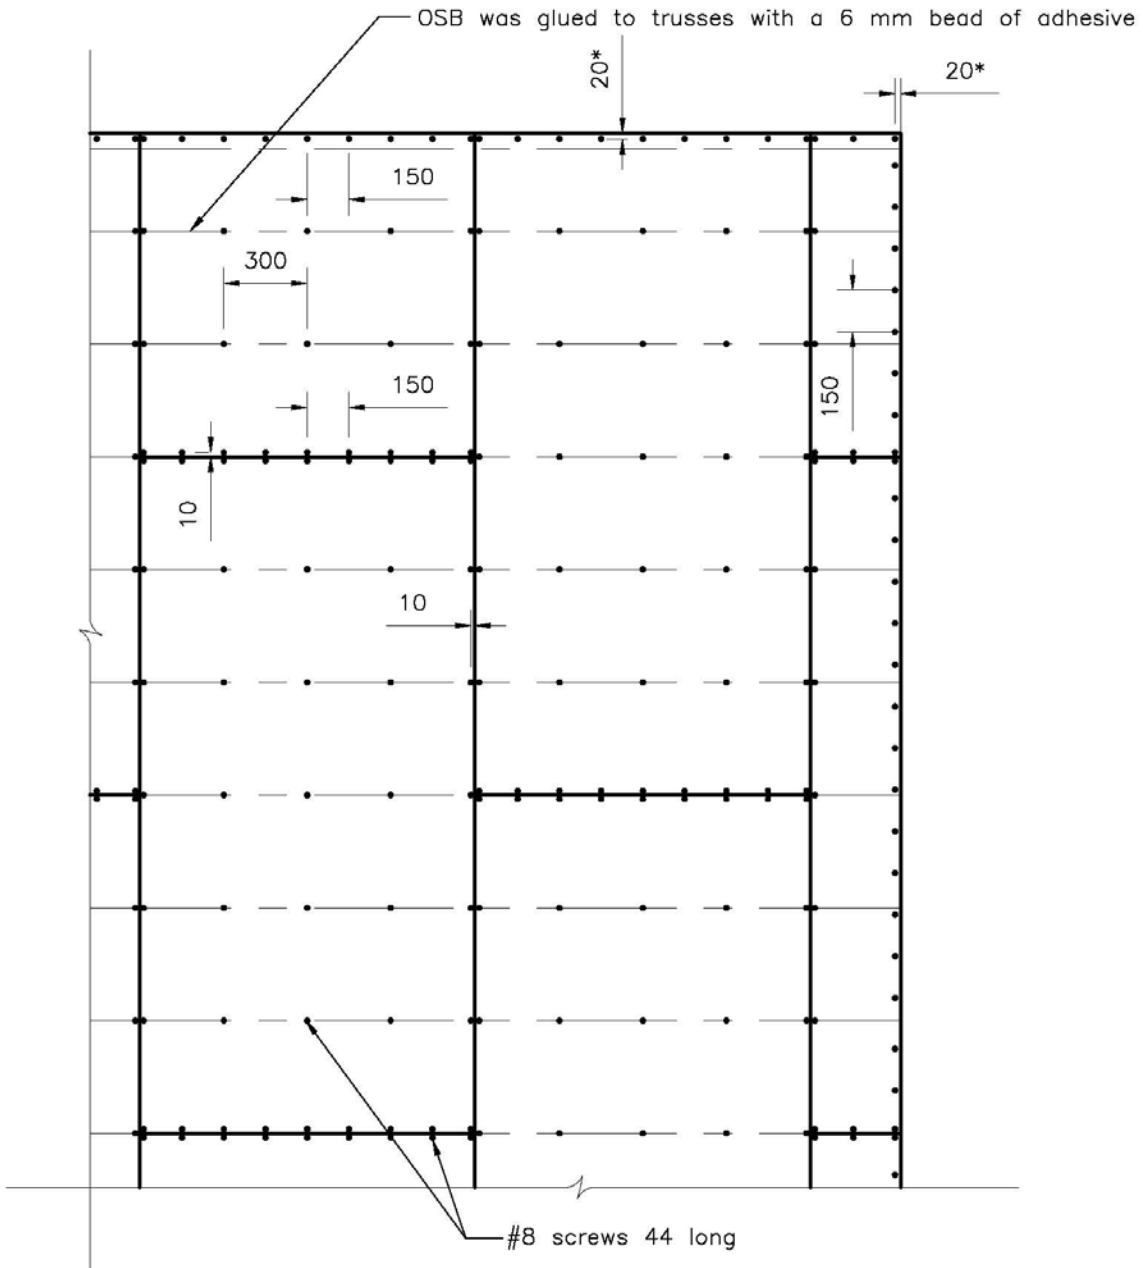
- Note: – OSB should be fully secured within 10 minutes of applying adhesive or sooner, if required by the subfloor adhesive manufacturer.  
 – Two 6 mm bead of adhesive shall be used at abutting panel edges.  
 \* 20 mm from edges to allow screws to be secured to the trusses due to the 9.5 mm thick rim board around the perimeter of the assembly.

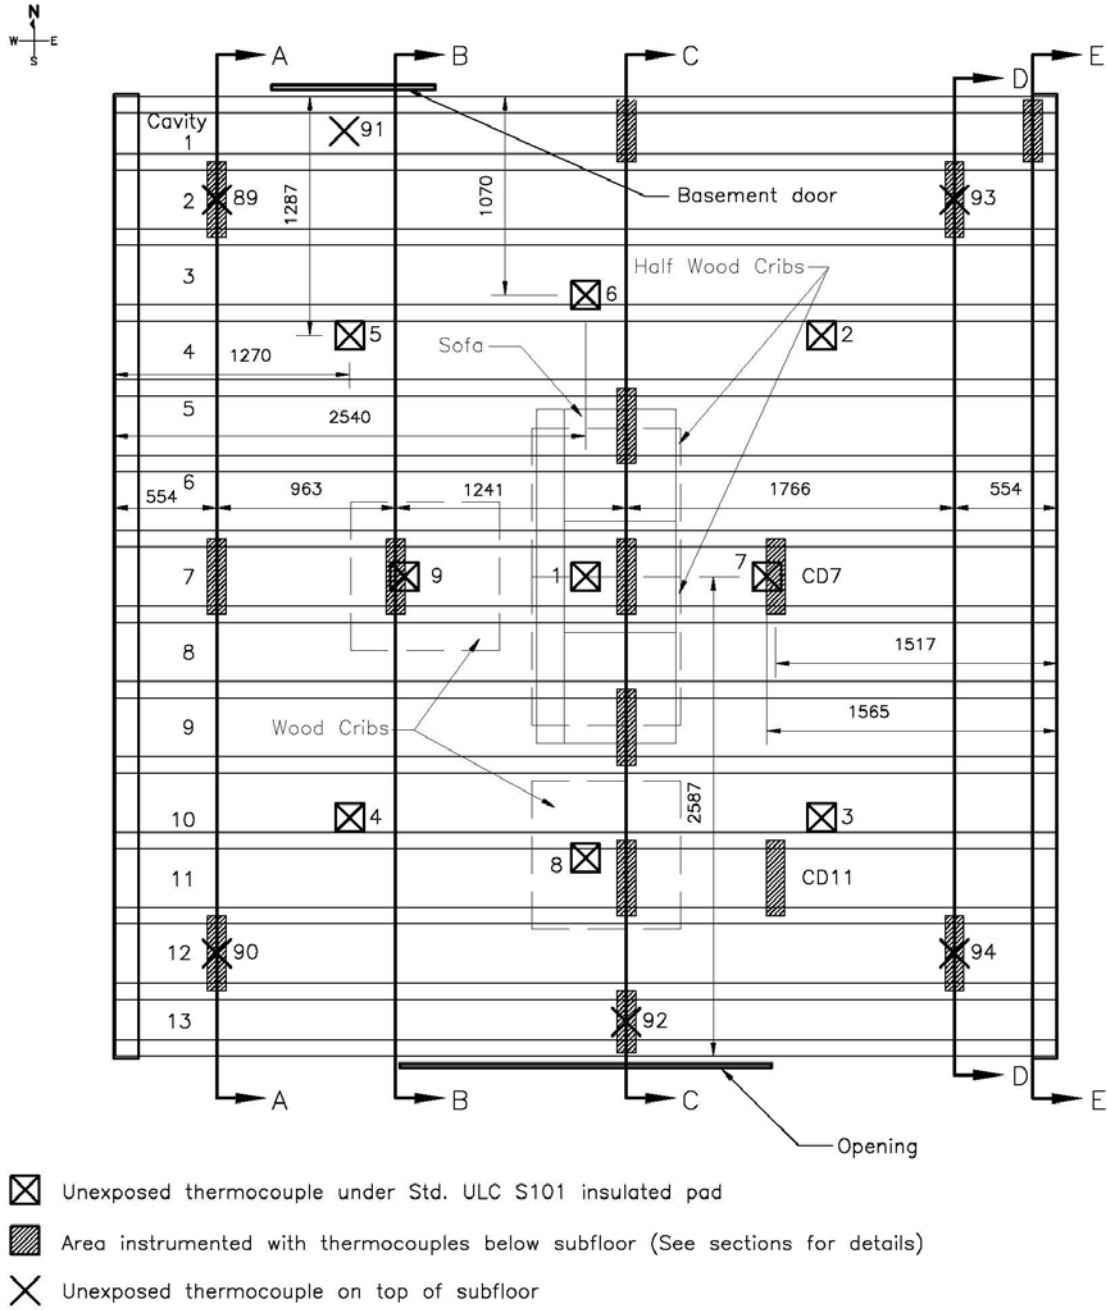
**Figure 15. Thermocouples locations (all dimensions in mm)**

One hundred and eight Type K (20 gauge) chromel-alumel thermocouples, with a thickness of 0.91 mm, were used for measuring temperatures at a number of locations throughout each assembly. The thermocouple locations on the unexposed and exposed sides of the assemblies are shown in Figure 15 and Figure 16. These locations were chosen to monitor the conditions of the assembly at critical locations during the fire tests.

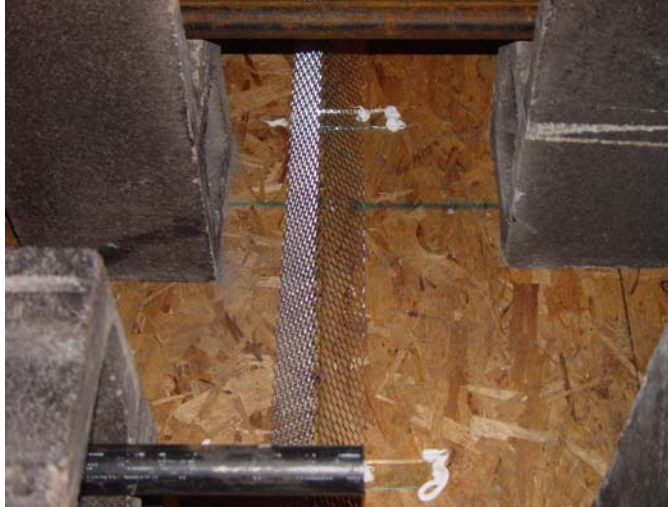
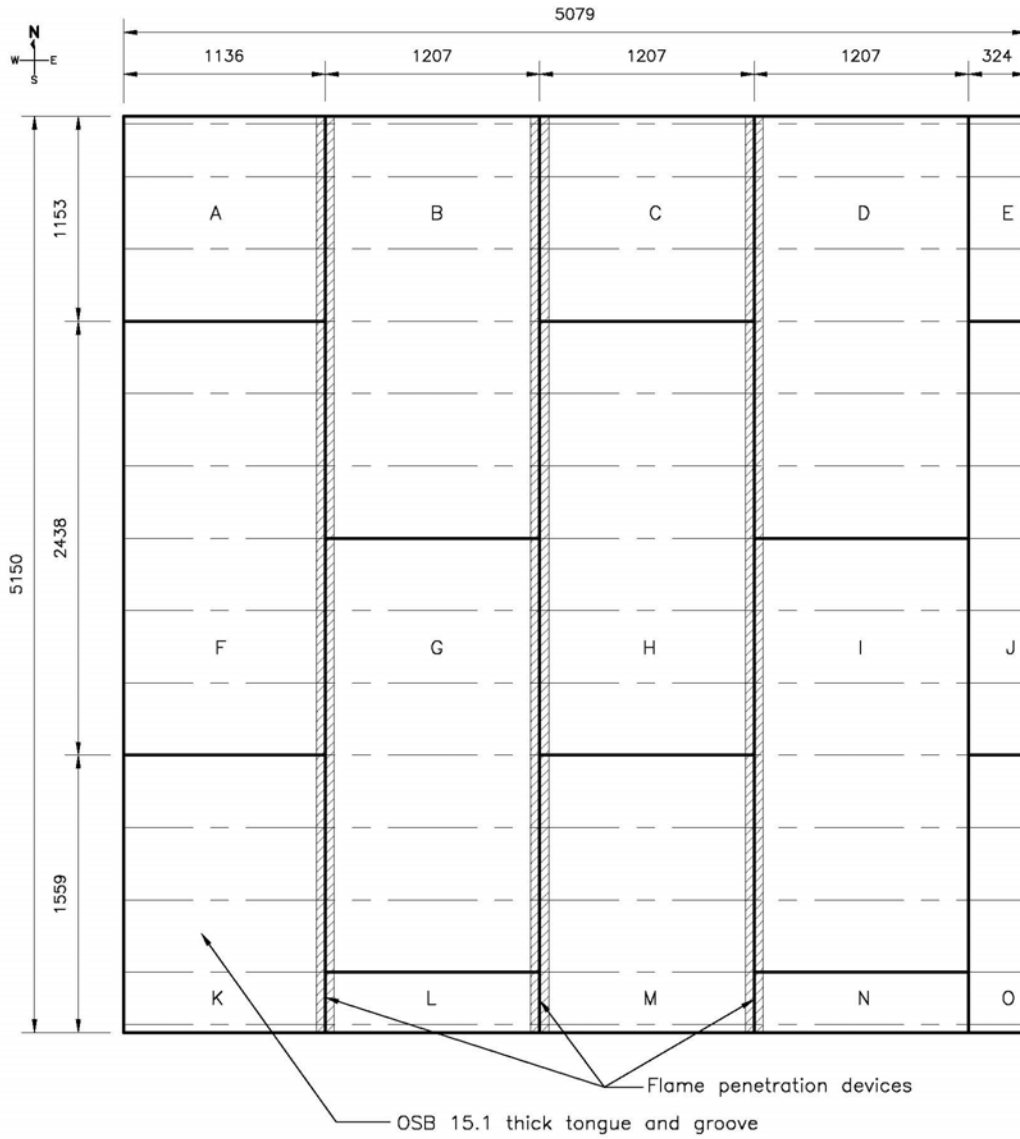
**Figure 17. Wire mesh device to detect flame penetration** (all dimensions in mm)

Flame penetration through the floor assembly is considered to be an initial indicator of the impending failure of the assembly. A device was developed and used for the tests to better determine the time for flames to penetrate the floor. The special device consisted of a wire mesh placed at 3 locations on the unexposed surface of the floor assembly, specifically at three of the tongue and groove joints, as shown in Figure 17. A detailed description of the device is provided in reference [8].

Figure 42 shows the results of the flame-sensing devices. Three wire meshes were installed on the top of three joints (East, Centre and West) on the unexposed side of the floor as shown in Figure 17 (instrumentation figure). There was a sudden increase in the voltage output of the flame-sensing device when flames penetrated through the floor and struck the wire meshes. As indicated by Figure 42, flame penetration occurred at the Centre Joint at 320 s, which was very close to the failure of the floor assembly.

Figure 43 shows the results from the three flame-sensing devices, which were installed on the top of three joints (East, Centre and West) on the unexposed side of the floor as shown in Figure 17 (instrumentation figure). There was an increase in the voltage output of the device when flames penetrating through the floor struck the device. As indicated by Figure 43, the flames penetrated at all joints at 470 s, which was very close to the failure of the floor assembly.

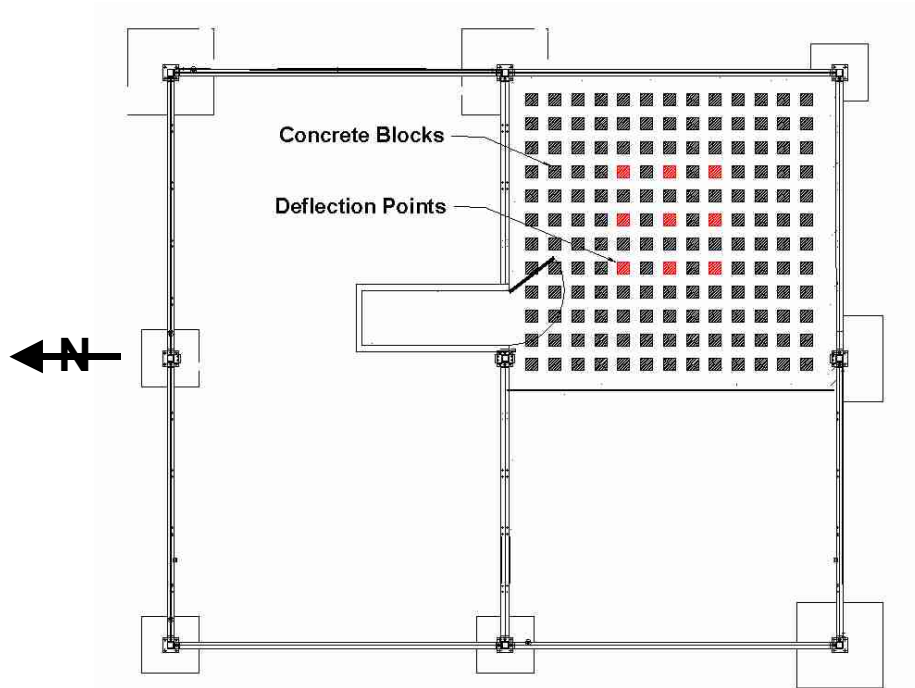
**Figure 18. Loading blocks and locations of the deflection measurement points on the unexposed side of the floor**

The floor deflection was measured at 9 points. The measurement technique utilized 9 rods that were touching the tops of 9 concrete blocks placed on the unexposed surface of the floor assembly at the locations shown in Figure 18. This ensured that the downward movement of the subfloor was monitored during the fire exposure. The deflections were recorded using the electro-mechanical method described in reference [9].

The loading method consisted of 144 concrete blocks (totalling 2490 kg) distributed uniformly on the floor as shown in Figure 18. The blocks were 190 x 190 x 390 mm (nominal 8" x 8" x 16") and weighed 17.3 kg each. To prevent the blocks from falling into the basement and causing any damage, a restraining system was designed using a series of pipes attached to beams on both ends, which were secured to the steel frame of the 3-storey house, as shown in Figure 19. The pipes were inserted through the hollow cores of the concrete blocks prior to the fire tests. The weight of the pipes was included in the total imposed load.

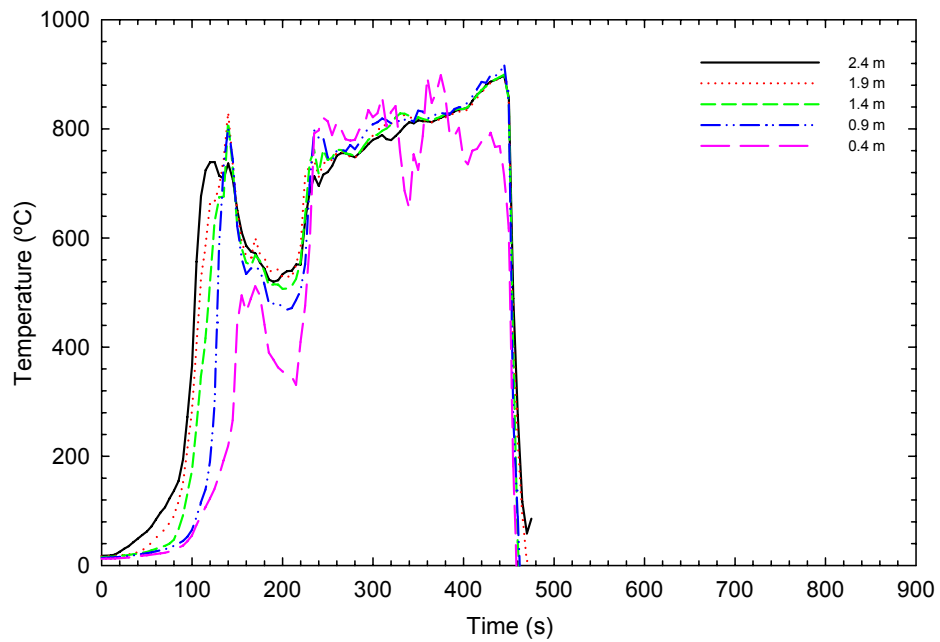
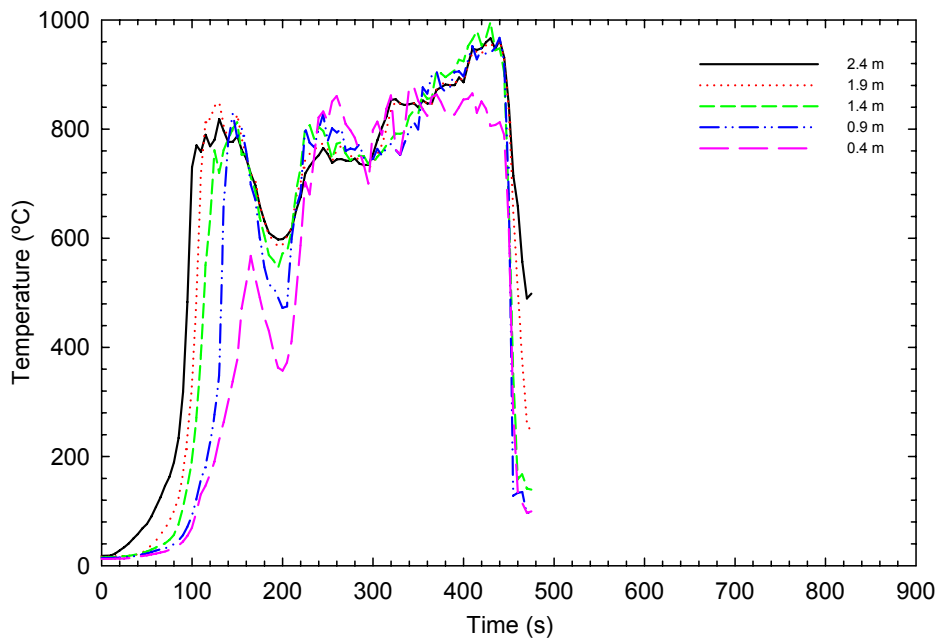
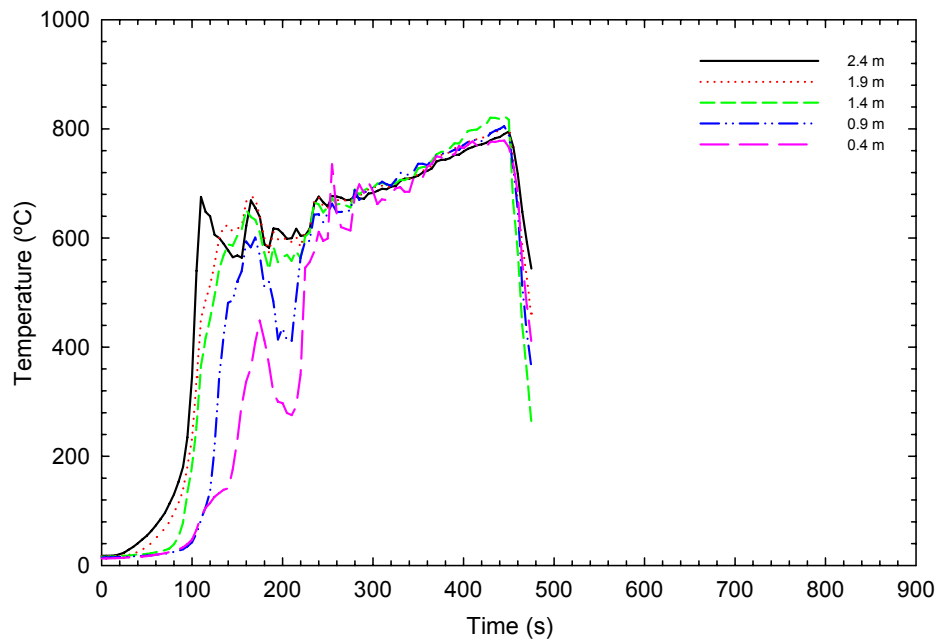
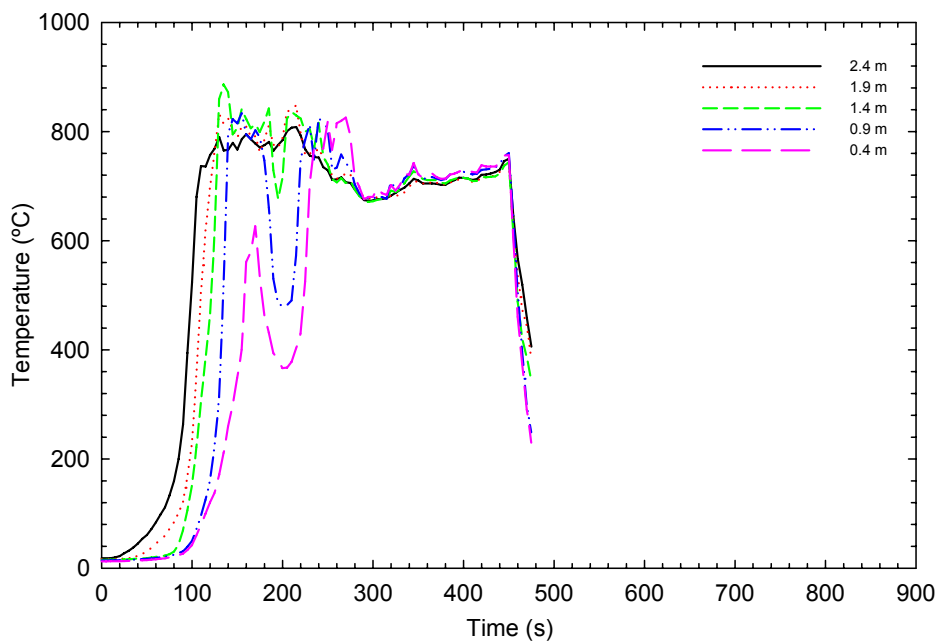
Figure 20 (a and b). TC Trees in the basement for Test UF-07

In Test UF-07 (open basement doorway, Figure 20), the temperatures rose to a maximum of 700 to 800°C in the first 100 to 130 s. The initial peak temperature was likely due to the high rate of heat release from the mock-up sofa near its peak burning rate. As shown in the figure, the initial temperature rise was faster at the 2.4 and 1.9 m heights than the other heights because the hot smoke layer formed first at the ceiling and flames also impinged on the ceiling. Just after the maximum temperature was reached, there was a slight decrease in temperatures likely due to the combined effect of opening the basement window at 95 s and the fact that a significant portion of the polyurethane foam component of the fuel package had been consumed. The temperatures decreased further after the exterior door on the first storey was opened, which created a movement of air and smoke between the basement and first storey. The fresh air coming from the basement window increased combustion of the wood cribs and the exposed floor assembly, which caused the temperatures to increase steadily again, reaching a maximum temperature of about 850 to 900°C in the SE and SW quadrants. It should be noted that the temperatures (due to the mock-up sofa burning) were lower at the location of the NE thermocouple tree. This may be partially attributed to the fact that the NE corner was less impacted by the fire, as it was farthest away from the fire source and that most of the hot gases were moving to the upper storeys through the SE to NW path.

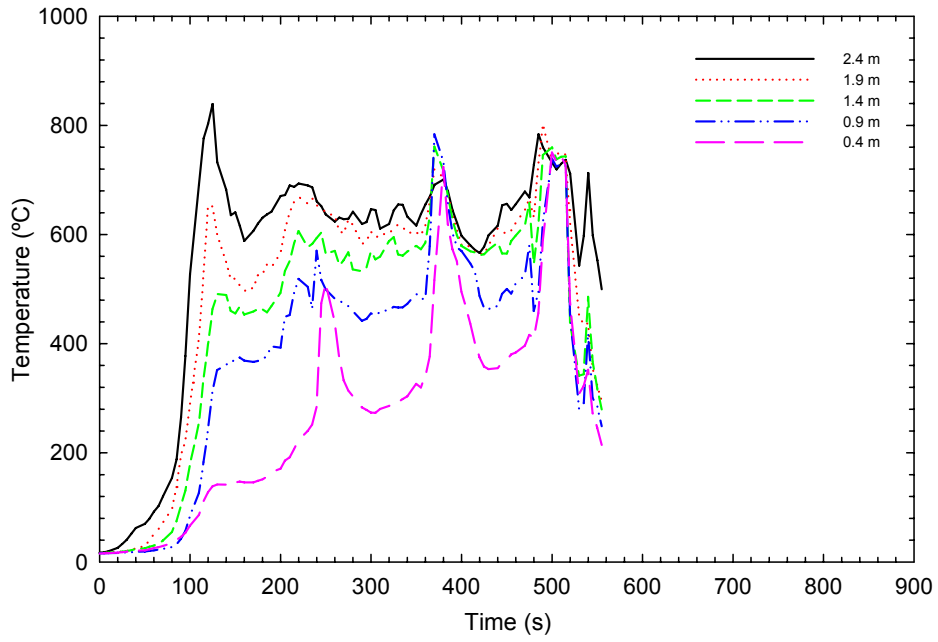
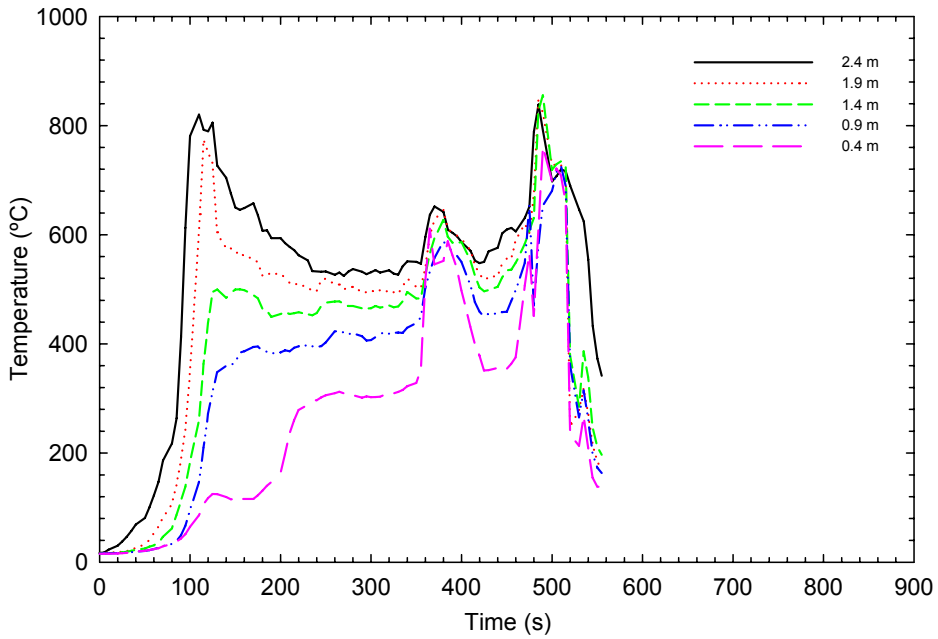
a) Basement SE quadrant

b) Basement SW quadrant

**Figure 21 (a and b). TC Trees in the basement for Test UF-08**
