Fire Performance of Houses. Phase I.  
Study of Unprotected Floor Assemblies in  
Basement Fire Scenarios  
Part 6

### **Part 6 – Results of Tests UF-07 and UF-08 (Metal-Web-Connected Wood Trusses)**

Research Report: IRC-RR-251

Date: March 31, 2009

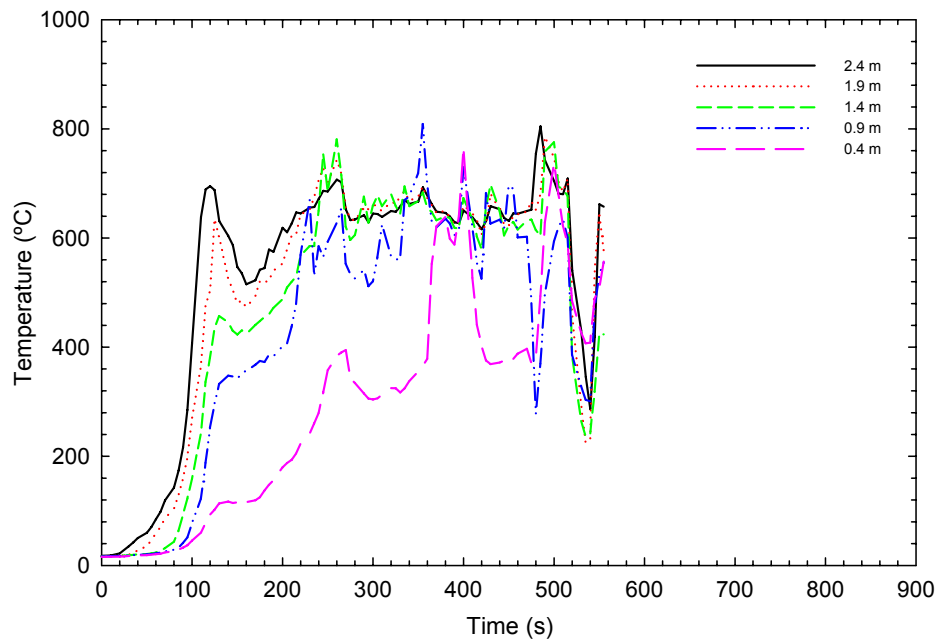
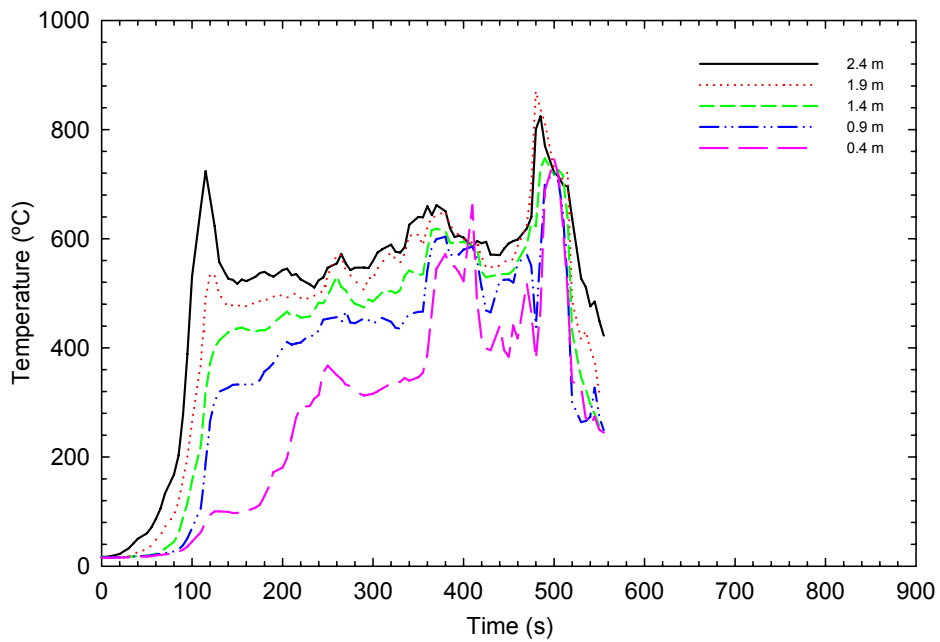
c) Basement NE quadrant

d) Basement NW quadrant

Figure 21 (c and d). TC Trees in the basement for Test UF-08

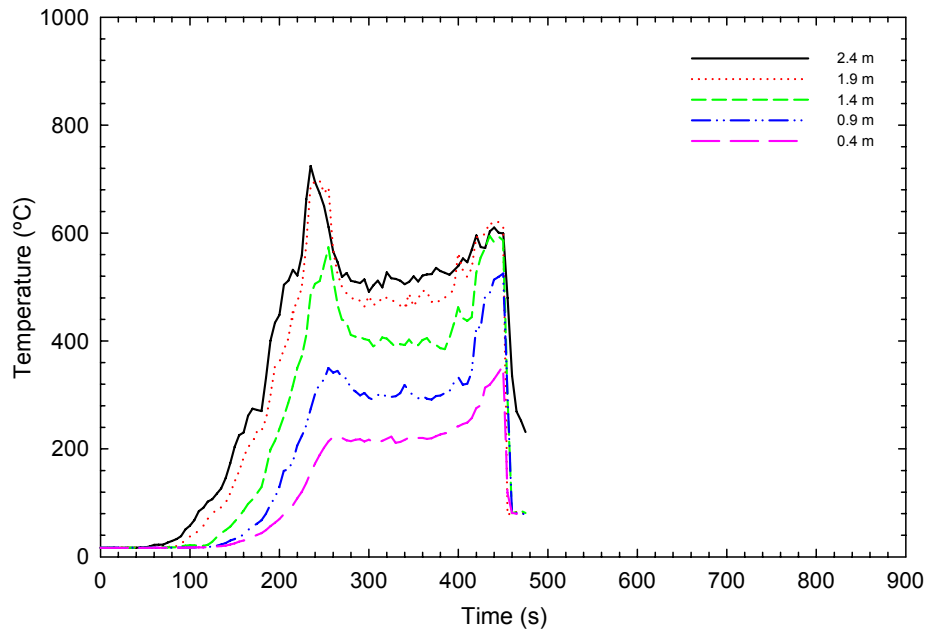
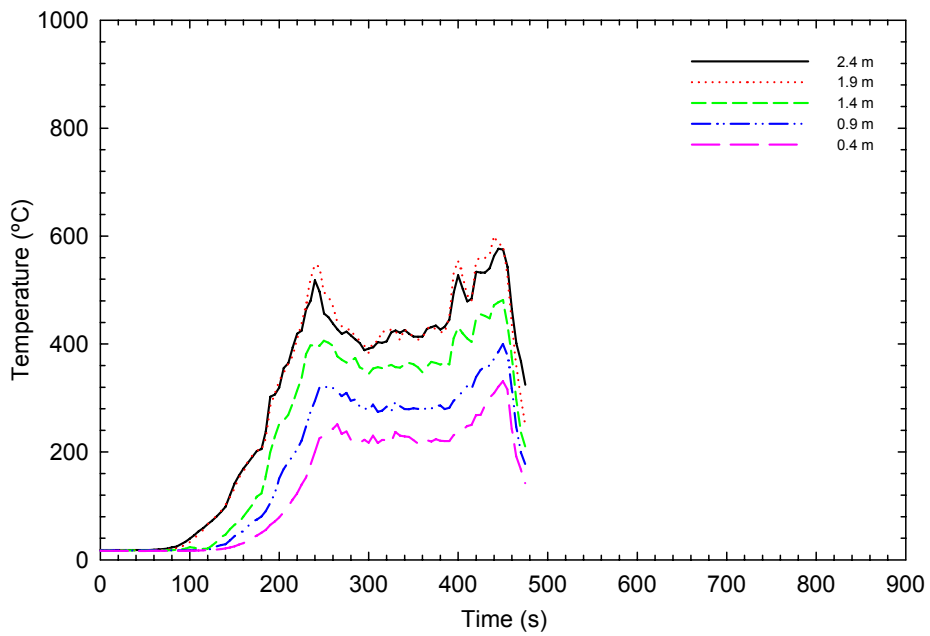
a) 1st Storey SE quadrant

b) 1st Storey SW quadrant

Figure 22 (a and b). TC trees in the first storey for Test UF-07

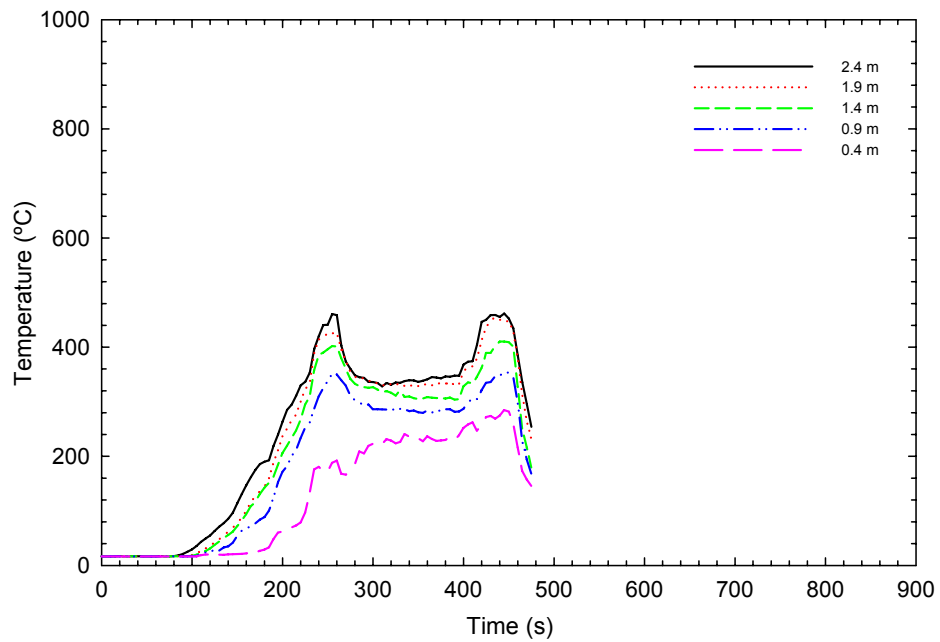
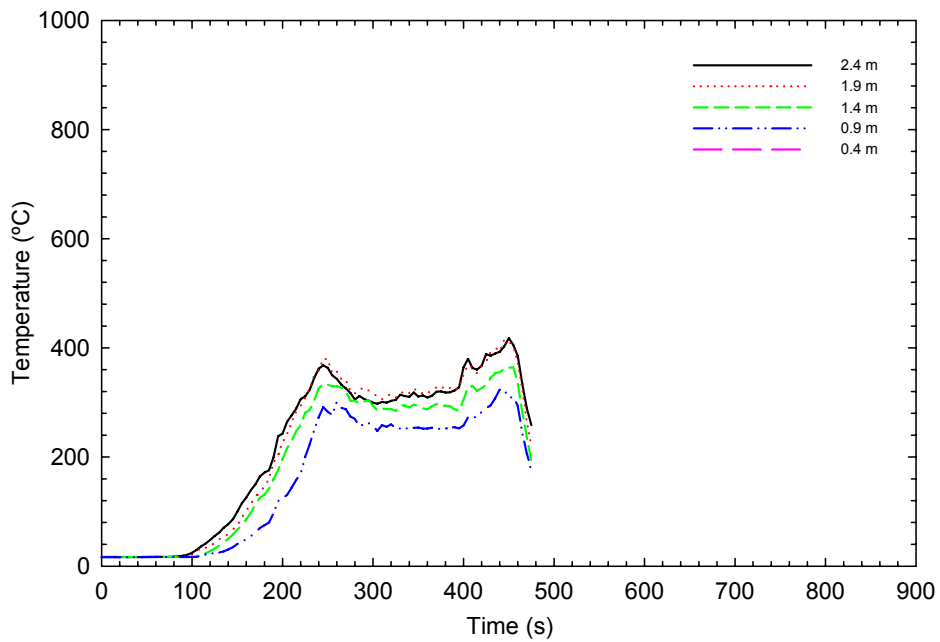
c) 1st Storey NE quadrant

d) 1st Storey NW quadrant

Figure 22 (c and d). TC trees in the first storey for Test UF-07

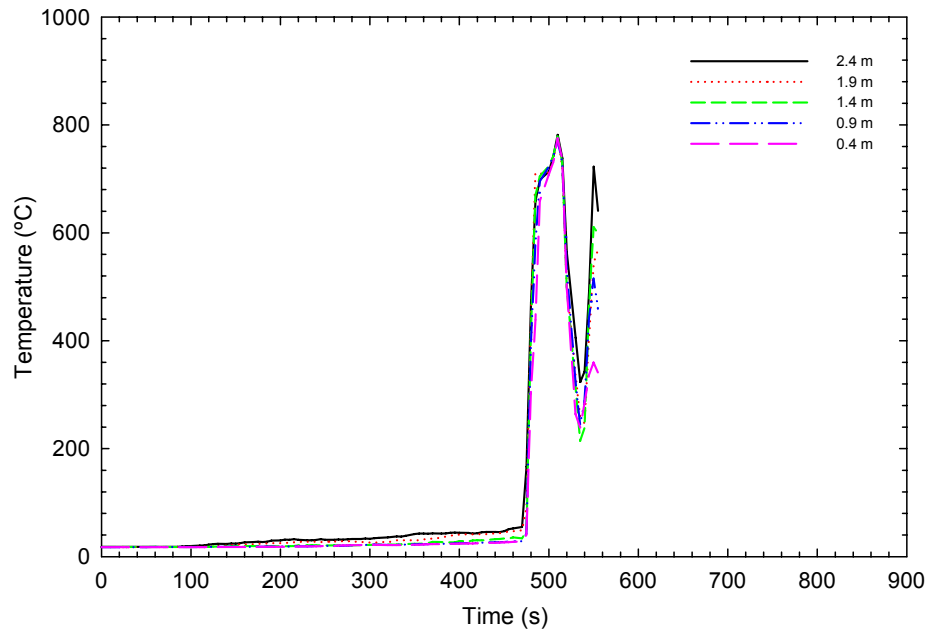
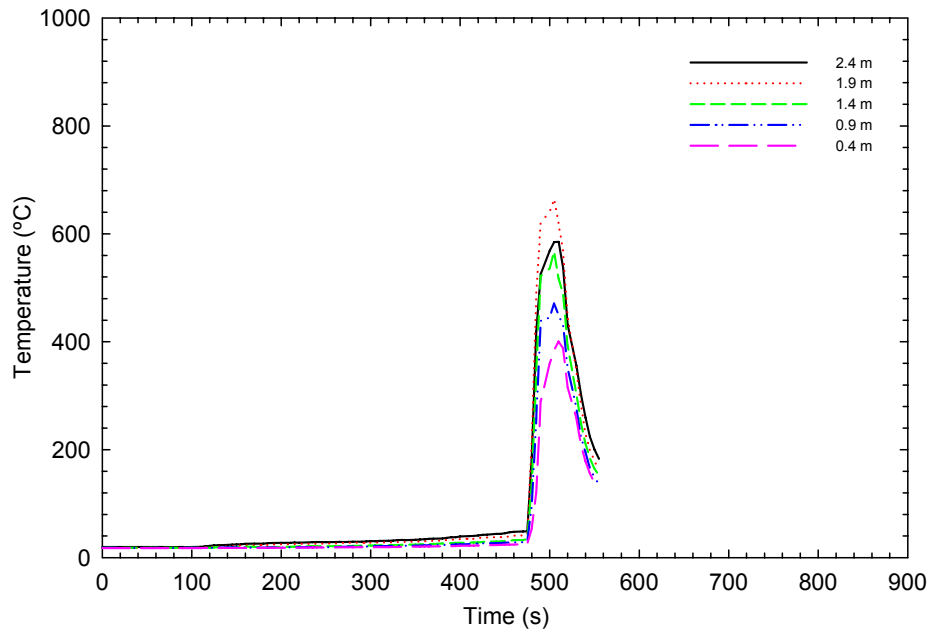
a) 1st Storey SE quadrant

b) 1st Storey SW quadrant

Figure 23 (a and b). TC trees in the first storey for Test UF-08

In Test UF-08 (closed basement doorway, Figure 23), the temperatures increased very slowly mainly because the doorway to the basement was closed. The migration of the hot gases and smoke to the first storey did not start until late in the test when openings started forming in the floor or the door to the basement started burning. Before 460 s, the temperatures measured at the thermocouple tree locations were low and comparable. Near the end of the test, there was a sharp increase in temperatures at the thermocouple tree locations. The test was terminated after the collapse of the floor assembly at 474 s; consequently the temperatures started decaying.

The temperatures recorded on the first storey for Test UF-08 were much lower before flame penetration occurred than those recorded in Test UF-07. After flame penetration, temperatures in Test UF-08 showed a very sharp increase.

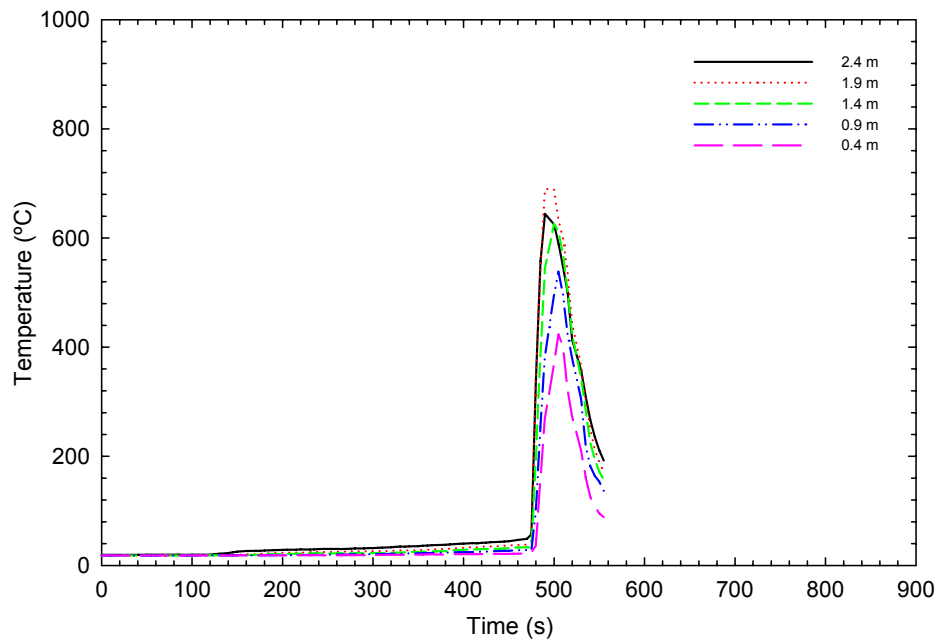
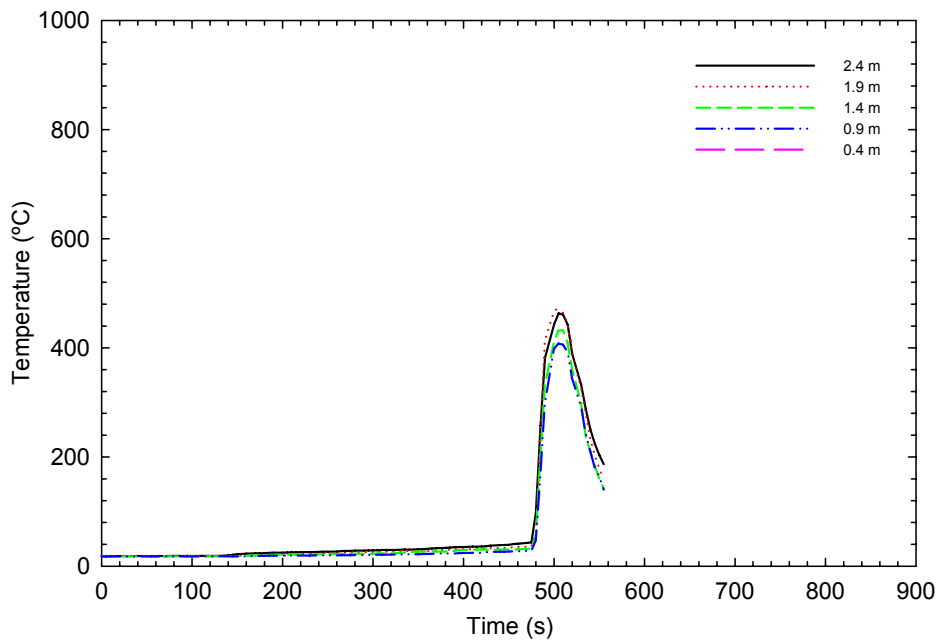
c) 1st Storey NE quadrant

d) 1st Storey NW quadrant

Figure 23 (c and d). TC trees in the first storey for Test UF-08

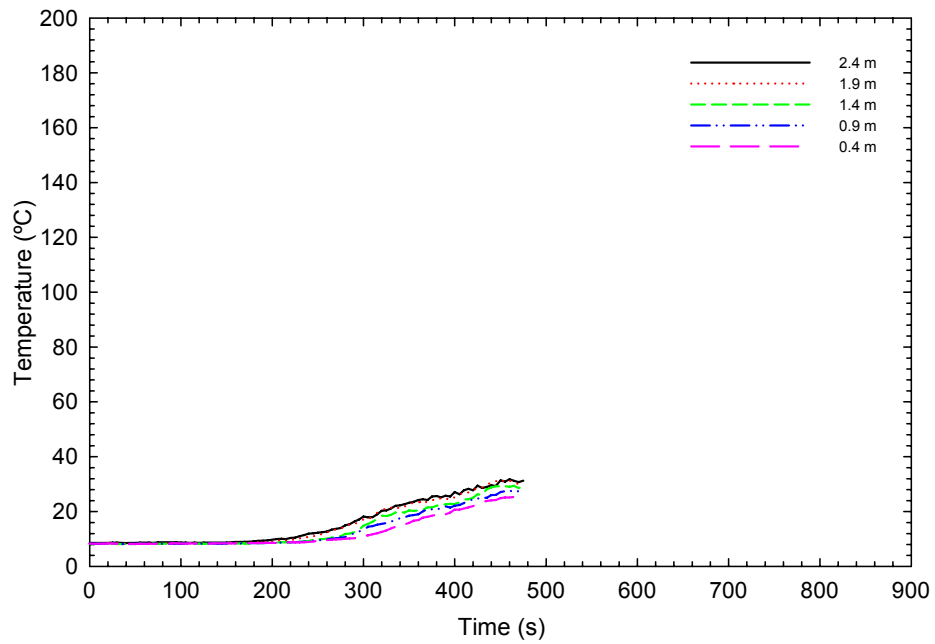
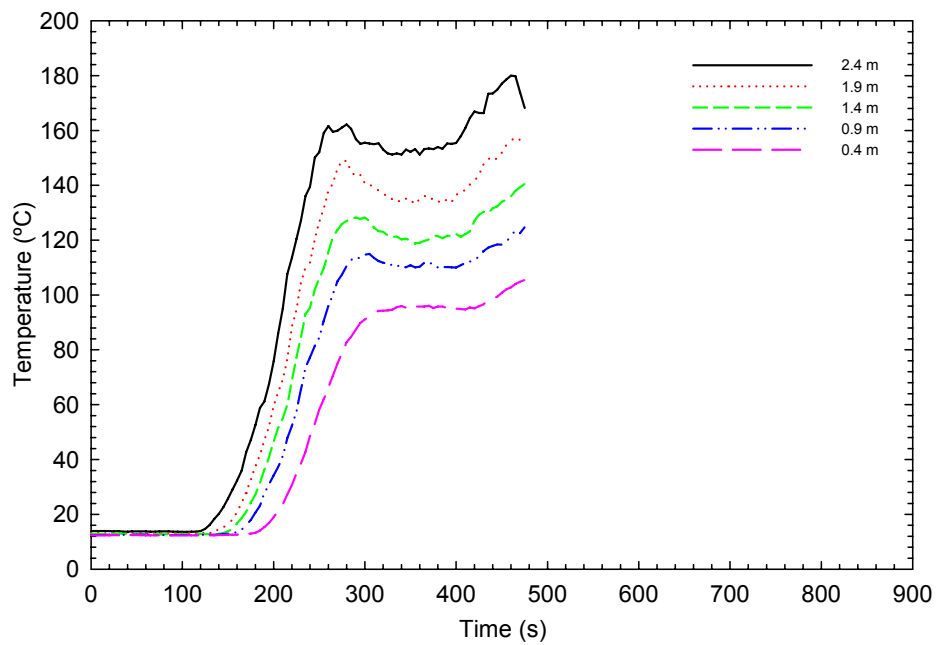
a) 2nd Storey SE bedroom

b) 2nd Storey SW bedroom

**Figure 24. TC trees in the second storey bedrooms for Test UF-07  
(SE bedroom: door closed; SW bedroom: door open)**

Figure 24 (a) and Figure 24 (b) show the temperatures in the SE and SW bedrooms, respectively for Test UF-07. The door to the SE bedroom was closed while the door to the SW bedroom was open. The temperatures remained at ambient temperature for about the first 200 s for the SE bedroom and 120 s for the SW bedroom. After these times, the temperatures, at different heights within the rooms, started increasing. This increase was greater for the SW bedroom than the SE bedroom because the door to the SW bedroom was open. Smoke entered the SE bedroom mainly through gaps around the door. Maximum temperatures of about 25°C and 160°C were reached at the 2.4 m height above the floor level in the SE and SW bedrooms, respectively. For the SW bedroom, the temperatures peaked around 250 s and subsequently decreased probably due to fresh air coming from the opening of the exterior door on the first storey.

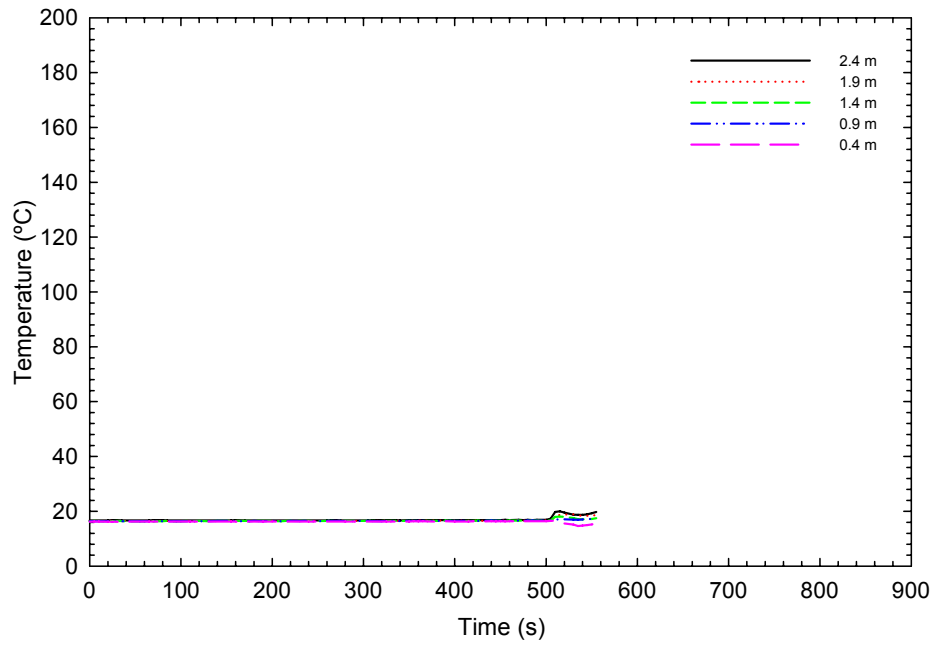
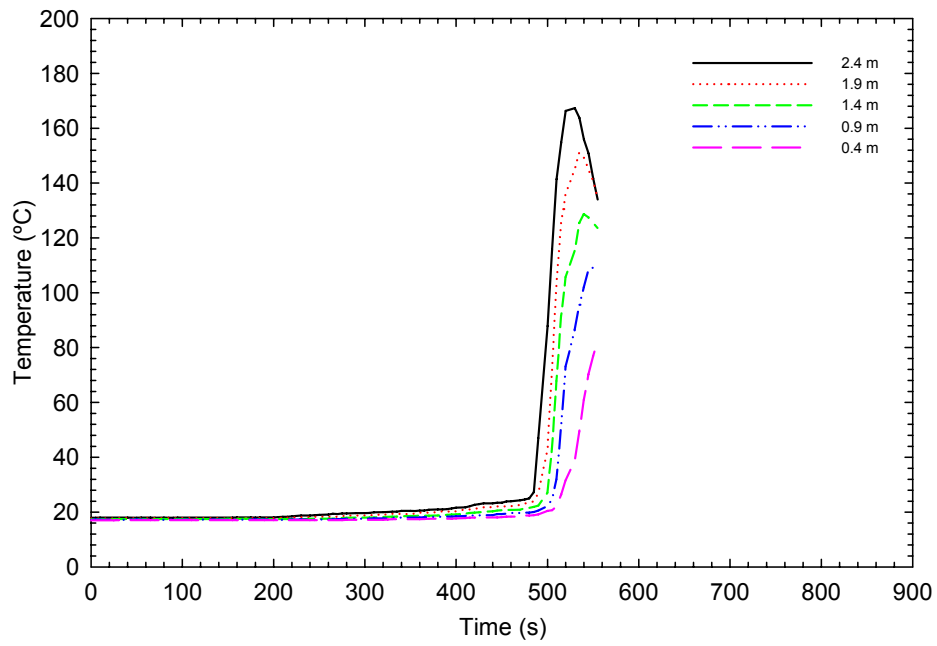
a) 2nd Storey SE bedroom

b) 2nd Storey SW bedroom

**Figure 25. TC trees in the second storey bedrooms for Test UF-08**

Figure 25 (a) and Figure 25 (b) show the temperatures in the SE and SW bedrooms, respectively for Test UF-08. The door to the SE bedroom was closed while the door to the SW bedroom was open. Ambient temperature was measured for the duration of the fire test in the SE bedroom and for about the first 200 s in the SW bedroom. After 200 s in the SW bedroom, the temperatures, at different heights, started increasing. The temperatures in the SW bedroom were higher than those in the SE bedroom because the door to the SW bedroom was open. The smoke entered the SE bedroom mainly through gaps around the door. Maximum temperatures of about 160°C were reached at the 2.4 m height above the floor level in the SW bedroom. For the SW bedroom, the temperatures showed a sudden increase around 480 s with flame penetration into the first storey, and then they started decaying after the extinguishment of the fire was initiated.

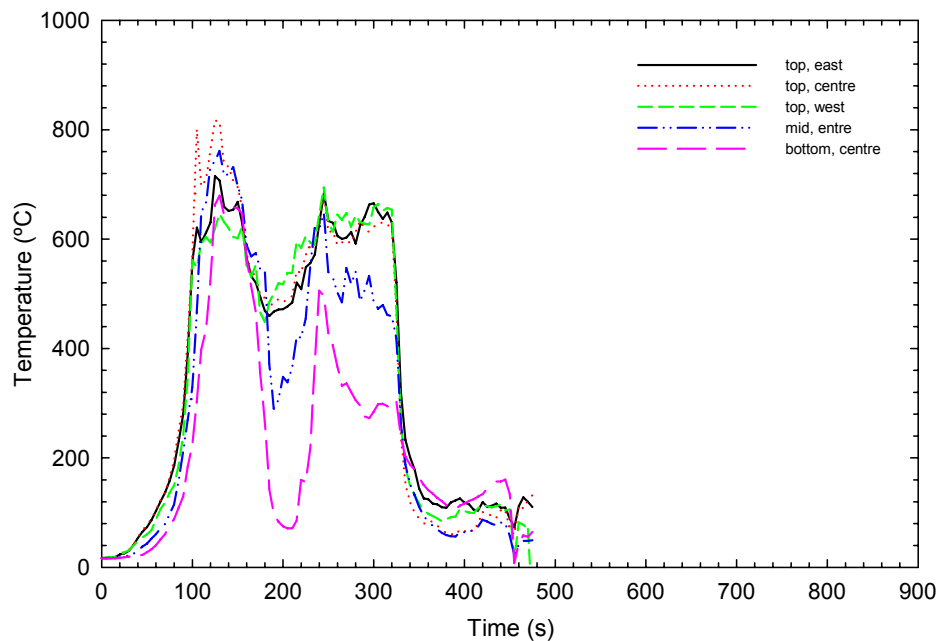
Figure 26. Temperatures at the window in the basement for Test UF-07

Figure 26 and Figure 27 show the temperatures recorded at the basement window for Test UF-07 and Test UF-08, respectively. For both tests, the temperatures increased to 600°C in the first 100 s. The window was opened 95 s and 90 s after ignition, for UF-07 and UF-08, respectively, when the temperatures reached 300°C at the window. After 120 s, due to air entering and smoke exiting the basement through the window opening, the temperatures varied depending on whether or not the flames were touching the thermocouples (the bottom TC was probably below the neutral plane).

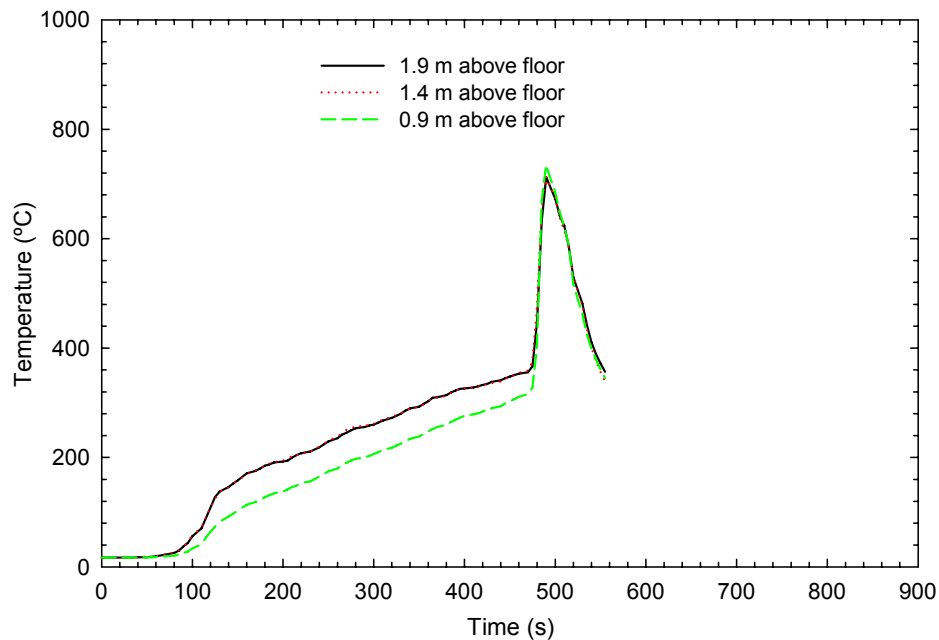
**Figure 28. Temperatures at the exposed side [basement side] of the basement door for Test UF-08**

The temperature at the doorway to the basement was measured for Test UF-08 only, since this test was conducted with a closed door to the basement. Figure 28 shows the temperatures on the exposed side [basement side] of the door at the centre and at three heights: 0.9, 1.4 and 1.9 m. The temperatures initially remained constant and then increased in the first 120 s to a value of about 160°C (due to rapid hot gas build up in the staircase); then there was a gradual increase to about 360°C between 120 and 470 s. Just after 470 s, the temperatures increased, at all the heights, to a maximum 720°C. The last peak is an indication of the burning of the door. The temperature decayed after the extinguishment of the fire.

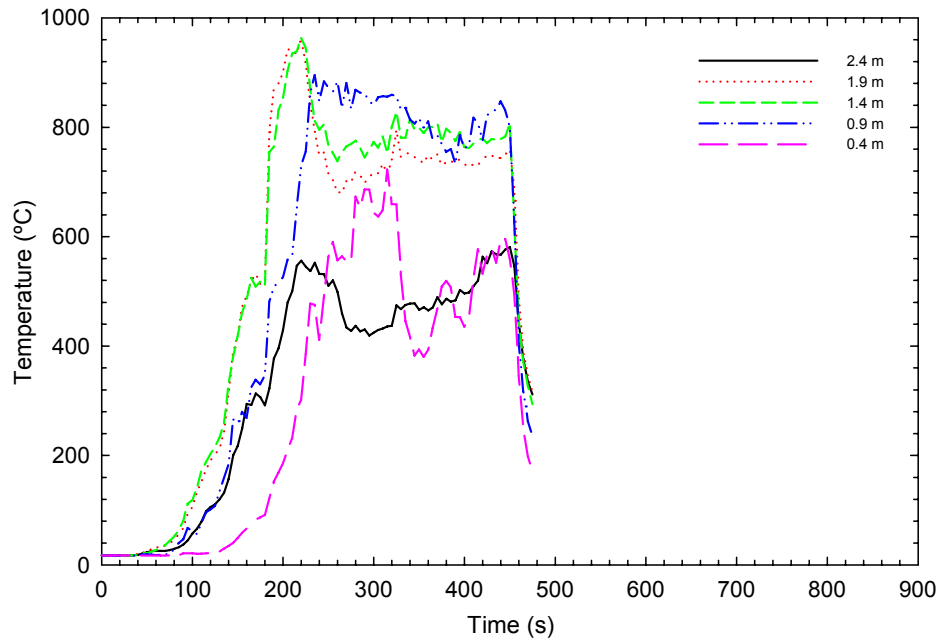
**Figure 29. Temperatures on the first storey at the top of the stairs from the basement for Test UF-07**

Figure 29 shows the temperatures at the top of the stairs on the first storey at different heights for Test UF-07. The conditions remained at ambient temperature for about the first 50 s. After this, temperatures, at different heights, started increasing due to the migration of hot gases and smoke from the basement to the upper storeys. A maximum temperature of about 960°C was reached and then there was a decline in temperatures after the exterior door on the first storey was opened and fresh air entered the compartment. The temperatures then increased at some locations. The maximum temperature was not at the 2.4 m level but at the 0.9, 1.4 and 1.9 m levels. This is probably an indication that cooler air was entering into the basement at both the upper level and lower level of the doorway.

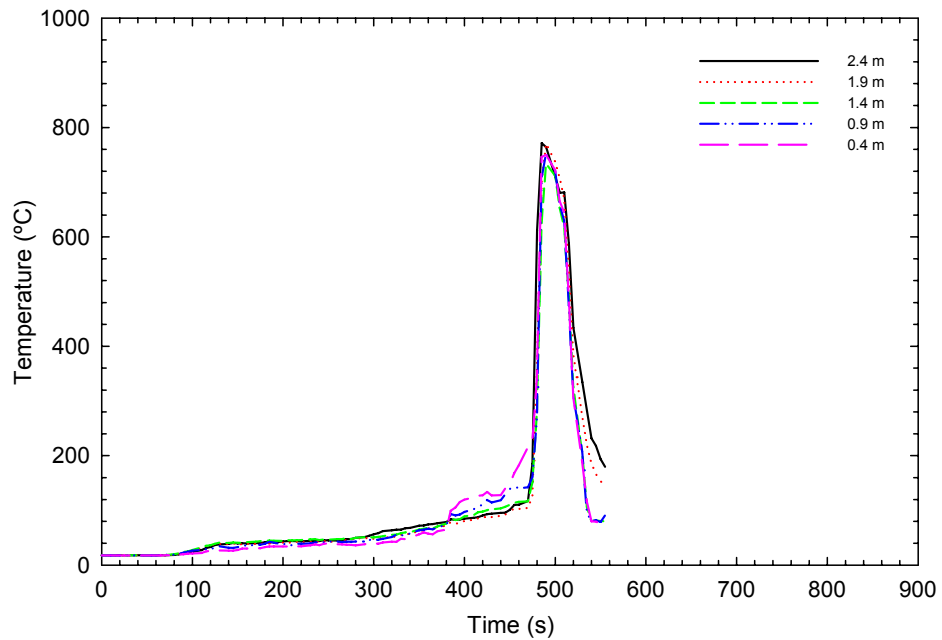
**Figure 30. Temperatures on the first storey at the top of the stairs from the basement [unexposed side of basement door] for Test UF-08**

Figure 30 shows the temperatures at the top of the stairs on the first storey at different heights for Test UF-08. The conditions remained at ambient temperature for about the first 80 s. After this time, the temperatures, at different heights, started increasing very gradually due to the migration of hot gases and smoke through gaps around the floor assembly. The temperatures showed a sudden increase at about 470 s, which may be related to flame penetrating into the first storey through the burning floor or flame breaching the door to the basement. The temperatures started decaying after the extinguishment of the fire was initiated. A maximum temperature of about 760°C was reached.

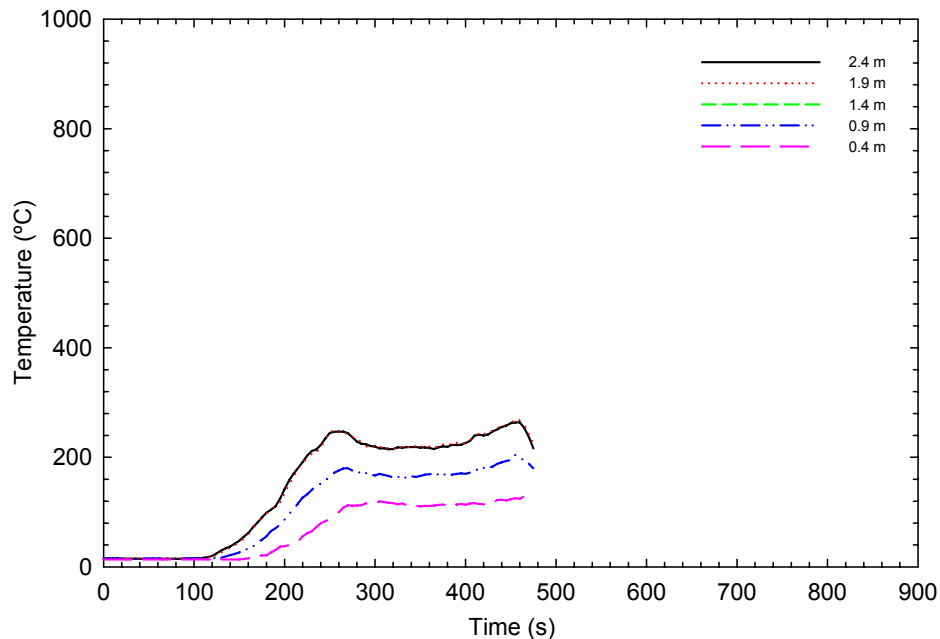
**Figure 31. Temperatures on the second storey at the stairs for Test UF-07**

Figure 31 shows the temperatures at the top of the stairs on the second storey at different heights for Test UF-07. The conditions remained at ambient temperature for about the first 110 s. After this, temperatures, at different heights, started increasing due to the migration of hot gases and smoke from the basement to the upper storeys. A maximum temperature of about 260°C was reached at the 2.4 m height.

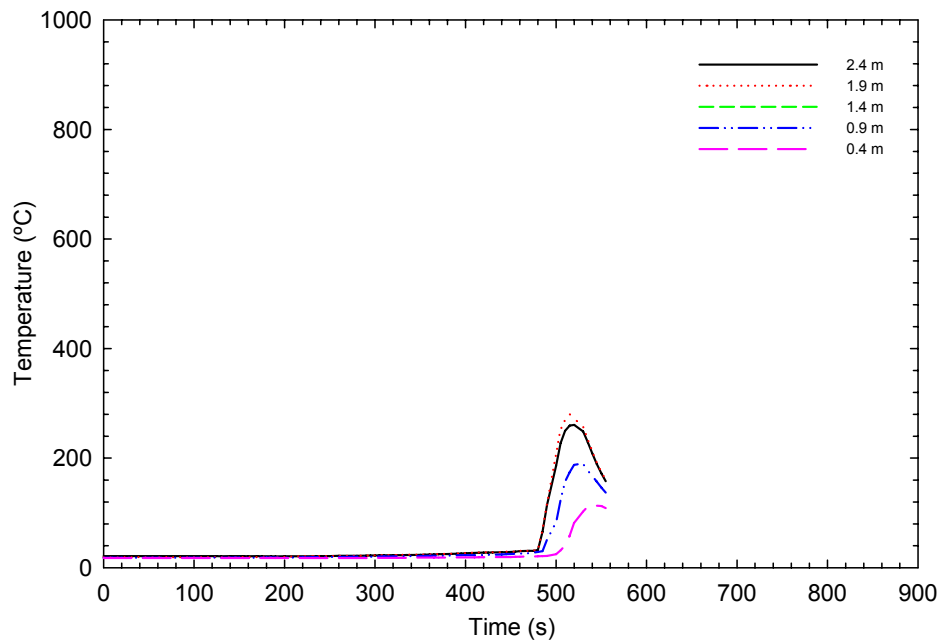
**Figure 32. Temperatures on the second storey at the stairs for Test UF-08**

Figure 32 shows the temperatures at the top of the stairs on the second storey at different heights for Test UF-08. The conditions remained at ambient temperature for about the first 300 s. After this time, the temperatures, at different heights, started increasing very gradually due to some migration of hot gases and smoke mainly through gaps around the floor assembly. The temperatures showed a sudden increase at about 480 s, which was related to flame penetrating into the first storey through the burning floor. The temperatures started decaying after the extinguishment of the fire was initiated.

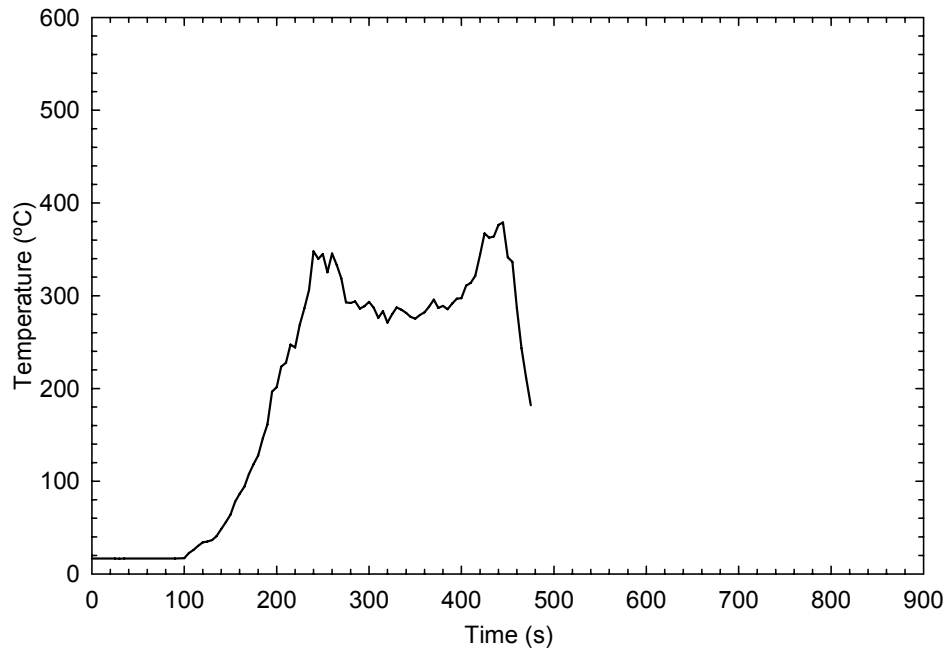
**Figure 33. Temperatures at the outside doorway on the first storey for Test UF-07**

Figure 33 and Figure 34 show the temperatures at the exterior doorway on the first storey for Tests UF-07 and UF-08, respectively. The temperatures were remained at ambient for about the first 100 s and 200 s in Test UF-07 and Test UF-08, respectively. After these times, the temperatures increased reaching 350°C at 220 s in Test UF-07 and 40°C at 470 s in Test UF-08 due to smoke and hot fire gases exiting through the open exterior door (smaller increase in temperature in Test UF-08 with the closed basement doorway). The temperature in Test UF-07 decreased after the first peak due to the opening of the exterior door on the first storey. There was a sharp increase in temperatures near the end of both tests (due to flame penetration through the floor producing more radiation and hot gases in the vicinity of the exterior door). The temperatures started decaying after the extinguishment of the fire was initiated.

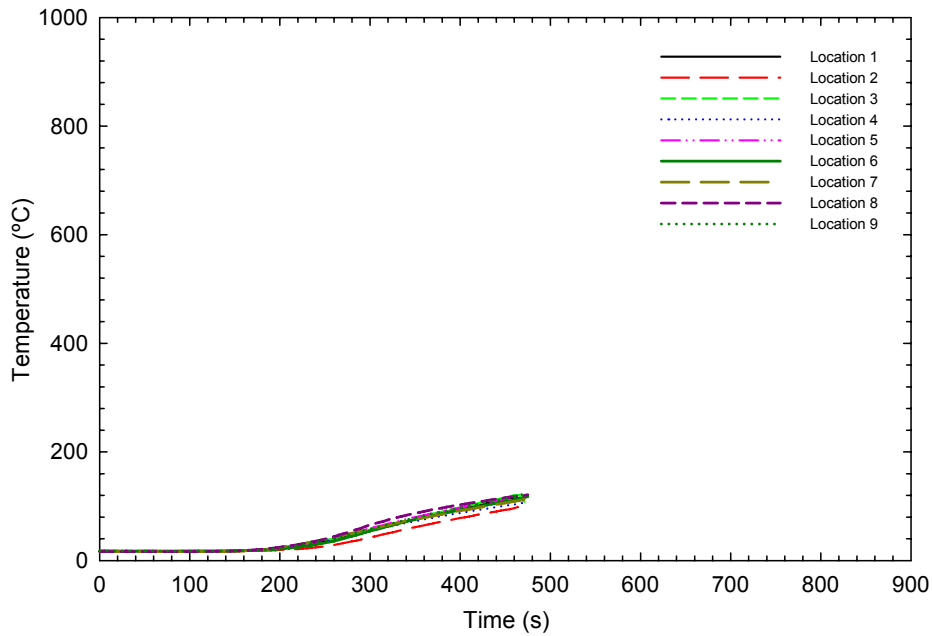
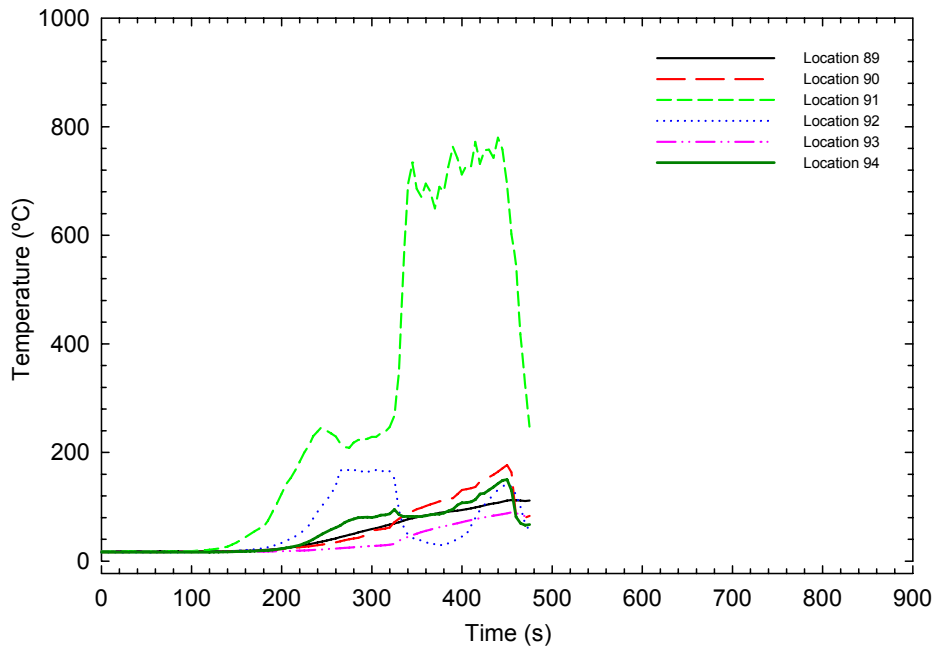
a) Unexposed TCs under insulated pad on top of subfloor

b) Bare TCs on the unexposed (top) side of subfloor

**Figure 35. Temperatures at the unexposed side of subfloor for Test UF-07**

Figure 35 (a and b) show the temperatures measured by thermocouples (TCs) No. 1 to 9 and No. 89 through 94 located on the unexposed side (top) of the OSB subfloor in the floor assembly (see Figure 15 and Figure 16). For TCs 1 to 9, the temperatures remained at ambient temperature for the first 200 s. After this, the temperatures increased gradually until the test was terminated. The maximum temperature reached was about 80°C before the end of the test. Temperatures at locations 89 to 94 had a similar trend with different values except for TC 91 which had a sudden increase in temperature at 325 s, indicating flame penetration through the floor.

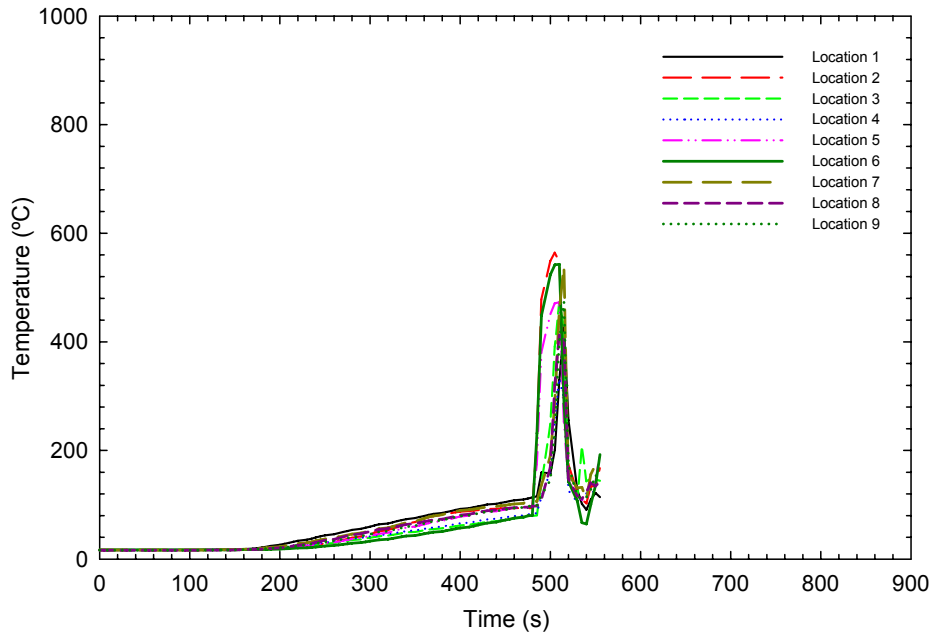
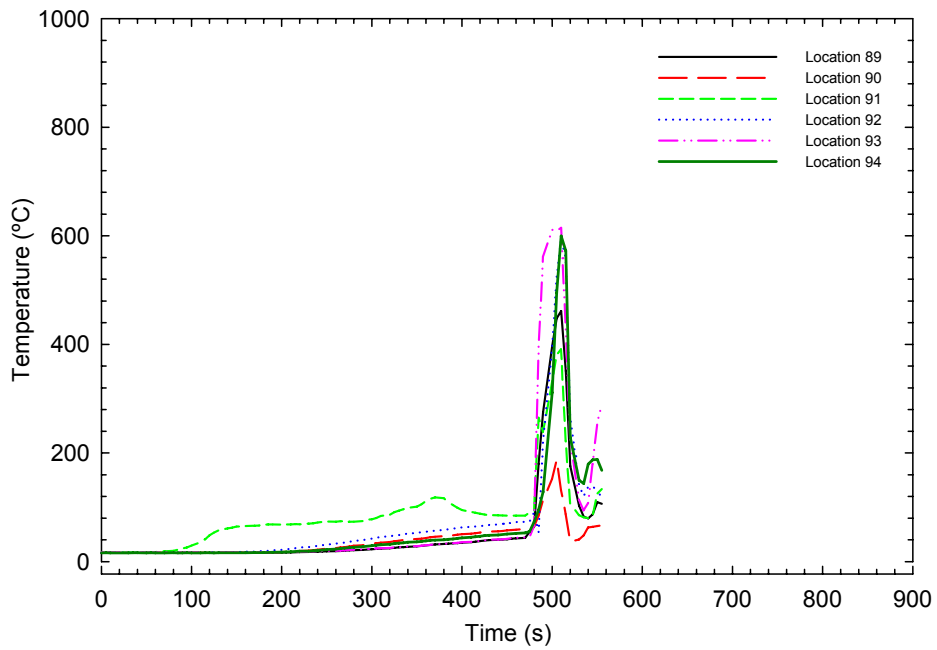
a) Unexposed TCs under insulated pad on top of subfloor

b) Bare TCs on the unexposed (top) side of subfloor

**Figure 36. Temperatures at the unexposed side of subfloor for Test UF-08**

Figure 36 (a and b) show the temperatures measured by thermocouples No. 1 to 9 and No. 89 through 94 located on the unexposed side (top) of the OSB subfloor in the floor assembly (see Figure 15 and Figure 16). For TCs 1 to 9, the temperatures remained at ambient temperature for the first 160 s. After this, the temperatures increased gradually until 470 s; thereafter, the temperatures had a faster rate of increase. This faster temperature rise was due to the critical positioning of the thermocouples and it is an indication that flames were penetrating through the floor as the floor was breached. The temperatures increased to reach a maximum temperature of 560°C at the end of the test. The time corresponding to flames penetrating the floor was comparable to those recorded using the flame-sensing devices. Subsequently, the temperatures decreased during the extinguishment of the fire. Temperatures at locations 89 to 94 had a similar trend with a maximum temperature of 600°C.

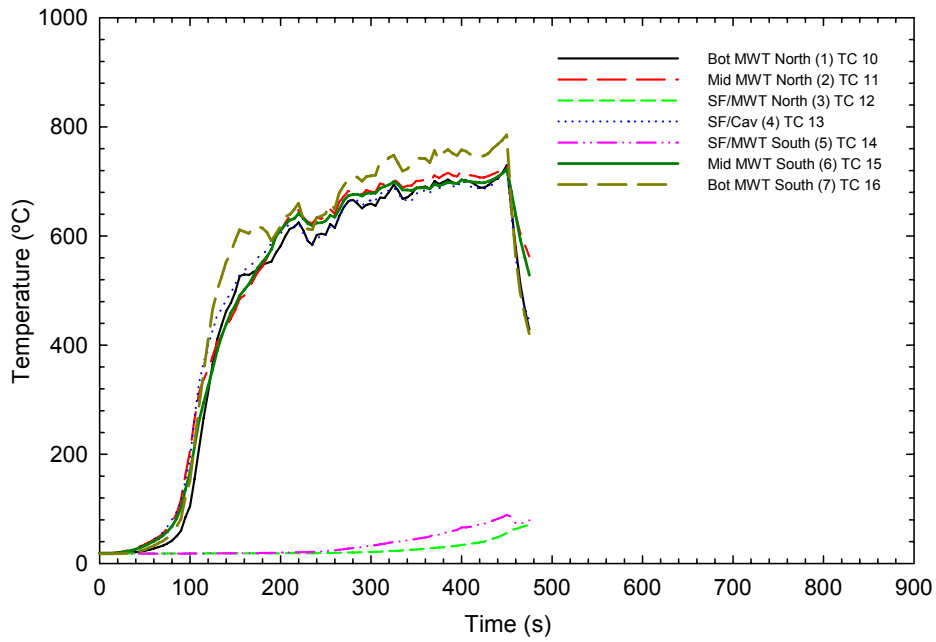
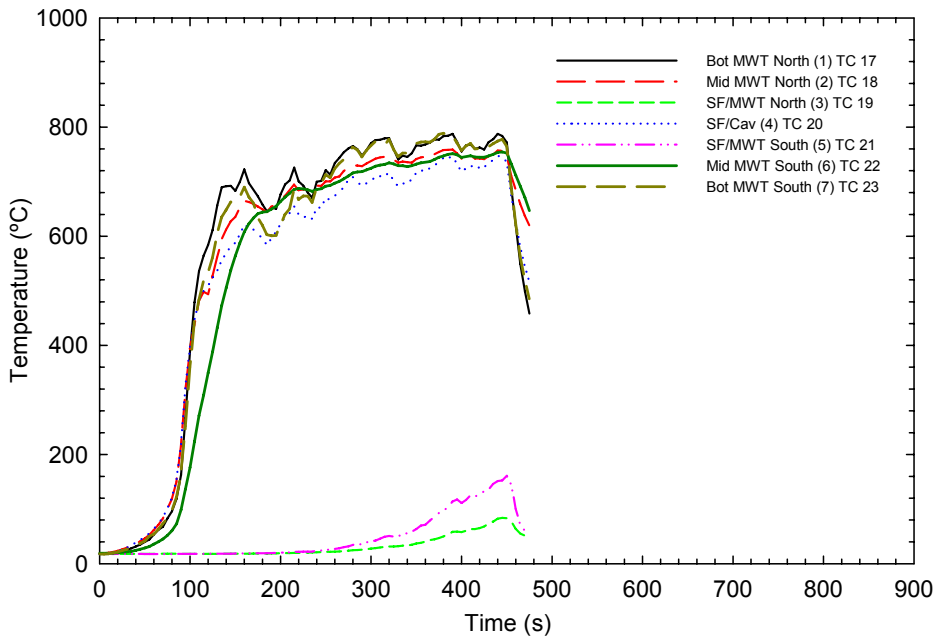
a) Thermocouples in cavity A-2

b) Thermocouples in cavity A-7

Figure 37 (a and b). Temperatures at the exposed side for Test UF-07

There were cases where there was no obvious drop in the temperature at 120 s (A-2, C-1 and E-1). This was because these locations were not in the proximity of the fuel package and thus had limited radiative impact from the fuel.

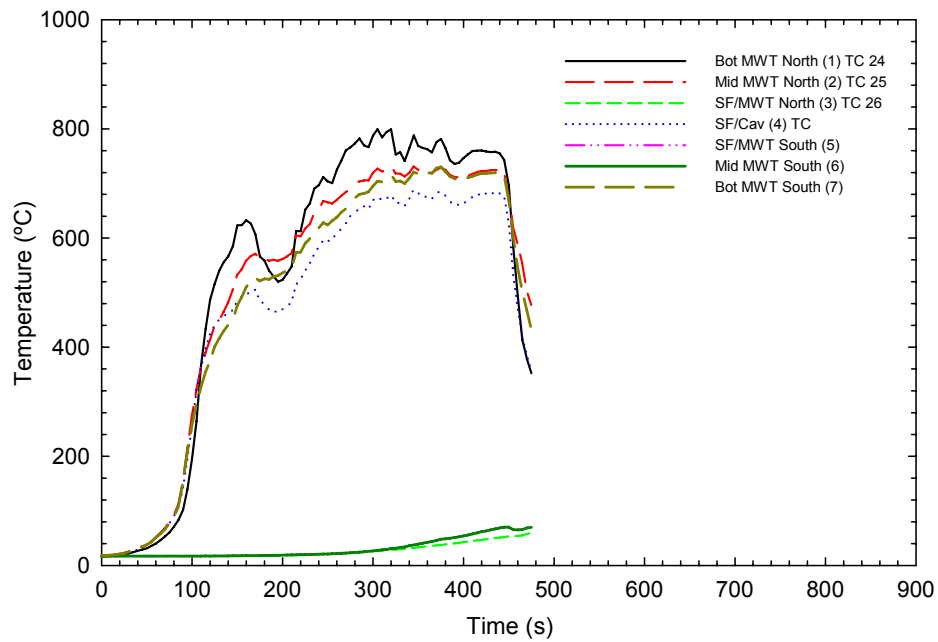
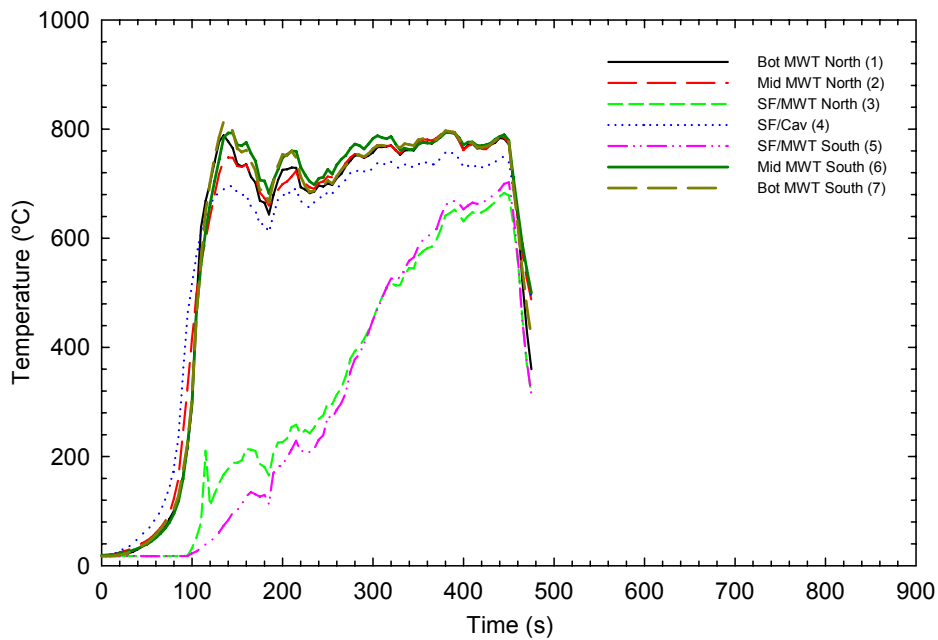
c) Thermocouples in cavity A-12

d) Thermocouples in cavity B-7

Figure 37 (c and d). Temperatures at the exposed side for Test UF-07

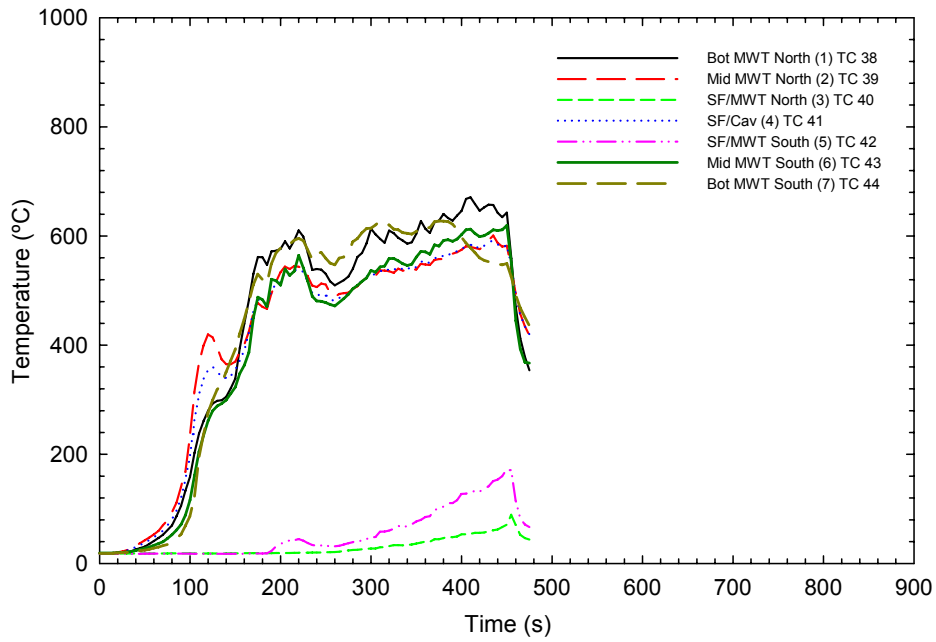
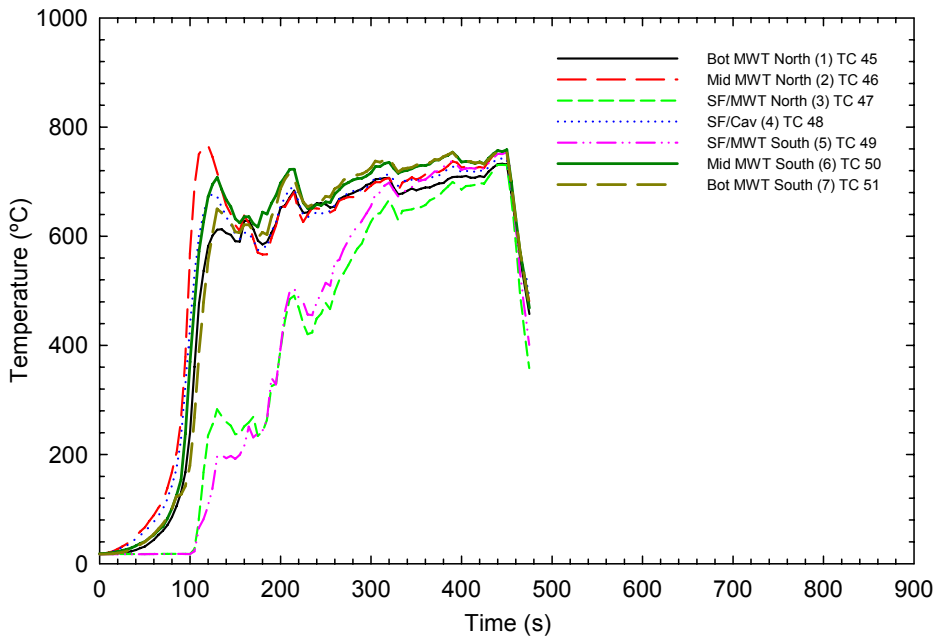
e) Thermocouples in cavity C-1

f) Thermocouples in cavity C-5

Figure 37 (e and f). Temperatures at the exposed side for Test UF-07
