Fire Performance of Houses. Phase I.  
Study of Unprotected Floor Assemblies in  
Basement Fire Scenarios  
Part 6

### **Part 6 – Results of Tests UF-07 and UF-08 (Metal-Web-Connected Wood Trusses)**

Research Report: IRC-RR-251

Date: March 31, 2009

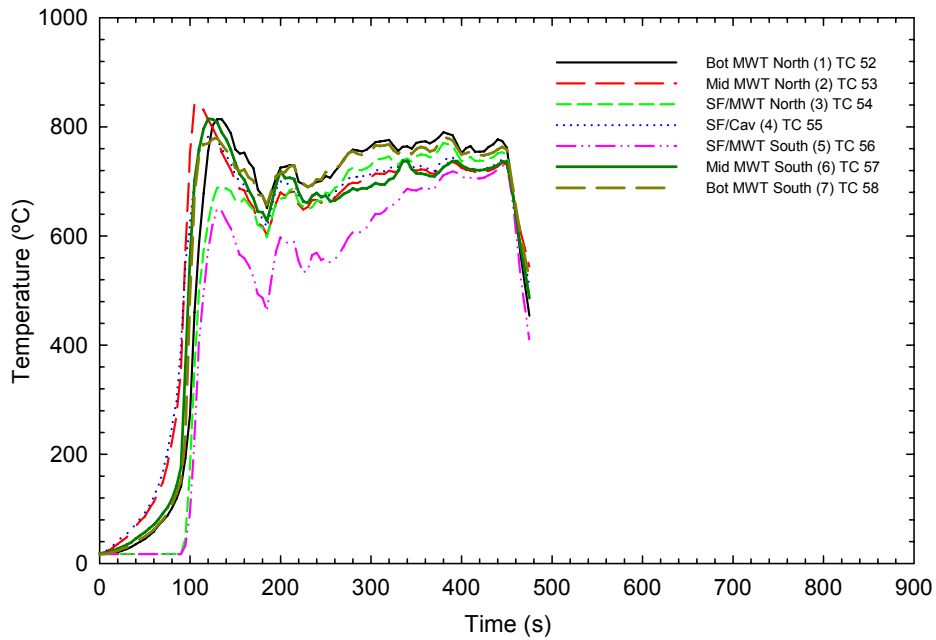
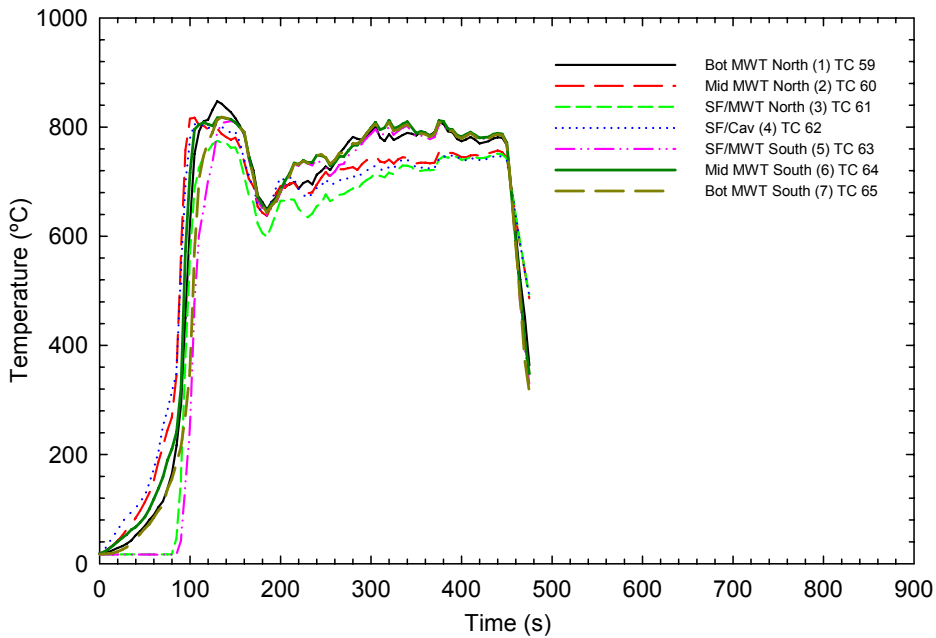
g) Thermocouples in cavity C-7

h) Thermocouples in cavity C-9

Figure 37 (g and h). Temperatures at the exposed side for Test UF-07

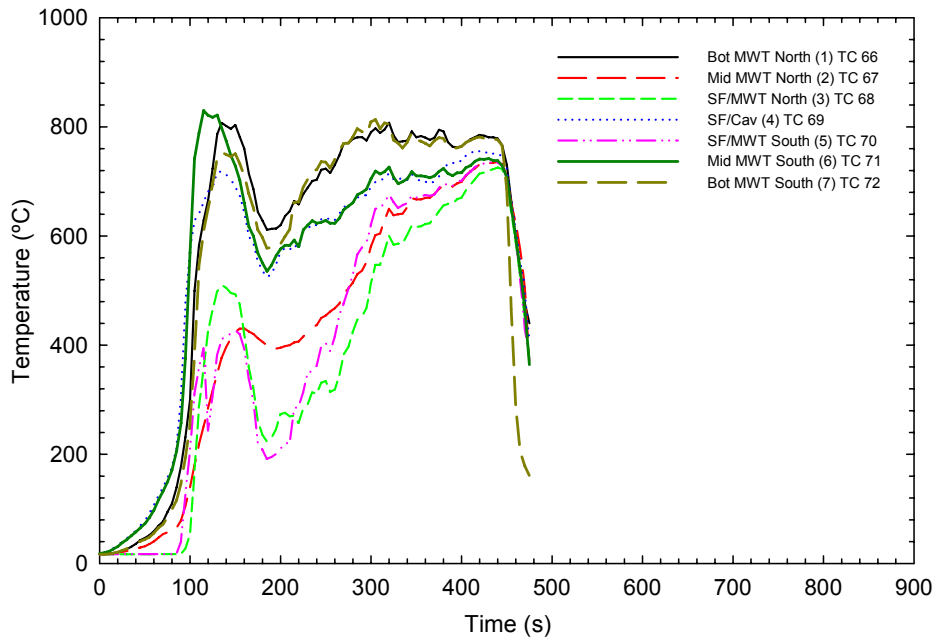
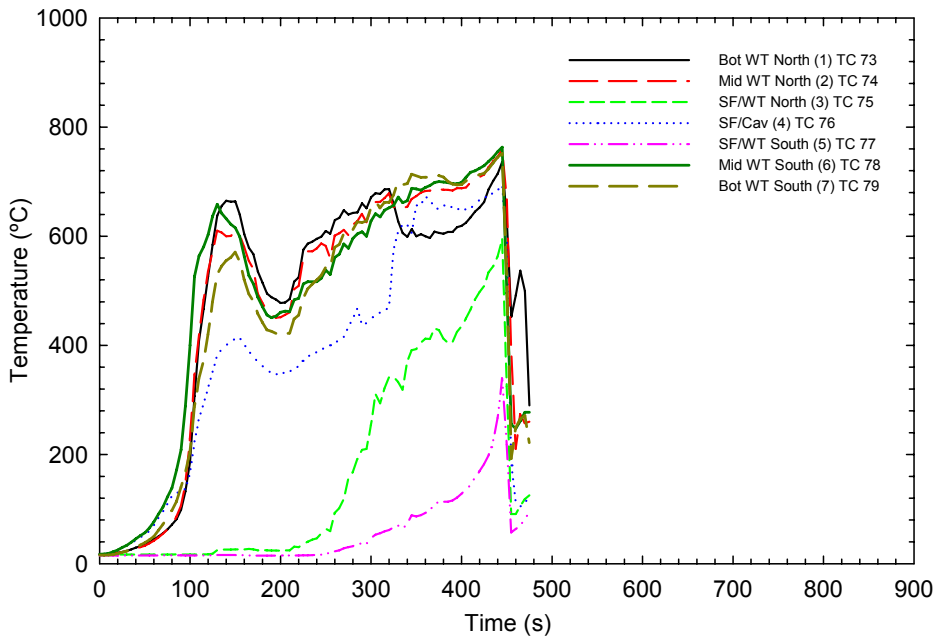
i) Thermocouples in cavity C-11

j) Thermocouples in cavity C-13

Figure 37 (i and j). Temperatures at the exposed side for Test UF-07

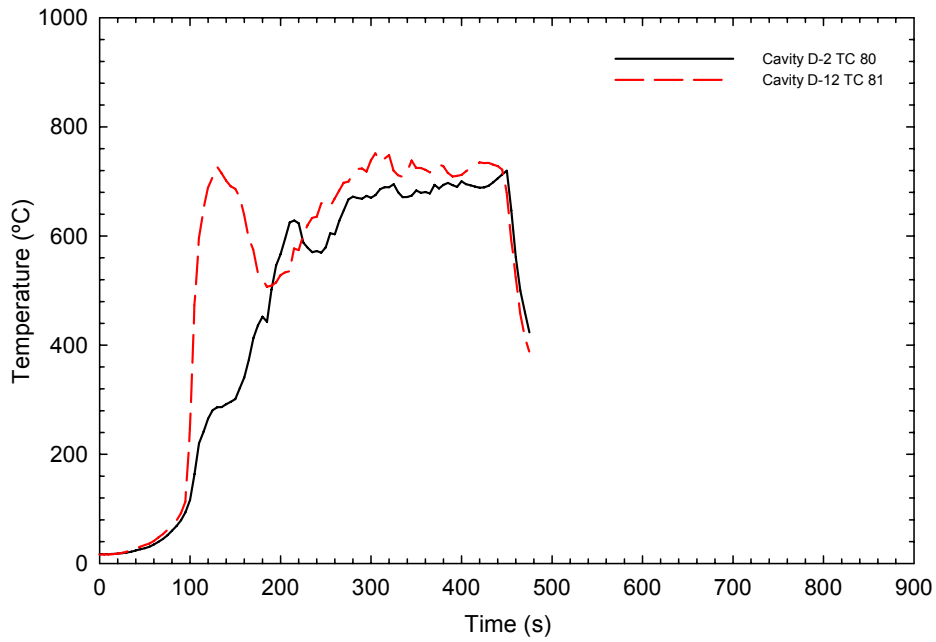
k) Thermocouples in cavity D-2 and D-12

For Section D, points D-2 and D-12 have the same trend as the exposed thermocouples in sections A-2, A-12 and E1.

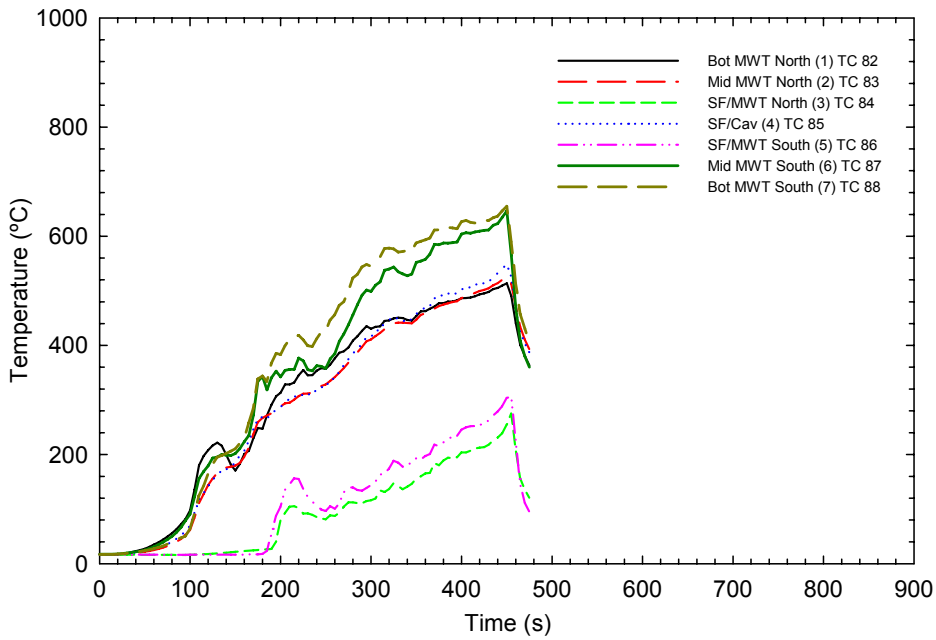
Figure 37 (k and l). Temperatures at the exposed side for Test UF-07

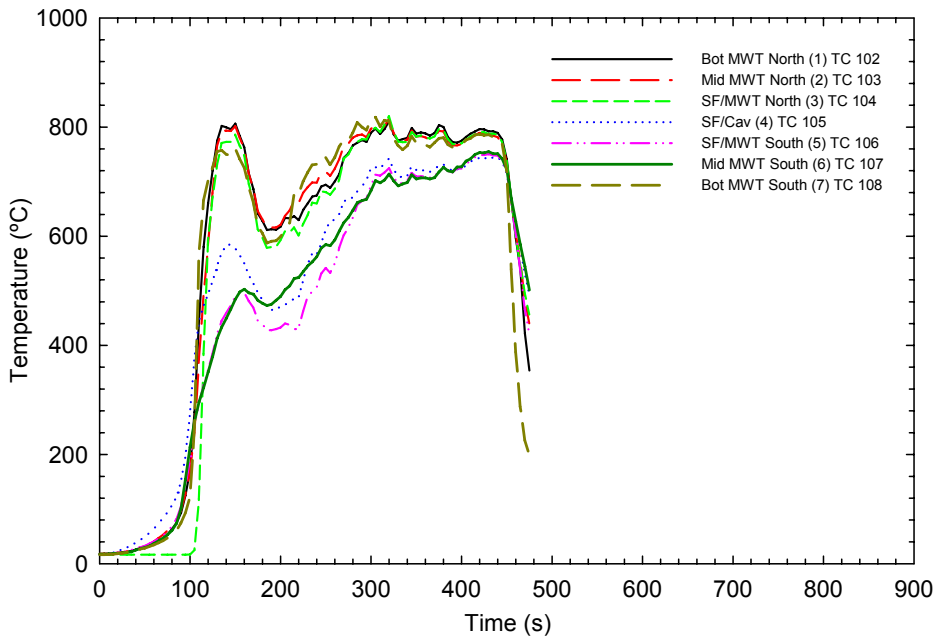
m) Thermocouples in cavity CD7

Figure 37 (m and n). Temperatures at the exposed side for Test UF-07

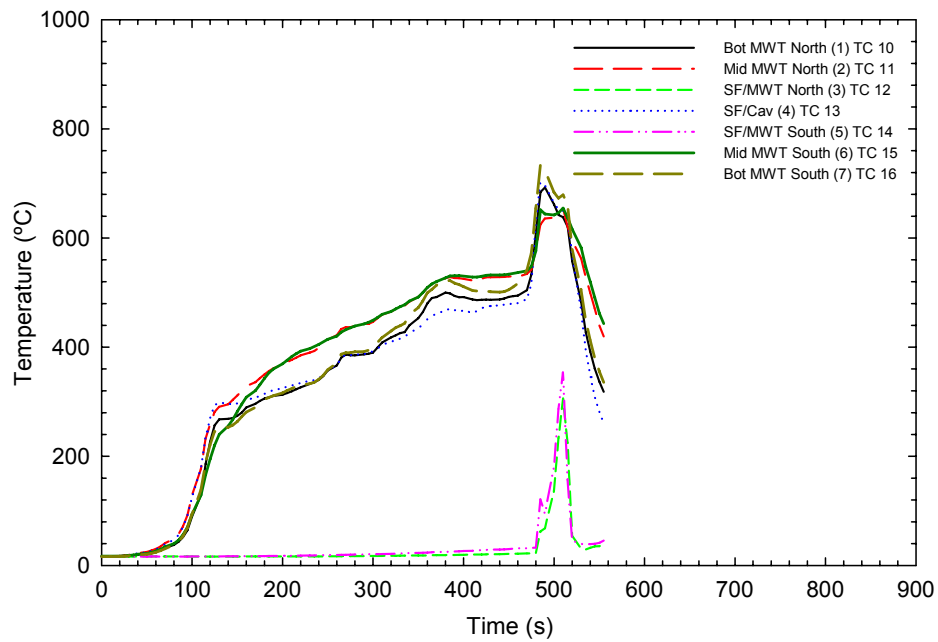
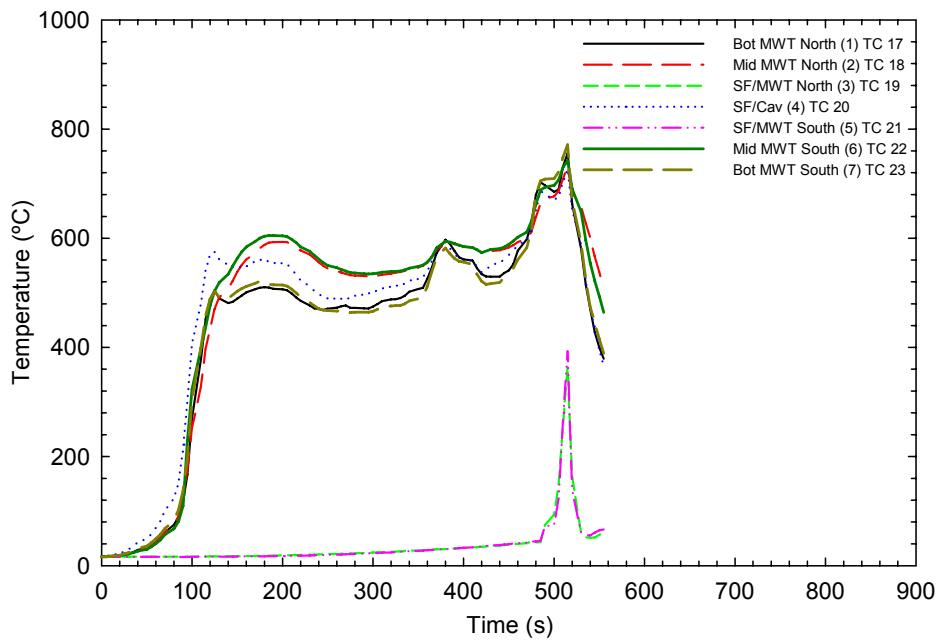
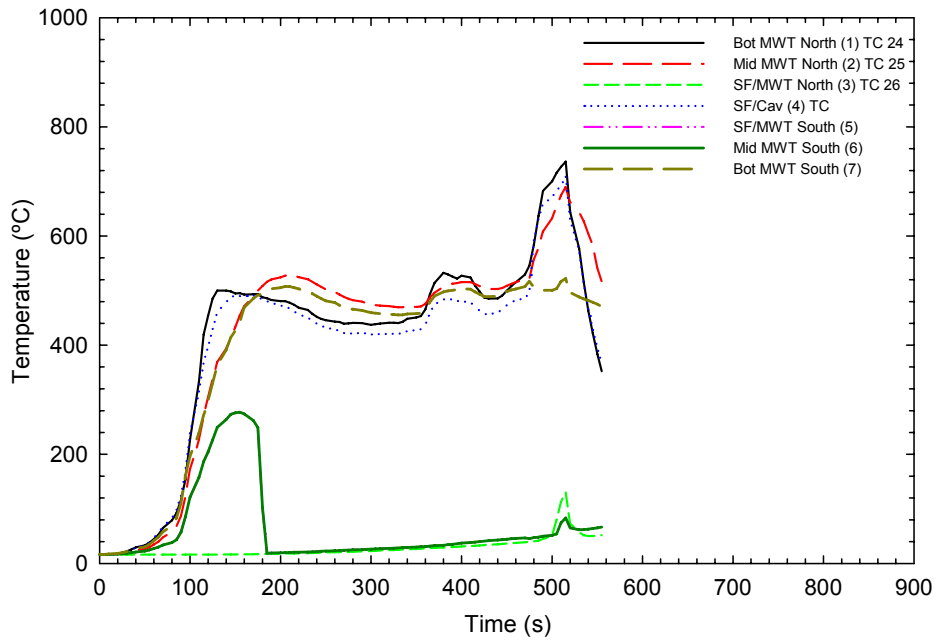
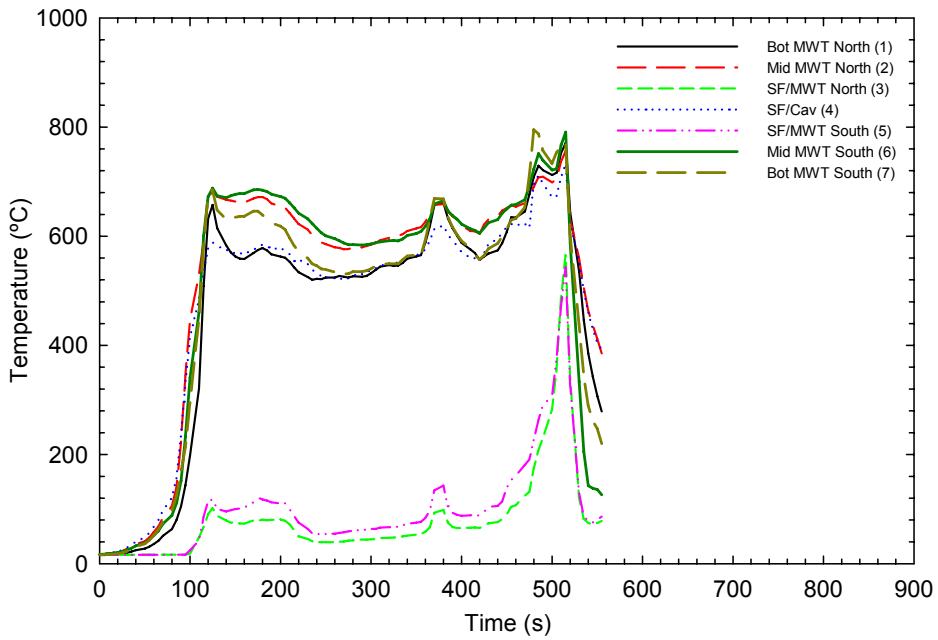
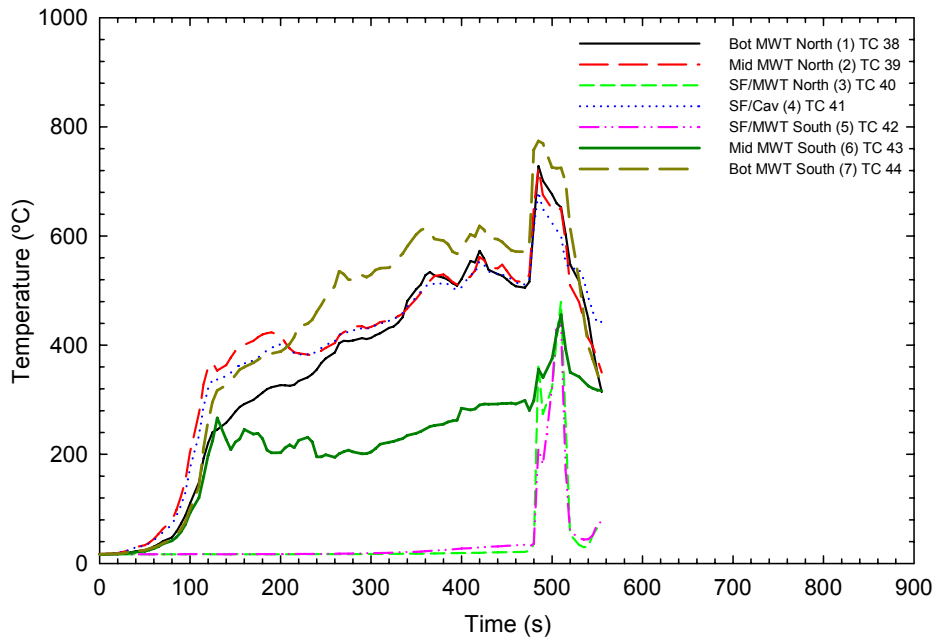
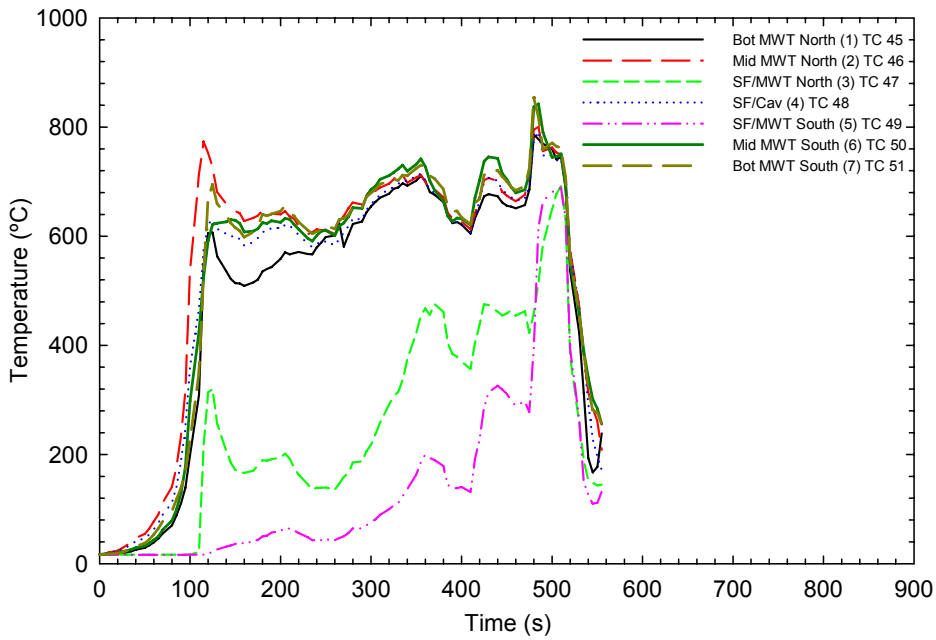
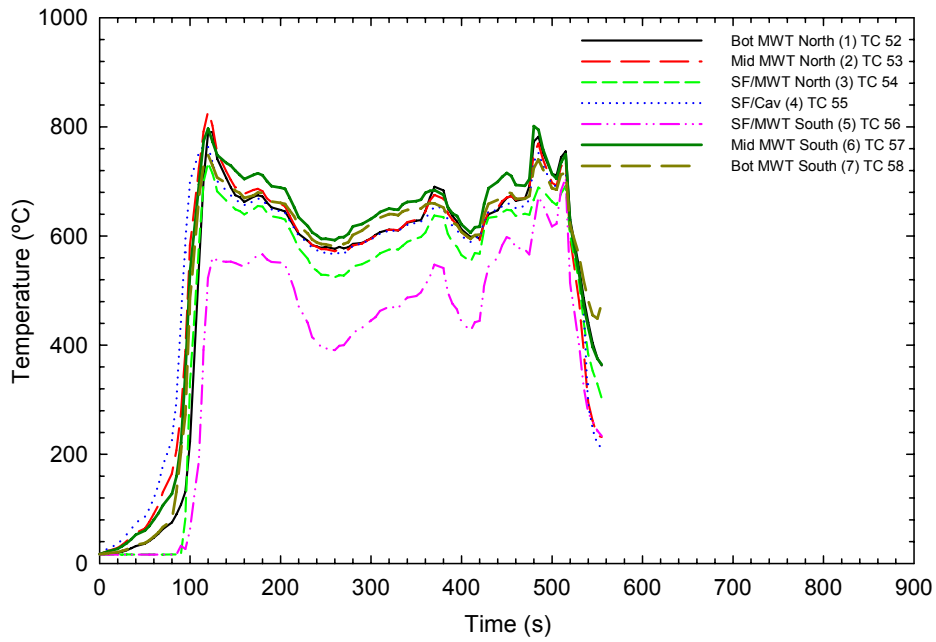
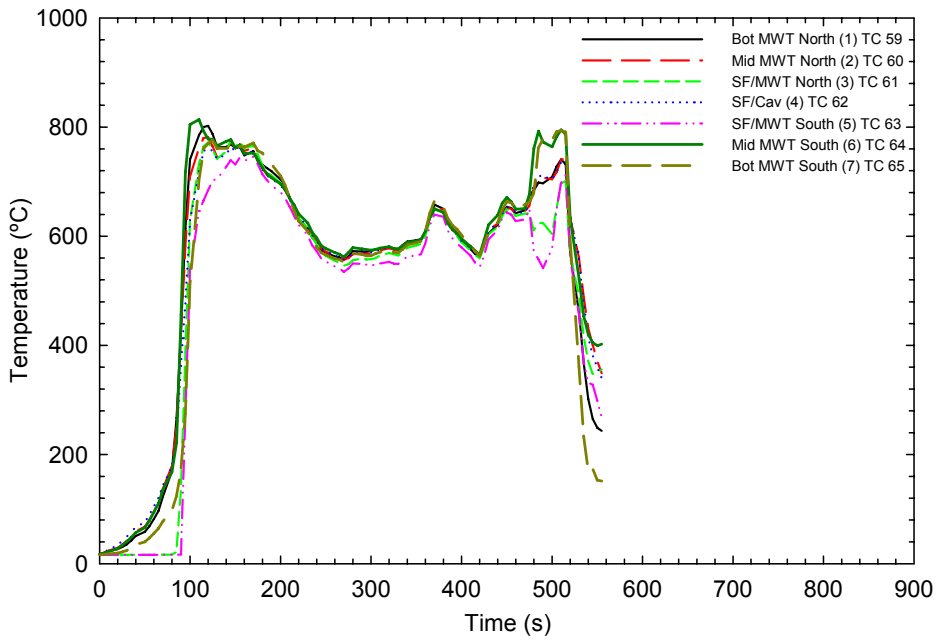
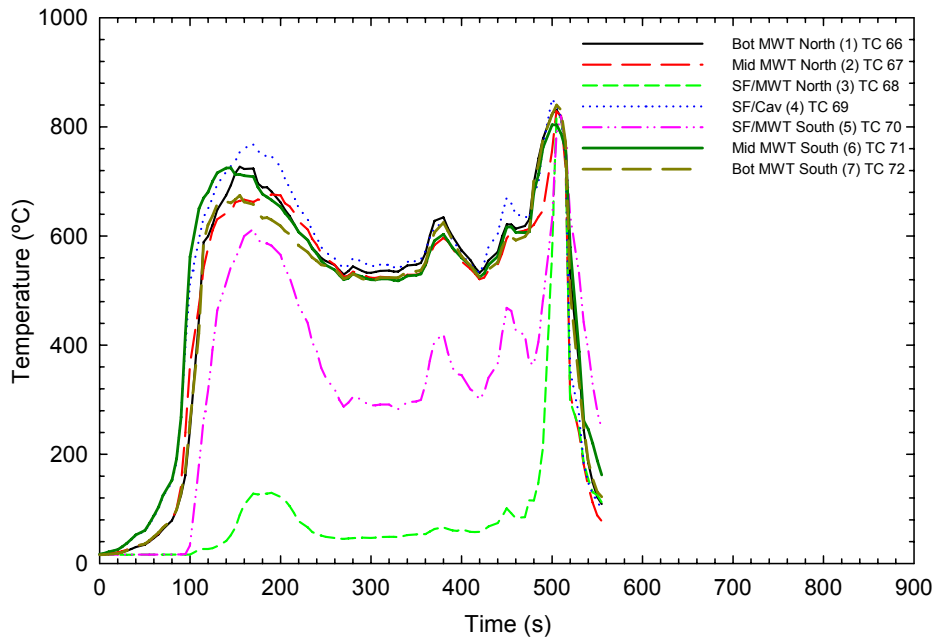
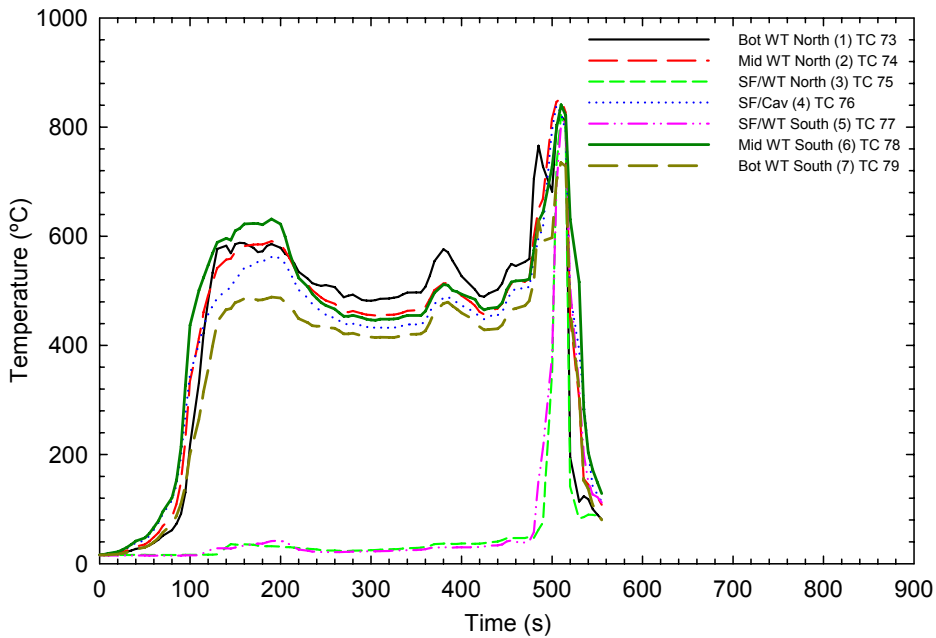
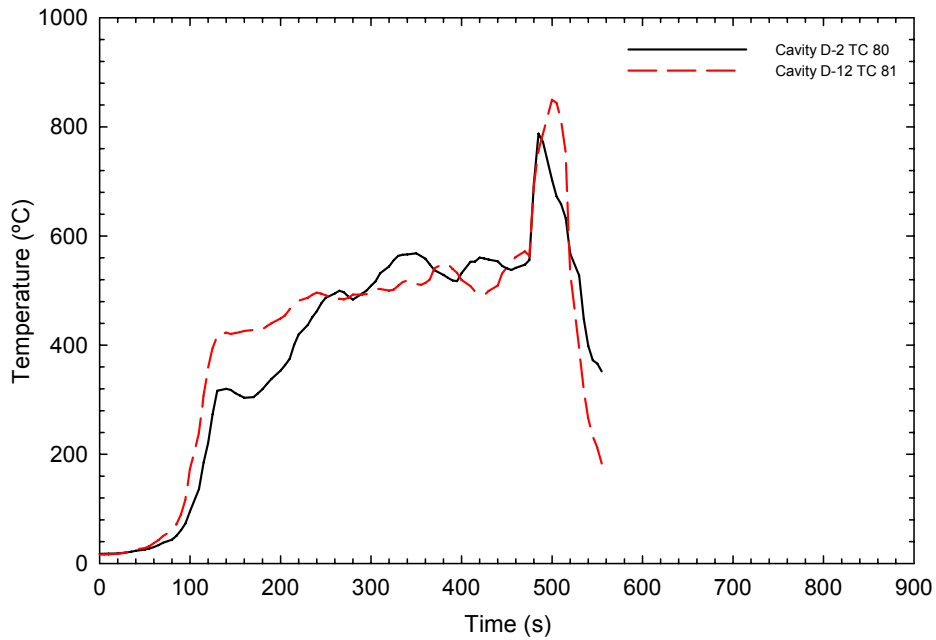
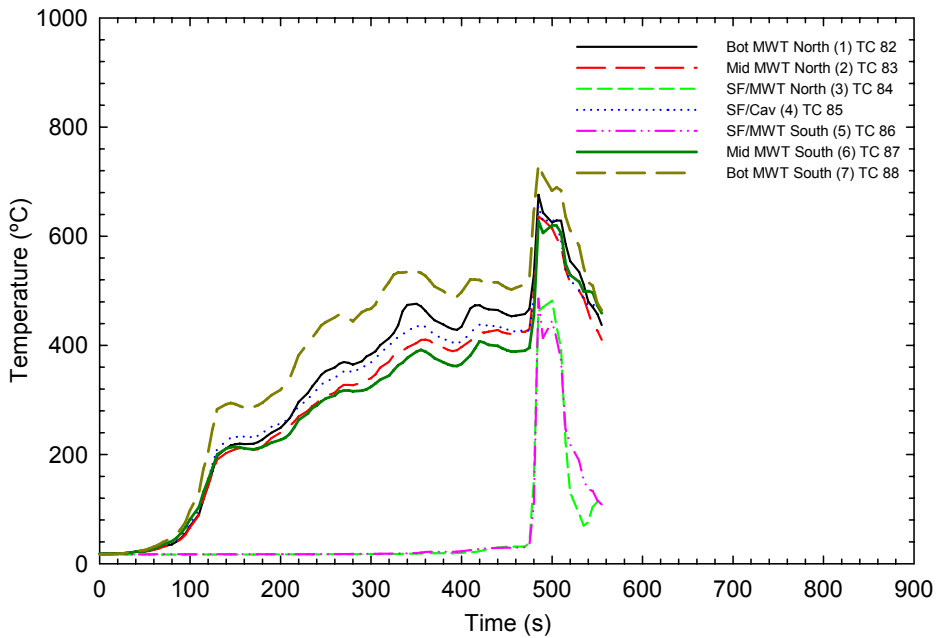
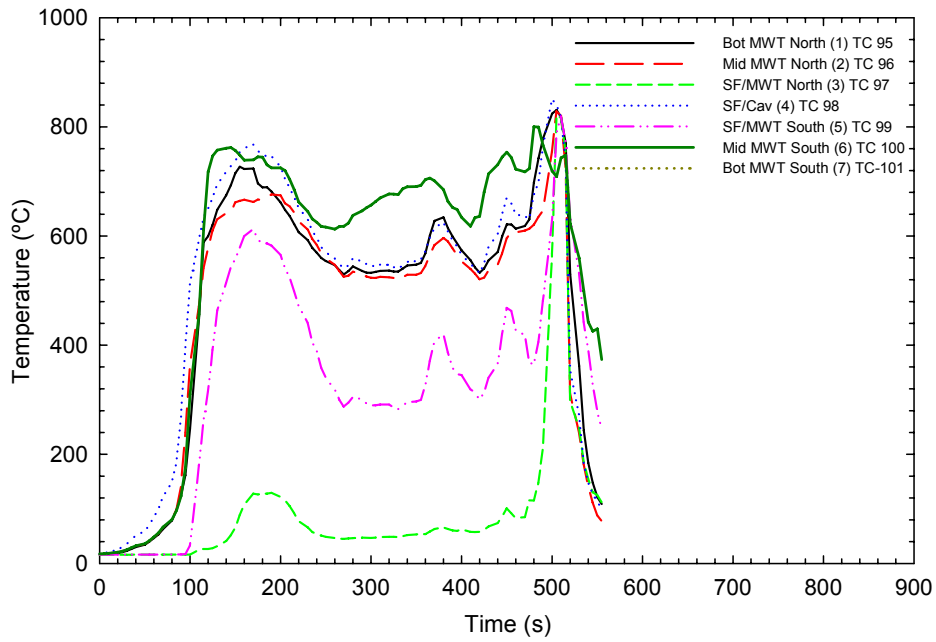
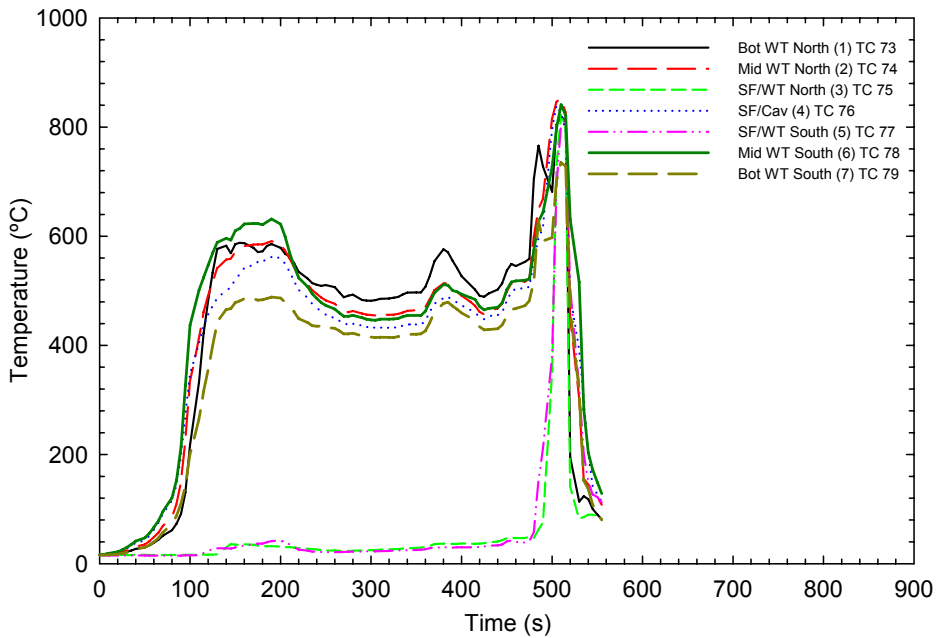
Figure 38 (a and b). Temperatures at the exposed side for Test UF-08

Figure 38 (c and d). Temperatures at the exposed side for Test UF-08

Figure 38 (e and f). Temperatures at the exposed side for Test UF-08

Figure 38 (g and h). Temperatures at the exposed side for Test UF-08

Figure 38 (i and j). Temperatures at the exposed side for Test UF-08

Figure 38 (k and l). Temperatures at the exposed side for Test UF-08

Figure 38 (m and n). Temperatures at the exposed side for Test UF-08

Figure 38 (a) to Figure 38 (n) show the temperatures measured by the thermocouples located on the exposed side of the floor. For all the locations with 7 thermocouples (A-2, A-7, A-12, B-7, C-1, C-5, C-7, C-9, C-11, C-13, E-1, CD-7 and CD-11), in almost every case the trend was similar with a sharp increase in temperatures for all the exposed thermocouples in the first 100 s to 120 s. For the thermocouples located at the interface between the top of a truss and the subfloor (SF/MWT), the temperature rise in most cases was relatively slow and gradual due to the shielding of the thermocouples by the trusses. When the temperatures at the SF/MWT North (3) and SF/MWT South (5) showed a temperature increase, which was sudden in some cases, it is an indication that gaps were forming between the top of the trusses and the subfloor at these locations allowing flames and hot gases into the gap. The increase in temperature happened at different times for the different locations.

For the exposed thermocouples, the highest initial peak temperature (820°C) was recorded at Sections C7 and C-9 (located directly over the burning mock-up sofa and the wood cribs).

For section D, points D-1 and D-12 have the same trend as the exposed thermocouples in section A2 and E1 (away from the fire).

At 460-470 s, the temperatures at the different locations had a sharp increase probably because the flames penetrated the floor and allowed more fresh air to enter into the basement. The section on “flame penetration” indicates that flames started to penetrate into the first storey around 470 s. The temperatures started to decrease after the extinguishment of the fire was initiated.

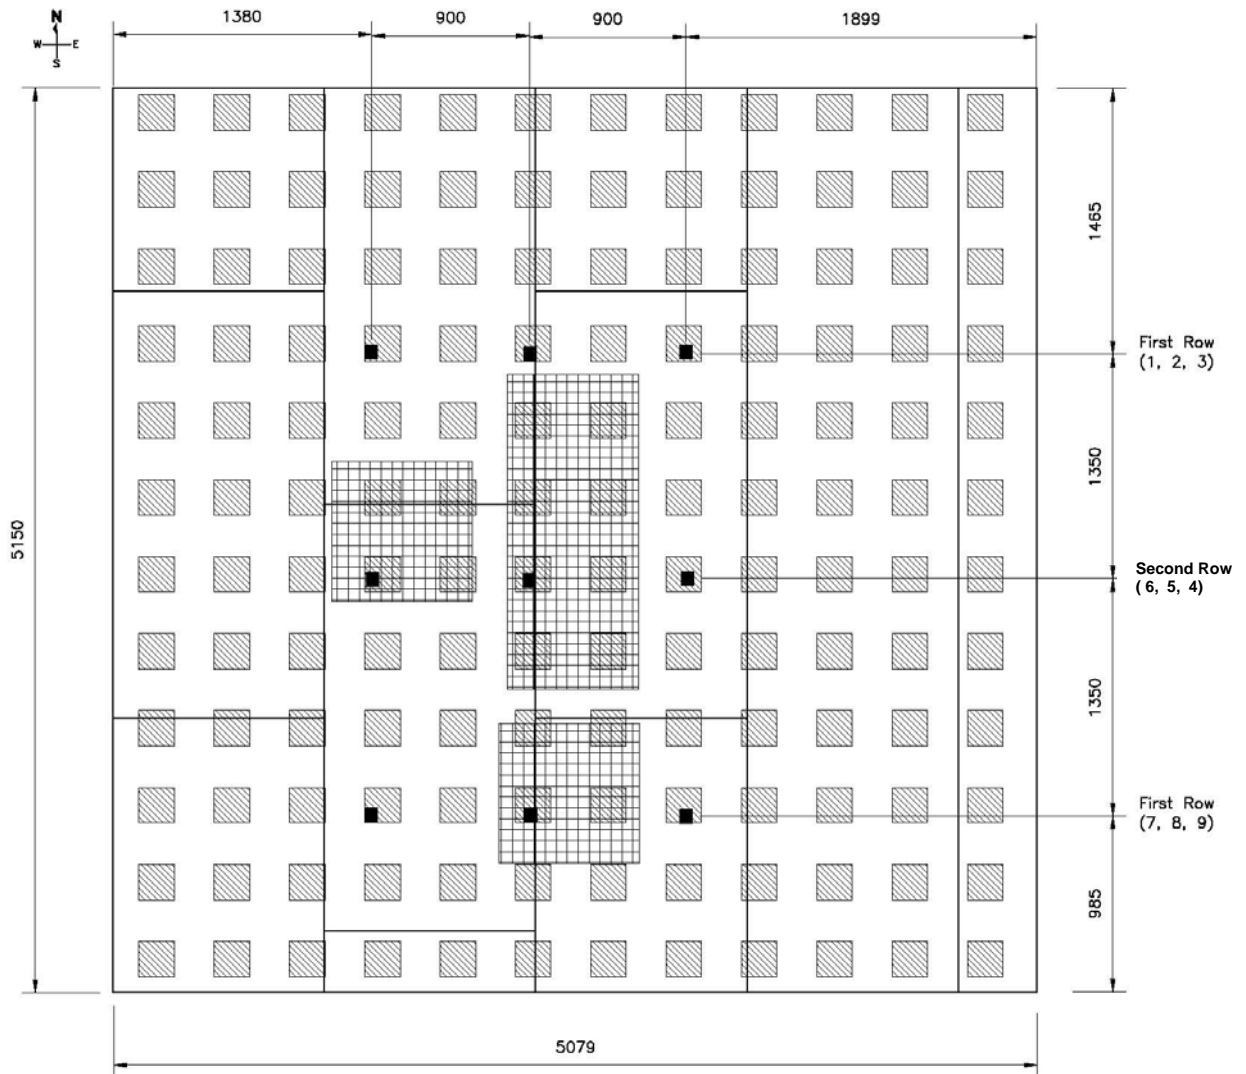
Figure 39. Deflection points measured (all dimensions in mm)

Figure 39 shows the 9 deflection measurement points (see also Figure 11 for the truss closest to the deflection points). The points of measurement were chosen as they were located in the middle of the fire compartment just above the fire load where the impact of the fire on the structural integrity of the floor assembly was anticipated to be the greatest. Some measurement points were aligned with one of the trusses, while the other row was positioned between trusses. Figure 40 and Figure 41 show the deflections at the 9 measurement points for Tests UF-07 and UF-08.

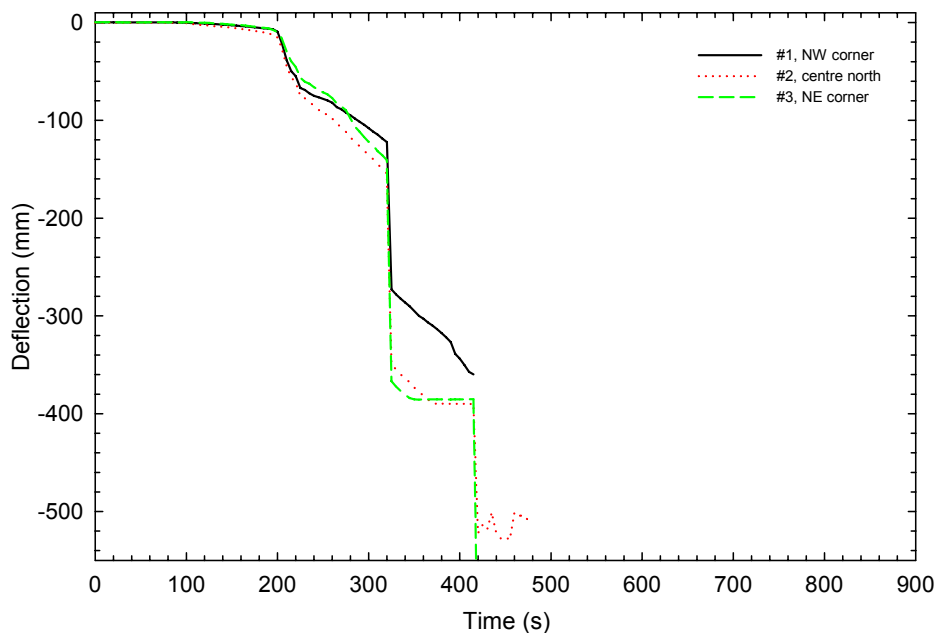
a) Floor Deflection, Row 1

**Figure 40 (a). Deflection measurements for rows 1, 2 and 3 for Test UF-07**

Figure 40 (a) shows the deflections measured in the first row (1, 2, and 3). Up to 200 s, the deflections were very small. After this time, the deflections increased at a relatively moderate rate, reaching about 120 mm at 320 s for point No. 1, 160 mm at 320 s for point No. 2, and 140 mm after 320 s for point No. 3. The sharp increase (vertical line) in deflection at 320 s indicates that the concrete blocks were falling and the floor was collapsing.

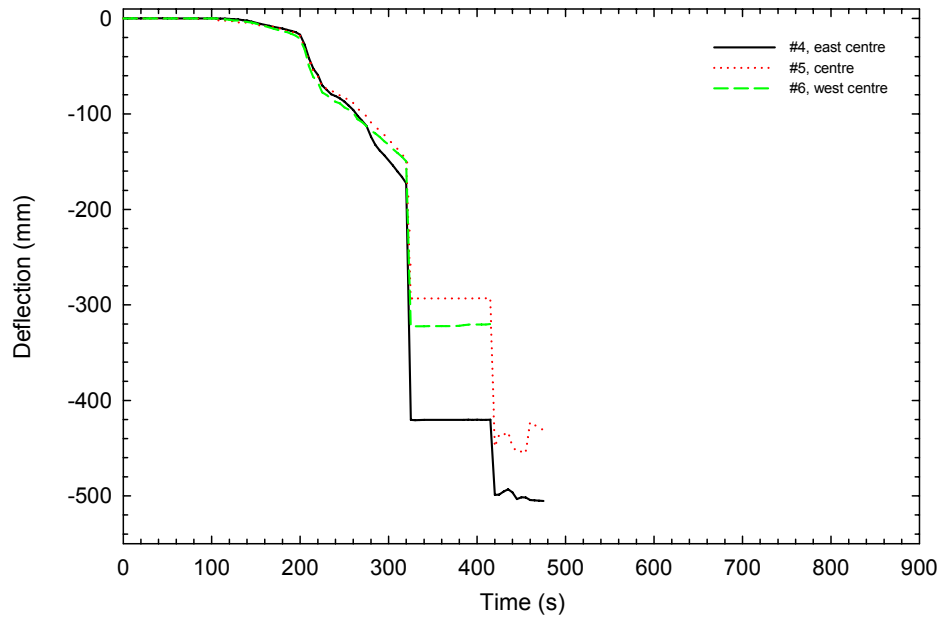
b) Floor Deflection, Row 2

**Figure 40 (b). Deflection measurements for rows 1, 2 and 3 for Test UF-07**

Figure 40 (b) shows the deflections measured in the second row (4, 5, and 6). Up to 200 s, the deflections were very small. After this time, the deflections increased at a relatively moderate rate, reaching about 170, 150 and 150 mm at 320 s for points 4, 5 and 6, respectively. The sharp increase (vertical line) in deflection at 320 s indicates that the concrete blocks were falling and the floor was collapsing.

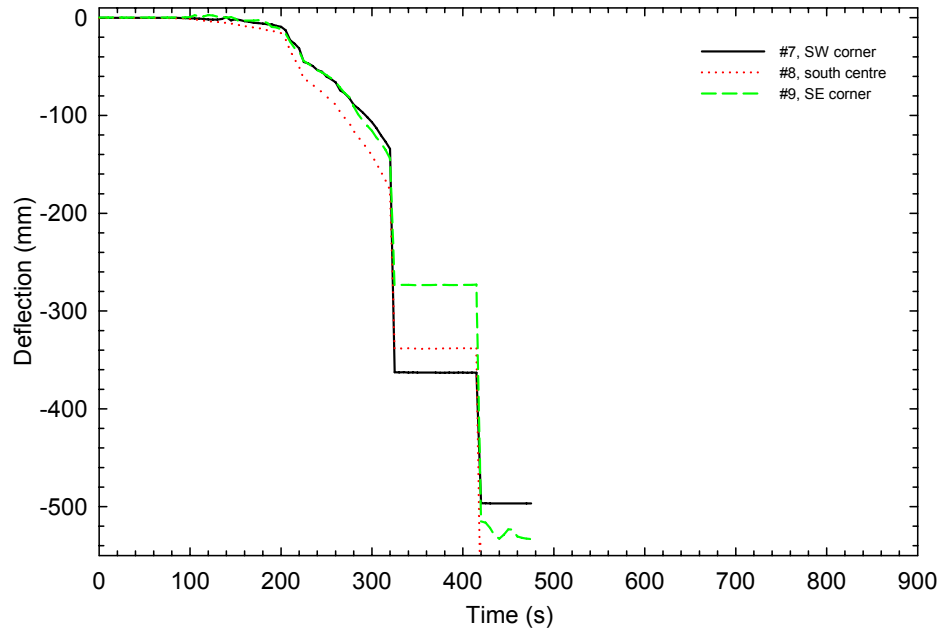
c) Floor Deflection, Row 3

**Figure 40 (c). Deflection measurements for rows 1, 2 and 3 for Test UF-07**

Figure 40 (c) shows the deflections measured in the third row (7, 8, and 9). Up to 200 s, the deflections were very small. After this time, the deflections increased at a relatively moderate rate, reaching about 140 mm at point No. 7, 180 mm at point No. 8, and 140 mm at point No. 9. The sharp increase (vertical line) in deflection at 320 s indicates that the concrete blocks were falling and the floor was collapsing. The time of floor collapse was 325 s (visually observed through the basement window opening).

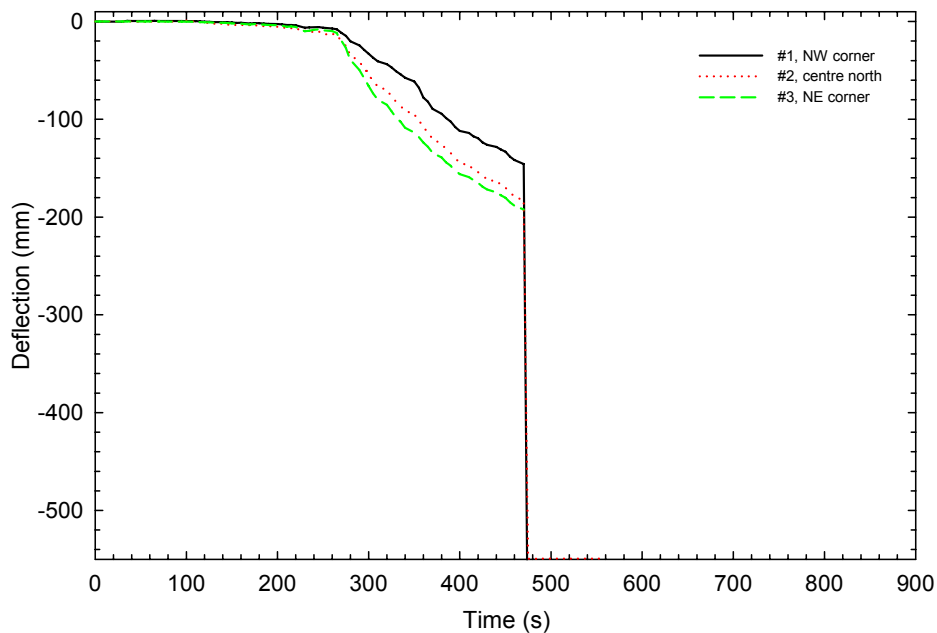
a) Floor Deflection, Row 1

**Figure 41 (a). Deflection measurements for rows 1, 2 and 3 for Test UF-08**

Figure 41 (a) shows the deflections measured in the first row (1, 2, and 3). Up to 260 s, the deflections were very small. After this time, the deflections increased at a relatively moderate rate, reaching about 140 mm at point No. 1, 170 mm at point No. 2, and 180 mm at point No. 3 at 470 s. The sharp increase (vertical line) in deflection after 470 s indicates that the concrete blocks were falling and the floor was collapsing.

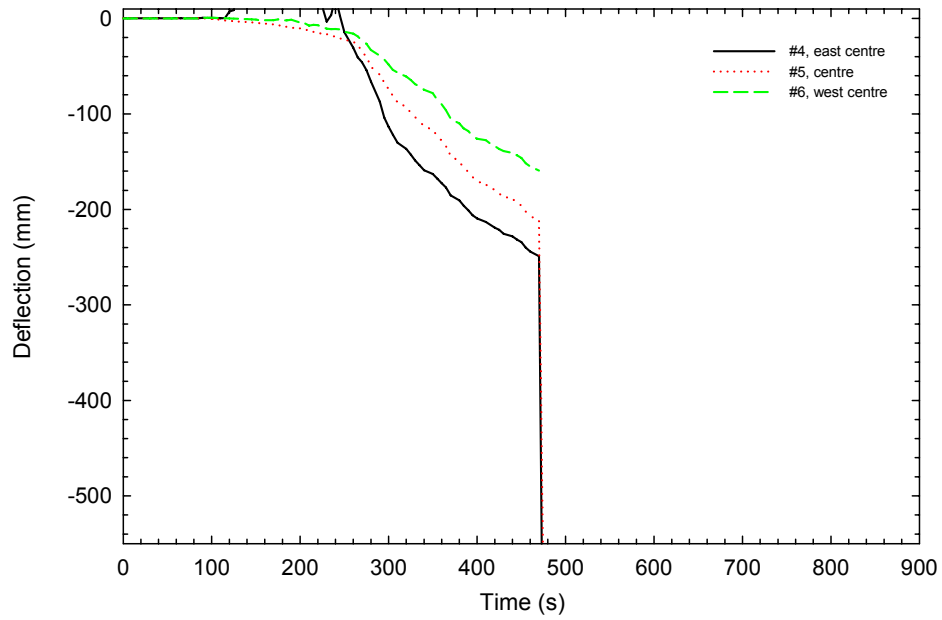
b) Floor Deflection, Row 2

**Figure 41 (b). Deflection measurements for rows 1, 2 and 3 for Test UF-08**

Figure 41 (b) shows the deflections measured in the second row (4, 5, and 6). Up to 200 s, the deflections were very small. After this time, the deflections increased at a relatively moderate rate, reaching about 250, 200 and 160 mm at 470 s at points 4, 5 and 6, respectively. The sharp increase (vertical line) in deflection after 470 s indicates that the concrete blocks were falling and the floor was collapsing.

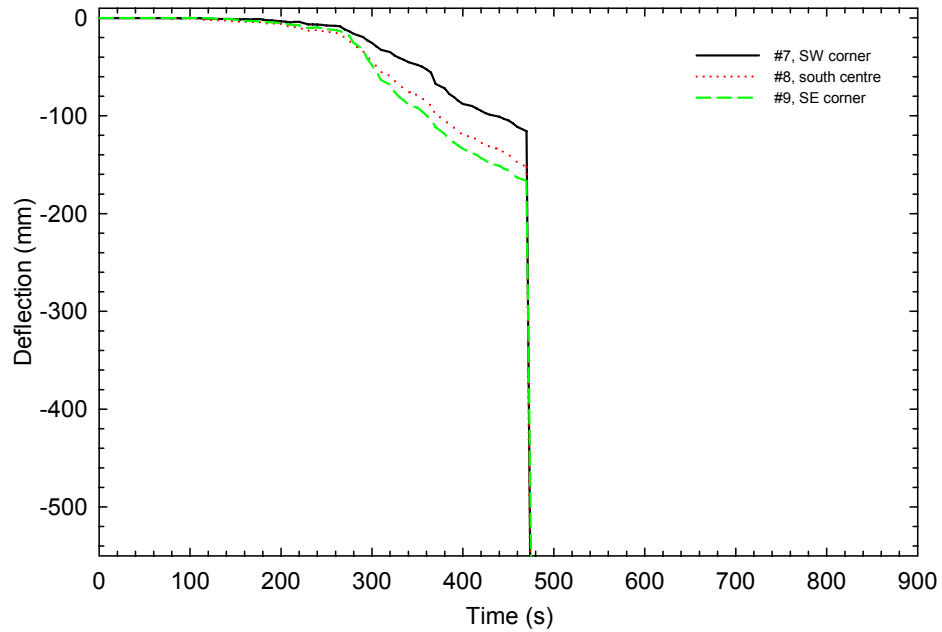
c) Floor Deflection, Row 3

**Figure 41 (c). Deflection measurements for rows 1, 2 and 3 for Test UF-08**

Figure 41 (c) shows the deflections measured in the third row (7, 8, and 9). Up to 260 s, the deflections were very small. After this time, the deflections increased at a relatively moderate rate, reaching 120 mm at point No. 7, 150 mm at point No. 8, and 160 mm at point No. 9 at 470 s. The sharp increase (vertical line) in deflection after 470 s indicates that the concrete blocks were falling and the floor was collapsing. The time of floor collapse was 474 s (visually observed through the basement window opening).

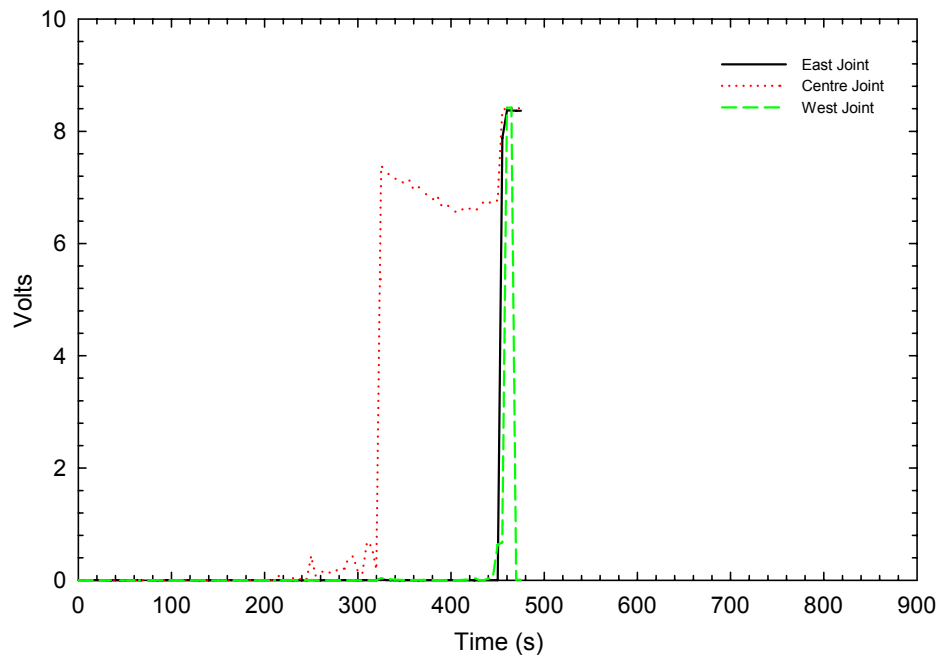
**Figure 42. Results of flame sensors at different joints for Test UF-07**

Figure 42 shows the results of the flame-sensing devices. Three wire meshes were installed on the top of three joints (East, Centre and West) on the unexposed side of the floor as shown in Figure 17 (instrumentation figure). There was a sudden increase in the voltage output of the flame-sensing device when flames penetrated through the floor and struck the wire meshes. As indicated by Figure 42, flame penetration occurred at the Centre Joint at 320 s, which was very close to the failure of the floor assembly.

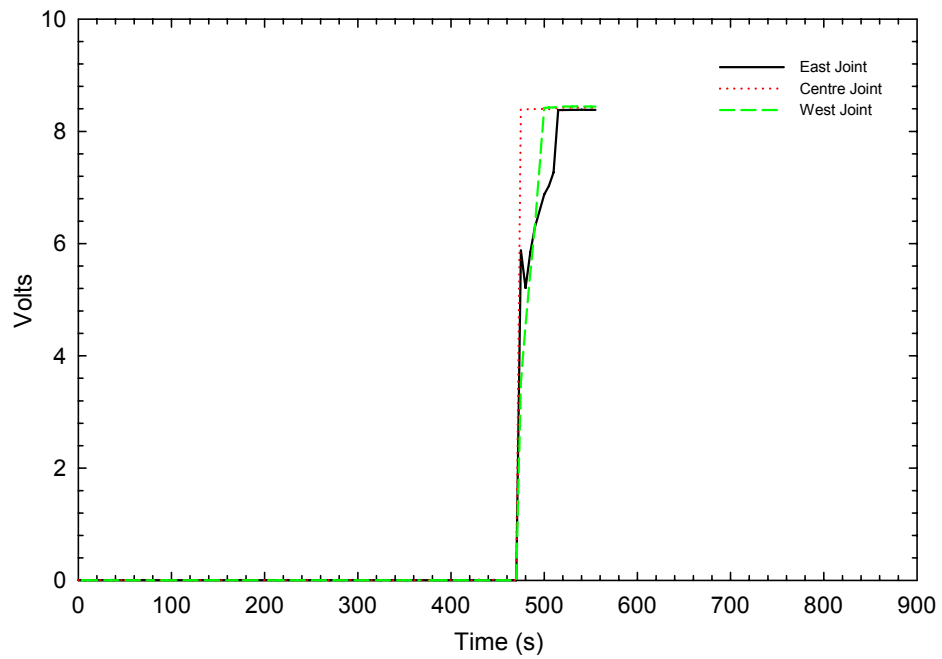
**Figure 43. Results of flame sensors at different joints for Test UF-08**

Figure 43 shows the results from the three flame-sensing devices, which were installed on the top of three joints (East, Centre and West) on the unexposed side of the floor as shown in Figure 17 (instrumentation figure). There was an increase in the voltage output of the device when flames penetrating through the floor struck the device. As indicated by Figure 43, the flames penetrated at all joints at 470 s, which was very close to the failure of the floor assembly.

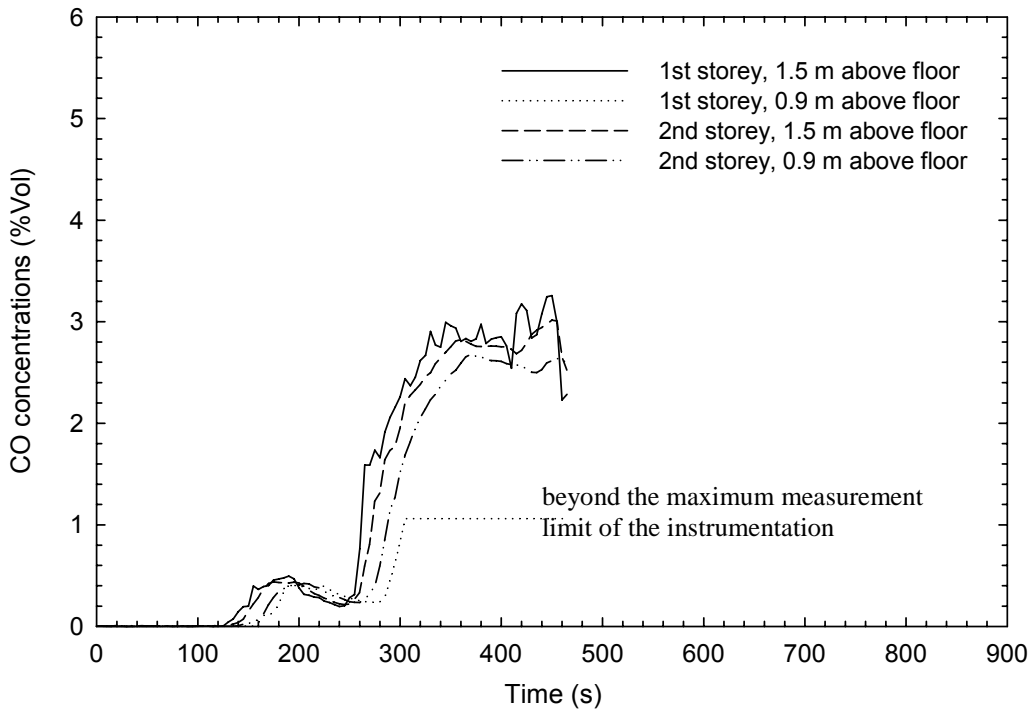
Figure 44. CO measurements for Test UF-07

Table 3 shows the maximum CO and CO<sub>2</sub> concentrations and the minimum O<sub>2</sub> concentrations for Tests UF-07 and UF-08. Figure 44 to Figure 46 and Figure 48 to Figure 50 (figures commence on page 85) show the CO, CO<sub>2</sub> and O<sub>2</sub> concentration-time profiles measured during Tests UF-07 and UF-08. The gases were well mixed in the test house.

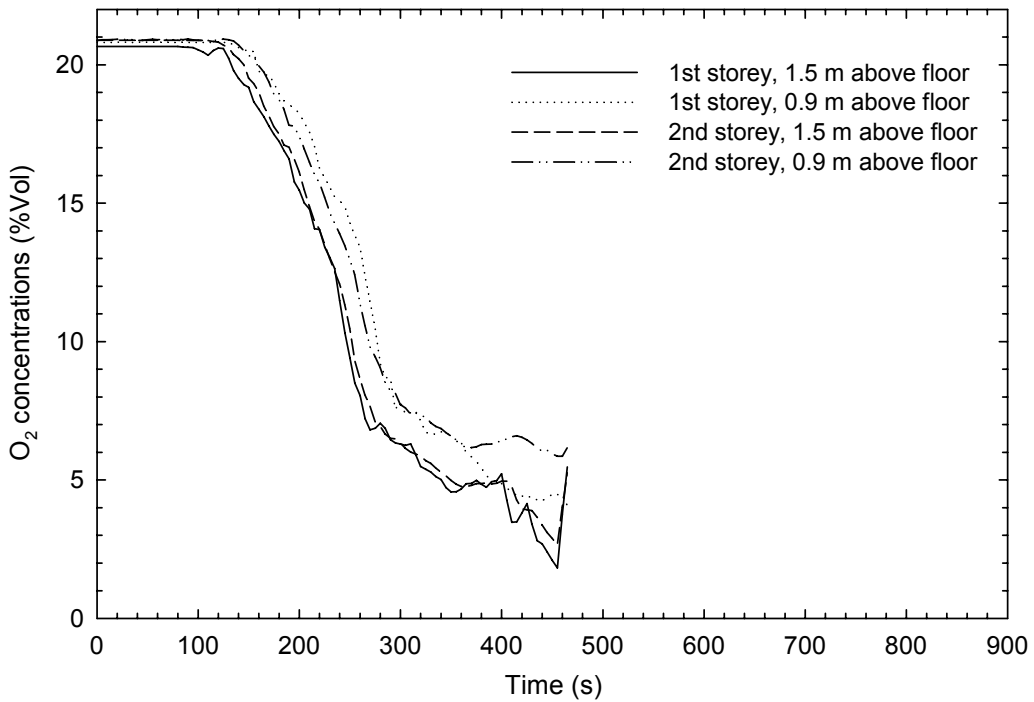
Figure 45. O<sub>2</sub> measurements for Test UF-07

In Test UF-07 (see Figure 45), the O<sub>2</sub> concentration on both the first and second storeys dropped to below 10% in 240 s and to 5% at 325 after ignition. The O<sub>2</sub> vitiation alone would cause incapacitation after 330-335 s (1<sup>st</sup> storey-2<sup>nd</sup> storey) using  $F_{in,O_2} = 1$  as a criterion, or after 285-290 s (1<sup>st</sup> storey-2<sup>nd</sup> storey) using  $F_{in,O_2} = 0.3$ .
