Fire Performance of Houses. Phase I.  
Study of Unprotected Floor Assemblies in  
Basement Fire Scenarios  
Part 6

### **Part 6 – Results of Tests UF-07 and UF-08 (Metal-Web-Connected Wood Trusses)**

Research Report: IRC-RR-251

Date: March 31, 2009

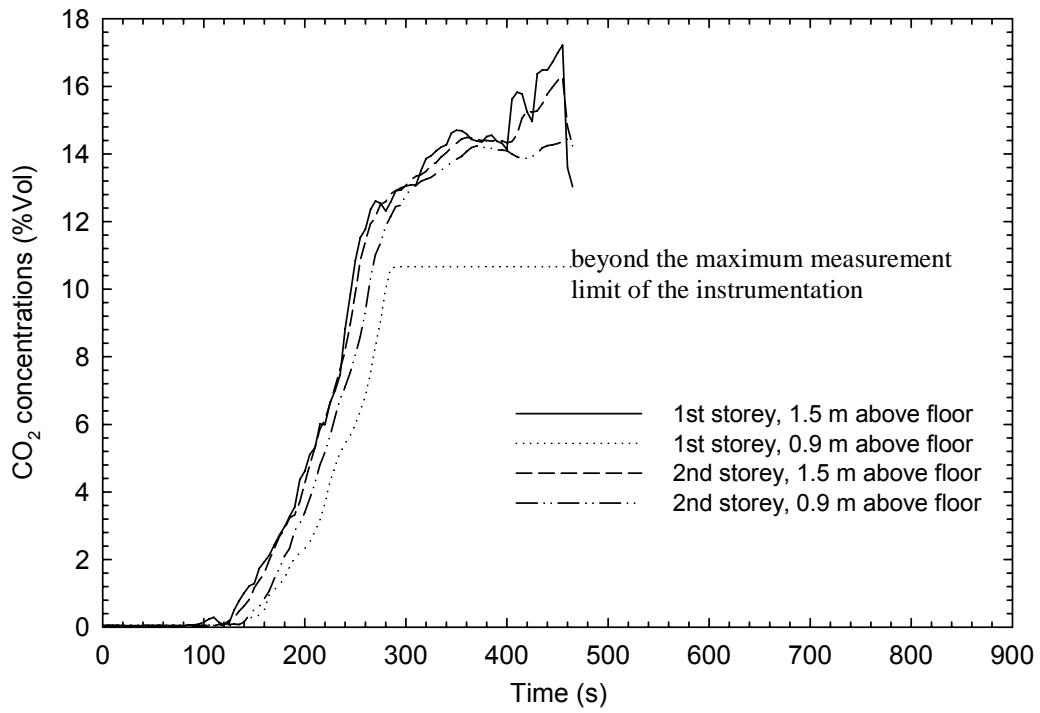
**Figure 46. CO<sub>2</sub> measurements for Test UF-07**

In Test UF-07 (see Figure 46), the CO<sub>2</sub> concentration exceeded 10% in 240 s. The increased concentration of CO<sub>2</sub> alone would cause incapacitation after 290-295 s (1<sup>st</sup> storey-2<sup>nd</sup> storey) using  $F_{in,CO_2} = 1$  as a criterion, and after 260-265 s (1<sup>st</sup> storey-2<sup>nd</sup> storey) using  $F_{in,CO_2} = 0.3$ .

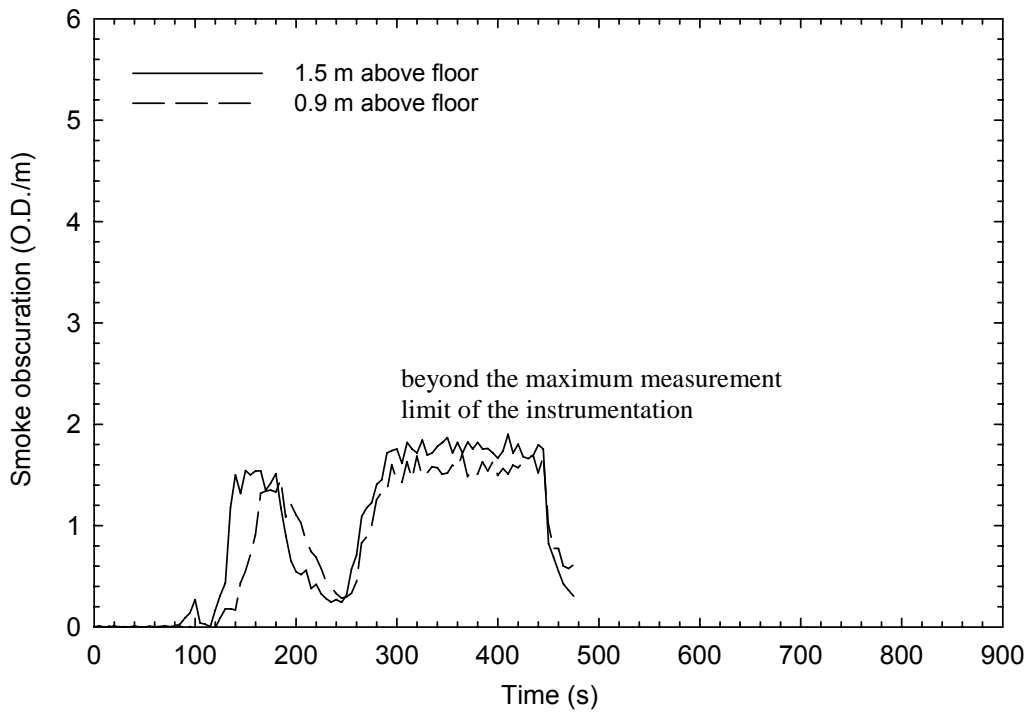
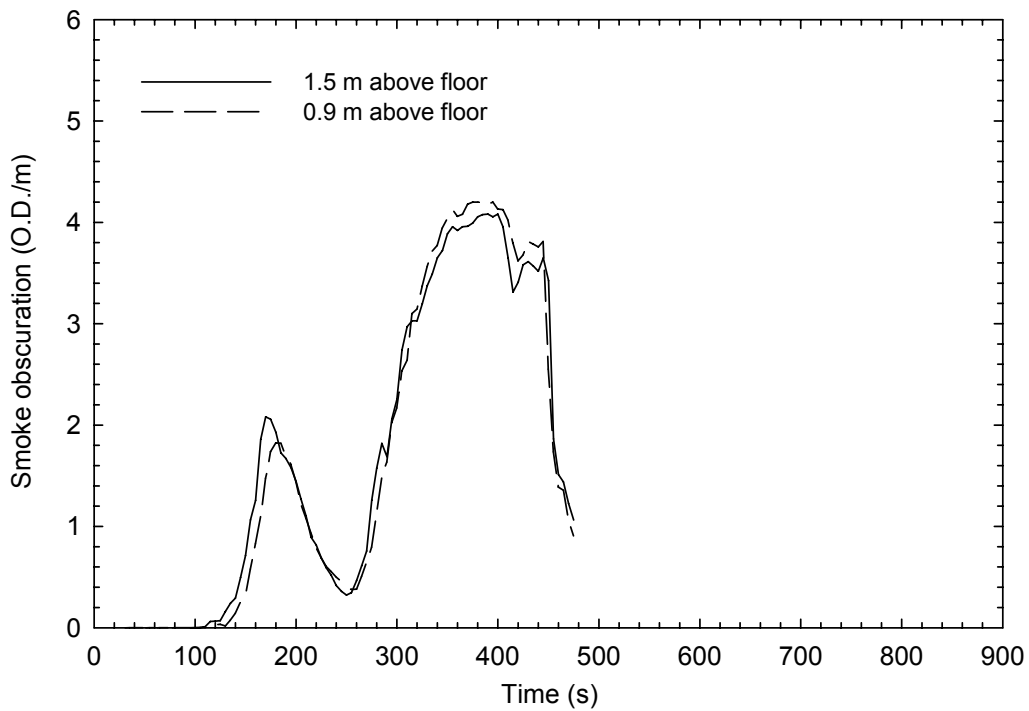
a) Smokemeters - 1st storey SW quadrant.

b) Smokemeters - 2nd storey corridor

Figure 47. Optical density measurements for Test UF-07

Figure 47 and Figure 51 show the optical density-time profiles measured on the first and second storeys. The times to reach various optical density levels at different locations for this series of the tests are listed in Table 8. It must be pointed out that the smoke density meters used for the first storey had a narrower range of signal output (0.15 to 0 V) while the smoke density meters used for the second storey had a wider working range (1 to 0 V). The starting voltage (0.15 or 1 V when there was no smoke) decreased due to smoke residue left over from the preceding tests on the light source and the detector inside the meters. This reduced the working range particularly for the smoke density meters used for the first storey, which became saturated at a lower OD level than the meters used for the second storey. The smoke density meters used for the first storey were not able to measure the smoke obscuration of  $OD = 2 \text{ m}^{-1}$  and beyond. The analysis of video records indicated that by the time when  $OD = 2 \text{ m}^{-1}$  was reached in the corridor on the second storey, there was complete smoke obscuration in the test house.

With the basement door closed in Test UF-08, the increase in  $OD$  was slower at various measurement points than in Test UF-07 (compare Figure 47 and Figure 51). The  $OD_{Limit} = 2 \text{ m}^{-1}$  was reached at 360 s in the corridor on the second storey. Both the

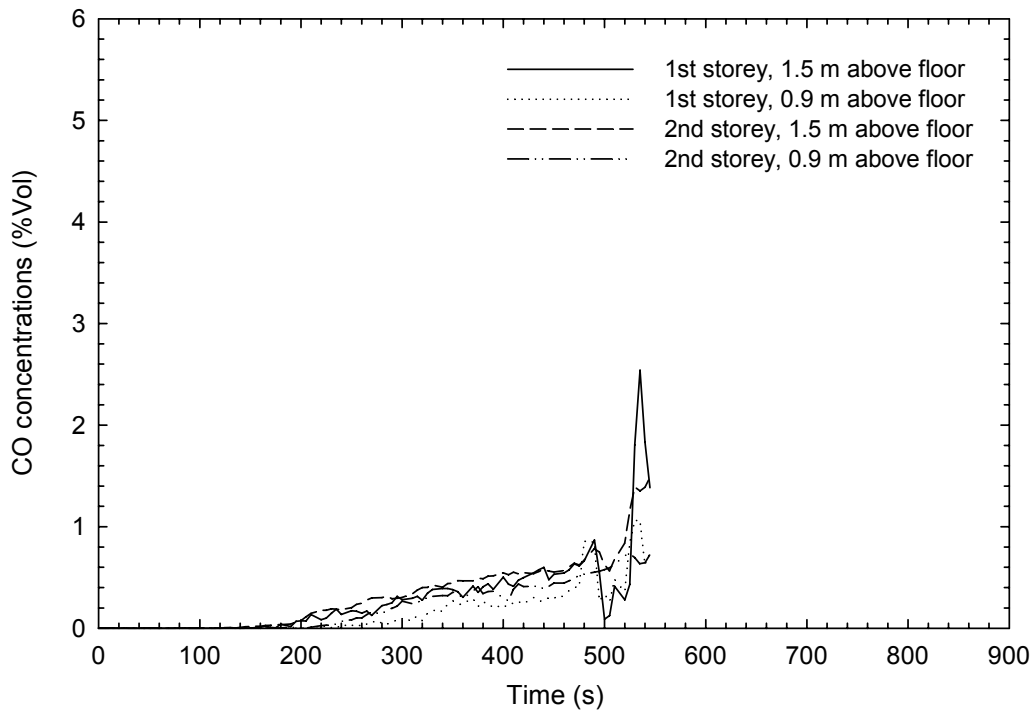
**Figure 48. CO measurements for Test UF-08**

Table 3 shows the maximum CO and CO<sub>2</sub> concentrations and the minimum O<sub>2</sub> concentrations for Tests UF-07 and UF-08. Figure 44 to Figure 46 and Figure 48 to Figure 50 (figures commence on page 85) show the CO, CO<sub>2</sub> and O<sub>2</sub> concentration-time profiles measured during Tests UF-07 and UF-08. The gases were well mixed in the test house.

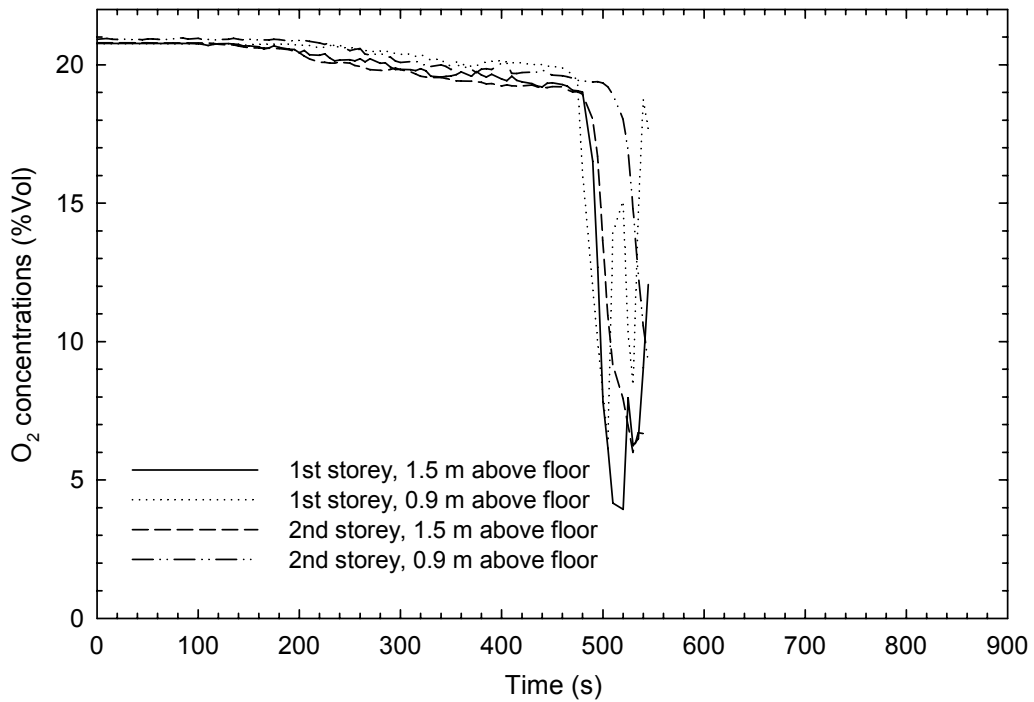
**Figure 49. O<sub>2</sub> measurements for Test UF-08**

In Test UF-08 (see Figure 49), the O<sub>2</sub> concentrations in both storeys were above 19% for the first 480 s, after which the O<sub>2</sub> concentrations fell to below 5%. The O<sub>2</sub> vitiation alone would not result in incapacitation until after structural failure.

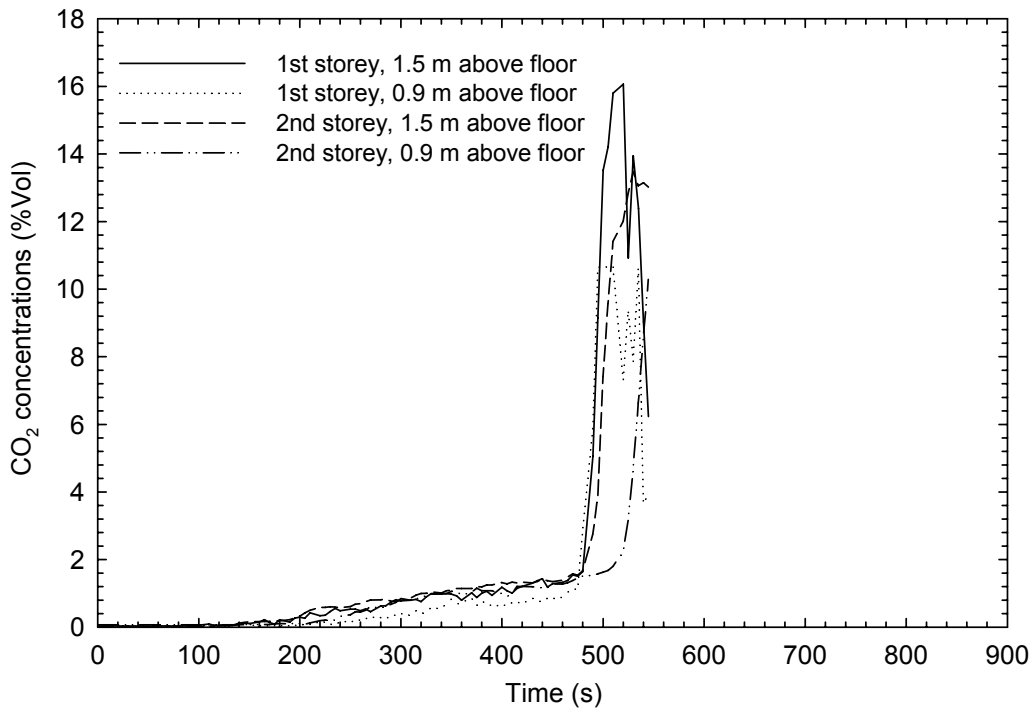
Figure 50. CO<sub>2</sub> measurements for Test UF-08

In Test UF-08 (see Figure 50), the CO<sub>2</sub> concentrations in both storeys were below 2% for the first 480 s, after which the CO<sub>2</sub> concentrations increased sharply up to 16%. CO<sub>2</sub> alone would only cause incapacitation on the first storey 500 s after ignition.

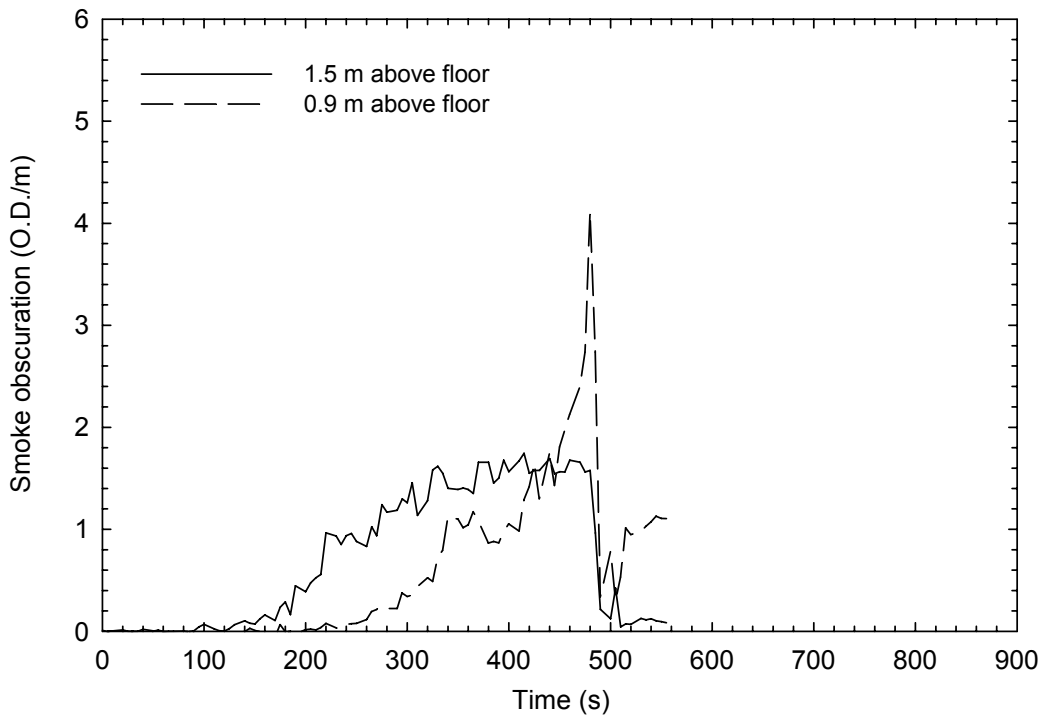
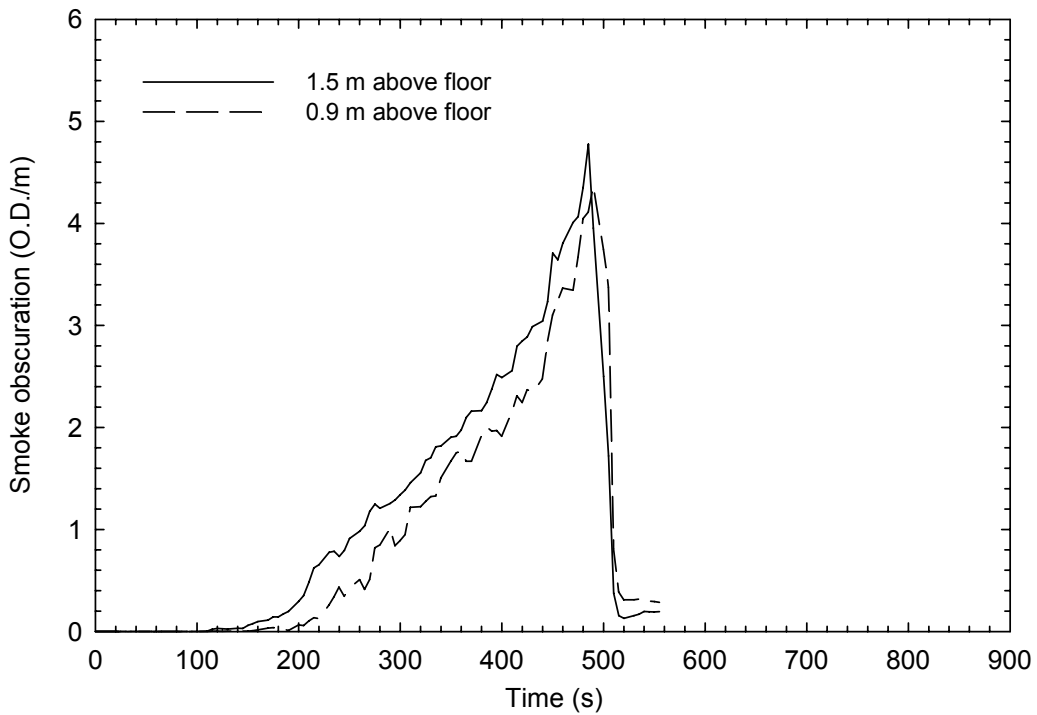
a) Smokemeters - 1st storey SW quadrant.

b) Smokemeters - 2nd storey corridor

Figure 51. Optical density measurements for Test UF-08

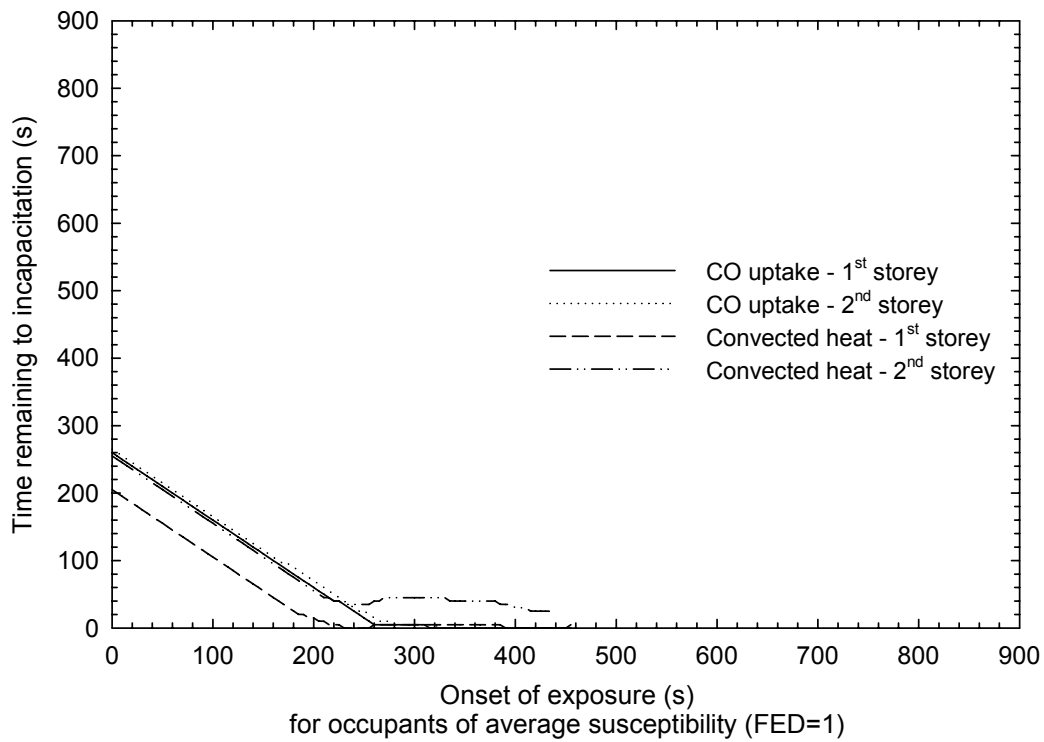
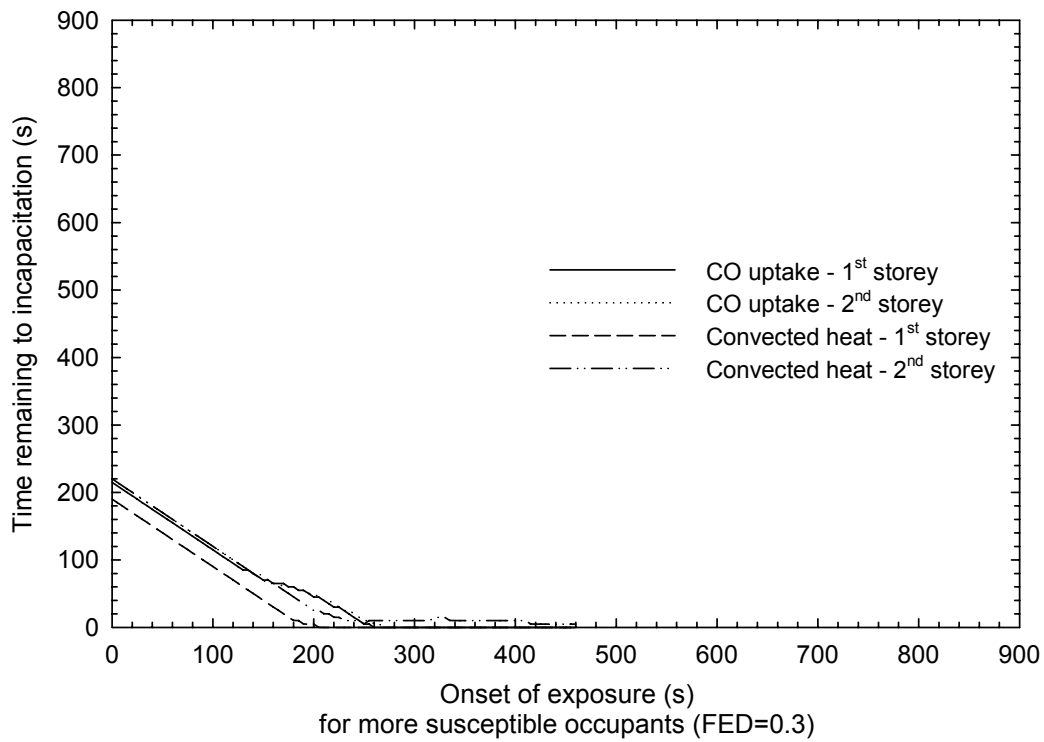
**Figure 52. Time remaining to incapacitation versus onset of exposure for Test UF-07 (ignition at time zero)**

Further analysis was also conducted for exposure starting at times later than ignition. This further analysis is important for occupants who would have been in the closed bedroom but tried to open the bedroom door to escape through the normal routes. Figure 52 and Figure 53 show the time remaining to incapacitation calculated from the convected heat and hyperventilated CO exposure for people of average susceptibility (FED=1) and for more susceptible occupants (FED=0.3) as a function of onset of exposure. Again, this calculation was associated with particular positions where the concentrations or temperatures were measured (each calculated time applies to an occupant who would have stayed at that particular location). The actual time to incapacitation would be in between the times calculated for different locations since an occupant would have moved through different locations during egress.

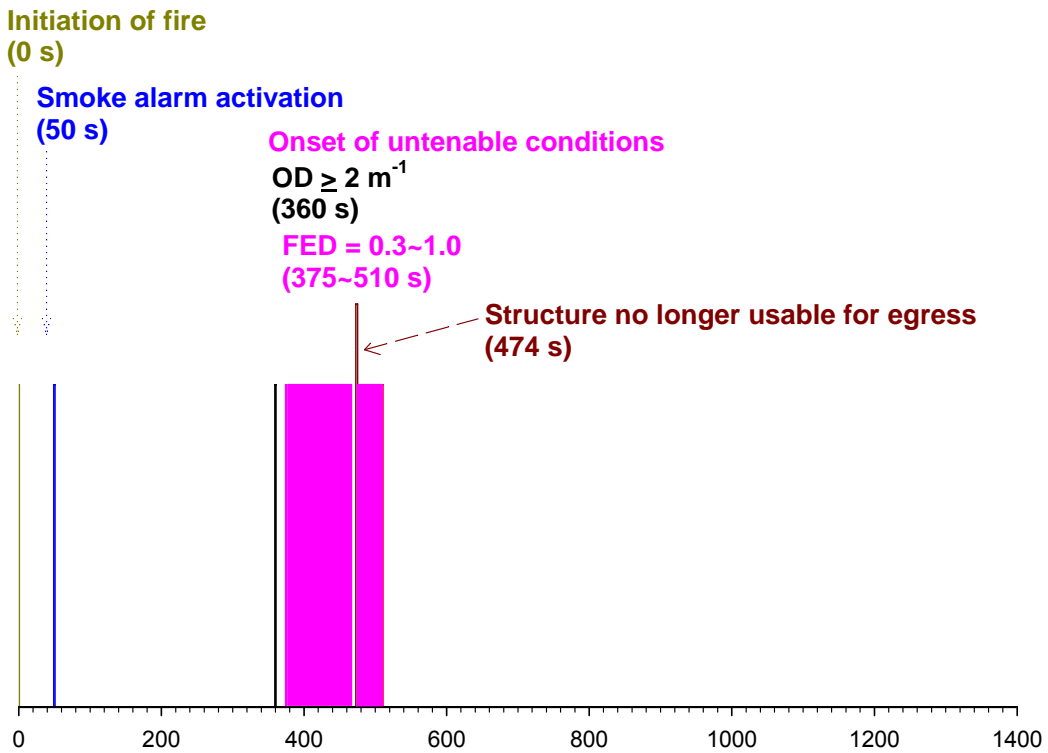
**Figure 55. Sequence of fire events in Test UF-08 (s)**

In Test UF-08, the presence of the closed door to the basement reduced the rate of fire growth in the basement, and slowed down the transport of combustion products from the basement to the upper storeys. This prolonged the time available for escape before the onset of untenable conditions, and also delayed the time for the test assembly above the basement to reach structural failure. In this closed basement doorway scenario, the floor assembly failed structurally before the tenability limits were reached for healthy adults of average susceptibility. Because the floor failed structurally before the tenability limits were reached, this would represent a risk factor for occupants.
