GARAGE PERFORMANCE TESTING FINAL REPORT

Garage Performance Testing

Final Report

January 19, 2004

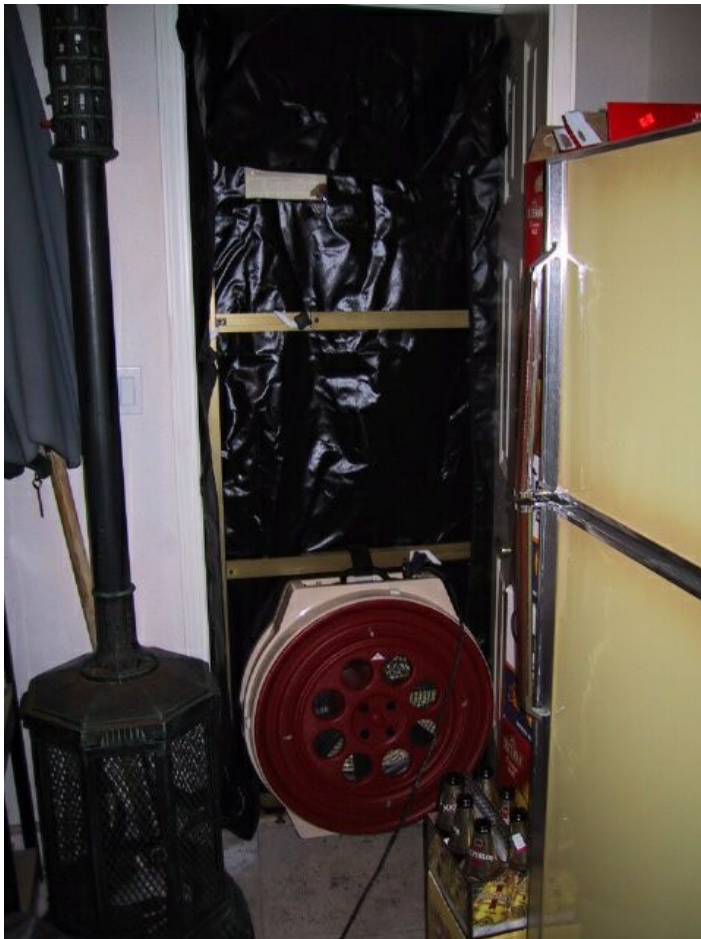
Figure 5: Fan Door Apparatus

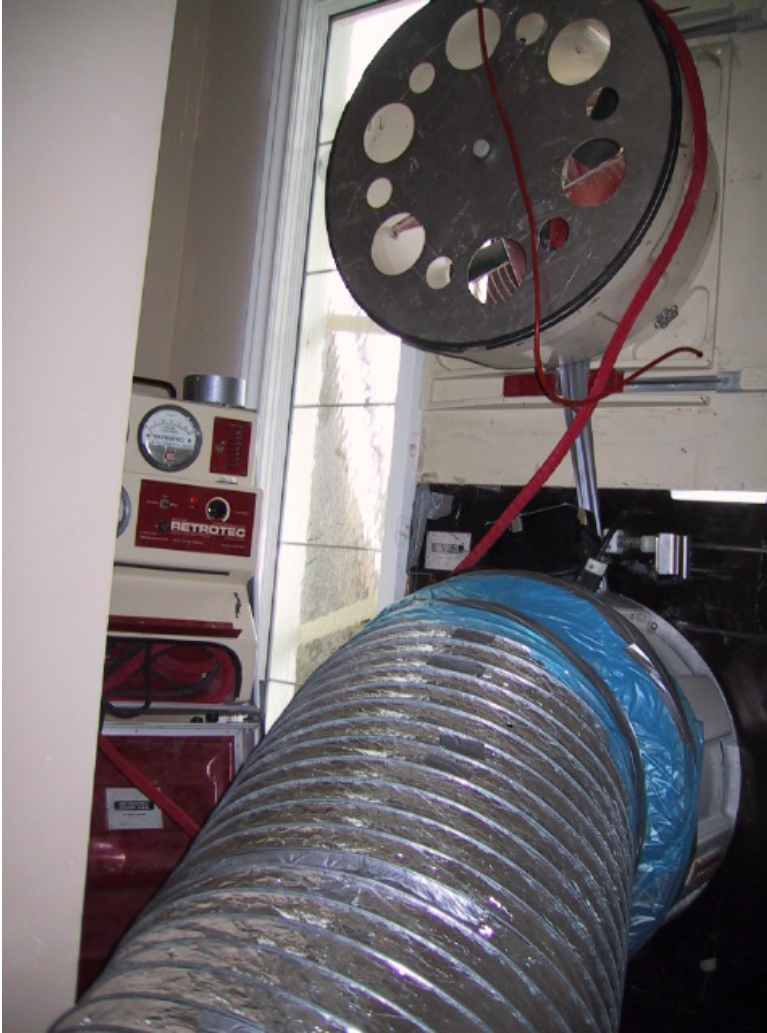
Figure 6: Flex Duct Configuration for Balanced Test

A number of the homes tested in Vancouver were row style. This added a level of complexity to the testing, as it was necessary to eliminate party wall leakage. This was done by testing end units and by using a third door fan to balance pressure across the party wall.

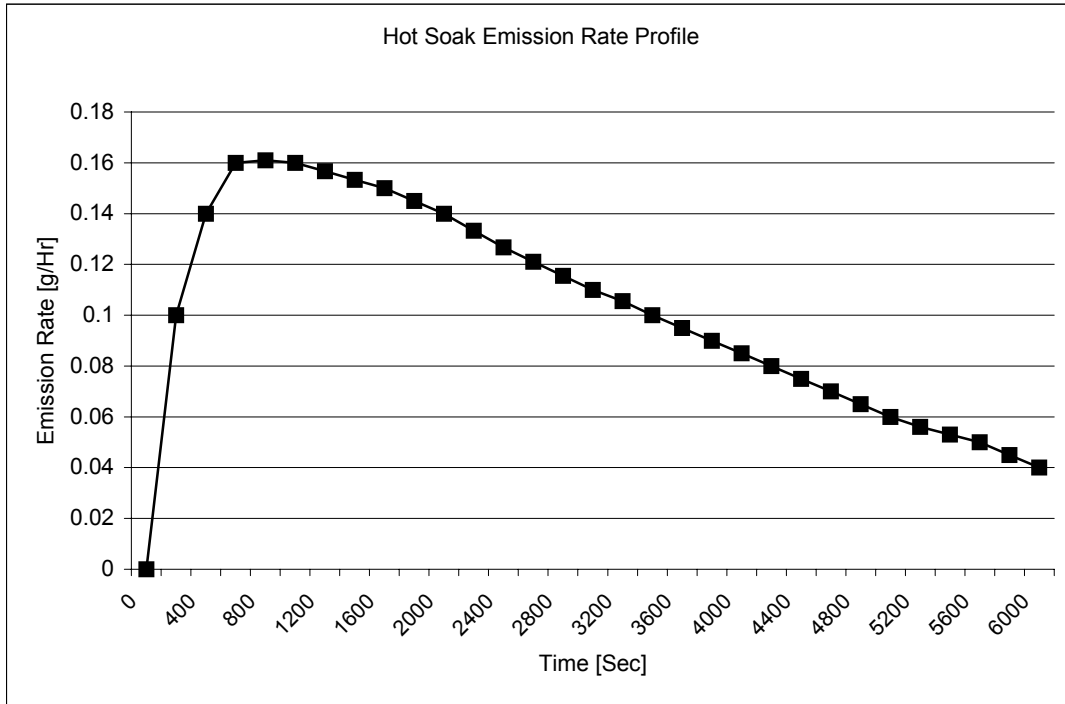
A hot soak test was simulated by releasing 10.5 mg of benzene, based on an emissions profile defined in Figure 7⁴. Ambient benzene concentrations were assumed to be 1.13 micrograms per cubic meter⁵. Chronic health effects are possible above a benchmark of 80 $\mu\text{g}/\text{m}^3$.⁶ Concentrations of benzene within the garage and living space were modelled in five-minute increments for 240 minutes.

Figure 7: Hot Soak Test Emission Profile

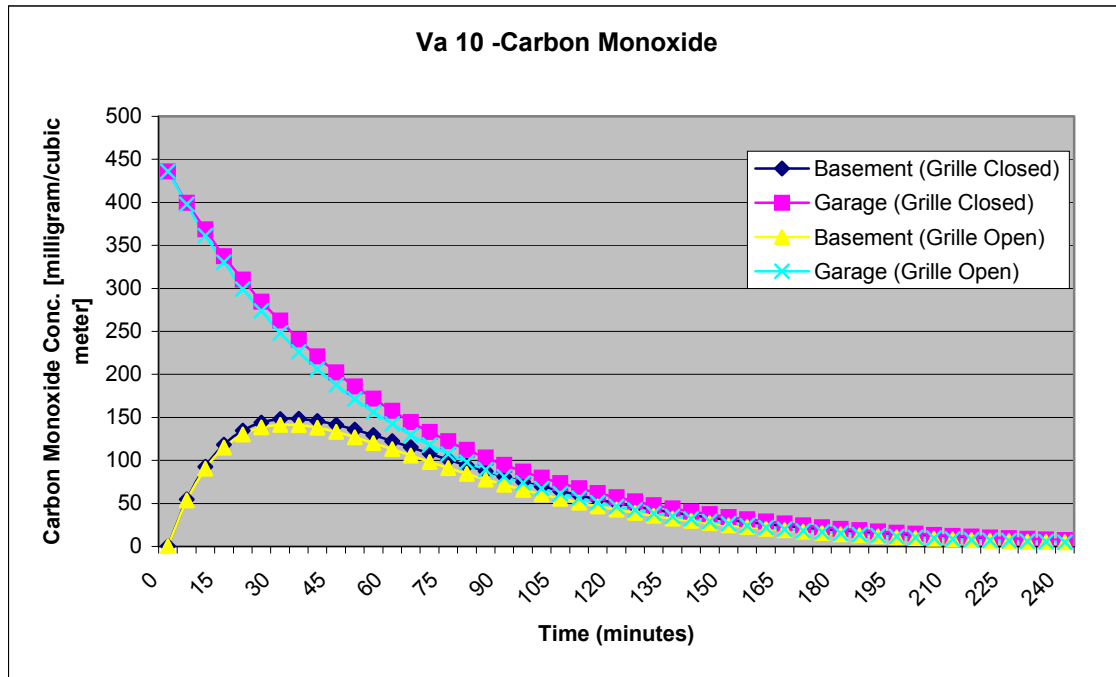
It should be noted in the table above that carbon monoxide concentrations remain constant with the transfer grille sealed or unsealed, whereas benzene concentrations vary. This difference is due to the test procedure modelled. In the case of the cold start test, a fixed amount of carbon monoxide is discharged at the beginning of the test, so the peak (initial) concentration of carbon monoxide in the garage is independent of mixing or dilution. Conversely, the benzene discharge in the hot soak test occurs over a two-hour period, so the peak concentration will depend on dilution and mixing.

Figure 10: Impact of Transfer Grille on Carbon Monoxide Concentration in Va 10

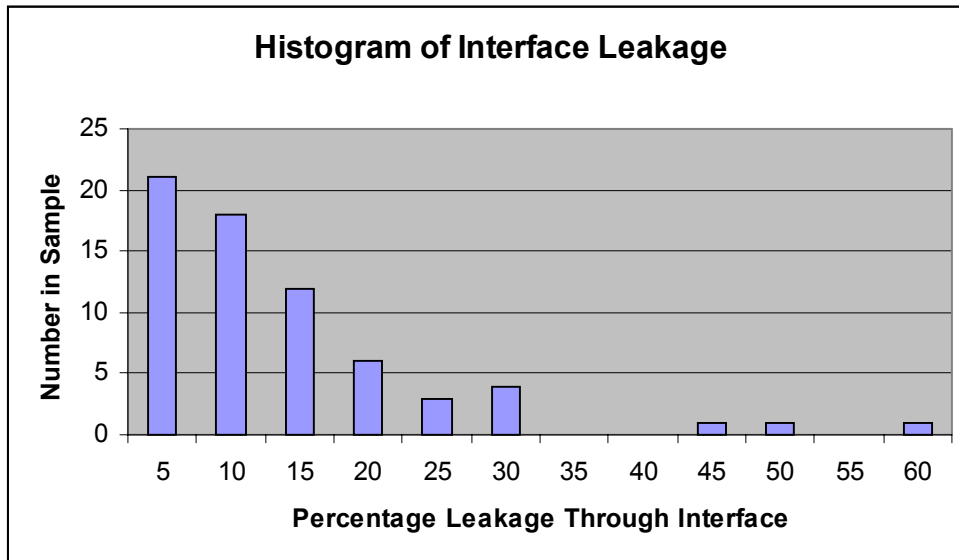
The 42 house sample results were combined with the Scanada results of 25 houses to develop a histogram of garage-to-house interface leakage. This information is summarised in Figure 14. As can be seen, 21 of the 67-house sample have a garage-to-house leakage of 5% or less. In fact, four in the sample had 0% of the leakage occurring through the garage-to-house interface. In total 60 out of 67 (90%) of houses tested have a garage-to-house interface leakage less than 25%. However, the remaining 10% have interface leakage that exceeds the threshold proposed.

Figure 14: Interface Air Leakage Histogram

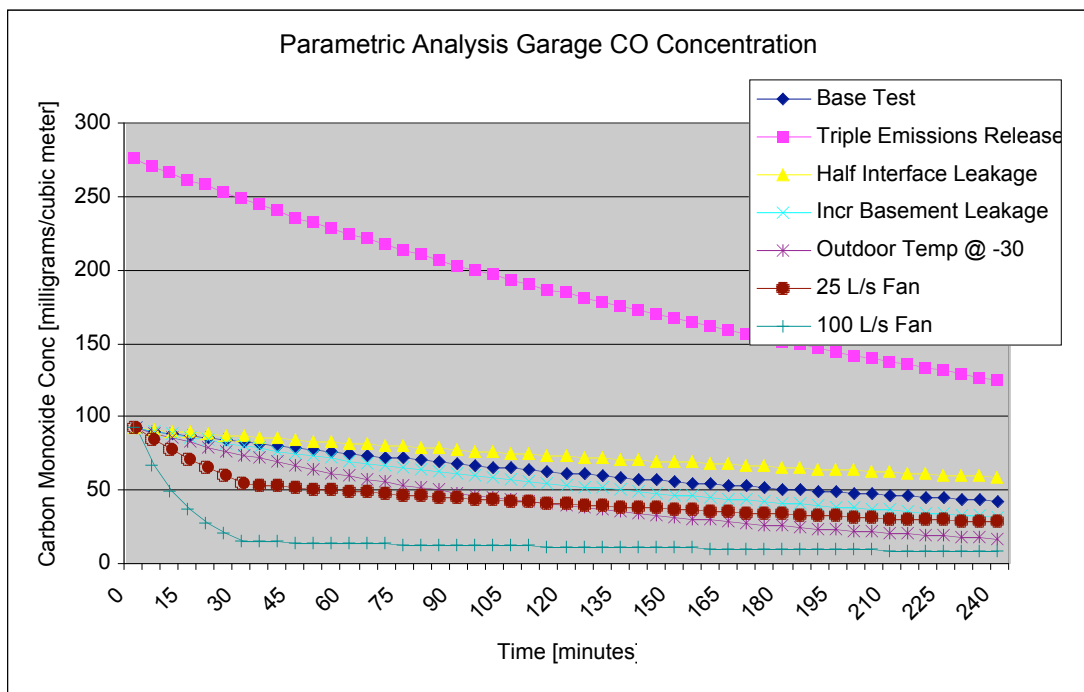
The results of these strategies on garage pollutant concentration and house pollutant concentration are shown in Figure 15 and Figure 16, respectively.

Figure 15: Parametric Results of Garage CO concentration

1. Increasing the pollutant concentration by a factor of three
2. Reducing the garage-to-house interface leakage by a factor of two
3. Reducing the outdoor temperature from 10 degrees Celsius to minus thirty degrees Celsius
4. Installing a 25 litre per second fan that runs for 30 minutes
5. Installing a 100 litre per second fan that runs for 30 minutes
