RESEARCH REPORT

COMPARISON OF UNDER-FLOOR INSULATION SYSTEMS

FINAL REPORT

June 2004

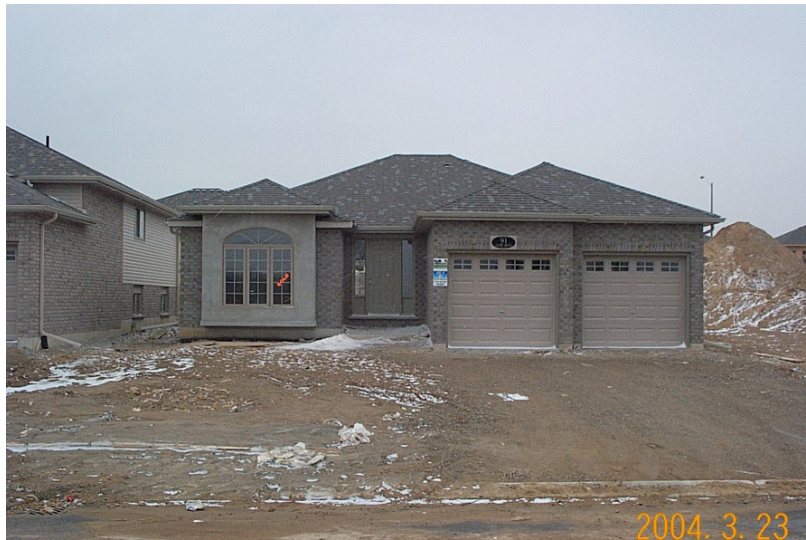
Figure 2.1: Typical Test House

This study involved monitoring four new houses in Paris, Ontario. The basement slab of the first house was left uninsulated, while the remaining three slabs were insulated. All four houses are located on the same block, have a basement floor area of roughly 112m² (1200ft²) and contain a single storey above grade with a full height basement directly below.

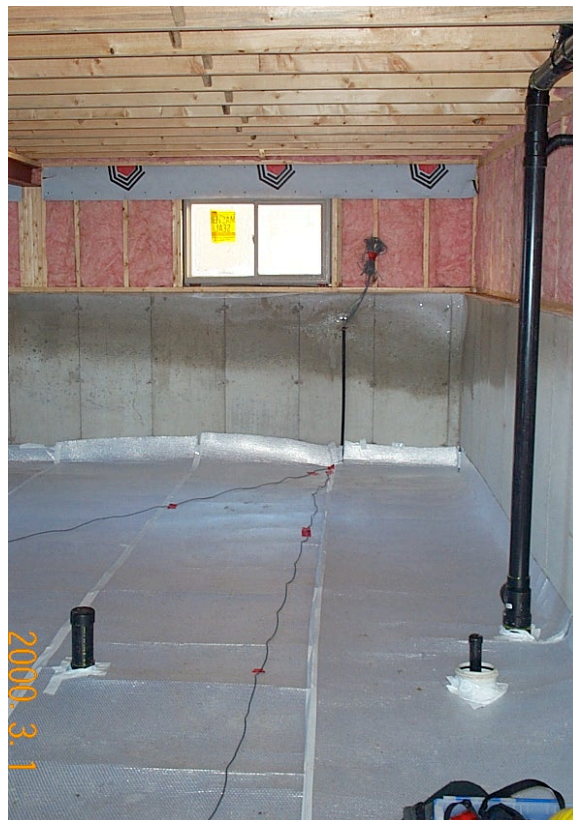
Figure 2.2: Ultra CBF Concrete Barrier rFOIL

Figure 2.2 shows the installation of the bubble pack, which consists of a reflective foil sandwiched between two layers of 7.9mm (5/16") thick clear bubble pack. Figure 2.3 shows the installation of polyurethane panels, which are 44.5mm (1 ½") of polyurethane insulation with a steel skin on either side. They are in fact reclaimed cut-outs from steel-skinned doors. Figure 2.4 shows the installation of 50mm (2") of extruded polystyrene.

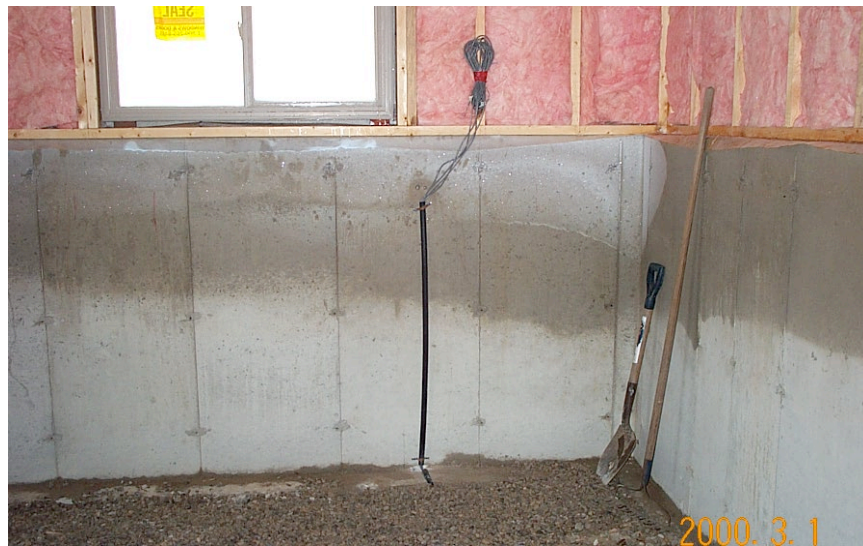
Figure 2.7: Installation of First Sensors

The first two sensors were installed at both locations (center and edge) several days before the insulation was put into place. The leads of these sensors were run over the granular

base to the foundation wall, up through plastic tubing and out through the foundation wall to the metering box (see Figure 2.7).

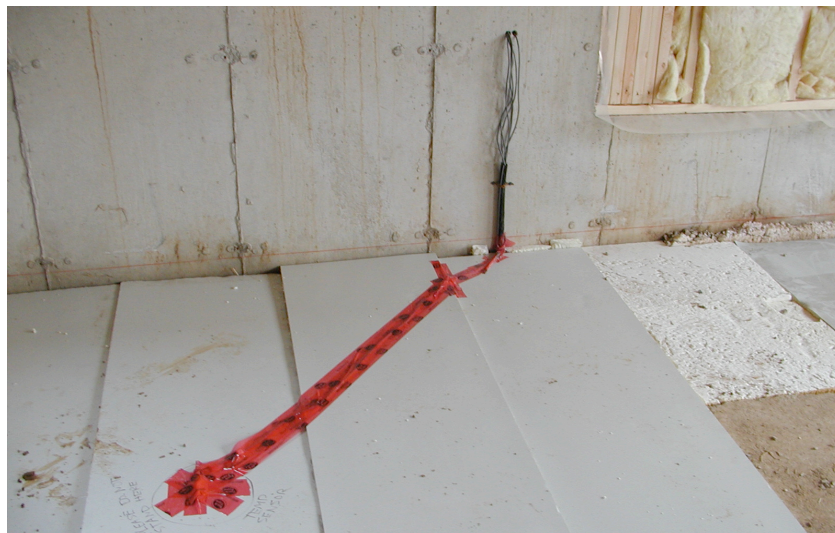
Figure 2.8: Sensor Installed on Insulation

After the insulation was installed and before the concrete slab poured, the third layer of sensors were installed (see Figure 2.8). The final sensors were installed after the concrete slab had been placed. A 15 mm deep saw-cut was made in the surface of the slab from the sensor location to the edge of the foundation wall. The RTDs were laid in the saw-cut and then grouted into place (see Figures 2.9 and 2.10). Measurements were made throughout the installation process to ensure that the sensors were installed directly over one another. In addition, each RTD was tested at the end of each stage to ensure they functioned properly. During the installation of the concrete slab in House #3 (Insta-Panels), the sensor on the insulation in the center of the basement (L1-S32) was damaged. This sensor reads "+OPEN" for the duration of the test period.

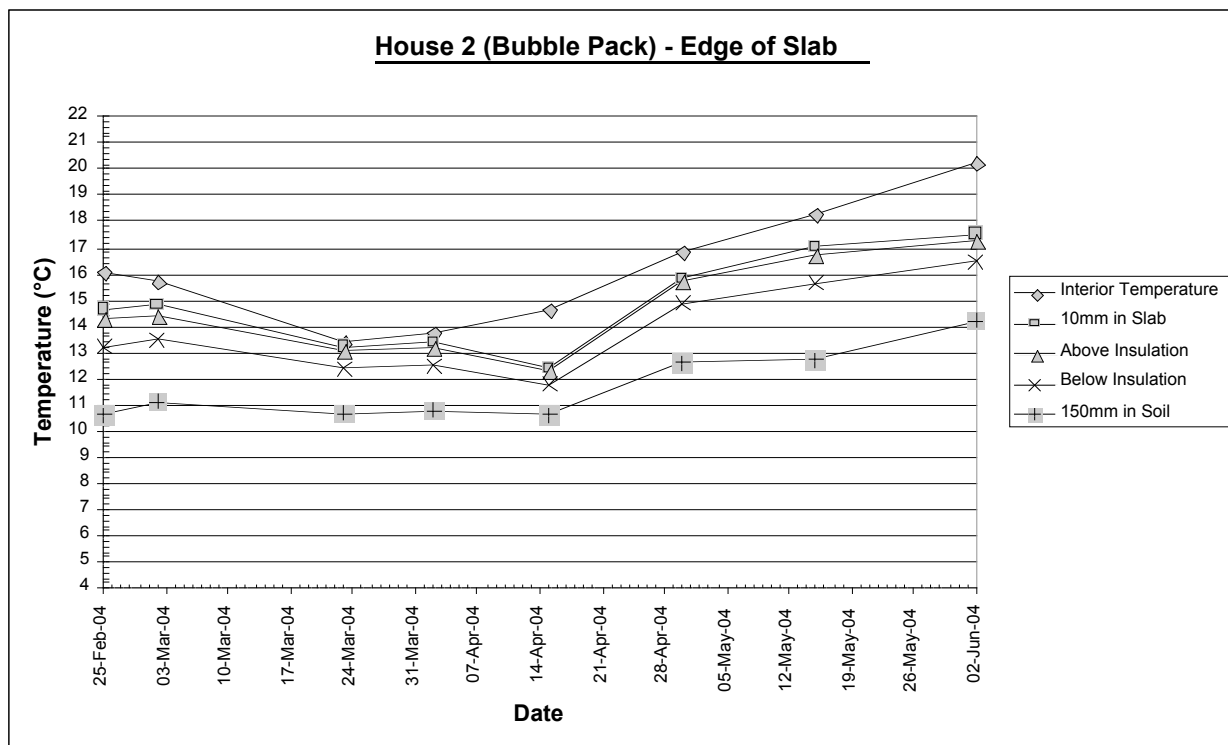
Measurements from the house with bubble pack insulation (see Figures 3.4 to 3.6) show the following:

- The four points from the top of the slab to 300mm below the insulation have a temperature differential slightly greater than that observed with no insulation. The average temperature difference between the slab and the deep soil temperature was 2.7°C , about double the value of the uninsulated slab.

- All of the recorded temperatures, including the deep ground temperature, appear to be influenced by the basement temperature. The influence of this temperature on the ground is evident during most measurement periods, as the ground temperatures generally move in the same direction as the slab temperature.

- As in the house with no insulation, the measured ground temperatures were higher than expected. Under the bubble pack insulated slab, the ground temperature was around 11°C at the beginning and 14°C to 15°C at the end of the test period.

- The temperature trends through the bubble pack insulated floor are similar in nature to those of the uninsulated floor.
