# RESEARCH REPORT

Understanding Vapour Permeance and Condensation in Wall Assemblies : Volume 2: Appendices

# APPENDIX A - REFERENCE LIST/SUMMARY

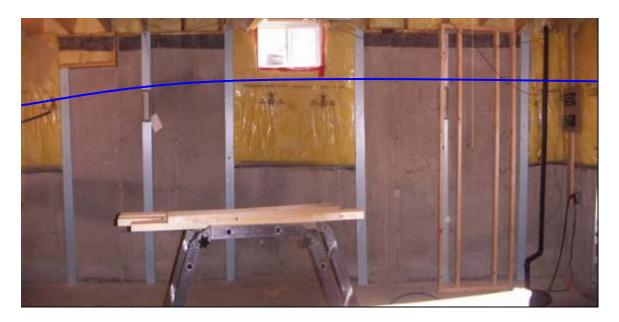
Figure 1.1: Basement walls under construction. Concrete foundation wall visible. Blue line indicates exterior grade level.

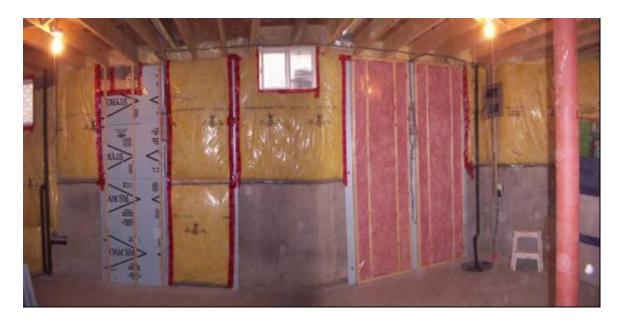
Figure 1.2: Basement walls under construction. Prior to gypsum board installation. From Left to right, XPS, Roll Batt, Stud w/ Poly, Stud w/o Poly.

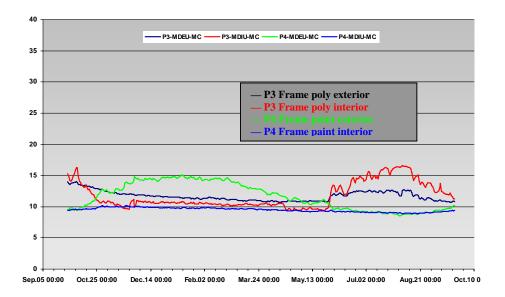
Figure 2.1: Upper framing moisture contents, exterior and interior sides

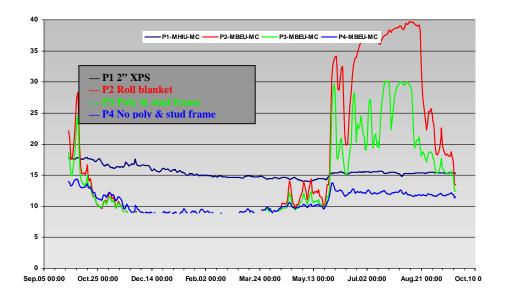
**Figure 2.2:** Upper moisture content wafers at concrete-insulation interface (XPS wall) or at insulation-vapour barrier/drywall interface (remainder)

The upper MC wafers in the four walls are compared in the plot above; field observations showed that the "no poly" wafer was intact, and the "poly" and roll blanket walls had mold growth. This clearly matches the data plotted above: the two wafers with mold growth had moisture content peaks at 30 to 40%, while the intact wafers had moisture contents in the 10-15% range.

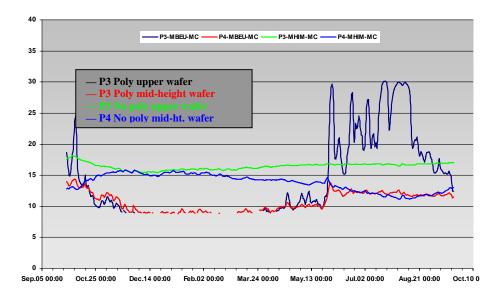
Figure 2.3: Upper and mid-height moisture content wafers in framed walls (P3 poly and P4 no poly)

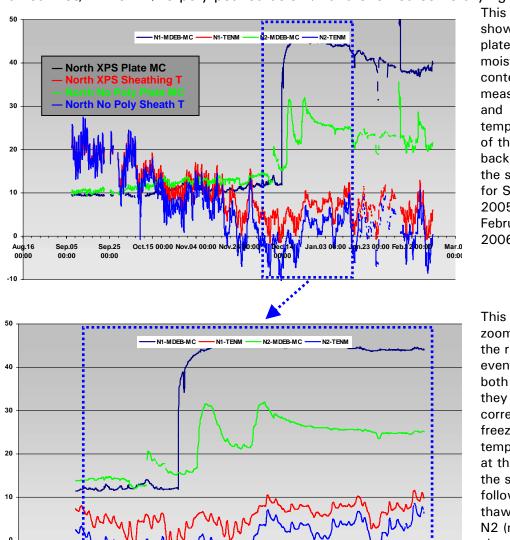
This plot shows sill plate outboard moisture content measurements and temperature of the backside of the sheathing for September 2005 through February 2006.

The north side XPS and no poly walls both had evidence of condensation on the interior side of the sheathing followed by rundown. However, the observed damage was substantially different: the XPS wall showed mold growth all along the bottom plate, while the no poly wall only showed some staining. This is correlated by the response of the outboard sill plate moisture content measurements: N1/XPS peaked at 45% and remained wet, while N2/no poly peaked at 32% and showed some drying.

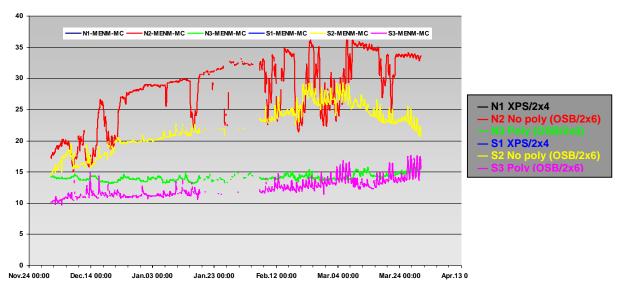
Note that the peak uncorrected moisture content of the south no poly OSB was around 28%: this is just at the boundary of condensation (100% RH), assuming a typical sorption isotherm. In comparison, the moisture content of the north side sheathing (37% maximum) suggests substantial condensation. This is in line with Susan Doll's work (2002), which demonstrated that fast mold growth occurs in the presence of liquid water, while it is much slower at non-condensing high humidity levels.

The north side no poly wall had consistent mold growth on the OSB, while the identical south wall had little if any evidence of growth. Both of the polyethylene walls showed completely intact OSB sheathing. The moisture content measurements of those four walls are compared: it shows the north side no poly wall peaked around 37%, while the south side peaked only around 28%. In comparison, the poly walls stayed below 18% MC through the winter.

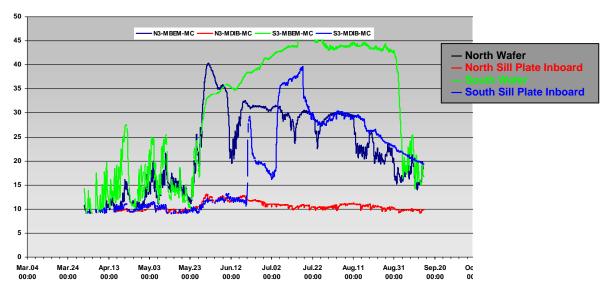
Results are consistent with observed behavior: the north framing remains dry throughout this period, but the north wafer shows wetting followed by slow drying over the summer. In comparison, on the south side, the wafer and sill plate both show substantial rises in moisture content. These results suggest that the wafer accurately reflects humidity conditions and condensation risk at an interface, but they do not necessarily indicate moisture damage suffered by the wood frame members at similar locations. This is likely a function of storage and thermal mass, as well as rundown of condensation.

It was interesting to note that in the polyethylene walls, both wafers showed mold, while the framing was moldy only on the south-side wall, on the inboard face. The plot below includes moisture content wafer and inboard sill plate measurements for both walls. The plot shows data for April through September.

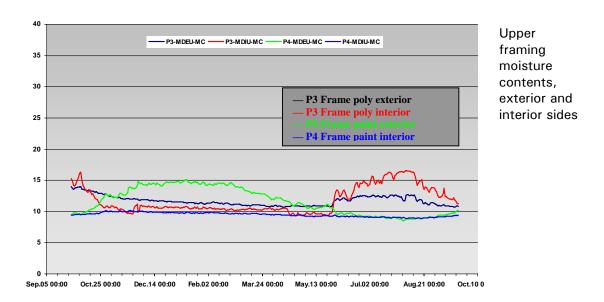
The framing in upper portions both walls showed little damage; the framing in the polyethylene wall on the inboard side shows some brown spotted marking that is likely microbial growth. The maximum moisture content seen at that location was approximately 17%. Although this is the highest moisture content in the plot above, it is considered well within the safe range. It is quite possible that the wetted area did not overlap the pin location to adequately reflect the degree of wetting.

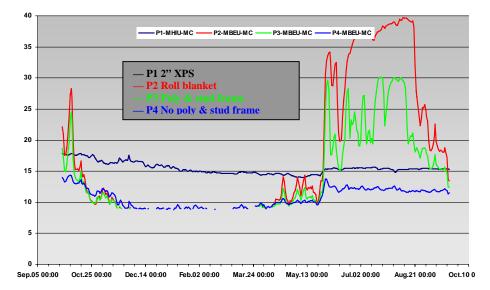
Upper moisture content wafers at concreteinsulation interface (XPS wall) or at insulationvapour barrier/drywall interface (remainder)

The upper MC wafers in the four walls are compared in the plot above; field observations showed that the "no poly" wafer was intact, and the "poly" and roll blanket walls had mold growth. This clearly matches the data plotted above: the two wafers with mold growth had moisture content peaks at 30 to 40%, while the intact wafers had moisture contents in the 10-15% range.

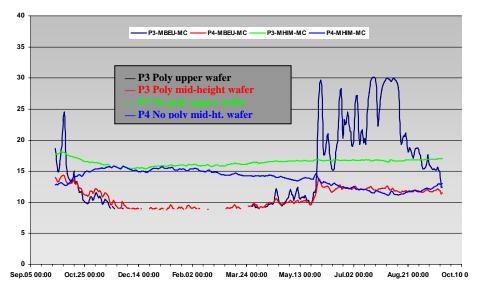
Upper and mid-height moisture content wafers in framed walls (P3 poly and P4 no poly)

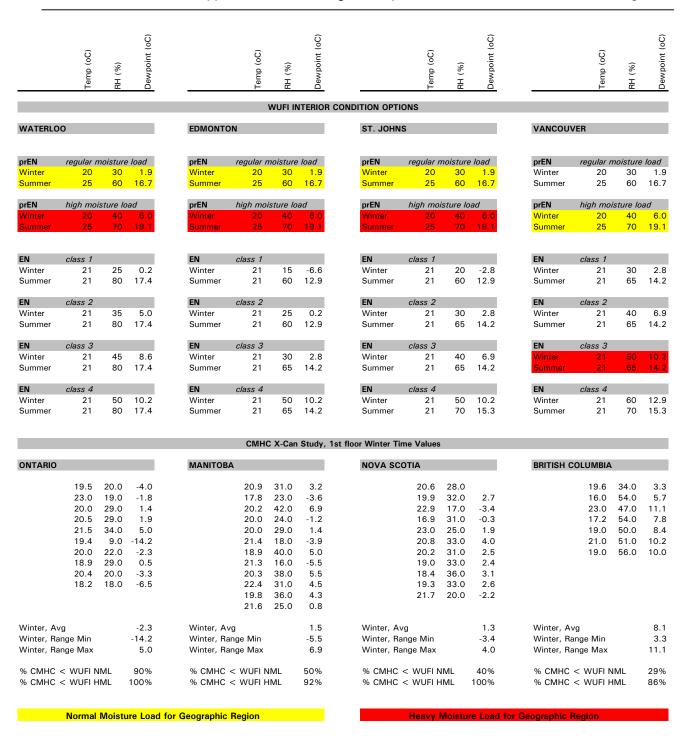
Figure 1.1: Comparison of Dewpoints for WUFI interior load options and measured regional interior loads from CMHC study "Field Testing of House Characteristics" by K.Russet et. al performed in 1993.

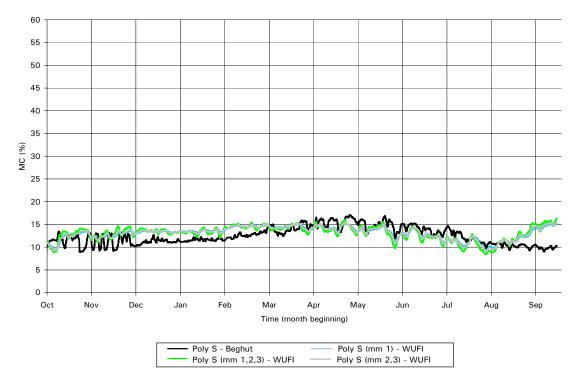
Figure 1.1: Poly South, OSB Moisture Content

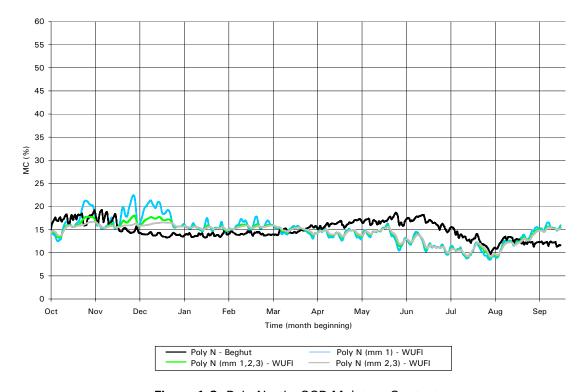
Figure 1.2: Poly North, OSB Moisture Content

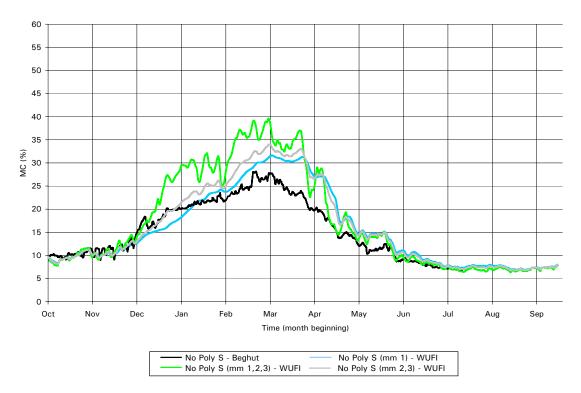
Figure 1.3: No Poly South, OSB Moisture Content

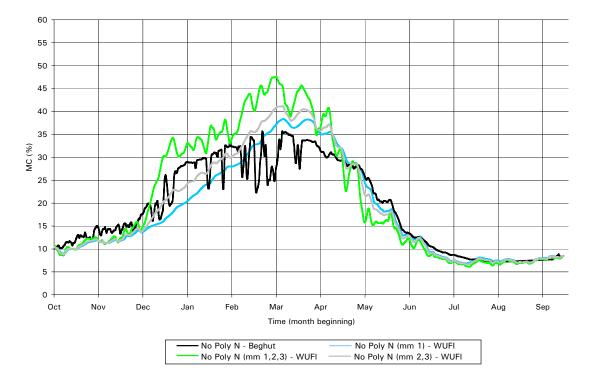
Figure 1.4: No Poly North, OSB Moisture Content

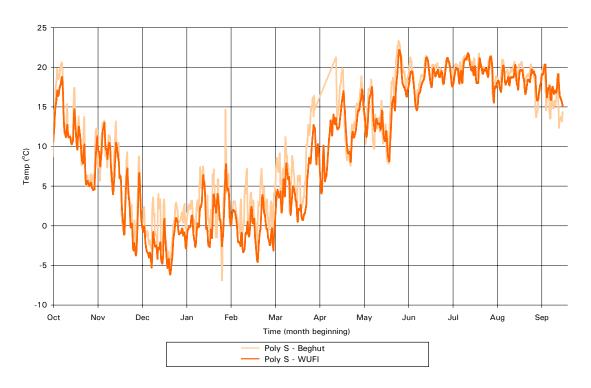
Figure 1.5: Poly South, Mid Fiberglass Batt Dew point

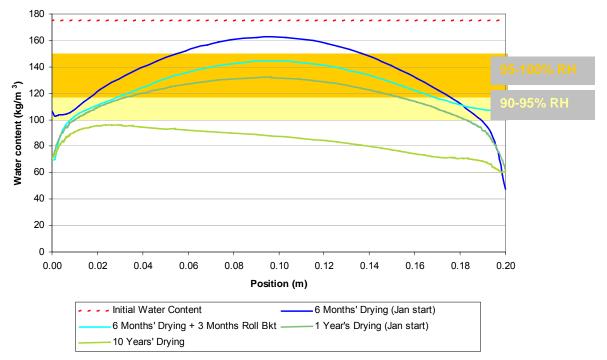
**Figure 1.1:** Moisture content profiles through concrete thickness (exterior = left; interior = right)

Figure 1.1 shows some moisture profiles generated under various drying conditions and periods; the exterior side is the left, and interior right. The initial moisture content is shown by the red dotted line (175 kg/m³); the equivalent relative humidity (via the sorption isotherm in material properties) is indicated by shading. Unless noted otherwise, the wall had no interior finishes during drying.

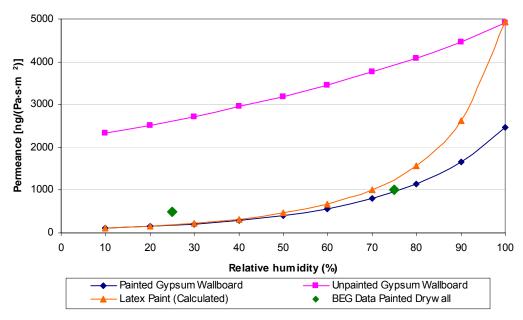
Figure 1.2: Gypsum wallboard permeability data (painted and unpainted) from Kumaran (2002)

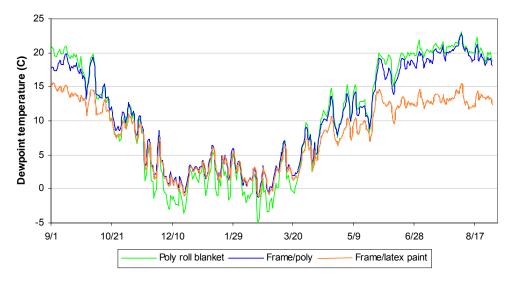
Figure 1.3: Daily average dewpoint (upper portion) comparison of Kitchener walls

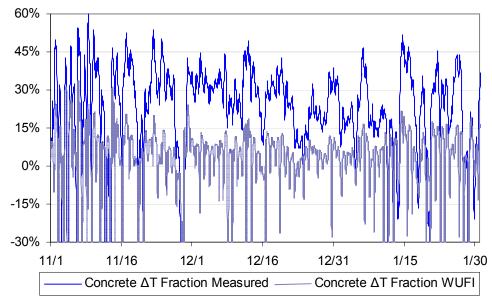
Figure 1.7: Concrete  $\Delta T$  as % of overall wall  $\Delta T$  (winter detail); monitored vs. model

Instead, the most likely explanation of the data is that the exterior air conditions recorded in weather data do not reflect the temperature difference that is operating across the wall. Inspection of the details of the wall assembly at this location indicates that it is likely that two-dimensional effects are significant (see Figure 1.8). Since the temperature sensor is roughly at grade level, the above-grade and below-grade environments both have an effect. Furthermore, the details at the rim joist, such as the brick ledge and the transition to the insulated wooden framing, result in further thermal anomalies. Finally, the aspect ratio of the wall at this location does not favor a one-dimensional simplification; a taller above-grade portion would be a better candidate. Only a small portion of this wall is reflected by the one-dimensional simplification, so two-dimensional effects seem quite likely.

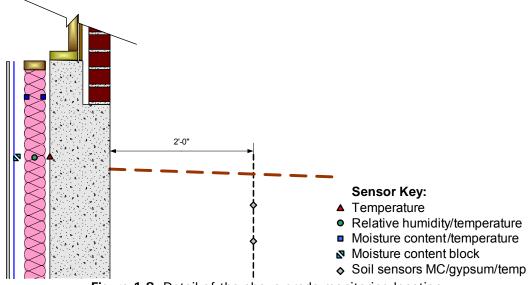
Figure 1.8: Detail of the above-grade monitoring location

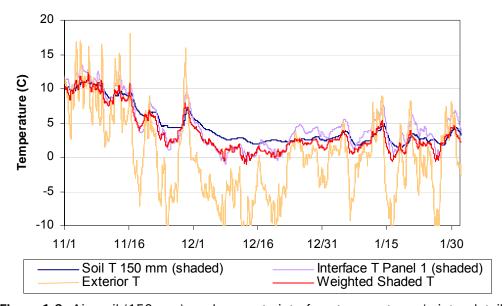
Figure 1.9: Air, soil (150 mm), and concrete interface temperatures (winter detail)

Further evidence of two-dimensional effects can be found by plotting the soil temperature at the 150 mm (6") depth with the wall interface temperature and exterior air temperature, as shown in Figure 1.9. The interface temperature tracks much more closely to the shallow soil temperature than the exterior air temperature. In fact, a closer approximation to the concrete interface temperature can be made using a weighted average of the air and soil temperatures ("Weighted Shaded T").

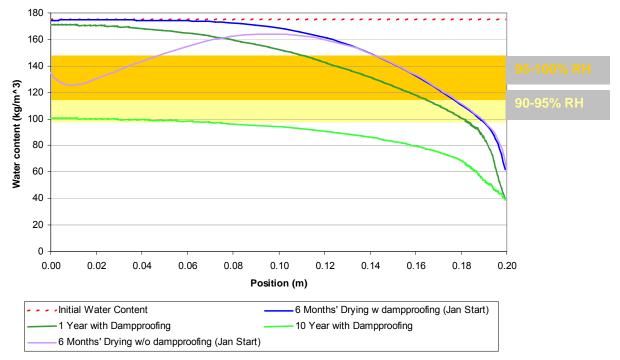
**Figure 1.12:** Concrete moisture content; parametric drying studies (exterior = left; interior = right)

parametric simulations were run to determine the effects of some extrapolations beyond the monitored walls, as shown in Figure 1.12.

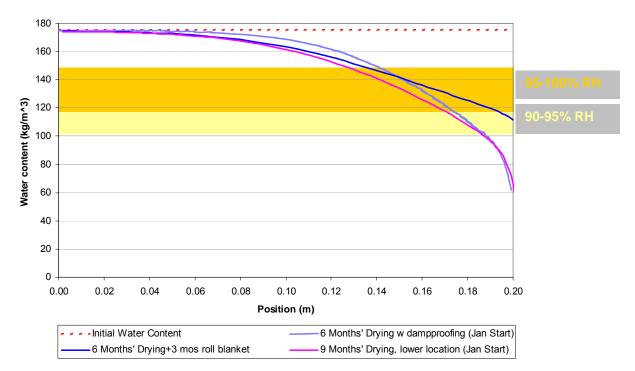
**Figure 1.13:** Concrete moisture content; initial conditions for simulation (exterior = left; interior = right)

equilibrium with dryer interior conditions. At the lower location, no insulation was installed before the test walls, so the profile for nine months of drying was used.

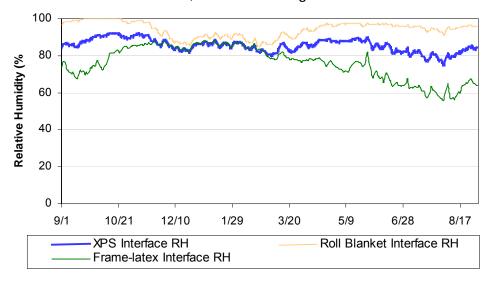
Figure 1.14: Monitored data: mid-height RH sensors at concrete-insulation interface

After running simulations, the simulation results were compared with monitored data. Due to the setup of the boundary conditions, temperature correspondence was high. The critical metric for moisture performance, however, is relative humidity. The monitored relative humidity data at the mid-height location, at the concrete-insulation interface, is shown in Figure 1.14.

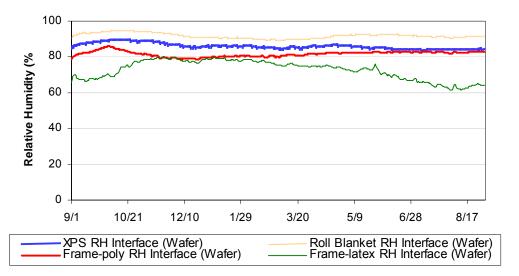
Figure 1.15: Monitored data: mid-height wafer sensors (calculated RH) at concrete-insulation interface

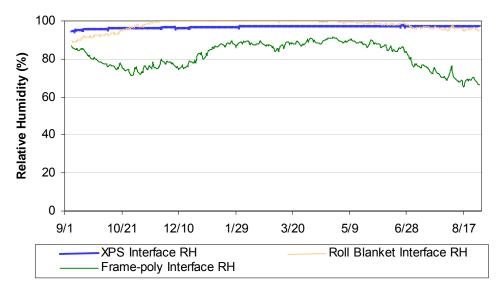
Figure 1.16: Simulation data: mid-height RH at concrete-insulation interface

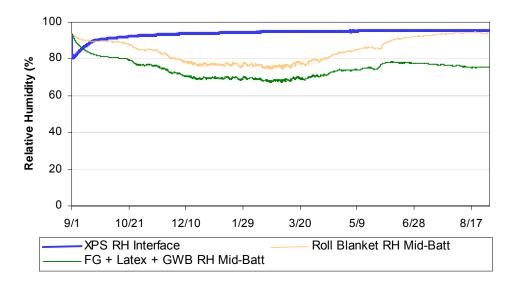
Figure 1.18: Simulation data: lower-height RH at interface and mid-batt

Note that this graph plots data from two different wall locations: the concrete-insulation interface (in the XPS wall), and mid-thickness in the batt (in the frame walls). The corresponding simulated data is shown in Figure 1.18.

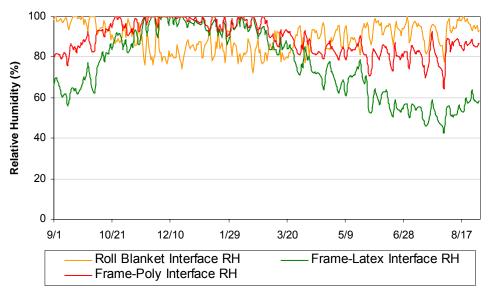
Figure 1.2: Monitored data: relative humidity at concrete-insulation interface; above-grade

A caveat must be noted for the monitored data: this is a calculated relative humidity value, based on the dewpoint temperature measured at the middle of the insulation, and the temperature of the concrete surface. However, the vapour resistance of batt insulation is very low, so this is a reasonable assumption for the purposes of this calculation.

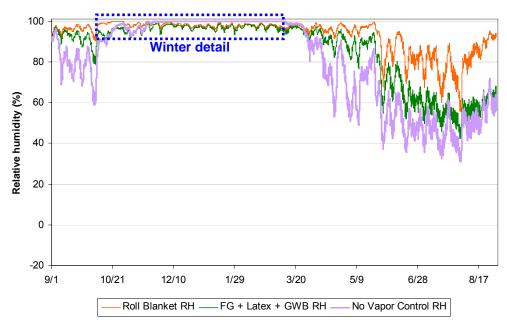
Figure 1.6: Simulation relative humidity at concrete-insulation interface, above grade portion

A sample use of this condensation layer is shown in the figures below, which examine the relative humidity at the interface between the concrete and insulation at the upper portion of walls with roll blanket insulation, fiberglass/latex paint, and no vapour control (but no air transport/bypass). In the whole-year plot (Figure 1.6), the high wintertime humidity levels are difficult to read.

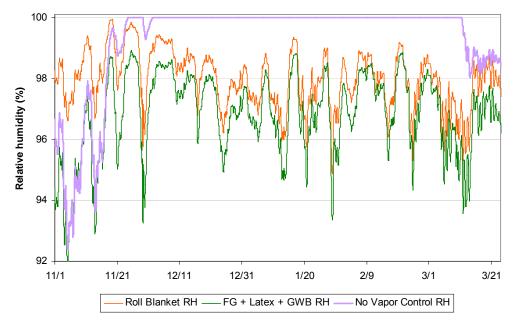
Figure 1.7: Simulation relative humidity at concrete-insulation interface, winter detail

other walls vary between 95-99% RH. Although this suggests that condensation is occurring at the "no vapour control" wall, it does not give an indication of the magnitude of the accumulation.

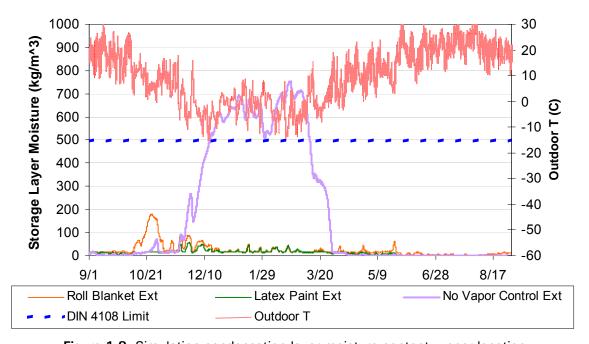
Figure 1.8: Simulation condensation layer moisture content, upper location

The relative performance of these walls is much clearer when the moisture content of the condensation layer is plotted in Figure 1.8 below; the accumulation can be compared with the  $500 \text{ g/m}^2$  limit used in the DIN 4108 standard. Exterior temperature is plotted for reference.

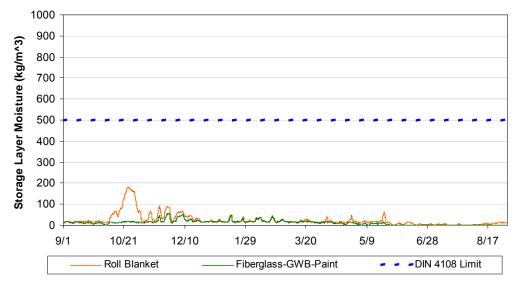
Figure 1.9: Concrete-insulation interface condensation layer MC, Kitchener data, above grade

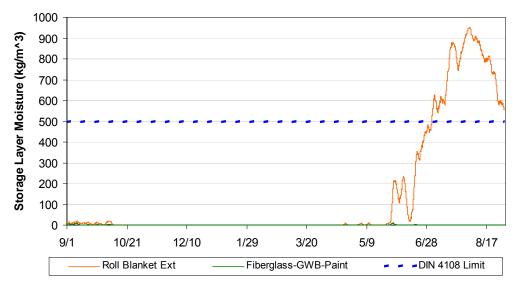
Figure 1.10: Vapour barrier condensation layer MC, Kitchener data, above grade

This is followed by a plot of the accumulation at the condensation layer located between the insulation and either the polyethylene or the interior side of the gypsum board (Figure 1.10). The first summer is dry for both walls; however, during the second summer, the polyethylene roll blanket shows accumulation that exceeds the DIN 4108 limit, peaking over 900 g/m². This matches monitored data and disassembly observations: the moisture content wafer at this location in the roll blanket wall clearly showed the presence of liquid water, well over the 100% RH level.

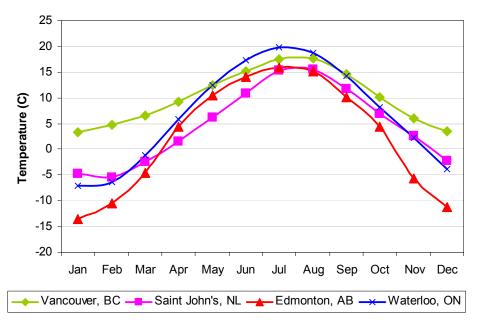
Figure 1.11: Monthly average temperatures for climate locations (Environment Canada data)

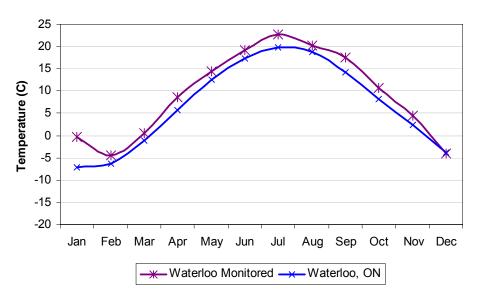
Figure 1.12: Comparison of monitored and climate average monthly temperatures for Waterloo

The historical data is compared with BEGHut weather conditions in Table 1.1 and Figure 1.12; the experimental year was warmer than average, especially in January 2006.

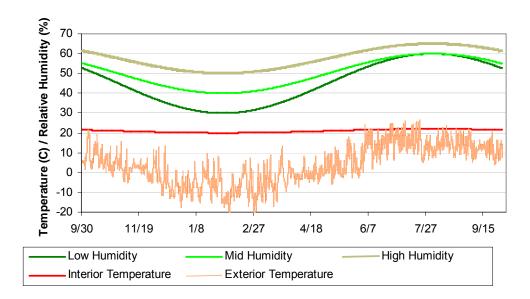
Figure 1.13: Summary of interior conditions (temperature and RH) with Waterloo exterior T

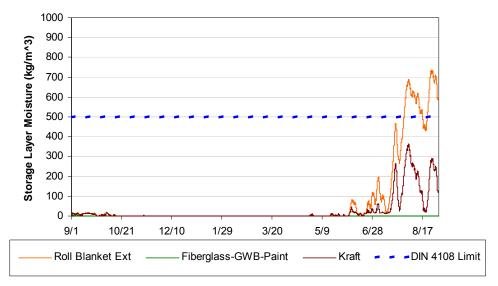
Figure 1.19: Interior cavity side condensation layer MC, Toronto AG, mid RH

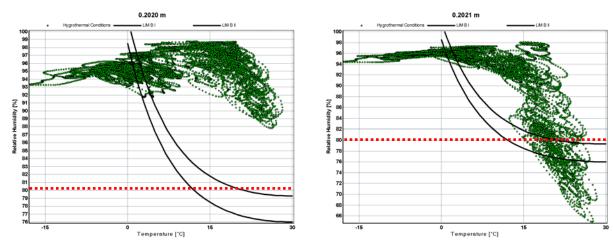
Figure 1.20: Roll blanket isopleth at concreteinsulation interface, "mid" humidity

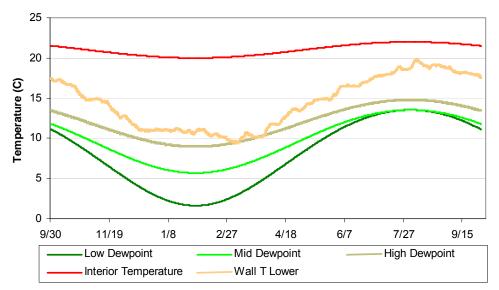
Figure 1.30: Interior dewpoint extrapolation conditions, and lower wall temperature

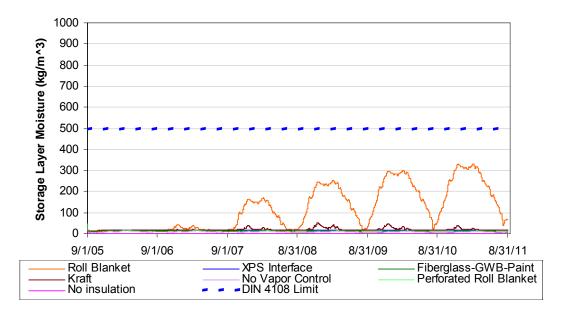
Figure 1.31: Condensation layer accumulation for lower location, "high" relative humidity

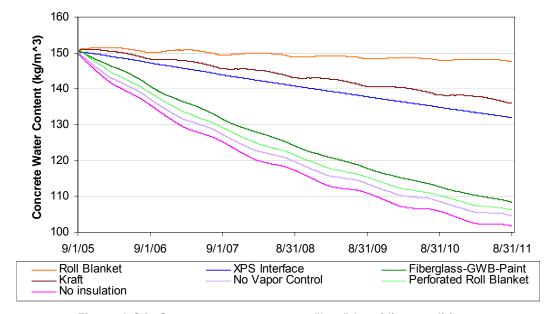
Figure 1.34: Concrete water content, "low" humidity conditions

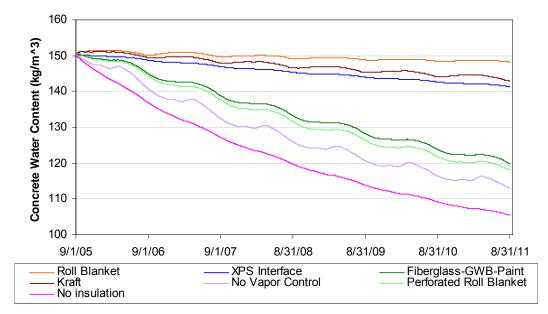
Figure 1.35: Concrete water content, "high" humidity conditions

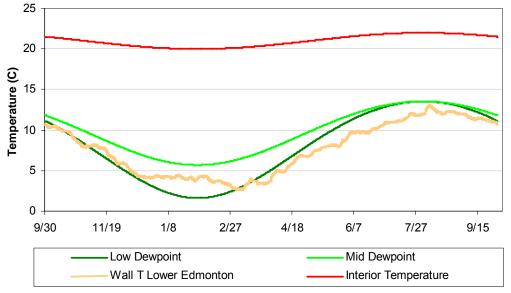
Figure 1.36: Interior dewpoints and lower wall T for Edmonton extrapolation

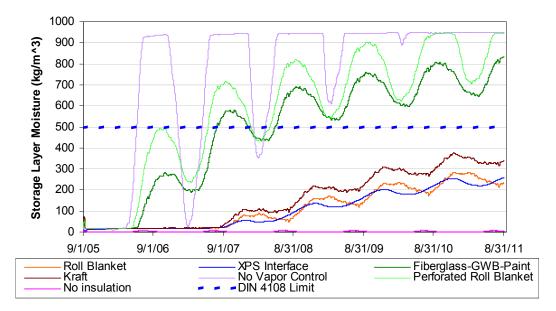
Figure 1.37: Accumulation at storage layer, Edmonton extrapolation, "low" humidity

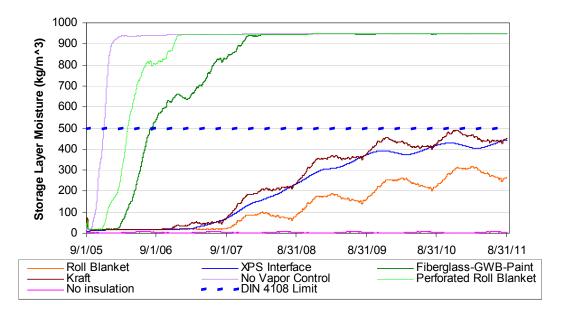
Figure 1.38: Accumulation at storage layer, Edmonton extrapolation, "mid" humidity

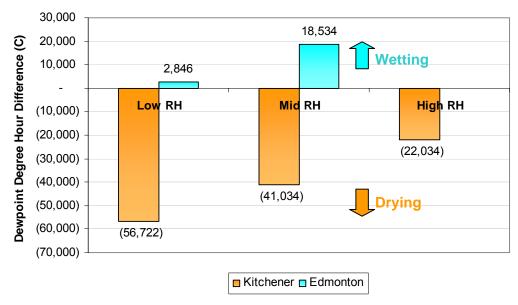
Figure 1.39: Dewpoint degree hour differences between concrete & interior conditions

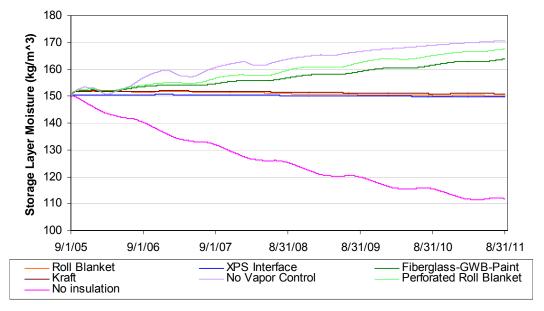
Figure 1.40: Concrete water content, "low" humidity conditions

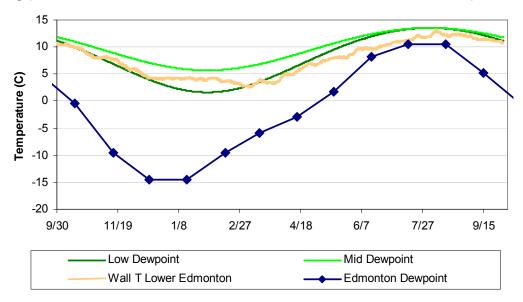
Figure 1.41: Interior dewpoint, lower wall temperature, and Edmonton exterior dewpoint

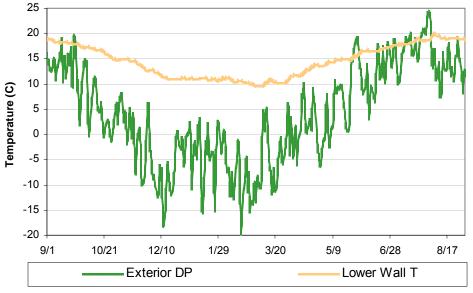
Figure 1.42: Exterior dewpoint and lower wall temperature from Kitchener data

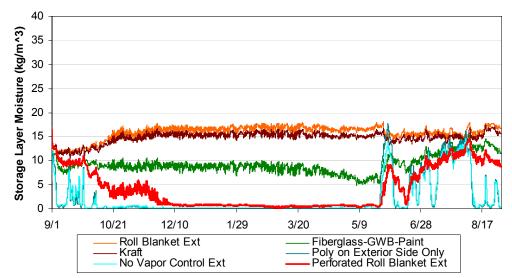
Figure 1.43: Results of Kitchener simulation with elevated summertime interior humidity

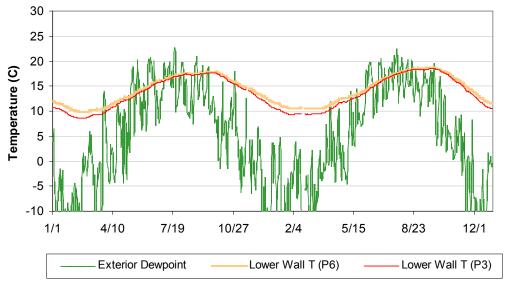
Figure 1.44: Exterior dewpoint and lower wall temperature from Huntley data
