Demonstration of Duct Installation in Houses Previously Without Ducting

R. Clarke Designs Ltd.
3 Sheffield Court
Oromocto, NB E2V 2N1

March 2004

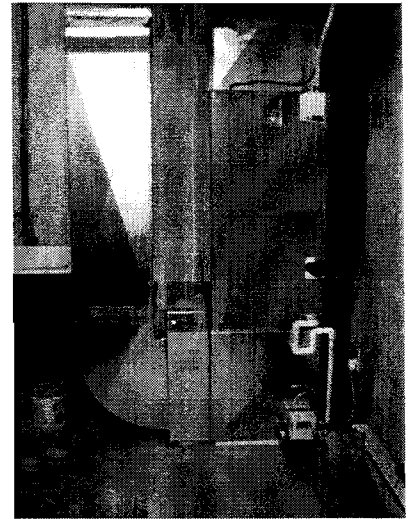
Picture, H1,001.jpg, shows the air-handler located in the corner of the basement, in fairly restricted quarters. Notice the utility sink to the left of the return-air drop. Although the contractor has put forth a good effort in sealing the main trunk ducts, connects at the air-handler have very typically been left unsealed.

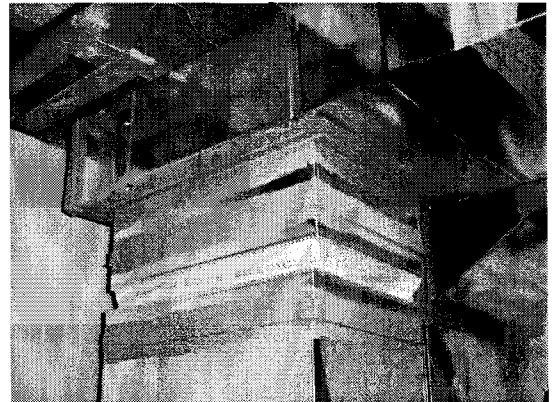
Picture, H1,002.jpg, shows the 14"x20" return-air drop with sealed connection to from 20"x8" return trunk. Photo also shows the sealed connection on both sides of the vibration isolation collar installed in the drop.

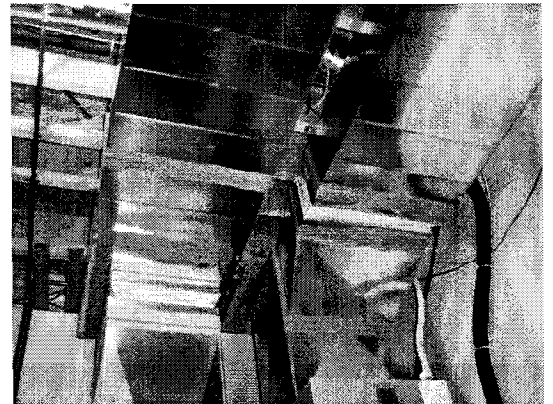
Picture, H1,003.jpg, shows the sealed joints in a continuation of return and supply trunks, both of which are 20"x8", the vibration collar located in the supply-air trunk is also shown.

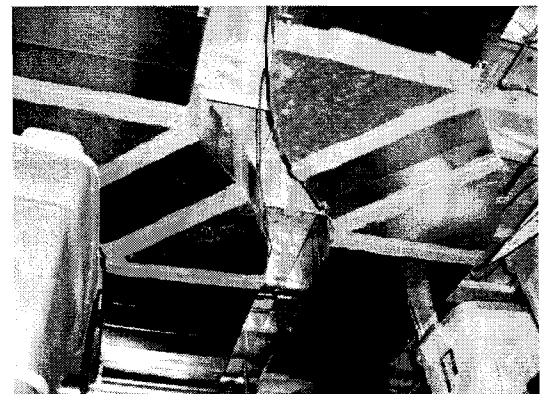
Picture, H1,004.jpg, shows the sealed joints in the off-set required in both supply and return trunks necessary to avoid plumbing drop and connections to city service, as well as location of electric domestic water heating tank connections.

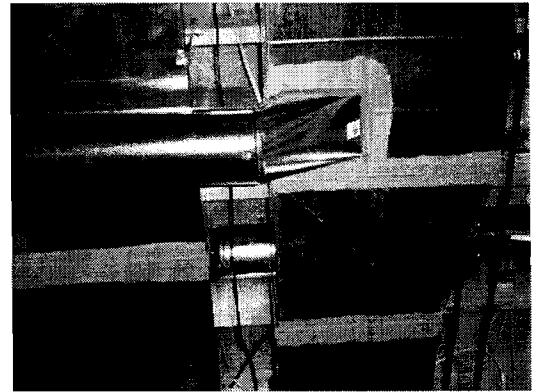
Picture, [H1,005.jpg](#), shows a typical branch take-off from the main supply trunk. This style take-off was used for both top and bottom connections to the trunk, and sealed in the manner shown. Also visible is the reduction in the supply trunk from 20"x8" to 16"x8". Existing water supply piping can also be seen to the right of the supply trunk. No water piping was relocated during this installation.

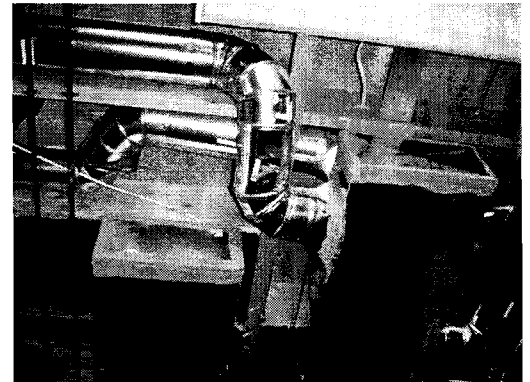
Picture, [H1,006.jpg](#), shows a complicated take-off arrangement at the end of the supply-air trunk. The contractor was challenged to avoid both framing and plumbing. The branch with the top take-off travels between the floor joist, but elbows were required to avoid a water pipe which is shown making its own connection up through the frame floor.

In order to avoid an existing light fixture the supply trunk was not extended and blocking to hold the light fixture was also in the way of a top take-off so a side take-off was used requiring an additional 3-90 deg. elbows.

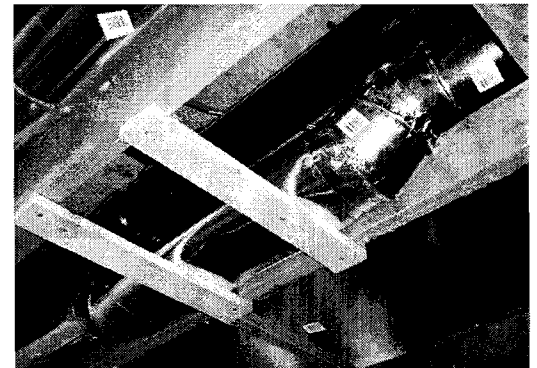
Picture, [H1,007.jpg](#), shows a complex arrangement around a plumbing connection. This is the same branch referenced first in the photo above. A 45 deg. elbow was required to lower the branch and also the 6" round duct was squashed slightly to avoid an unseen plumbing connection to this main drain pipe. There was not enough room for a rectangular or square section of duct.

Return-air joist panning is also shown, note sealant used between sections of metal pan and between pan and joists.

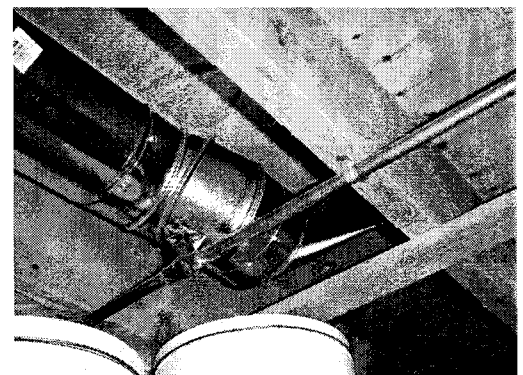
Picture, [H1,008.jpg](#), shows the warm-air supply to the main floor bathroom. The existing valve controlling an outdoor hose bib required the branch to be offset with a couple 45 deg. elbows.

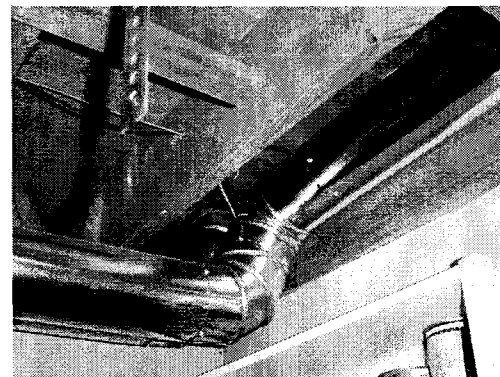
Picture, [H1,009.jpg](#), the two branches shown can also be seen on the right side of H1,006 above as they take-off from the main supply trunk. Due to the light fixture shown in H1,006 the main trunk was terminated requiring at least 3 additional 90 deg. elbows in each of these two branches.

It is also noted, duct sealant was not used on any joints of supply branches.

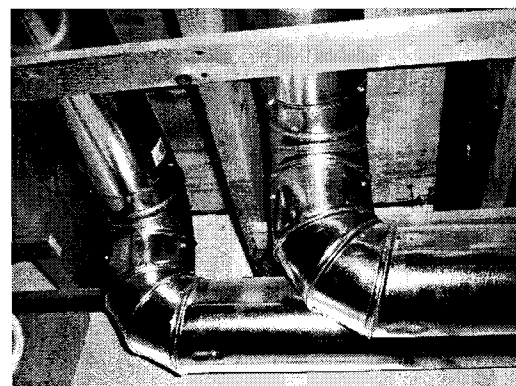
Picture, [H1,010.jpg](#), shows a very typical direction change encountered on site. In this case two supplies are required in rooms on main floor rooms located behind the garage. If the designer is not familiar with framing layout, the two extra 90 deg. elbows required, may be missed in the duct design process.

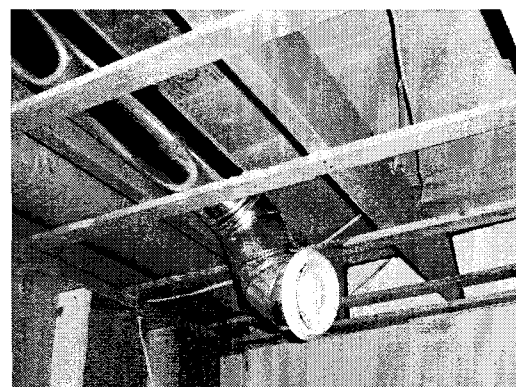
Picture, [H1,011.jpg](#), shows a supply-air branch serving a workshop space in the basement. Rather than using the expected end boot termination for this branch the contractor, at the homeowner's request, installed 2 extra 90 deg. elbows and a round plastic diffuser. It is noted this style of round plastic diffuser creates much more resistance to airflow than the standard metal rectangular diffuser.

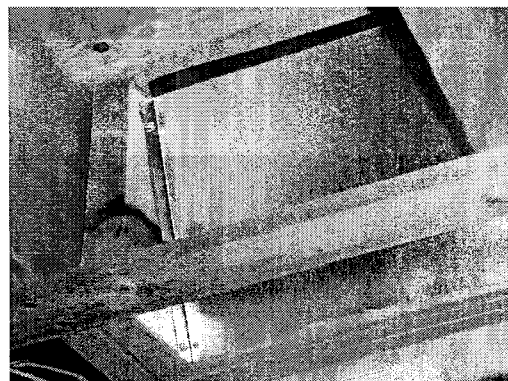
Picture, [H1,012.jpg](#), shows an end block of a panned joist return air branch. Note that although care was taken to seal metal pan to floor joists, as seen in other photos, no sealant has been used around this block. Air leakage into the return duct around such an end block can reduce volume of air intended to be returned from a nearby floor grille.

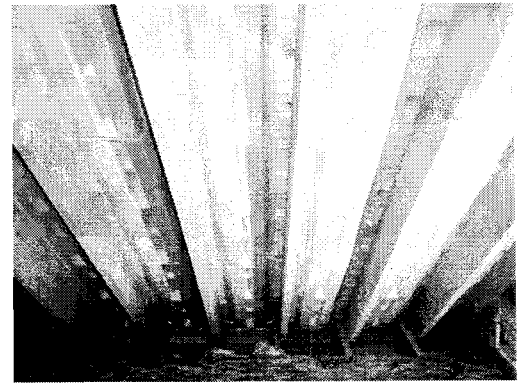
Picture, H2.001.jpg, shows installation of “tru-vents” between rafters of attic space during renovation to conditioned mechanical room.

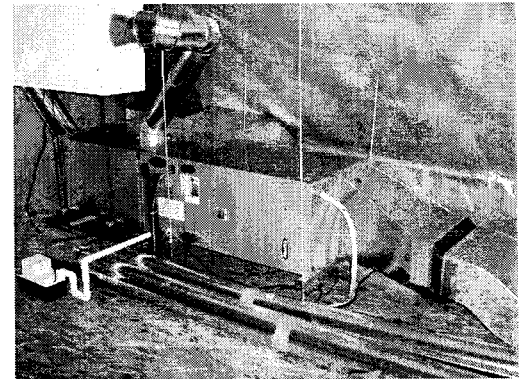
Picture, H2.002.jpg, shows the air-handler located in the corner of the newly created attic mechanical room. The unit was suspended in a horizontal position on adjustable threaded rods from the roof rafters. A by-pass filter system can be seen in the upper left of the picture. A vibration collar can be seen in the main supply-air trunk at the right side of the picture.

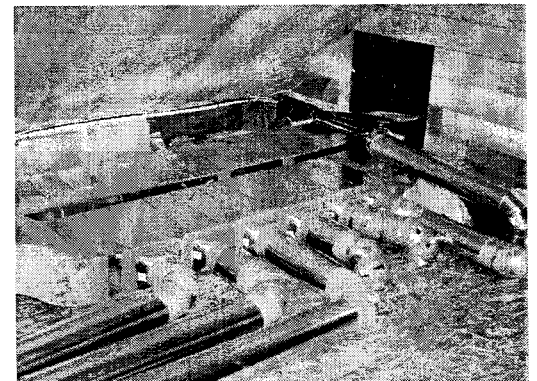
Picture, H2.003.jpg, shows the main supply trunk in the foreground with several 6" diameter branches attached. Distribution dampers can also be seen in sections of straight duct near the main truck. Note brush-on duct sealant has been used. The original end-wall separating the finished upper floor from the un-conditioned attic space can be seen at the right of the picture. The original attic access from a conditioned storage space was used as a duct passage.

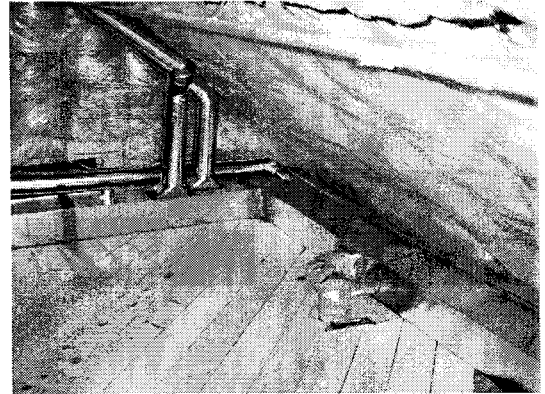
Picture, [H2.004.jpg](#), shows the main supply trunk as it travels around the perimeter of the original conditioned attic storage area. Note the two 6" dia. ducts rising from the trunk, these were previously supply-air leads from the HRV serving two bedrooms, and were converted to warm-air supplies from the heat pump. It was impossible to serve the two bedrooms with warm-air ducts in the floor/ceiling, as this space was full of insulation above existing electric radiant ceiling panels. A warm-air supply to the Master Bedroom can be seen passing through the board floor.

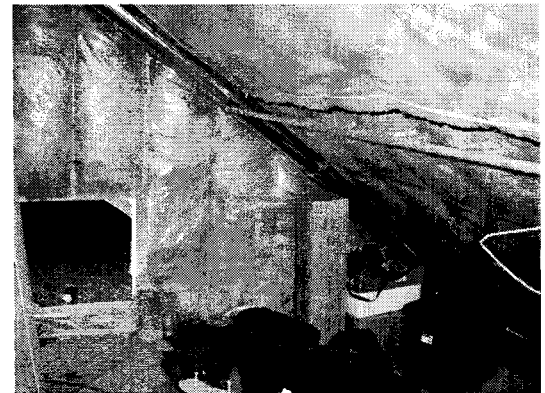
Picture, [H2.005.jpg](#), shows view of conditioned attic storage space prior to installation of system. Note ducts previously used by the HRV can be seen following the roof profile.

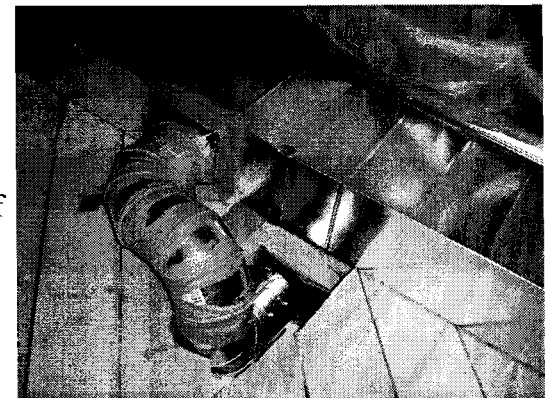
Picture, [H2.006.jpg](#), shows the warm-air supply boot passing through the ceiling of the Master Bedroom below. The boot appears to be located just beneath the edge of the main trunk duct, note the elbows required to make the connection. Location of warm-air supplies in the ceiling was made difficult by the presence of electric radiant heating panels. The contractor took advantage of 4" wide ceiling strapping locations as a position to cut through the ceiling and avoid the panels. It is noted the trunk duct connection was not sealed.

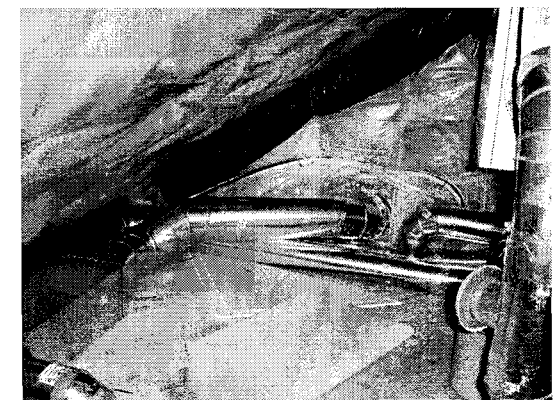
Picture, [H2.007.jpg](#), shows the opposite end of space shown in H2, 004.jpg. The HRV can be seen in the upper right side of the picture. The end of the rectangular warm-air supply trunk can be seen on the left side of the picture. The 8" diameter warm-air supply duct is shown passing through the attic wall to the un-conditioned garage attic space. It is noted joints in the 8" diameter duct were not sealed at time of this photograph. Also seen is the connection of the round metal duct to the insulated flex duct used in the adjoining attic space. At time of photograph, end wall vapour barrier had not been re-sealed.

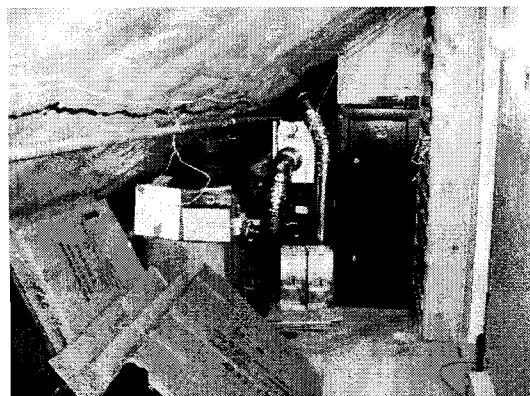
Picture, H2,008.jpg, shows the original condition of the conditioned attic storage space shown in the previous picture.

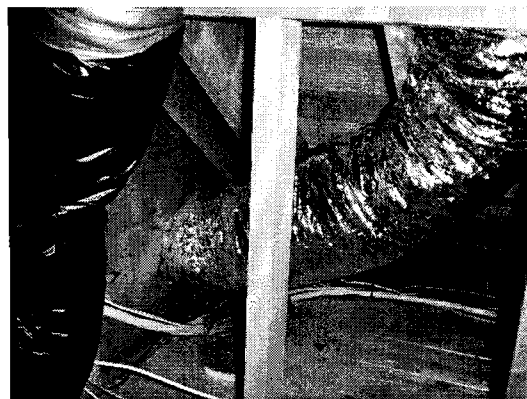
Picture, H2,009.jpg, shows the 8" diameter insulated flex duct used as the supply air duct passing through the unconditioned garage attic space. It was originally intended this duct track along side the end wall of the conditioned space to minimize effective duct length; however, it was decided to pass over top of the space in order to avoid disrupting the homeowners current use of space.

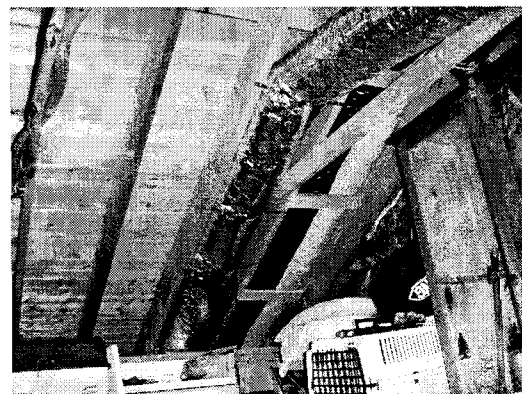
Picture, H2,010.jpg, shows the 8" diameter insulated flex duct passing over the garage attic space, and following the roof down to a space above the conditioned rooms behind the garage. Temperatures were measured on a hot summer afternoon with the following result:

- Temperature in duct before leaving conditioned space: 54 F.
- Temperature at ceiling diffuser at end used point: 58.6 F.
- Temperature in garage attic space: 107 F.
- Temperature in attic between roof sheathing and duct: 126 F.
- Outdoor temperature: 84 F.

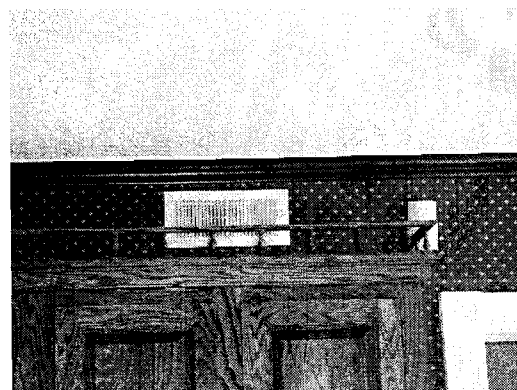
Picture, H2,011.jpg, shows warm-air supply diffuser located in kitchen above wall cabinets. As mentioned with H2, 004.jpg, the kitchen could not be supplied through the ceiling. The diffuser shown is supplied through the flex duct shown in the previous picture. Unable to place diffusers in low wall, at this end of the house diffusers are all high, making it difficult to maintain a comfortable temperature for heating at floor level. Owner will rely on original radiant heating panels. High wall diffuser placement will be an advantage during the cooling cycle.

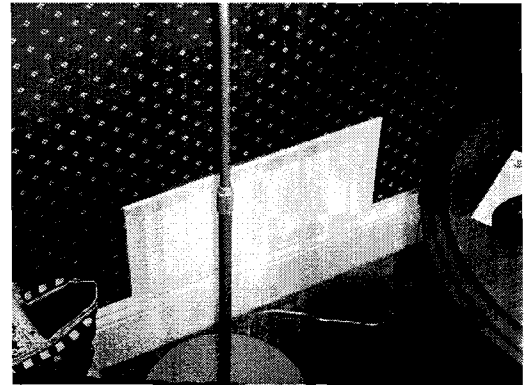
Picture, [H2,012.jpg](#), shows typical low wall return-air grille which allowed air into the stud cavity to be drawn up and through a joist cavity back to the return-air trunk.

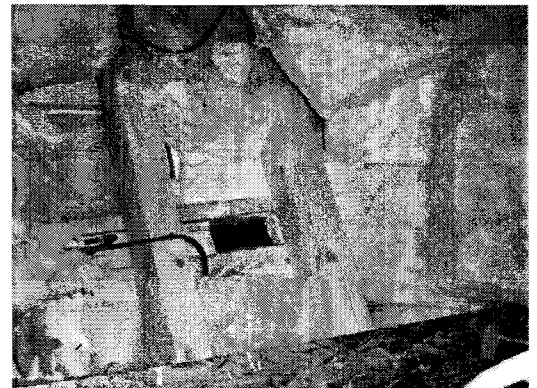
Picture, [H2,013.jpg](#), shows plate opening at top of stud space, alignment of studs and joists does not always allow for a full stud pass to be open to a single joist space. Insulation required for the radiant heating panels had to be removed from those cavities used for passage of return air and cavities had to be sealed from neighbouring spaces. Insulation was still required above that portion of the ceiling containing radiant ceiling panels.

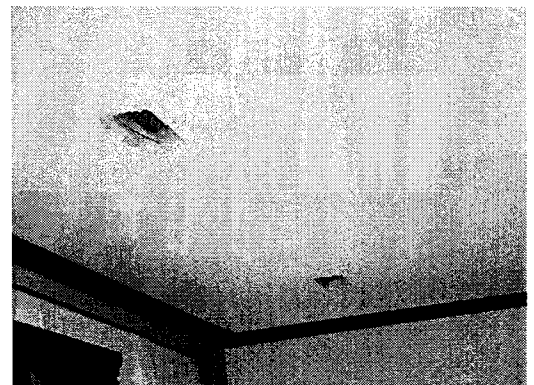
Picture, [H2,014.jpg](#), shows ceiling cut-outs to receive diffusers. In all main floor rooms served from the ceiling, it was necessary to avoid existing electric radiant ceiling panels. Portions of 4" wide ceiling strapping were removed to make room for the diffusers. As a consequence, the diffusers were limited to location and not always able to be placed close to the outside wall.

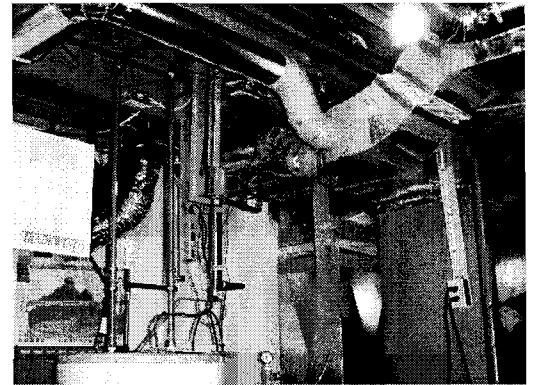
Picture, H3,001.jpg, shows the air-handler located near the end of the basement next the water heater and the central load bearing beam. The return-air drop can be seen between the air handler cabinet and the wall. Also seen in the foreground is a secondary supply trunk serving several spaces on the side of the beam opposite the main supply trunk.

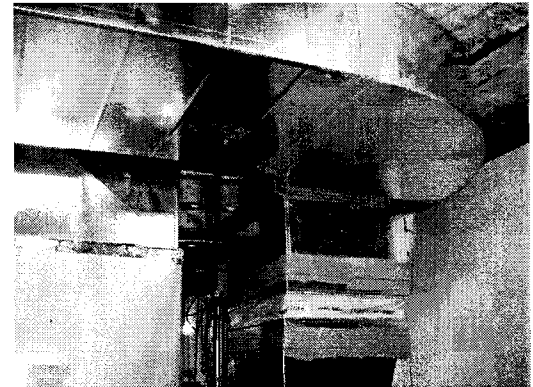
Picture, H3,002.jpg, shows the 20"x8" return-air trunk turning to the back of the air-handler and connecting to the 16"x18" drop. The vibration isolation collar and sealant of trunk joints can be seen.

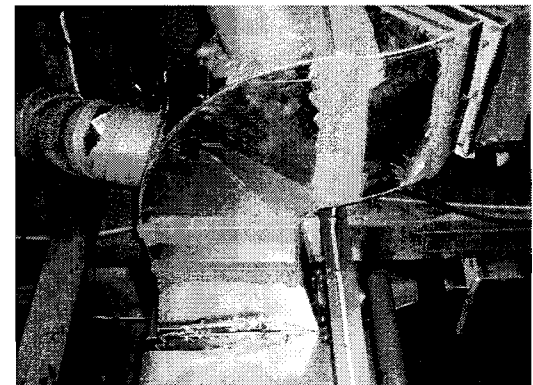
Picture, H3,003.jpg, shows the secondary supply-air trunk passing beneath the beam, and the take-off to the center bedroom and bathroom. Note sealant and vibration isolation collars.

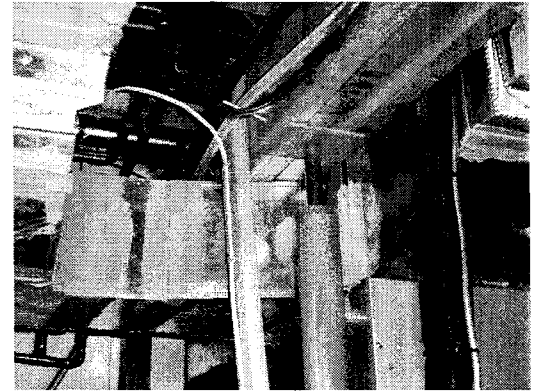
Picture, [H3,004.jpg](#), shows another view of the secondary supply-air trunk connection to the main plenum. Notice the restricted distance from top of air-handler to underside of beam.

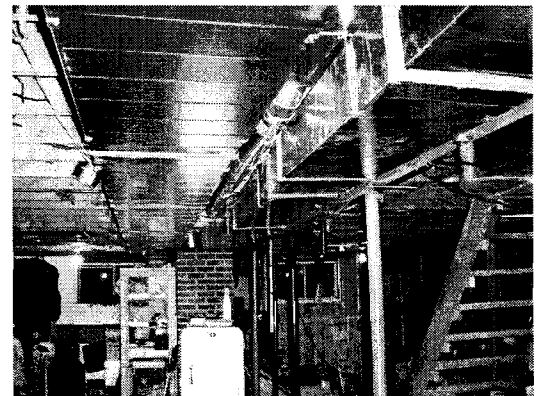
Picture, [H3,005.jpg](#), shows the main return-air (left) and supply-air (right) trunks extending along the basement. The foundation for the brick fireplace can be seen in the path of the main trunks. The stair opening can be seen to the right. The load bearing beam and steel posts can be seen next to the warm-air trunk.

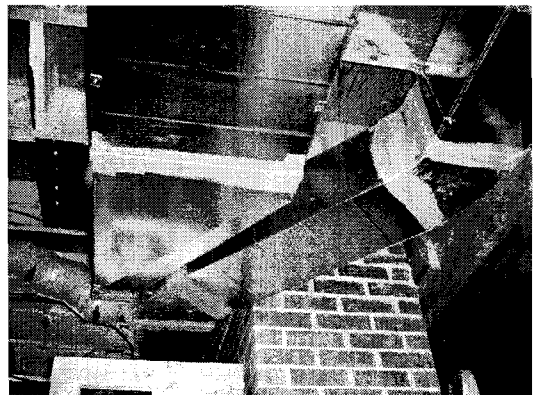
Picture, [H3,006.jpg](#), shows the tapered end on the return-air trunk, used by the contractor to extend the return-air far enough to pick up the floor return-air grille from the living room. The taper was also necessary to enable continuation of the 10"x8" supply trunk.

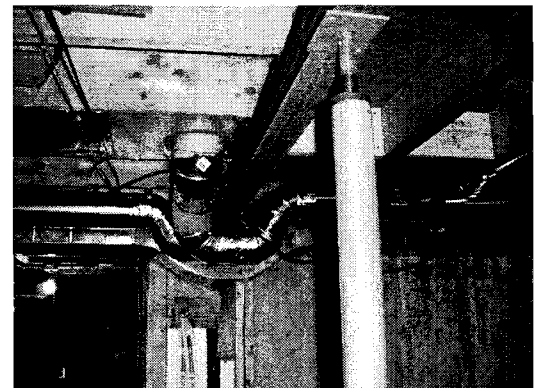
Picture, [H3,007.jpg](#), shows the secondary supply-air trunk as it passes beneath the 5" deep steel beam at the junction of the "L" portion to the main rectangle of the basement. The return-air branch from the master bedroom is also visible as it passes beneath the same steel beam and connects to a section of panned joist. It is noted the panned joist is not sealed, nor is the joint between the joists and the floor sheathing which create the upper portion of the panned space. Also note the change in joist direction.

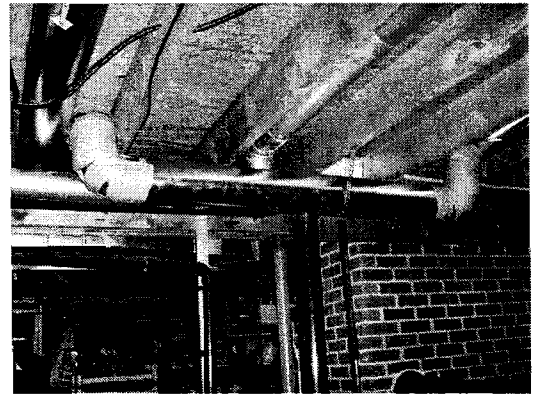
Picture, H3,008.jpg, shows a supply-air branch to the livingroom which connects across and above the center beam, elbows down and extends parallel to the beam and elbows up into floor joist space to extend out to perimeter wall.

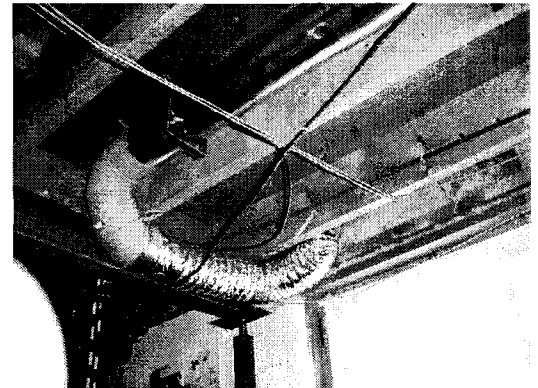
Picture, H3,009.jpg, shows the supply-air branch to the bathroom. The contractor kept the branch duct away from the basement window and used a section of flexible duct. This was the only 5" diameter branch to be installed.
