Flight Comment

ISSUE 3, 2012

SAR
SEARCH AND RESCUE

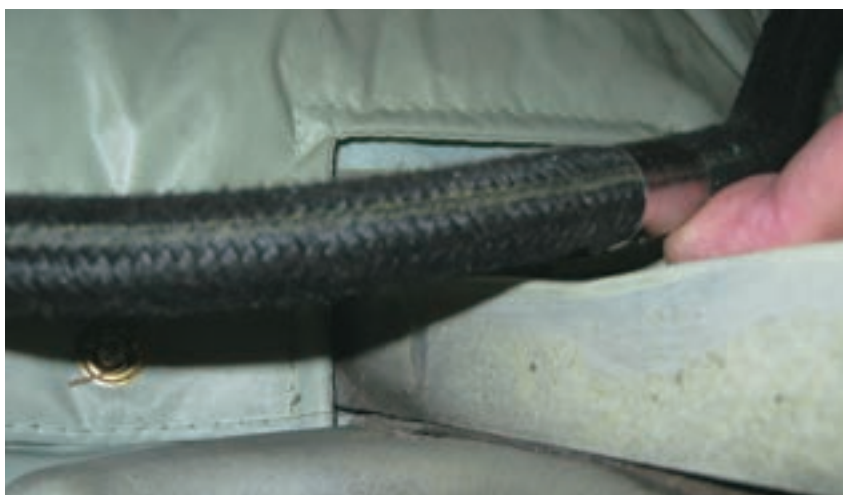
Notice that the wear on the structure has been repainted, yet the hose is still able to rub.

It is never ideal to route electrical wires near lines that carry flammables such as fuel, hydraulics or oxygen, yet we all know with the space limitations involved with aircraft design it is not always possible to have the ideal clearances. The separation of wires, fluid lines or oxygen lines from the aircraft structure and each other is critical and when a technician is inspecting these areas, they should always be on the lookout for any

indication of wear or interference. It is imperative that the vibration and gravitational forces that flight applies to wiring and flexible hoses be taken into consideration. You cannot simply move a hose or a wire and expect it to stay. They must be secured in an approved manner, and odds are if you find rubbing or chafing of a wire or hose and they have been installed in accordance with the CFTO

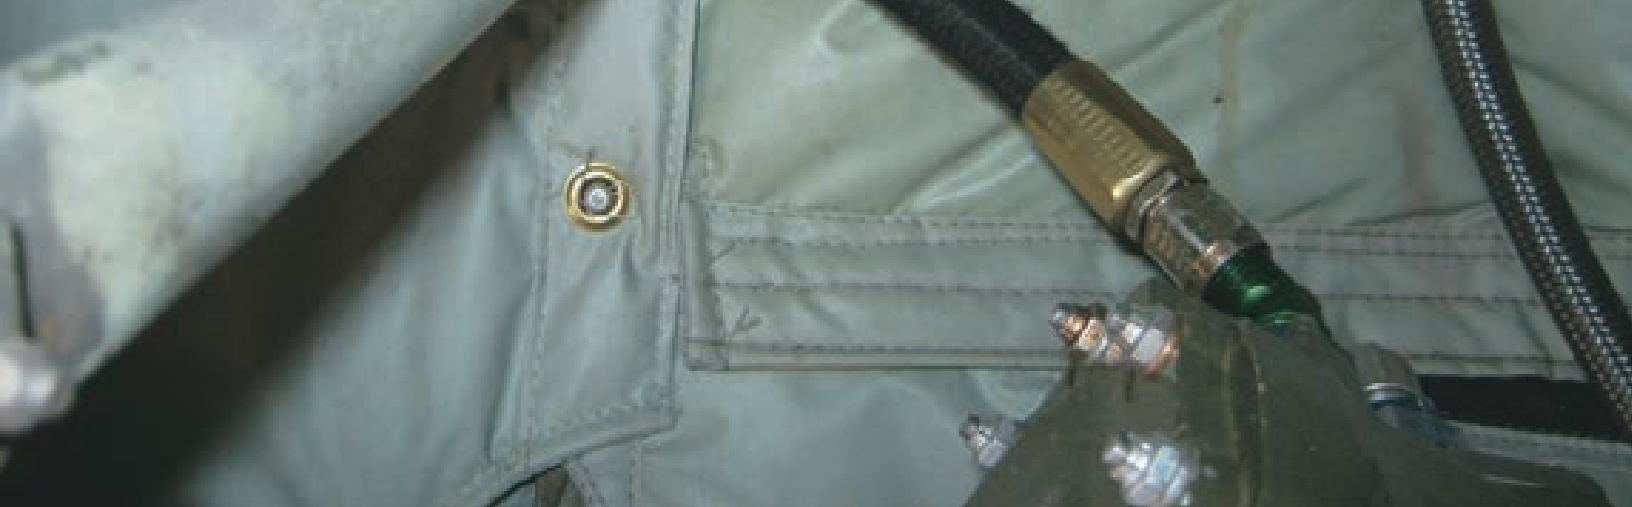
and forethought. If you notice a polished area on a structure near a wire bundle or flexible line, get a mirror and carefully inspect the wire bundle or line for evidence of contact. Generally, if the structure is aluminum and near a steel braided line, the aluminum will display wear. Repainting the structure and not clamping the hose to prevent further contact, is not the answer.

In the case of wiring and aluminum, it will depend on the type of wire and the insulation that is used. The damage could be mostly on the wire, the aluminum structure or both could be equally worn. There is no good form of contact between these items, but it is especially dangerous if the contact point is a sharp angle or the squared edge of the aircraft structure or a bracket. Squared edges will quickly work through the insulation of a wire and if it becomes jagged it can even damage the braid on a steel braided hose as well.

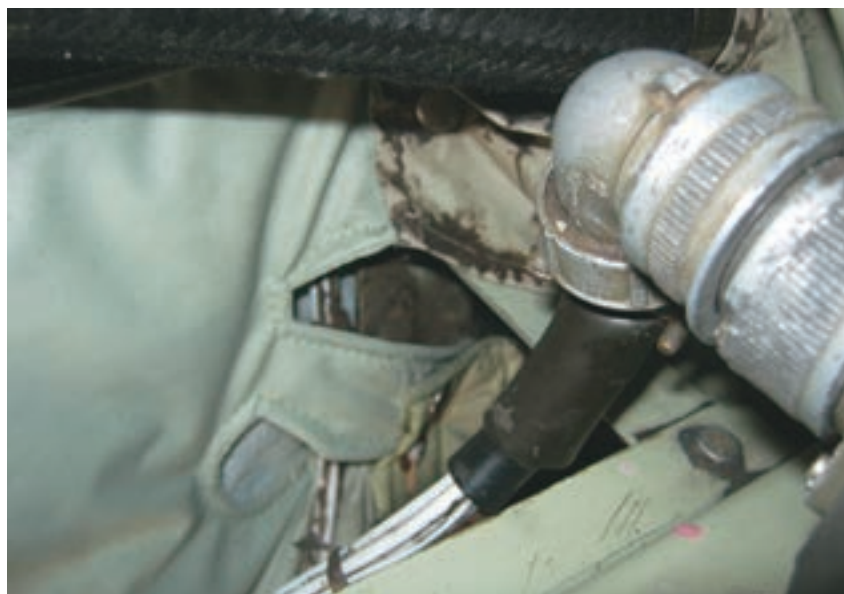
Adjusting the position of the back shell, would probably correct any interference issues.

Contact of wiring to aircraft structures is not always due to improper clamping. It can also be caused by inattention when installing a cannon plug. Cannon plugs are designed so that the position of the back shell can be changed to avoid interference or aid in achieving the required clearance from a line or structure. Just because there were no issues before you changed a component, does not mean that you will not be required to adjust the position of a cannon plug back shell to ensure you still have the required clearance or proper routing for the wiring.

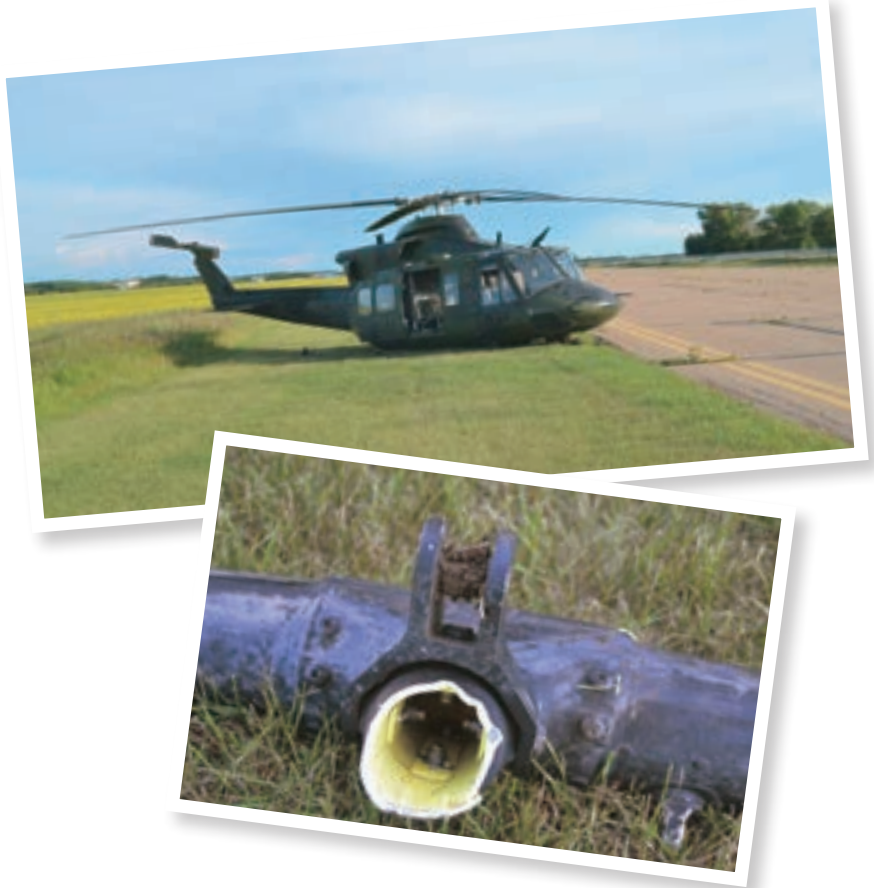
The helicopter impacted the ground in a slight nose up and right skid low attitude. The skid landing gear broke away from the aircraft, which came to rest on the underside of the fuselage near the edge of the Foxtrot taxiway. The aircraft sustained “C” category damage.

During a basic handling and emergency training flight, *Griffon* CH146437, from 408 Tactical Helicopter Squadron (THS), experienced a hard landing at 1903 hours (local). Both pilots were unscathed but the flight engineer suffered minor injuries.

After having completed the planned manoeuvres, the Aircraft Captain (AC) terminated the mission and requested a straight-in approach to the fuel pumps. The advisory controller acknowledged the request and reported the winds as calm. The First Officer (FO), who was also the Flying Pilot (FP), then verbalized his plan to approach to the south of the fuel pumps, turn right and taxi into refuelling spot 1. He next conducted a modified left circuit and rolled out north of the helipad at approximately 150 feet above ground level, at 75 knots, and on a heading of 222 degrees. The approach was slightly fast and steep but under control until the aircraft reached 60 feet. The FO had just begun the right turn when he felt the aircraft rapidly sink. He increased collective in order to arrest the descent but to no avail. The AC reached for the collective but judged that it was already at its maximum position and, therefore, did not attempt to increase it. Unable to arrest the descent, the FO attempted to ensure that the aircraft was level prior to impact.

The investigation is focussing on power management, approaches to the 408 THS ramp and fuel pumps, aircrew flying rates, experience, and mentorship. ♦

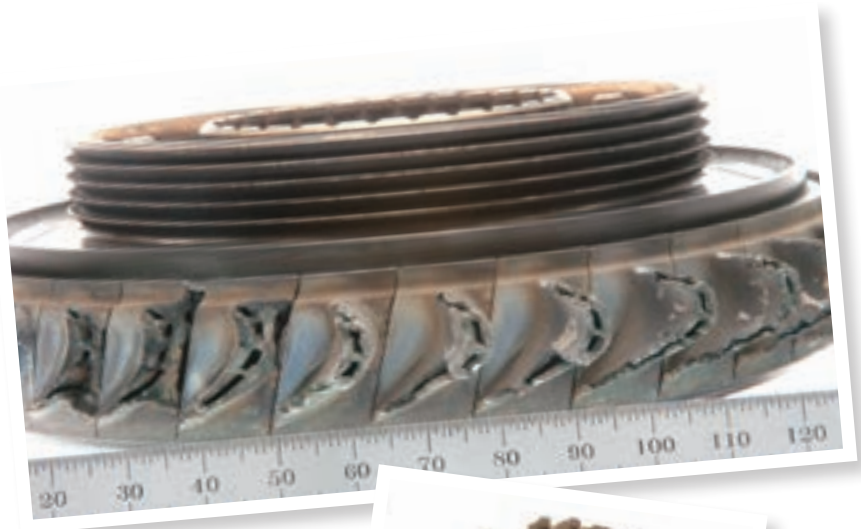
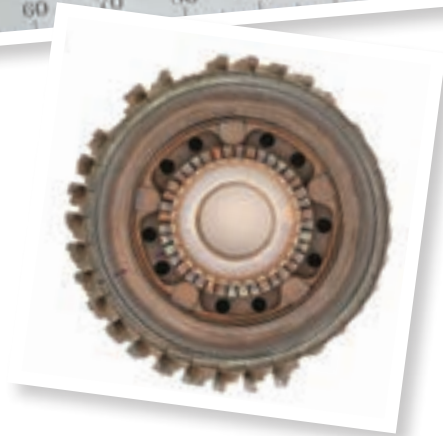
A teardown inspection revealed catastrophic damage to the stage-1 turbine blades and less severe decreasing damage to the other three turbine stages.

Sulfidation, or hot-corrosion, is a chemical process that occurs in high temperature environments where trace amounts of sulfur from either petroleum-based fuels or airborne particulate is transported to the hot section blades through cooling bleed air. Sulfur deposits then build-up on blade roots, shrouds, and, to a lesser extent, the blade airfoil, corroding turbine blade surfaces. The engine Original Equipment Manufacturer (OEM) indicated that similar sulfidation has been observed not only on this type of engine, but also on a commuter aircraft.

Stage-1 turbine blades from seven engines, all with TSNs above 3000 hours, were inspected; all were found with corrosion damage to the blades' protective layers. Once the protective layer is compromised, it is just a matter of time before a crack initiates and leads to blade failure.

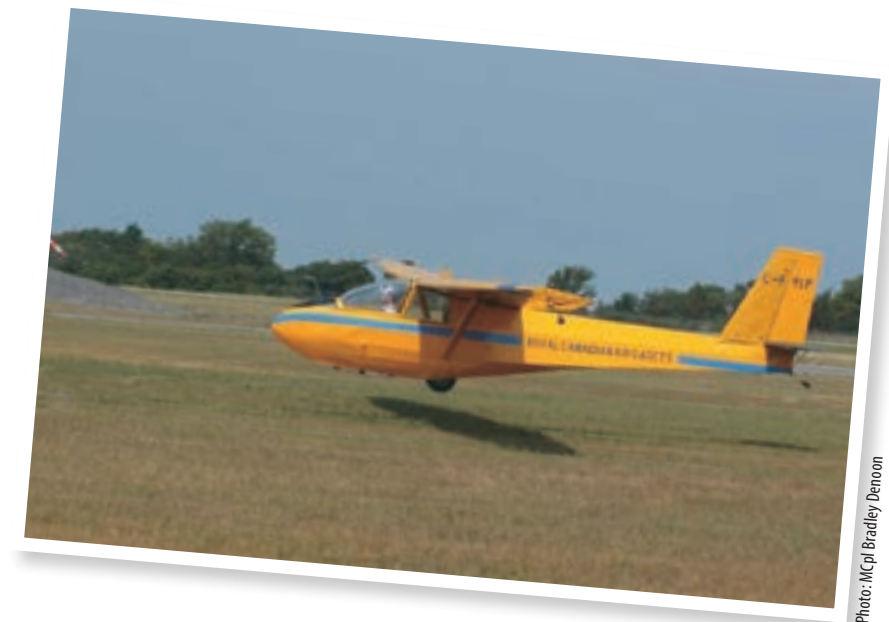
Photo: MCpl Bradley Denoon

At approximately 30 feet AGL, the SI initiated an abrupt and rapid pull-up of the glider. Upon seeing the glider's nose rise above the horizon, the GI took control from the SI; however, the glider stalled from a height of approximately 10-20 feet AGL, struck the ground firmly on the forward skid and wheel, and then bounced before stopping straight ahead. Both pilots egressed the aircraft on their own and were seen at the local hospital before being released. The front seat pilot suffered serious injuries while the rear seat pilot was uninjured. There was no damage to the glider.

The investigation found that inappropriate technique by the SI placed the glider in a position from which neither he nor the GI could safely recover. Latent cause factors included expectancy and motivation as well as inadequate training.
