Compendium of Monitoring Activities at Disposal at Sea Sites in 2005-2006

Canadian Edition

Disposal at Sea Program
Environmental Protection and Operations Directorate
Environment Canada

March 2007

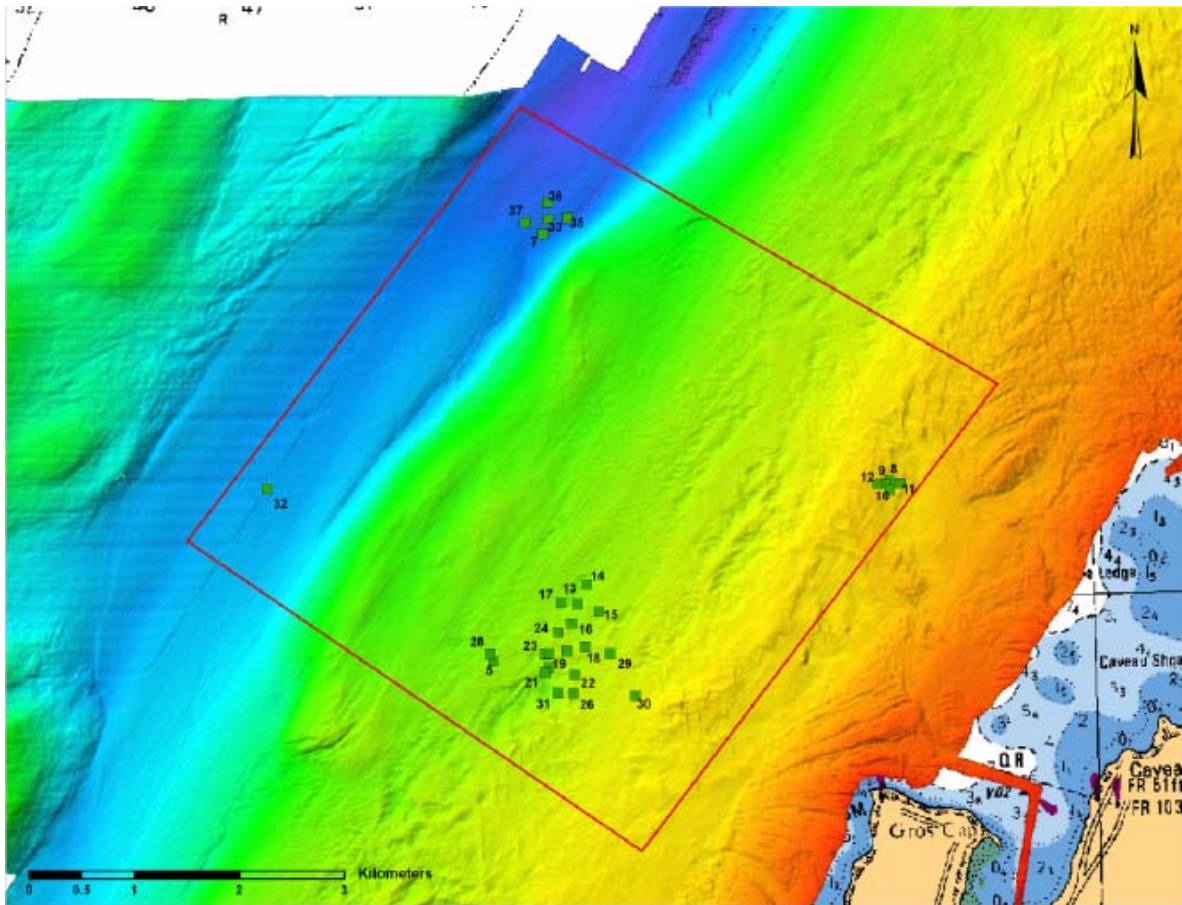
Figure 2. Seafloor grab sample locations taken during survey *Opilio* 2005030, July 2005.

were taken to provide additional information as to the character and composition of the sediments on the seafloor (Figures 2 and 3).

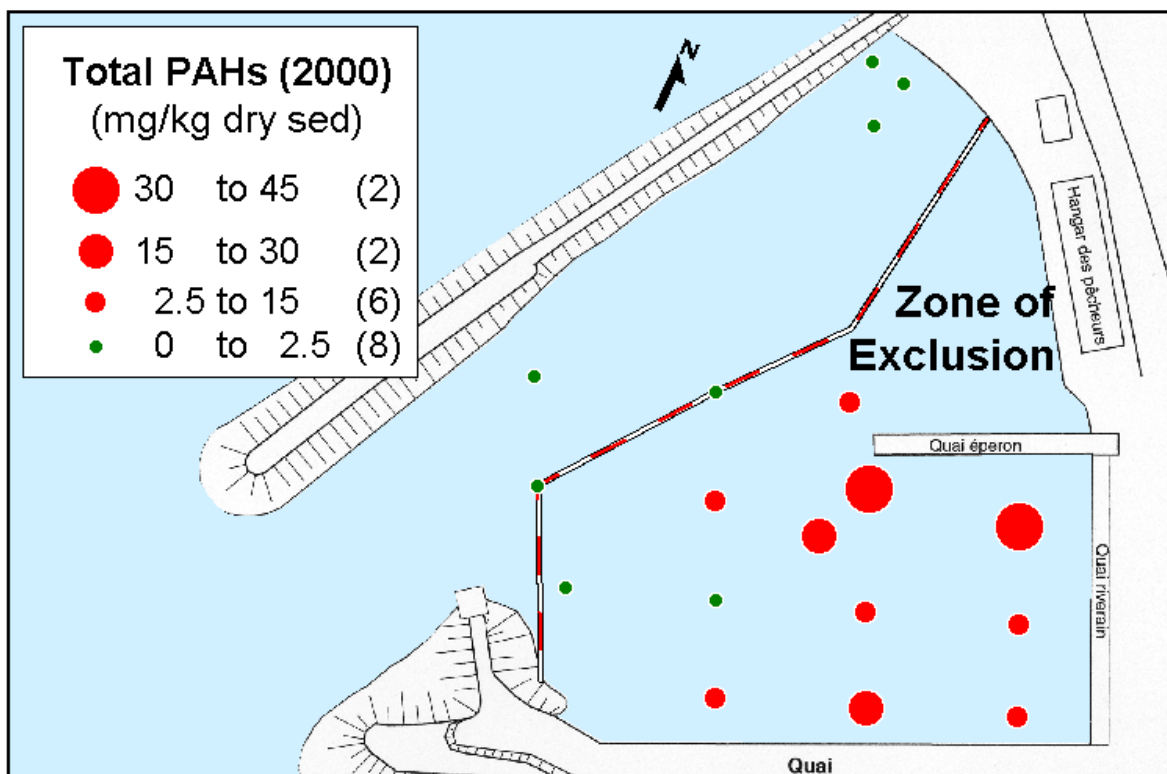
Figure 15. Total PAH content in the Pointe-Basse Harbour sediments as measured in 2000. The red line represents the zone of exclusion boundaries. Sediments originating within this zone cannot be disposed of at sea.

Between 1995 and 1999, and prior to the establishment of the zone of exclusion, it is possible that dredged materials with elevated PAH levels were disposed of at the PB-8 site, resulting in PAH contamination. This possibility, and the fact that the PB-8 site is representative of other disposal sites in the area, triggered monitoring at the PB-8 site.

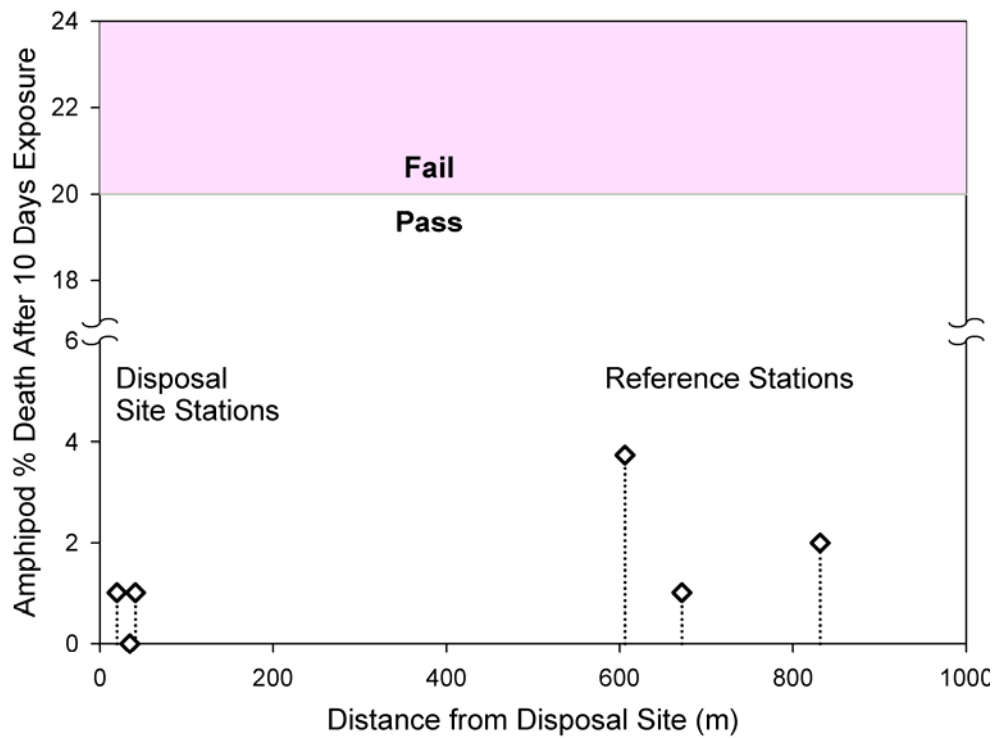
Figure 17. Amphipod mortality percentage after 10 days of sediment exposure.

Note: The points to the left of the chart represent the results for stations located at the disposal site. Those on the right are the results from the reference stations.

Based on the pass/fail criteria associated with each biological test, neither the disposal nor the reference site sediments were toxic (Figures 17, 18, and 19). A single sample, taken from the REF-3 reference station, was toxic to sea urchin gametes.

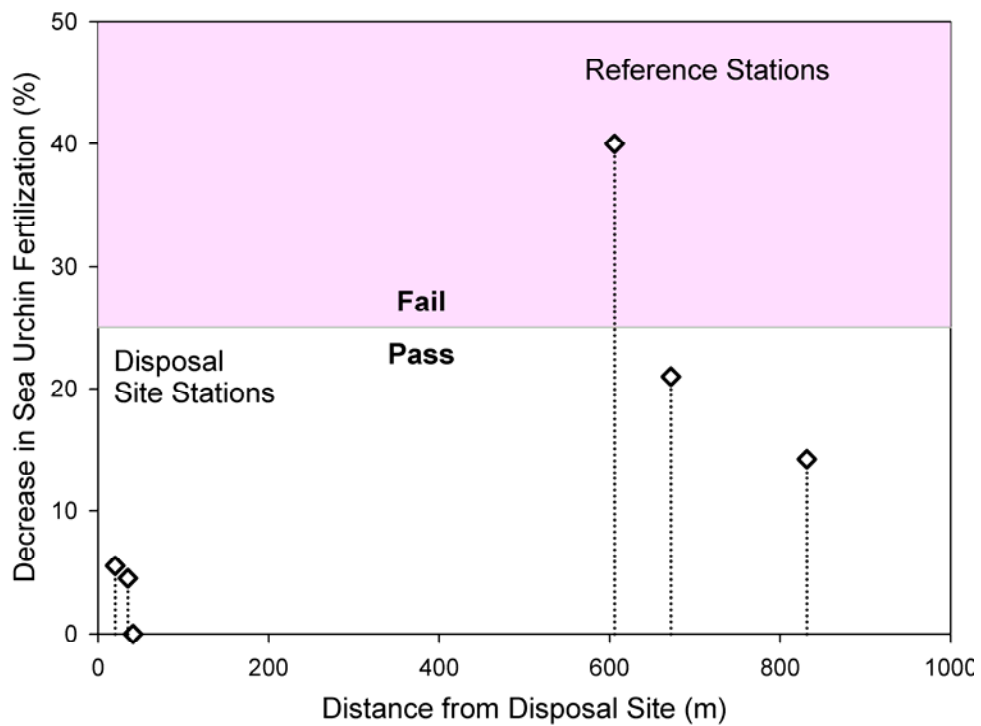
Figure 18. Percent inhibition of sea urchin fertilisation.

Note: The points to the left of the chart represent the results for stations located at the disposal site. Those on the right are the results from the reference stations.

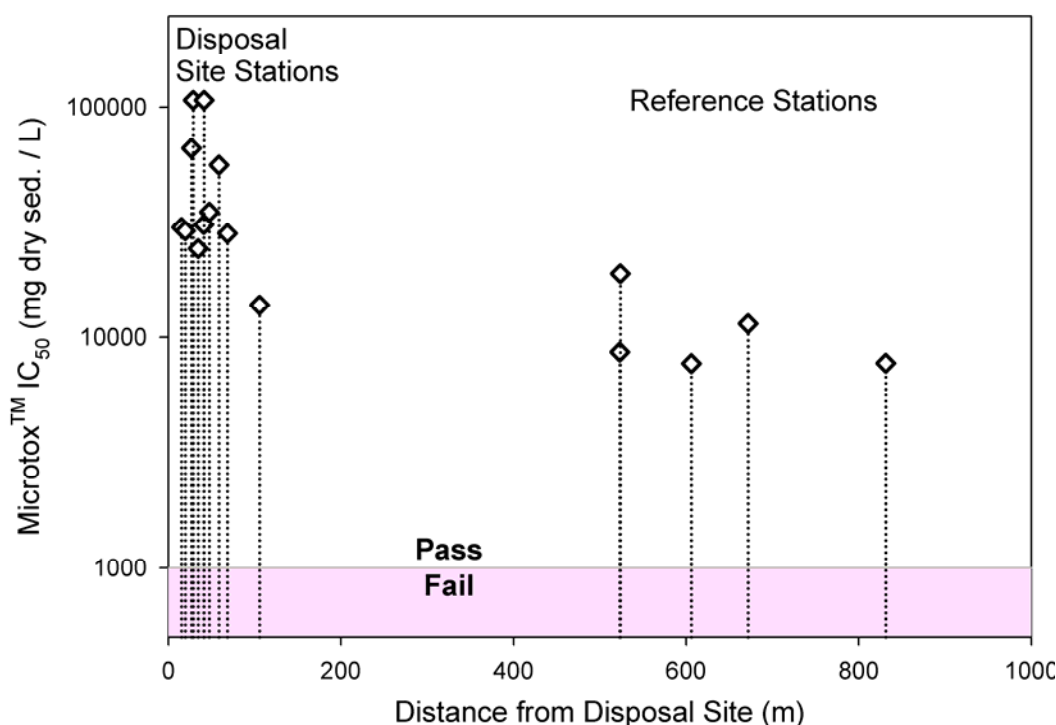
Figure 19. IC₅₀ obtained through biological tests for acute toxicity on the photoluminescent marine bacteria *Vibrio fischeri* in the solid phase

Note: The points to the left of the chart represent the results for stations located at the disposal site. Those on the right are the results from the reference stations.

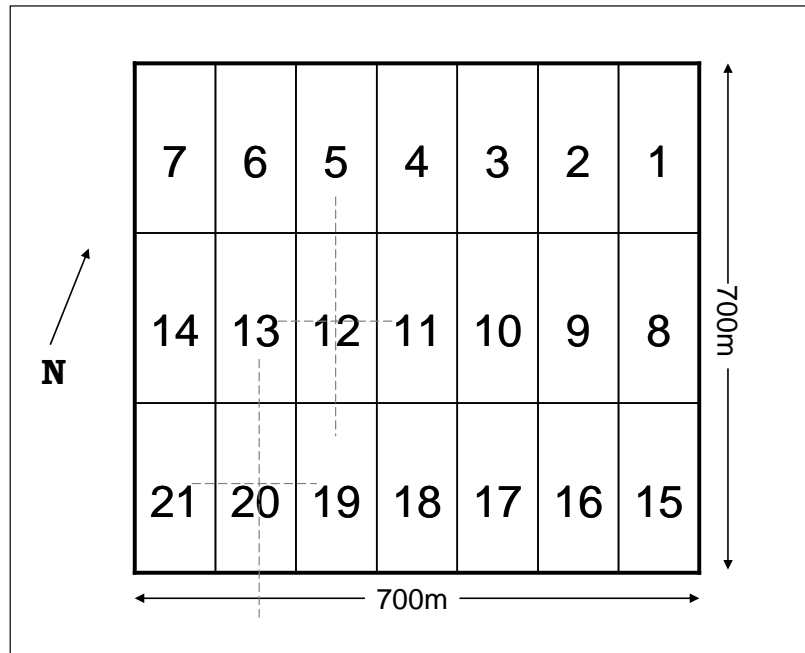
Figure 22. Schematic showing disposal site sectors and sampling lines at the new disposal site .

Sediment samples were collected at a total of 20 stations laid out in lines to cross sectors 12 and 20 where the majority of the sediment was deposited (see Figure 22). The axes of the sampling lines were oriented to ensure that they began and ended in undisturbed ocean sediment. The “vertical” (North by NW) axis is 350 m and was sampled at six points, while the horizontal (East by SE) axis is 200 m long and was sampled at four points. The axes parallel the sides of the sector and extend at least 100 metres beyond the top and bottom of the sector and 50 metres each side. Differential

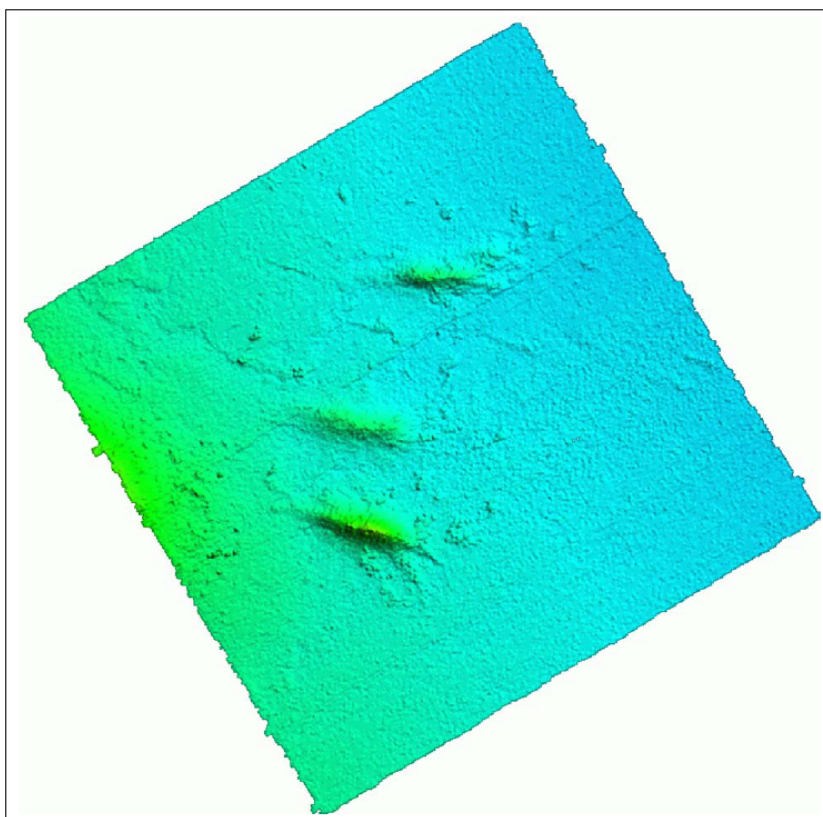
Figure 23. 2001 multibeam sonar survey of disposal area showing distinct piles of dredged spoil.

Graphic depictions of the sonar survey data collected in 2001 and 2002 are presented in Figures 23 and 24. The sounding equipment performed well, but inclement weather in 2002 introduced the “wave noise” evident in Figure 24. Figure 25 was generated by subtracting the 2001 survey from the 2002 survey and demonstrates that some changes have taken place in the topography of the site. Qualitatively it is obvious that the contours of the three spoil piles have softened but they can still be clearly seen in the survey. Analysis indicated that the maximum change at any given spot in the survey area was approximately 2.1 m of loss and 1.3 m of deposition. High transport and deposition totals were not typical of the site, and further analysis indicated that these peak numbers could likely be attributed to the ice scour that is evident on the 2002 survey near the northernmost disposal pile. The ice scour is 2.1 m deep and the shoulders of the scour are 1.3 m high which correlates well with the maximum transport and deposition amounts noted above. More typical results indicate that the height of the material on the site has declined by less than 10 cm which is consistent with minor off site transport combined with settling and ice scour.

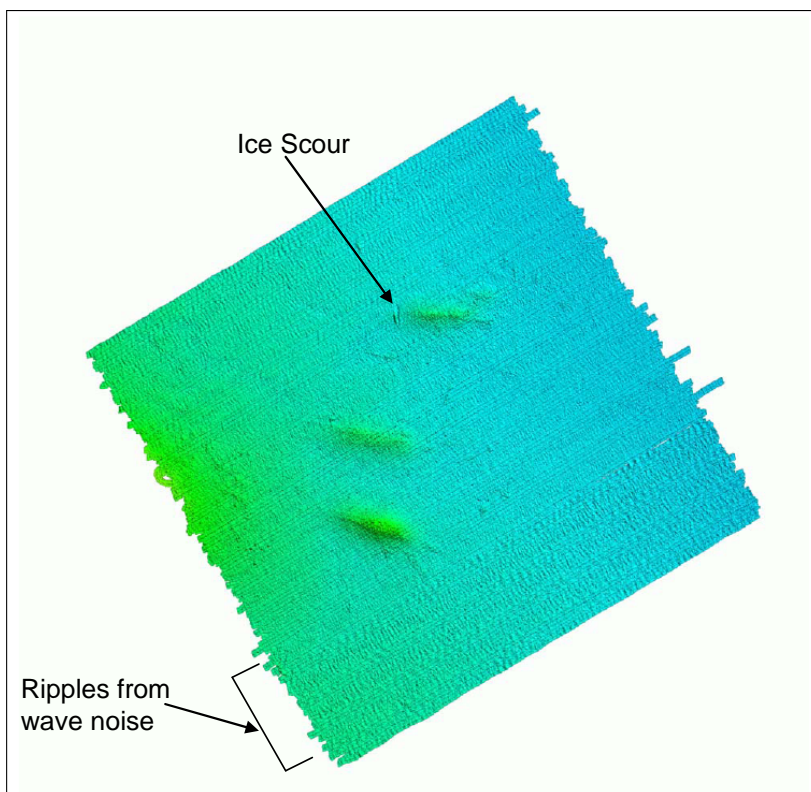
Figure 24. 2002 multibeam sonar survey of the disposal, carried out in 2 sessions.

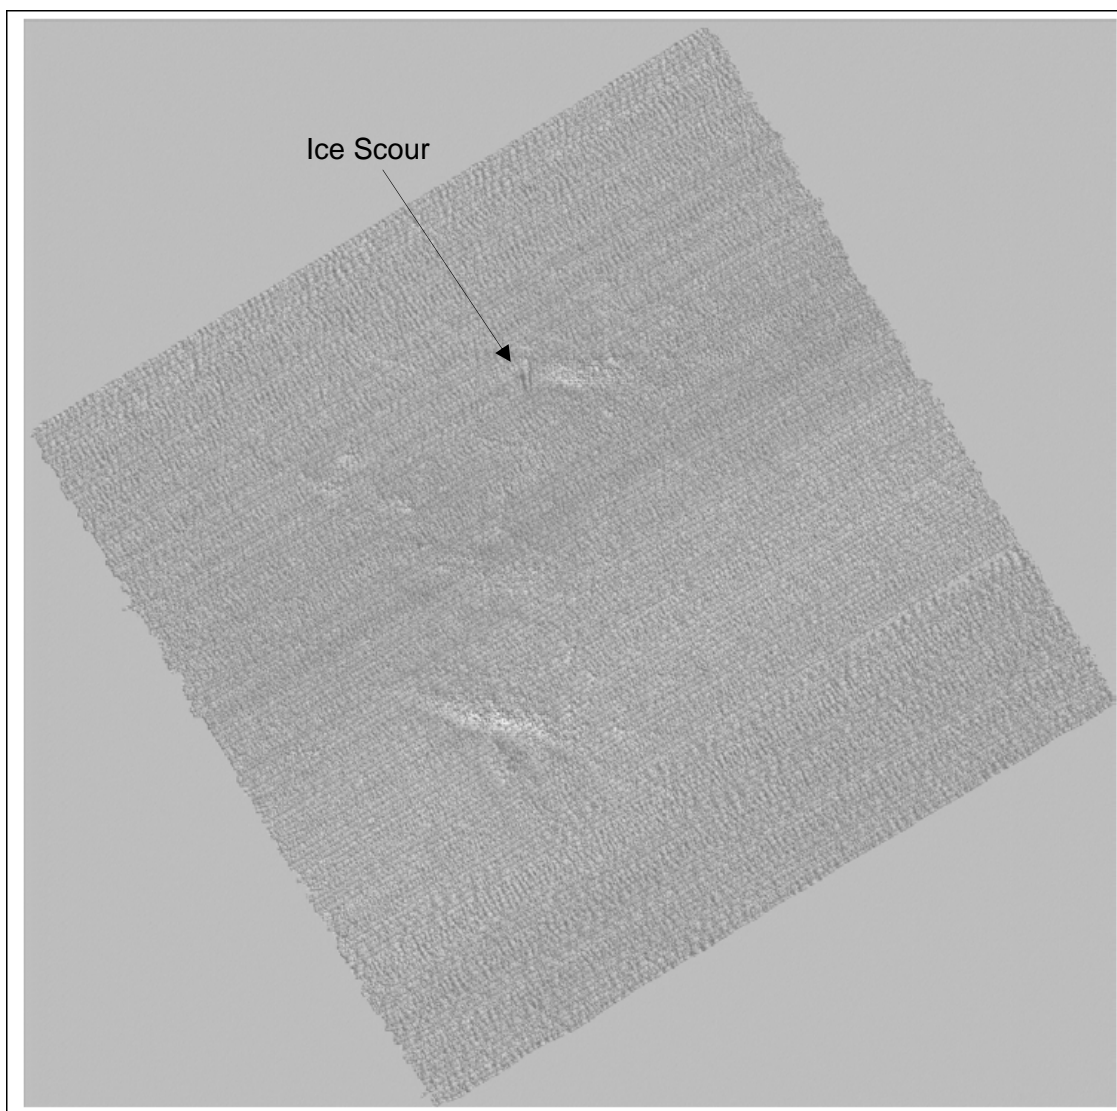
Figure 25. Overlay (subtraction) of 2001 and 2002 surveys; light shades indicate erosion while dark shades indicate deposition.

In general the evidence suggests that the predictions made regarding site stability and recovery in the pre-permit EAR were accurate. More specifically, the differences observed between the 2001 and 2002 sonar surveys are largely due to settling and minor off site transport. The surveys also clearly show that the material was deposited in the areas prescribed in the permit, and sediment chemical and particle size analyses support this conclusion. As predicted, no evidence of metal contamination was found in the deposited material. Both the video and sediment sample evidence confirms that the benthos is colonizing the site but indicate that the density and diversity of organisms is still low. Though not quantified, the benthos colonization of harder substrates appears to be faster than on the surrounding sandy substrate. The particle size data gathered during this study support the conclusions presented by the proponent in their EAR.
