CHAPTER FOUR OPERATIONS

CHAPTER FIVE EVENTS BEFORE EVACUATION

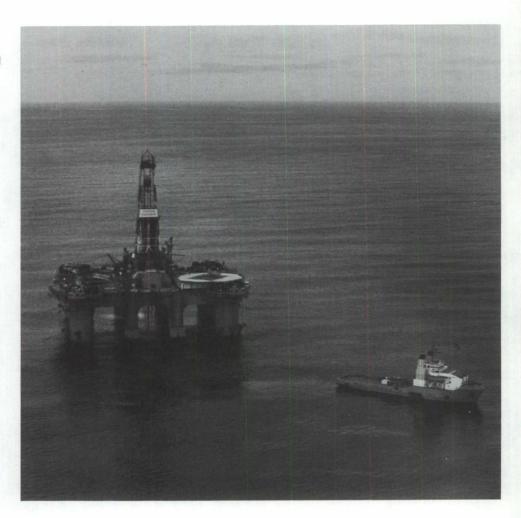
4.1 The Ocean Ranger with a Sikorsky S-61 on the helideck. The supply vessel Ravensturm is at close standby, as required during all helicopter operations.
