# FLIGHT

## COMMENT

3/1996

The Canadian Forces  
Flight Safety Magazine

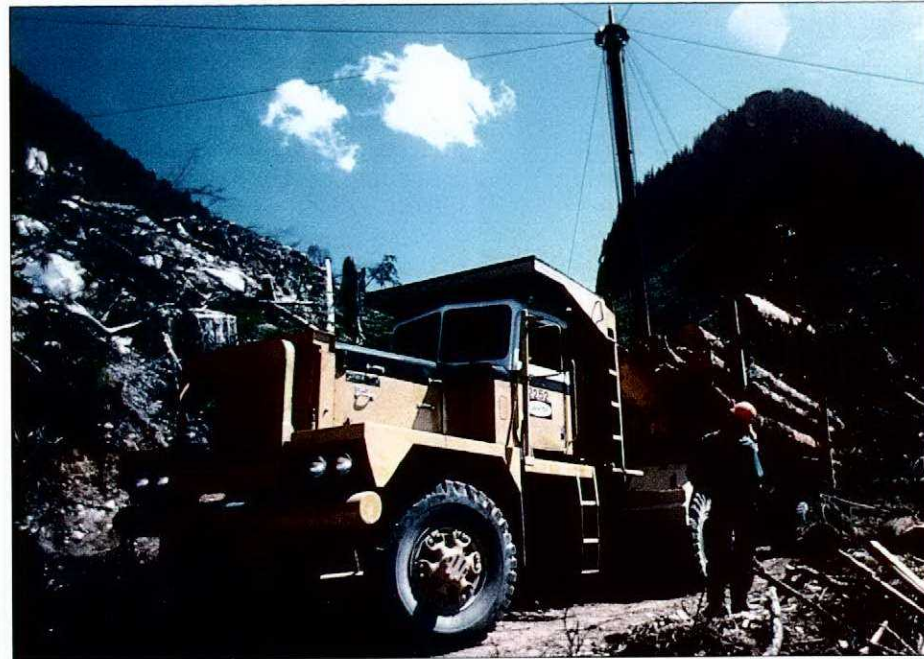
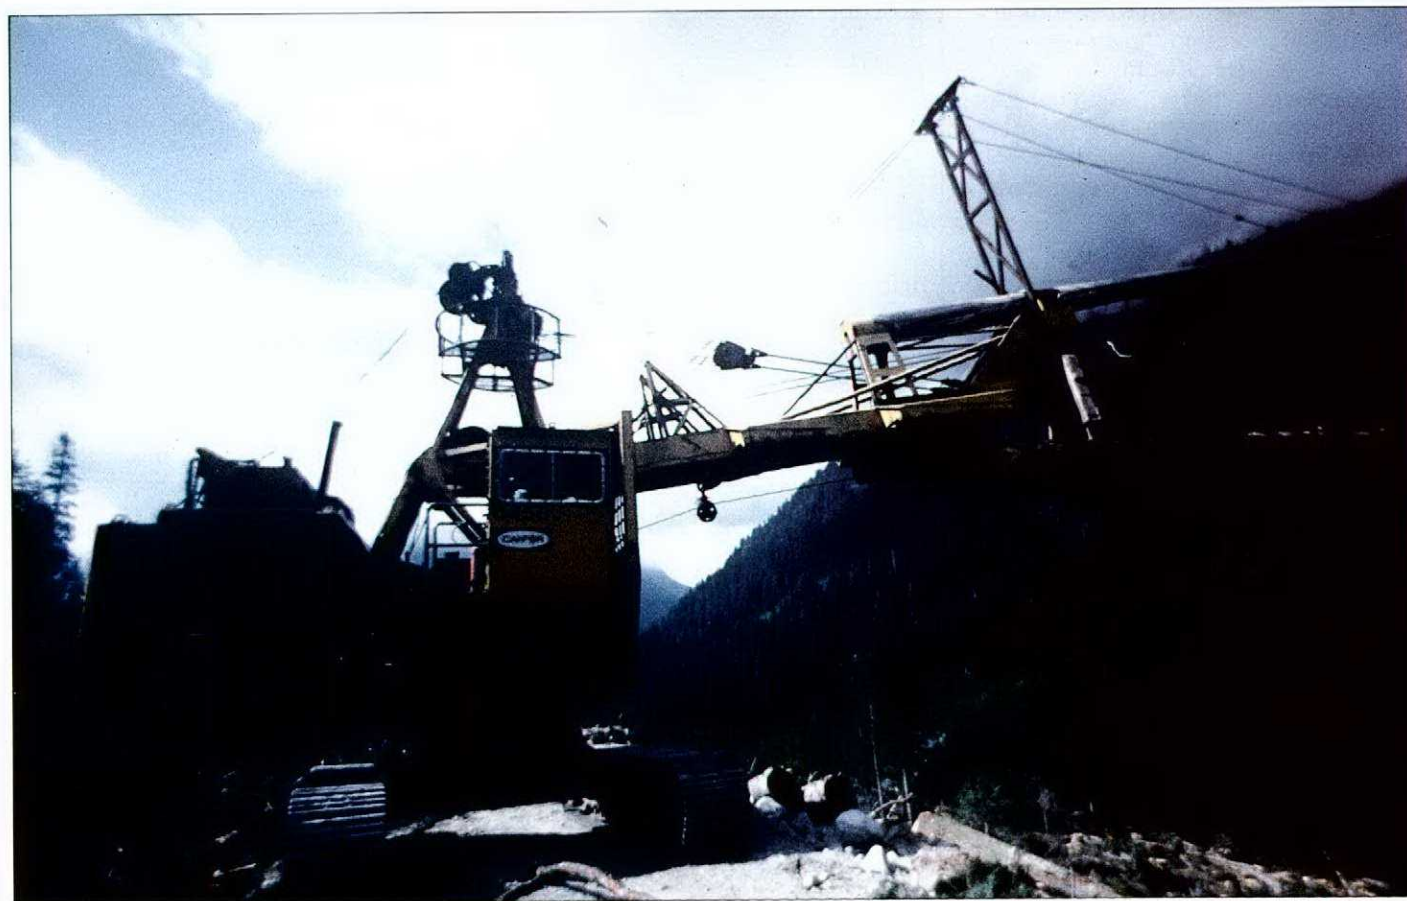
Skyline logging is becoming one of the preferred methods of extracting timber from the side of BC's mountainous valleys. It is basically a pulley and winch system that hoists logs from the top of a hill, down to the trucks below. Cables can span valleys up to 8000 feet across and up to 2000 feet high. The cables are unmarked, blend into the surrounding terrain and are very difficult to see. One operation recently claimed one of the RCMP helicopters.

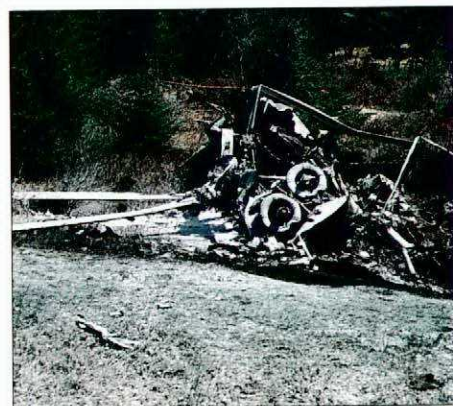
CH12425 Seaking crash site St John, N.B.

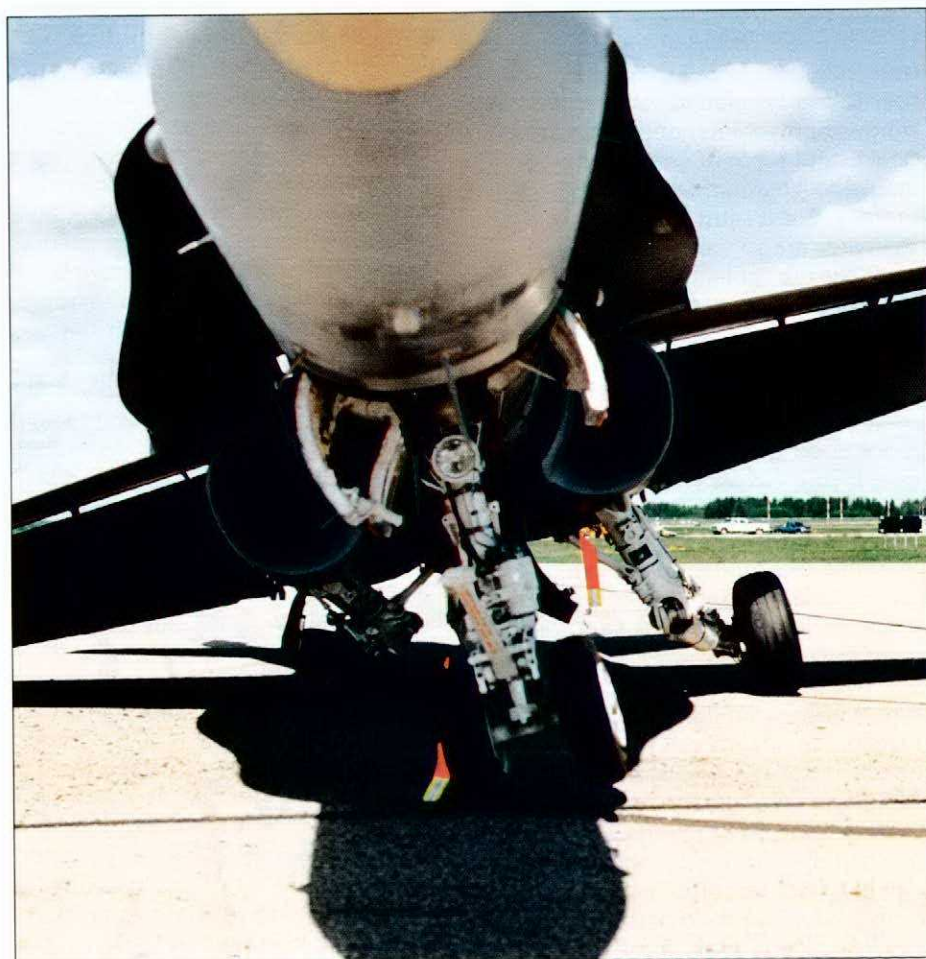
CF188928 Hornet landing gear accident in Cold Lake

confirmed that no progressive failure had taken place prior to the hard landing. Finally, upon the FSII's recommendation to have QETE further investigate the cause of CF188928 landing gear failure (Aug 95), QETE was able to prove that the cause that had initially been identified was an effect rather than a cause, and that the actual cause originated from the unlocking of the planing link mechanism.

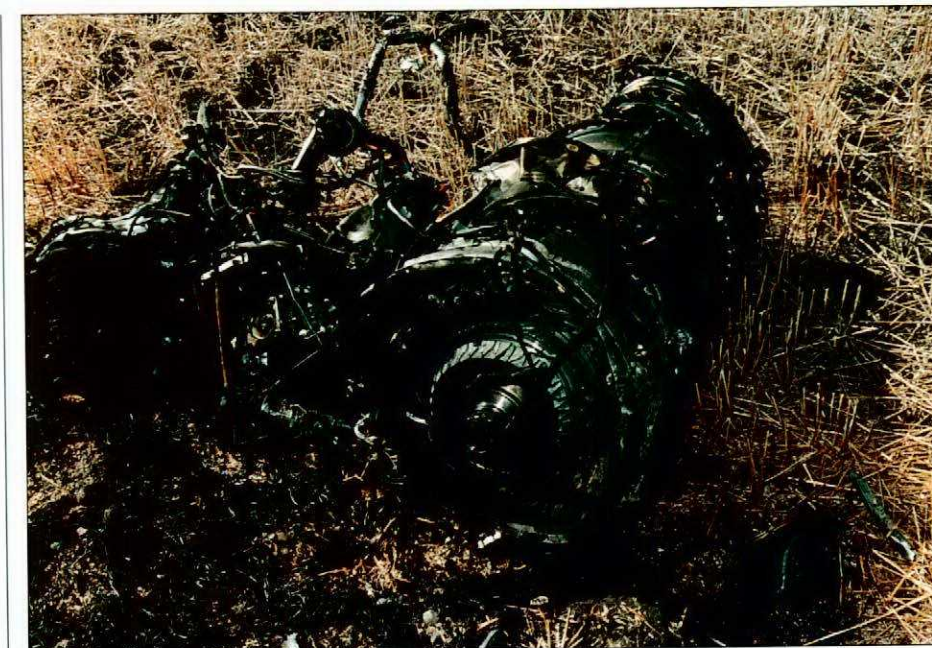
CT 114079 Tutor engine at crash site in Moose Jaw

QETE has historically demonstrated itself as a valuable partner in the resolution of Flight Safety technical problems. Some recent examples of this activity include the CT114079 snowbird

accident (Mar 94) where the investigation centered on the engine flameout and the inability to restart. The fault was caused by the fatigue failure of the engine variable geometry system feedback cable. This discovery and the assessment of the cables' condition on the Tutor and CF-5 fleet (at the time) led to the replacement of all feedback cables on the J-85 type engines to eliminate a Flight Safety hazard. In the case of CH12425 (Apr 94), QETE was also instrumental in determining the root cause of the fire that fatally injured several of the crew and destroyed the aircraft. QETE's assistance to the CC144613 Board of Inquiry (Apr 95)

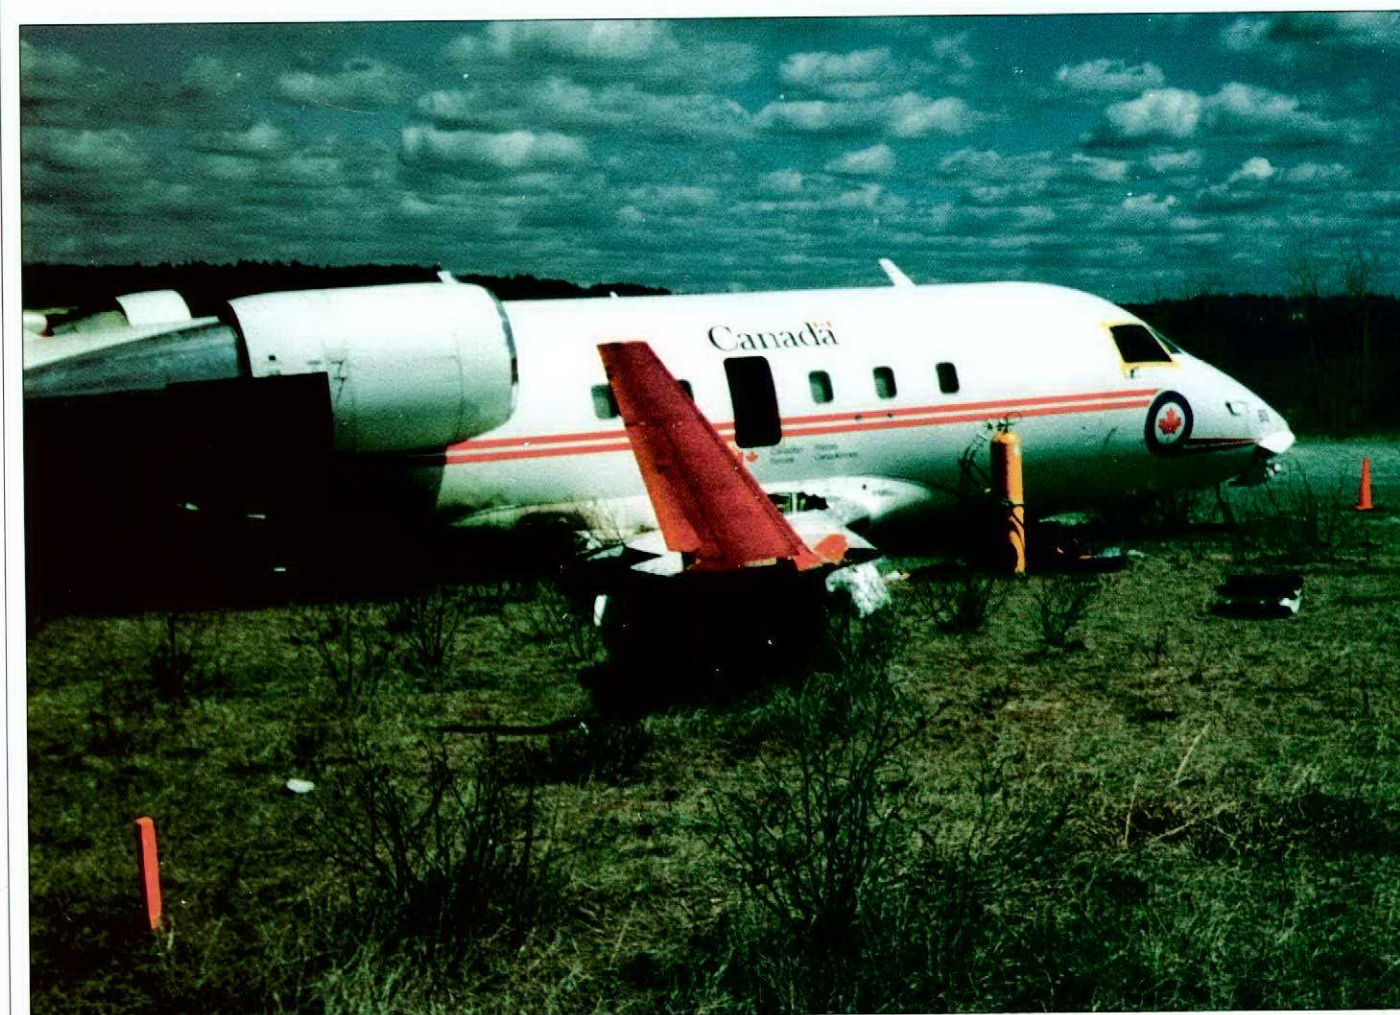
CC144613 Challenger final resting position in Shearwater

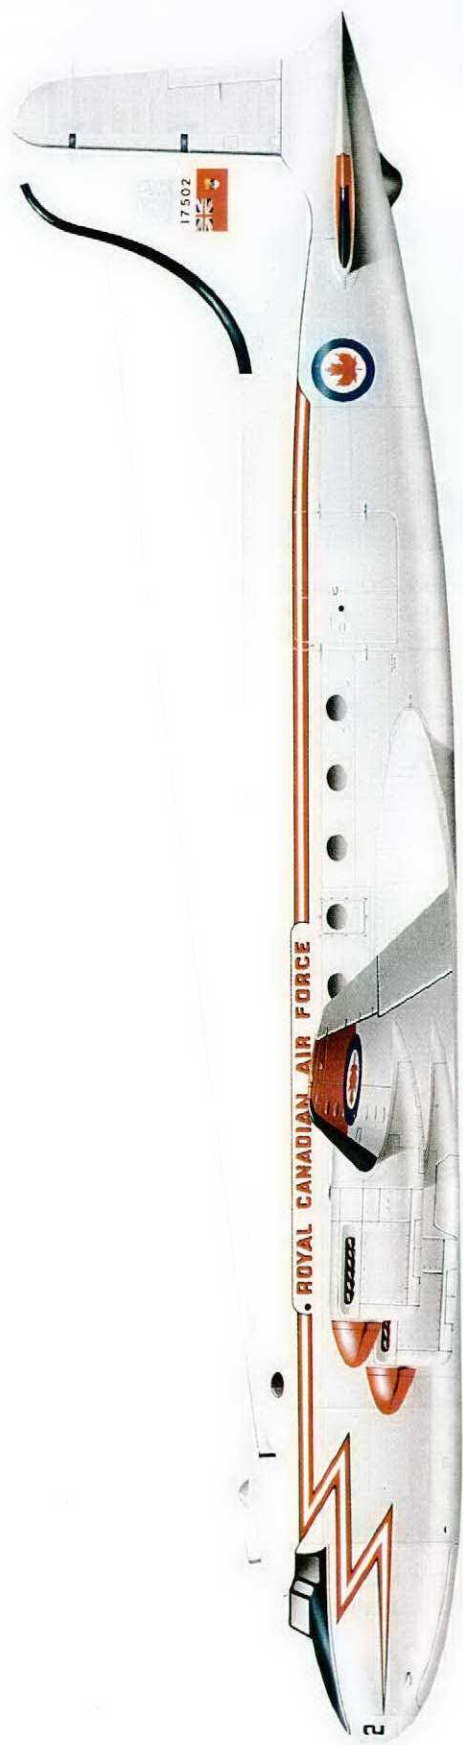
Canadair North Star Mk 1 17502 of No. 426 Squadron Royal Canadian Air Force at Dorval, Quebec during the time of the Korean conflict.
