ISSUE 3, 2015

# Flight Comment

## DOSSIER

Use It or Lose It

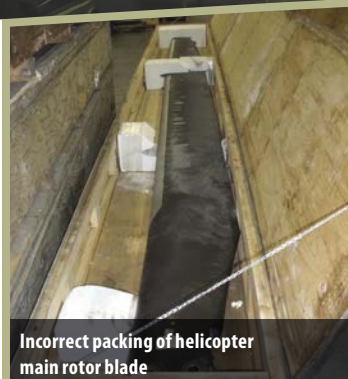
Incorrect packing of helicopter main rotor blade

aspects of aircraft maintenance. When receiving a part from supply, it will arrive in a proper container with adequate protection (bubble wrap, foam, etc.). The U/S component should be returned through supply in the same condition and preferably in the same container the replacement part arrived in. This will ensure that the component is well protected passing through the supply chain, until it arrives at contractor for repair.

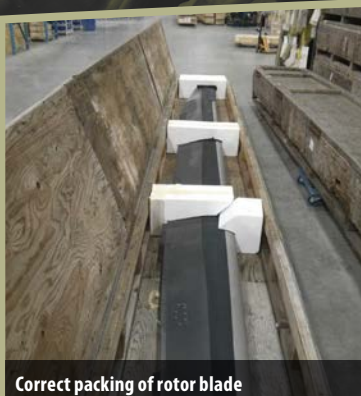
Correct packing of rotor blade

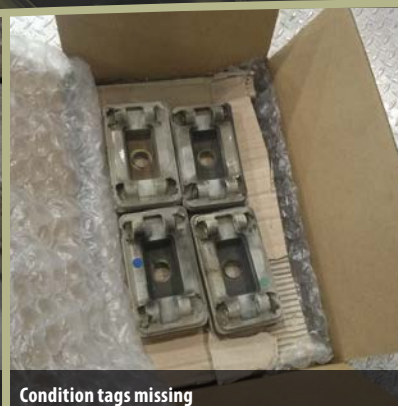
Condition tags missing

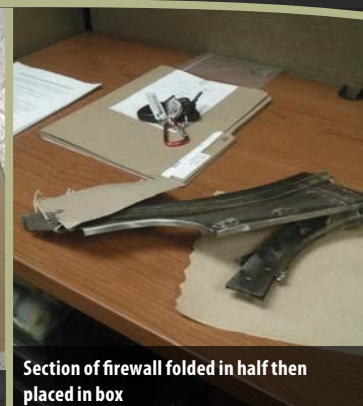
Section of firewall folded in half then placed in box

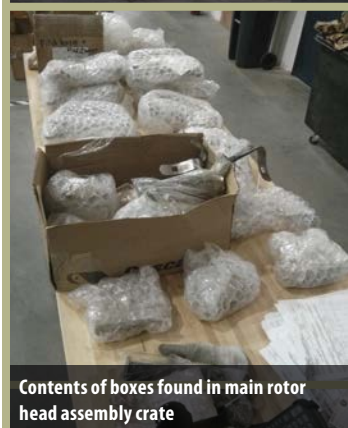
Contents of boxes found in main rotor head assembly crate

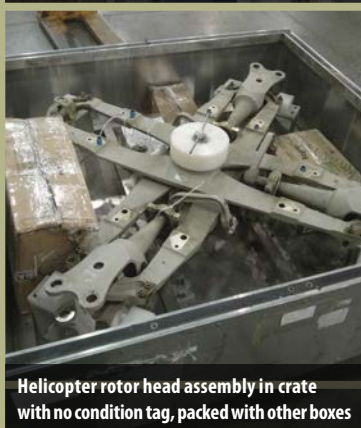
Helicopter rotor head assembly in crate with no condition tag, packed with other boxes

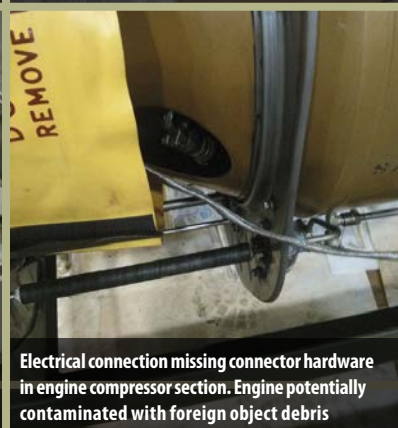
Electrical connection missing connector hardware in engine compressor section. Engine potentially contaminated with foreign object debris

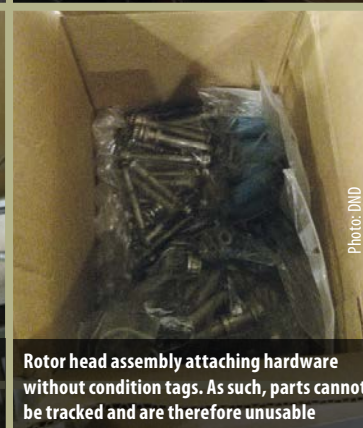
Rotor head assembly attaching hardware without condition tags. As such, parts cannot be tracked and are therefore unusable

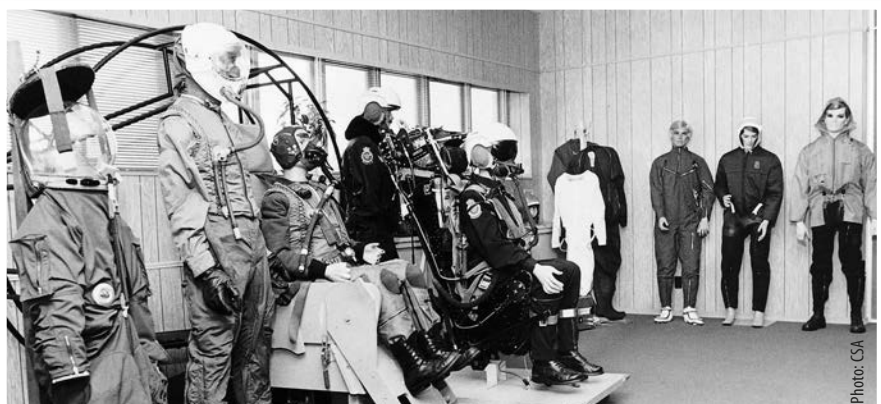
A photo of some of the early models of the pressure suit

In the fighters, it was sufficient to wear a pressure vest and anti-G suit that could be inflated differentially if the aircraft lost pressure or created G forces. To accomplish this, Stubbs developed a pressure-gravity valve that was fitted to the pressure vest and went down to the G-suit. If the pilot experienced G forces, only the G-suit inflated. If cabin pressure was lost, both the G-suit and the pressure vest were inflated and a pressure oxygen mask was activated.

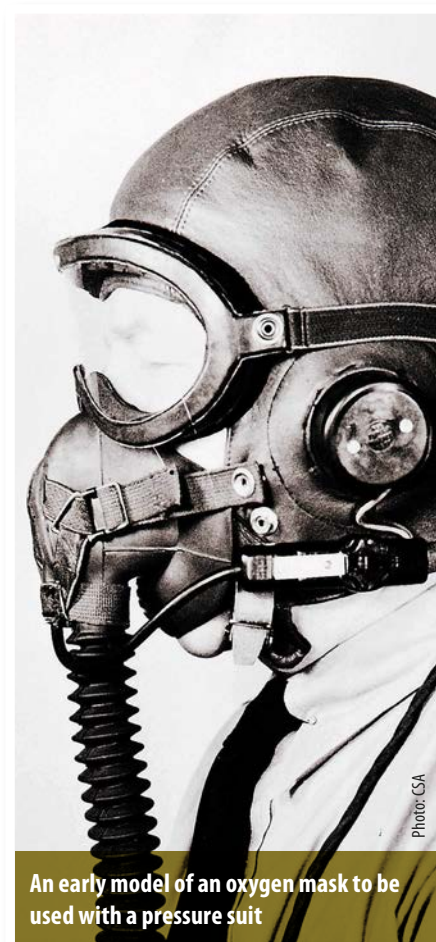
An early model of an oxygen mask to be used with a pressure suit

The standard oxygen mask used at the time, known as the Pate suspension mask, was not adequate to deliver oxygen under pressure, said Soper. It had straps strung through rollers that were used to pull the mask tight to the face but they did not provide a strong enough seal for positive pressure breathing. “Even when you turned up the tension to counter the oxygen pressure, you got a lot of leaking.” The new British helmet, on the other hand, “had a visor built into it and you could get a lot of pressure built up with this thing.”

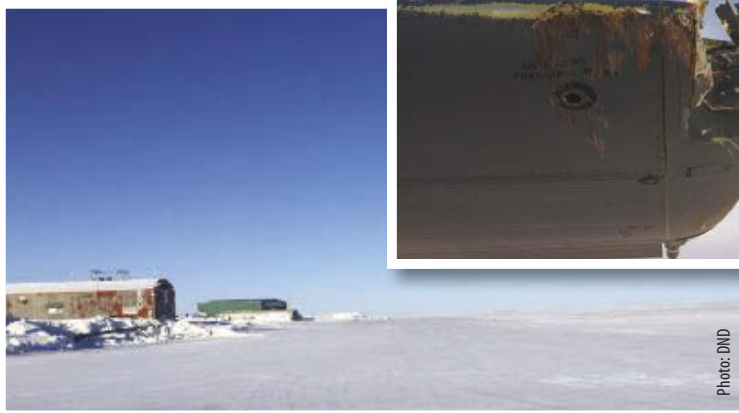
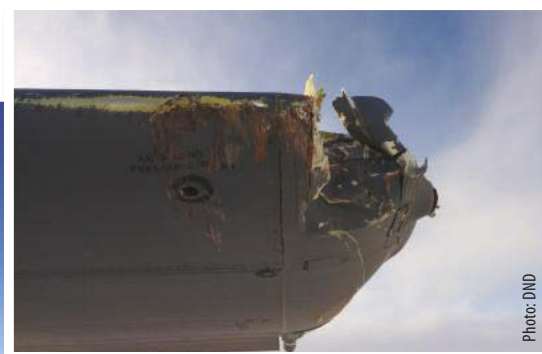
After considering the predicament and confirming that the wingtip was clear of the storage shed, the AC elected to continue taxiing to the Polar Shelf apron where the aircraft was parked and the engines shut down. A preliminary assessment was conducted revealing considerable damage to the outer two feet of the left wingtip. Following this, the crew unloaded their passengers and cargo, terminating the mission.

A full assessment of the damage revealed serious damage (C-Category) to the outer two feet of the left wing. The Preventive Measures focussed on task prioritization, communication, training and correction of routine deviations from standard procedures. ✈
