174      Bosworth Creek (NWT)  
Literature Review

Environmental Studies Research Funds  
Report No. 174

## **Bosworth Creek (NWT) Literature Review**

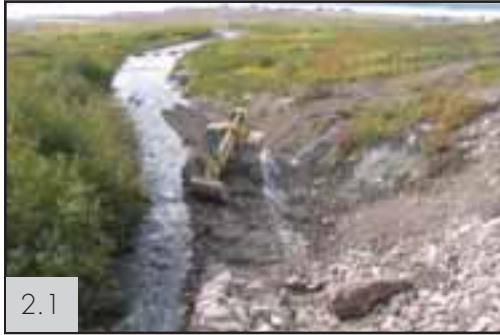
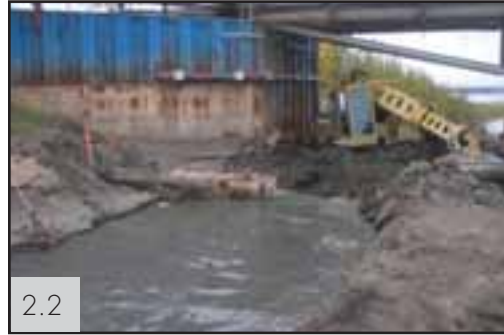
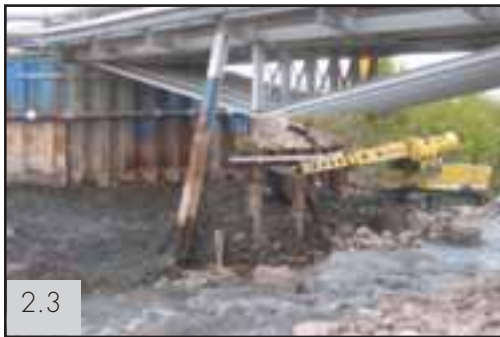
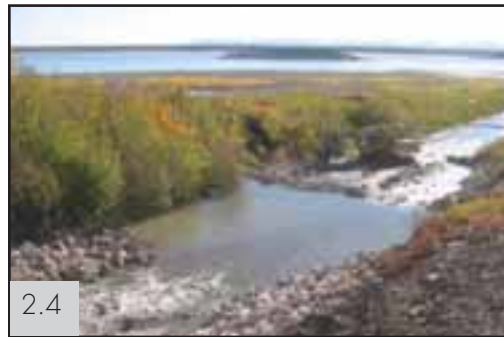
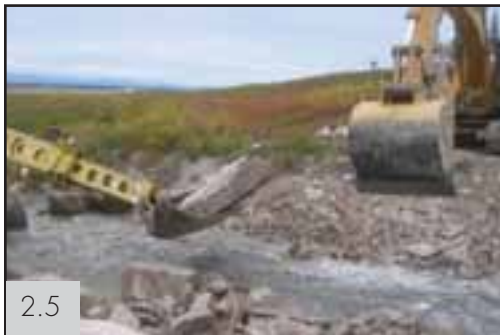
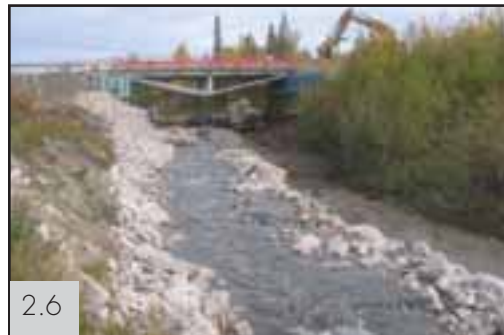
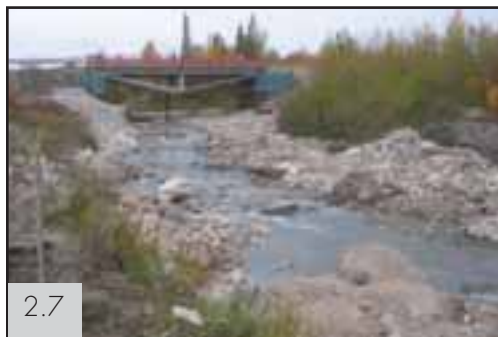
**FIGURES 2-1 THROUGH 2-7**  
PRECISION GRADALL WORK ON BOSWORTH CREEK

Several pictures of works around the weir area on Bosworth Creek were located and are shown in Figure 2-1 through Figure 2-7 (Precision Gradall 2008). These pictures document the re-contouring of Bosworth Creek and show that efforts were made to stabilize the banks and mitigate erosion through placement of rip-rap and gravel along the shore, either during re-contouring, or as part of the weir construction and/or decommissioning. From Figures 2-6 and 2-7, it appears that during re-contouring, the creek was modified including the creation of several riffles.

Dismantling of the weir was initiated in the fall of 2004 and completed in 2005. Following removal, a project was initiated to re-contour the bed and banks of Bosworth Creek to allow fish (specifically arctic grayling) access to traditional spawning areas upstream of the lower Bosworth bridge (Imperial Oil Resources 2005). An engineering design was developed to facilitate fish movement by re-contouring the creek bed to a slope of approximately 30. This 30 grade represented a lower-angled creek-bed than the historic grade based on earlier engineering diagrams (Imperial Oil 2005). Hydraulic analysis of the rehabilitated stream was conducted to determine the capacity of the creek and the flow velocities during high flow. Flow velocity below the bridge was calculated to be on the order of 2.3 m/s. Flow velocities in the pool area ranged from approximately 2.6 to 2.8 m/s depending on proximity to rocky outcrops. Flow velocities in these areas were approximately 3.1 m/s. Further details of the water management techniques, design modifications, construction work, final survey and hydraulic analysis are given in Komex 2005. At the request of DFO, Streamworks Unlimited was asked to provide advice on the channel and bank stabilization with respect to long term fish habitat and passage (Bates 2005). There were some initial concerns such as the placement of large boulders at 5-m spacing along each bank as potential resting places for fish. It was felt that these boulders may not be adequate at higher flow conditions for fish spawning. Modifications were suggested to the earlier surface design, and included the construction of three riffles and pools along the channel which would improve stability by dissipating energy, and provide areas for fish resting and holding. The three riffles were placed approximately 30-m apart and constructed to be about 0.9-m in height, allowing each riffle to backwater the toe of the next riffle upstream.
