Recent Morphological Changes And Future Management Of Crescent Beach, Lunenburg County, Nova Scotia

R. B. Taylor

2675

May 1993

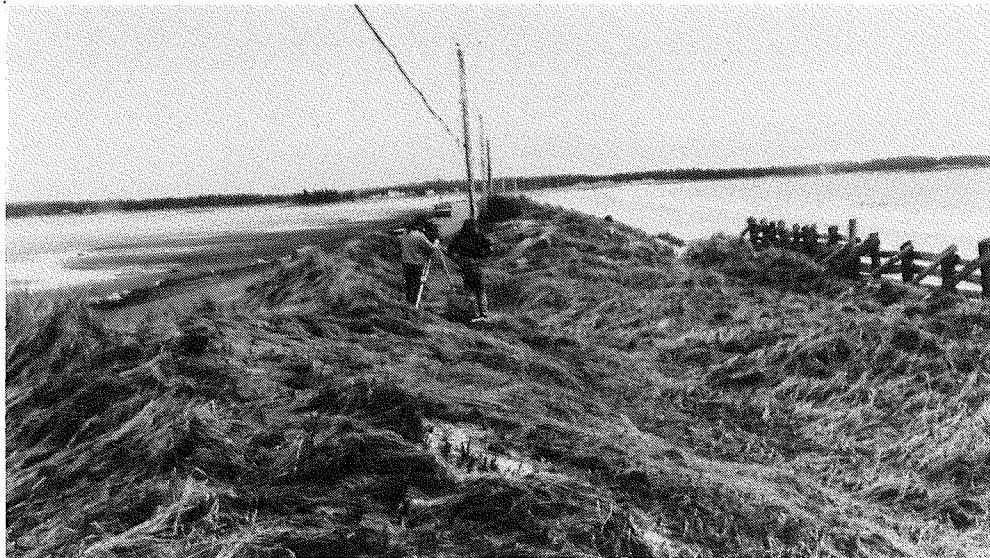
Figure 2. View to the east along Crescent Beach (people at line M) illustrating the narrow duneline, the tidal flats of Dublin Bay (left), the location of the highest dunes (background), and position of the wooden retaining fence (photo May 13, 1992).

The sand dunes of Crescent Beach have been breached, eroded and severely degraded during storm events and by intense useage by people (Table 1, Fig. 2). It is implied in the report by Bowen et al. (1975) that the beach has been in roughly the same location since the turn of the century however older maps and air photos were not available to confirm longer term changes in the beach position.

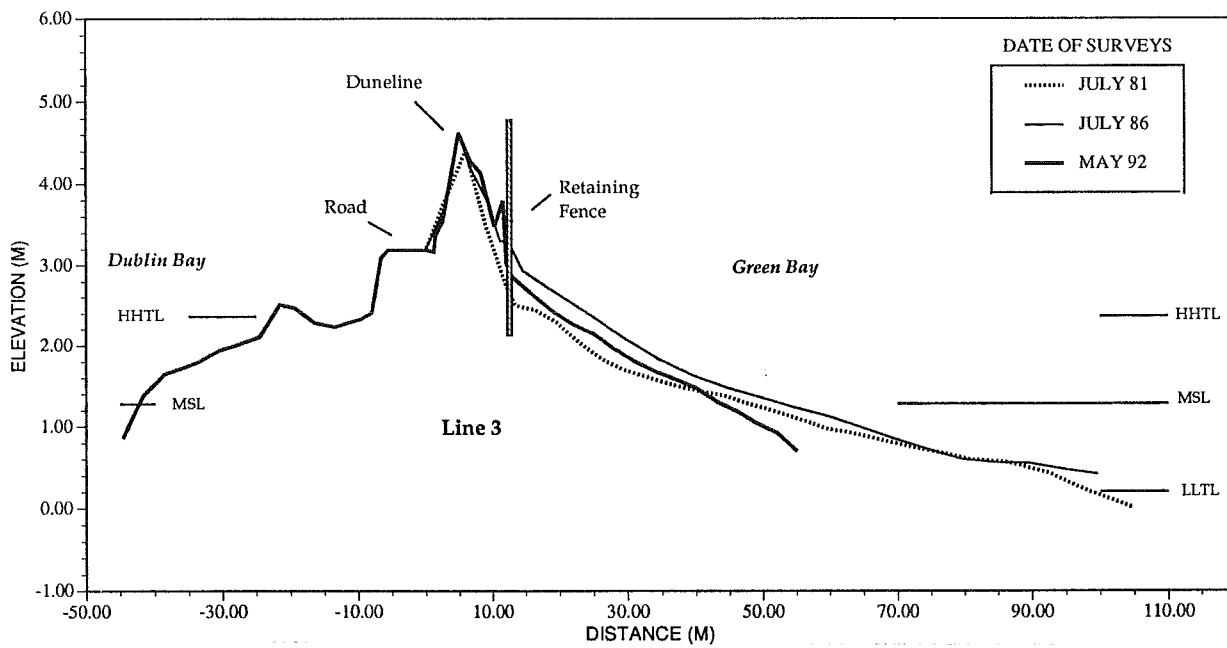
Line 3- In 1981 scouring occurred at the base of the wooden fence and the main duneline but by 1986 sand levels had increased by 0.2 to 0.7 m across the beach and dunes (Table 2, Fig. 3a). The greatest accretion was registered just seaward of the wooden retaining fence. The crest of the primary dune aggraded by 0.3 m but shifted 1.5 m landward by 1986. By 1992 the dune crest again had increased in height but a net loss of 0.4 m of sand was recorded at the retaining fence and across the lower beach face. The most disturbing change registered between 1986 and 1992 was the steepening of the lower beach face and its resultant 50 m landward retreat at lower low tide level (Fig 3a).

Figure 3. (Opposite page) Cross-section profiles surveyed between 1978 and 1992 at: a) line 3, b) line M, and c) line 38, Crescent Beach. The location of survey lines is shown in Figure 1. Survey datum was mean sea level (1.28 m).

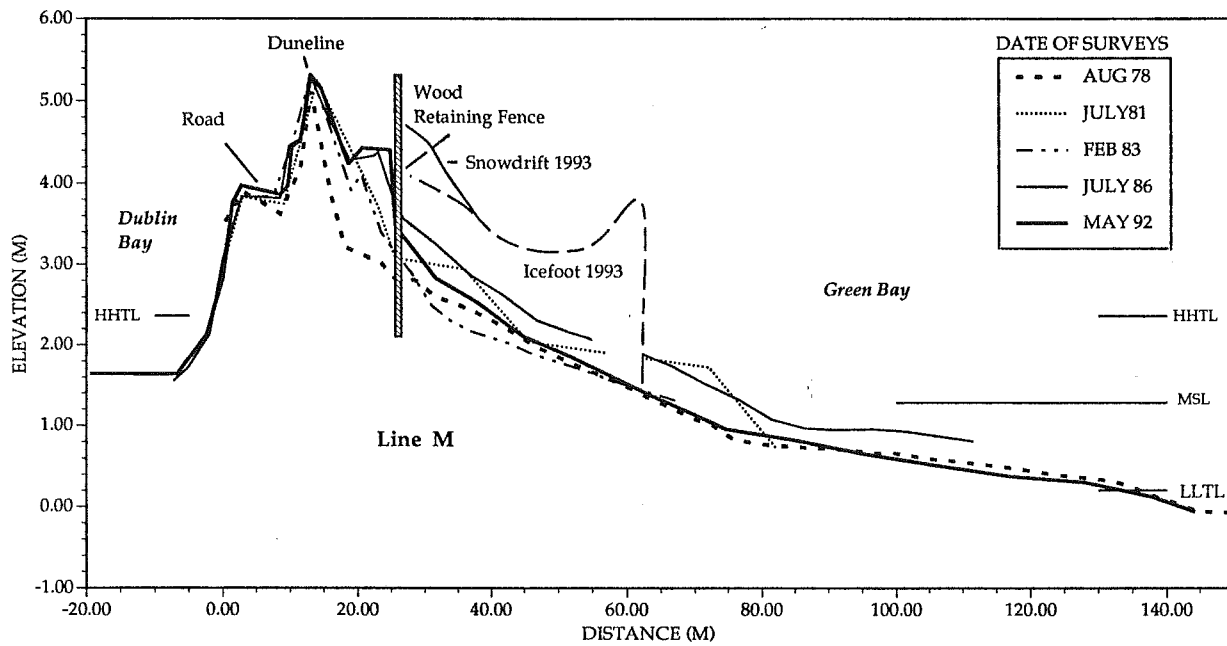
Line M- By 1986 a net sand accumulation of close to 1 m was measured along both sides of the wooden retaining fence and the beach registered the highest sand levels since 1981 (Fig. 3b). Sand accumulation decreased to less than 0.6 m farther landward from the fence. By 1992 there was a slight increase in height (0.2 m) and landward shift in position of the primary dune crest. The reduction in dune growth between 1986 and 1992 suggests that sand levels have reached an equilibrium level relative to the height of the wooden fence. Sand levels in 1992 on the landward side of the fence were 0.8 to 0.95 m below the upper fence rail. By 1992 waves had scoured 0.2 to 0.3 m of sand from around the base of the fence (another log line exposed-Fig. 4); damaged parts of the fence and sand levels across the beach face had not yet recovered to their 1986 level. Very little of the dunes had survived seaward of the fenceline (Fig. 4). A comparison of surveys in 1986 and 1992 also suggested that the northern shoulder of the road had been built up, possibly as a result of road grading to compensate for the winnowing of material by waves at the base of the road bank.

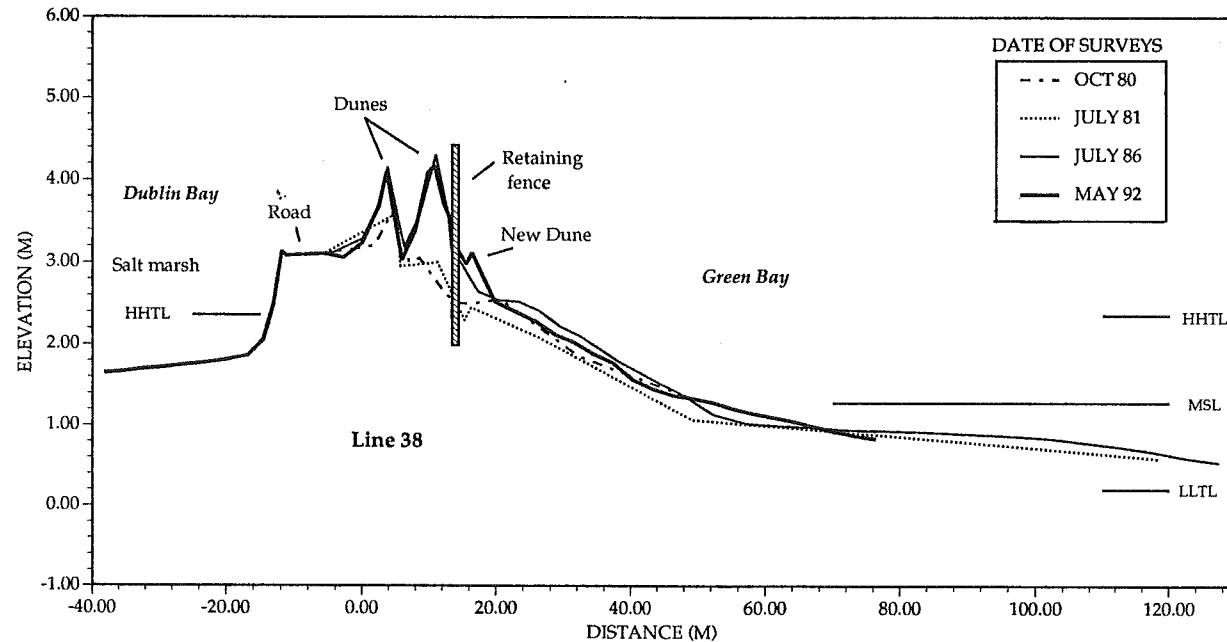
Line 38- Sequential surveys since 1980 have shown that the beach face slope is very stable and that this is an area of substantial dune growth (Fig. 3c). Net fluctuations in sand levels across the beach face were generally less than 0.3 m between surveys. Landward of the retaining fence the dunes grew by as much as 1.3 m in height and 10 m in width between 1980 and 1986. The seaward dune slope was covered by lush marram in 1986 as a result of sediment accumulation. Six years later in 1992 there was little net change in dune morphology. Only a small reduction in dune height adjacent to the wooden fence was observed and the cover by wild rose was much greater adjacent to the road. Seaward of the retaining fence the foredune had increased in width (5 m), height (0.5 m) and become densely vegetated despite showing signs of having been flooded by waves. New dunes extended eastward and westward of the survey line but stopped about 20-30 m to the west near survey line 35 where the beach orientation changed. Between 1981 and 1992 the upper foreshore slope experienced only a net lowering of 0.2 m.

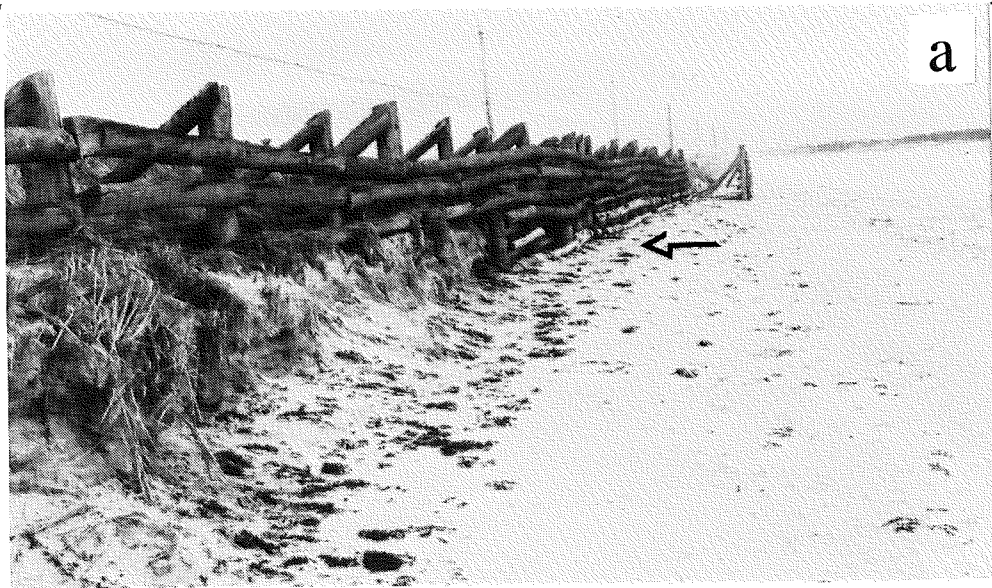
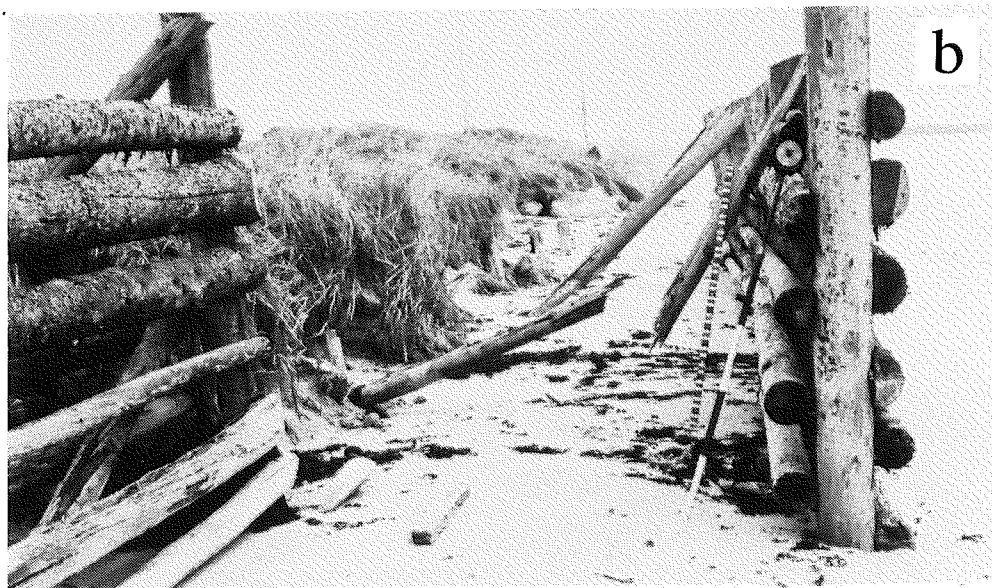
Figure 4. (a) General and (b) close-up views of sediment scouring observed along retaining fence at and near survey line M (arrow) in 1992.

2. that the wooden retaining fence be maintained and possibly extended along the central part of the beach. Despite the unsightly appearance, the wooden retaining fence with its widely spaced, horizontally aligned logs has proven to be successful in trapping sand and in securing the duneline. The fence also allowed a free exchange of wind blown sediment between the foreshore and the dunes at all times. Foreshore sands are nitrogen rich. A constant supply of new sand to the dunes enhances vegetation growth which in turn helps to stabilize the dune. Local wave scouring was experienced along the fence but because of its size and stability (as opposed to snow fences) the scouring of the dunes has been much less than if the fenceline had not been established. In winter the fence also causes snow drifting along its seaward side which protects the fence and dunes against storm waves. An extension of the fence along the central part of the beach could enhance sediment accumulation across the backshore but it may be harder to stabilize the sediment because this is also an area of greater wave exposure and potential wave scouring.

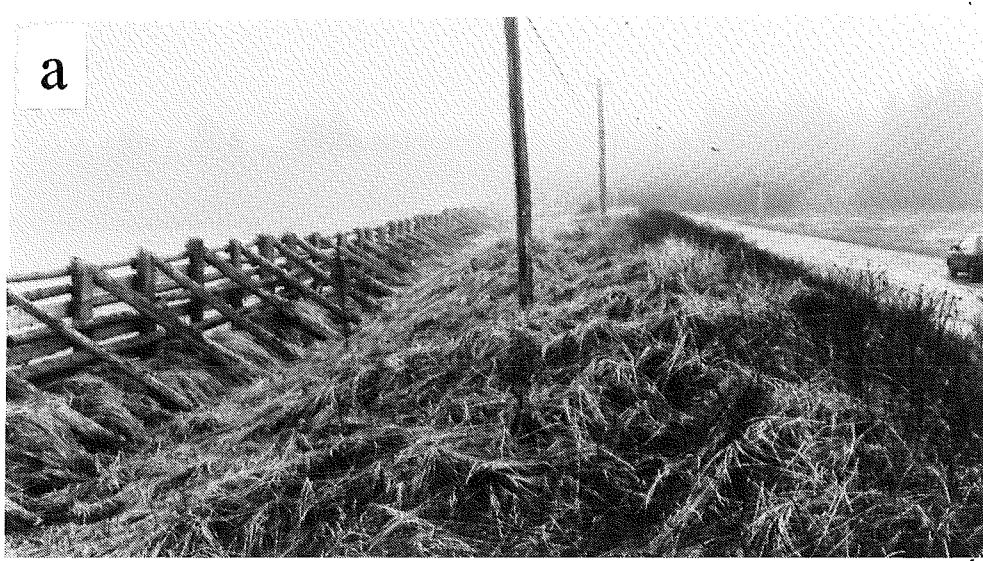
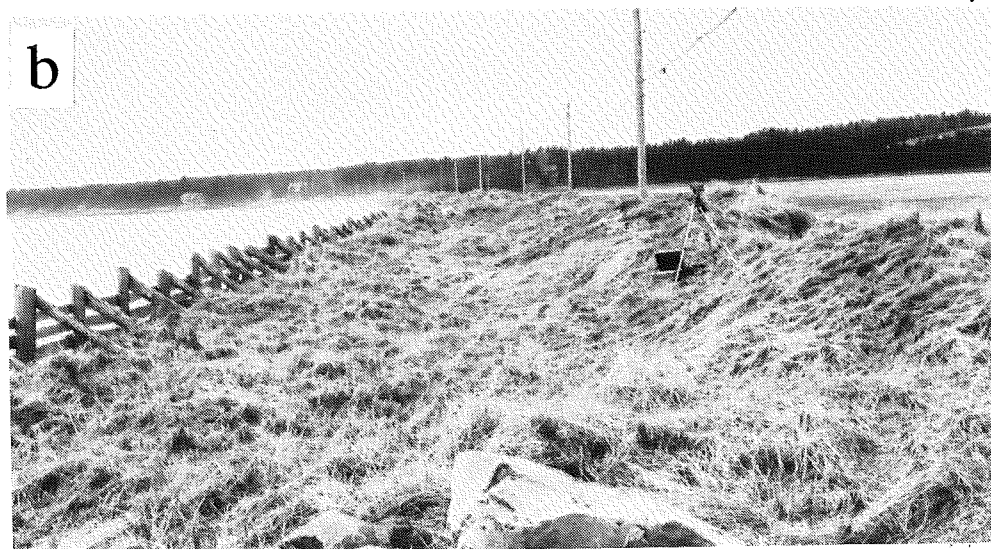
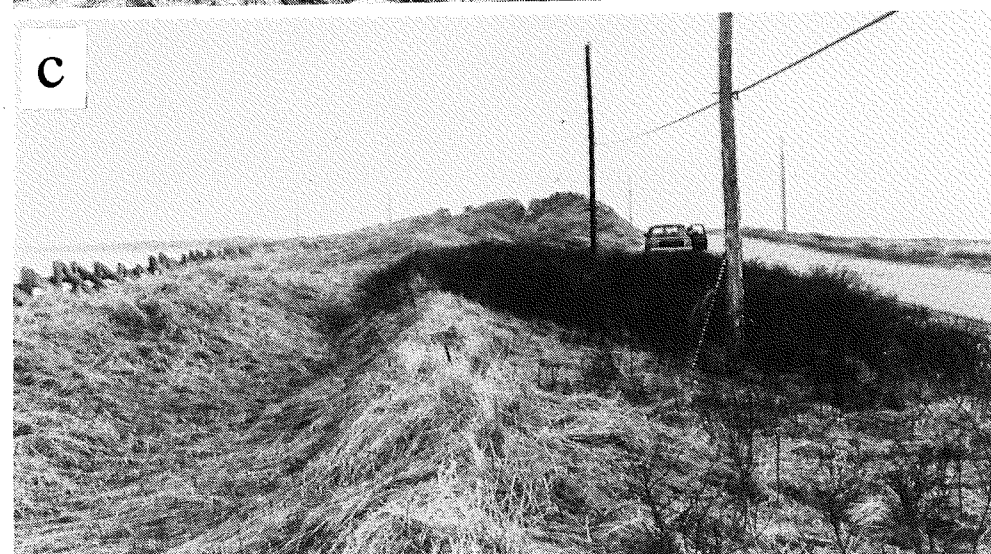
Figure 7. Views looking westward showing the condition of the primary duneline in May 1992: (a) at line 3 where sand has not completely infilled landward side of the wooden fence; (b) at line M where sediment accumulation was greater back of the fence; and (c) at line 38 where a new dune developed back of the wooden fence and wild rose bushes are spreading and stabilizing the backdune slope.
