**J. L. HART Cruise Northumberland Strait, N.B. (95-140)**  
**23 May - 6 June, 1995**

Geological Survey of Canada Open File 3176

## CRUISE SUMMARY SHEET

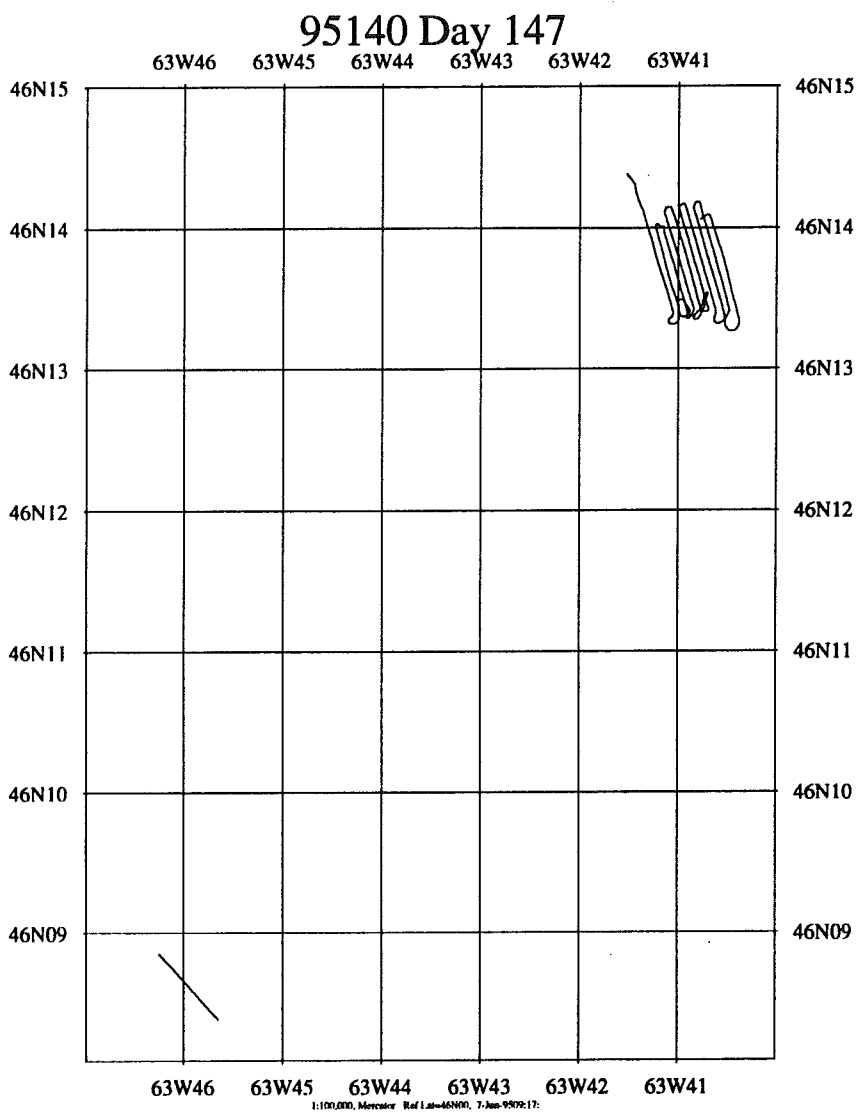
**Figure 8.1.3.** A detailed track plot of the mosaic of disposal site # 2.

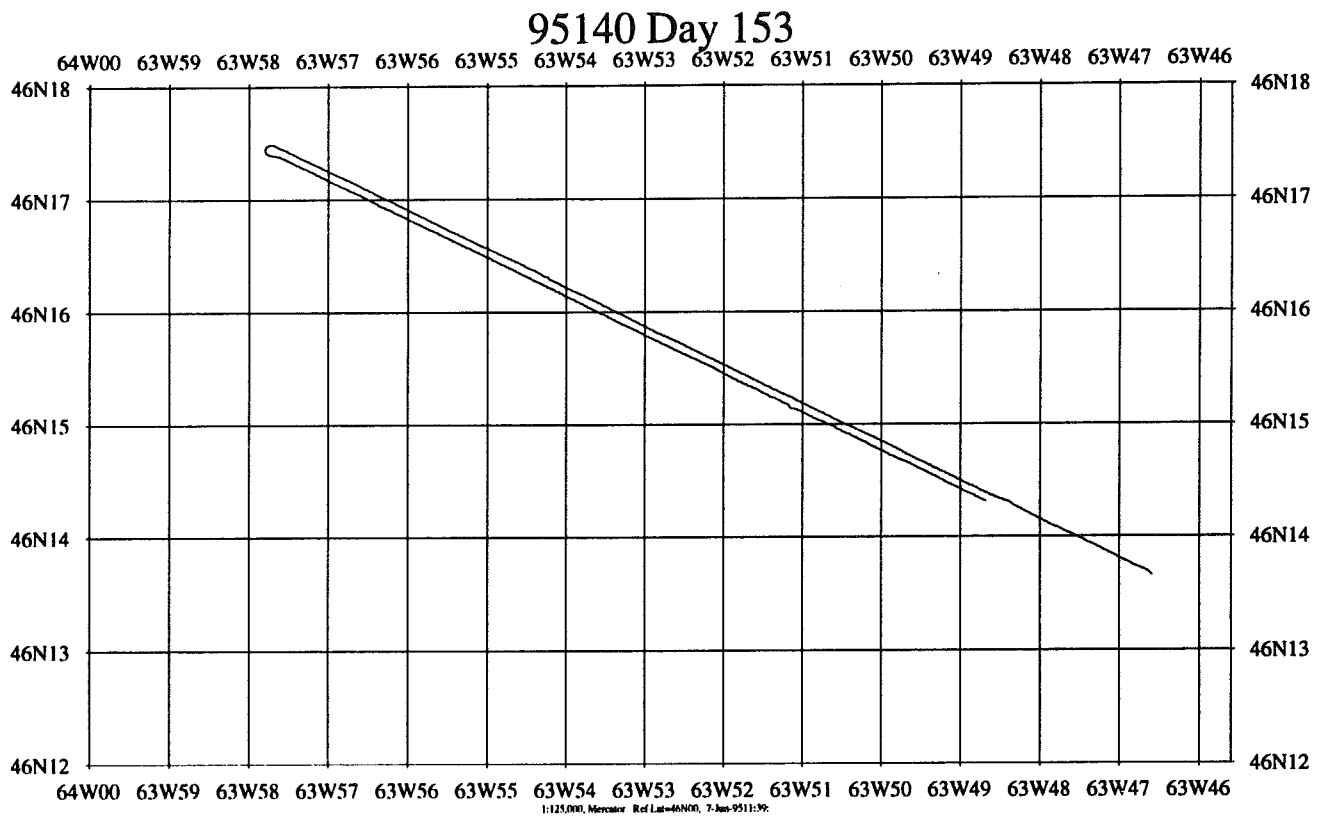
**Figure 8.1.6.** A detailed track plot of the channel approaches to Summerside (DPW survey).

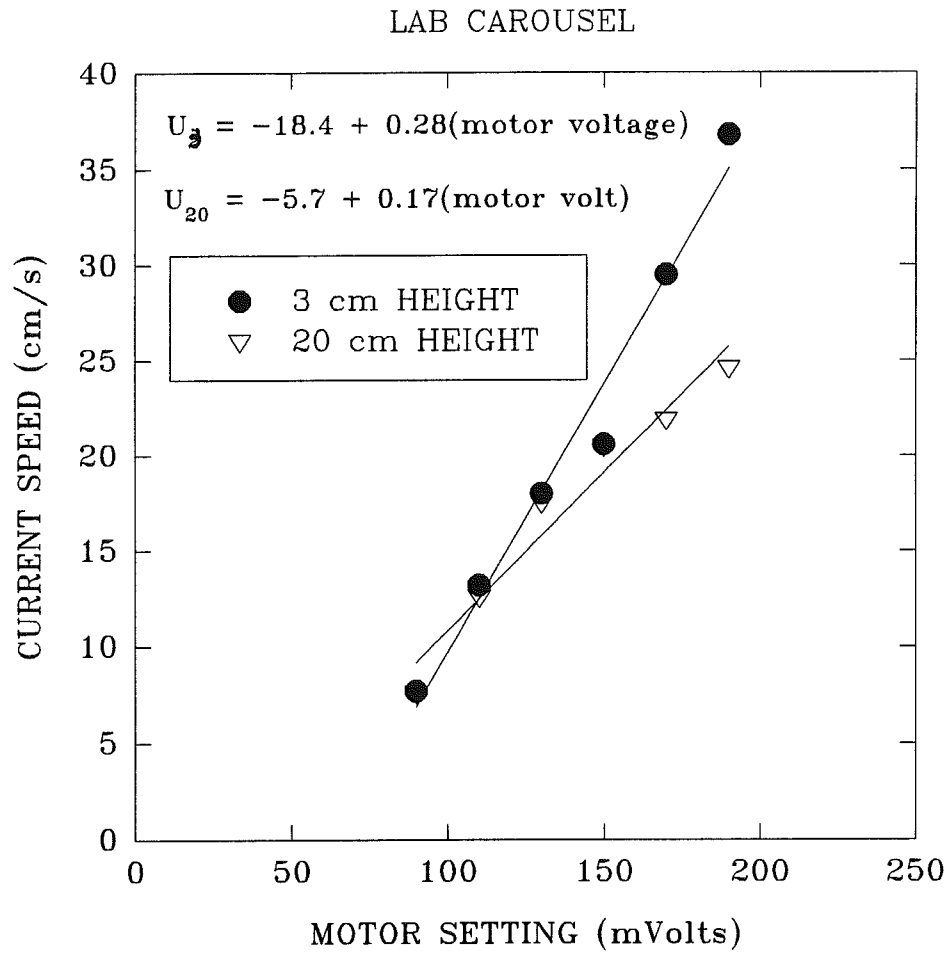
**Figure 8.4.2.** A regression analysis of the motor setting (mV) and current speed (m/s) measured at heights of 3 and 20 cm in the Lab Carousel.

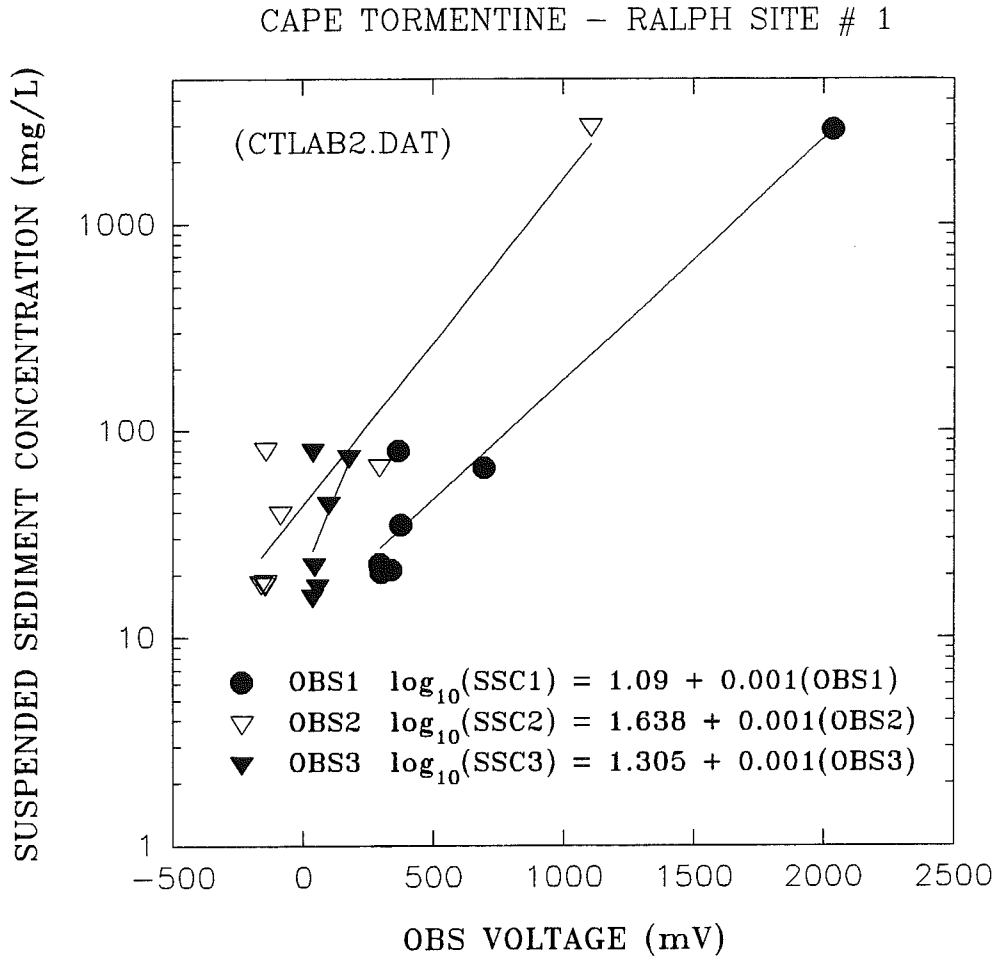
**Figure 8.4.4.** A regression analysis of OBS output (mV) and suspended sediment concentration (mg/L) for Lab Carousel experiment Ctlab2 (RALPH2 site # 1).

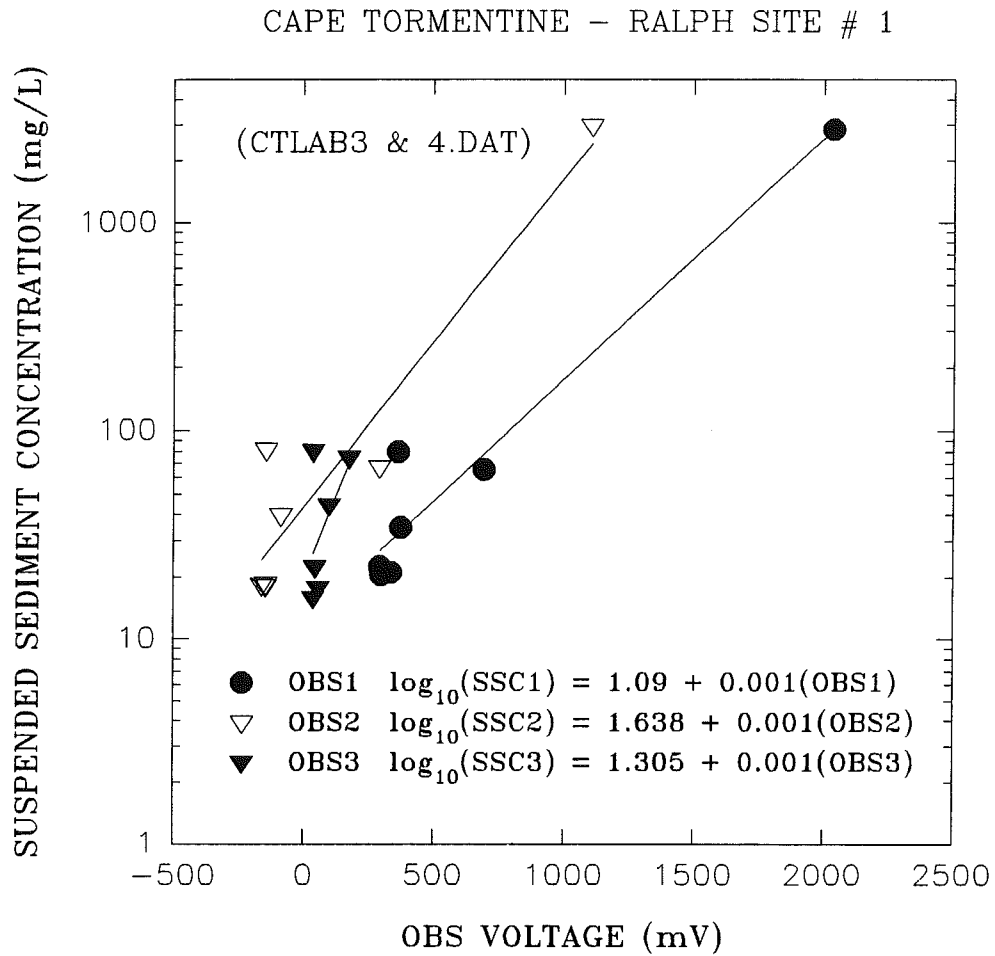
**Figure 8.4.5.** A regression analysis of OBS output (mV) and suspended sediment concentration (mg/L) for Lab Carousel experiment Ctlab3 (RALPH2 site # 1).

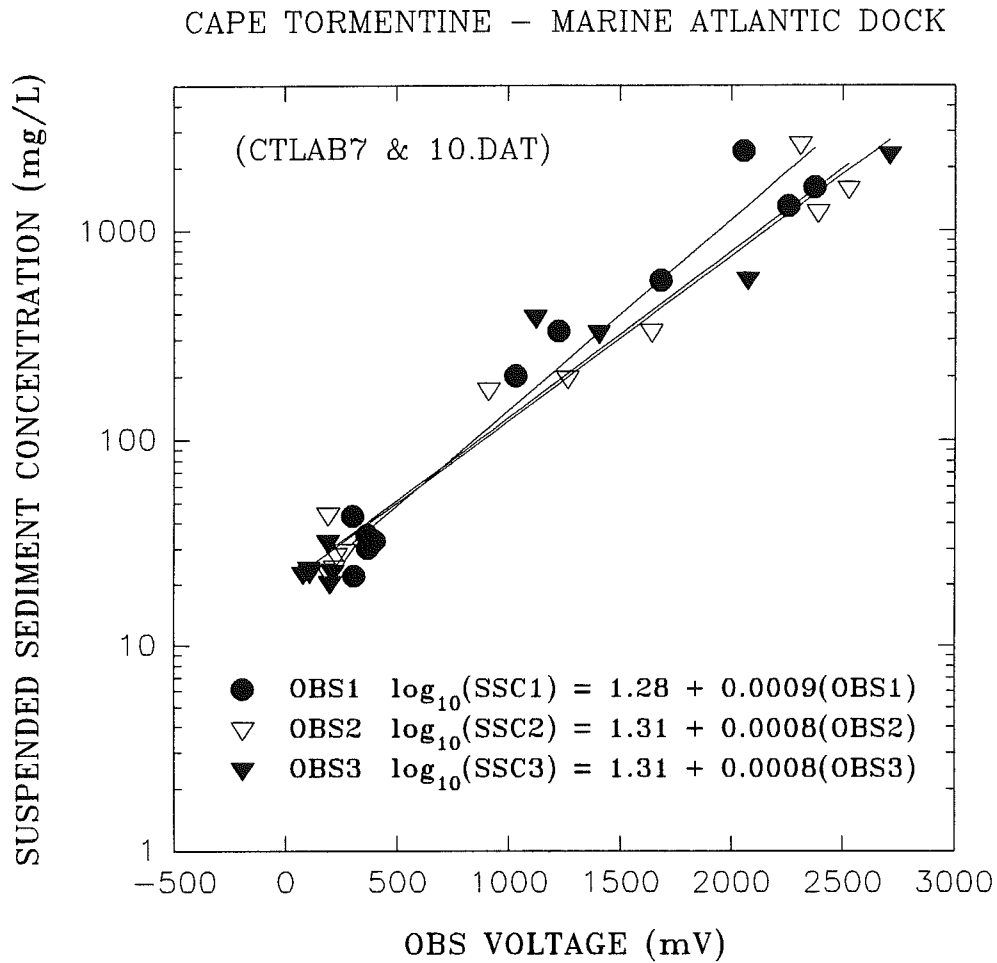
**Figure 8.4.7.** A regression analysis of OBS output (mV) and suspended sediment concentration (mg/L) for Lab Carousel experiment Ctlab7 & 10 (Marine Atlantic dock).

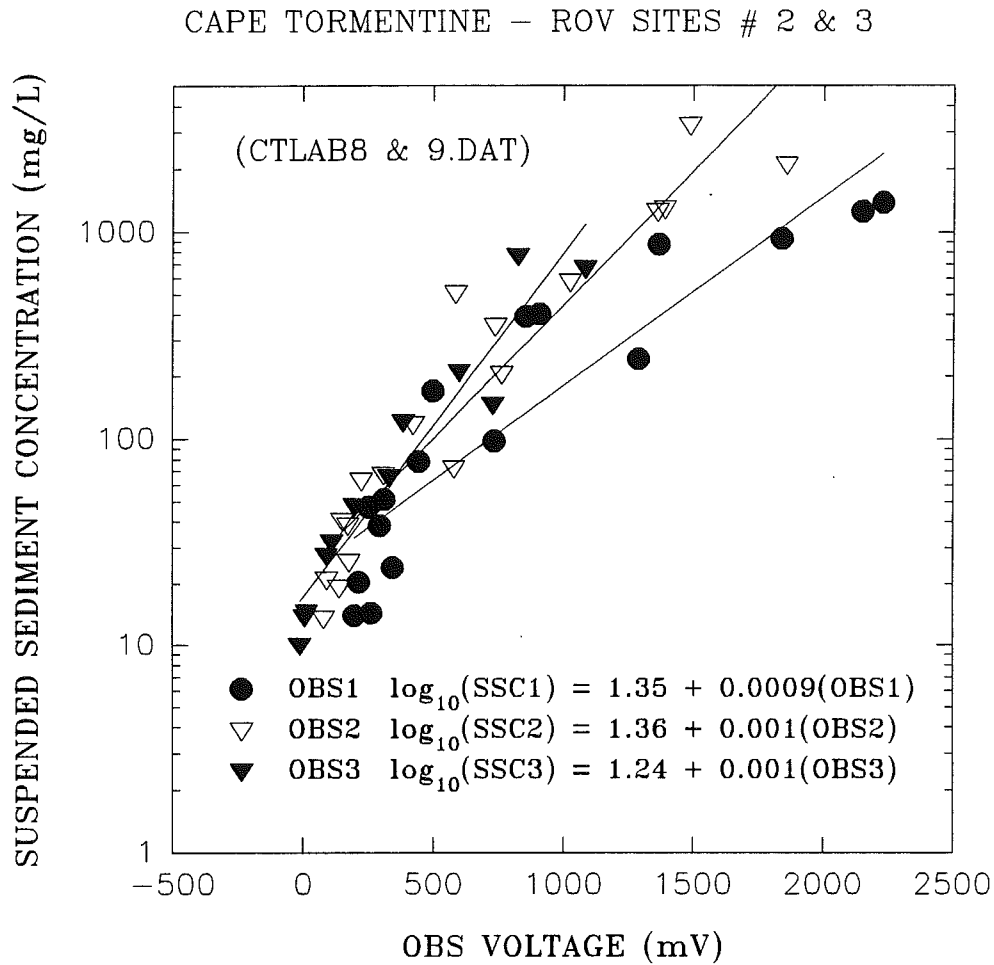
**Figure 8.4.8.** A regression analysis of OBS output (mV) and suspended sediment concentration (mg/L) for Lab Carousel experiment Ctlab8 & 9 (ROV sites 2 & 3).

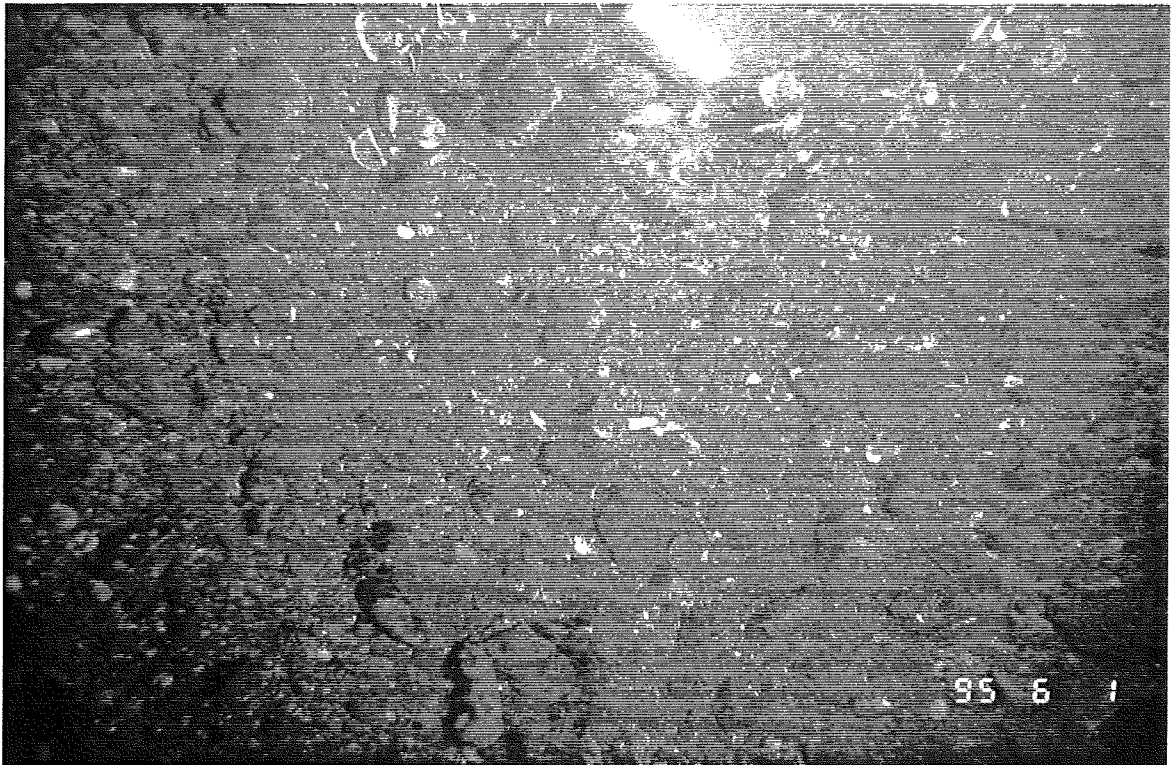
**Figure 8.6.20.** Seabed photographs from the western end of the Fixed Link Crossing. The seabed is composed of poorly-sorted, angular gravel. There is an abundance of shelly material.

Figures 8.6.19 to 8.6.23 were taken from the western Fixed Link site. The seabed was dominated by shelly gravel with a matrix of fine sand. The gravel appeared to be well-sorted and highly compacted (Figure 8.6.23B). The sand was strongly current-rippled (Figure 8.6.22B). All shells appeared whole but disarticulated. No benthic fauna was observed.

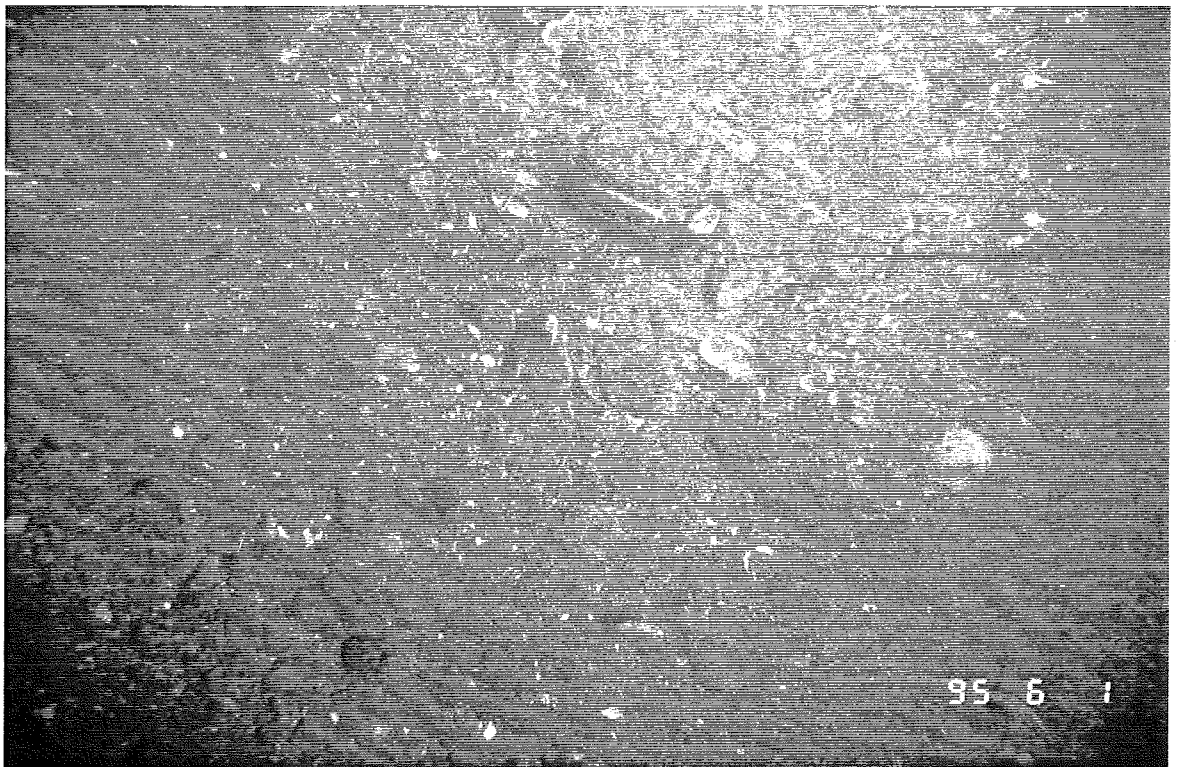
**Figure 8.6.21.** Seabed photographs from the western end of the Fixed Link Crossing. The seabed is composed of sorted gravel covered with a thin layer of sand.

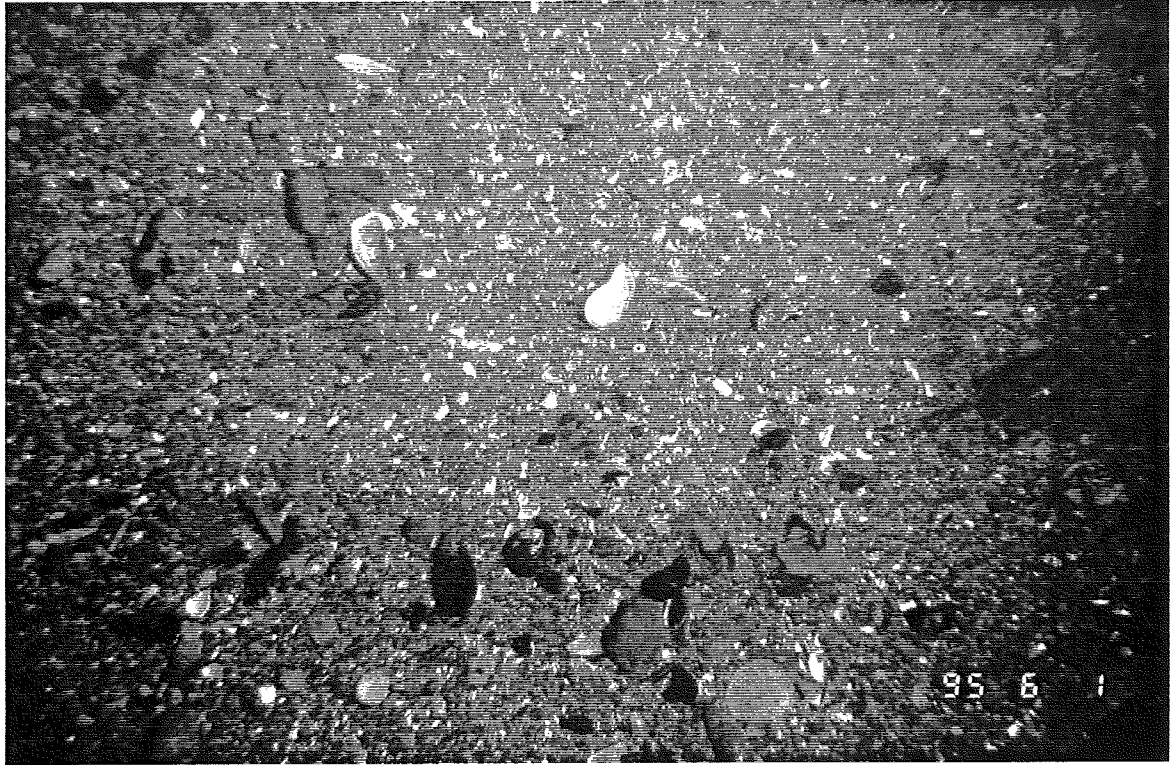
**Figure 8.6.26.** Seabed photographs from the centre of the Fixed Link Crossing. The seabed is composed of sorted shelly gravel, and rounded cobbles.

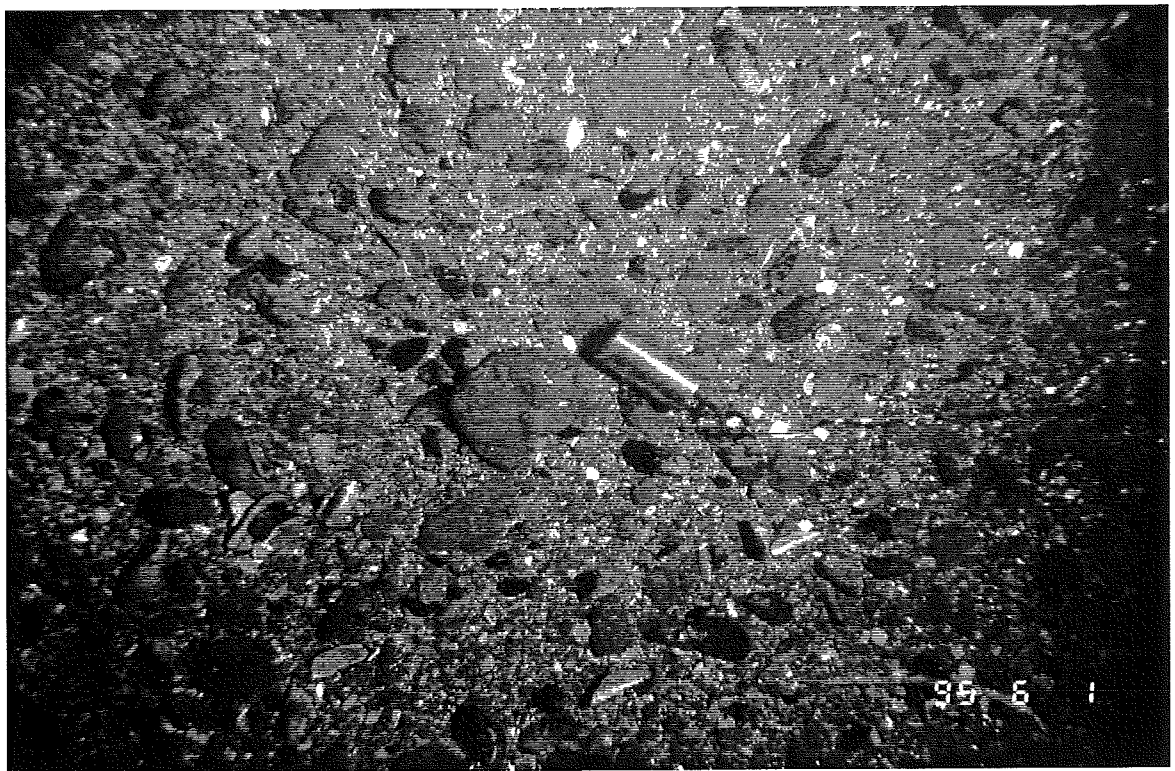
**Figure 8.6.29.** Seabed photographs from the eastern end of the Fixed Link Crossing. The seabed is composed of sorted shelly sand over densely packed sorted and rounded cobbles and pebbles.

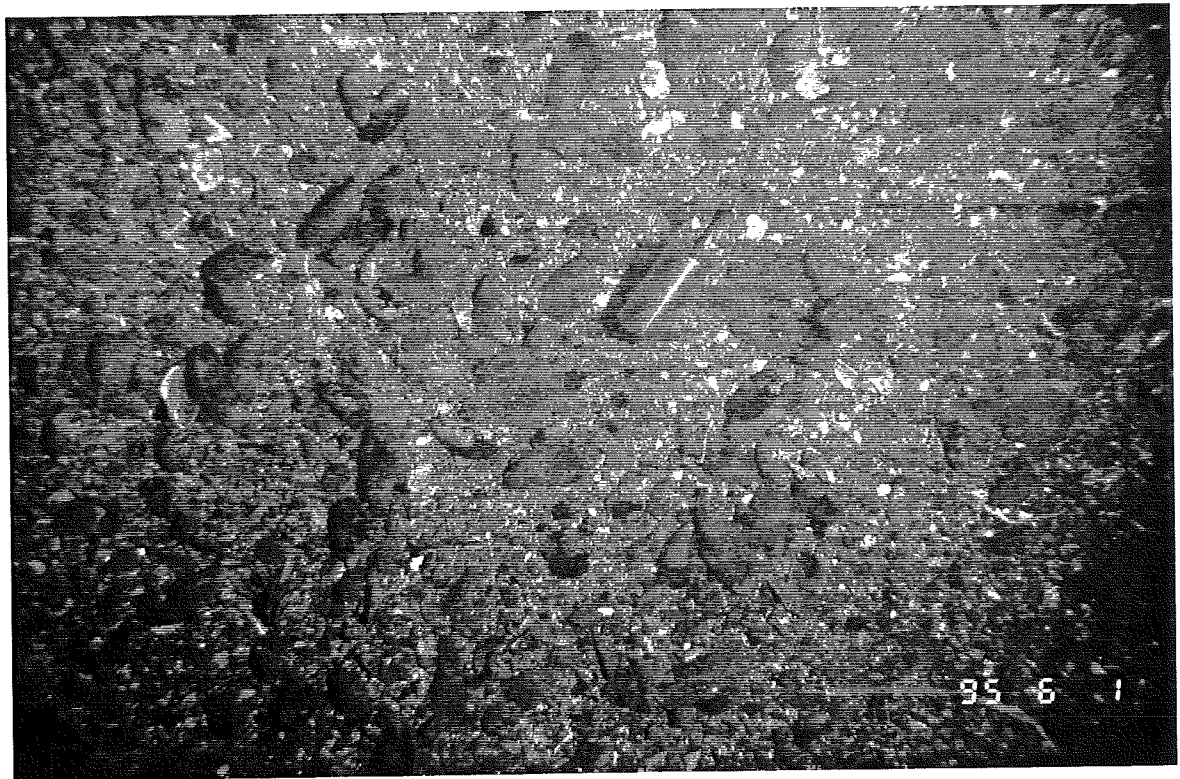
**Figure 8.6.32.** Seabed photographs from the eastern end of the Fixed Link Crossing. The seabed is composed of sorted shelly sand over densely packed sorted and rounded cobbles and pebbles.
