IVVAVIK NATIONAL PARK COASTAL EROSION STUDY

S.M. Solomon

OPEN FILE REPORT

3323

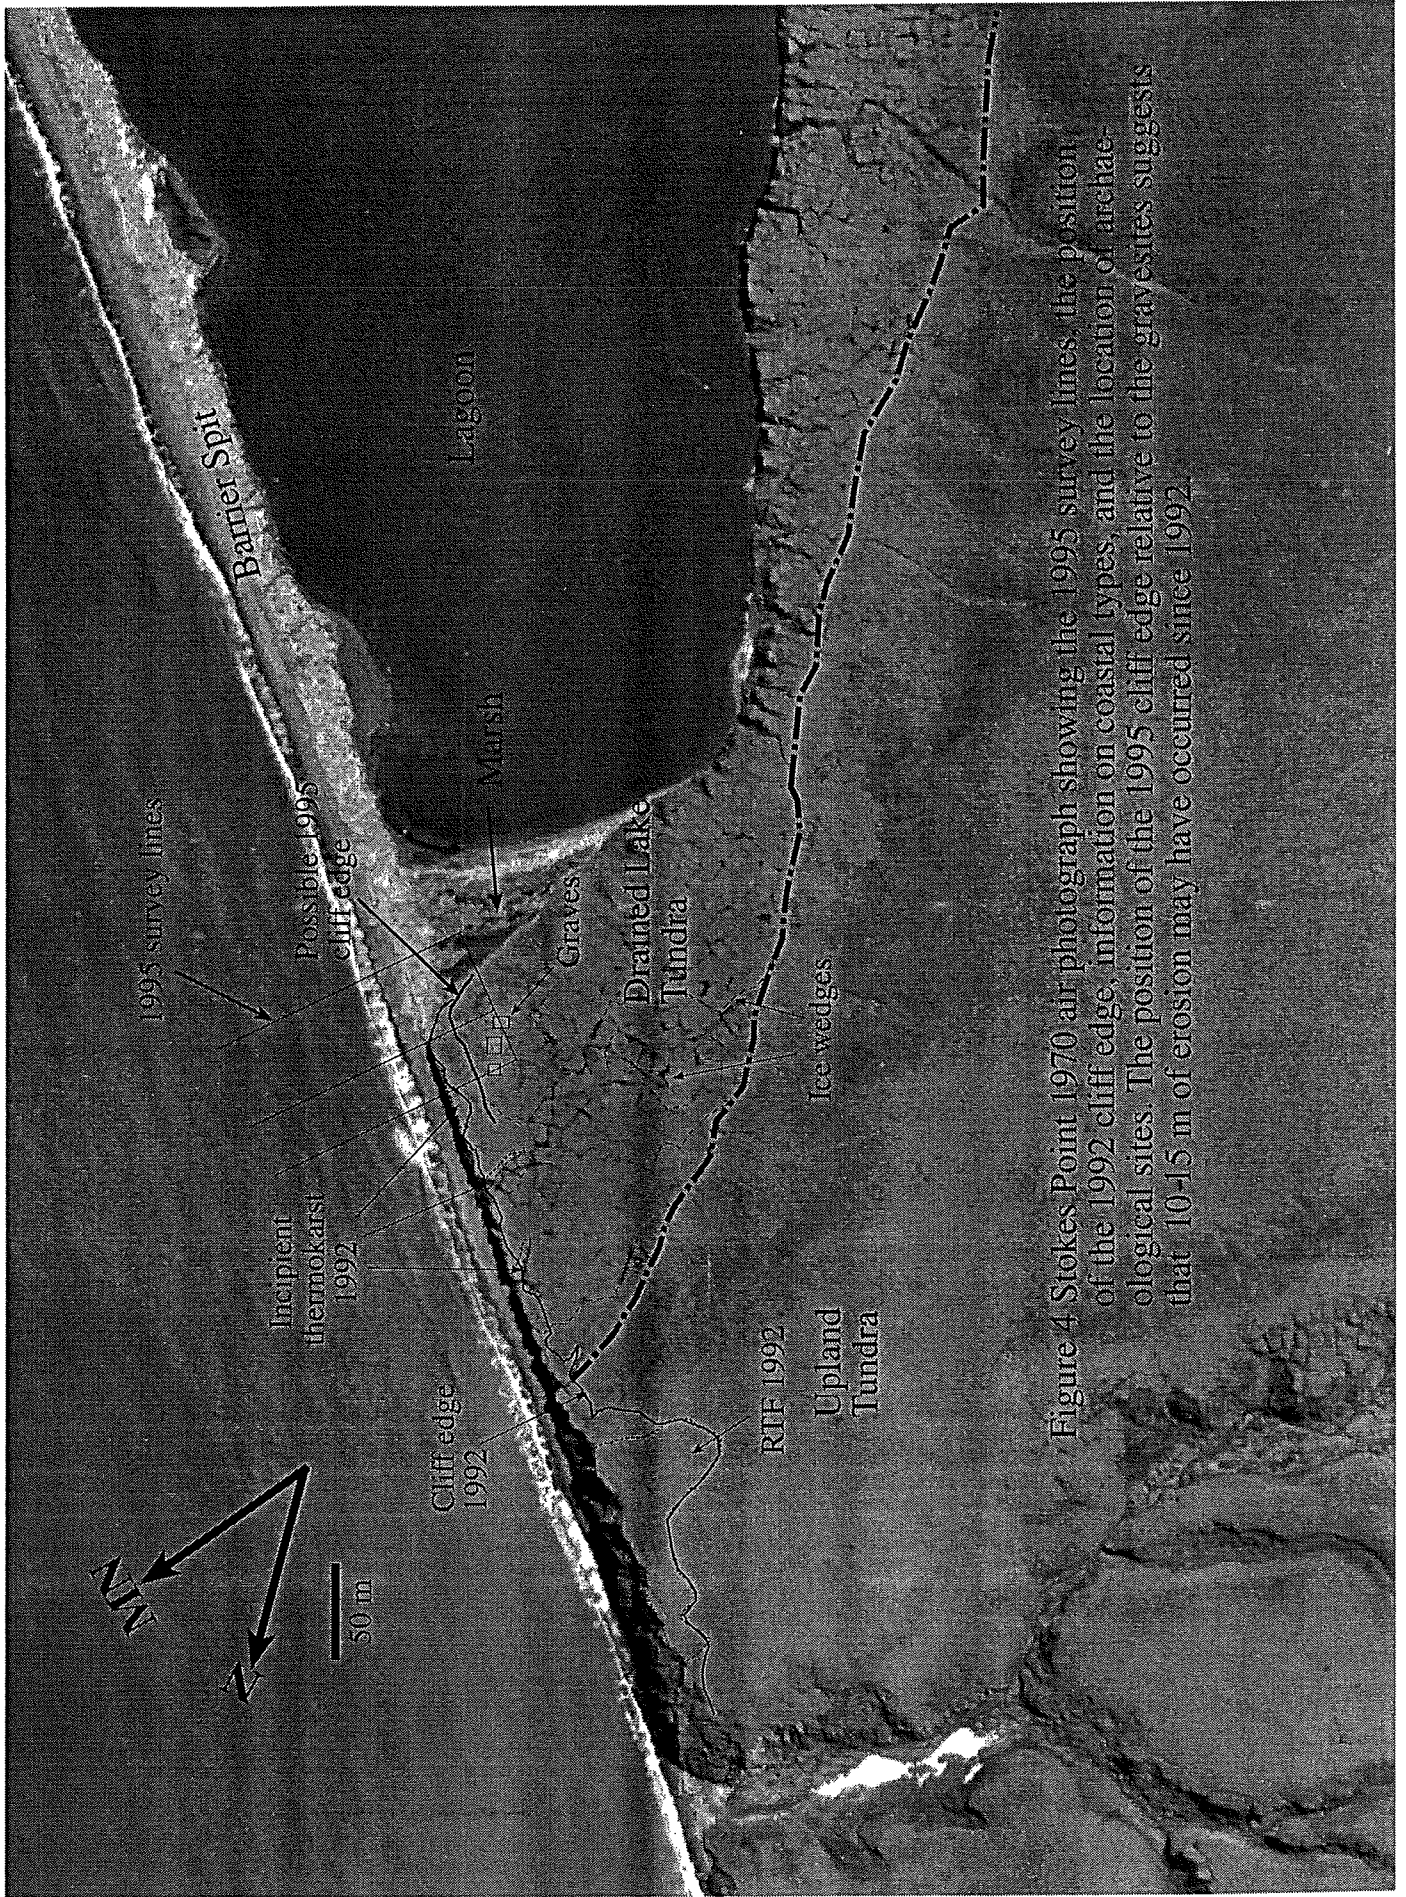
Figure 4 Stokes Point 1970 air photograph showing the 1995 survey lines, the position of the 1992 cliff edge, information on coastal types, and the location of archaeological sites. The position of the 1995 cliff edge relative to the gravestones suggests that 10-15 m of erosion may have occurred since 1992.

The Stokes Point site is at the northwestern end of a lagoon which is almost entirely enclosed by a barrier spit (**Figure 4**). The coastline in the area is oriented northwest/southeast and the morphology of the spit indicates that sediment transport is dominantly to the east. This has led to the formation of a large prograded system of beach ridges at the southeastern end of the lagoon. Highly polygonized tundra of probable drained lake origin characterizes most of the site with one

Three profiles were established within the drained lake tundra and marsh zones surrounding the gravesites (**Figure 4**). In this area, ice wedge polygons in various stages of degradation are ubiquitous and form incipient drainage networks. The edge of the coastal bluff is actively eroding with blocks of tundra falling over the bank. The sediments comprising the bluff are dark grey organic mud with abundant fragments of wood. Grasses and sedges (e.g. cotton grass) dominate the vegetation. The bluff is fronted by a narrow (10-15 m wide) pebbly sand beach with a driftwood line at the base of the bluffs and a gravel berm at the high tide line. The spit line is backed by a low marsh which shows evidence of flooding during storms. There is a fresh driftwood line seaward of the beach crest and weathered driftwood scattered landward of the crest and up to the edges of the marsh.

Three profiles were surveyed at Stokes Point: Stokes East, Stokes BM145 and Stokes West (**Figures 4 and 5, Table 1**). Distances between survey lines are: 36 m from BM145 to Stokes West and 56.6 m from BM145 to Stokes East. An echosounding survey to illustrate the nearshore profile was performed at each profile (**Figure 6**). Stokes East characterizes the spit which fronts the Stokes lagoon (**Figure 5**). Elevations are relative to the water level at the time of the surveys. The maximum elevation of the spit was 1.48 m. Stokes BM145 and Stokes West profiles are located on the low bluffs composed of ice-wedge-rich drained-lake tundra. Elevations are 4 to 5 m with a steep active bluff edge (**Figures 5 and 6**). The beach slope at all three profiles is similar: 5-6° (gradient of 1:10 to 1:12). A small bench is present just below the water line at Stokes East and West, but not at the BM145 line. A prominent nearshore bar is present within about 50 m of the

Stokes West is located such that it crosses one gravesite (**Figure 4**). The seaward timbers of the grave are within several metres of the cliff edge. This suggests that the bluff edge has retreated substantially (as much as 10-15 m) since the 1992 airphoto. It is possible that the severe storm and the accompanying surge which occurred in 1993 (Solomon, 1995) could have been responsible for a dramatic alteration of retreat rate. It will be necessary to re-survey the area in detail (especially the graves themselves) to tie the surveys to air photo retreat measurements. An additional air photography mission would be very helpful in quantifying the changes since 1992.

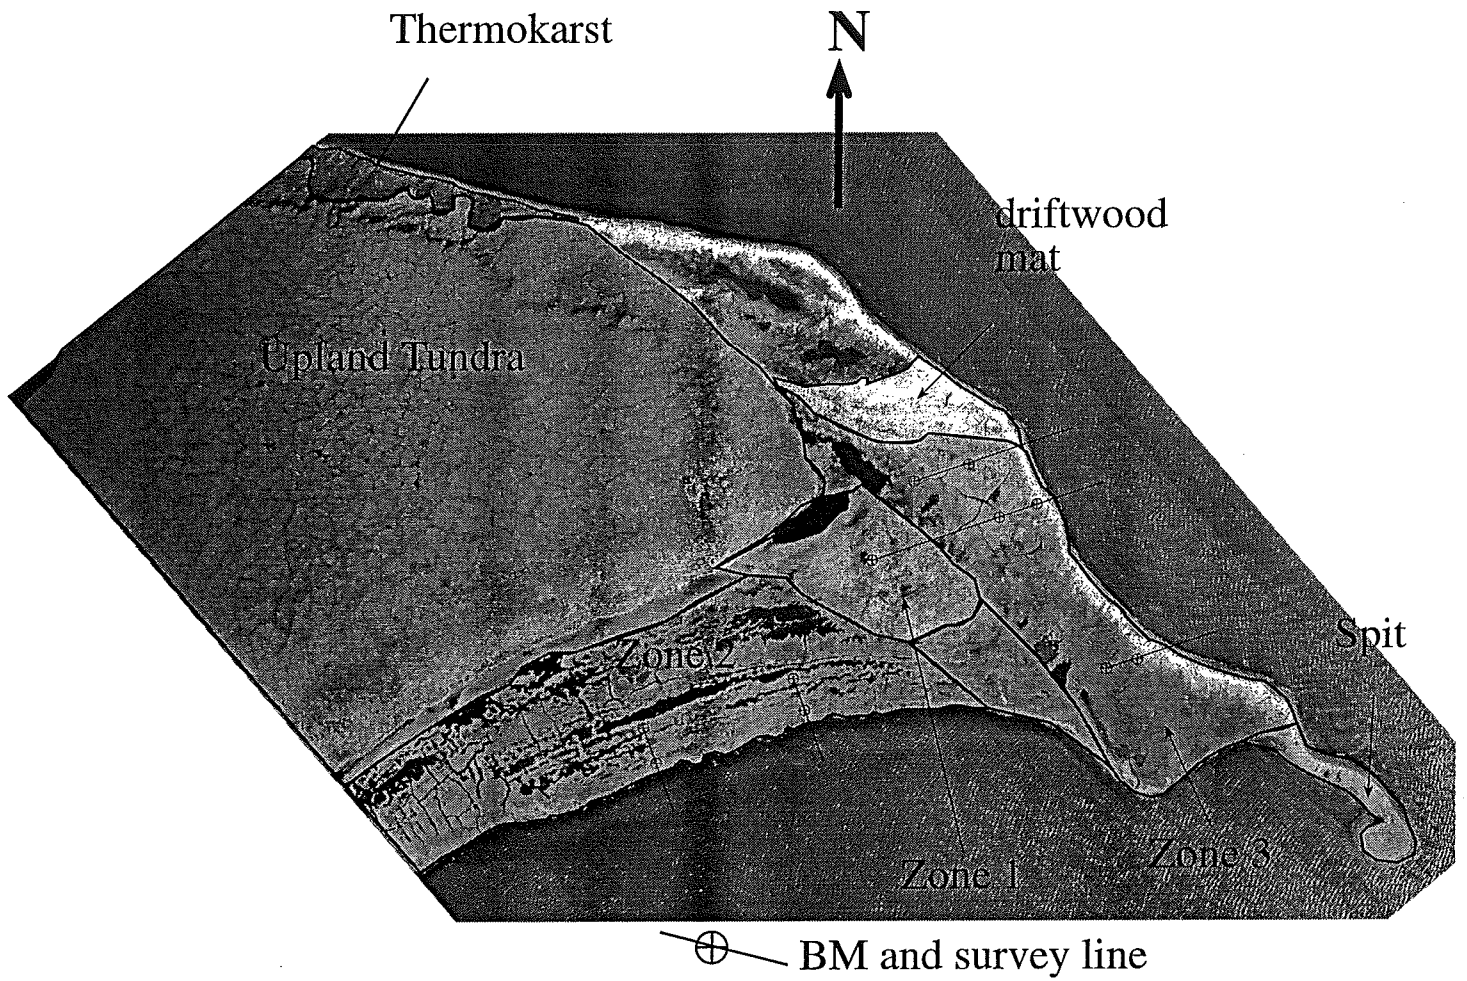
Figure 9 Niakolik 1992 air photo illustrating the coastal zonation and the 1995 survey sites. Cultural and archaeological artifacts are located in zone 1 and on the upland tundra. Zone 1 is slightly higher than zones 2 and 3. Zone 2 is primarily peat and degrading ice wedge polygons. Zone 3 is mostly sand and gravel.

- zone 2: a zone to the south of the cabin which is heavily dissected by degrading, low, rectangular ice-wedge polygons. These are melting into extensive ponds and marsh oozes. The host sediments are largely peats and this area is likely the remains of a drained lake. The elevations are less than 1 m (relative to water level at the time of the survey) so this area is inundated frequently. Driftwood logs are scattered over the surface of this zone; they are concentrated into lines at higher elevations. There is no beach at the water's edge; the peat shore slopes steeply down into the water.

- zone 3: this area consists of lowlying sands and driftwood which have been transported by wind-driven waves and currents. The source of the sands lie to the west where the higher upland tundra cliffs are characterized by retrogressive thaw failures and block failures. The stratigraphy of the cliffs to the west is 0-3 m peat at the top, underlain by 1-3 m of silt and sand which is underlain in turn by 1-5 m of till or sand and gravel (MacDonald and Lewis, 1973). This zone is relatively complex and contains beaches, spits, small ponds and driftwood-filled lowlands. Ice wedge polygons are forming on the surface of the vegetated backshore; these polygons are larger than those in zone 2 and have more than 4 sides. This suggests a different substrate than that of zone 2. Peaty material is present below a sand/gravel lag immediately offshore from this zone. The seaward edge of this zone is

- Figure 8** Nunaluk profiles - note the similarity between profiles across the beach (below 1 m elevation).
- Figure 9** Niakolik 1992 air photo illustrating the coastal zonation and the 1995 survey sites. Cultural and archaeological artifacts are located in zone 1 and on the upland tundra. Zone 1 is slightly higher than zones 2 and 3. Zone 2 is primarily peat and degrading ice wedge polygons. Zone 3 is mostly sand and gravel.

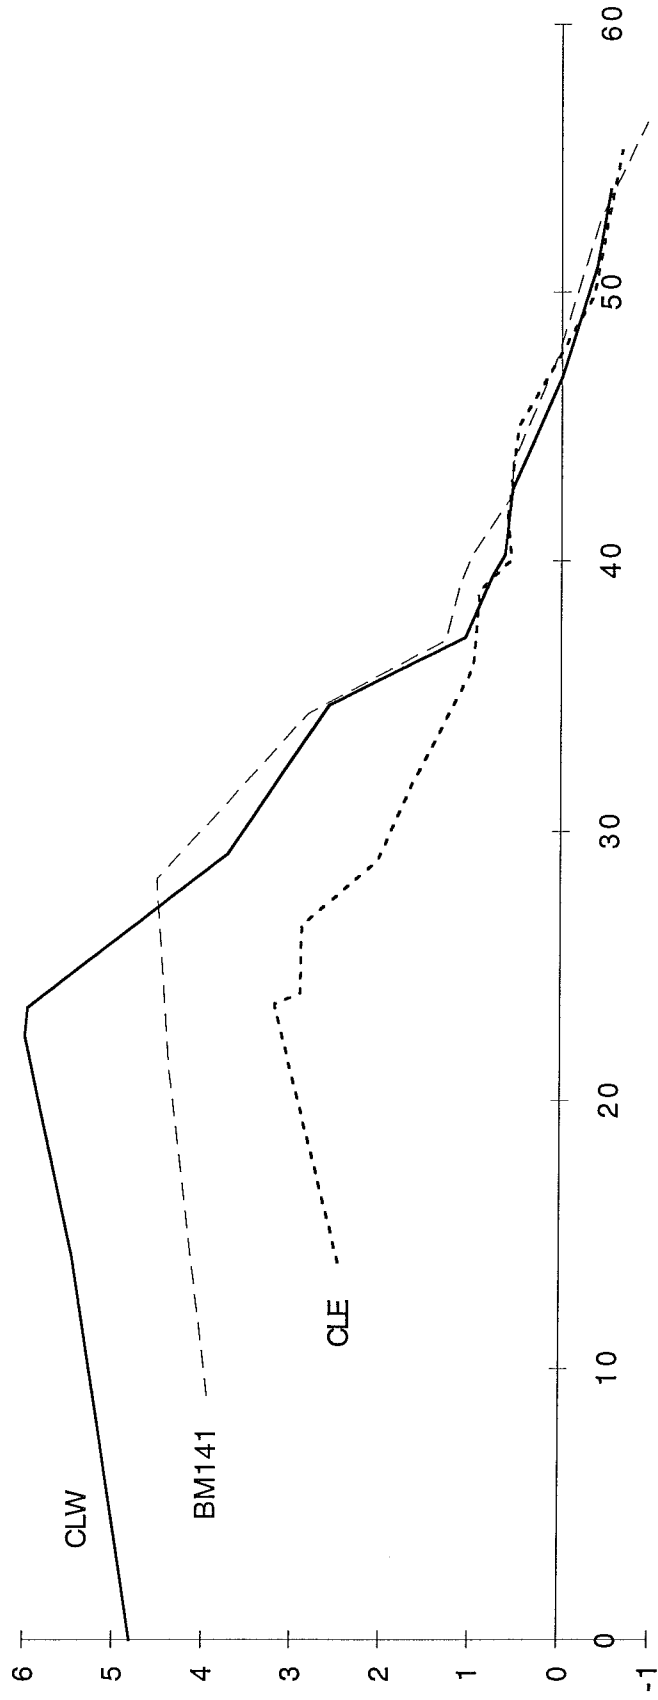
Figure 13 Clarence Lagoon profiles. The cliffs rise rapidly and steepen towards the west, but the beach slope is consistent on each profile.

The coastal bluffs ascend gradually to the west from the barrier. As they rise, the bluff face becomes wetter suggesting an increase in the ice content. The upper surface of the bluffs is characterised by sedges and grasses and is dissected by networks of ice-wedge polygons. The polygons become more prominent from east to west. Bluff slopes are actively eroding with many small thaw failures which are centred on ice wedges. In fact, the planform of the coastal bluffs appears to be controlled by the ice wedge configuration with promontories forming between the wedges. The mudflows at the bluff bases are generally solid enough to walk upon. Muddy diamicts with boulders reaching more than 1 m in diameter (typically 30-50 cm) form the bluff sediments. The upper beach sediments consist of well-sorted gravel with scattered driftwood and boulders. The coarsest gravel is found on top of the upper beach storm berm; the sediments

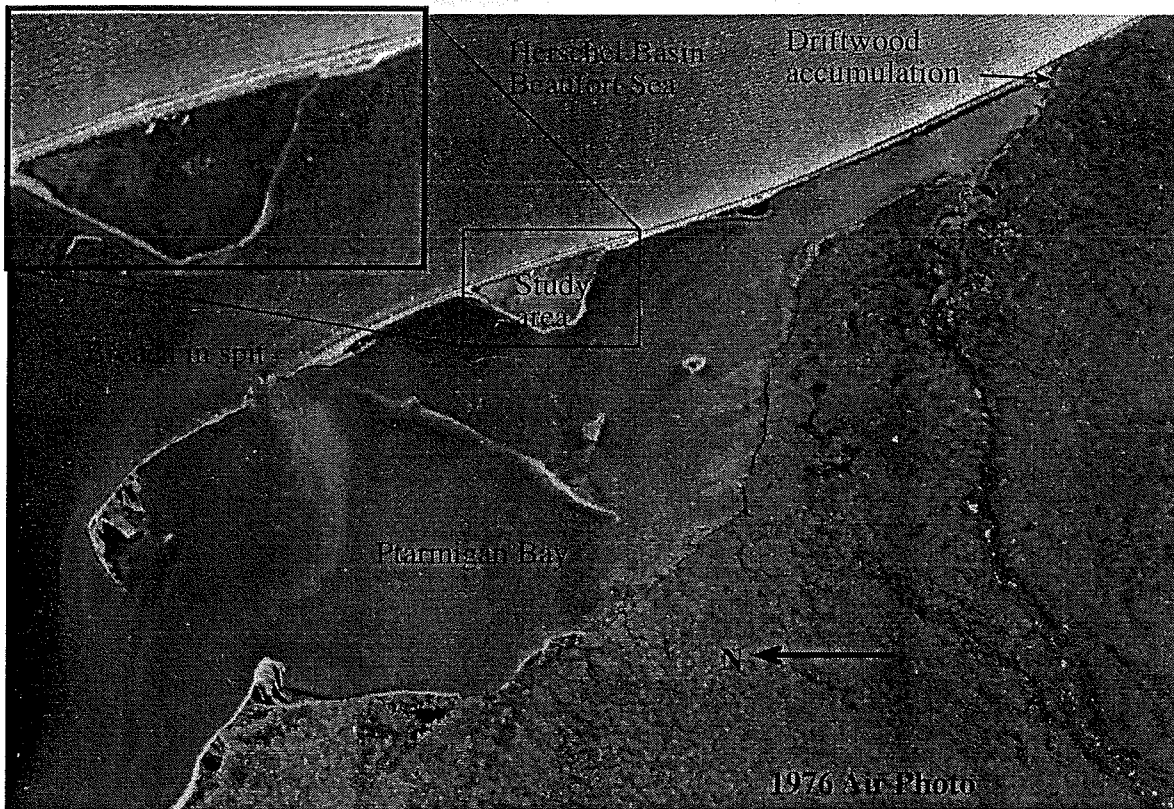
Figure 14 Catton Point survey site. The upper image is based on a 1976 air photo; the study area is the large tundra remnant anchoring the spit. The lower image is based on a larger scale 1970 air photo. The lagoon behind the spit is a major sink for organic matter eroded from peat cliffs and for driftwood. Sediment transport is to the north on the outside of the spit and to the south on the inside. The break in the spit to the north of the tundra remnant has healed since the photo was taken.
