Barrier Breaches and Washover Features Martinique Beach, Nova Scotia

R.B. Taylor and D. Frobél

Geological Survey of Canada
Open File Report
3823

October 1999

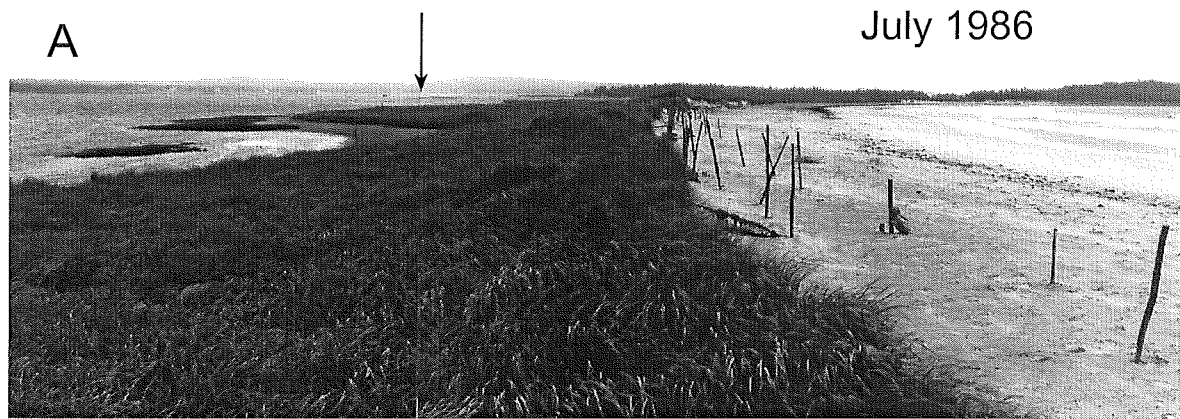
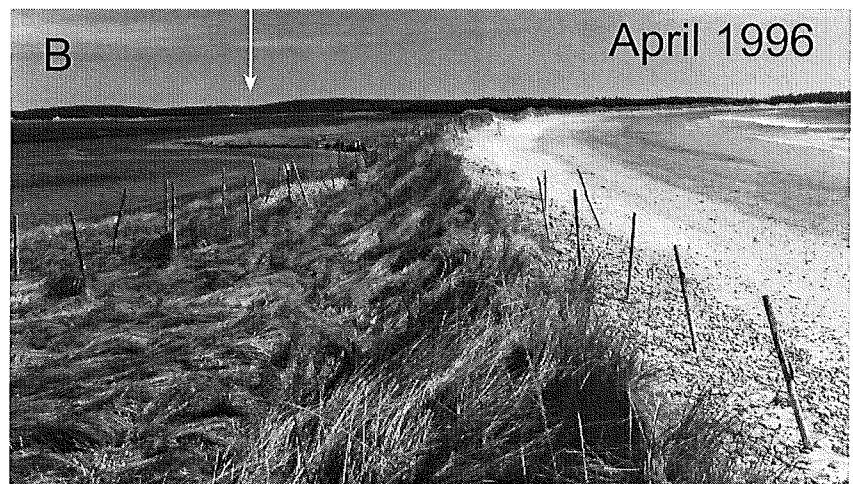
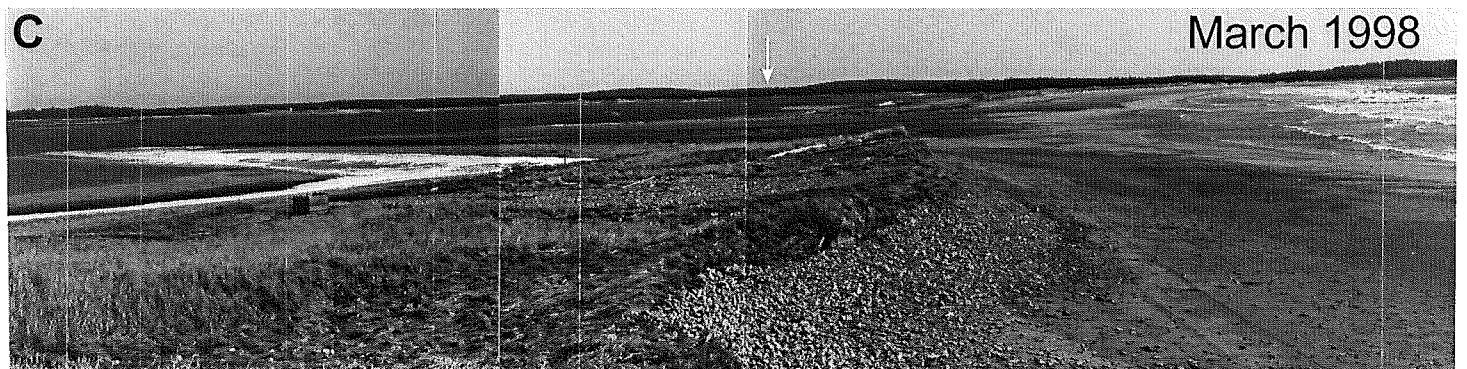
Figure 2. Ground photos taken at line 6 in: (A) July 1986, (B) April 1996, and (C) March 1998 after the formation of the breach (arrows are for visual alignment of same point). The wooden posts are all that remain of sand fencing which was used to encourage sand accumulation and widening of the beach during the 1980s. Note the increase in pebble cobble clasts at the base of the dune in 1996 and 1998.

Between March 13 and 27, 1998, waves continued to cut down the beach and seaward duneline and expand the width of the breach. By March 27, 1998 the barrier breach had expanded to 136 m wide at its mouth, i.e. at the seaward duneline, and extended 138 m landward to the main estuary channel (Fig. 3, 4). Within the breach, the main washover channel was 70 m wide. It cut down to mean sea level at the mouth of the breach and the channel bed sloped downward to - 0.7 m elevation where the washover fan intersected the estuarine channel (Fig. 4b). The channel was bounded on its sides by 1 m high levees which were built over top of the previously existing backshore deposits (Fig. 2, 3).

Despite the closure of the 1977 breach, the duneline farther west continued to retreat and become very narrow near the site of the 1998 breach (Fig. 2). A comparison of beach surveys at line 6 (site of the 1998 breach) in the mid-1970s and 1981 showed that the upper beach and seaward duneline had retreated an estimated 9 m (Taylor et al., 1985). Despite a well developed beach berm and higher sand levels in 1981, the base of the seaward duneline was scarped. By mid-1986 (Fig. 2a) the duneline had retreated another 6 m landward leaving only a 4 m wide dune ridge. Several attempts were made to trap sand and widen the dune using sand fences between 1981 and 1986. Fencing erected in the late 1980s (Chris Trider, pers com., 1989) trapped sediment and resulted in a higher dune ridge by 1996 (Fig. 2b) but it was still very narrow and much of the fencing had been destroyed by waves. Only posts remained of the seaward fences and pebble- cobble clasts had accumulated along the seaward base of the duneline by 1996. The appearance of gravel is the consequence of the landward movement of coarser clasts derived from the steepening and lowering of the lower beach face and in some cases the re-exposure of gravel following the retreat of the duneline. Pebble cobble had been observed in 1981 along the base of the dune east of line 7 (Fig.1). Between 1981 and 1986 the lower beach slope at line 6 was steepened and lowered by 0.4 to 0.7 m. There were no surveys to confirm whether the beach slope continued to lower after 1986 or whether its level fluctuated from year to year. Increased scouring of the duneline and the increased abundance of gravel along the upper beach (Fig. 2c) suggest there had been more periods of low, than high sand levels since 1986.

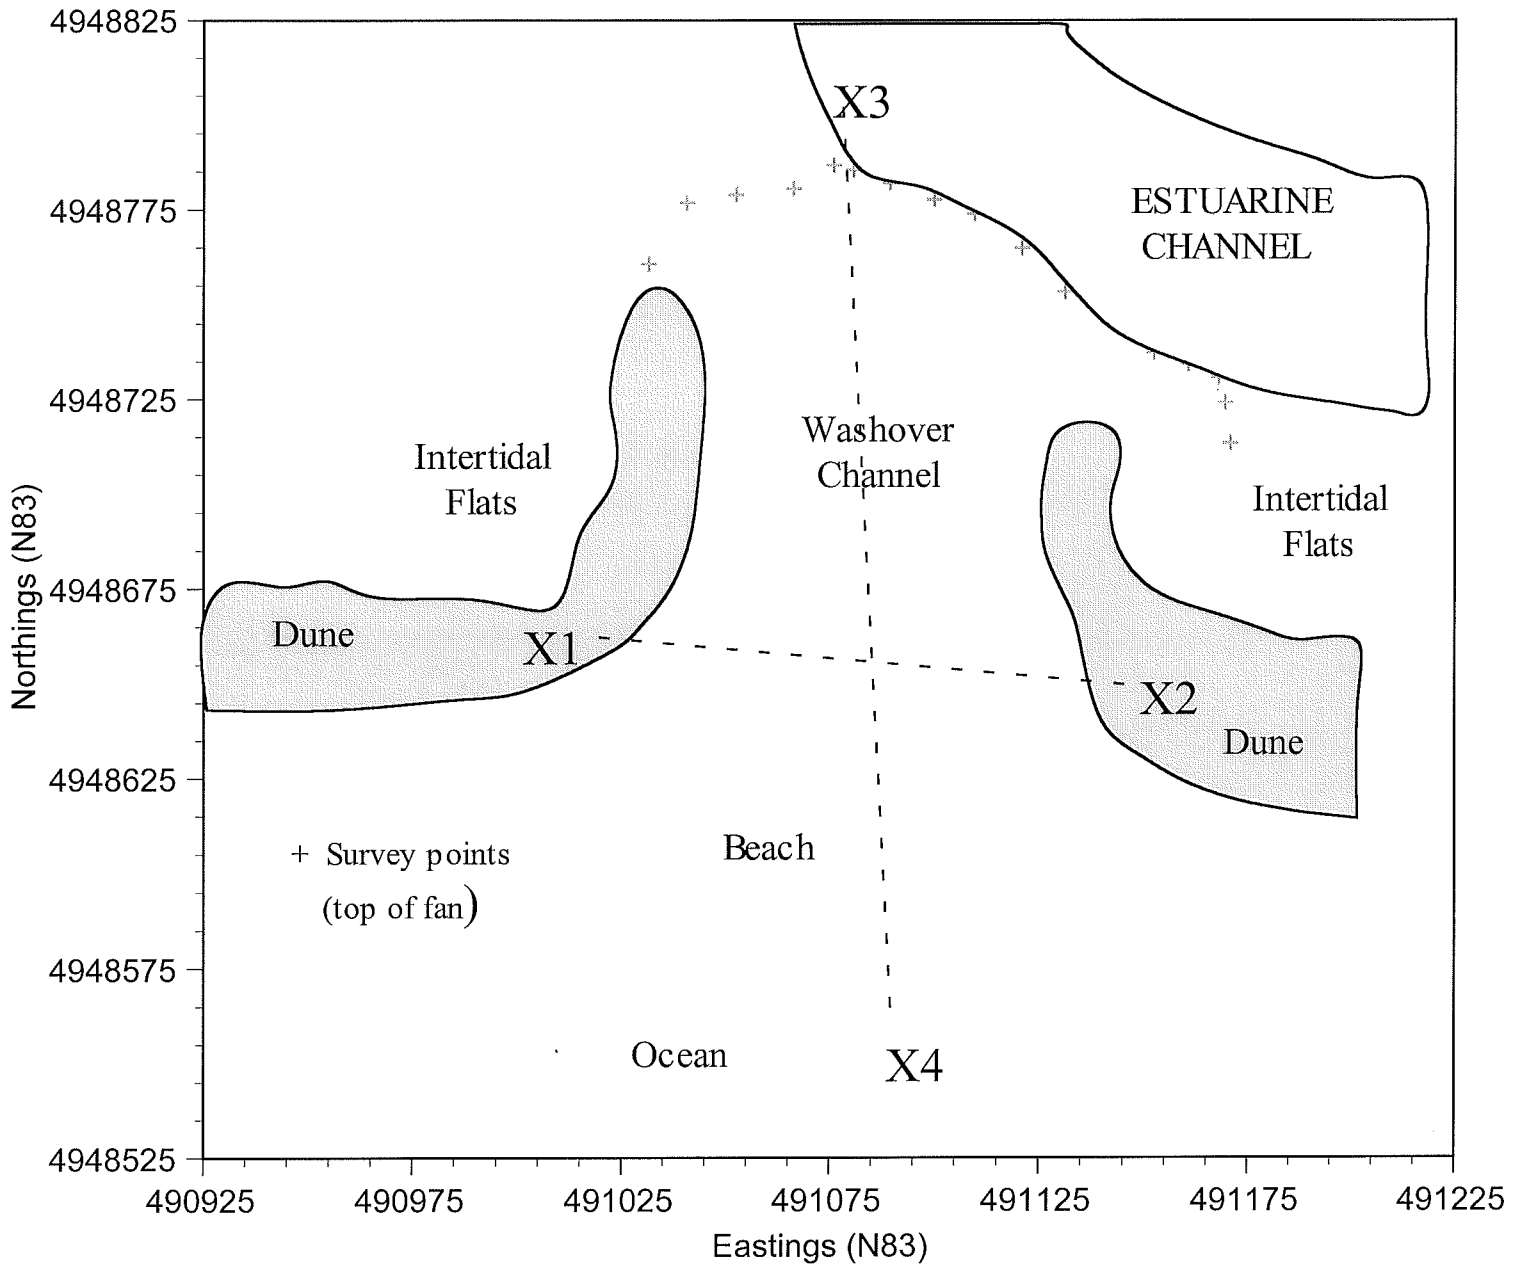
Figure 3. Plan map of the wave washover channel cut through the east end of Martinique Beach in February 1998. The map was surveyed on March 27, 1998 using differential GPS with a Geotracer system 2000. X1-X2 and X3-X4 mark the locations of profiles shown in figure 4.

The impacts of the February 25th, 1998 storm were most evident along the eastern part of Martinique Beach. Waves combed down the beach, cut a scarp along the base of the primary duneline and formed washover channels across the backshore where the duneline was lowest. The largest cut or breach through the dunes occurred at beach line 6 (Fig. 1, 2) where waves overwashed the beach reaching the estuary channel behind. On March 13, 1998 water was flowing through the washover channel at high tide but only a trickle of water flowed landward and seaward from the mouth of the breach at low tide (Fig. 2c). Surveys of the breach were completed on March 27, 1998, and June 11, 1999, one month and 16 months after the storm. Differential GPS surveys were completed using a Geotracer system 2000 in the real time kinematic mode. The base station for the surveys was established at Nova Scotia benchmark 10051 at Philip Head west of the beach (Fig. 1). Points were surveyed relative to the North American Datum 1983 (NAD 83) and plotted using the UTM (Universal Transverse Mercator) mapping projection (Zone 20). Elevations are relative to Geodetic datum.

Sediment eroded from the outer beach and dune was added to the washover fan which was building northward into the main estuary channel (Fig. 1, 3). Maximum depth of the estuarine channel was unknown but it was more than 2 m deep where the washover channel intersected it. The top edge of the washover fan was extremely unstable in March 1998 because sand was being deposited very rapidly and there had been little time for the new slope to consolidate and stabilize. Initially the unstable slope posed a possible hazard to curious onlookers who walked too close to the edge, but within a year the deposit was much firmer.

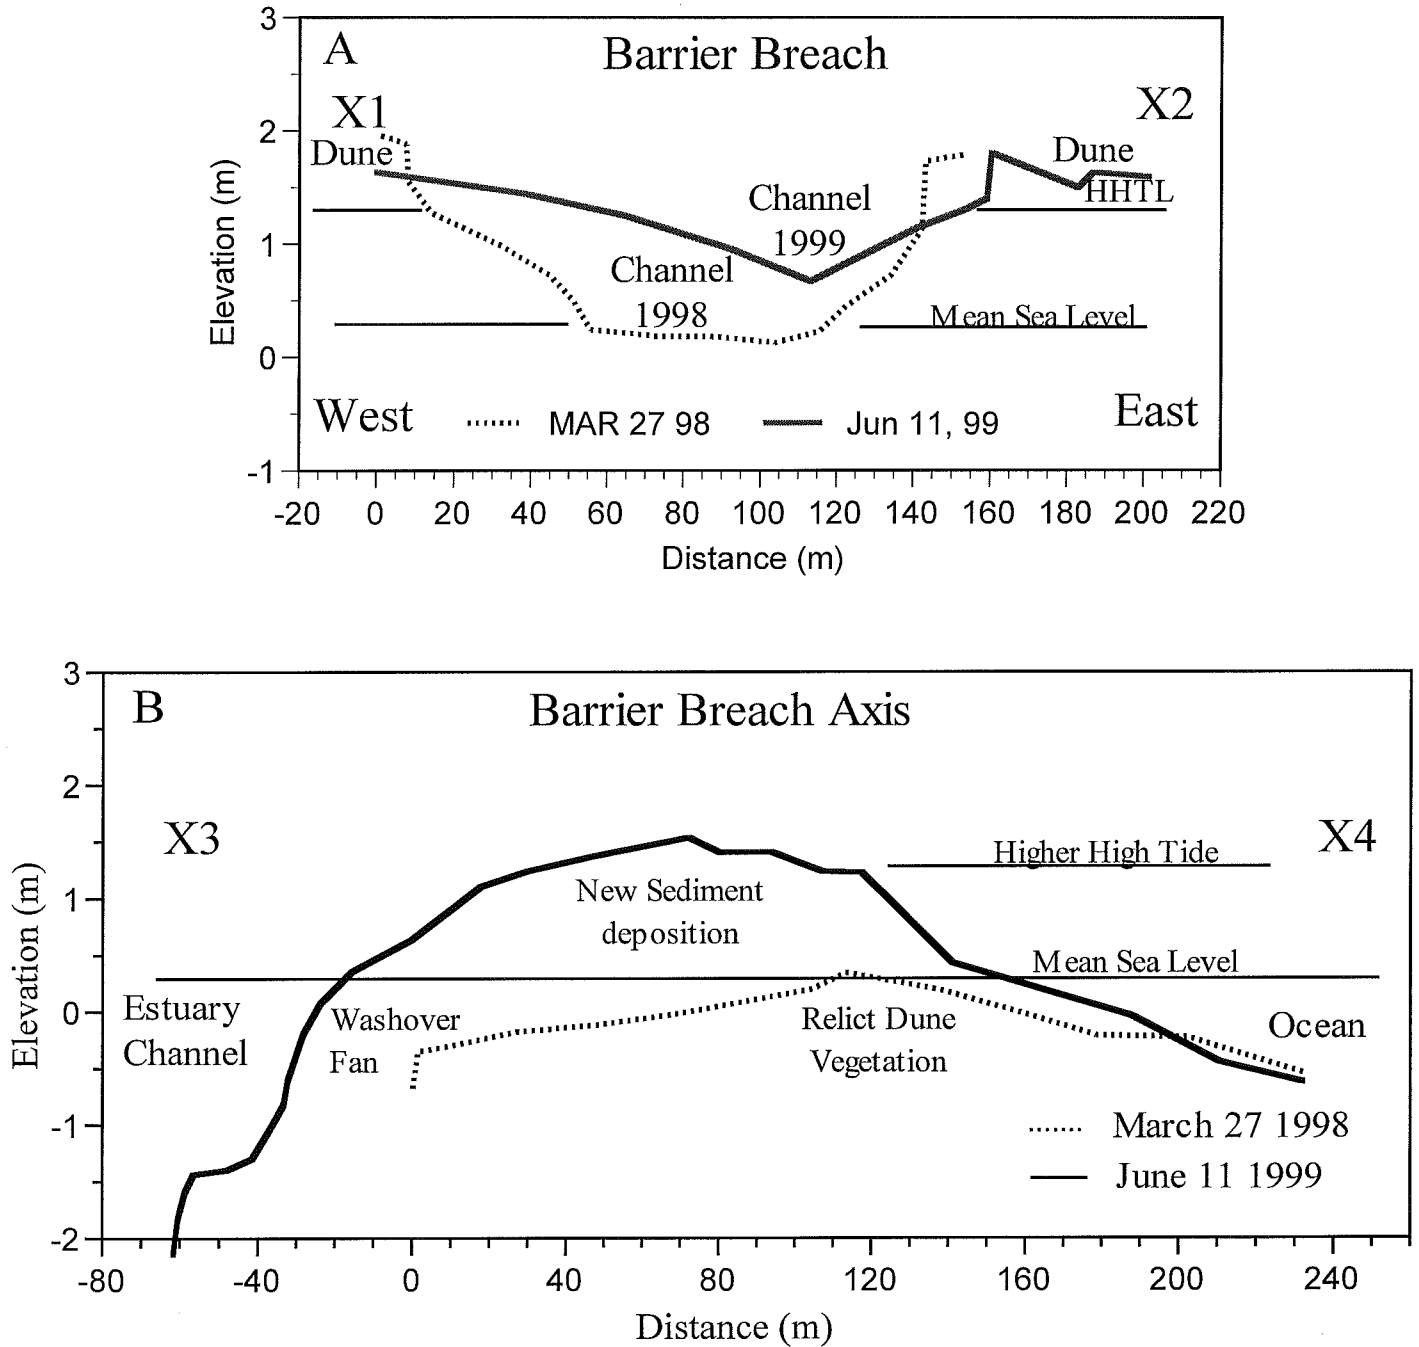
Figure 4. Cross-sectional views of the 1998 barrier breach: (A) across its mouth and (B) along its axis showing changes in its morphology between March 1998 and June 1999. The location of the profile lines is shown on figure 3.

During spring high tide, the depth of water flowing through the channel varied from 0.9 m at the mouth to nearly 1.5 m at the washover fan (Fig. 4). Across the backshore, the channel bed

In 16 months the mouth of the breach had widened by nearly 30 m and the seaward duneline west of the breach had been cut back by 10 to 14 m and to the east of the breach the dunes were cut back 3 to 12 m (Fig. 6). The original washover channel had infilled by 1.1 m at its mouth and 1.6 m farther inland (Fig. 4a). The main washover channel had shifted eastward. It was 0.5 m deeper than the western part of the breach but shallower than the 1998 channel (Fig. 7). By August 4, 1999, the mouth of the breach was again built up and tidal flow stopped. However the lower landward side of the breach was being flooded from the estuary.

At the back of the breach, the upper edge of the washover fan was extended 32 m farther northward and the toe of the fan was nearly 60 m north of its March 1998 position (Fig. 4b, 6). The eastern side of the washover fan had been extended by less than 10 m. The growth of the washover fan was greatest toward the west as sediment accumulated over top of older deposits that fringed the estuary channel (Fig. 5b). The gradient of the washover fan was 14 to 19 degrees ($\tan \phi$ 0.258 to 0.350) along its eastern slope and the base of the fan was at an elevation of -1.9 m. Along the northern and western slope, the base of the fan appeared to be at -1.6 m but it may have extended farther into the estuary channel which was too deep to survey. An estimated 36,506 m³ of sediment accumulated within the breach since March 1998 (Appendix 1). If we assume the original duneline lost was 136 m long, 15 m wide and 1.5 m thick, then 3060 m³ of sediment was derived from the initial breakthrough. This volume is only 8% of the total sediment that has been transported into the breach. A large volume of sediment is being derived from erosion of the duneline east and particularly west of the breach.

The area of sediment between X3 and X4 using -2.0 as the base level between the two surveys was $717.38 - 447.31\text{m}^2 = 270.07\text{ m}^2$. The area it represents is 108 m wide, east to west, therefore the total volume of sediment would be $108 \times 270.1 = 29,171\text{ m}^3$.

If we assume the base of the washover fan is actually at -1.6 m then the volume of material would be $599.88 - 354.49\text{ m}^2 = 245.4\text{ m}^2$ which when multiplied by 108 = $26,503\text{ m}^3$.

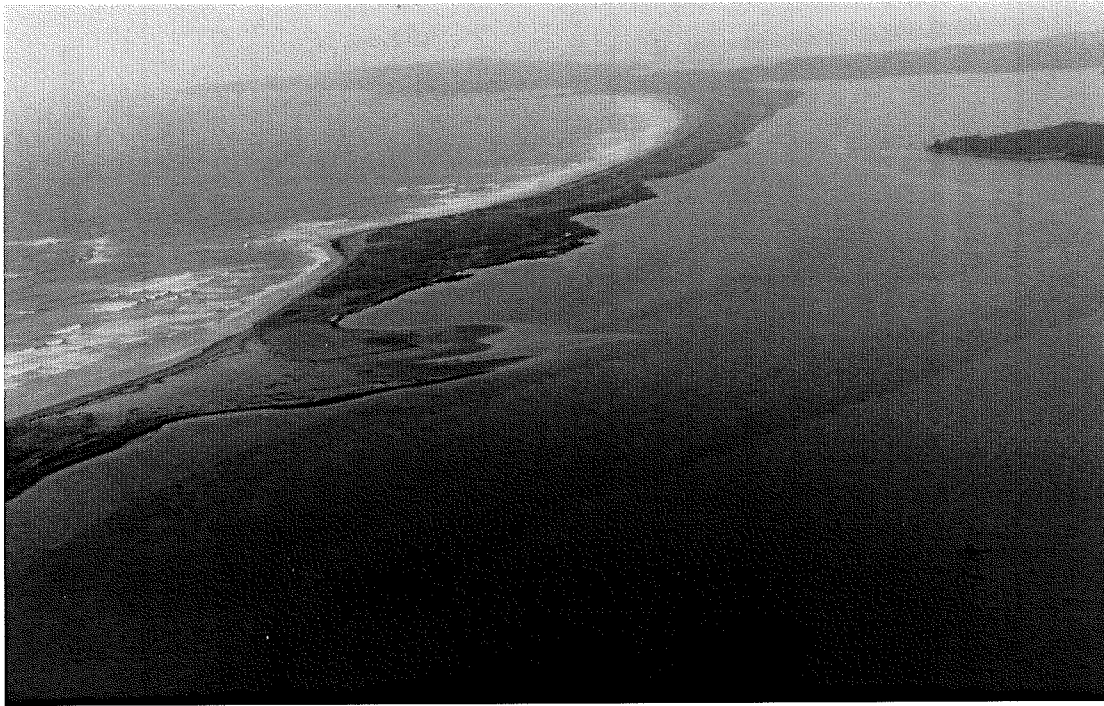
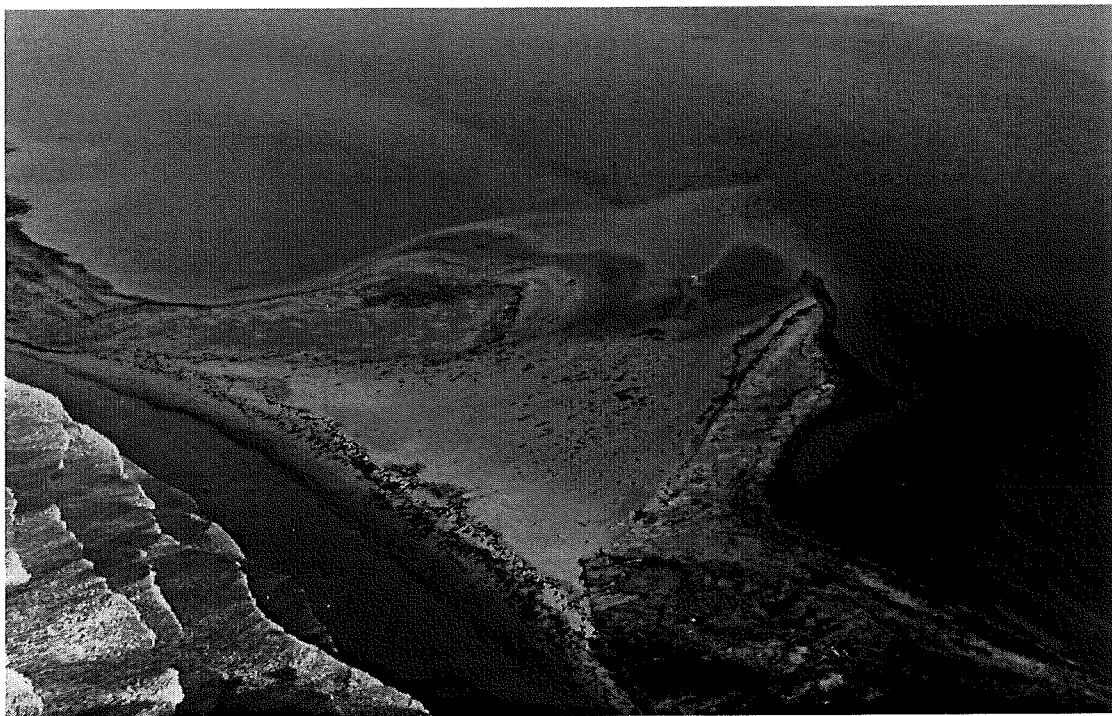
Figure 5. Aerial views of the 1998 breach showing its extension westward over shallow estuarine deposits and northward into the deeper estuary channel. Sediment accumulation at the mouth of the breach had temporarily stopped the flow of water through it. (Photos taken May 29, 1998, by D. Dauphinee, Nova Scotia Department of Natural Resources).

Aerial photos (Fig. 5) taken of the site in May 1998 by D. Dauphinee, Nova Scotia Department of Natural Resources showed the washover fan had extended westward, and the mouth of the breach widened. Despite the widening, sediment accumulation at the mouth had temporarily stopped wave overwash and flow from the ocean (E. Crowell, 1998, pers. com.). It is not known how long the channel remained closed. On March 1, 1999 there was some wave overtopping along the east side of the breach but no well defined tidal channel. Beach sands blown alongshore from the east were being deposited within the breach. In contrast, by early June 1999 there was a better defined tidal channel with water flowing through it at high tide.

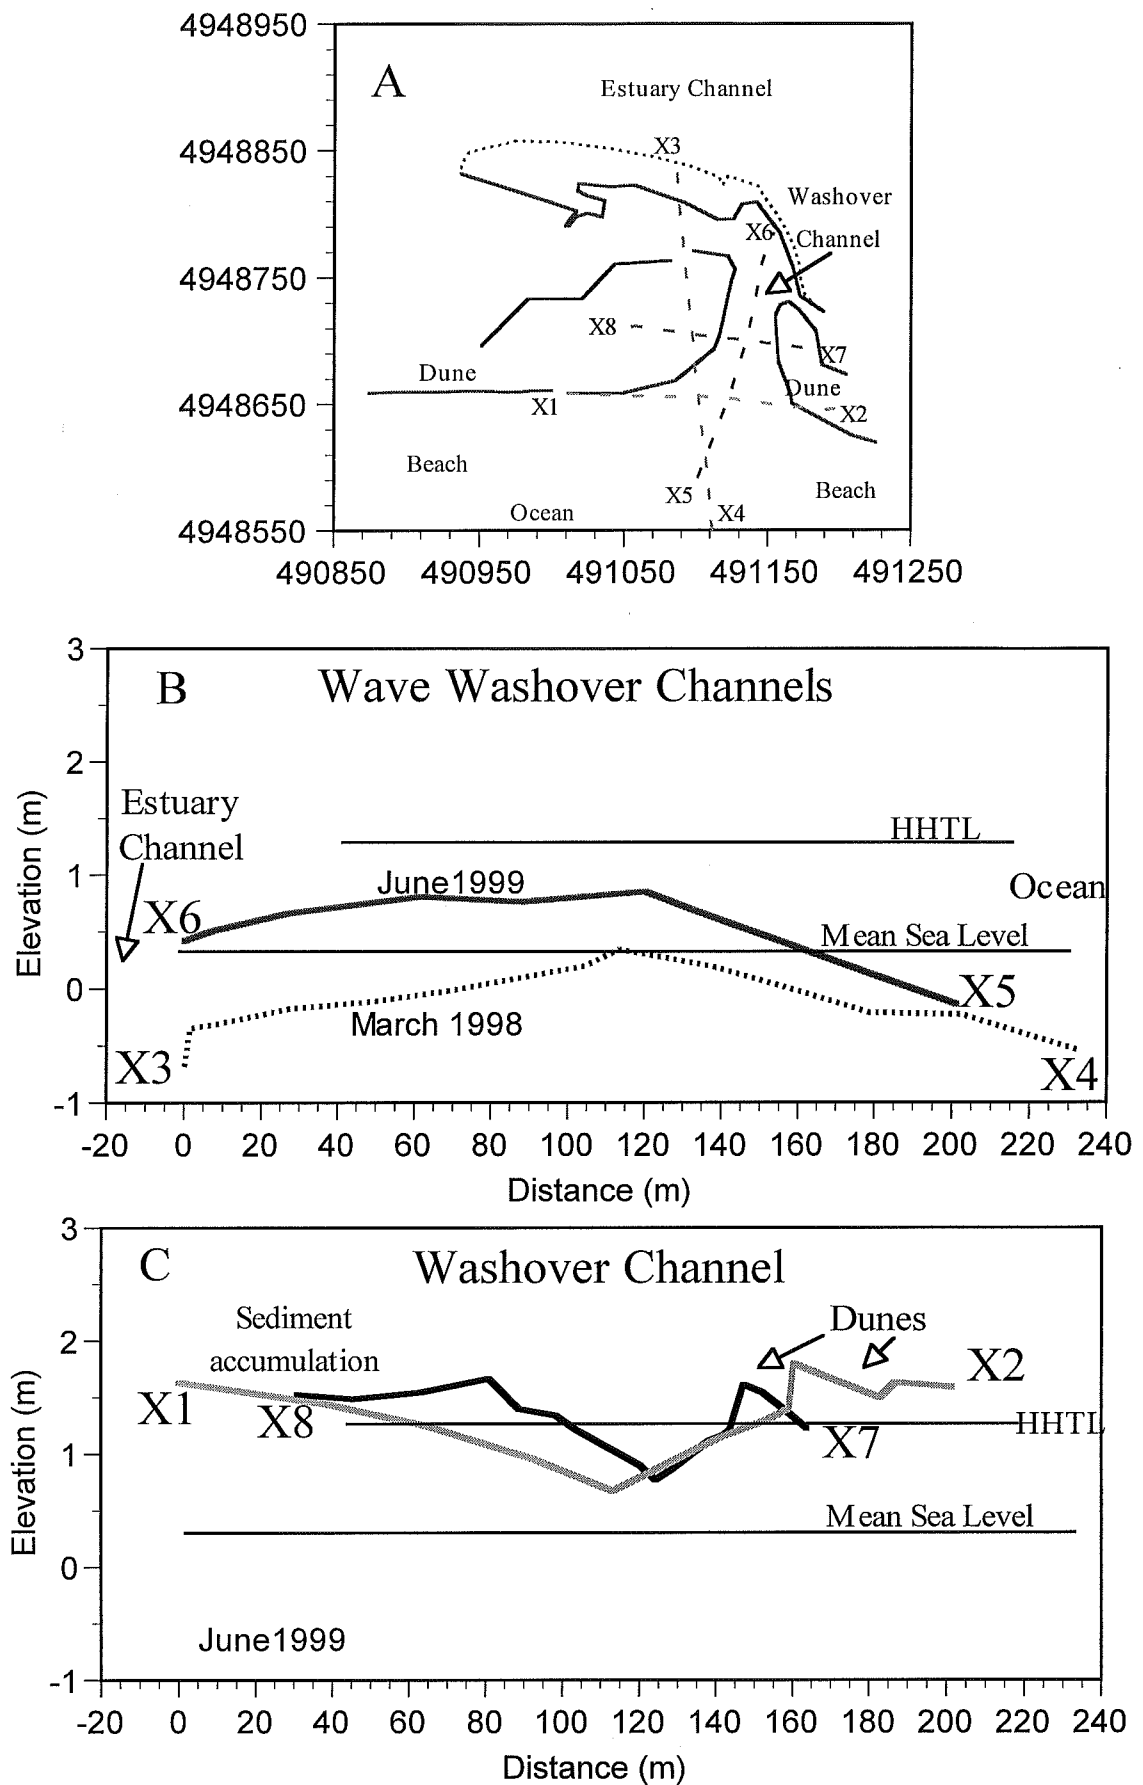
Figure 7. (a) Location of profiles surveyed in June 11, 1999 and profiles (b) showing the depth of scouring along the axis of the 1999 channel relative to the one observed in March 1998 and (c) cross-channel profiles at the mouth (X1-X2) and inner portion (X8-X7) of the breach. The profiles in 7c are aligned along a common UTM Easting.

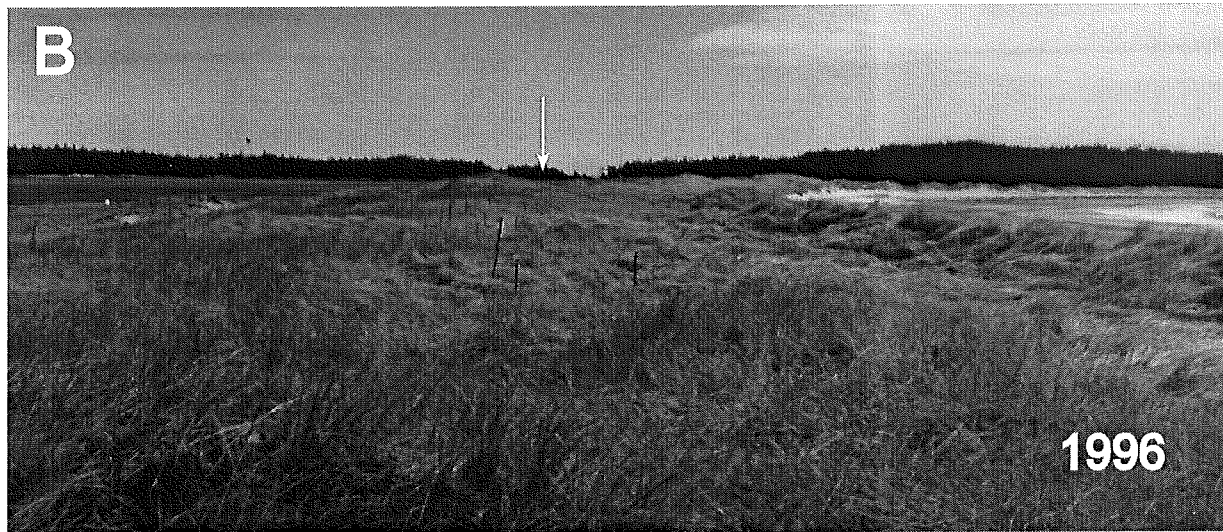
Figure 10. Ground views of the area of sand fencing established within the 1977 barrier breach (a) September 1981 when the dunes were only partially vegetated, (b) April 1996 with dense vegetation cover and natural building along the seaward edge of the duneline and (c) March 1998 with good vegetation cover but increased scouring along the seaward duneline. Arrow provides visual reference of same location on each photo.

Breach “C” (Fig. 1, 9, 10) was initiated in 1977 and is probably the best documented of the older breaches (Taylor et al., 1985). There are no surveys available but from photos it appears that the breach was similar in size to the one formed in 1998. Several attempts were made to trap sand in the breach using christmas trees and sand fences. It took until late 1979 before water stopped flowing through the breach and sufficient sediment accumulated to allow new sand fencing to survive. By 1981 the breach was infilled by partially vegetated dunes that extended to elevations of 2.4 m (Fig. 9, 10a). If one assumes a width of 100 m the breach was infilled by roughly 3000 m³. Sand levels remained high in 1986-87 and by April 1996 the seaward dune was being cut back and built higher (Fig. 10b). During the 20 years the dunes grew to an elevation of 3.5 m and to 4.1 m along their seaward edge (Fig. 9). In 1999 the duneline was 3 m farther seaward than in 1981, it contained 600 m³ more sediment but it was already in a retreat phase. The duneline extended farther seaward in the late 1980s (Fig. 9, 10b,c). Between 1981 and 1999 the beach had been cut down by 1.8 to 2 m (Fig. 9) which over a width of 100 m is roughly equivalent to 9000 m³ of sediment. In March 1999 a significant volume of sand was being blown westward from the beach toward and into the ‘98 breach. It is possible that much of the beach lowering observed at line 7 occurred in response to the ‘98 barrier breach which has become a major sink for beach sediment.

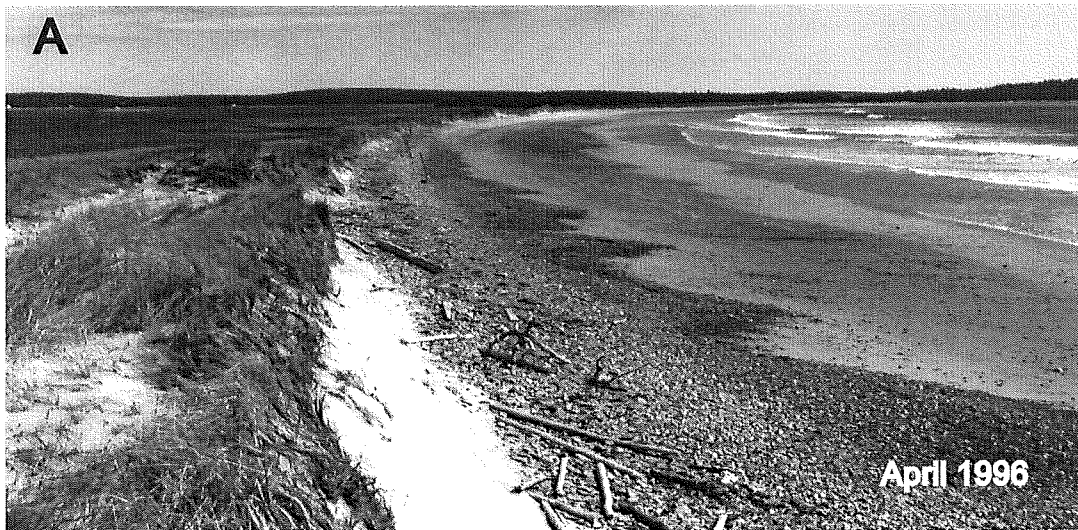
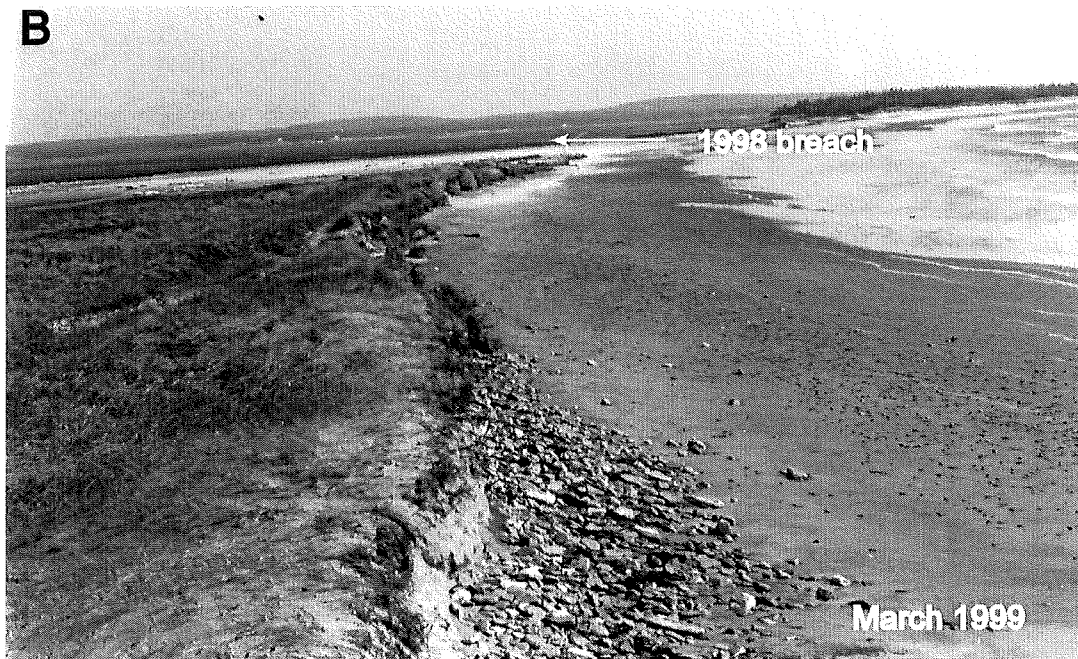
Figure 11. Views to the east toward the site of the 1998 barrier breach (a) in April 1996 and (b) March 1999. The 1998 breach formed in one of the narrowest parts of Martinique Beach and since its formation the duneline west of the breach has retreated 15 m leaving a low backshore vulnerable to increased wave overwash and the expansion of the 1998 breach further westward. The higher sand levels across the beach in 1999 compared to 1996 were partly attributed to the retreat of the duneline.
