**GEOLOGICAL SURVEY OF CANADA
OPEN FILE 5802**

Impacts of Post-tropical Storm Noel (November, 2007) on the Atlantic Coastline of Nova Scotia

Observations of coastal infrastructure and detailed surveys of physical changes at eight beaches document the impacts of Post-tropical Storm Noel that struck the Atlantic coast of Nova Scotia on November 3-4, 2007. The surveys were part of an ongoing investigation of the impacts of major storms on different shore types and their rate of recovery. In addition, flood water levels and wave run-up extent were documented to better define shores vulnerable to these coastal hazards.

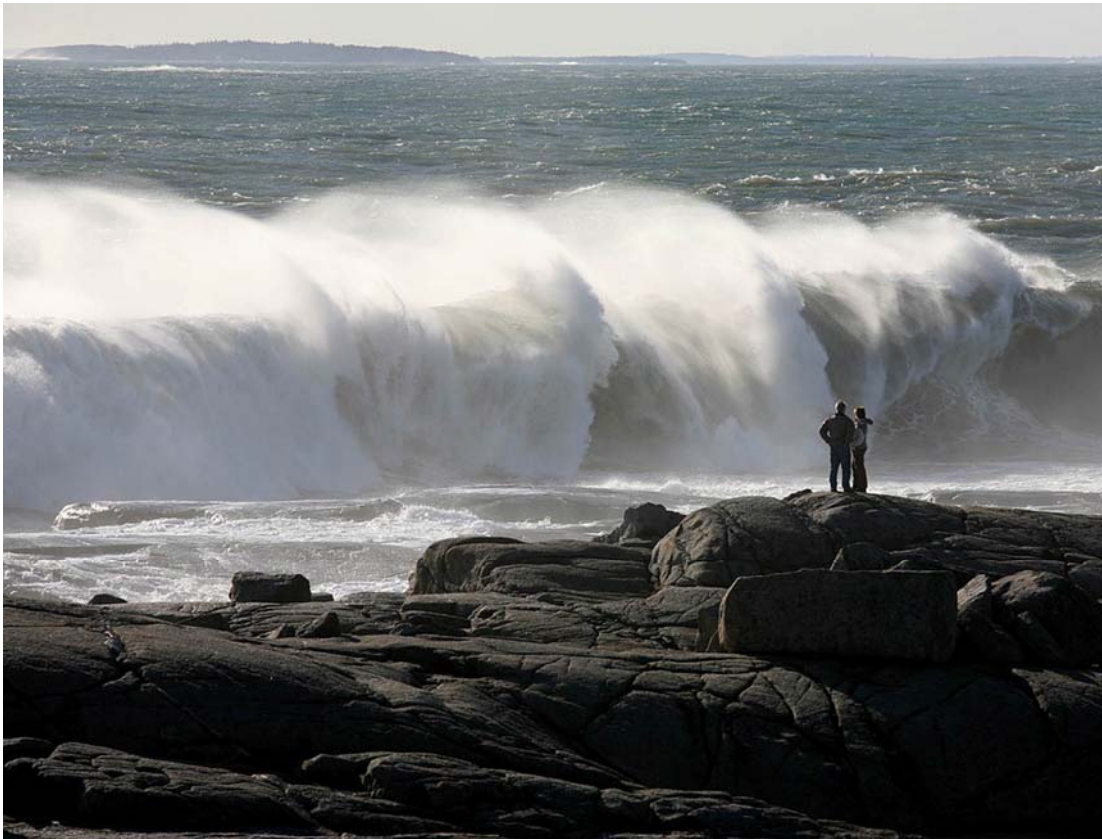
Figure 2. Example of breaking waves generated by Post-tropical Storm Noel at Peggy's Cove, NS on Nov. 4, 2007 (unknown photographer).

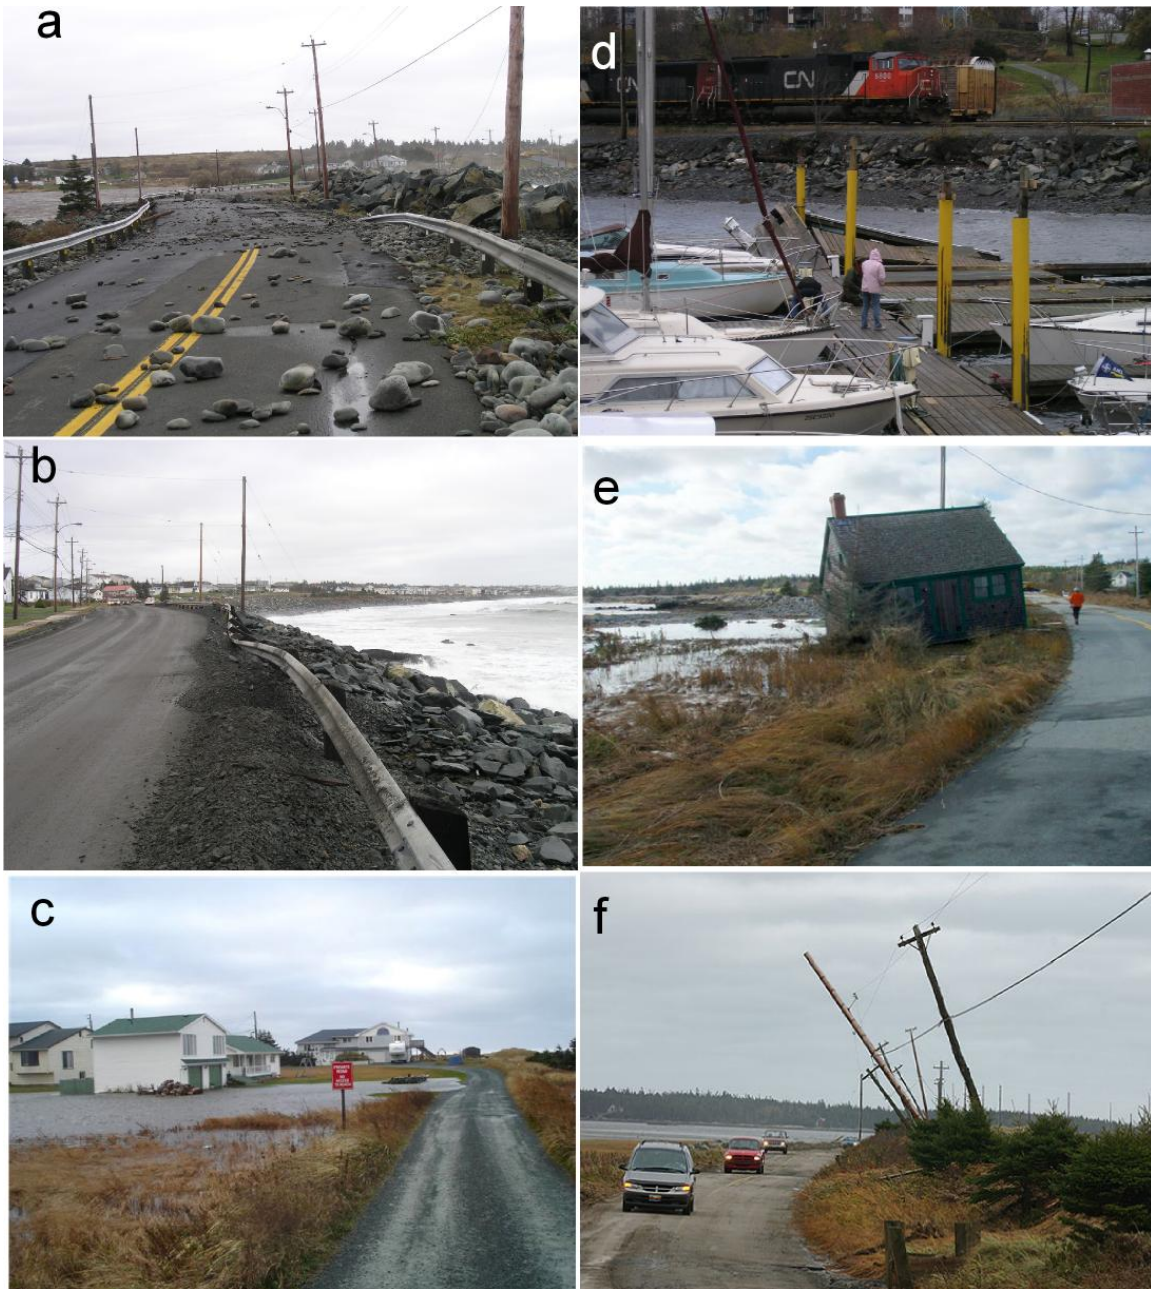
Figure 4a. Examples of wave impacts from Noel to coastal infrastructure along the Atlantic coast of Nova Scotia (a) rock debris and damage to pavement Cow Bay Road; (b) bent guard rail and debris, Eastern Passage Shore Road; (c) flooding at Wyndenfog Lane, Lawrencetown Beach (Betty, Houghton); (d) damage to wharves and sailboats Halifax Harbour; (e) floating structures, West Berlin, N.S. (Kirsty Toussignant); and (f) downed power lines Crescent Beach Lunenburg Co. (Bridgewater News). All photos were taken on November 4, 2007 by R. Taylor (GSCA) unless noted.

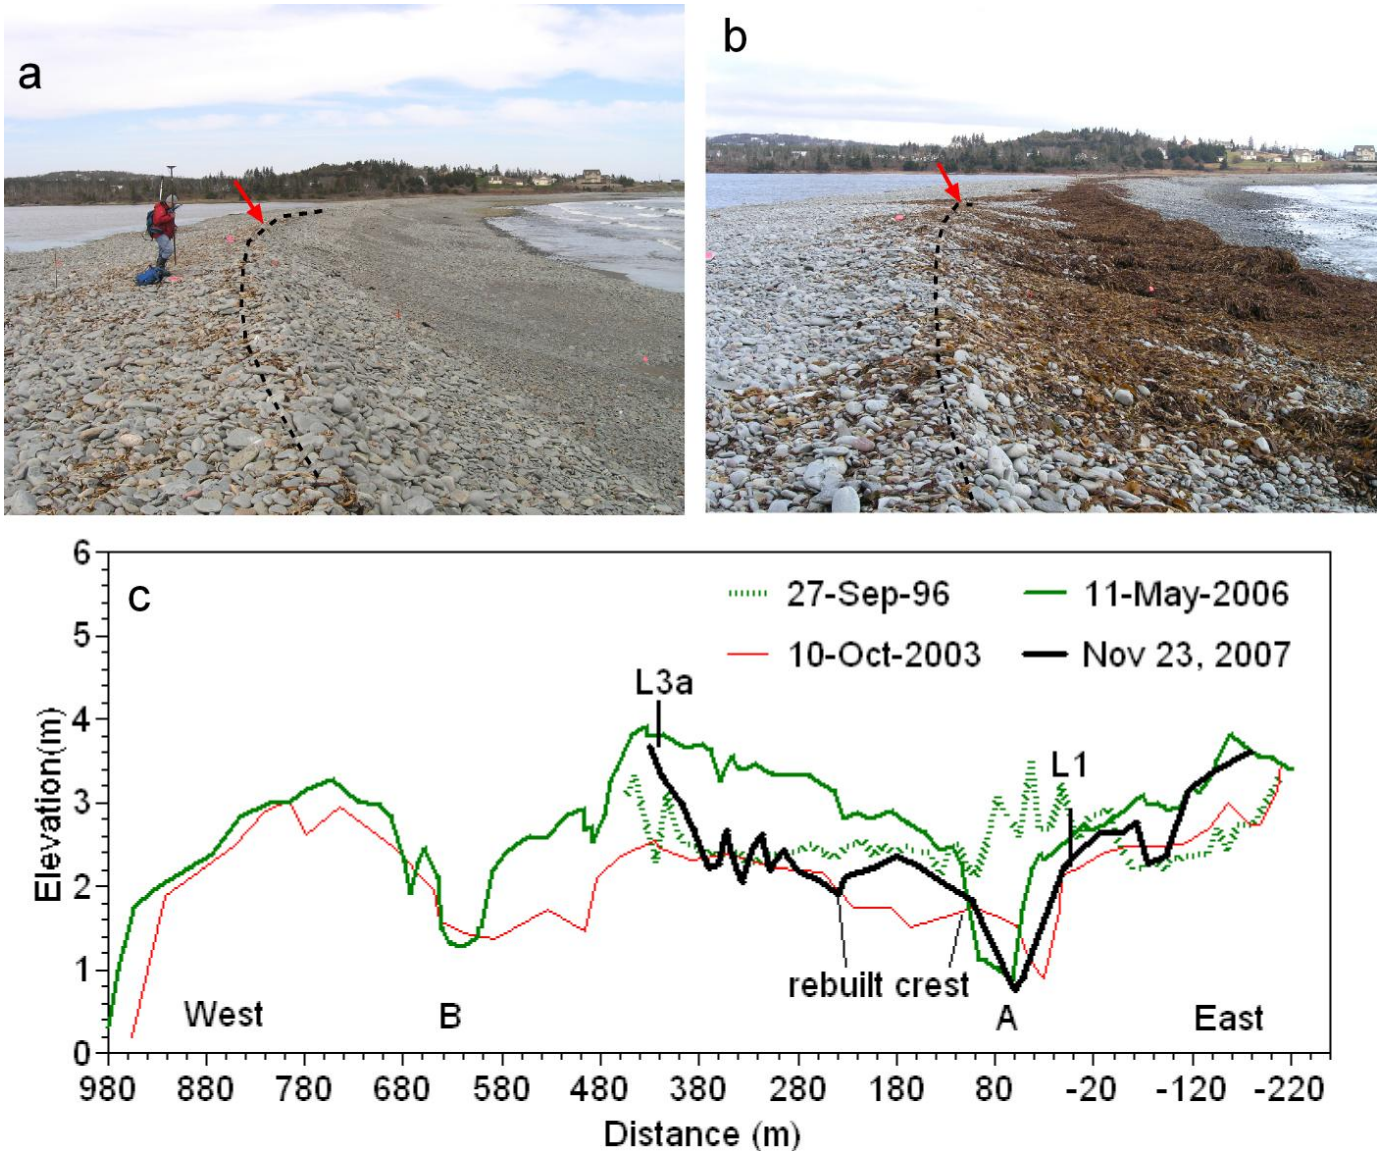
Figure 7. Views of Cow Bay Beach looking east from cross-shore survey line 3a (flags and person mark the line) (a) May 12, 2006 and (b) Nov. 23, 2007 showing the decrease in the beach crest (dash line) elevation caused by Noel (east of the arrow) and the new crest rebuilding (seaweed pile) by November 23. (c) Longshore profile of the beach crest showing its elevation after Hurricane Hortense (27-Sept-96) (Taylor et al. 1997b), and Hurricane Juan (10-Oct-03) (Taylor et al. 2004), its natural rebuilding by May 2006 and its position after Noel (23-Nov-07). In all three cases the beach was lowered to a similar elevation and was rebuilt. Wave washover channels at A and B have remained tidal channels at mid to high tide since Hurricane Juan.

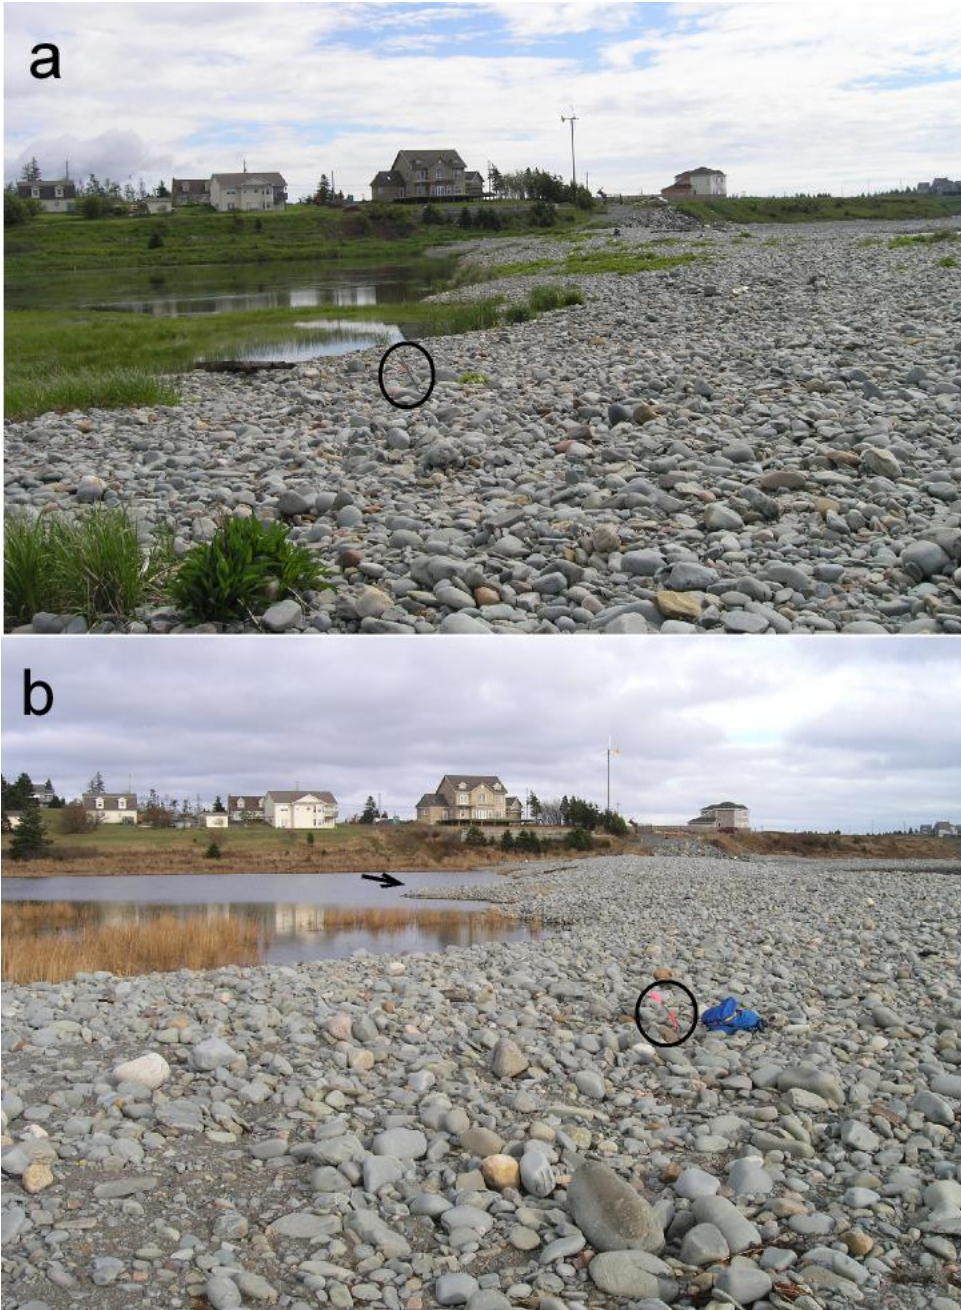
Figure 8a,b. Views looking east along Cow Bay Beach at survey line 1 in (a) June 2007 and (b) Nov. 23, 2007 after Noel showing the new lobe of sediment (arrow) deposited in the pond and the change in surface sediment texture. The same marker on line 1 is circled on both photos for visual reference. (photos P1010067, PB230837, R. Taylor).

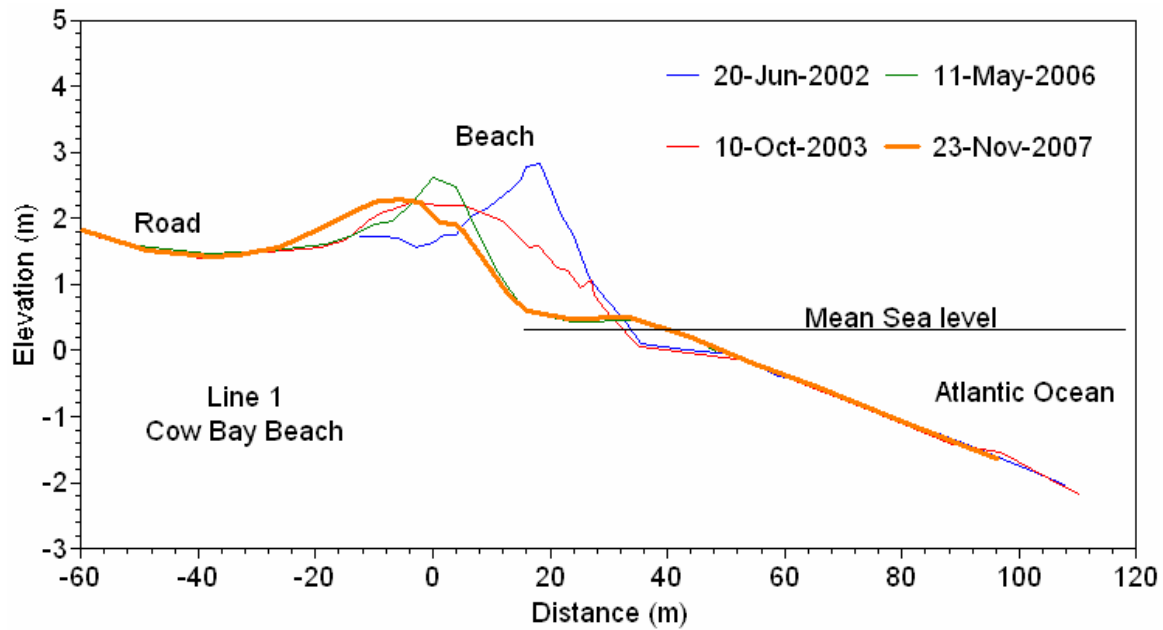
Figure 8c. Sequence of cross-shore beach changes at line 1 Cow Bay Beach resulting from Hurricane Juan in October 2003 and Post-tropical Storm Noel in November 2007. The beach crest is built up after each major storm but it moves farther landward.

During Noel, waves flowed over all but a few small areas (>3.9m) of the beach and through two channels into Cow Bay Lake and continued the natural rapid breakdown and landward migration of this beach. The beach was flattened and lowered to an elevation observed after Hurricanes Hortense and Juan. After all events, the beach naturally recovered and was rebuilt, albeit farther inland. Beach migration has accelerated by nearly 3 times, from a mean of 1.8 m/a (1991-01) to 4.8 m/yr (2002-07) which causes a decrease in substrate compaction and stability. The beach can rebuild but there is increased potential for further rapid retreat and complete barrier collapse in future storms.

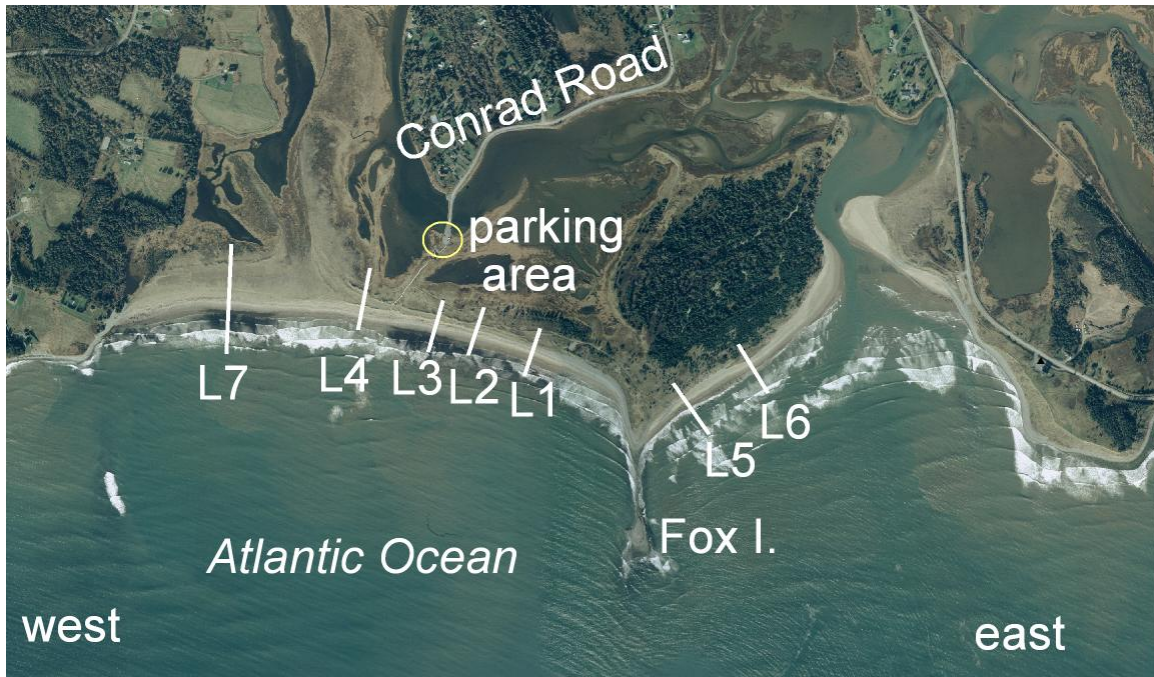
Figure 9. Location map of cross-shore survey lines 1 to 7 established on Conrads Beach in the 1980s. Lines (L) 2 and 4 were resurveyed following Post-tropical Storm Noel on Nov 6, 2007. (Digital 2003 air photo 4460633 & 4465633, courtesy NS Department of Natural Resources).

Conrads Beach is a mainly sand beach complex, that developed in the lee of a headland that extended offshore at Fox Island. Between 1962 and 1989 large quantities of sand and gravel were swept inland through a tidal channel that formed between lines 7 and 4 (Fig. 9). Since the natural sediment infill of the tidal inlet the beach has been building seaward at 3 to 6m/year.

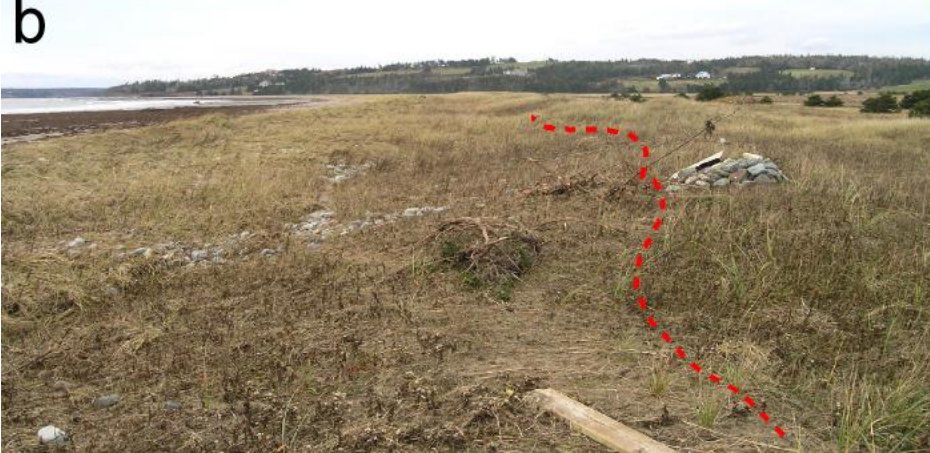
Figure10. Extent and impacts of wave overwash on the backshore dunes at Conrads Beach (a) across the low backshore west of Line 4 where dense marram grass was flattened as it dissipated the flood water and incurred little damage and (b) across the higher dunes between Lines 1 and 2 where flotsam and pebble- cobble were deposited to 3.6 m to 4.0 m elevation. (photos PB060467, PB060439, Nov.7, 2007, R. Taylor).

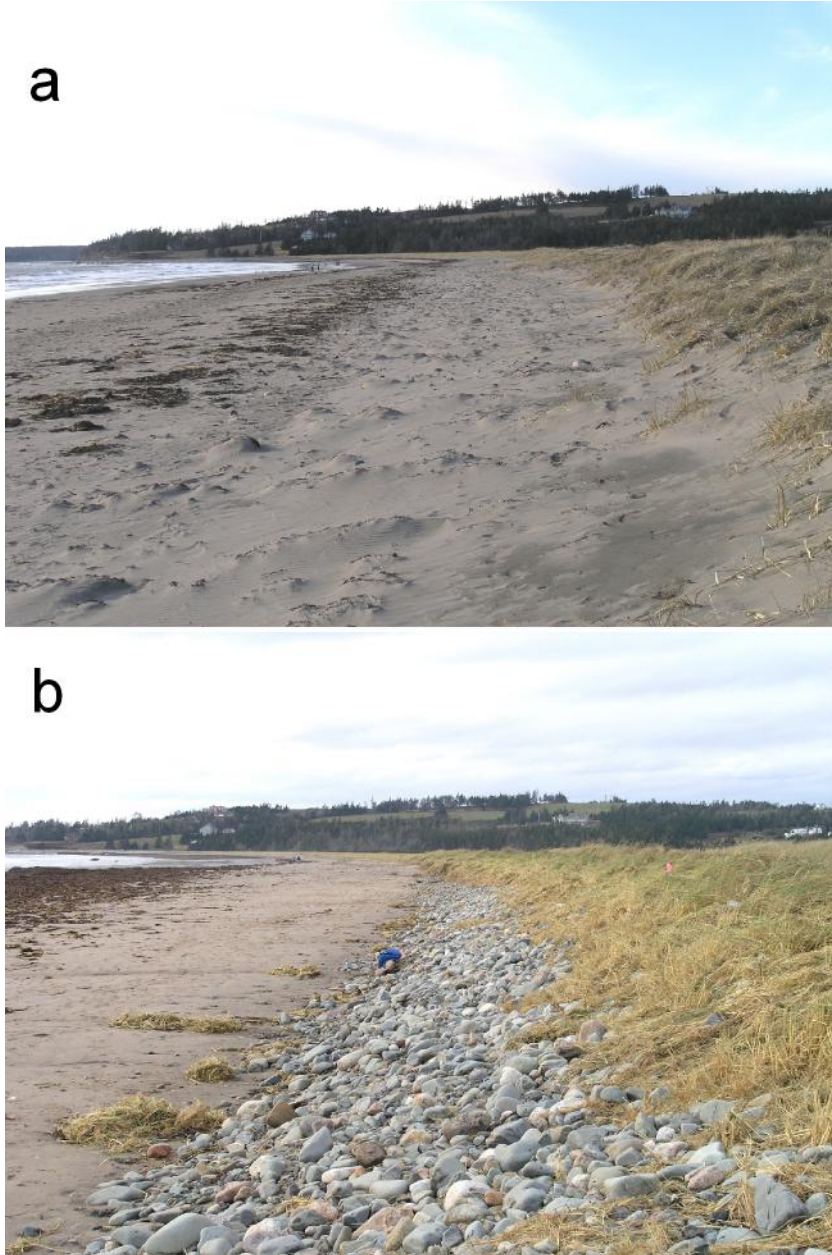
Figure 11. Conrads Beach, line 2 on (a) Dec 25, 2006 when sand had accumulated across the upper beach and (b) Nov 6, 2007 after Post-tropical Storm Noel (blue pack for scale). Waves flowed over the dunes, scoured the sand cover exposing a pebble-cobble deposit which protected the dune from scouring. (photos PC250008, & PB060451, R. Taylor)

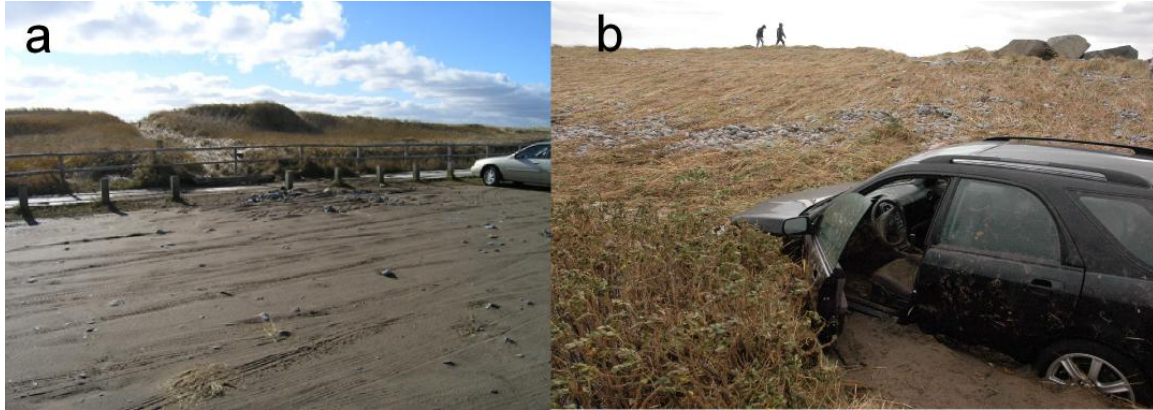
Figure 14. Views of wave overwash across dunes at the west end of Lawrencetown Beach (a) a low area where channelised flow carried pebble-cobble to the parking lot (Fig. 13 orange arrow) and b) sheet washover of gravel and partial burial of an abandoned vehicle (photos PB170727 R. Taylor and 154116, D.L. Forbes, 4 Nov. 2007).

Primary weak points (Fig 13 red and orange arrows) along the beach where water and debris flowed farthest inland were observed at low dune areas at the west end of the beach, east and west of the parks canteen, and where dune craters exist along the

backshore such as west of Wyndenfog Lane. These are key vulnerable spots to monitor during future storms.

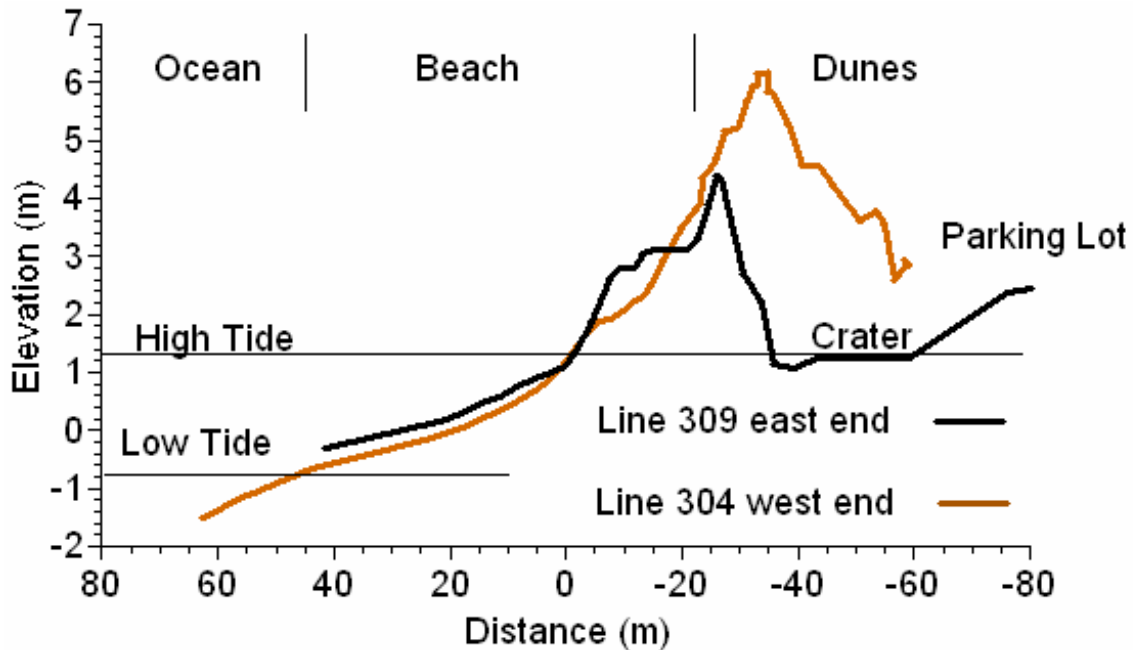
Figure 15. Comparison of the size of backshore dunes at the east and west end of Lawrencetown Beach. During Noel water flowed over the top of the dunes at Line 309 and reached 6 to 6.3 m elevation along the dune crest at Line 304. The greatest changes were observed across the upper beach at 2 to 4 m elevation. In the east the pebble-cobble storm ridge was pushed landward into the low backshore whereas along the west beach pebble-cobble was mostly combed downslope and only transported landward where the dune was low or non-existent. Between survey lines 303 and 305 a rhythmic pattern of beach cusps was observed with a wavelength of approx. 80-100m.

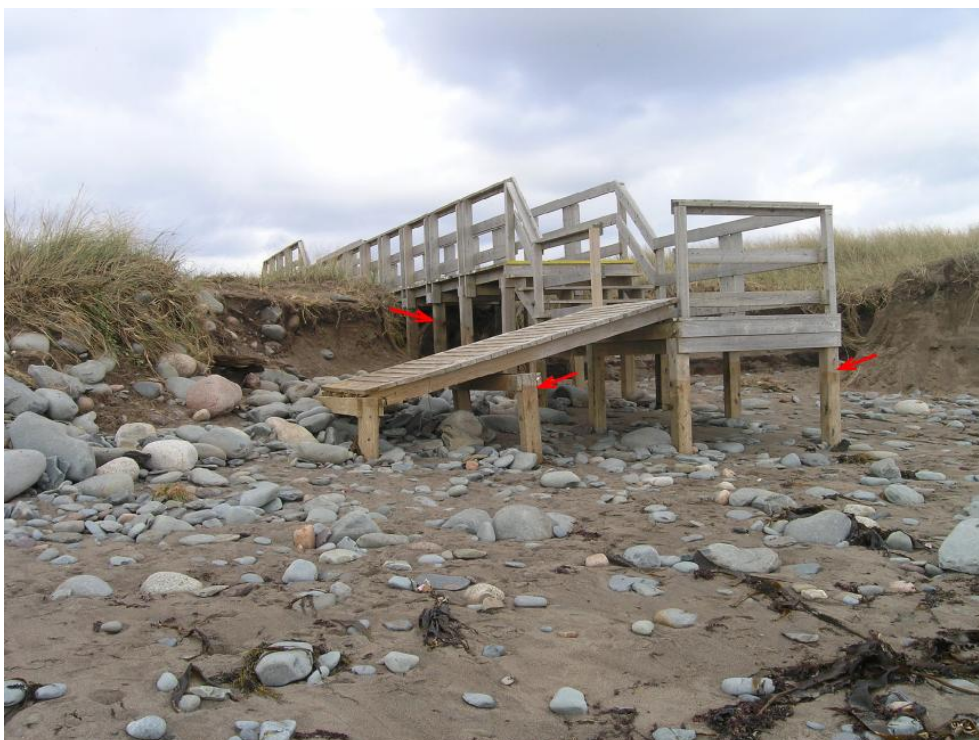
Figure 16. View of boardwalk just west of Line 303 where waves scoured a significant portion of beach and dune as indicated by the former ground surface marked by a stain line (arrows) on the support posts (photo PB050359, R. Taylor).

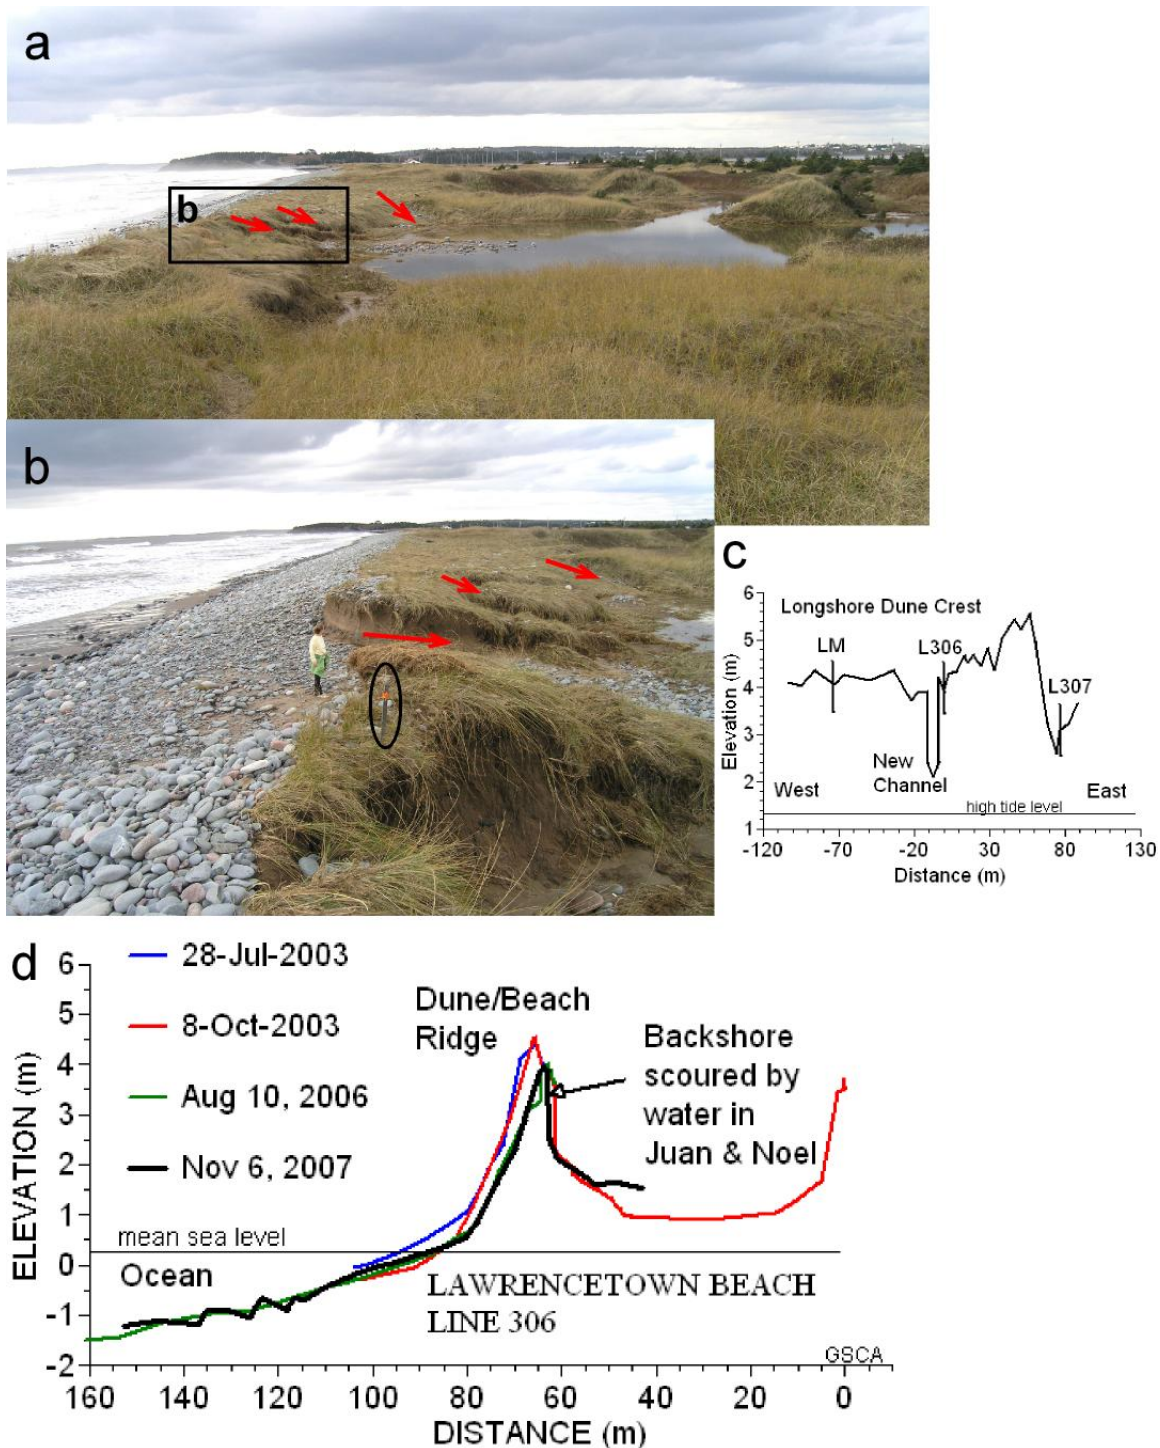
Figure 17. (a) View of dunes and large craters at east end of Lawrencetown Beach where waves overwashed the narrow dune, scouring its backslope (arrows), and (b) close-up of channel cut through the dunes just west of survey line 306 (T-bar circled). (c) longshore crest profile from line M to line 307 showing the spacing of dune cuts which is approx 80 m. (d) Repetitive surveys at line 306 illustrate the decreasing size of the dune since 2003 making it vulnerable to scouring and destruction during Noel (photos PB050388, PB050396, R. Taylor, Nov. 5).

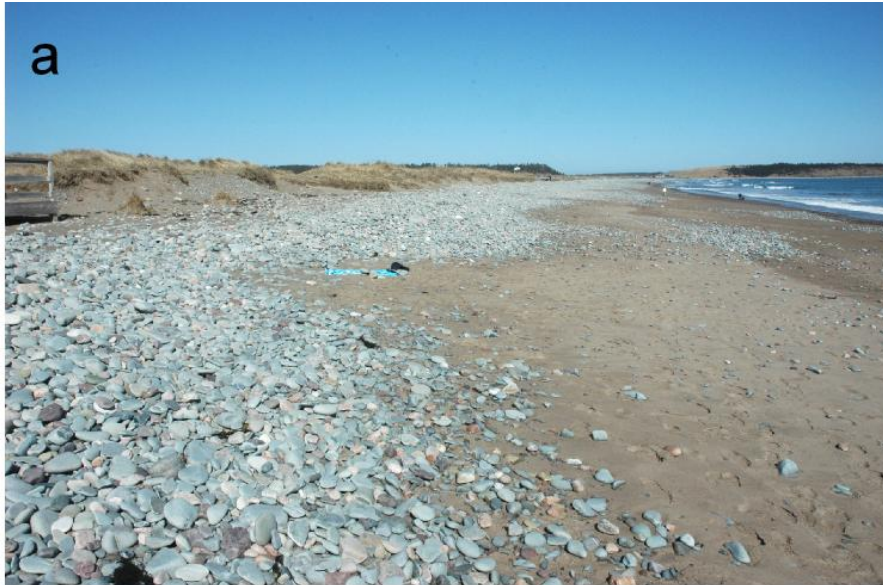
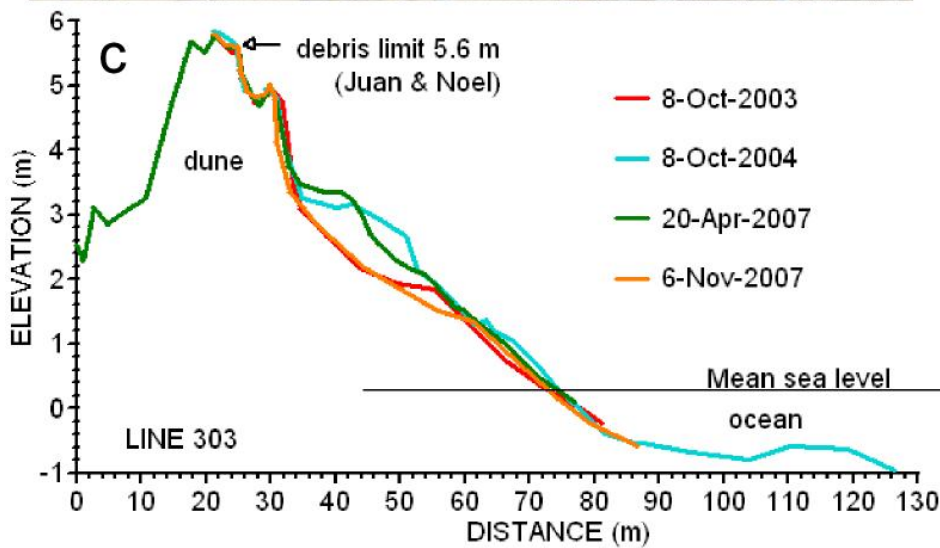
Figure 18. Views of Lawrencetown Beach at line 303 where a large pebble -cobble storm ridge built against the dune after 2003, as shown in (a) Oct. 2004. It was modified in April 2007 and erased (b) during Noel in Nov. 2007; (c) Repetitive cross-shore surveys at line 303 illustrate the similarity in upper beach scouring during Noel and Hurricane Juan (photos 35-8-2004 and PB050348, R. Taylor).

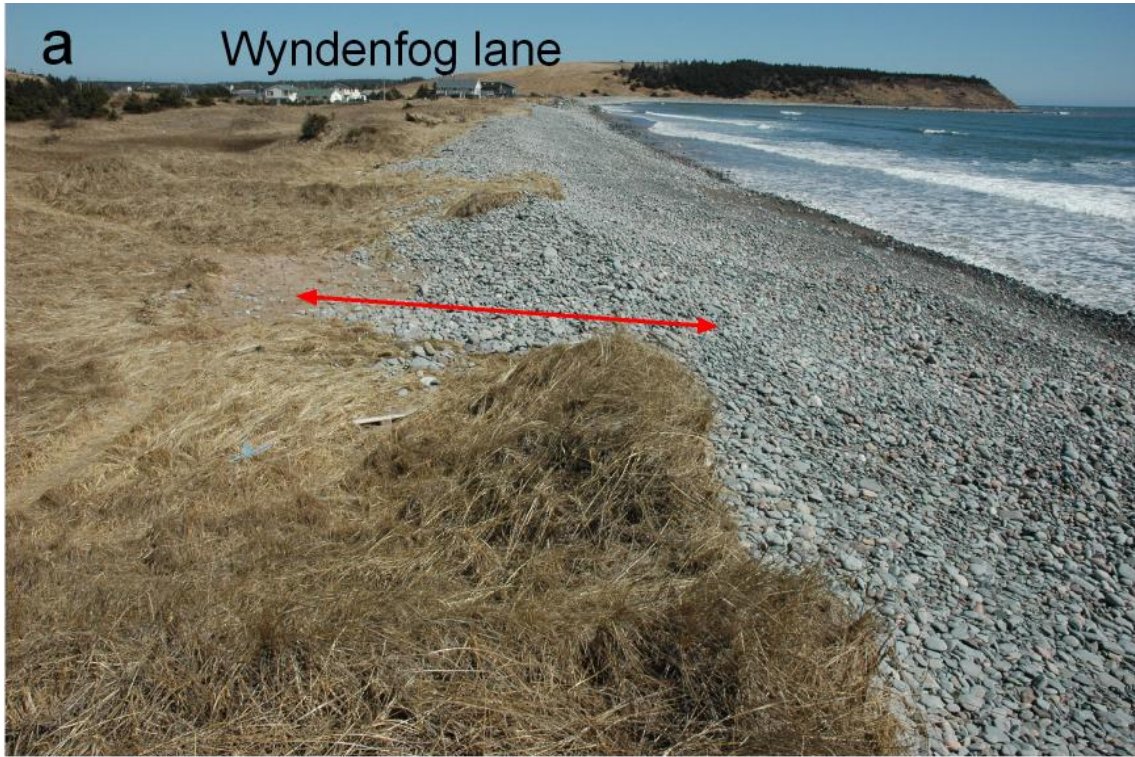
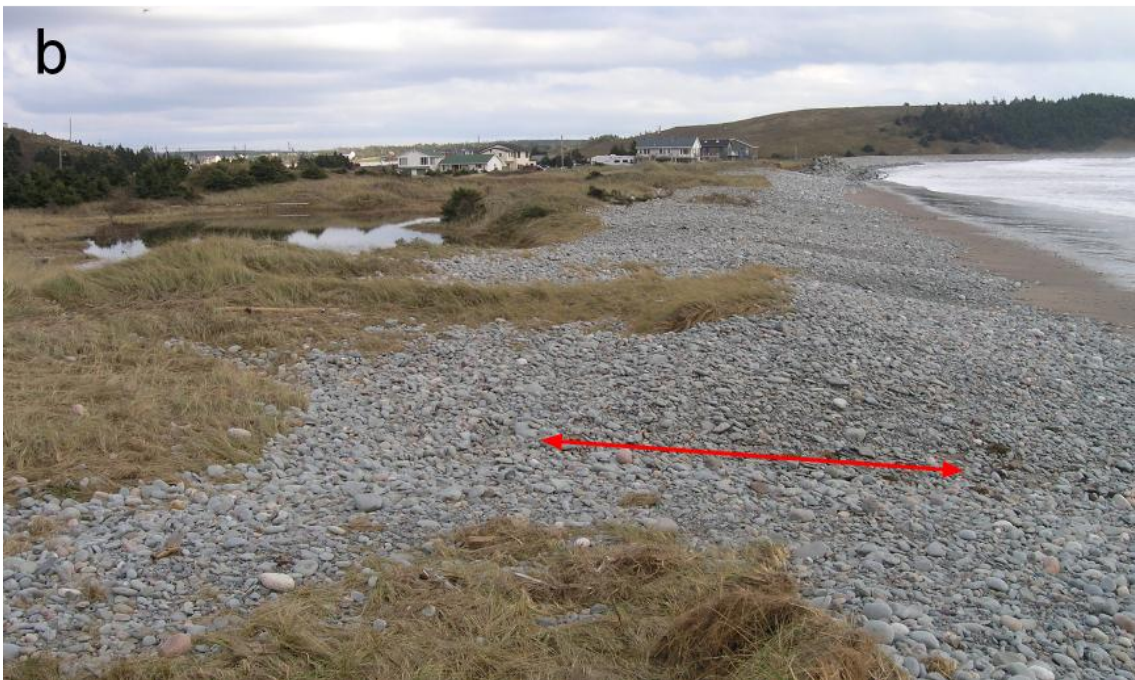
Figure 19. View of east end of Lawrencetown Beach at line 307 (arrow), (a) in April 2007, before Noel, and (b) Nov. 5, after Noel, where cobble is accumulating ovetop of low dunes and (c) cross-shore surveys showing the major loss of dune during Hurricane Juan in 2003 and the subsequent landward beach migration. (photos 174416, D.L. Forbes Apr. 20 & PB050385, R. Taylor, Nov.5, 2007).

Along the eastern part of the beach, waves smoothed the upper beach slope and pushed the pebble-cobble crest landward covering and infilling the backshore dunes. Net landward beach crest retreat was least at line M and most at line 307 where it was pushed 3.6 m landward (Fig.19). Along all but the highest dune areas, pebble -cobble gravel and other debris covered the backshore dune and craters. Where craters existed back of the primary dune (e.g. at line 306), overwash scoured the landward side of the dune, decreasing the dune width. The scouring has left the dune very vulnerable to break-through during future storms, as we observed during Noel at line 306.

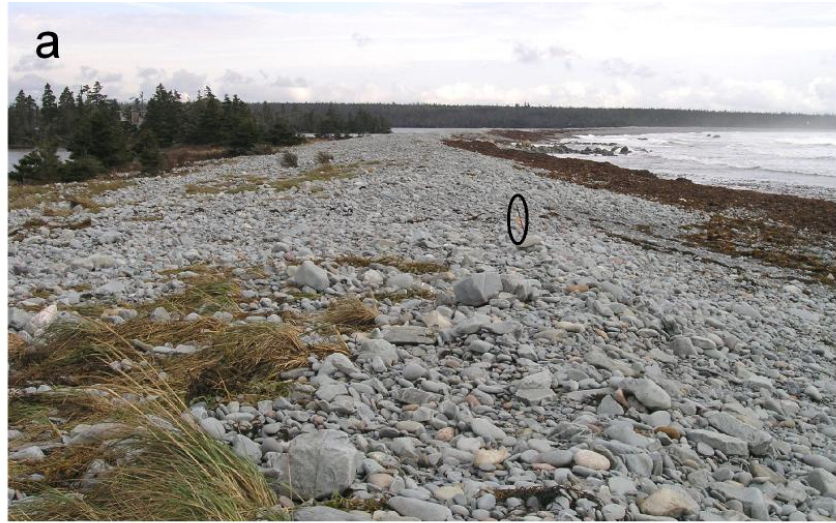
Figure 21. (a) View looking east along Miseners -Long beach on Nov. 7 at line -1 (marker circled) where the crest was lowered by 0.4 m and more of backshore grass was covered by cobble and (b) longshore crest profile with position of cross-shore survey lines illustrating the largest crest reduction was between lines 2 and 3. In general the crest was not lowered as much as following Hurricane Juan (photo PB070473, R. Taylor).

Extensive deposits of cobble across the backshore, particularly at the west end of the beach suggested most of it had been overwashed by waves. In May 2007 before Noel struck the highest beach crest was in the vicinity of Lines 3 and 4 where it extended to 4.4 m. After Noel there was only a short segment of crest remaining above 4.4m. Changes along the crest and sediment deposition across the backshore indicate that waves easily overwashed the beach where the crest was less than 4 m but they also toppled a section of beach that was 4.4 m elevation. The beach crest was most impacted between lines 2 and 3 where it was lowered in elevation by an average of 0.46 m and a maximum of 0.64 m (Fig. 20). Elsewhere along the western beach, the crest was only lowered an average of 0.2m. In general beach crest lowering was not as extreme as during Hurricane Juan but the pattern of where it occurred was similar (Fig. 21).

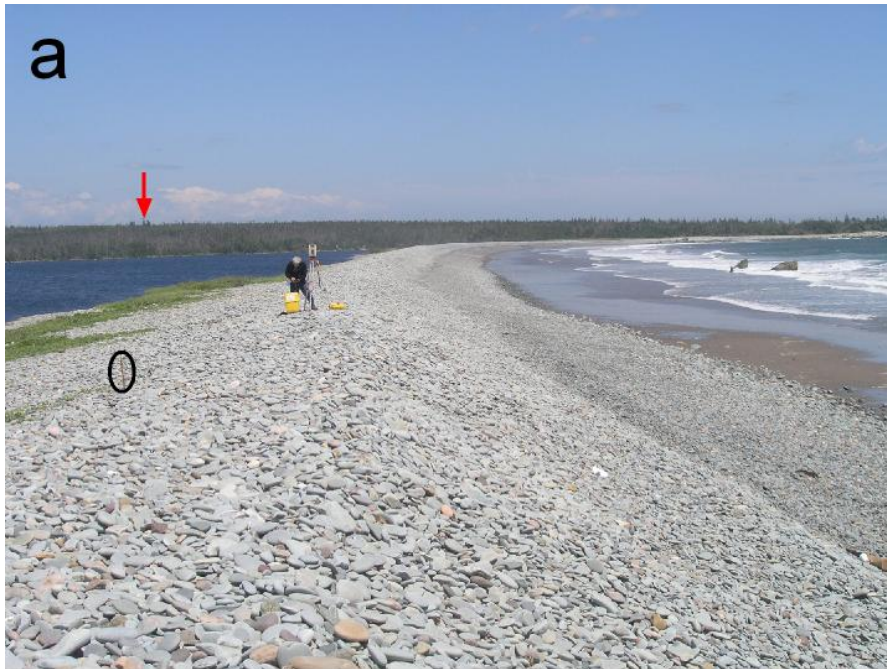
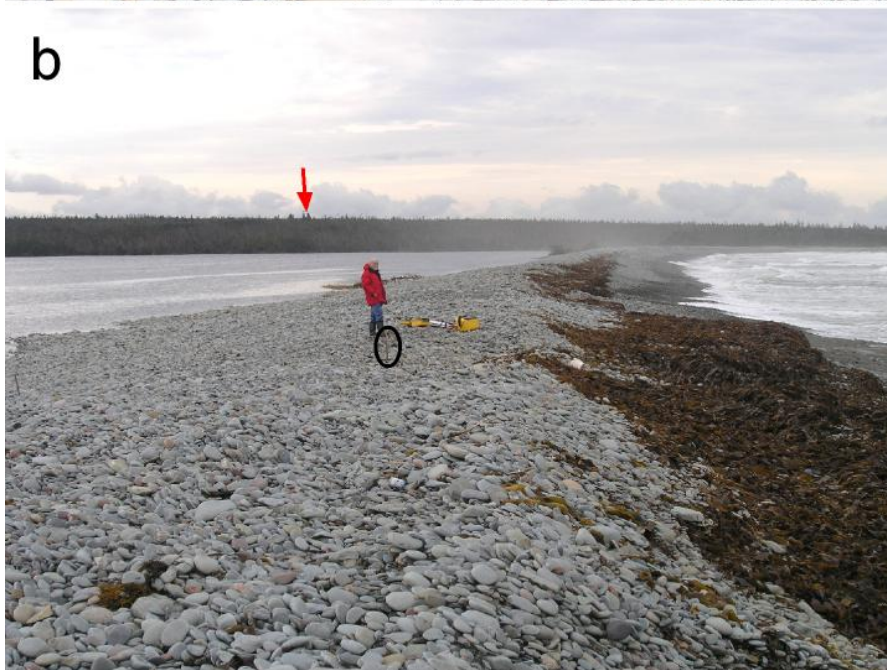
Figure 22. Views of changes caused by Noel at Line 2 Miseners -Long Beach (a) 13 July 2007; (b) Nov. 7, 2007.

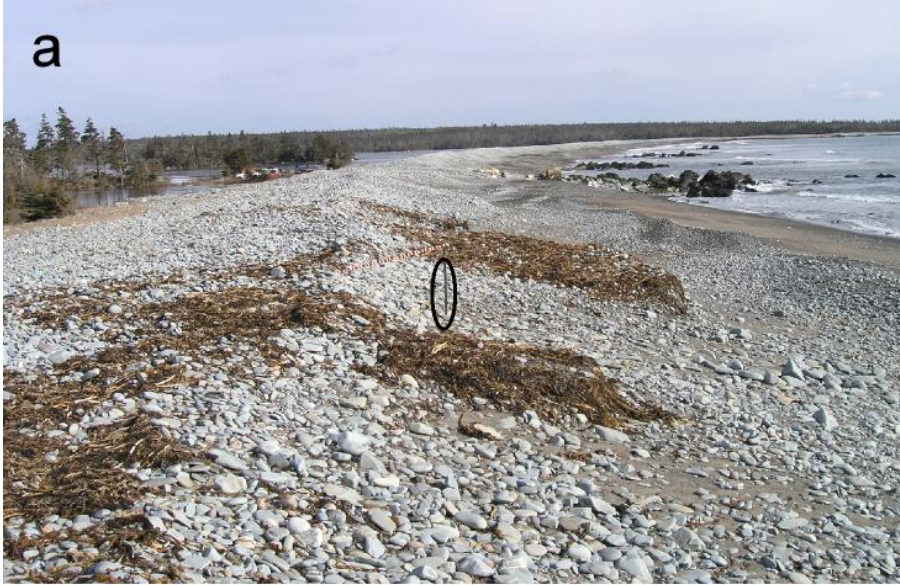
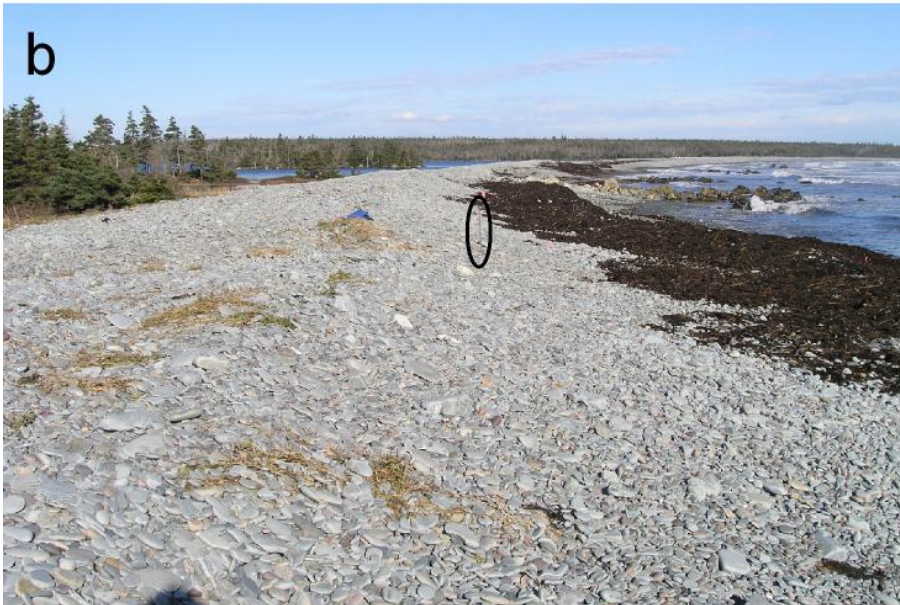
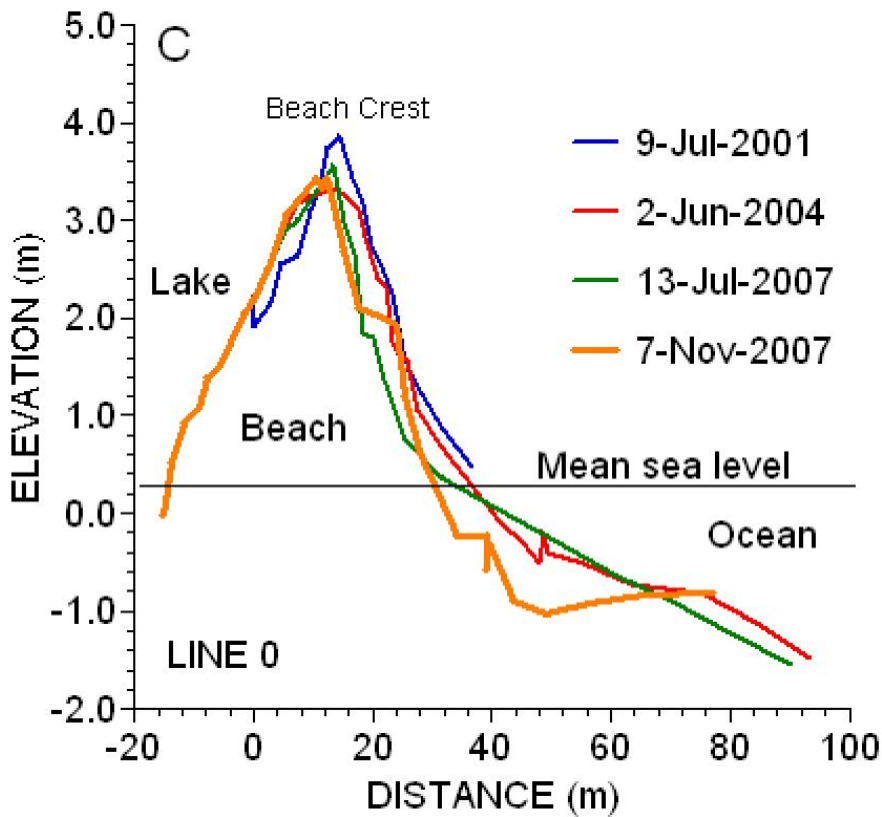
Figure 24. Views of beach at Line 0 (line marker circled) (a) in September 2006 and (b) 7 Nov. 2007 showing conditions before and after Noel and (c) repetitive surveys across the beach showing gradual lowering of the beach crest, the volume of backshore sediment deposition from Noel compared with changes between 2001 to 2004 which included changes caused by Hurricane Juan (photos P2090012 and PB070524, R. Taylor).

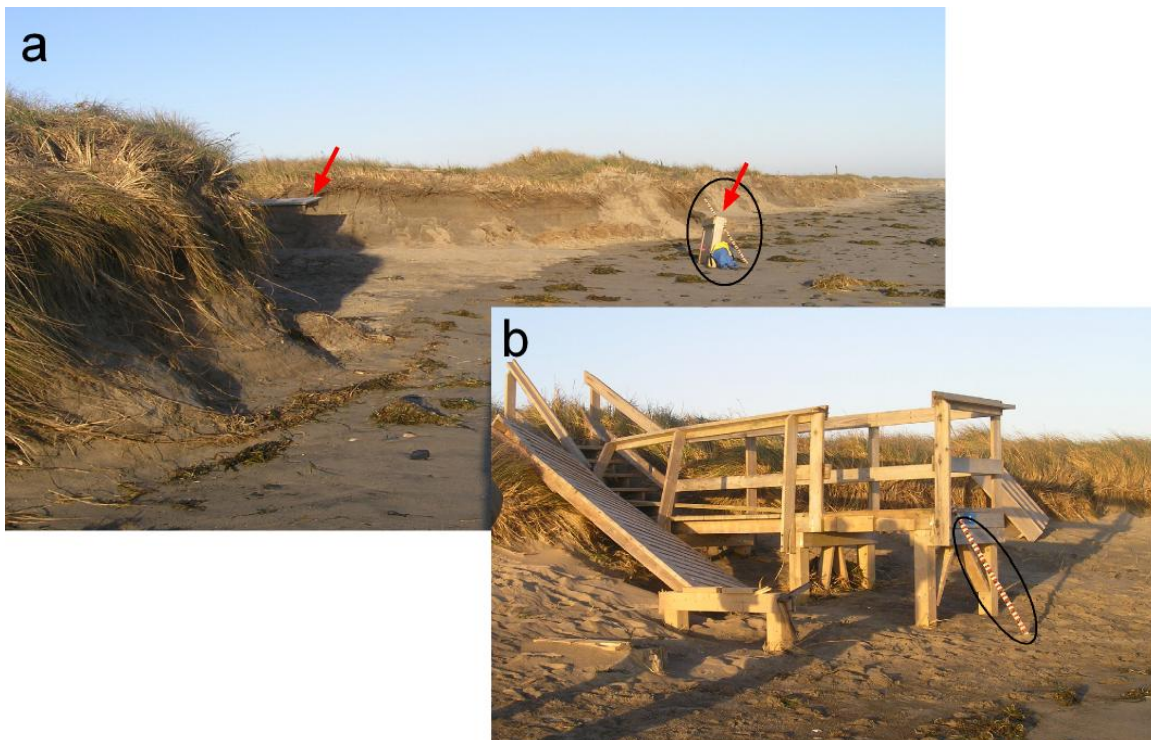
Figure 26. Damage to boardwalks on Martinique Beach varied depending upon their location and condition of beach prior to the storm (a) complete loss of platform (between arrows) between supports and severe scouring of adjacent dunes and b) tossing of access ramp against main boardwalk and steps into the dunes at parking area 8. Most large pieces of boardwalk broken away were carried toward the east end of the beach. A 1.5m long survey pole (circled) is provided for scale in each photo (photos PB040292 and PB040310, Nov. 4, 2007, R.Taylor).

The most dramatic impacts included damage to the beach access boardwalks and associated scouring of the adjacent dune (Fig. 26) deposition of wave overwash debris e.g. cobble, driftwood and grass across the backshore road and parking areas, the trimming and flattening of dune grass by waves (Fig. 27), and the cutting of a narrow breach through the dunes to the backshore estuary at cross-shore line 5 (Fig. 28).
