**GEOLOGICAL SURVEY OF CANADA
OPEN FILE 5802**

Impacts of Post-tropical Storm Noel (November, 2007) on the Atlantic Coastline of Nova Scotia

Observations of coastal infrastructure and detailed surveys of physical changes at eight beaches document the impacts of Post-tropical Storm Noel that struck the Atlantic coast of Nova Scotia on November 3-4, 2007. The surveys were part of an ongoing investigation of the impacts of major storms on different shore types and their rate of recovery. In addition, flood water levels and wave run-up extent were documented to better define shores vulnerable to these coastal hazards.

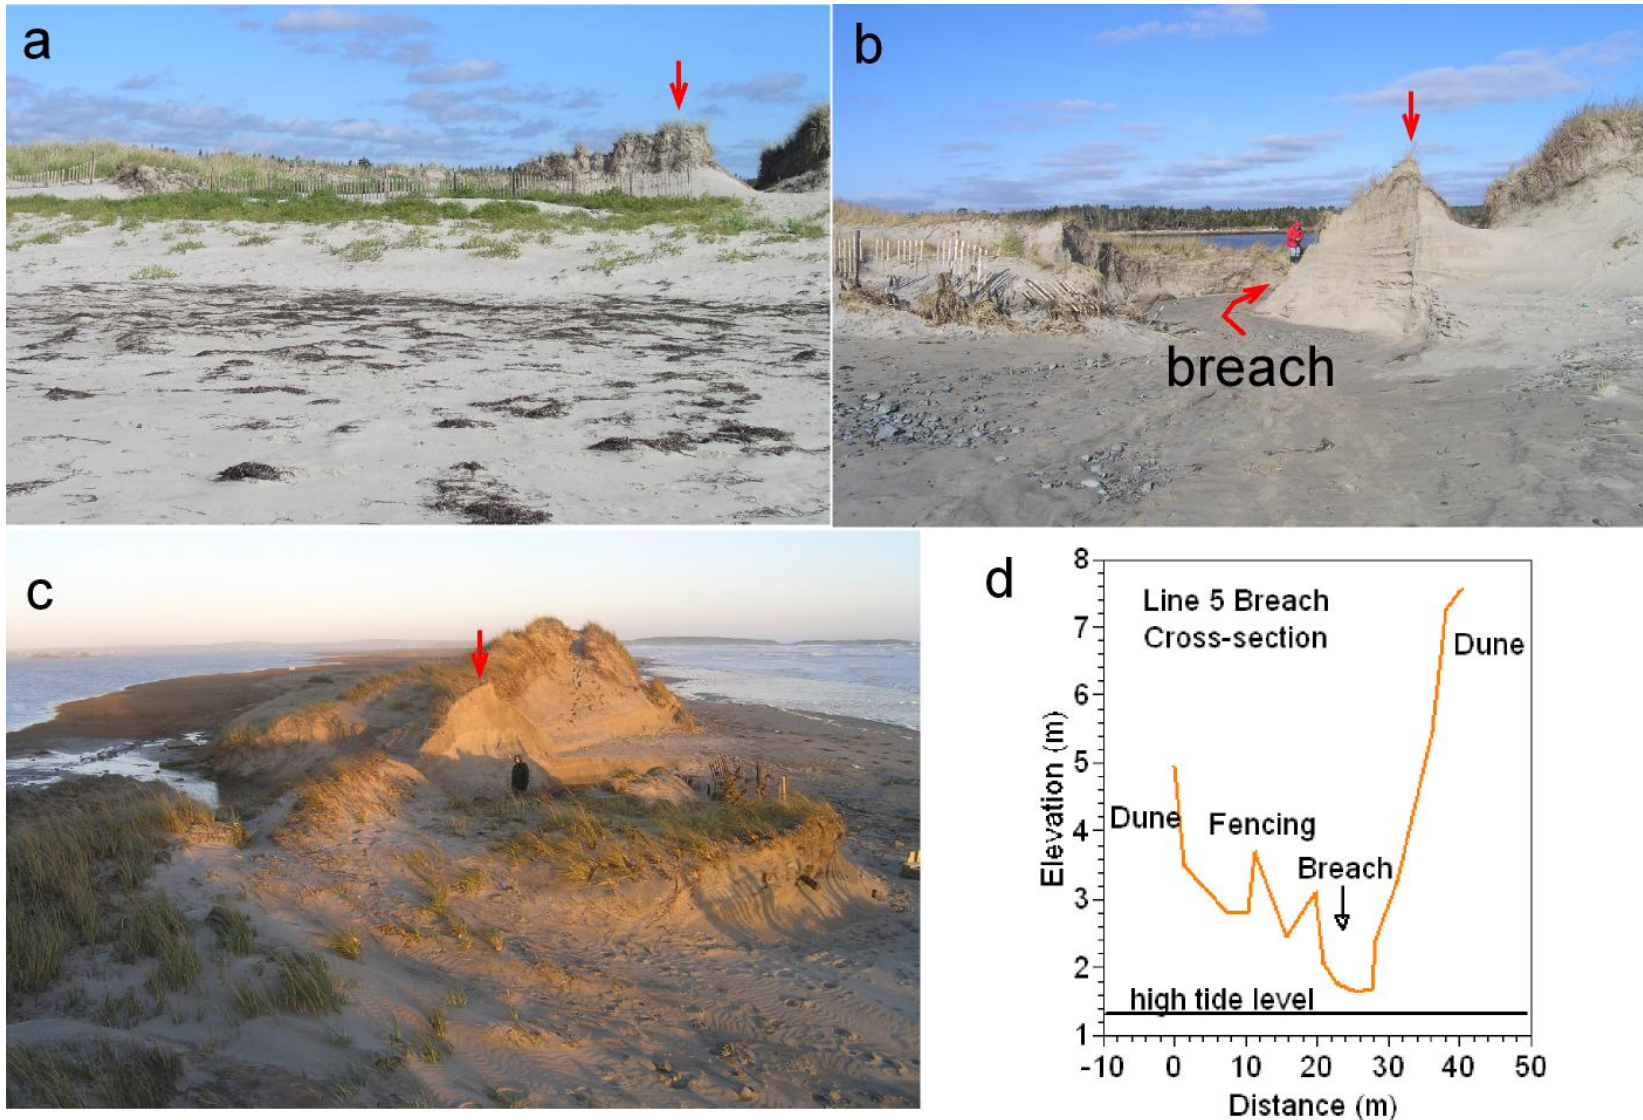
Figure 28. Views of beach at Line 5 (a) in September 2007 before Noel when a large foredune was developing seaward of fence lines (photo and (b) November 21, 2007 when our survey was completed after Noel (photo PB210782) (c) November 4, 2007 just after waves from Noel cut a channel through the dunes to the estuary behind (note water on left) (photo PB040320) and (d) longshore profile across the breach showing the extent of the breach relative to high tide level. Repetitive surveys across the dunes at Line 5 are illustrated in figure 29. Arrows mark the same location on each photo for reference.

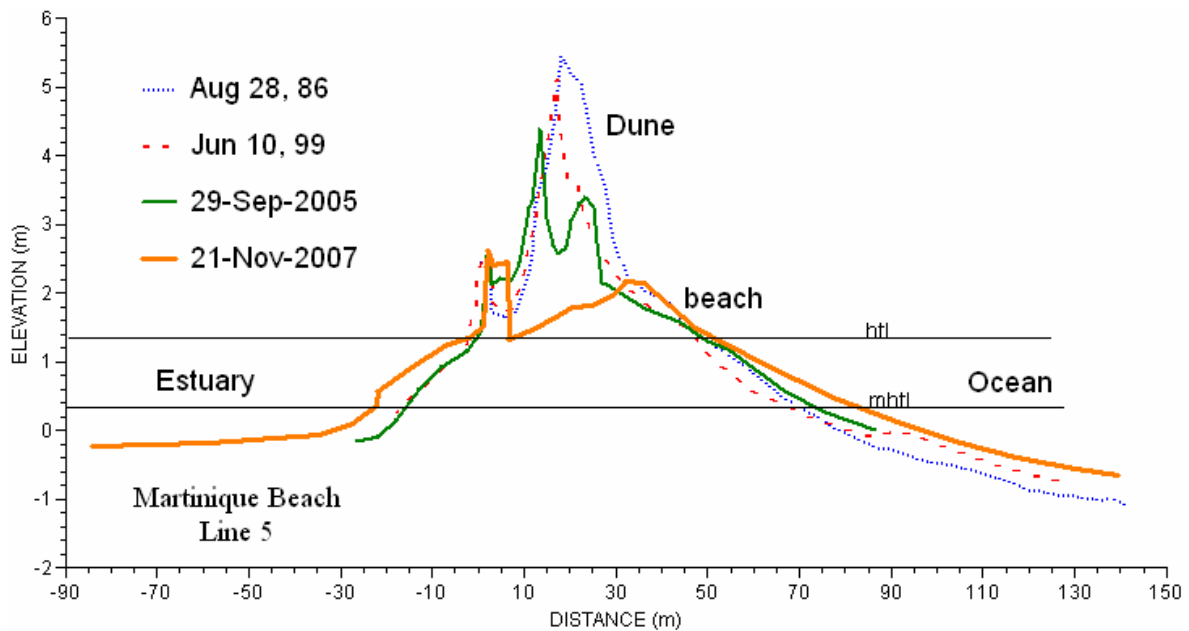
Figure 29. Repetitive cross-shore surveys at Line 5 where the blowout through the dune has progressed eastward since the mid 1980s leaving less and less backshore dune until it was cut by waves during Noel on Nov 3,4, 2007. The beach remains higher than the channel so only when waves extend above high tide level will water enter the breach and flow into the estuary.

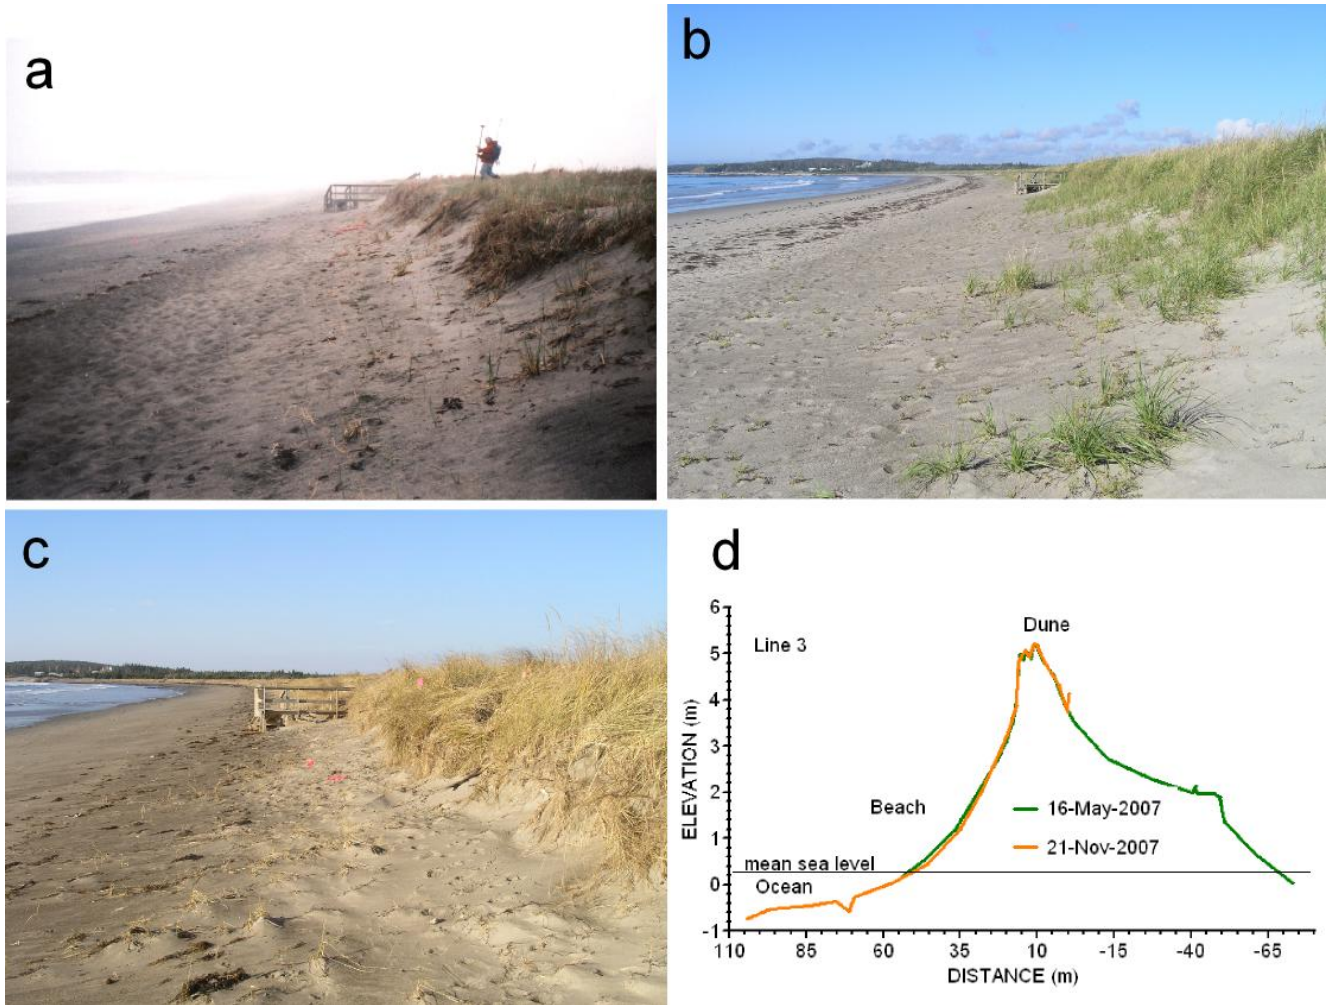
Figure 30. Views of the beach at Line 3 (a) on May 16, 2007 after a storm in April, (photo 3-02-2007) (b) in September 19 when the upper beach was built up by sand (photo P9190132) and c) Nov. 21 after Noel when the dunes were scoured by waves (photo PB210736). (d) repetitive surveys in May and Nov. show little net change in the beach but it does not reflect losses of sand accumulation between surveys in September 2007.

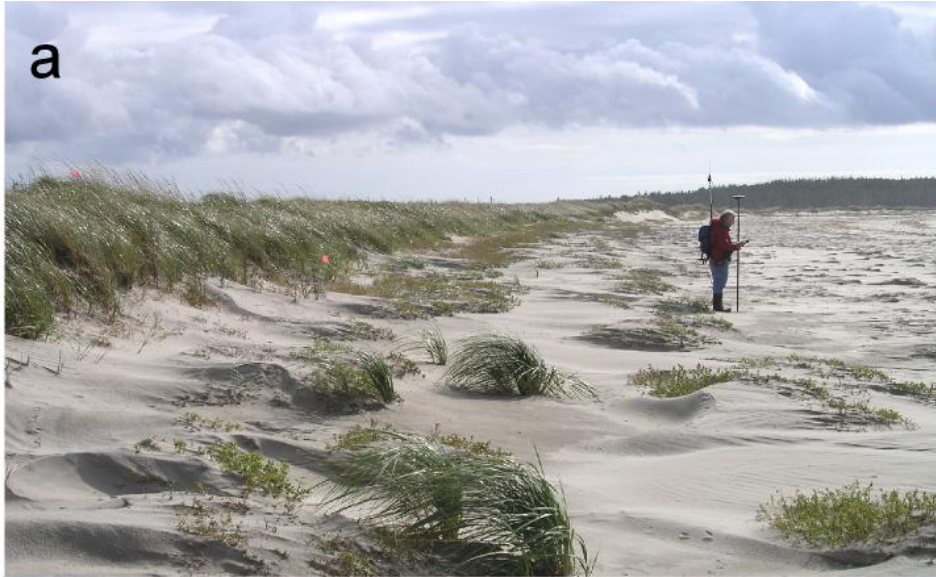
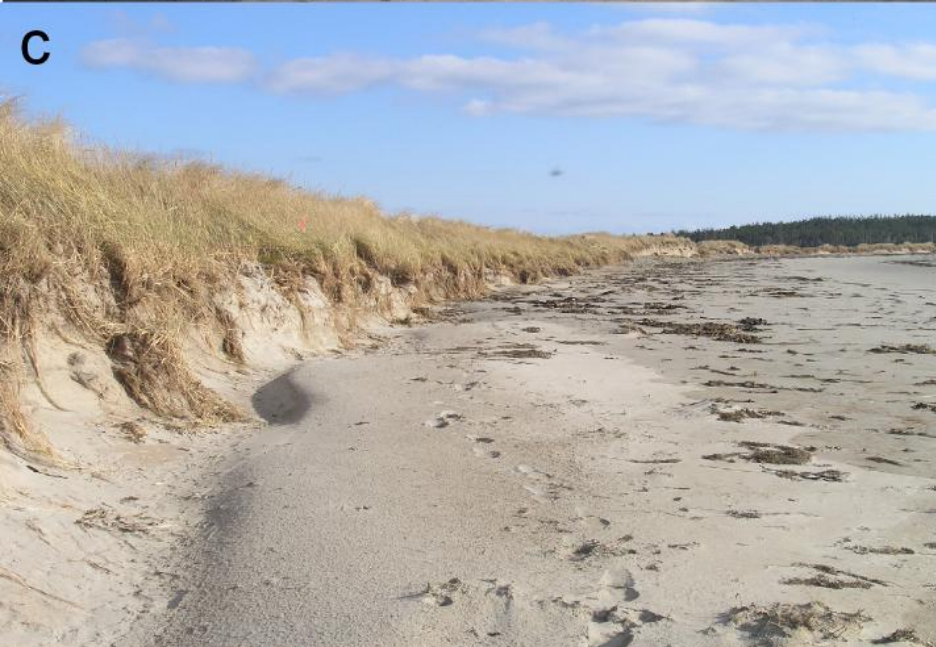
Figure 31. Views of Line 7 where sand was accumulating in (a) Sept. 2005 (photo P9290047) and (b) in May 2007 when a sand ramp existed (photo 17-02-2007) and (c) Nov. 21, 2007 when wind blown sand was rebuilding the base of the dune scoured by Noel on Nov. 4, 2007 (photo PB210792).

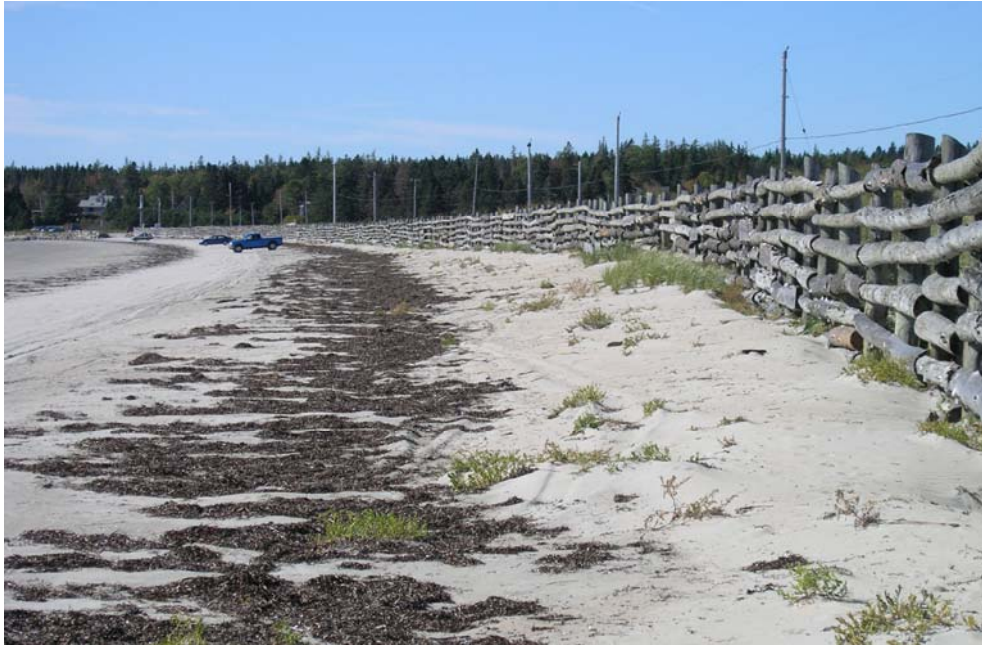
Figure 34. By early October 2007 sand had accumulated along parts of the seaward side of the wooden fence forming a small foredune similar to what had occurred in September 2003 just prior to Hurricane Juan (photo PA070198, R. Taylor)

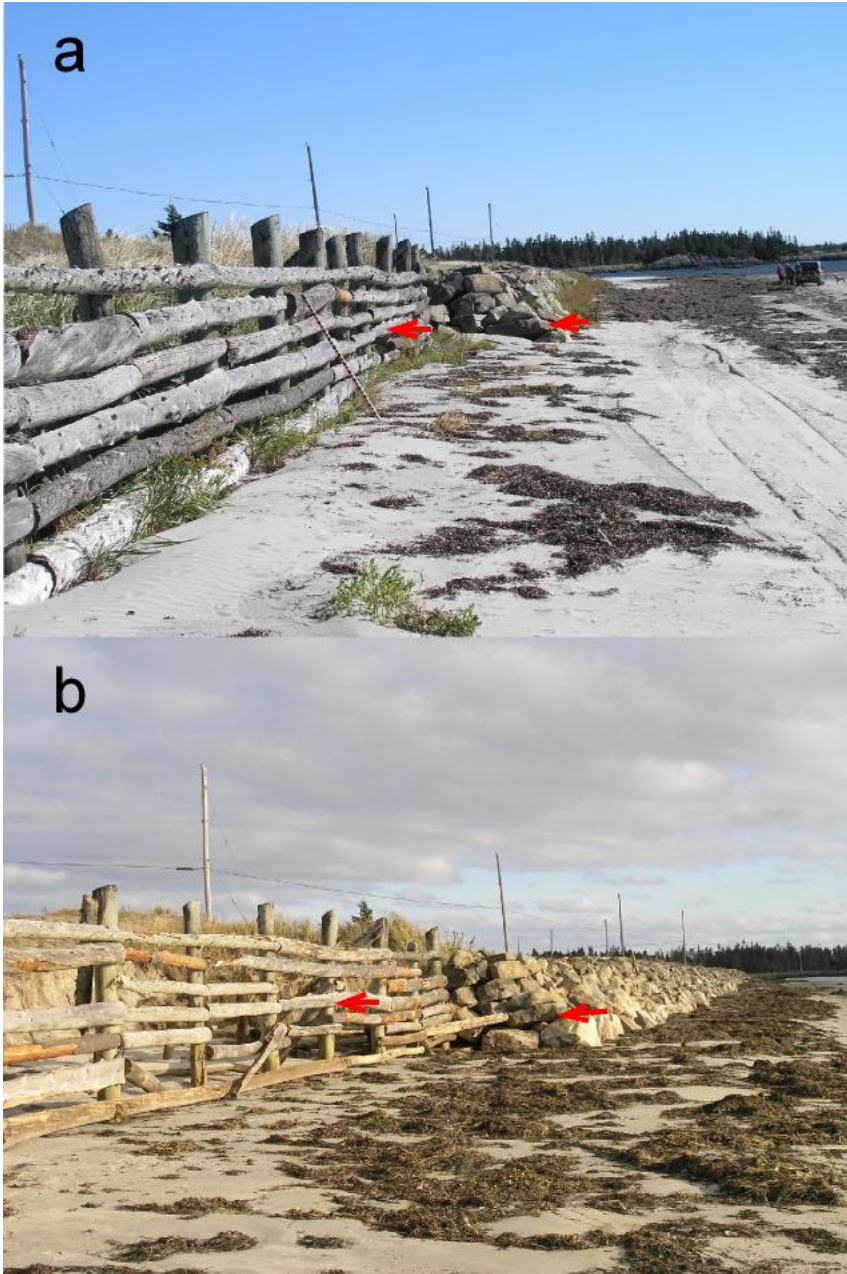
Figure 36. View of the fence and rock wall at the east end of Crescent Beach at Line 38 on (a) Oct. 7, 2007 and (b) Nov 9, 2007 showing a similar depth of wave scouring by waves during Noel at the two interfaces. Arrows mark the same location on each photo. The survey pole against the fence in (a) is 1.54 m long. (photo PA70205 and PB090685, R. Taylor)

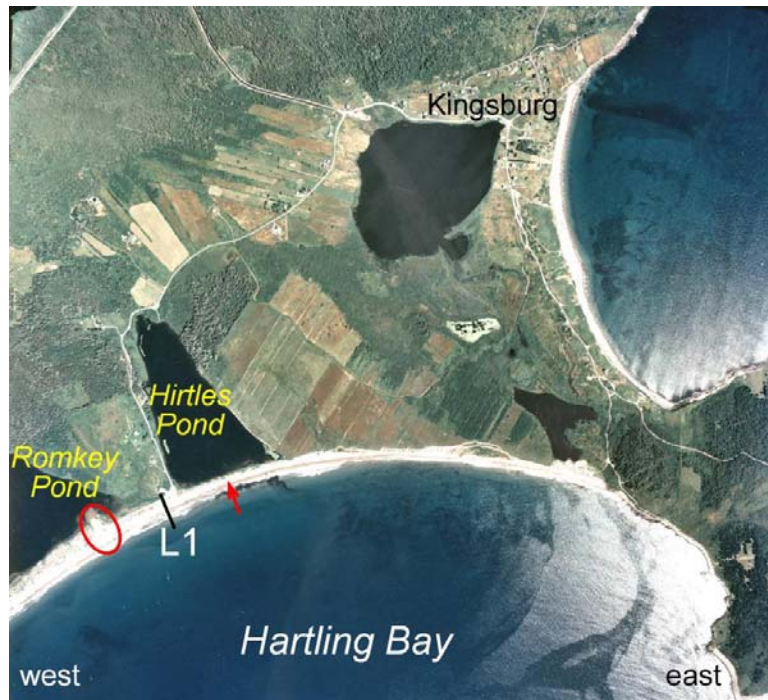
Figure 38. Aerial view of Hirtles Beach at the head of Hartling Bay showing the location of survey line L1, the new channel cut through the beach during Noel (arrow) and site of the tidal channel (circle) that flows into Romkey Pond (air photo 92354-143; July31,1992).

Hirtles Beach is a 2.6 km long mixed sediment beach backed by a series of ponds and drumlins at the head of Hartling Bay (Fig. 38). In the past when water levels rose in Hirtles Pond, water was directed toward Romkey Pond and emptied through a tidal channel (Fig. 38 circle) which frequently linked Romkey Pond to the ocean.

The most dramatic change to Hirtles Beach, Hartling Bay was the cut (Fig. 38, 40 red arrow) through the barrier beach fronting Hirtles Pond which became drained following the breach. Local residents do not remember a channel ever joining the ocean and this pond. The waves cut a 35 m wide channel 4 m deep through the barrier beach (Fig. 41). Base level of the channel was -0.75 m geodetic which is at or below low tide level. After Noel the top of the barrier beach had an elevation of 3.1 to 3.4 m.

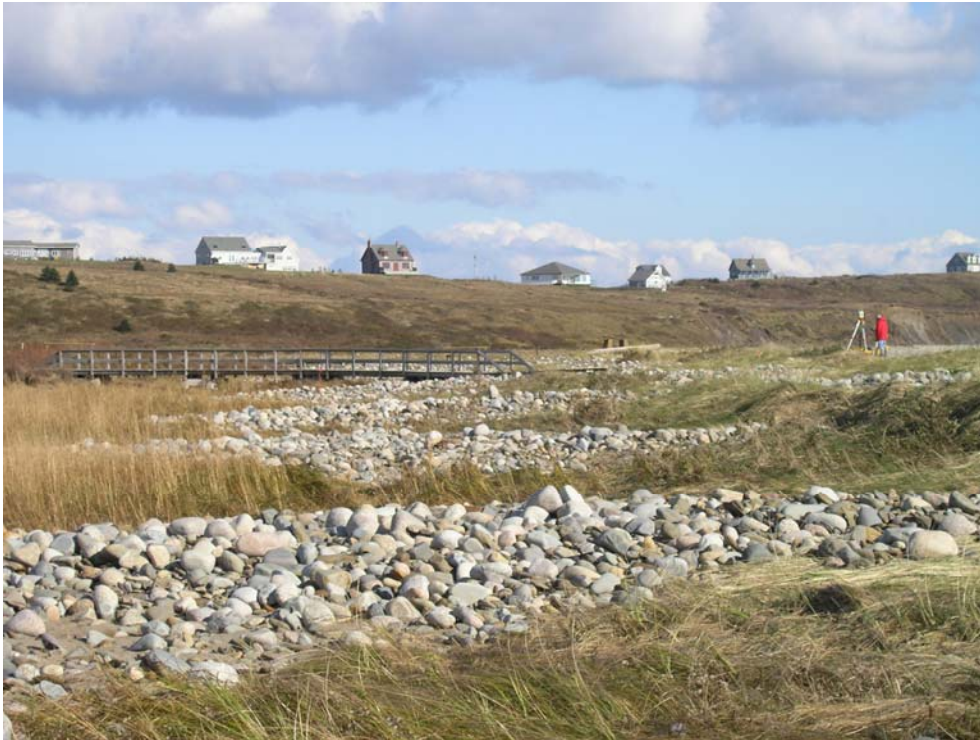
Figure 39. Extent of wave overwash and deposition of coarse clasts between Hirtles and Romkey ponds as a consequence of Post-tropical Storm Noel, Nov. 4, 2007. Beach survey line 1 extends from the parking lot, at left side of footbridge, past where the surveyor is standing. (PB080551, Nov 8, 2007, R. Taylor)

Waves from Noel overwashed the beach ripping away the backshore boardwalk between Hirtles and Romkey Ponds, leaving only the more secured parts leading from the parking area to the beach. Most pieces of boardwalk were floated into the backshore to elevations of 2.0 to 2.7 m, as much as 67 m landward of their original location. The highest wood and grass debris line was at 2.9 to 3.1 m elevation along the backshore upland slope. Waves from Hurricane Juan had had a similar impact on the boardwalk in 2003. After Juan the boardwalk was rebuilt back of the dune in roughly the same location.

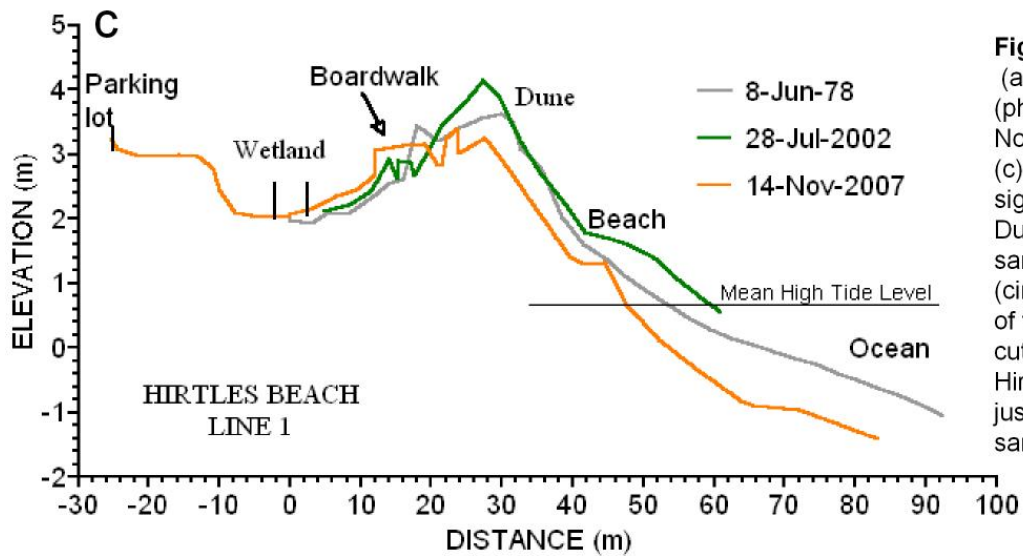
Figure 40. Views of Hirtles Beach from line 1 (at surveyor) before Noel on (a) October 7 (photo PA070215) and (b) after Noel on November 8, 2007 (photo PB080544) and (c) repetitive surveys at line 1 showing a significant depletion of the dunes since 2002. During Noel, waves transported the beach sand offshore exposing large boulders on shore (circle in b) and changing the sediment texture of the upper beach. A tidal channel was also cut through the barrier beach fronting Hirtles Pond (arrow, b). Note: Photo a was taken just downslope and a few metres east of b. The same houses are circle on each photo for reference.

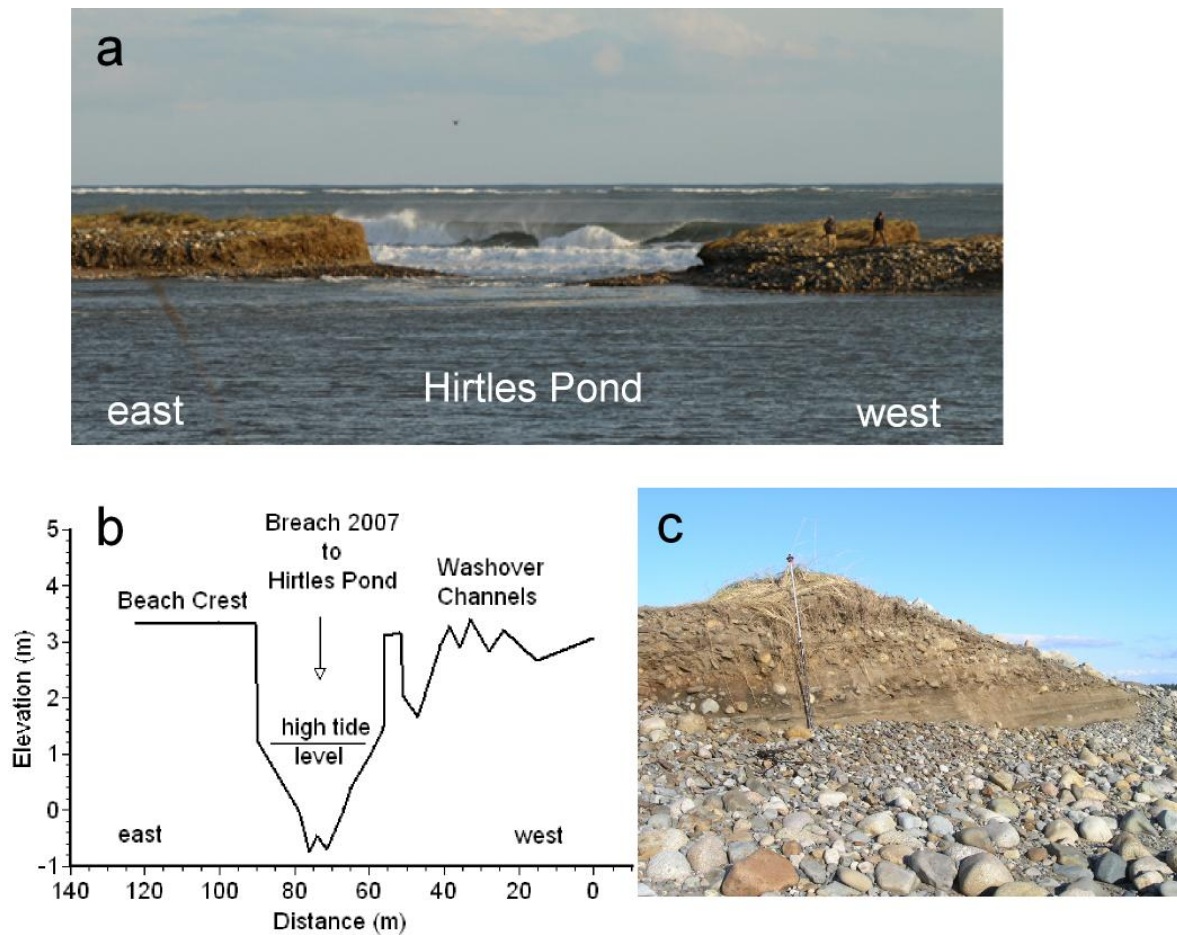
Figure 41. (a) View (Nov. 5, 2007) looking seaward across Hirtles Pond at the new tidal channel cut through the barrier beach during Noel (b) a cross-sectional profile of the channel surveyed on Nov. 8, 2007 and (c) a close-up of the barrier beach stratigraphy on the east side of the channel. Scale-the pole leaning against the bank is 2m long. (photos (a) D. Mercer; (c) PB080563, Nov. 8, 2007, R. Taylor).

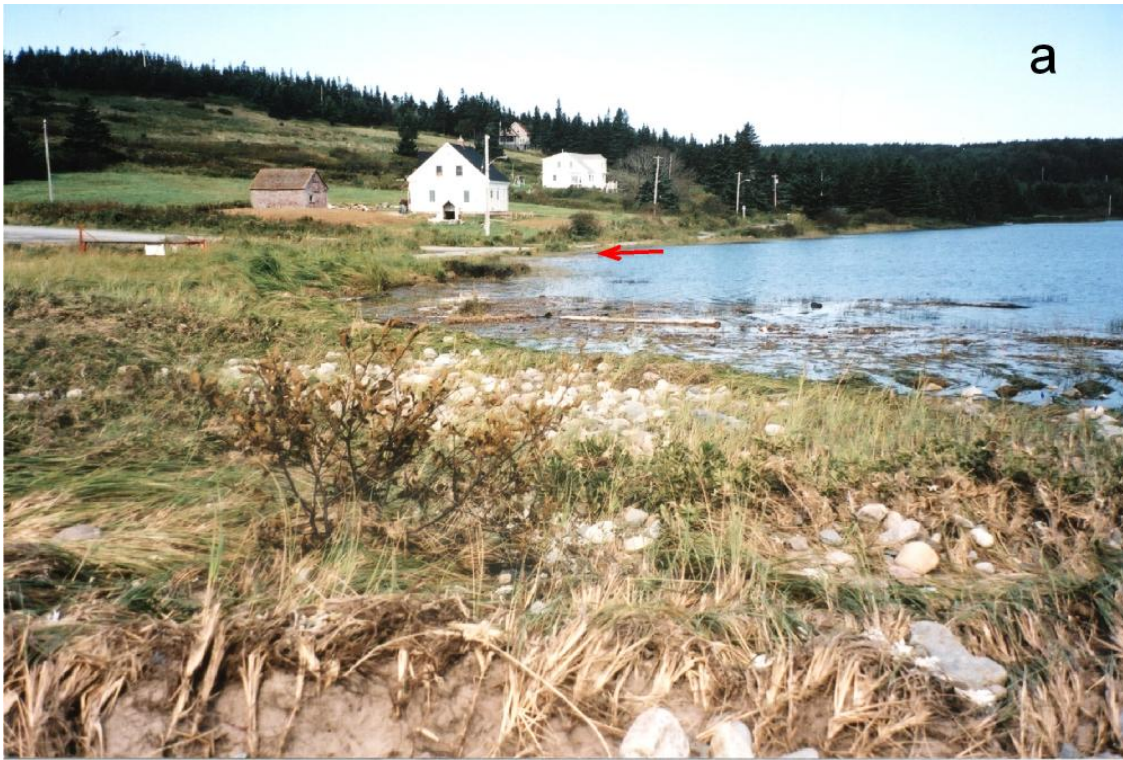
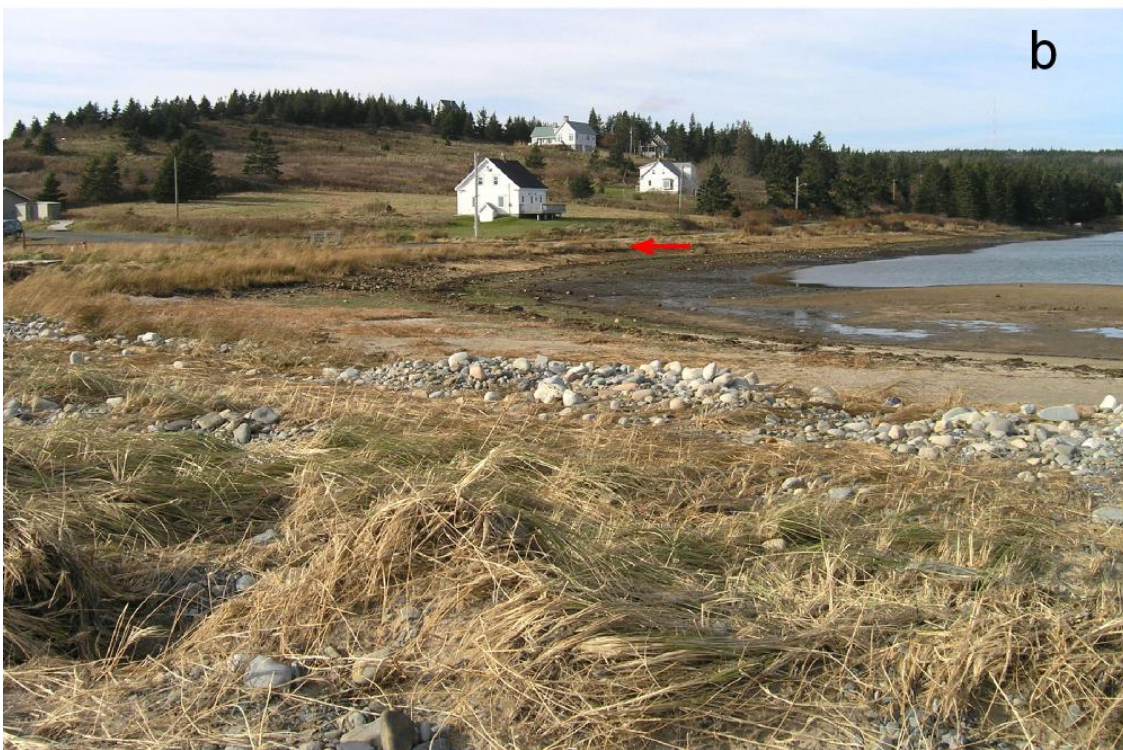
Figure 42. Comparison of water levels in Hirtles Pond (a) before and (b) after a channel was cut through the barrier beach to the pond during Post-tropical Storm Noel Nov. 4, 2007. Arrows in both photos mark the water level before drainage. Water levels are now tidal and the vertical difference in water level in the two photos is 1.1 m (photo 14-29-2003 by J. Comolli and PB140711 by R. Taylor).

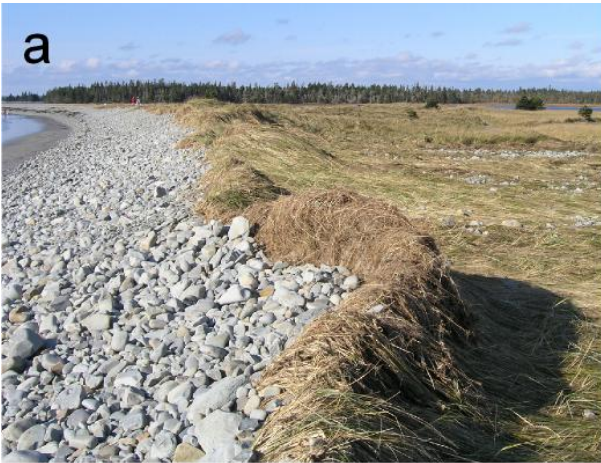
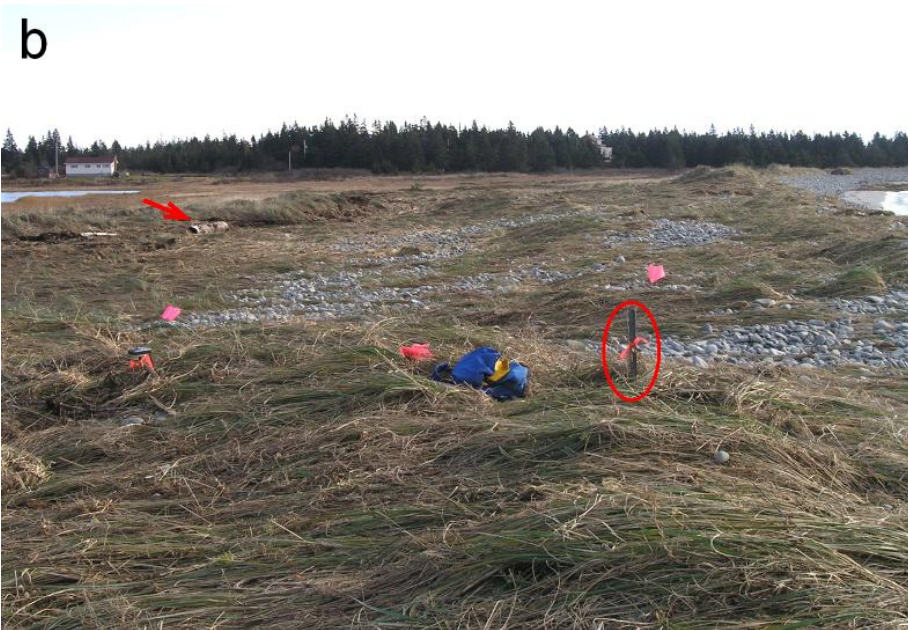
Figure 44. Waves from Noel (a) rolled back the seaward edge of the dune as cobble was pushed higher upslope and (b) transported flotsam and pebble cobble material as much as 75 m into the backshore as shown just east of cross-shore line 1 (marked by pink flags and t-bar circled) . (photos PB090615 and PB090607, Nov. 9, R. Taylor).

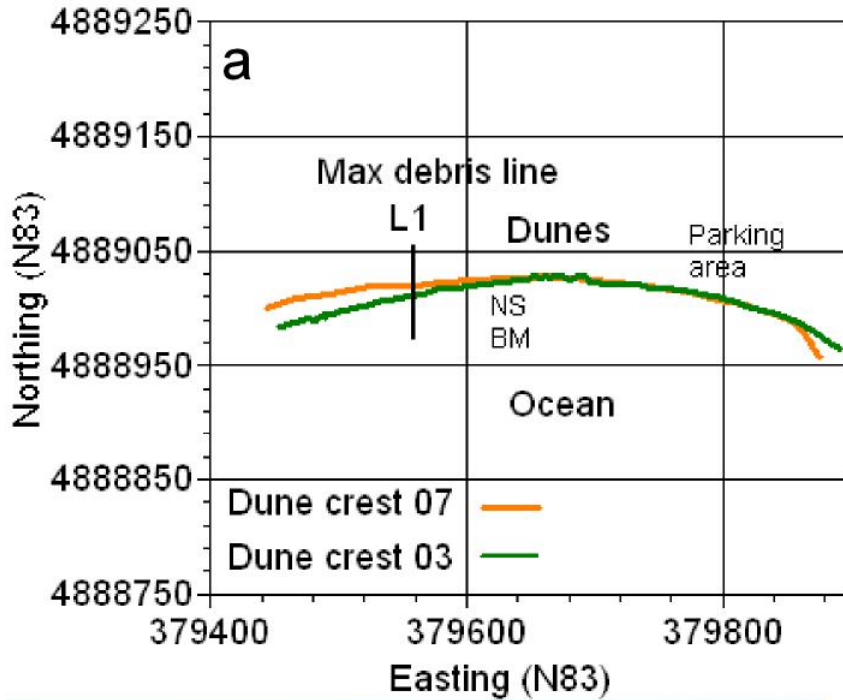
Figure 45. View and graphs of east end of Cherry Hill Beach showing changes to primary dune crest as a consequence of wave attack during Noel, Nov. 4, 2007. (a) positional changes in the dune crest since 2003 (following Hurricane Juan) and after Noel; largest landward migration was at the west end of the survey whereas at the east end beach ridges built seaward of the dune. (b) two channels cut through the dune at the main parking area. Location of parking area is shown on graphics a and c. (photo PB090612, Nov. 9, 2007, R. Taylor) and (c) longshore profile of dune crest showing the areas of greatest lowering and scouring and the small area that remained intact- To better understand this profile pretend you are standing offshore looking back at the beach looking at the highest part of the beach which consists of many low areas cut by waves.

Since our last longshore crest survey in 2003 the dune crest has migrated progressively farther landward toward the west. The maximum recorded retreat was 20.4 m landward at the western end of our 2007 survey where the dune was essentially erased being lowered by as much as 1.4 m and buried by pebble cobble. After Hurricane Juan the central part of Cherry Hill Beach was extensively overwashed and the lagoon shoreline was pushed farther landward. It is believed the lagoon shoreline was pushed farther landward during Noel particularly just east of Cooper Island where a lobe of sand nearly extends to the mainland. Furthermore and the zone of extensive wave overwash has been extended 140 m farther eastward approaching the position of our cross-shore survey line. Despite increased sediment deposition into the back lagoon the connection remains open back of Cooper Island between the east and west lagoons.

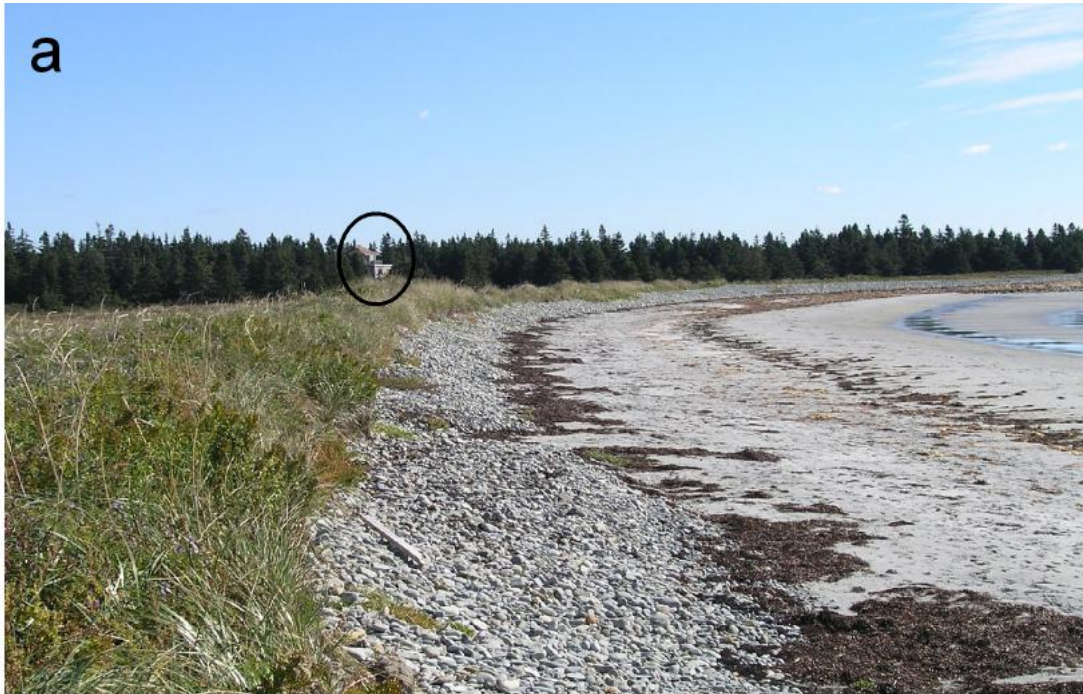
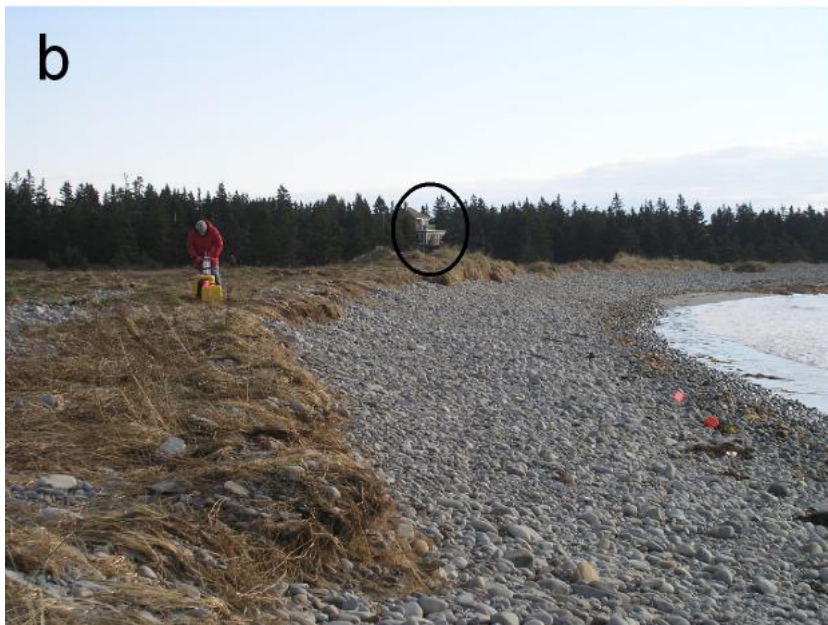
Figure 46. Views looking east of cross-shore survey line 1 (a) on October 7, 2007 just before Noel and (b) on Nov 9, 2007 just after Noel (photos PA070160 and PB090599, R. Taylor).

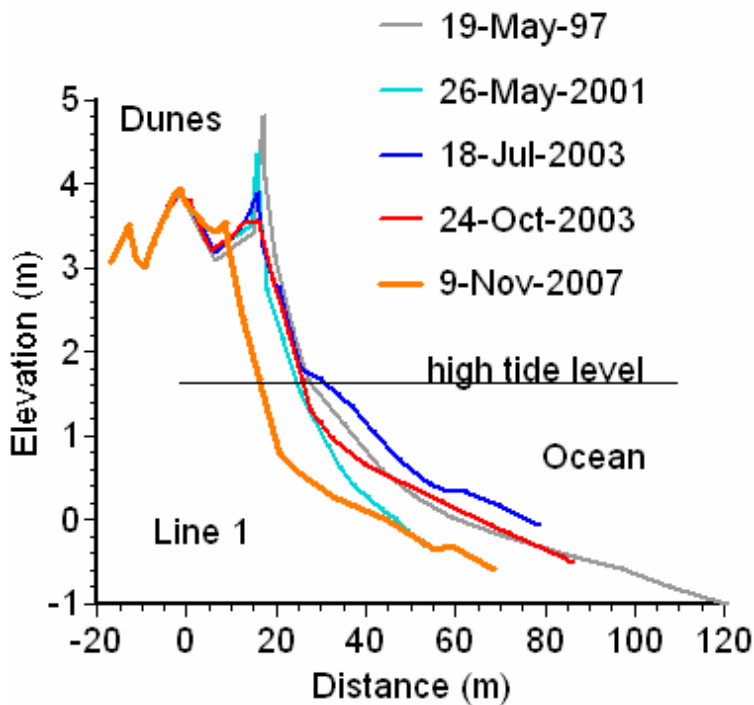
Figure 47. Repetitive surveys of line 1 showing nearly 10 m of landward retreat at high tide level since 1997. Since 1997 the primary dune was lowered in elevation by 1.3 m and it retreated by 8.5 m (Table 3). Photos of Line 1 before and after Noel are shown in Figure 46.

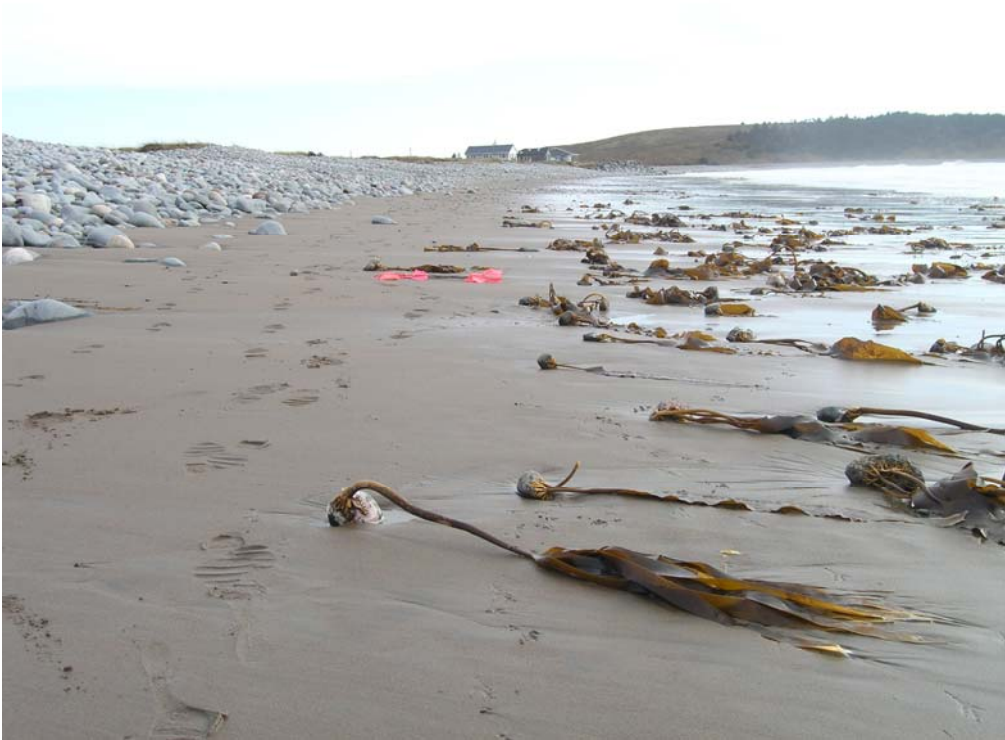
Figure 48. View of seaweed and cobble holdfasts carried onshore at the east end of Lawrencetown Beach after Post-tropical Storm Noel. It is a mechanism of transporting larger clasts onshore from offshore. Piles of seaweed accumulated alongshore also provided temporary protection for the beach against further wave attack (photo PB060423, R. Taylor).

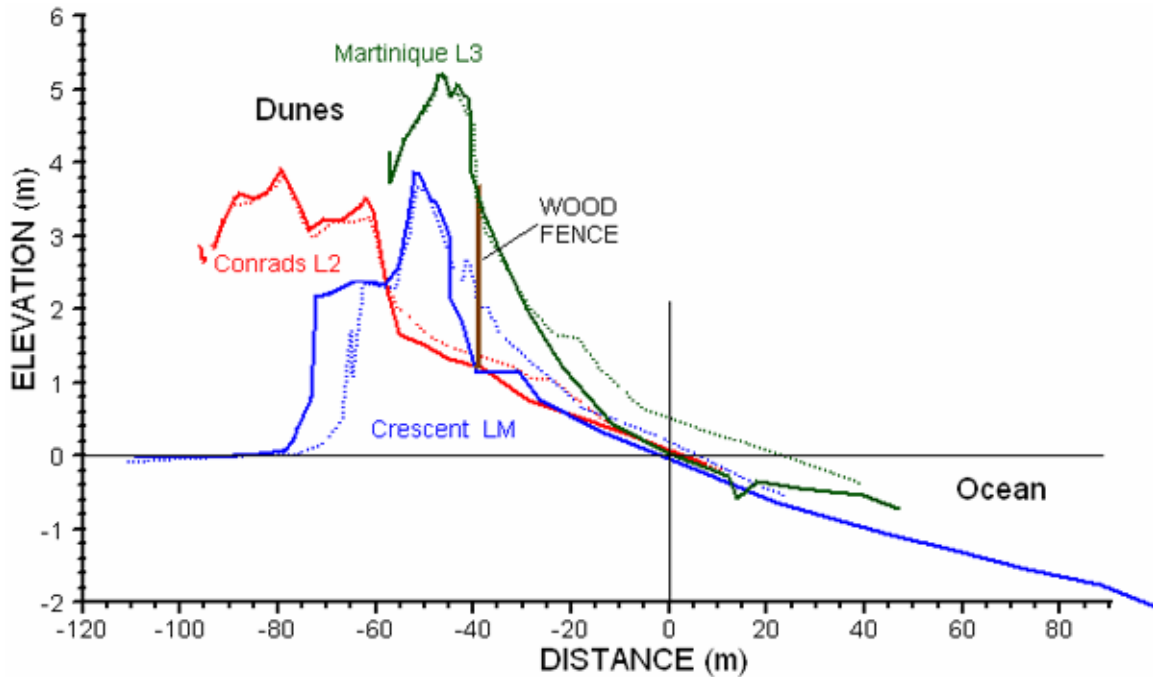
Figure 49. Cross shore profiles of sand dunes at Crescent, Conrads and Martinique beaches aligned where the beach slope intersects 0.0 m elevation in Nov. 2007. The zone of net beach erosion from two to three years ago (dash line) until after Noel (solid line) is shown for each beach. The position of the sand fence on Crescent Beach is also plotted.

Why were the dunes of Crescent Beach, Lunenburg County more severely scoured and damaged than at Conrads and Martinique beaches?

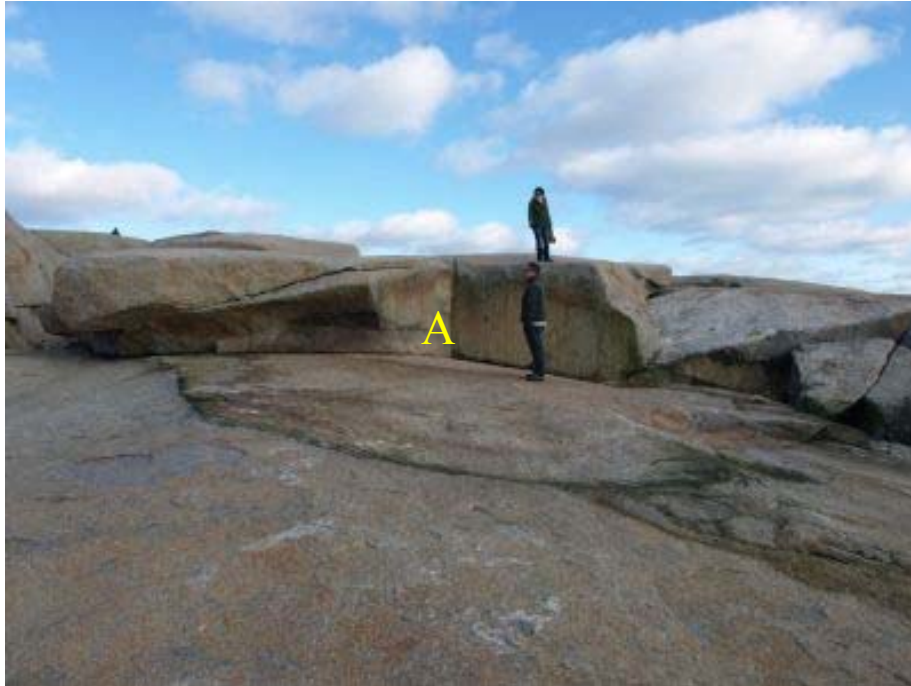
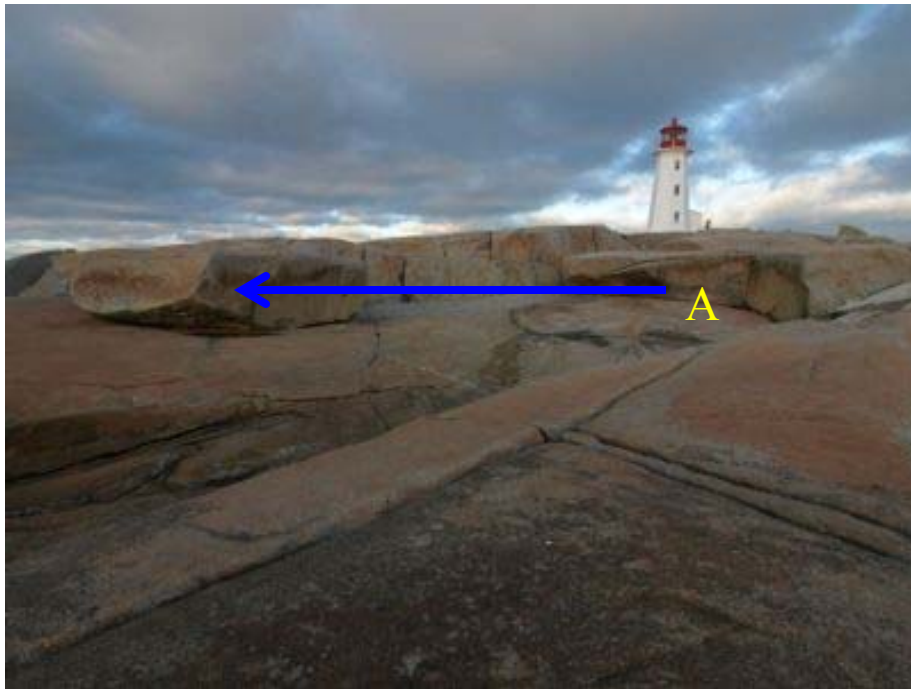
Figure 3-1: The top image shows the footprint of the original location of the rock, labeled by A, with people for scale. The lower image shows the rock about 15 metres to the left of its origin. The rock is estimated to be 150 tonnes.

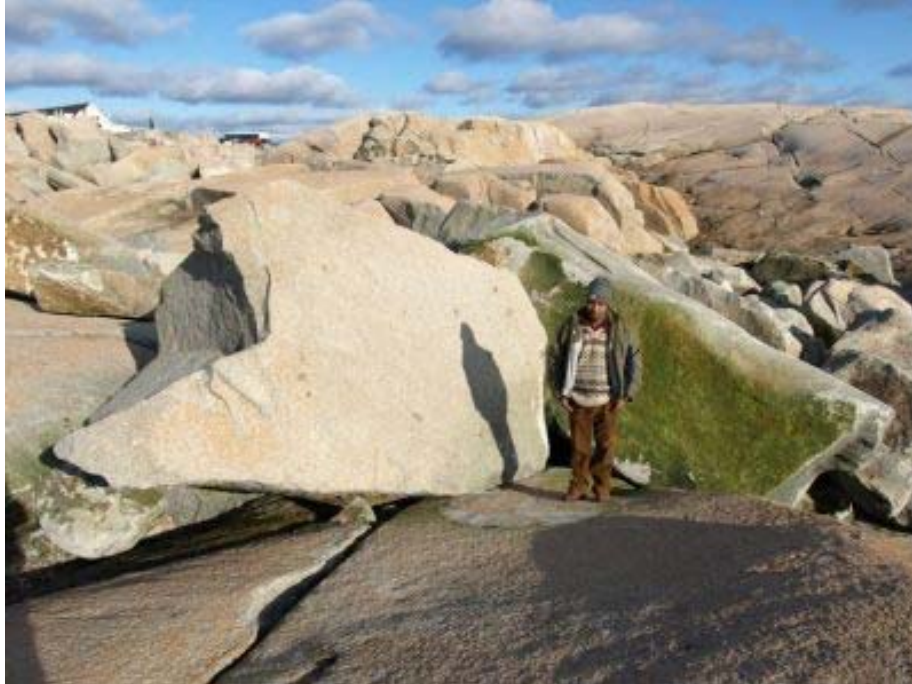
Figure 3-2: The rock on the right of the person is flipped, the one on the left has been broken on the left side. The location is 4 metres above sea level, and the person is 1.65 metres (5ft, 5in) tall.

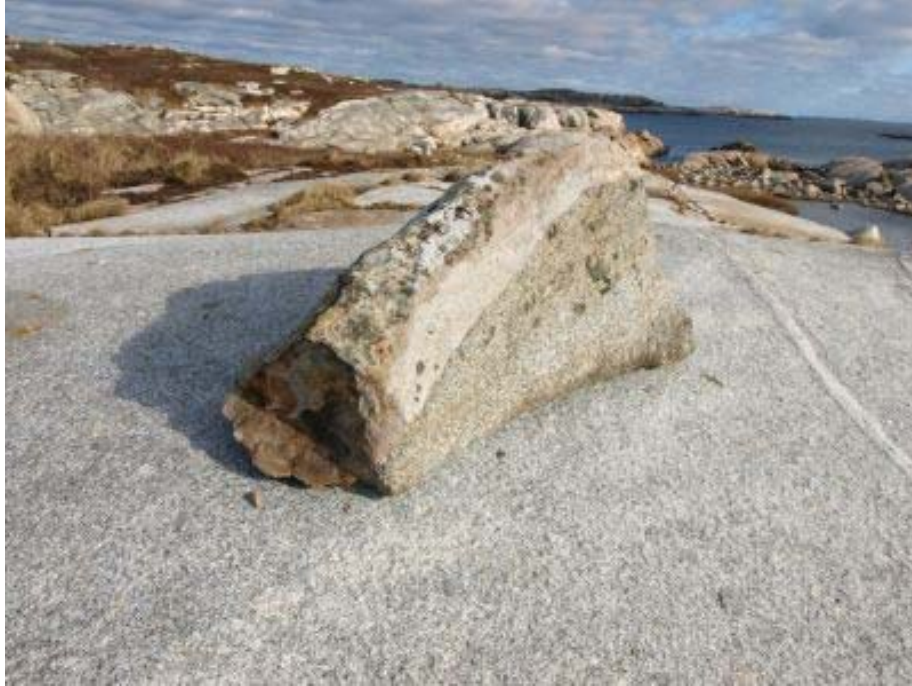
Figure 3-3: This rock was broken and swept upslope from the south valley to about 8 metres above sea level.

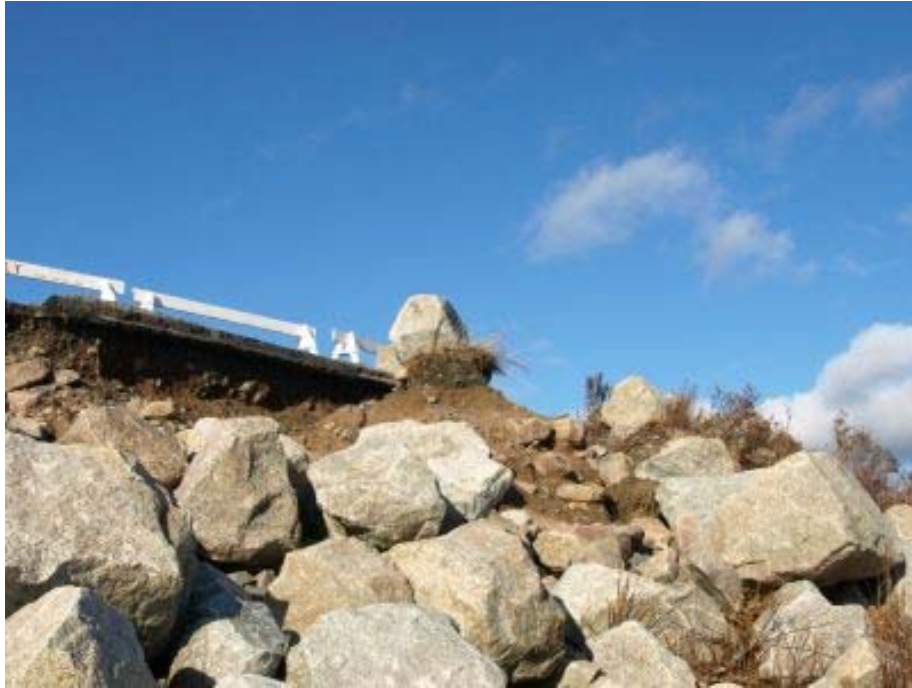
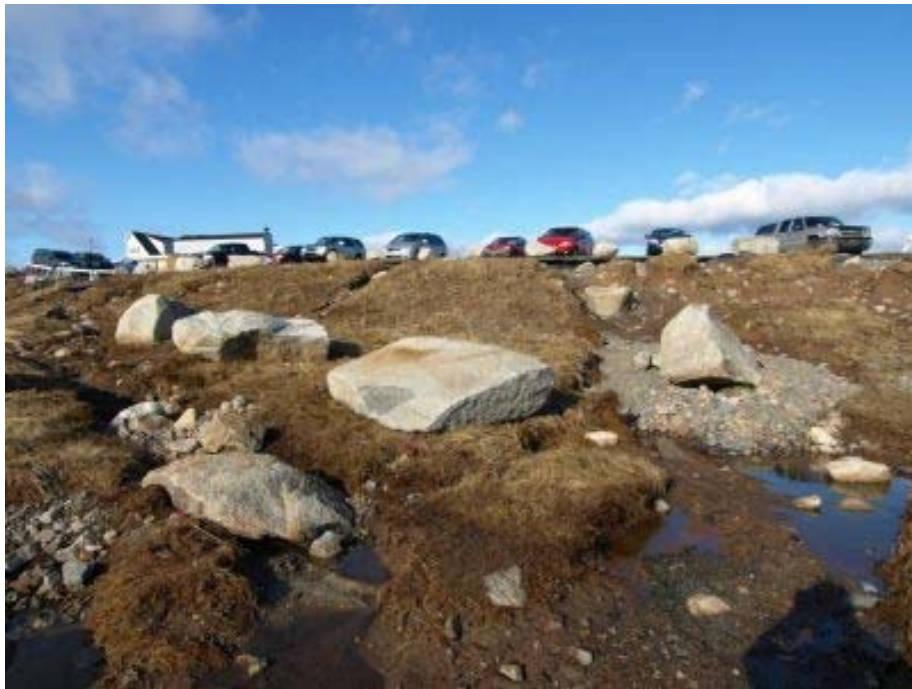
Figure 3-4: (Top) Erosion around east side of restaurant parking lot. (Bottom) All the large rocks shown were moved, some on top of paths.
