**GEOLOGICAL SURVEY OF CANADA
OPEN FILE 5802**

Impacts of Post-tropical Storm Noel (November, 2007) on the Atlantic Coastline of Nova Scotia

Observations of coastal infrastructure and detailed surveys of physical changes at eight beaches document the impacts of Post-tropical Storm Noel that struck the Atlantic coast of Nova Scotia on November 3-4, 2007. The surveys were part of an ongoing investigation of the impacts of major storms on different shore types and their rate of recovery. In addition, flood water levels and wave run-up extent were documented to better define shores vulnerable to these coastal hazards.

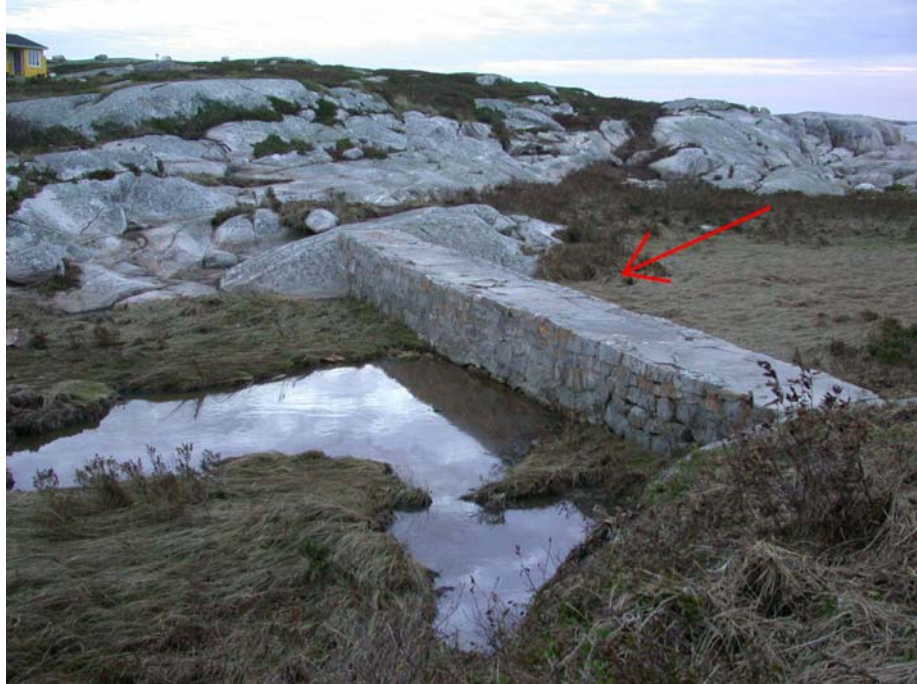
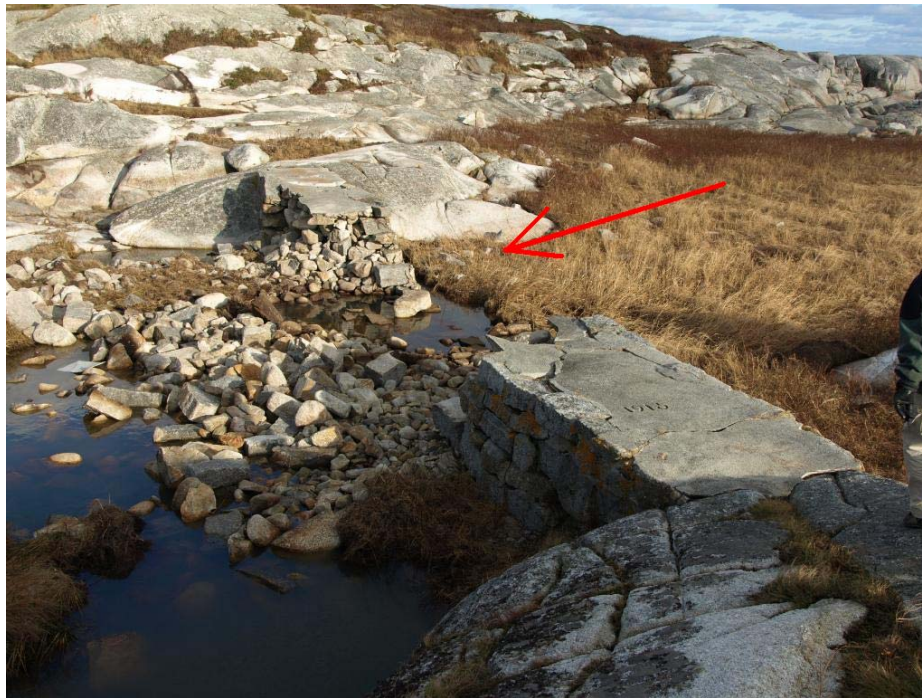
Figure 3-5: (Top) Breakwater (arrow) after Juan, with no significant damage. (Bottom) After Noel, with about half of it totally destroyed. The breakwater was built over 100 metres from the ocean and has remained undamaged for 92 years.

- **Northern valley,**
 - There is a stone breakwater/dam at the highest point of a valley (see figure 3-5). which drains west into the harbour and east into the ocean. The breakwater was designed to protect the inner village from flooding during major storms. It has been there since 1915, and has never been damaged in living memory.

- The breakwater was breached during Noel (Figure 3-5). After hours of steady pounding, it broke at about 3 am. A continuous flow of water up to 2 feet deep flowed over the harbour road.
