# HISTORICAL CHANGES IN COW BAY BEACH, HALIFAX REGIONAL MUNICIPALITY, NOVA SCOTIA

R.B. Taylor, D. Frobel and E. Patton

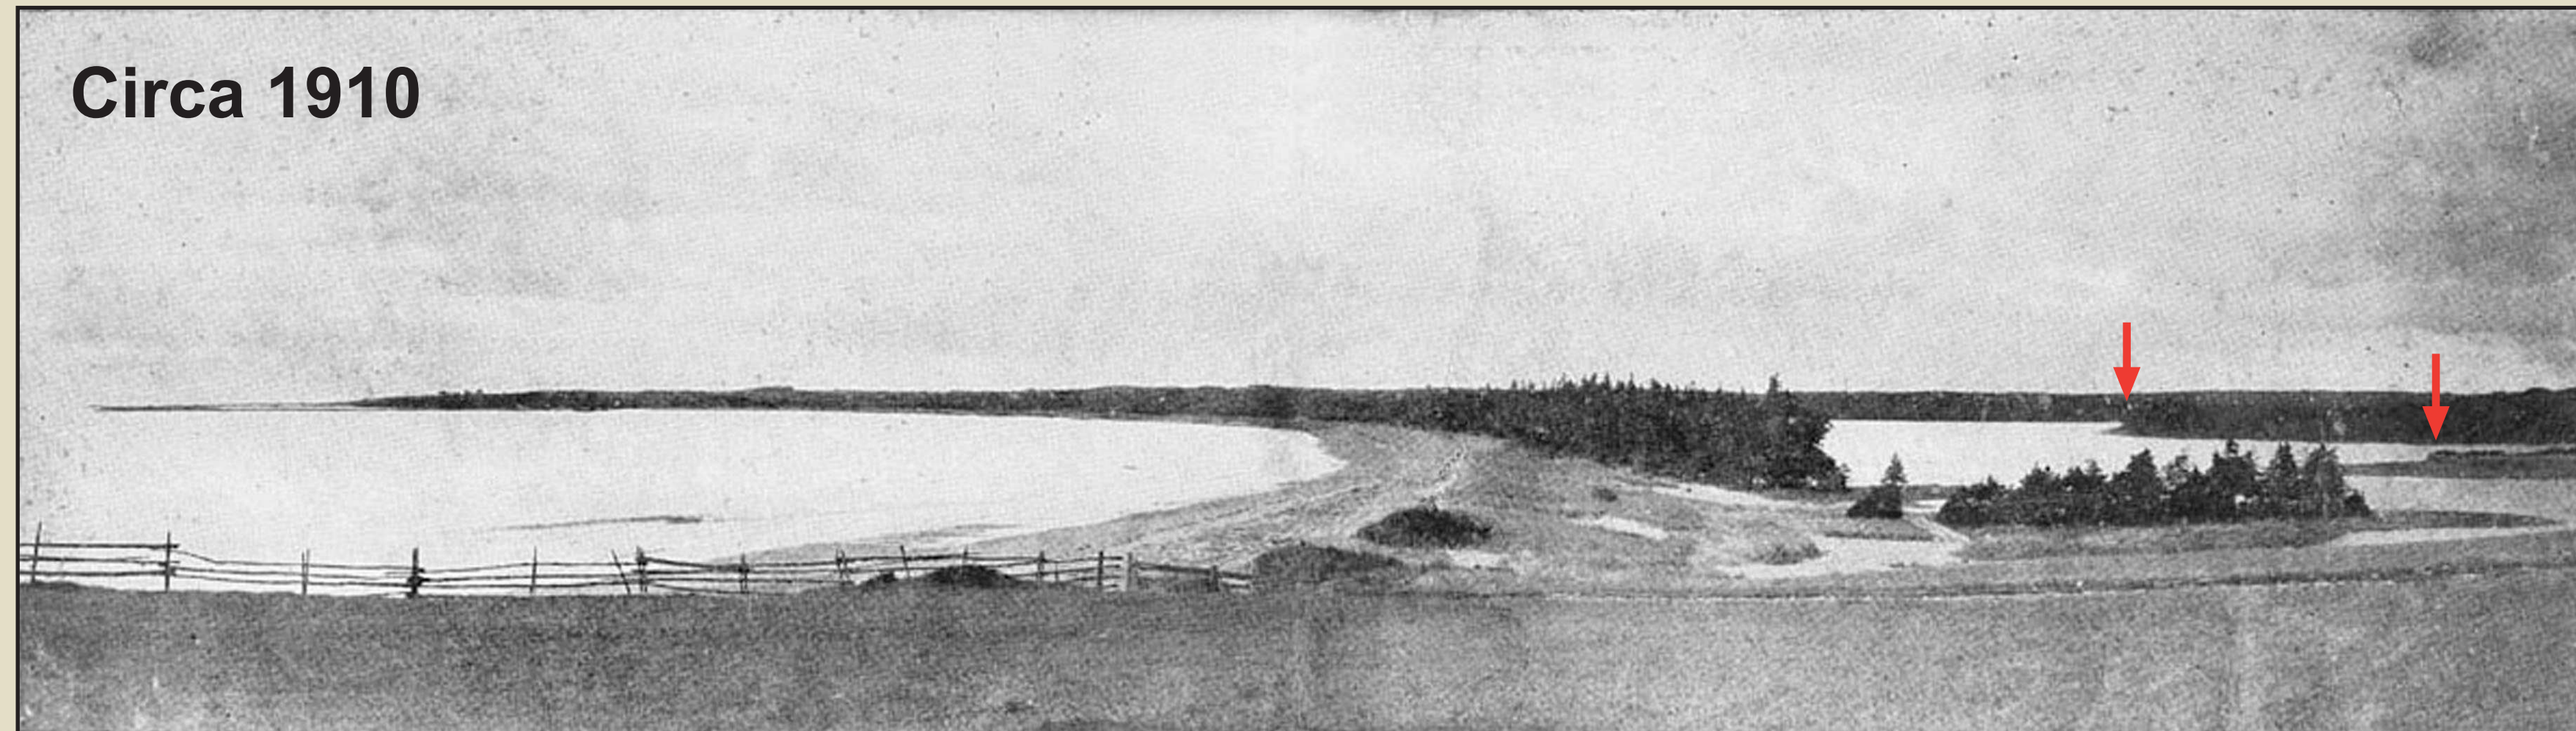
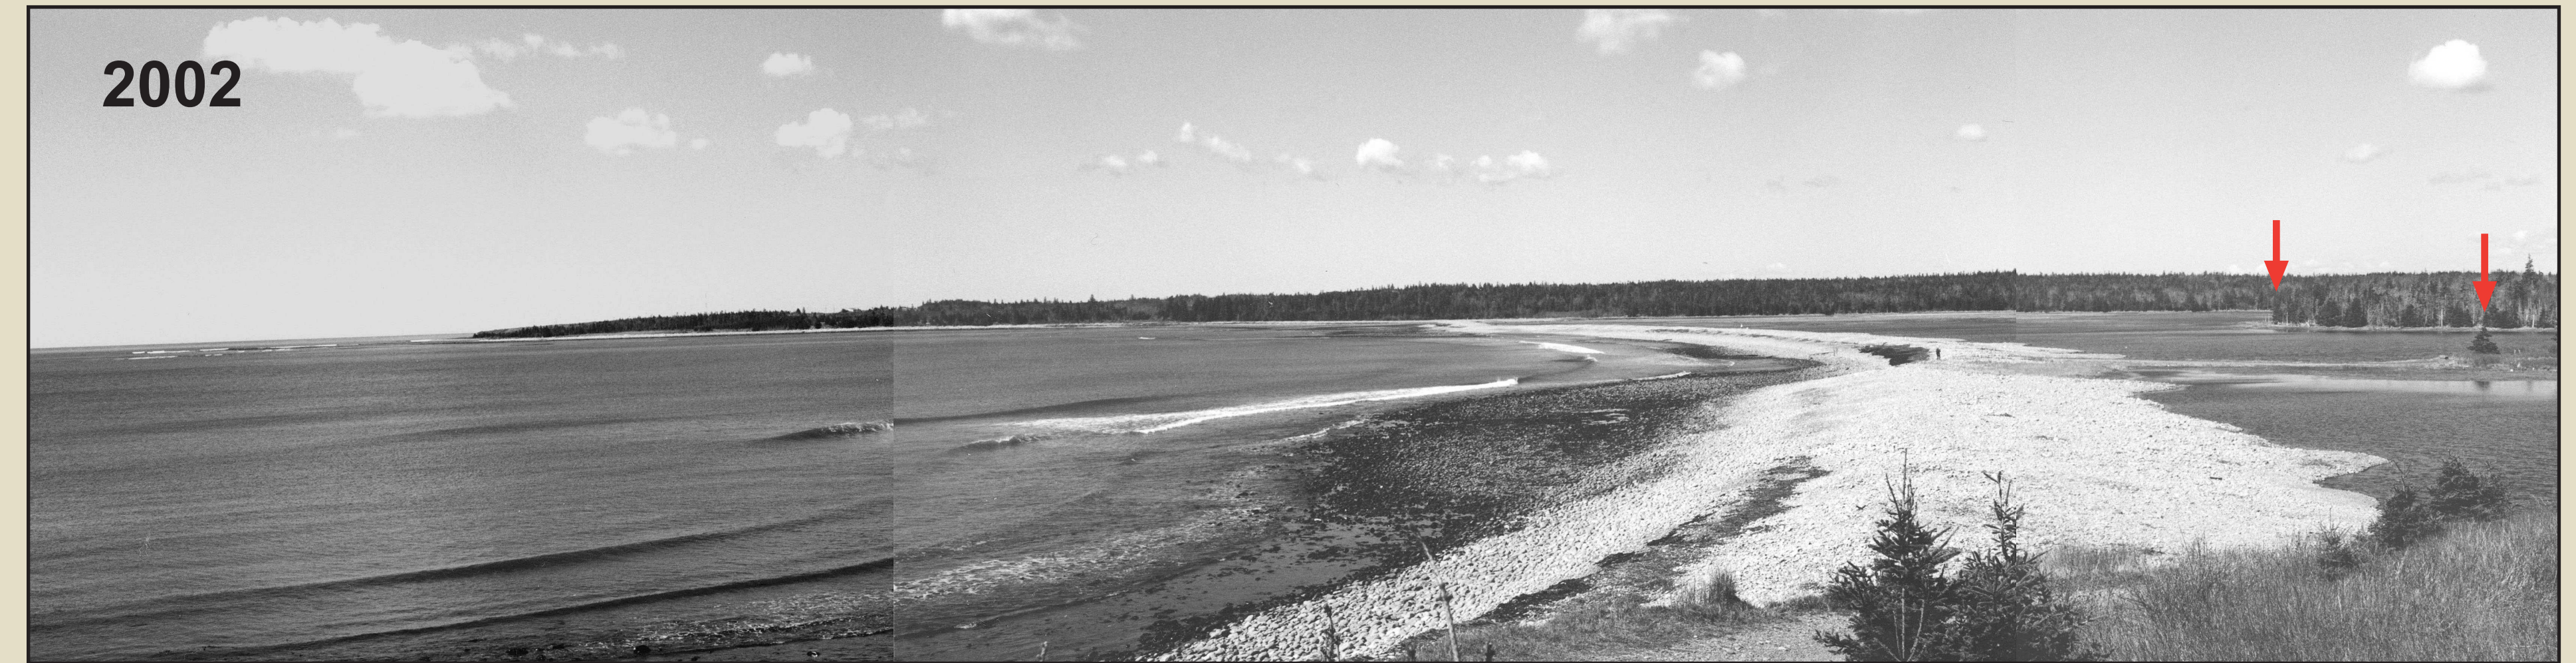
Views of Cow Bay Beach from its east end circa 1910 and 2002 showing dramatic changes in its size and forest cover. For visual reference, arrows mark the same locations in both photos.

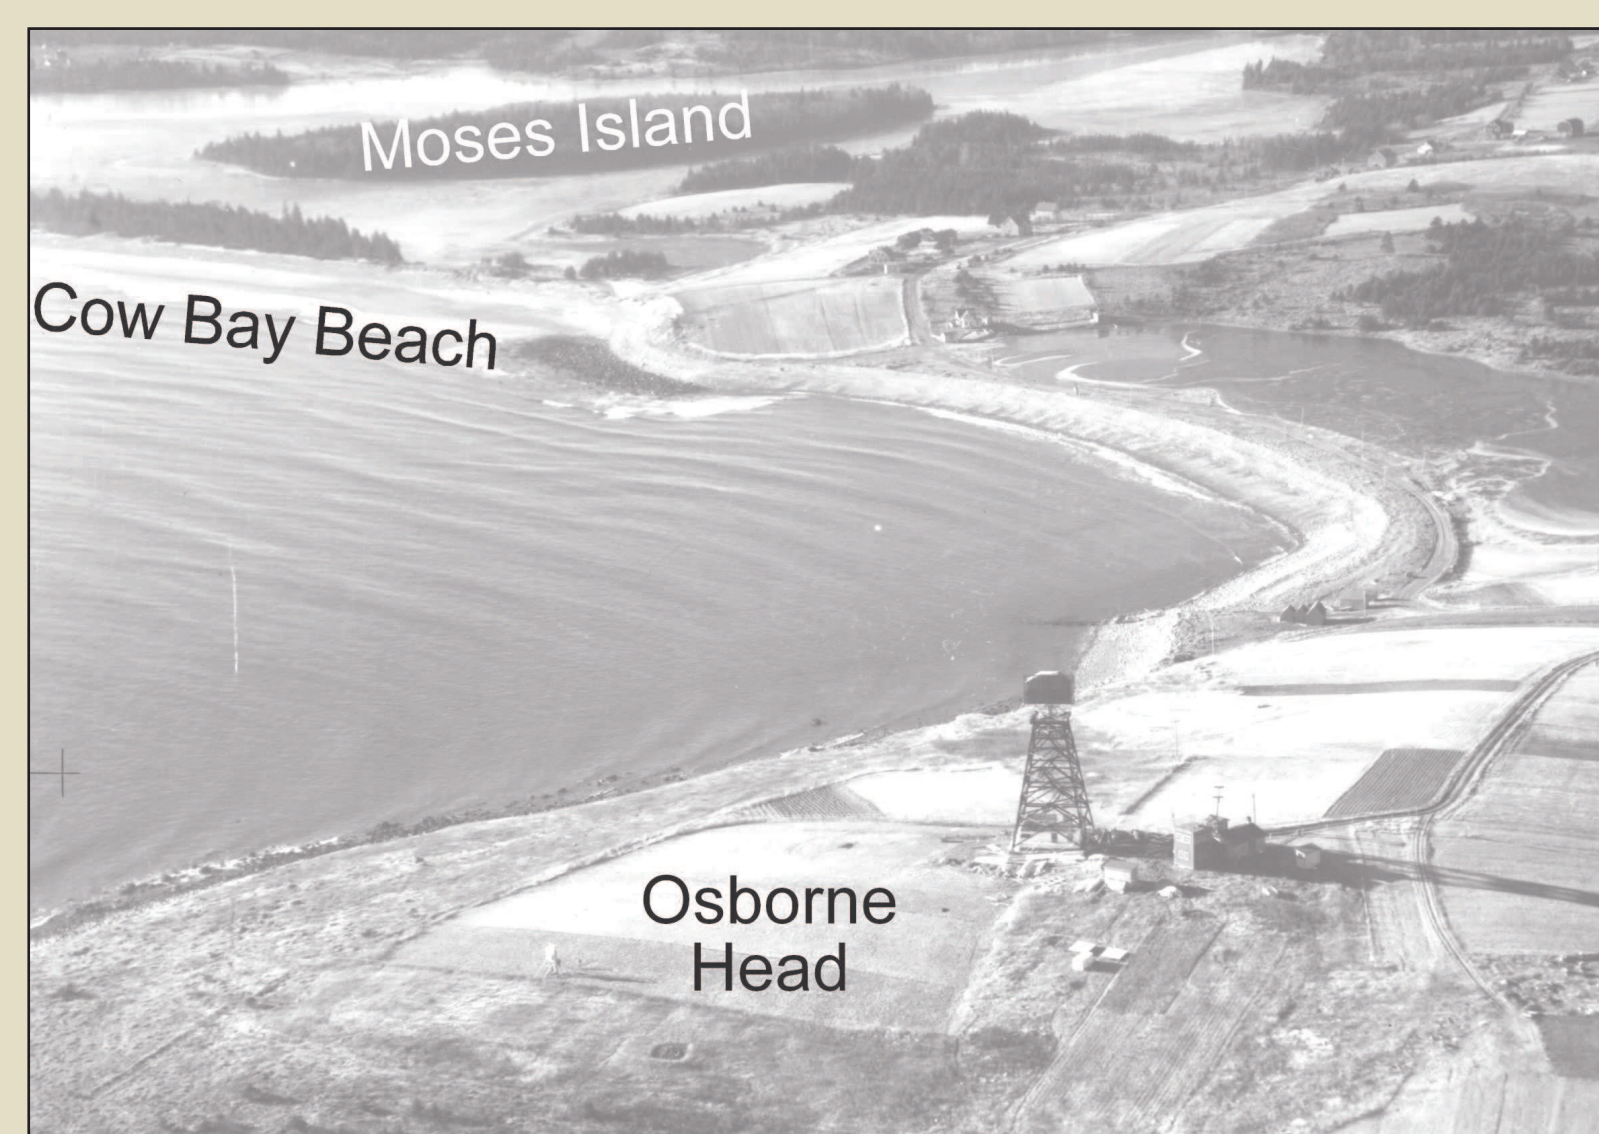
## AERIAL VIEW, OSBORNE HEAD AND COW BAY BEACH 1941

Aerial view shows the extensive woods that still existed on Cow Bay Beach, including those seaward of the pond at the east end of the beach. (photo REA 251-450, courtesy of DND)

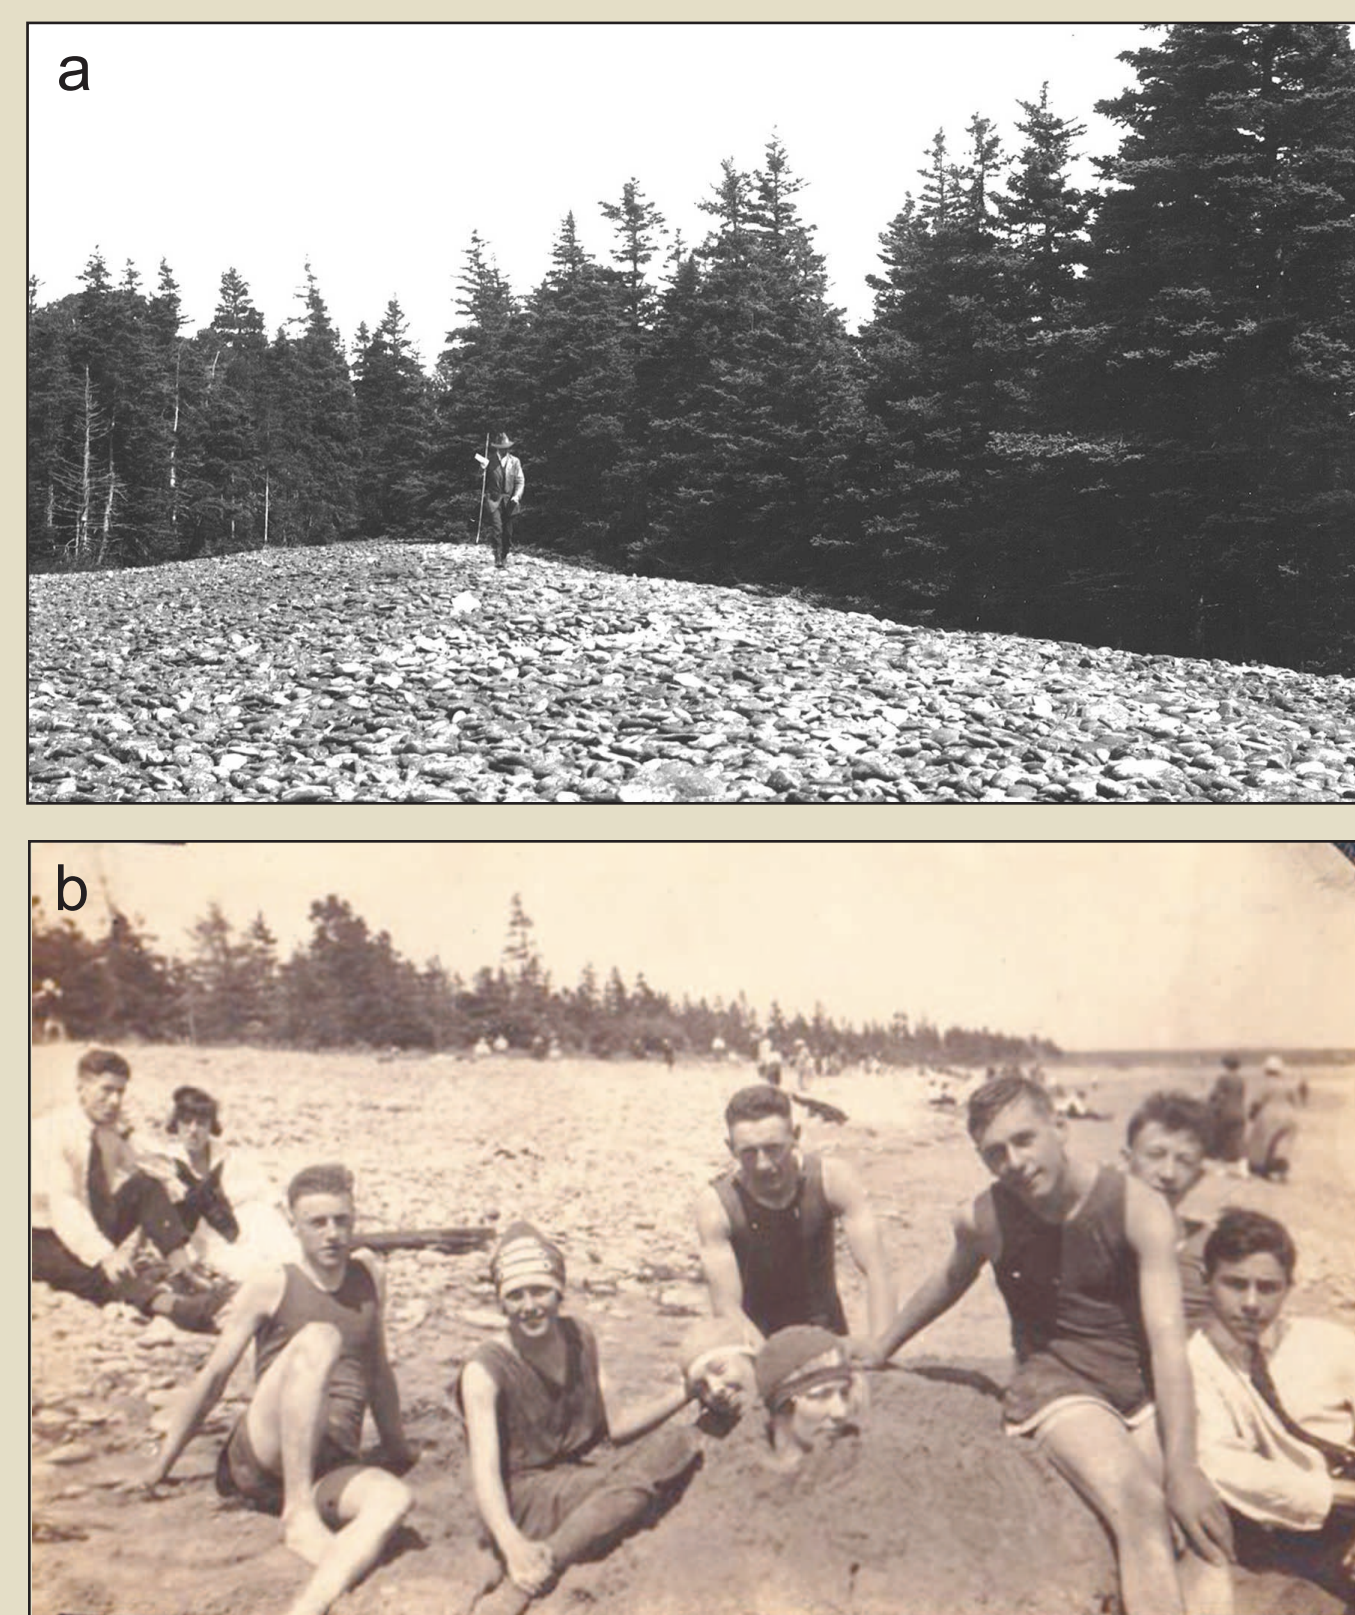
Views looking east: (a) in 1914 of the high cobble beach ridge along eastern Cow Bay Beach and (b) in the 1920s showing the same ridge from the ocean side. (photos courtesy of: (a) J.W. Goldthwait, from GSC Archives, Ottawa; (b, c) Marie (Porter) Curran and (d) G. Stockley & Mosher family, Cow Bay, N.S.)

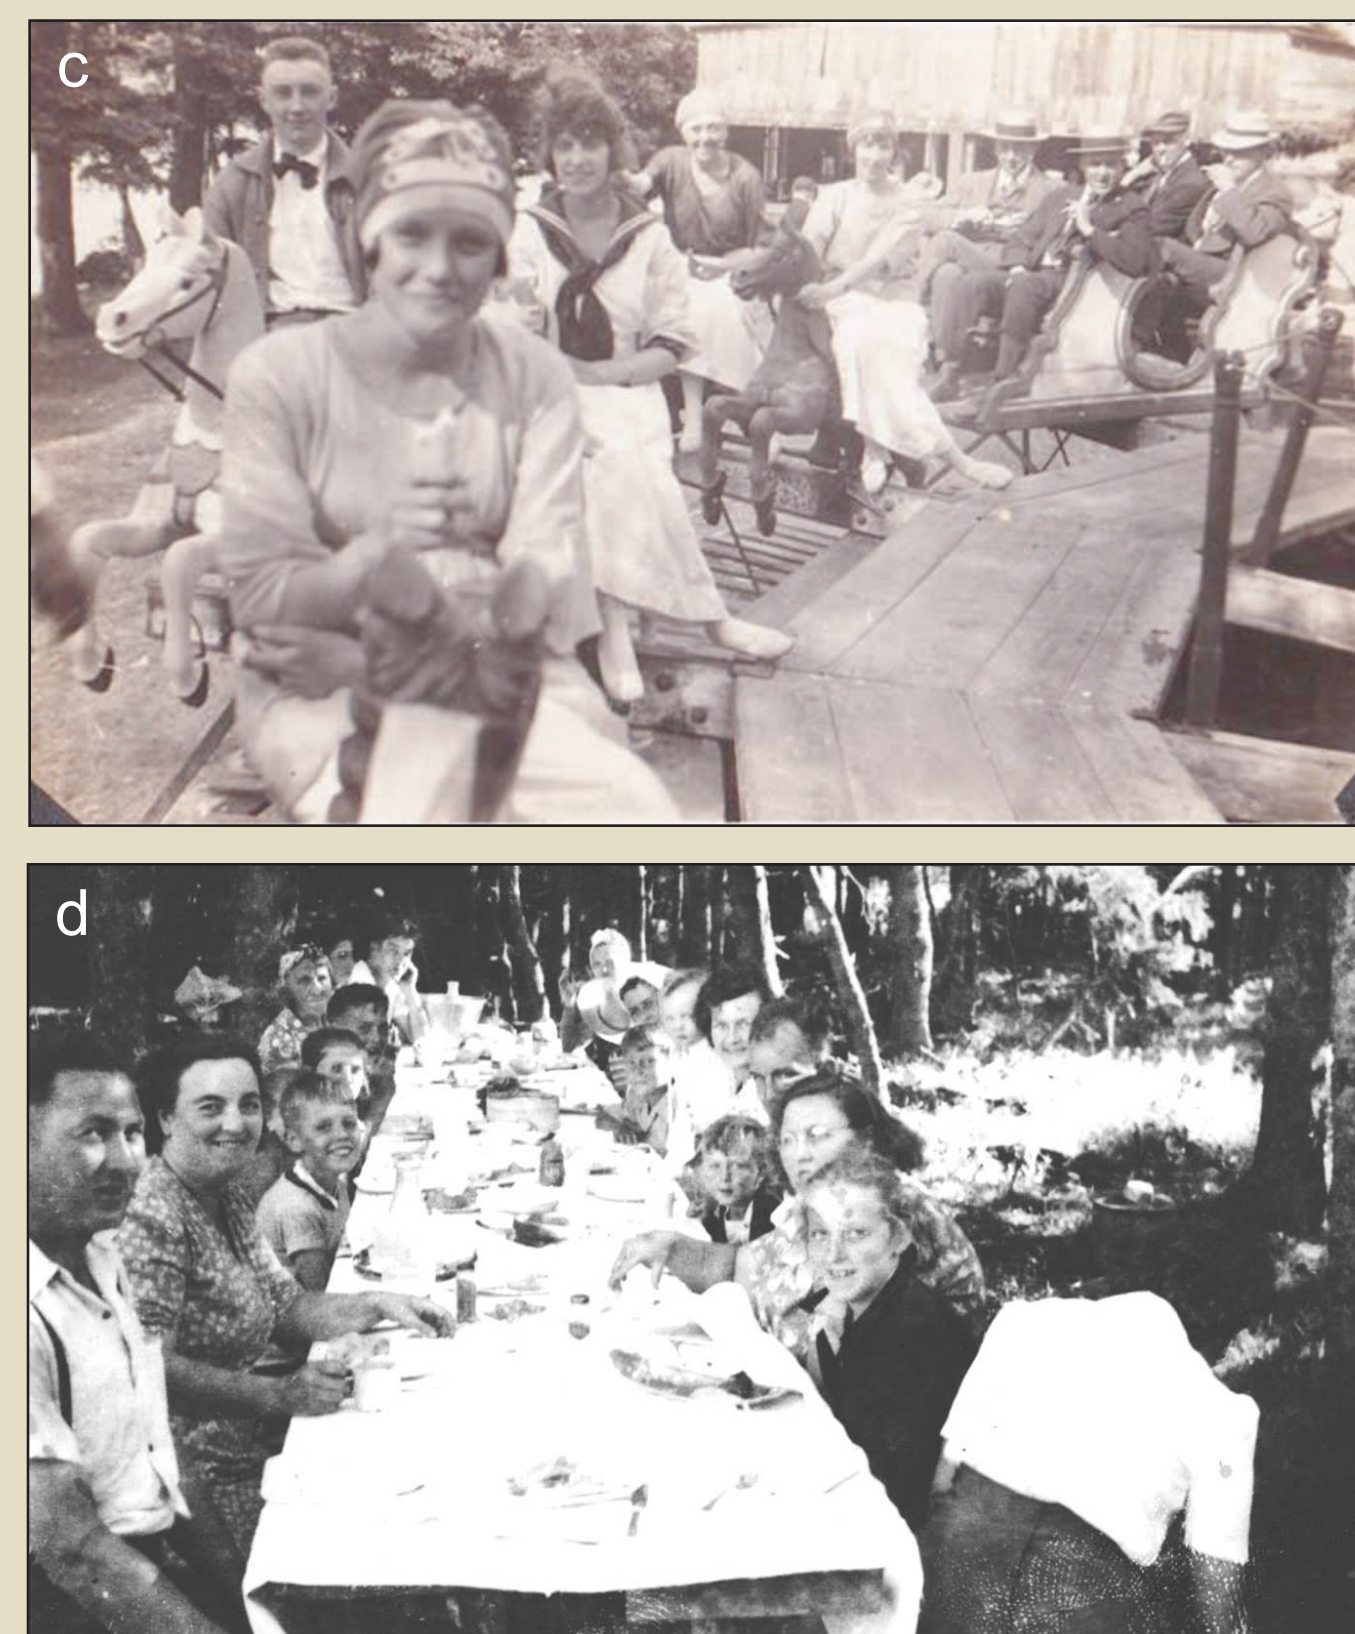
Trees provided shelter from the winds and an ideal location for a merry-go-round in the 1920s, and for family and company picnics in the 1950s.

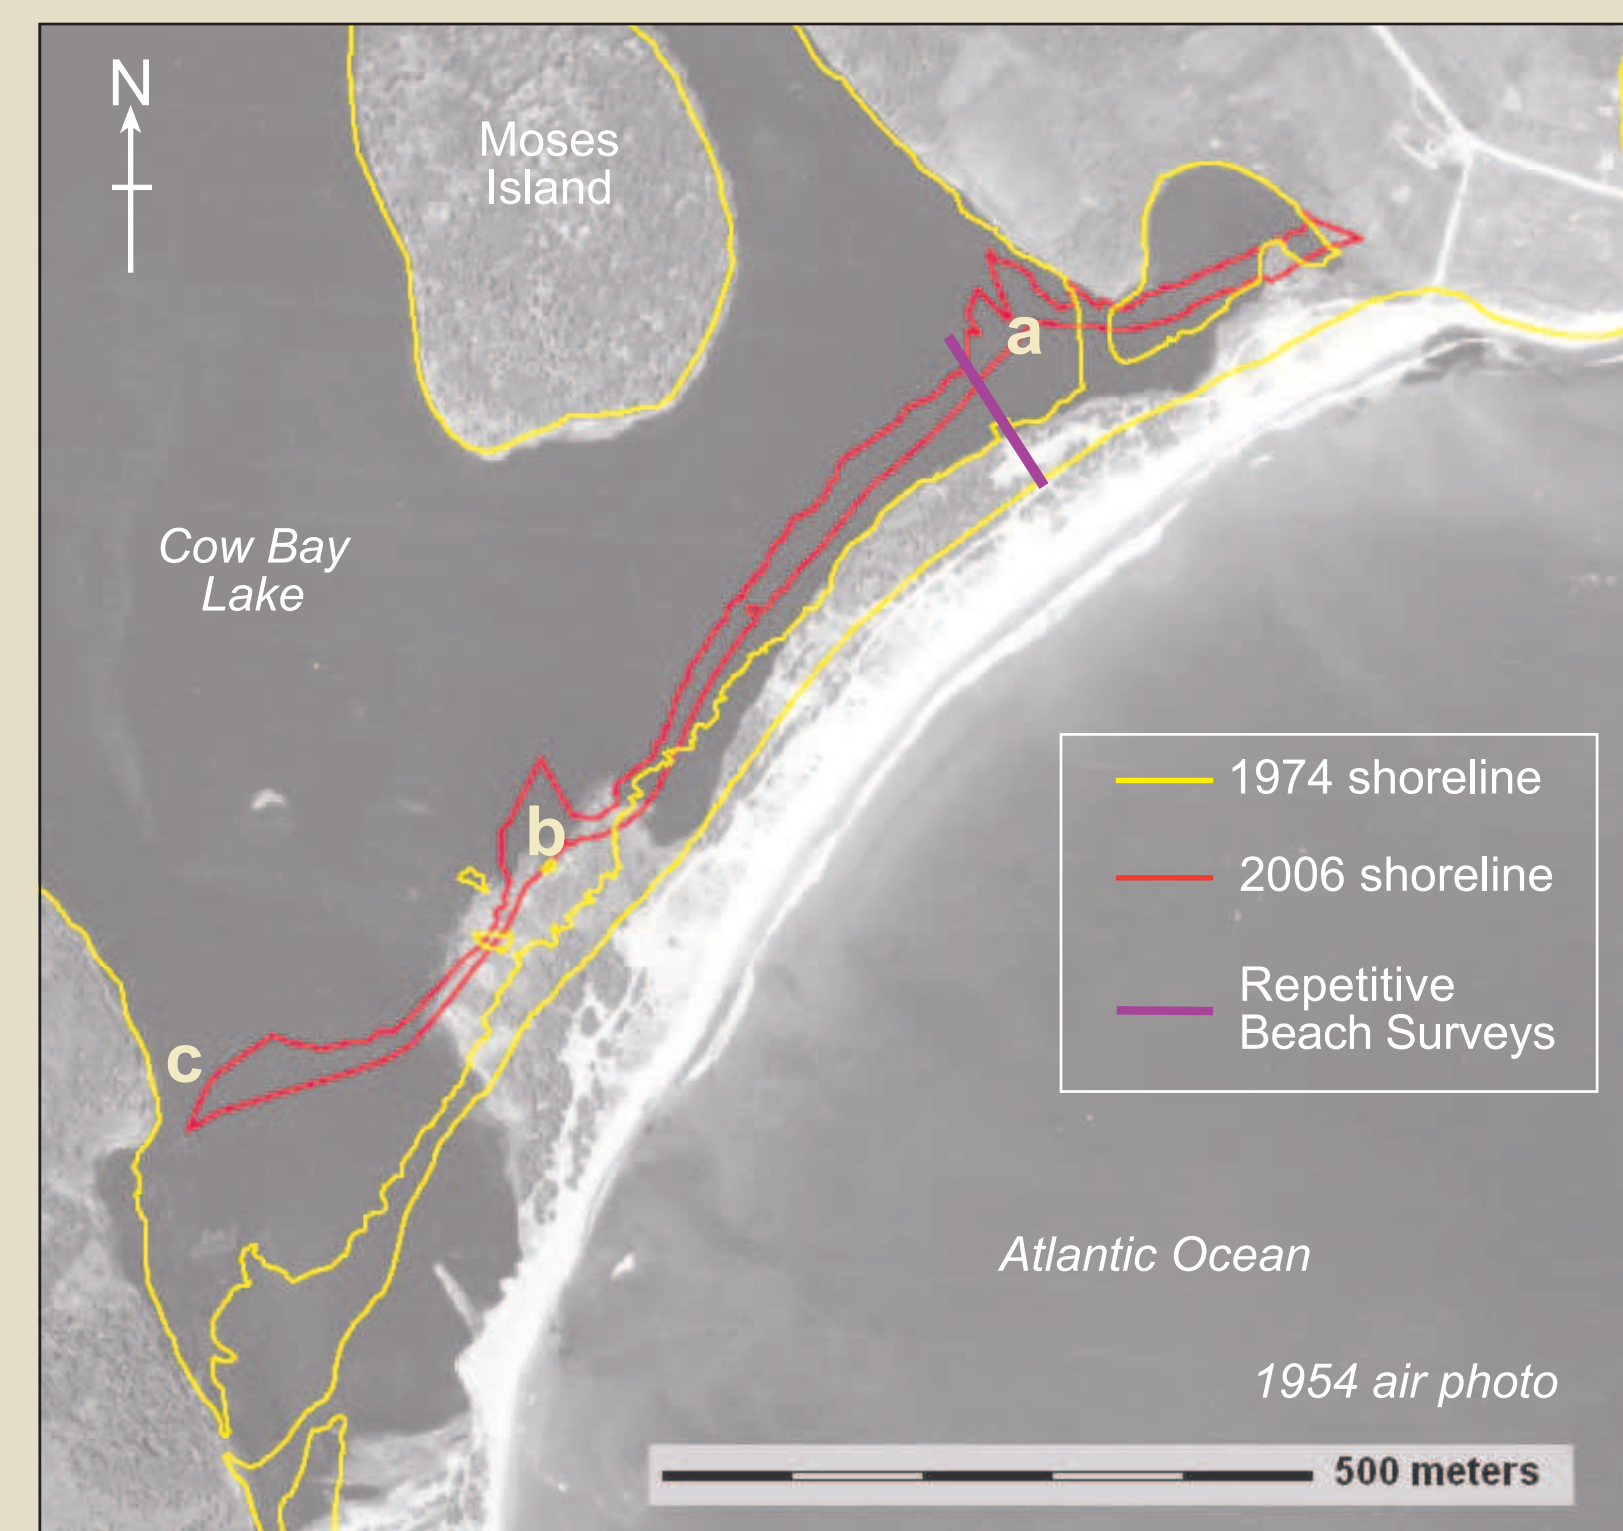
## BEACH CHANGES 1954 TO 2006

Vertical air photos of Cow Bay Beach were georeferenced and overlain to show the reduction in its size and landward migration between: 1954 (air photo), 1974 (yellow lines), three years after sediment excavation had stopped, and in 2006 (red lines). Between 1954 and 2006, the central beach (between a & b) was reduced from 200 m to less than 30 m wide and its seaward edge had migrated nearly 170 m landward. By 2003, the beach was cut into three segments by two wave washover channels (a,b) and an inlet (c) at the west end of the beach.

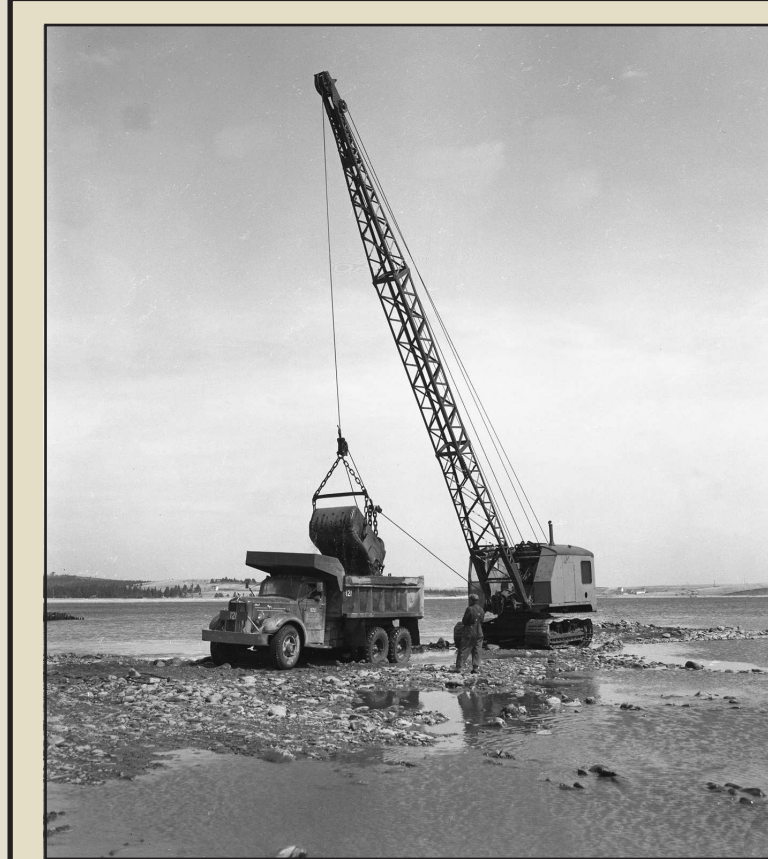
In April 1957 power shovels, drag cranes and large trucks removed more than a million tons of sand and gravel. Excavation began at the west end of the beach (shown here) and continued eastward.

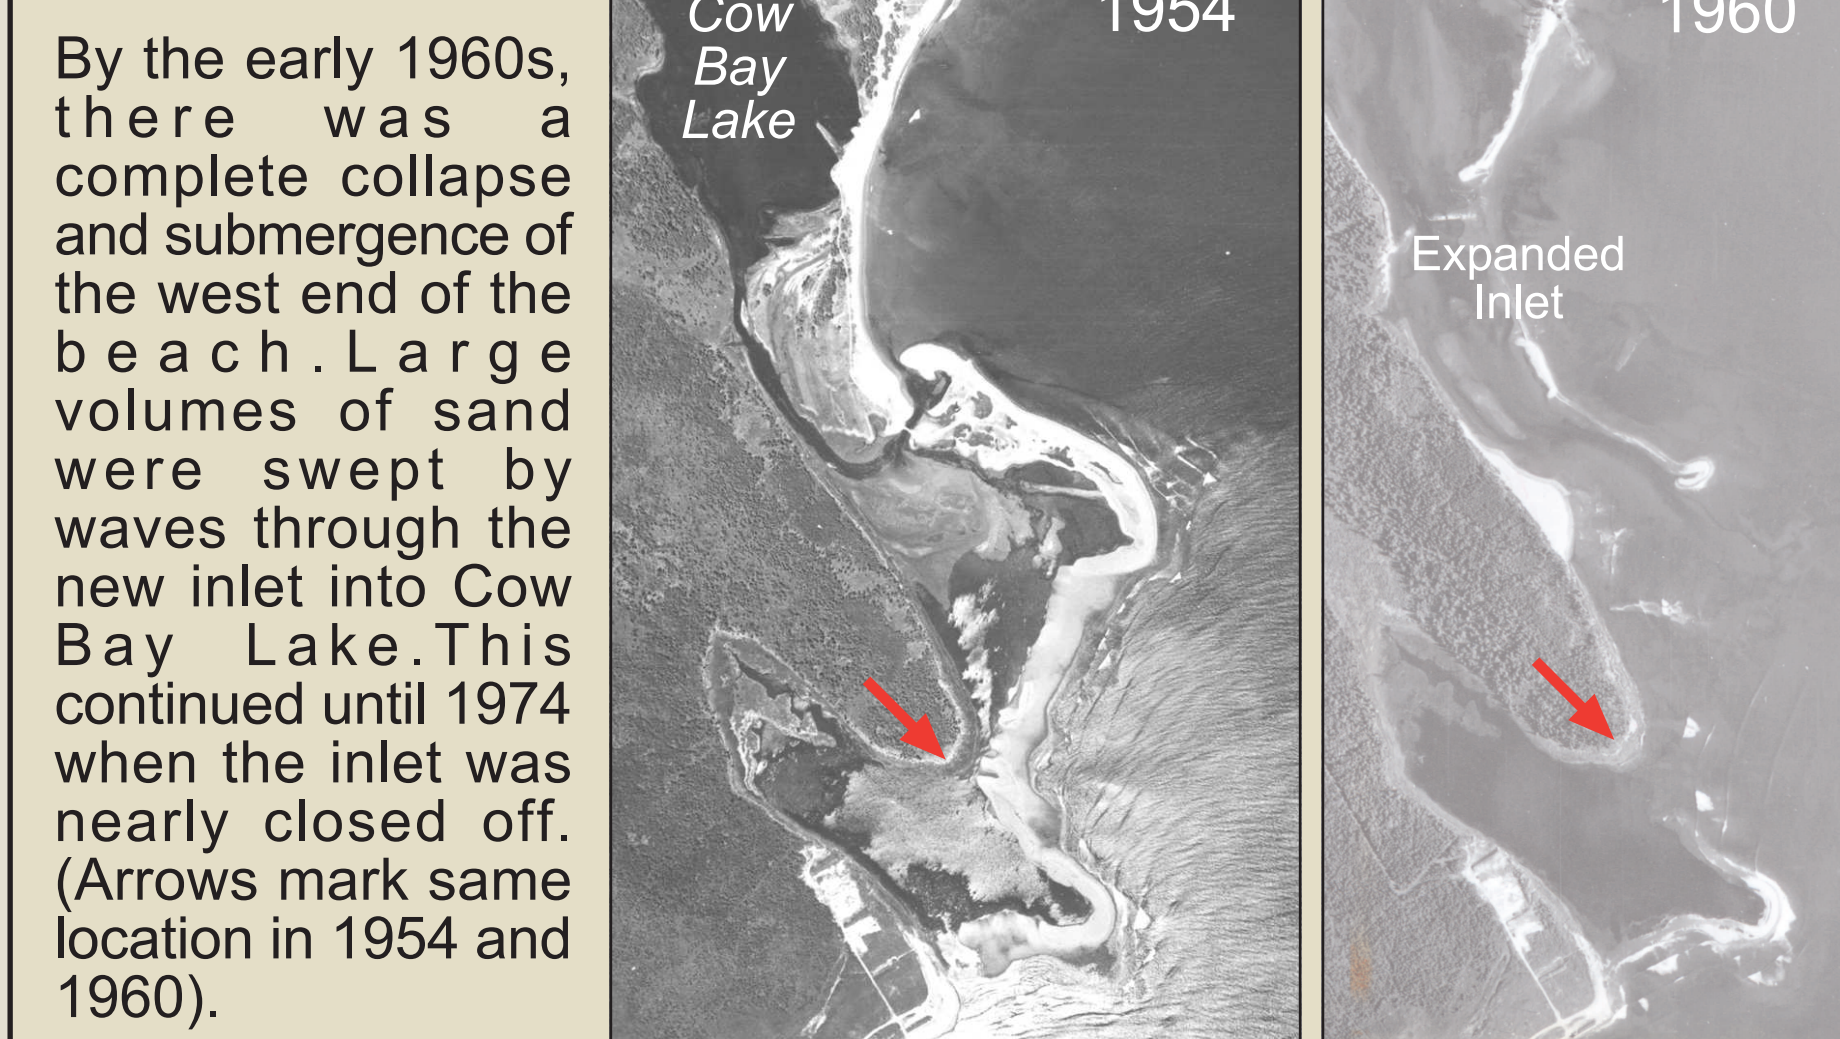
By the early 1960s, there was a complete collapse and submergence of the west end of the beach. Large volumes of sand were swept by waves through the new inlet into Cow Bay Lake. This continued until 1974 when the inlet was nearly closed off. (Arrows mark same location in 1954 and 1960).

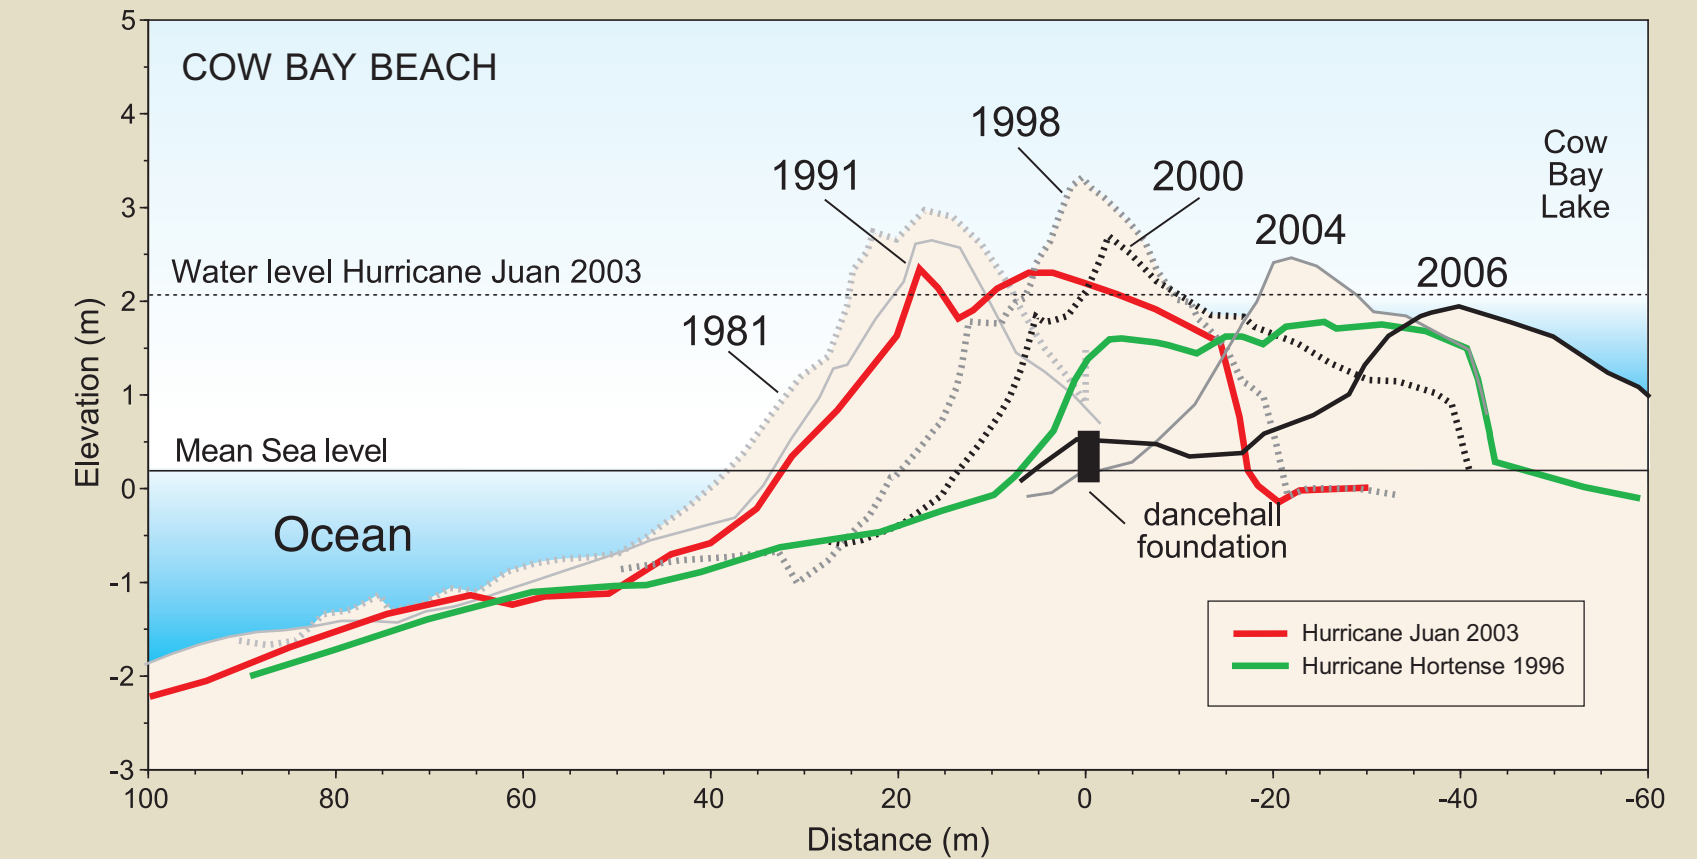
Repetitive cross-shore surveys illustrate how the central part of Cow Bay Beach (between a & b, photo to left) migrated landward. It is repeatedly built up, pushed over and flattened, particularly during large storms such as hurricanes Hortense and Juan, shown on graph. Between 1991 and 2006 the beach was completely rolled over (what used to be the back of the beach is now the front).

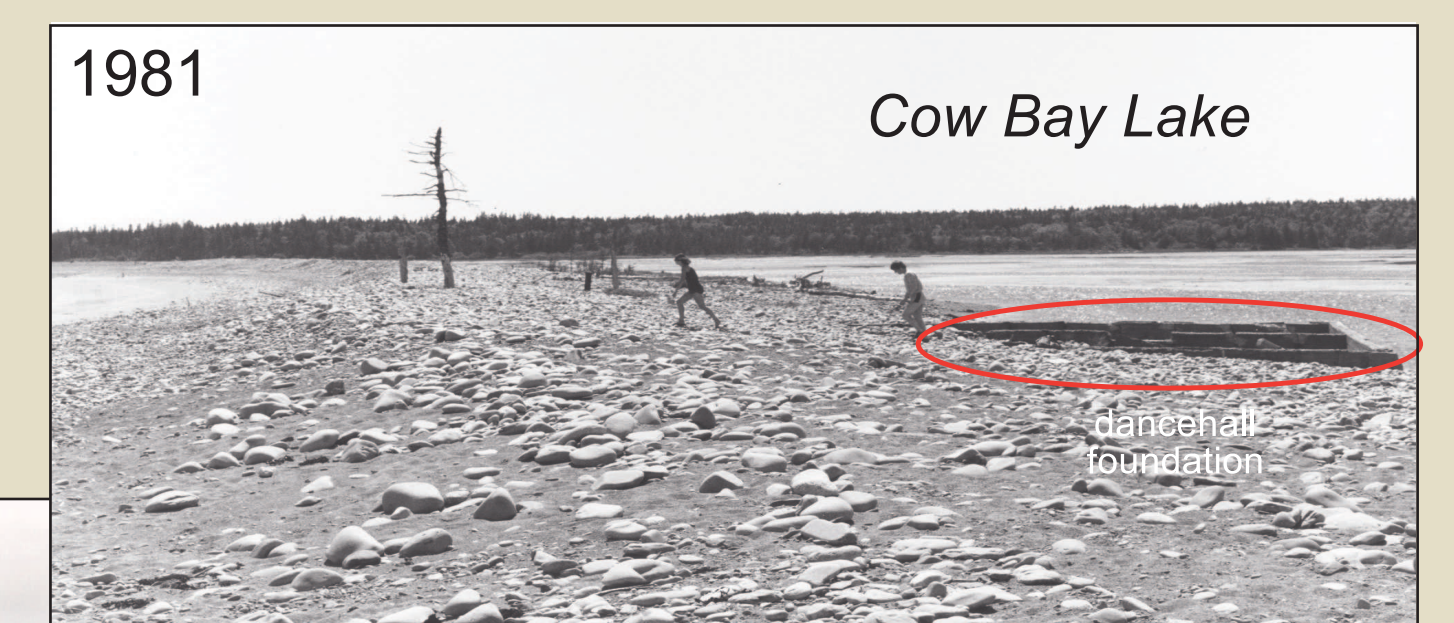
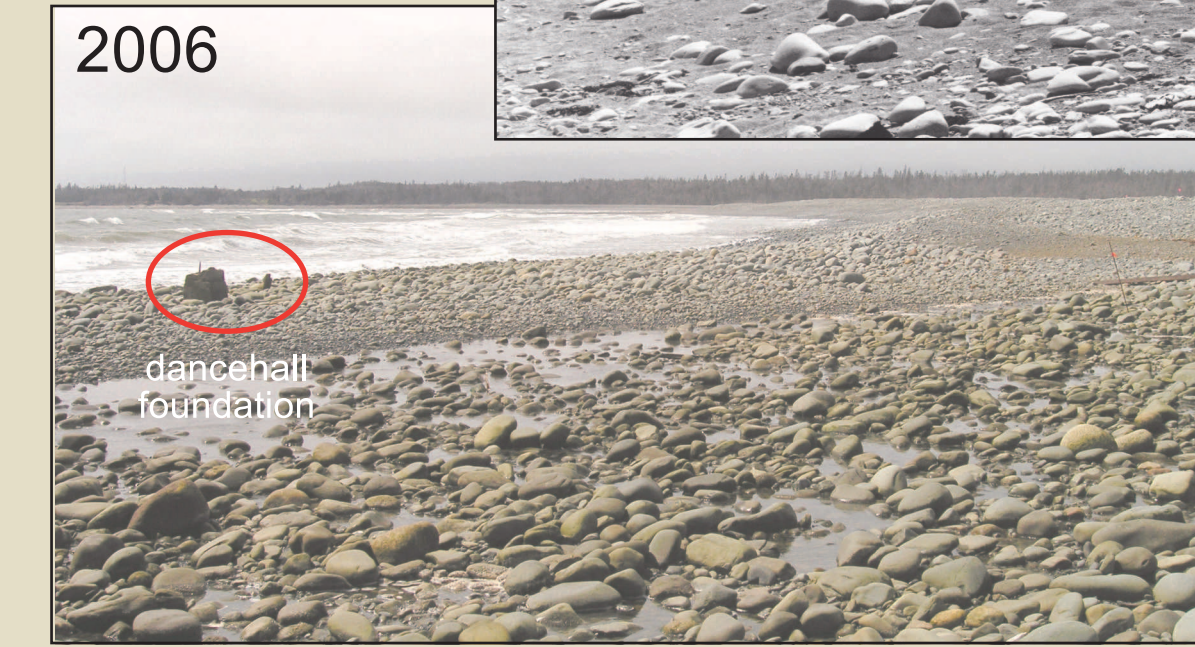
The foundation of the dancehall provides a reference for watching the beach migrate landward. In 1981, the foundation (circled in red below) existed at the back of the beach. During the 1990s it was buried in the beach and re-exposed seaward of the beach in 2004 as the beach migrated past it. At this location the beach has migrated 53 m landward from 1981 to 2006.

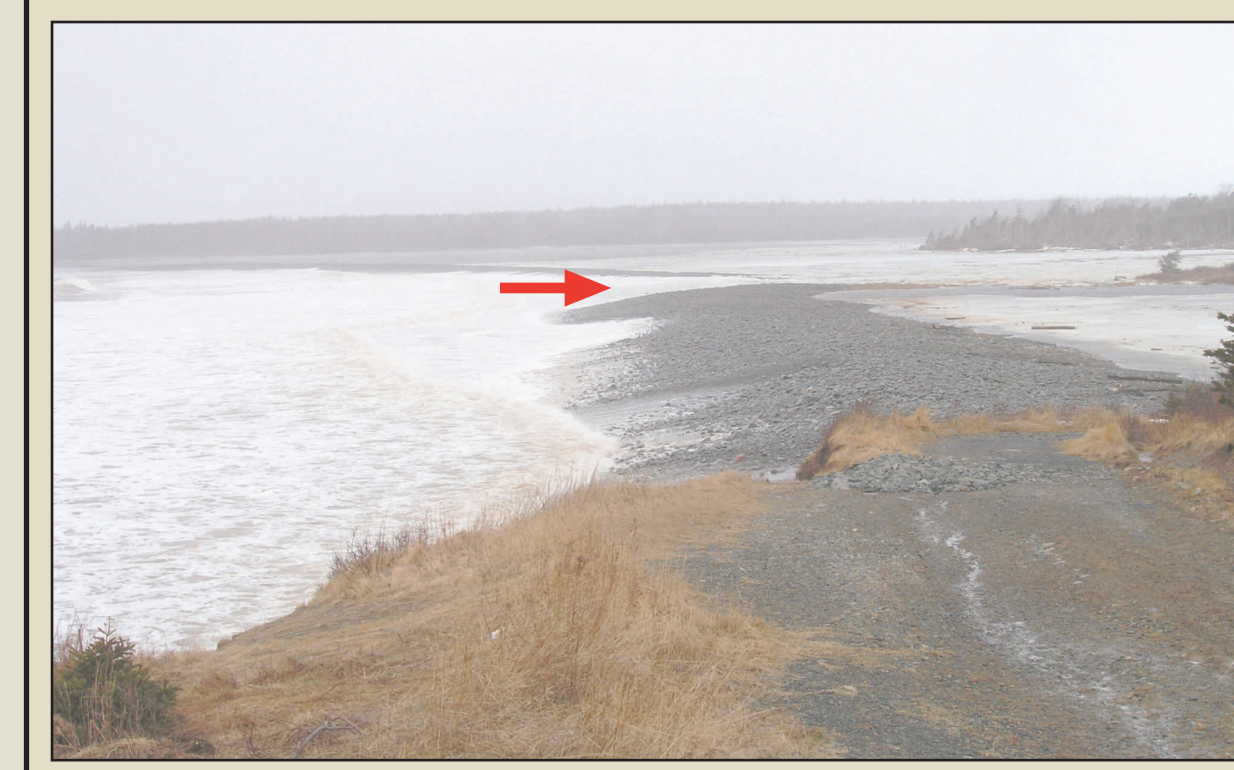
## BEACH BREAKDOWN

Waves cut through Cow Bay Beach at the red arrow in March 2005. In 2006, the central barrier (left of cut) was migrating landward at 7 metres/year in contrast to <1.5 metres/year at the ends of the beach.
