**GEOLOGICAL SURVEY OF CANADA
OPEN FILE 6268**

**South Bay Ingonish and Black Brook Cove Beaches,
Cape Breton Island, Nova Scotia**

R.B. Taylor and D. Frobel

Taylor, R.B. and Frobel D. 2009: South Bay Ingonish and Black Brook Cove Beaches, Cape Breton Island, Nova Scotia; Geological Survey of Canada, Open File 6268, 90p.

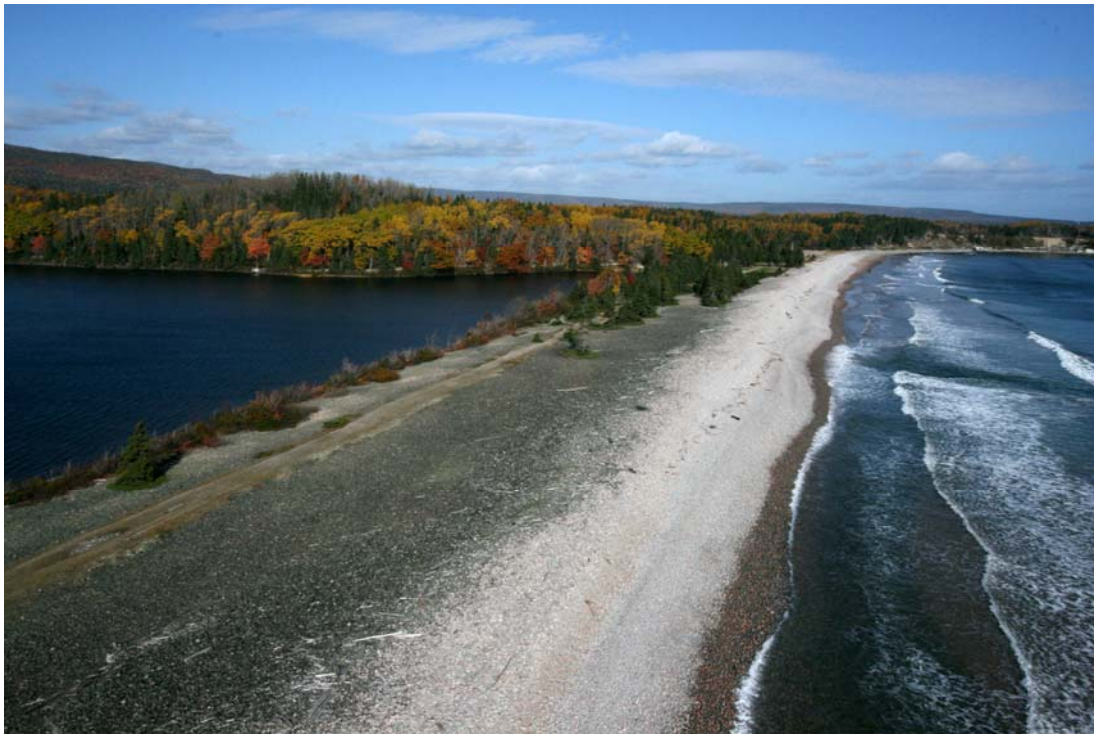
Front Cover: Aerial view from a kite looking north along Ingonish Beach taken by G. Harvey, Cape Breton Highlands National Park on October 24, 2008. The photo illustrates conditions at the time of our 2008 beach surveys when higher energy waves had combed most beach sand offshore (Parks Canada photo IMG 6145, 2008).

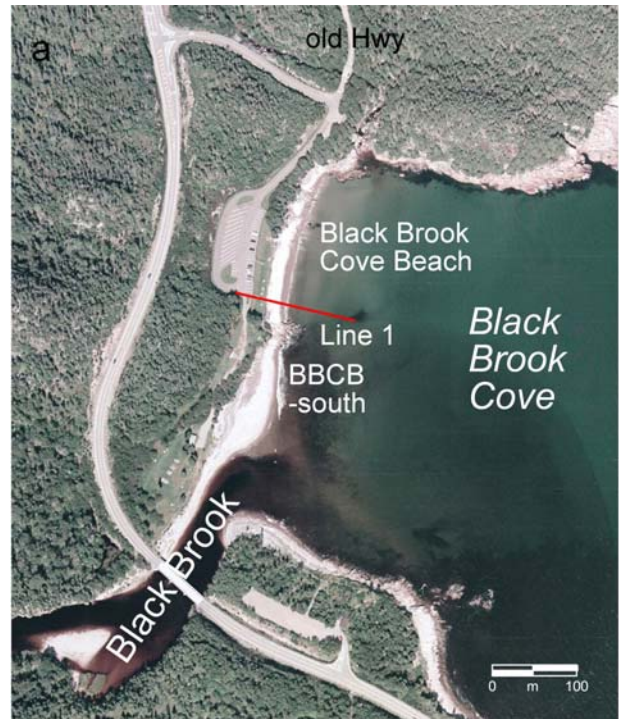
Figure 3. (a) Vertical air photo from 1999 and (b) a 1992 aerial oblique photo looking southeast, showing Black Brook Cove, Black Brook, Black Brook Cove Beach (BBCB)- the main study site and BBCB-south where fewer observations were made.

Marine geology surveys have not been completed within Black Brook Cove although it is reported by EERL (1978) that sand and gravel are found offshore. Water depths of 11 m exist between the outer headlands (CHS, 1974). Closer inshore at the head of Black Brook Cove the seabed consists of sand of an unknown thickness. The continuity of the deposit is affected by variations in discharge and direction of flow from Black Brook which has the second largest drainage system (67.4 km²) in the national park (EERL, 1978). Aerial photographs taken roughly 30 years apart in 1936, 1966 and 1999 (Fig. 32) show that a wide sand deposit nearly closed off the stream mouth in 1936, but was breaking apart by 1966 and was not visible in 1999 (Fig. 3a, 31). Field observations confirm that sand can intermittently rebuild on coarse shoals across and adjacent to the river mouth. For example, in June 1983 stream flow was forced northward and cut back the beach, whereas in August 1985 flow was more to the south and the beach was fringed by a wide sand foreland (Fig. 32). Sand also plugged the river mouth in 1992 (Fig. 3b).

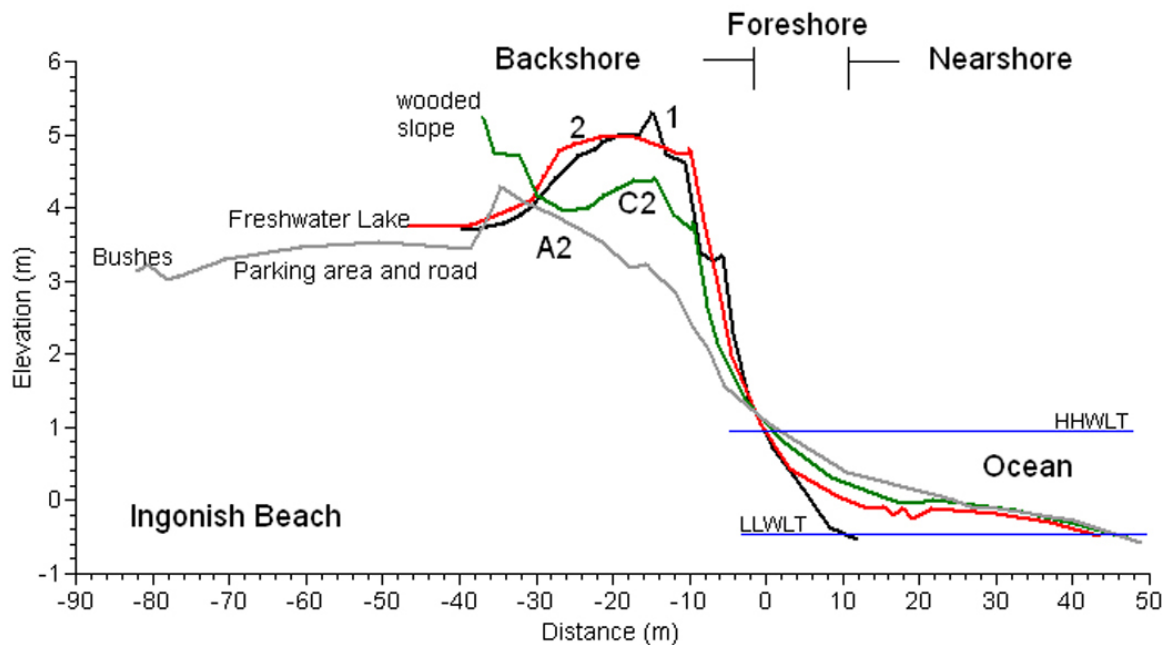
Figure 6. A comparison of cross-shore morphologies observed along Ingonish Beach. Lines 1 and 2 represent the barrier beach fronting Freshwater Lake, Line A2 represents the north shore segment with a low backshore and Line C2 represents the anchor /hinge point between the other two shore segments. The survey lines are aligned where the 1m elevation (~HHWLT) intercepted the beach in 2008.

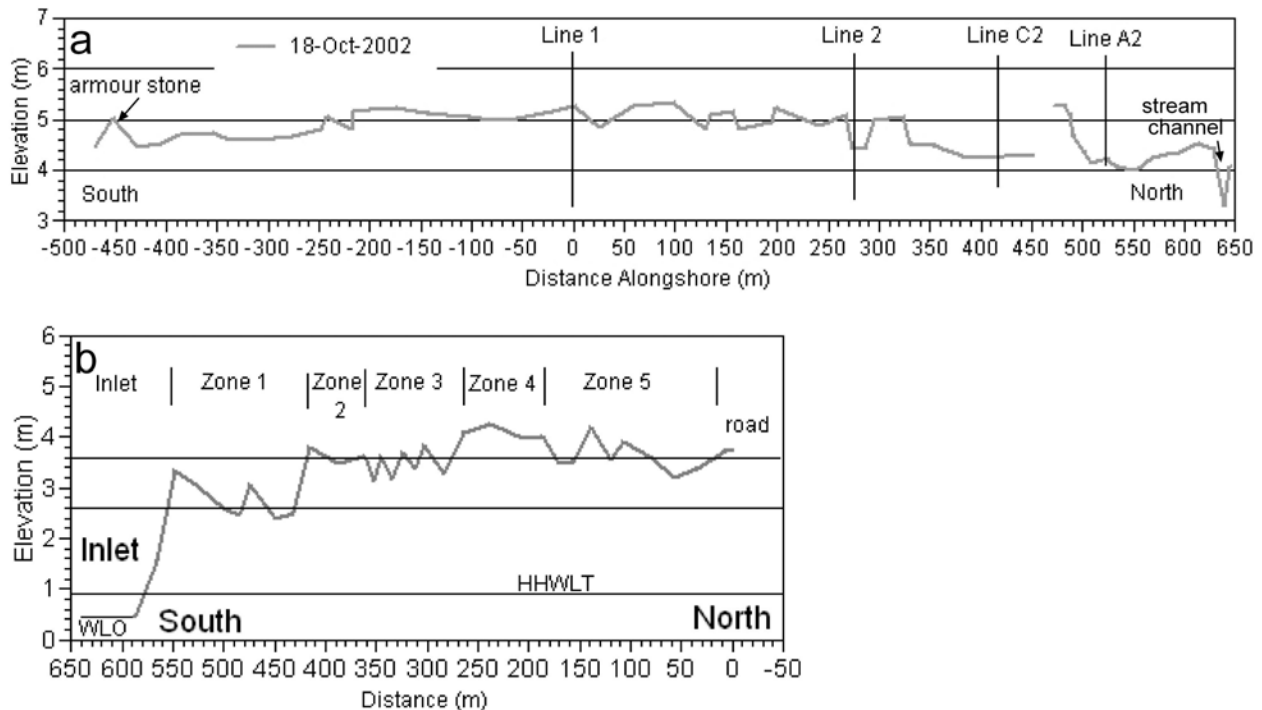
Figure 8. Longshore crest profile for (a) Ingonish Beach from Beach Crossing Road north to the stream cut near Middle Head and (b) along Ingonish Harbour Beach. To understand the graph pretend you are standing offshore looking back along the top of the beach. The highest part of the beach was adjacent to line 1. The high spot between lines C2 and A2 is where a relict stone wall and dune existed adjacent to the parking lot. Beaches greater than 2.6 m elevation have a potential to naturally rebuild where sediment is available (Taylor et al., 2003).

October 2002 (Fig. 8b) was part of that investigation.

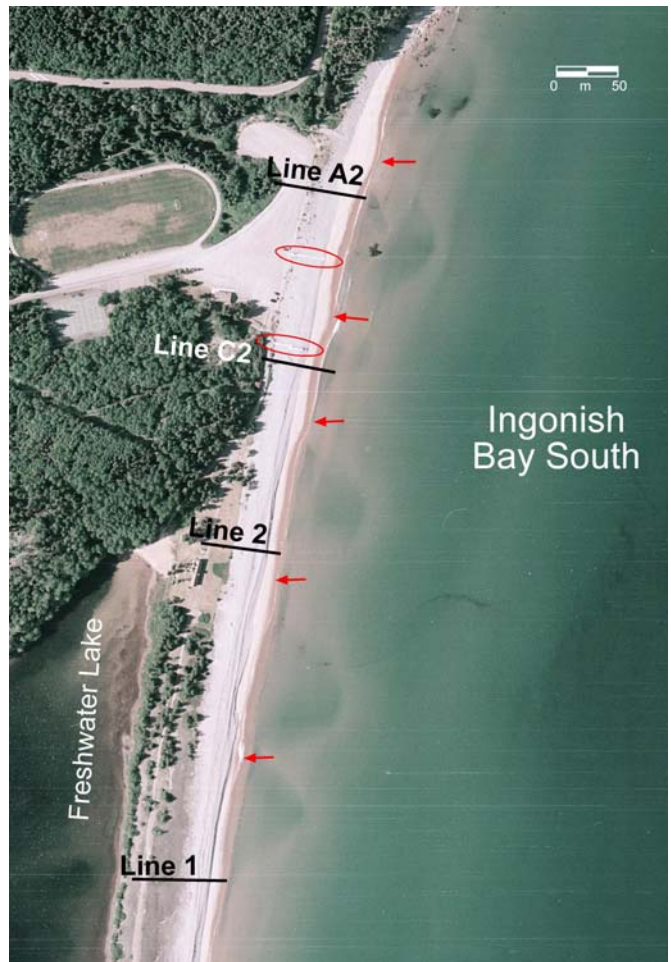
Figure 15. Close-up of inner bar and beach morphology on June 11, 1999 showing the relative position of our cross-shore lines and how the mega beach cusps (cusp horns marked by arrows) mirror the inner bars. In 1999 the temporary access boardwalks (circled) constructed across the beach coincided with the location of bar troughs where the beach (sand) width was narrower.

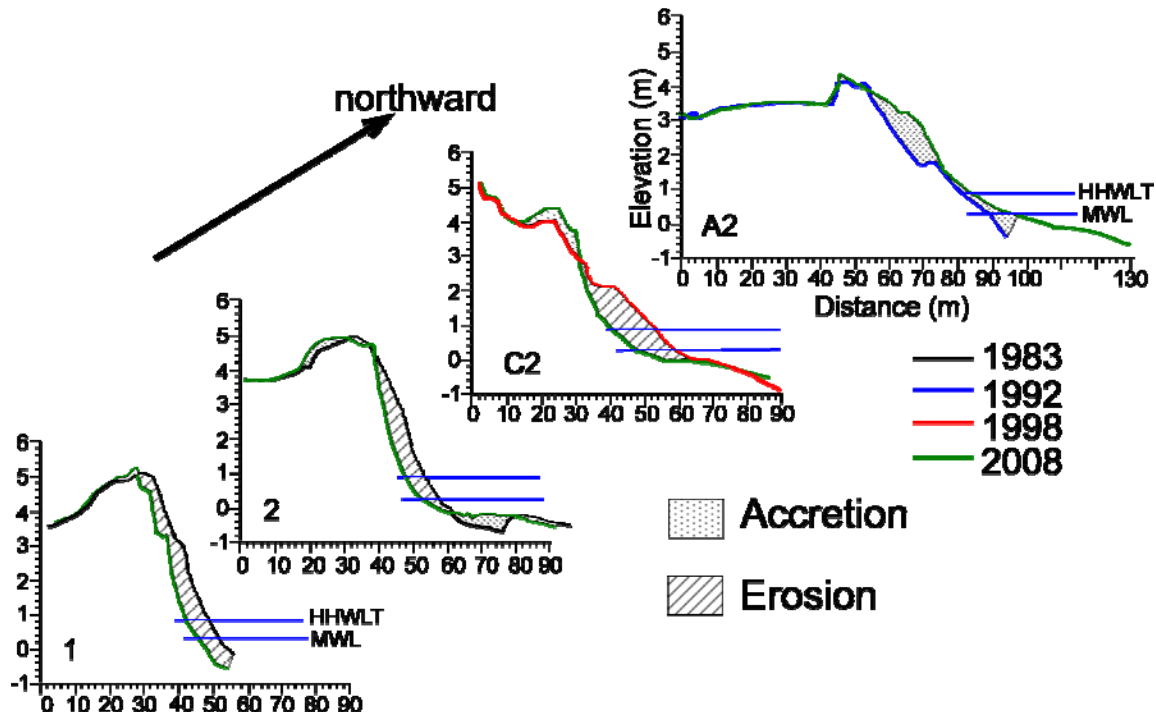
Figure 20. Repetitive cross-shore surveys on Ingonish Beach showing net physical changes and areas of accretion (dots) and erosion (striped) from 1983 to 2008. Location of survey lines is shown on Figure 4.

Repetitive surveys of Lines A2 and C2 only began in 1992 and 1998 respectively but at both locations the beach crest has built seaward (Table 6, Fig. 20). Sand accumulated onshore in all five years of survey and the most sand was observed in October 2002 when a well defined sand berm and runnel developed (Fig. 11c).

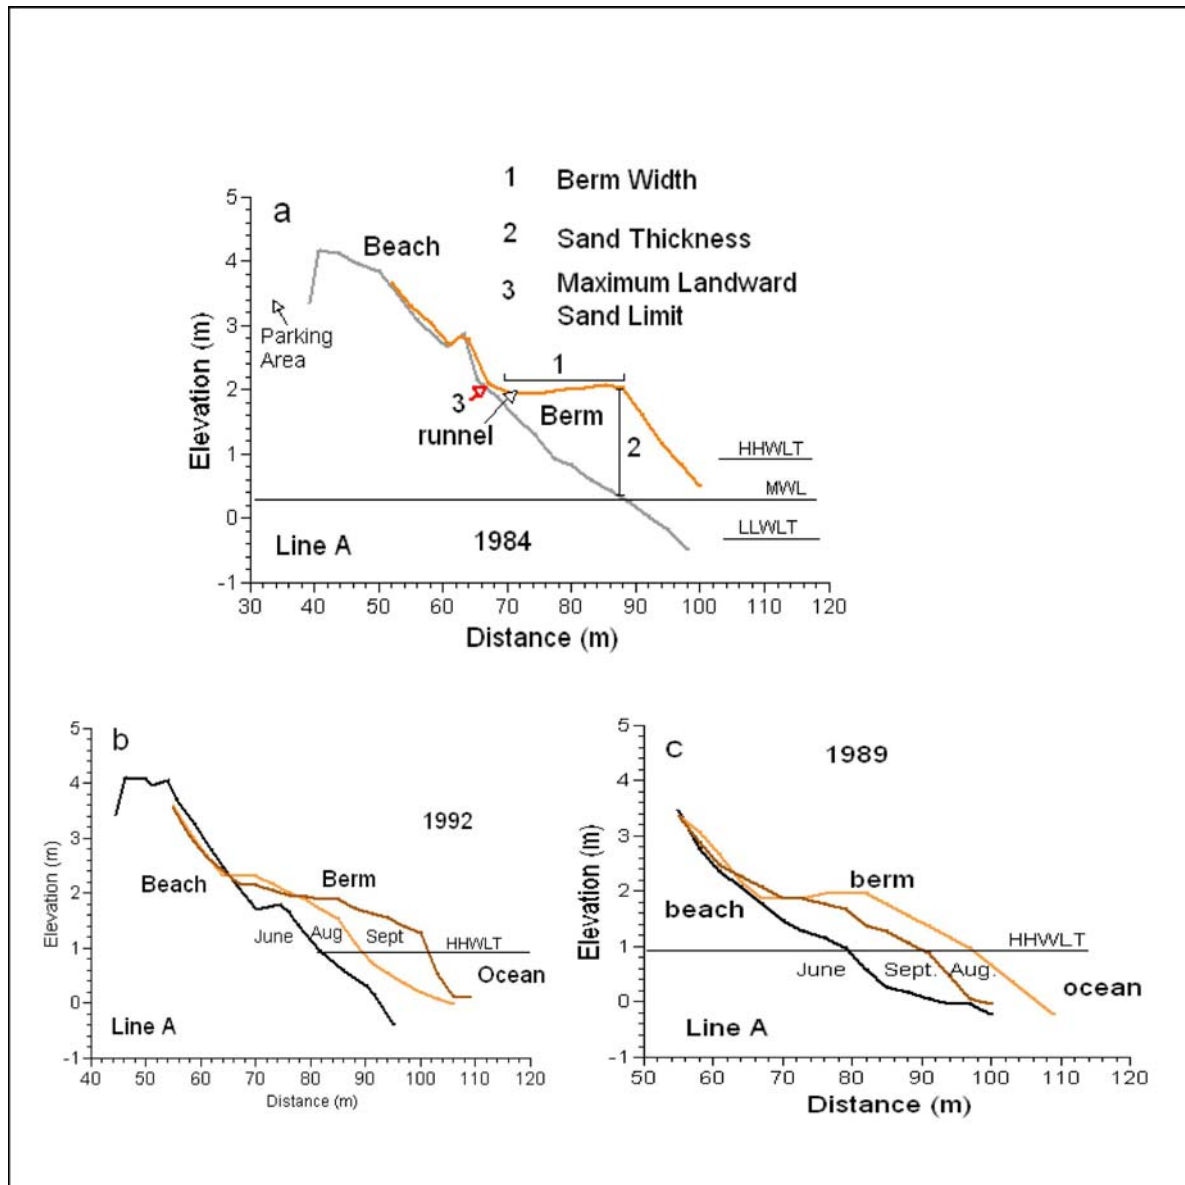
Figure 23. (a) Beach terminology and location where seasonal sand accumulations were measured (refer to table 8) and (b, c) examples of seasonal berm morphology based on repetitive cross-shore surveys at Line A, Ingonish Beach. (b) Progressive berm growth in 1992 and (c) decay of berm after larger wave reworking during Sept. 1989.

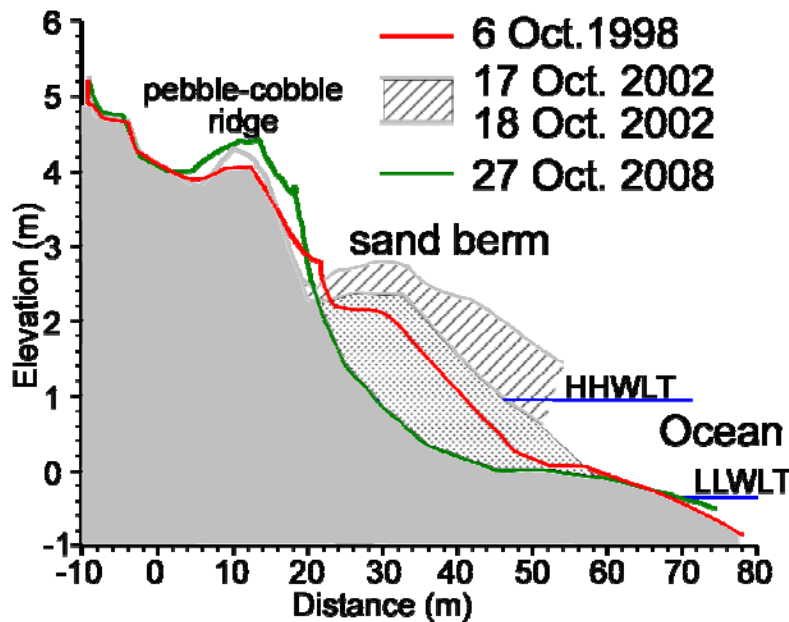
Figure 24. Example of berm development at line C2 in October 1998 and 2002 and its complete removal in 2008. Repetitive surveys in October 2002 (striped) illustrate the volume of sand that can be removed during 24 hours of larger waves. It is estimated based on this survey that the main beach fronting the parking lot lost 6000 m³ of sand in the 24 hours.

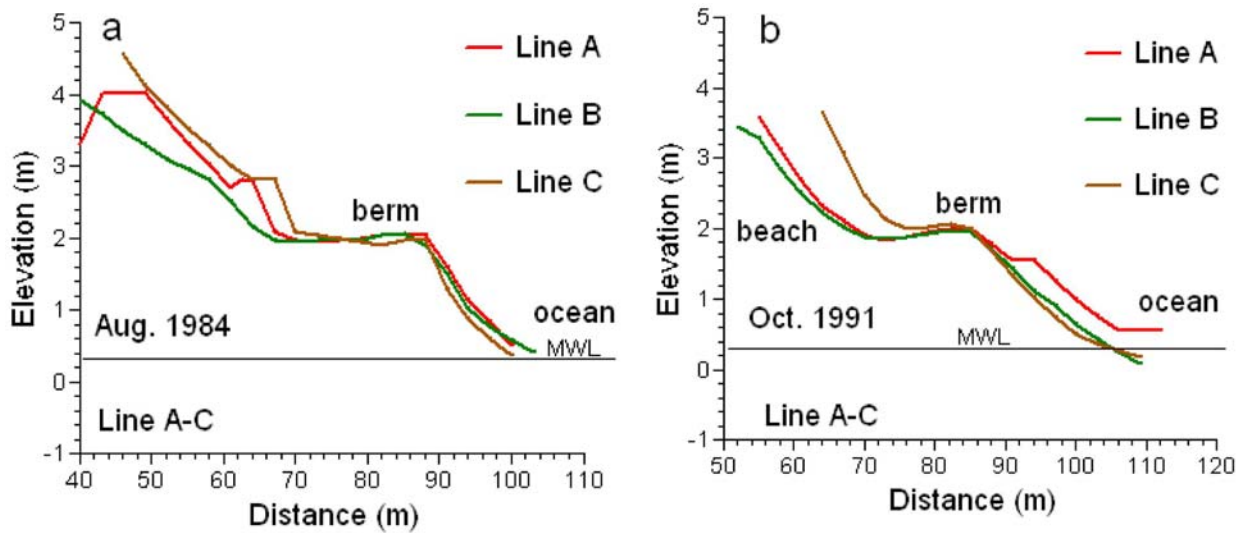
Figure 25. Examples of three cross-shore survey lines A, B, C showing their similarity in berm position and morphology. The top seaward edge of the berms were aligned for these plots.

The timing and extent of sand build-up and erosion, the average elevation of sand accumulation upslope, berm elevation and thickness of sand at its seaward edge were similar at all three survey lines, A, B and C (Fig. 25, Tables 7-9). However local differences in maximum sand accumulation and berm width were observed. Rhodes (1994) found a strong correlation between beach slope and the width of sand deposits and a poor correlation between slope and the landward elevation of sand deposits. He also illustrated the relatively uniform elevation of landward sand deposits and a slightly rhythmic width in sand deposits alongshore. The width of sand berm was nearly twice as wide at line A/A2 than at line C/C2. The mean width at line A was 21 m and at line C it was 12 m (Table 8).

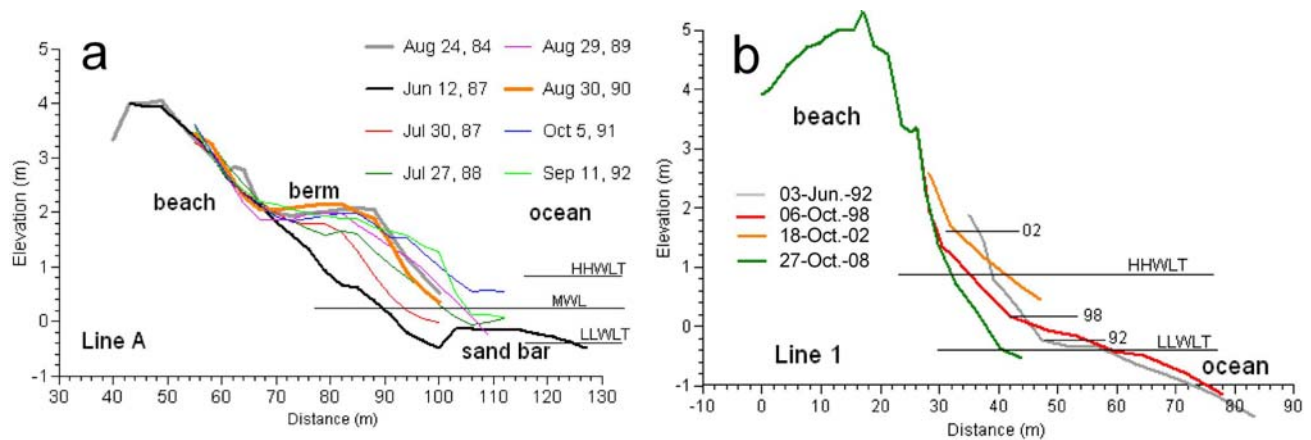
Figure 26. Sweep profiles of sand deposits observed at (a) Line A showing when a maximum sand berm was recorded each summer and fall from 1984 to 1992 and (b) Line 1 when a sand ramp built against the steeper beach. The highest level of sand is marked for each year in graph b. The June 1987 profile in (a) represents the pebble-cobble beach profile when no sand had accumulated on the beach and is stored in a sand bar just offshore. The October 2008 profile in (b) represented a time of high energy waves when no sand remained on the beach.

A plot of all surveys for a given location when the berm was at its maximum development provides a range of morphological changes observed between 1984 and 1992. The plot is often referred to as the "sweep" profile which illustrates an envelope of "normal" variations documented at a site for a given period of time. If repetitive surveys extend over many years the envelope can provide a reference tool. Beach changes observed in the future that fall outside of this envelope would be considered abnormal and possibly signal a shift in beach stability. The sweep profile for line A shown in figure 26a is considered representative of sweep changes at lines B and C as well. At lines 1 and 2 more of a sand ramp built against the steeper cobble slope than a horizontal berm (Fig. 26b). Since 1983 although there were years with substantive sand accumulation none matched the width of sand shown in 1954 (Fig. 5a).

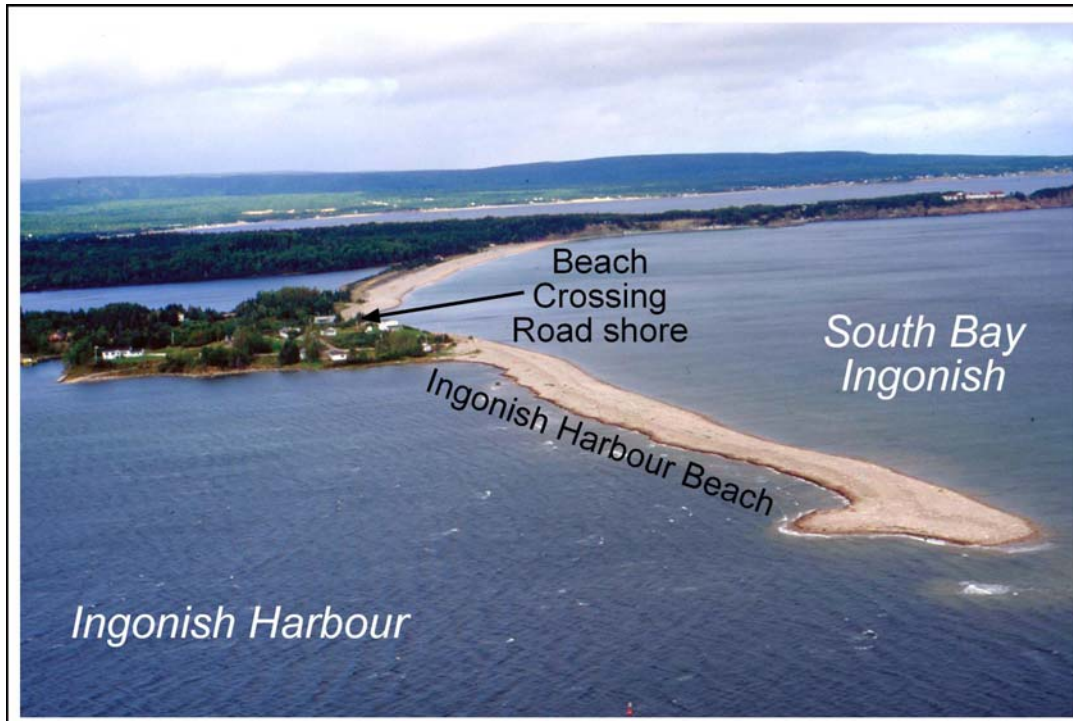
Figure 27. Aerial view on 30 September 1992 of South Bay Ingonish showing the north barrier of Ingonish Harbour Beach and the tidal inlet (foreground). The change in shoreline orientation south of Beach Crossing Road Shore, is a major factor in controlling the southern extent of the sand bars present off Ingonish Beach.

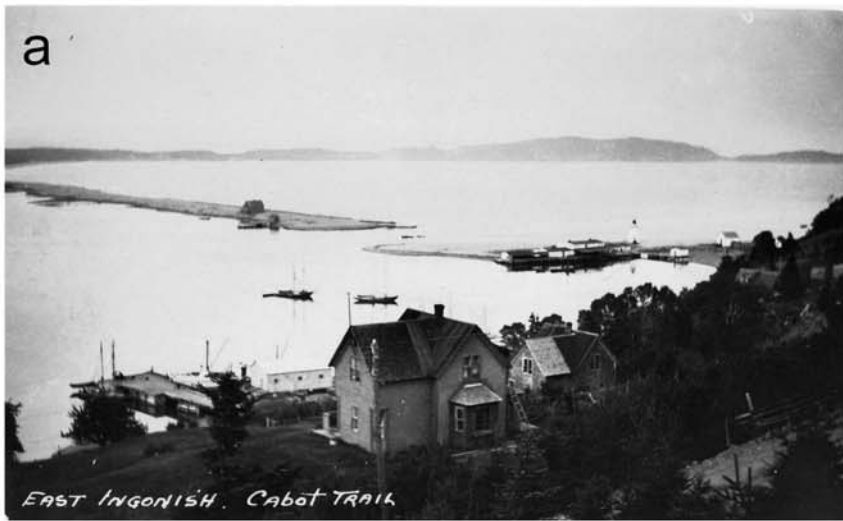
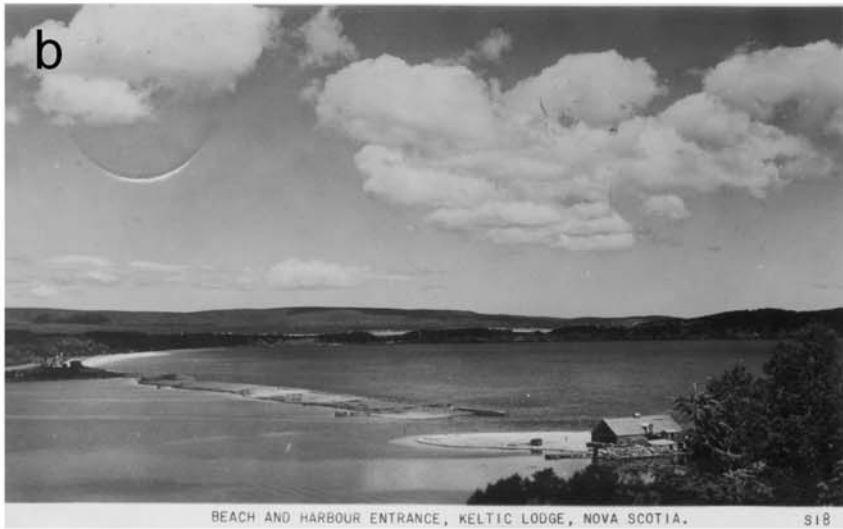
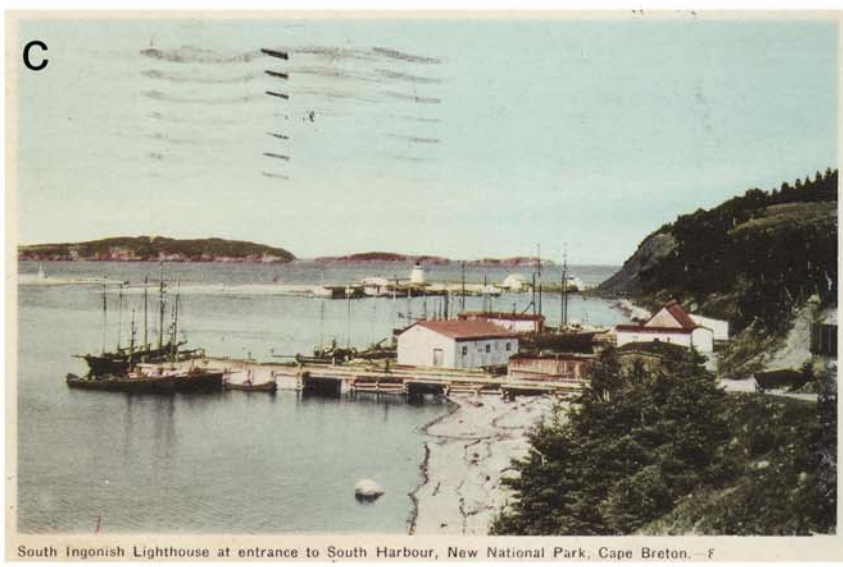
Figure 28. Views of Ingonish Harbour Beach and tidal channel from postcards circa 1940s. There was no postmark on (a) but the wharves and buildings on south barrier are similar to those observed on the 1936 vertical air photos, (b) postmark 1950, the building was gone from the north barrier but the wharves remain intact, (c) view of wharf and lighthouse at Ingonish Ferry (postmark 1949).

Since the late 1800s, the inlet and barrier beaches have been impacted by human activities (Fig. 28). Fournier and Lajoie (1984) provided a historical overview of natural and artificial changes to the tidal inlet. From 1873-1876 a tidal channel 60 m wide, extending 4.3 m below low tide was improved by Department of Public Works. The northern side of the channel was protected by a 150 m long pier which received extensive damage from storms during its existence (1882, 1918, 1939....). Several pier reconstruction and beach protection programs were conducted after 1870. By 1936 two pier structures remained on north barrier at the north side of the inlet (Fig. 28a, 29).

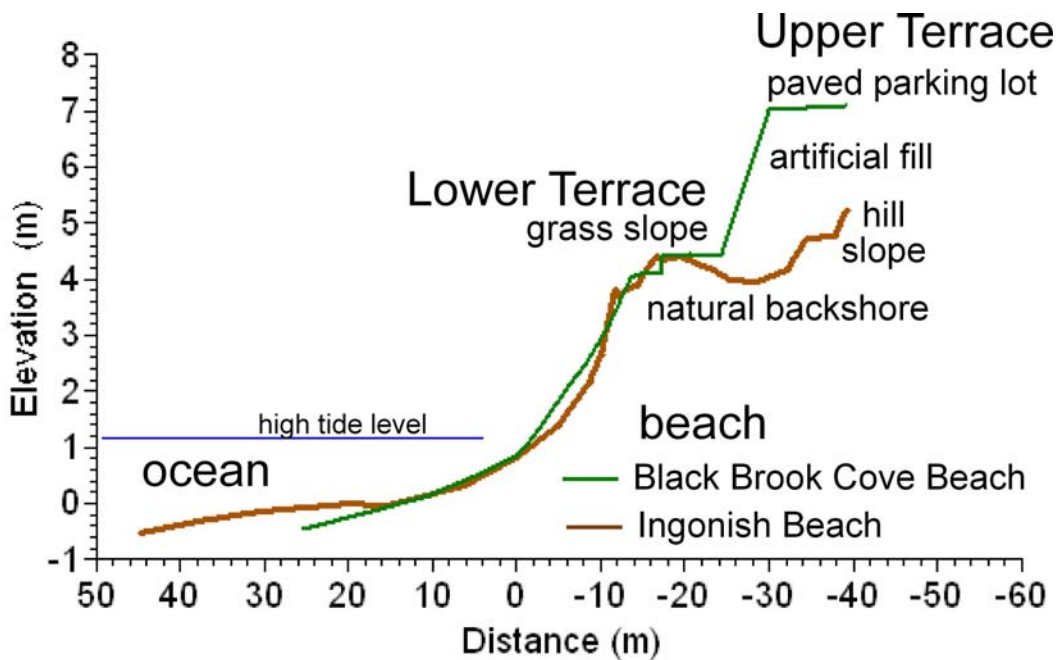
Figure 33. A comparison of beach profiles from Black Brook Cove (BBCB) and Ingonish beaches. The lower grass terrace at BBCB, interpreted as the original backshore, is at the same elevation and position as the natural backshore at line C2, Ingonish Beach. The upper terrace, where the paved parking lot presently exists, was built up with artificial fill as part of the coastal highway.

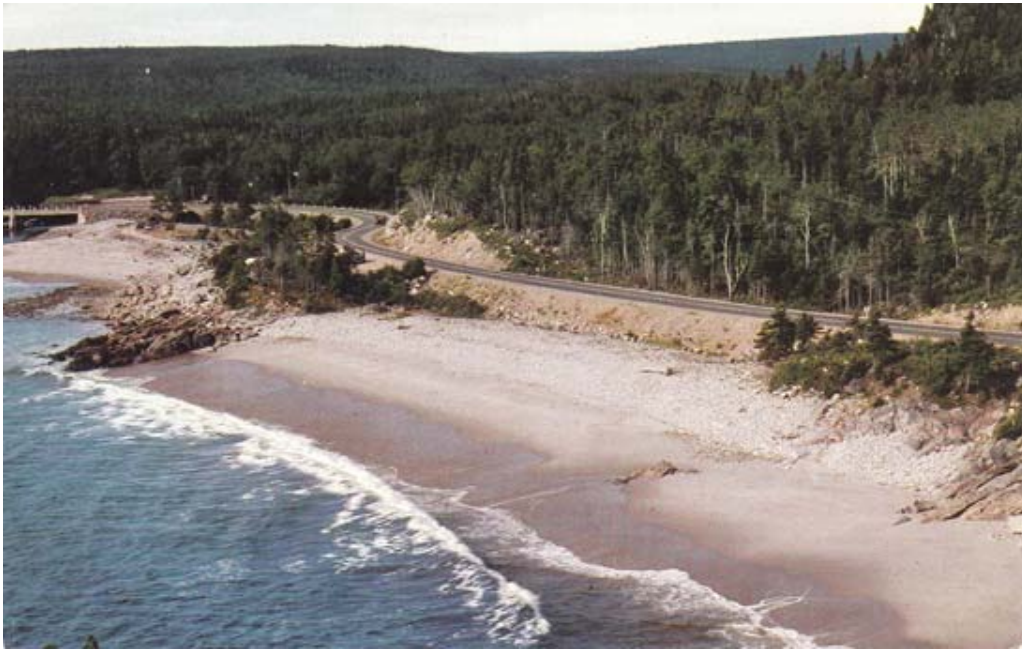
Figure 34. Postcard showing Black Brook Cove Beach in the 1950s (postmarked 1957). A wide sand foreshore and pebble cobble upper beach fringed the coastal highway which was built along the back of the natural backshore. After the road was moved landward in the early 1970s, the former road was widened into a parking area and grass was laid across the backshore (see Fig 3b).

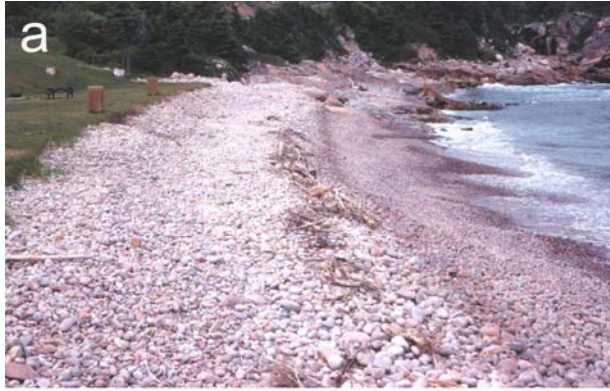
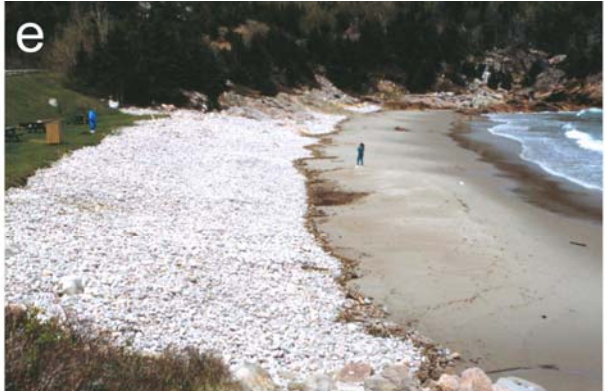
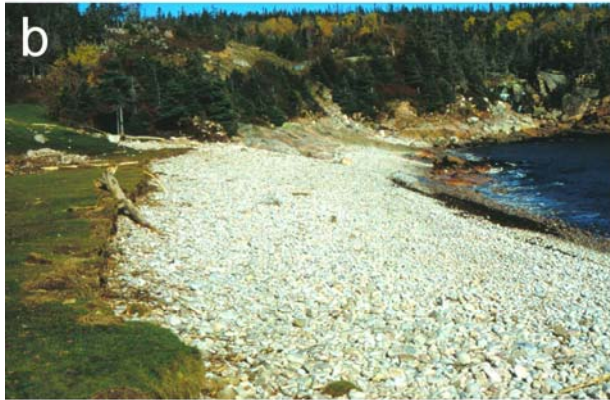
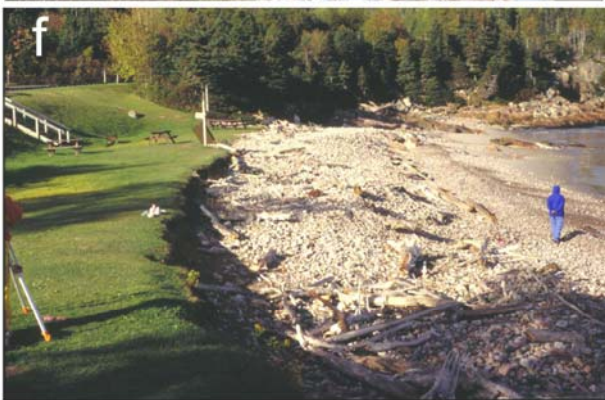
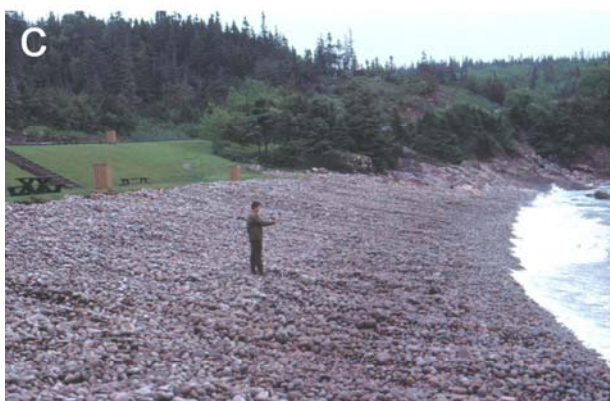
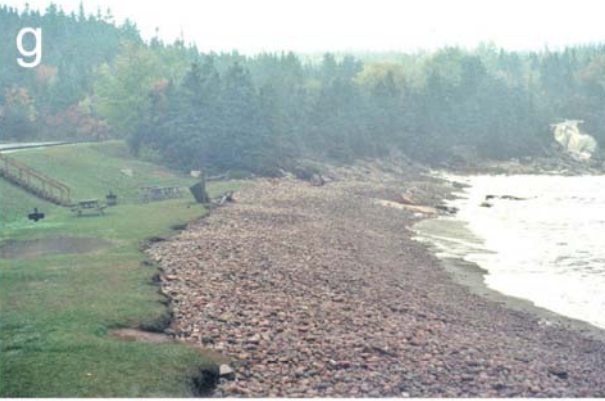
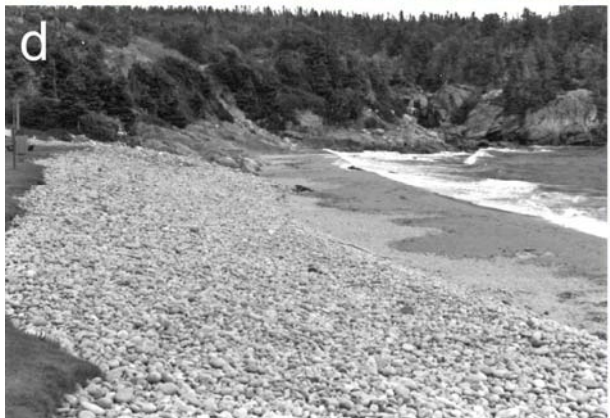
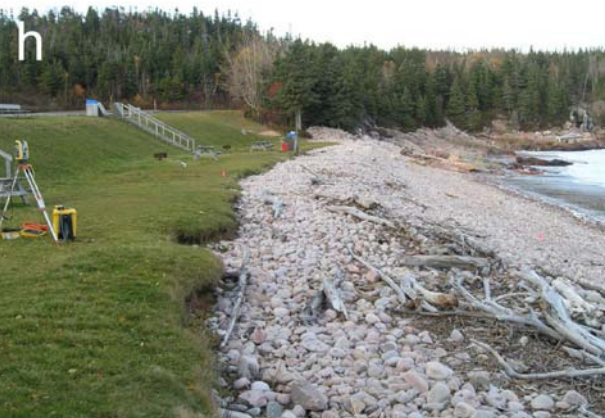
Figure 36. (next page) Views northward along Black Brook Cove Beach showing different types of morphology observed from 1983 to 2008 and the processes which produced them: (a) June 1983 large swash ridge-moderate waves, (b) November 1983,-upper beach smoothing -post-storm (c) June 1984-upper beach smoothed by machine and (d) August 1985-lower beach - maximum sand accumulation, (e) June 1992 -lower beach with sand berm, (f) October 1998-post storm -upper beach cut bank and hummocky storm ridge, (g) October 2002 -post storm -upper beach smoothing and (h) October 2008 bank cut and upper beach ridge left as moderate waves reworked the mid to lower beach.

When our field surveys began in June 1983 the beach had a steep slope with a storm swash ridge. The lower beach was more concave and small beach cusps were developing (Fig. 36a). The presence of flotsam and gravel cusps along the upper beach suggested that wave run-up commonly reaches the edge of the grass terrace. This was confirmed in October 1983 when the coast was struck by a severe Northeaster that produced a storm surge of 0.76 m in Sydney (Oja, 1984; Taylor and Kelly, 1984). Our first cross-shore survey of this beach was on November 1, 1983 immediately after that storm so only repetitive photographs from June and November 1983 provide an estimate beach change (Fig. 36a, b).

By June 1984 when the next beach survey was completed the grass terrace had been cleared of debris left by the storm. Cobbles tossed across the grass were returned to the beach. The entire beach slope was smoothed out by machinery and the erosional bank along the grass terrace was infilled with cobble (Fig. 36c). Within a few days of artificially smoothing out the beach, waves began forming a new swash ridge near high tide level (Fig. 36c, Fig. A2-3, Appendix 2) and the beach was returning to a natural profile. No negative impacts were observed on shoreline stability as a result of this human activity.

James Bridgland, Parks Naturalist reported that BBCB was severely impacted by Hurricane Hortense in September 1996 but it is unknown if the beach changes surveyed in 1998 were the consequence of Hortense or other storms occurring between 1996 and 1998 (Fig. 36f, 37). Sometime after 1992 the upper beach and grass terrace were scoured down; however, the upper beach had been rebuilt by mounds of pebble cobble and wood debris by October 1998 (Fig. 36f). Repetitive surveys from 1992 and 1998 show mid to upper beach rebuilding to pre-1992 levels and the edge of the grass terrace was cut deeper by 1998 (Fig. 36e-f, 37b, A2-3, Appendix 2). The whole upper beach was reworked by large waves and the occurrence of gravel mounds either suggested waves had formed cusped deposits or sea ice had been involved during one or more storm events. Just prior to our survey in October 1998 the waves had combed most of the sand offshore leaving only a veneer of sand across the lower foreshore. Most sand remained below low tide level (Fig. 37b).

The next visit to the beach was not until 2002 (Fig. 36g) and the next cross-shore survey was not until 2008 (Fig. 36h, 37a). In October 2000 a northeaster with heavy rains struck the area. Sections of the Cabot Trail were closed due to flooding. Waves caused widespread deposition of pebble-cobble and debris across the grass terrace (Andy Doherty, Parks Canada, pers. comm. 2008) which was removed and piled at the far north end of the beach (Fig. 39). The metal culvert at the south end of the beach was also replaced after the storm. At the low beach area adjacent to Black Brook the picnic shelters and backshore were completely covered by foam (Danielson, 2007) which required machinery to remove it.

A much smoother, convex pebble cobble upper beach slope existed in October 2002 and the bank at the edge of the grass terrace was infilled (Fig. 36g). Our visit in 2002 was during a period of stronger winds and waves. Sand was being pulled offshore although some sand remained providing conditions similar to those of 1998. The lack of irregularity, swash ridges, and debris across the upper beach on October 18, 2002 suggested waves had not reached the upper beach recently. A comparison of photos from 1998 and 2002 showed the grass terrace, north of the survey line, was trimmed back slightly and also confirmed net retreat of the grass terrace during the October 2000 storm also was small (Fig. 36f-g).

In late October 2008, when the next survey was completed, there had been several days of strong waves from the SE. As a result a large amount of sand had been pulled offshore but the remaining sand was more than we observed in 1998 and in 2002. Re-exposure of the bank along the grass terrace indicated that waves had reached that level after 2002 and had subsequently rebuilt the upper beach just seaward of the grass terrace (Fig. 36h, Fig. A2-3, Appendix 2).

Maximum sand accumulation measured during the five surveys was 1.3 m in 1992 when sand extended upslope to an elevation of 1.82 m. A comparison with beach photographs from August 1985 (Fig. 36d, e) suggested sand accumulation was higher in 1985 than 1992 therefore the maximum sand accumulation also was not captured in our surveys. In 1983 and 1998 the base of the beach slope consisted of boulders which marked the base of mobile sand. It was reported (Andy Doherty, pers. comm. 2008) that sand can cover the base of Black Brook Cove Beach at any time of the year especially after a period of strong offshore winds. Sand is pulled offshore whenever there are strong onshore waves striking the beach. Surveys in 1992 and 1998 recorded sand as much as 40 m seaward of the beach and the thickness varied by 0.5 m in those years (Appendix 1, Fig. A2-3, Appendix 2).

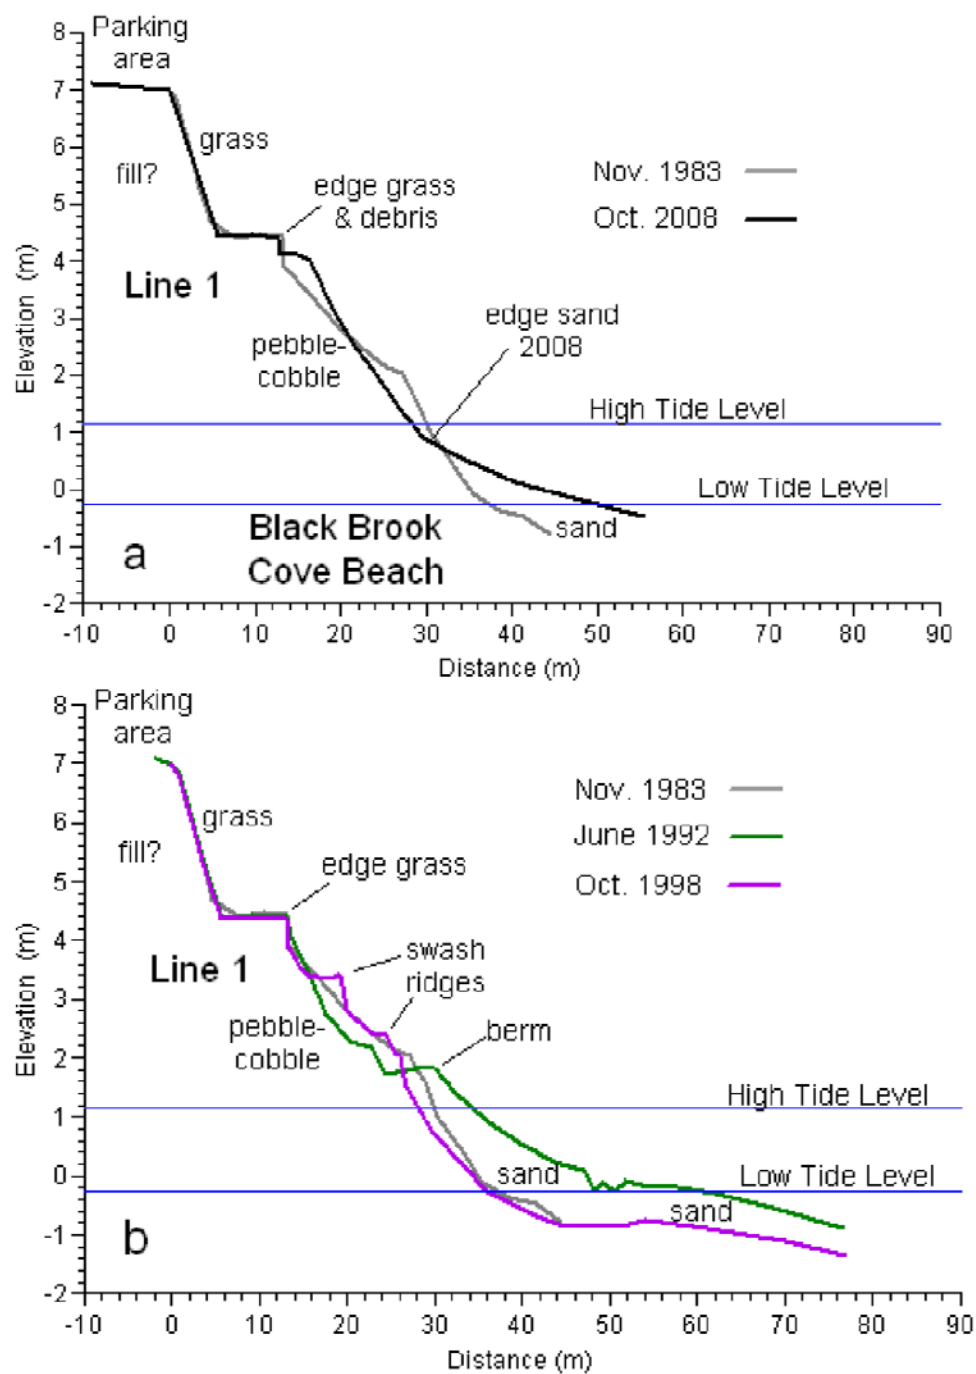
Figure 37. Repetitive surveys of Black Brook Cove Beach at line 1 showing (a) net change between 1983 and 2008, and (b) beach changes during the 1990s compared to 1983. A sweep profile showing the maximum range of change observed at this site is shown on Fig. 41a. All survey lines completed at this site are plotted in Figure A2-3 Appendix 2.

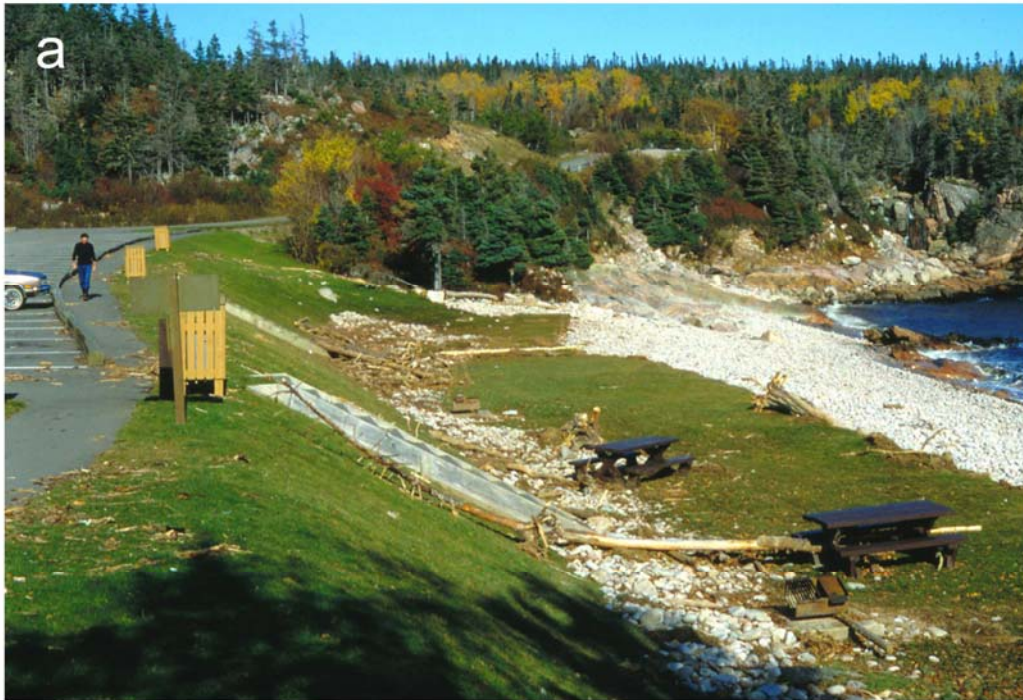
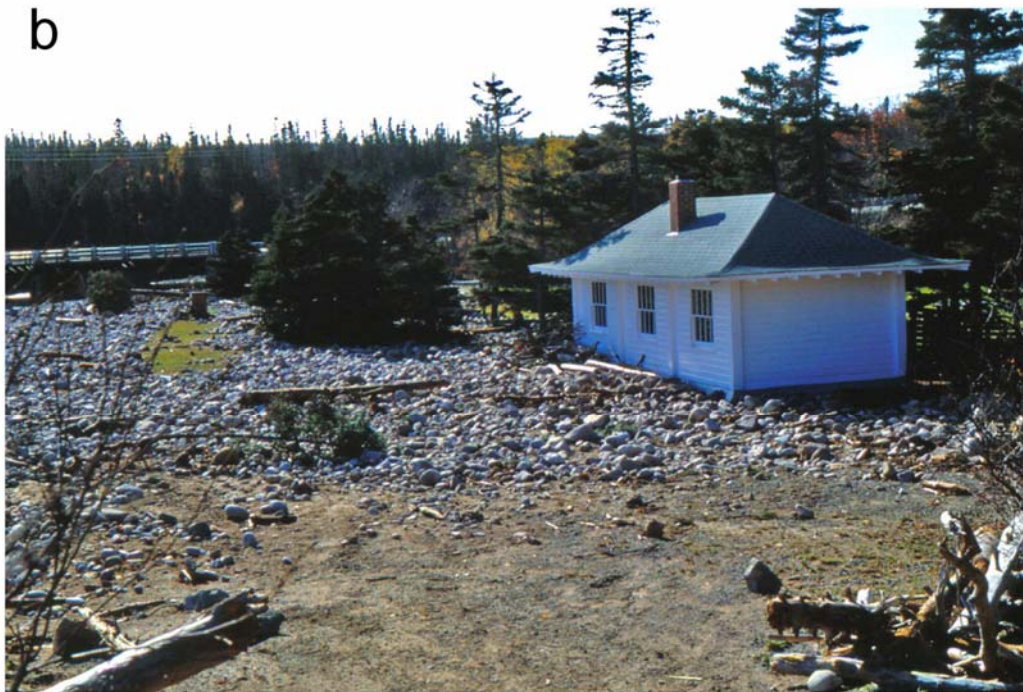
Figure 38. Views of the damage caused by the storm surge October 26, 1983. (a) cobbles and debris carried up the smooth grass slope to 4 and 7 m elevation on BBCB and (b) cobbles and flotsam were carried landward against the picnic shelter and base of the highway along BBCB-south.

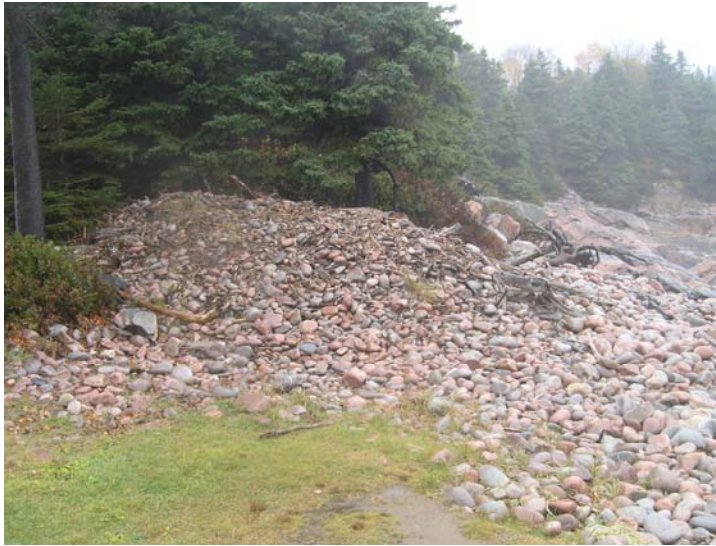
Figure 39. Pile of sediment and flotsam at the north end of BBCB which was cleared from the lower grass slope after the October 2000 storm (A. Doherty, 2008, pers comm). Sediment and debris deposited across the grass terrace or parking lot when cleared should be returned to the natural beach to facilitate post-storm beach recovery.

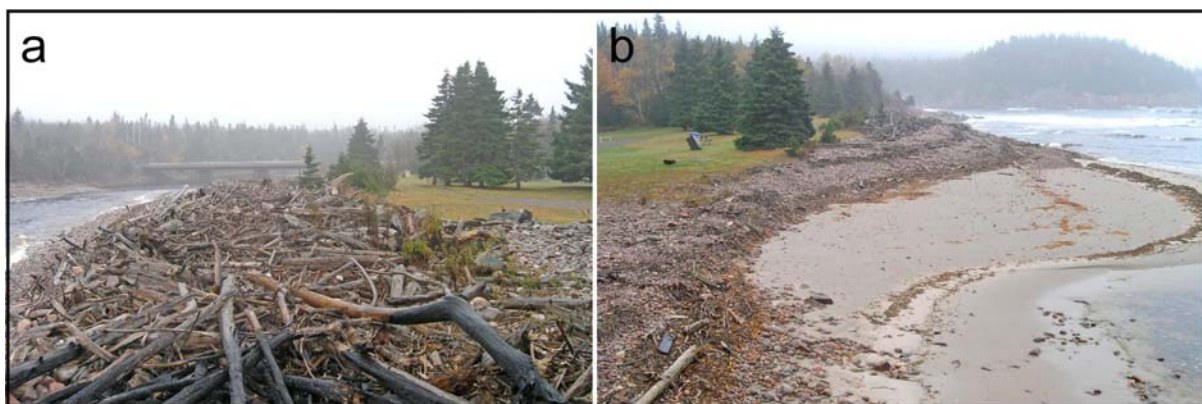
Figure 40. Views of Black Brook Cove Beach-south picnic park in October 2008 (a) toward the highway bridge and (b) from the bridge showing its build-up as it migrates landward. Driftwood has facilitated the trapping of sediment along this beach crest.

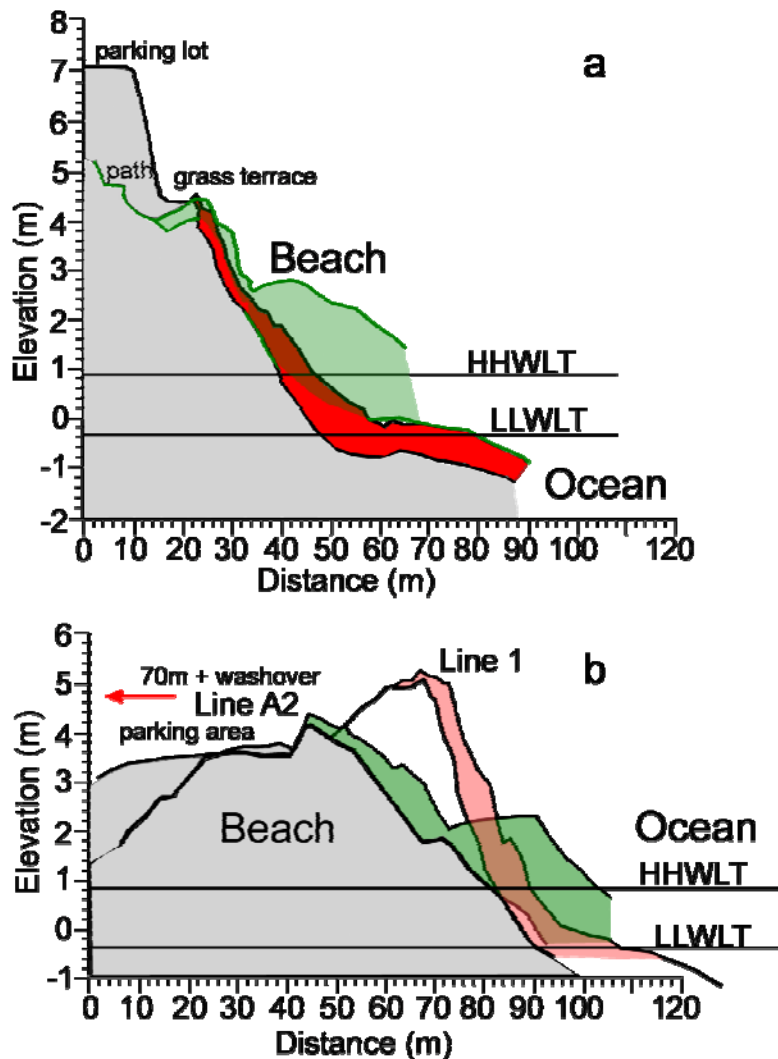
Figure 41. Sweep profiles of (a) two non-barrier beaches -Black Brook (red) and Ingonish (green) and (b) two segments of Ingonish Beach illustrating the horizontal and vertical limits of change observed during a 25 year period (1983-2008). Sediment was tossed higher (to the parking lot) at Black Brook Beach and only to just above the path at Ingonish beach because of trees and shrubs. For the beach lines shown in (b), A2 was flooded and covered by overwash deposits farther because of its low elevation. At line 1 the higher barrier was only impacted to just landward of its crest and sand accumulation was restricted farther seaward.
