**GEOLOGICAL SURVEY OF CANADA
OPEN FILE 6268**

**South Bay Ingonish and Black Brook Cove Beaches,
Cape Breton Island, Nova Scotia**

R.B. Taylor and D. Frobel

Taylor, R.B. and Frobel D. 2009: South Bay Ingonish and Black Brook Cove Beaches, Cape Breton Island, Nova Scotia; Geological Survey of Canada, Open File 6268, 90p.

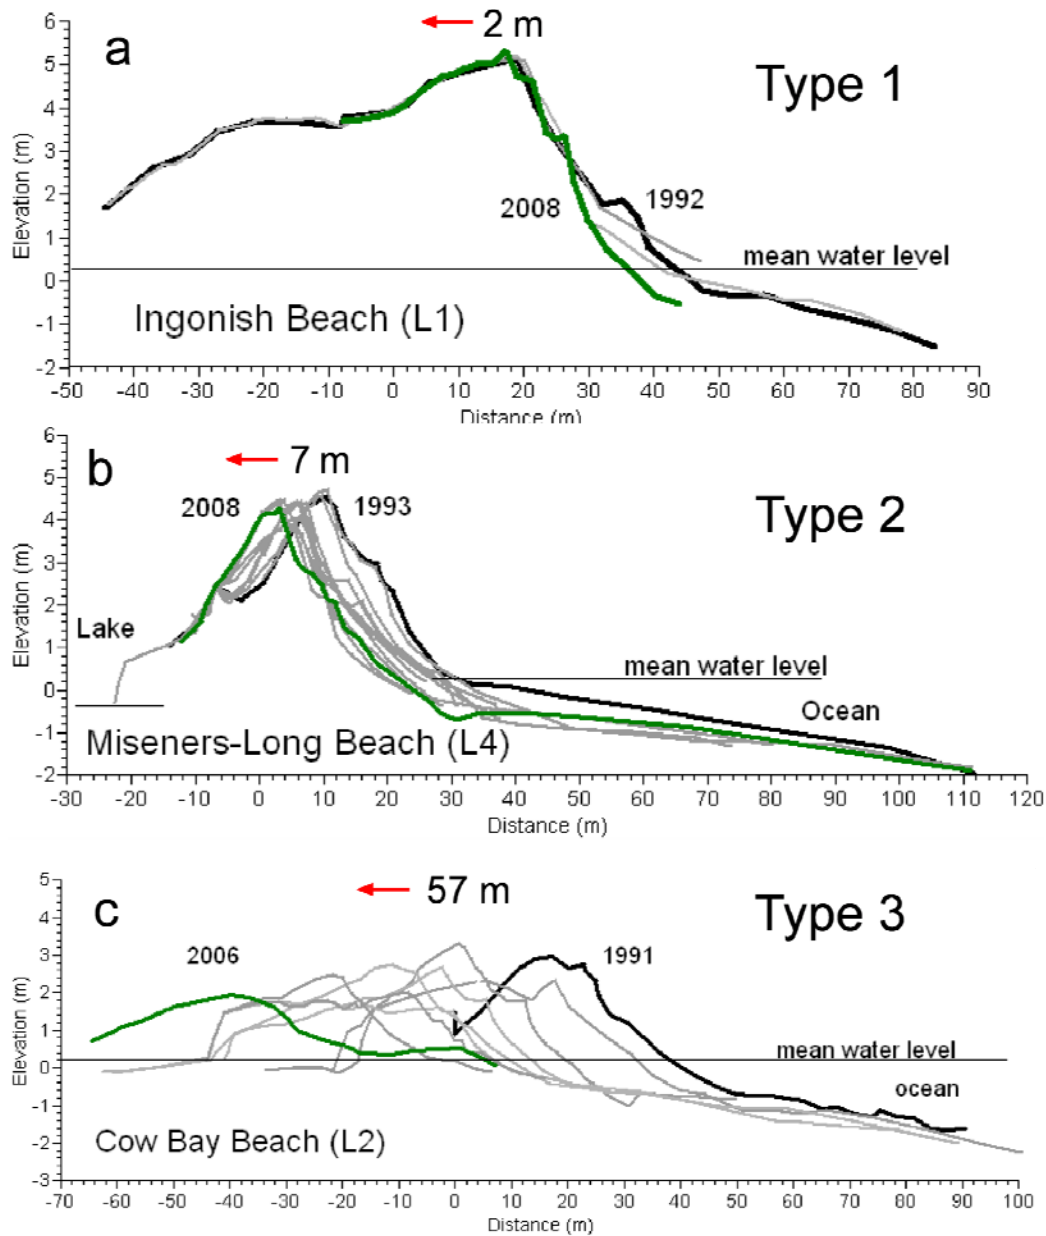
Figure 42. Rates of landward beach migration and their resilience to change can vary significantly for different types of gravel barriers. Barrier size, crest elevation and exposure to different process conditions, ie tidal range and waves, are critical factors. Changes at Ingonish beach are compared with two beaches located near Halifax, NS from early 1990s to 2006/08 (a) Type 1 -central Ingonish Beach crest changes were less than 2 m but natural rebuilding was slower (b) Type 2 Miseners Long Beach- short interval episodic retreat of 7 m but faster rebuilding and (c) Type 3-Cow Bay Beach rapid crest retreat of 57 m. Frequent wave overwash and less compacted material increased beach mobility, yet crest rebuilding was rapid. Ingonish Harbour Beach is a Type 3 barrier. It experienced rapid breakdown and retreat of 25 to 38 m until artificially reinforced in 2004.

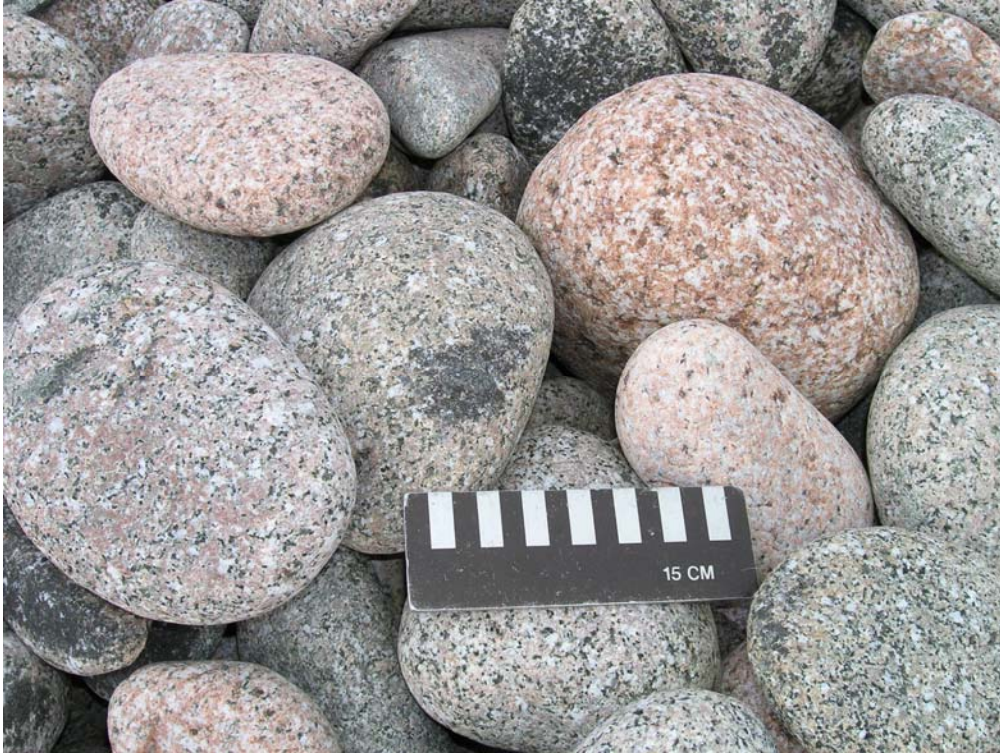
**Line 1
Beach Crest
(PA 273291)**

Photos were taken in October 2008 of sediment at cross-shore survey lines, at Ingonish Beach, NS. Clast size measured from photos is provided in table 4 of the report.

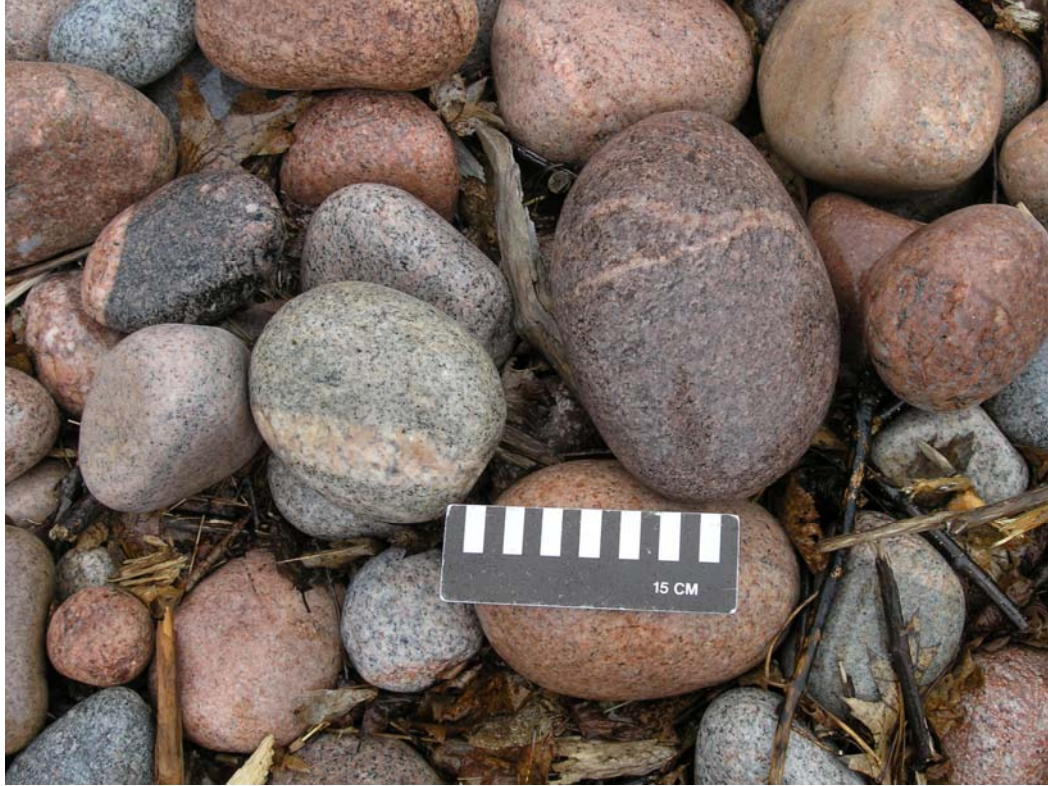
**Line 1
Storm Ridge
(PA 283343)**

Photos were taken in October 2008 of sediment at Line 1, Black Brook Cove Beach, NS. Clast size measured from photos is provided in the text.
