**GEOLOGICAL SURVEY OF CANADA  
OPEN FILE 7053**

**2011 Canadian High Arctic Seismic Expedition:  
CCGS Louis S. St-Laurent  
expedition report**

**D.C. Mosher**

**2011 Canadian High Arctic Seismic Expedition:  
CCGS Louis S. St-Laurent expedition report  
August 18 – September 29, 2011  
Kugluktuk to Cambridge Bay, Nunavut**

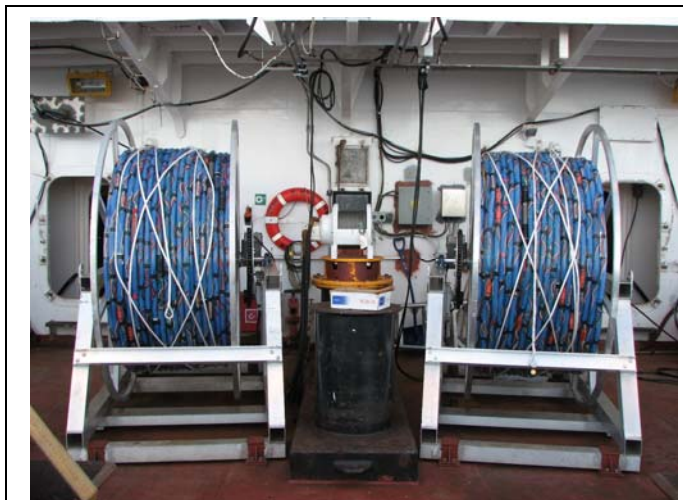
*Figure 1-4. Two Geometrics GeoEEL Streamers on the quarter deck of the LSSL.*

Two identical Geometric GeoEel streamers were utilised for seismic operations (Fig. 1-5). The active elements in the GeoEel streamer were Benthos Geopoint hydrophones. There were eight groups of four Geopoint hydrophone cartridges in each active section. Thus, with two active sections, the streamer had a total of 16 active channels, each with four Geopoint cartridges. Seismic signals received by the hydrophone elements in the streamer were digitized by 24 bit A/D modules which form part of the streamer system. Digitized seismic signals were sent up the cable as USP

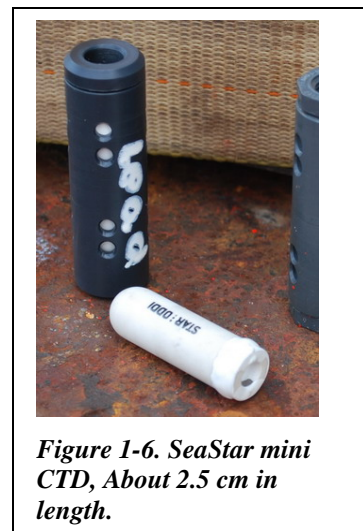
*Figure 1-6. SeaStar mini CTD, About 2.5 cm in length.*

Following the damage to the streamer on August 27, it was decided not to use the banana floats on the streamer. Lines 2-4 have no CTD information, therefore, as the depth sensors on the streamer seemed to be functioning appropriately. The depth monitoring CTD's were re- attached to the streamer jacket using black electrical tape

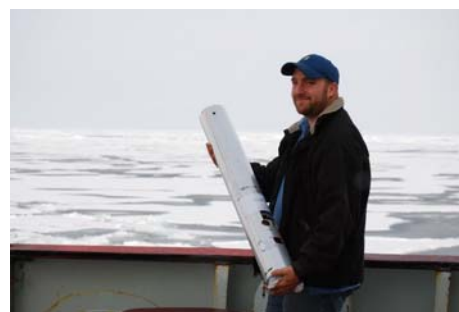
*Figure 1-14. Sonobuoy being deployed off the quarter deck*

Sonobuoy radio signals were recorded on GSCDIG #4 as standard SEG-Y files.

They were also recorded on the prototype Pledge digitizer in SEG-Y format. The seismic trigger pulse from the Zyfer clock was supplied to the digitizer to initiate recording. For the GSCDIG, the record window length was only slightly shorter than the fire period. For the Pledge digitizer, the sample window was set at 25 to 30 seconds. This system can synchronize multiple shots without a delayed write period.

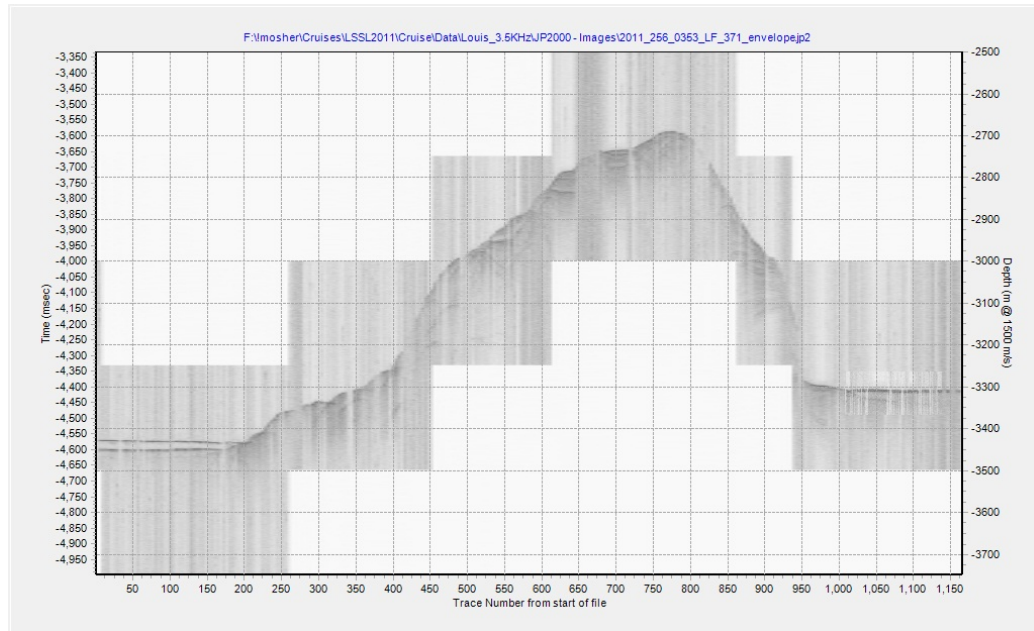
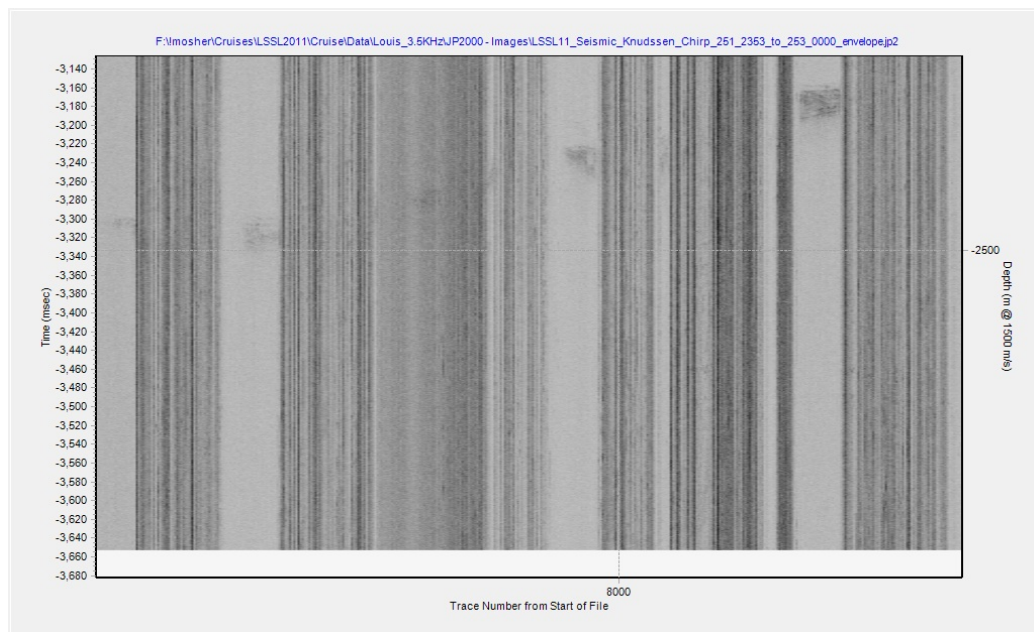
**Figure 1-17.** Chirp data acquired from the *Louis S. St-Laurent*. Top is a profile across one of the Sever Spur Ridges during which Healy broke ice ahead of the *Louis*. Below is a typical example of chirp data during heavy ice breaking operations.

During drydock, the Louis S. St-Laurent had a 12 element Knudsen 3260 Chirp subbottom profiler installed in its drop-keel. The system was operated by CHS during the expedition and was run for the entire expedition. Records are of mixed quality, depending on ice breaking conditions. Fig. 1-19 shows some examples of these data. All data were recorded in SEG Y format and converted to JP2000 post-acquisition. The USCGC HEALY joined the LOUIS S. ST-LAURENT on August 23rd and departed September 22nd, during which time additional hydrographic data were collected with their EM122 deep water multibeam and Knudsen Chirp profiler systems (Fig. 1-20). Total track length of the Healy while engaged on this program was 4,485 line-km.

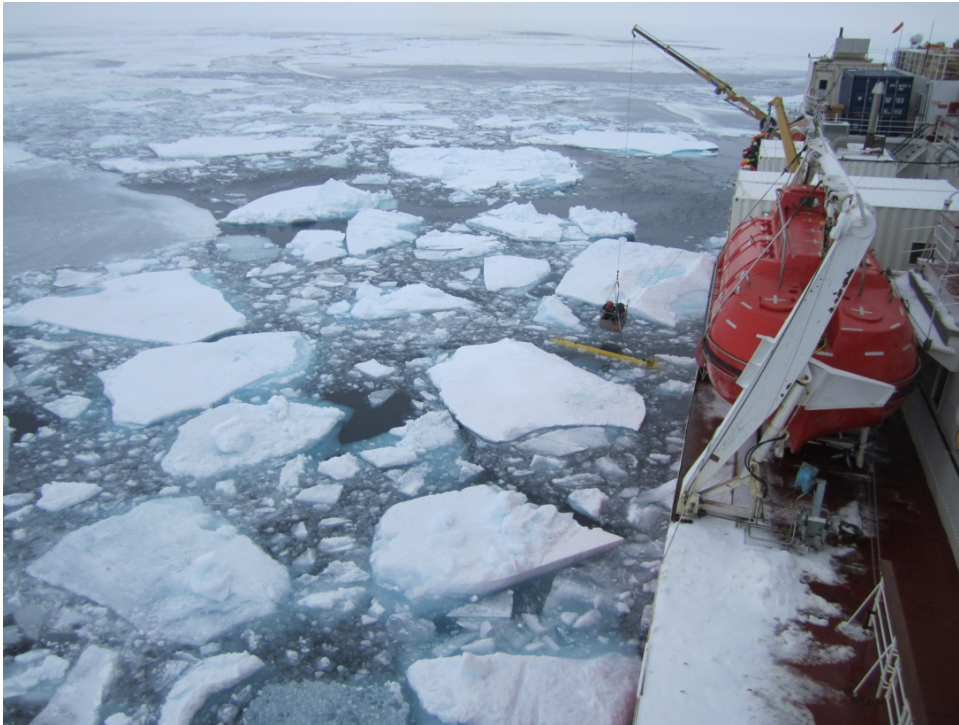
*Figure 1-23. AUV recovery.*

Despite close proximity of ice breaking activities by the LSSL to free the AUV, the only damage incurred was some cracking to the fiberglass nose cone and two damaged planes.

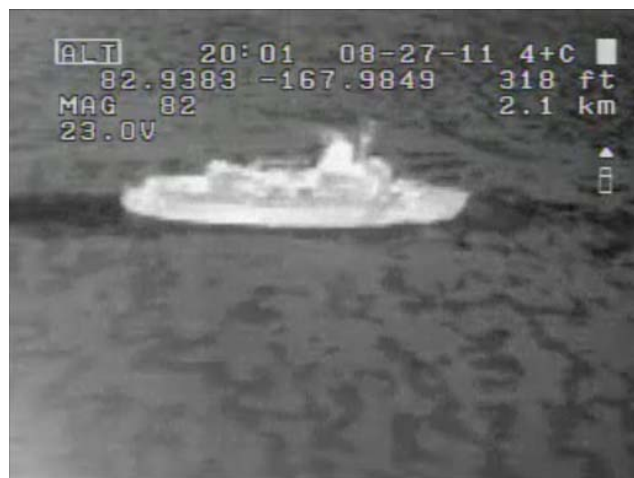
*Figure 1-35. Infrared image of the LSSL from the UAV.*

**Results:** On August 26th, with Cpt. Wackowski as Pilot-in-Command and Flight Engineer Steve Lloyd of Transport Canada as mission commander, the first-ever SUAS flight in the high Arctic from a moving icebreaker was conducted. RQ-11A "RAVEN", serial number 0613, flew for nearly 30 minutes for a distance of 4.7 kilometres from its origination point on the LSSL. It was launched from 'Monkey's Island' (Fig. 1-34) and recovered on the helicopter landing pad. A RAVEN remote video terminal was left onboard the HEALY and the RAVEN's full motion video (FMV) feed was viewed live on her bridge. Flight Engineer Lloyd served as the RAVEN mission commander for the remainder of the deployments, during which they conducted a series of successful day and night flights using both Electro-optical and Infrared cameras (Fig. 1-35), both from the ship and on the sea ice. All flights took place above the 80th parallel north (80° N). These flights demonstrated the benefits of on-demand, airborne FMV for intelligence, surveillance, reconnaissance (ISR) purposes for the crews of Arctic icebreaking vessels. After the initial demonstration of the

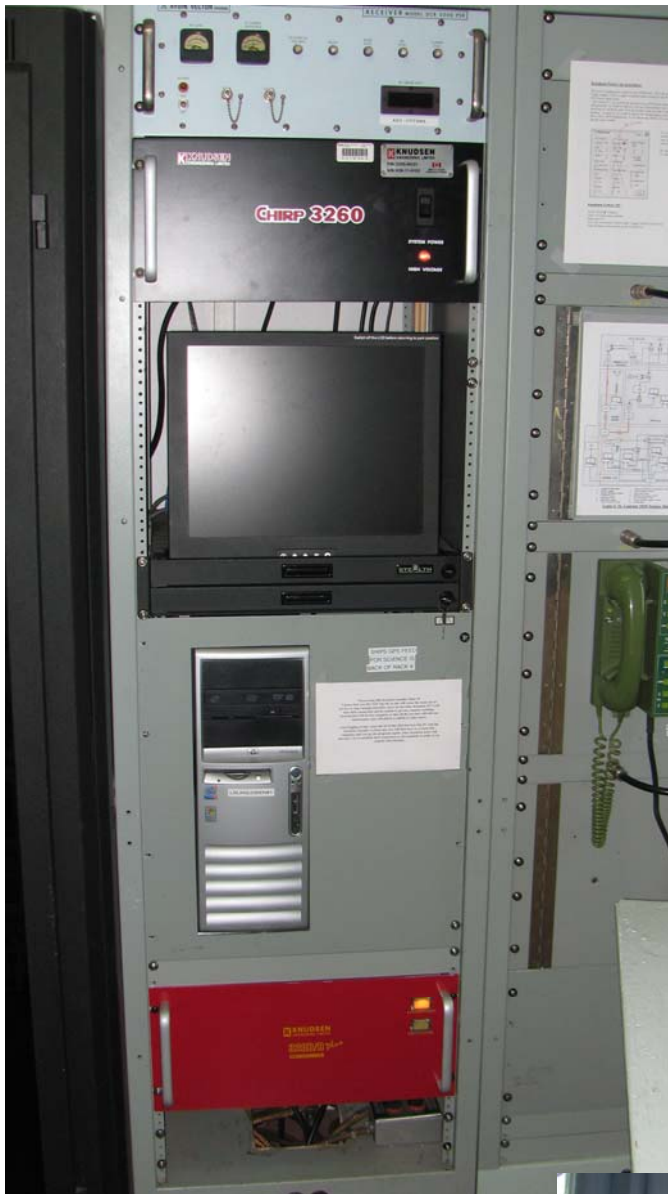
**Figure 2-2. Rack showing both Echo sounders located in the Oceanographic lab on the 300 level - Knudsen 320B/R Plus sounder (bottom) and PC interface (above). The sounder is a tri frequency configuration with the frequencies set to 30 kHz, 12 kHz and 3.5 kHz. Knudsen Chirp 3260 Dual Channel Echosounder is a dual frequency set to 3.5 kHz and 12 kHz (top) The Knudsen 3260 was controlled by a laptop computer shown below.**

Two single beam sounding methods were employed to collect data on the Louis S St Laurent: conventional ship sounding (Figure 2-3 to 2-6) and helicopter spot sounding (Fig. 2-5, 2-6). The only difference from past years was a 3.5 kHz transducer installed providing the ship the capacity to collect sub –bottom bathymetry data. The helicopter, a Messerschmitt MBB BO105, was used to maximize the area covered and to collect spot sounding data inaccessible to the ship because of ice conditions. AUV collected approximately 110 kms of data.

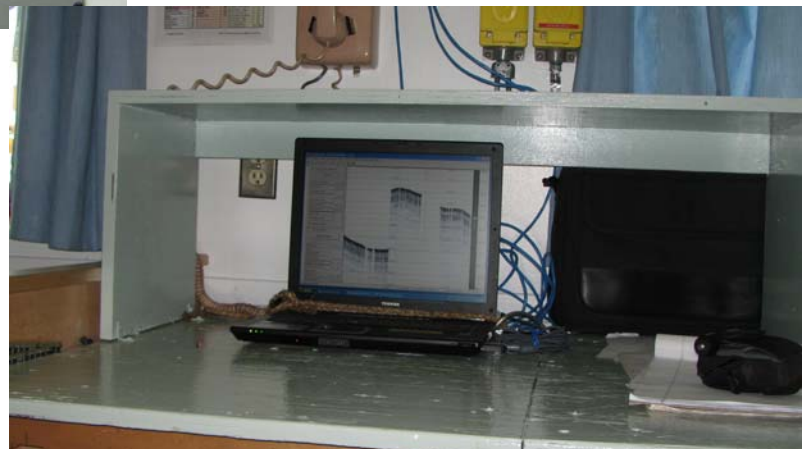
**Figure 2-3. Above diagrams of the Louis S St Laurent illustrate the locations of the transducers and the Novatel GPS antenna. 12 kHz transducer 2.03 m port, 10.3 m aft of GPS antenna and 3.5 kHz transducer is 2.03 m port and 18.3 aft of GPS Antenna**

The ship collected bathymetry using the Knudsen 320B/R Plus sounder attached to a 12 kHz transducer and a Knudsen 3260 sounder attached to the 3.5 KHz transducer. The 3.5 kHz transducer configuration was installed during dry dock operations this spring.

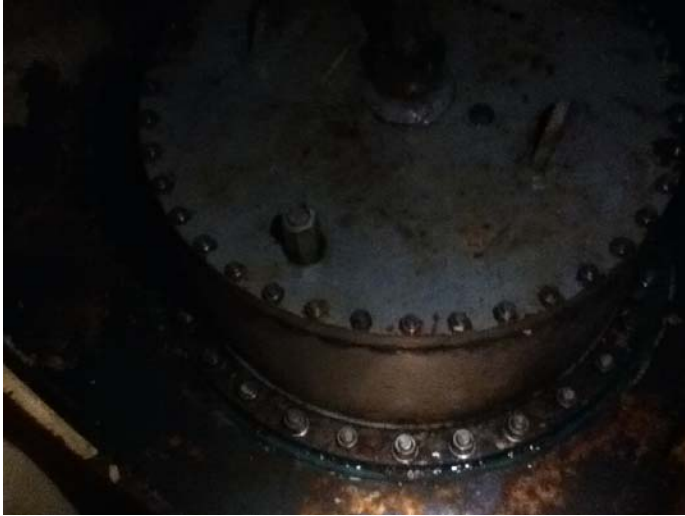
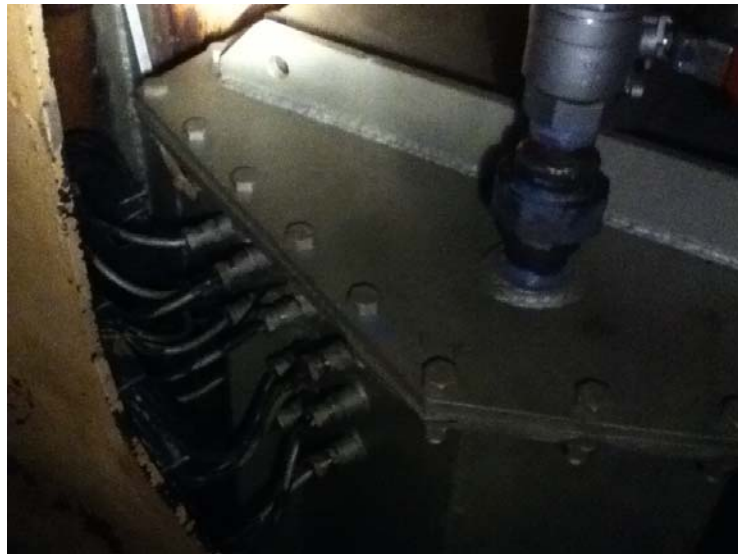
12 kHz transducer well

3.5 kHz transducer with 12 element-transducer well

**Figure 2-4 Photos of the 12 kHz and 3.5kHz transducer wells.**

The systems use Chirp pulse generation technology. The Knudsen 320B/R sounder system was operated remotely using Knudsen Echo Control Client and Echo Control Server software via a network connection in the aft seismic lab. The Knudsen 3260 was operated remotely using a remote connect software. The 3.5 kHz transducer performed significantly better (quality) with the newer Knudsen 3260 sounder. Both sounders are capable of dual frequency operations but the older Knudsen 320B/R was problematic when coupled to both transducers. The sounder would stop periodically and require a software restart/reboot of the computer. The sounder was disassembled and reassembled with no noticeable issues apparent. A laptop computer with remote desktop software was installed which was networked to the aft seismic lab for control of the Knudsen 3260 sounder. As when sounding with an icebreaker, bottom detection was lost due to interference from ice/ship's bubbler system and sea state. Knudsen Echo Control Client and Echo Control Server software was used for acquisition and PostSurvey software was used for viewing during post processing of the data.

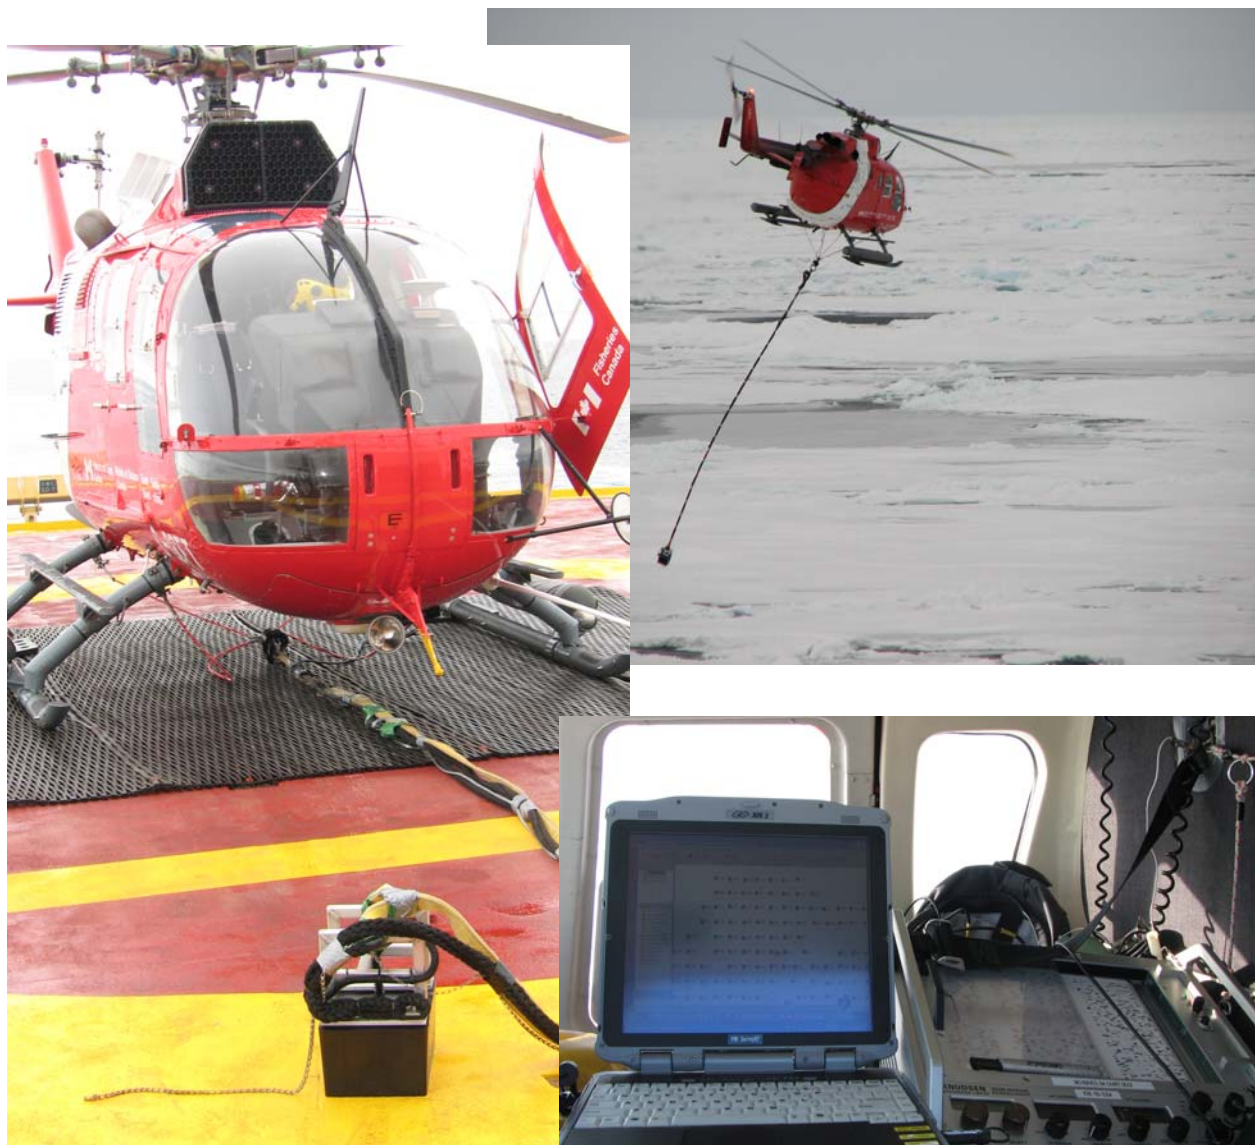
**Figure 2-5. Helicopter Spot sounding (12 kHz) setup.**

As in previous years the Knudsen sounder and computer interface on the ship would periodically lock up and require a system reboot. The spot sounding procedure was done in open water. The open water technique was achieved by slinging the transducer below the helicopter and placing into the water while in a hover. The Knudsen 320M was used which was prone to HF radio transmissions interference (reset sounder) and simply required a ground wire to the aircraft frame to rectify the problem. The sounders were set to a fixed velocity of 1500 ms/sec and then corrected to an averaged true velocity derived from the sound velocity casts. In the open water, marks were placed on the tether to which the pilot would submerge the transducer and this number was applied as a draft value to the sounding. The whole process under ideal conditions was expected to take 2 to 4 minutes per location. The ice conditions were in most cases was lighter than previous years. The data was logged to a laptop and post processed in Excel. The helicopter logged 14.1 hours of flight time to collect 75 spot soundings. As in the previous seasons the weather hampered the operations.

A small chain was added to the sling below the transducer and grounded to the aircraft frame (hook). This eliminated most of the static electrical charge that the aircraft built up during flight. A break away electrical connection to the transducer point was also incorporated for emergency use. The laptop was not connected to helicopter power but ran on its internal batteries to eliminate any problems with static electricity.

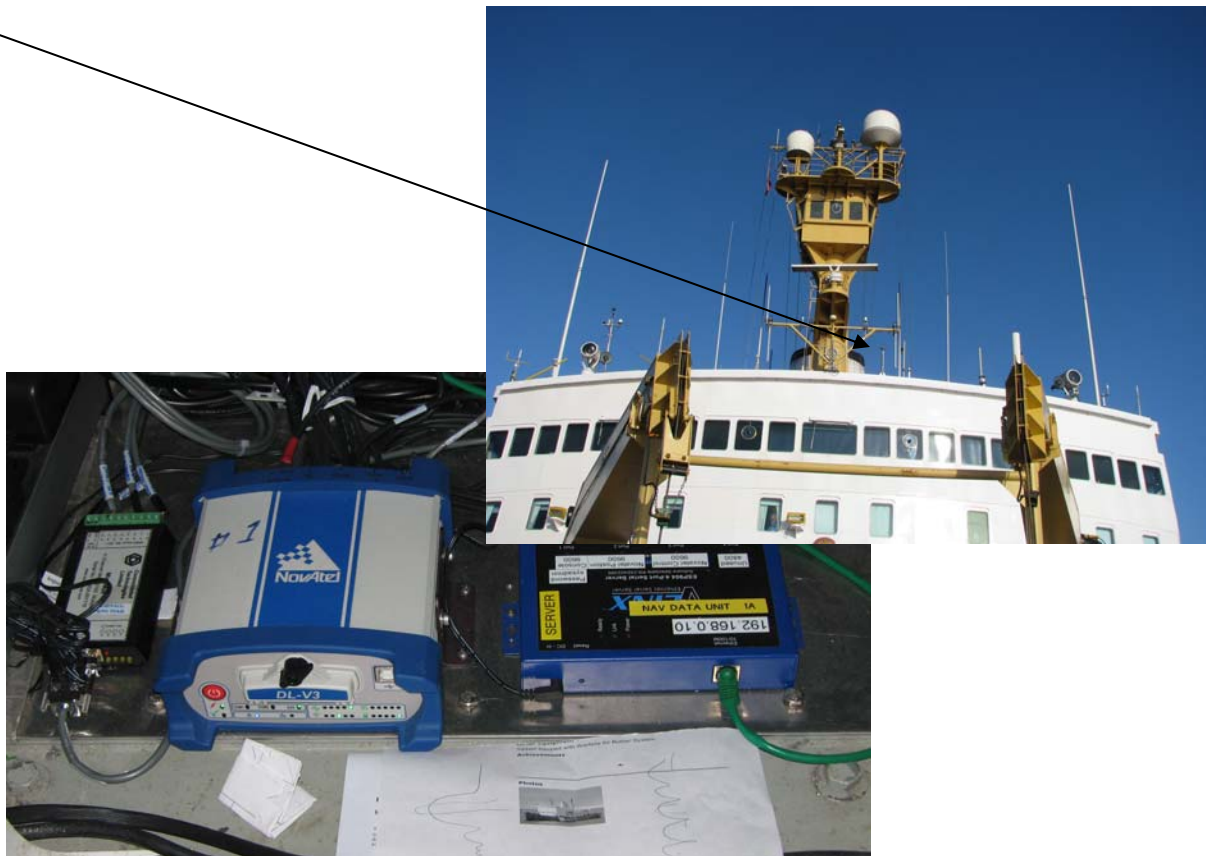
**Figure 2-7 NovAtel DL V3 GPS receiver in the equipment rack located on the bridge of the ship. Positional data were fed directly to the seismic lab for distribution to various computers and navigation programs.**

NovAtel GPS receiver located on bridge and antenna on monkey's island above ship's bridge.

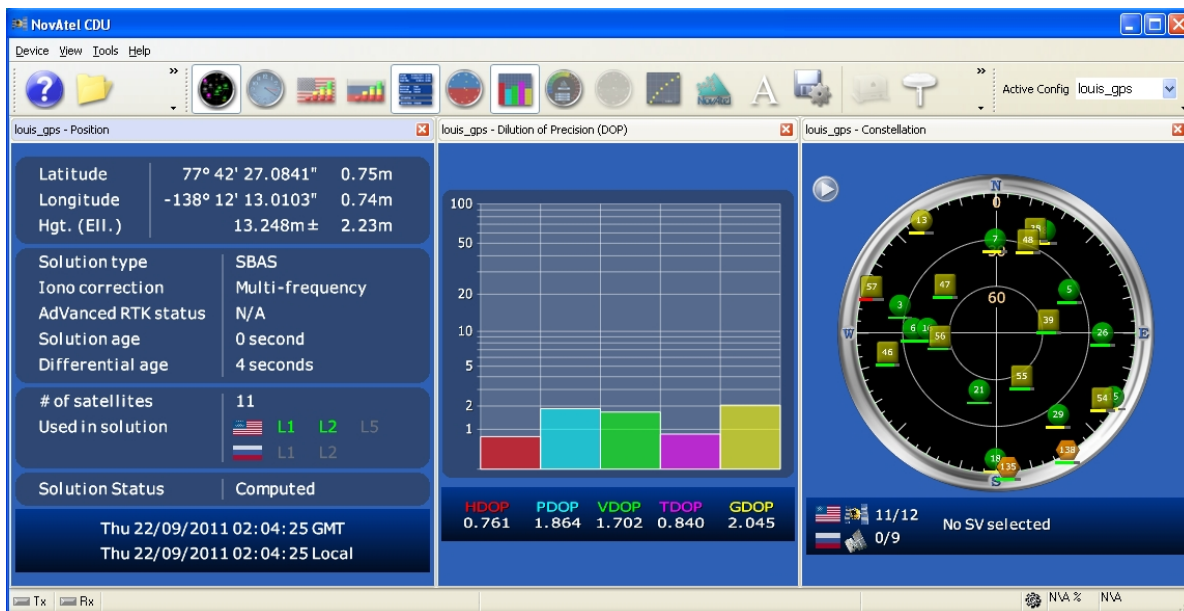
**Figure 2-8. NovAtel positional display**

NovAtel software (CDU – Control and Display Unit) interface was used to configure and monitor the NovAtel GPS receiver. The position was computed using corrections from a Satellite Based Augmentation System (SBAS).

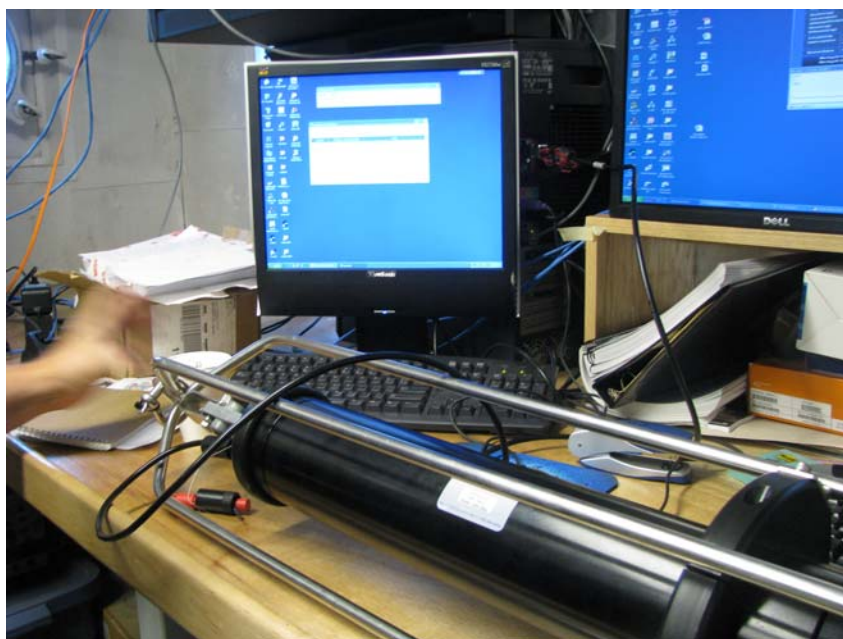
**Figure 2-9. SV Plus v2 using Smarttalk v2.27 software and Lockheed Martin Sippican hardware. The setup used for downloading XSV02 using the MK21 USB DAQ.**

XSV02 (eXpendable sound velocity) probes were launched by a hand launcher LM-3A from the stern of the ship into the ocean to measure the speed of sound to a depth of 2000 m. (maximum range for these probes) The data was communicated back to a digital data converter (MK-21 USB DAQ) and a computer onboard the ship by a fine wire.

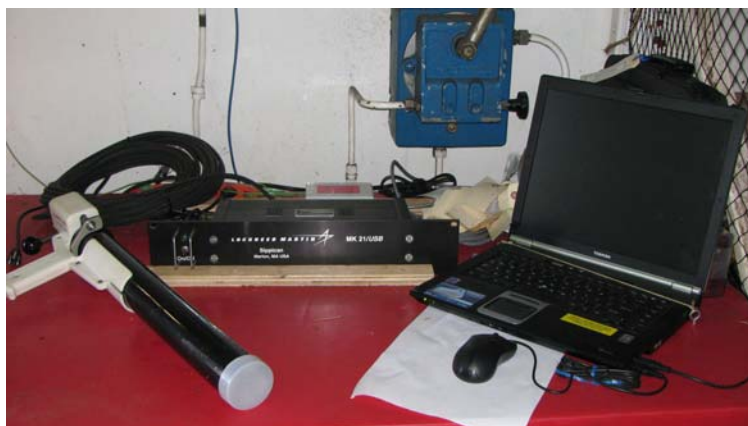
**Figure 2.10. Surface ship Bathythermograph Data Acquisition system and LM-3A Hand-Held Launcher (Lockheed Martin Sippican).**

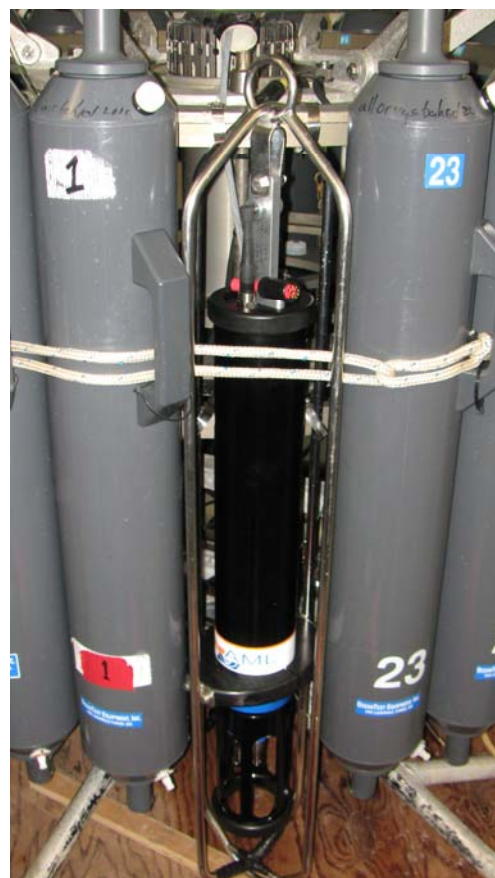
**Figure 2-11. (right) Science rosette with SV Plus v2 (sound velocity meter) depth range 5000 metres (SVP) mounted.**

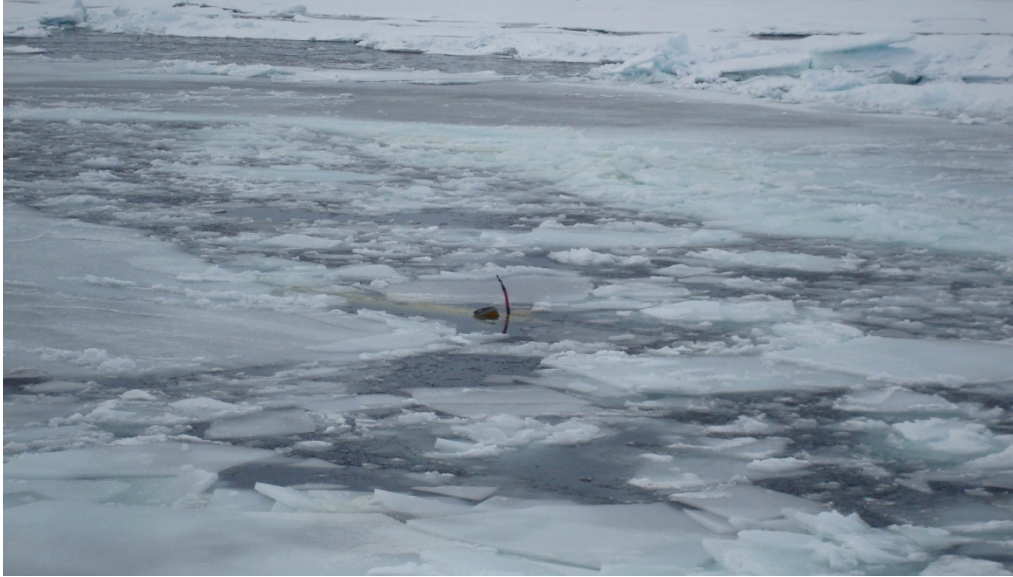
***Figure 3-1. Too little ballast***

A second in water check confirms that the AUV appears to be adequately ballasted. However after releasing the AUV from the crane, there was actually not enough ballast and the vehicle would only nose into the water with the aft antenna sticking out of the water (Fig. 3-1). It is suspected that the top fresh water layer is preventing the vehicle from sinking through into the sea water layer beneath.

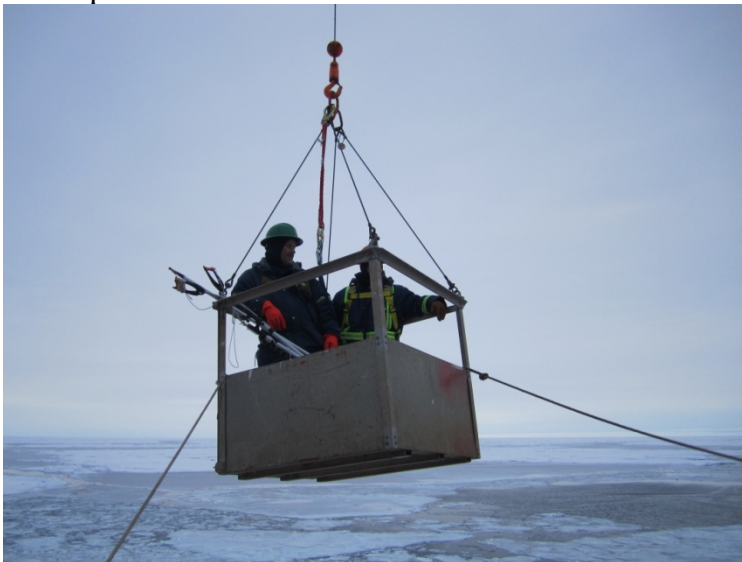
***Figure 3-2 Two Person Man-Basket***

The AUV was recovered from the open pond using the 2 person man basket (Fig. 3-2) This technique worked well.

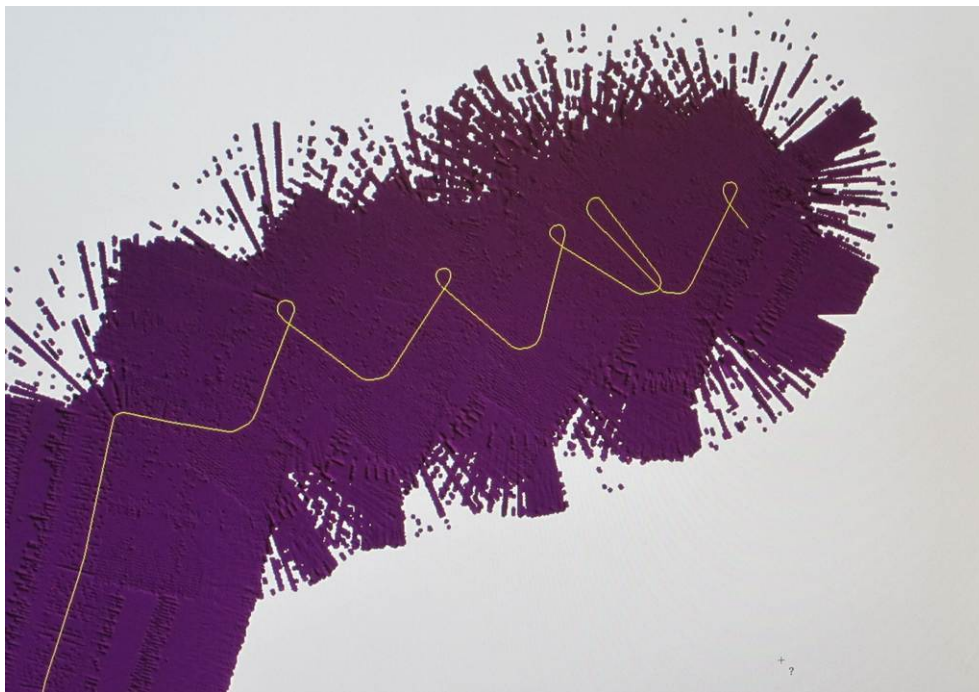
*Figure 3-9 Actual AUV Homing track pattern*

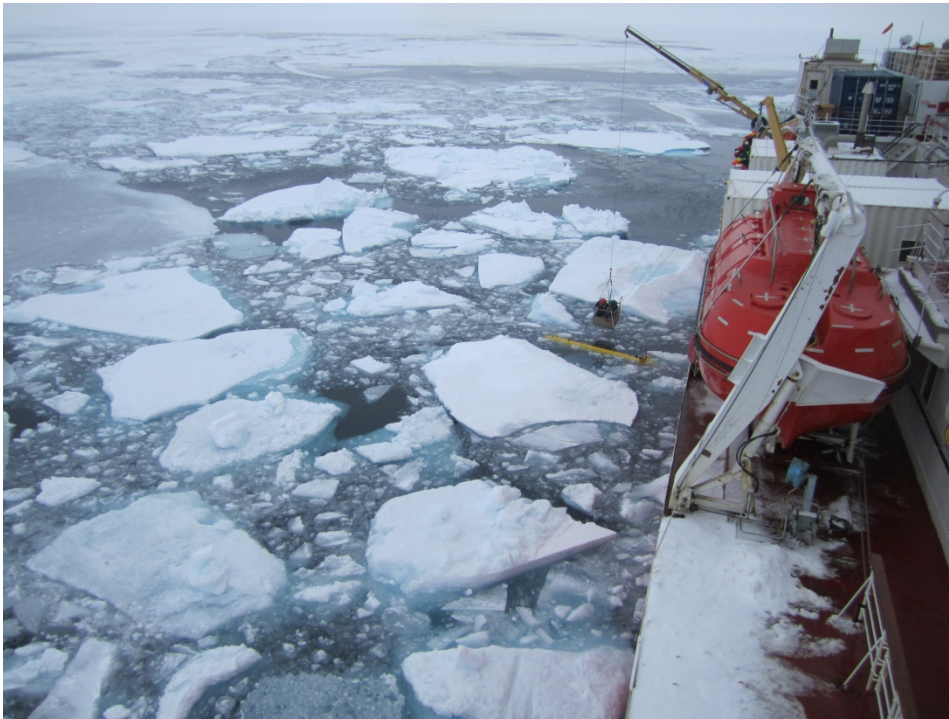
*Figure 3-13. AUV recovery*

The double man-basket method was used to attach all lines to B06. The ISE AUV team member in the man-basket mentioned using rubber gloves this time which kept his hands dry, with no loss of dexterity. By 1317 lift and tag lines had been secured to B06. At 1330 B06 is secured on the cradle on the flight deck. A post dive check of the vehicle was conducted and the sonar data downloaded for analysis. The only damage incurred was some cracking to the fiberglass nose cone and two damaged planes. i.e. stripped stop pin which is sheared off. This should be relatively easy to repair.

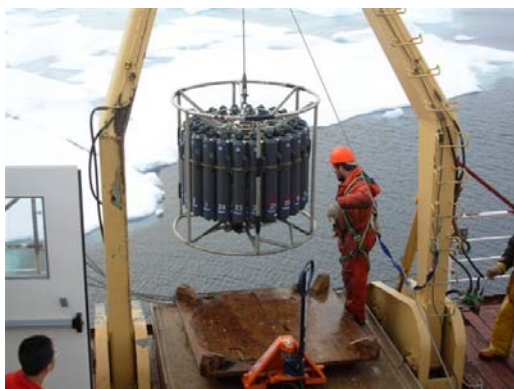
Figure 6.2. The 24-bottle rosette with the SBE9+ CTD is deployed from the mid-ships A-frame (photo 2008).

The SBE9+ CTD overall performance was good. Editing and calibration have not yet been done, but the data will likely meet or exceed the SBE9+ performance specifications given by Seabird. Header information of position, station name, and depth has not been quality controlled yet. Salinity and oxygen were sampled from the water and can be used to calibrate the sensors.

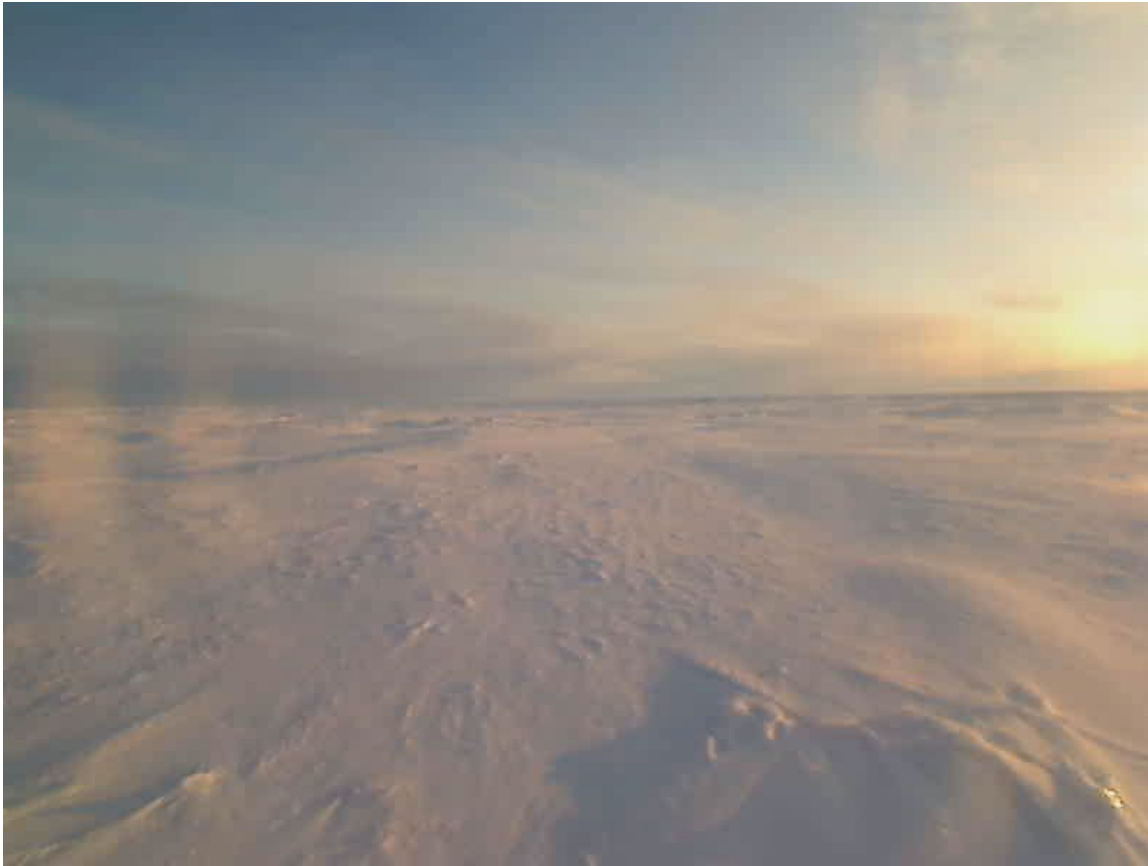
Met data

The ice surrounding O-buoy 4 (apr. 88.1° N and 160° W) recorded through the “eye” of the web camera on September 19, 2011.

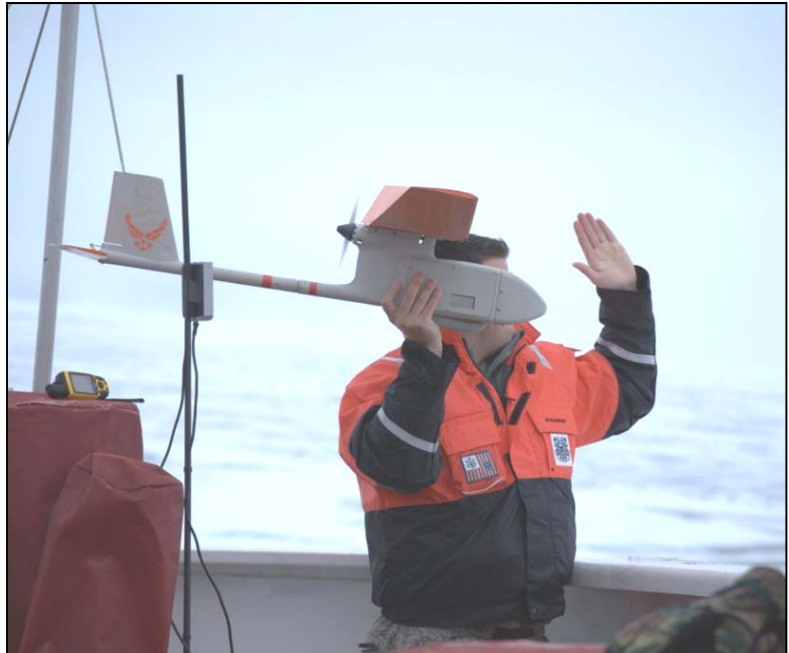
RQ-11A seconds before first high Arctic flight

RAVEN “A” model was selected as preferred airframe for Arctic Icebreaker flights for several reasons, including:

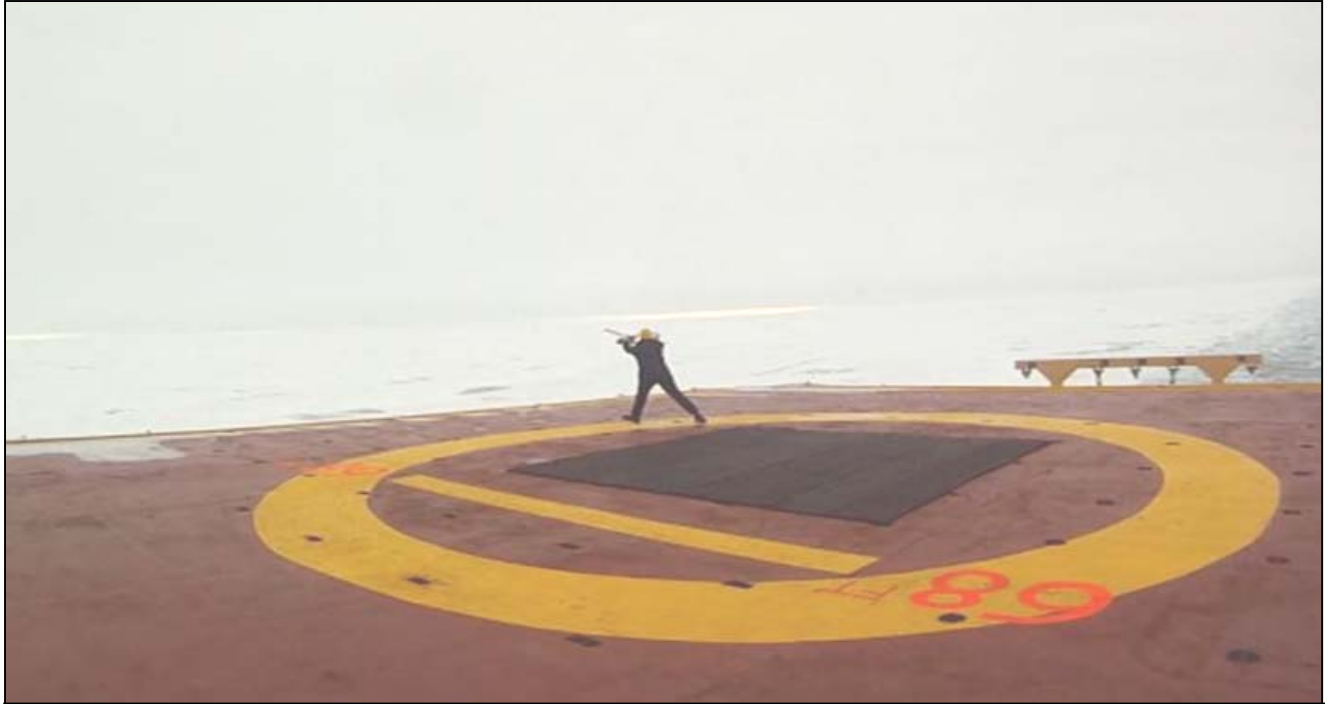
RQ11 capture by Canadian Coast Guard Cadet on deck of CGC LOUIS, September 2, 2011 (flight 4)

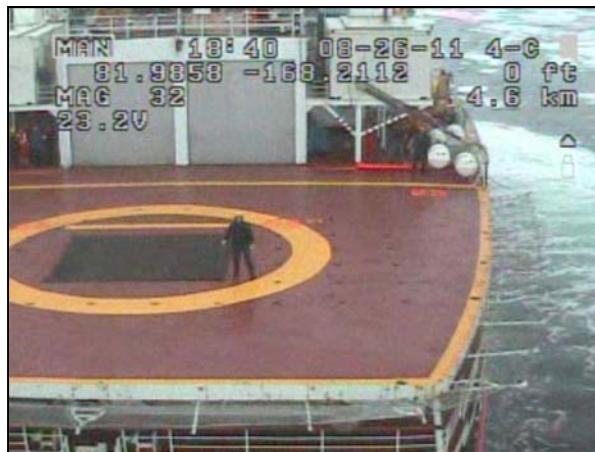
RAVEN flight 1 on final approach

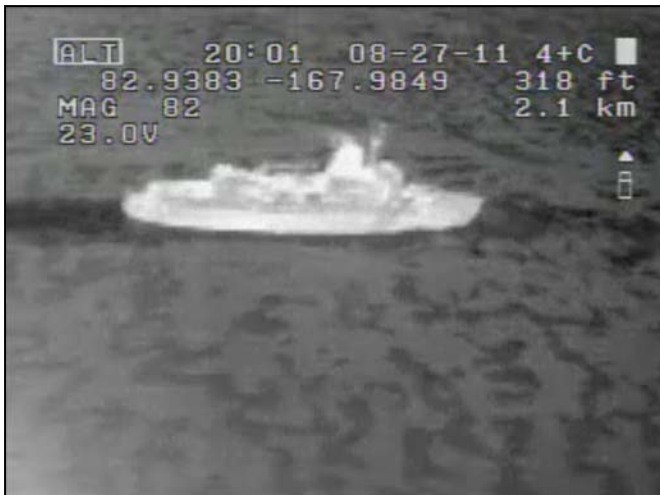
LOUIS on IR Camera (white hot)

Date: 27 August 2011  
Duration: 50 minutes  
Launch: LOUIS antenna deck  
Recover: LOUIS Helicopter pad  
Camera: Side look IR  
Notes: Cold weather test for battery performance—no effects at 34 F. IR test in day conditions.

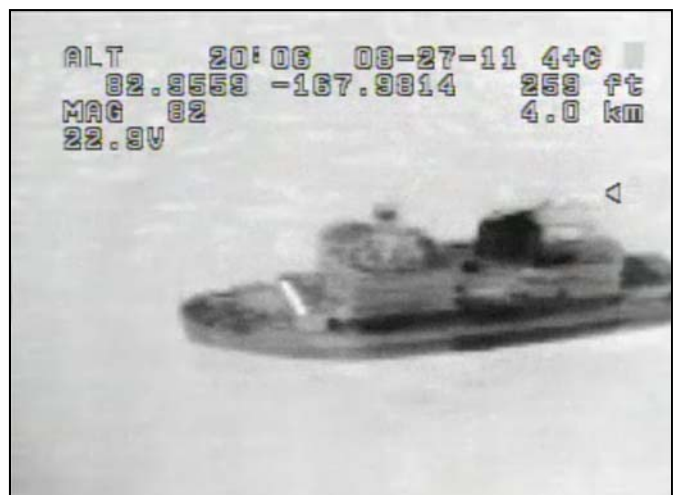
HEALY on IR Camera (black hot)

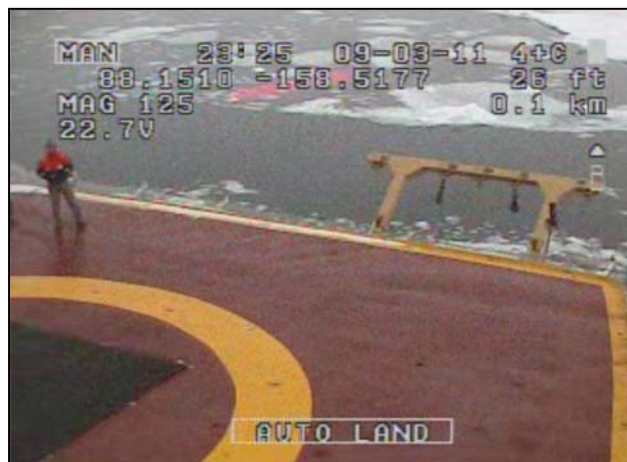
Bow-directed landing approach

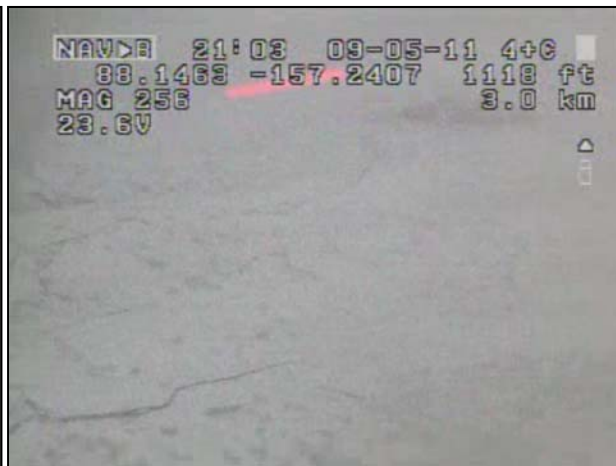
Forward-looking camera gathering frost

Note: Performed polar bear safety patrol. AV flew through freezing fog layer and front camera was iced over.

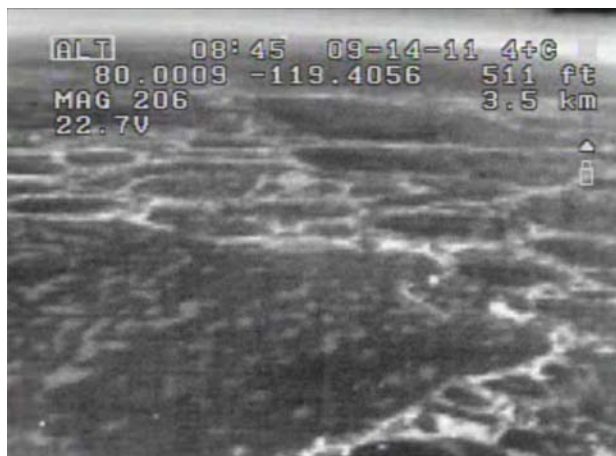
Ice ridges 2km ahead of LOUIS (white hot)

Notes: Performed Ice reconnaissance in light snow. Ice imagery with IR camera is excellent in night conditions. Flight occurred about 120 nautical miles from magnetic north pole. Magnetic compass did not deviate more than 10 degrees in level flight.

Furthermore, during periods of darkness manned ice reconnaissance is not feasible as neither ship is outfitted with a FLIR system. In this scenario, the RAVEN proved most useful. The IR cameras of the system worked very well in little-to-no light conditions. Pressure ridges in the ice showed up wonderfully at night.

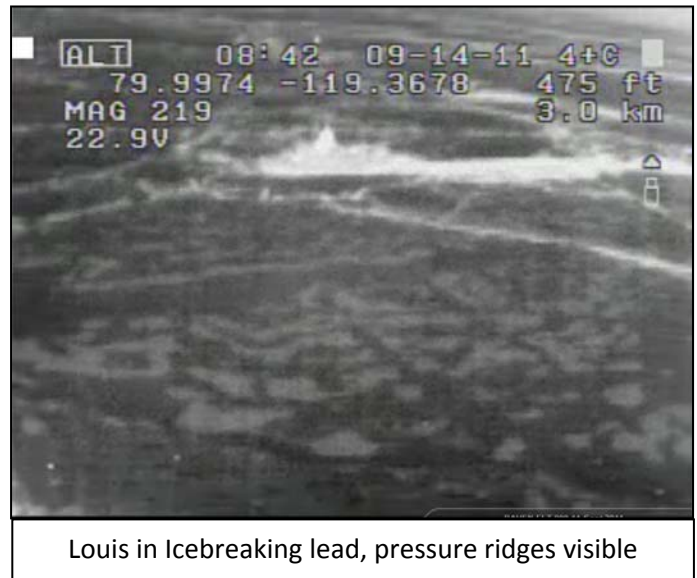
Louis in Icebreaking lead, pressure ridges visible
