ICE FREEZE-UP AND BREAKUP OBSERVATIONS IN
THE UPPER GRAND RIVER: 1980-81 AND
1981-82 OBSERVATIONS

J. Wong and S. Beltaos
84-2

Environmental Hydraulics Section
Hydraulics Division
National Water Research Institute
Canada Centre for Inland Waters

May 1983

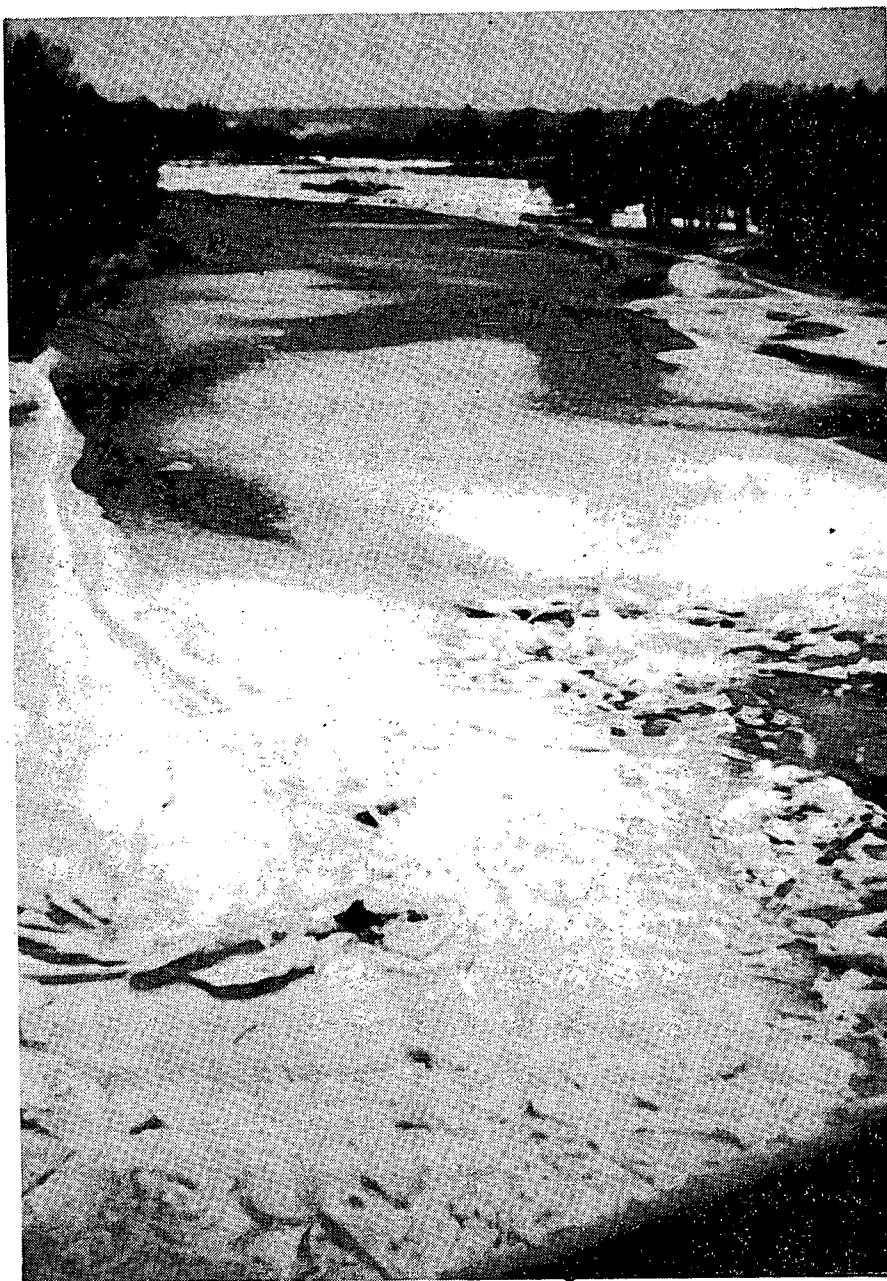
Figure 9 GRAND RIVER NEAR WEST MONTROSE, LOOKING
DOWNSTREAM FROM HWY. 86 BRIDGE. JAN. 1983.
NOTE ICE ACCUMULATIONS ON BANKS AND
LOWER STAGE OF SOLID ICE COVER.

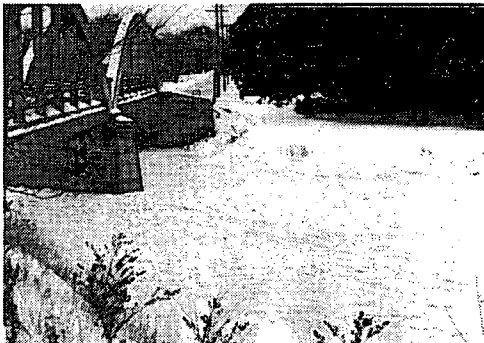
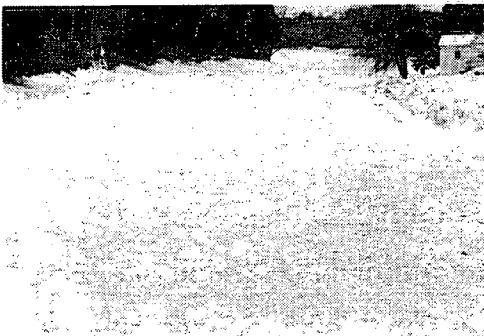
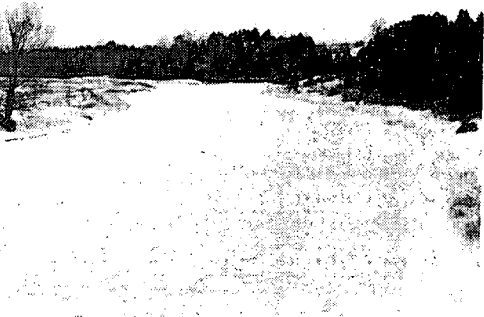
↑
A1-A3 Crossing east of Grand Valley.
Note rough ice surface.

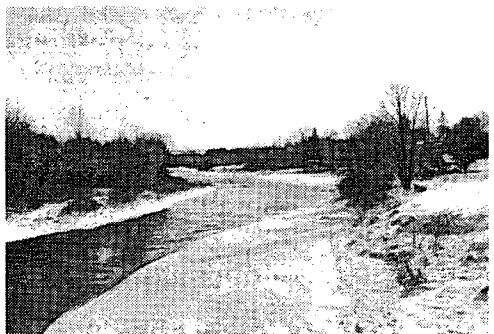
↑
A4-A6 Waldemar crossing. Note border
ice, moving frazil slush.

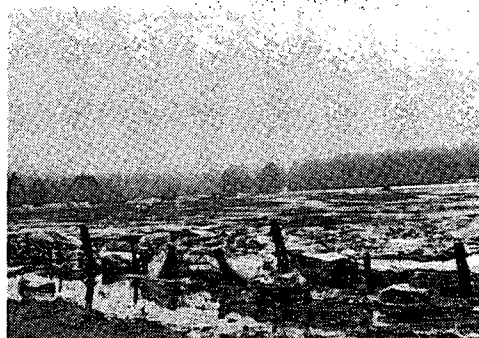
B8 Upper Belwood.
Flooded left bank, 1030h,
Feb. 21.

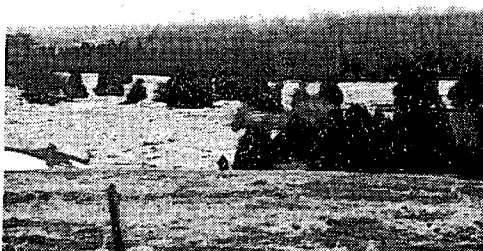
B11 Ice jam, 1600h, Feb. 21,
~2.8 km u/s Hwy. 86 crossing,
looking toward right bank.

At 1400 h, the head of a major jam was observed about 3 km upstream of the Highway 86 bridge. The toe of this jam was located about 100 m downstream of the bridge. Downstream of the toe there was relatively intact ice cover with open water side strips to, at least, Winterbourne.

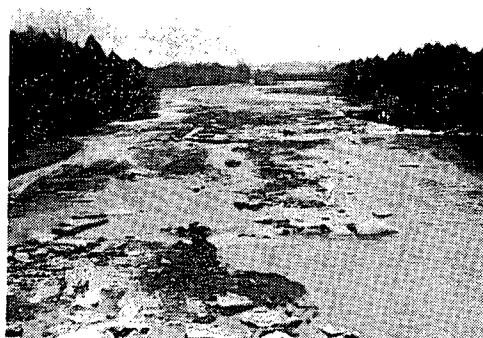
B12 Toe of jams, 1450h, Feb.21.
Looking d/s from Hwy. 86 bridge.

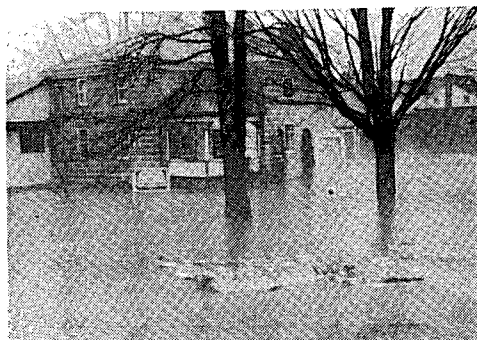
B14 Flooding of left bank near covered bridge, 1025h, Feb. 23.

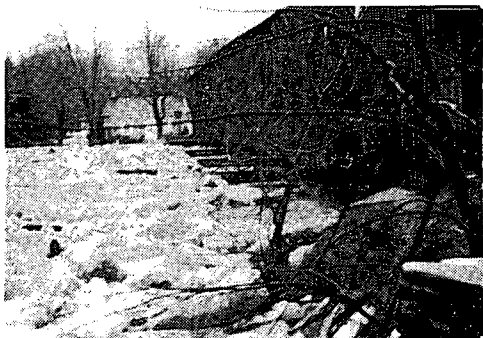
B15 U/s side of covered bridge, ice close to superstructure. 1110h, Feb. 23.

In the 1980-81 season, the freeze up process began in mid-December. The study reach produced a large amount of frazil and, in general, the ice cover was formed by a combination of the formation of border ice and the accumulation of the frazil ice particles. Warm weather and rainfall in mid-February caused a "premature" breakup, i.e., breakup with strong ice cover. Ice jams developed at numerous locations in section I and the water overflowed the banks at some of these locations. A major ice jam occurred at West Montrose where the ice level had risen to the base of the historical covered bridge. The jam, however, cleared with no damage to the bridge.

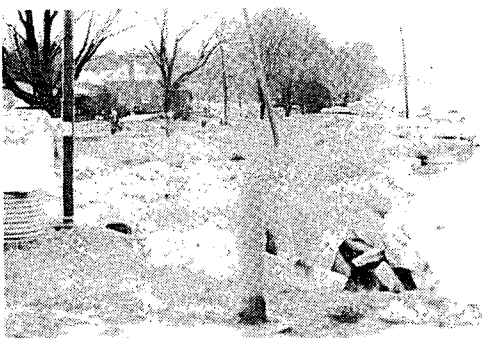
B17 Looking d/s from covered bridge, 1428h, Feb 23. Ice jam remnants on left bank.

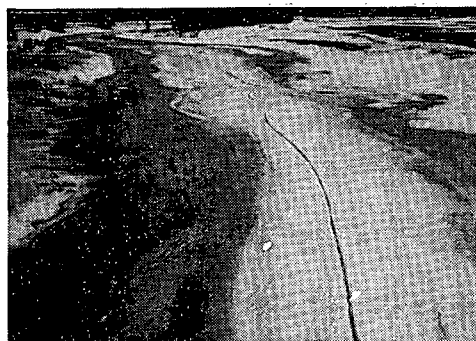
D2 2nd crossing u/s of Waldemar
looking u/s. 1238h, Mar. 25, 1982.

Cracks extending along the length of the river were visible at Leggatt, at the 3rd crossing upstream of Grand Valley, at the 2nd crossing upstream of Grand Valley, and at the 2nd crossing upstream of Waldemar. Photographs of these cracks are shown in Photos D1 and D2 in Appendix D.

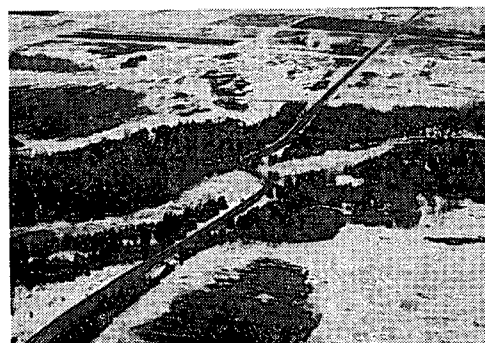
D5 Ice jam at Marsville gauge site.
1030-1120h, Mar. 30, 1982.

The ice conditions in the study reach remained the same until the rainfall began at 1940 h. The 600 m long jam at Marsville released at 2028 h and the water level dropped 0.53 m within 14 minutes after the

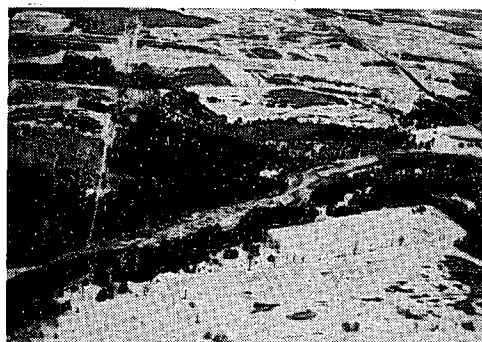
D8 Ice jam just u/s of Upper
Belwood crossing. 1030h, Mar.
30, 1982.

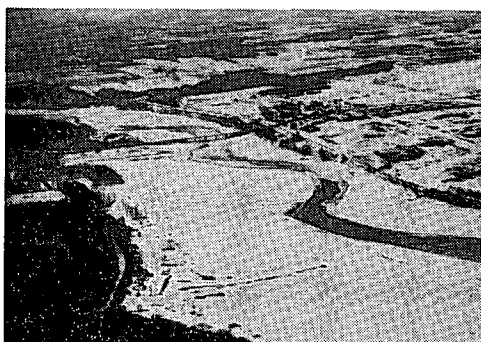
D9 Belwood crossing. 1030-1120h.
Mar. 30, 1982.

In section II, Lake Belwood was ice covered but the ice was deteriorating in the upper portion of the lake. The ice conditions at the Belwood crossing are shown in Photo D9.

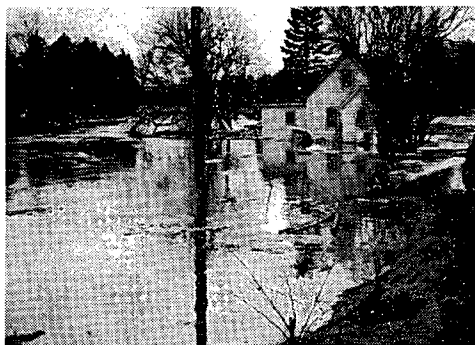
D16 Flooding along right bank d/s of Amaranth St. bridge in Grand Valley. 1456h, Mar 31, 1982.

In the 1981-82 season, freeze up began in mid-December and the breakup process took place between March 16 and April 1. Most of the field observations were done in section I where there were a number of small jams and one major jam in the town of Grand Valley. The (possibly) grounded toe of the major jam caused a rapid increase in water level resulting in extensive flooding in Grand Valley. The jam released at 1600 h on March 31.

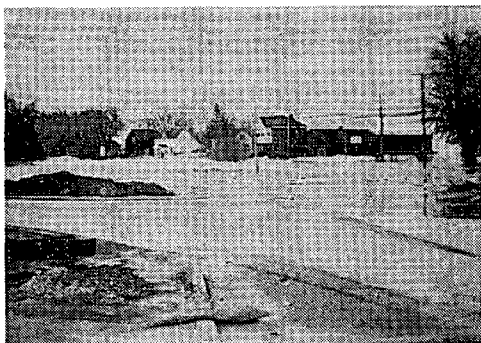
D17 Flooding along Hwy 25 near Main St. bridge in Grand Valley. 1148h, Mar. 31, 1982.

D18 Flooding along Hwy 25 near Main St. bridge in Grand Valley. 1148h, Mar. 31, 1982.

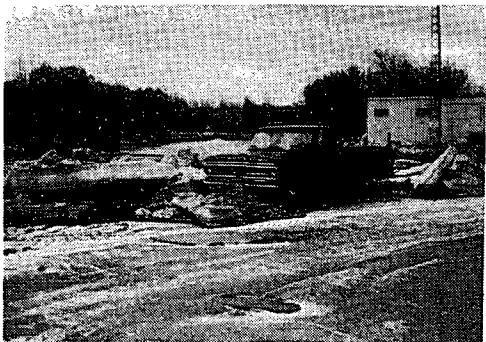
D19 Ice blocks remaining near Fire Hall in Grand Valley. 0725h. April, 1982.

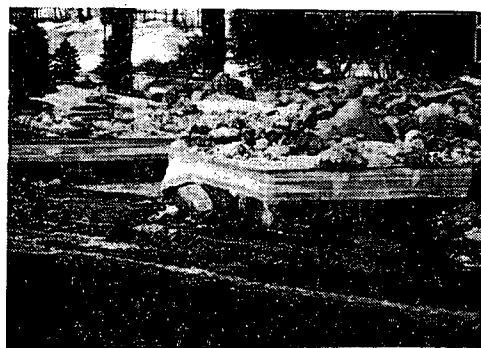
D20 Ice blocks remaining on Hwy. 25 d/s of Main St. bridge in Grand Valley. 0810h, April, 1982.
