**ICE FREEZE-UP AND BREAKUP
IN THE LOWER THAMES RIVER:
1981-82 OBSERVATIONS**

by
S. Beltaos

Environmental Hydraulics Section
Hydraulics Division
National Water Research Institute
Canada Centre for Inland Waters
P.O. Box 5050
Burlington, Ontario, Canada L7R 4A6

January 1985

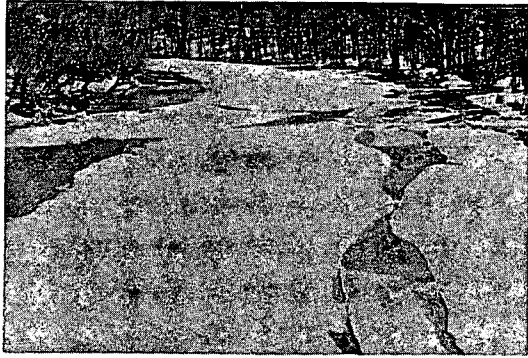
10. → D/S FROM DUTTON RD. BDG, 1200, MAR. 15. NOTE LONGITUDINAL AND TRANSVERSE CRACKS.

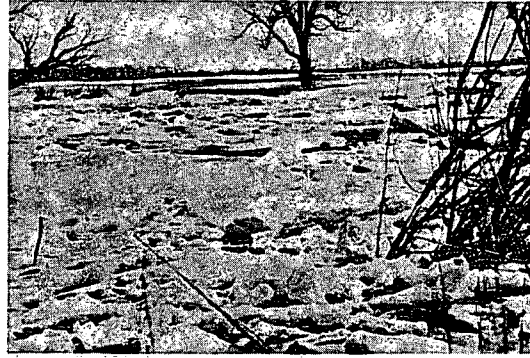
11. → LB NEAR FAIRFIELD MUSEUM, 1450, MAR. 14. HEAD OF JAM.

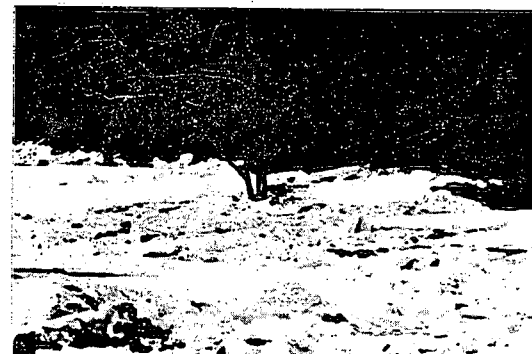
27. SAME VIEW AS IN PREVIOUS PHOTO,
DURING RELEASE OF JAM. NOTE MOVING
ICE AND HIGHER STAGE. 1350 MAR. 19.

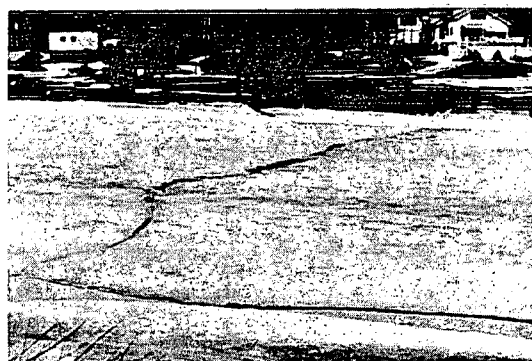
30. → LB. TRANSVERSE CRACK NEAR LTVCA OFFICE (CHATHAM) MAR. 16 (*).

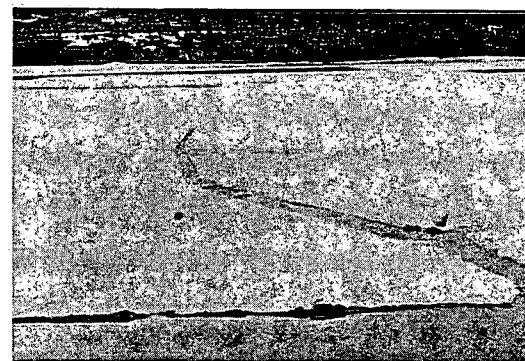
31. → LB. TRANSVERSE CRACK NEAR HOLIDAY INN (CHATHAM), 0900 MAR. 15.
