NWRI CONTRIBUTION 85-12

**ICE FREEZE-UP AND BREAKUP IN
THE UPPER GRAND RIVER:
1982-83 OBSERVATIONS**

by
J. Wong and S. Beltaos

May 1985
Revised September 1986

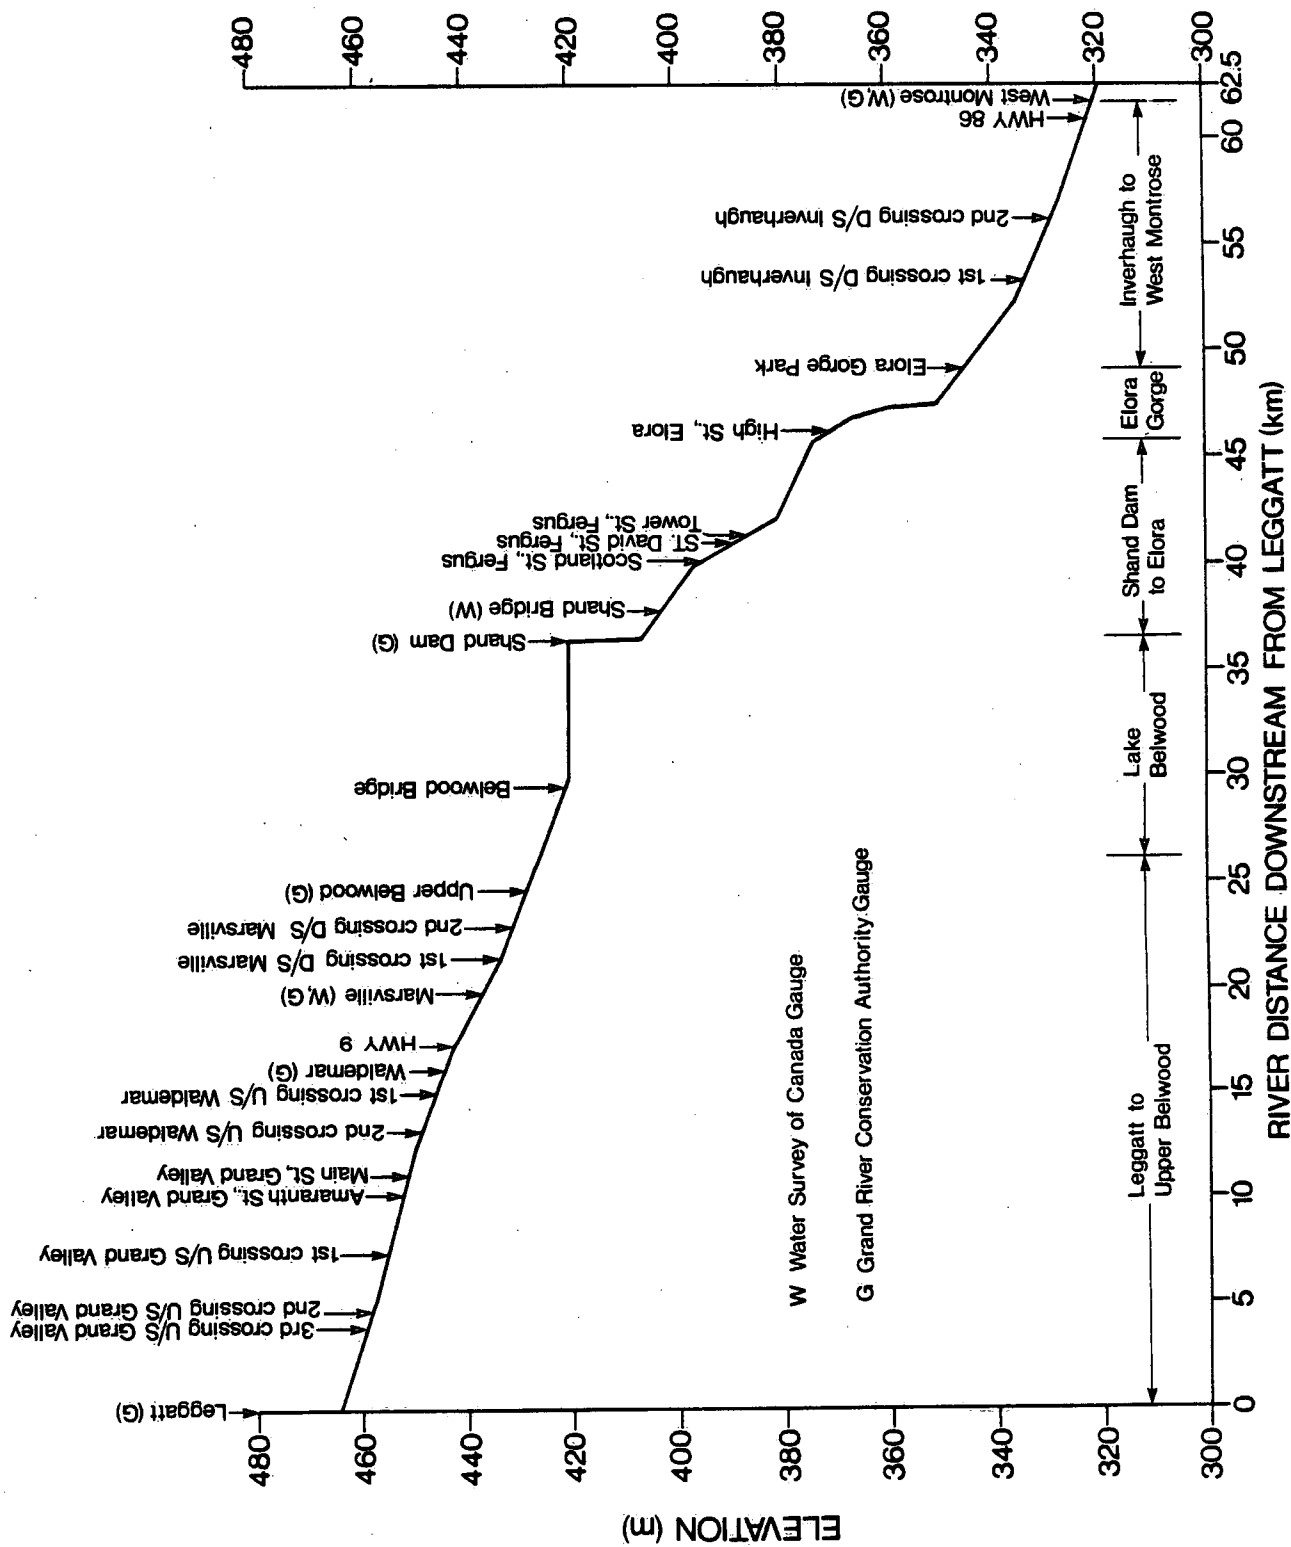
Figure 2 LONGITUDINAL PROFILE OF UPPER GRAND RIVER

Figure 2 is an approximate water surface profile of the study reach. Water surface elevations have been obtained from a series of 1:50,000 topographic maps at the intersections of elevation contours with the stream boundaries. Straight lines have been drawn between points representing successive contour intersections. River crossings and gauge locations are also shown in Figure 2.

The study reach may be divided into five sections as shown in Figure 2. The divisions are based on the average slopes and the ice regimes in the sections. The sections are listed below and their average slopes and lengths are summarized in Table 2.

There are three Water Survey of Canada (WSC) gauges and six Grand River Conservation Authority (GRCA) gauges within the study area. Locations of the gauges are noted in Figure 2 and Table 1. River characteristics for the three WSC gauges are summarized in Table 3 for the period 1970 to 1979. At Marsville, the minimum and maximum recorded daily discharges are 0.03 m³/s (July 1979) and 306 m³/s (April 1975). The ten-year average discharge is 7.70 m³/s. At this flow, the average open water width, depth and velocity in the vicinity of this site are calculated as 38.0 m, 0.63 m and 0.56 m/s based on nearby hydrometric surveys. The average river slope is approximately 2.31 m/km and the Manning coefficient of the river bed, n_b , is 0.052 at Q (discharge) = 7.70 m³/s.

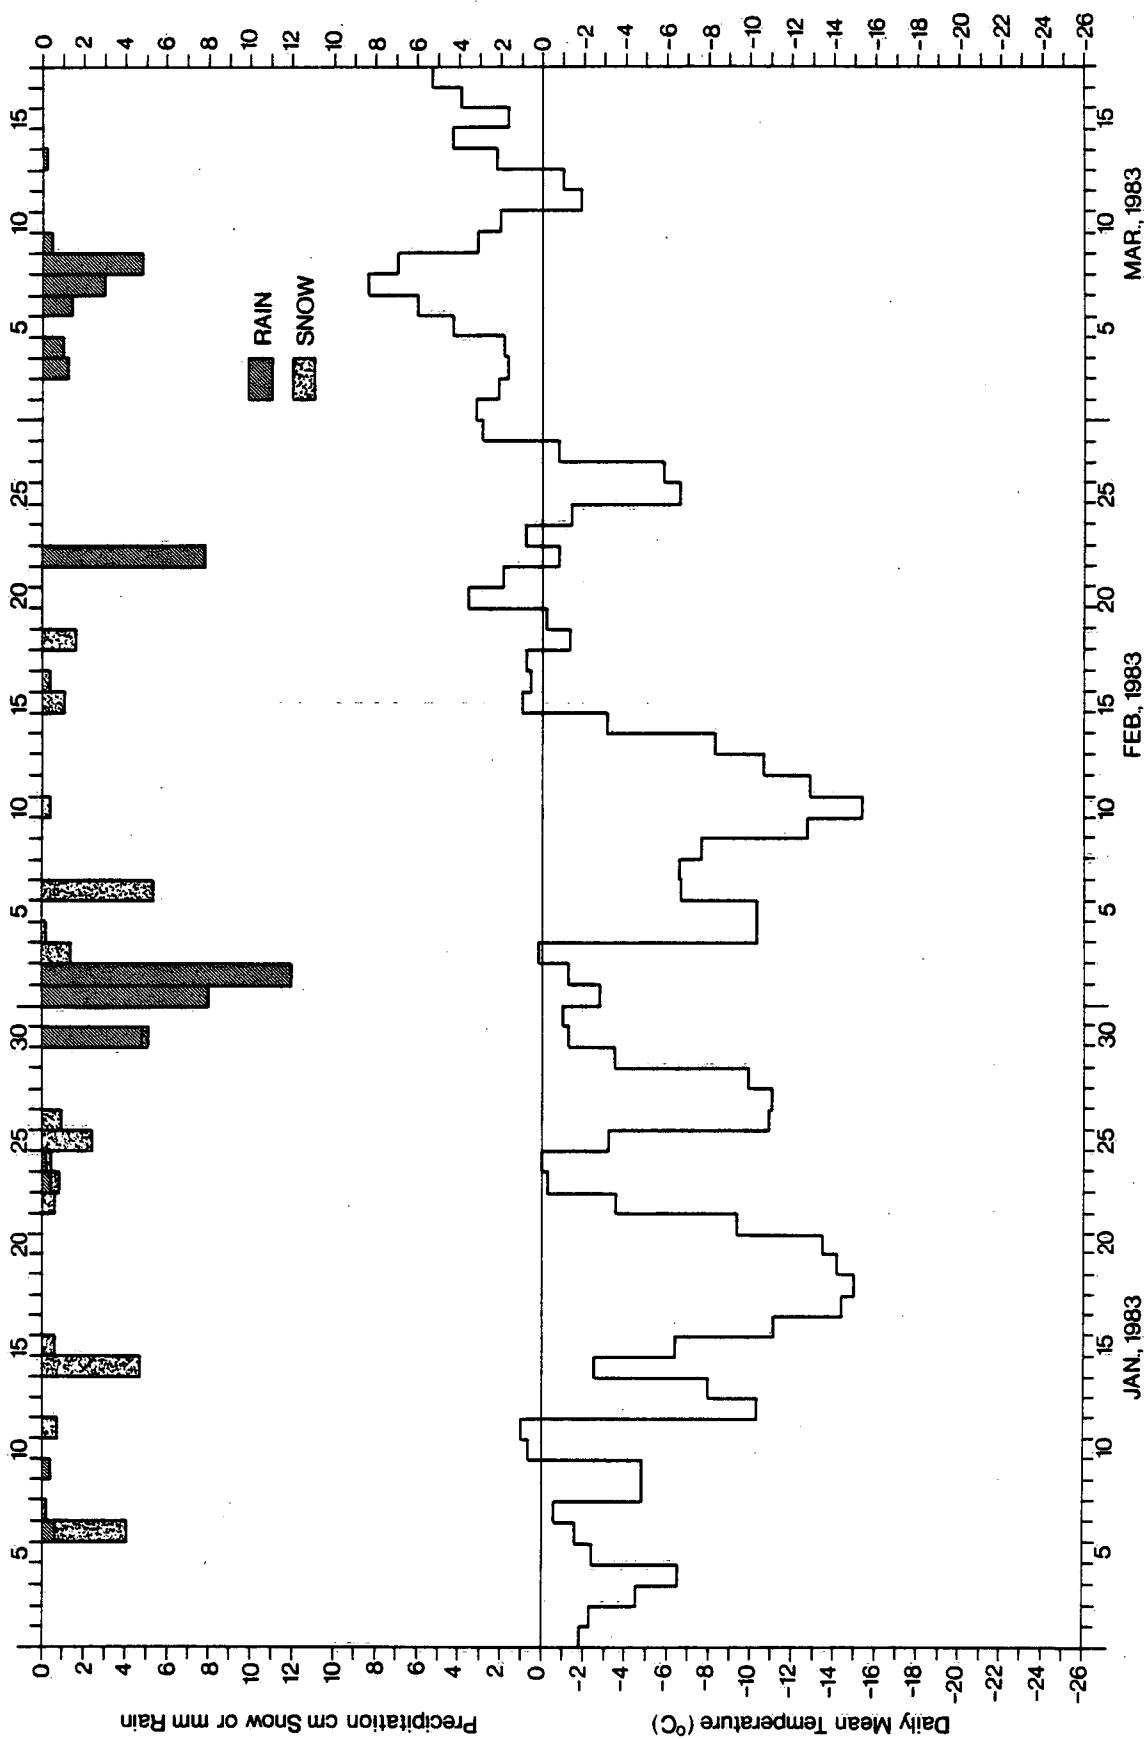
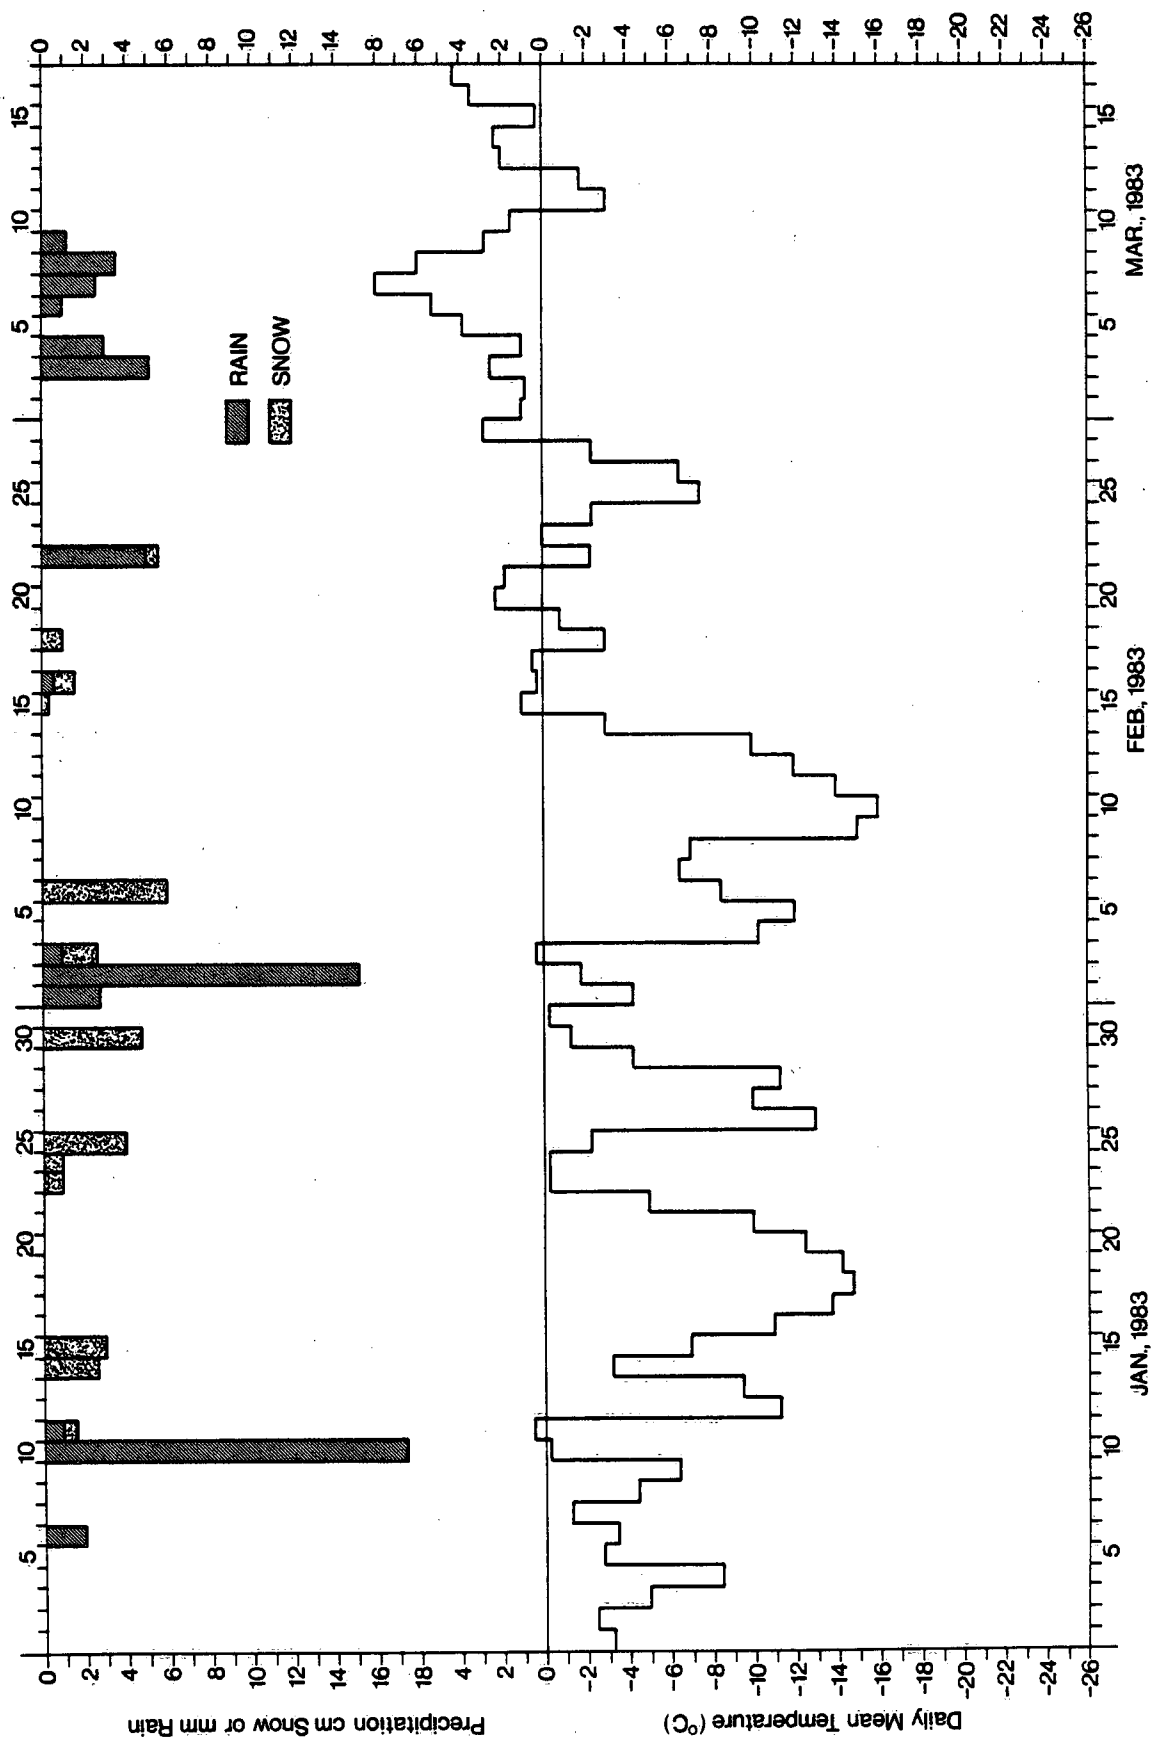
Figure 3a Daily Meteorological Data at Elora Station 1982-83

Figure 3b Daily Meteorological Data at Grand Valley WPCP Station 1982-83

Other factors which may account for the lower $Rate_{ic}$ are warmer temperatures between January 13 and 16 (Figures 3(a) and 3(b)) and a decrease in the discharge. Both factors would cause a reduction in frazil slush production. The water level variation with time during the freeze-up in Figure 4 shows that the average daily gauge reading on this date was $H_f = 1.45$ m (Elev. = 427.80 m). By 1423 h, the leading edge was ≈ 700 u/s of the bridge. $Rate_{ic} \approx 0.10$ km/h. The ice cover progressed at a faster rate after passing the Upper Belwood bridge.

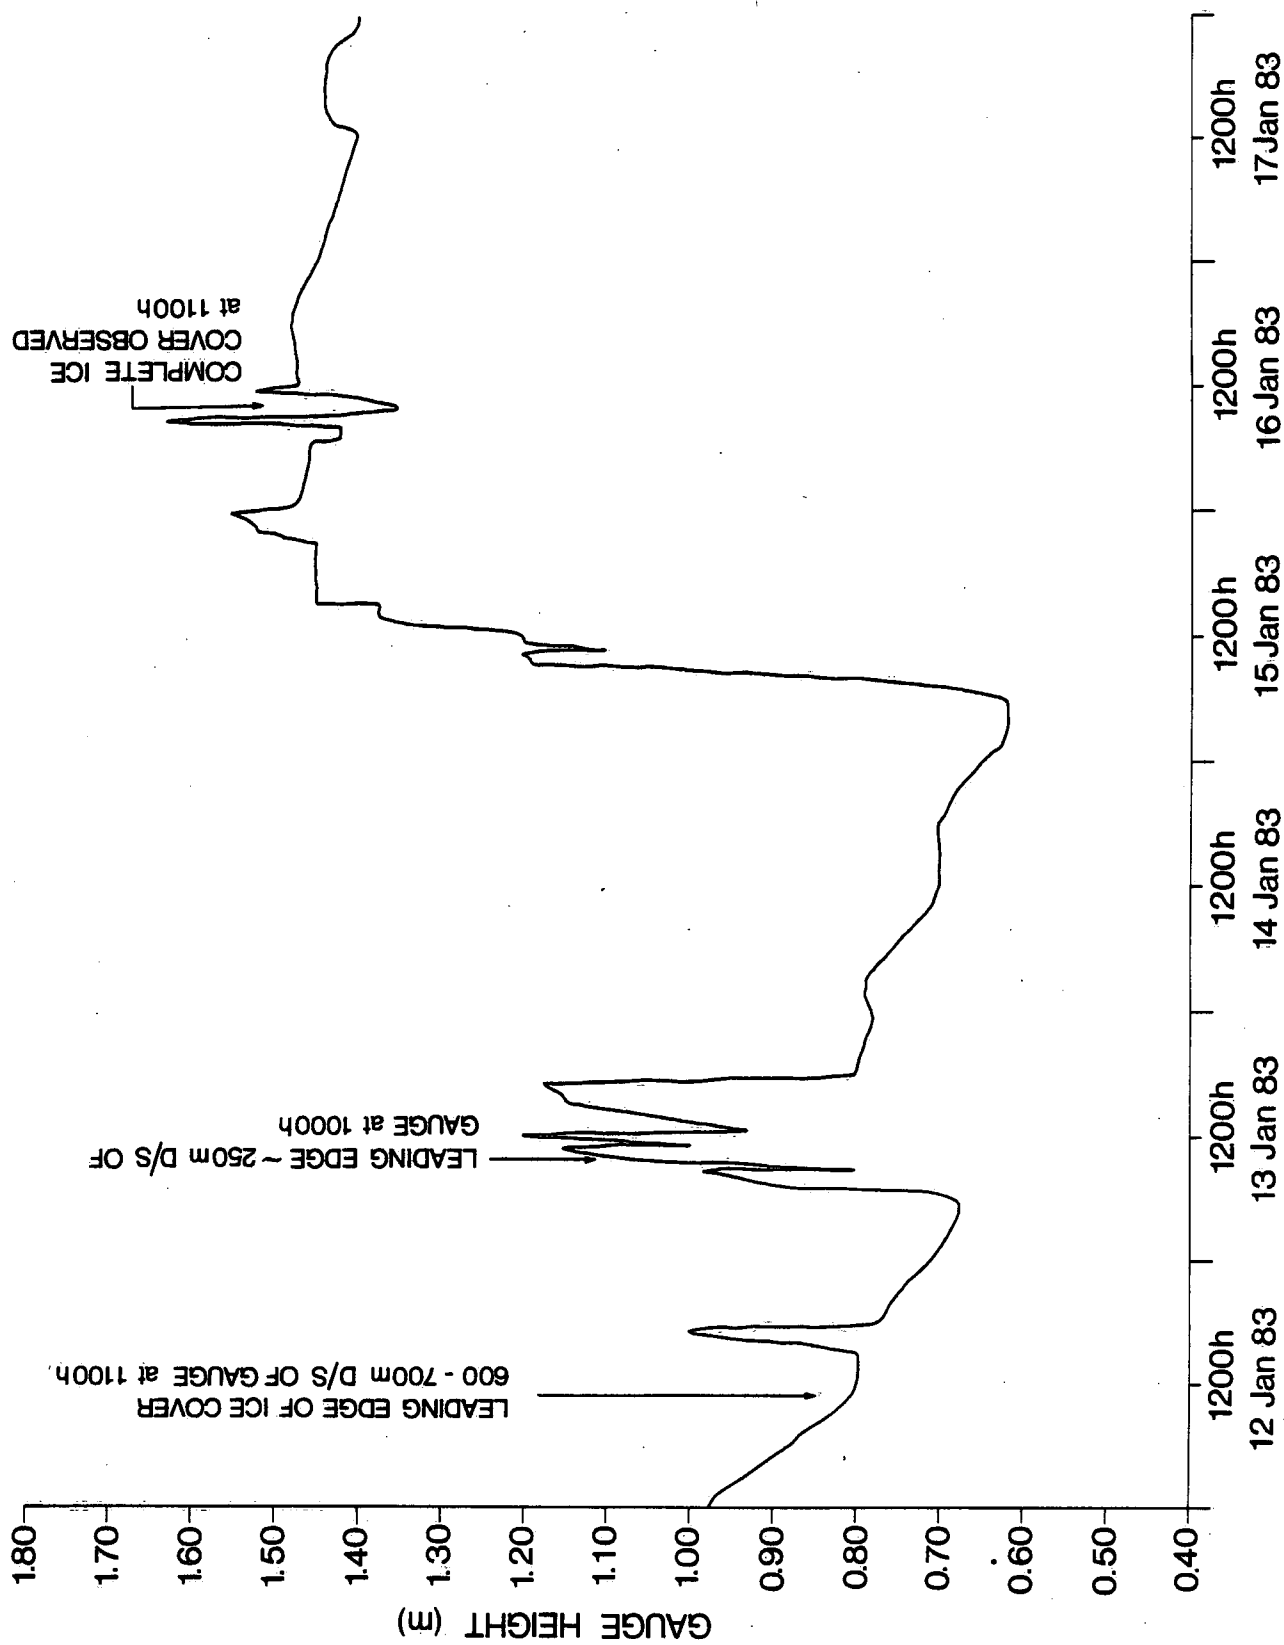
Fig.4 Water level variation with time at Upper Belwood. Freeze up 82-83. Jan 12-17, 1983.

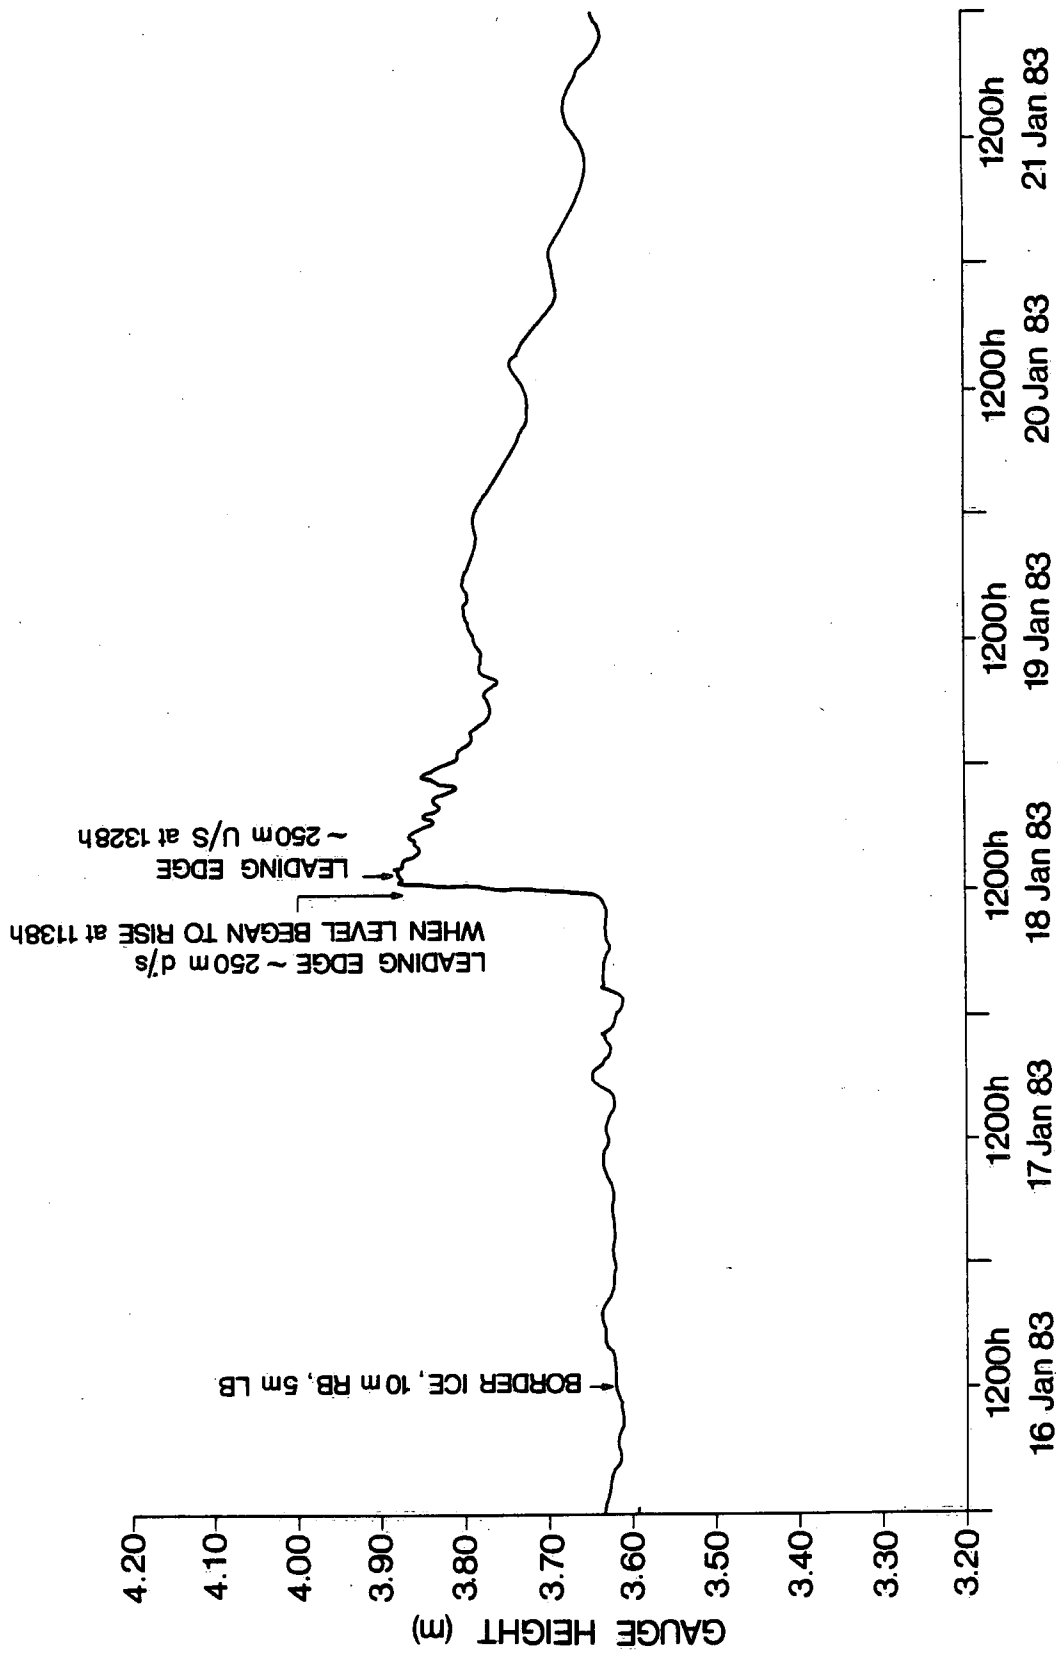
Fig. 5 Water level variations with time at Marsville. Freeze up 82-83. Jan 16 - 21, 1983.

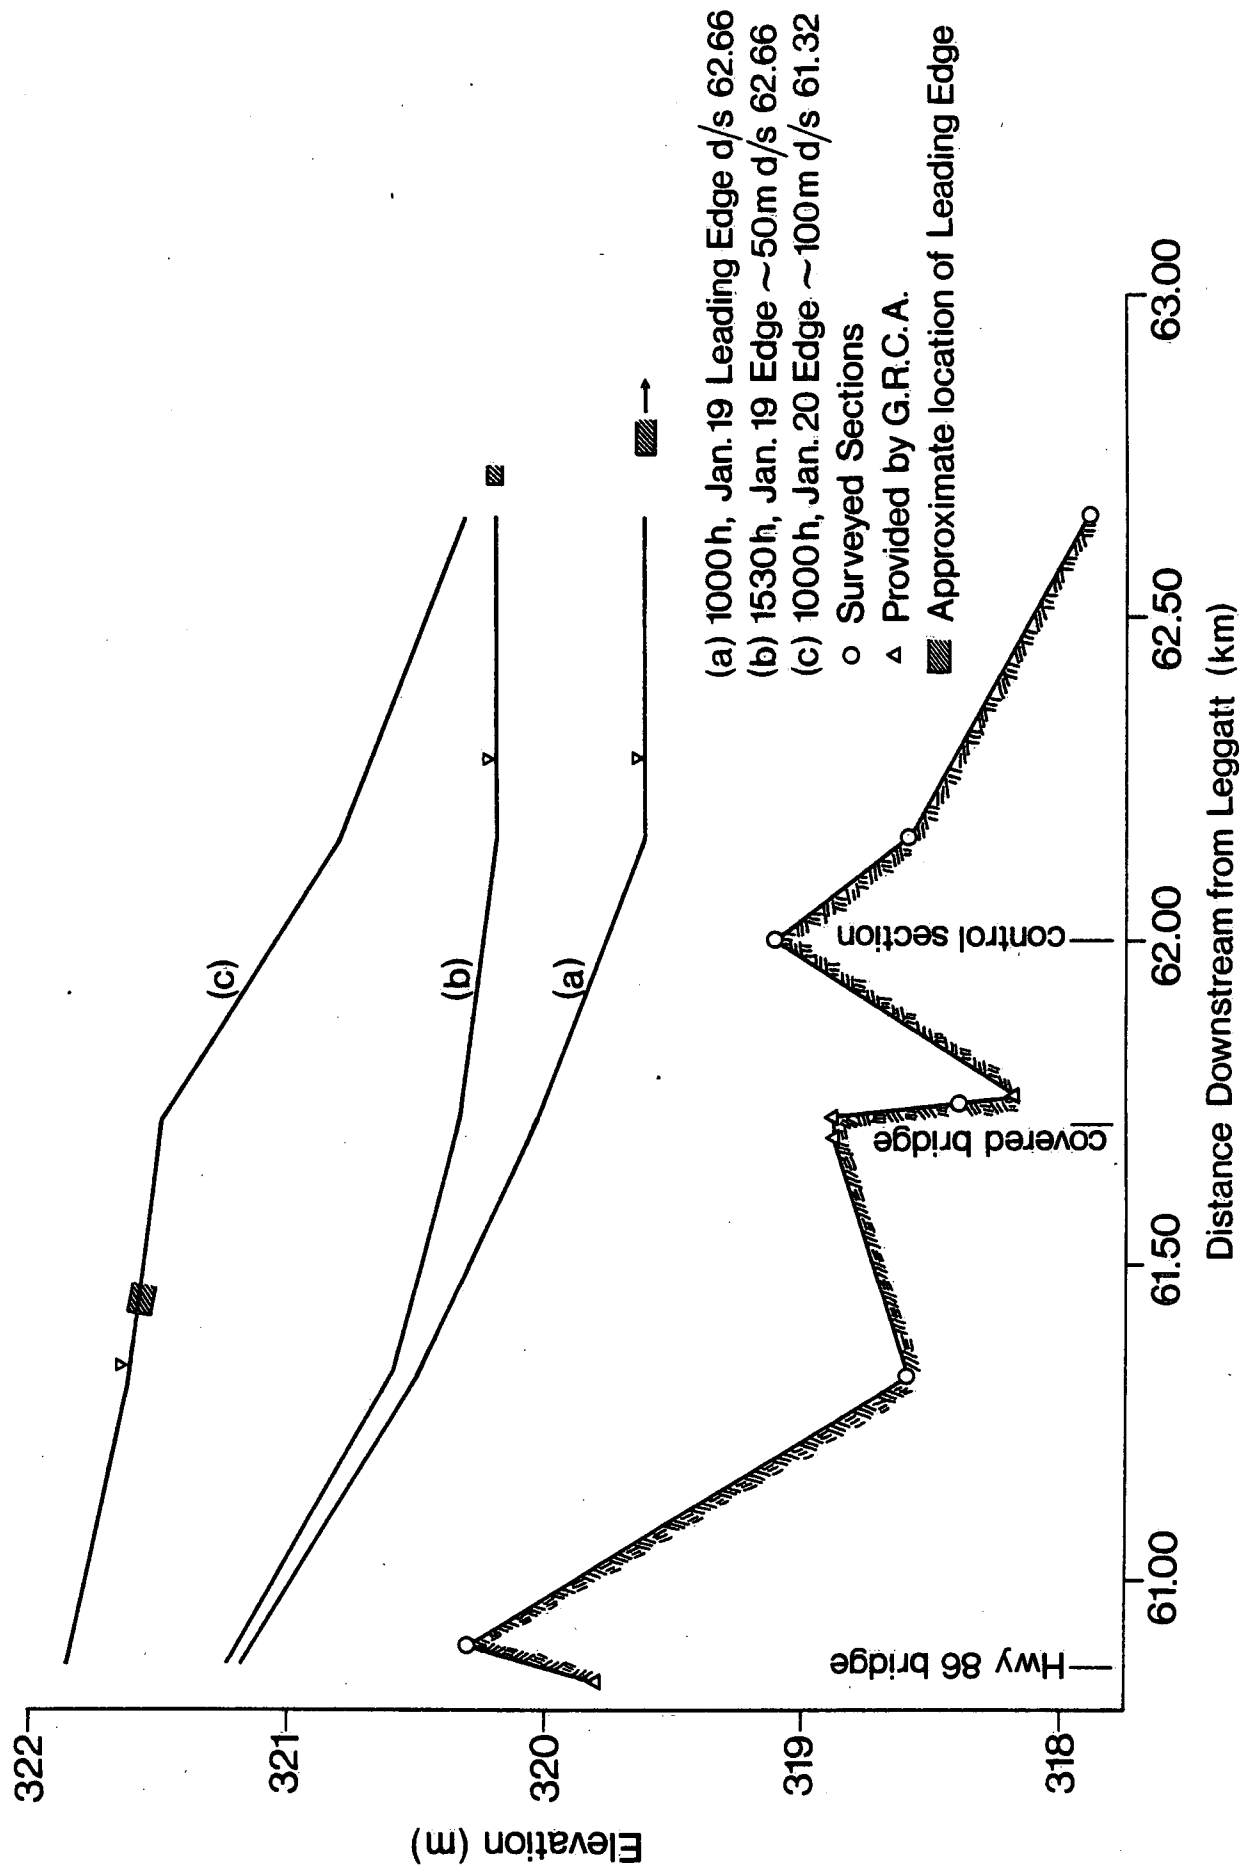
Figure 6 Bottom elevation and water level profiles during freeze up at West Montrose.

At 1450 h, the leading edge of the ice cover was still located ≈ 900 m d/s of the West Montrose bridge. By this time, the water level at the bridge began to rise. A water surface profile was taken between 1515 h and 1600 h (Figure 6). The freeze-up process was similar to that observed at Upper Belwood. Some incoming slush submerged at the leading edge while the rest gathered behind the edge. The slush accumulation slowly extended upstream until the newly formed cover collapsed or shoved reducing its length and, at the same time, increasing its thickness. This action is reflected in the Water Survey of Canada gauge chart in Figure 7. The water level rose quickly until 1608 h when the gauge reading was 11.91 m (Elev. = 320.35 m). The collapse of the ice cover then caused a sharp decline in the water level, thereby creating a spike on the gauge chart. A number of these spikes may be observed throughout the freeze-up period.

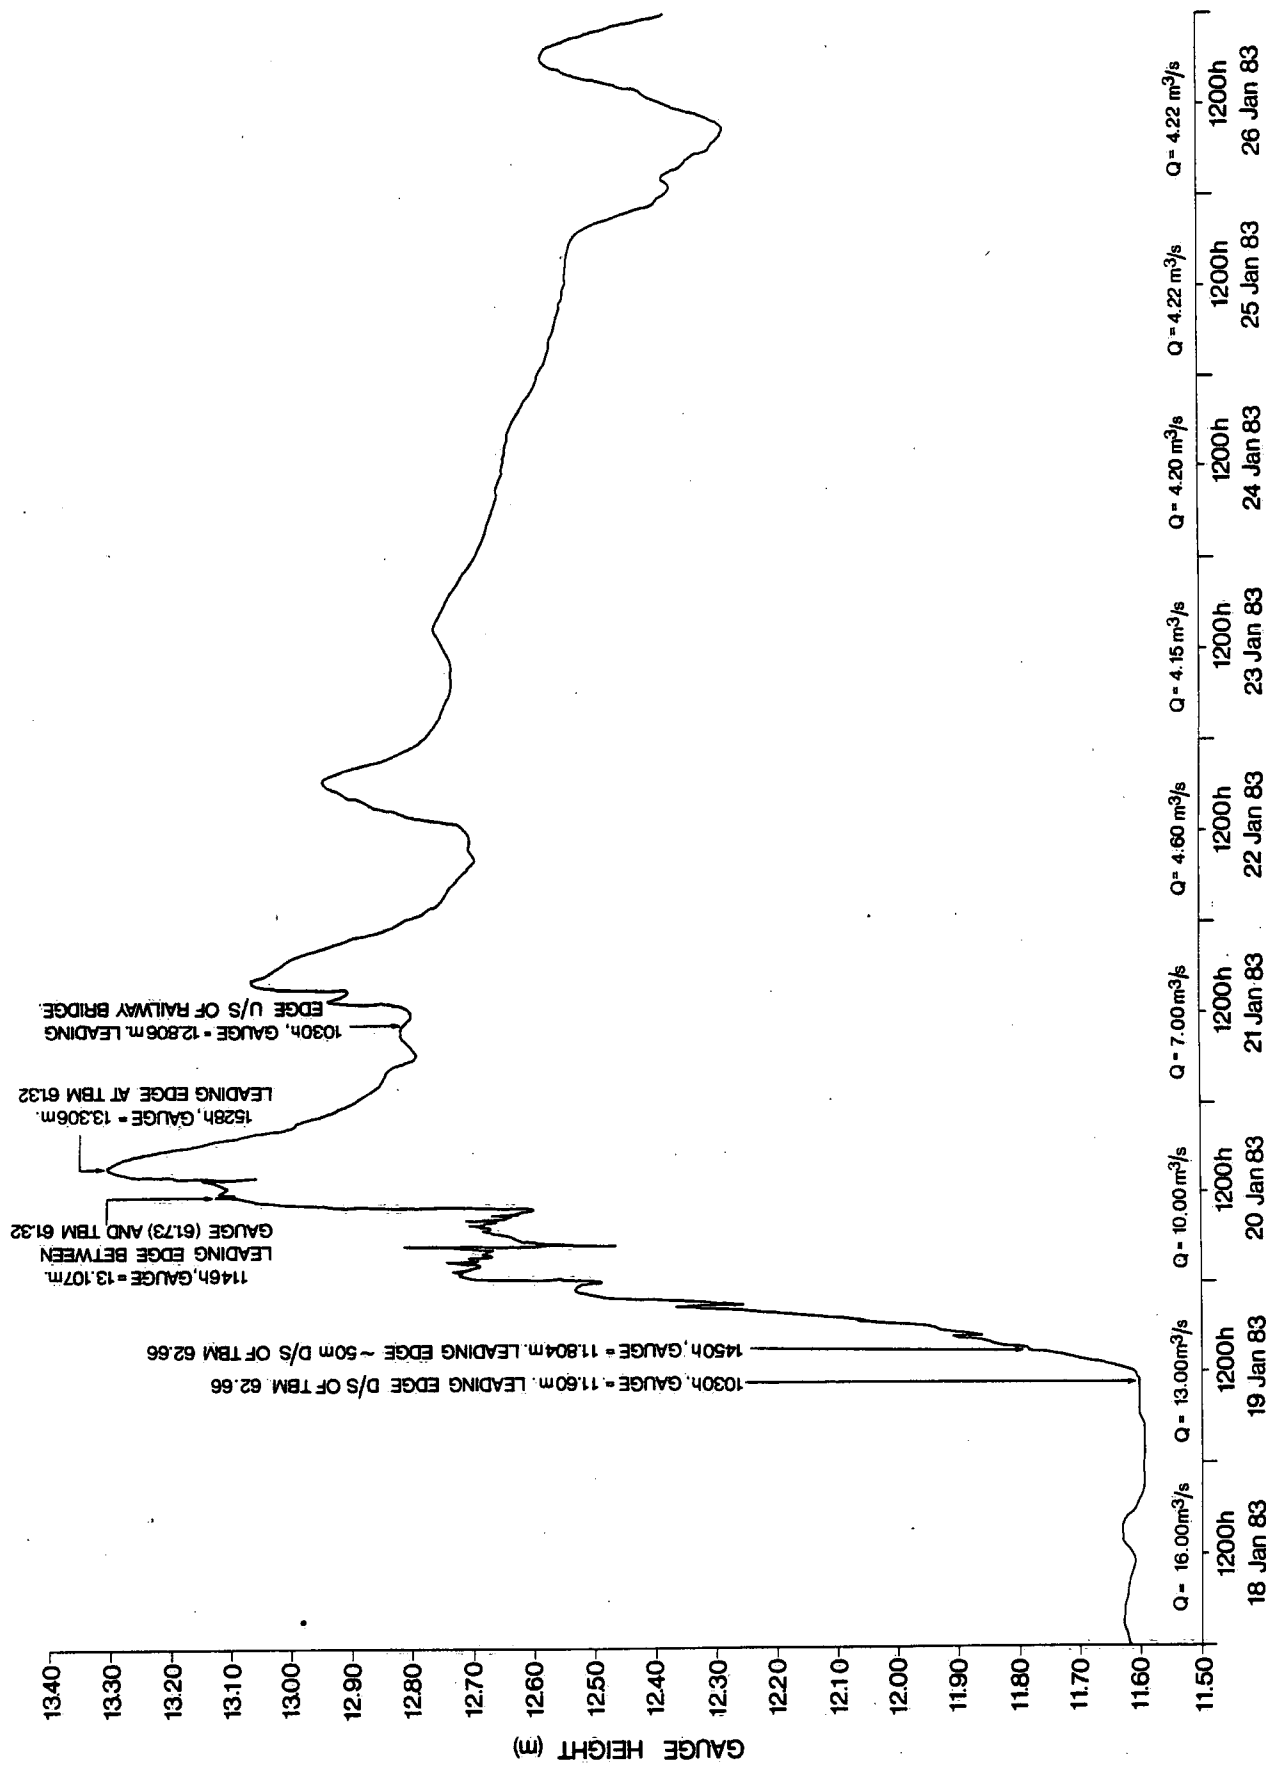
Fig.7 Water level variation with time at West Montrose. Freeze up 82-83. Jan 19 - 26, 1983.

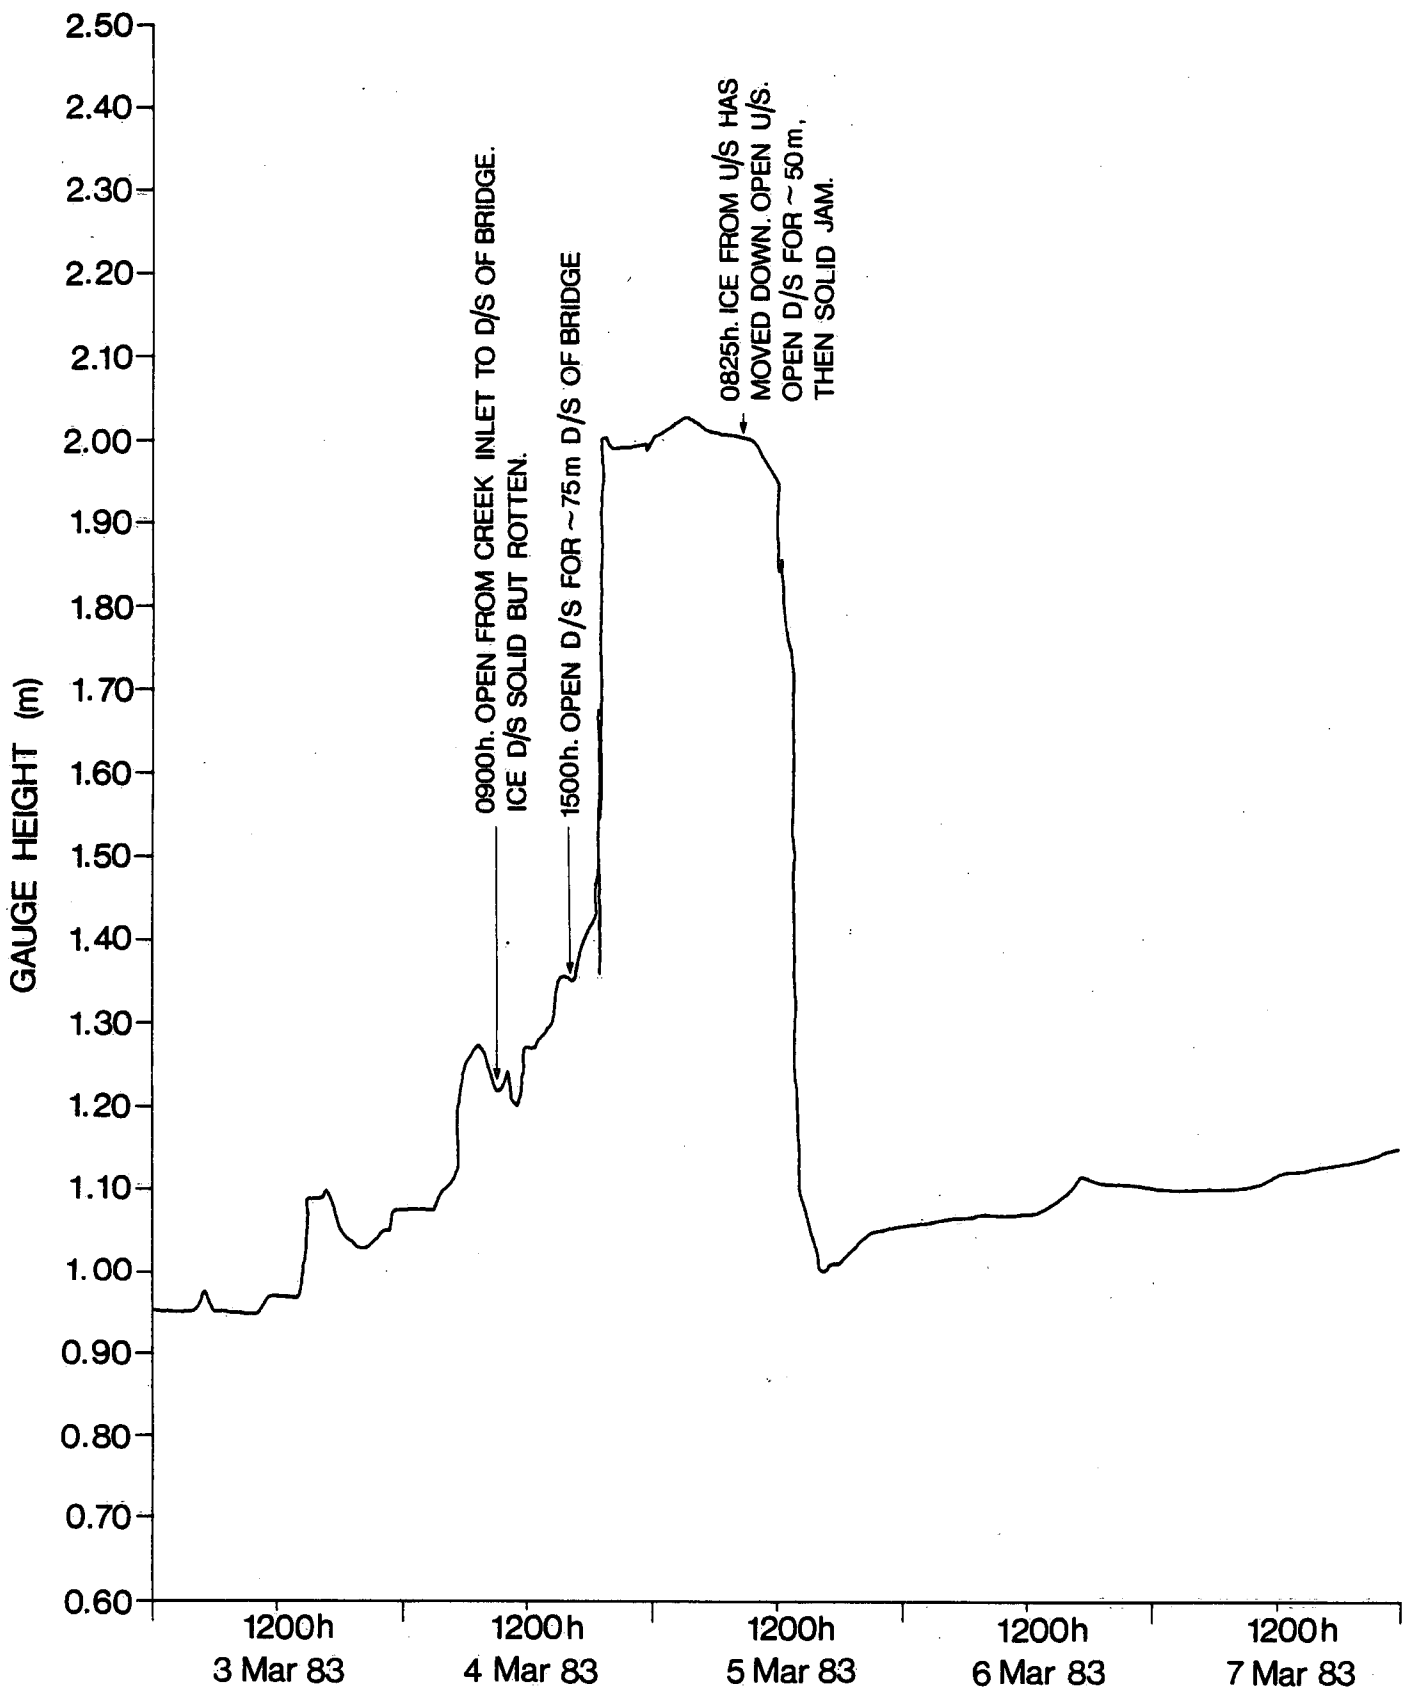
Fig.10 Water level variation with time at Upper Belwood. Breakup 82-83. Mar 3-7,1983.

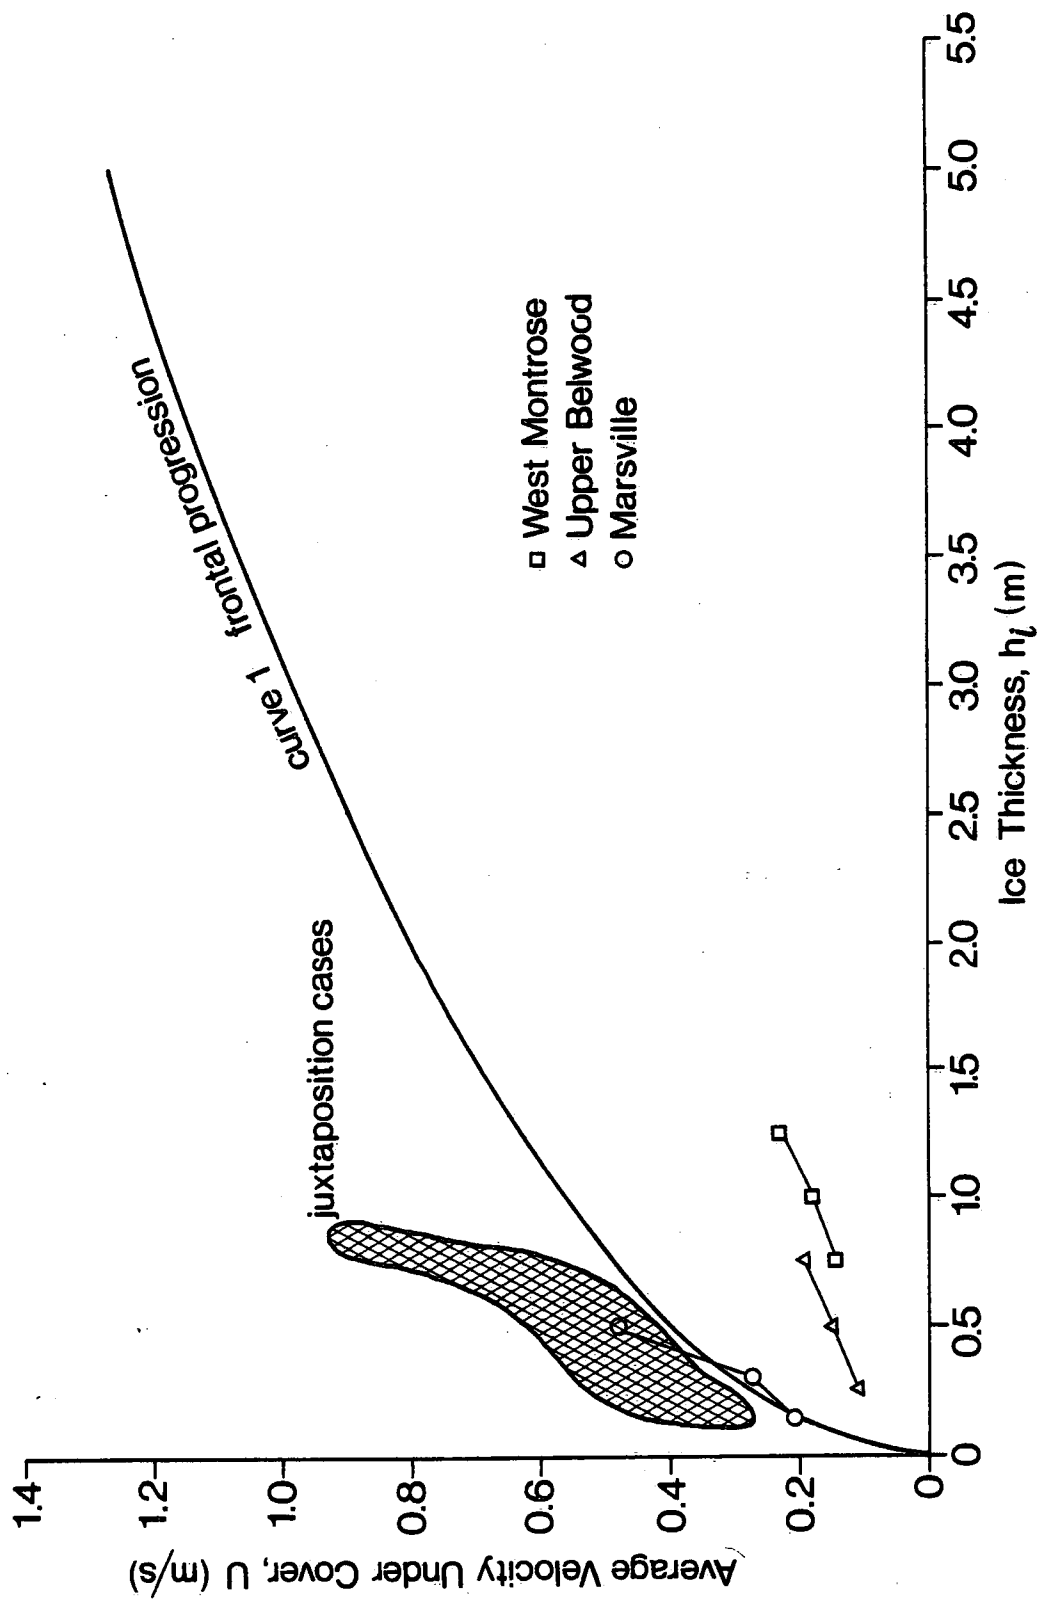
Figure 12 Universal representation of measured thickness of ice covers at time of formation. (Michel 1983)
 Curve represents best fit for data from these large rivers in five winter. Data points from Upper Grand River also included.

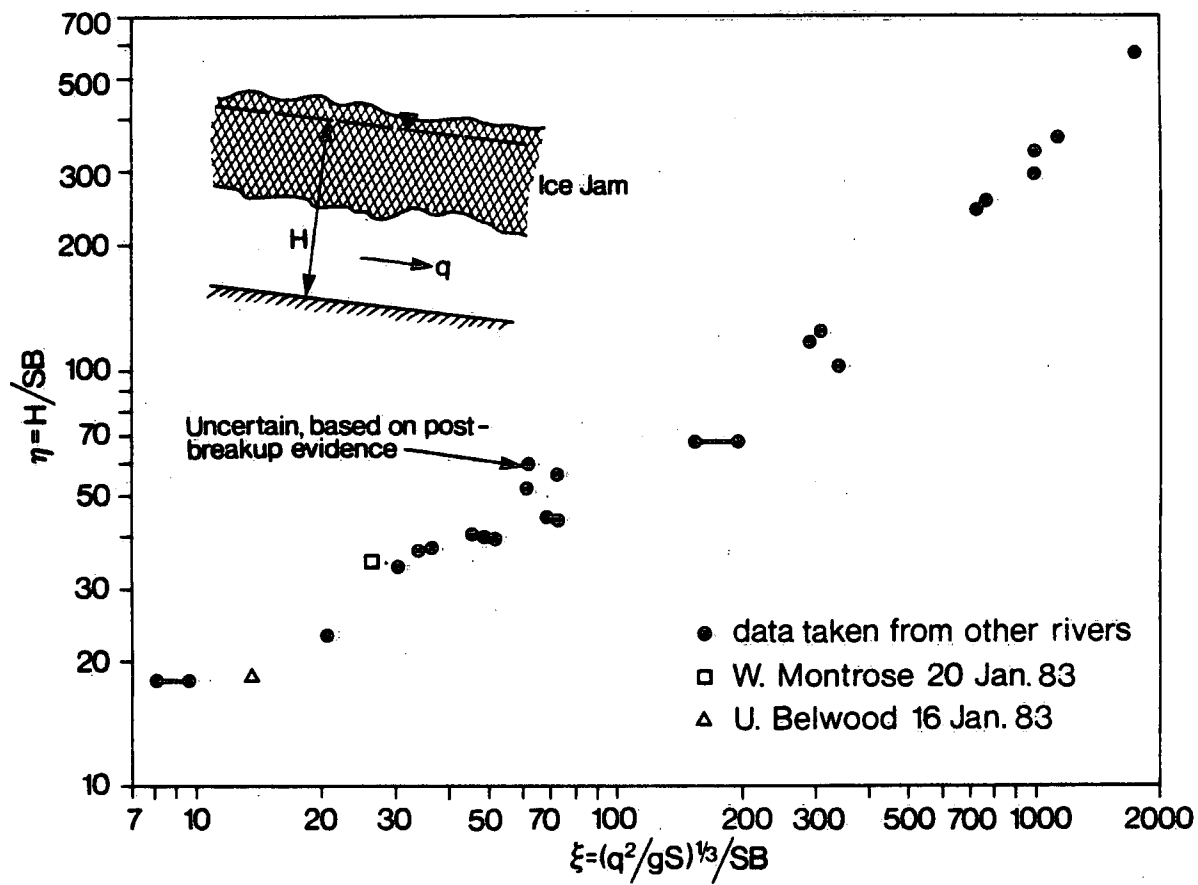
Figure 13 Dimensionless jam stage versus dimensionless discharge. Grand River data.

Figure 13 shows available data taken from various Canadian rivers, plotted in the form of Eq. 2. These data represent breakup conditions, i.e., jams comprising accumulations of solid ice blocks with prevailing air temperatures being positive or not much below freezing. On the other hand, freeze up jams consist mainly of frazil slush and may have different strength and hydraulic roughness characteristics. Therefore, the present data need not be consistent with those of Figure 13 but a comparison would be of interest.
