NWRI CONTRIBUTION 85-12

**ICE FREEZE-UP AND BREAKUP IN
THE UPPER GRAND RIVER:
1982-83 OBSERVATIONS**

by
J. Wong and S. Beltaos

May 1985
Revised September 1986

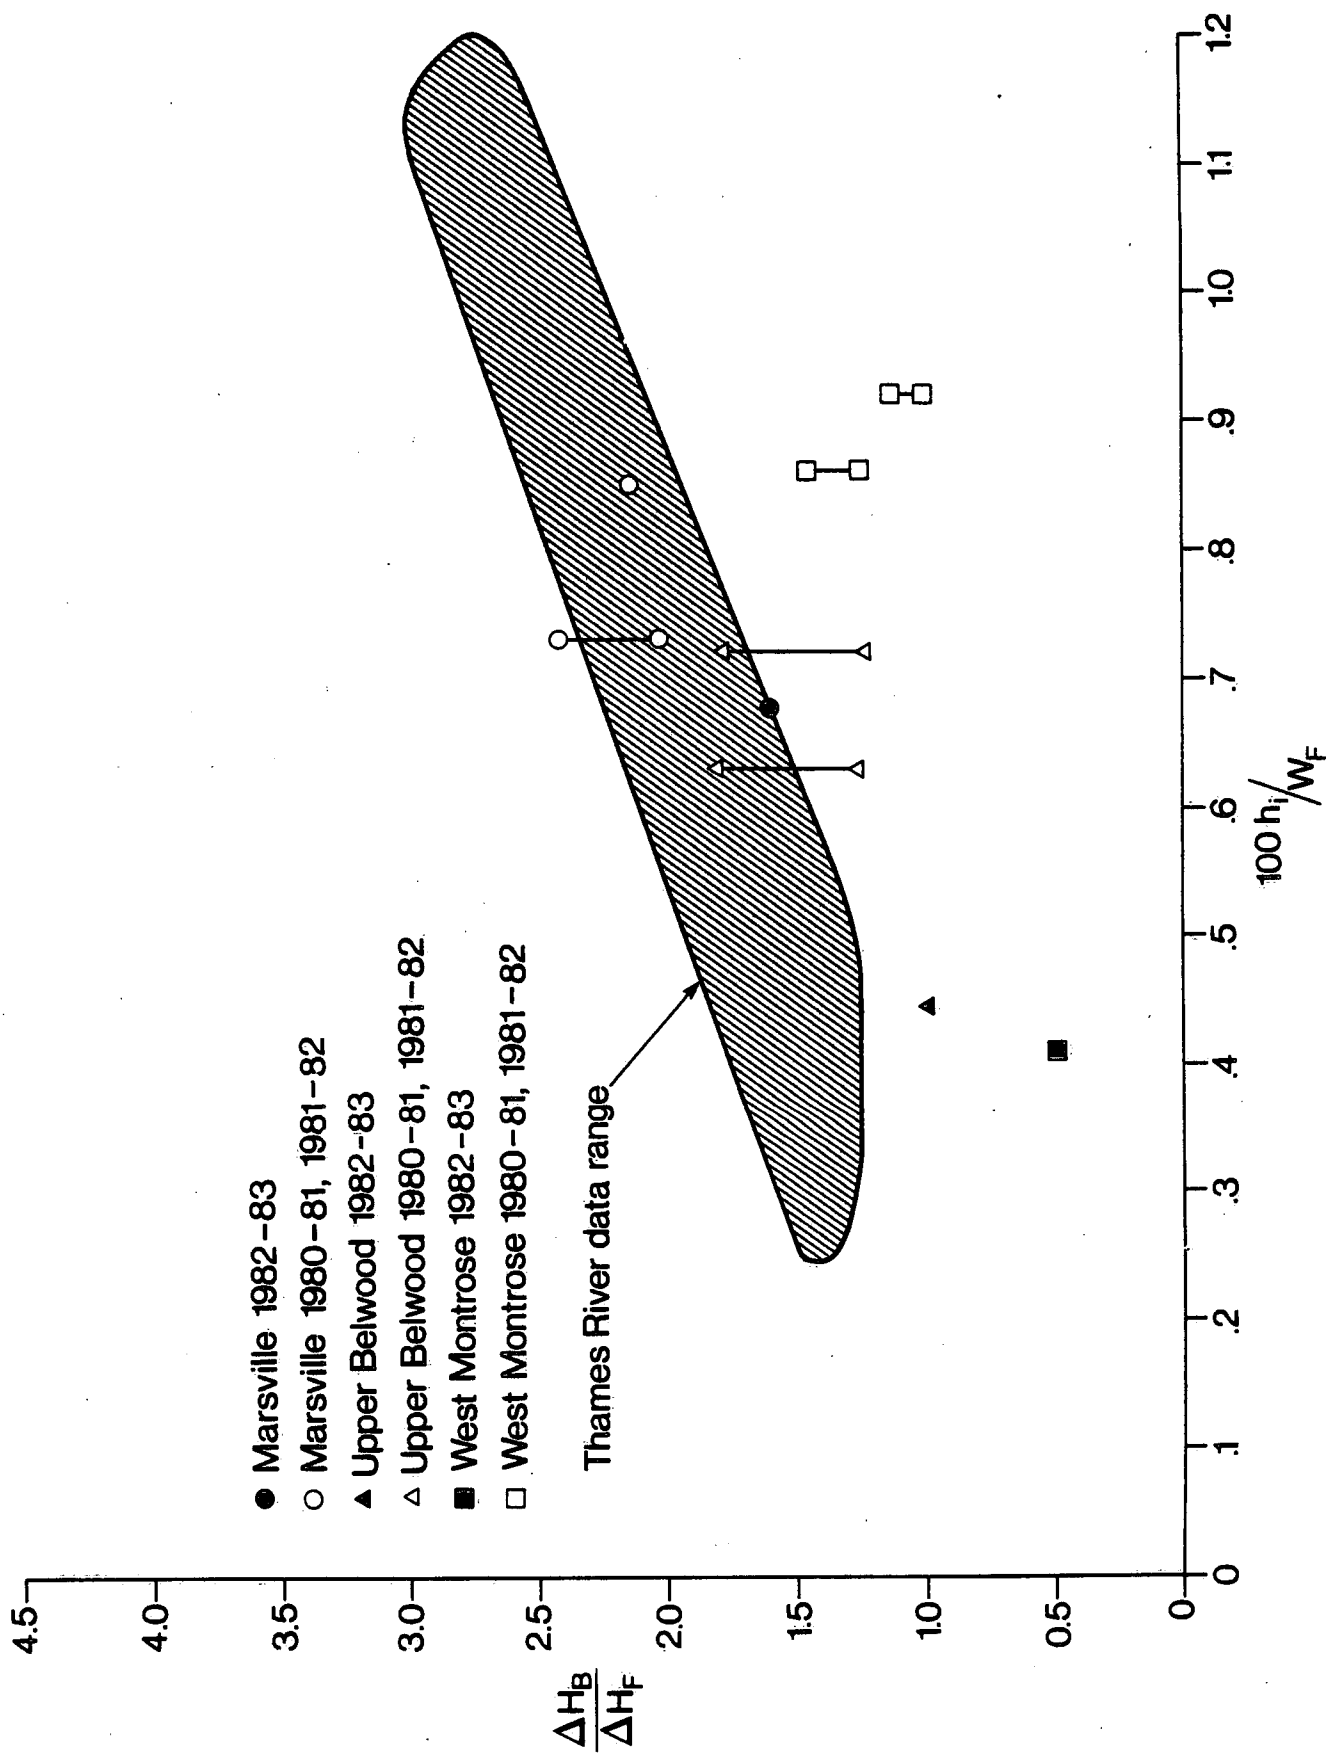
Figure 14 DIMENSIONLESS BREAKUP AND INITIATION STAGES VERSUS DIMENSIONLESS ICE THICKNESS. GRAND RIVER AT MARSVILLE, UPPER BELWOOD AND WEST MONTROSE.

the water, ice strength and channel geometry. Because W usually varies as a power of Y (= average flow depth), the ratio W_B/W_F can be replaced by Y_B/Y_F . Considering also that ΔH (= stage in excess of stage at zero discharge) is a rough measure of Y , Y_B/Y_F can be approximately replaced by the more convenient parameter $\Delta H_B/\Delta H_F$.

The available data for the 1982-83 season are listed in Table 6. H_F and H_B were deduced from observation notes and from gauge records provided by Water Survey of Canada and by Grand River Conservation Authority. The ice thickness measurements listed in Table 5 enable ice growth patterns to be established for the three gauge sites. The ice thickness is related to the degree-days of frost after freeze-up and estimates of ice thicknesses at the time of breakup are listed in Table 6.

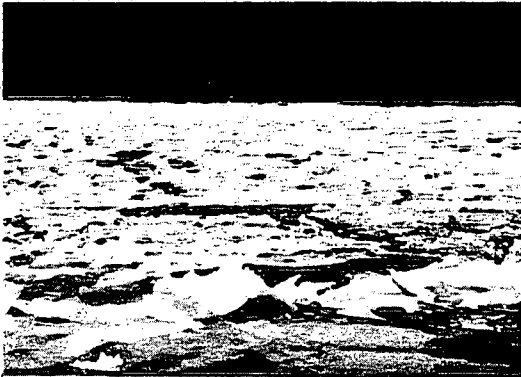
**A1. UPPER BELWOOD. 1415h,
Jan 12, 1983. Texture of ice accumulation
near leading edge.**

At 1451 h, the leading edge (the upstream end) of an ice cover was observed 650 m downstream of the Upper Belwood bridge. A portion of the incoming slush submerged upon arriving at the leading edge, while the rest of the incoming slush gathered on the water surface causing the leading edge to move upstream until a shove occurred and the cover thickened. This process was repeated as the leading edge moved upstream. Photo A1 shows the texture of the ice cover near the leading edge.

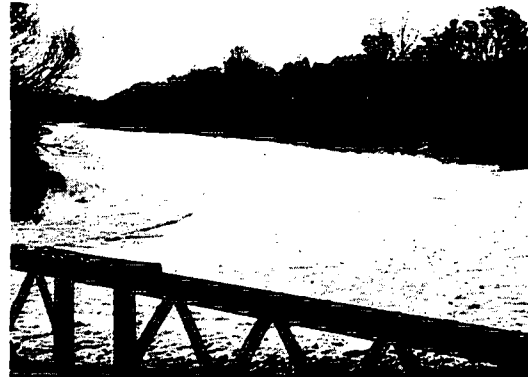
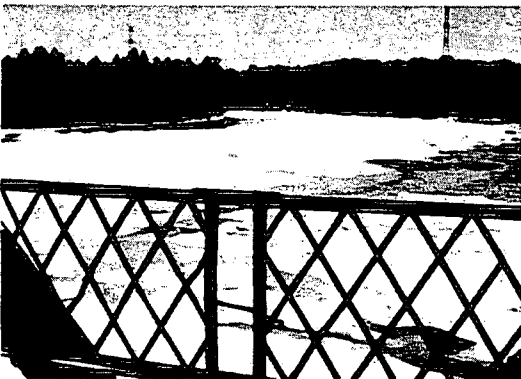
**A2. UPPER BELWOOD. 1100h,
Jan 16, 1983. Ice cover formation.
Looking d/s from bridge.**

**A3. UPPER BELWOOD. 1100h,
Jan 16, 1983. Ice cover formation.
Looking u/s from bridge.**

By 1100 h, the ice at Upper Belwood progressed past the bridge and beyond the bend 350 m u/s of the bridge (Photo A2 and A3). $\text{Rate}_{ic} \approx .008 \text{ km/h}$. By comparing the Rate_{ic} values, it is seen that the ice cover progressed at a slower rate as it moved towards and past the Upper Belwood bridge. The slower rate was probably due to the river bed profile. The steep section upstream the bridge followed by a deeper,

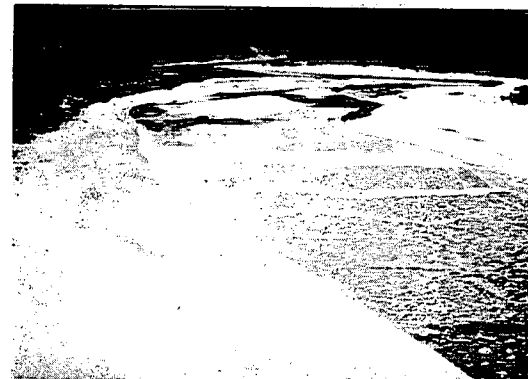
**A4. MARSVILLE. 1015h, Jan 18,
1983. Control section d/s of bridge was
open.**

At 1015 h, the river at Marsville gauge site was still open with slush flowing downstream and with some border ice at the side. Photo A4 shows the condition of the control section ≈ 250 m below the gauge. The Water Survey of Canada chart for this gauge in Figure 5 shows that the water level had been fairly constant over the past two days and that the approaching ice cover had not yet affected the level.

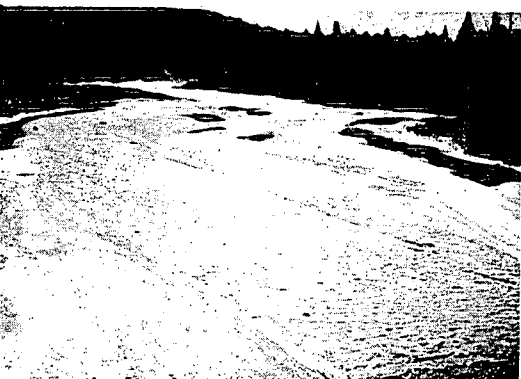
**A5. MARSVILLE. 1240h, Jan 18,
1983. Newly formed ice cover d/s of
bridge.**

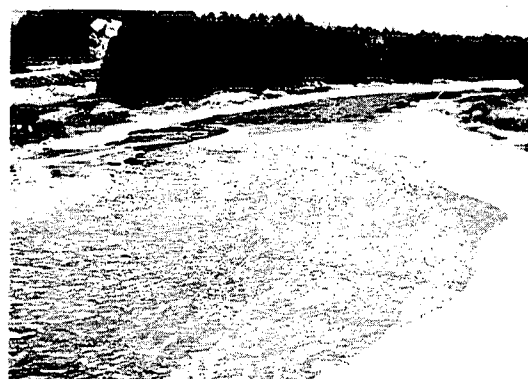
**A6. MARSVILLE. 1240h, Jan 18,
1983. Newly formed ice cover u/s of
bridge.**

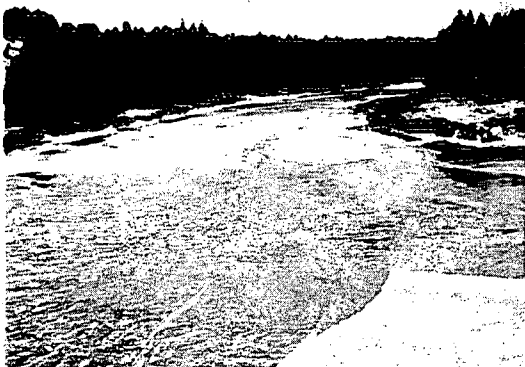
A7. MARSVILLE. 1316h, Jan 18, 1983. Newly formed ice cover u/s of bridge.

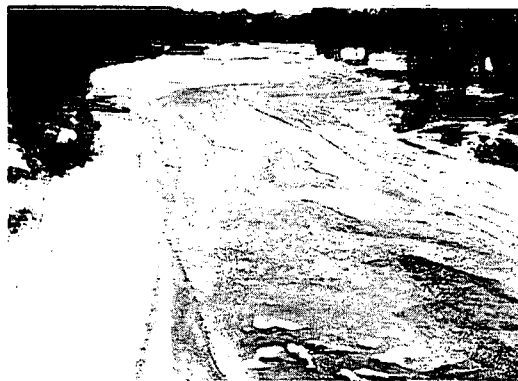
A8. IRVINE BRIDGE. 1311h, Jan 19, 1983. Smooth ice cover initiated just d/s of bridge.

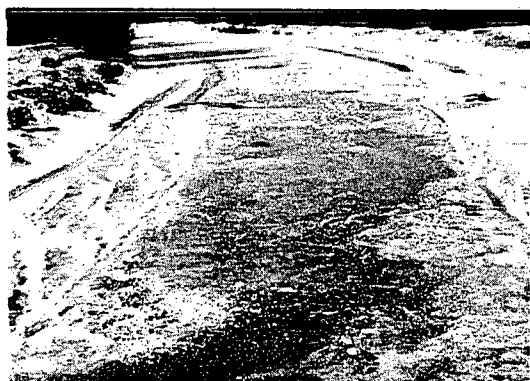
A9. IRVINE BRIDGE. 1311h, Jan 19, 1983. Smooth ice cover u/s of bridge.

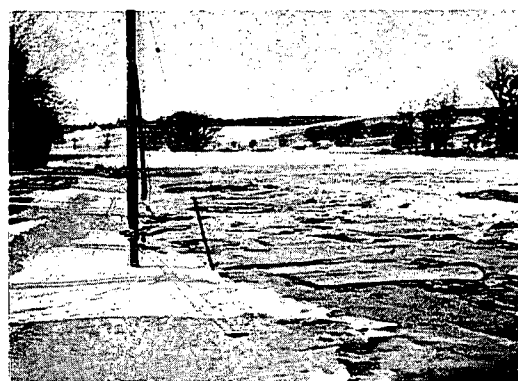
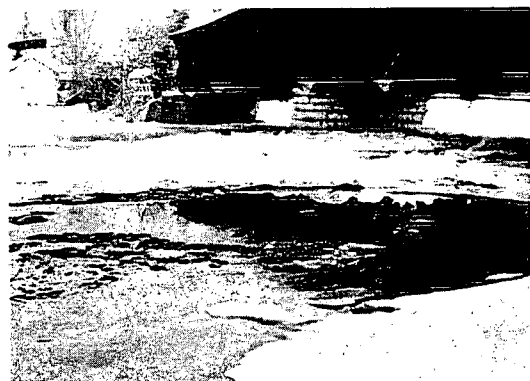
A10. WEST MONTROSE. 0958h, Jan 20, 1983. Slush/ice cover d/s of wooden bridge.

A11. WEST MONTROSE. 1000h, Jan 20, 1983. Slush/ice cover at wooden bridge.

At 0958 h, the leading edge was at the wooden bridge. The condition of the ice cover at and downstream of the bridge is shown in Photo A10 and A11.

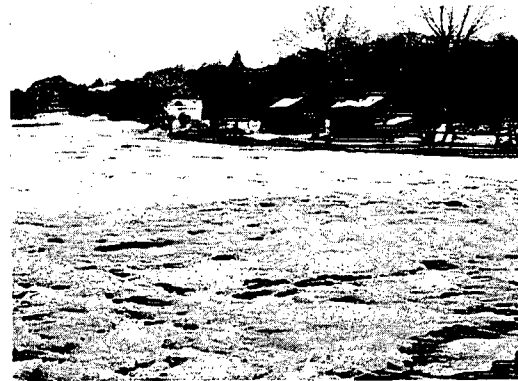
A12. WEST MONTROSE. 1530h, Jan 20, 1983. Rough slush/ice cover u/s of bridge. Looking u/s from LB.

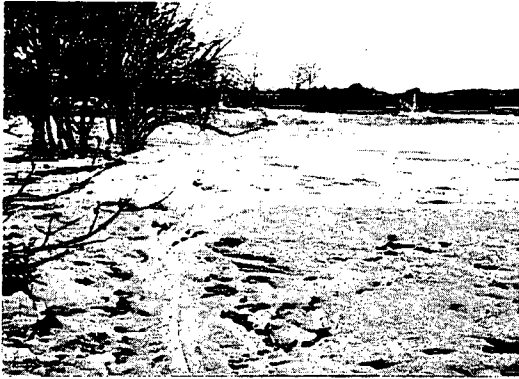
**A13. WEST MONTROSE. 1530h,
Jan 20, 1983. Rough slush/ice cover u/s
of bridge. Looking u/s from RB.**

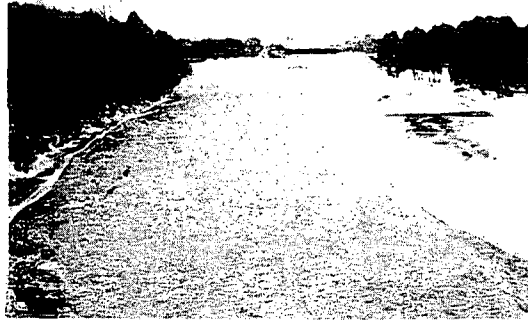
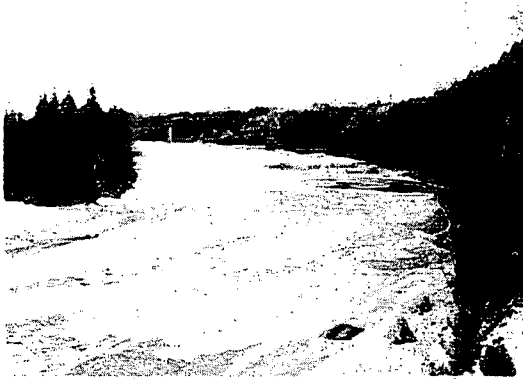
**A14. HWY 86. 1050h, Jan 21, 1983.
Looking d/s towards West Montrose.**

**A15. HWY 86. 1050h, Jan 21, 1983.
Looking u/s towards R/R bridge.**

The water level at West Montrose had fallen overnight and at 1030 h, the gauge reading was 12.82 m (Elev. = 321.25). By this time, the ice cover had extended past Hwy. 86 and past the railway bridge. Ice conditions downstream and upstream of Hwy. 86 are shown in Photos A14 and A15. The ice surface seems to be smoother downstream of the bridge.

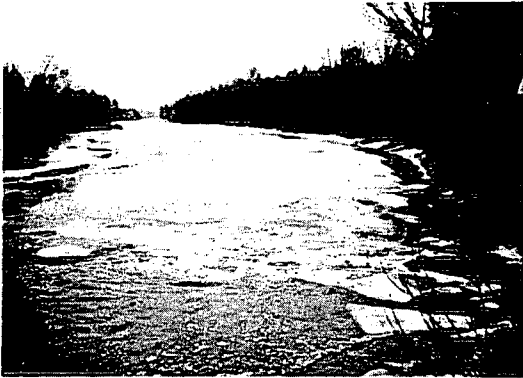
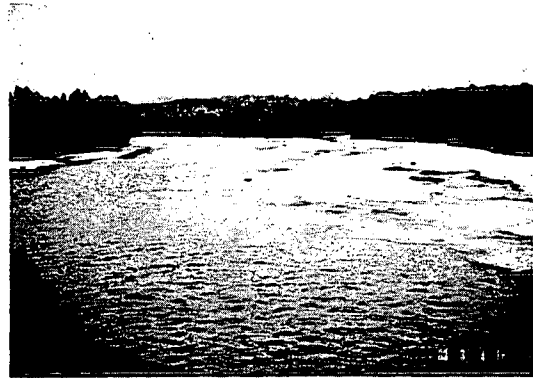
B1. UPPER BELWOOD. 0900h, Mar 4, 1983. Looking d/s. Open to ~30m d/s.

B2. UPPER BELWOOD. 0900h, Mar 4, 1983. Looking u/s. Open to creek outlet.

At 0900 h, the river at Upper Belwood was open from the creek inlet to ~30 m d/s of the bridge. Photo B1 looking downstream shows the broken ice blocks gathered behind the ice cover which was still intact. Photo B2 looking upstream shows the open reach between the bridge and the inlet of the creek.

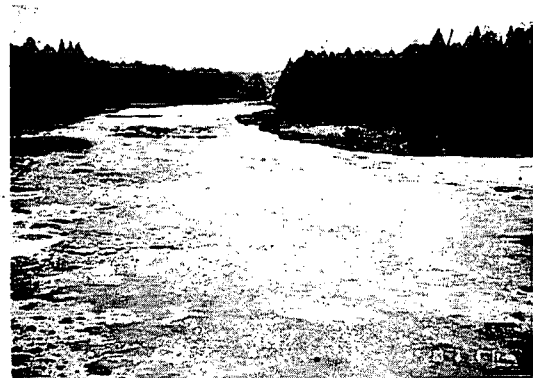
B4. MARSVILLE. 0930h, Mar 4, 1983. Looking u/s. Open area along RB.

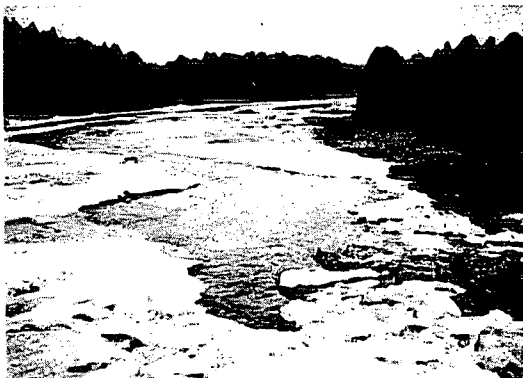
B5. 1st CROSSING D/S OF MARSVILLE. 1110h, Mar 3, 1983. Looking d/s at toe of jam.

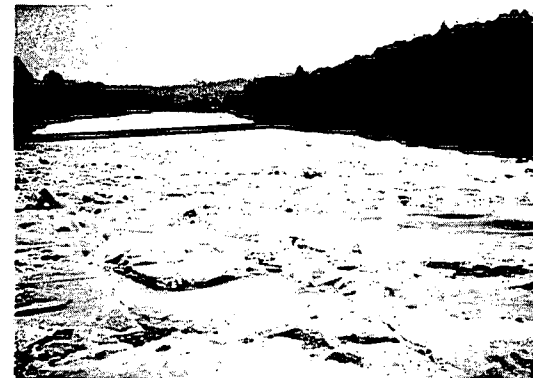
B6. 1st CROSSING D/S OF MARSVILLE. 1110h, Mar 3, 1983. Looking u/s at jam.

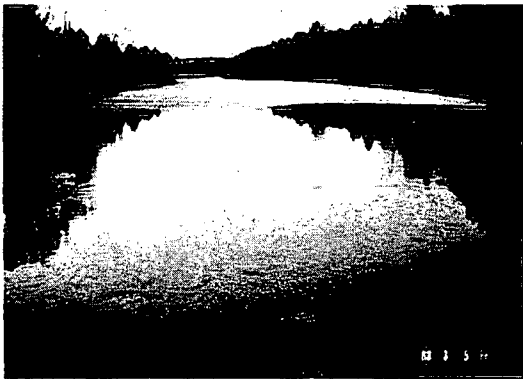
**B7. UPPER BELWOOD. 0825h, Mar 5,
1983. Looking d/s to head of jam.**
