**GEOLOGICAL SURVEY OF CANADA
OPEN FILE 8045**

**Groundwater Level Monitoring near Killarney
and Cartwright, Manitoba, 2010-2014**

M.J. Hinton

2016

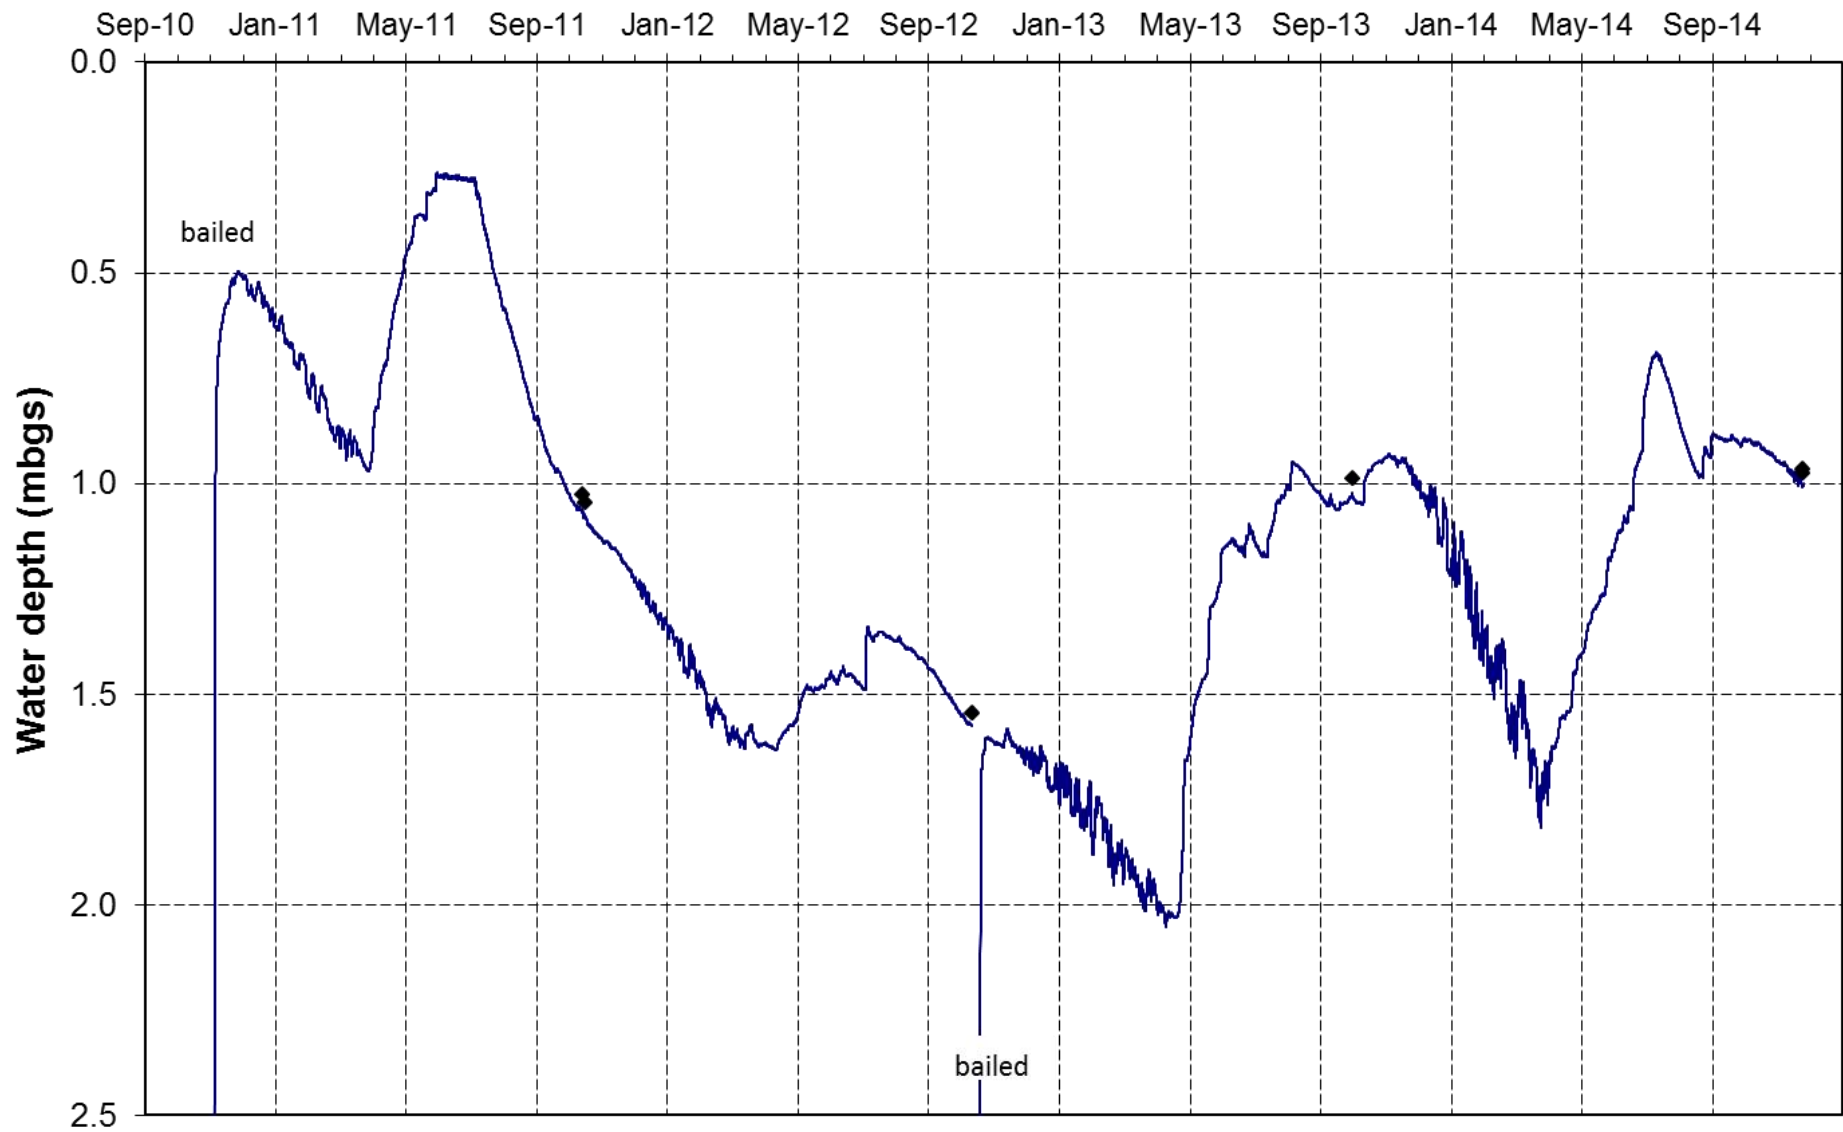
Figure 6. Water depth, GSC-SW-02-p2.

GSC-SW-02-p2 had a similar seasonal pattern although the response to spring melt was smaller and more delayed and there was seldom a response to late summer and autumn rainstorms (Figures 6 and 7). The initial water level rise in October 2011 was the recovery from well development.

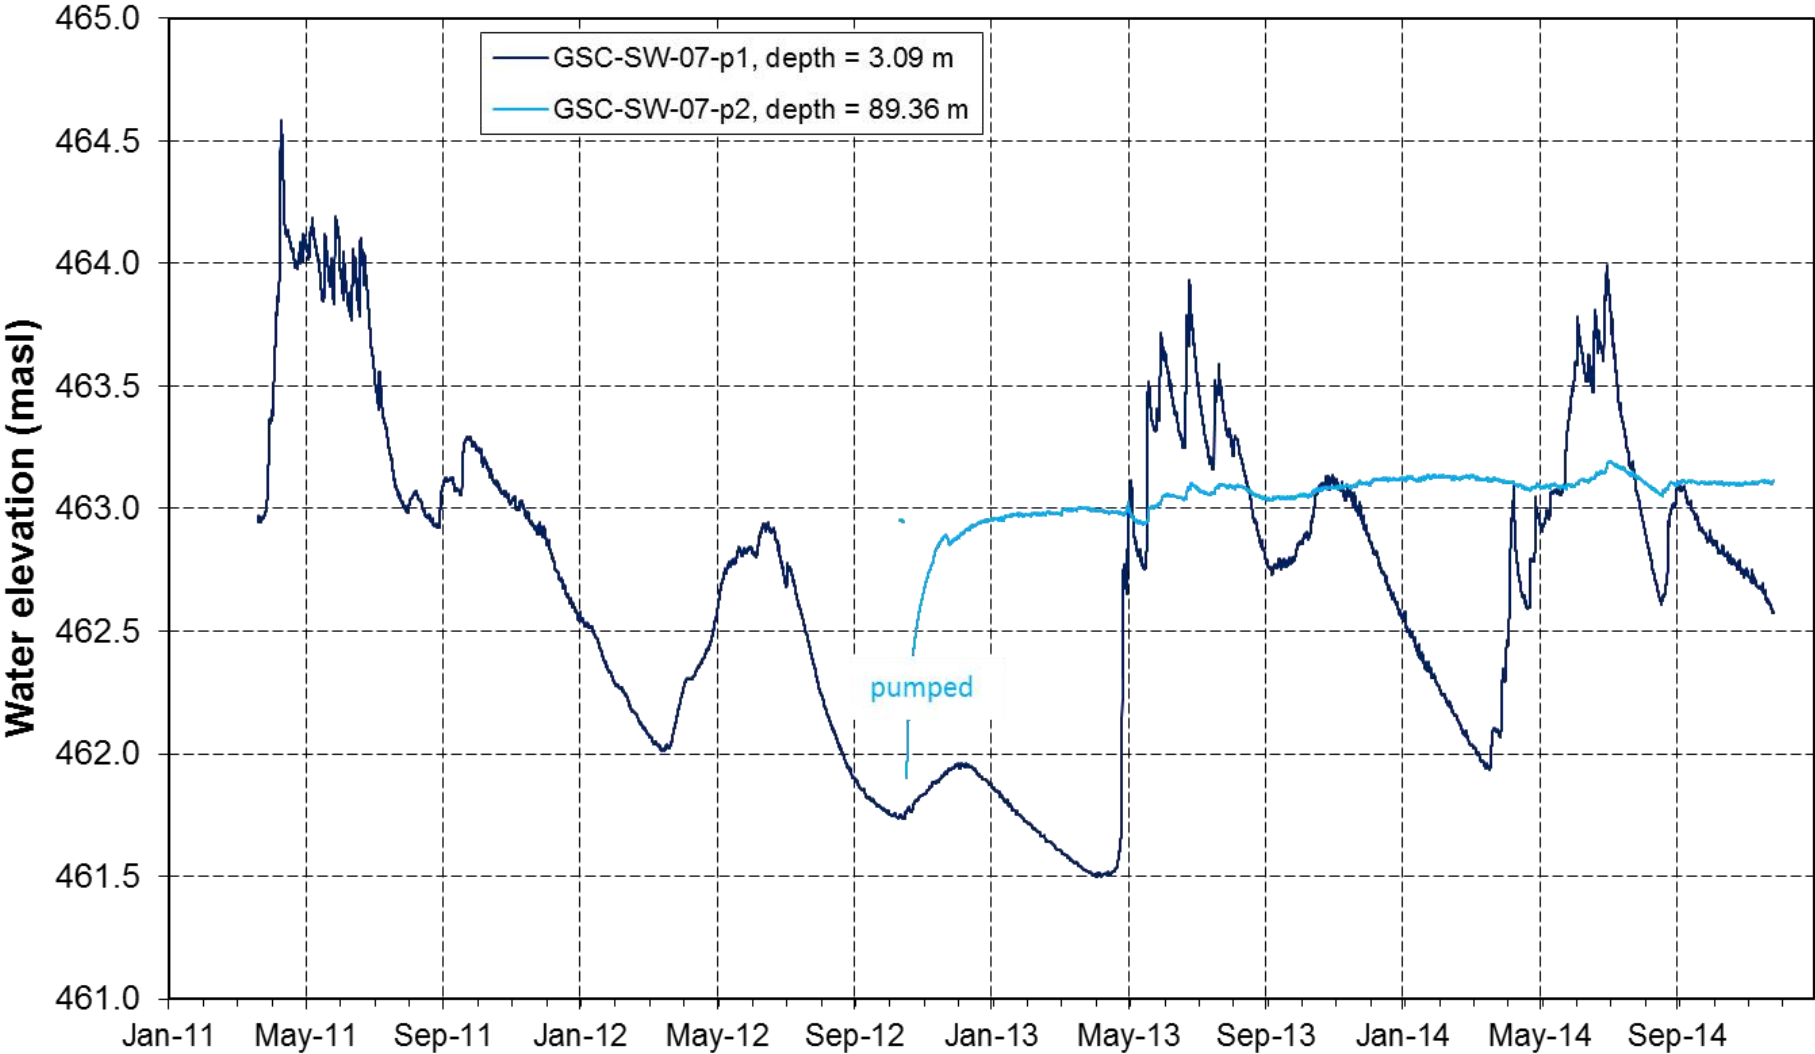
Figure 23. Groundwater elevations, GSC-SW-07-p1 and GSC-SW-07-p2

Except for the recovery following pumping, piezometer GSC-SW-07-p2 fluctuated over a small range of water levels (Figures 21 and 22). The large seasonal responses in shallow piezometer GSC-SW-07-p1 were not observed in deep piezometer GSC-SW-07-p2 where increases from spring melt were much smaller and delayed (Figure 23). Whereas winters were extended periods of steady water level decline in GSC-SW-07-p1, water levels in GSC-SW-07-p2 were stable or gradually increasing at these times. Although the two piezometers are screened too widely apart to interpret vertical gradients meaningfully, the water levels in GSC-SW-07-p2 are generally above those in GSC-SW-07-p1 except following significant recharge events such as spring melt (Figure 23).

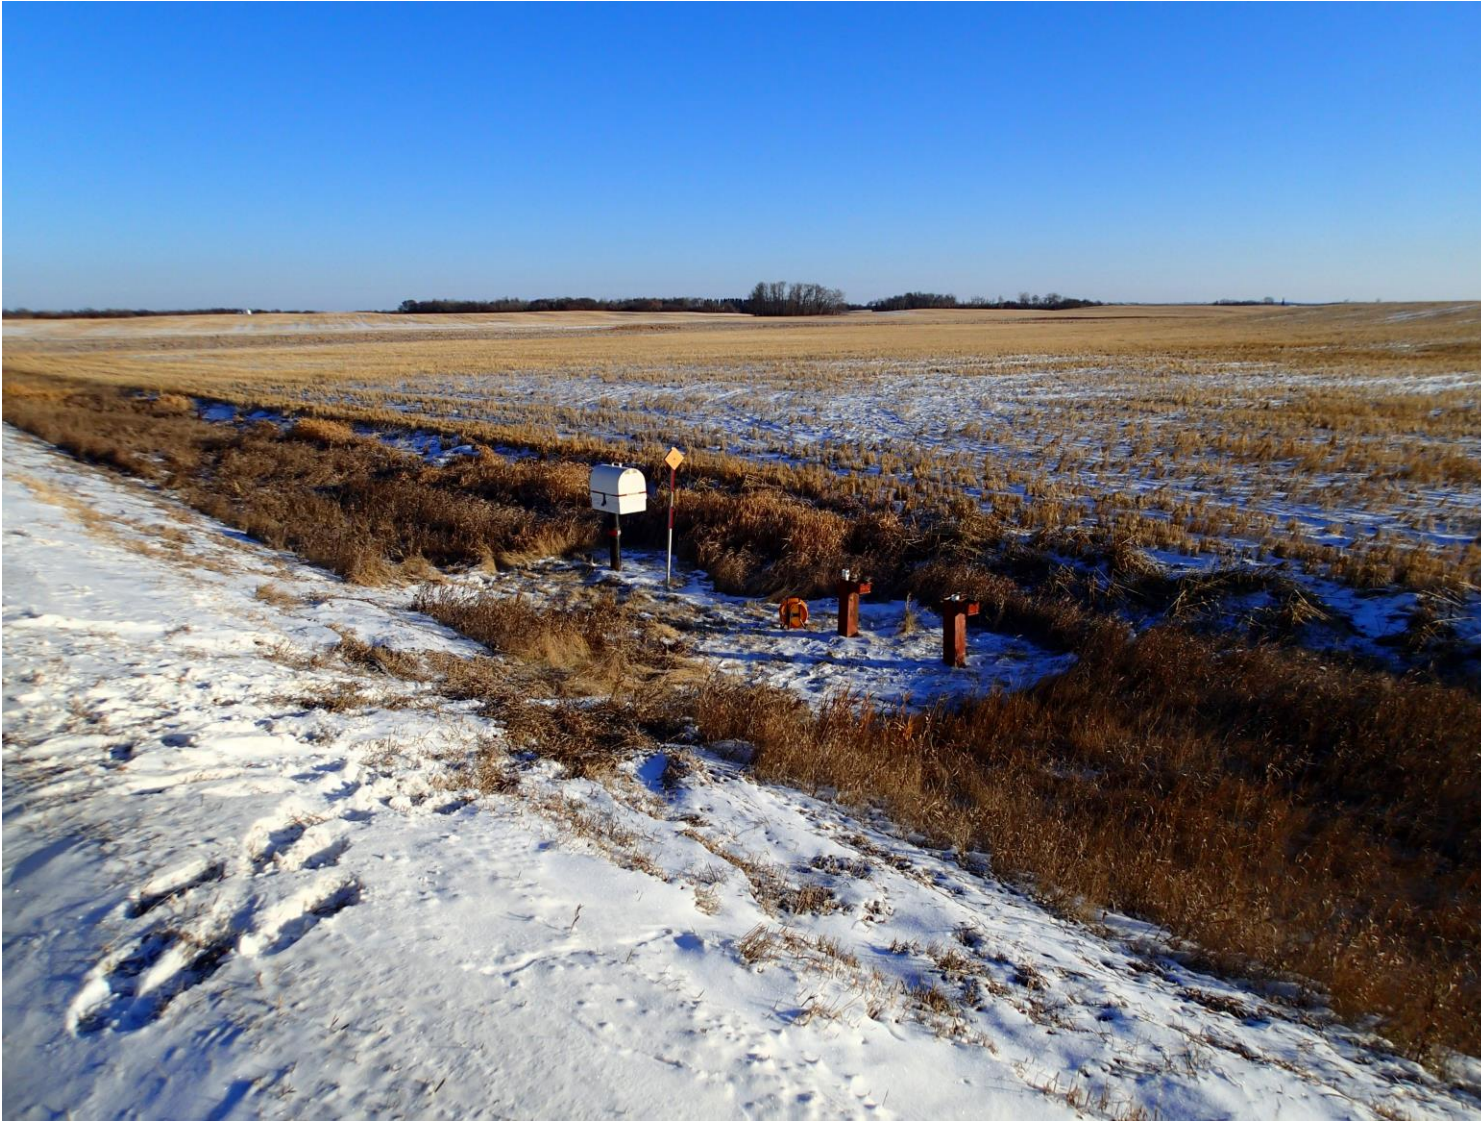
Photograph A1. Site GSC-SW-02 showing slight ditch in which piezometers are located. Piezometers from left to right: CWS well G05OA010, GSC-SW-02-p2, GSC-SW-02-p1. Photograph taken 26 November 2014, facing northeast.

The monitoring record was longest (4 full years) at this site as it was the only site instrumented in November 2010. This site was located within a gentle ditch along an unpaved road (see photograph A1 in Appendix 1) and was probably subjected to temporary surface ponding as noted by above-ground water levels in GSC-SW-02-p1 during spring melt in 2011, 2013, and 2014 (Figure 4).

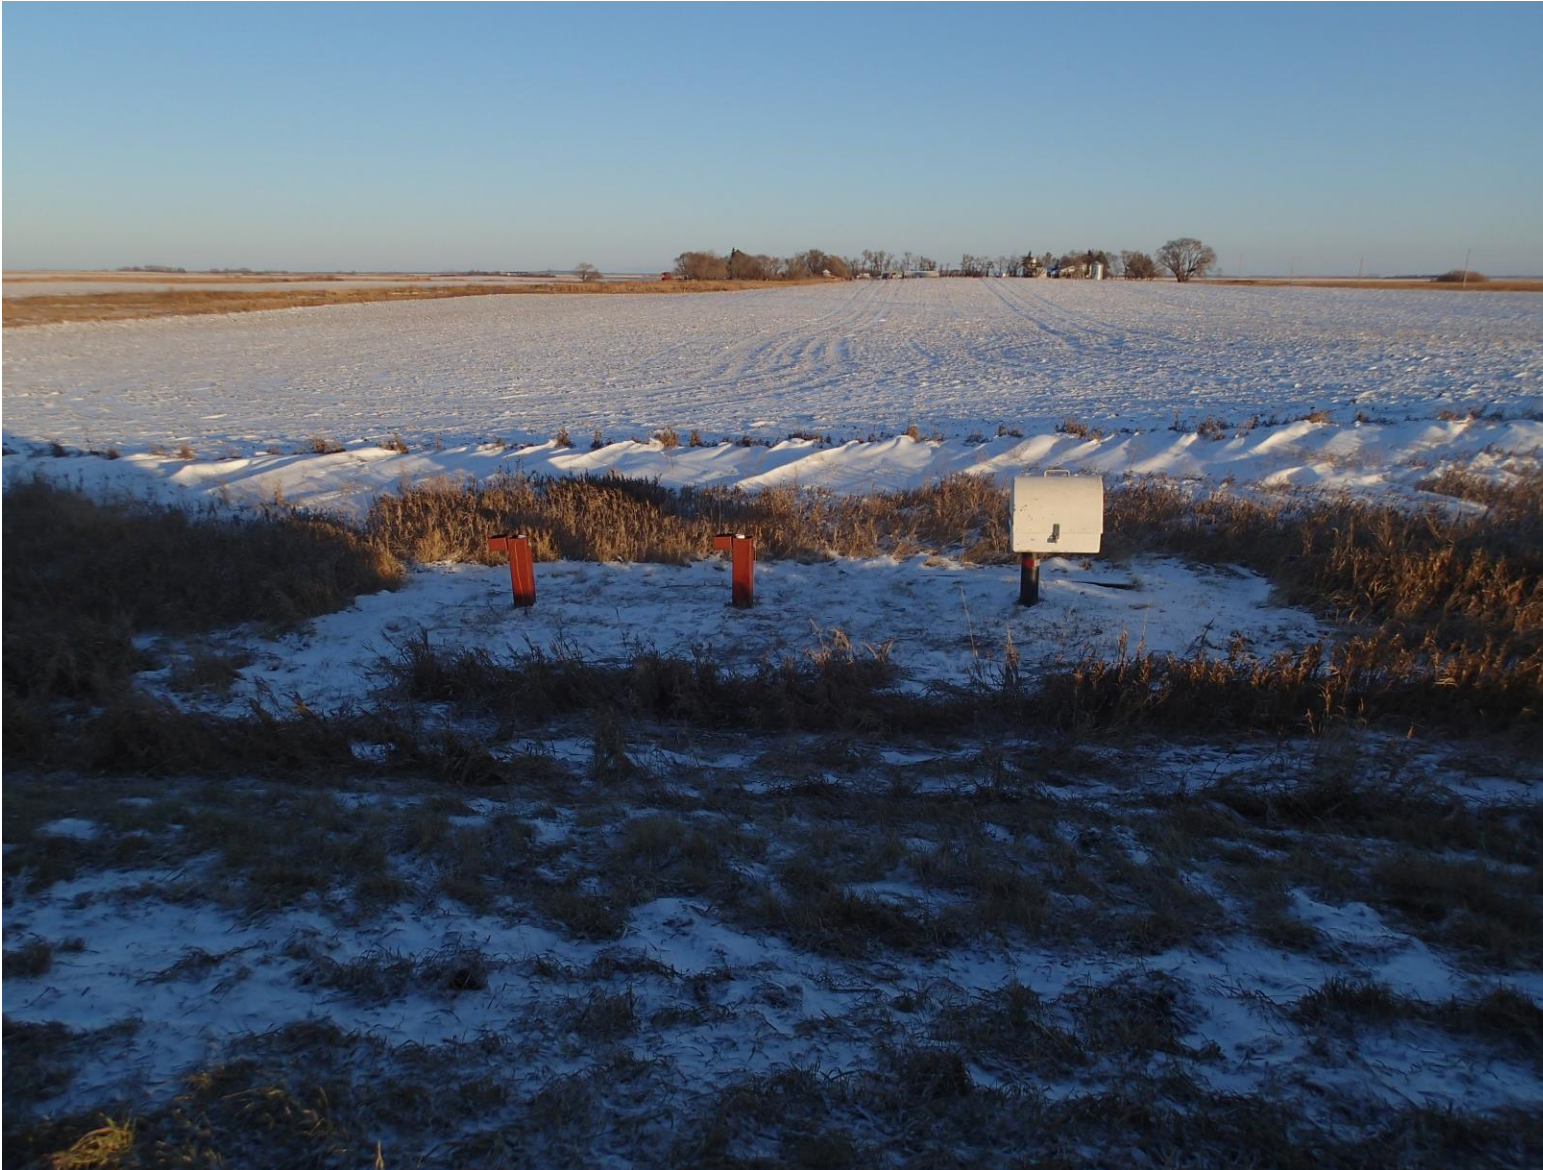
Photograph A2. Site GSC-SW-03. Piezometers from left to right: GSC-SW-03-p1, GSC-SW-03-p2, CWS well G05OA009. Photograph taken 26 November 2014, facing north.

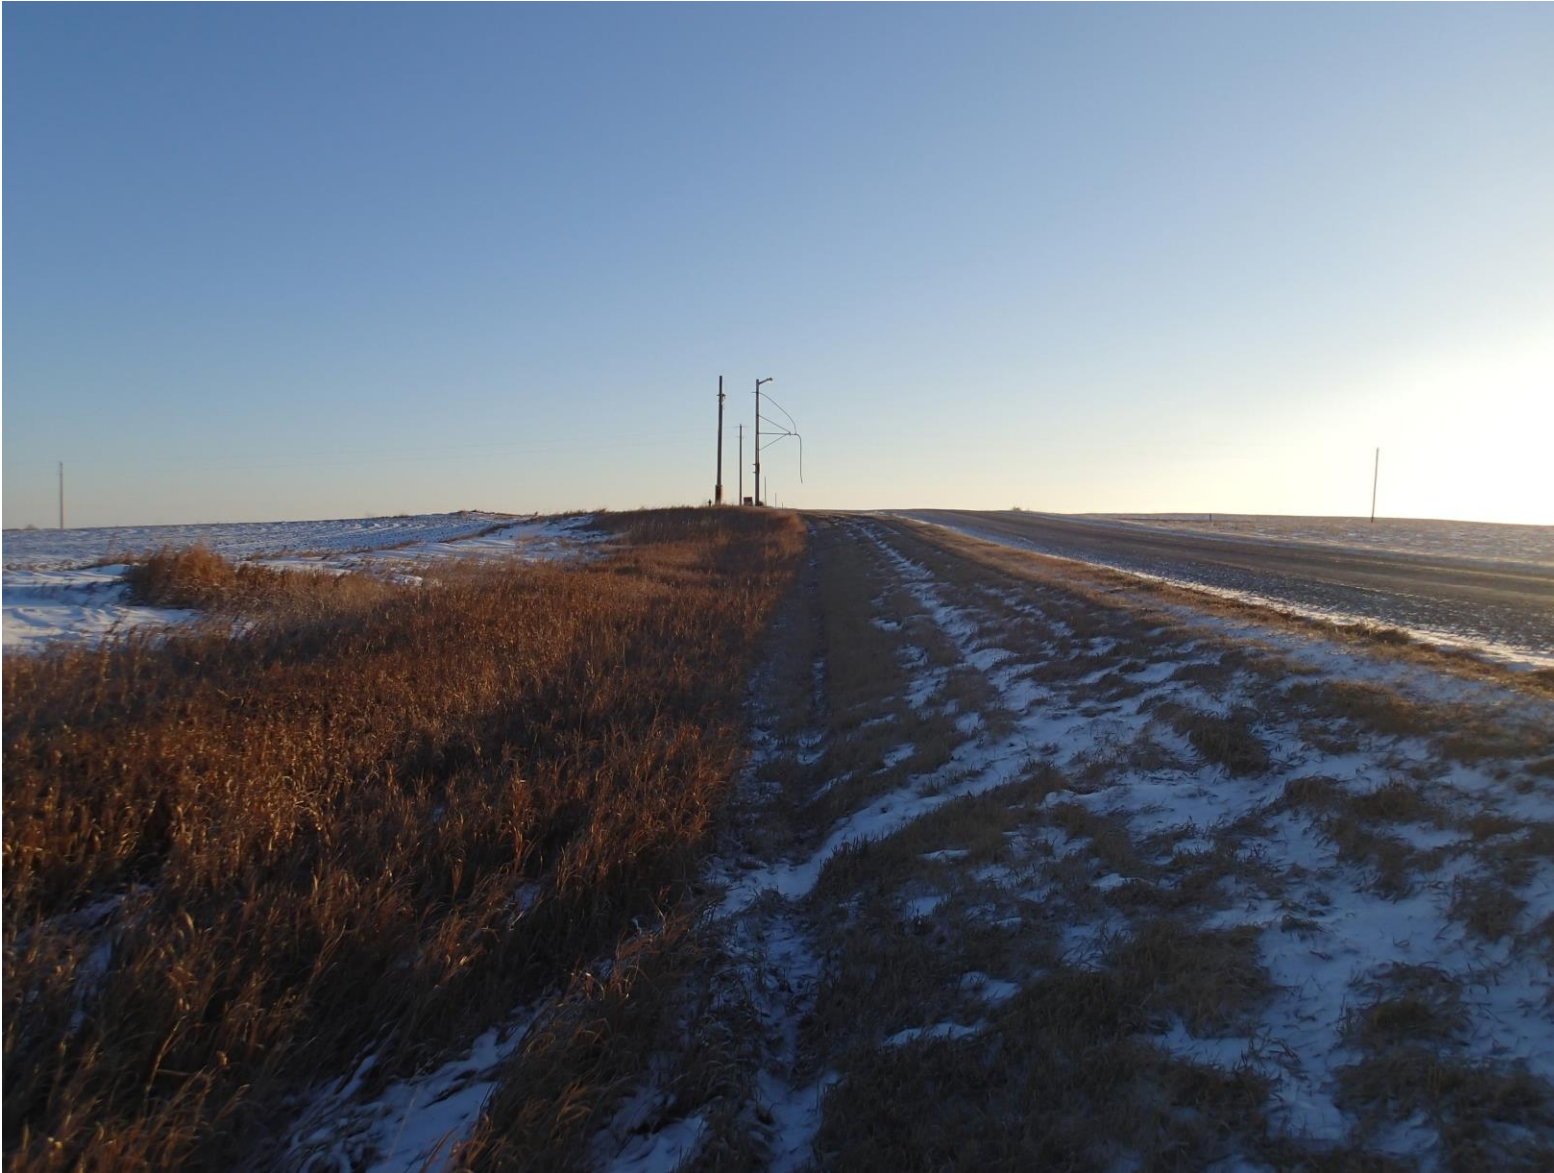
Photograph A3. Ditch facing east from site GSC-SW-03. Loading station well in the distance. Photograph taken 26 November 2014.

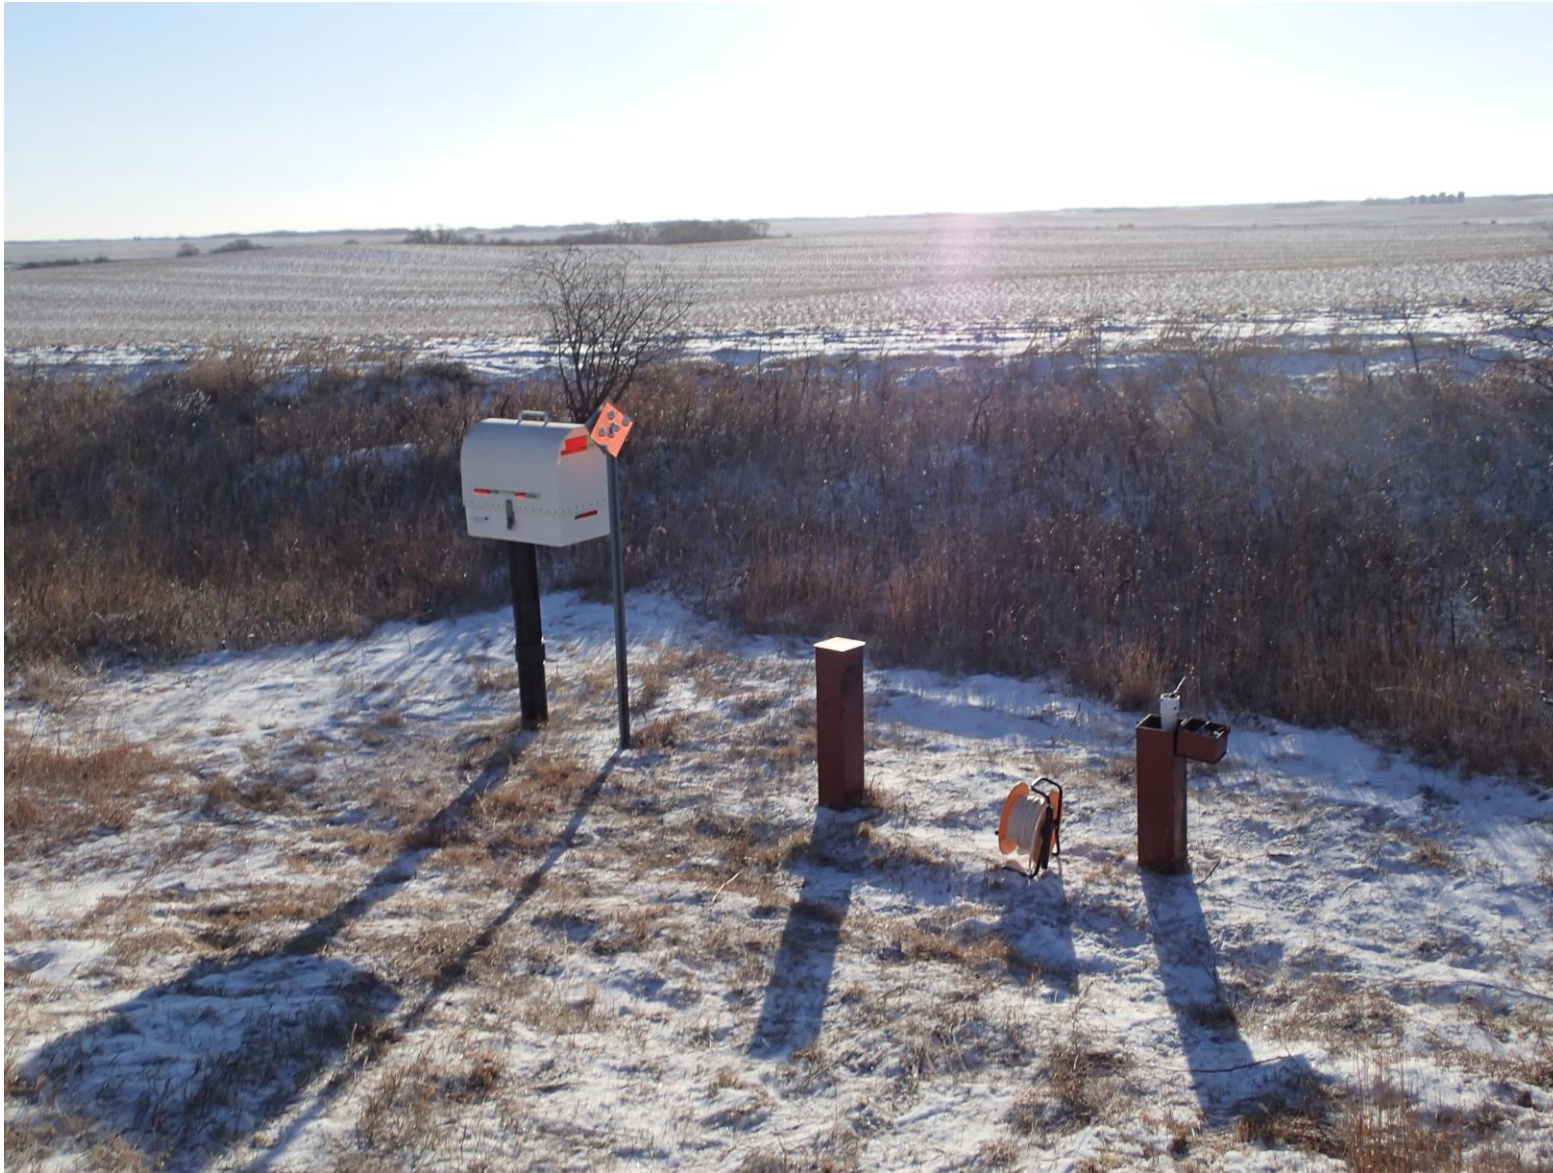
Photograph A4. Site GSC-SW-04. Piezometers from left to right: CWS well G05OA008, GSC-SW-04-p2, GSC-SW-04-p1. Photograph taken 26 November 2014, facing southeast.

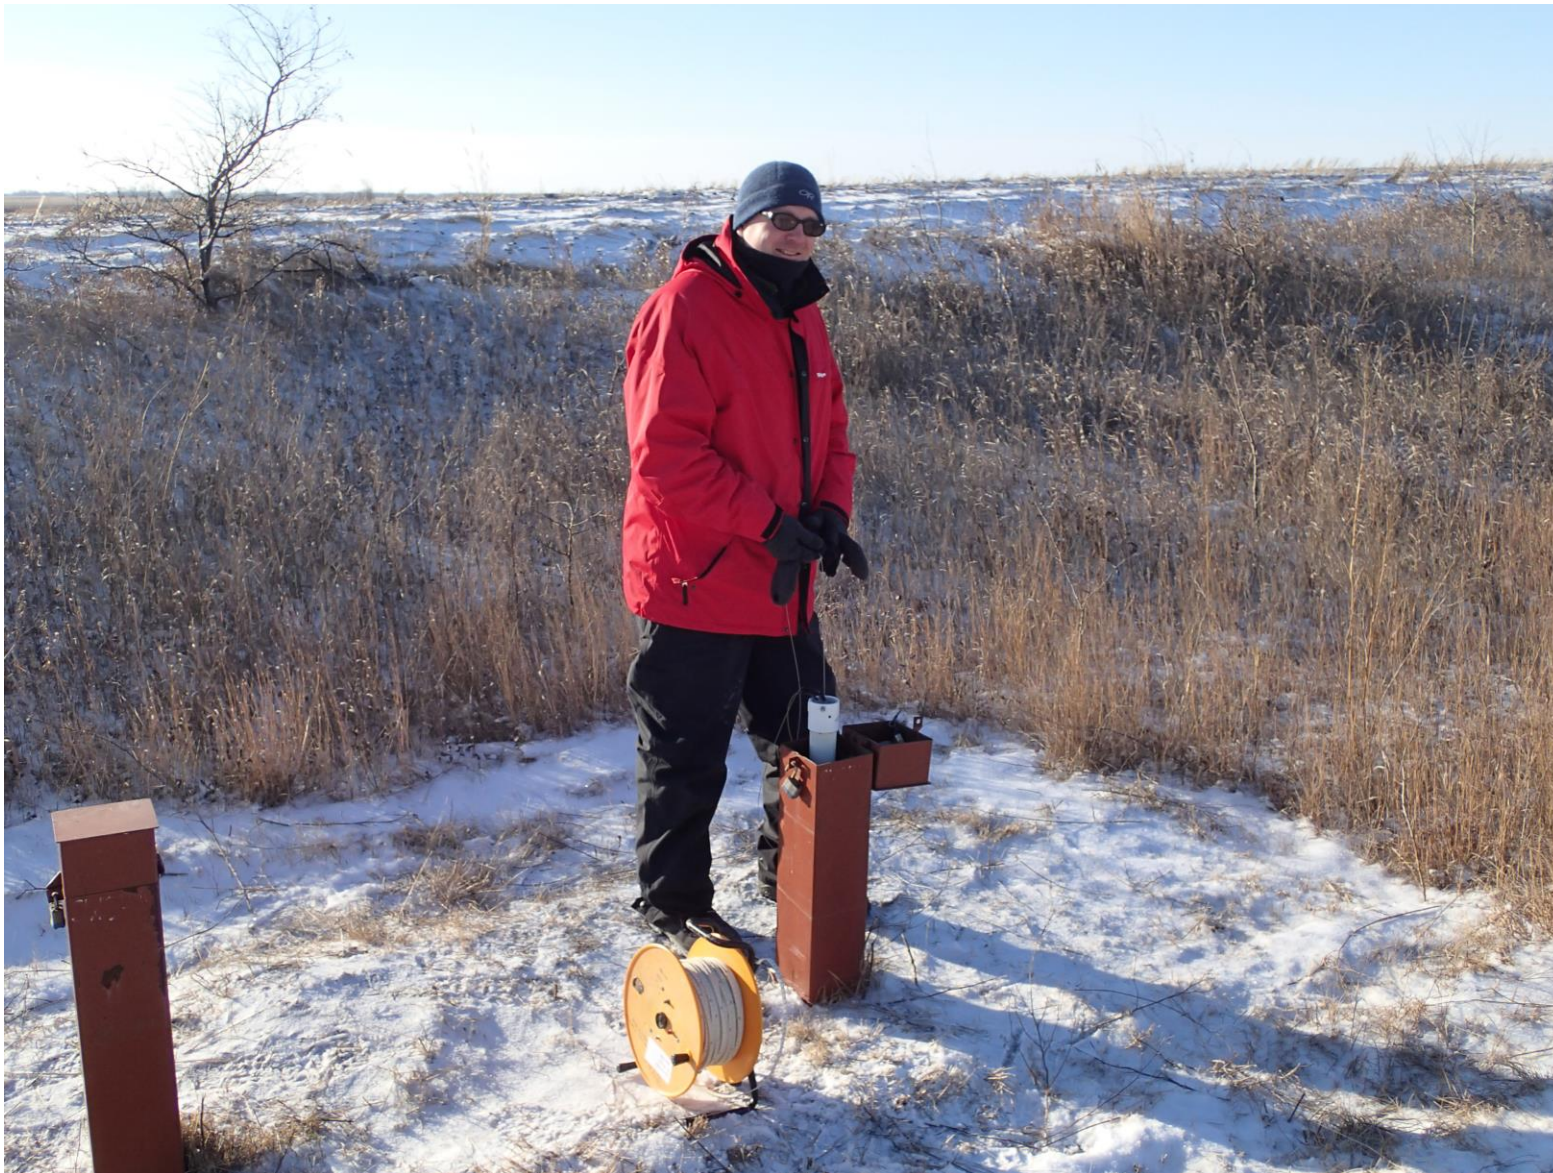
Photograph A5. Charles Logan retrieving Levellogger from piezometer GSC-SW-04-p1 for download. Note two cables in piezometer: one for the Levellogger, the other for the Barologger. Photograph taken 26 November 2014, facing southwest.

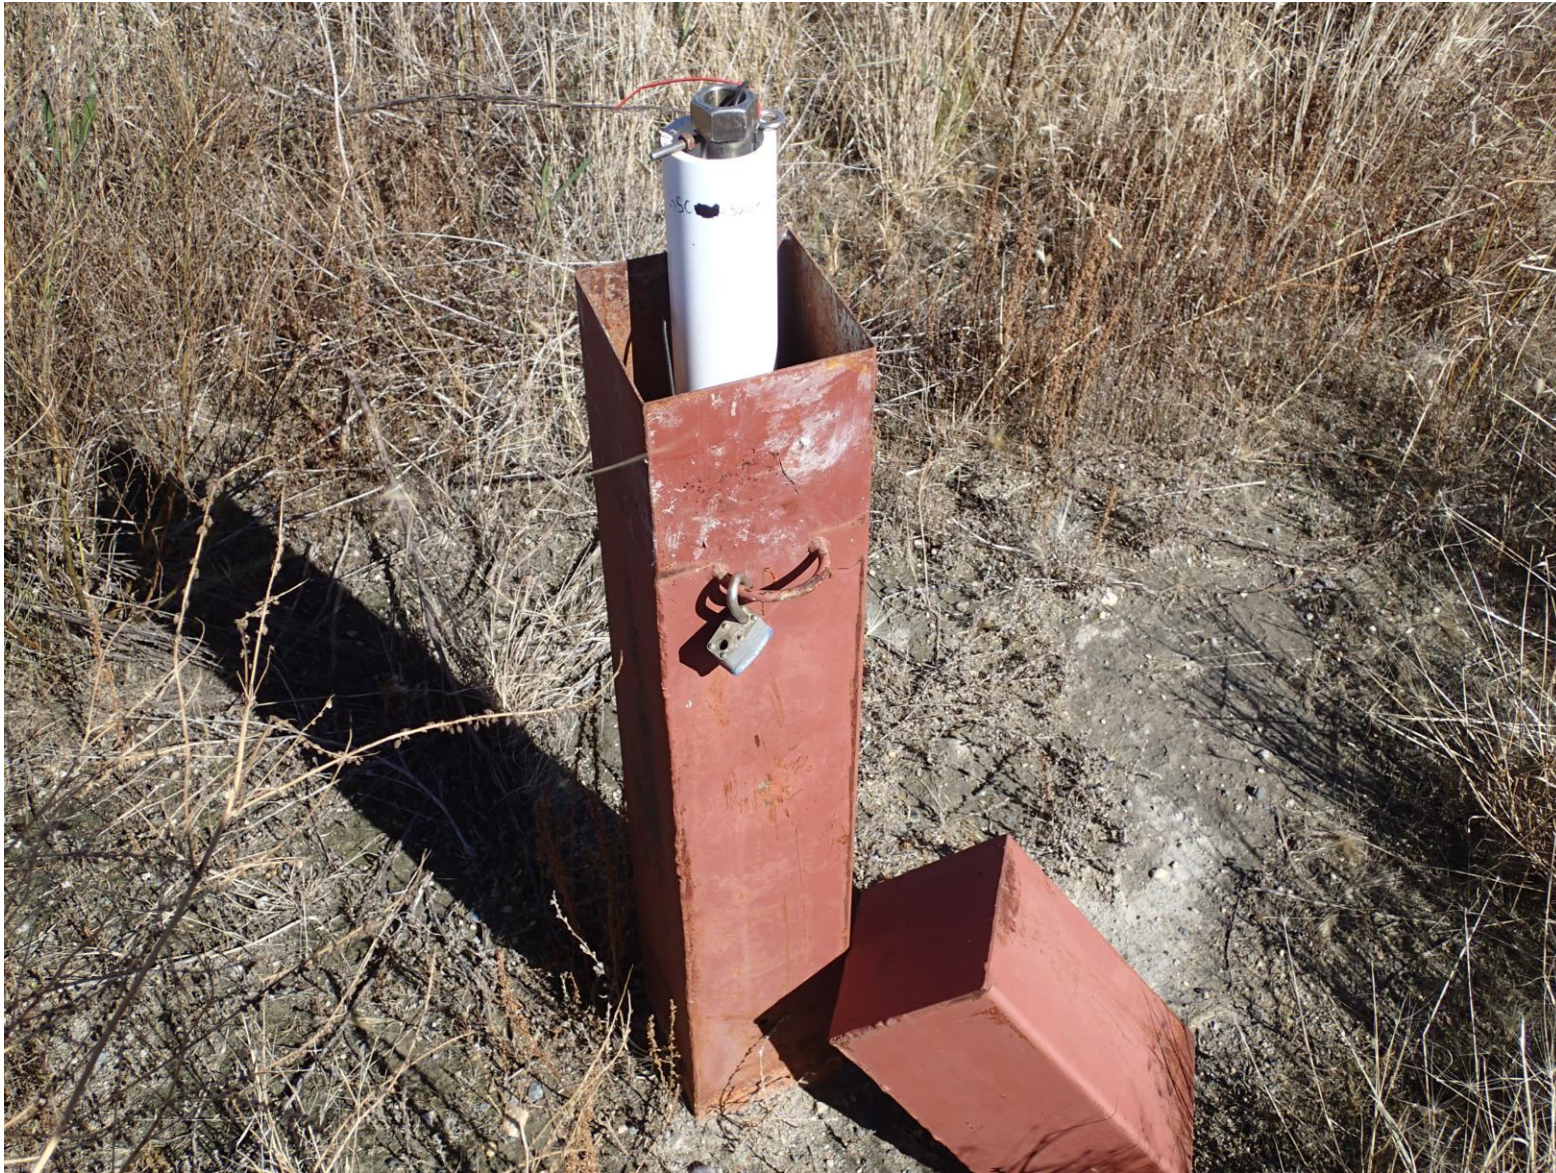
Photograph A6. Piezometer GSC-SW-07-p2 with the packer installed. Photograph taken 1 October 2013.

When GSC-SW-07-p2 was initially drilled, the water level was near ground surface and there was some concern that freezing of the water in the well might occur and could damage the integrity of the PVC casing. Therefore, a 3.12 m long packer was custom built (Well Busters, Belleville, ON) for this monitoring well and was installed in October 2011 (photograph A6). The packer included a Solinst Direct Read cable (a cable connected directly to the Levellogger, allowing it to be read *in situ* from the

surface) installed through the middle to allow a Levellogger to be deployed below the packer and controlled by computer from the cable connection above ground surface. The packer leaked slightly along the Direct Read cable during its first deployment and was re-caulked in October 2012 without any subsequent leaking.

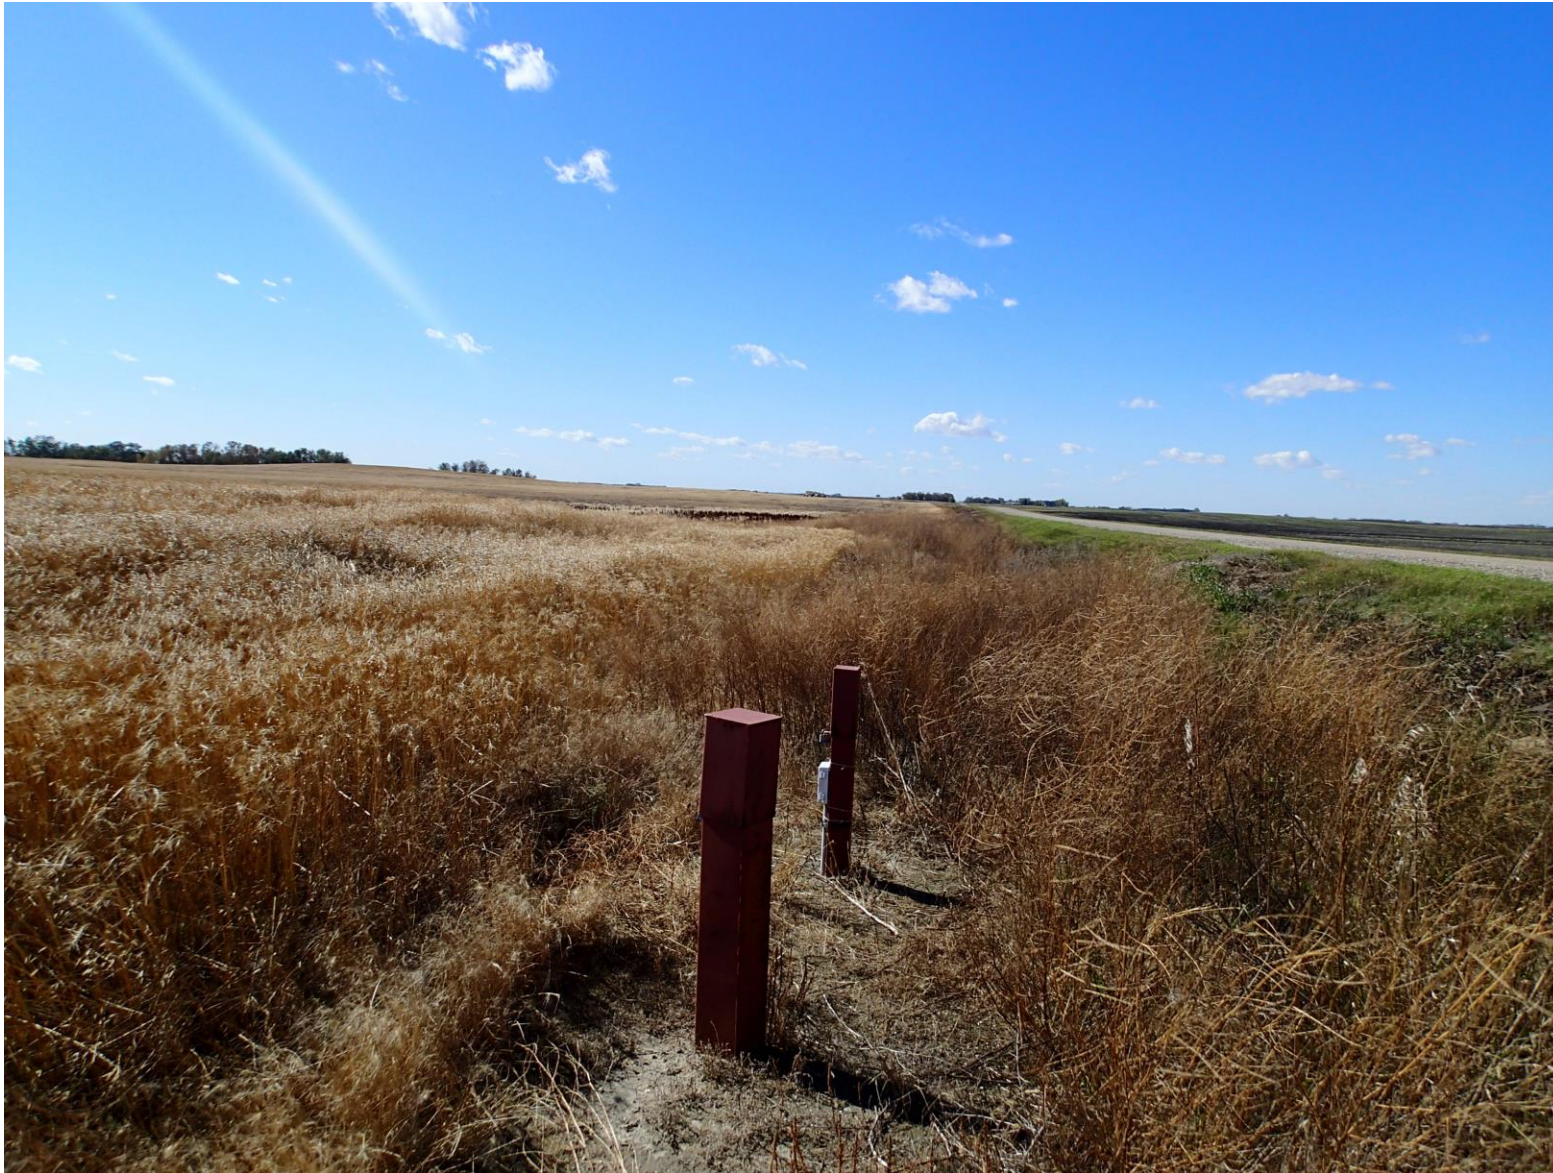
Photograph A7. Site GSC-SW-07 showing swale/ditch in which piezometers are located. Piezometers from left to right: GSC-SW-07-p2, GSC-SW-07-p1. Photograph taken 1 October 2013, facing west.

Water levels in piezometer GSC-SW-07-p1 responded to both spring melt and autumn rain in each of the four years of monitoring with the spring melt showing the largest response (Figures 19 and 20). The site's position within the swale/ditch along the roadside could have led to enhanced recharge due to snow accumulation and runoff from the road (see Photographs A7-A10). The response during spring 2011 was particularly large and likely produced a temporary water table within the snow pack and standing water in the swale as water levels were up to 53 cm above ground surface (Figure 19). It is possible that drilling mud deposited within the swale could have contributed to these high water levels.

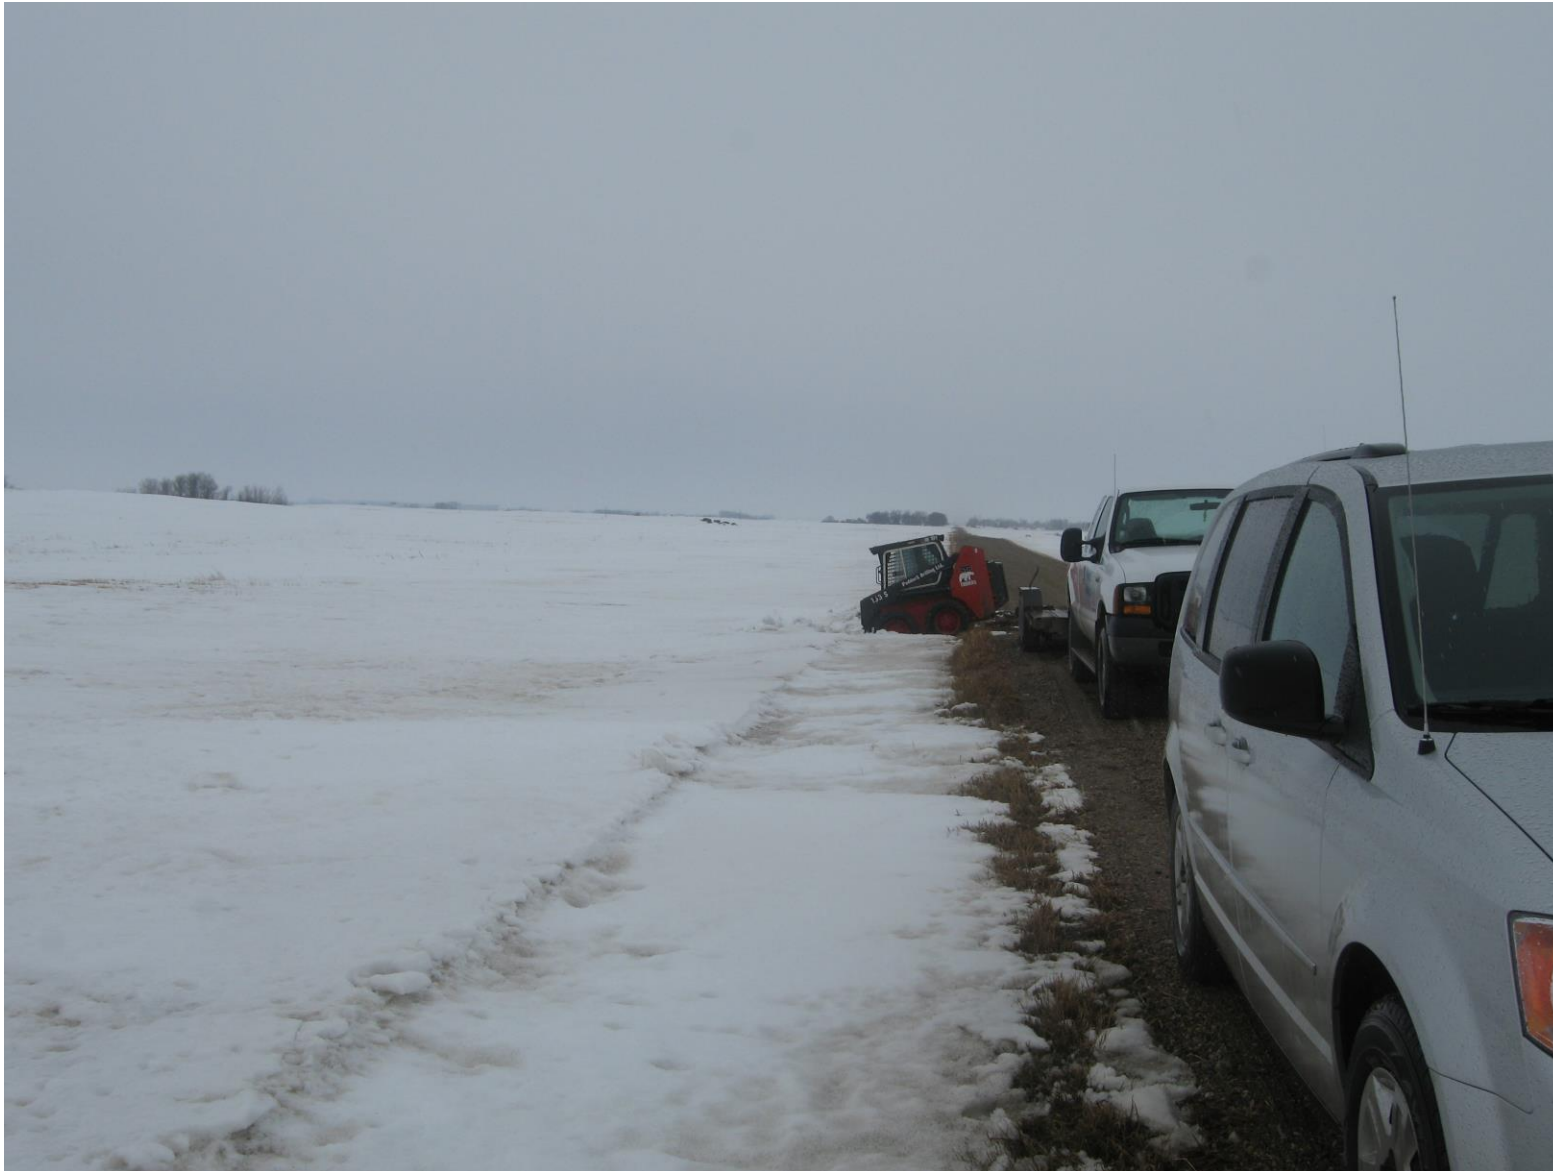
Photograph A8. Heavy snowfall during the winter of 2010-11 completely filled the swale/ditch at site GSC-SW-07 and required snow removal prior to drilling. Photograph taken 16 March 2011, facing west.

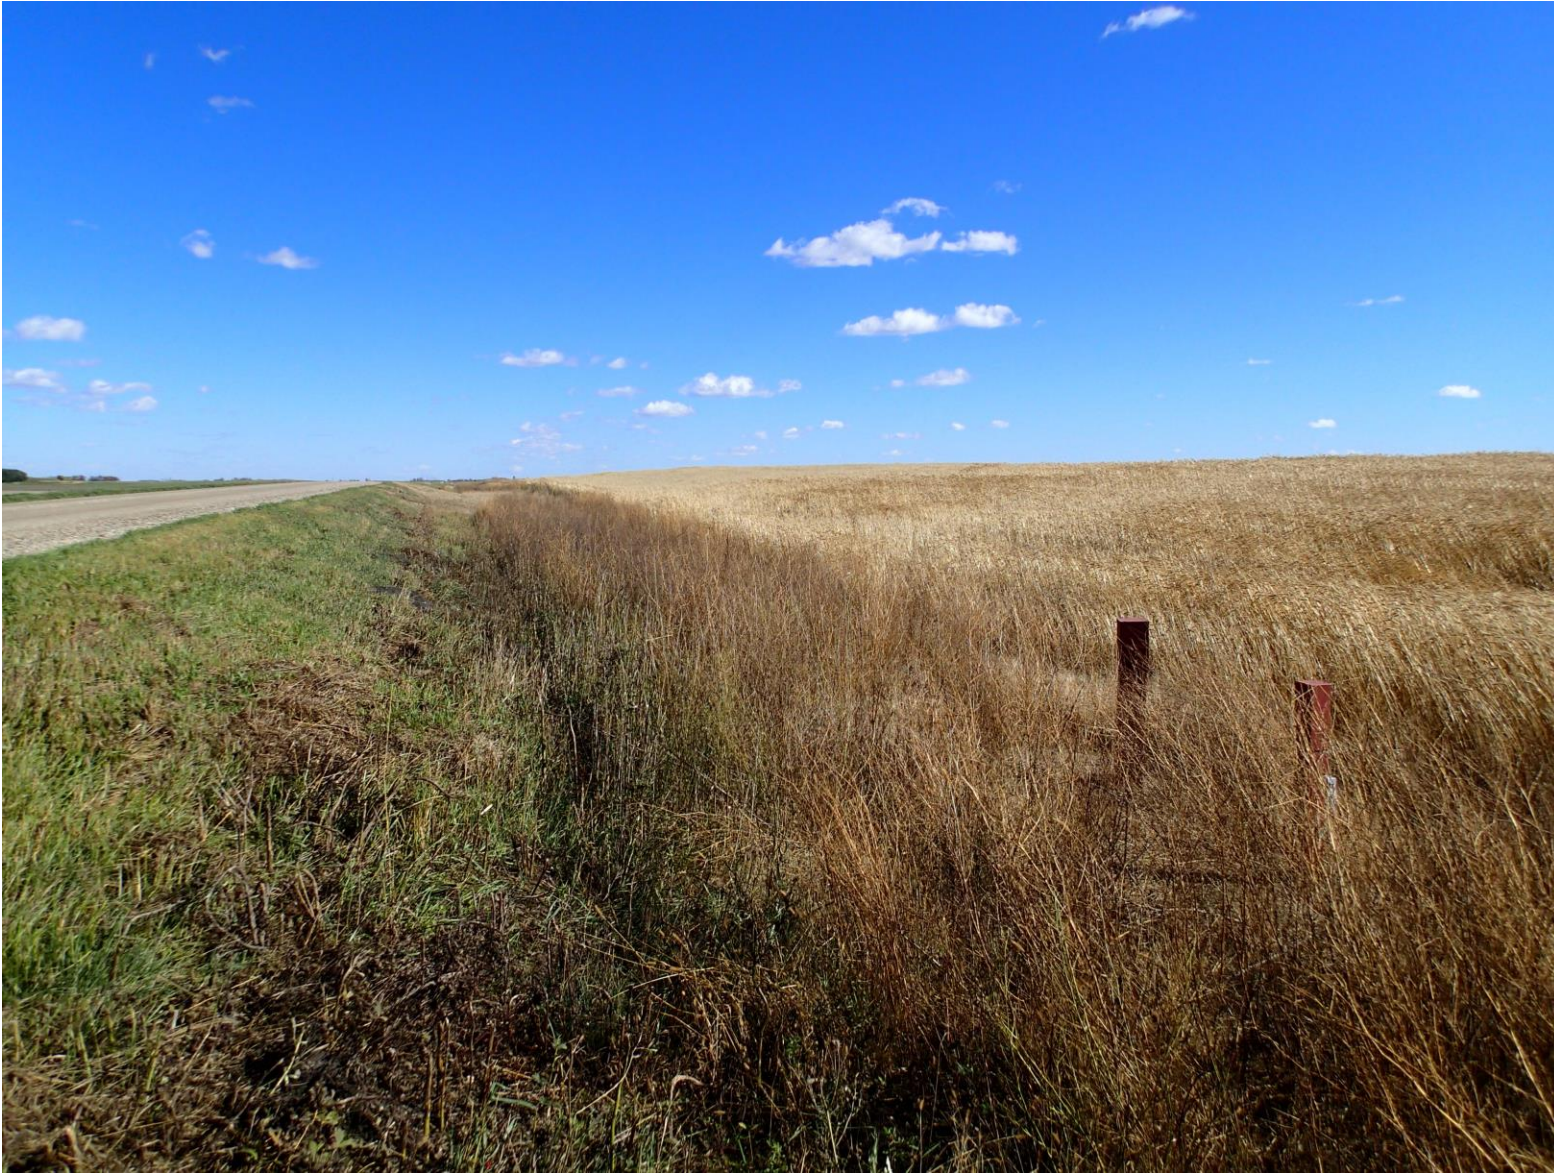
Photograph A9. Swale/ditch along the roadside at site GSC-SW-07. Photograph taken 1 October 2013, facing east.
