**GEOLOGICAL SURVEY OF CANADA
OPEN FILE 8045**

**Groundwater Level Monitoring near Killarney
and Cartwright, Manitoba, 2010-2014**

M.J. Hinton

2016

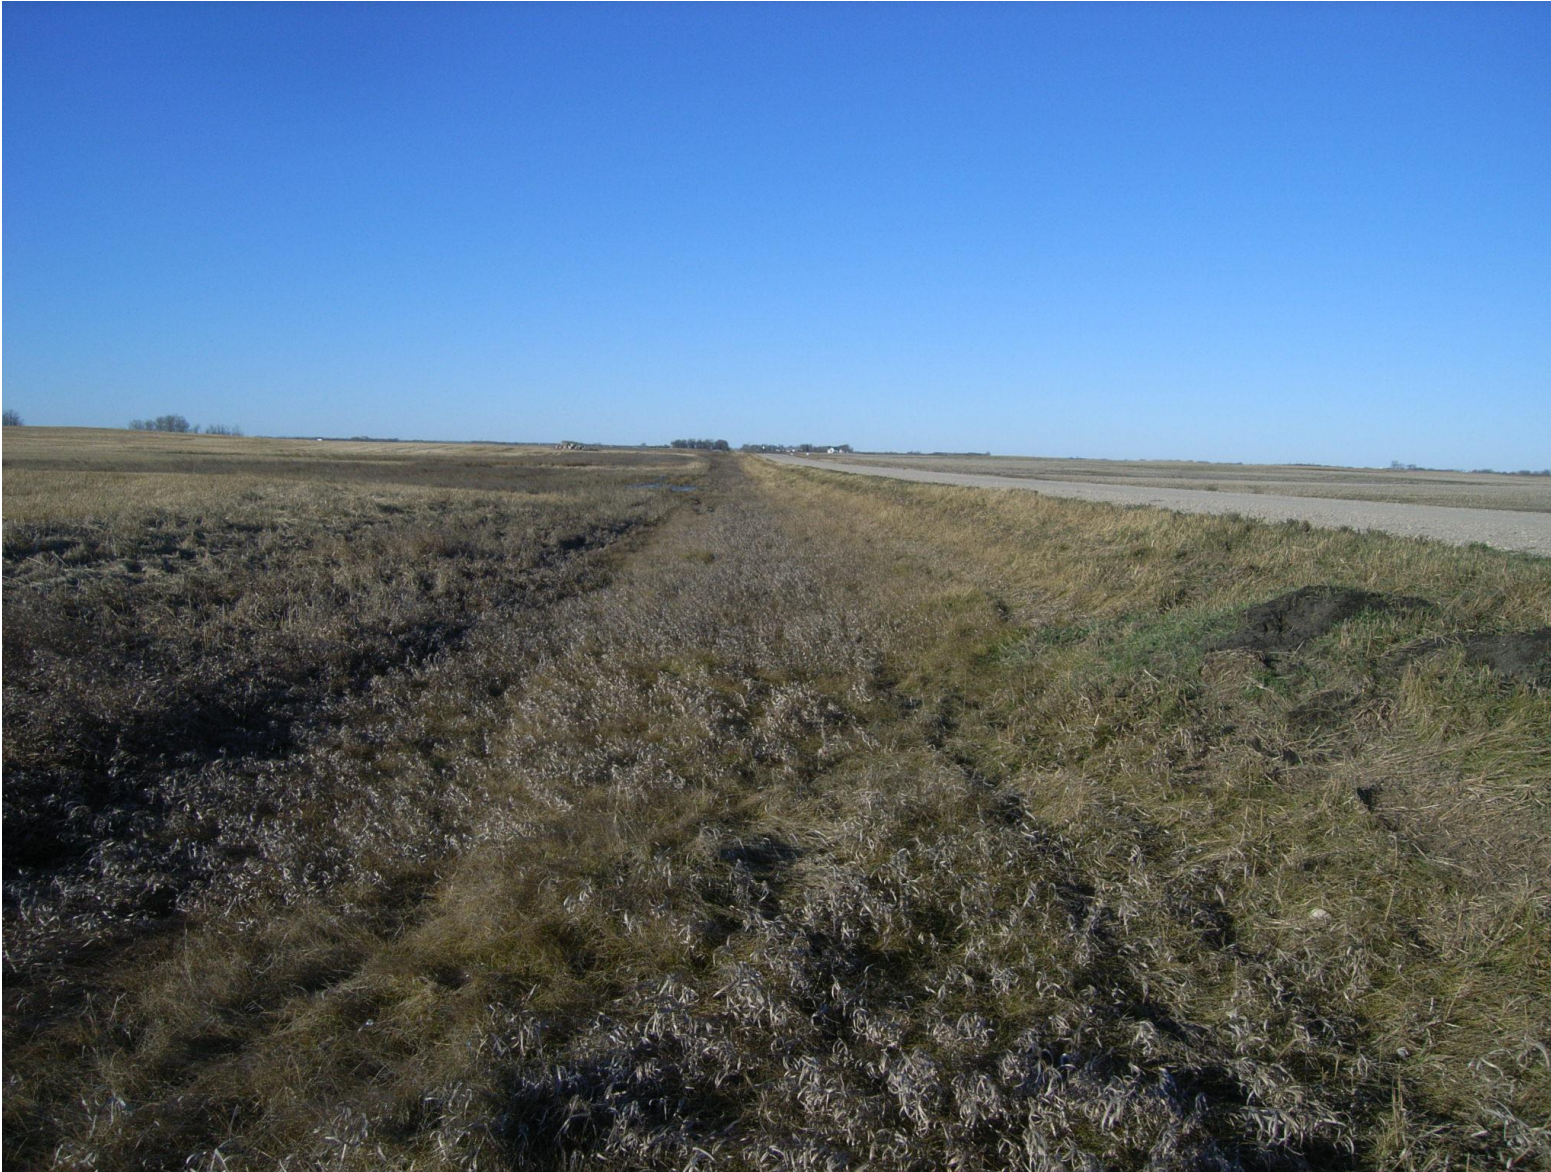
Photograph A10. Swale/ditch along the roadside at site GSC-SW-07 prior to drilling and piezometer installation. Photograph taken 3 November 2010, facing west approximately 15 m east of the eventual drilling location.

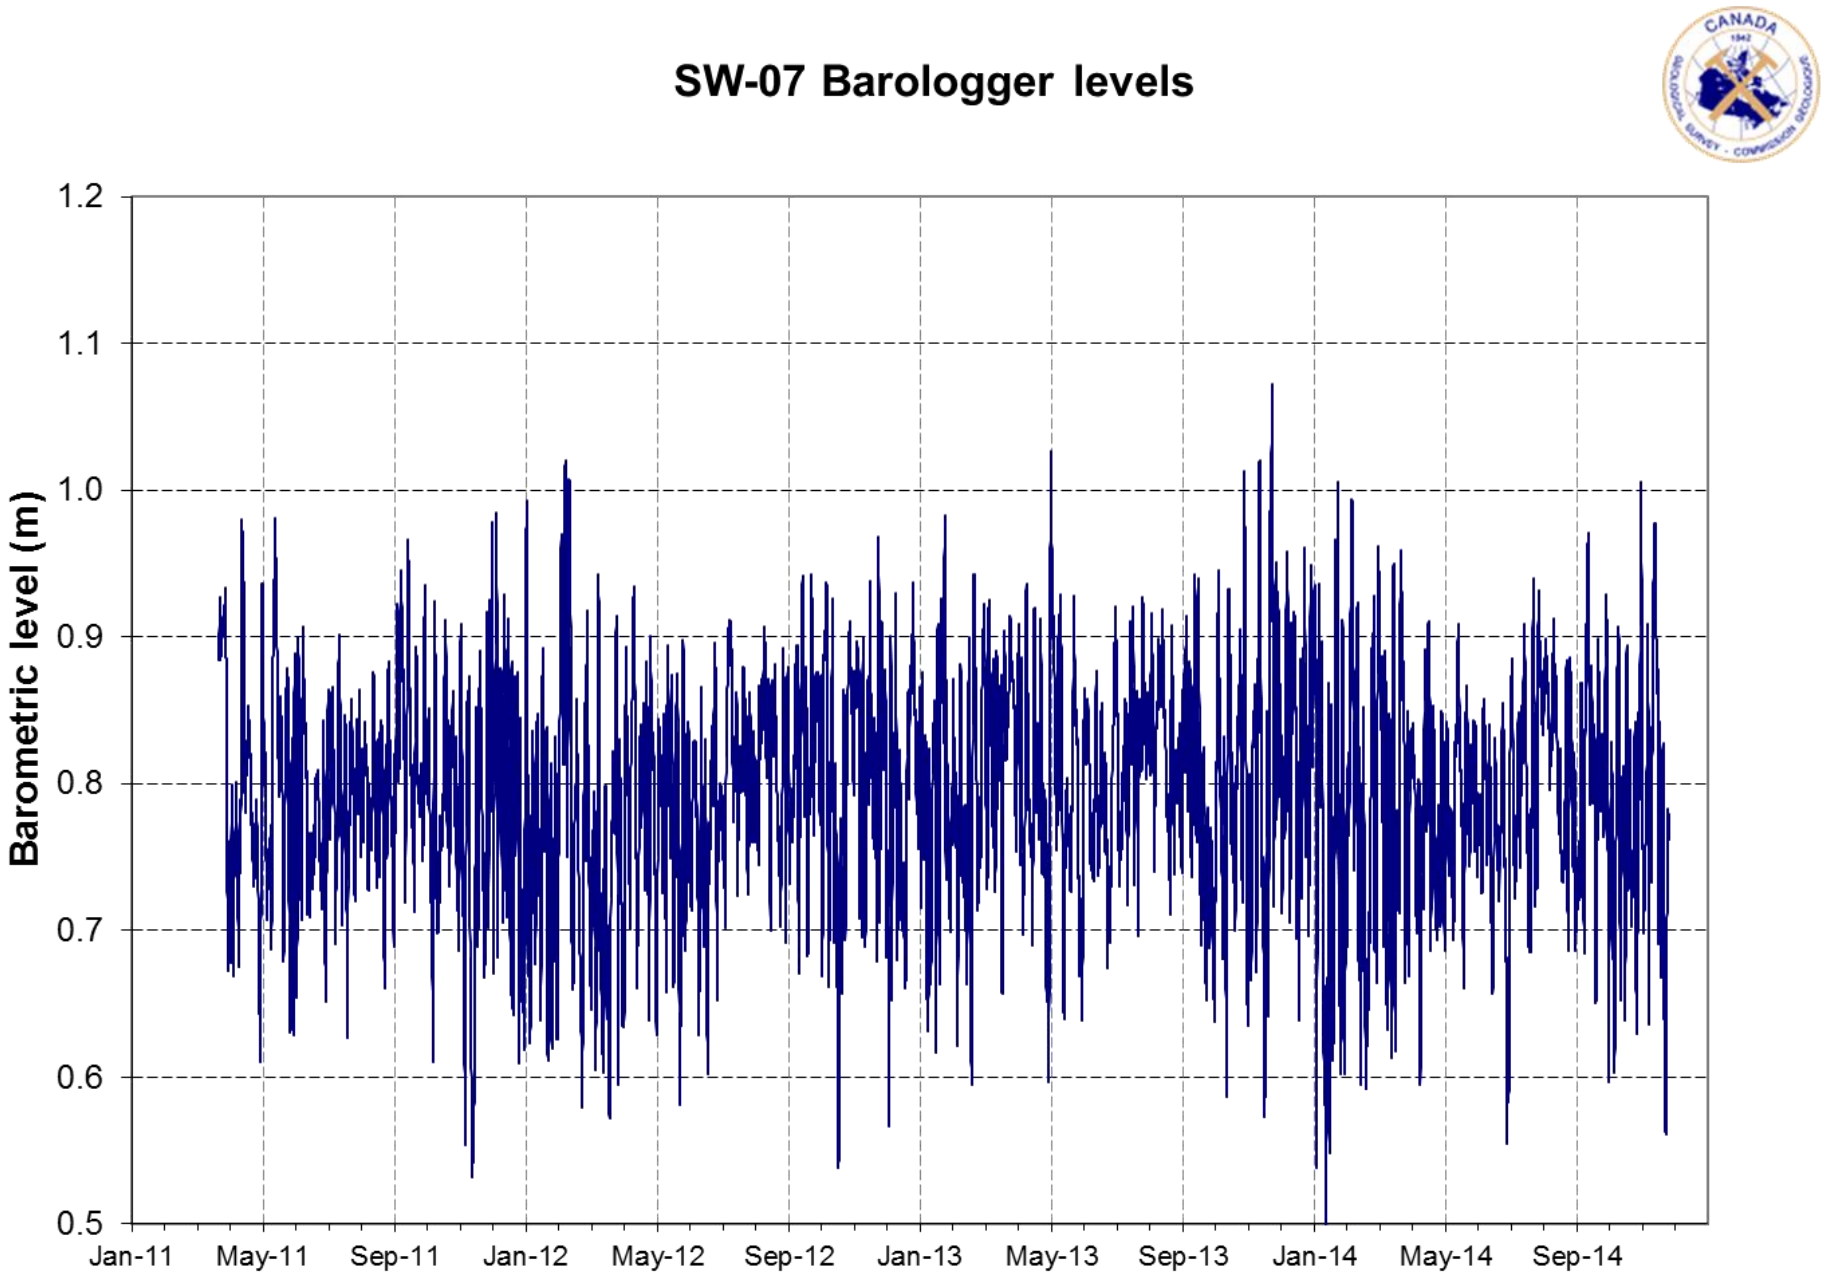
Figure B4. Barometric levels GSC-SW-07.

Piezometer GSC-SW-07-p2 showed a strong delayed response to barometric pressure fluctuations so they were corrected with Kansas Geological Survey barometric response function software (Bohling et al., 2011) based on the method discussed by Butler et al. (2011) and Stotler et al. (2011). Barometric response functions were calculated for 12 time lags (12 hours) with no earth tide corrections.

The Barologger deployed within piezometer GSC-SW-07-p1 became flooded during spring melt in 2011 and, therefore, recorded both atmospheric pressure and an additional water pressure. The hourly station pressure at the Environment Canada Brandon weather station (Station ID 5010480) was highly correlated with the Barologger readings ($r^2 = 0.99$) and was, therefore, used for barometric correction of GSC-SW-07-p1 from 12 April to 30 June 2011.
