# **Investigation of Black Soot Staining in Houses**

**April 2000**

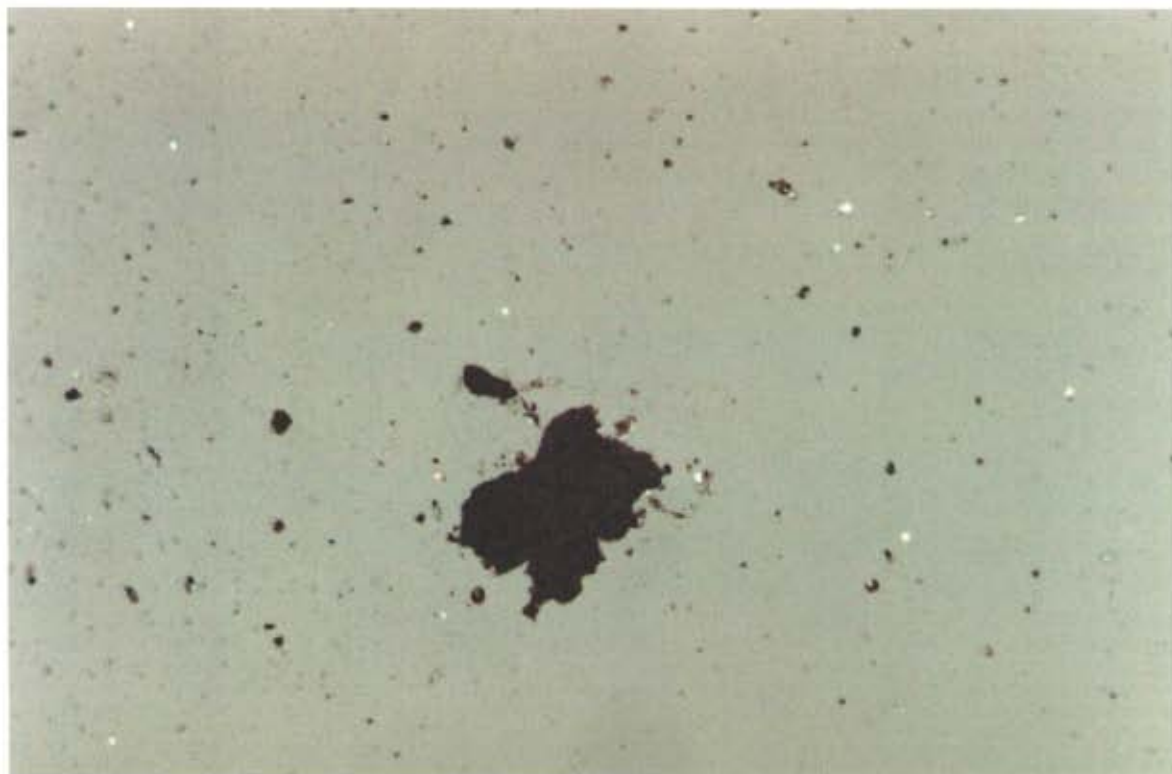
Figure 3.1: Photomicrograph of House#3 Window Frame Swab

In the above samples the mineral type particulate may be common elements of house dust, sand, road dust or drywall compound.

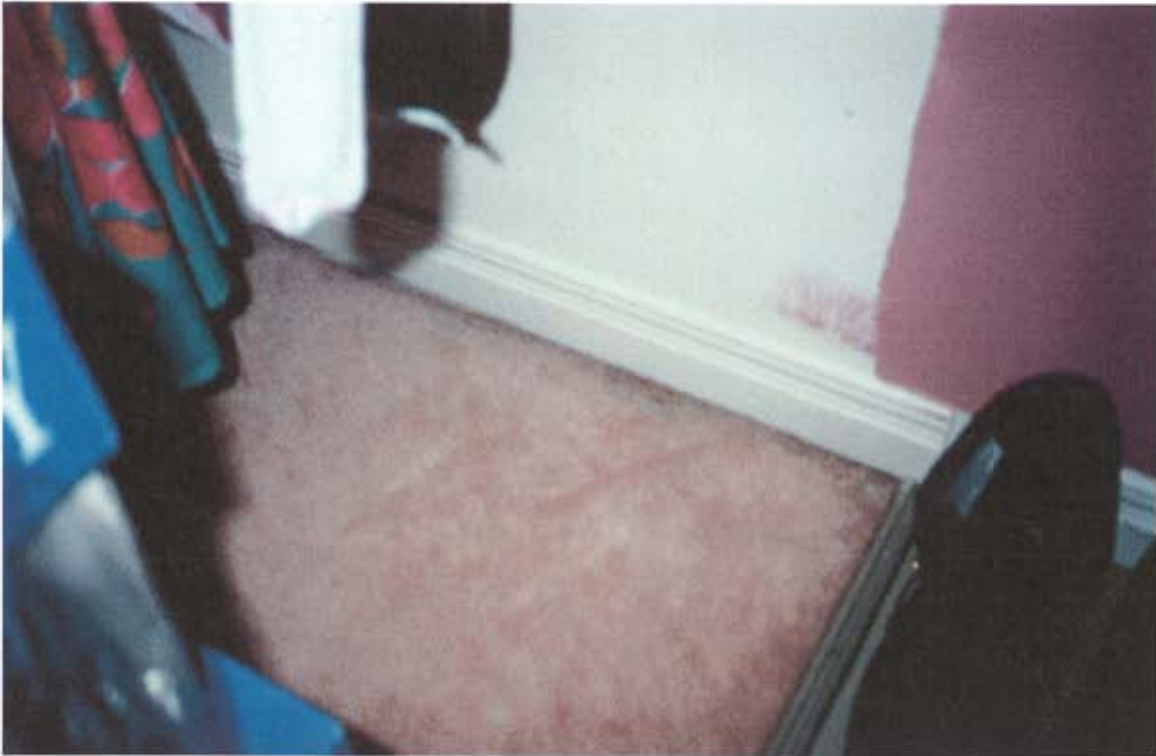
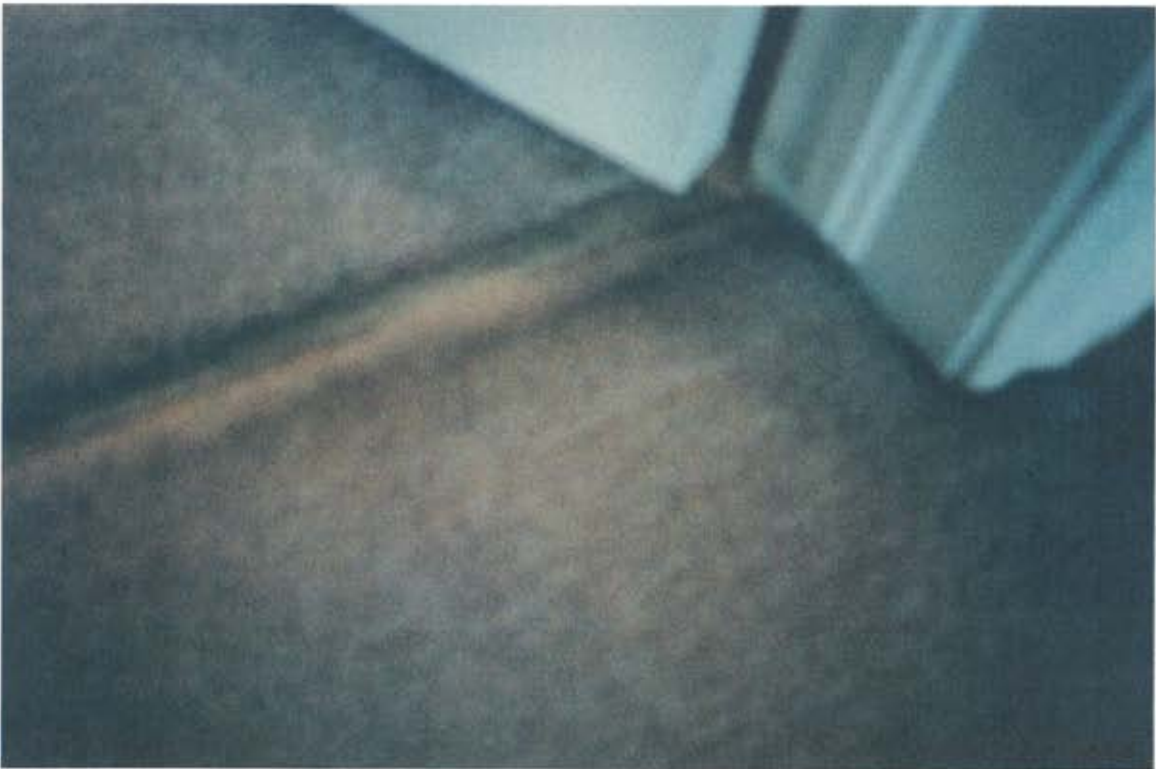
## Sample Pictures

In the above samples the mineral type particulate was consistent with surfacing material such as drywall compound or texture coat.
