REPORT FOR CANADA MORTGAGE AND HOUSING CORPORATION

In Situ Testing of the Thermal Performance of Wall Sections in N.W.T.

G. K. YUILL AND ASSOCIATES LTD.

AUGUST 1 , 1989

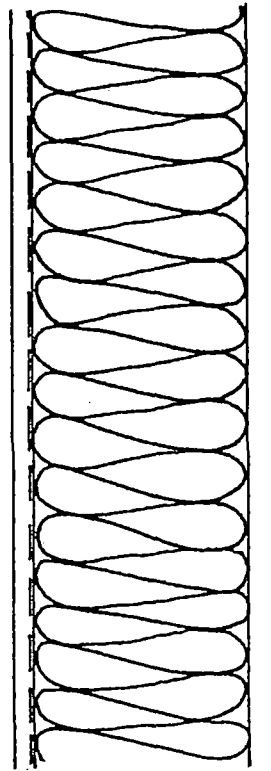
Figure 1. Exterior Wall Section of House No. 1

12.7mm GYPSUM BOARD
6ml POLY VAPOUR BARRIER
R.S.I. 3.5 BATT INSULATION
38 x 140 STUDS @ 600 O.C.
15.5mm CEDAR SIDING

The nineplex was a multi-unit structure that consisted of nine separate dwelling units. The units were situated side-by-side, forming a long complex with the end units having three exterior walls, and the middle units having two exterior walls. The walls were of typical wood frame construction with 38 mm x 140 mm studs, 400 mm O.C. The walls (from interior to exterior) were composed of 12.7 mm gypsum board, vapour barrier, R.S.I. 3.5 batt insulation in the wall cavity, and 15.5 mm cedar siding. Figure 1 shows the cross section of the exterior wall in the nineplex.

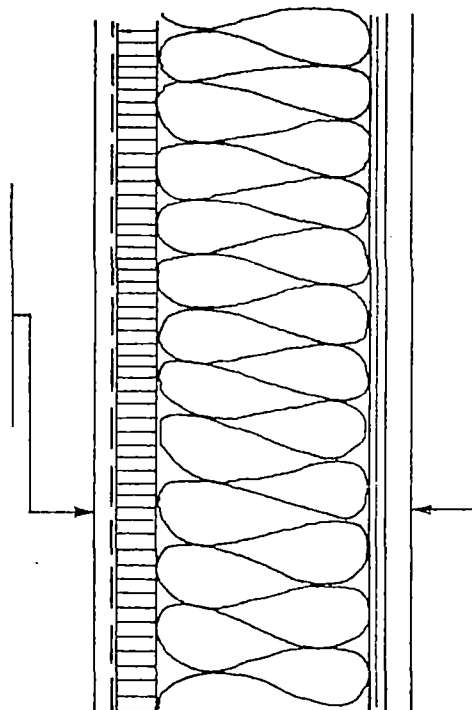
Figure 2. Exterior Wall Section of House No. 2

12.7 GYPSUM BOARD
VAPOUR BARRIER
25 mm RIGID INSULATION
R.S.I. 3.5 BATT INSULATION
38 x 140 @ 600 O.C.
AIR BARRIER
15.5 mm PLYWOOD SIDING

The duplex was a two-dwelling structure with each unit having two stories. The walls were of typical wood frame construction with 38 mm x 140 mm studs, 600 mm O.C. The walls (from interior to exterior) were composed of 12.7 mm gypsum board, vapour barrier, 25 mm rigid insulation, R.S.I. 3.5 batt insulation in the wall cavity, air barrier, and 15.5 mm plywood siding. Figure 2 shows the cross section of the exterior wall in the duplex.

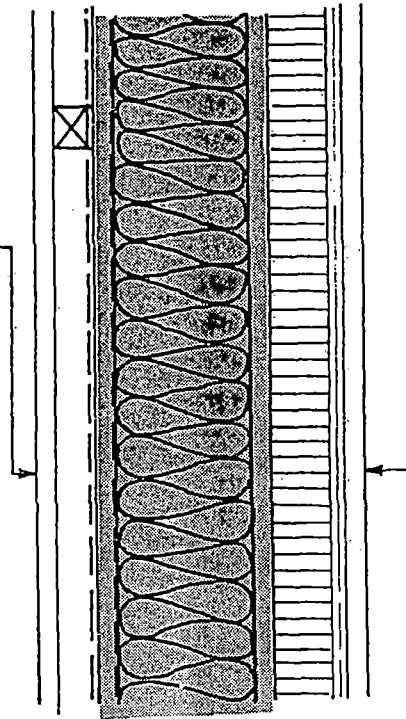
Figure 3. Exterior Wall Section of House No. 3

GYPSUM BOARD WALL FINISH ON
1 x 3 WOOD STRAPPING @ 16" O/C
6 mil POLY VAPOUR BARRIER ON
EXISTING WALL ASSEMBLY c/w 2 x 2
VERT. WOOD STRAPPING @ 4'-0"
O/C WITH 1 1/2" GLAS-CLAD
BETWEEN c/w AIR BARRIER PAPER
c/w PREFINISHED PLYWOOD SIDING

House No. 3 was a single detached dwelling unit that was constructed in 1976, and retrofitted in 1986. The original walls were of typical wood frame construction with 38 mm x 89 mm studs, 400 mm O.C. The wall cavity was insulated with R.S.I. 2.1 batt insulation. The retrofitted wall section had a gypsum board wall, horizontal strapping, and vapour barrier on the interior side of the original wall assembly, and 38 mm glas-clad complete with air barrier paper, and prefinished plywood siding on the exterior side of the original wall assembly. Figure 3 shows the cross section of the exterior wall in the 1986 retrofit.

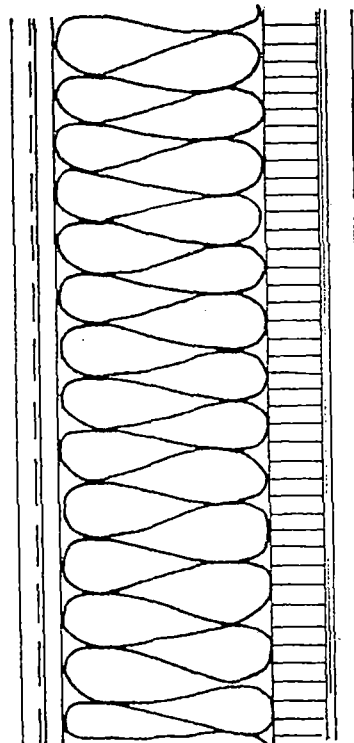
Figure 4. Exterior Wall Section of House No. 4

12.7mm GYPSUM BOARD
6ml POLY VAPOUR BARRIER
9.5mm PLYWOOD
R.S.I. 3.5 BATT INSULATION
38 x 140 @ 600 O.C.
38mm GLAS-CLAD
AIR BARRIER
15.5mm PLYWOOD SIDING

The duplex was a two-dwelling structure with each unit having two stories. The walls were of typical wood frame construction with 38 mm x 140 mm studs, 600 mm O.C. The walls (from interior to exterior) were composed of 12.7 mm gypsum board, vapour barrier, 9.5 mm plywood, R.S.I. 3.5 batt insulation in wall cavity, and 38 mm glas-clad complete with air barrier paper, and prefinished

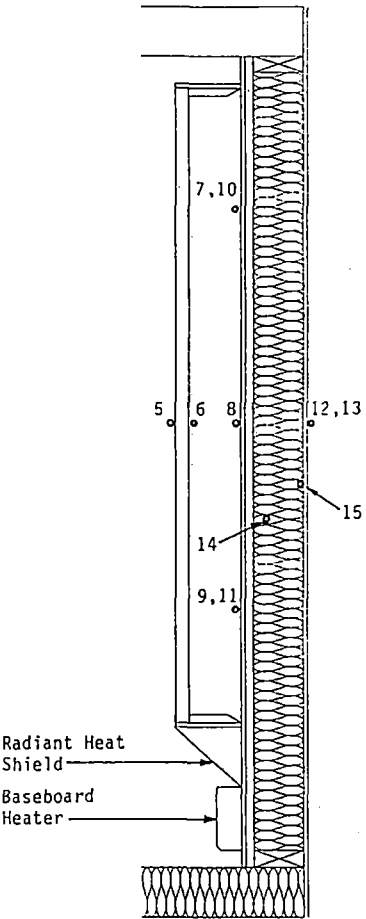
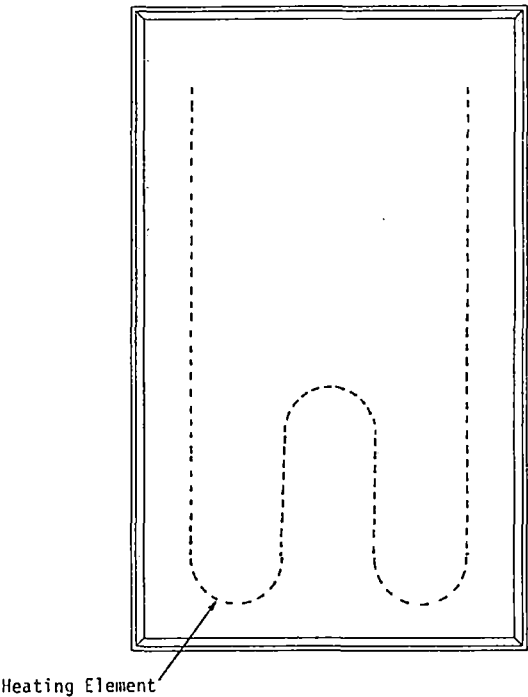
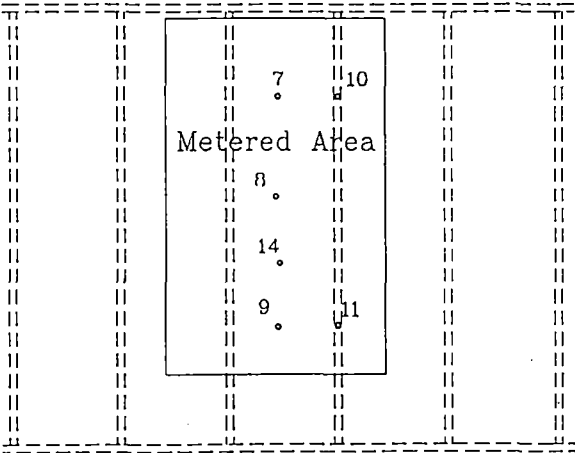
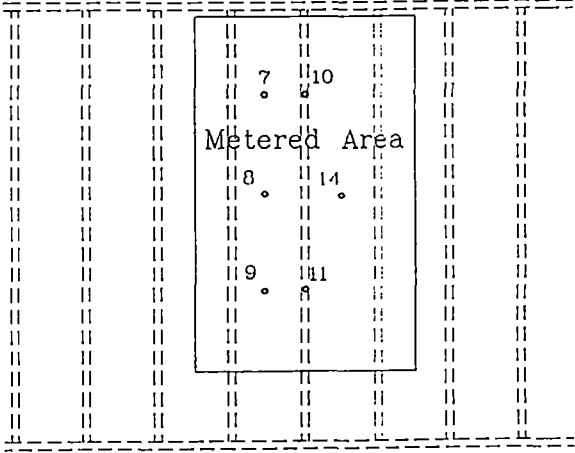
Figure 5 Temperature Sensor Placement

Figure 5 shows the approximate placement of the temperature sensors during monitoring.

38 x 140 Stud Wall 600 O.C.

38 x 140 Stud Wall 400 O.C.

Two steps were taken to ensure that the baseboard heaters did not affect the calorimeter testing. The first step was to mount the hot box as high as possible above the baseboard heater. In the three installations made in the present project, the hot box calorimeters were mounted 6 to 8 inches above the baseboard heaters. The second step was to shield the underside of the hot box with aluminum foil. This involved running aluminum foil from the wall at the top of the baseboard to the base of the hot box approximately 0.2 m out from the wall. Thus, there was an air space between the hot box calorimeter and the shield. This provision is portrayed in Figure 5.

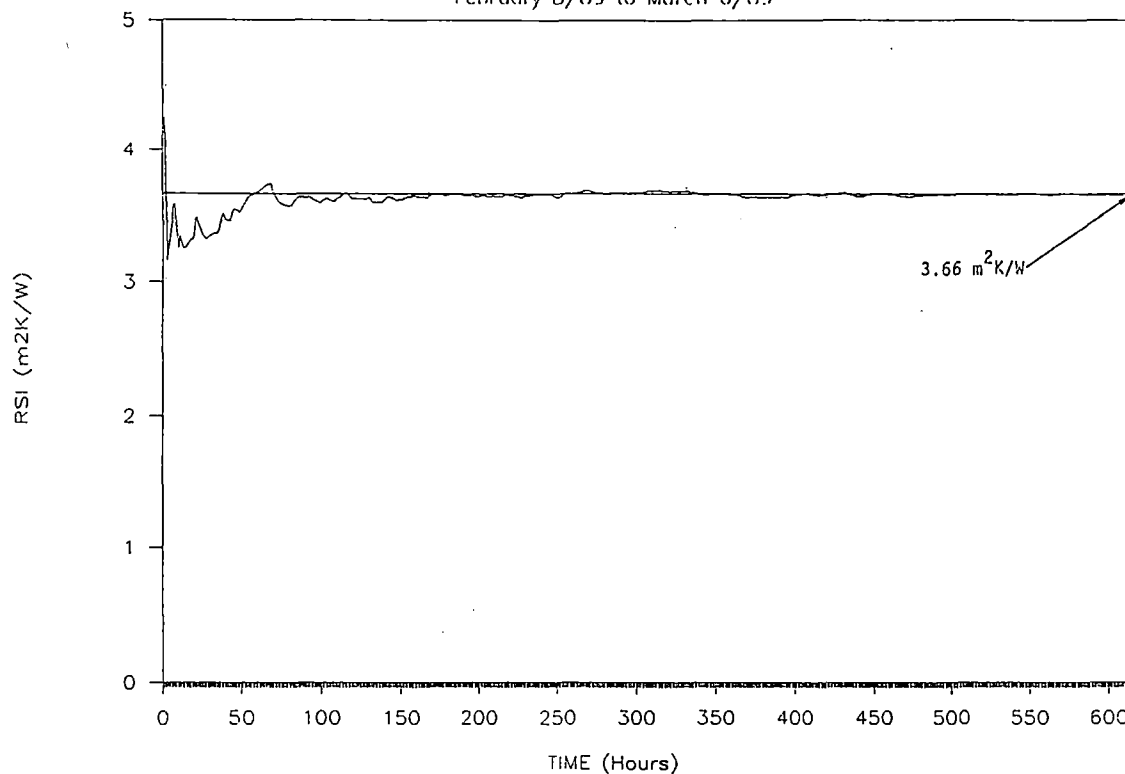
The net result from continuous monitoring is shown in Figure 6 where measured RSI value is plotted against time. A review of this figure indicates that the effects of stored energy were minimized after approximately 180 hours of monitoring. The effective RSI value for the selected wall section in House No. 1 was measured to be $3.66 \text{ m}^2\text{K/W}$.

HOUSE NO.1: 1984 NINEPLEX

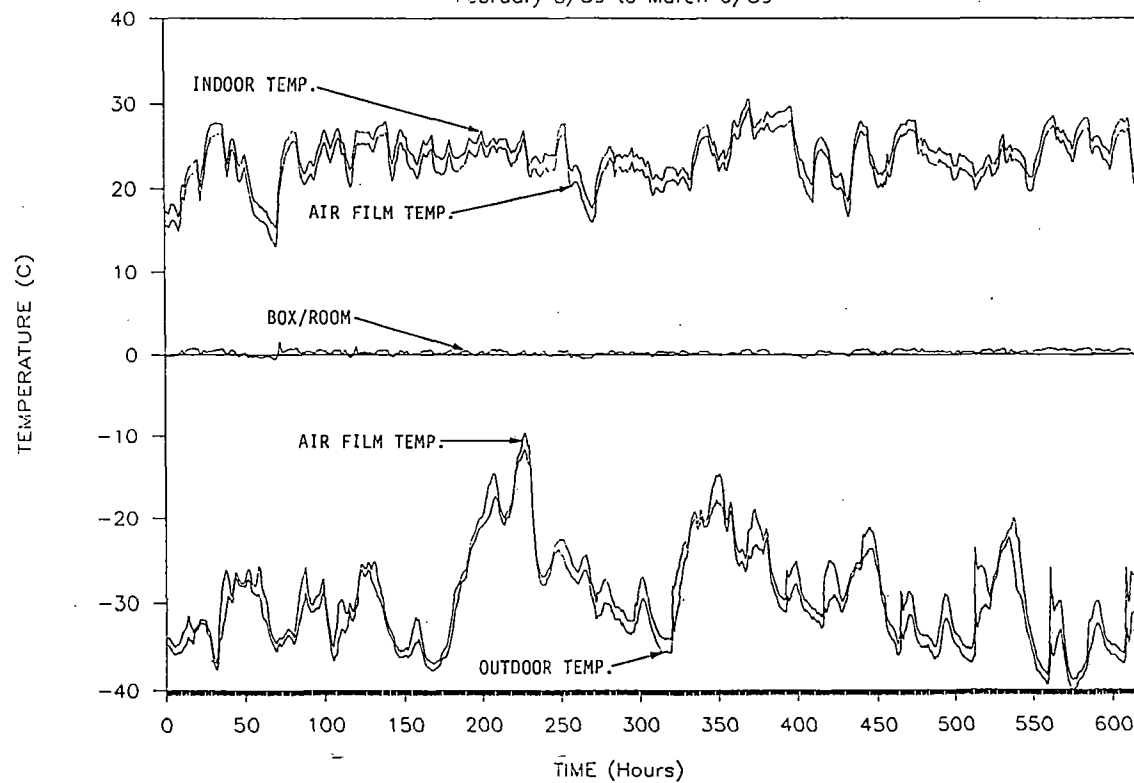
Figure 7

A log of selected temperatures is shown in Figure 7. Indoor air temperatures fluctuated between 15.2°C and 30.6°C with the average being 24.3°C . Outdoor air temperatures fluctuated between -9.5°C and -39.9°C with the average being -30.2°C . Over the entire monitoring period, the average differential temperature across the wall section (air film to air film) was 51.2°C .

HOUSE NO.1: TEMPERATURE LOG

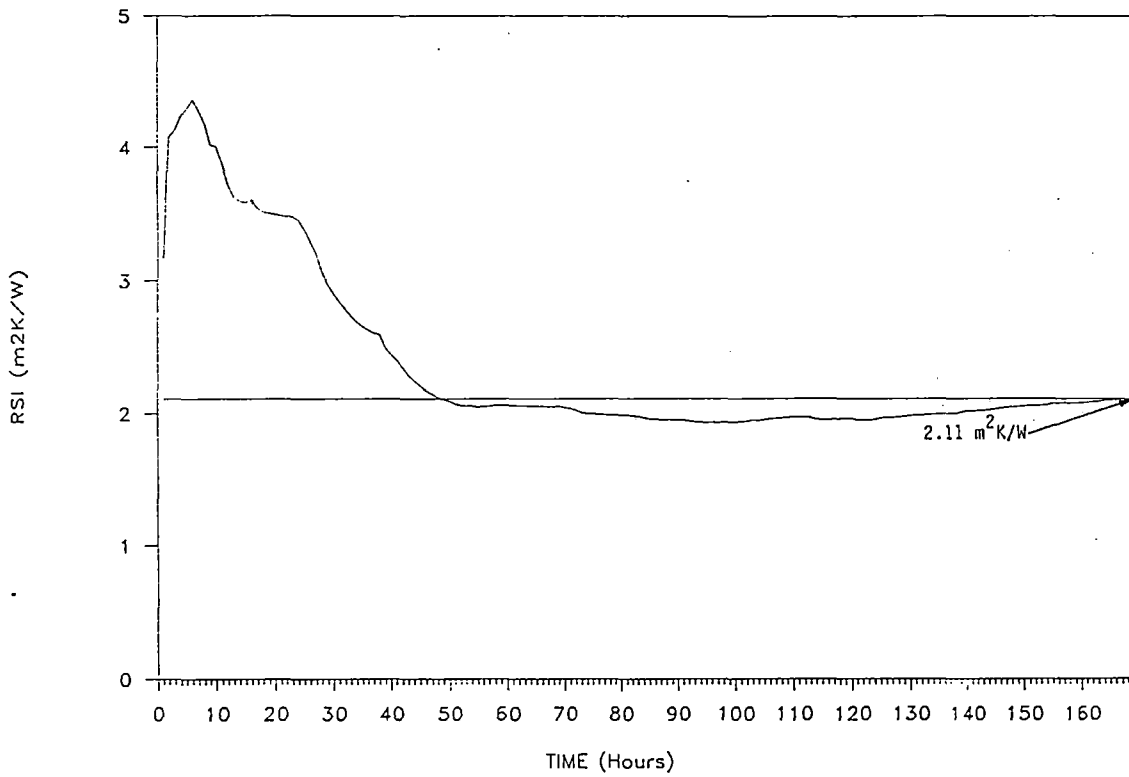
Figure 10
HOUSE NO. 3: 1986 RETROFIT
March 9/89 to April 5/89

The measured effective RSI value of the wall section in House No. 3 was found to be 42% lower than the calculated theoretical value. Housing officials in Rankin Inlet indicated that the existing wall sections in many of the retrofitted houses were damaged by moisture. However, the infrared thermography scan did not indicate signs of moisture damage. It is important to note that there was an air space behind the gypsum board wall which the guarded hot box calorimeter was attached to. Cold spots that were close to the metered area but not immediately behind it may have provided a route for heat to escape from the adjoining air space.

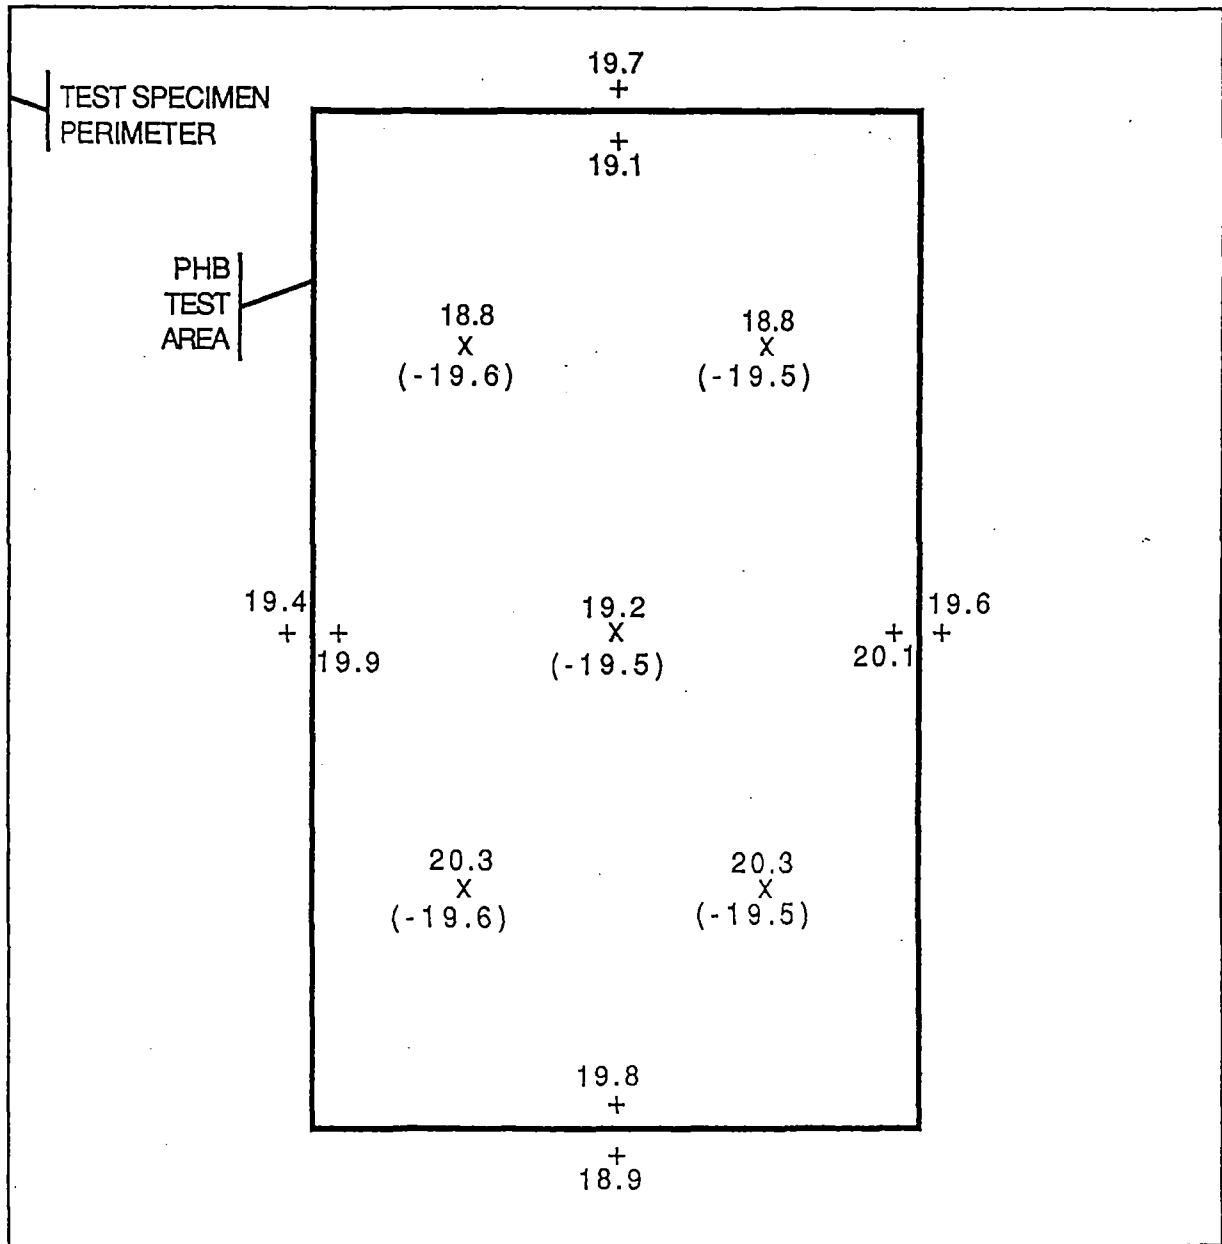
Figure 1. Temperatures measured on warm and cold surfaces of test specimen with PHB #1 installed.

- viewed from room side
- $T_h = 21^\circ\text{C}$; $T_c = -20^\circ\text{C}$
- cold surface temperatures in brackets

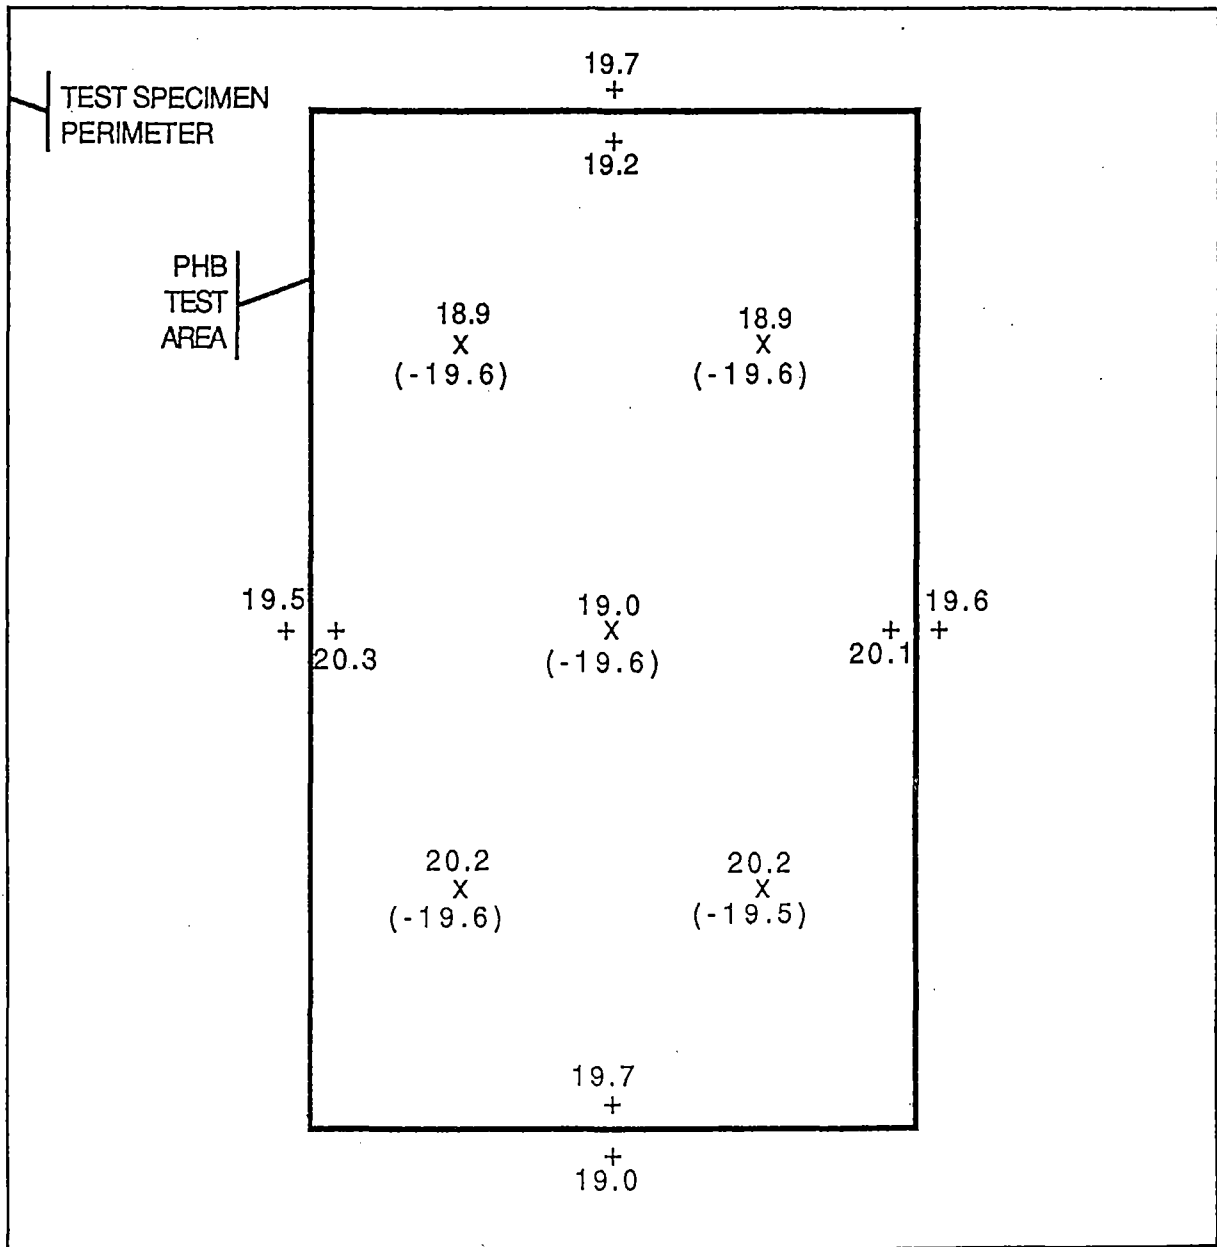
Figure 2. Temperatures measured on warm and cold surfaces of test specimen with PHB #2 installed.
- viewed from room side
- $T_h = 21^\circ\text{C}$; $T_c = -20^\circ\text{C}$
- cold surface temperatures in brackets

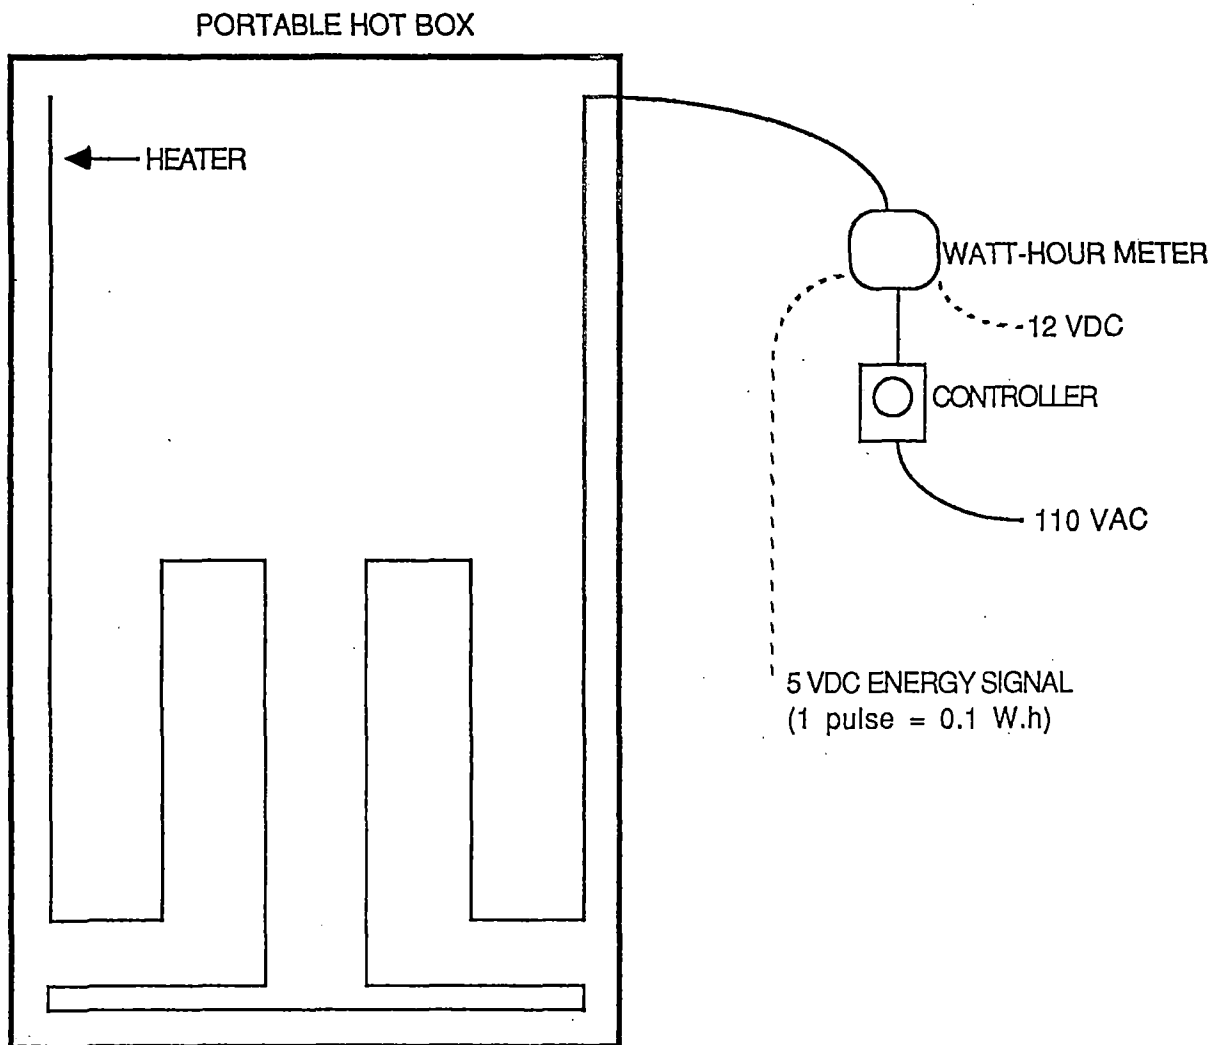
Figure 3. Schematic of portable hot box wiring diagram.

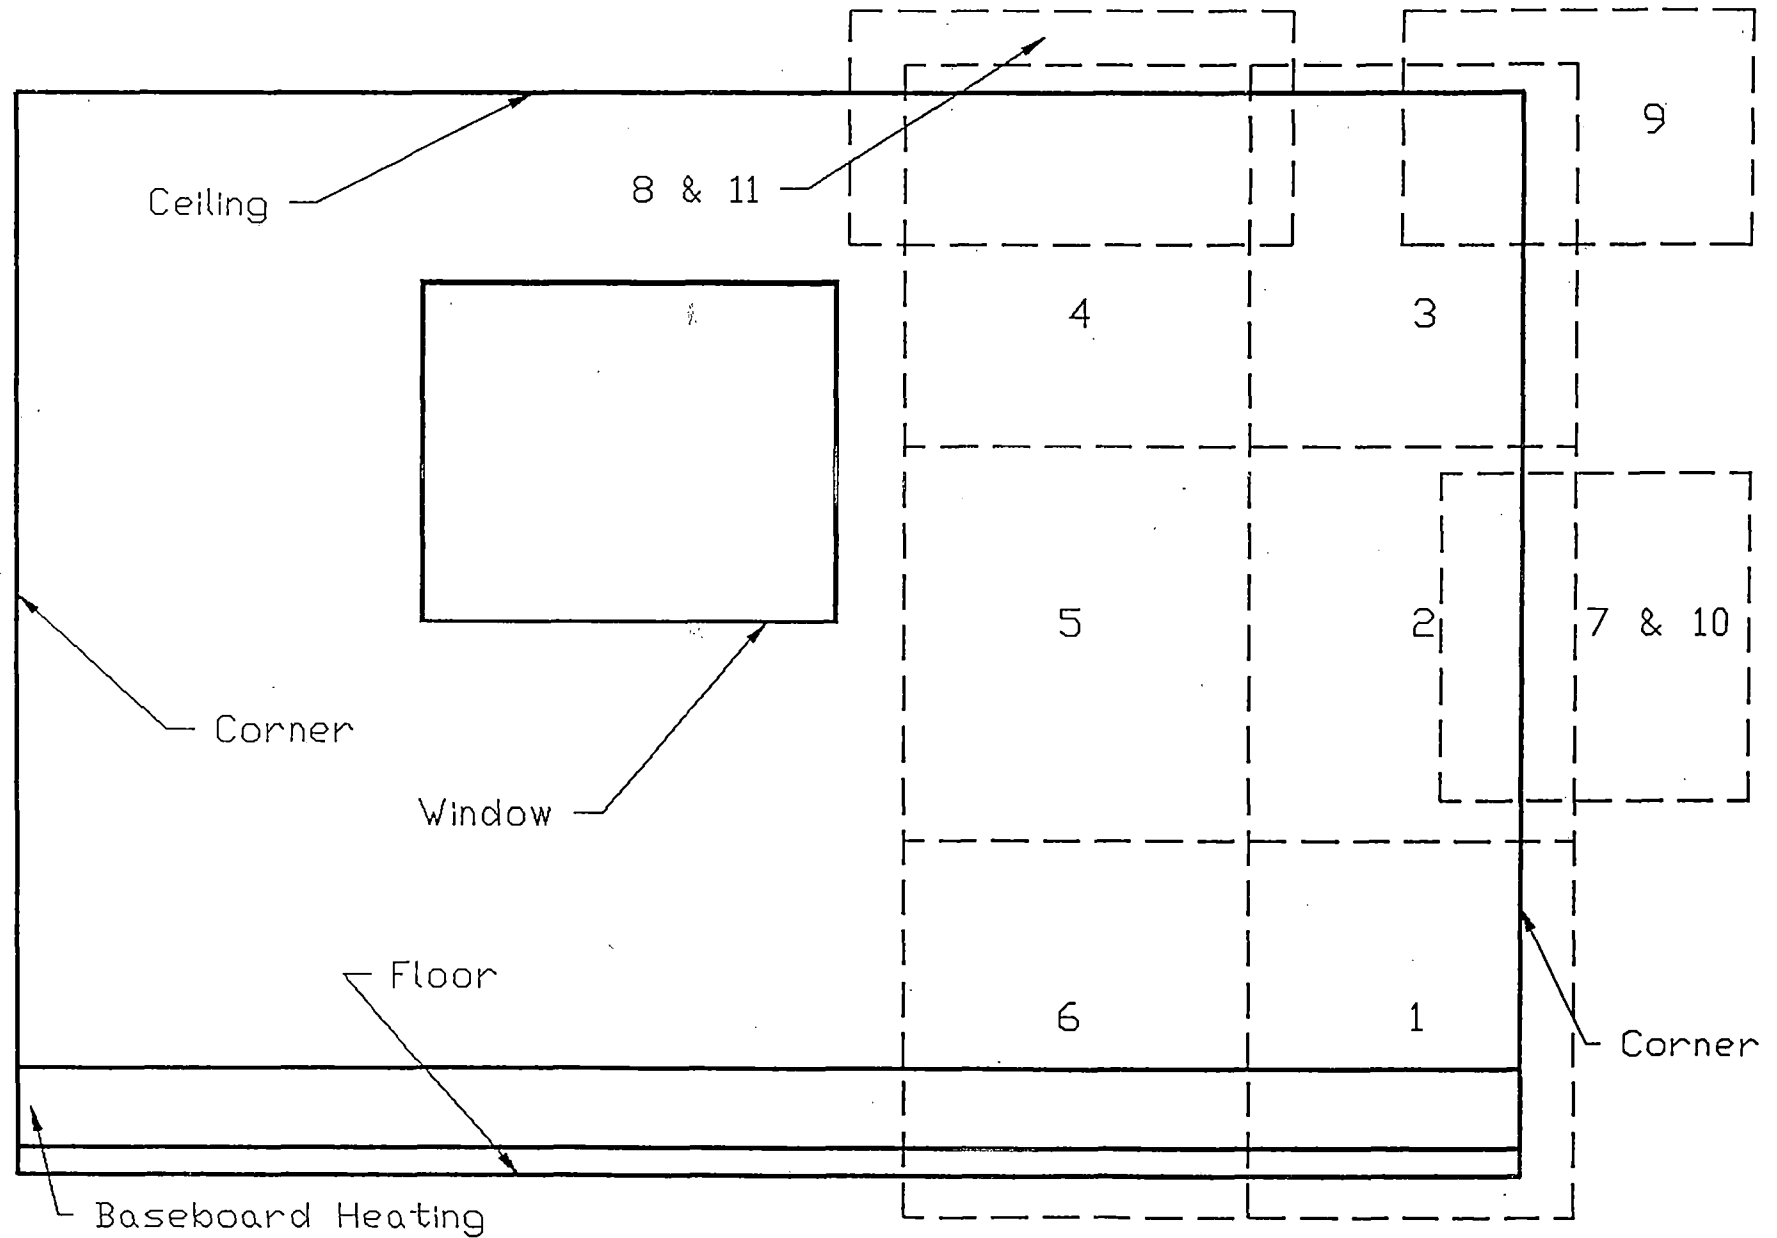
House No. 1: 1984 Nineplex Unit

The infrared thermography scan was conducted from inside the house where low lighting made for ease in viewing the black and white monitor of the scanner. From this view point, grey or black images on the monitor represented cold spots on the wall. No apparent cold spots were observed in the vicinity of the metered area on the wall section selected. One cold spot was observed on an adjacent wall in the first wall cavity from where the two walls met.

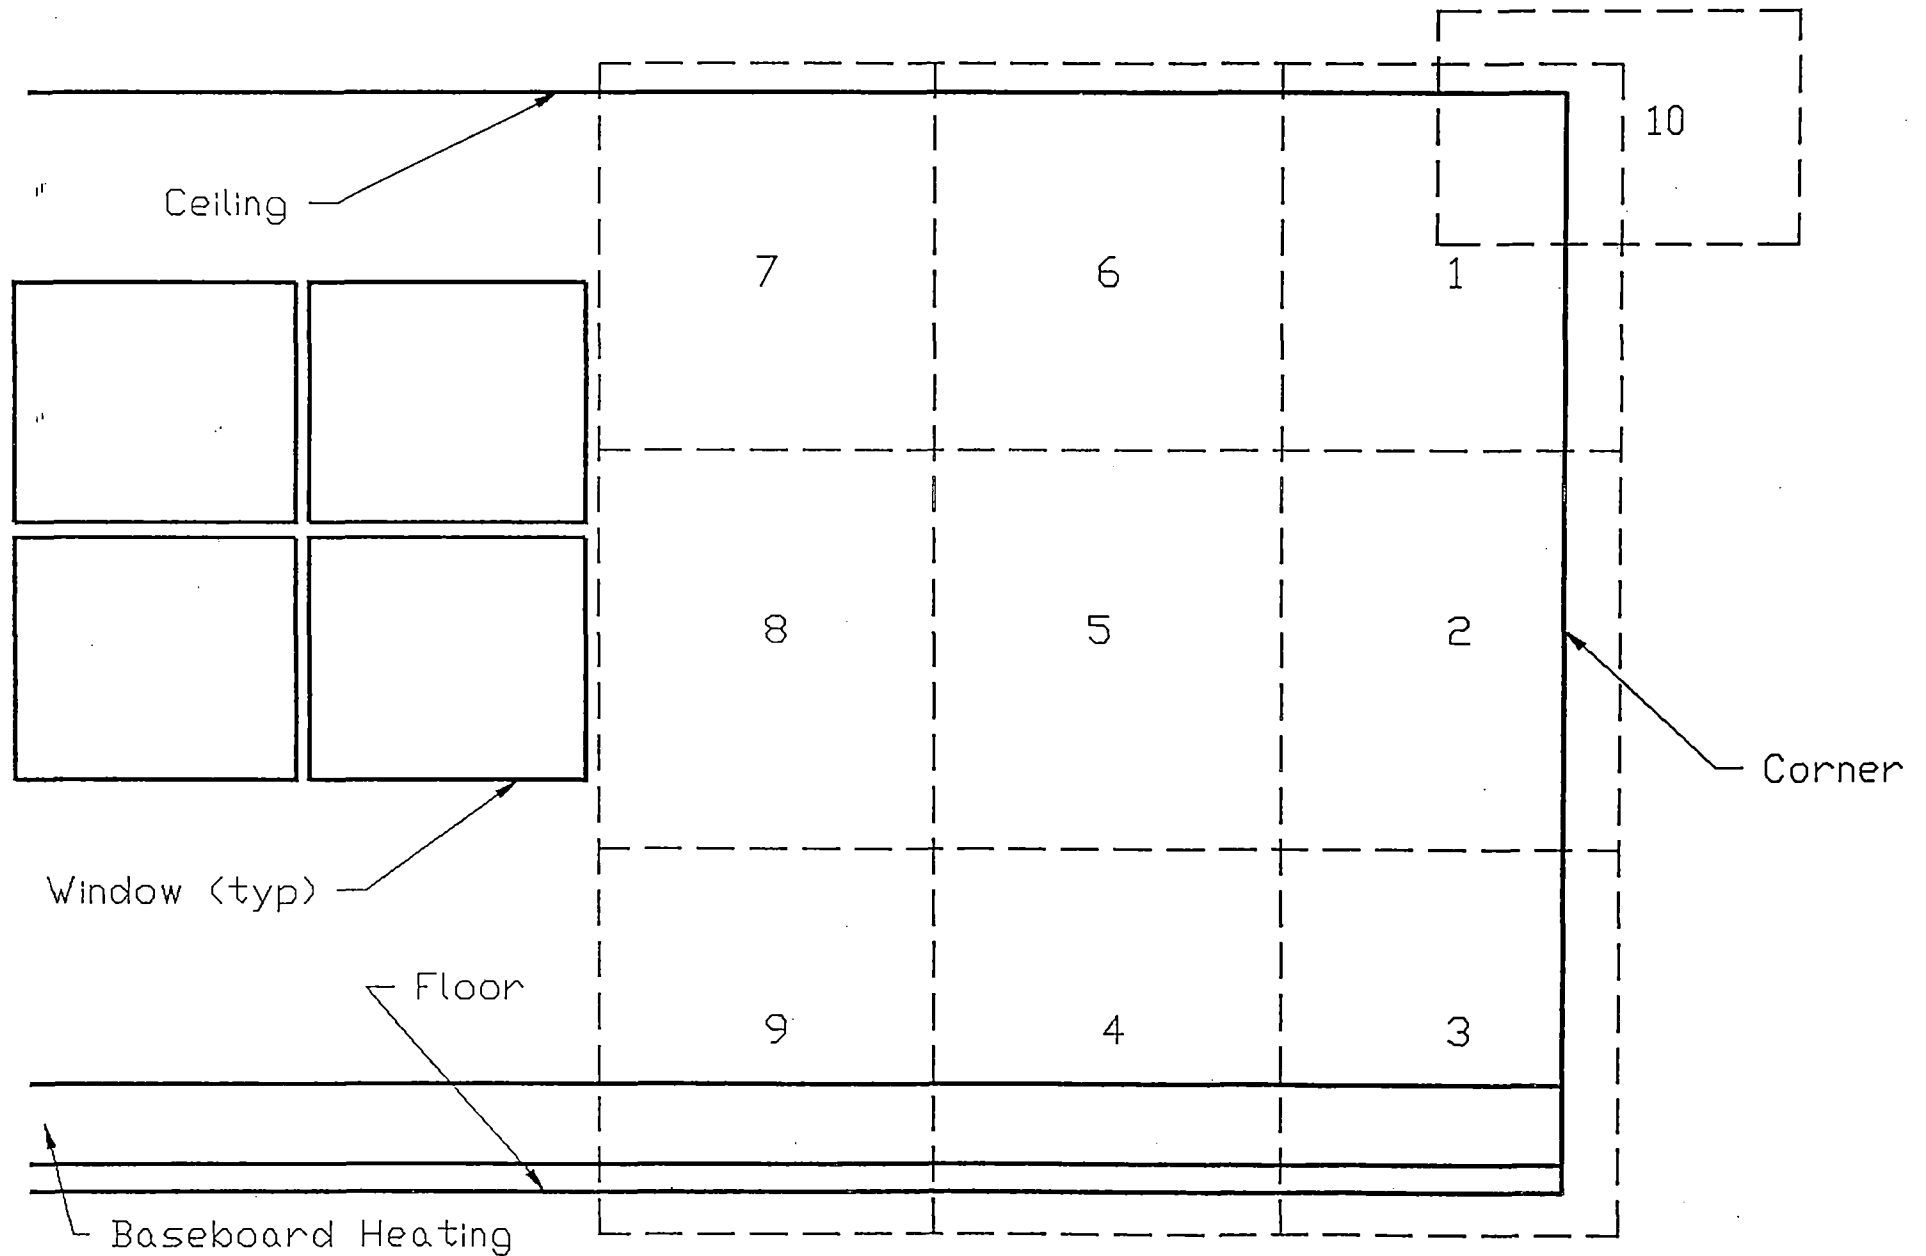
House No. 2: 1986 Duplex Unit

An infrared thermography scan of the selected wall section showed no signs of wall deterioration.

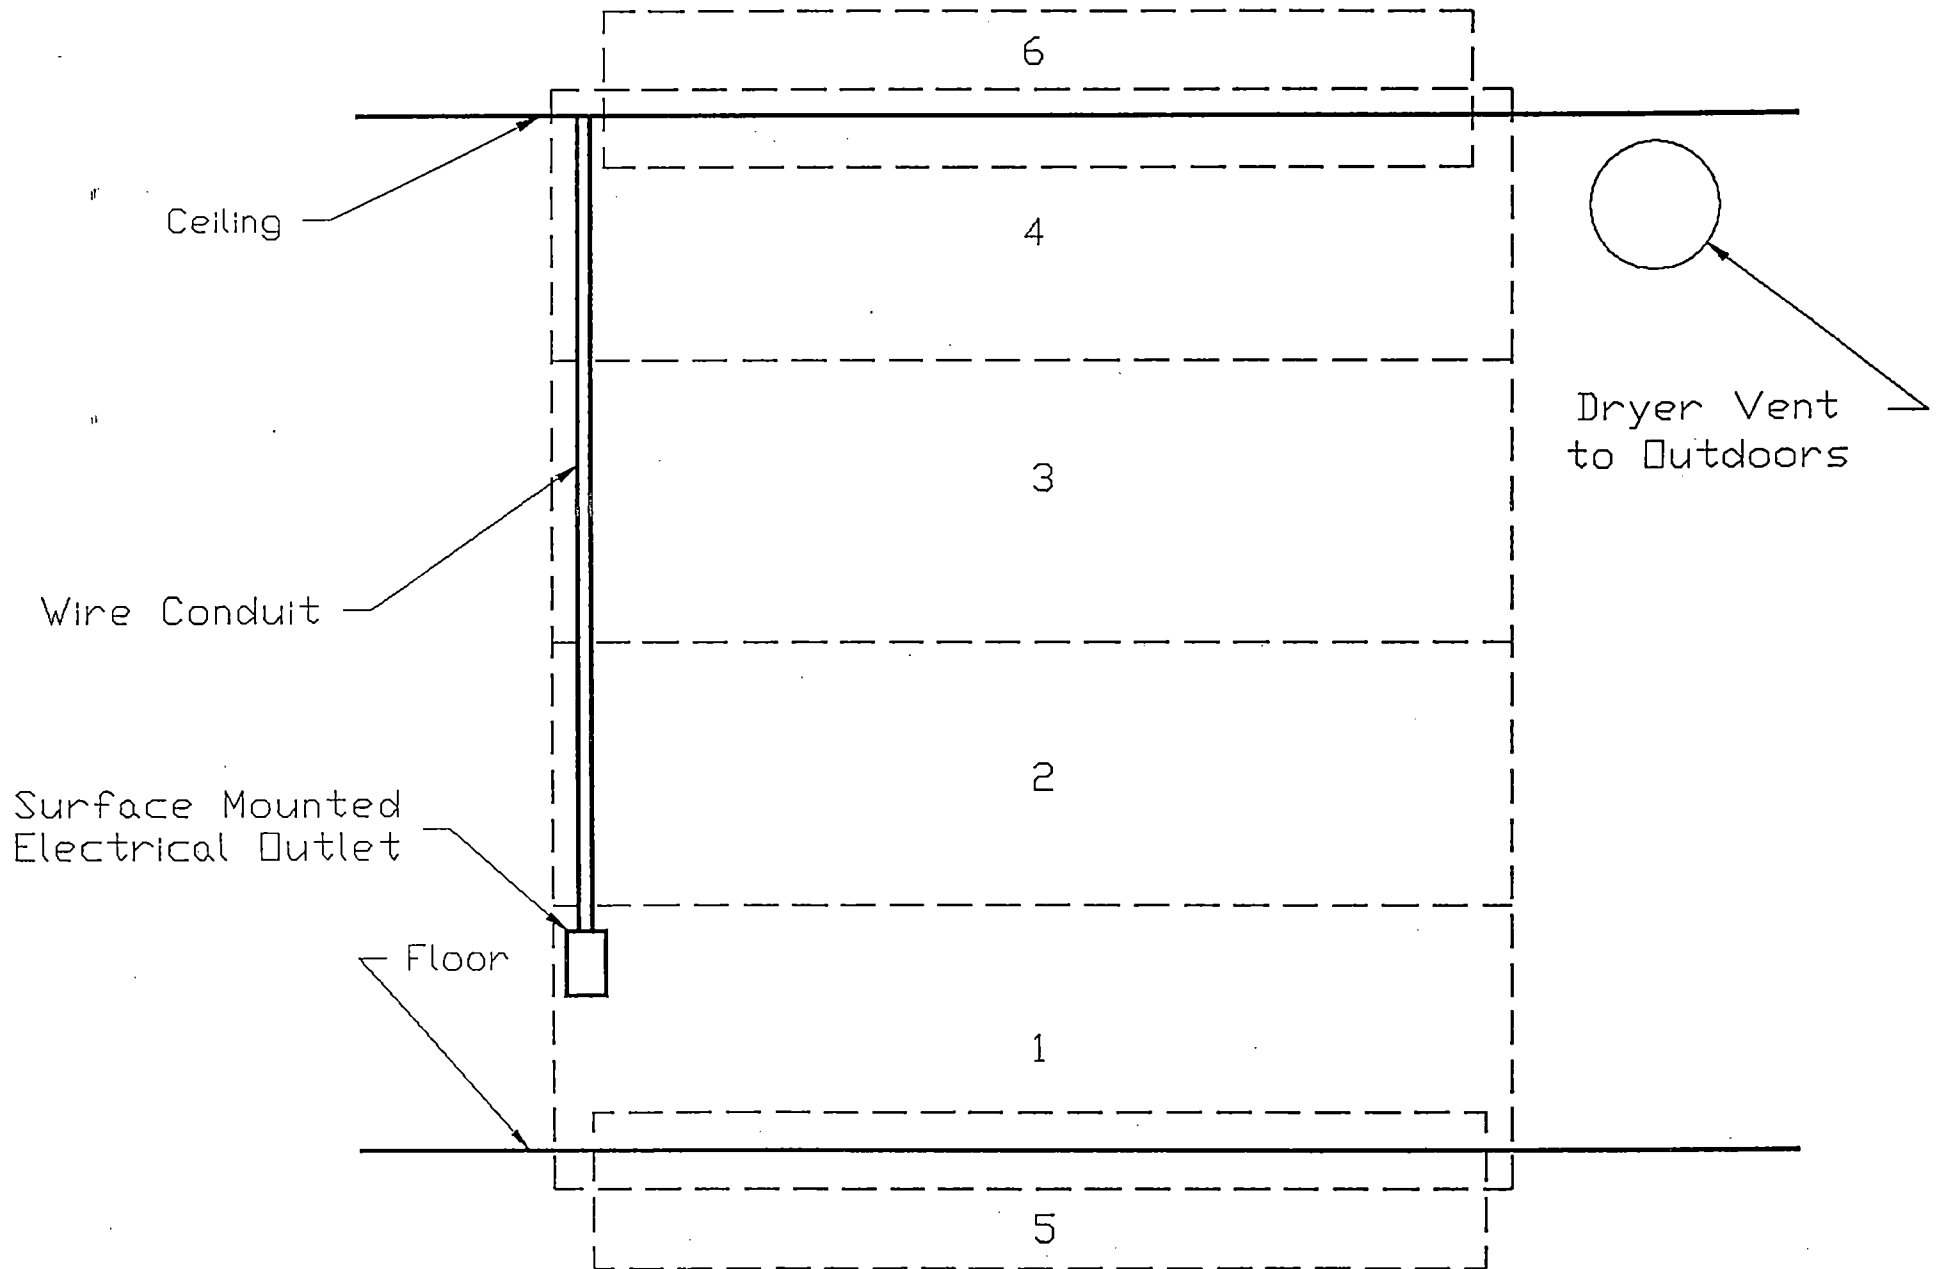
House No. 3: 1986 Retrofit Unit

Unlike the other three houses tested, the retrofit unit had a considerable amount of space on the north wall for accommodating the guarded hot box calorimeter. This was due to fewer windows and no baseboard heating on the selected wall section. The infrared thermography scan on this wall revealed several cold spots. Most were at the ceiling/wall and floor/wall interfaces. However, because the north wall was quite large an area showing essentially no cold spots was identified for locating the guarded hot box calorimeter. In this area, only the strapping behind the gypsum board wall appeared dark on the monitor of the infrared scanner.
