Assessment of the Takla Landing Contour Trench Wastewater Disposal System

A Report to:
Canada Mortgage and Housing Corporation
Environment Canada
Health & Welfare Canada
Indian & Northern Affairs Canada
Takla Lake Band

May, 1989

NovaTec Consultants Inc.
Environmental Engineers & Scientists

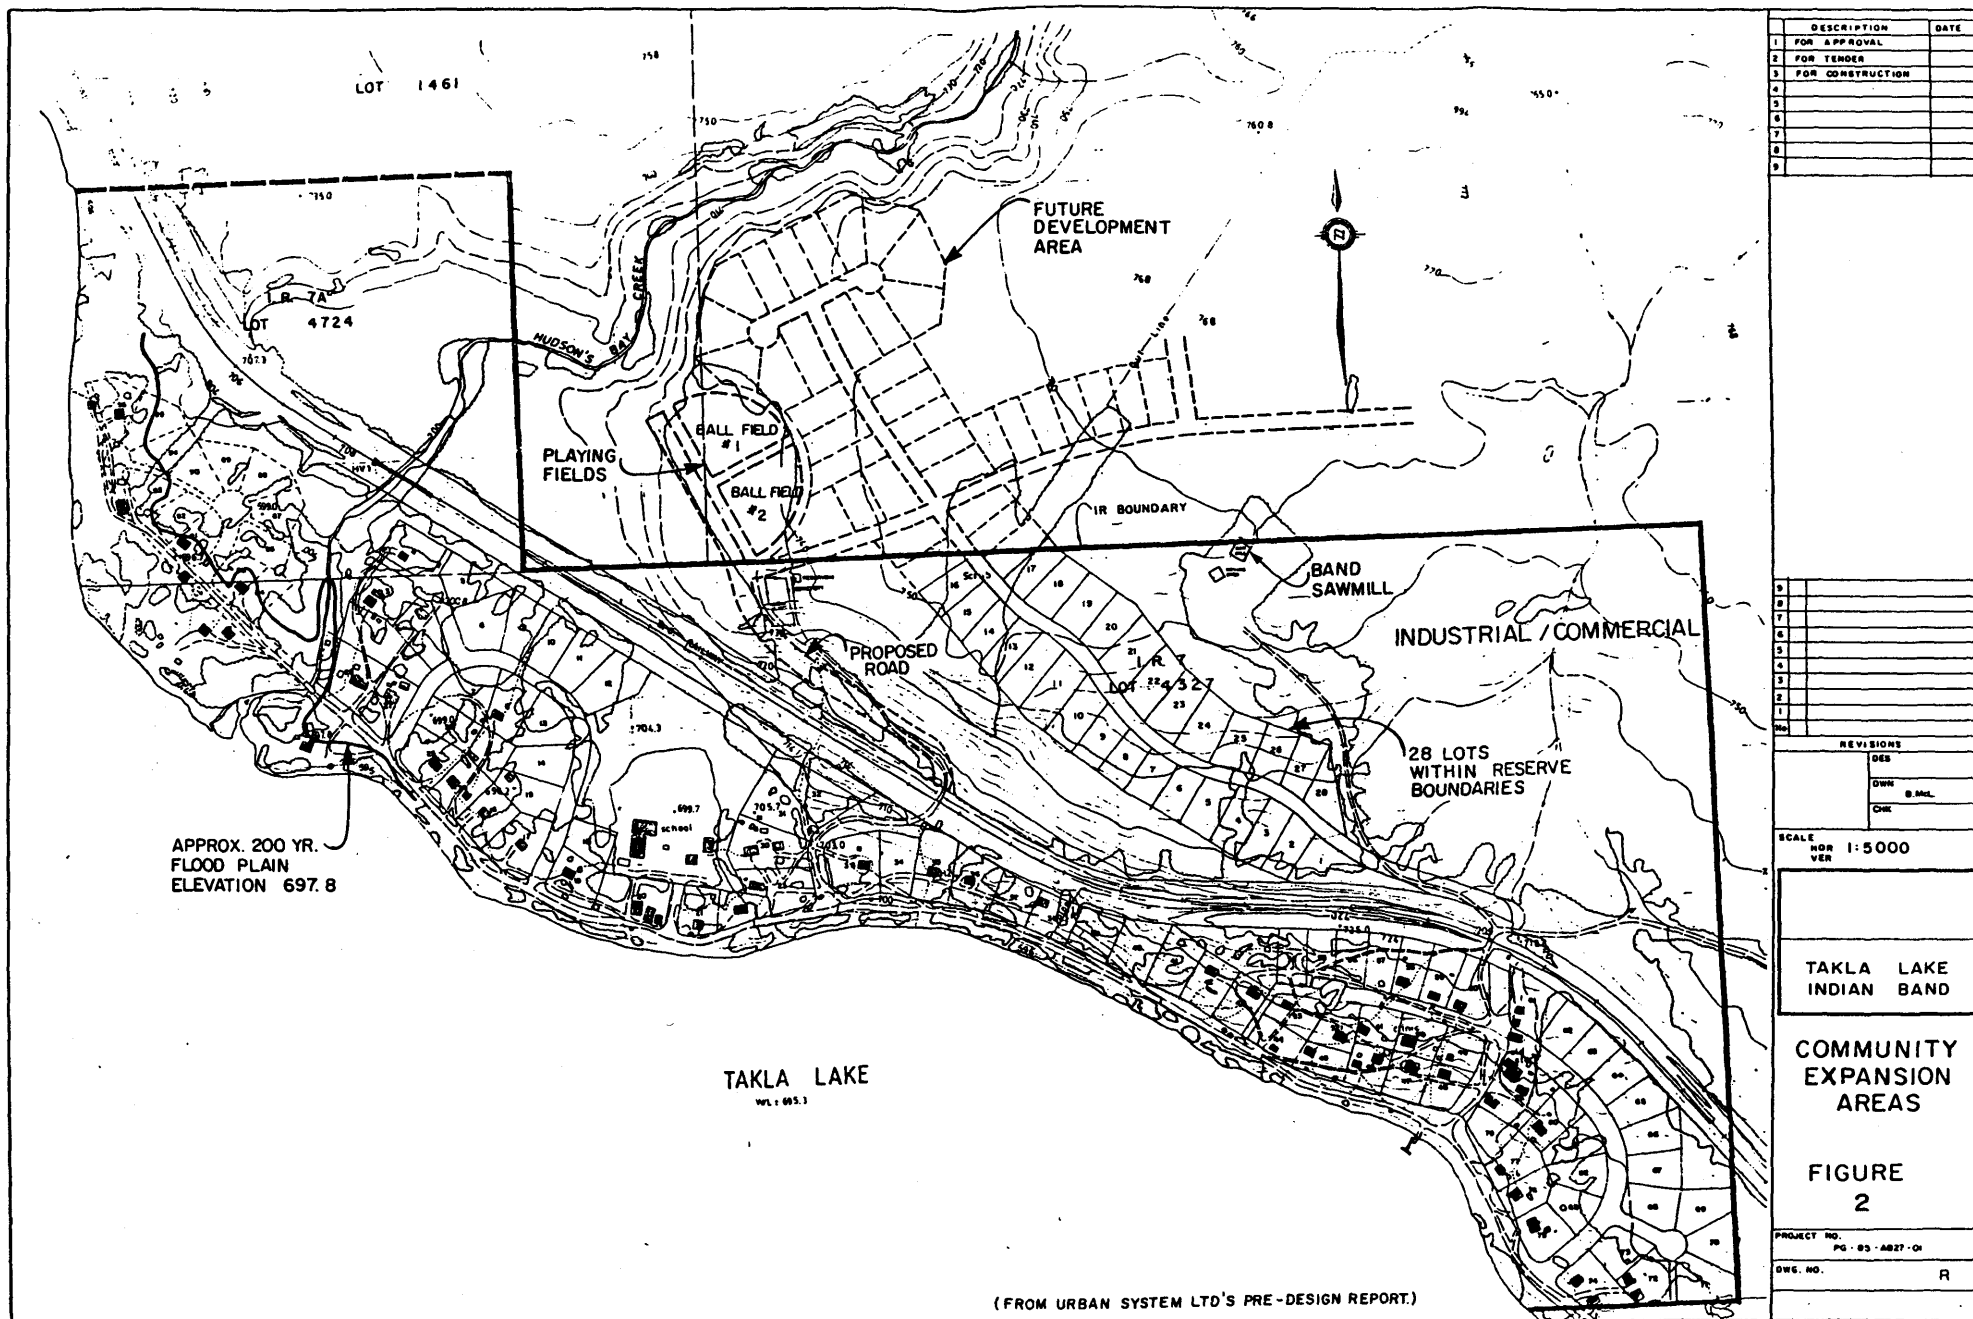
Figure 2 illustrates the overall layout of the Takla Lake community and shows the general topography and other physical features. Present developed area suitable for housing is somewhat limited, being confined by Takla Lake to the west and the B.C. Railway right-of-way to the east. The railway has not been used or maintained for a period of over 10 years.

The present population of the community is estimated to be approximately 350. As illustrated in Figure 2, the community includes about 60 houses, a school, two teacher's residences, a church, a medical clinic, and the Band Office. The majority of houses on the reserve are located south-east of Hudson's Bay Creek. Proposed development north-east of the railway includes 28 lots within the reserve boundary and additional lots and playing fields between the boundary and Hudson's Bay Creek.

(FROM URBAN SYSTEM LTD'S PRE-DESIGN REPORT.)

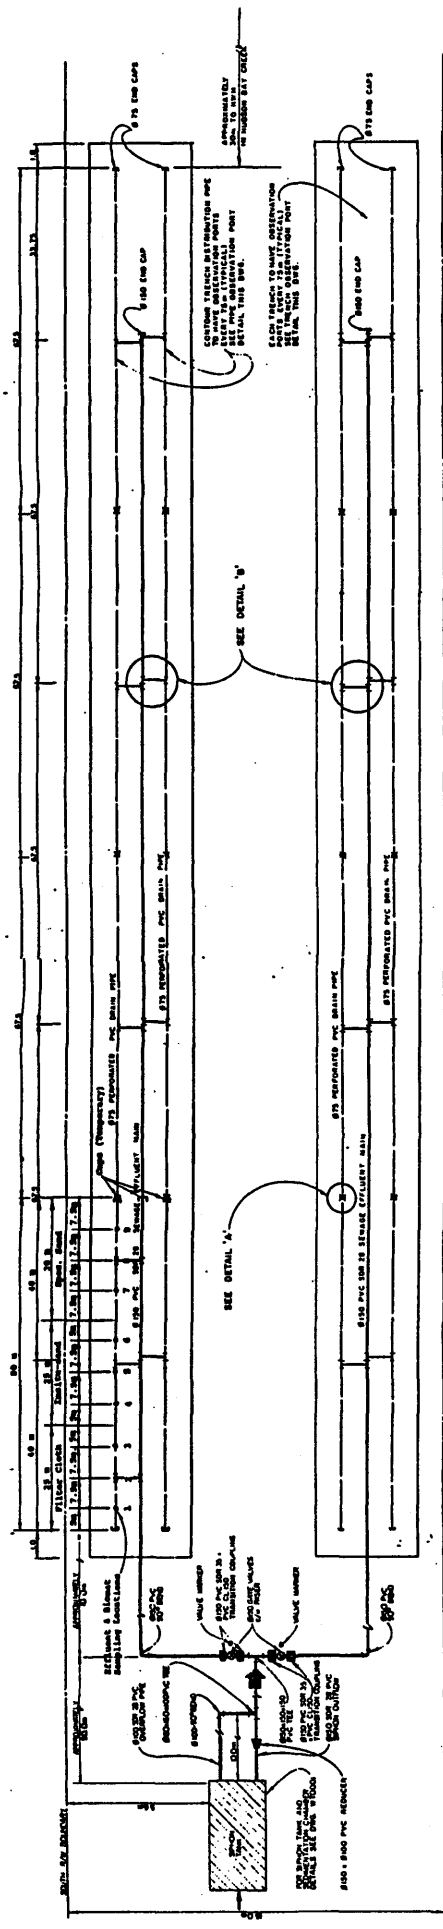
The test area consisted of an 80 m long section of one of the trenches of the Takla Landing contour trench effluent disposal

PLAN VIEW OF CONTOUR TRENCH
SHOWING TEST SECTION

field (see Figure 3). The area was subdivided into three sections of approximately equal length, each having three effluent and three biomat samplers, set out in pairs. Each of the three sections had one of the following infiltrative surface materials at the trench bottom:

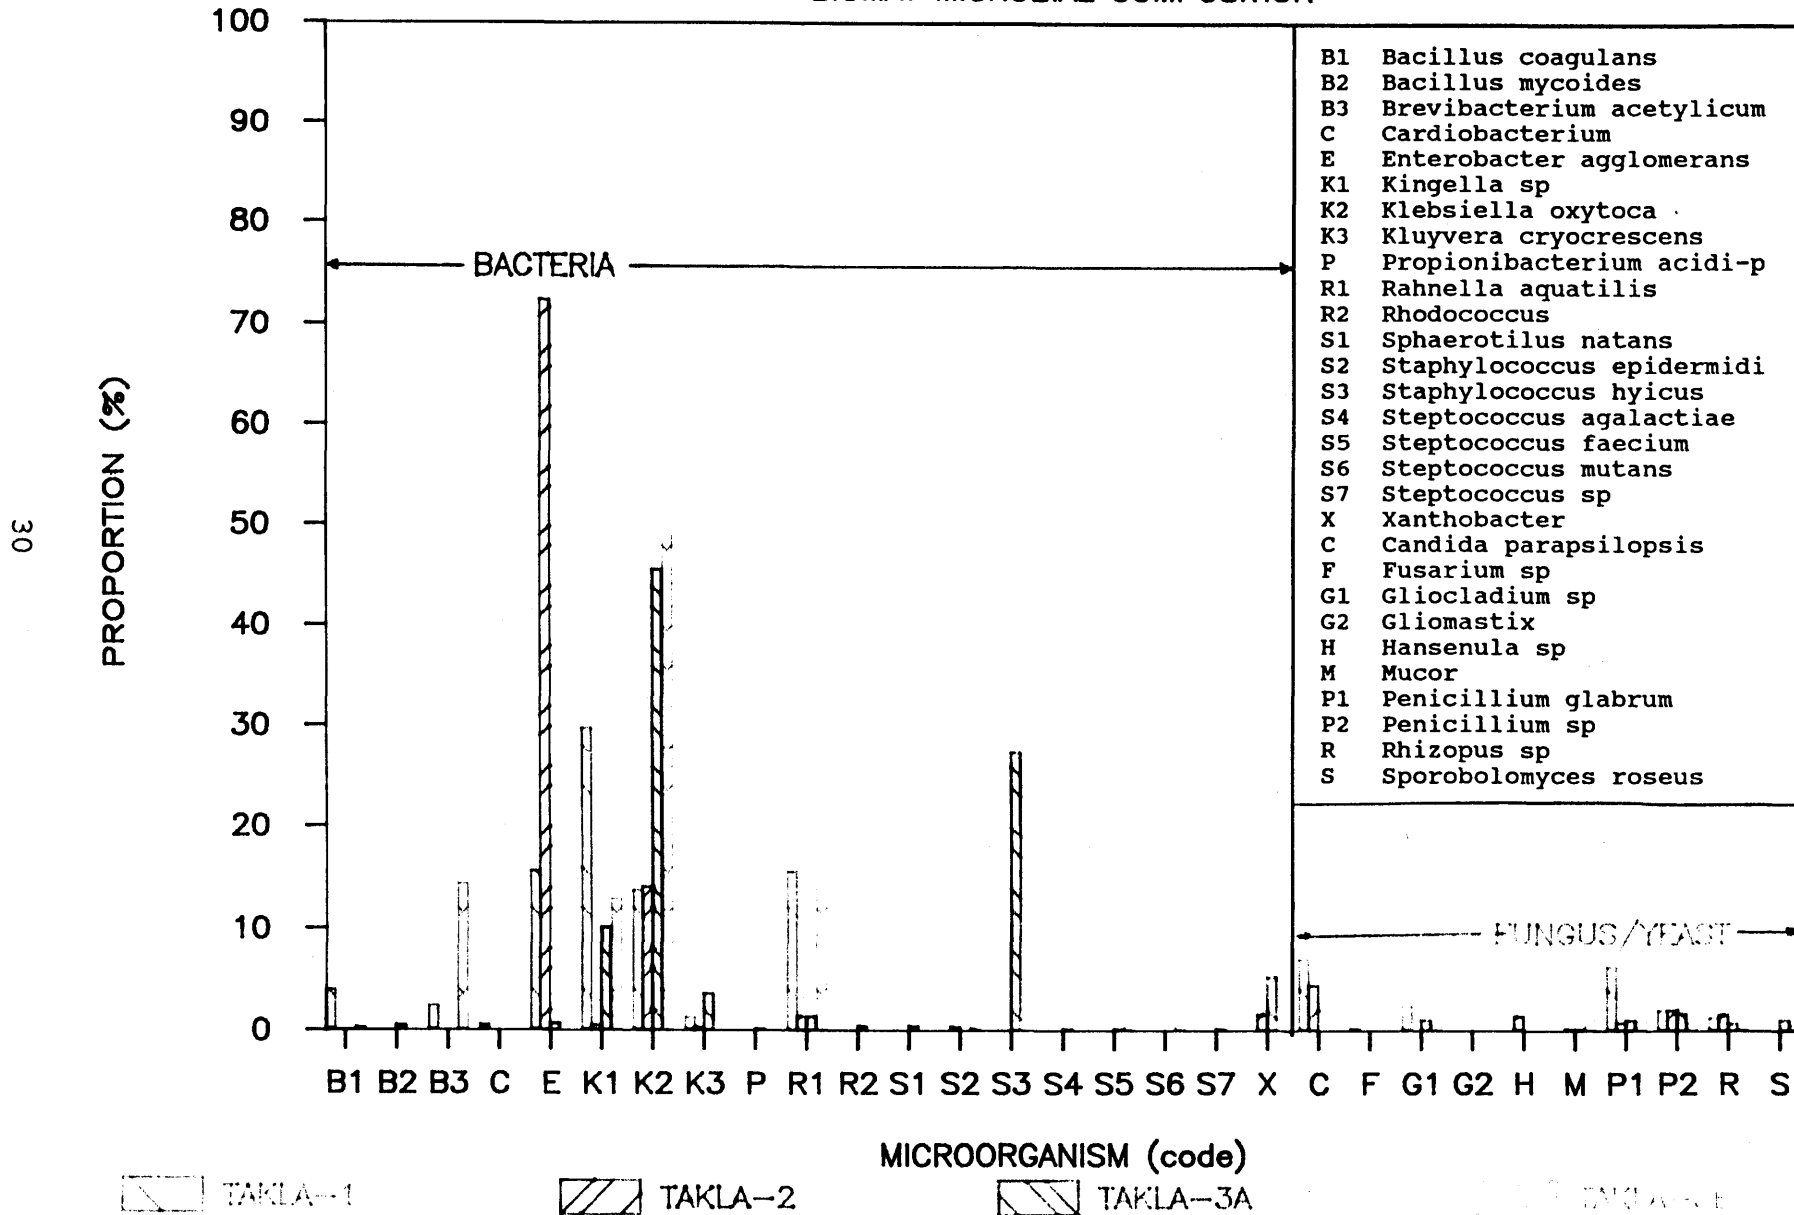
FIGURE 4

BIOMAT MICROBIAL COMPOSITION

The results from the microbial identification carried out on scrapings from the geotextile biomats taken during the March 1988 site visit are presented in Table 14. It is important to note that the organism count data (expressed as CFU/100cc) are only useful in expressing the relative number of organisms within each sample and do not provide a meaningful comparison between the number of organisms in different samples. A graphical representation of the relative numbers and types of organisms found in each sample is presented in Figures 4-6. Two scrapings were taken from Biomat Sampler No. 3 in an attempt to sample the two distinct layers. These are reported as 3 (A) and 3(B).

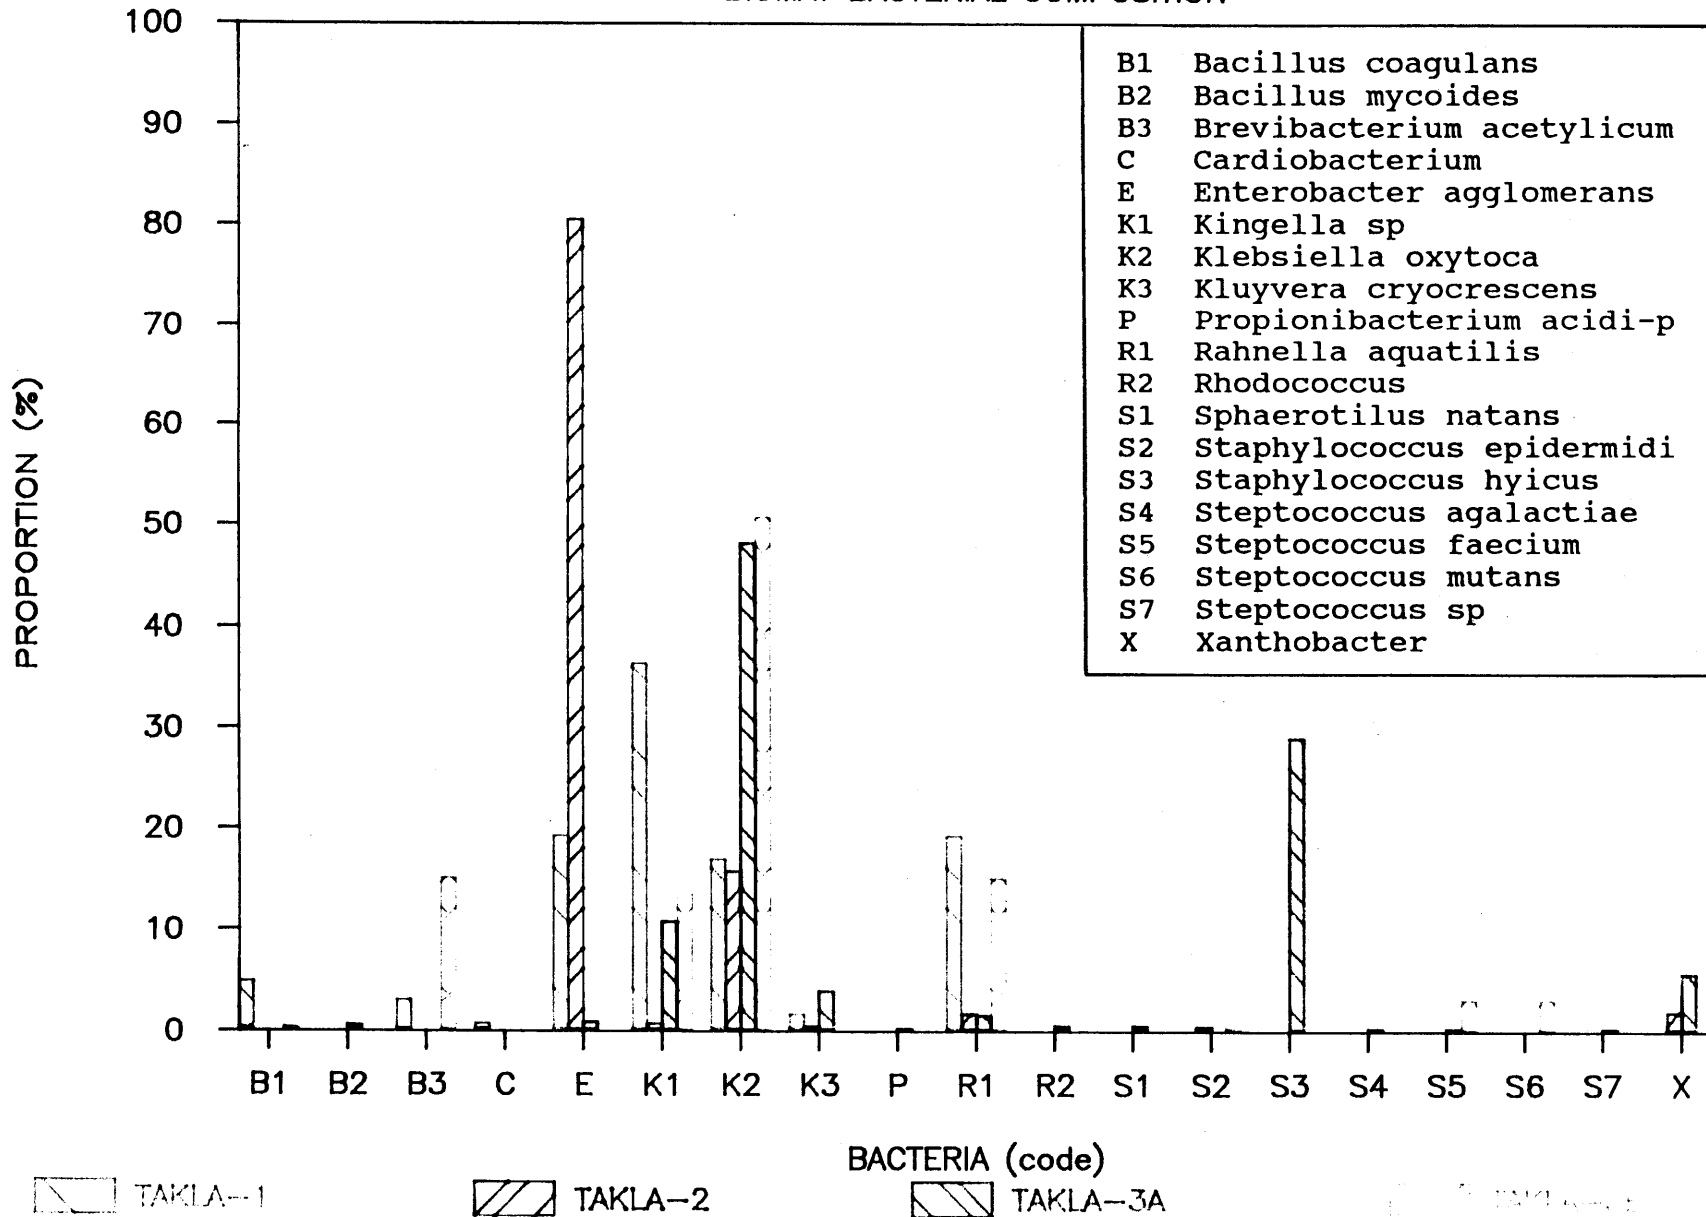
FIGURE 5

BIOMAT BACTERIAL COMPOSITION

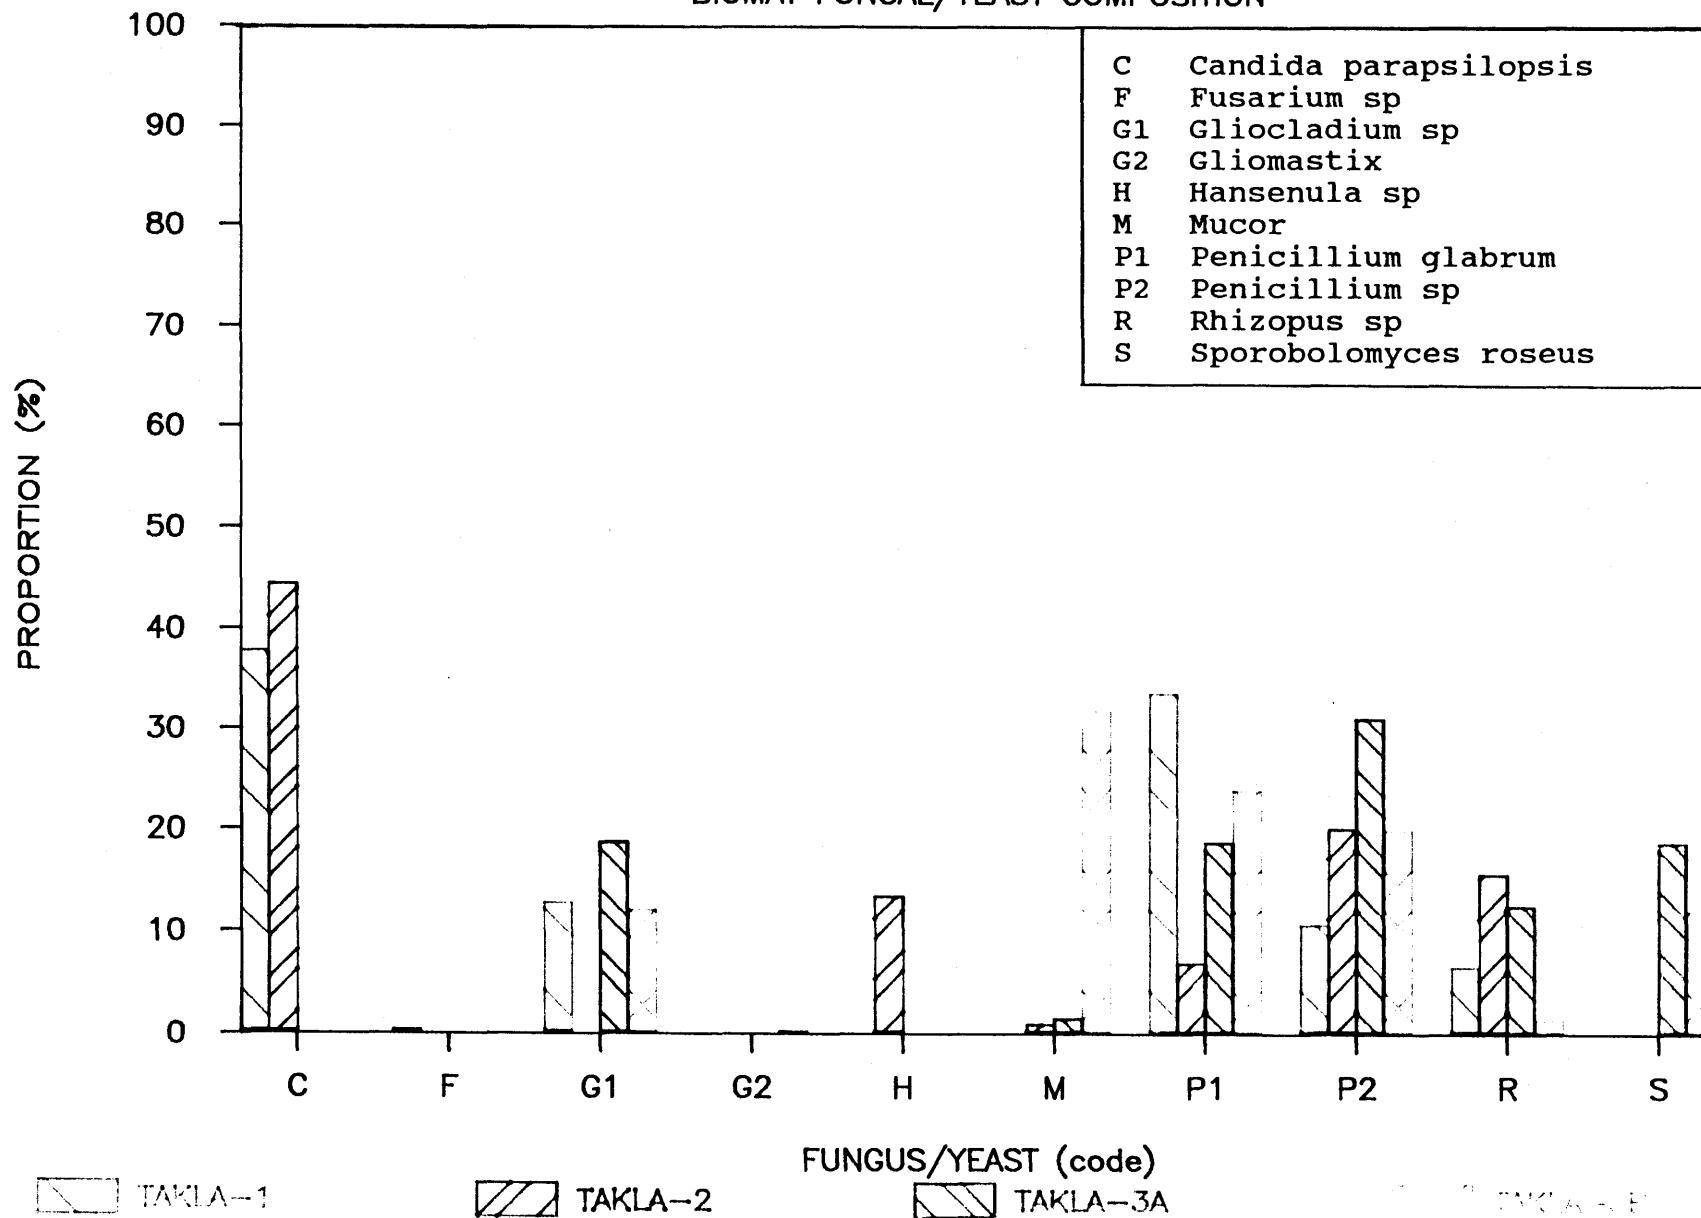
FIGURE 6

BIOMAT FUNGAL/YEAST COMPOSITION

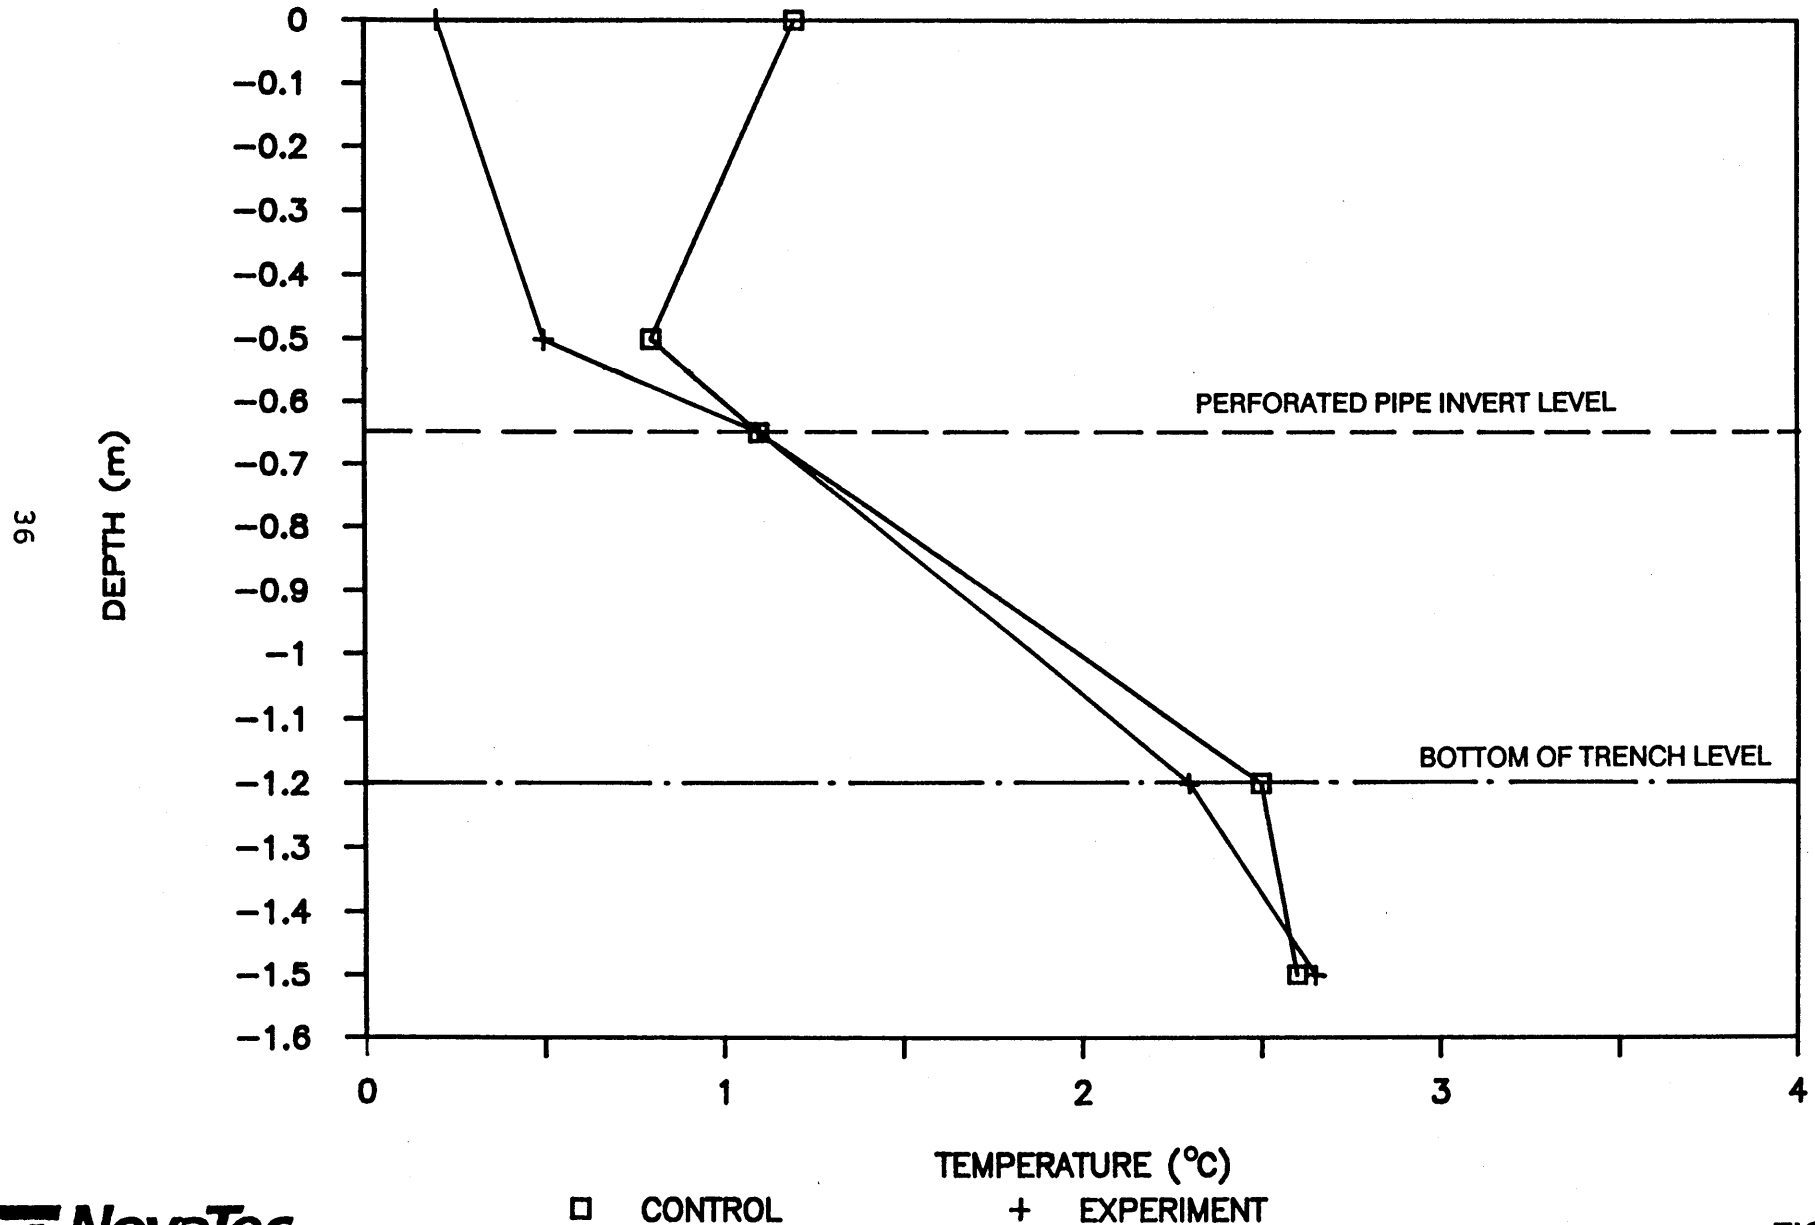
GROUND TEMPERATURE PROFILES: MARCH 1988

At the time of the site visit, the frost penetration at Takla Landing was estimated to be 1.5 m and it was not possible to retrieve the biomat samplers as the PVC pipe monitoring ports had contracted tight around the insulating plugs with the cold temperature, and the plugs could not be removed. Background and trench ground temperature profiles were taken.

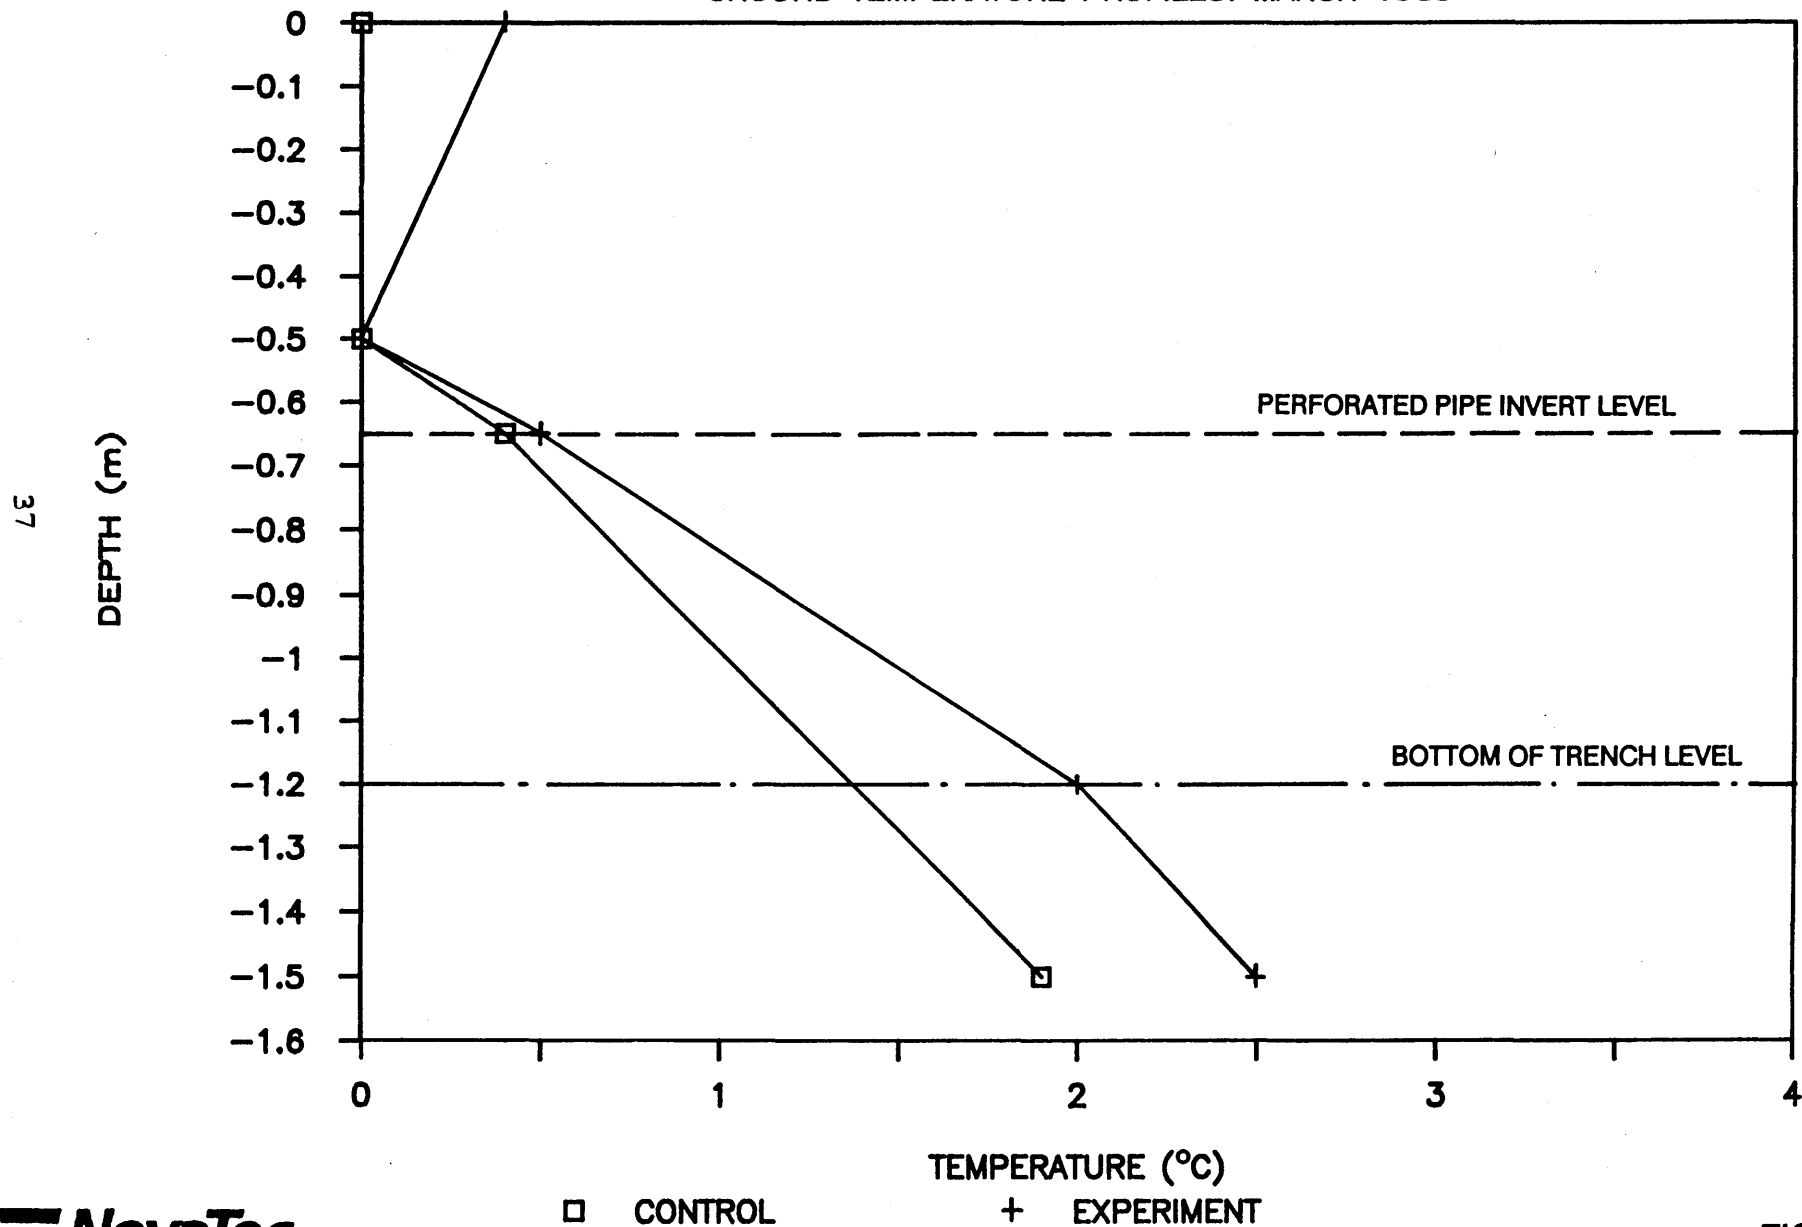
and these are presented in Figure 8. The profiles are not substantially different at the greater depths, with some variation occurring at the ground level and 0.5 m depth. The ground level temperature variation is not considered to be of any significance as the thermistor arrays were placed inside protective boxes and the recorded temperature was largely a function of instantaneous site conditions at the time of measurement.

The winter conditions in 1988/89 were more severe than in 1987/88. As a result of prolonged temperatures below -20°C , the site visit was postponed until late March. The 0°C ground temperature at 0.5 m depth at both locations was probably a result of the prolonged intense cold.

GROUND TEMPERATURE PROFILES: MARCH 1989

- 6) The depths of the perforated disposal pipe and the trench bottom (0.65 m and 1.2 m, respectively) were sufficient to prevent severe freezing under prolonged extreme cold temperature conditions.

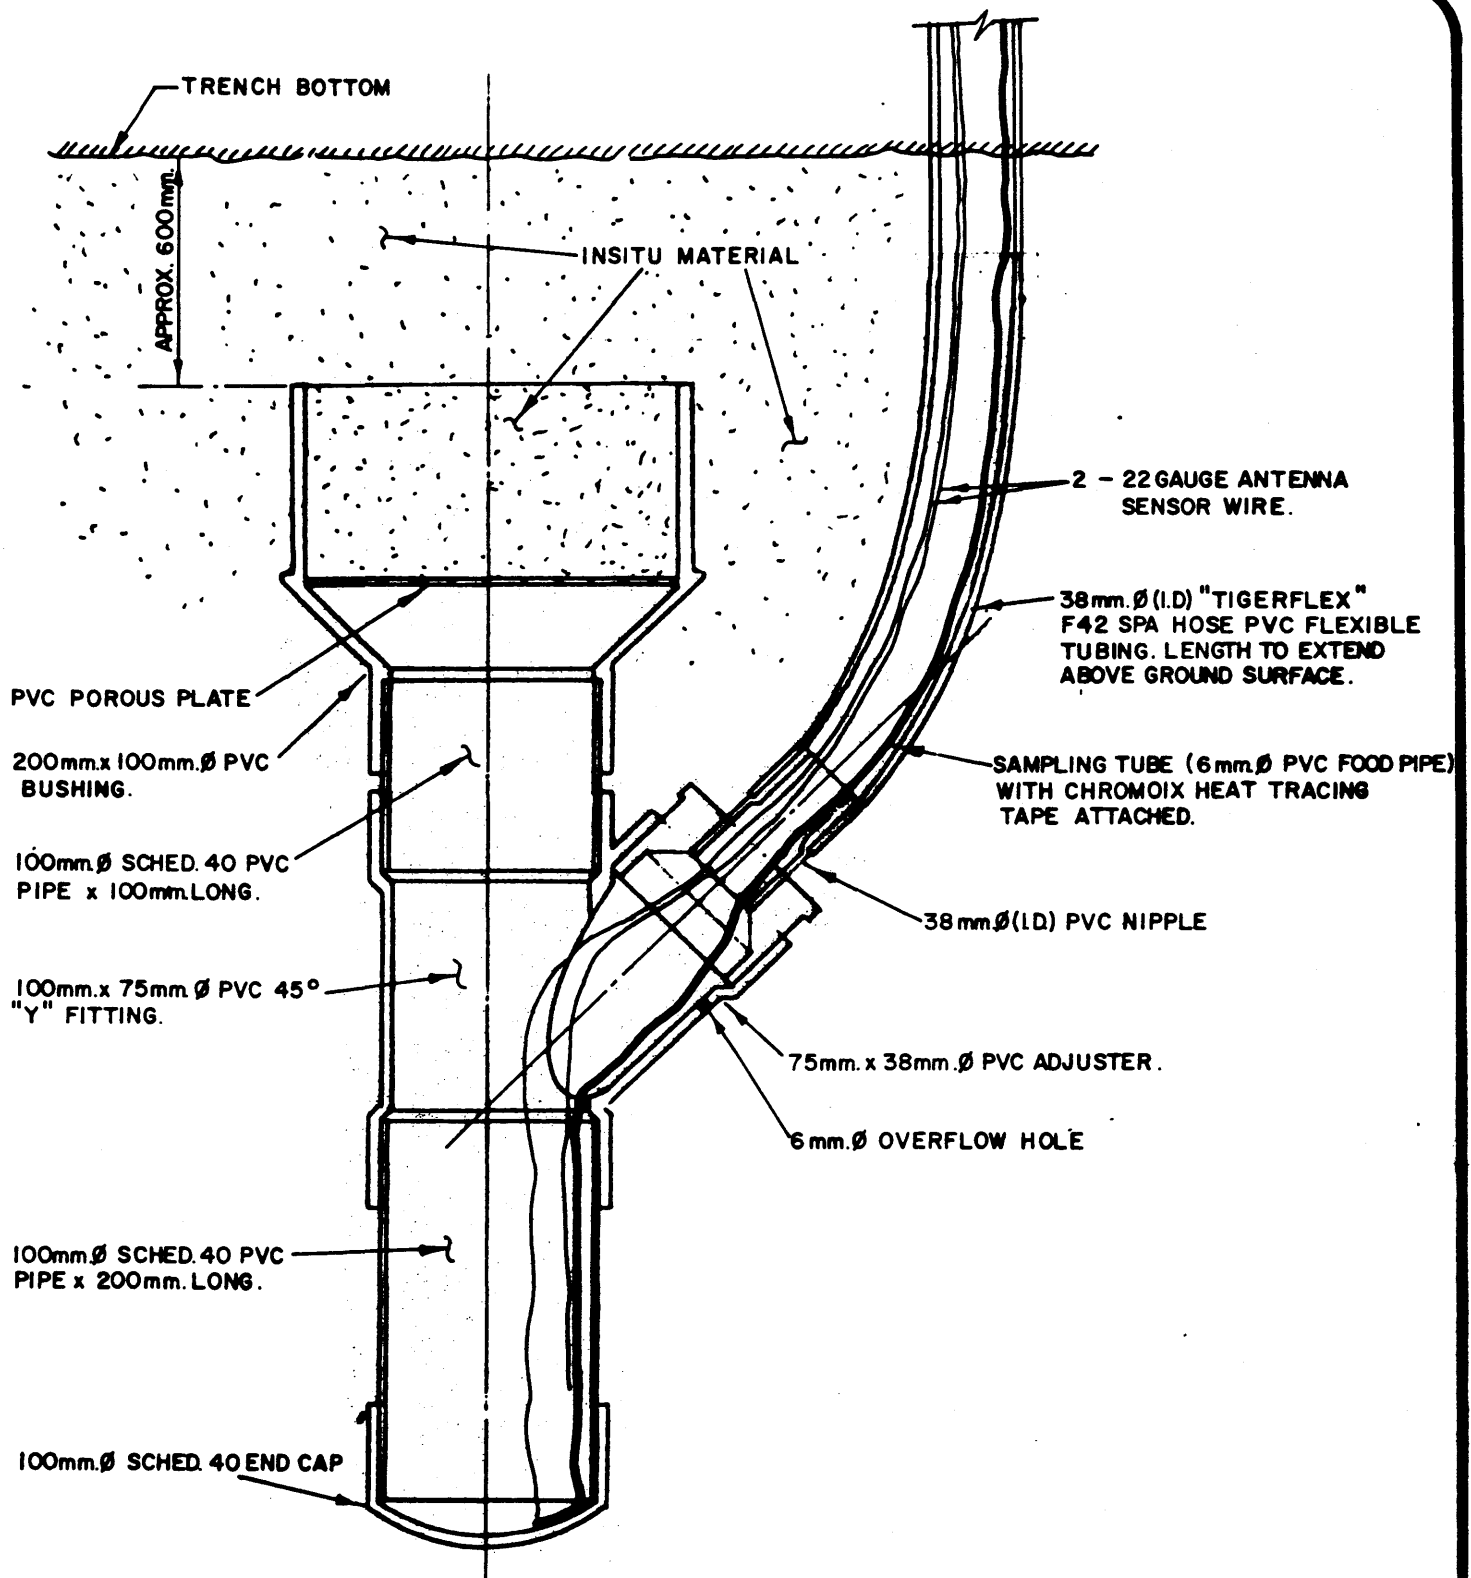
**FULLY EQUIPPED EFFLUENT
SAMPLER**

The effluent samplers were to provide the capability of comparing the effect of the three biomat formation media on micro-organism and nutrient concentrations in the effluent. Three effluent samplers were installed directly underneath each of the three infiltrative surface media. A length of 38 mm PVC flexible tubing, containing a 6 mm PVC sampling tube, connected the sample chamber to the ground surface. By connecting the sampling tube to a vacuum flask and pump, the sample chamber was drained during visits by the project team. Each sample chamber was fitted with an overflow pipe that limited the storage capacity of the chamber to approximately 2 L. This modification of the original sampler design ensured that a sample taken at any time during the

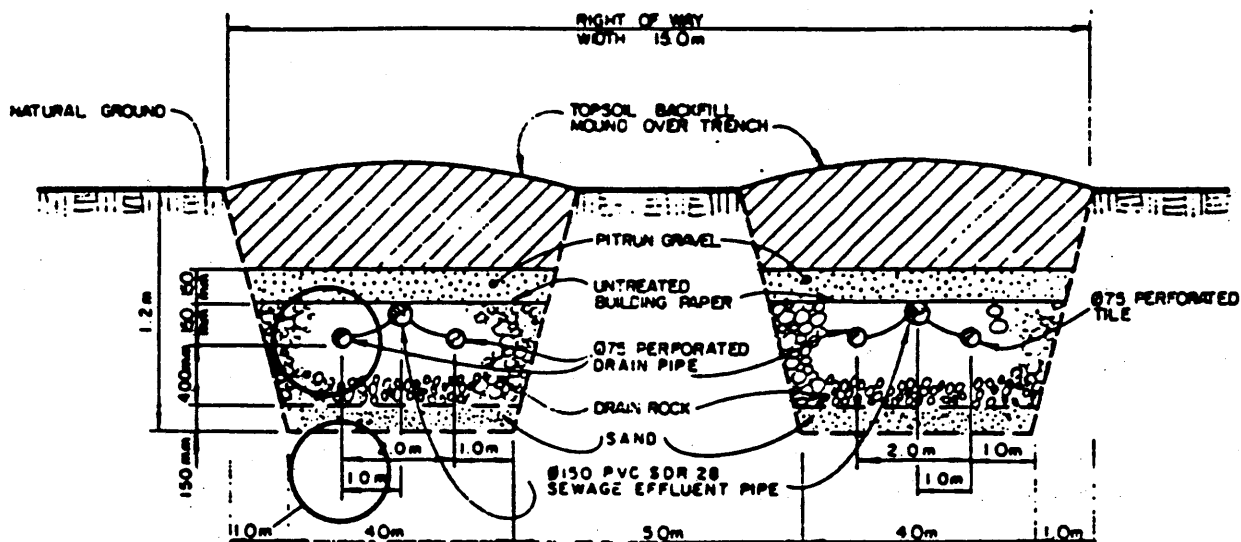
CROSS SECTION OF CONTOUR TRENCH

(AS DESIGNED BY URBAN SYSTEMS LTD.)

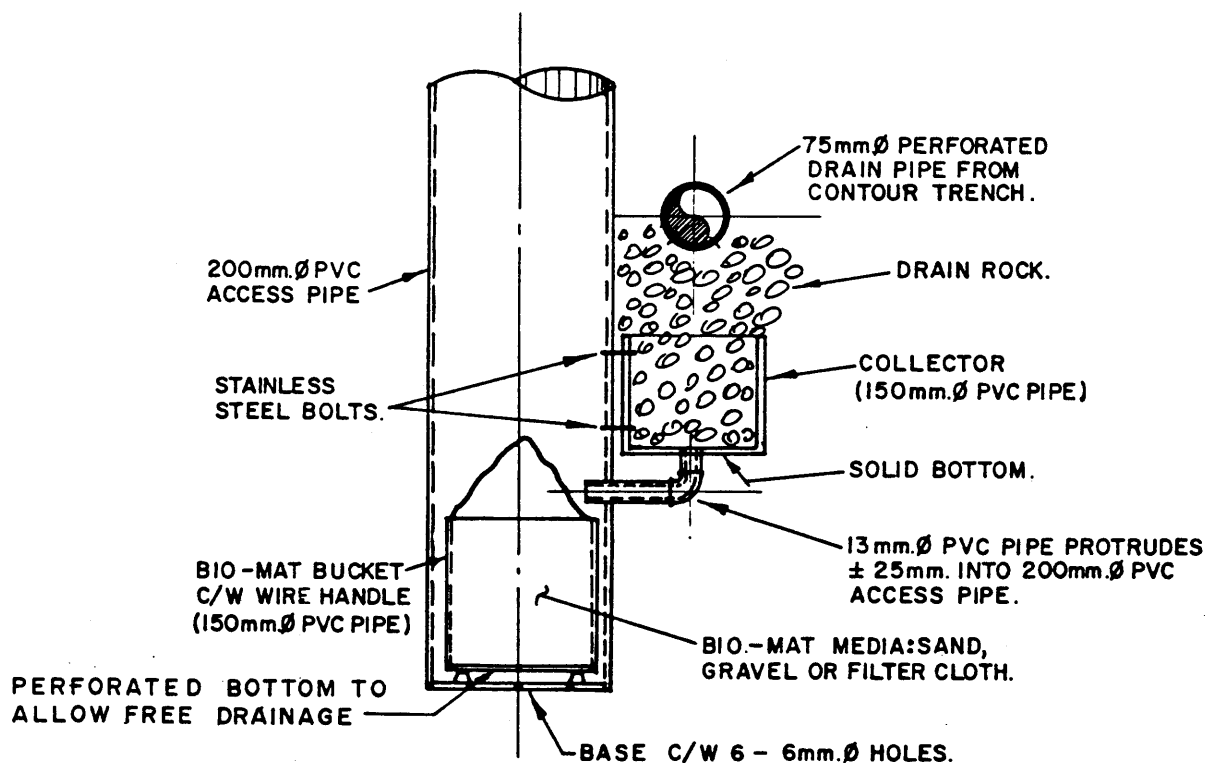
BIO - MAT SAMPLER

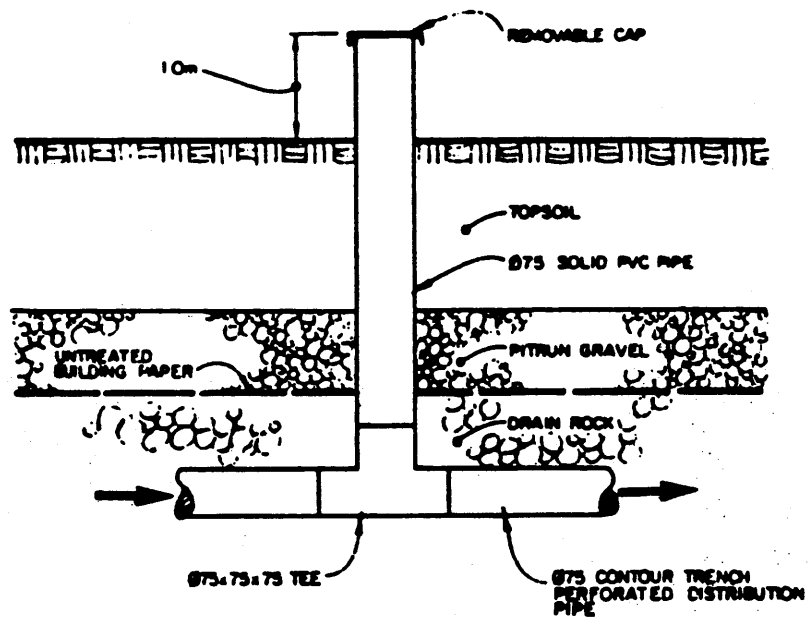
PIPE OBSERVATION PORT DETAIL

NOT TO SCALE (AS DESIGNED BY URBAN SYSTEMS LTD.)

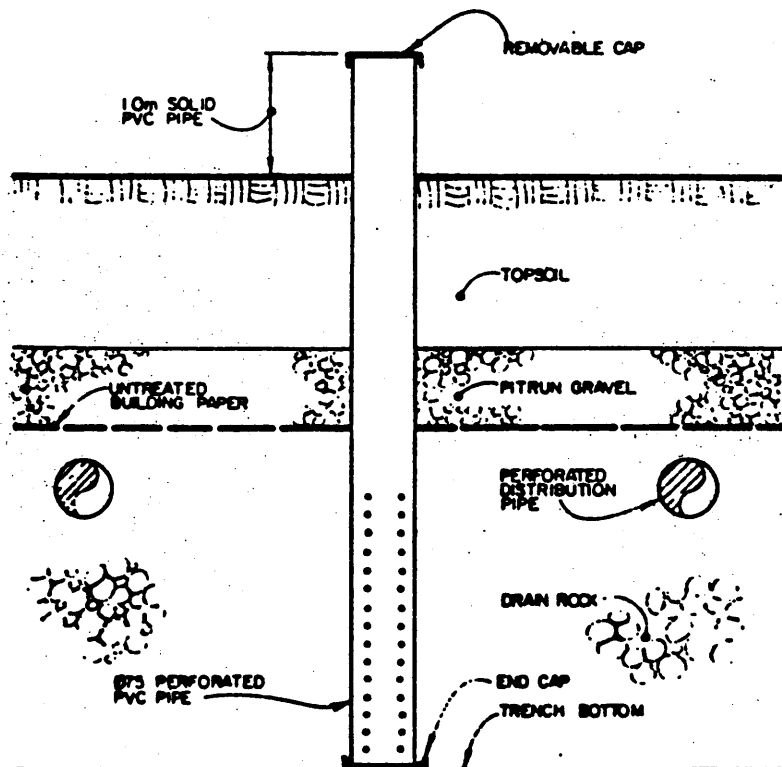
TRENCH OBSERVATION PORT DETAIL

NOT TO SCALE (AS DESIGNED BY URBAN SYSTEMS LTD.)

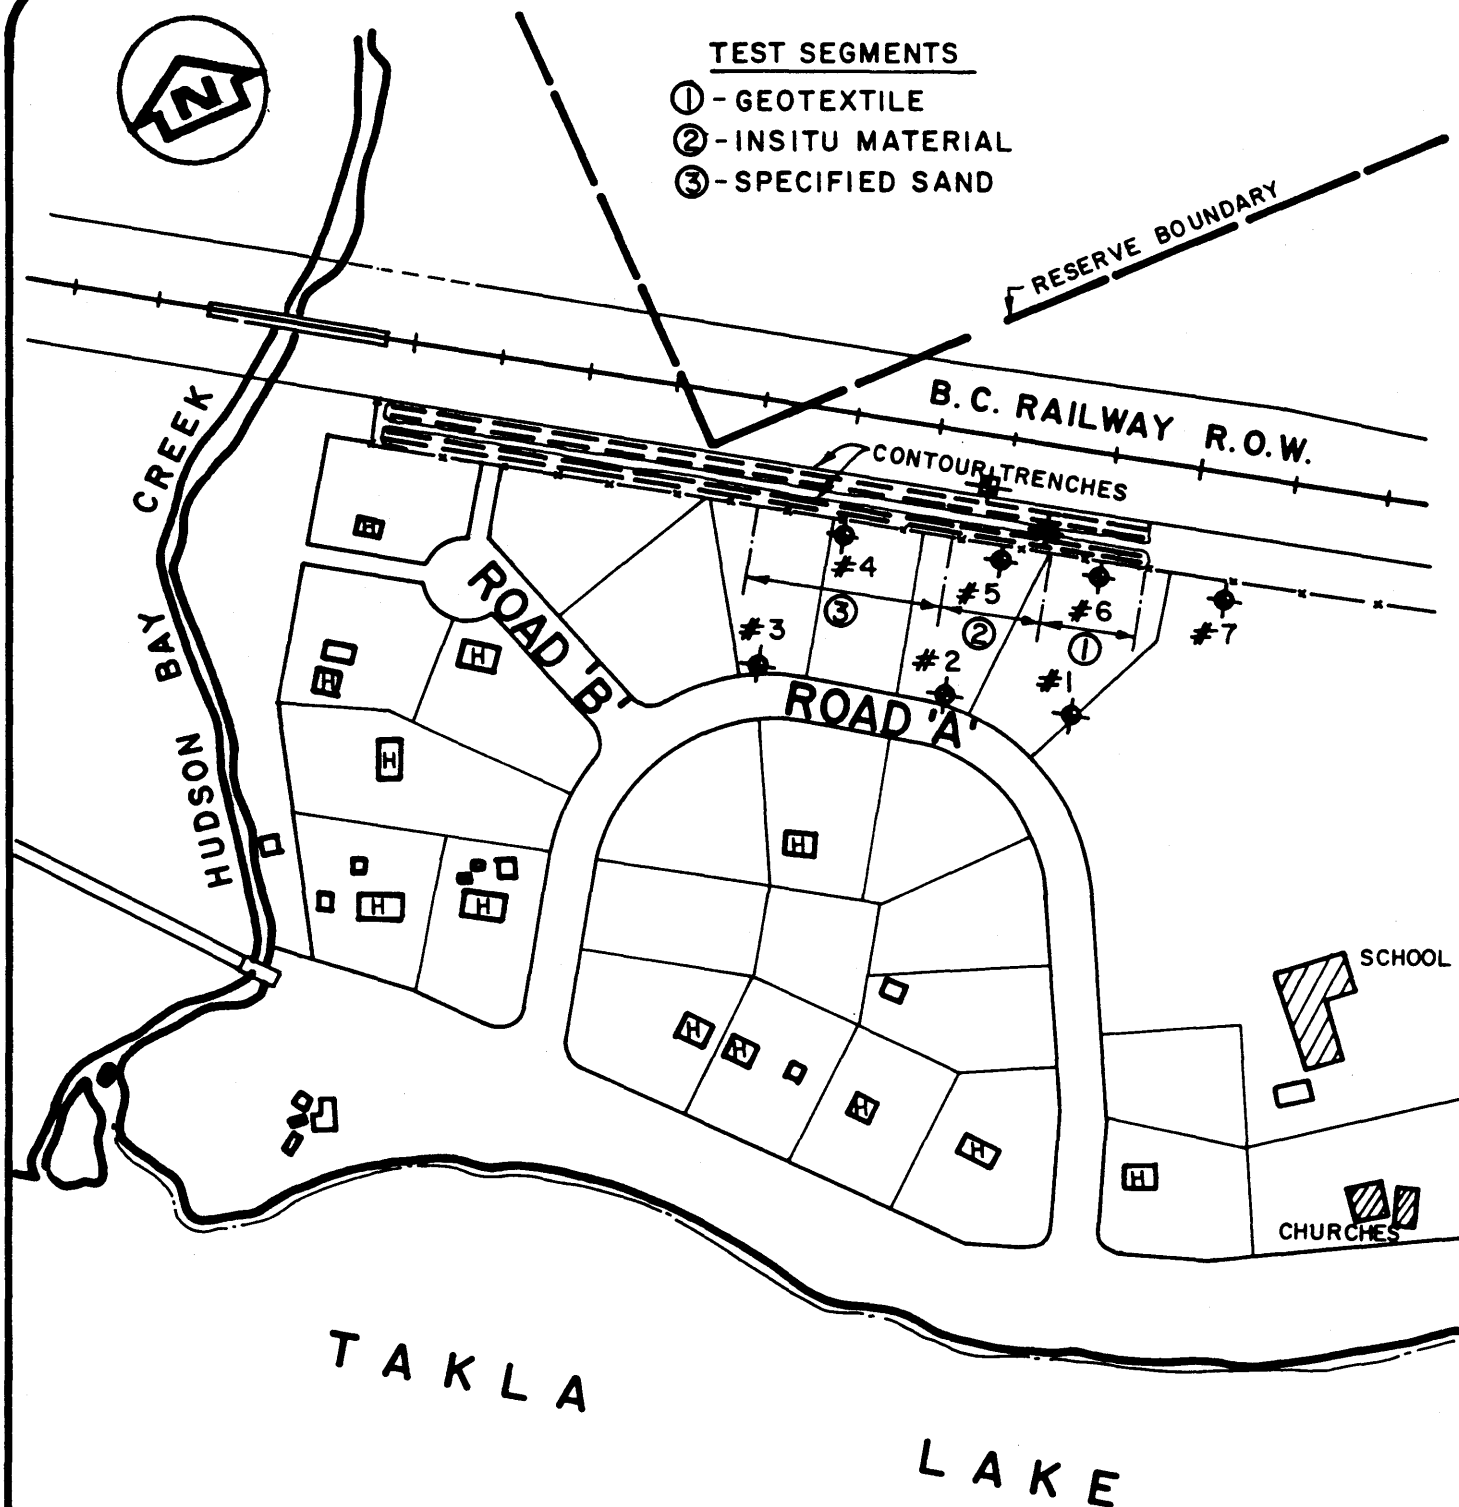
TEST SEGMENTS

- ① - GEOTEXTILE
- ② - INSITU MATERIAL
- ③ - SPECIFIED SAND
